Investigation and Assessment of Colored Concrete Pavement

Minnesota
Department of
Transportation

August 2014

Research Project
Final Report 2014-26

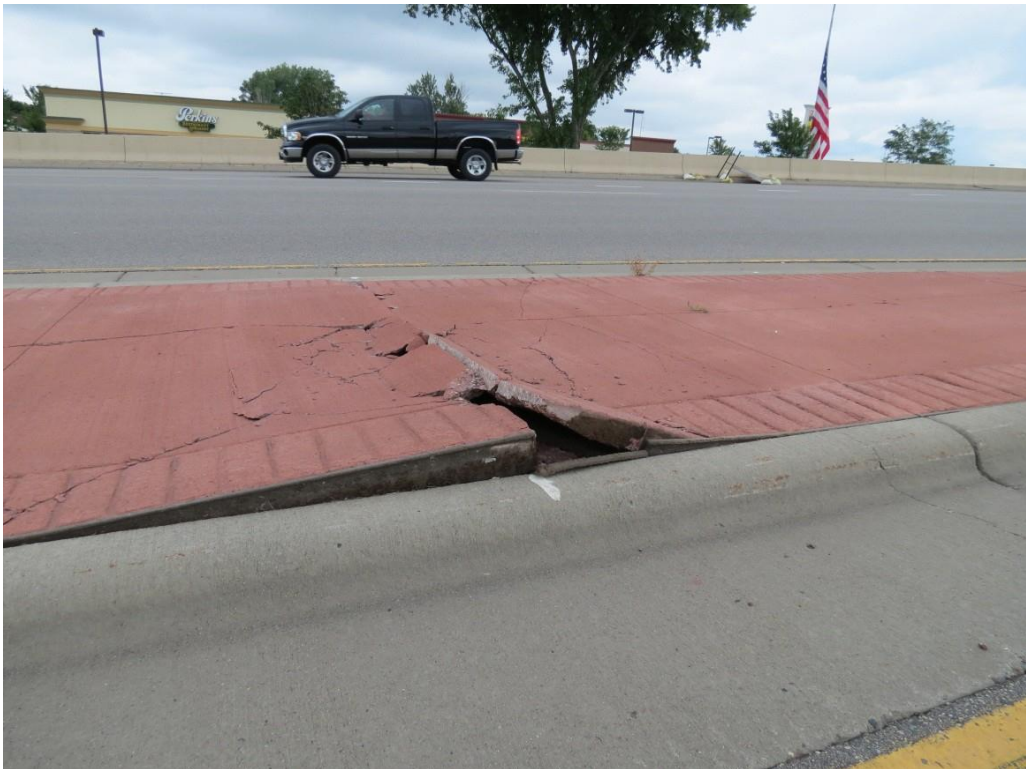
Figure 2.18 Blaine – Edge spalling of median within County Rd 14

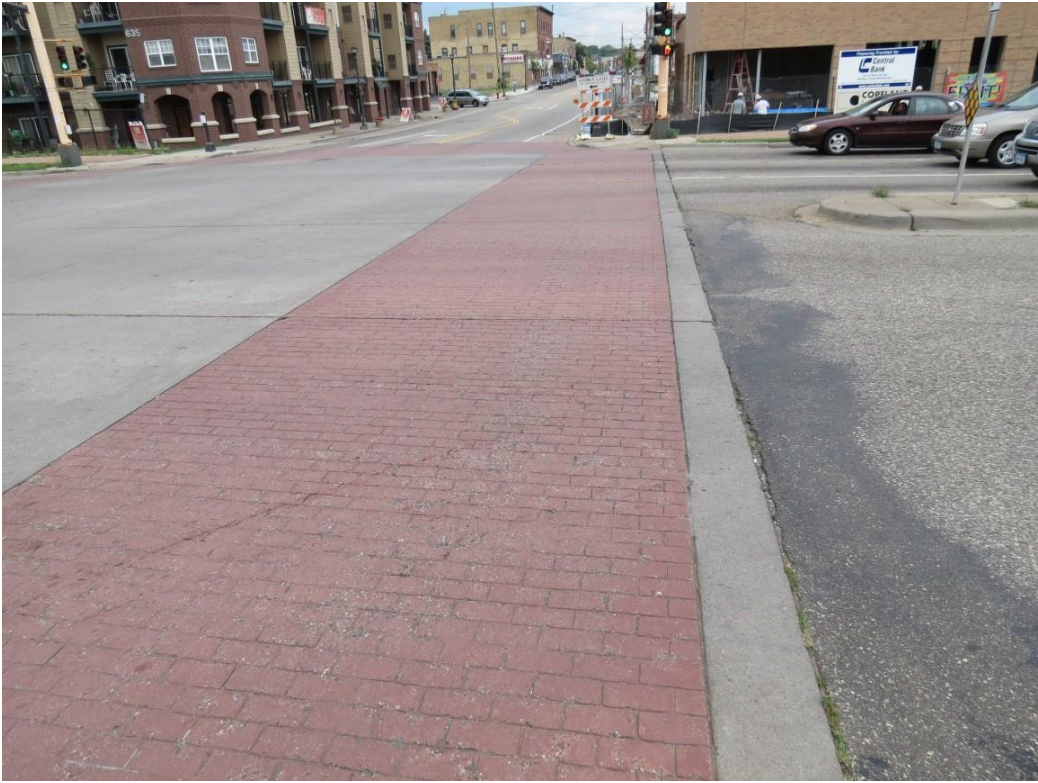
Figure 2.51 St. Paul – Noticeable wear on surface of colored concrete crosswalk at intersection of Phalen Boulevard and Payne Avenue

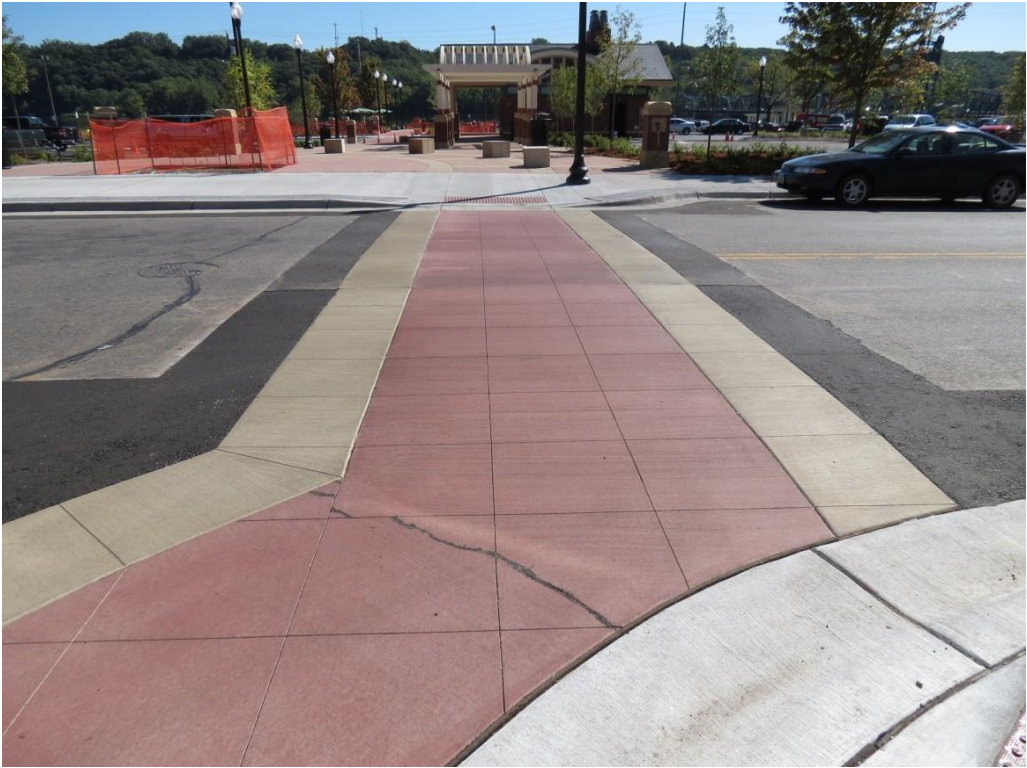
Figure 2.61 Stillwater – Panel cracking in new colored concrete crosswalk at intersection of Main Street North and Commercial Street

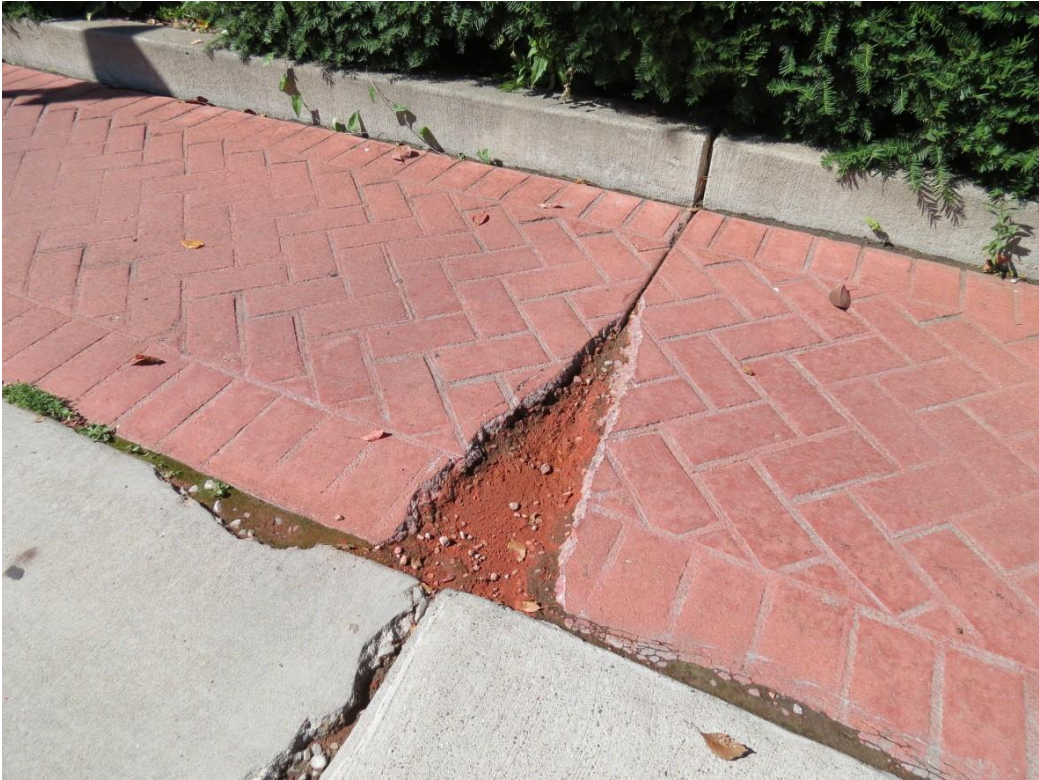
Figure 2.62 Stillwater – Significant joint distress in colored concrete sidewalks along 2nd Street North between Myrtle Street East and Commercial Street

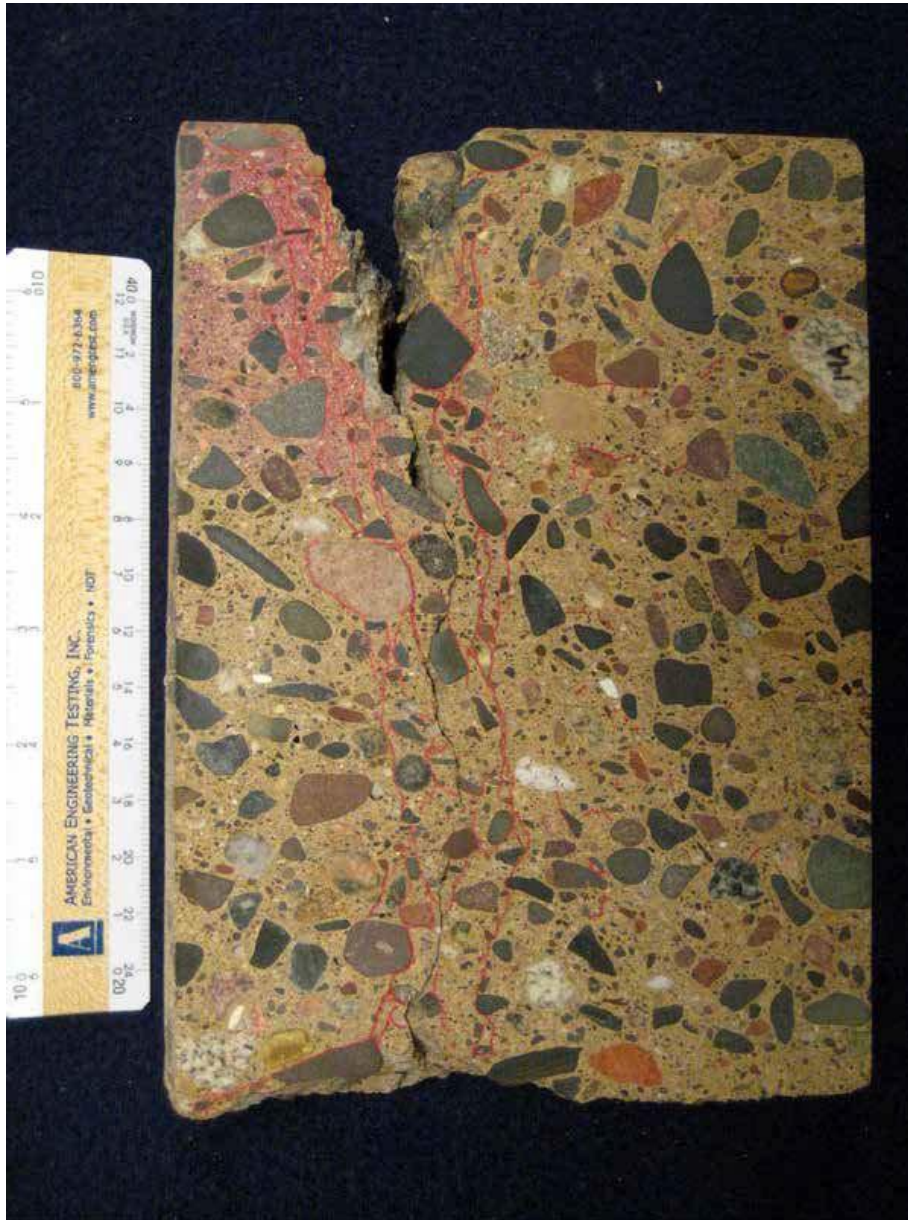
Figure 4.8 Centerville - Vertical cracking in Core 14A, highlighted by red ink

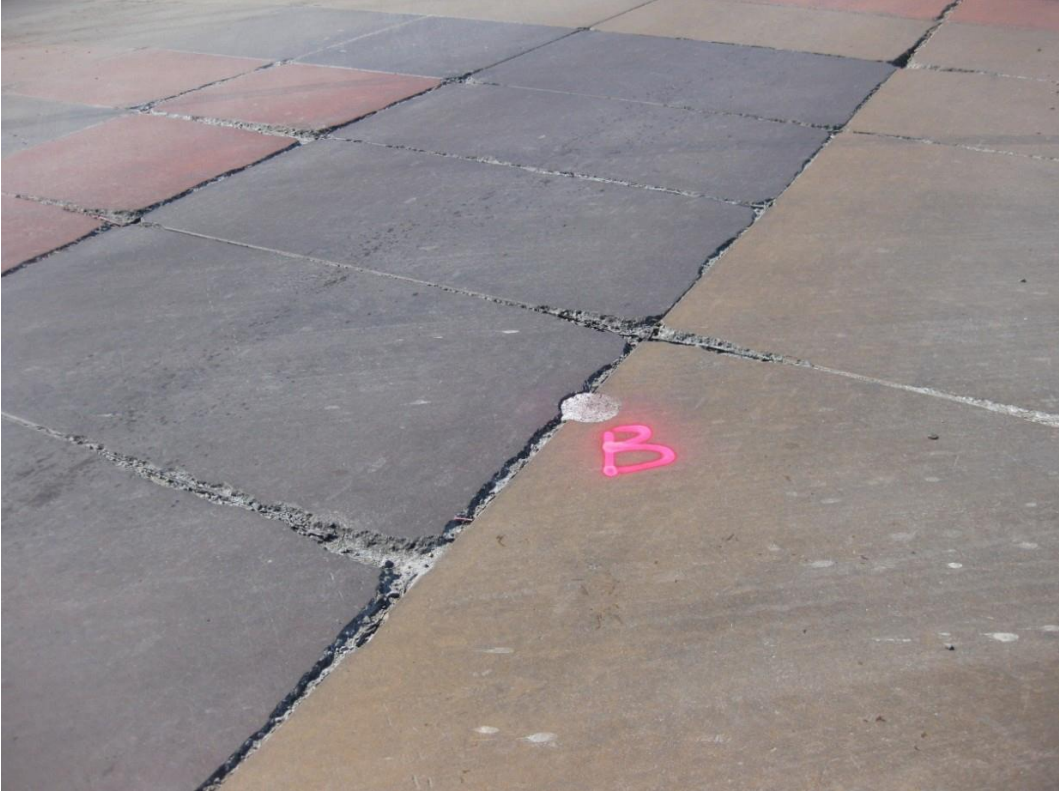
Figure 4.11 Centerville - Core location 14B, May 2013, showing progression of joint distress

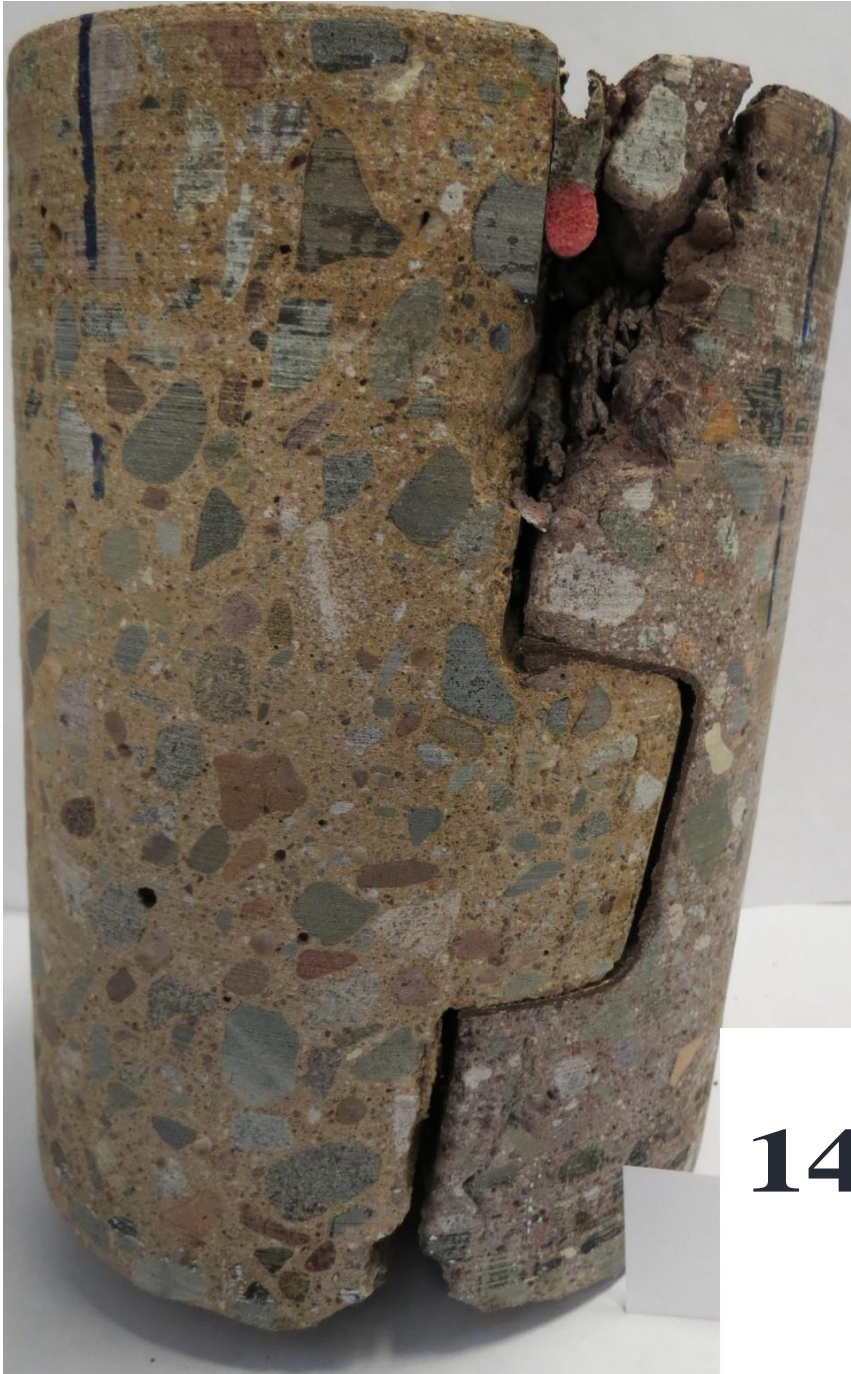
Figure 4.12 Centerville - Core 14B showing joint deterioration predominantly on side with darker concrete. Note that a parallel crack formed above the lower deterioration.

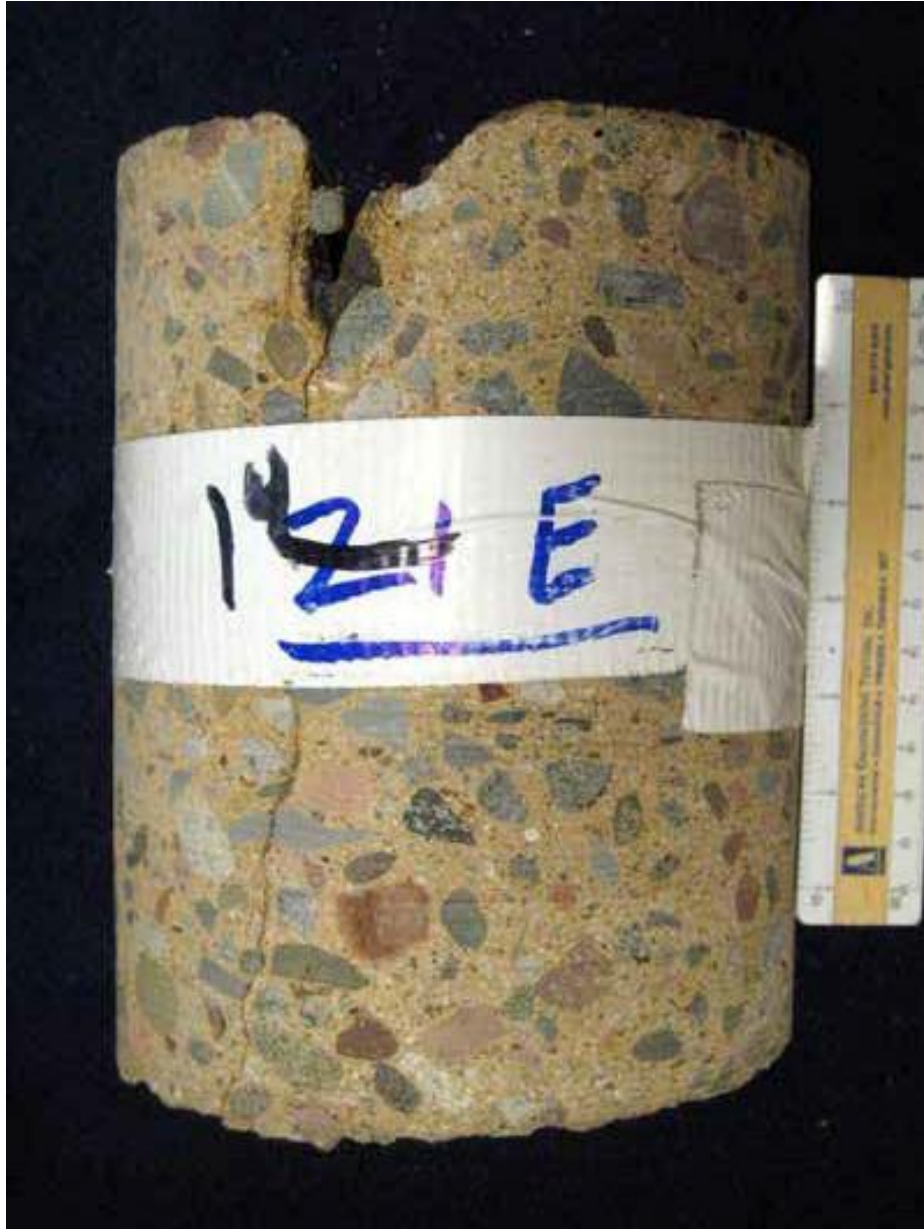
Figure 4.21 Centerville - Core 14E showing joint deterioration near surface

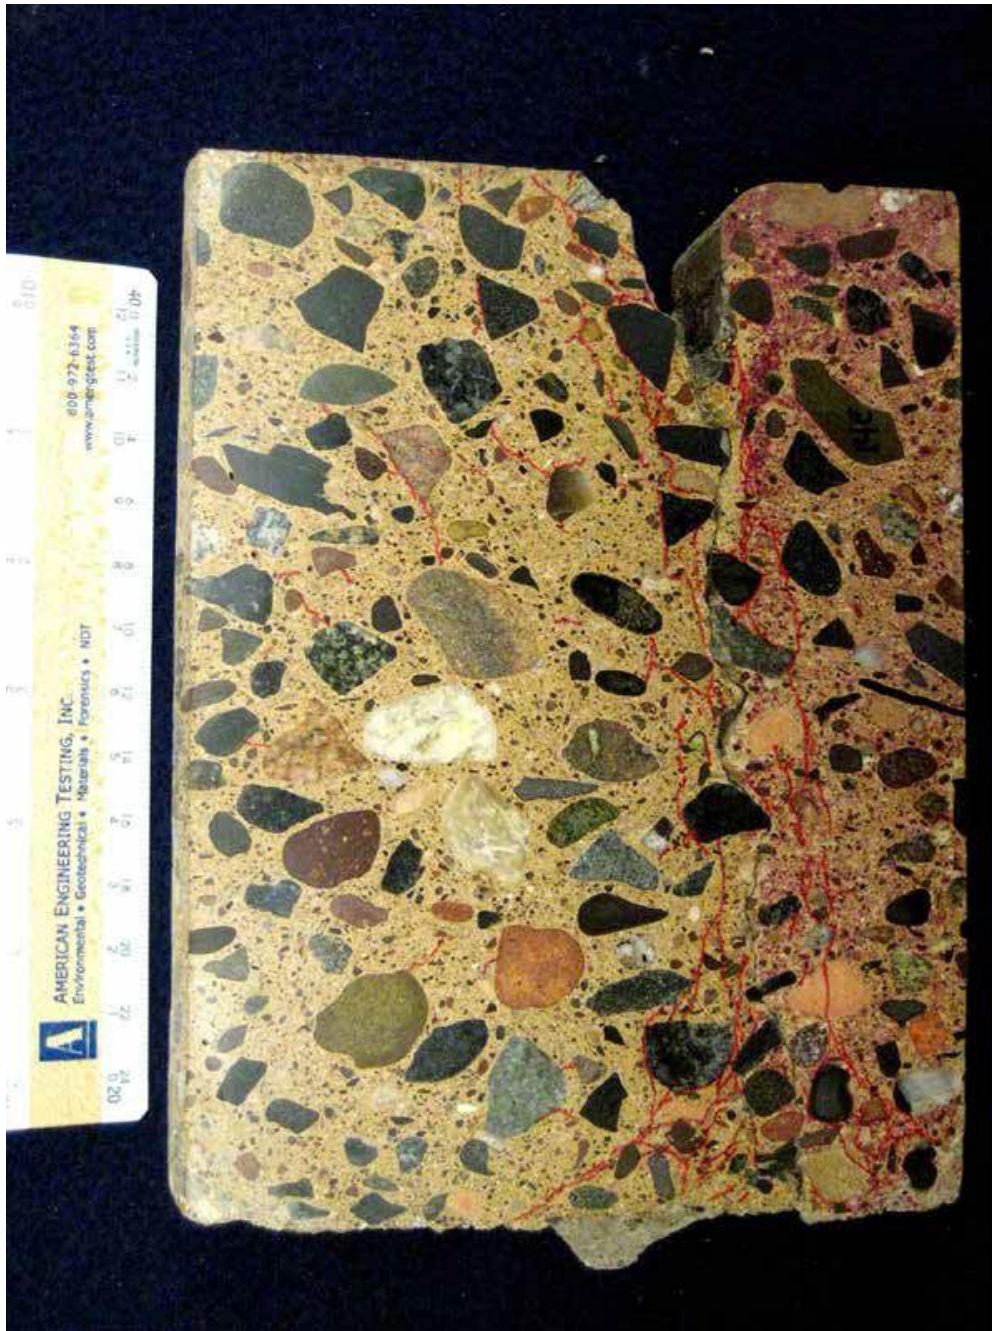
Figure 4.22 Centerville - Vertical cracking in Core 14E, highlighted by red ink

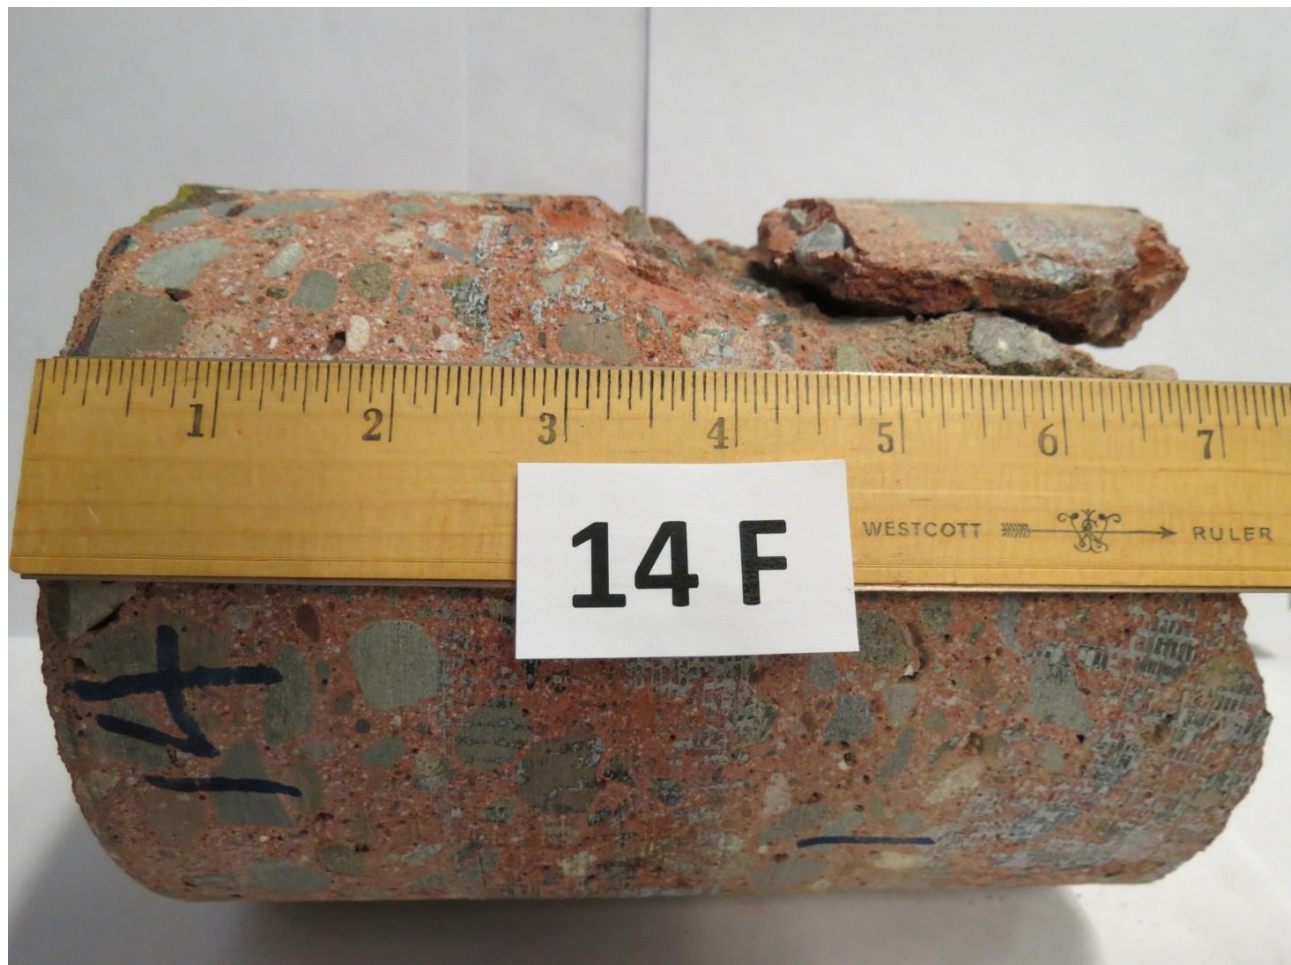
Figure 4.26 Centerville - Core sample 14F showing possible deterioration within neighboring joint

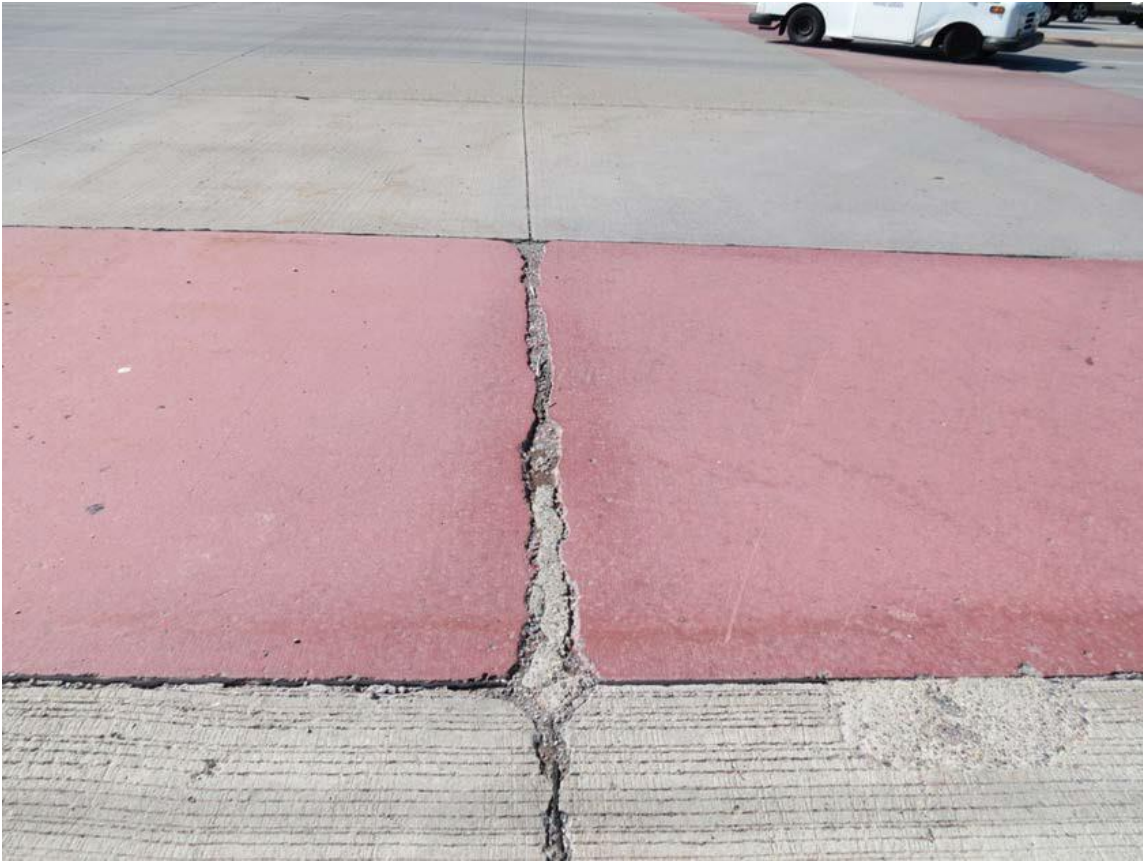
Figure 4.27 Typical joint deterioration occurring in colored concrete crosswalks at intersection of County Highway 96 and Greenhaven Drive in Vadnais Heights, MN

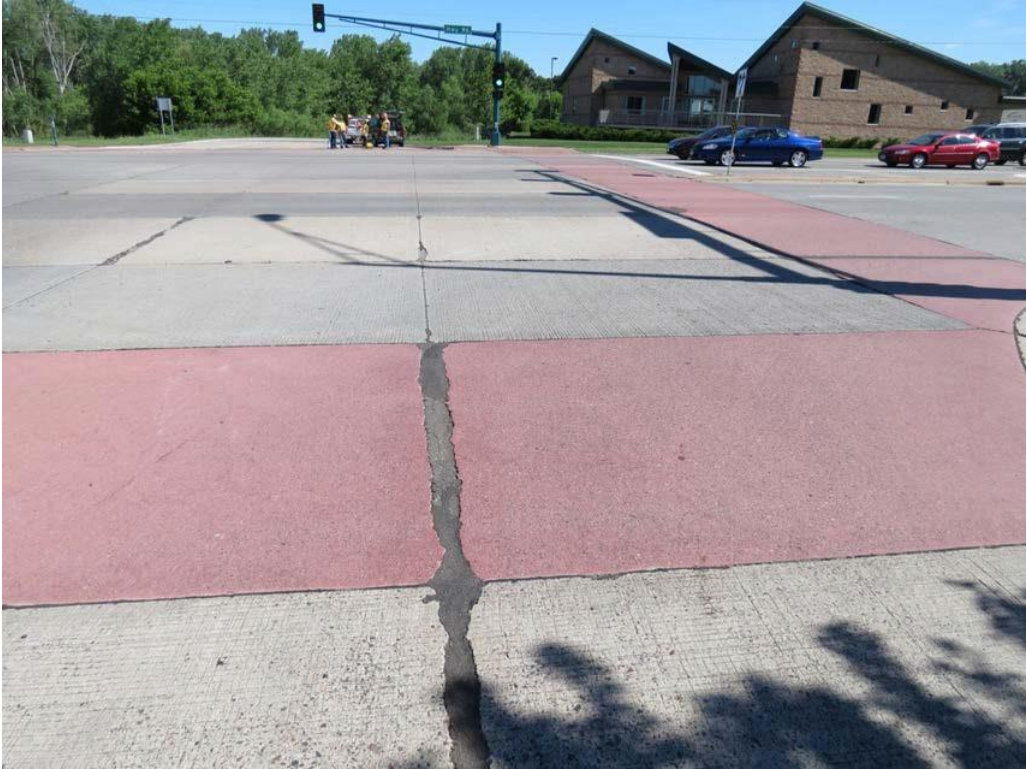
Figure 4.28 Patched colored concrete crosswalk joint at intersection of County Highway 96 and Greenhaven Drive in Vadnais Heights, MN

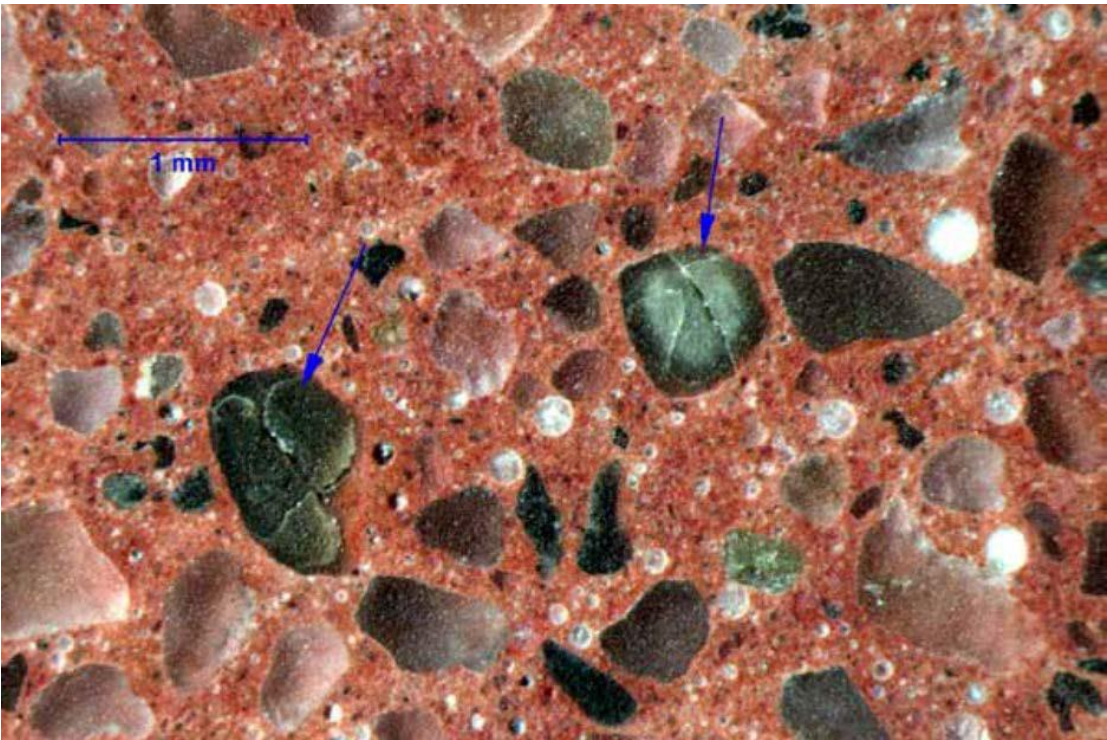
Figure 4.33 Vadnais Heights - Core sample 96A showing reactive shale particles among the fine aggregates

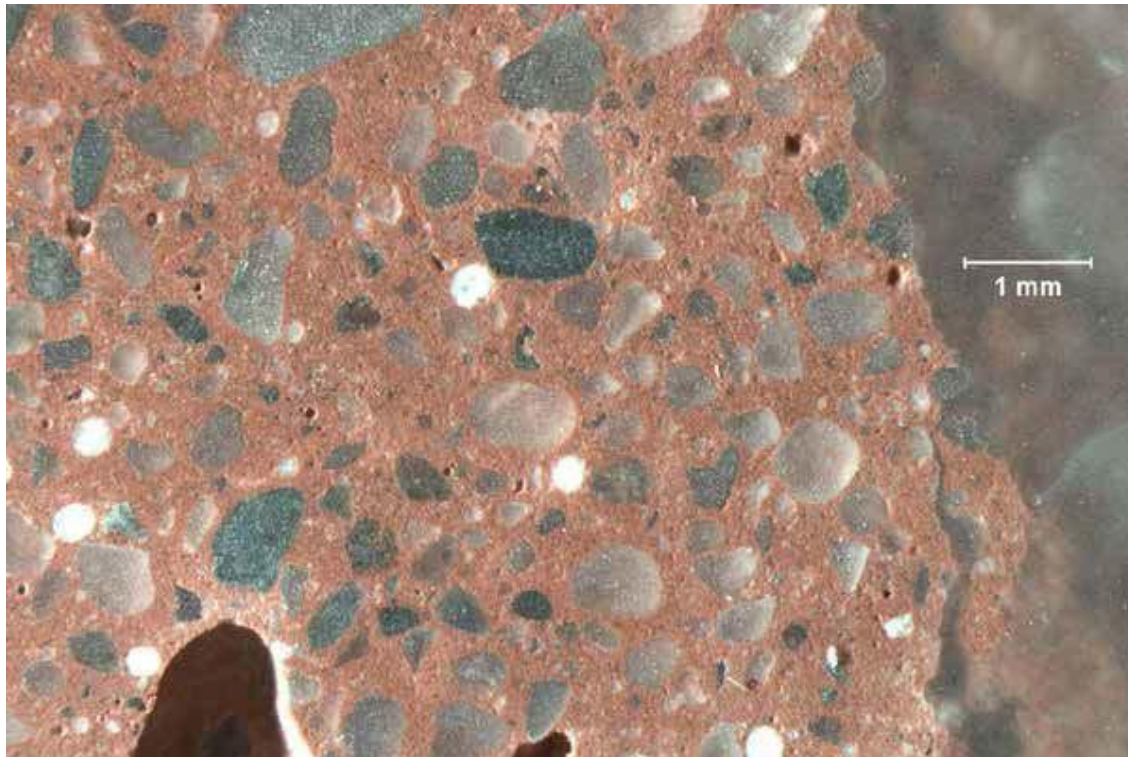
Figure 4.36 Vadnais Heights - Core sample 96A showing air voids filled with secondary ettringite near joint and bottom of pavement

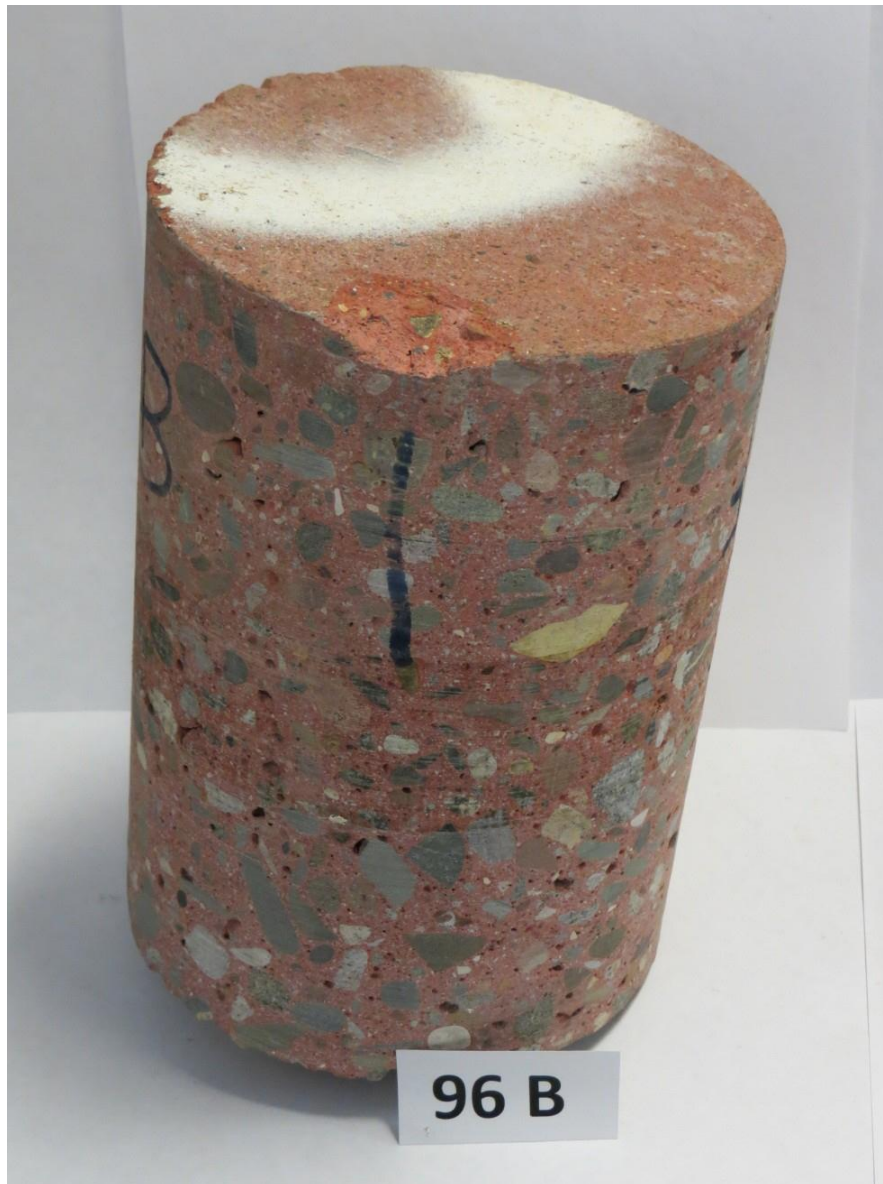
Figure 4.42 Vadnais Heights - Core 96B showing large number of air pockets throughout sample

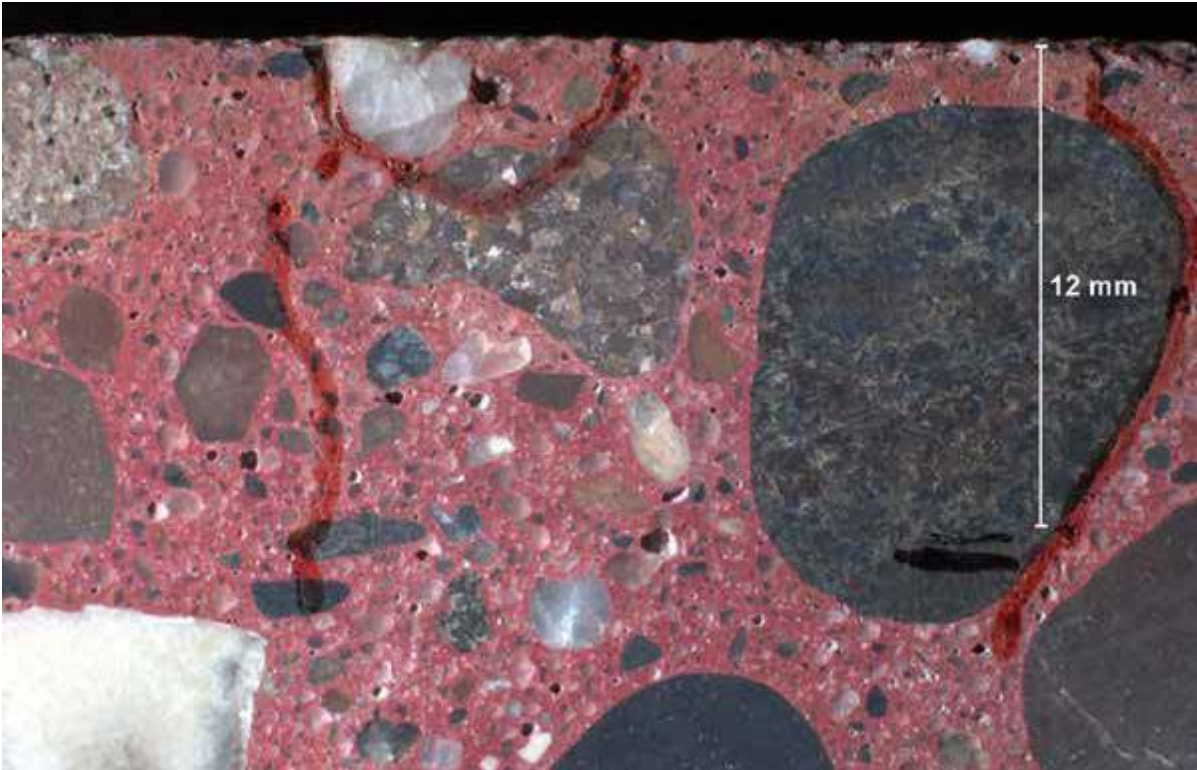
Figure 4.45 Vadnais Heights - Core sample 96C show drying shrinkage cracks near surface (highlighted in red ink)

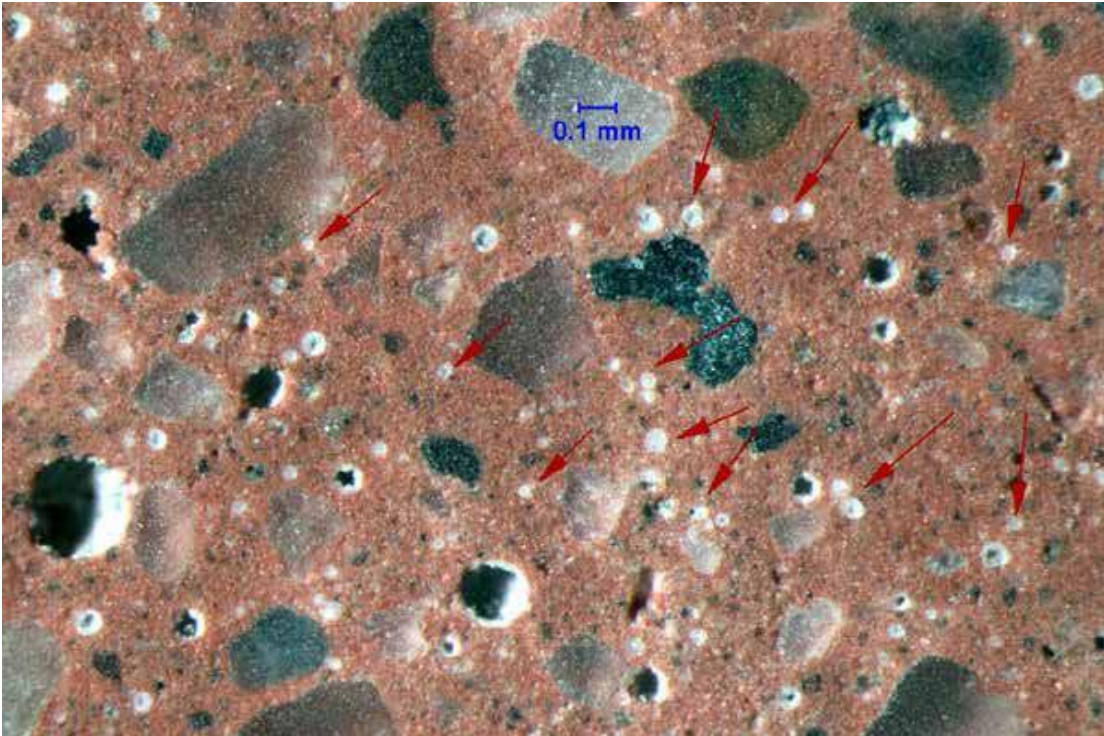
Figure 4.46 Vadnais Heights - Core sample 96C showing air voids filled with secondary ettringite near the bottom of the pavement

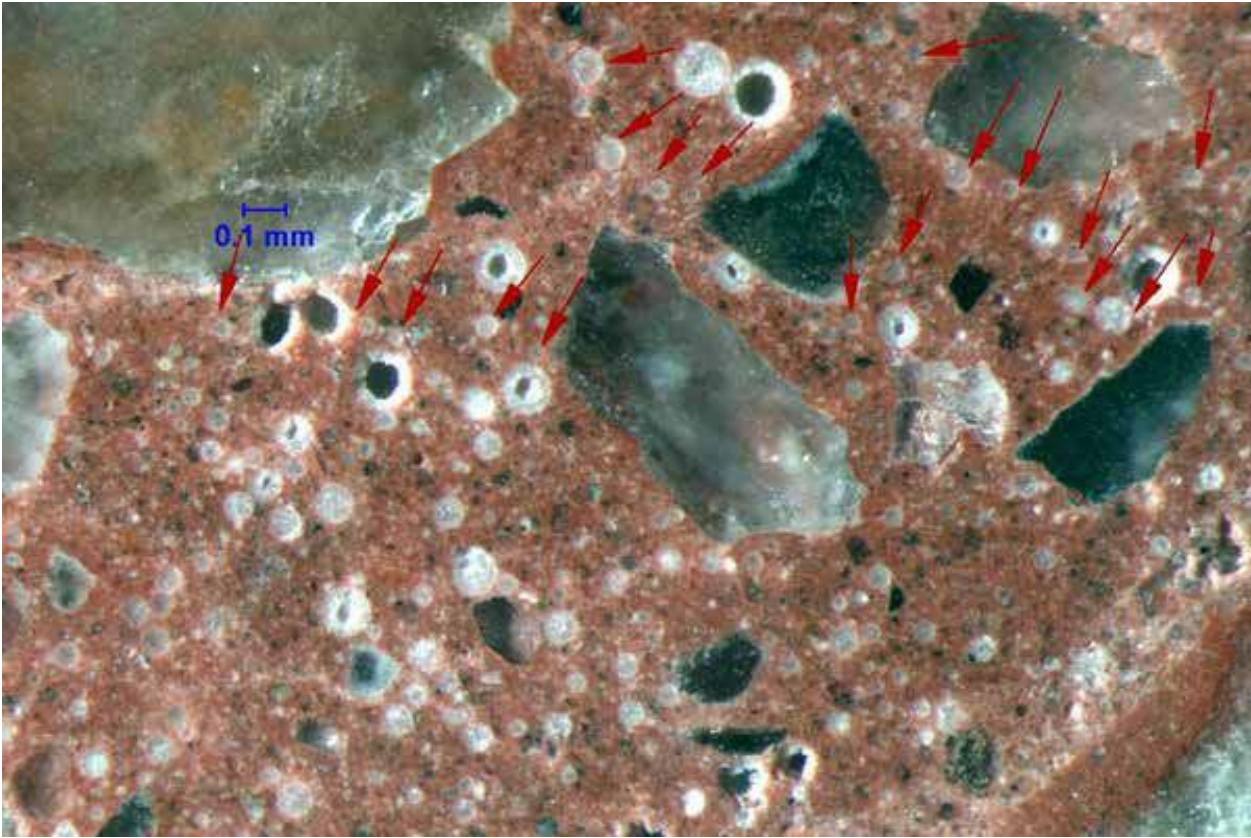
Figure 4.58 Arden Hills - Core sample LJEB-A showing ettringite lining and filling air voids at a depth of 60 mm

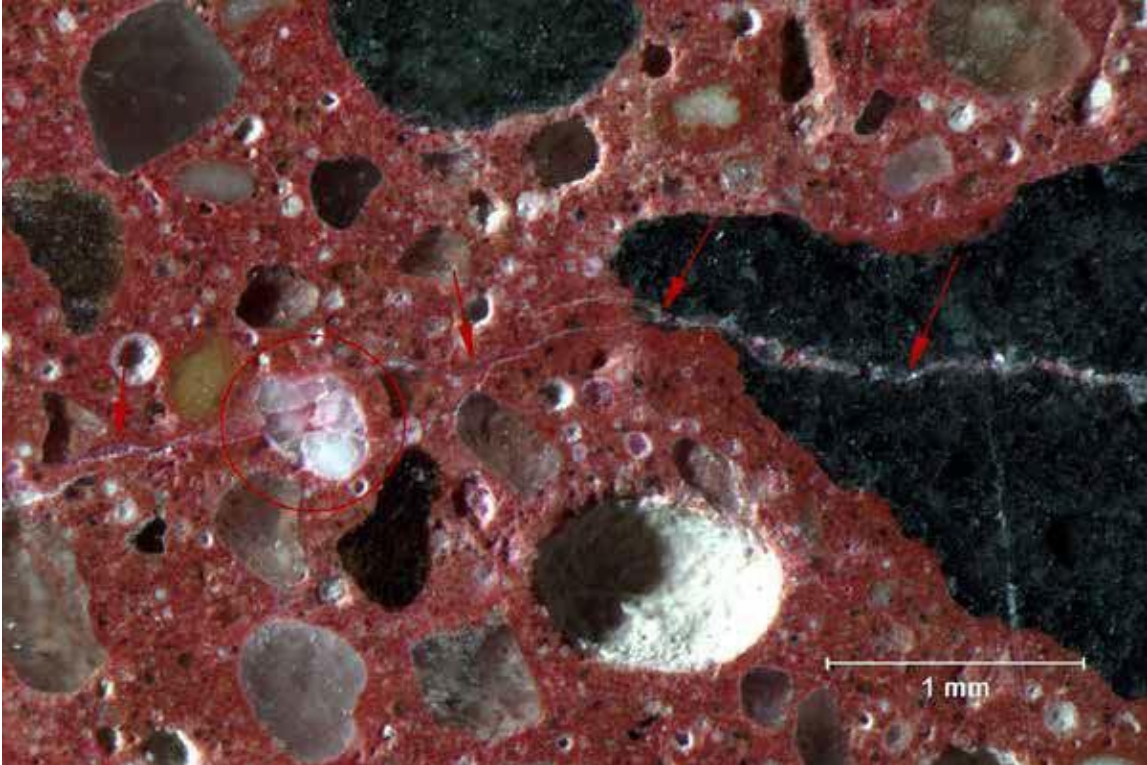
Figure 4.60 Arden Hills - Core sample LJEB-A showing clear ASR gel product within microcracks traversing both the paste and a greywacke coarse aggregate particle

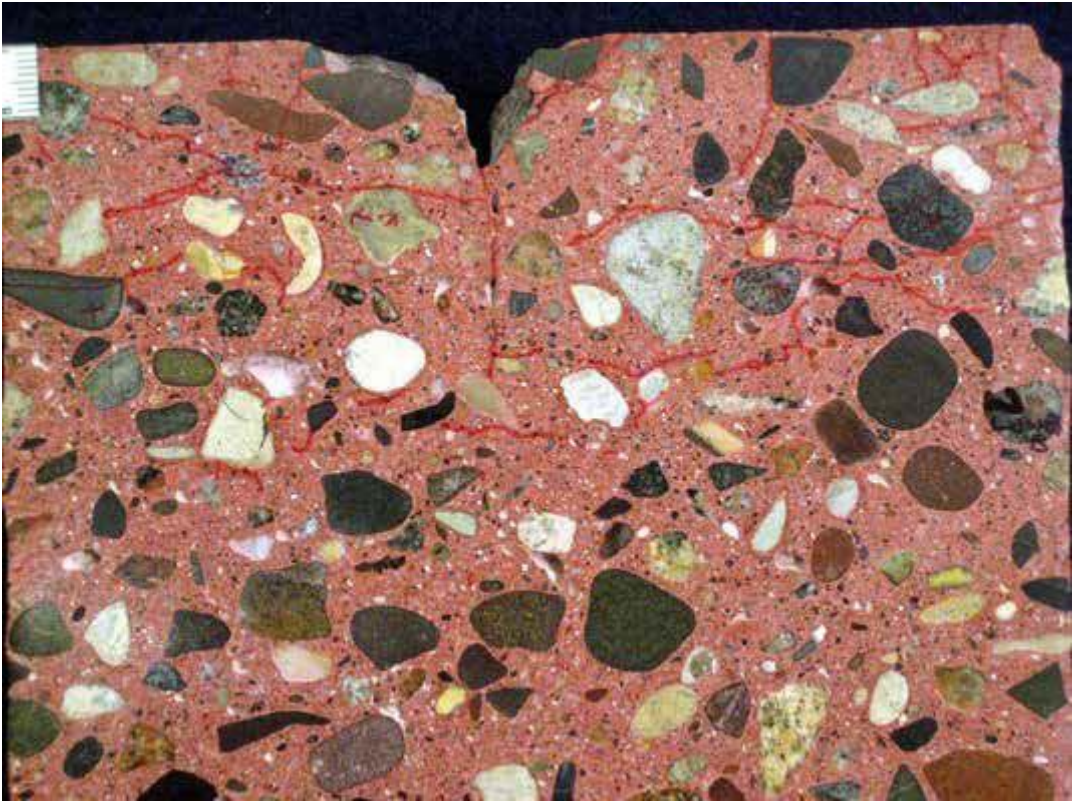
Figure 4.63 Arden Hills - Core sample LJWB-B showing vertical and horizontal ASR-induced cracks (highlighted in red ink)

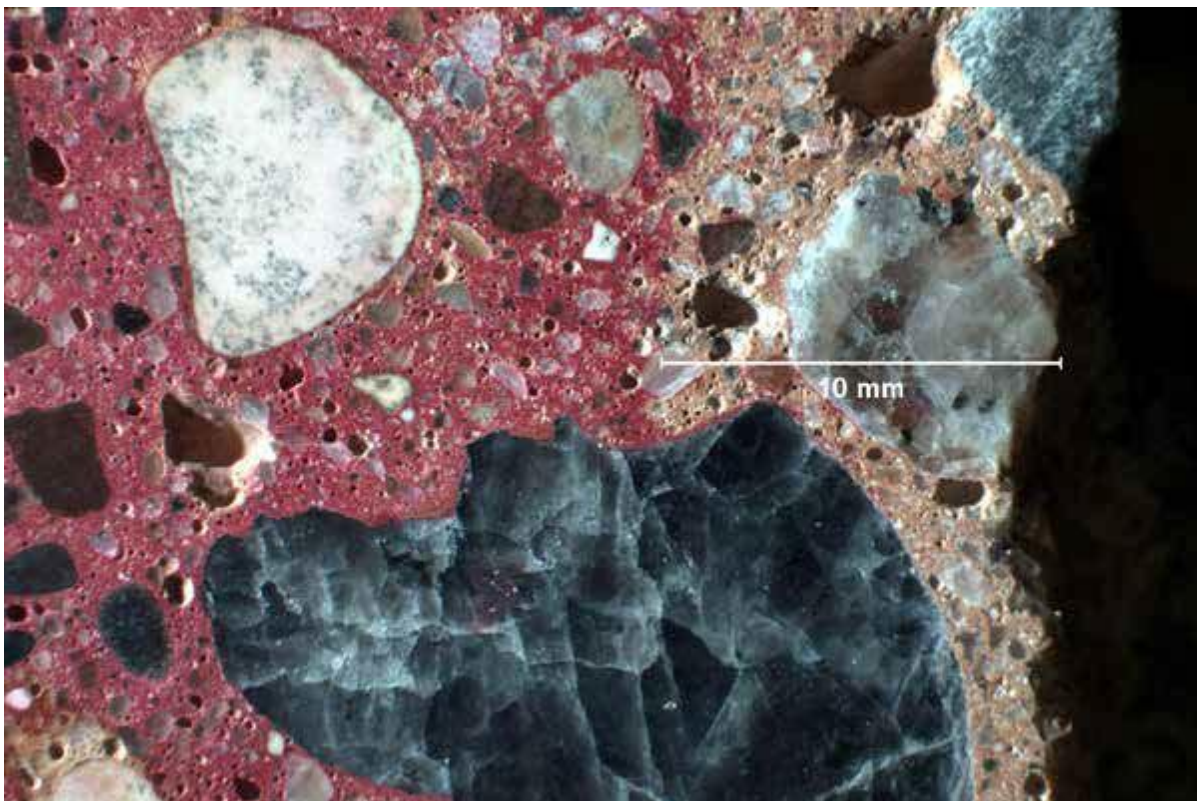
Figure 4.73 Roseville - Core sample L&F-A showing carbonation (unstained paste) proceeding up to 10mm depth from the joint crack plane (on right)

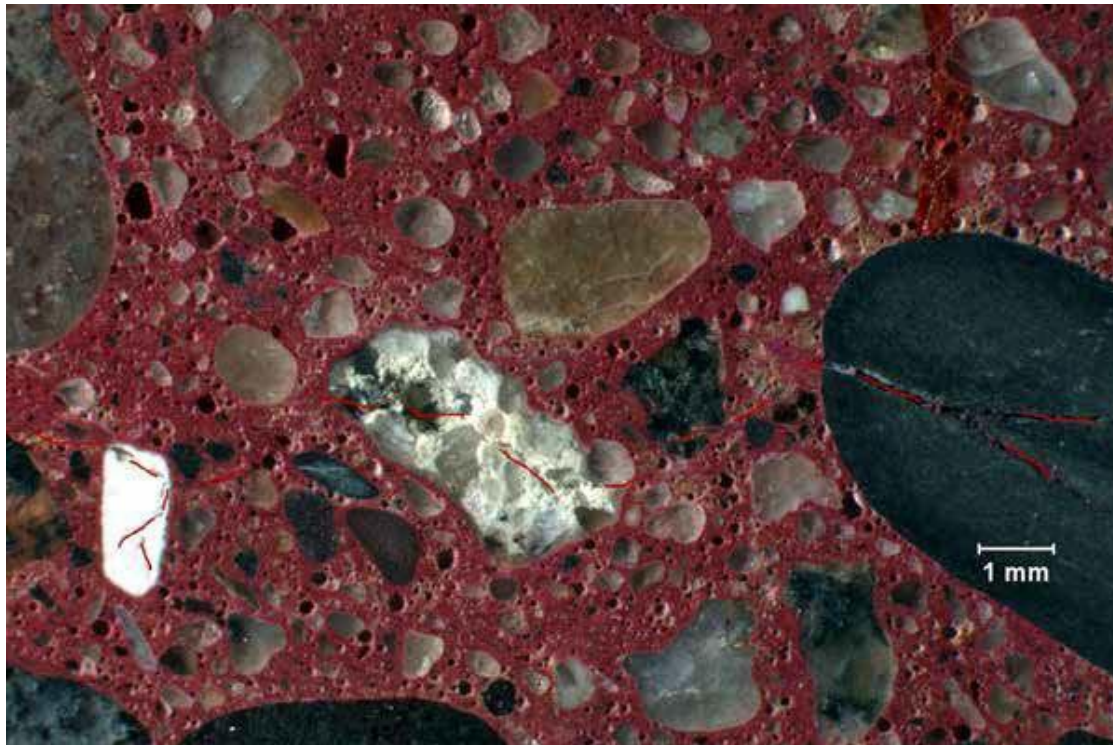
Figure 4.77 Roseville - Core sample L&F-B showing ASR gel product (highlighted in red ink) within microcracks traversing the paste, fine and coarse aggregate particles

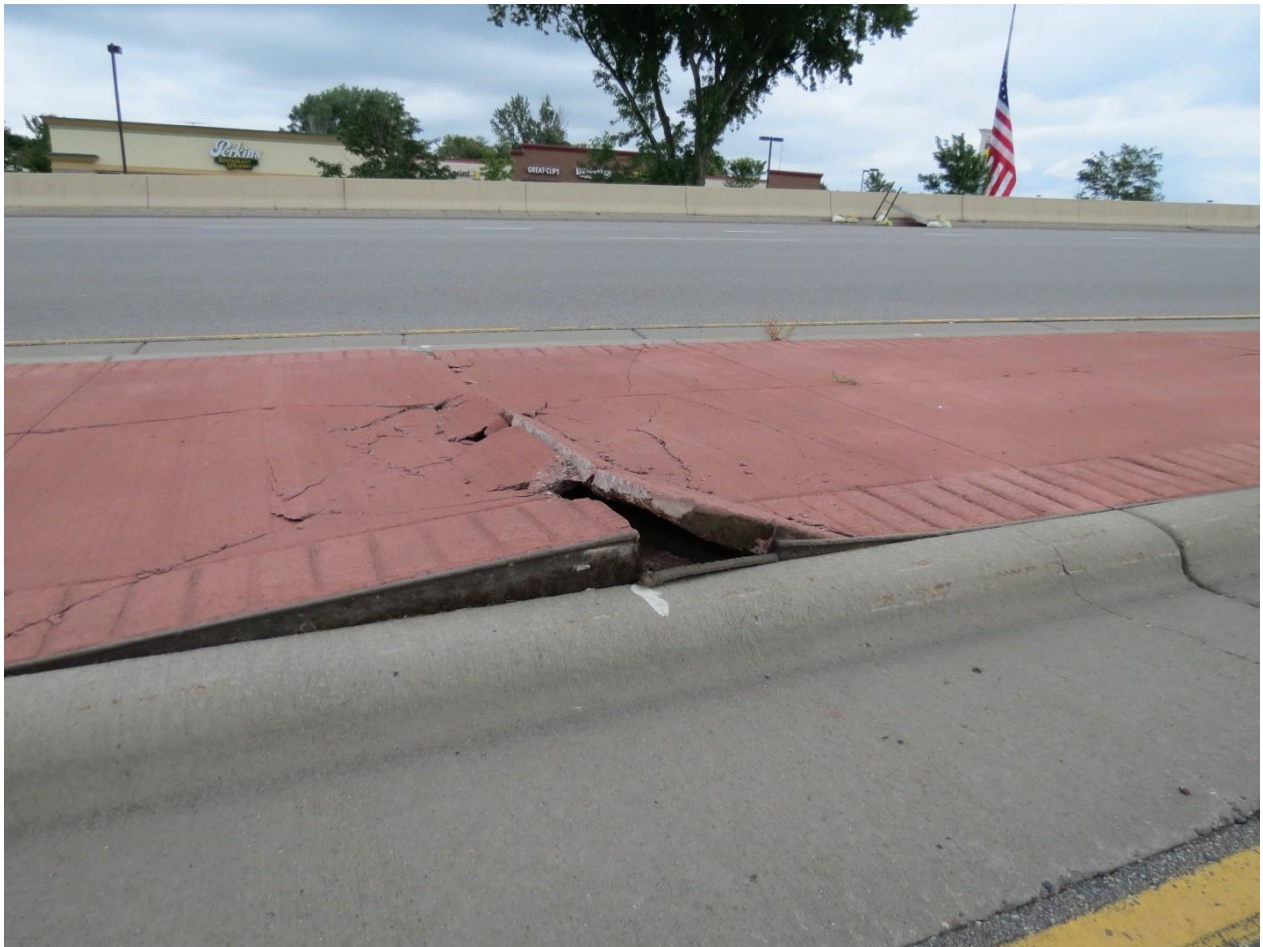
Figure 6.1 Buckled median caused by expansive forces in colored concrete
