Investigation and Assessment of Colored Concrete Pavement

Minnesota
Department of
Transportation

August 2014

Research Project
Final Report 2014-26

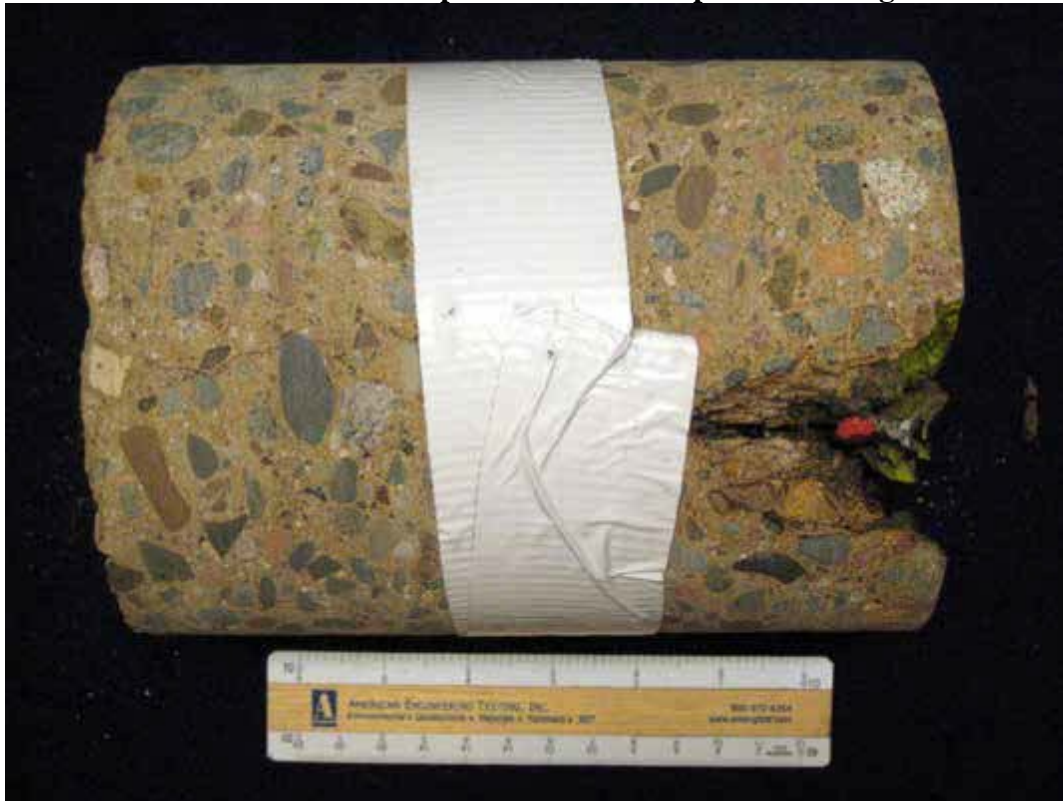
14A DESCRIPTION: Top surface of the core sample, with sliver spalled joint, as received.

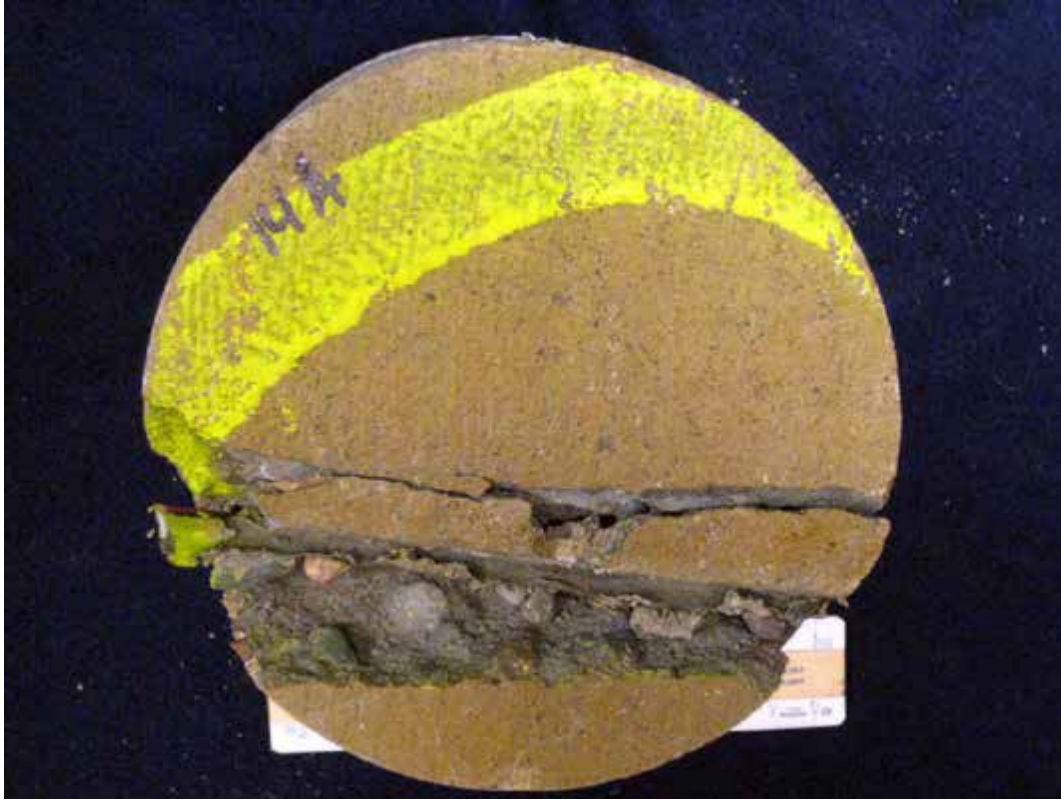
14A DESCRIPTION: Sliver spalling and severe incipient distress (sub-vertical micro and macro cracking) in the concrete paste directly adjacent to the "activated", tooled and sawcut control joint crack; mapped in red ink in sawcut and lapped cross sectore.

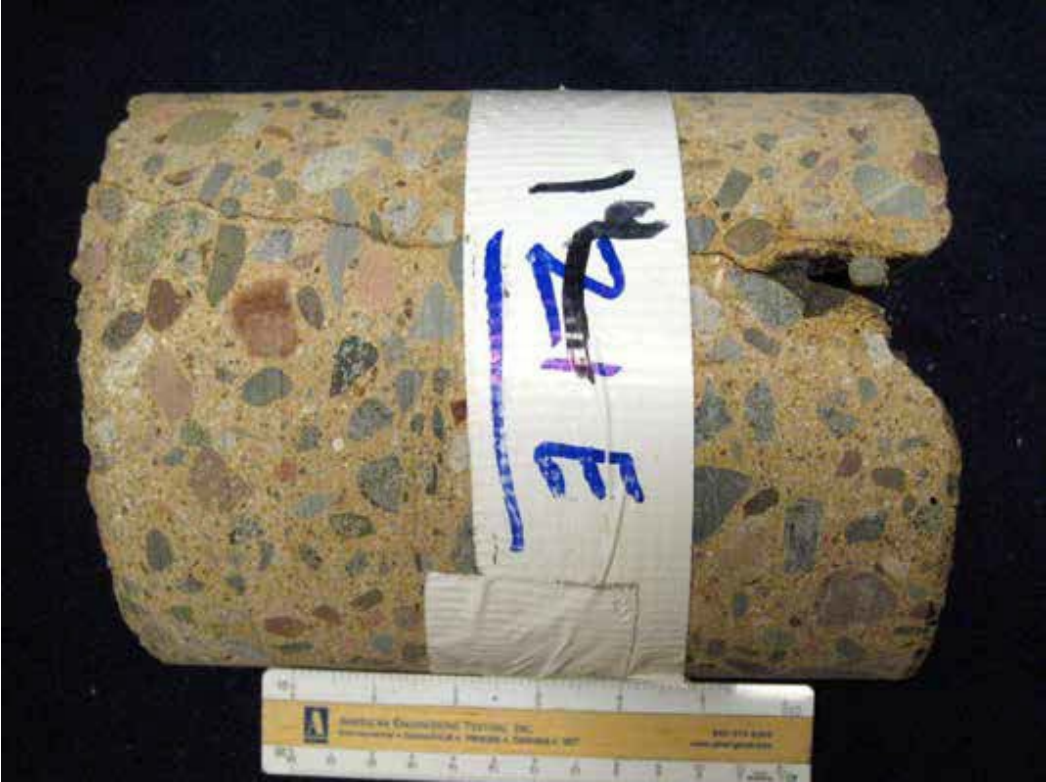
14E DESCRIPTION: Top surface of the core sample as received. Note spalled joint.

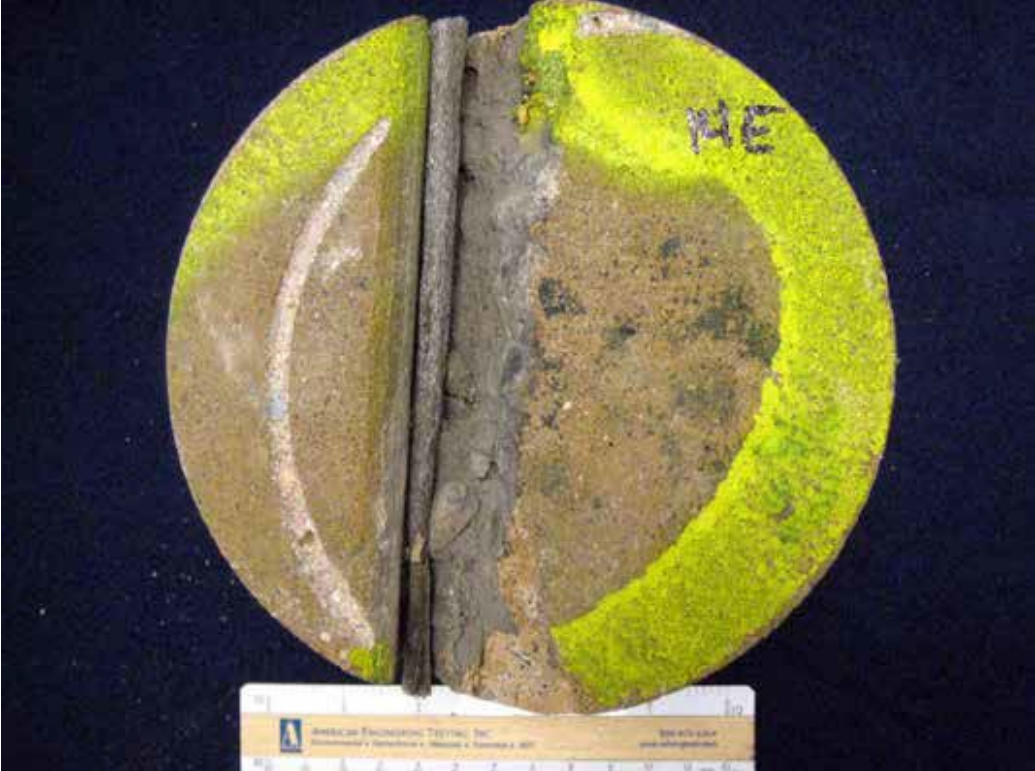
14E DESCRIPTION: Sliver spalling and severe incipient distress (sub-vertical micro and macro cracking) in the concrete paste directly adjacent to the "activated", tooled and sawcut joint in red ink in sawcut and cross section of core.

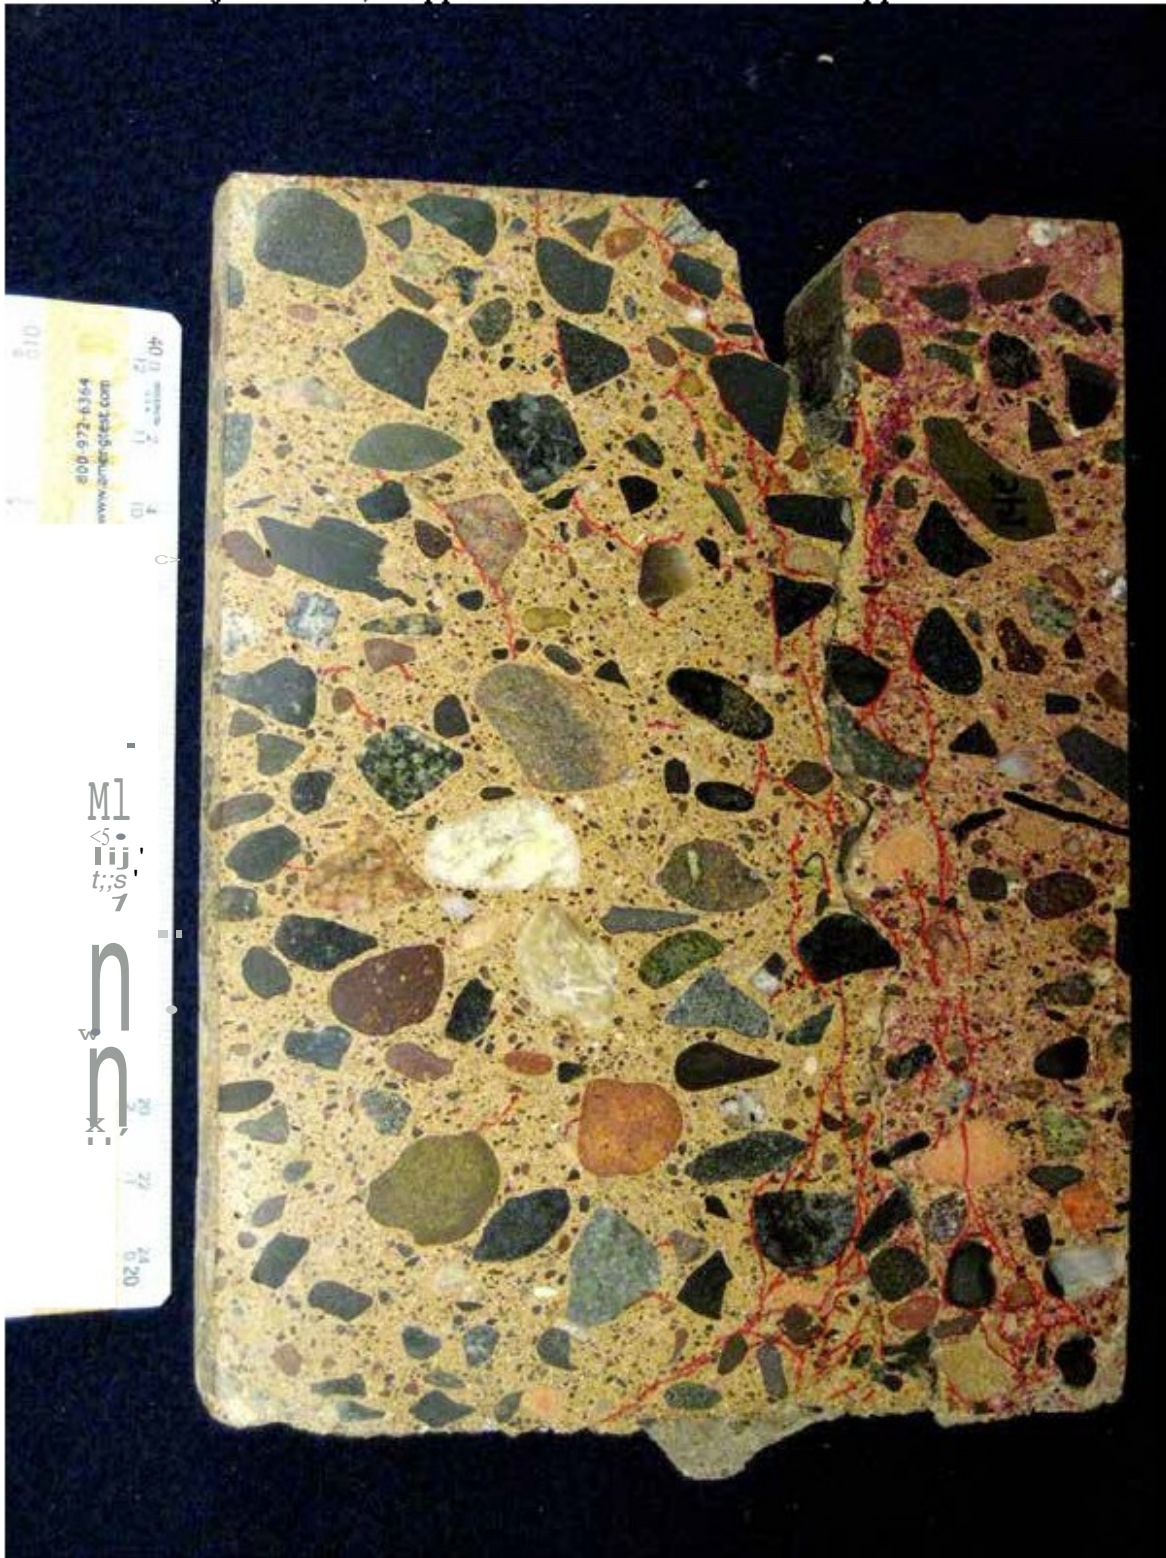
14E DESCRIPTION: Carbonation (unstained paste) proceeds up to 2mm depth from the traffic-worn top surface of the core. In freshly sawcut and lapped cross section of core exposed to phenolphthalein pH indicator. MAG: 10x

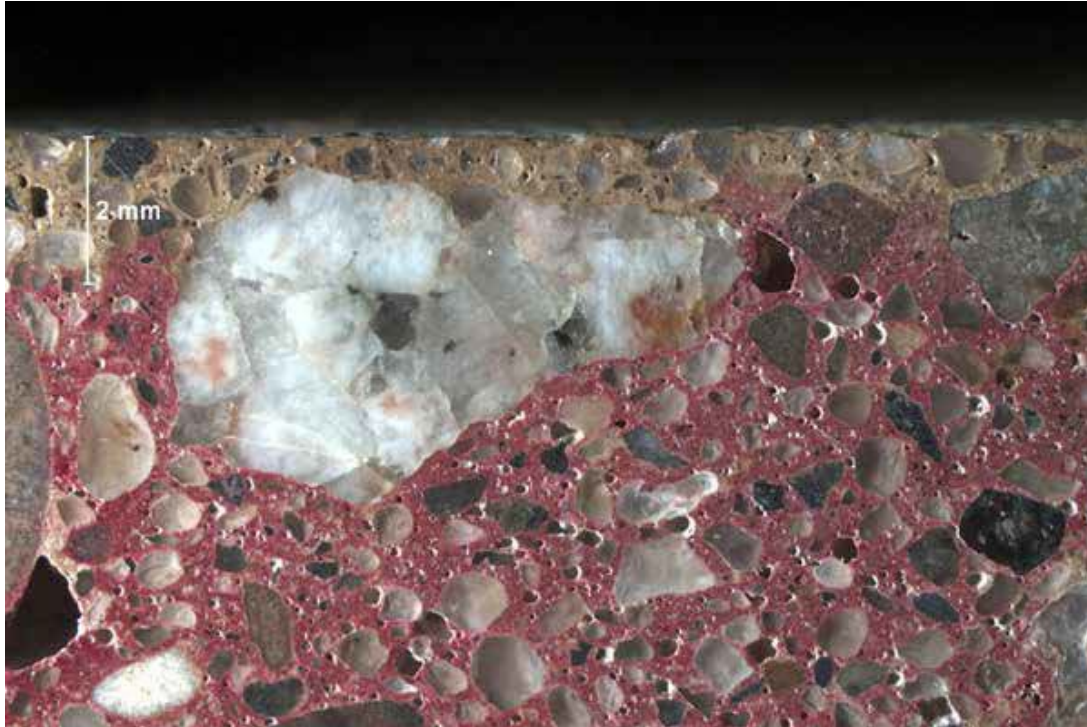
14E DESCRIPTION: Most fine entrained-sized air void spaces within the distressed paste adjacent to the joint plane are filled with secondary ettringite. MAG: 15x

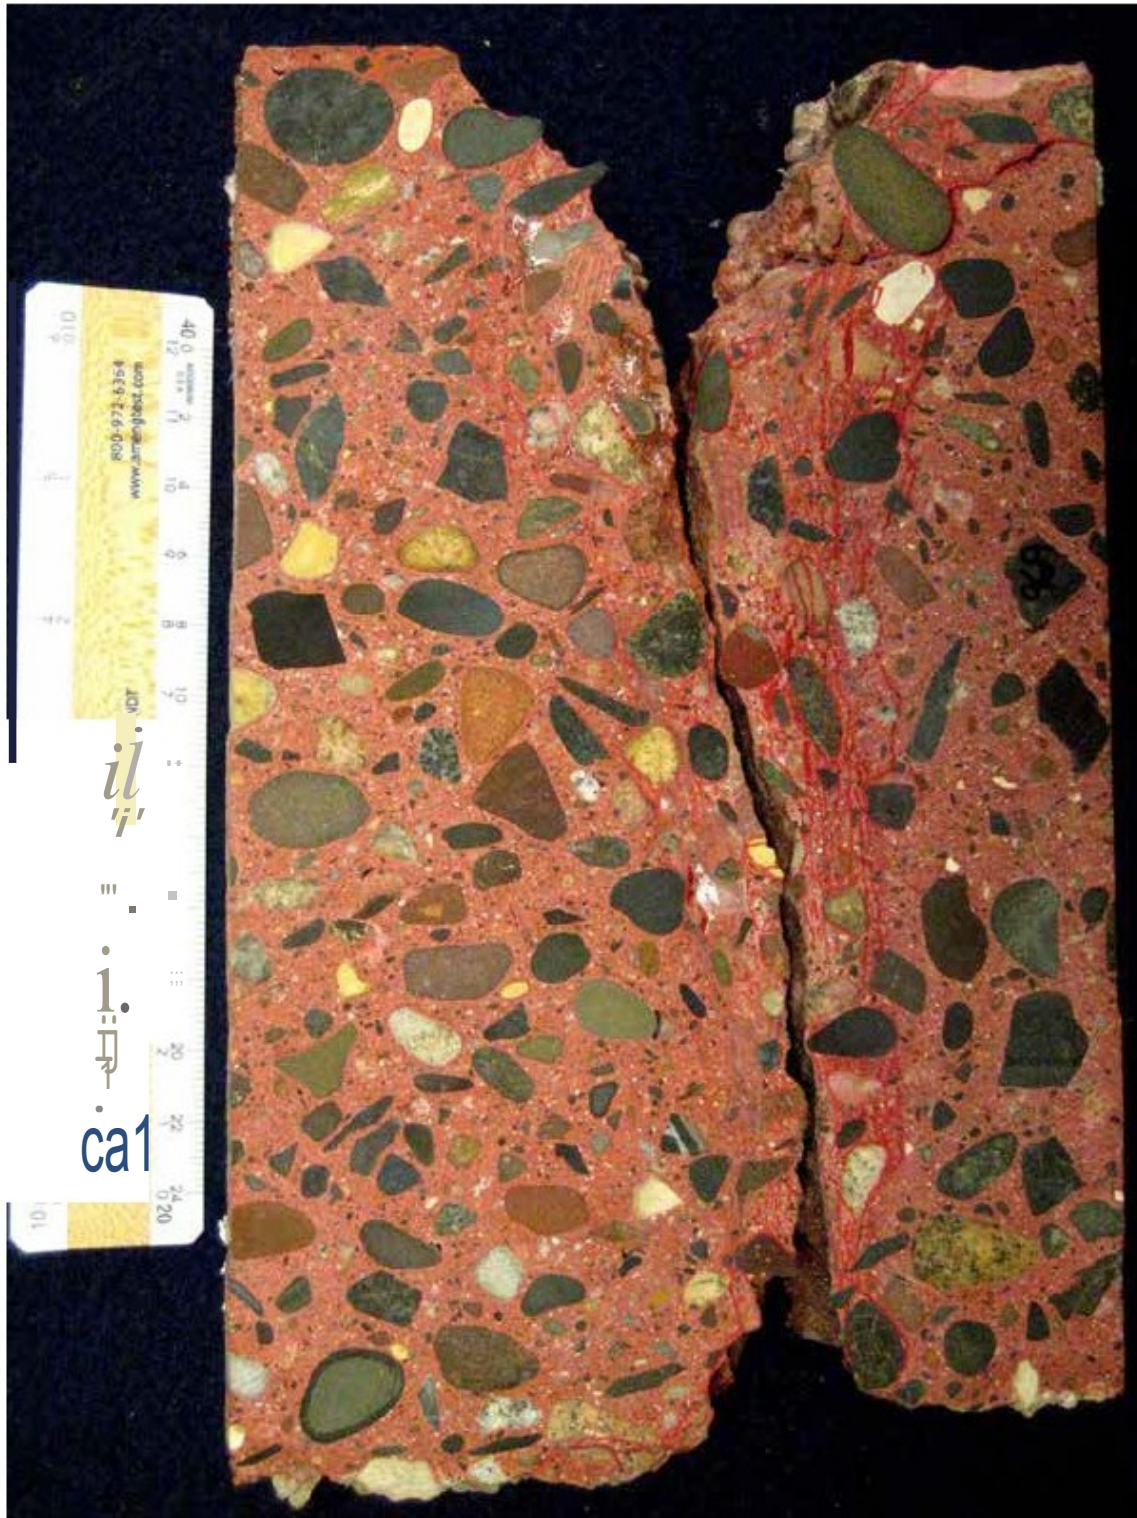
96A DESCRIPTION: Highly distressed paste occurs within 22mm of the spalled corner of the joint. Some microcracking is mapped in red ink. Concentrated fine microcracking filled with epoxy is present between the mapped microcracking and the spalled corner of the joint. MAG: 5x

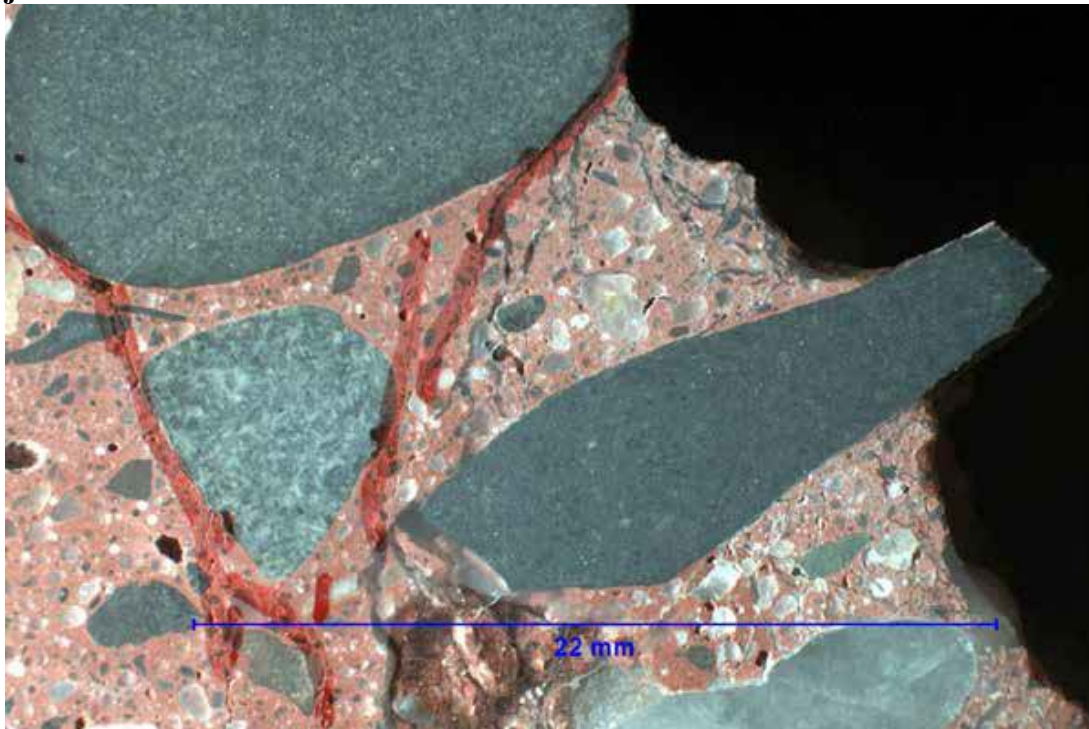
96A DESCRIPTION: Concentrated, sub-vertical microcracking within 14mm of the distressed joint plane is filled with white ettringite. MAG: 10x

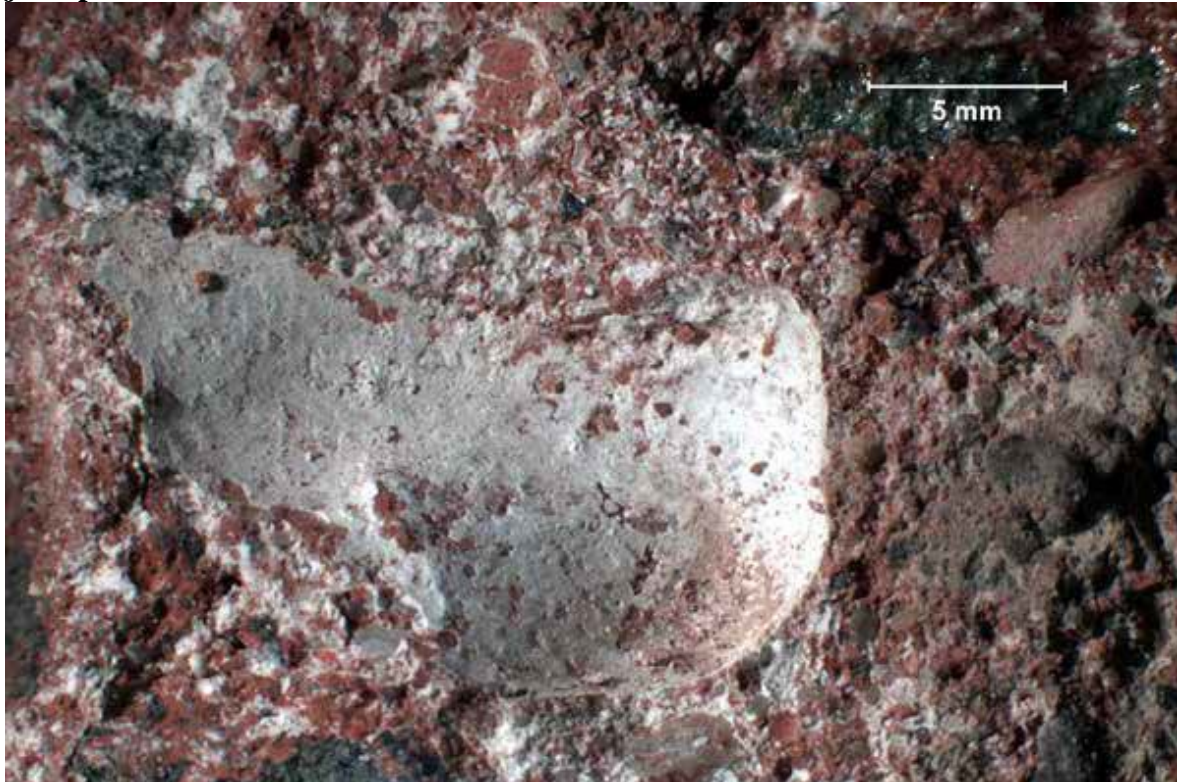
96A DESCRIPTION: Reactive shale particles common in the fine aggregate. MAG: 30x

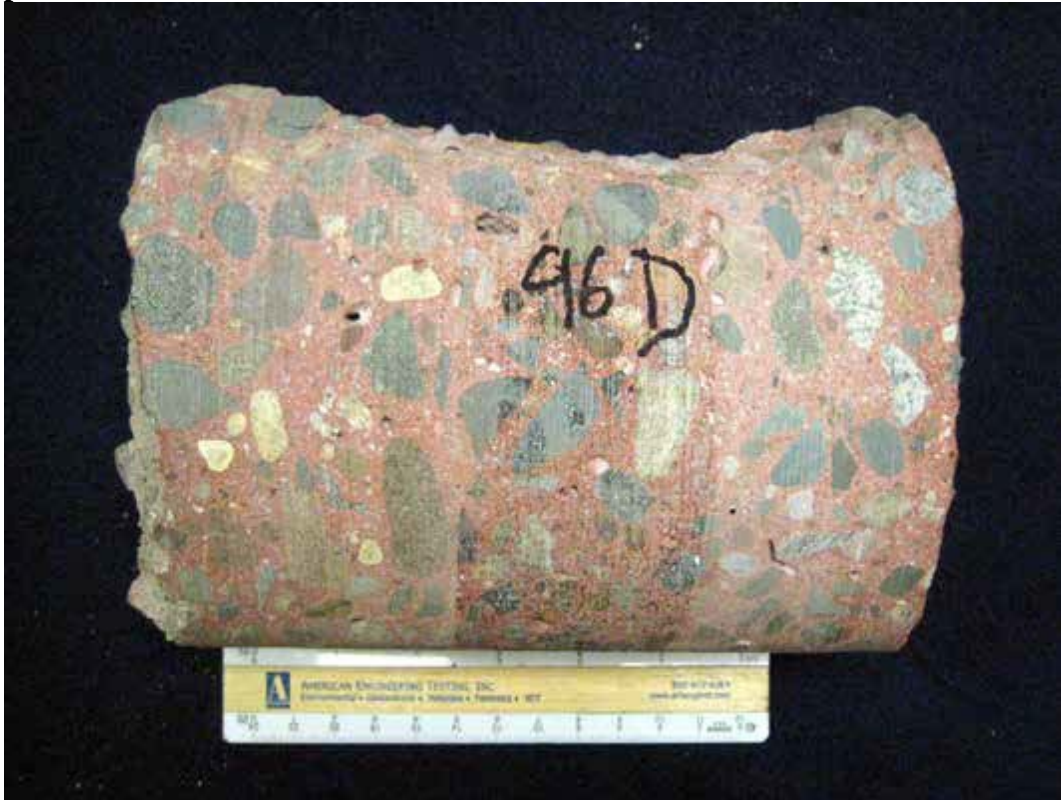
96D DESCRIPTION: Lightly textured and traffic worn/mortar eroded top surface of the core sample as received. Note raveled joint edge (bottom) and shallowly scaled area (right side of image).

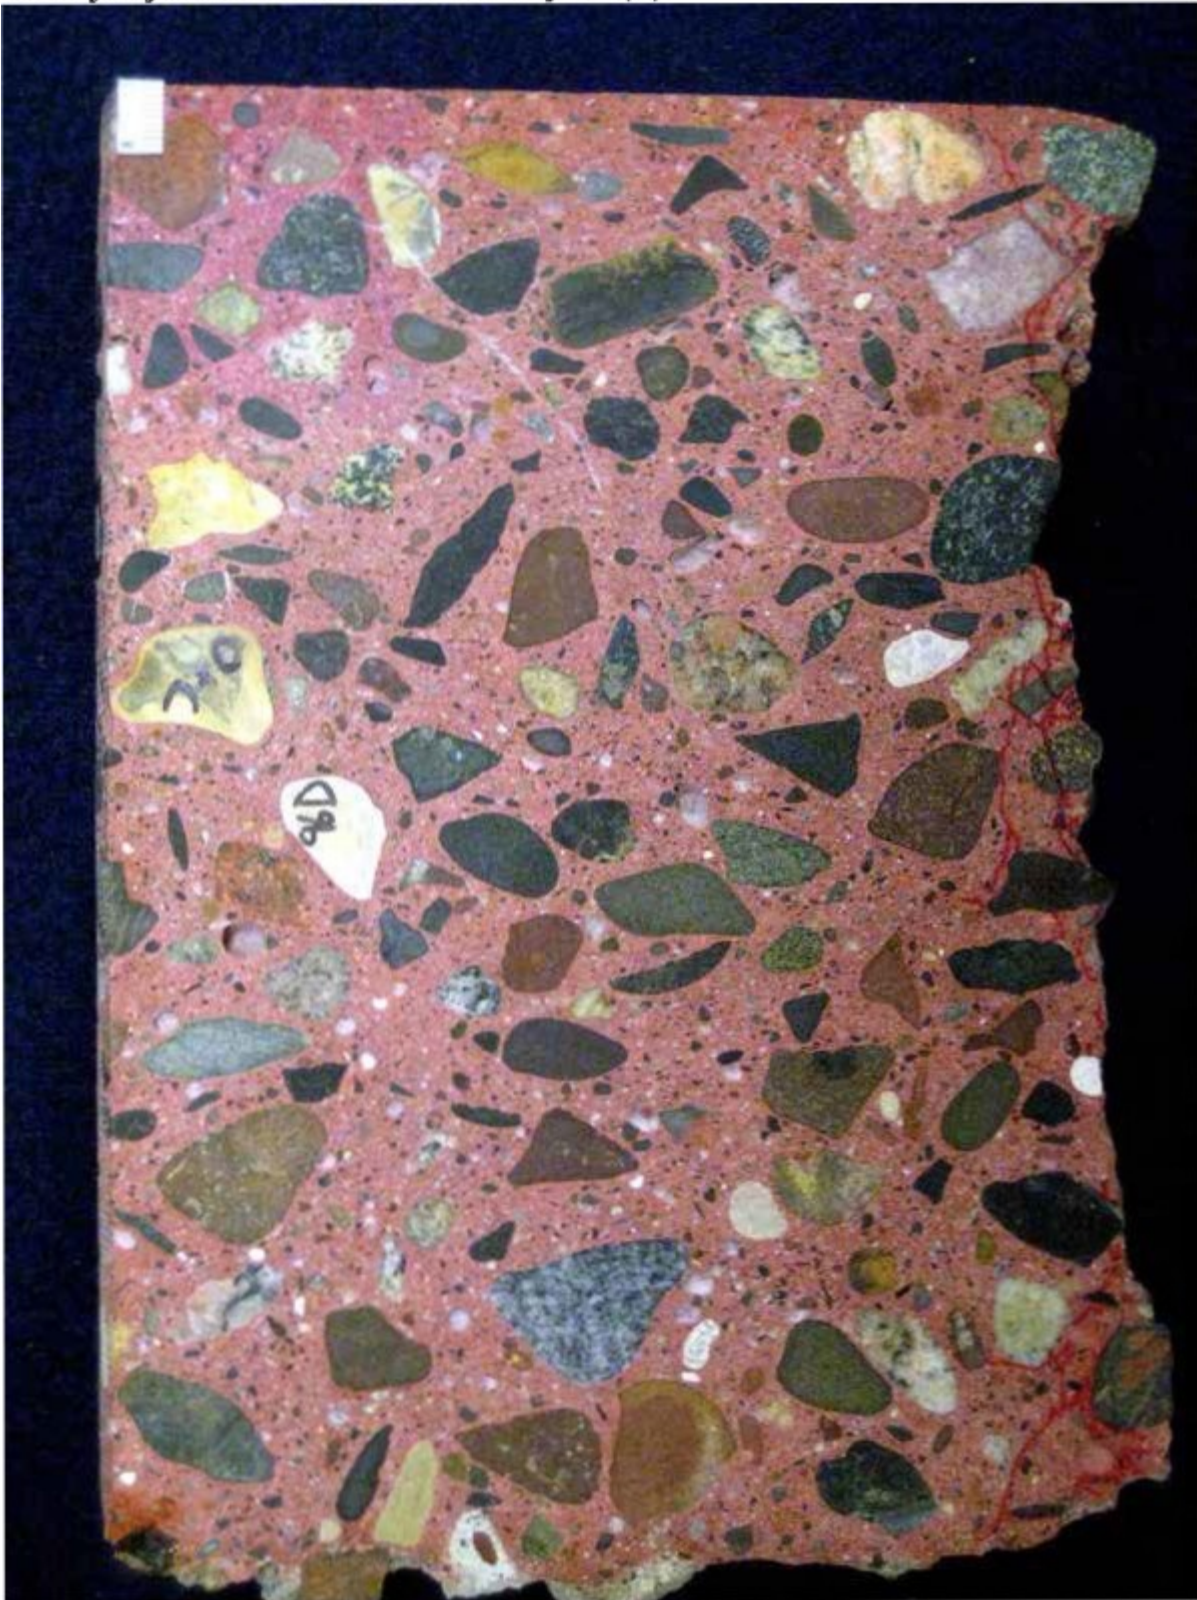
96D DESCRIPTION: Incipient spalling (microcracking mapped in red ink) adjacent to the spalled edge of the core. MAG: 5x

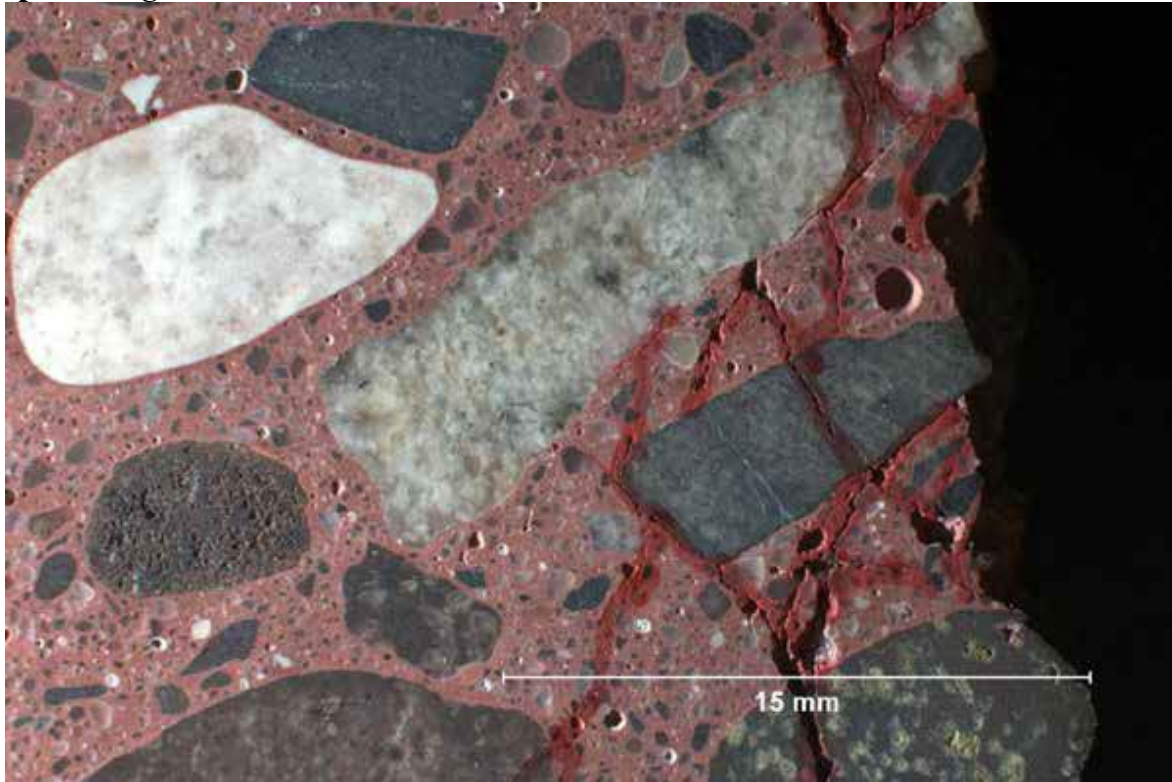
96D DESCRIPTION: The concrete contains little un-filled air voids adjacent to the spalled edge of the core. Image from 165mm depth in the core. MAG: 15x

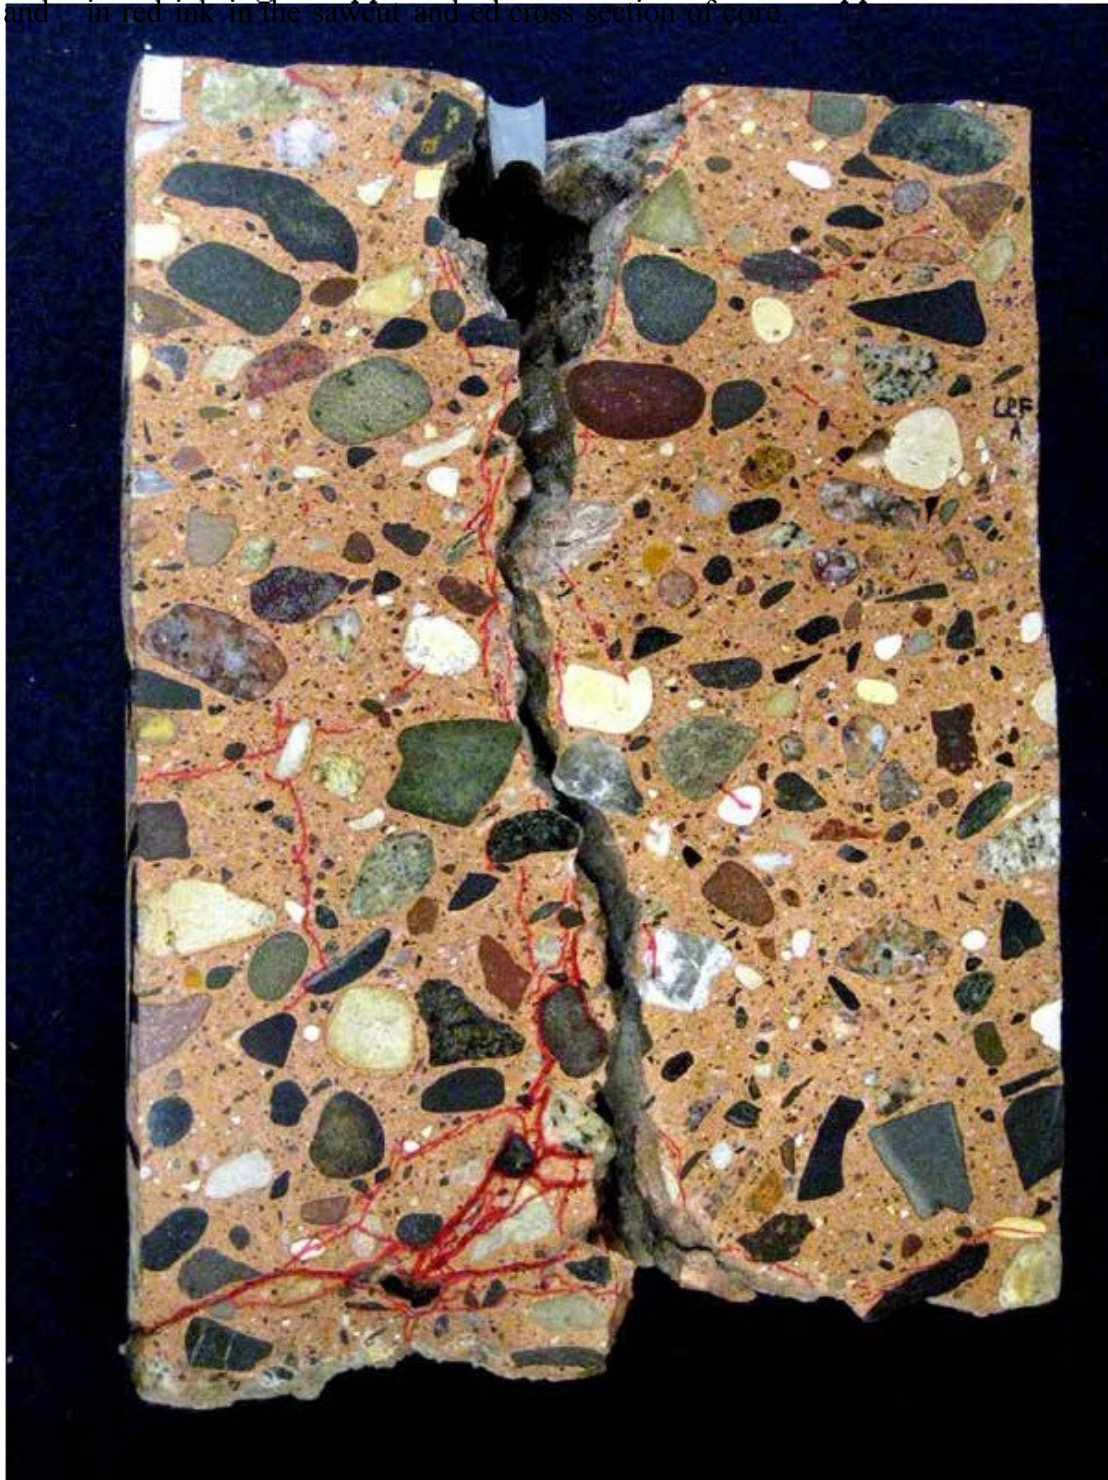
L&F A DESCRIPTION: Carbonation (unstained paste) proceeds up to 10mm depth from

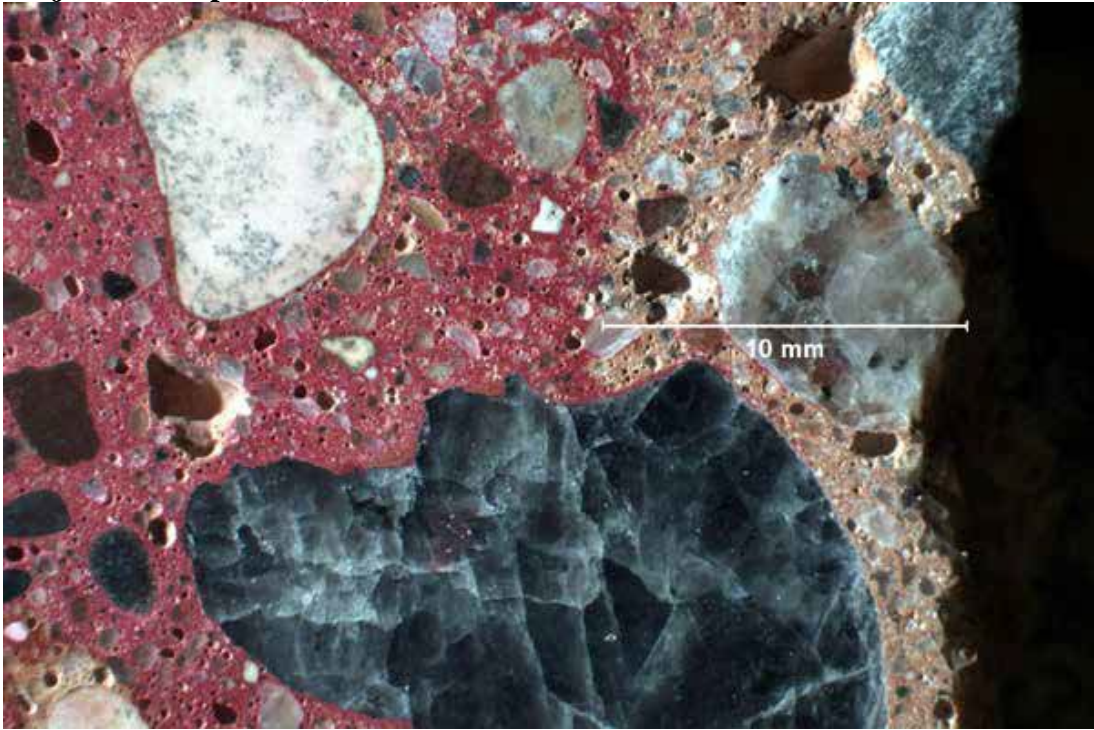
L&F A DESCRIPTION: The distressed outer 4mm of the concrete paste contain little un- filled air voidspace. MAG: 10x

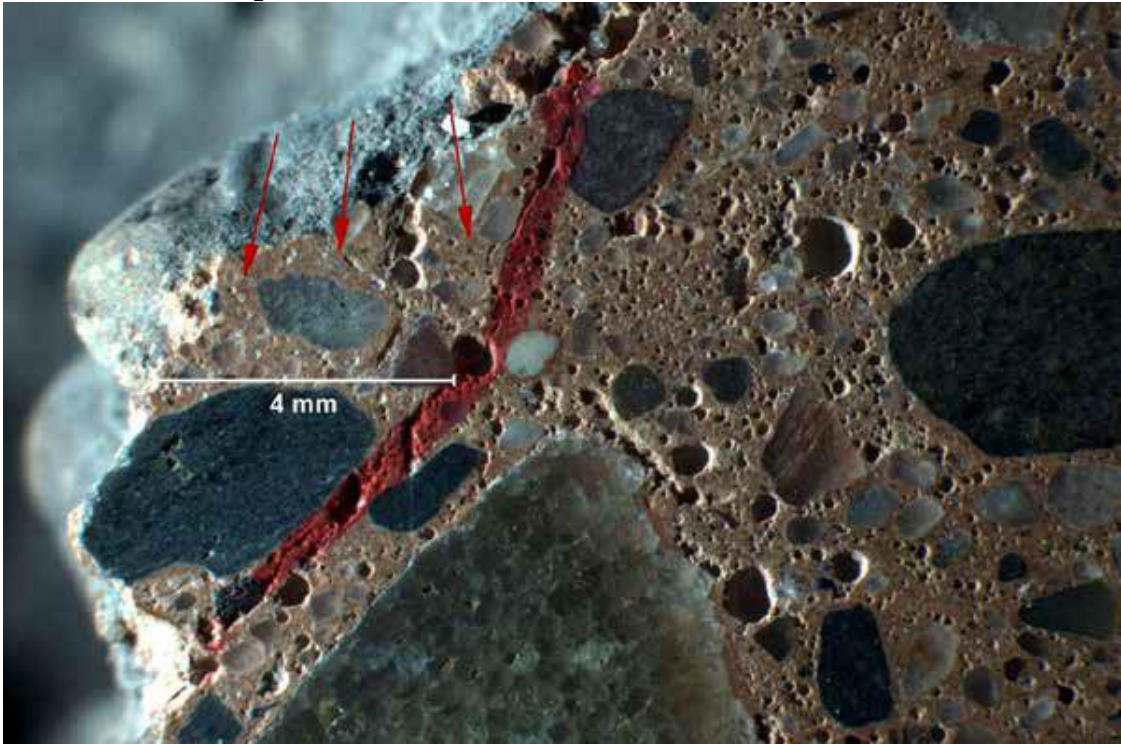
L&F A DESCRIPTION: Portions of the outer up to 10mm of paste directly adjacent to the distressed joint crack plane (R) are relatively soft. MAG: 10x

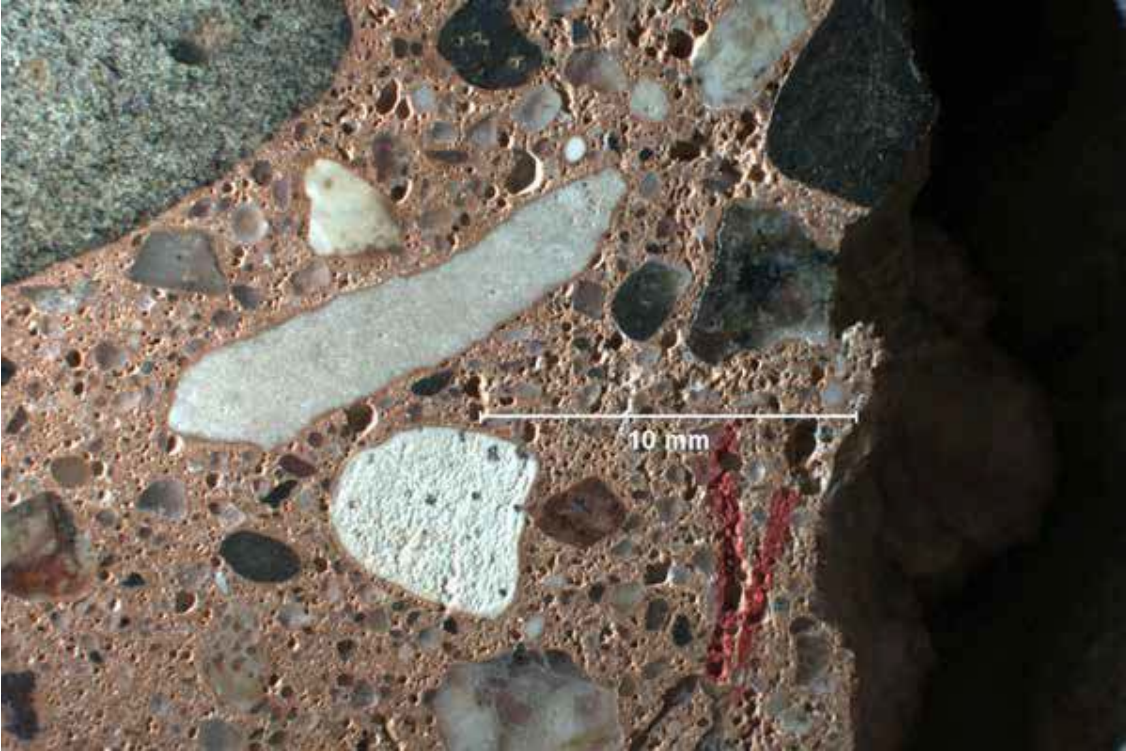
L&F A DESCRIPTION: Softer paste characterizing the outer 4mm of distressed concrete directly adjacent to the spalled joint surface at 15mm depth from the top surface plane. MAG: 10x

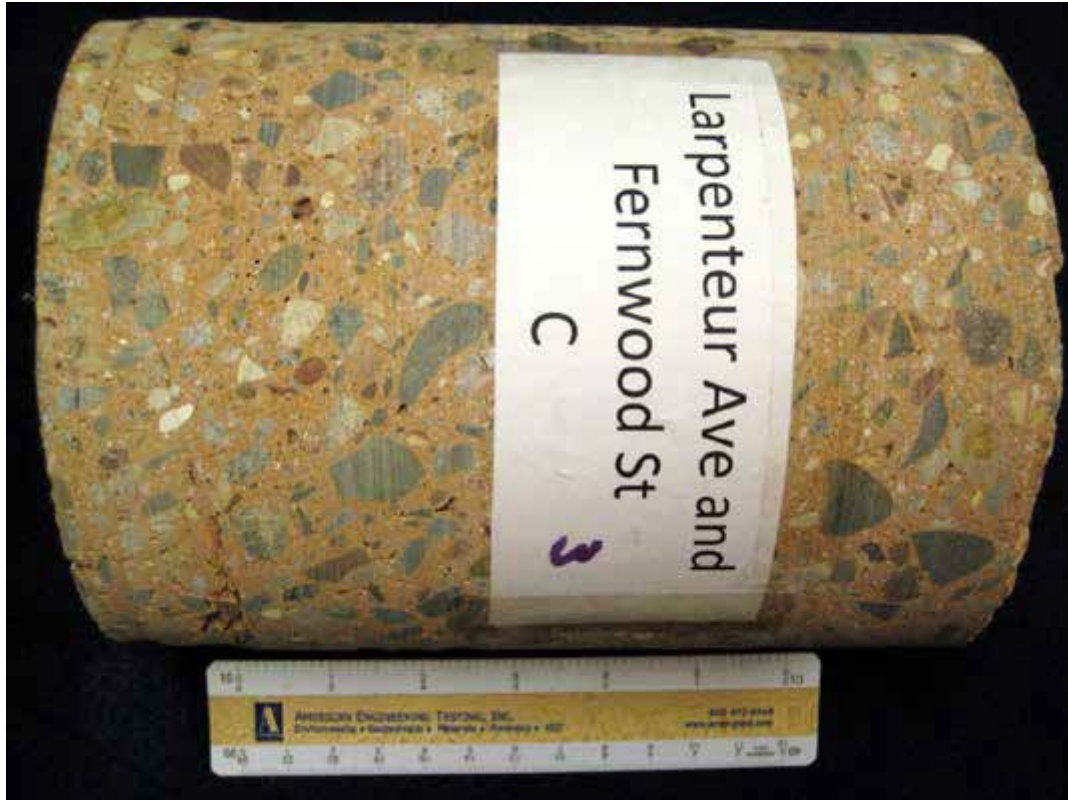
L&F C DESCRIPTION: Traffic-worn top surface of the core sample as received. Note cracking.

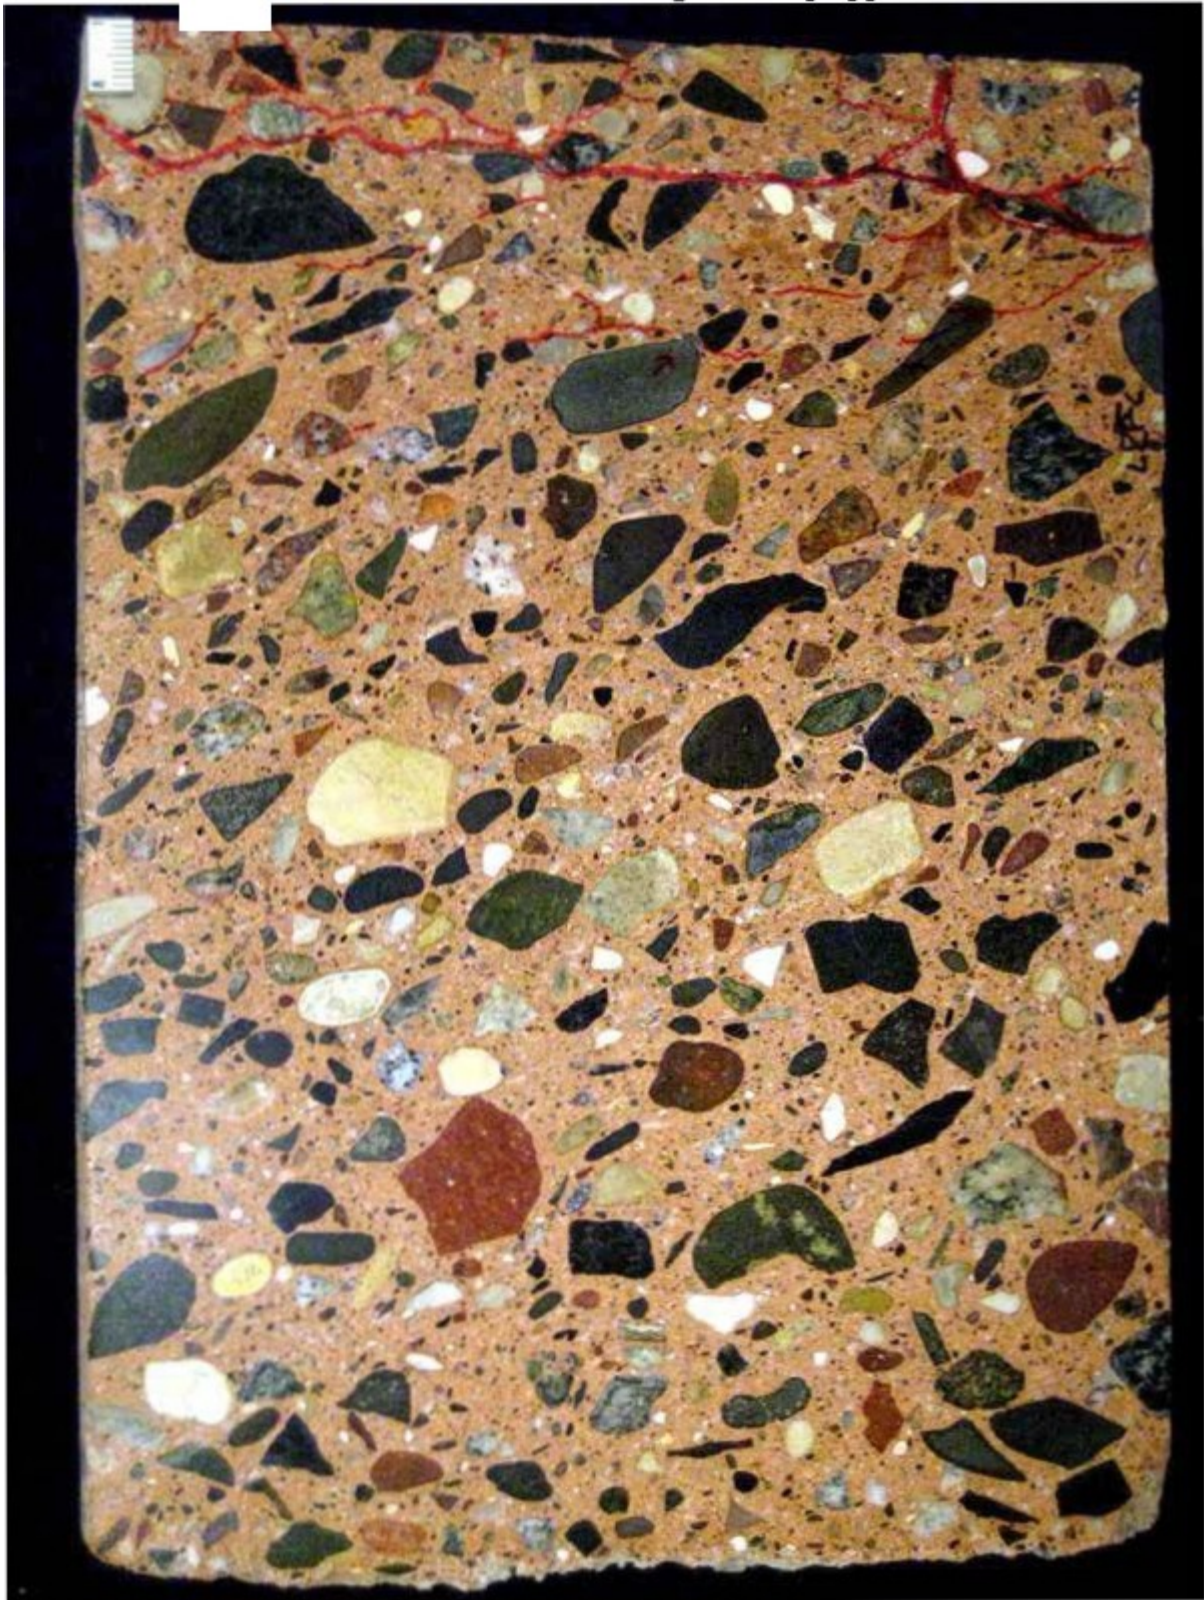
L&F C DESCRIPTION: Alkali-silica reaction (ASR) induced microcracking is mapped in red ink. The sub-horizontally oriented cracking is confined to the top 50mm and proceeds through several coarse and dozens of fine aggregates.

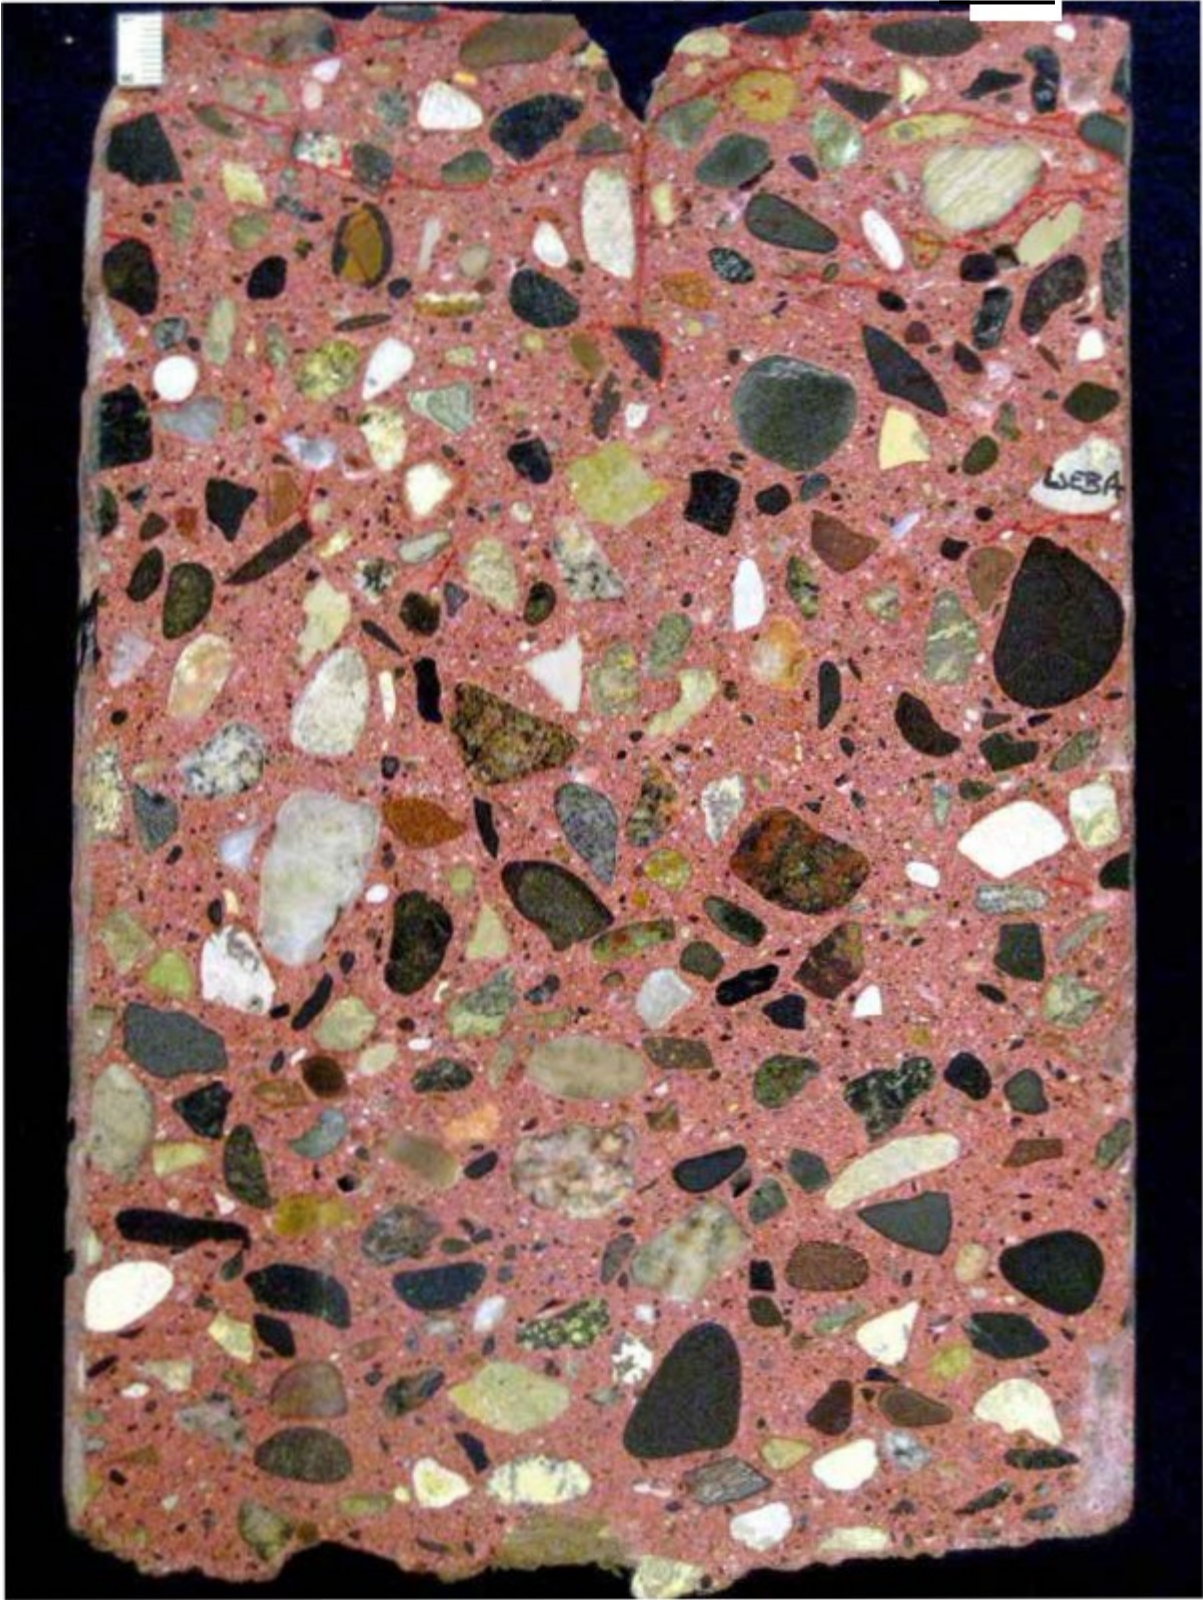
LJ EB A DESCRIPTION: ASR induced microcracking is mapped in red ink. The sub-horizontally oriented cracking is confined to the top 76mm and proceeds through several coarse and dozens of fine aggregates. Note un-activated, tooled, control joint.
