Investigation and Assessment of Colored Concrete Pavement

Minnesota
Department of
Transportation

August 2014

Research Project
Final Report 2014-26

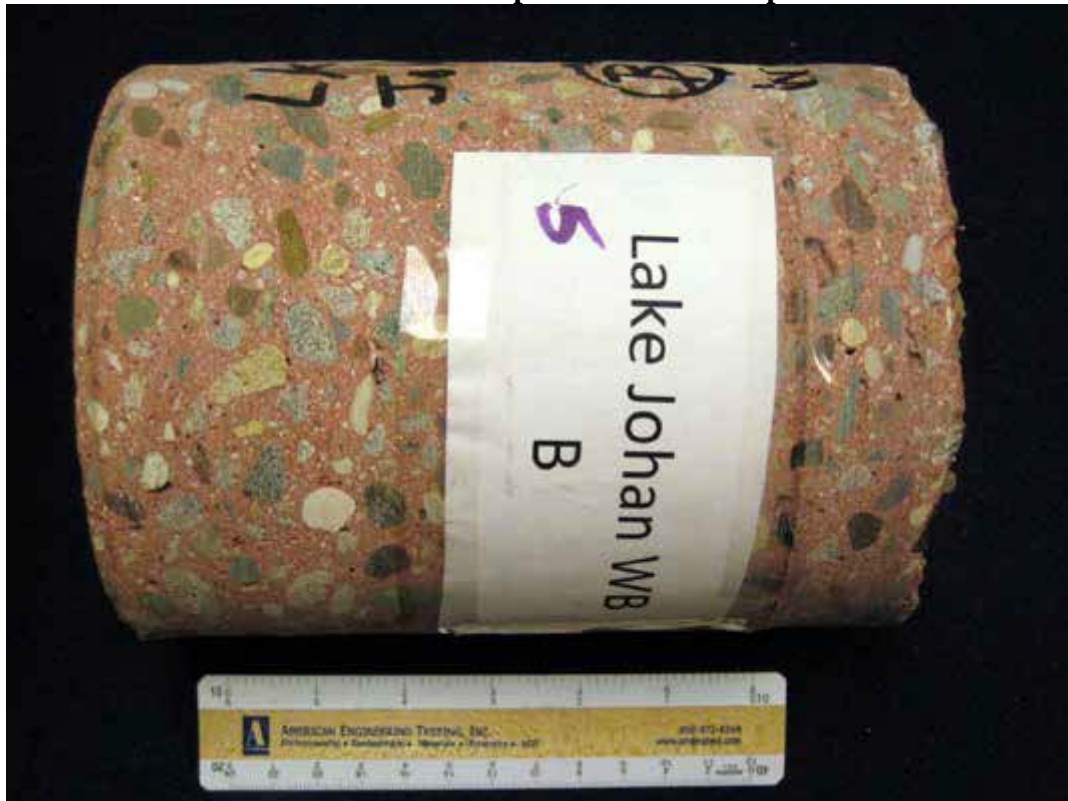
LJ WB B DESCRIPTION: Lightly textured and traffic-worn top surface of the core sample as received. Note spalling adjacent to un-activated joint.

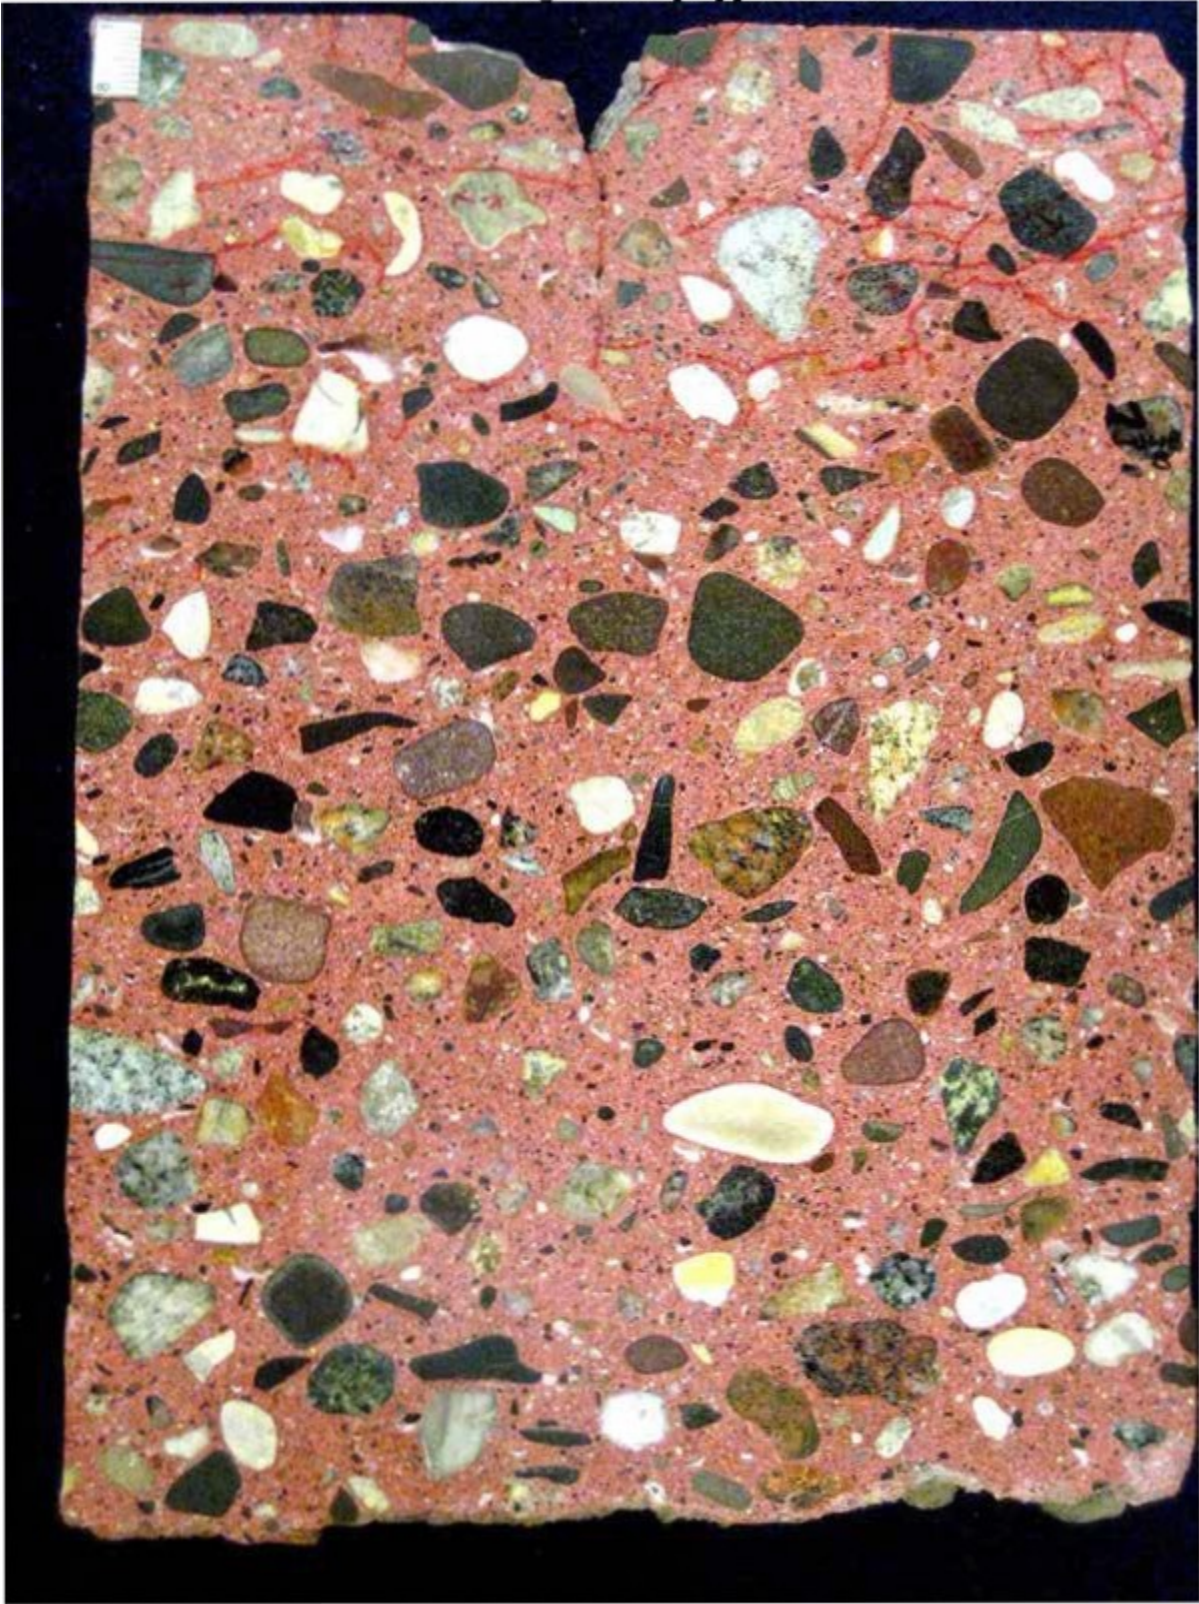
LJ WB B DESCRIPTION: ASR induced microcracking is mapped in red ink. The sub-horizontally oriented cracking is confined to the top 58mm and proceeds through several coarse and dozens of fine aggregates. Note un-activated, tooled, and spalled control joint.

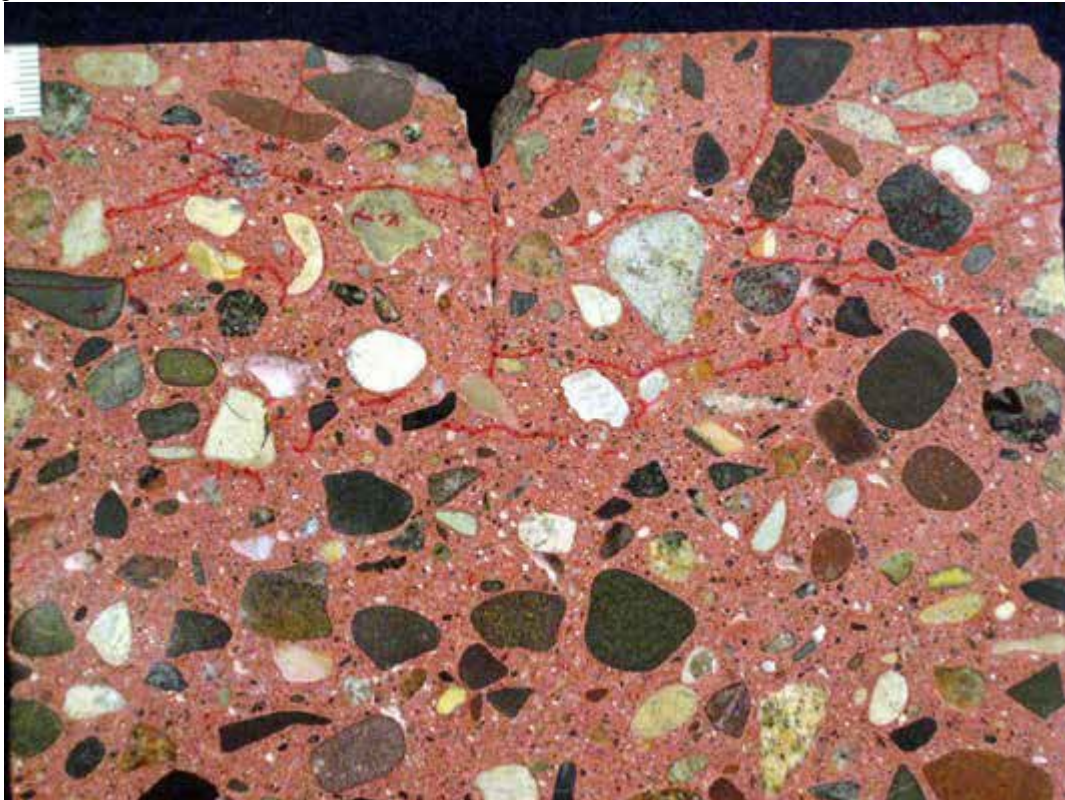
LJ WB B DESCRIPTION: Incipient spalling at the tooled joint occurs within a hard, sound and durable aggregate and is most likely a result of impacting. MAG: 5x

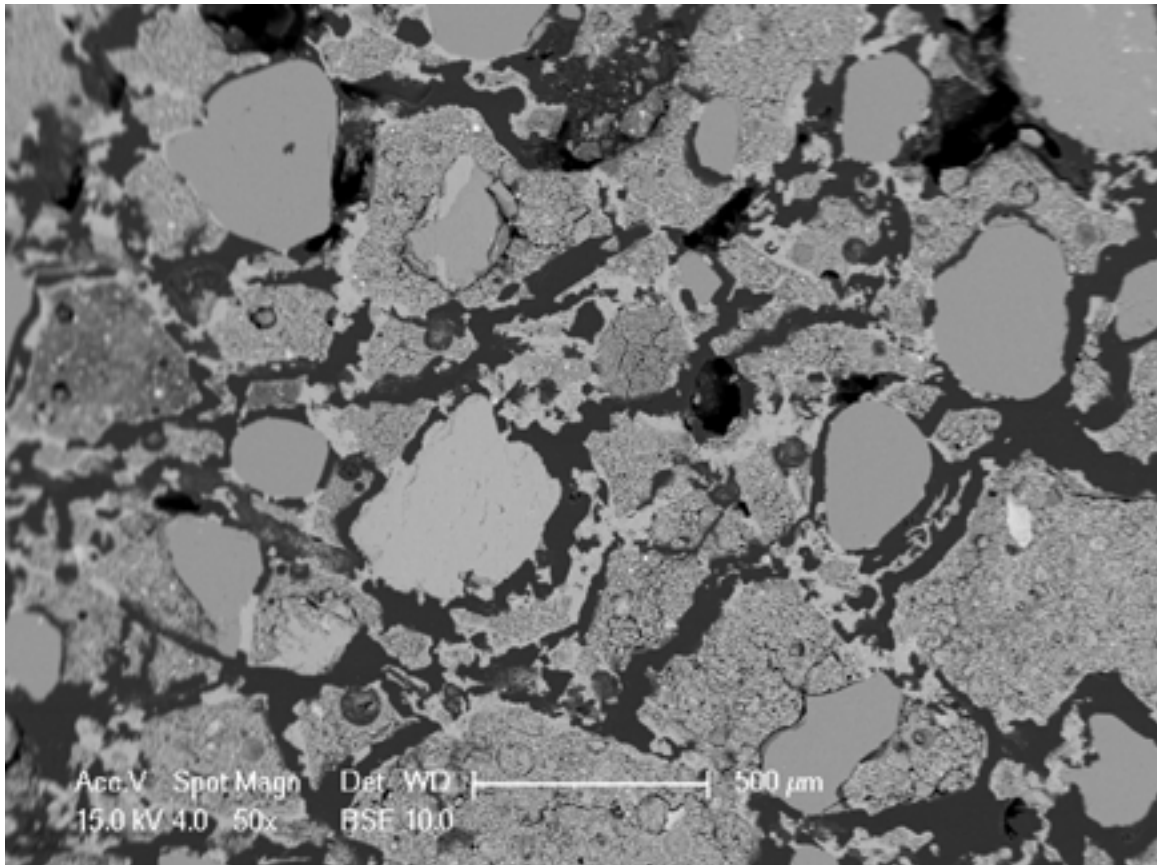
Figure 4. Backscattered electron image of badly cracked and weathered cement paste and aggregate at the joint. Specimen prepared from core sample 96A.
