# Aggregate Road Surface Rejuvenation

Charles Jahren, Principal Investigator  
Department of Civil, Construction, and Environmental Engineering  
Construction Management and Technology, Institute for Transportation  
Iowa State University

**April 2015**

Research Project  
Final Report 2015-04

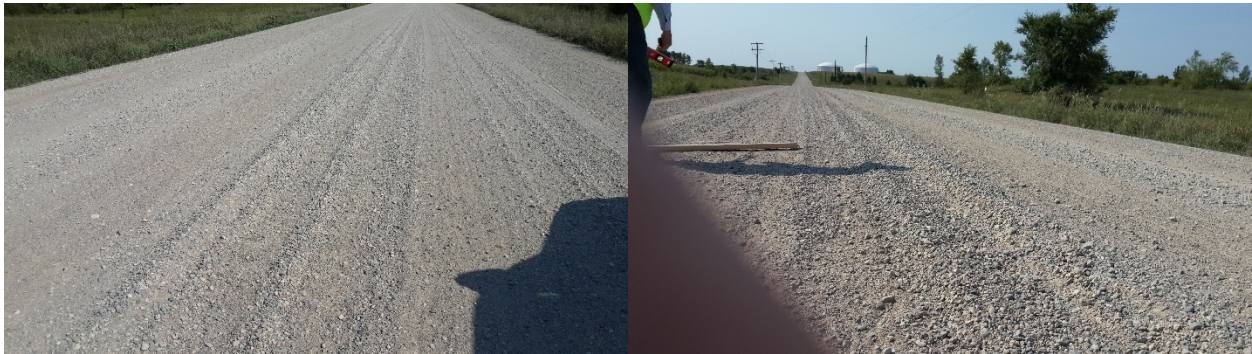
**Figure 1. Excessive Floating Aggregate on Pope County CR 35 July 2013**

Numerous problems stem from having excessive loose aggregate on the road surface. The loose aggregate tends to accumulate outside of the wheel paths, forming ridges. The ridge pairs provide water channels that retain water. Water retention is believed to be one of the major causes for distresses and failure of a gravel road. Crust formed on the surface will be softened, leading to rutting and potholes (Skorseth and Selim 2000). In addition, excessive loose aggregate compromises the comfort and quality of the ride, impairing the safety of road users under some severe circumstances.

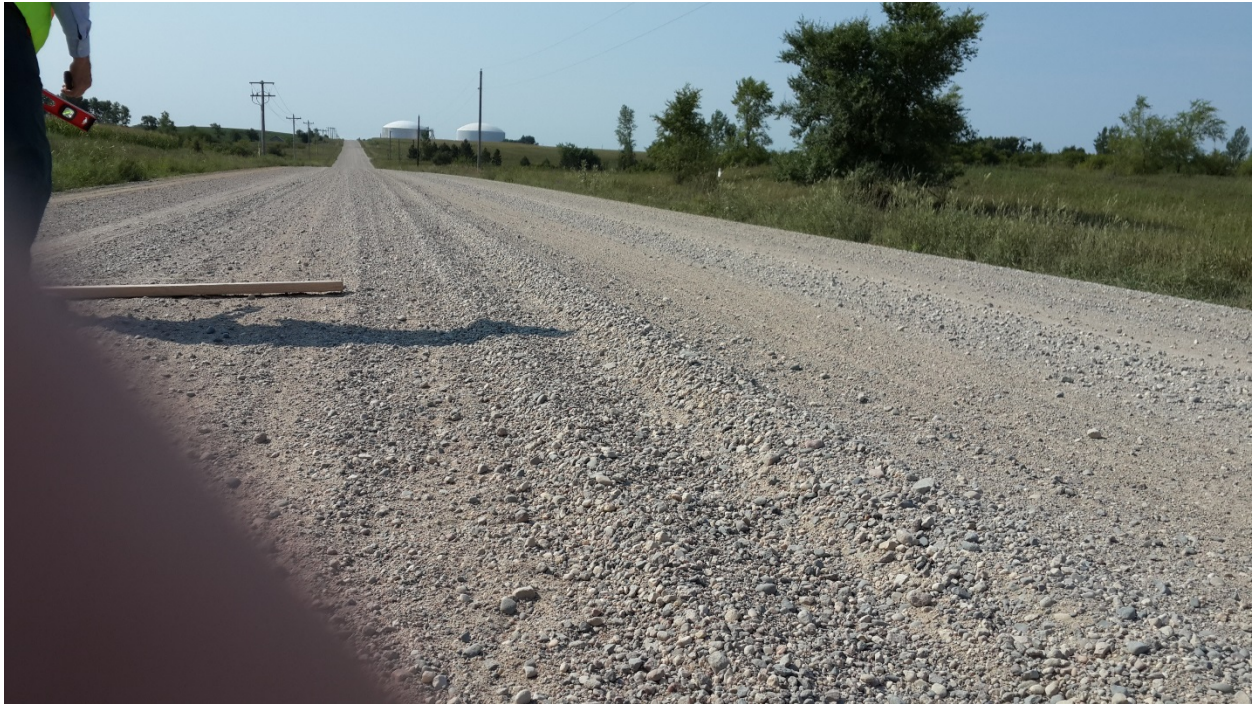
The research team visited Pope County in July 2013. CR 35 was considered a typical road section that has a considerable amount of floating aggregate (see Figure 15). The volume of floating aggregate was estimated to be 307.24 tons per mile based on an estimate involving the scrape test.

**Figure 15 Floating Aggregate on CR 35 in Pope County**

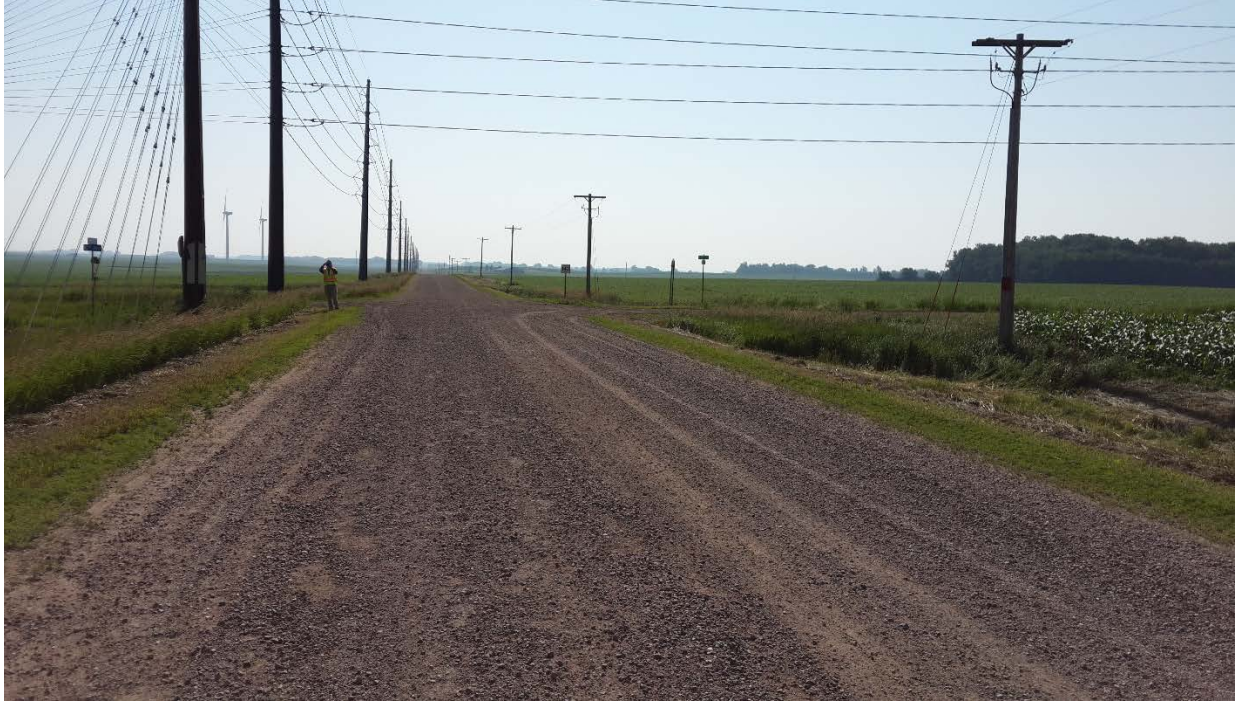
**Figure 16. Jackson County CR 76 Surface Conditions in July 2013**

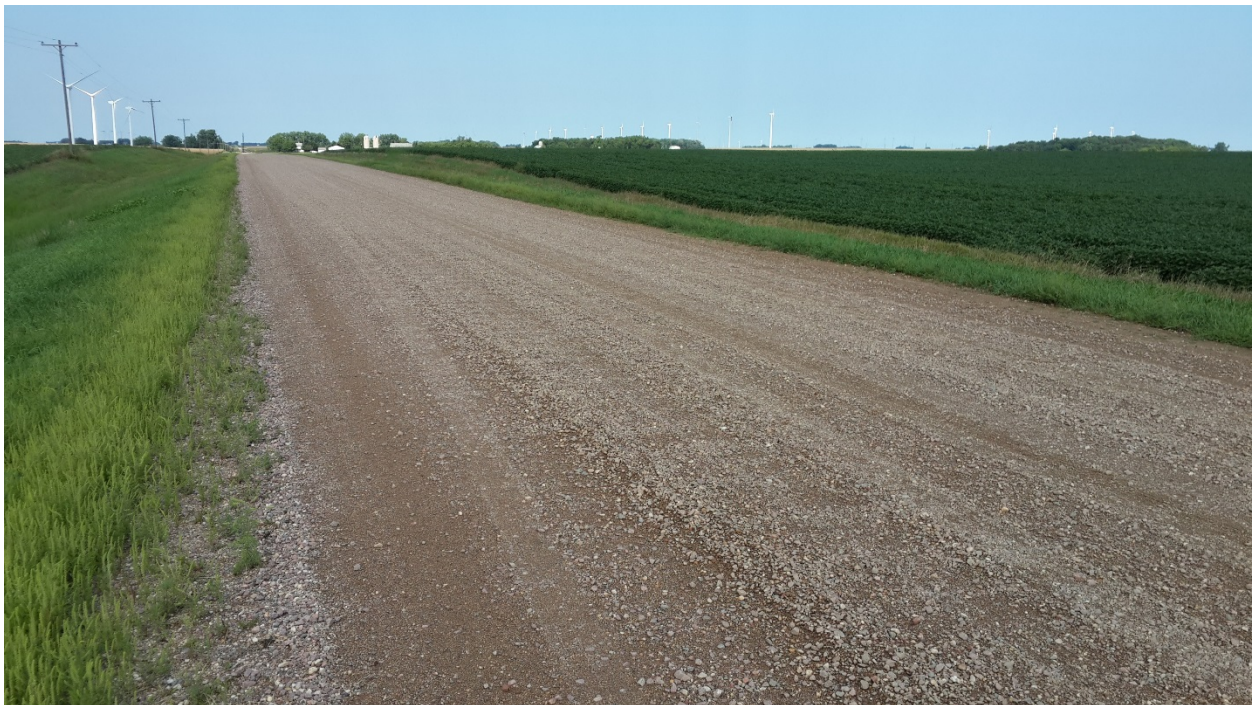
**Figure 17. Jackson County CR 76 Surface Conditions in August 2013**

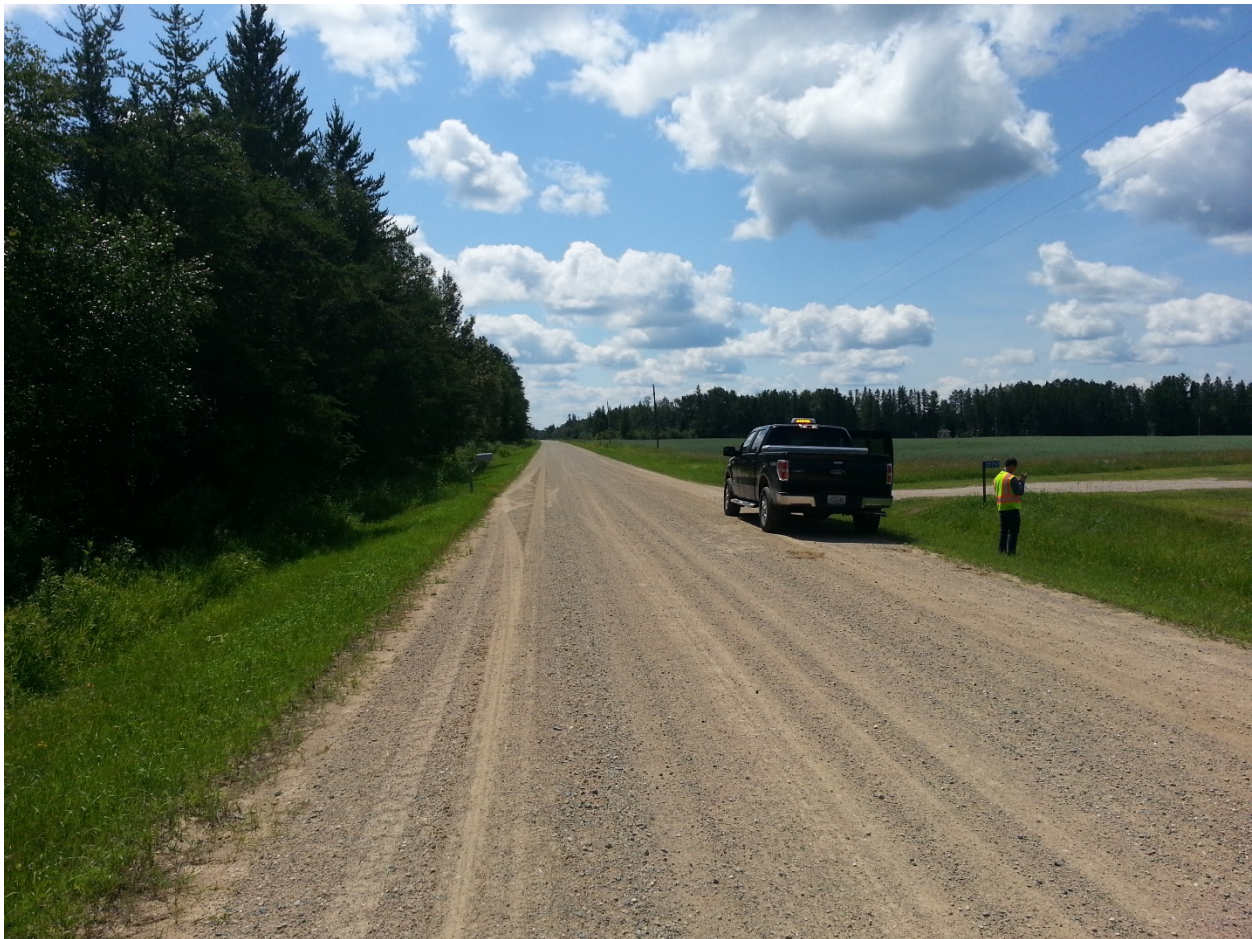
The research team visited the Beltrami County CR 23 test site in July before construction. The floating aggregate problem was not pronounced, as shown in Figure 18, although there was scattered floating aggregate.

**Figure 18. Beltrami County CR 23 Surface Conditions in July 2013**

Floating aggregate tonnage was estimated to be 91.3 tons per mile according to estimates based on scrape test results. The road did not comply with typical crown slope recommendations.

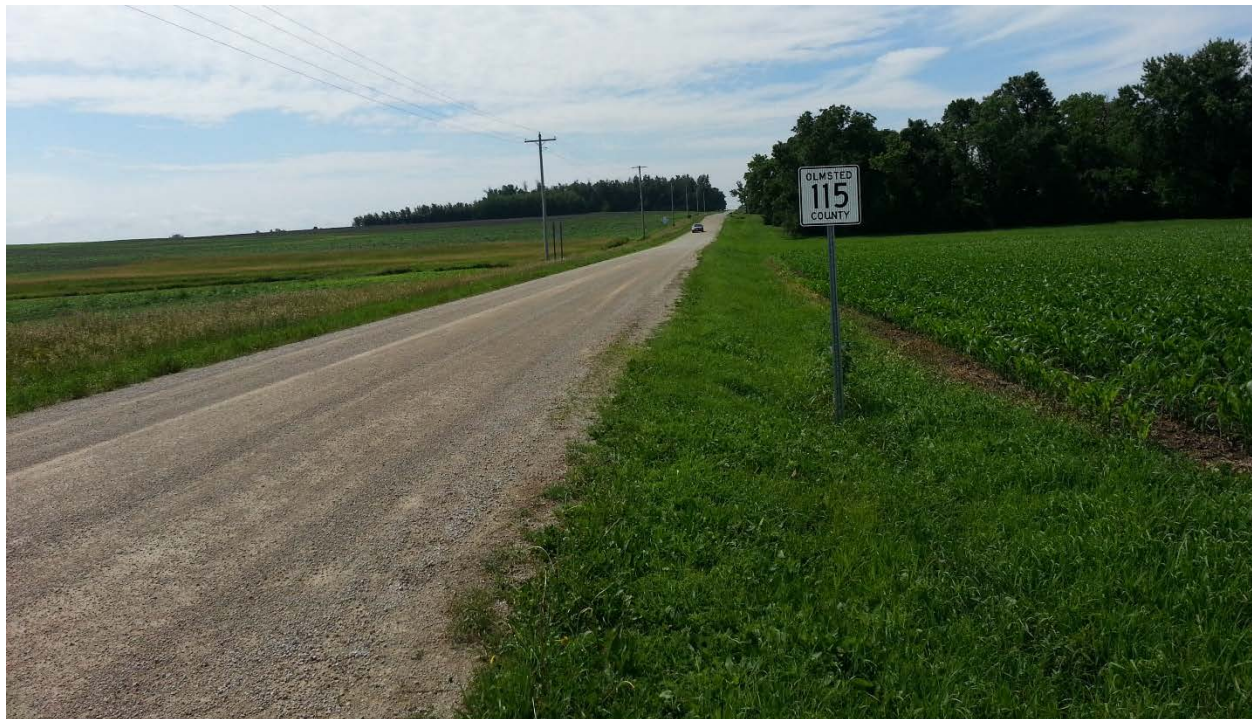
The research team visited the Olmsted County CR 115 test site in July before construction. A small amount of floating aggregate was present on the road. Wheel paths are clearly seen in Figure 19. The wheel paths are highly compacted and had the appearance of an aged pavement.

**Figure 19. Olmsted County CR 115 Surface Conditions in July 2013**

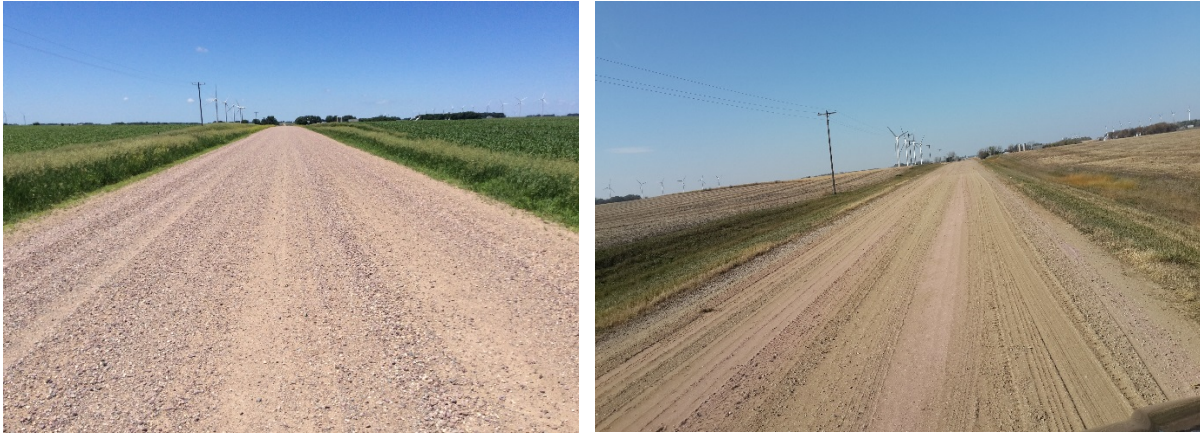
**Figure 38. Jackson County CR 76 Seven Months after Construction**

Both experimental sections appeared to have failed to provide the desired performance.

Scrape test results seven months after construction indicated an estimated 96.99 tons per mile of loose aggregate on the surface of the Middle/Second Section (which had 12 tons of crusher dust added) and 96.53 tons per mile of loose aggregate on the surface of the East/Third Section (which had 7 tons of crusher dust added). These loose aggregate estimates were 40 percent higher than that on the surface of the West/First (control) Section (which had 19 tons of Class 5 aggregate added). A trace of crusher dust was visible in the Middle/Second Section.

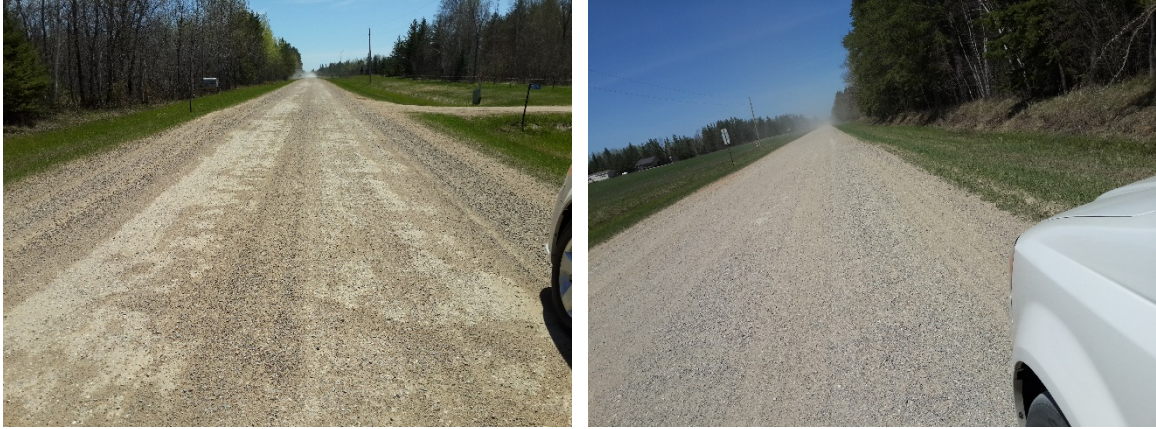
The first follow-up visit to the Beltrami County test sections was May 23, 2014, approximately six months after construction. The North/First (control) Section (which had 166 tons of Class 1 Standard Material added) and Middle/Second Test Section (which had 83 tons of crusher dust added) were holding up in a satisfactory manner, as shown in Figure 49.

**Figure 49. Beltrami County CR 23 North/First (Control) Section (left) and Middle/Second Test Section (right)**

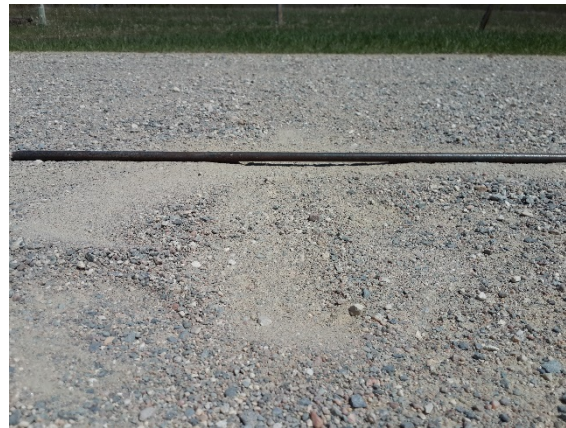
**Figure 50. Typical Corrugation in the Beltrami County South/Third Test Section**

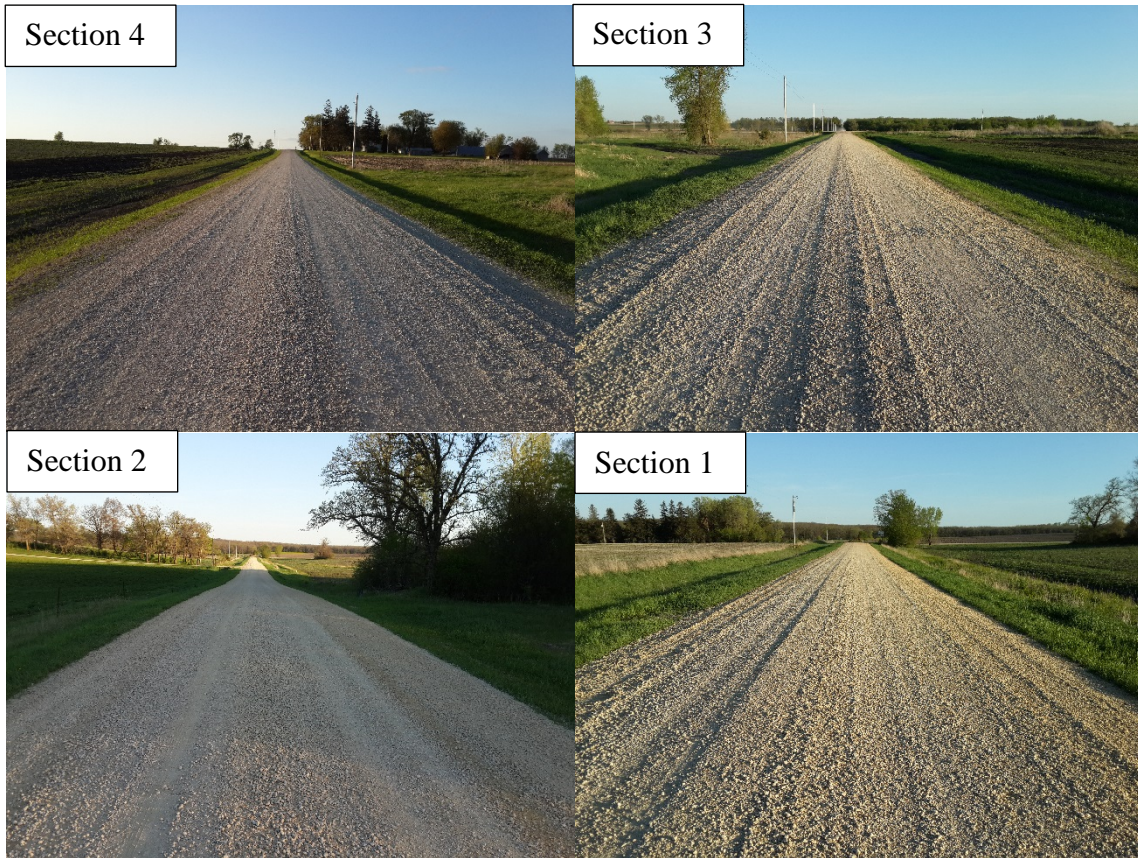
**Figure 60. Olmsted County CR 115 Test Section Surfaces**

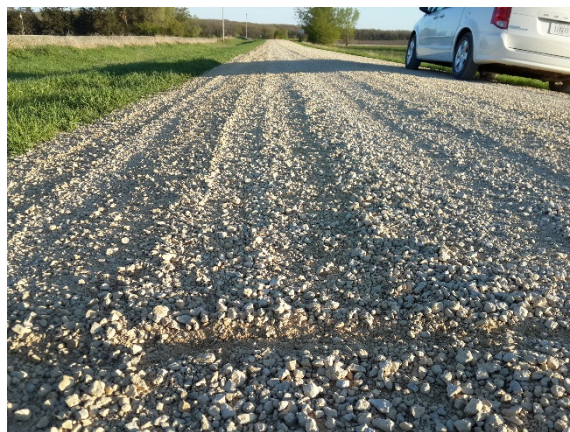
**Figure 61. Extensive Floating Aggregate on the Surface of the Olmsted County CR 115 First South (Experimental) Section**
