# Construction Report for a Thin Unbonded Concrete Overlay on Minnesota TH 53

Minnesota  
Department of  
Transportation

Research Project  
Interim Report #2010-23

## **Interim Report**

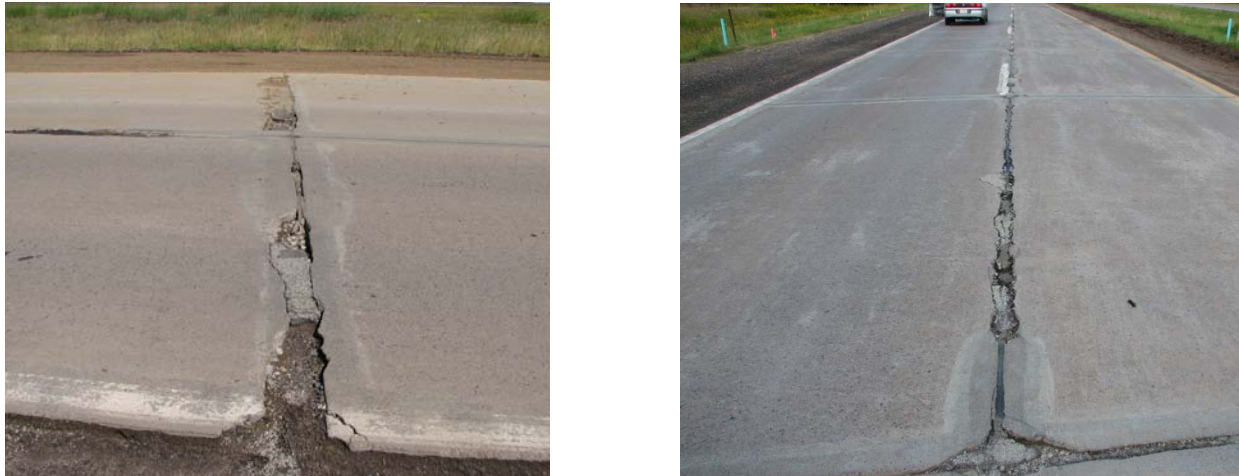
Prior to overlay construction, the pavement had received two concrete pavement repair (CPR) operations, which included joint sealant removal and replacement in 1983 and joint repair in 1992. Figure 3.4 shows transverse and longitudinal joint condition prior to overlay placement in 2008 (note that the repair treatments are still visible). Some joints had deteriorated down to the base material.

Figure 3.4. Typical Transverse and Longitudinal Joint Condition Prior to Overlay

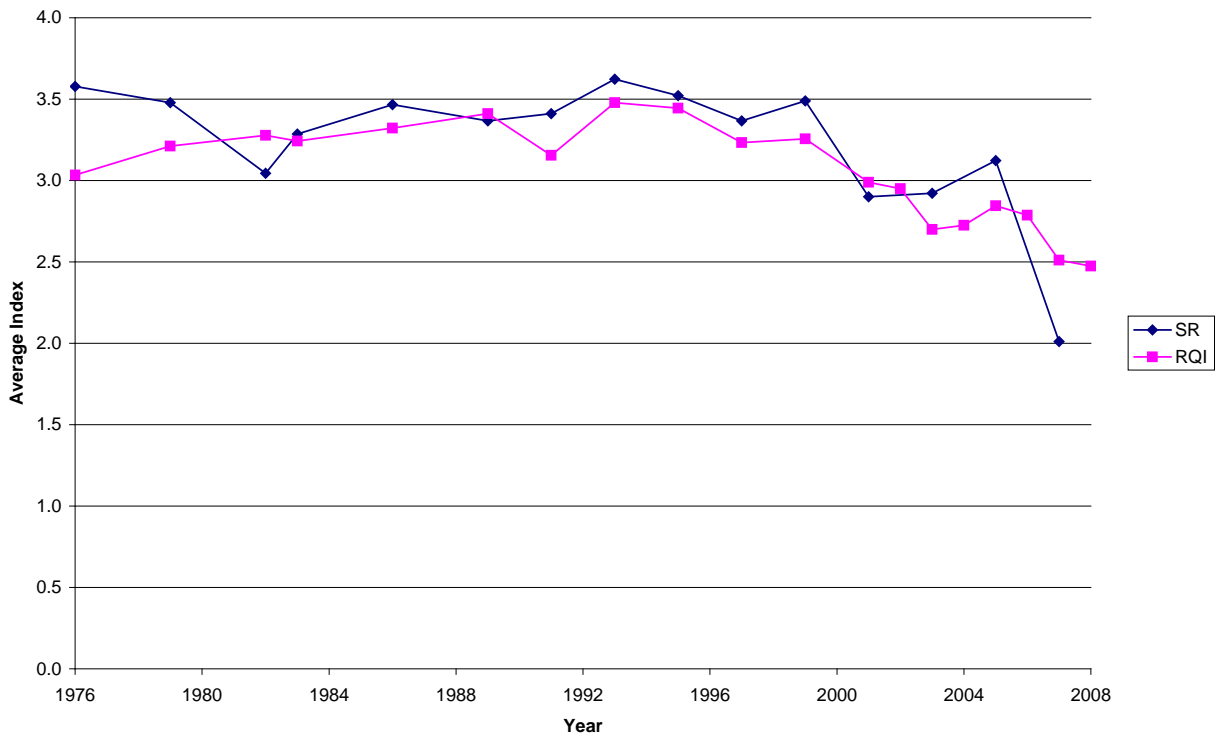
Pavement performance data on ride and distress has been gathered routinely on the trunk highway (TH) system in Minnesota since 1976. Two important measures gathered are the surface rating (SR), which is a rating of visual distresses on a scale of 0.0 to 4.0 (a 4.0 represents a road with no visible distresses), and ride quality index (RQI), which is an indication of pavement roughness on a scale of 0.0 to 5.0, as described in Table 3.1. Figure 3.5 shows the average surface rating (SR) and ride quality index (RQI) recorded by the Mn/DOT Pavement Management Section for TH 53. Note that just prior to the concrete overlay, the RQI had deteriorated to a “fair” condition, and the SR had deteriorated to a level of 2.0, which is lower than the commonly accepted default threshold value of 2.5 or “fair condition”.

Figure 3.5. Average Pavement Condition Prior to Overlay

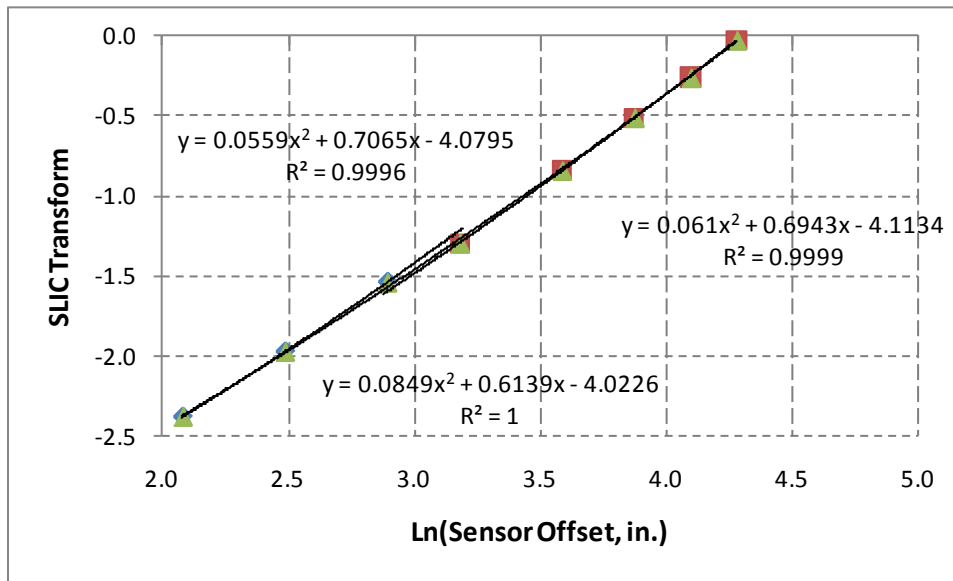
linear or concave down. Also, there is a slight jog in the plot line between the third and fourth SLIC plot point indicating a slight discontinuity in the deflection basin. This discontinuity also shows up between the same sensors when comparing the measured and backcalculated deflection basins. The source of this slight discontinuity cannot be determined until SLIC results of deflections by this FWD using the same setup is evaluated. If it remains over several different pavement types, it is from the machine, but if not, it is a pavement response characteristic. The unbound concrete section (very stiff over thin soft over very stiff) might be the source.

Figure 4.2. SLIC Check of Mid-Panel Deflection Data

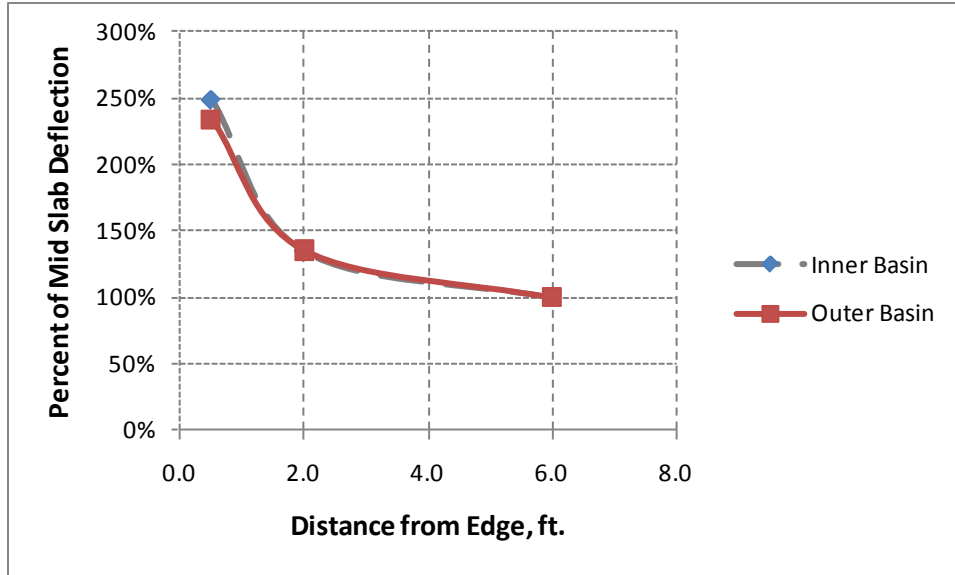
The mid-panel deflections tend to be lower than the deflections at the edges of the slab. The two plots in Figure 4.6 show the deflections increase as the load moves from the center of the slab toward the edge. The ‘Inner Basin’ plot comparison is for the sensors 0 to 24 inches from the center of the load and the ‘Outer Basin’ plot compares the deflections from the sensors 36 to 72 inches from the center of the slab. Both the inner and outer part of the basin increase about the same amount with the inner part increasing slightly more than the outer part. This infers that much of the increase is due to the combined effect of being closer to the edge and less support under the edge of the slab.

The critical loading locations for conventional concrete pavements are at the corners and edges. This unbonded pavements also had the highest deflections at the corners and edges, but the deflections are lower. The average corner deflections under the load plate are about 2.75 times greater than that measured at the center of the slabs. There were a couple center lane joint tests and the deflections there were similar to that measured at the center of the slab. The deflection difference between the center of the load plate was actually smaller than measured mid-slab, possibly due to higher slab temperatures at the surface during mid-day August testing.

Figure 4.6. Comparison of the Deflections by Distance from Center of Slab

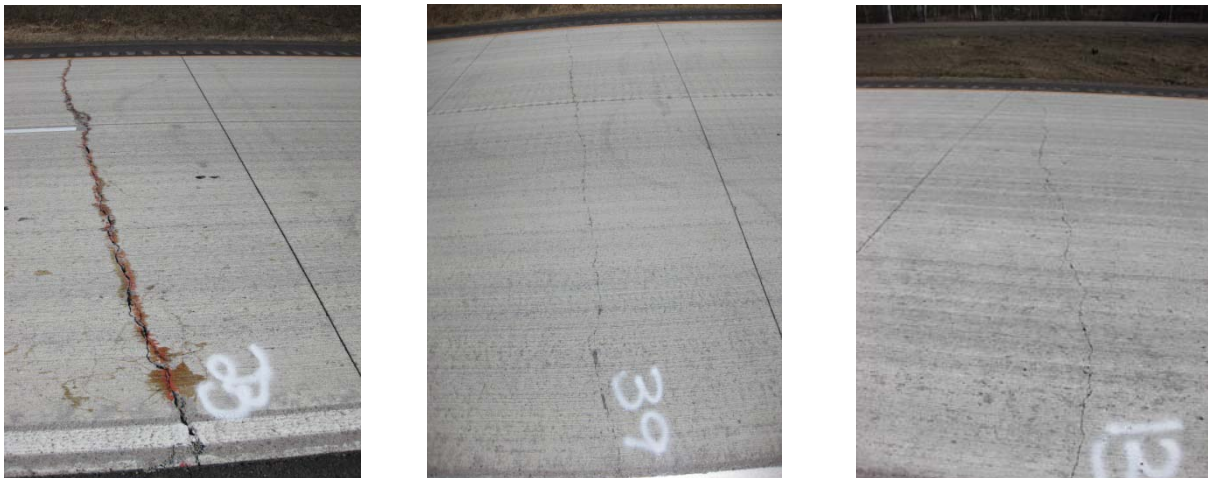
In spring 2009, a detailed visual distress survey was carried out (over the entire 9+ project length) to ascertain both the number and condition of distresses present in the overlay after the first winter. The survey found that approximately 40 cracks had formed in the overlay, with severity ratings of: 7% high, 41% medium, and 51% low. Figure 5.2 shows a qualitative depiction of the different severity levels.

Figure 5.2. From Left to Right: High (3), Medium (2) and Low (1) Severity Cracking

Based on the random occurrence of the transverse cracks through the panels, it is deduced they were likely caused by late sawing of the joints. It seems that paving the thin concrete overlay progressed much faster than the capabilities of the sawing equipment on site. The higher surface to thickness ratio of the overlay also presented additional challenges in timing the saw cuts. The skewed nature of some of the cracks (Figure 4.3, rightmost photo) leads one to believe they are more reflective in nature. In addition to transverse cracking through the panels, the fall 2009 survey also revealed the presence of other distresses, notably joint spalling, which was again most likely caused by improper timing (early) of the joint sawing. It should be noted that no mid panel cracks have appeared in the overlay section with 6-foot by 6-foot panels.

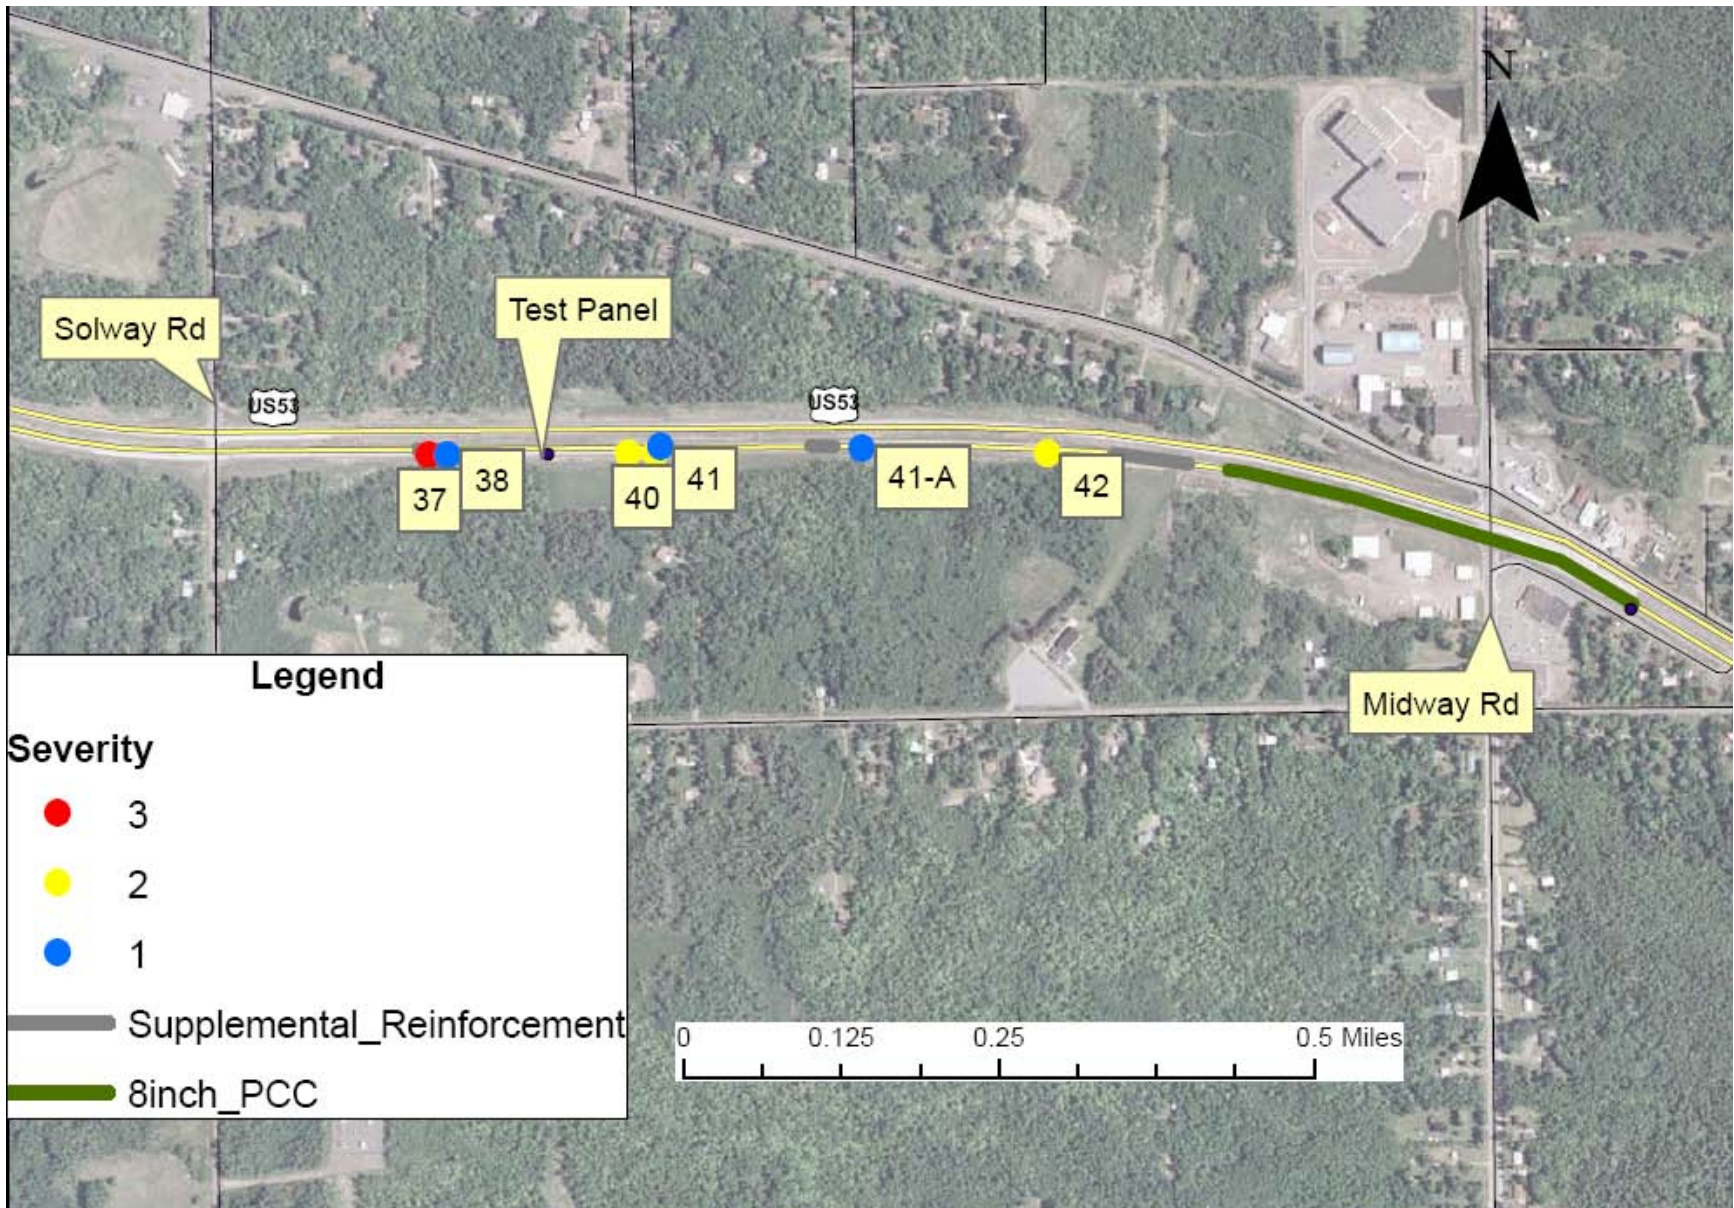
Figure 5.3 to Figure 5.7 show the locations of surface distresses observed during the second distress survey, conducted in August 2009. The distresses were visually rated for severity (Figure 5.2). Note that 3, 2 and 1 denote high, medium and low severity cracking, respectively. Each crack was assigned an I.D. number that can be used to reference a picture of the distress in Appendix A. These figures also show locations of the full depth (8-inch thick) concrete pavement sections constructed on TH 53, and the approximate locations of the supplemental panel reinforcement installed over excessively cracked portions of the original concrete pavement. Note that the fall survey was only conducted on half of the project length, due to restrictions that arose from construction of a similar TUBOL on the adjacent northbound lanes of TH 53.

Figure 5.3. TH 53 Distress Map [Midway Rd to Solway Rd], April 2009 (Farm Service Agency, 2002)

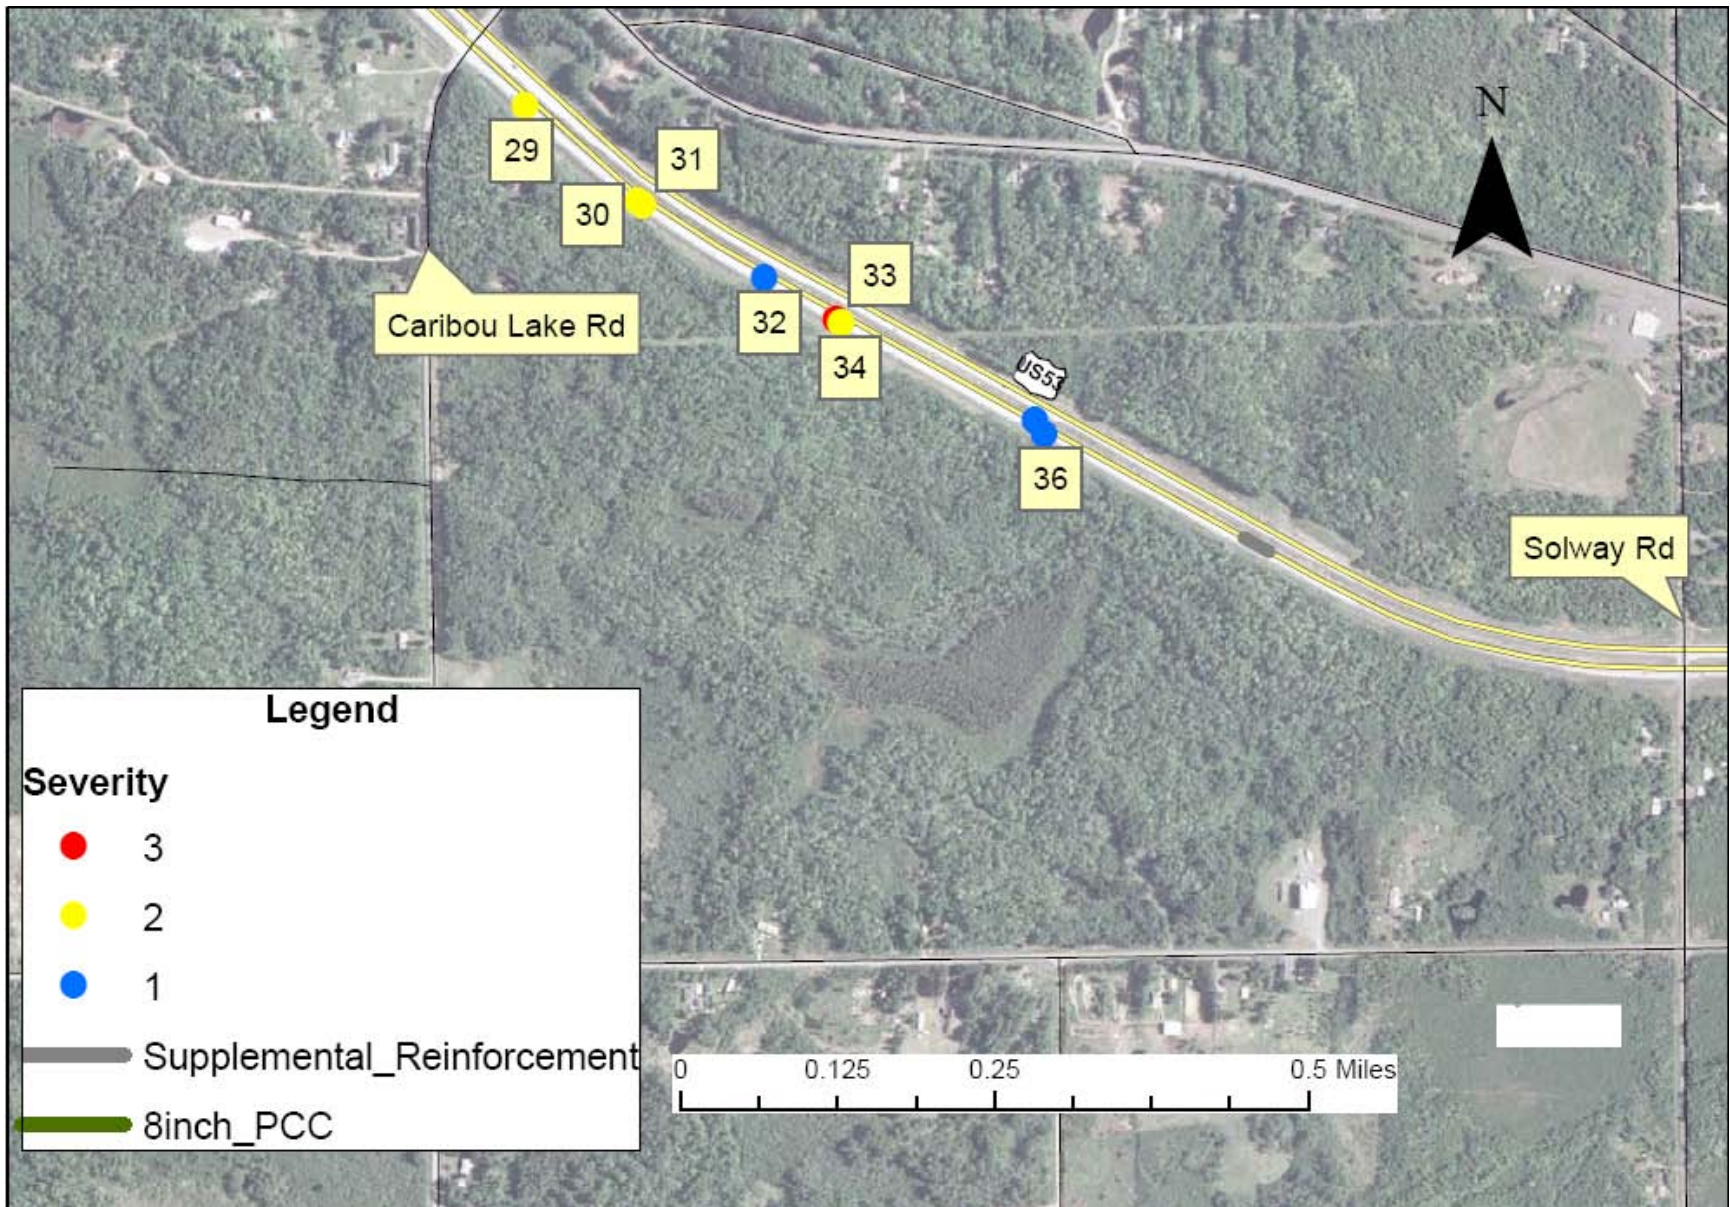
Figure 5.4. TH 53 Distress Map [Solway Rd to Caribou Lake Rd], April 2009 (Farm Service Agency, 2002)

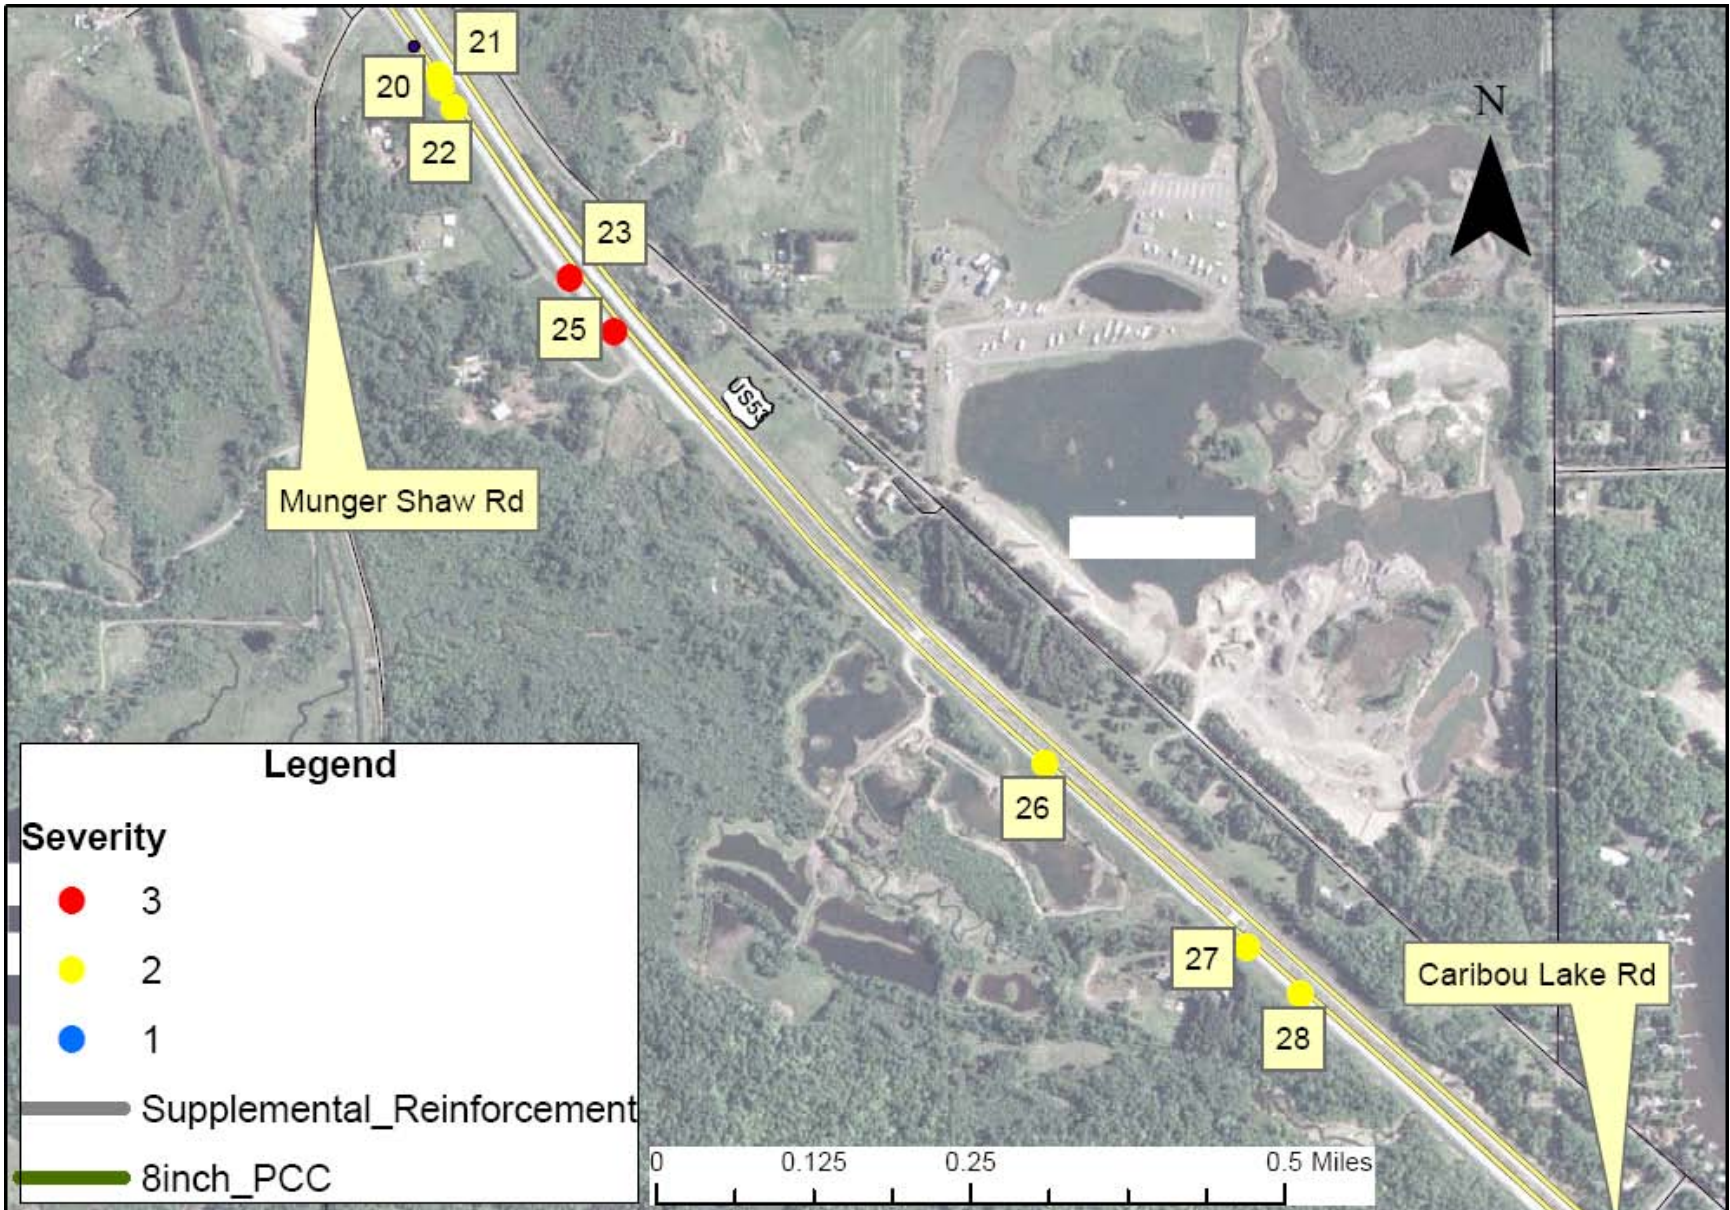
Figure 5.5. TH 53 Distress Map [Caribou Lake Rd to Munger Shaw Rd], April 2009 (Farm Service Agency, 2002)

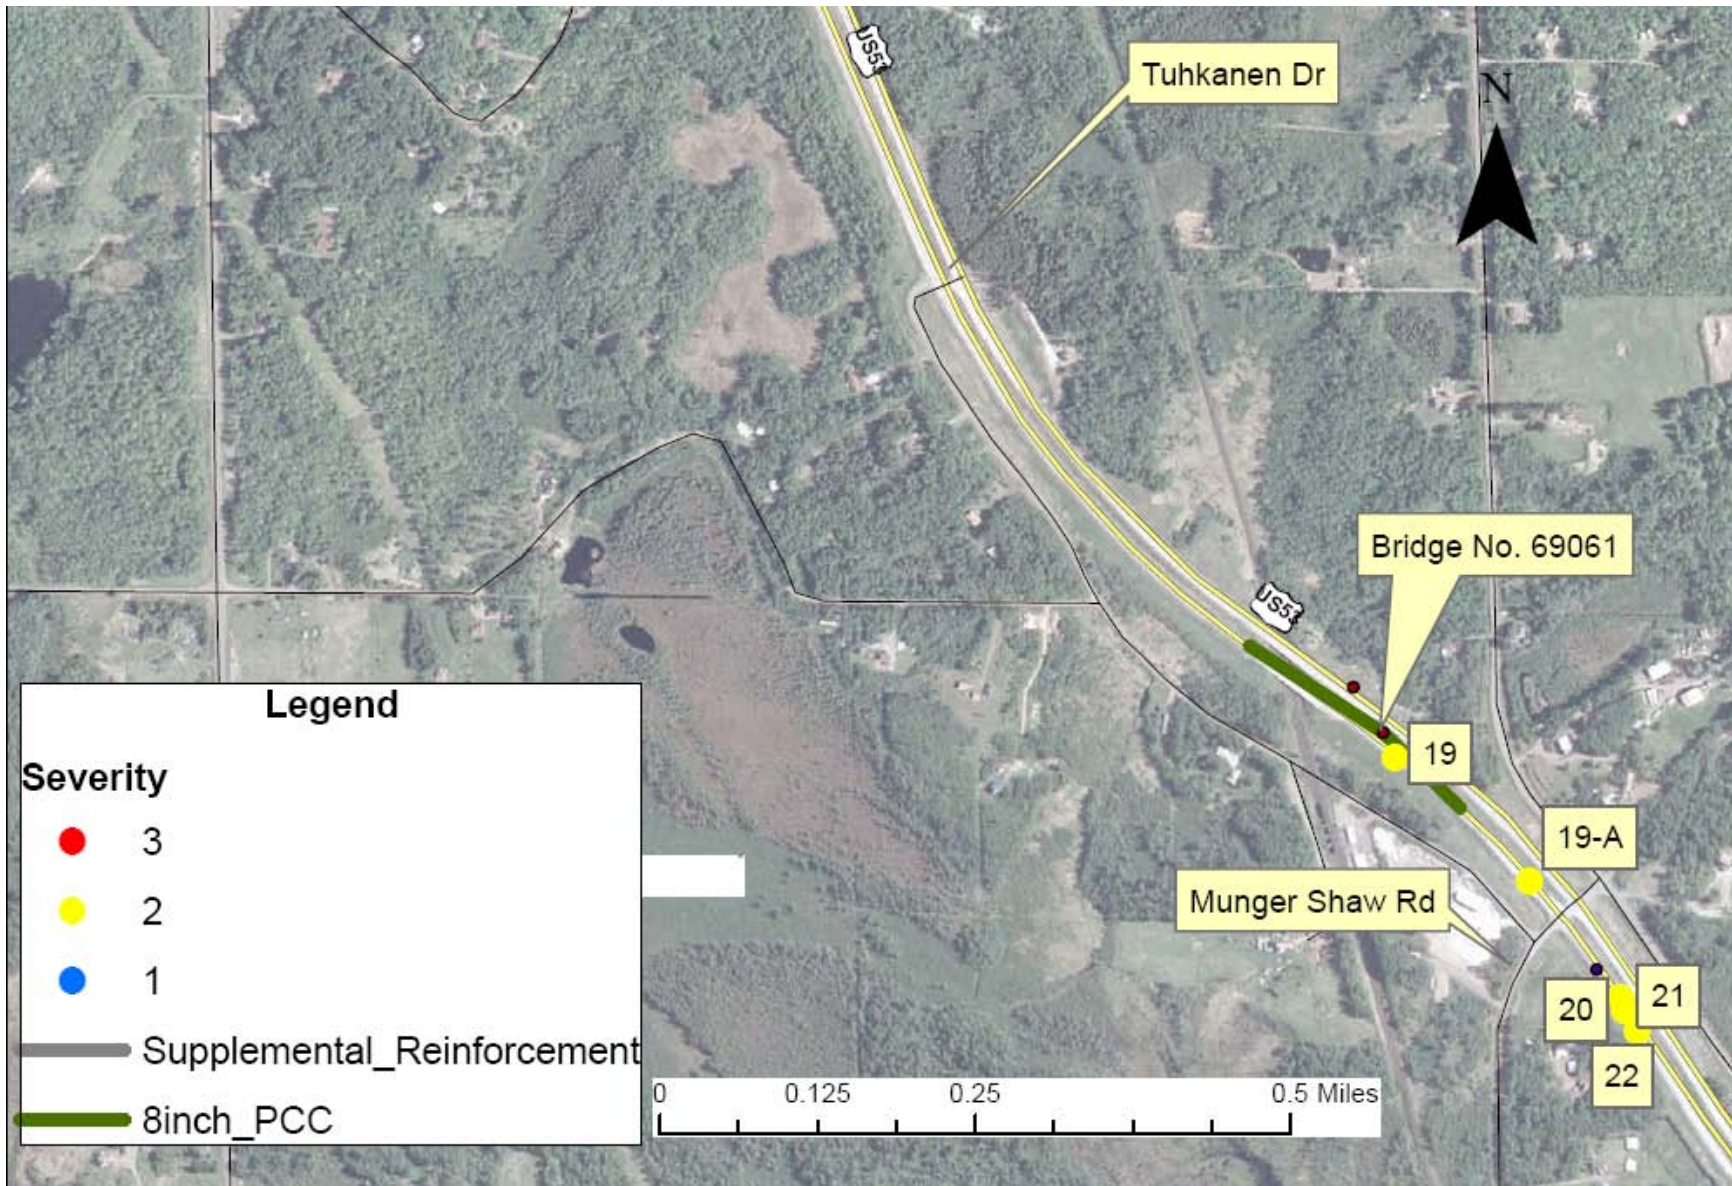
Figure 5.6. TH 53 Distress Map [Munger Shaw Rd to Tuhkanen Dr.], April 2009 (Farm Service Agency, 2002)

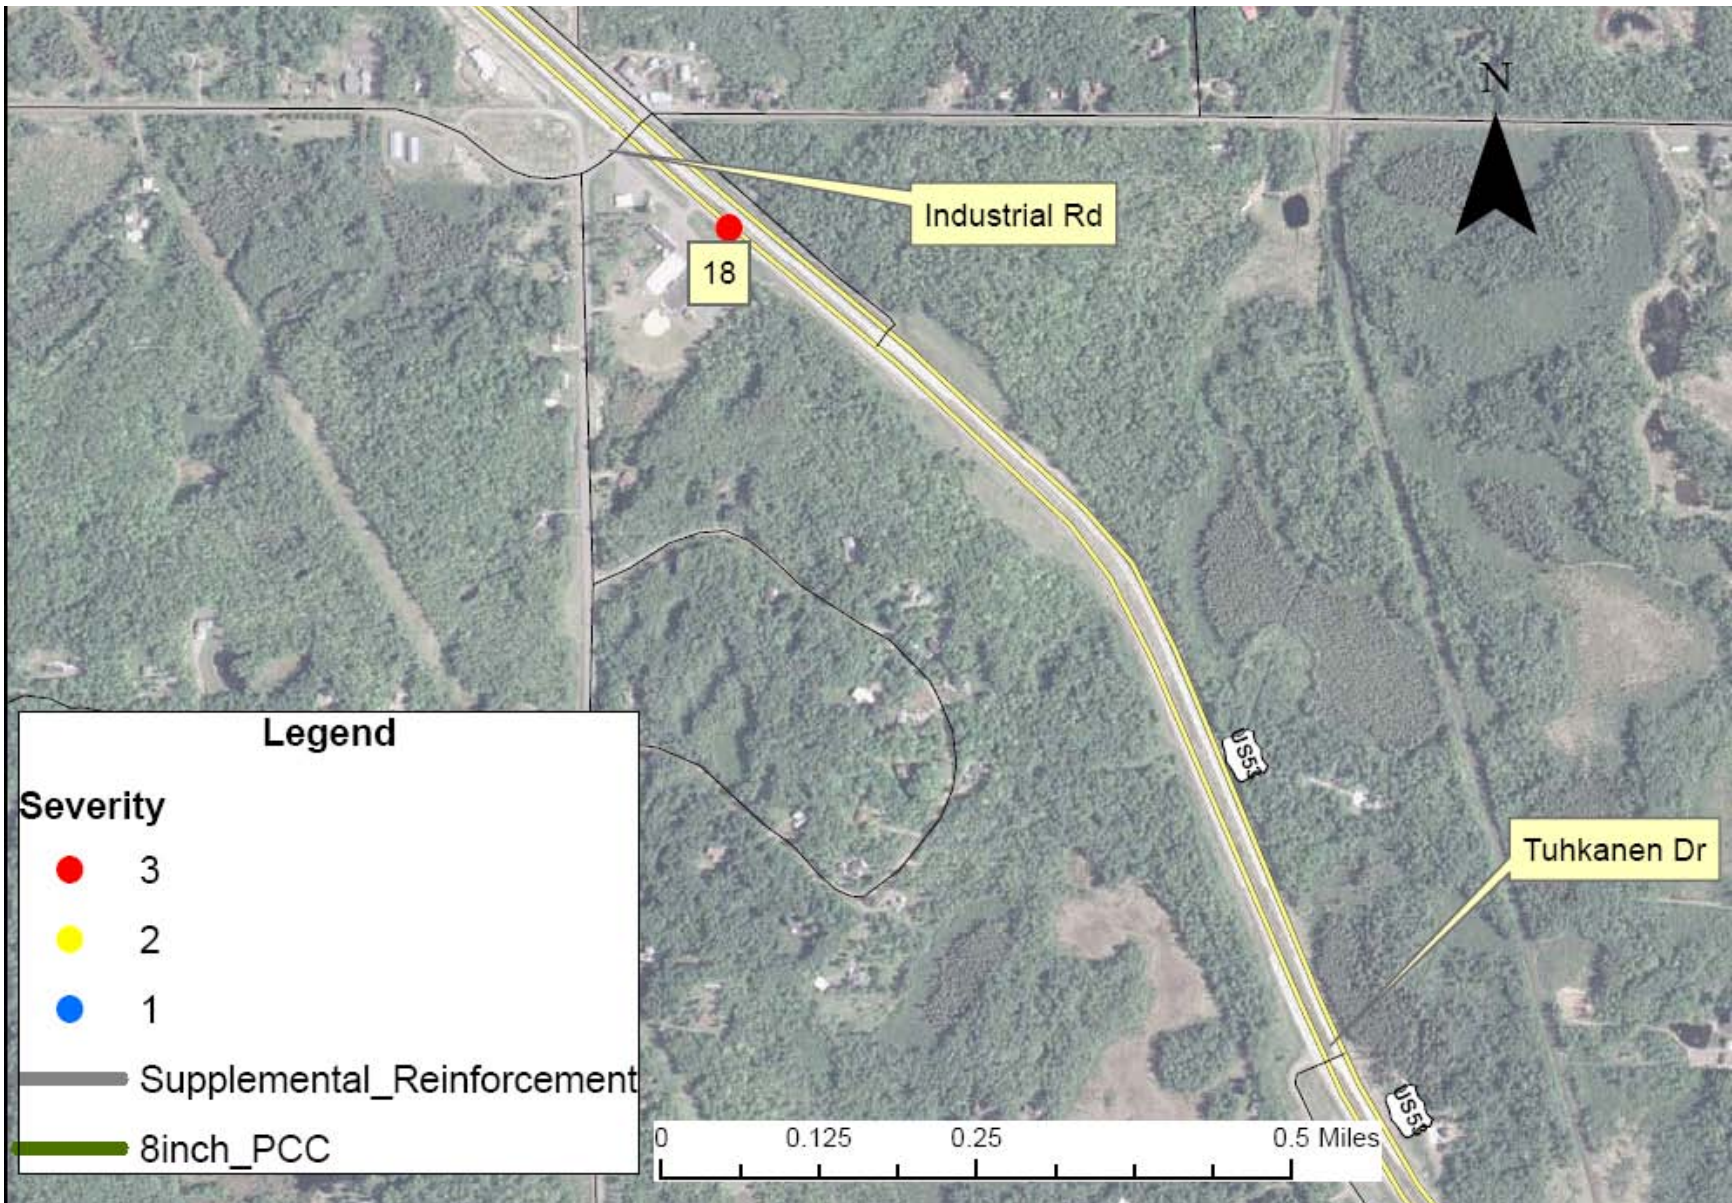
Figure 5.7. TH 53 Distress Map [Tuhkanen Dr. to Industrial Rd], April 2009 (Farm Service Agency, 2002)
