RESEARCH SERVICES

TECHNICAL SUMMARY

Identifying Grouting Problems on Post-Tensioned Bridges

This Technical Summary pertains to Report 2012-09, “Development of Best Practices for Inspection of PT Bridges in Minnesota,” published April 2012. The full report can be accessed at <http://www.dot.state.mn.us/research/documents/201209.pdf>.

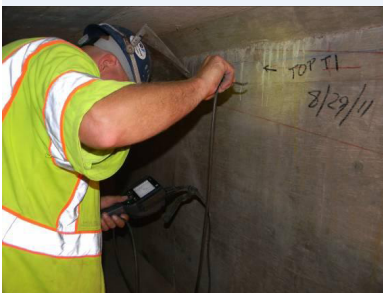
To visually inspect grout and post-tensioning strands within a duct, researchers inserted a borescope, which consists of a small camera lens mounted at the end of a flexible tube.

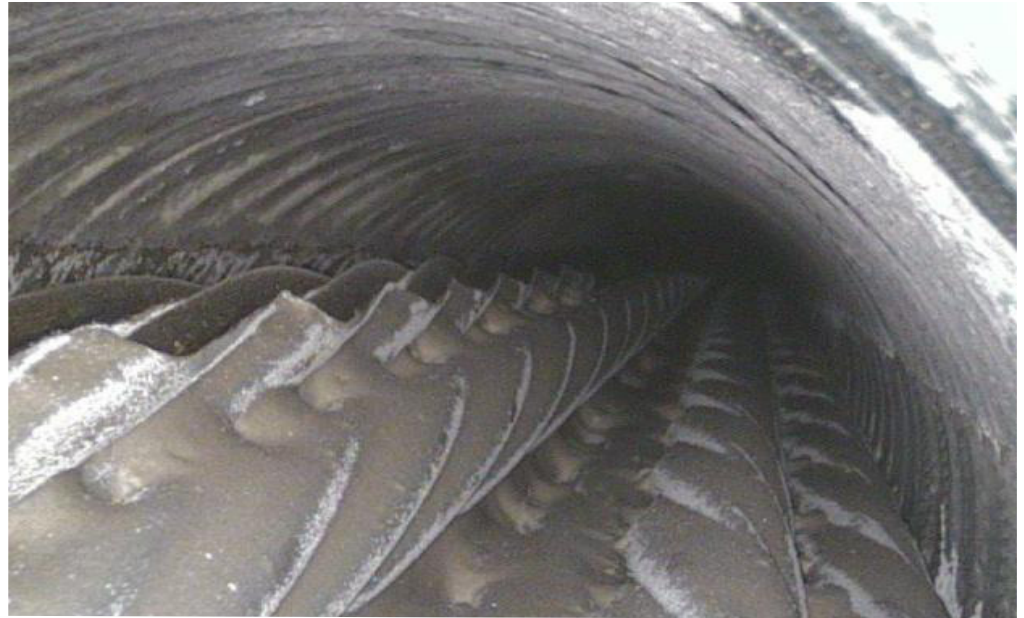
A borescope inserted into a duct reveals a large void, with post-tensioning strands covered only by a thin layer of grout. Ideally the grout would completely fill the duct, protecting strands from corrosion.
