Concrete Bridge Deck Crack Sealant Evaluation and Implementation

Minnesota
Department of
Transportation

Matthew S. Oman, Principal Investigator
Braun Intertec Corporation

Research Project
Final Report 2014-34

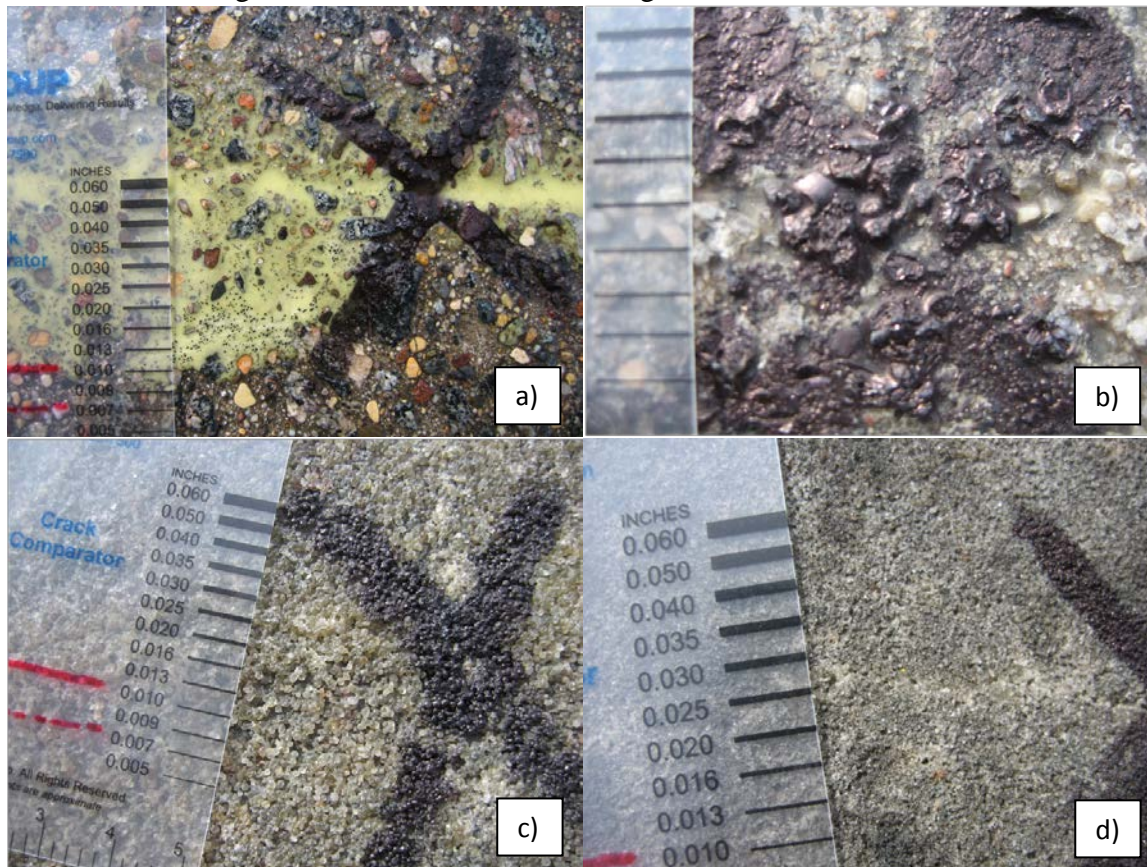
Figure 7. Products With No Cracking After One Winter: a) TK Products TK-9030 [Test 7B] b) KwikBond [Test 20A] c) Sikadur 55 SLV [Test 22A] d) Dural 50 LM [Test 26A].

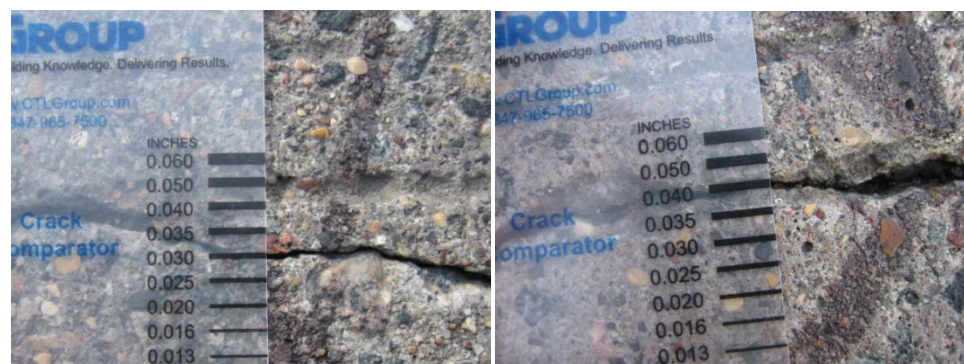
Figure 14. Accuflex Gel-Seal (left) Compared to Control Section (right)

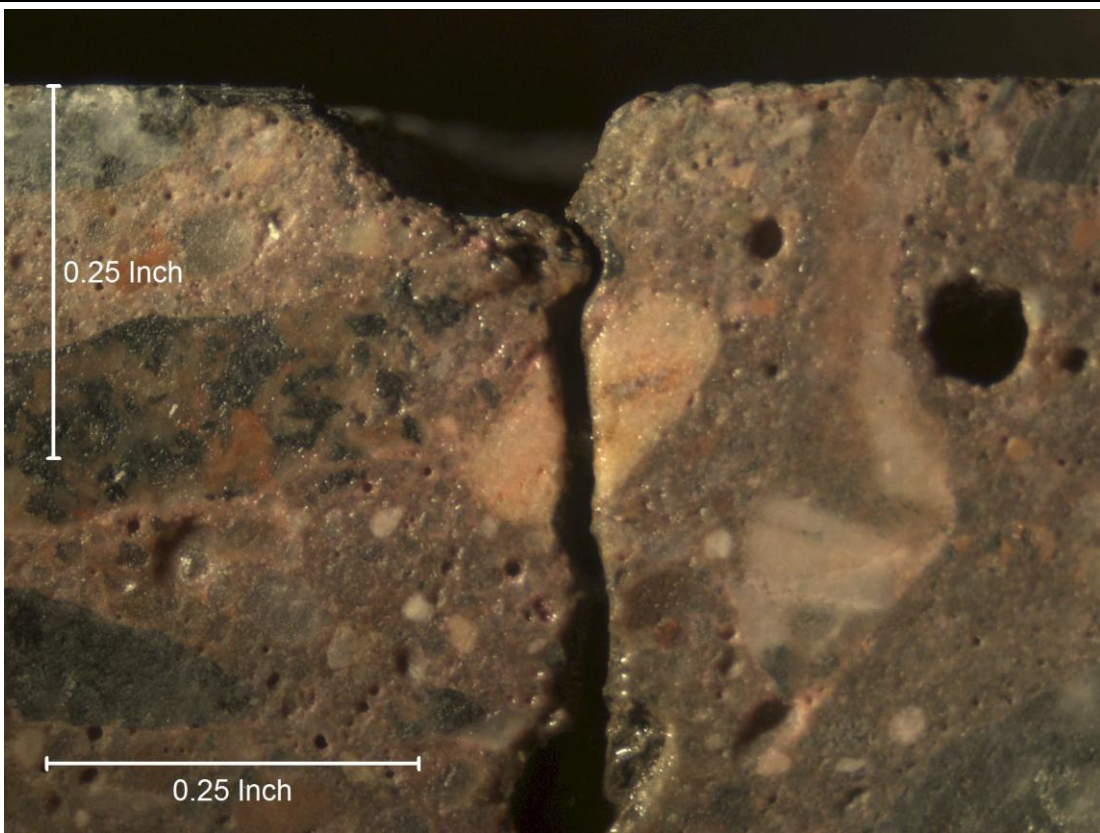
Core #: 1A
Subject: Test Section 1, Test 1A - Accuflex Coatings, Gel Seal
Notes: Depth of Maximum Penetration is 0.000 in.

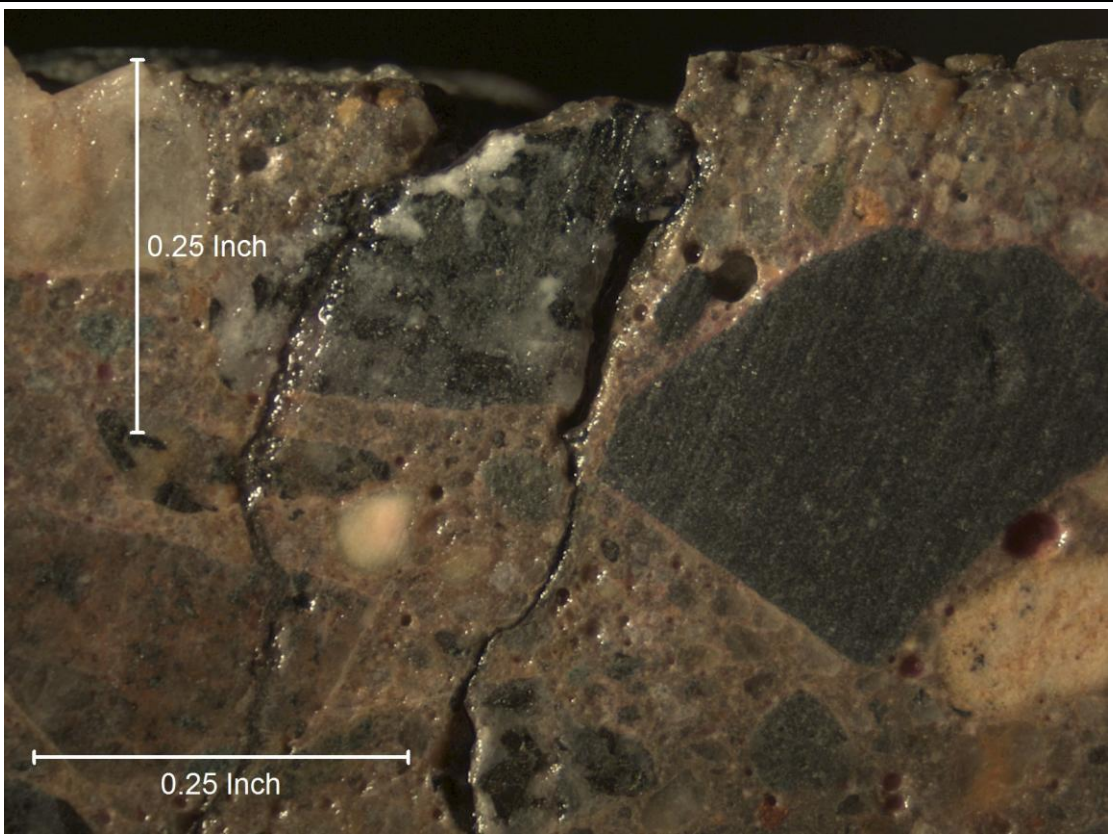
Core #: 2A
 Subject: Test Section 1, Test 2A - Accuflex Coatings, Gel Seal
 Notes: Depth of Maximum Penetration is 0.000 in.

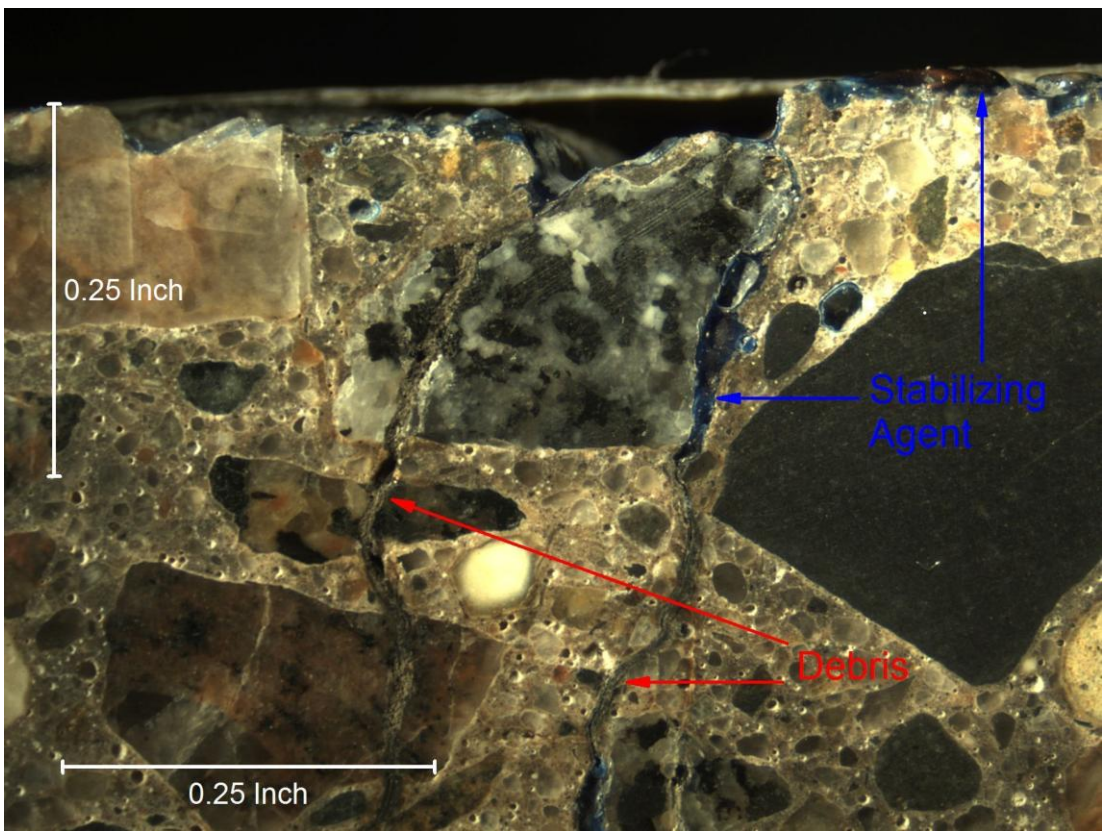
Core #: 2A
 Subject: Test Section 1, Test 2A - Accuflex Coatings, Gel Seal
 Comments: Depth of Maximum Penetration is 0.000 in.

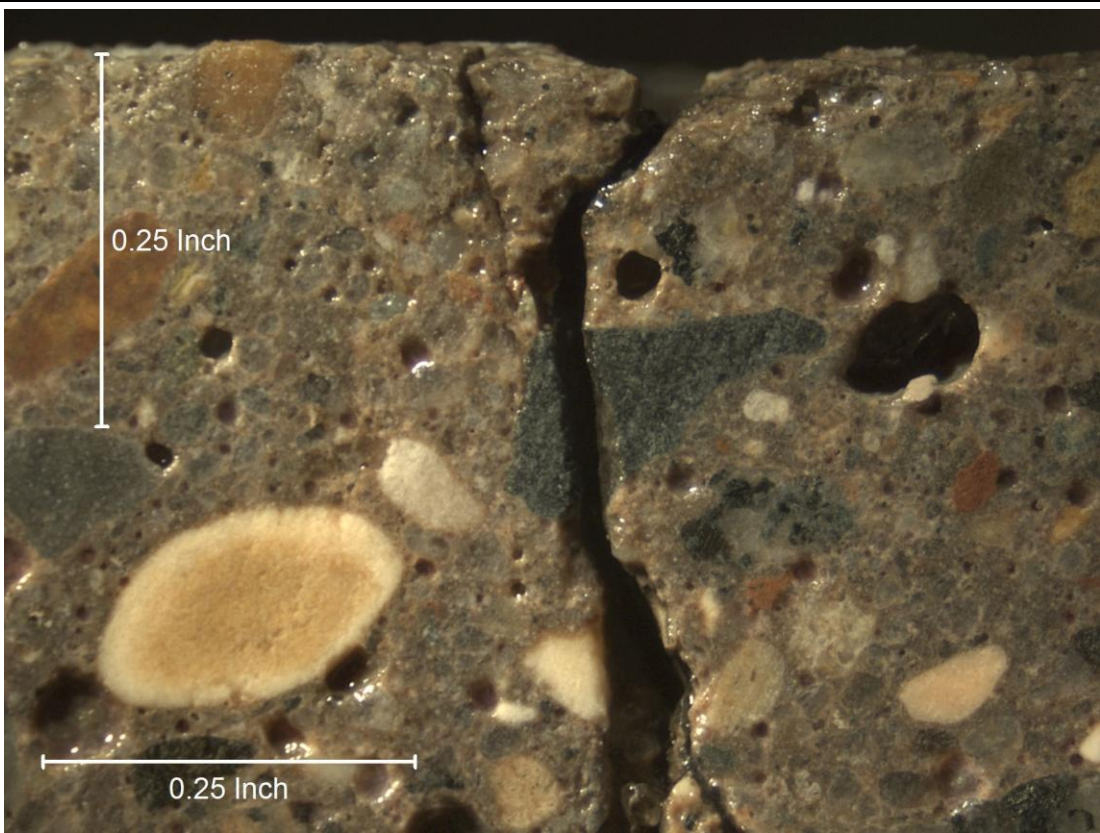
Core #: 4B
Subject: Test Section 2, Test 4B – Control
Notes: Depth of Maximum Penetration is 0.000 in.

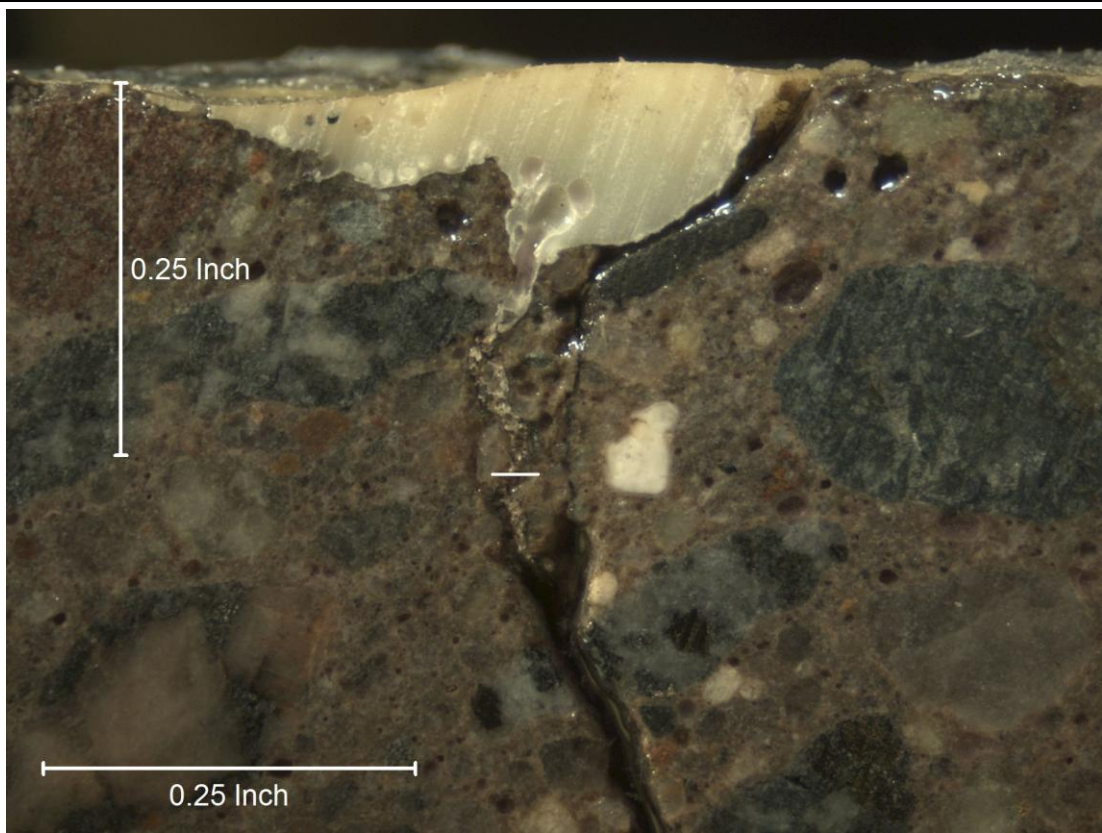
Core #: 7B
 Subject: Test Section 3, Test 7B - TK-9030
 Notes: Depth of Maximum Penetration is 0.274 in. White horizontal line marks the approx. depth of sealant.

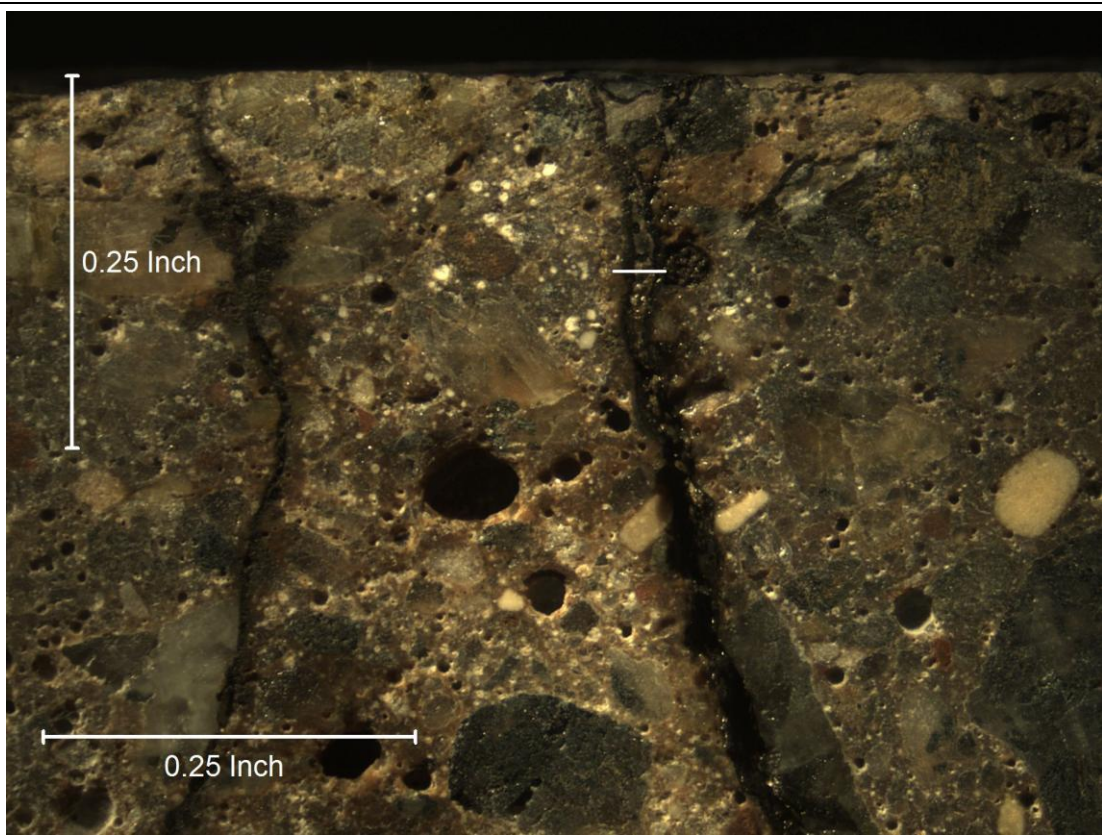
Core #: 8A Project BL-09-03973
 Subject: Test Section 3, Test 8A - TK-9030
 Notes: Depth of Maximum Penetration is 0.134 in. White horizontal line marks the approx. depth of sealant.

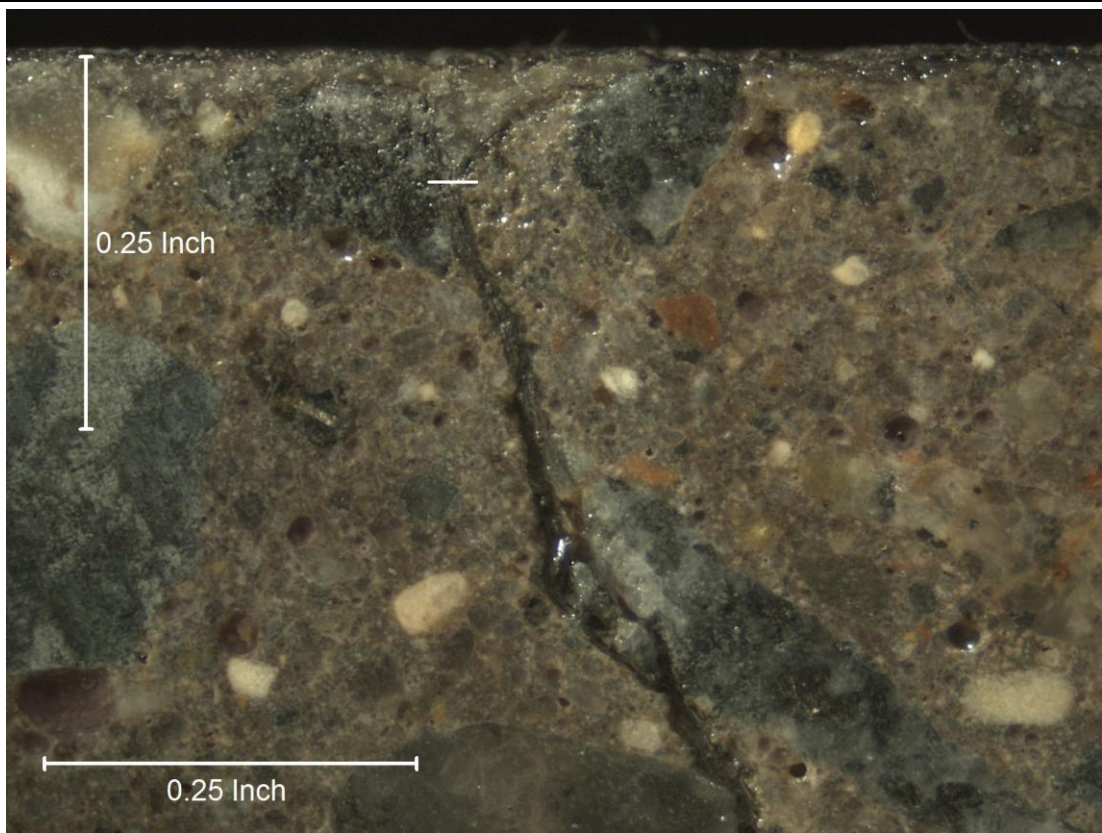
Core #: 9A
 Subject: Test Section 4, Test 9A - TK-2110
 Notes: Depth of Maximum Penetration is 0.092 in. White horizontal line marks the approx. depth of sealant.

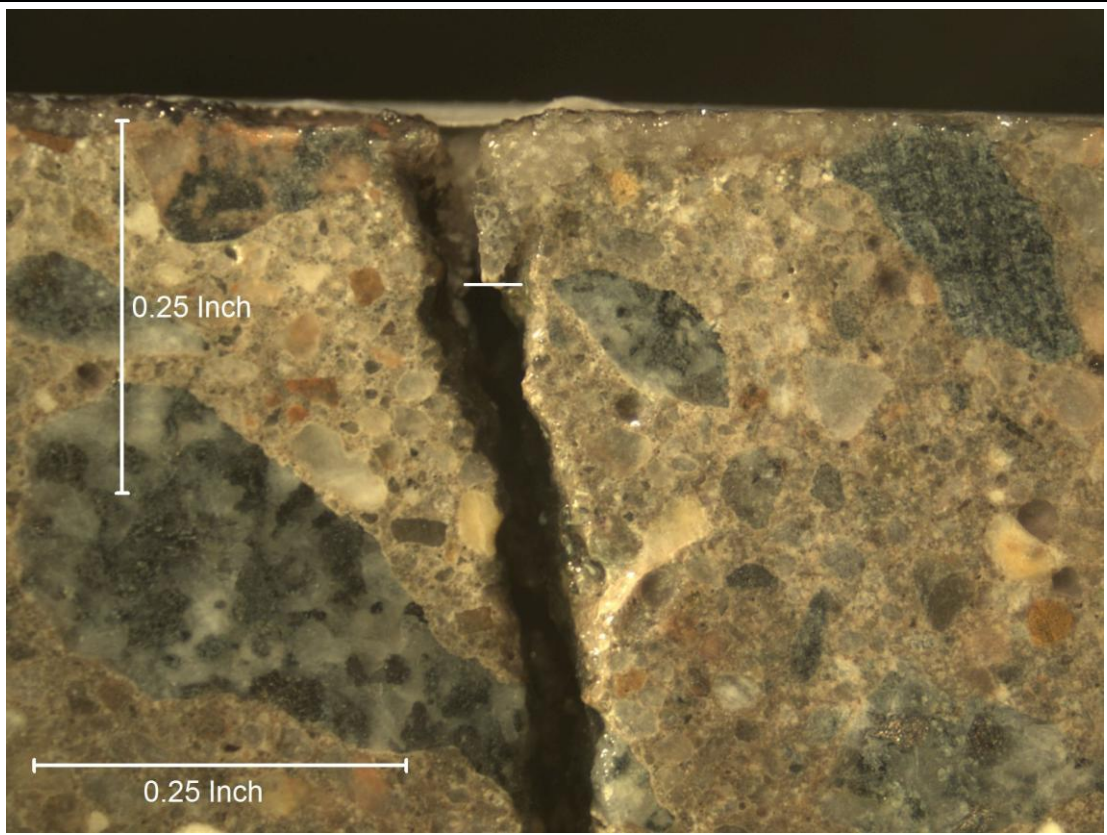
Core #:	10B	Project BL-09-03973
Subject:	Test Section 4, Test 10B - TK-2110	BRAUN INTERTEC
Notes:	Depth of Maximum Penetration is 0.117 in. White horizontal line marks the approx. depth of sealant.

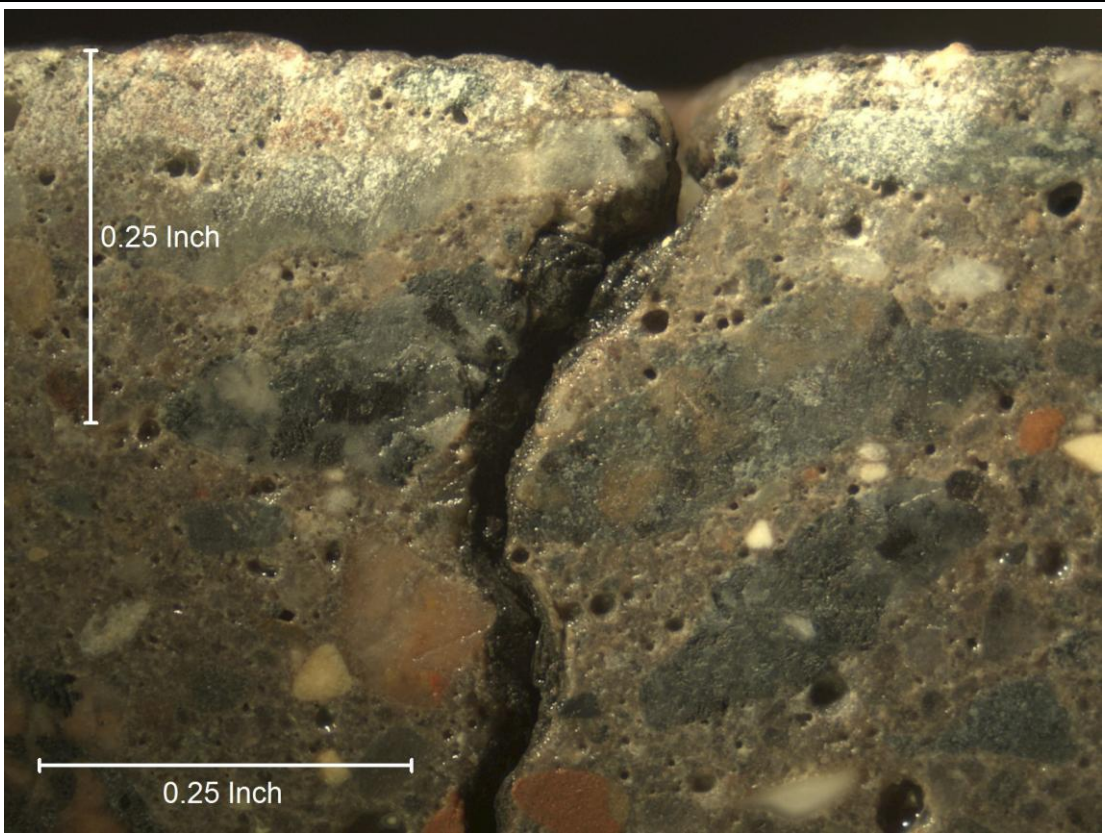
Core #: 12A
Subject: Test Section 5, Test 12A - TK-2414
Notes: Depth of Maximum Penetration is 0.000 in.

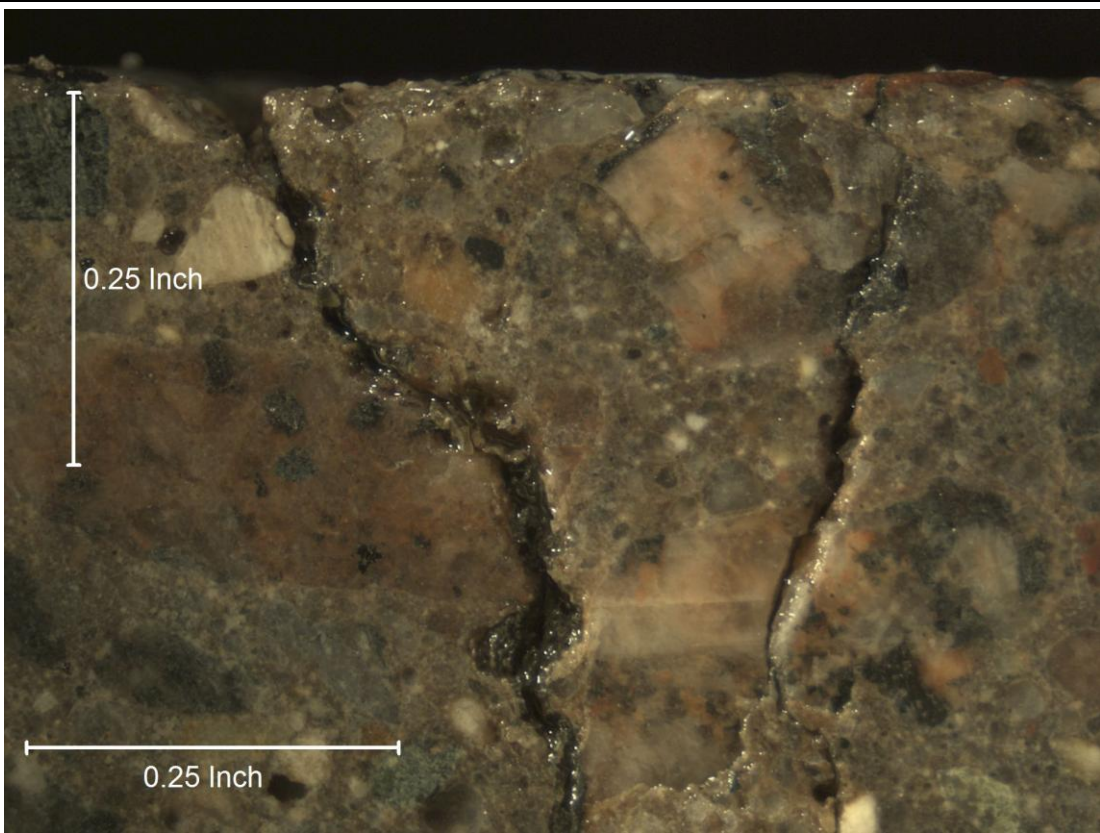
Core #: 12B
Subject: Test Section 6, Test 12B - Control
Notes: Depth of Maximum Penetration is 0.000 in.

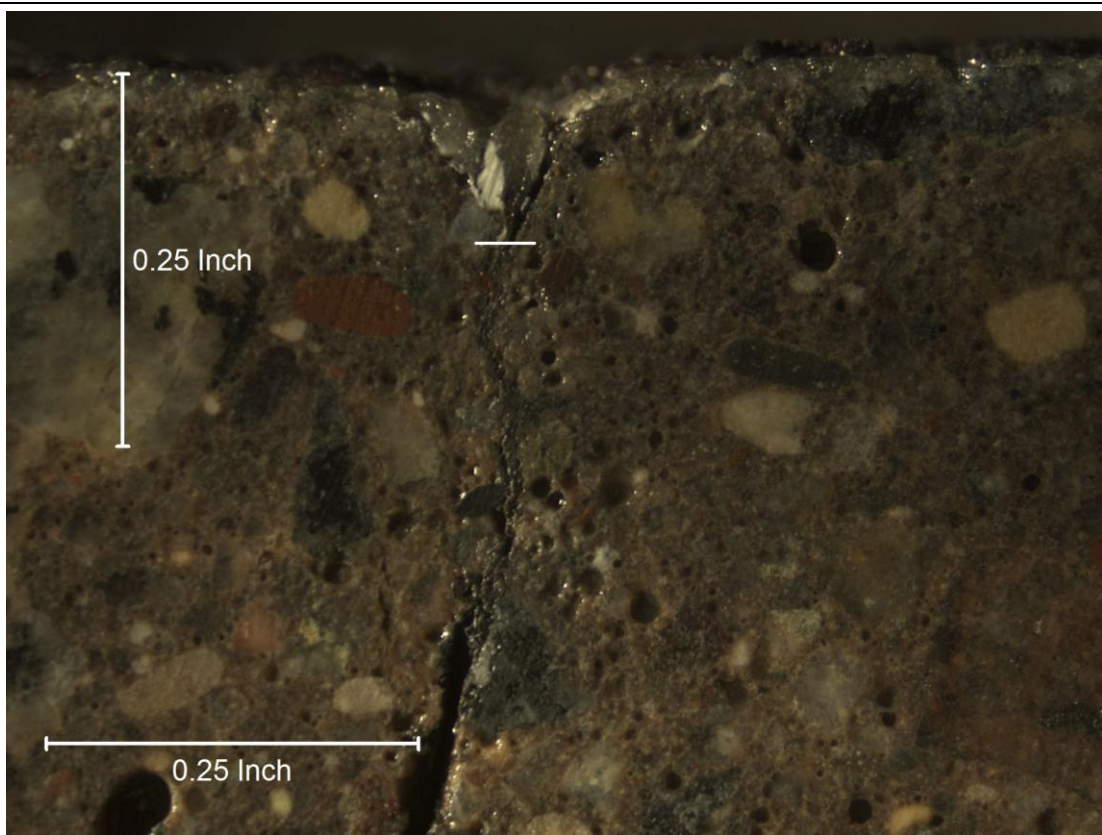
Core #: 17A
 Subject: Test Section 7, Test 17A –Epoxyal GS Structural
 Notes: Depth of Maximum Penetration is 0.115 in. White horizontal line marks the approx. depth of sealant.

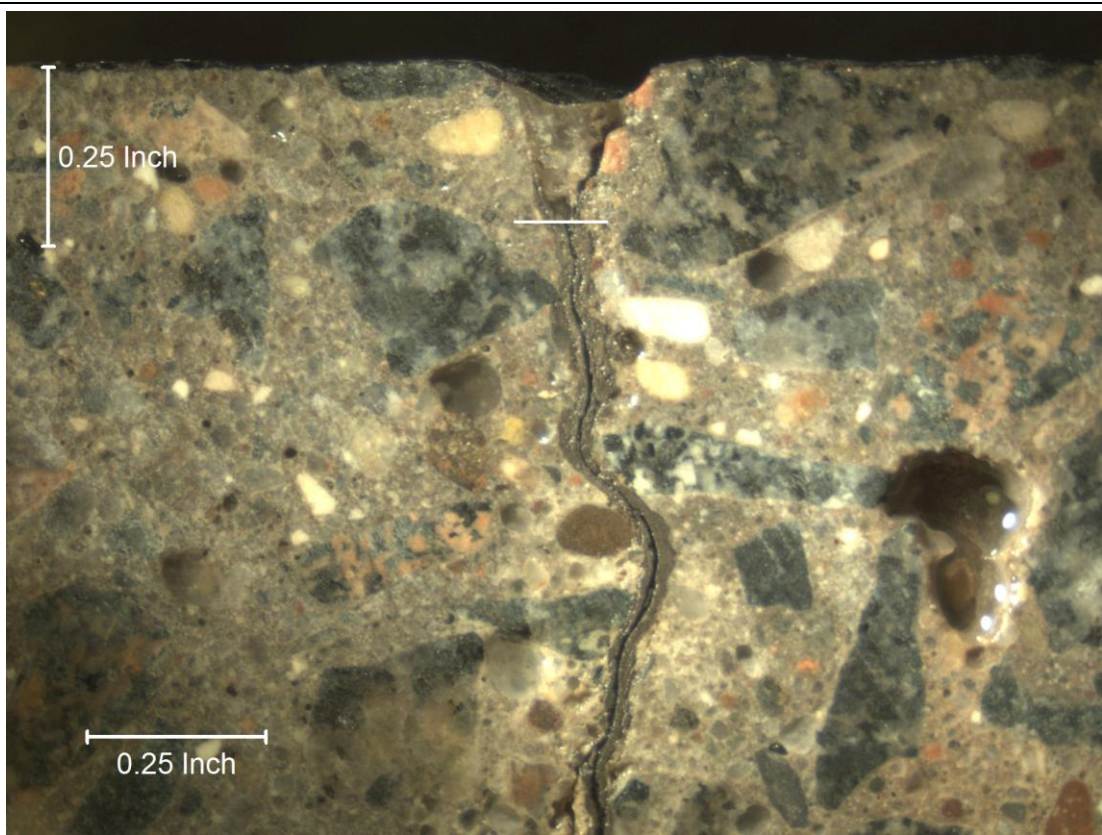
Core #: 19A
 Subject: Test Section 7, Test 19A –Epoxy GS Structural
 Notes: Depth of Maximum Penetration is 0.202 in. White horizontal line marks the approx. depth of sealant.

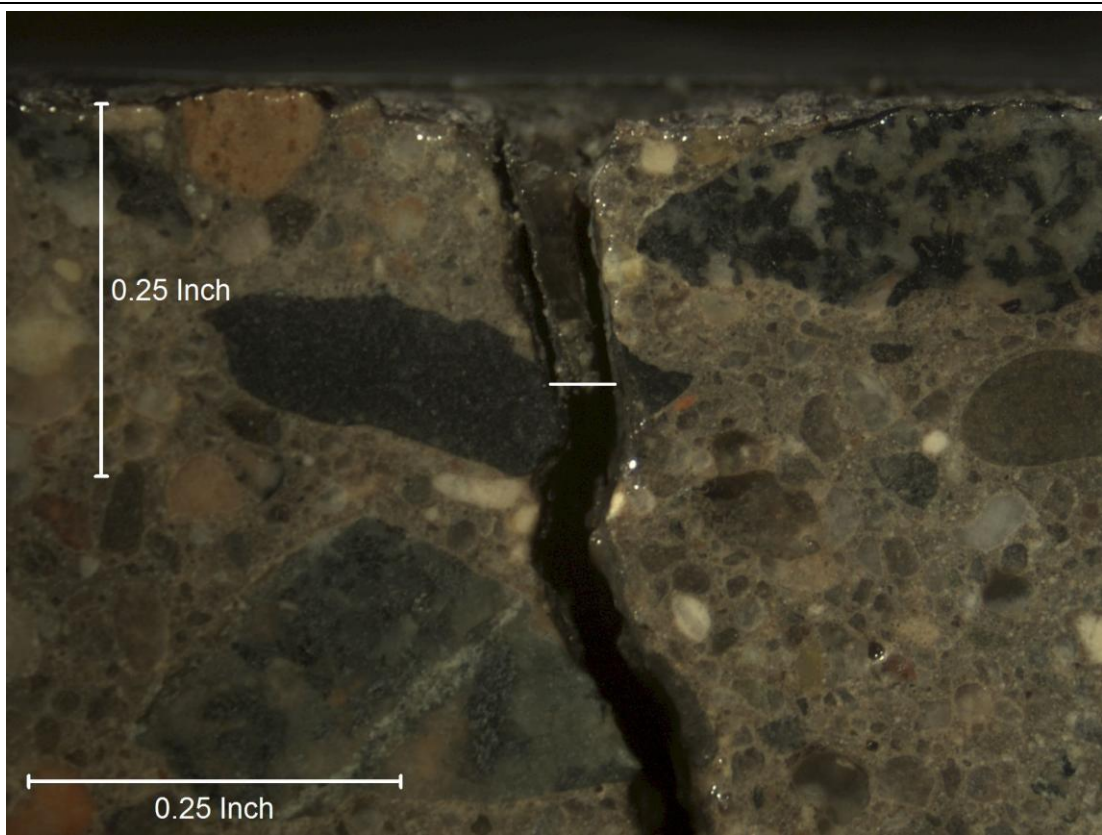
Core #: 18A
 Subject: Test Section 8, Test 18A – Kwik Bond KBP 204
 Notes: Depth of Maximum Penetration is 0.193 in. White horizontal line marks the approx. depth of sealant.

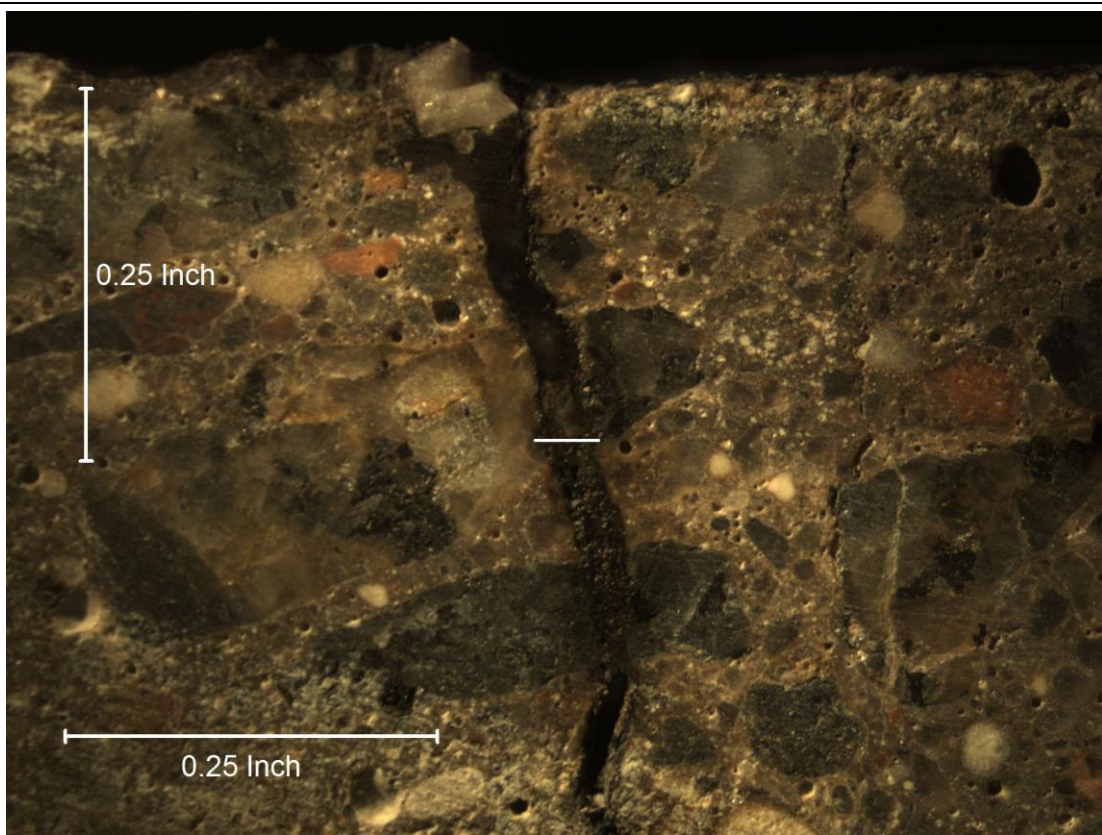
Core #: 20A
 Subject: Test Section 8, Test 20A – Kwik Bond KBP 204
 Notes: Depth of Maximum Penetration is 0.239 in. White horizontal line marks the approx. depth of sealant.

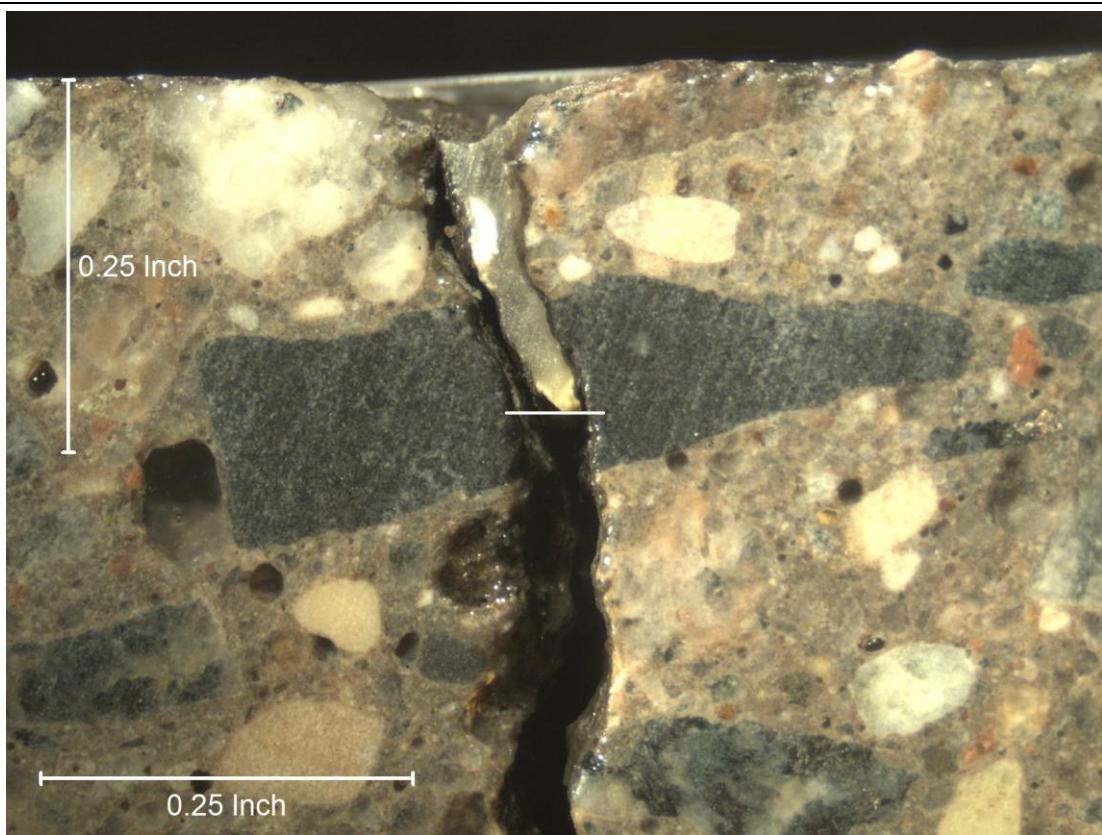
Core #: 21A
 Subject: Test Section 9, Test 21A – Degadeck Crack Sealer Plus
 Notes: Depth of Maximum Penetration is 0.226 in. White horizontal line marks the approx. depth of sealant.

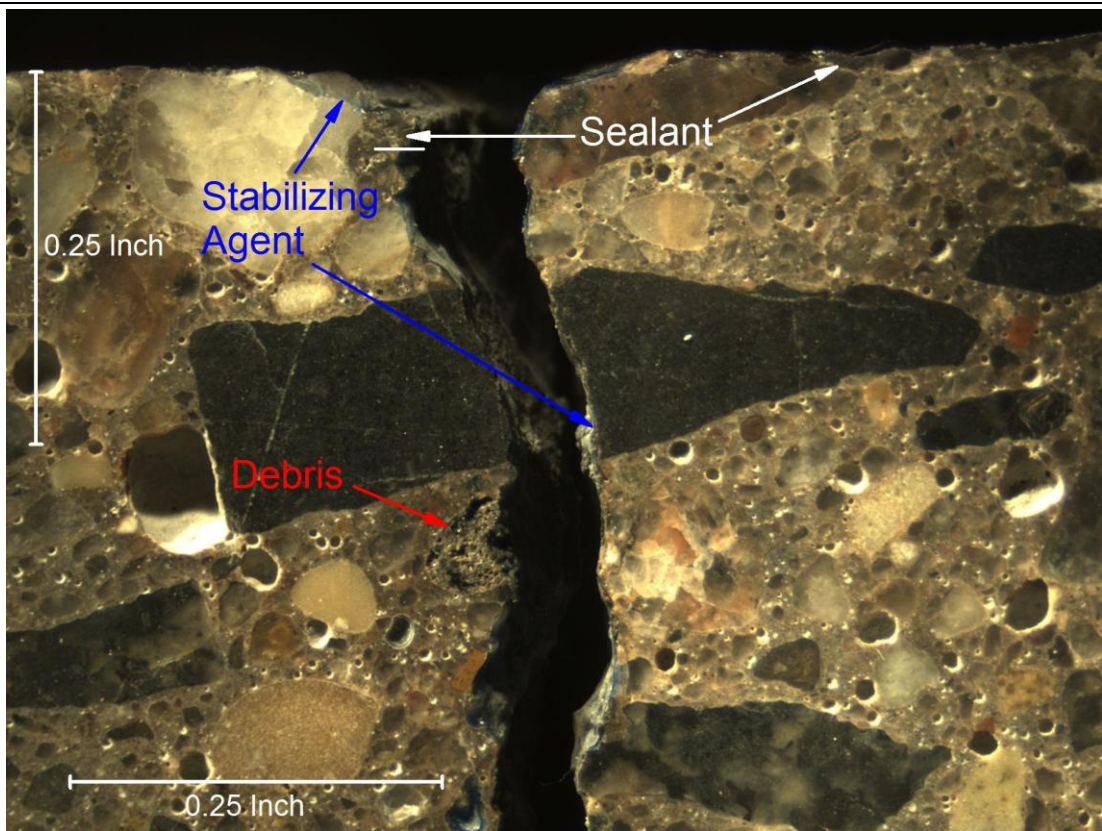
Core #: 21A
 Subject: Test Section 9, Test 21A – Degadeck Crack Sealer Plus
 Comments: Depth of Maximum Penetration is 0.057 in. White horizontal line marks the approx. depth of sealant.

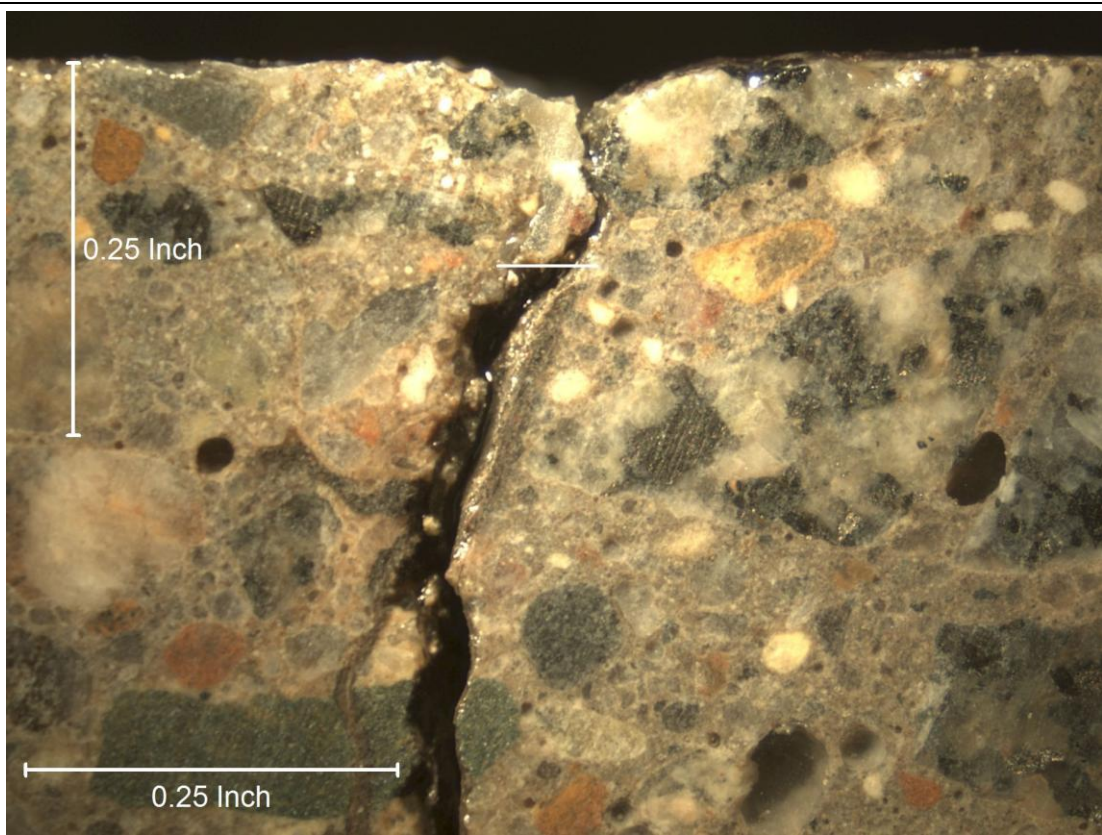
Core #: 21B
 Subject: Test Section 9, Test 21B – Degadeck Crack Sealer Plus
 Notes: Depth of Maximum Penetration is 0.134 in. White horizontal line marks the approx. depth of sealant.

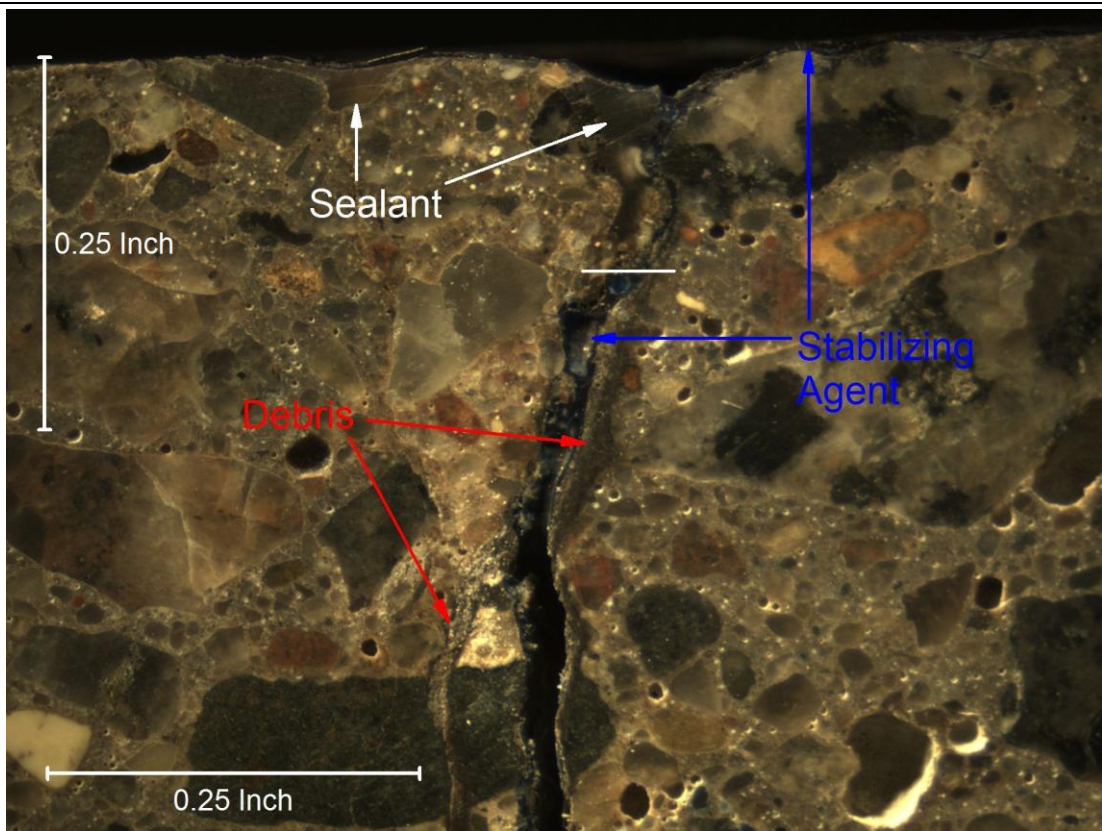
Core #: 21B
 Subject: Test Section 9, Test 21B – Degadeck Crack Sealer Plus
 Comments: Depth of Maximum Penetration is 0.158 in. White horizontal line marks the approx. depth of sealant.

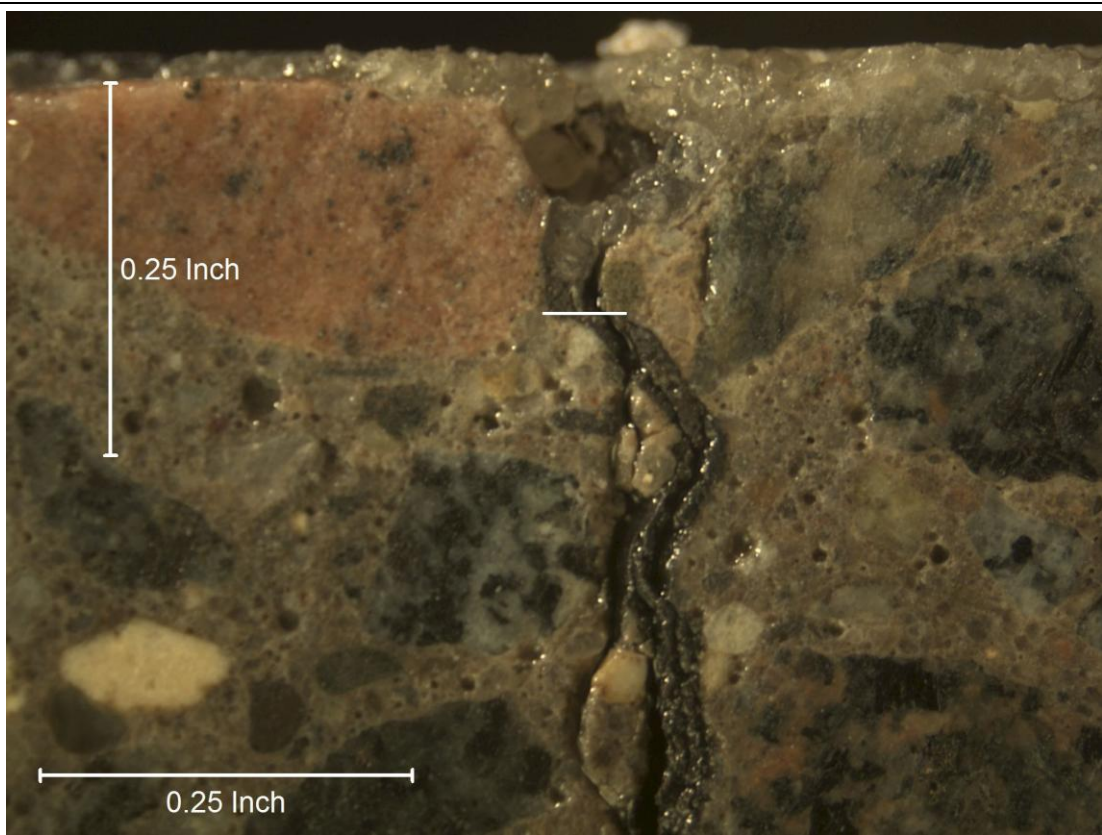
Core #: 22A
 Subject: Test Section 10, Test 22A – Sikadur 55 SLV
 Notes: Depth of Maximum Penetration is 0.159 in. White horizontal line marks the approx. depth of sealant.

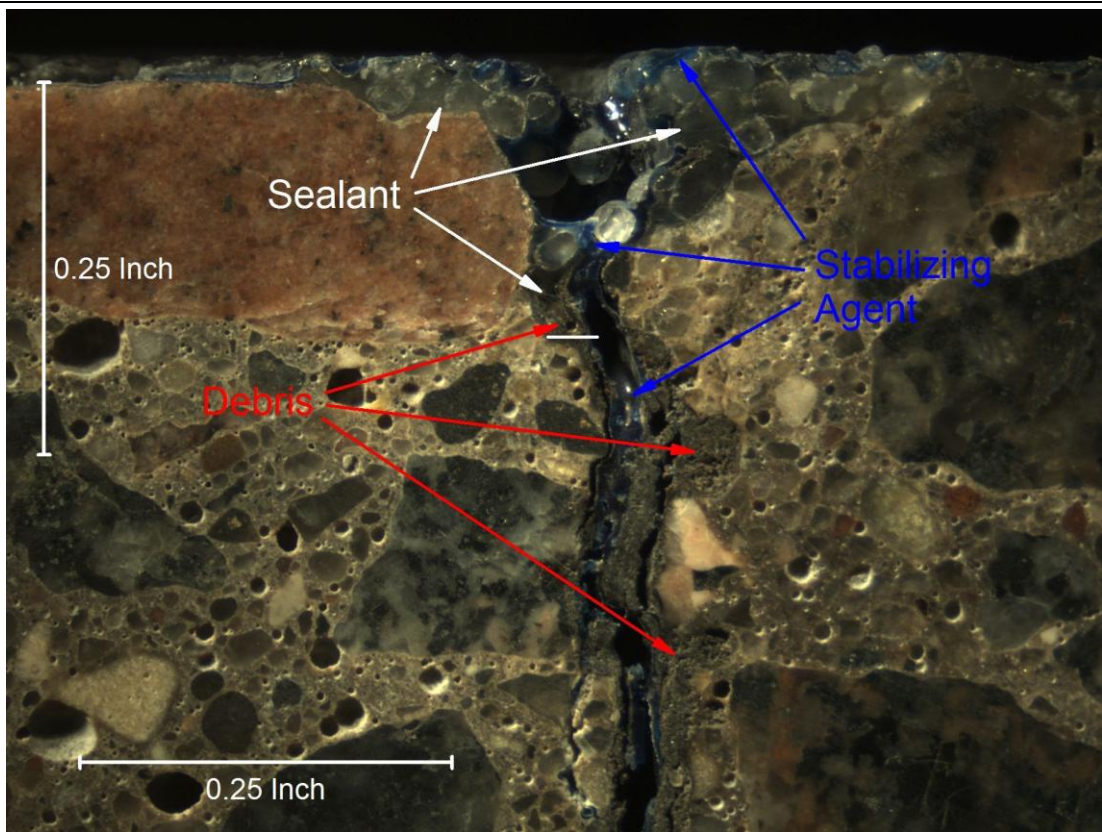
Core #: 22A
 Subject: Test Section 10, Test 22A – Sikadur 55 SLV
 Comments: Depth of Maximum Penetration is 0.180 in. White horizontal line marks the approx. depth of sealant.

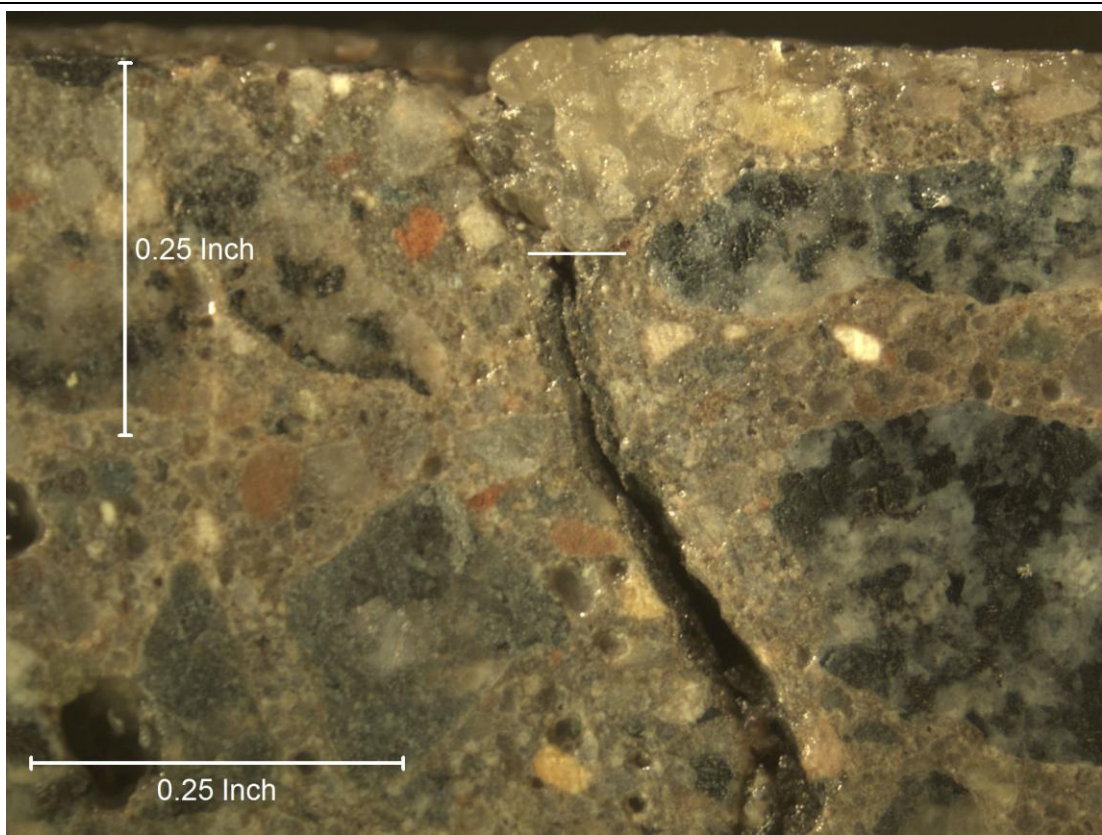
Core #: 23A
 Subject: Test Section 10, Test 23A – Sikadur 55 SLV
 Notes: Depth of Maximum Penetration is 0.124 in. White horizontal line marks the approx. depth of sealant.

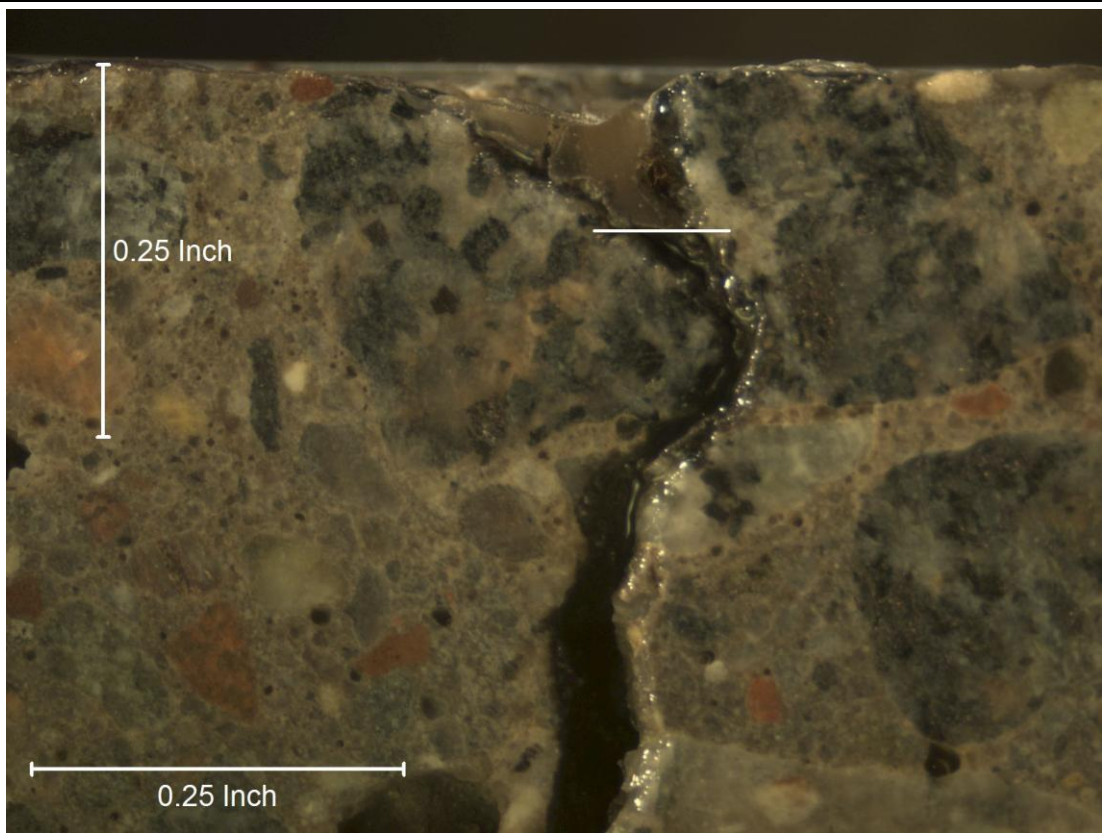
Core #: 22B
 Subject: Test Section 11, Test 22B, Paulco TE-3008-1
 Notes: Depth of Maximum Penetration is 0.109 in. White horizontal line marks the approx. depth of sealant.
