Concrete Bridge Deck Crack Sealant Evaluation and Implementation

Minnesota
Department of
Transportation

Matthew S. Oman, Principal Investigator
Braun Intertec Corporation

Research Project
Final Report 2014-34

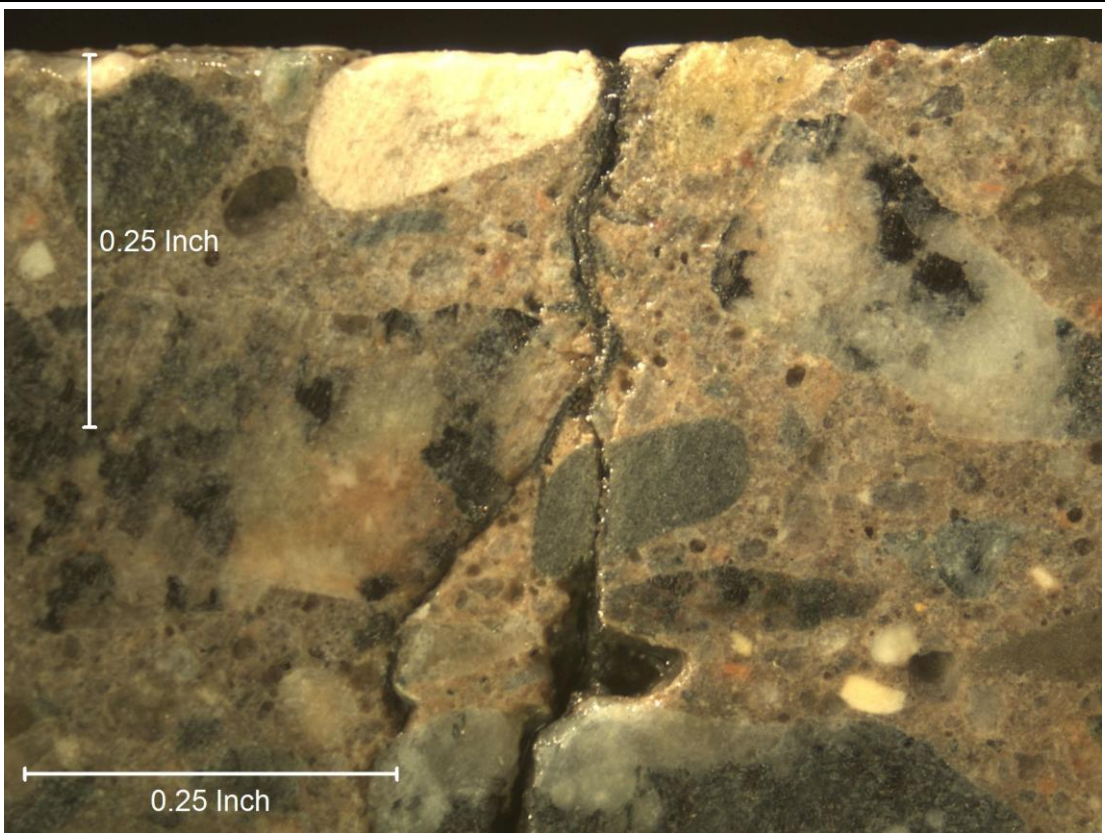
Core #: 24A
 Subject: Test Section 12, Test 24A – Paulco TE-2501
 Notes: Depth of Maximum Penetration is 0.000 in.

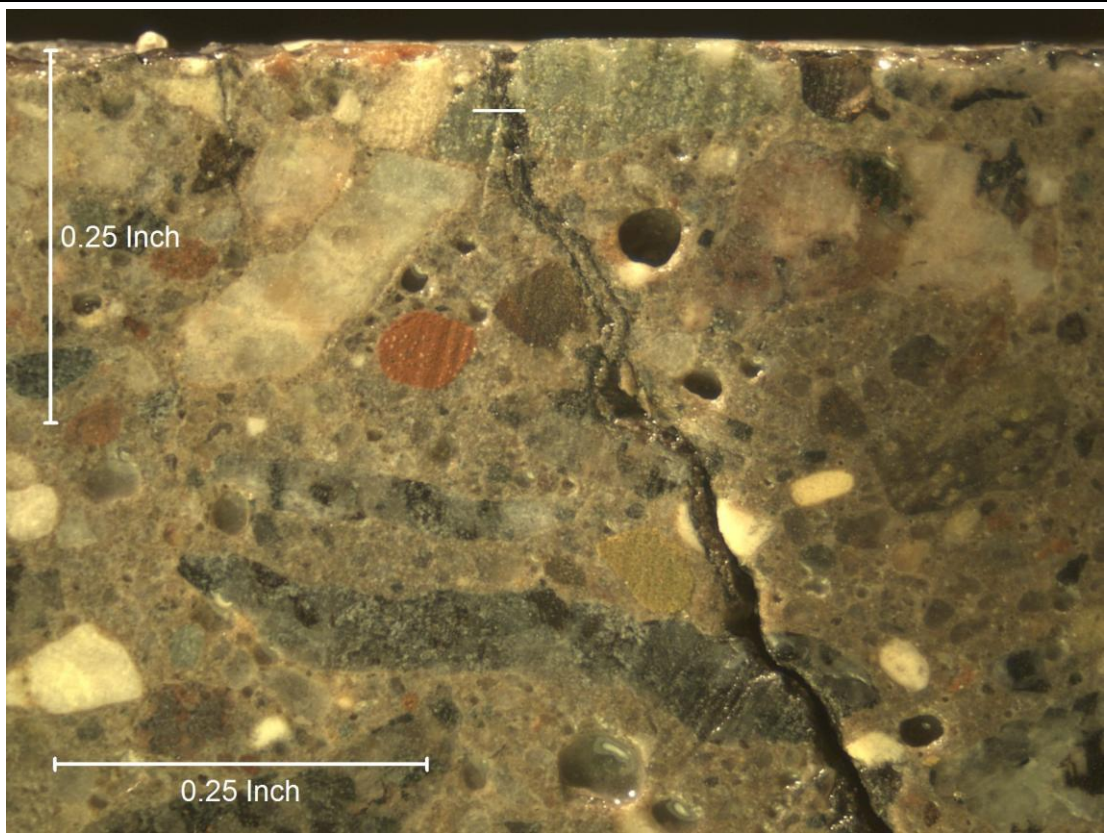
Core #: 35A Project BL-09-03973
 Subject: Test Section 12, Test 35A – Paulco TE-2501
 Notes: Depth of Maximum Penetration is 0.041 in. White horizontal line marks the approx. depth of sealant.

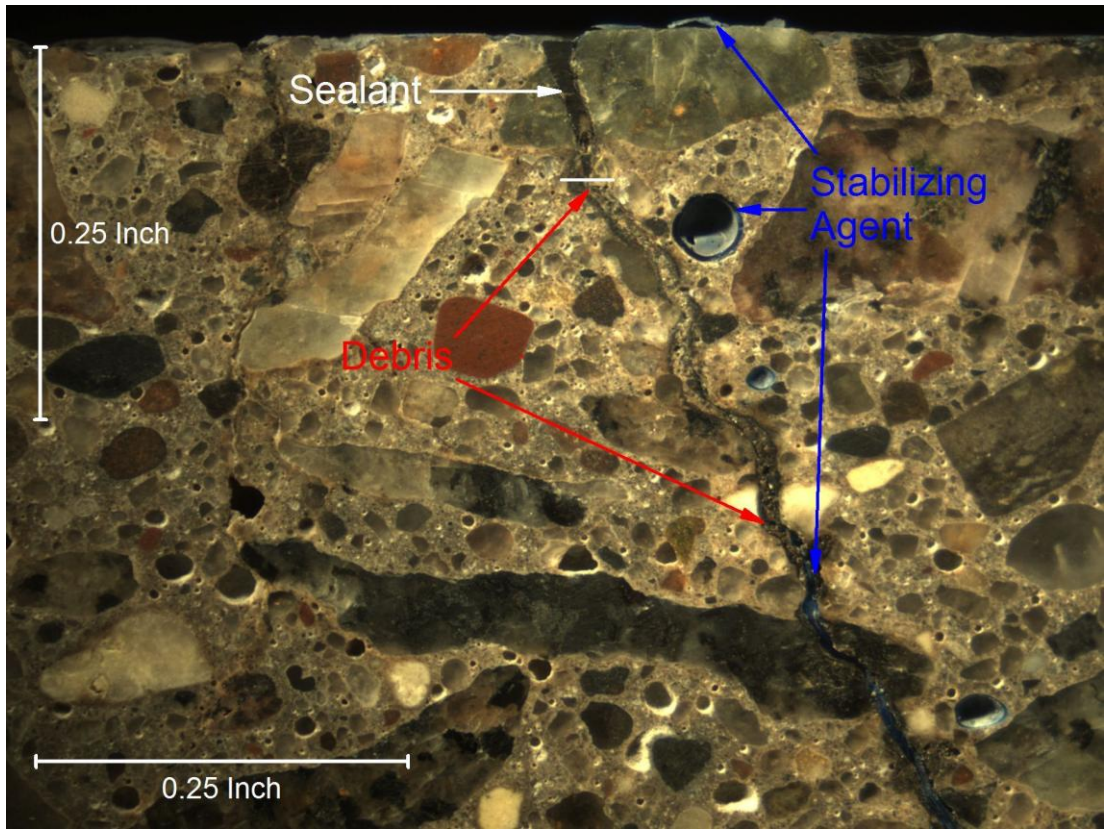
Core #: 35A Project BL-09-03973
 Subject: Test Section 12, Test 35A – Paulco TE-2501
 Comments: Depth of Maximum Penetration is 0.106 in. White horizontal line marks the approx. depth of sealant.

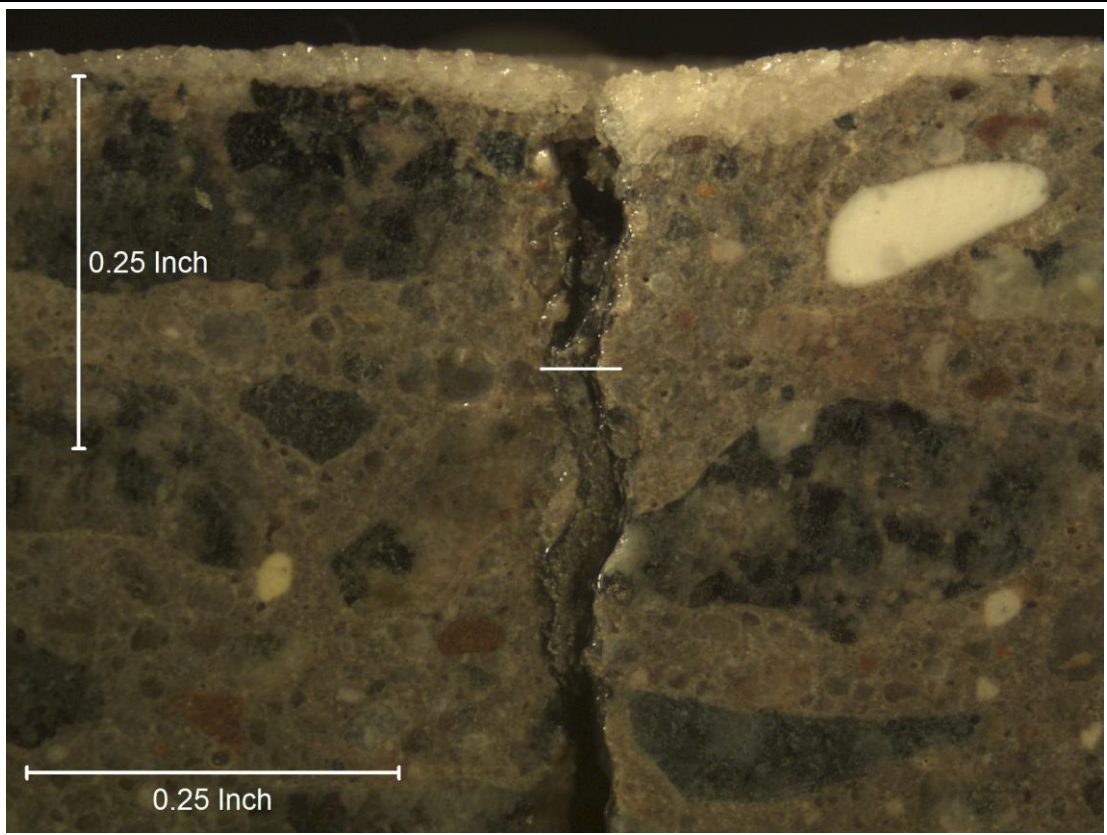
Core #: 25A Project BL-09-03973
 Subject: Test Section 13, Test 25A – Euclid, Dural 50 LM
 Notes: Depth of Maximum Penetration is 0.194 in. White horizontal line marks the approx. depth of sealant.

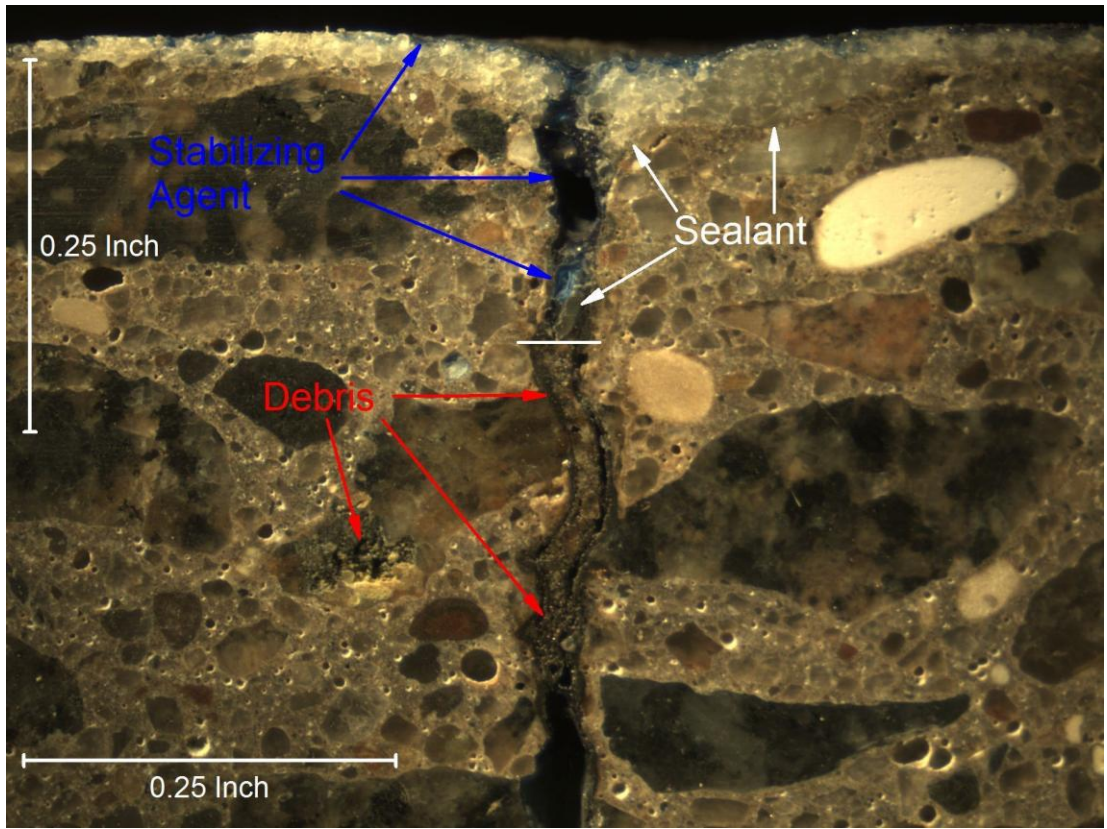
Core #: 25A Project BL-09-03973
 Subject: Test Section 13, Test 25A – Euclid, Dural 50 LM
 Comments: Depth of Maximum Penetration is 0.196 in. White horizontal line marks the approx. depth of sealant.

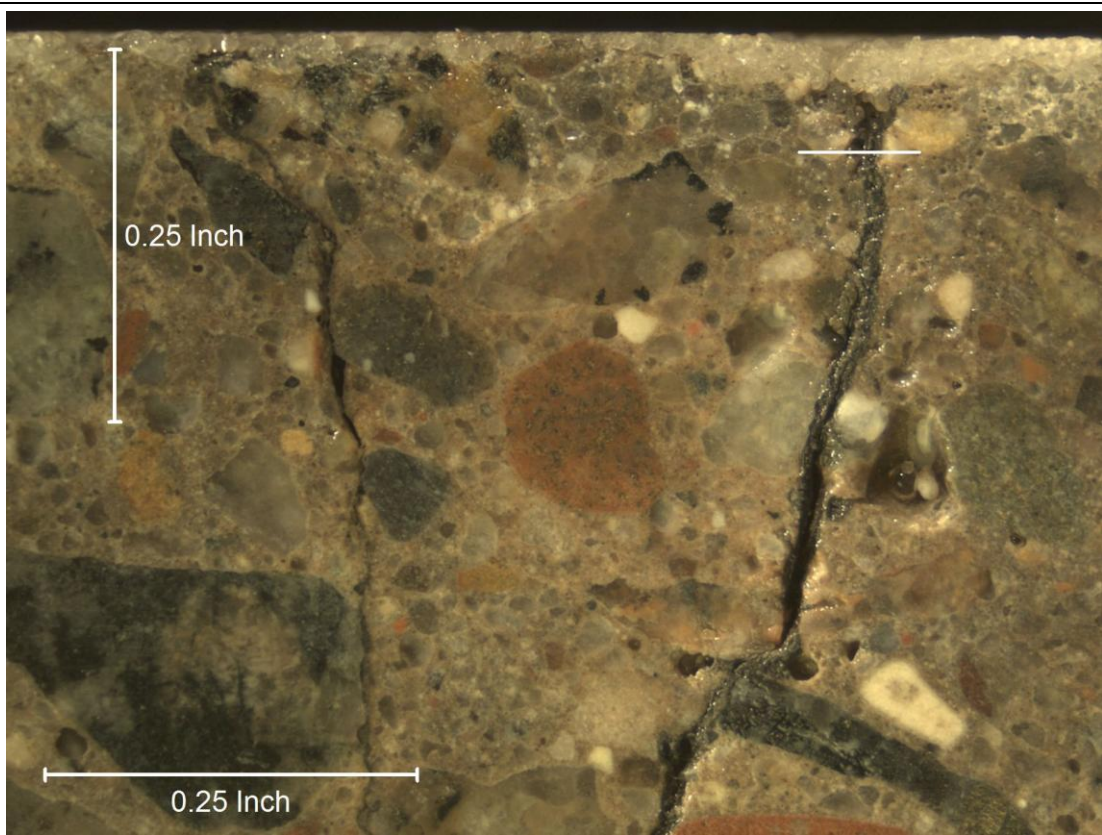
Core #: 26A
 Subject: Test Section 13, Test 26A – Euclid, Dural 50 LM
 Notes: Depth of Maximum Penetration is 0.064 in. White horizontal line marks the approx. depth of sealant.

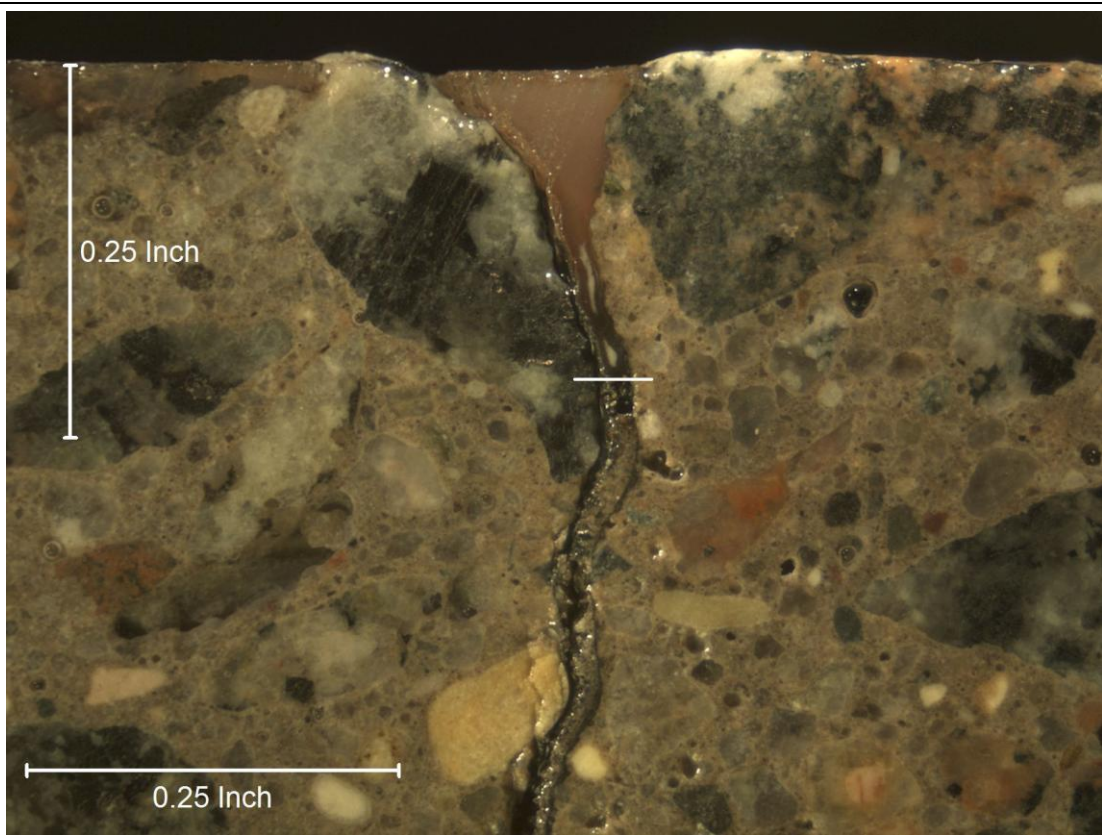
Core #: 27A
 Subject: Test Section 14, Test 27A – Transpo T-70, MX-30
 Notes: Depth of Maximum Penetration is 0.214 in. White horizontal line marks the approx. depth of sealant.

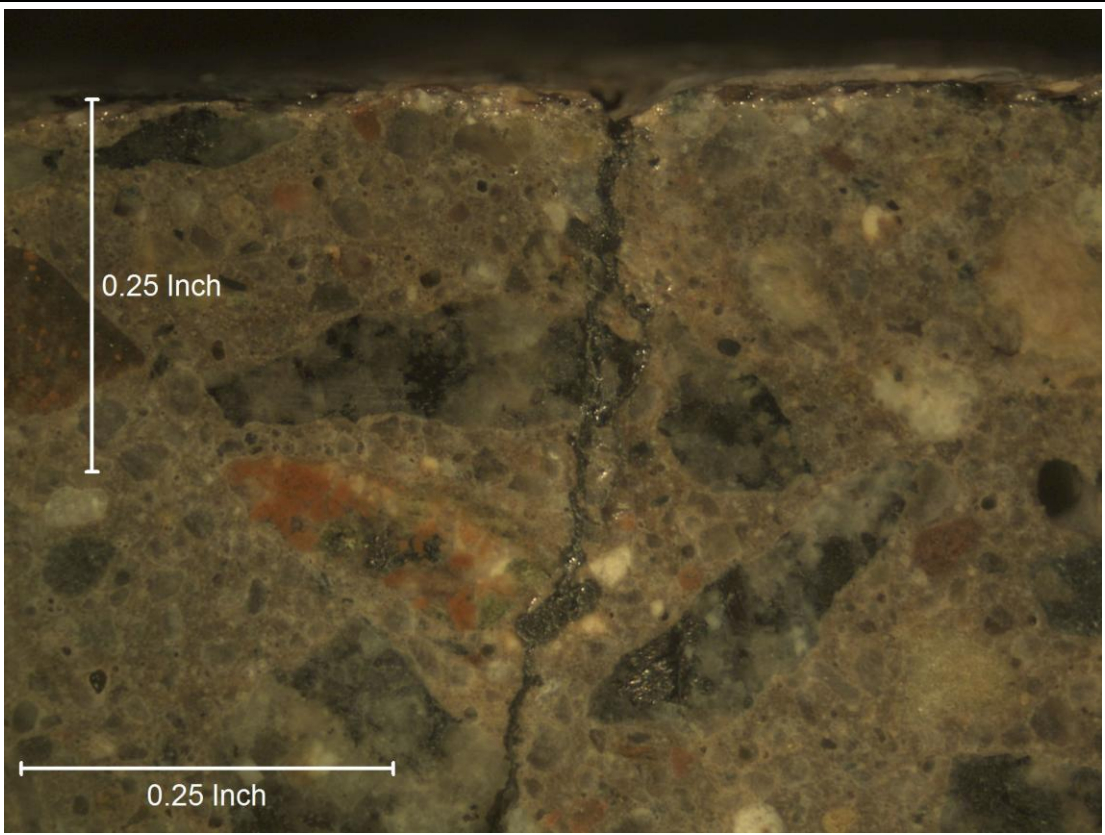
Core #: 28A
Subject: Test Section 14, Test 28A – Transpo T-70, MX-30
Notes: Depth of Maximum Penetration is 0.000 in.
