Minnesota
Department of
Transportation

Scour Monitoring Technology Implementation

September 2014

Research Project
Final Report 2014-37

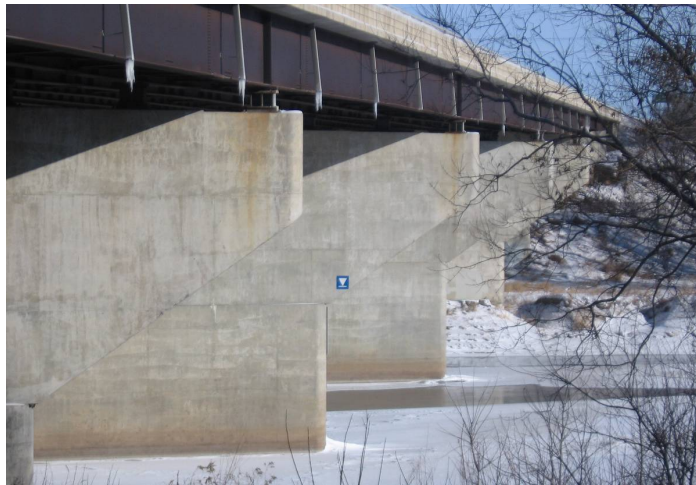
Figure 1: Bridge 07011 - Upstream profiles of piers 3 through 6

The piers of Bridge 07011 are solid and aligned with the flow direction. Scour is mostly limited to local pier scour. A dike and the dolomite rock feature contain the river

The Underwater Inspection Report noted one-foot diameter logs lodged against piers indicating large debris accumulation is an issue at this site. The report also noted that the bed around pier 4 was silty sand and bedrock is the subsurface material. The bed at pier 5 is typically above the water level and the bed at pier 4 is typically underwater.

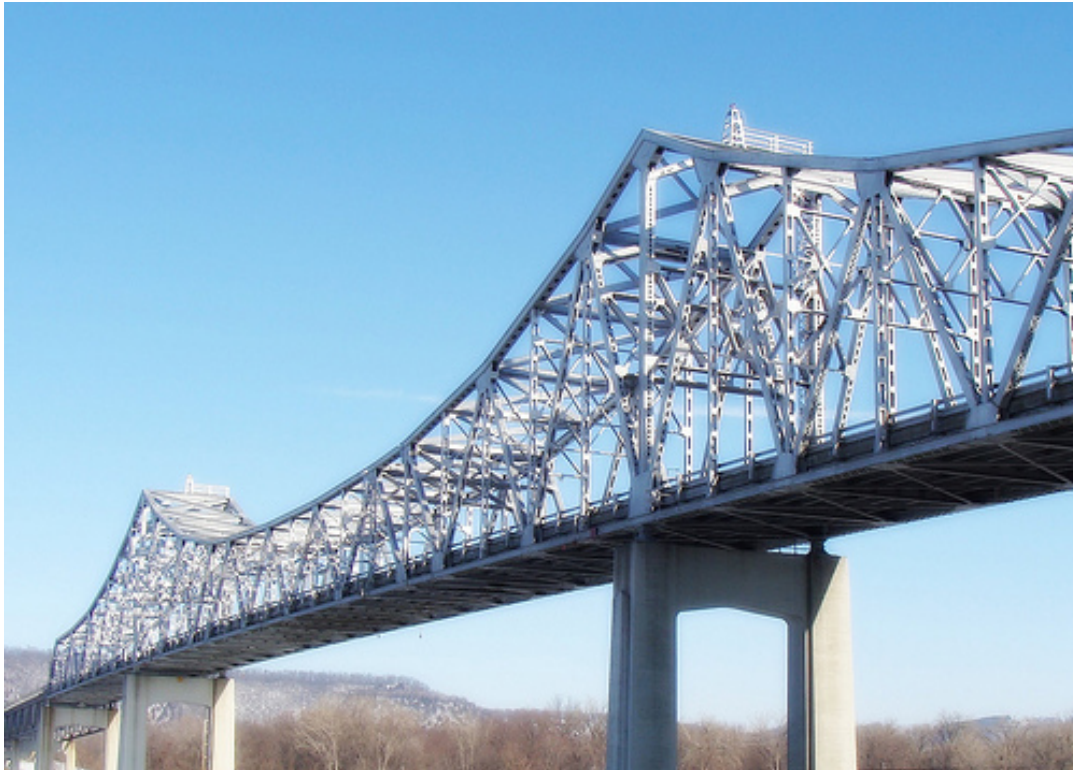
Figure 2: Bridge 5900 - Piers 18, 19, and 20 from Right to Left

Pier 18 is partially covered by riprap from the levee on the south side of the bridge. Scour depressions were found on the upstream side of piers 19 and 20. The bed material at the base of piers 19 and 20 was noted as sand, but no information was given for piers 21 and 22.

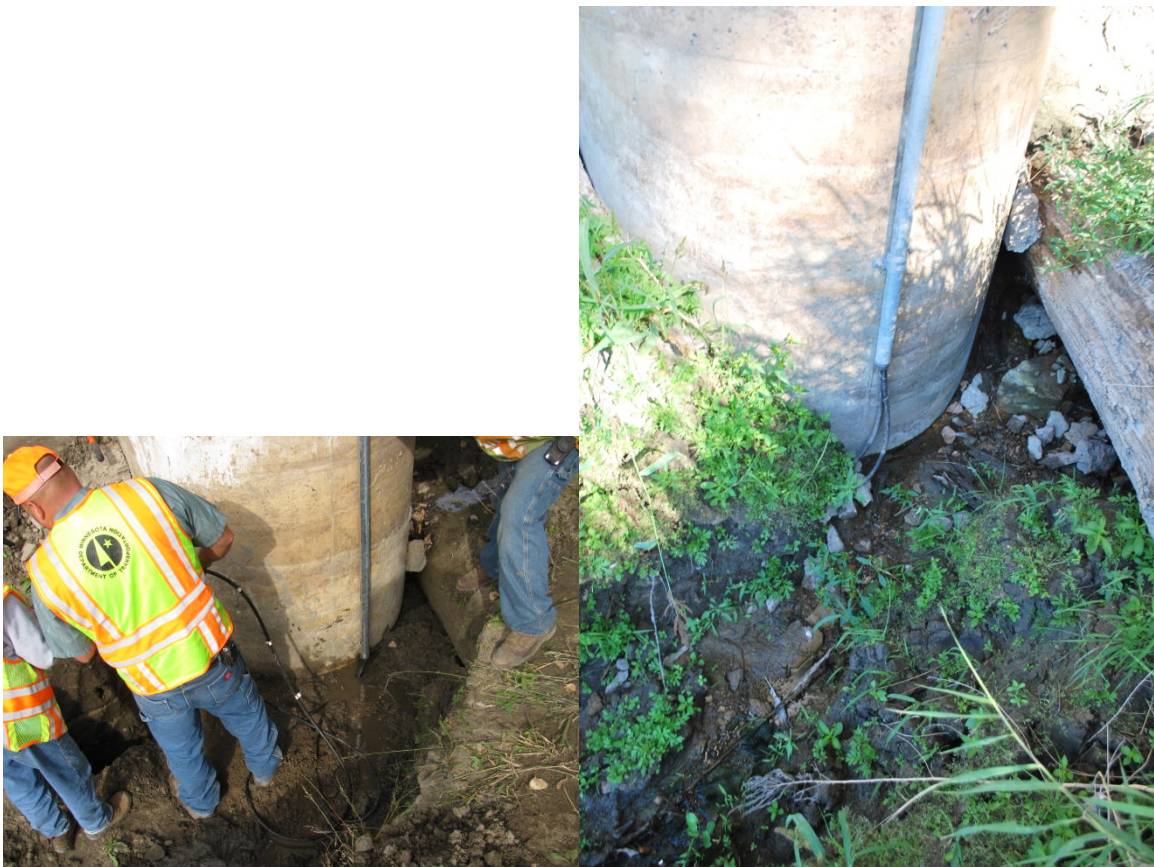
Figure 24: Pier 5 at Installation (10/25/2011) and Testing Event (9/12/2013)

During installation, the float-out receiver may have been activated and transmitted three signals to the receiver. The receiver was not reset after installation of the float-out. This was determined to be the most likely reason the receiver did not operate correctly during the 9/12/2013 testing event.

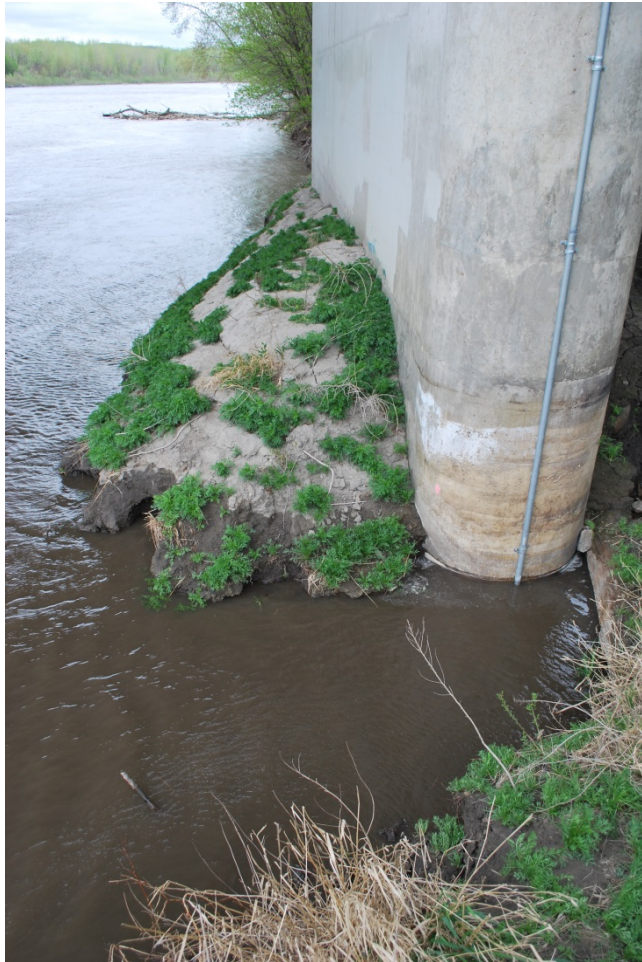
Figure 26: Pier 5 during 5/13/2014 Testing Event

A third testing event was performed on 5/13/2014 with a float-out device to ensure that the receiver, datalogger, and automated alert system were all fully functional. The float-out device unburied during the 9/12/2013 testing event was activated under the bridge. This location under the bridge closely simulates the location where the float-out would become active if removed by scour.

The float-out was not reburied at this time.

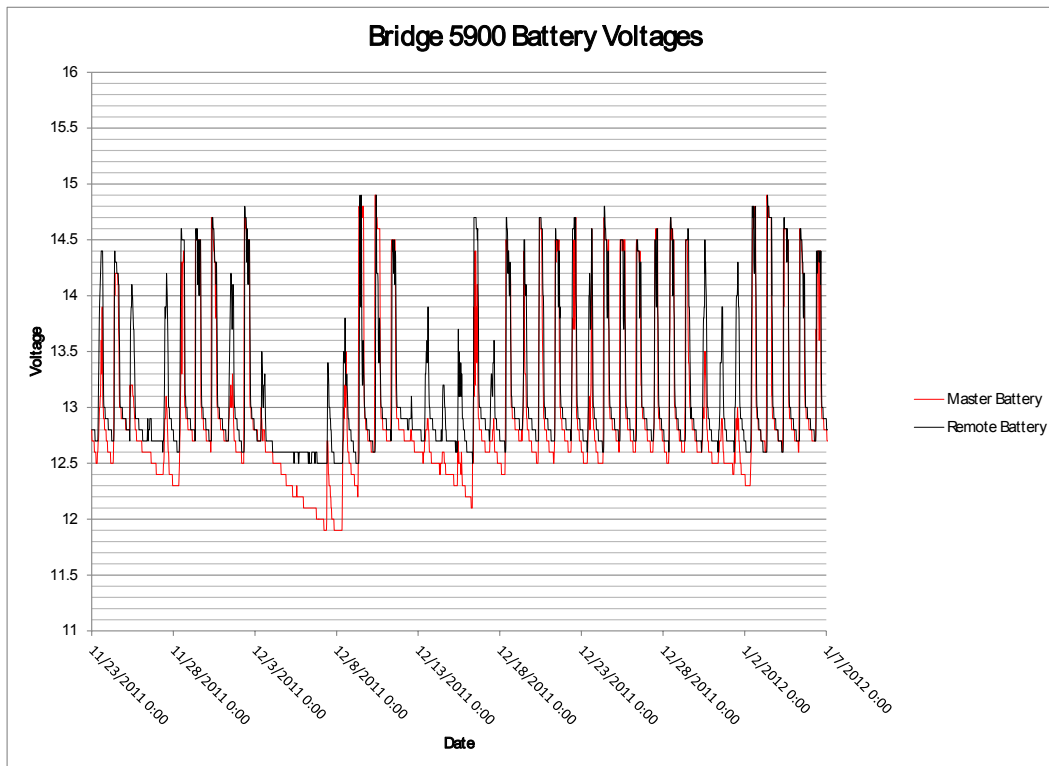
Figure 41: Bridge 5900 Voltage

The gap in reported voltage shown in Figure 41 is due to a communication error with a Gmail server during the weekly update email. The time of the last reported data was 6:00 AM and the weekly message was due to be sent at 6:25 AM. This communication error caused the program to stall and no data was collected from 3/10 to 3/24. ETI likely restarted the program to remove the error. The portion of the code that sends the email has been removed until the operating system is updated, which according to Campbell Scientific, should resolve the Gmail communication issue.

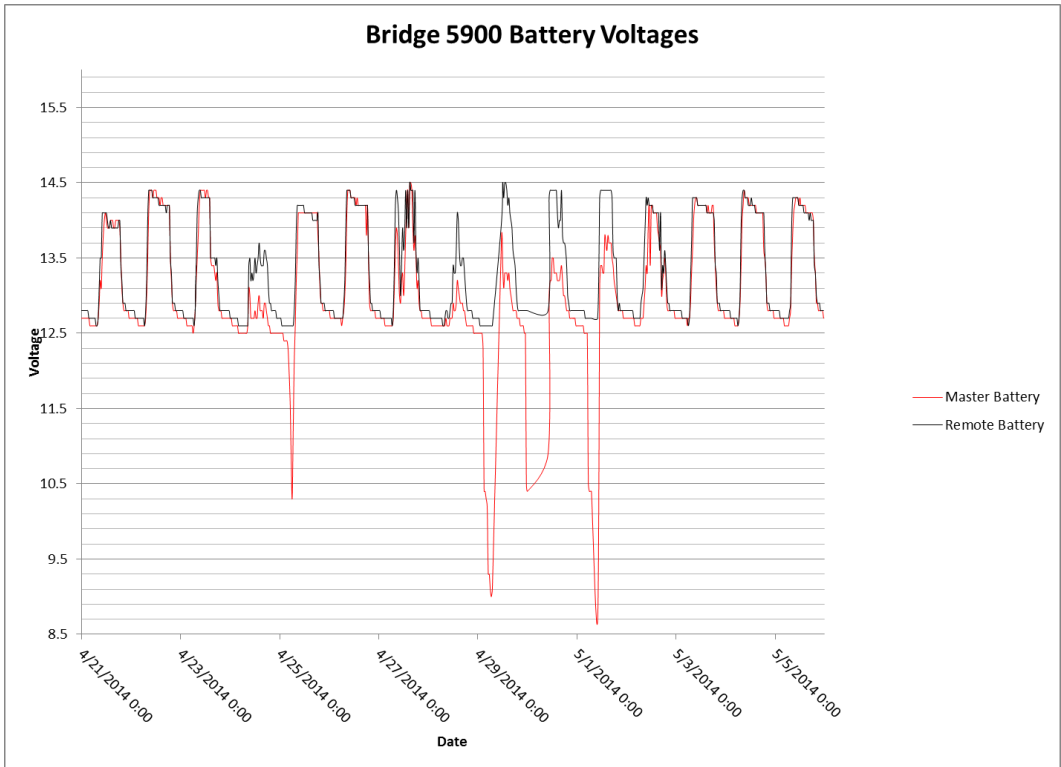
Figure 43: Degraded Master Station Battery Capacity

During 2012-2013 administration, the lowest battery voltage during the time period from 6/1/2012 to 6/30/2013 was 11.8 volts. This occurred on 12/21/2012 on the master battery after six days of minimal solar charging.

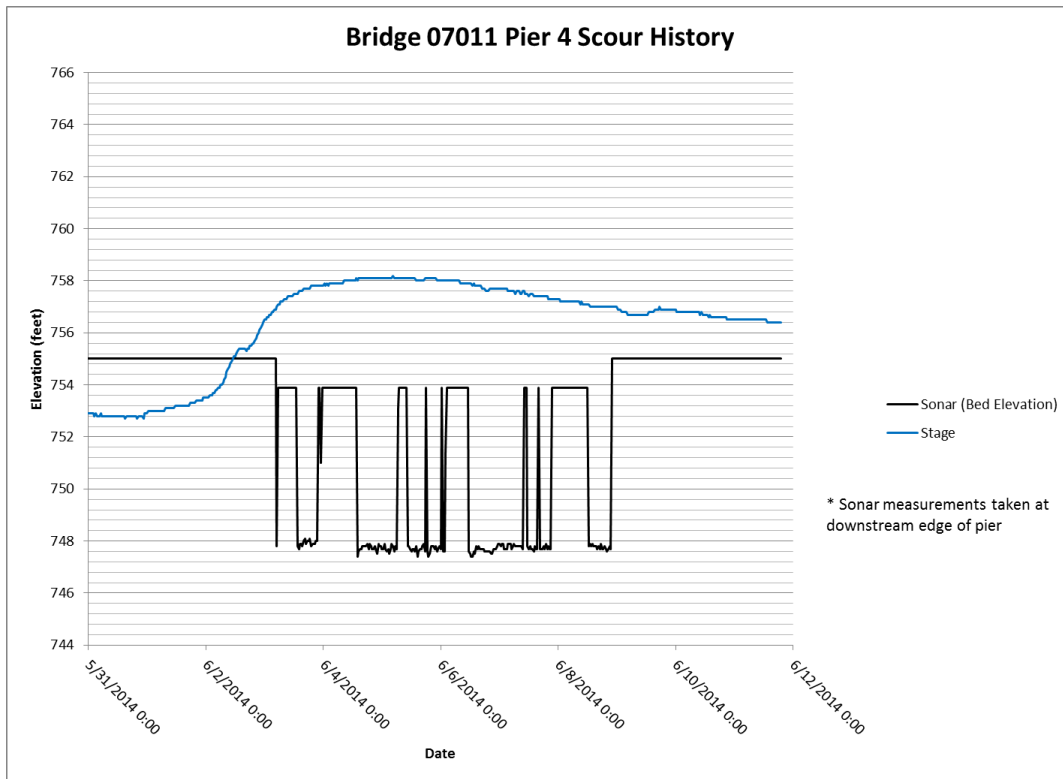
Figure 52: Pier 4 Downstream Pier Elevation – Administration 2013-2014

As with the previous yearly report, there were false readings which returned incorrect bed elevations. These false bed elevations were 753.9 ft and were more persistent when compared to the previous year. The most likely explanation for these recorded elevations is suspended sediment caused a return at the minimum range for the sensor. The sediment concentrations in the river are not readily available online. However, this event was due to a rainfall event which may cause high amounts of suspended sediment in the river. This may have also caused the more persistent false readings.

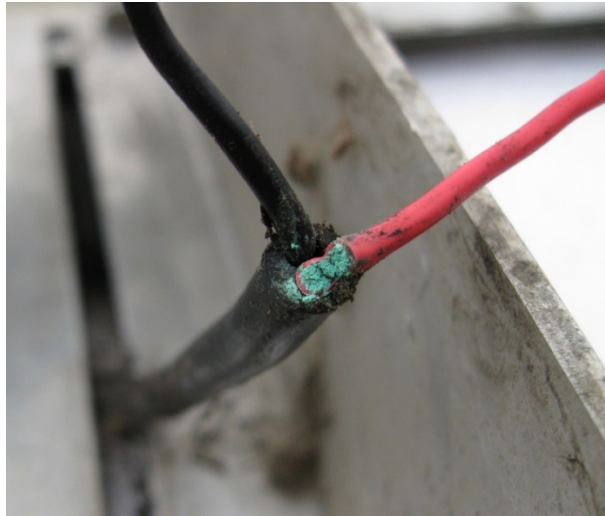
Figure 55: Wire Corrosion on Solar Panel Wire

The solar panel and regulator on the Master Station of Bridge 07011 were the most likely to corrode of all the solar panels installed during this project because of its location just outside the bridge barrier. This solar panel was most likely to come into contact with roadway spray and plowed snow.

Unplanned maintenance costs are usually high for fixed scour monitoring. An estimate for the first year would be \$5,000 and decreasing to about \$1,000 for following years. Actual costs were much less than this. On-site maintenance was required only three times. Two times were needed to replace batteries and at third time was needed to rewire a solar panel cable that had rusted.

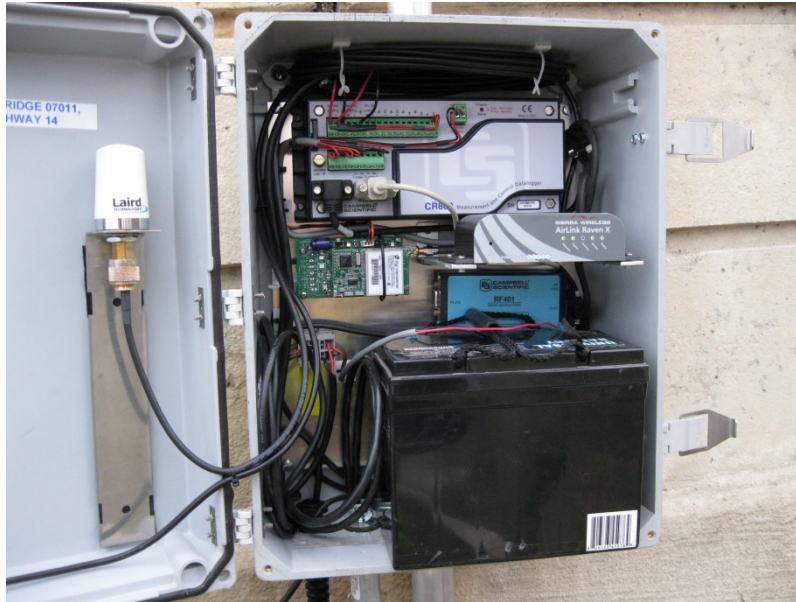
Figure 57: 35 Amp-hour Battery Replacement on Bridge 070011 Master Station

The initial 12 A-hour was not appropriately sized to handle the large current draw required by the wireless receiver, which accounts for 75% of all current draw from the system. It was replaced with a 35 Amp-hour battery shown in the following figure.

- a. Batteries need replacement every three years. Batteries should be sealed with enough energy storage (Amp-hours) to run the system for five days with no charging.
- b. Batteries were undersized for the equipment’s power needs and solar recharge rates in Minnesota. The power budget for solar-based deployments should be carefully reviewed for determining solar panel size and battery’s energy storage capacity. Campbell Scientific provides a technical application note which should be followed and is listed in the references of this report.
