Development and Integration of Advanced Timber Bridge Inspection Techniques for NBIS

Brian Brashaw, Principal Investigator
Natural Resources Research Institute
University of Minnesota Duluth

Research Project
Final Report 2015-01

**BRIDGE # 69529
CSAH 52 over DITCH**

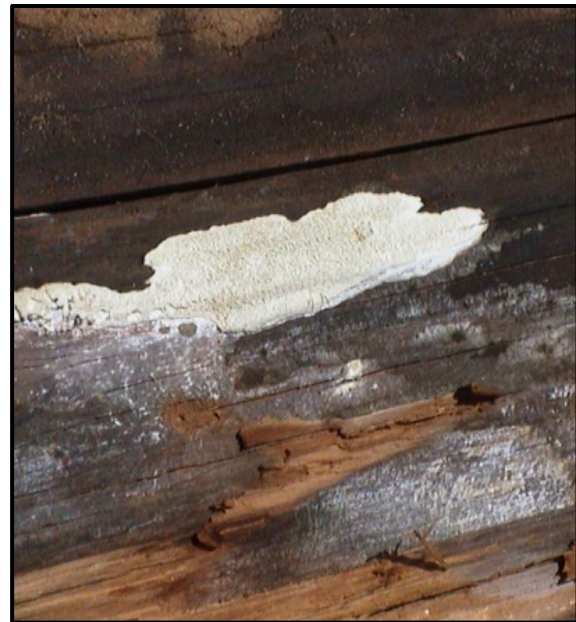
Figure 3.2. Douglas fir bridge member showing visual evidence of a fruiting body on the surface in addition to visual evidence of decayed timber.

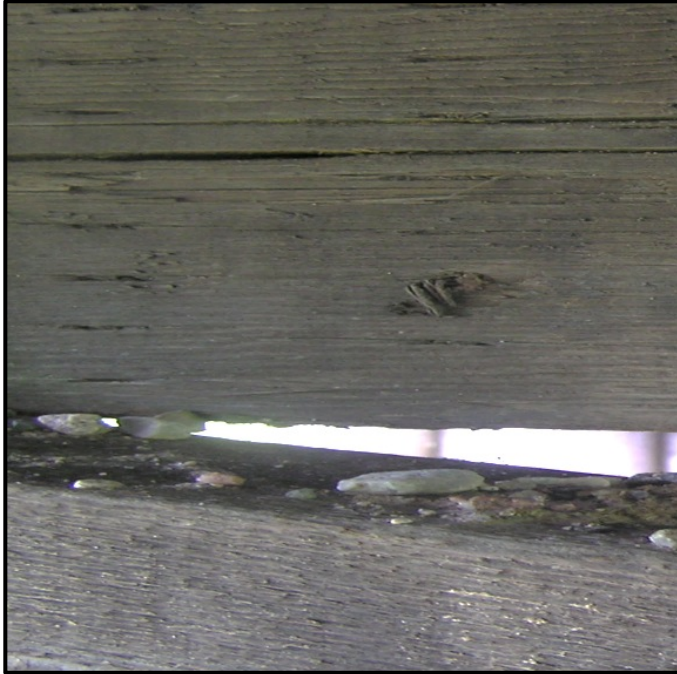
Figure 3.8. A timber abutment cap that has been initially deteriorated by decay. Carpenter ants are nesting in the cap, with frass being deposited onto the cross bracing member.

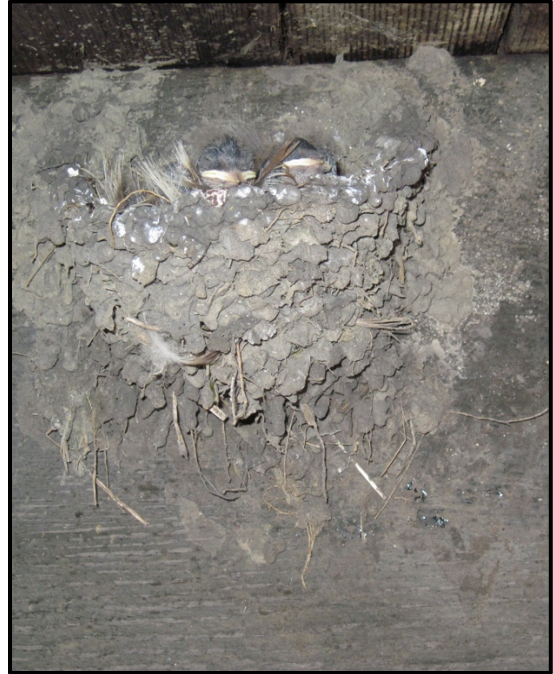
Figure 3.9. Nesting birds are often found under timber bridges and their nests can trap and hold moisture against timber beams and bracing.

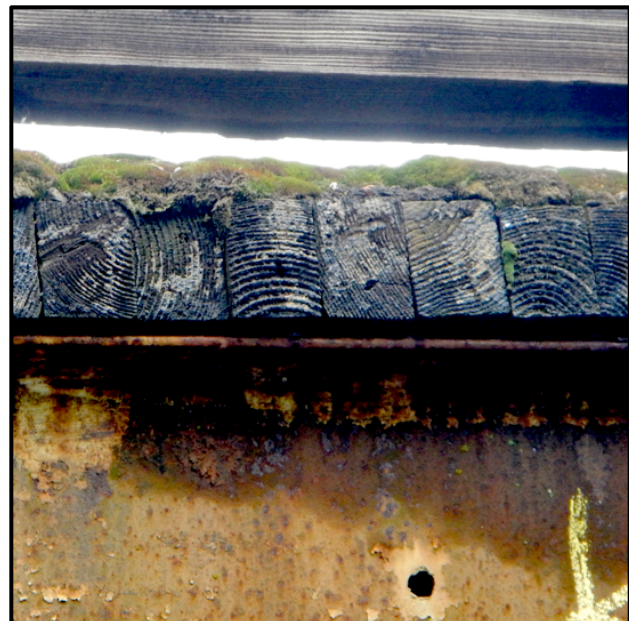
Figure 3.10. Moss growing on the surface of a nail laminated timber deck supported by steel beams along the curb/scupper zone.

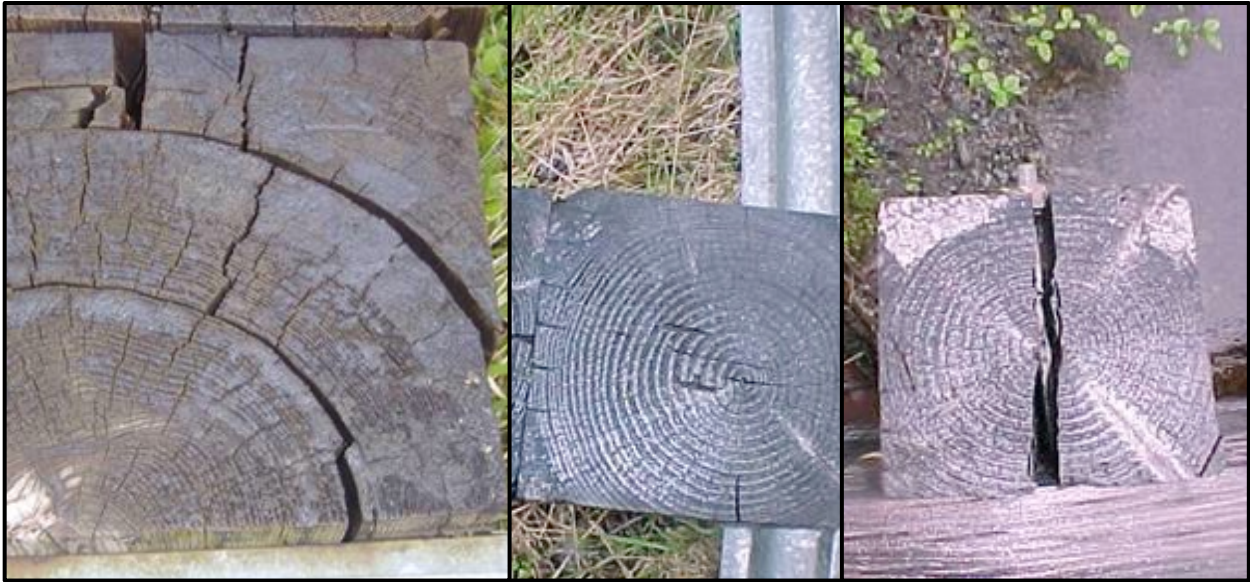
Figure 3.12. Timber railing posts showing various types of deterioration. From left to right, the posts show ring shake, small end checks, and severe through splits.

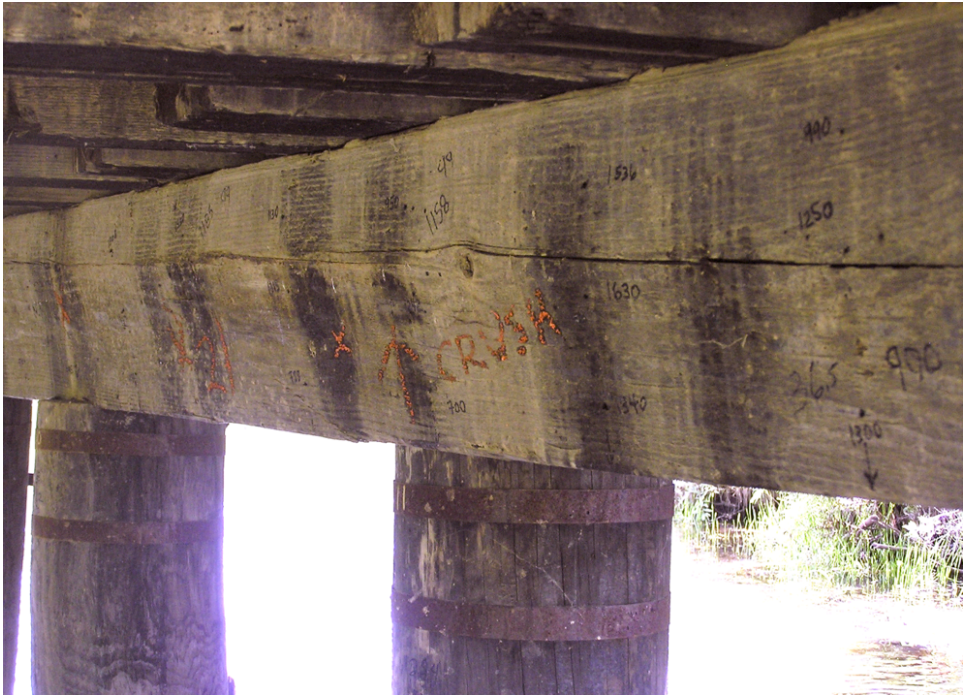
Figure 3.13. A long horizontal split provides an opportunity for moisture passing through the timber deck to enter the abutment cap, leading to substantial decay.

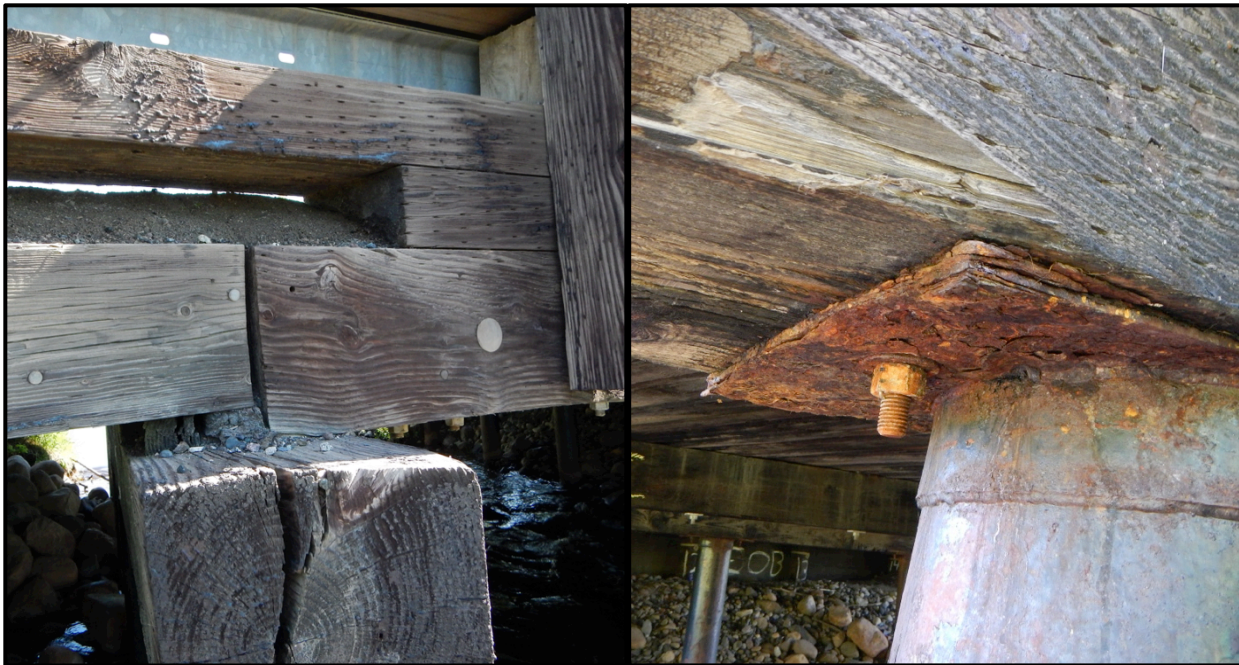
In **Figure 3.14**, a severe through split in an abutment cap provides an opportunity for moisture to absorb into the element, resulting in conditions that allow for potential decay as well as deterioration of the surrounding steel elements such as the CIP bearing plate.

Figure 3.14. Visual assessment of a pier cap split. The split allows moisture from the deck to enter the member beyond the protective layer of preservative treated wood, resulting in increased likelihood of future decay and allows for deterioration of hardware such as the CIP bearing plate that supports this element.

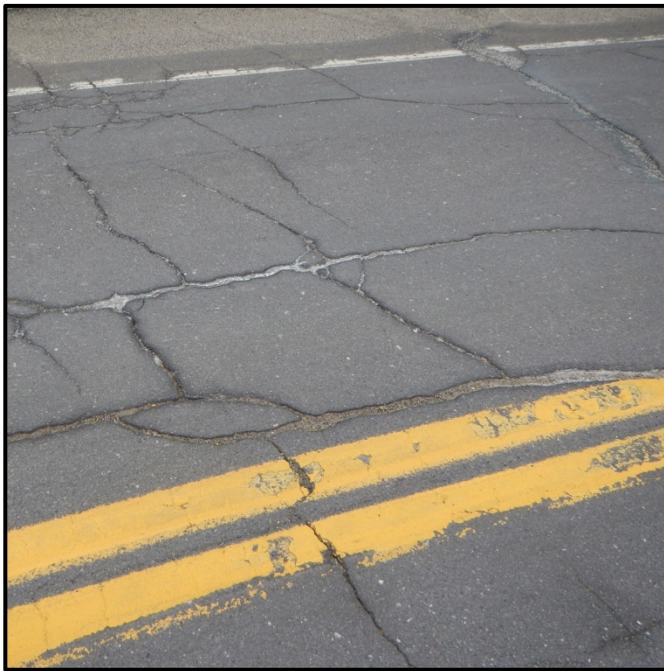
Figure 3.16. Cracking and deterioration of bituminous wear layers create opportunities for water to pond on the deck and seep into the superstructure elements creating decay potential.

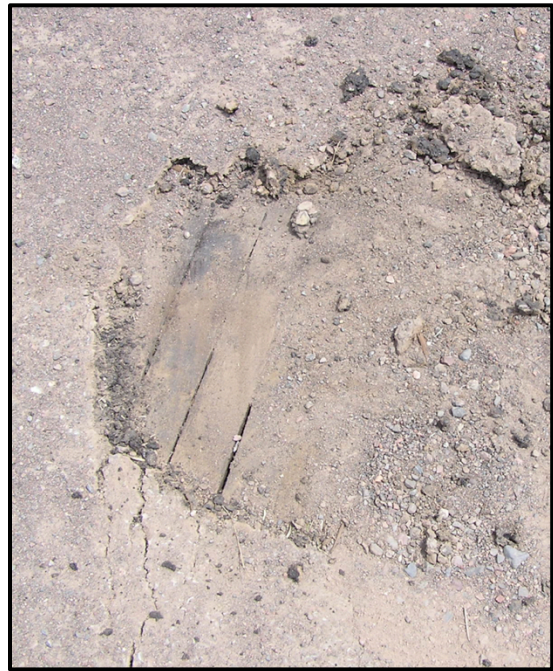
Figure 3.17 shows an exposed timber deck on the surface of a bridge where the wear layer has been completely removed. This creates an entry point for moisture infiltration into the timber decking, beams, abutments and piers.

Figure 3.17. The bituminous wear layer has deteriorated exposing structural timber decking to moisture and potential deterioration.

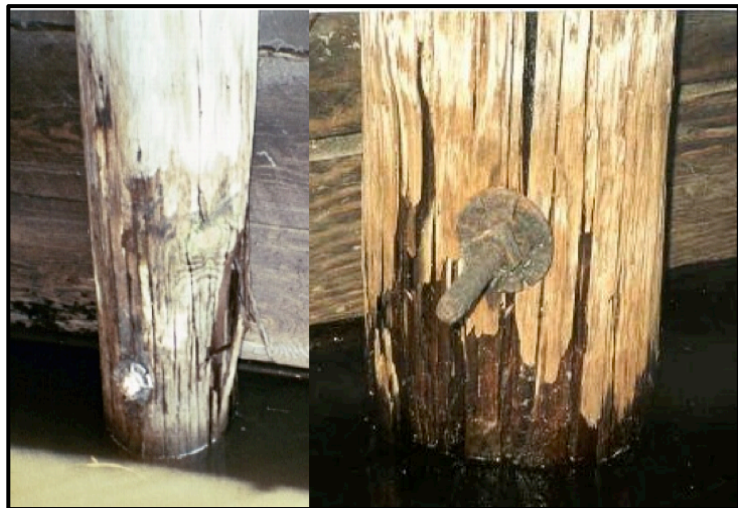
Figure 3.18. Shell damage to timber piling at or near the water line, often caused by freeze thaw cycles, ice damage or flotsam floating down the river.

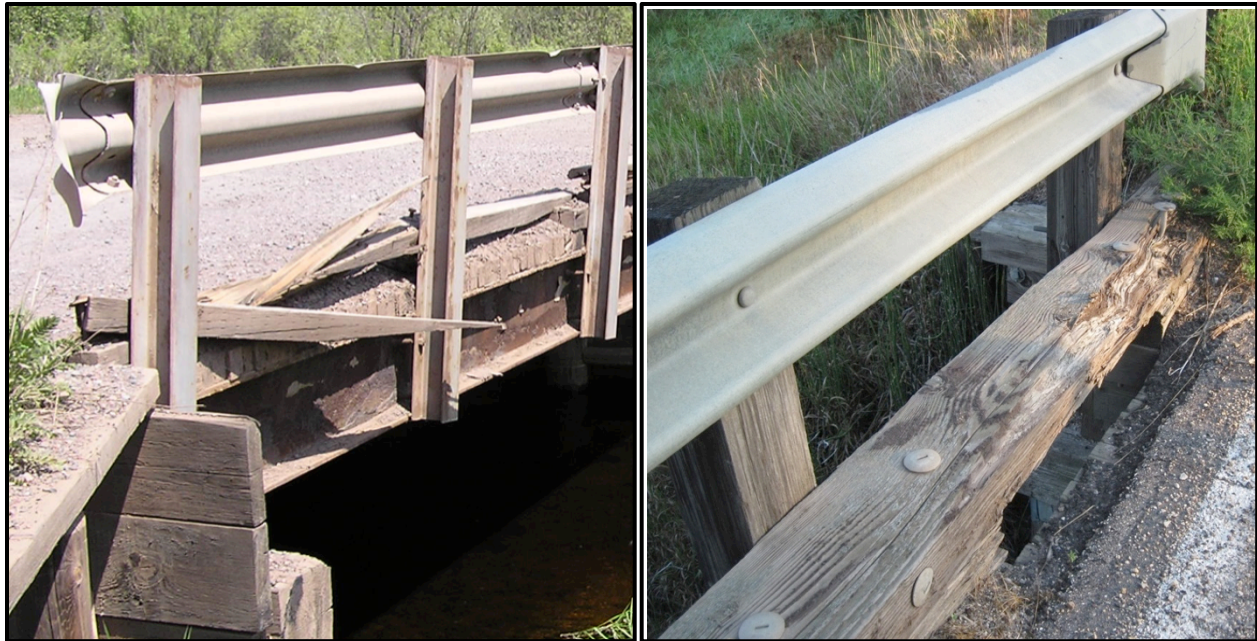
Figure 3.19. The timber curbs shown have significant damage from a snowplow or other vehicle exposing untreated wood to high levels of moisture.

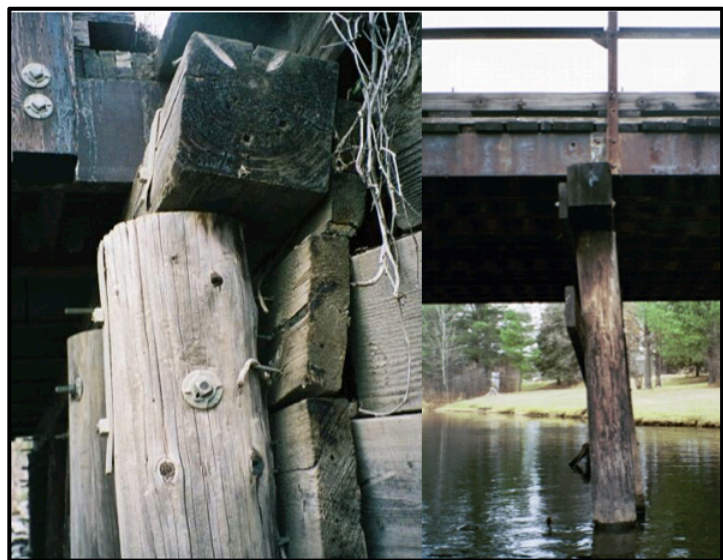
Figure 3.20. Rotation of timber pilings and pile caps in an abutment (left) and timber pier (right).

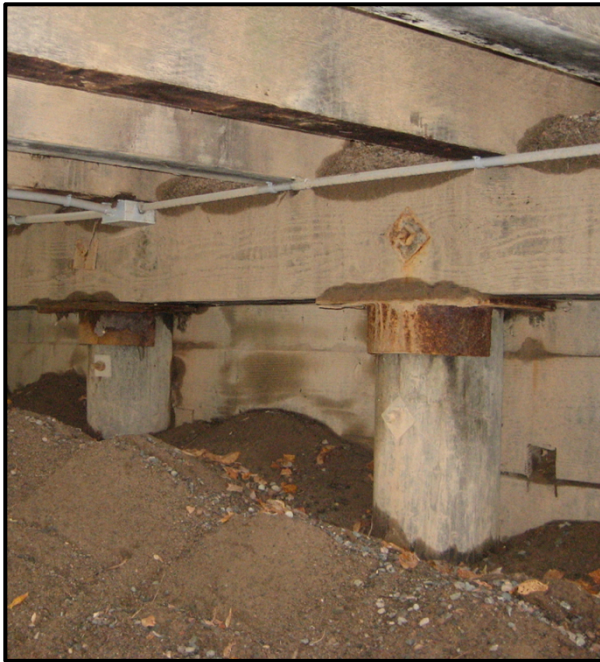
Figure 3.21. Sand and gravel are shown on top of the timber abutment cap as deposited through vehicle traffic or road maintenance through a timber deck.

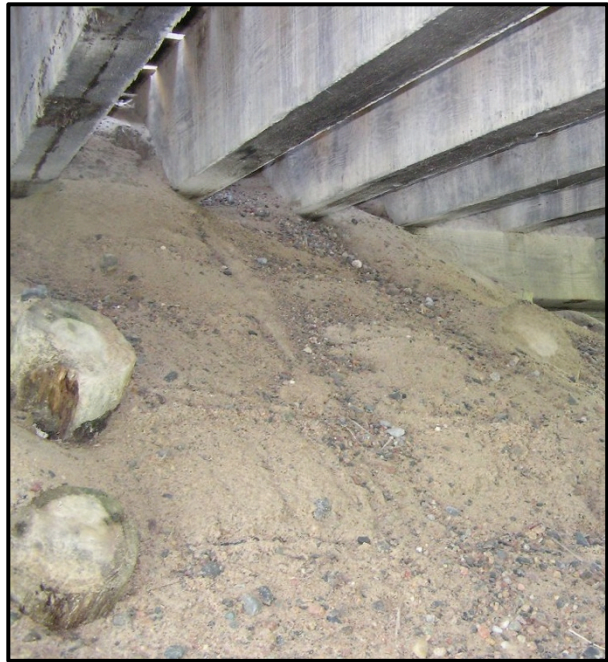
Figure 3.22. Sand and gravel are covering the timber abutment cap and the longitudinal timber beams, holding moisture against these elements.

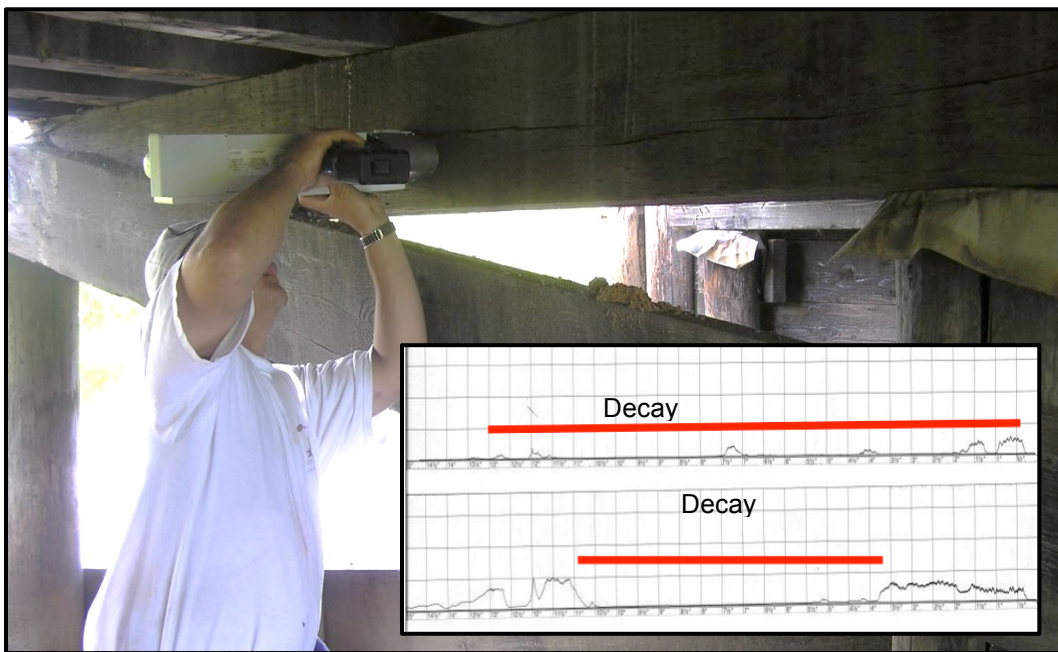
Figure 6.5. Resistance microdrilling showing significant decay in the bridge pile cap. The inlay shows the paper chart readout from a commercial drilling unit.

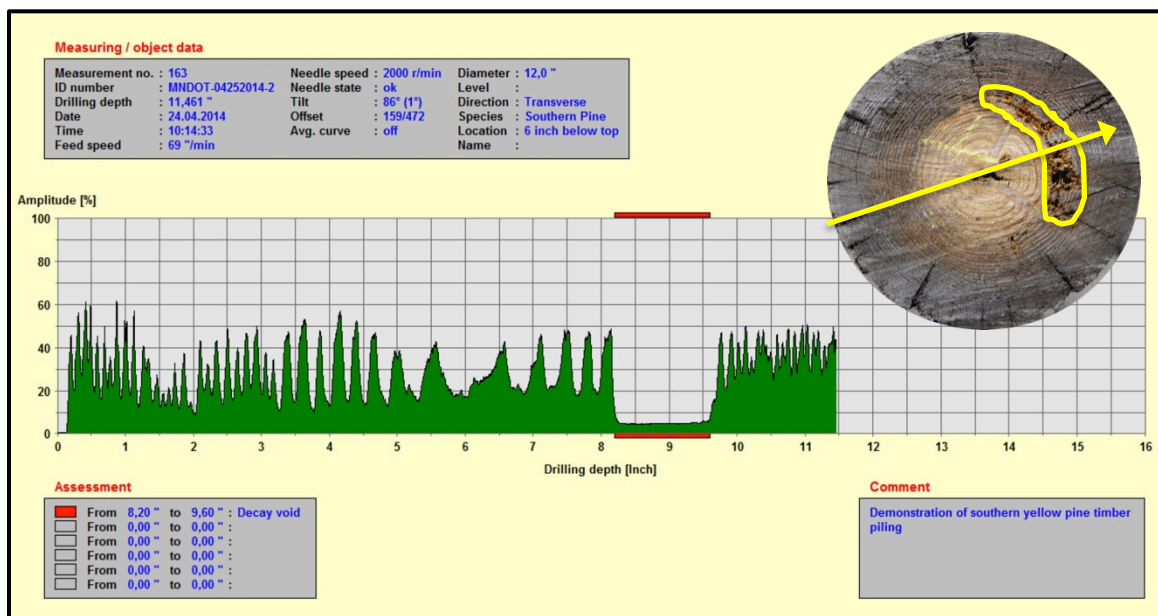
Figure 6.8. Electronic view of a southern yellow pine timber piling showing a decay pocket between 8 and 10 in. of the drilling profile.

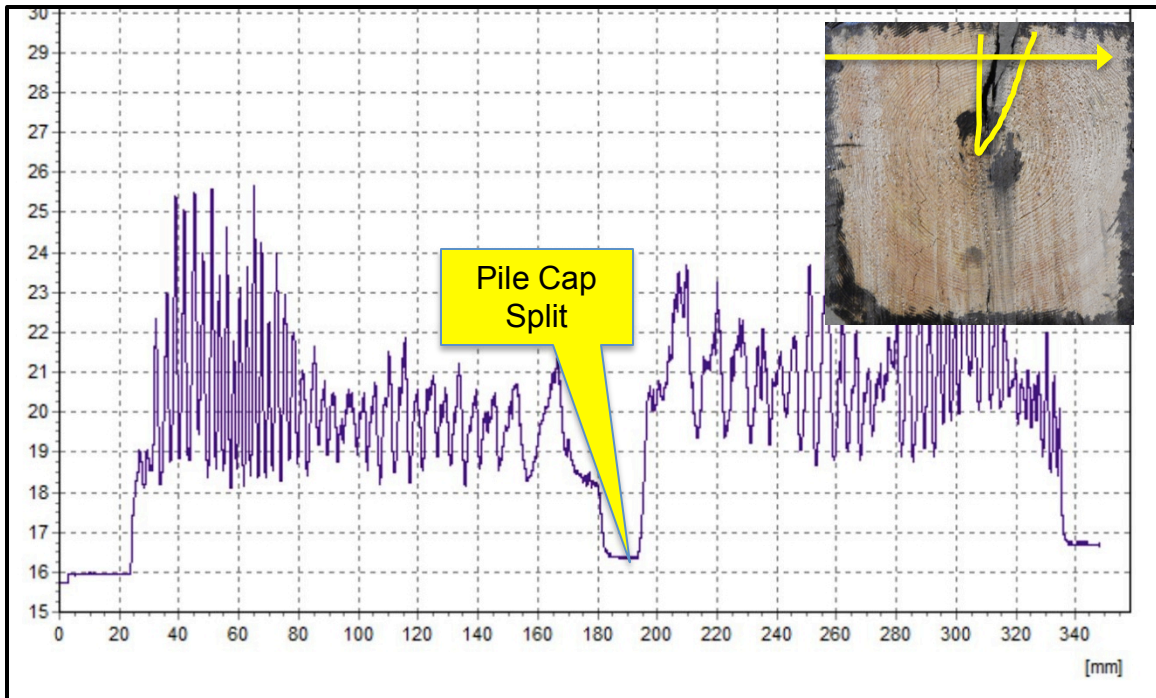
Figure 6.9. Electronic resistance chart of a Douglas fir pile cap showing a large crack between 180 and 200 mm (7.0 and 7.9 in) along the drilling path.

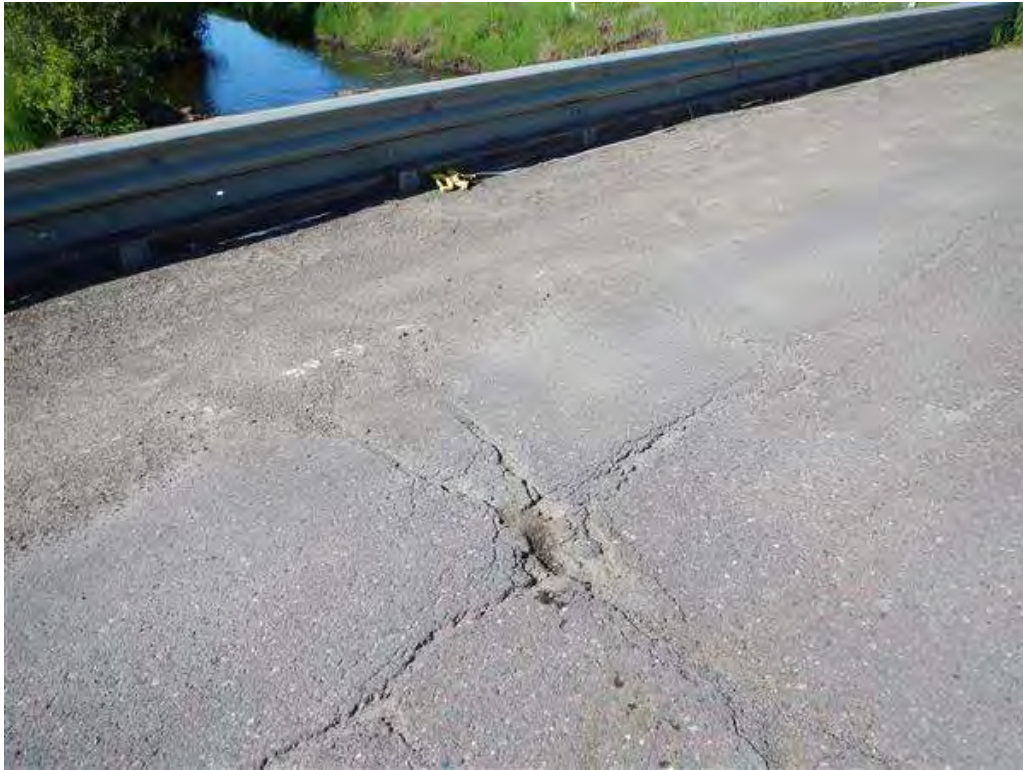
Photo 2 - Deck - Pot hole above Pier 2 with longitudinal cracking

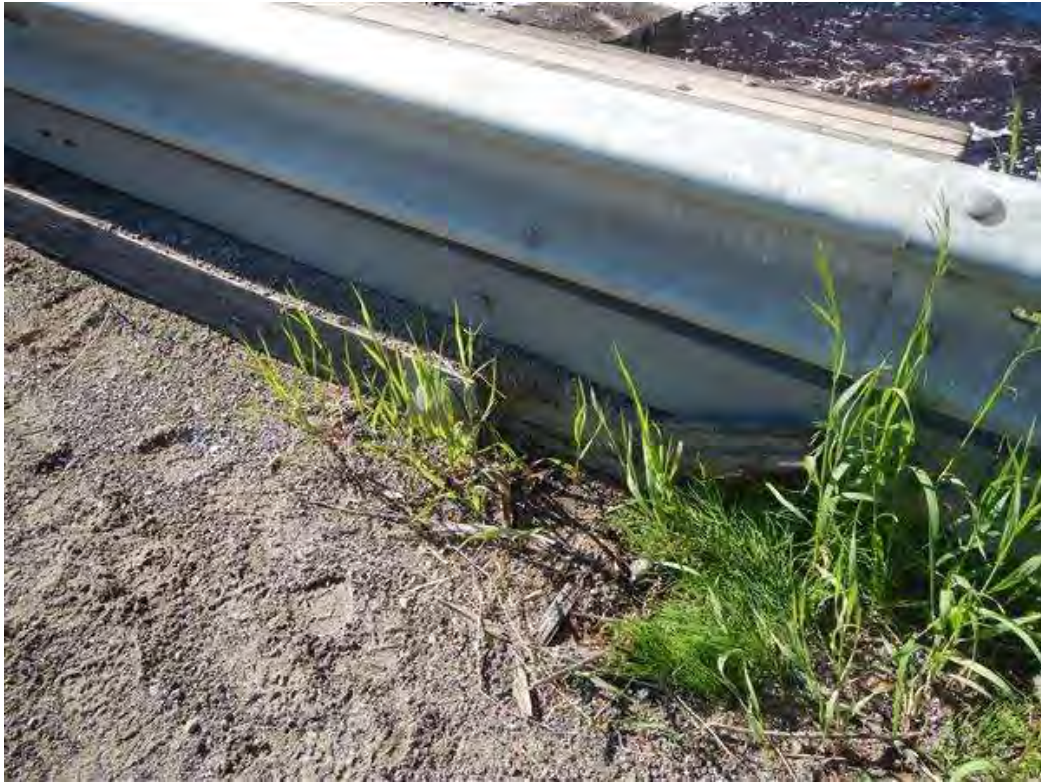
Photo 5 - SW corner of bridge showing vegetation and gravel/sand near curb. Deterioration noted.

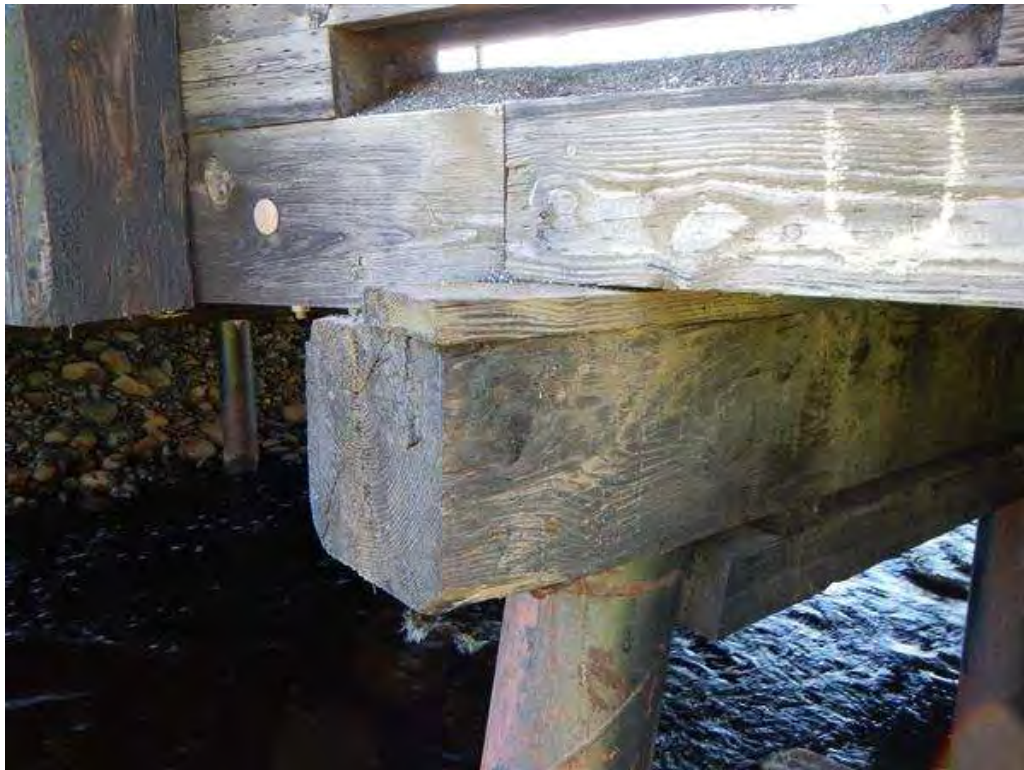
Photo 6 - Pier 1 - North End - Through split extending 80% of full length of cap. SWT over 500 but R drill showed only crack with no decay

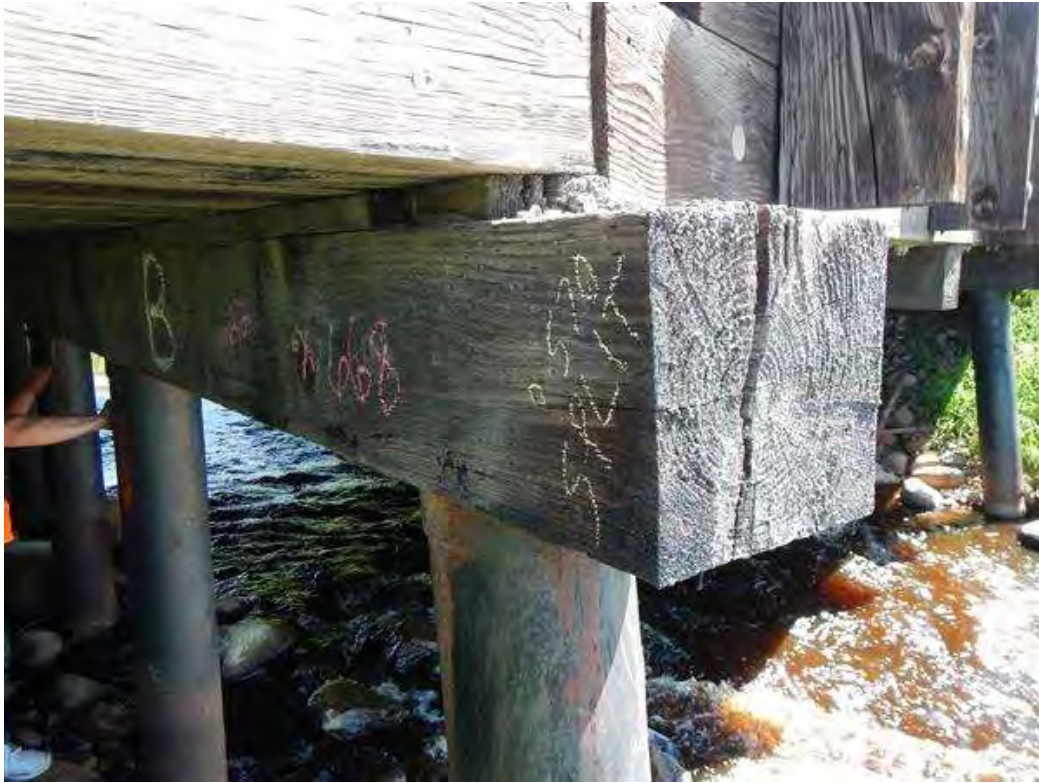
Photo 7 - Pier 1 - South End - Through split extending 36"

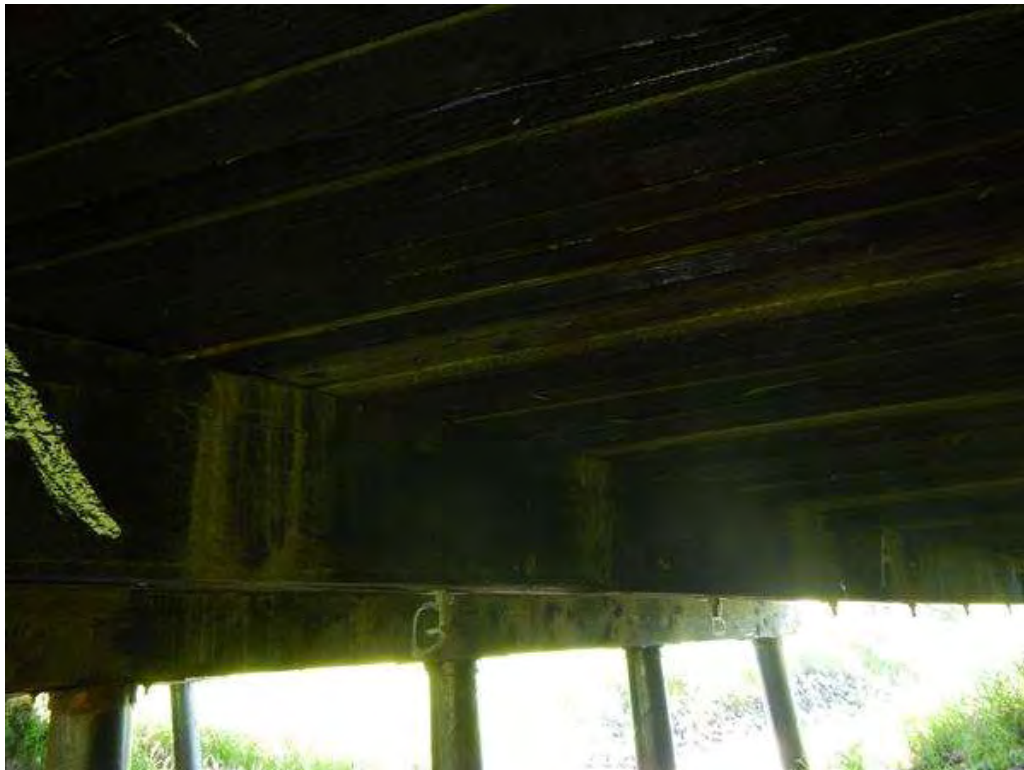
Photo 8 - Span 1 - Moisture pen. through deck.

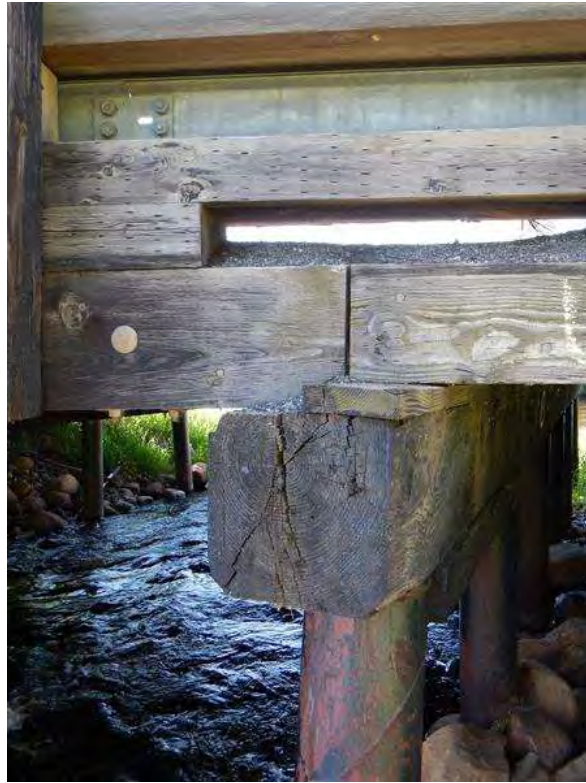
Photo 9 - Pier 2 - South end - Through split continuing 24 inches into cap.

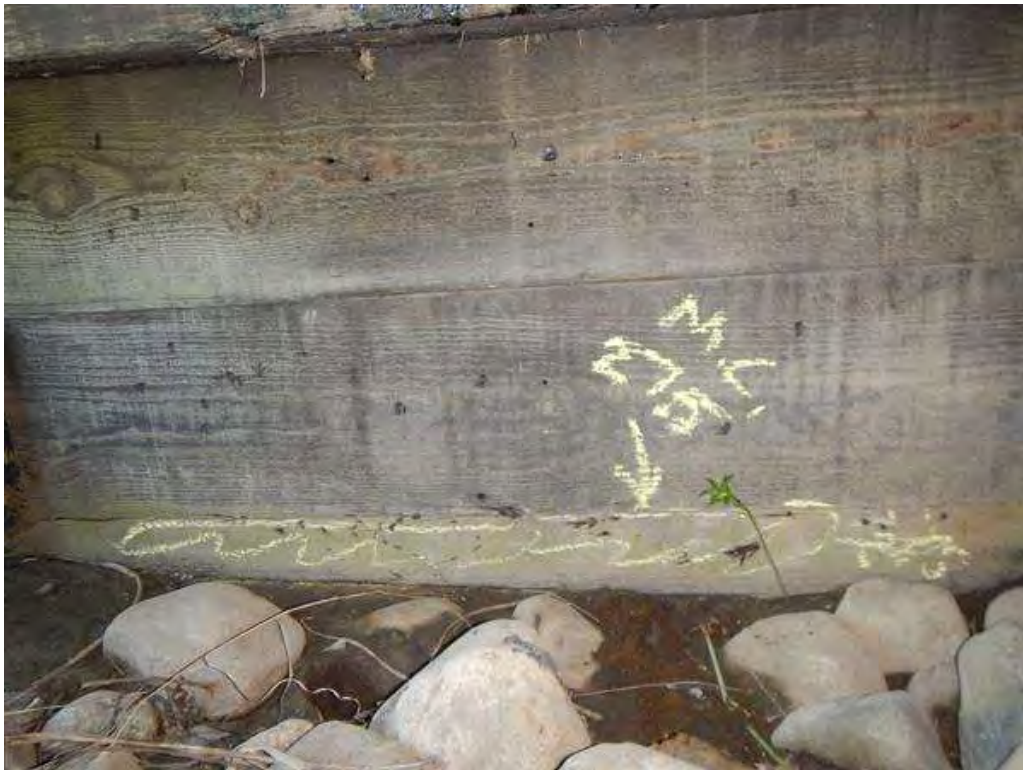
Photo 12 - High moisture abutment wall between piles 8 and 9. Moisture content over >25% but no decay present.

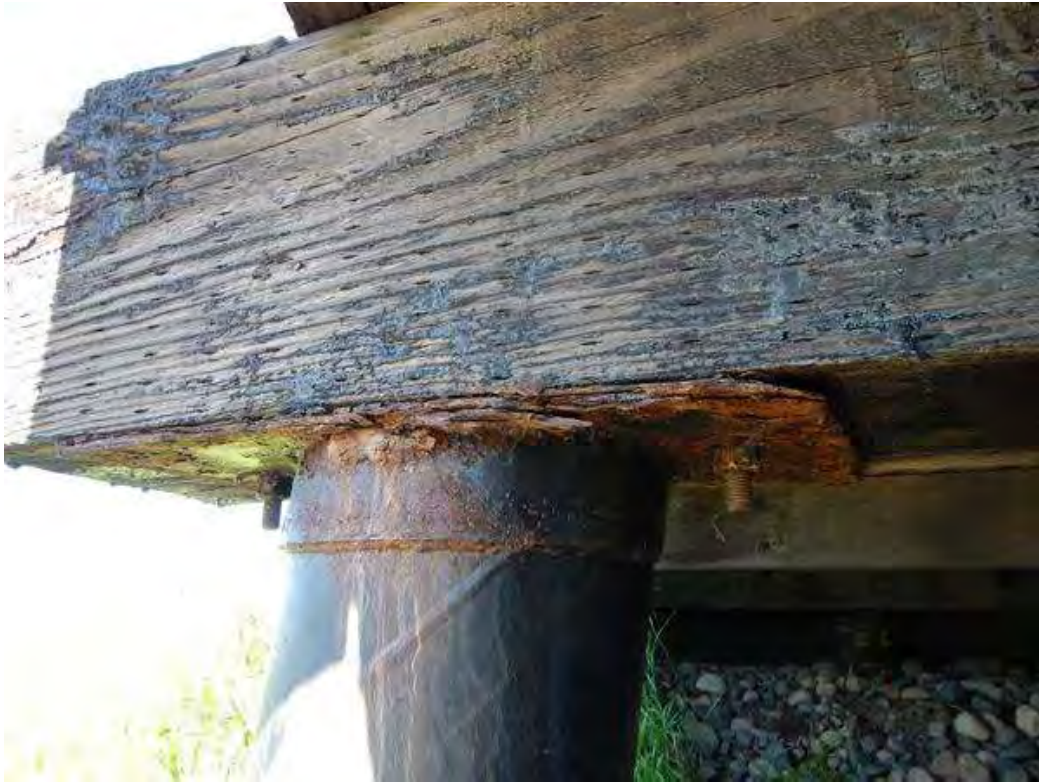
Photo 13 - Pier 1 -CIP cap plate rusting with section loss.

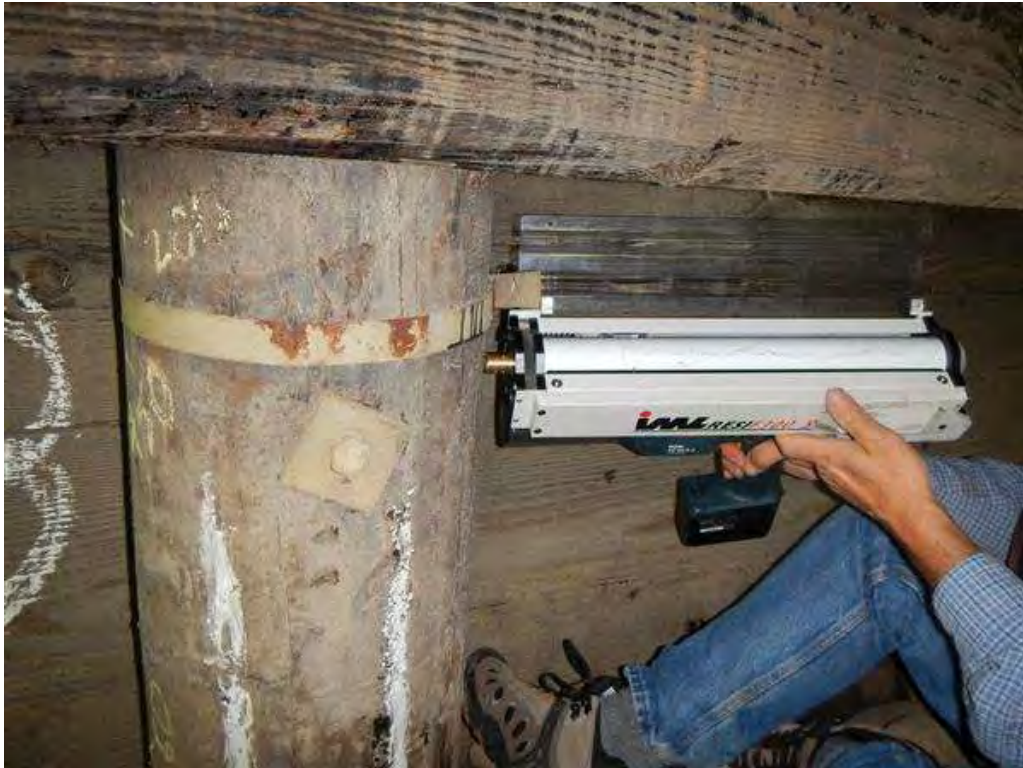
Photo 14 - E abut - Pile 11 - Sound condition

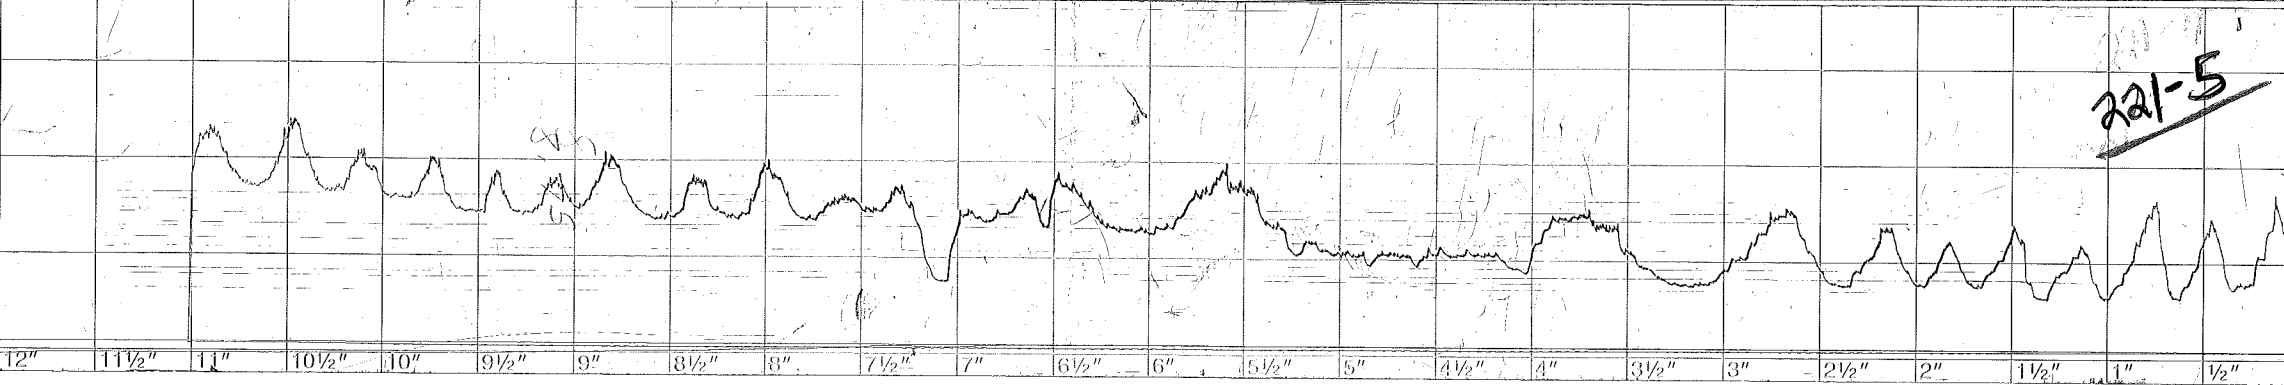
Name/Name: 830 us Pile Cap "B"
 Datum/Date: 16 8 from up
 Nr./No.: Visual crack underside
 Bemerkung/Comment:

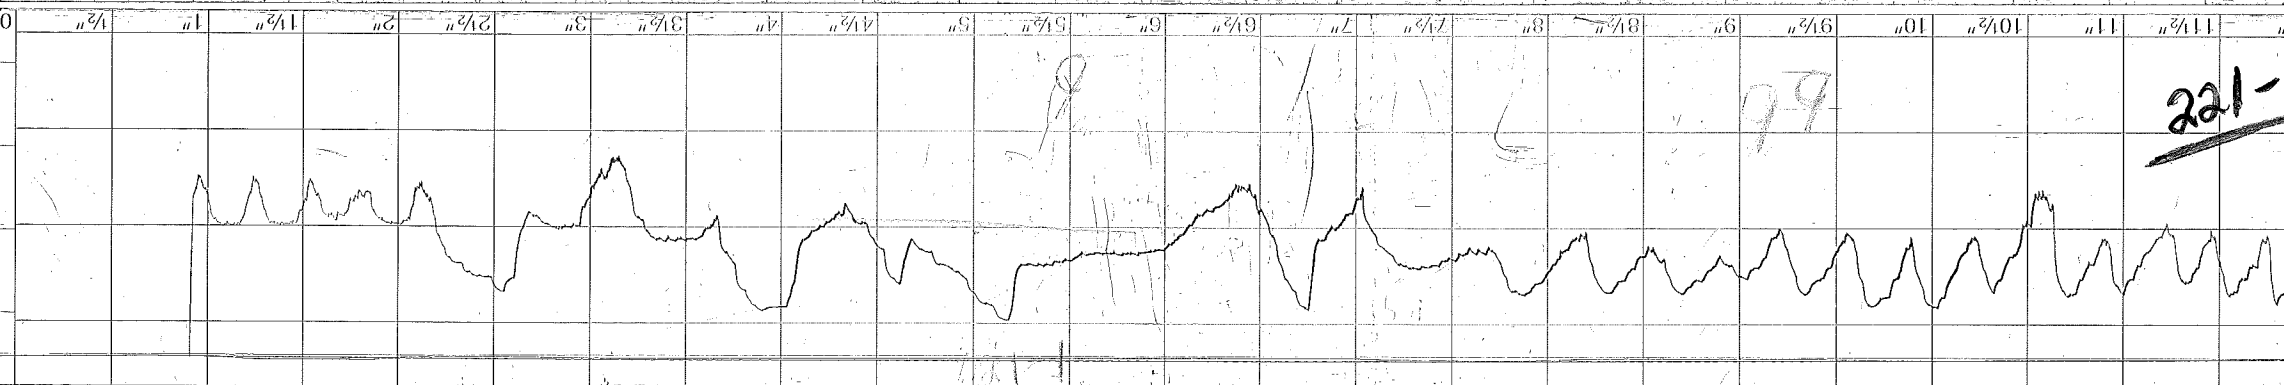
Name/Name: Beam B (Pile Cap)
 Datum/Date: 811 us, seems to be large split caused more than decay
 Nr./No.: 1' 5" from up
 Bemerkung/Comment:
