Performance of Various Partial-Depth Repair Materials at the MnROAD Facility

May 2016

Research Project
Final Report 2016-16

Office of Materials and Road Research
Minnesota Department of Transportation

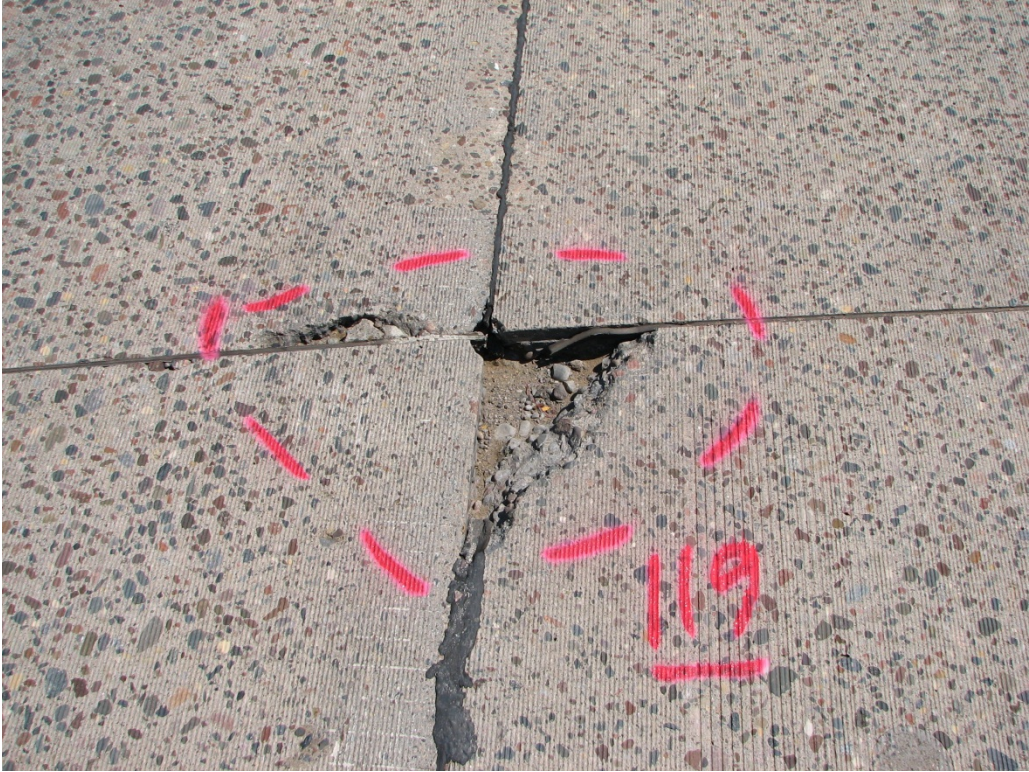
Figure 1.1 Distress near the surface of a concrete pavement at intersection of transverse and centerline joints.

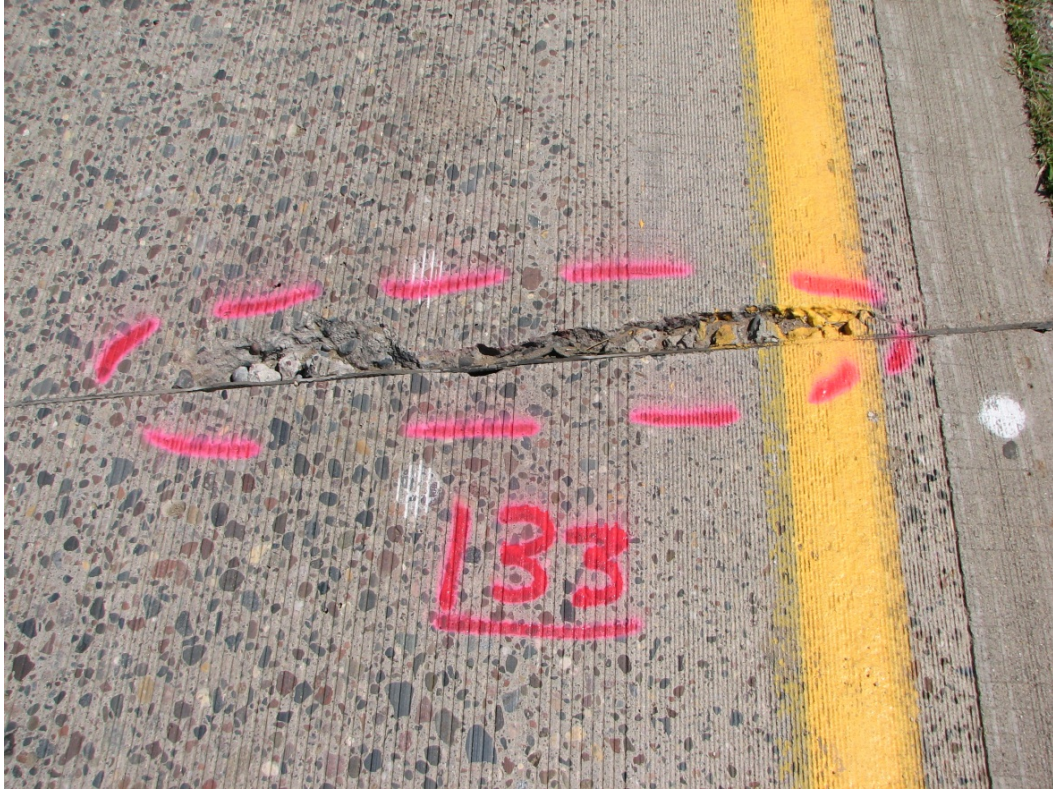
Figure 1.2. Distress near the surface of a concrete pavement along a transverse joint.

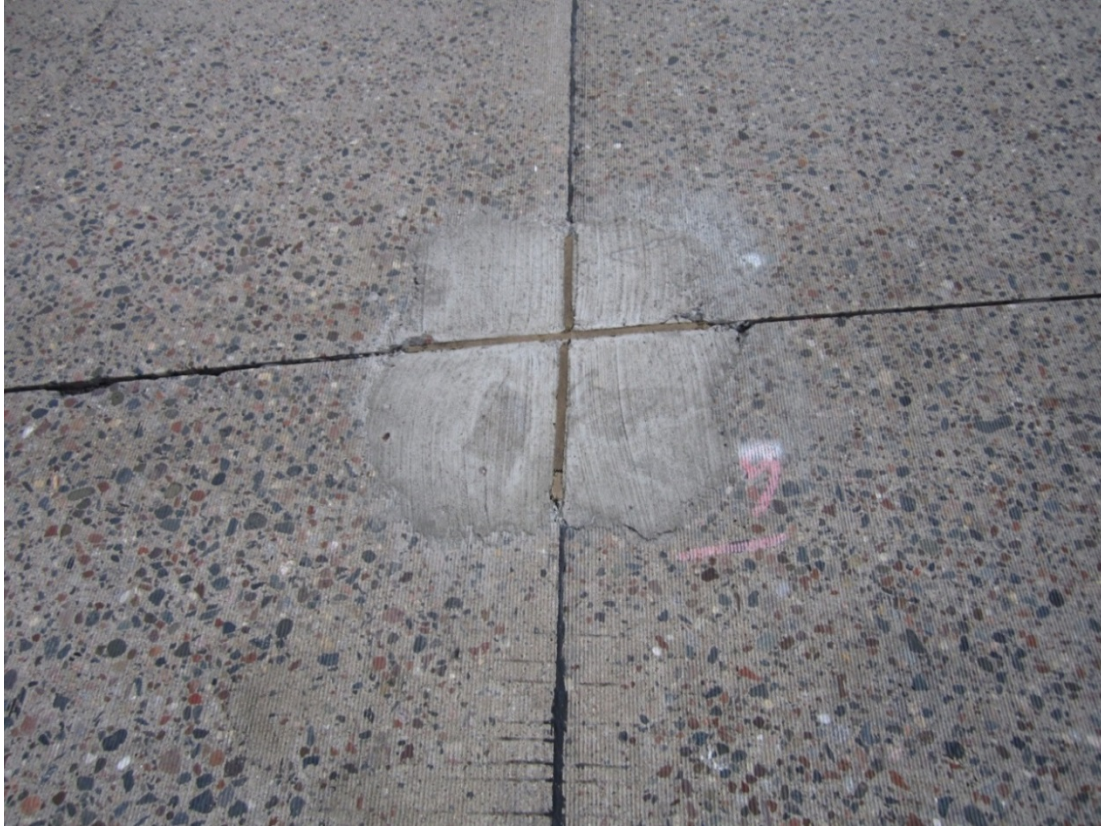
Figure 1.4. Typical MnROAD partial-depth repair with cementitious-based material.
