# Evaluation of the SafeLane™ Overlay System for Crash Reduction on Bridge Deck Surfaces

Minnesota  
Department of  
Transportation

Research Project  
Final Report #2010-13

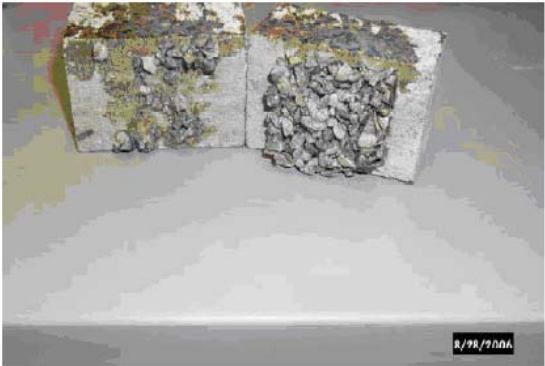
Figure 3.3. Failure of bonding.

As shown in the following figure, bond rupture was observed at the SafeLane™ - concrete interface.

Specimen 1 (7 day strength) failed mainly by de-bonding at the interface. Specimen 2 (7 day strength not shown) failed by a combination of de-bonding and tension within the overlay in the overlay. Specimen 3 (28 day strength) failed by de-bonding. Failure loads are shown in the following table.

The tests above do not have a published reference with which one can compare results. Compared to bond strength requirements of ASTM C-882, which is a different procedure, these results are low.

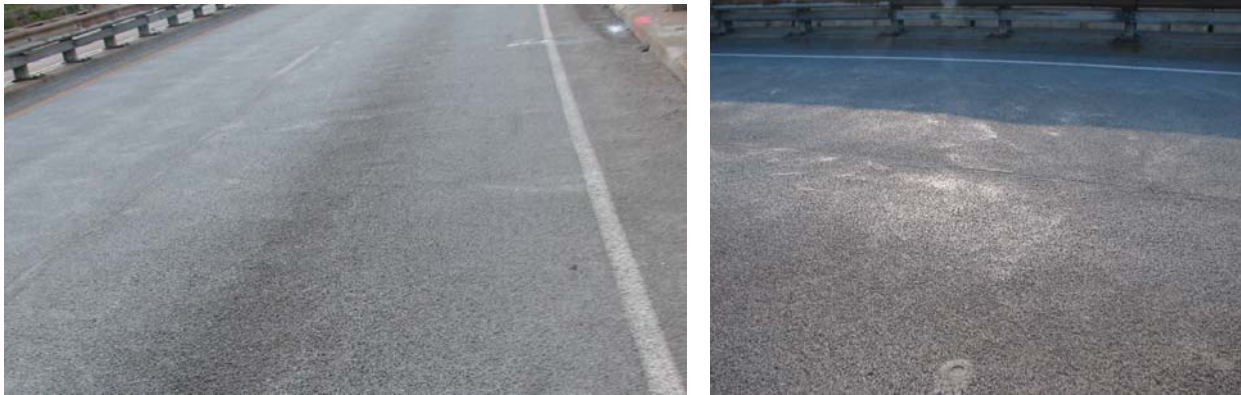
Figure 4.4. Photographs showing general overall integrity of the Hibbing SafeLane™ installation after two years (left: September, 2008) and three years (right: July, 2009).

More qualitative observations of the sealcoat performance of the SafeLane™ overlay at this site are consistent with the performance inferred from the chloride data presented above. In general the lanes were found to be almost crack-free throughout the three-year span of this study (Fig. 4.4). Bonding integrity for this time span was outstanding with evidence of de-bonding found only at expansion joints that experienced extreme plow shear forces (Fig. 4.5), and one area where the overlay was placed over top of an asphalt repair patch (Fig. 4.6). However, it should be noted that the manufacturer recommends this overlay not be used over asphalt.

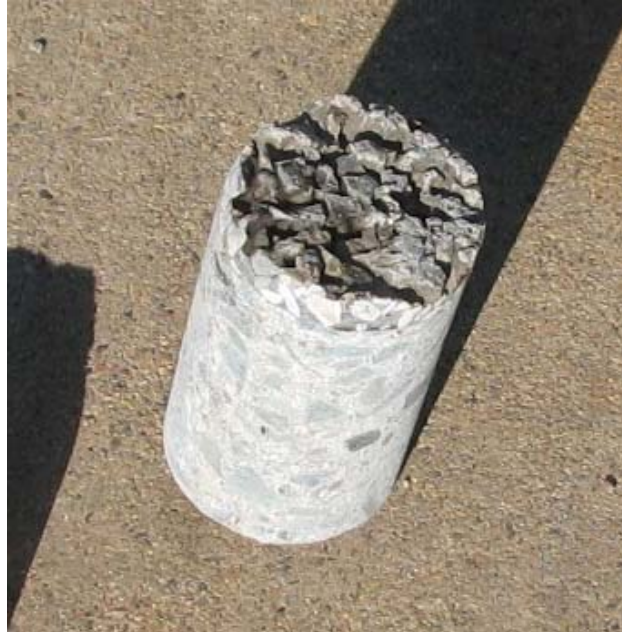
Figure 4.7. Photograph of core sample taken in September 2008. Location was at the edge of installation; outside of travel lane

Core samples taken for chloride analyses all showed excellent bonding between the concrete and the overlay as typified by the photograph shown below (fig 4.7).

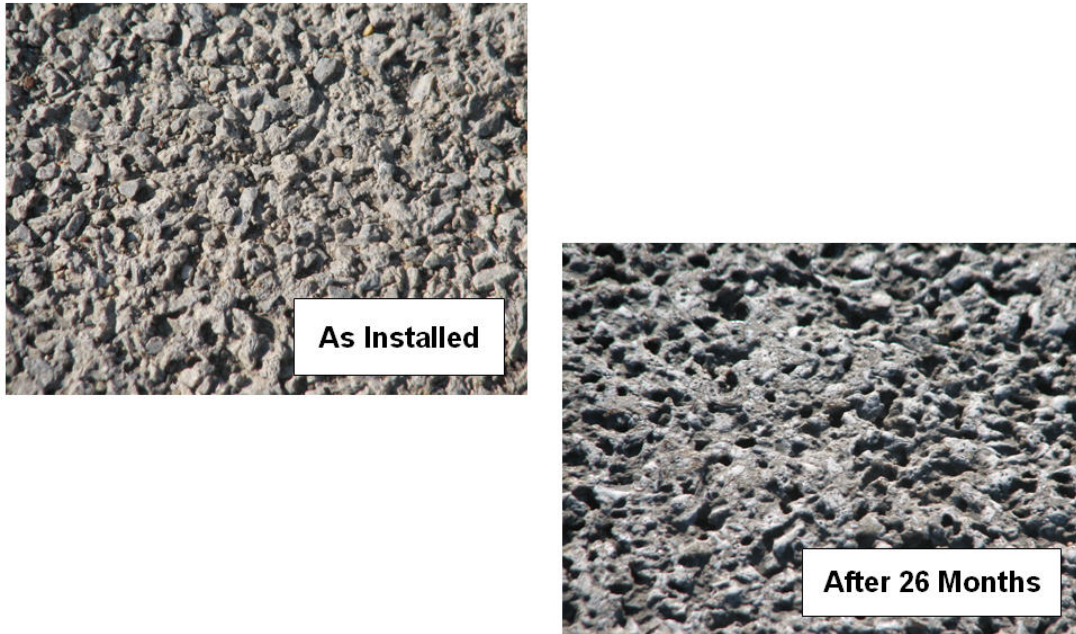
Figure 5.1. Photographs showing surface wear after two winters. Areas shown are approximately 4 x 6 inches.

Although the integrity of the bonding of this overlay system to the concrete surface of the bridge deck on which it was installed was found to be excellent, as discussed in the previous chapter, other aspects of the mechanical performance of the system were less than satisfactory. These relate to wear observed in both the wheel lanes and the overall surface that were attributed to normal traffic and plowing. The plows used for winter maintenance all use significant down-force on the blades. Both contributed to significant shearing as shown in the photos below.

The wear seemed in large part to be attributable to shearing of the aggregate and epoxy (above right). There was little, if any evidence of the aggregate being pulled out of the epoxy sealcoat, rather the surface appeared to have been milled after the first two winters, and more extensively so after the third. The consequences of this wear are twofold. Firstly there is a reduction of interstitial depressions between the aggregate pieces, which leaves less area to trap deicing chemicals between winter storms or icing “events”. Secondly, there is a significant reduction in traction as the surface wears. Both of these are expected to contribute adversely to performance from a traffic safety perspective.

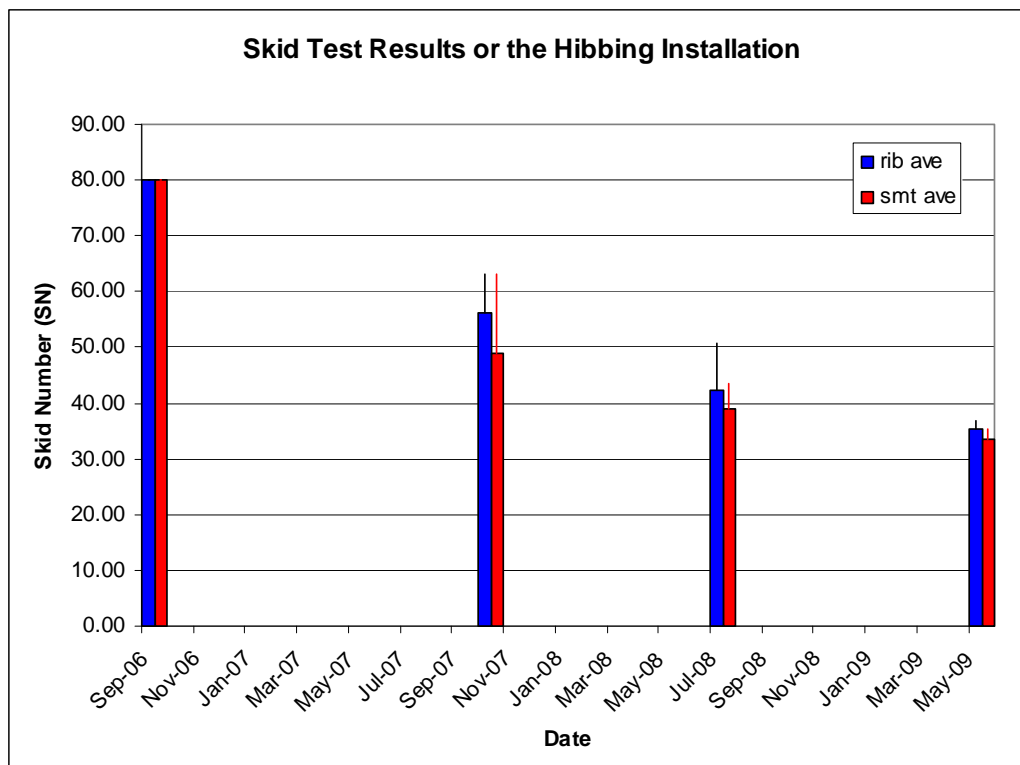
Figure 5.3. Skid test results for the Hibbing site. Error bars are at the 95% confidence level.

The data taken shortly after installation (9/06) is a minimum estimate provided by the operator. The traction was so good that the skid trailer would not skid for either tire type (ribbed vs smooth). This excellent initial performance degraded rather significantly after the first winter,

and continued to decline afterwards. These data are consistent with the qualitative observations discussed earlier.

Using the data from Figure 6.2, exponential decay functions were fit to the data. A least squares fit to the ribbed tire data yielded a correlation coefficient of 0.9908, while that for the smooth tire data gave a value of 0.9640. In each case the regression equation was used to predict the time a value of 15 would be expected for a smooth tire, and likewise a value of 25 for a ribbed tire, giving a value of 3.6 years for the ribbed tire data, and a value of 5.0 years for the smooth tire data. Unfortunately, either of these predictions suggests an unacceptably short service life for the overlay system.

The term of this study is too short. It is recommended that this overlay system be subjected to more long-term studies to determine if the short service life predicted above is correct. Other overlay systems that utilize aggregates that are less susceptible to ablation by plow blade shearing should also be evaluated for comparison.
