Investigation of Joint Deterioration in MnROAD Phase 1 Jointed Concrete Pavement Test Sections

Minnesota
Department of
Transportation

April 2010

Research Project
Final Report #2010-18

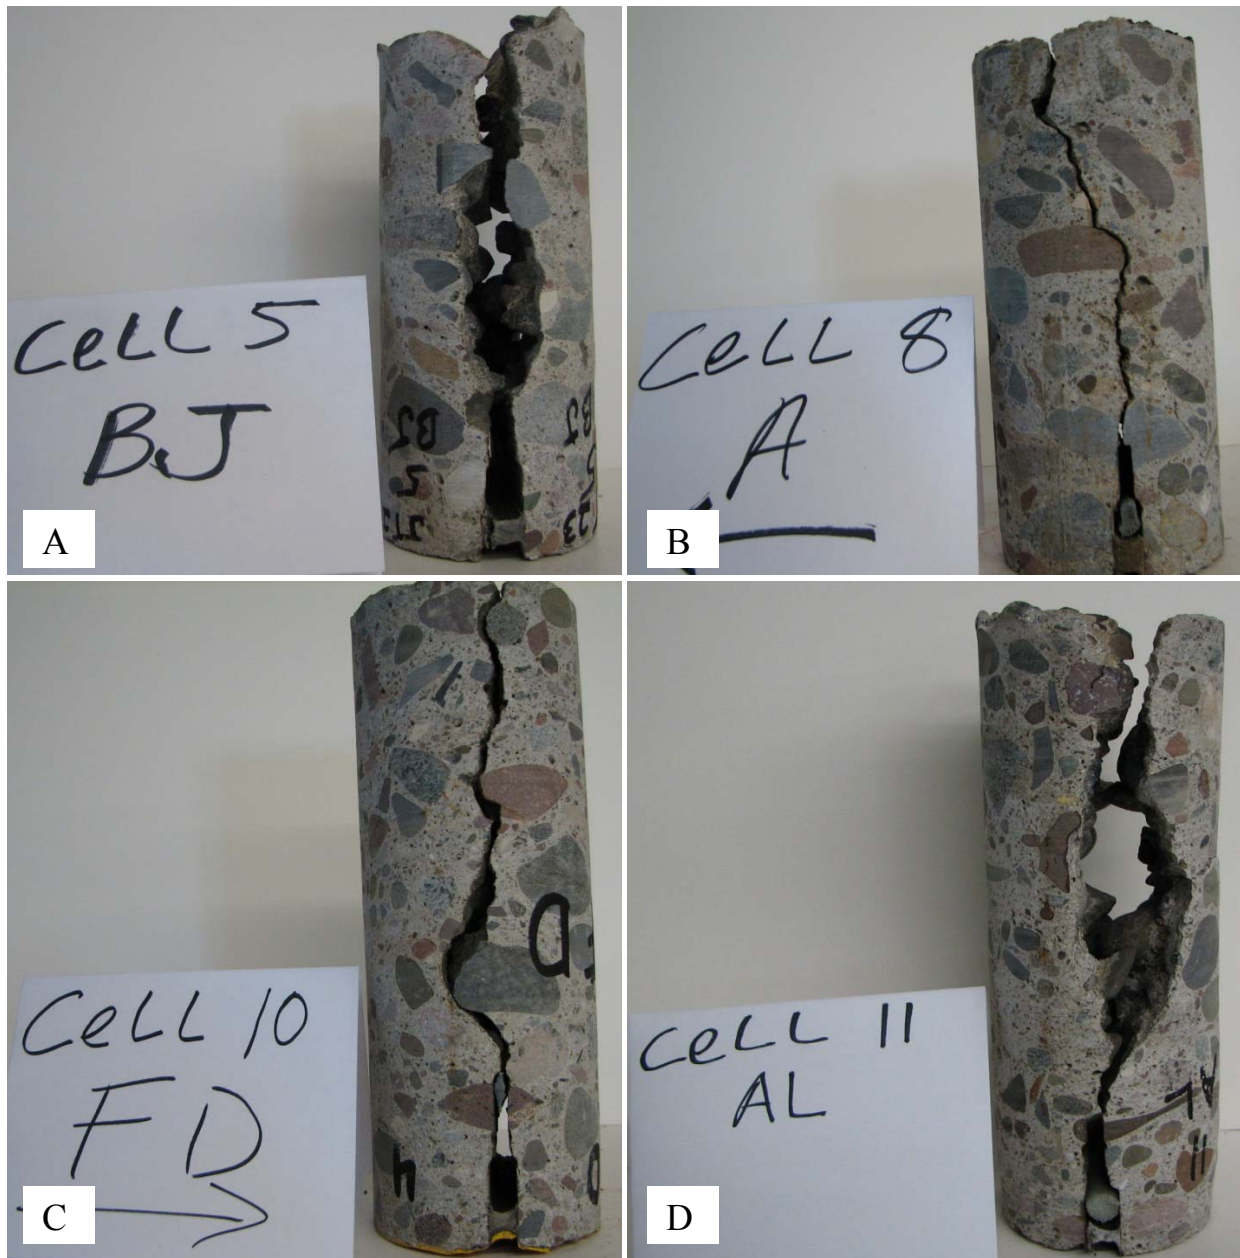
The extraction of the first core samples in 2007 instantly revealed some interesting phenomena occurring within the transverse joint areas. In many of the core samples extracted from cells constructed with an undrained gravel base a significant amount of concrete material was missing from the middle section of the core. More specifically, it was noted that the area of greatest distress in those cores was just below the saw cut in the 7.5 inch thick design slabs, and approximately at the mid-depth for the 9.5 inch thick design slabs. This distress would not have been discovered in surface distress surveys, since the pavement surface looked very good (very limited spalling near the joints), there was very little faulting of the joints, and the silicone joint sealant remained intact. Figure 3 shows core samples from test cells 5 and 11 exhibiting the “hole” at the mid-depth of the core. Also shown in Figure 3 is the notable observation that core samples from test cells with a drainable (PASB) base (cells 7-10) did not exhibit similar distress.

FIGURE 3 A) Core sample (shown upside down) from cell 5, a 5 year design with Class 4 base; B) core sample from cell 8, a 5 year design with PSAB base; C) core sample from cell 11, a 10 year design with Class 5 base; D) core sample from cell 10, a 10 year design with PSAB base.

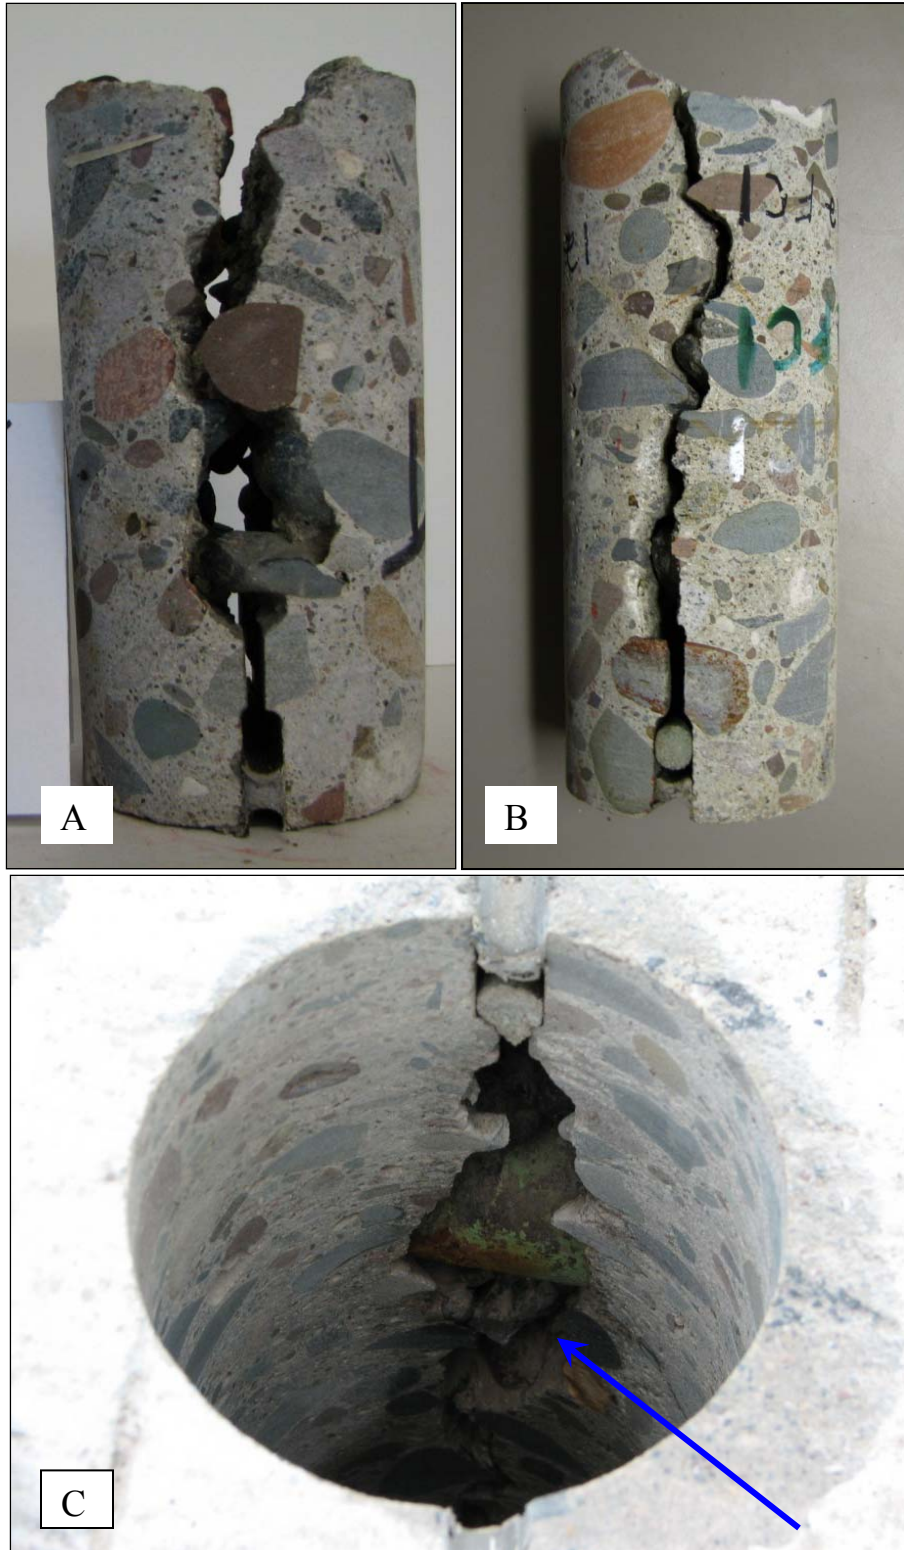
As shown in Figure 4A, additional observations of the core samples revealed that test cells built on Class 4 or 5 bases typically had widening of the transverse joints from the bottom of the slab to just beneath the saw cut. Test cell 12 was a 10 year design test cell with a Class 5 aggregate base and longitudinal edge drain. As shown in Figure 4B, this test cell did not have deterioration of the transverse joints. The transverse joints in cell 12 were still in very good condition (but not as tight as the test cells with drainable bases). Figure 4C shows a pocket that formed around a dowel bar in test cell 13.

FIGURE 4 A) Widening of joint from top to bottom of core sample (shown upside down); B) core from cell 12 (longitudinal drains); C) pocket of missing material around dowel bar in test cell 13.

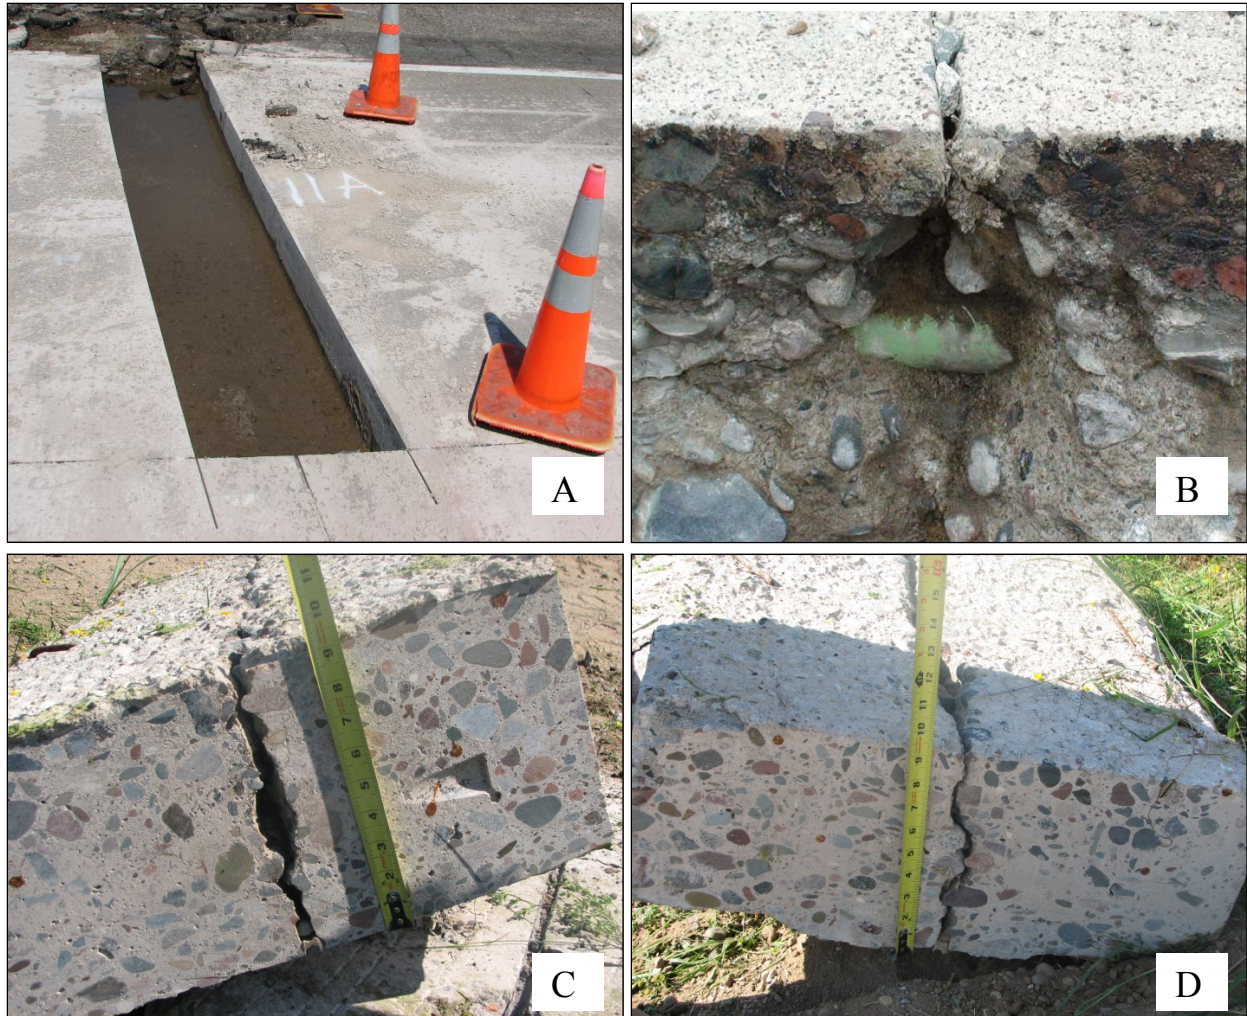
In 2008, larger slab-type samples were sawed and extracted from the test cells before they were removed in preparation for new Phase 2 test cells. Several interesting observations were revealed both immediately following the removal process, as well as from the large samples themselves. Figure 5A shows the remaining trench area in test cell 11 one day after removal of some slab pieces with a water cooled walk behind pavement saw. Note the amount of water, from sawing, still ponded in the trench area. It was observed that 3 days later, the base material was still considerably wet on top (though not ponded anymore). Clearly the Class 5 special base material over the clay subgrade is a very slow draining pavement system.

Additional forensic investigation of the larger pieces removed in 2008 recently confirmed the distresses discovered in the core samples. Several large pieces were lifted and dropped until they broke apart to reveal the condition of the joints near the dowel bars and the extent to which the “hole” distress occurred along the transverse joint. Figure 5B shows the pocketed areas near the dowel bars from a joint in cell 13. Note the deterioration of the epoxy coating on the dowel bar in the vicinity of the joint. Sandy material could be found packed into areas like this. The remaining distressed areas were lined with clean large coarse aggregates protruding from remaining sound areas of paste and aggregate. There was no cracking or delamination of the concrete observed near the dowels. As shown in Figure 5C and 5D, it was also observed that joint deterioration was more prevalent near the shoulder edge of the driving lane.

FIGURE 5 A) Photo of water from saw cutting sitting on Class 5 base one day after a panel was removed; B) Socketed areas near the dowel bars from a joint in cell 13; C) Joint deterioration at the shoulder; D) center line of the driving lane on Cell 13.

As demonstrated in Figure 5A, any water that got into MnROAD joints over a dense graded gravel base layer tended to remain there for many days. Certainly these conditions would occur during the springtime thaw period, when the frost in the base and subgrade layers melts and creates saturated conditions within or above the base layer. Night time freezing temperatures certainly will cause ice to reform within the joints and cause expansive stresses that would damage any susceptible concrete material.

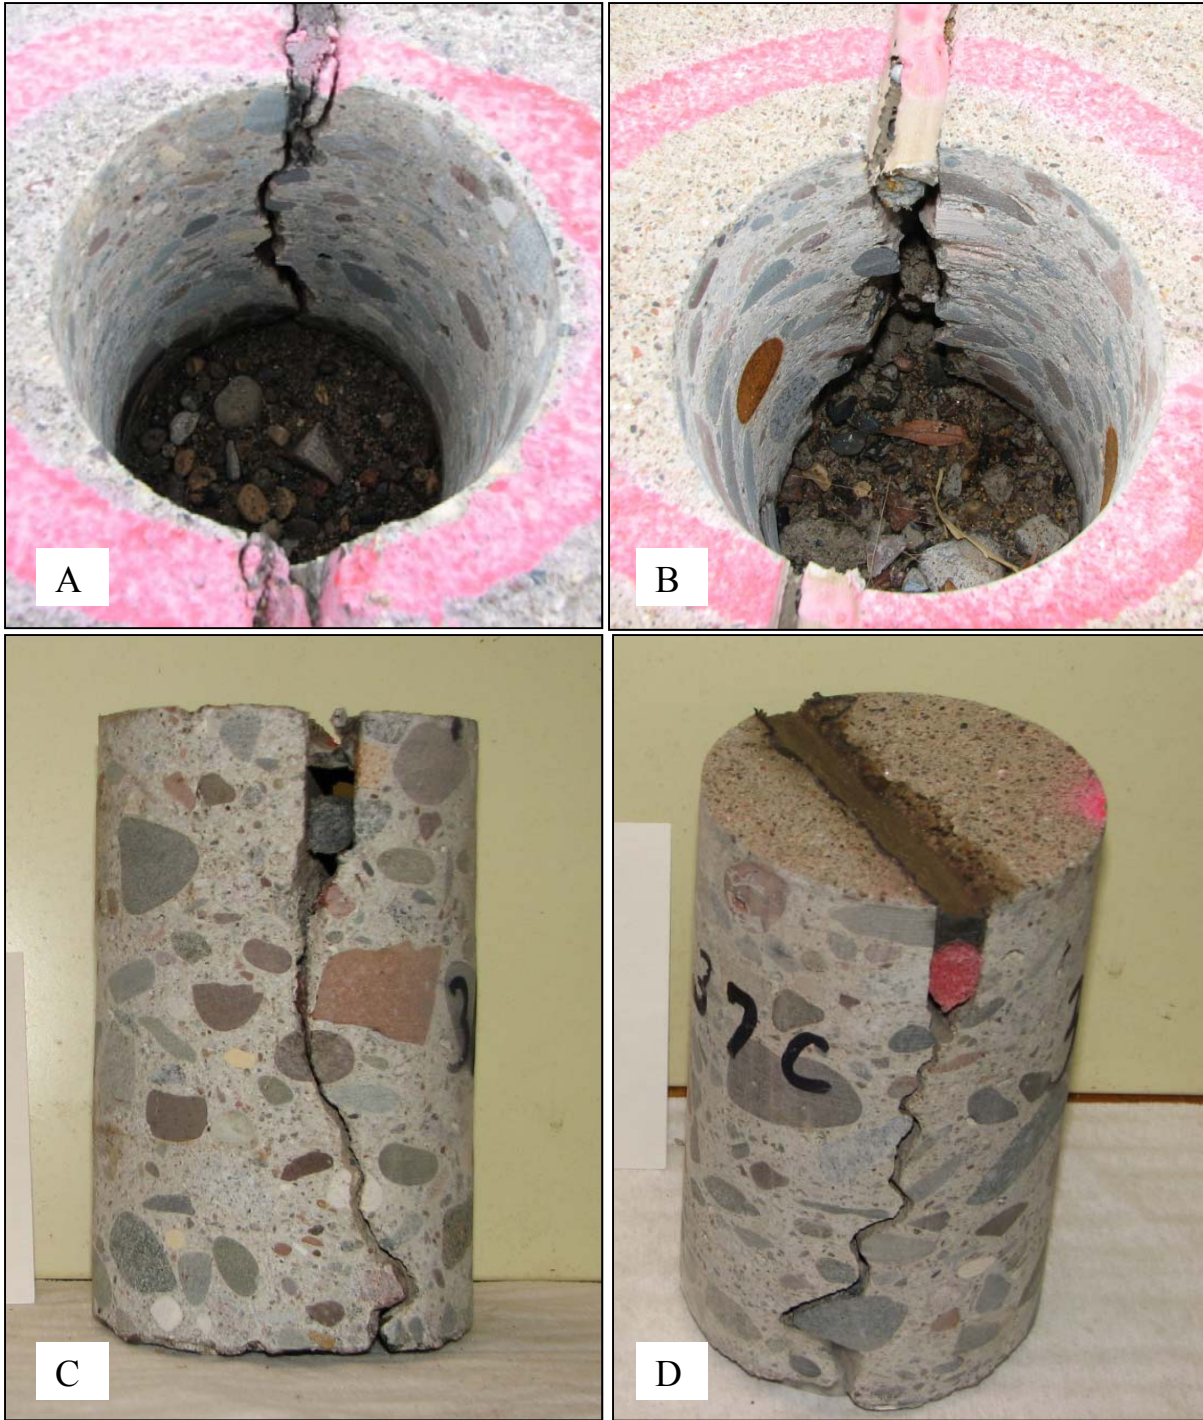
Overall, the condition of the transverse joints in the LVR test cells was much better than on the MnROAD mainline. Transverse joints where the joints sealant was in good condition were still in good condition as shown in Figure 6 and 7. In areas where the joint sealant had failed (Figure 6B), joint deterioration similar to that observed on the mainline was present. Figure 6C shows that after 15 years the transverse joints were in very good condition if the joints were sealed and the amount of water able to enter the base layers was reduced. Where the joint

sealant was in poor condition and did not prevent water from entering the base, the joints started to deteriorate and widen (Figure 6B).

FIGURE 6 A) Core hole from cell 32, a 5 inch JPCP with Class 1 base; B) core hole from cell 36 where joint sealant was in poor condition; C) core from cell 36 where joint sealant was in good condition; D) core from cell 37 where joint sealant was in good condition.

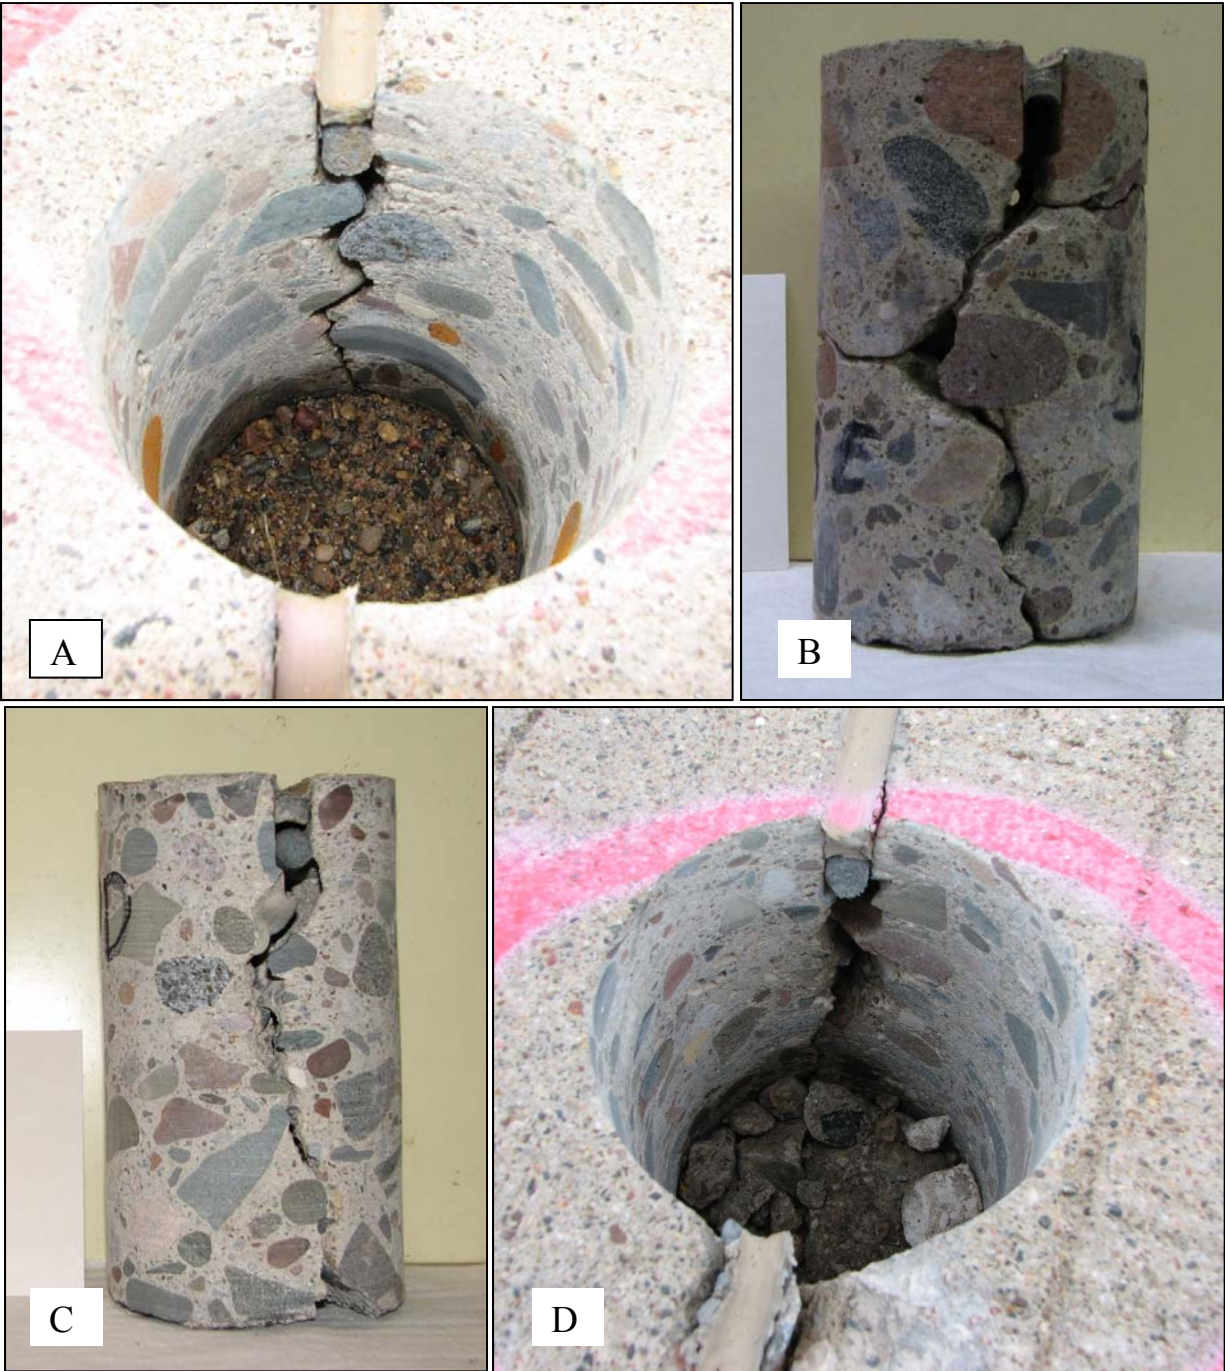
FIGURE 7 A) Core hole from cell 38, where joint sealant was in good condition; B) core hole from cell 38 where joint sealant was in poor condition; C) core from cell 40 where joint sealant was in good condition; D) core from cell 40 where joint sealant was in poor condition.

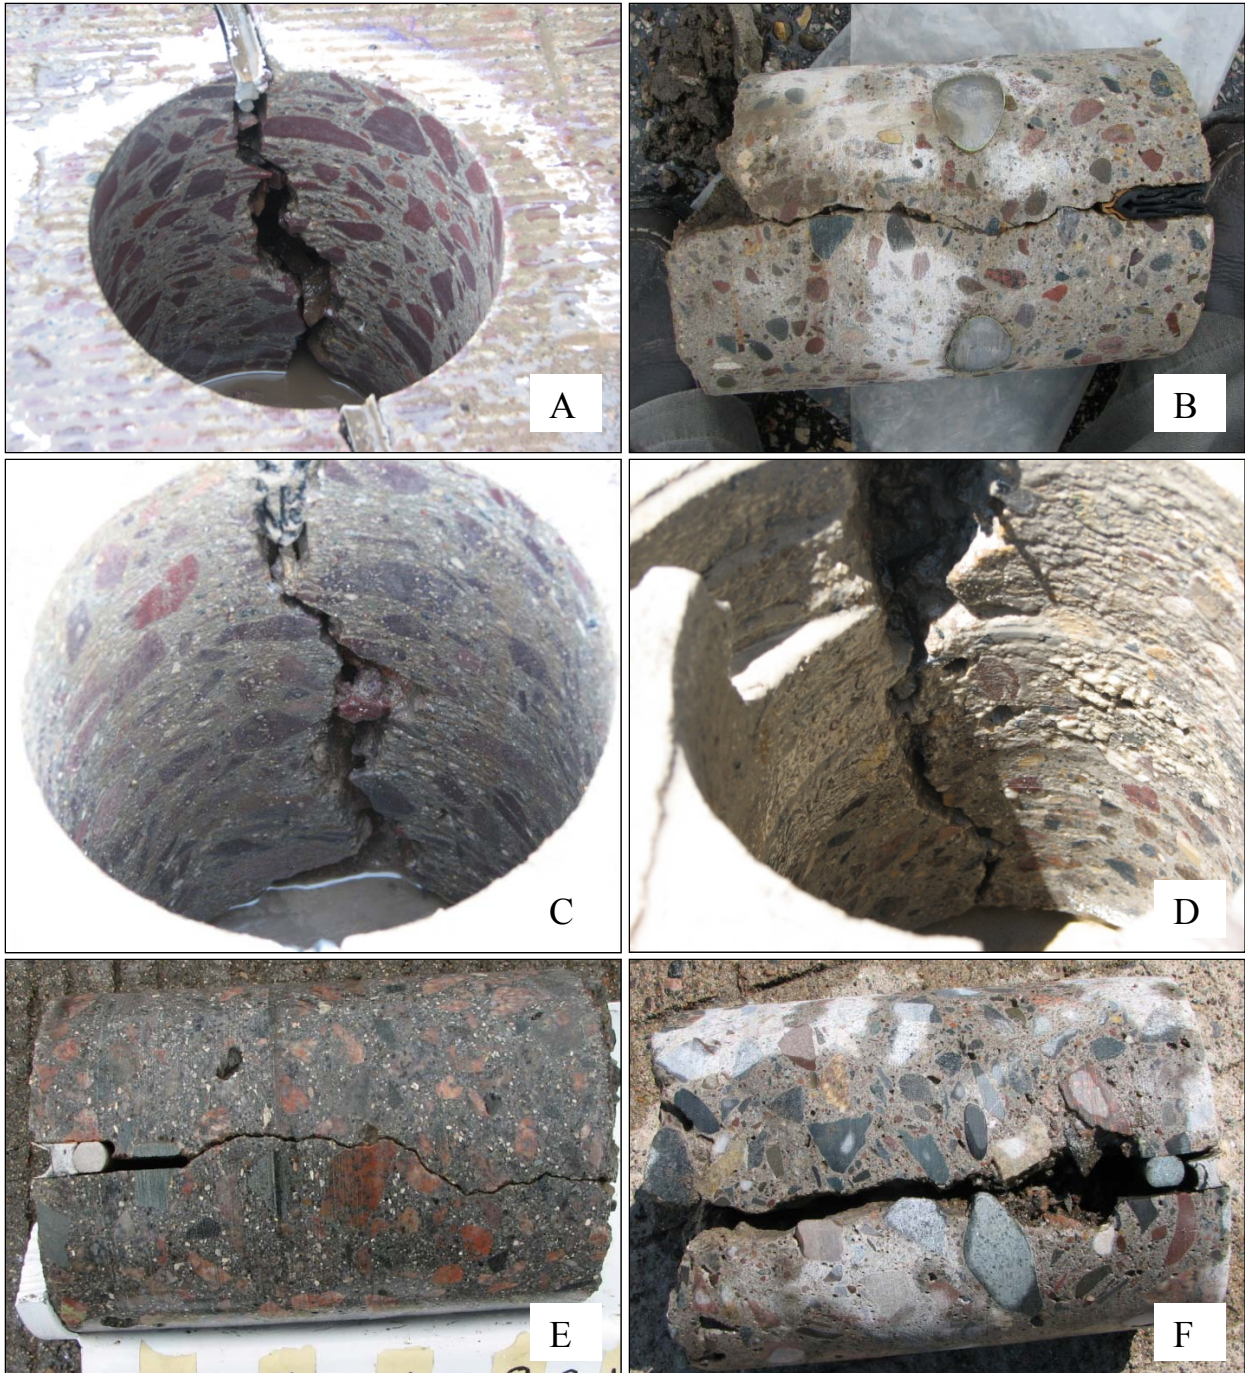
In order to determine if the same joint deterioration found at MnROAD was occurring in other pavements in Minnesota, core samples were taken from six different pavements throughout the state. Each of the chosen sections had similar slab thickness, age (within 6 years), subgrade and base type, and concrete mix design as the MnROAD Phase 1 sections. All sections were jointed plain or jointed reinforced concrete pavements with doweled joints. Five of the pavement sections had Class 5 bases, while the other had a drainable open graded (OG) base. Additional design features of each section are summarized in Figure 8 and Table 3. The following sections summarize the observations from the forensic cores taken in spring 2008. Refer to Figure 9 for photos of cores from each section.

US trunk highway 14 is a two lane, 8 inch thick JRCP with 1.25 inch diameter dowels and 27 ft long panels built in 1990. This pavement section has a Class 5 base. There was no observed distress on the concrete surface where the cores were taken. The water used during the coring of the joints did not drain through the base in four of the five core holes. The joint where the water did drain through was in good condition. Three of the five cores taken had widened joints, and cores that went through the dowel bars showed deterioration to the concrete near the dowel bar similar to what was observed at MnROAD. Deterioration was also greatest at the edge of the slab.

Minnesota trunk highway 60 is a 4 lane divided, 8 inch thick JRCP, with 1.0 inch diameter dowels and 27 ft long panels. Eight core samples were taken, with five along an inclined portion of the route and three cores in a low area. There was some widening of the joint at the bottom of the slab at one core location in the low laying area but the other joints were in good condition. The surface of the concrete from the inclined section was in good condition, but in the low area there were transverse cracks at each midpanel. Even though the base layer in this pavement was Class 5, the water from coring drained through the base in some of the core holes.

US trunk highway 59 is a two lane, 8 inch thick JPCP, with 1.0 inch diameter dowels and 15 ft long panels. This section has an open graded, drainable base. All of the joints in this section were in very good condition and there was no surface distress.

US trunk highway 169 is a two lane, 7.5 inch thick JPCP, with 1.25 inch diameter dowels and 15 ft long panels. In two of the five joints, directly beneath the widened saw cut, there was a deteriorated region in the cores. When taking these cores, the cooling water did not drain

through the base. The other three transverse joints were in good condition, and the water drained rapidly during the coring process.

Minnesota truck highway 60 is a 4 lane divided, 8 inch thick JPCP, with 1.25 inch diameter dowels and 15 ft long panels. Again some of the water from coring drained through the base in some locations. The joints were in good condition except for some slight deterioration immediately under the saw cut. In the joints where the base was not drainable, this deterioration was worse and the entire joint was widened, with the greatest deterioration at the bottom of the slab.

US trunk highway 52 is a four lane divided, 8.5 inch thick JRCP, with 1.0 inch diameter dowels and 27 ft long panels. The water from coring did not drain at any of the cored joints. None of the joints had the distress that was found at MnROAD. All of the joints were tight, but all of the cores were delaminated, either near the bottom or at the level of the dowels.

FIGURE 9 Core samples taken from: A) US-14; B) US-52; C) MN-60; D) US-169; E) US-59; F) MN-210.

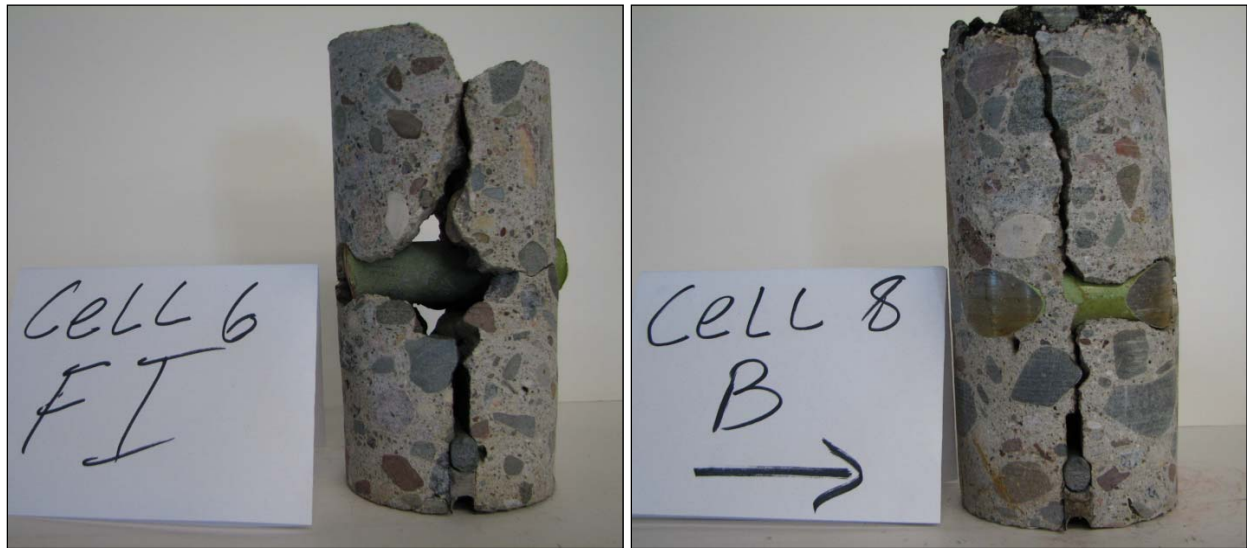
High dowel bar stresses are most likely not the cause of the observed joint distress. Figure 10 shows cores from cells 6 and 8. Both pavements had similar slab geometry, but different base types. Both should have experienced the same dowel bar stresses over their lifetime. Certainly the socketing of the concrete material around the dowel bar in cell 6 is not prevalent in cell 8. High dowel bar stresses likely caused cracking in cell 38. As shown in Figure 7B, this resulted in tight cracks parallel to the pavement surface and not widening of the joints as was present on the MnROAD mainline.

FIGURE 10 Comparison of condition of joint in vicinity of the dowel bar in a test cell with an undrained (cell 6) and drained base layer (cell 8).
