Performance of Various Partial-Depth Repair Materials at the MnROAD Facility

May 2016

Research Project
Final Report 2016-16

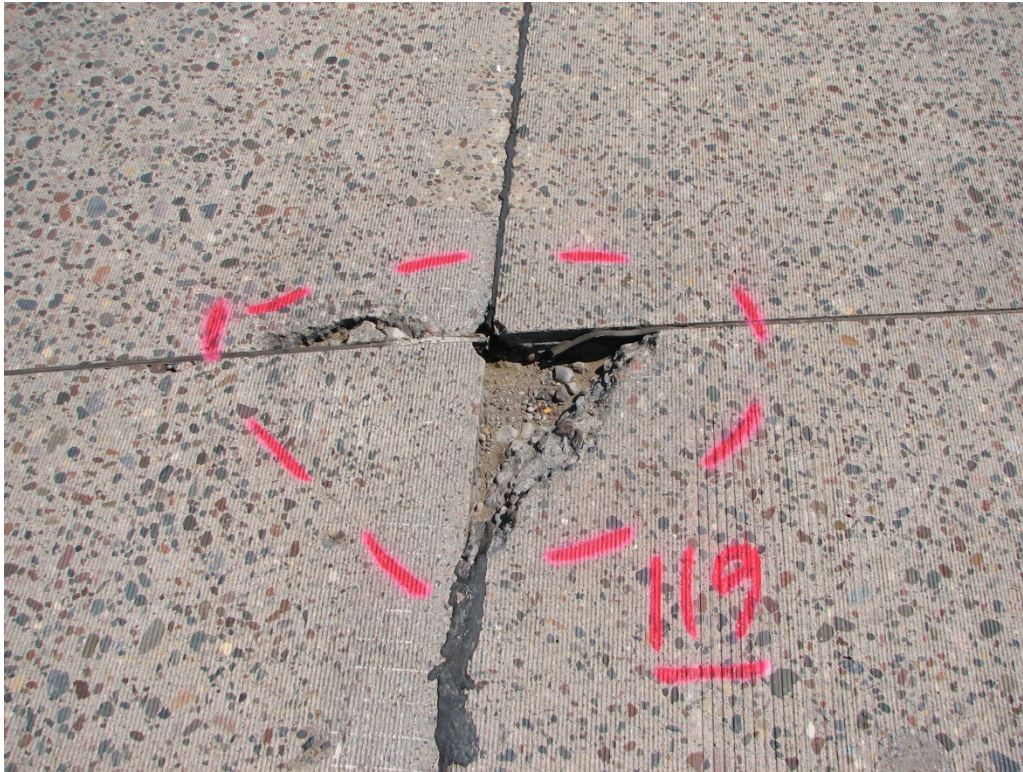
Figure 1.1 Distress near the surface of a concrete pavement at intersection of transverse and centerline joints.
