TECHNICAL SUMMARY

Preventing the Occurrence of Bumps in HMA Overlays

This Technical Summary pertains to the LRRB-produced Report 2010-31, “Predicting the Occurrence of Bumps in Overlays,” published August 2010. The full report can be accessed at <http://www.lrrb.org/PDF/201031.pdf>.

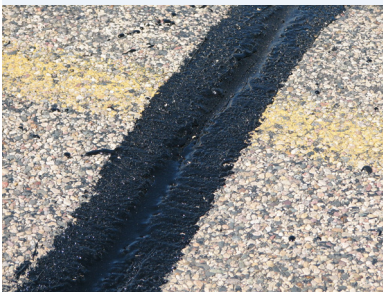
Researchers recommend avoiding sealant overbanding on the sides of cracks.

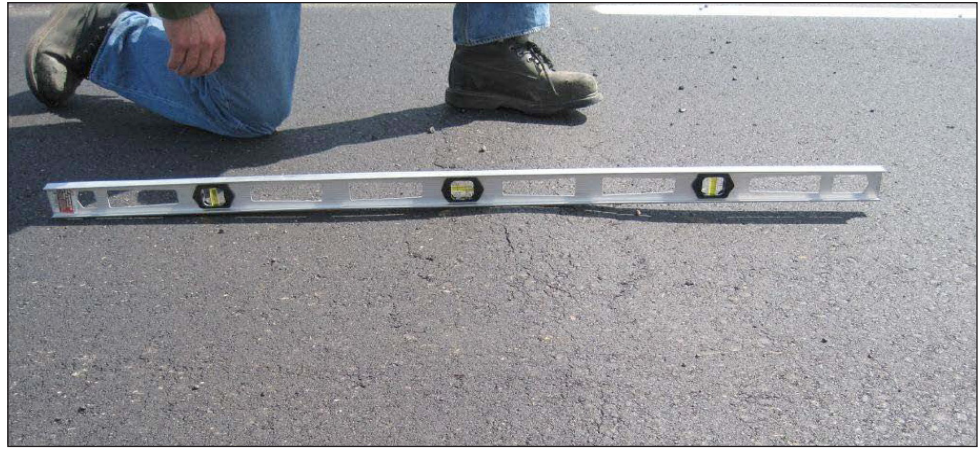
Researchers often found bumps during the first field visit, including this 1/2-inch tall bump with hairline cracking, indicating that compaction equipment had been operated when the HMA temperature was not optimum.

- Rolling when air and pavement temperatures are lower, below 80°F and 125°F, respectively, and possibly slightly delaying rolling operations so that the overlay mat cools while the underlying sealant material heats up.
- Using low-modulus and crumb rubber sealant types, and possibly allowing sealant materials to age at least one year before applying the overlay.
- Routing narrow and shallow crack reservoirs, avoiding sealant overbanding, and possibly leaving sealant material below the pavement surface or removing it before overlay construction.
- The use of pneumatic rollers for breakdown compaction through 200°F followed by a single steel finishing roller.
- The use of nonvibratory breakdown rollers.
