Minnesota
Department of
Transportation

Acoustic Emission Monitoring of a Fracture-Critical Bridge

March 2014

Research Project
Final Report 2014-15

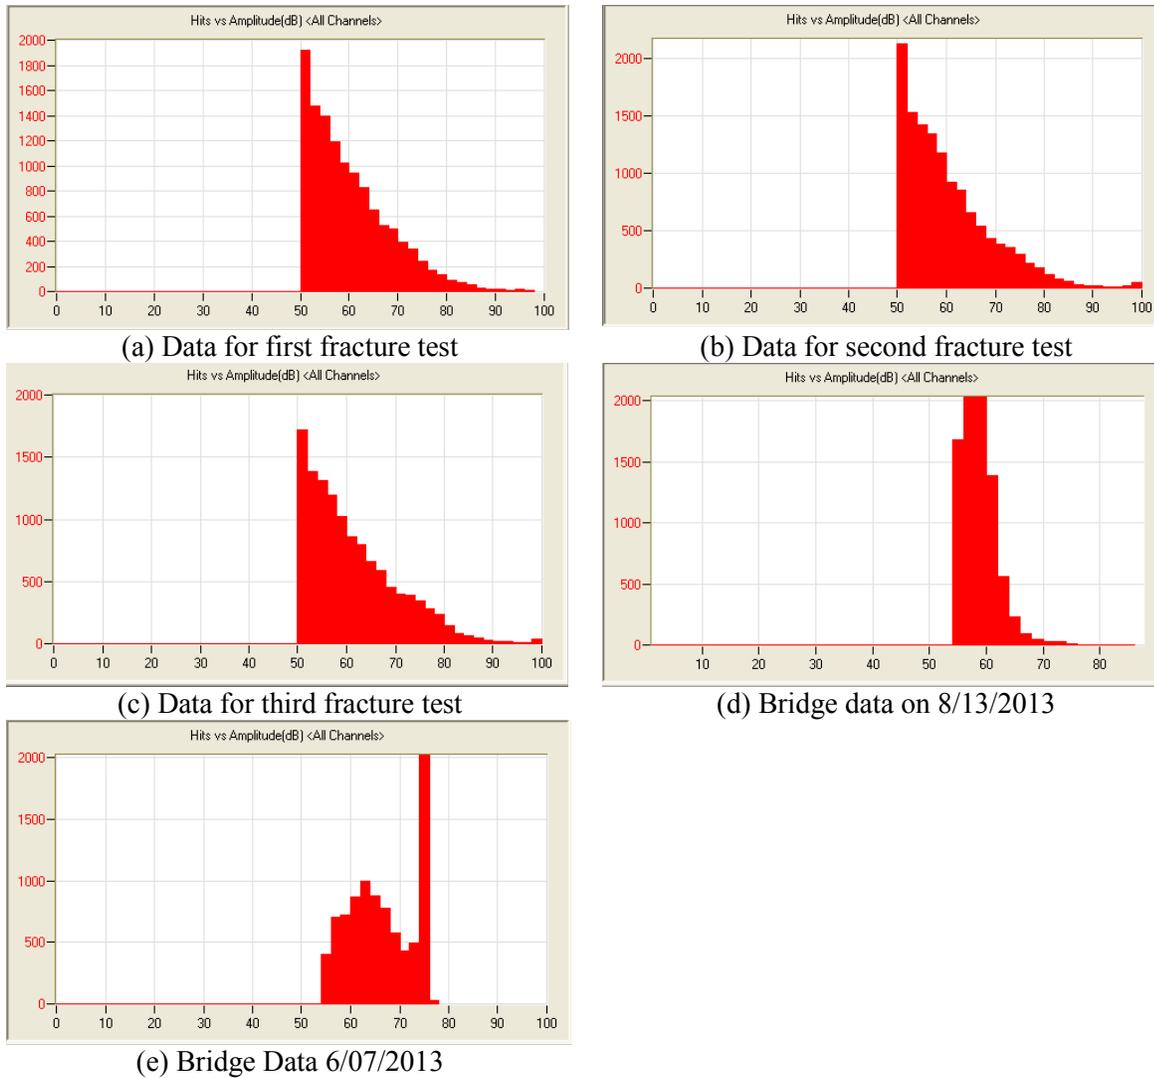
Figure 6.3: Hits vs. amplitude (dB)

The anomalous bridge data obtained in June 7, 2013 (Fig. 6.3(e)) shows an uncommon trend to what is typically observed, with a large amount of hits with amplitudes in excess of 70 dB. Additionally, the shape of the distribution is surprisingly different to that observed for normal bridge behavior (Fig. 6.3(d)) and for fracture (Fig. 6.3(a) – (c)).

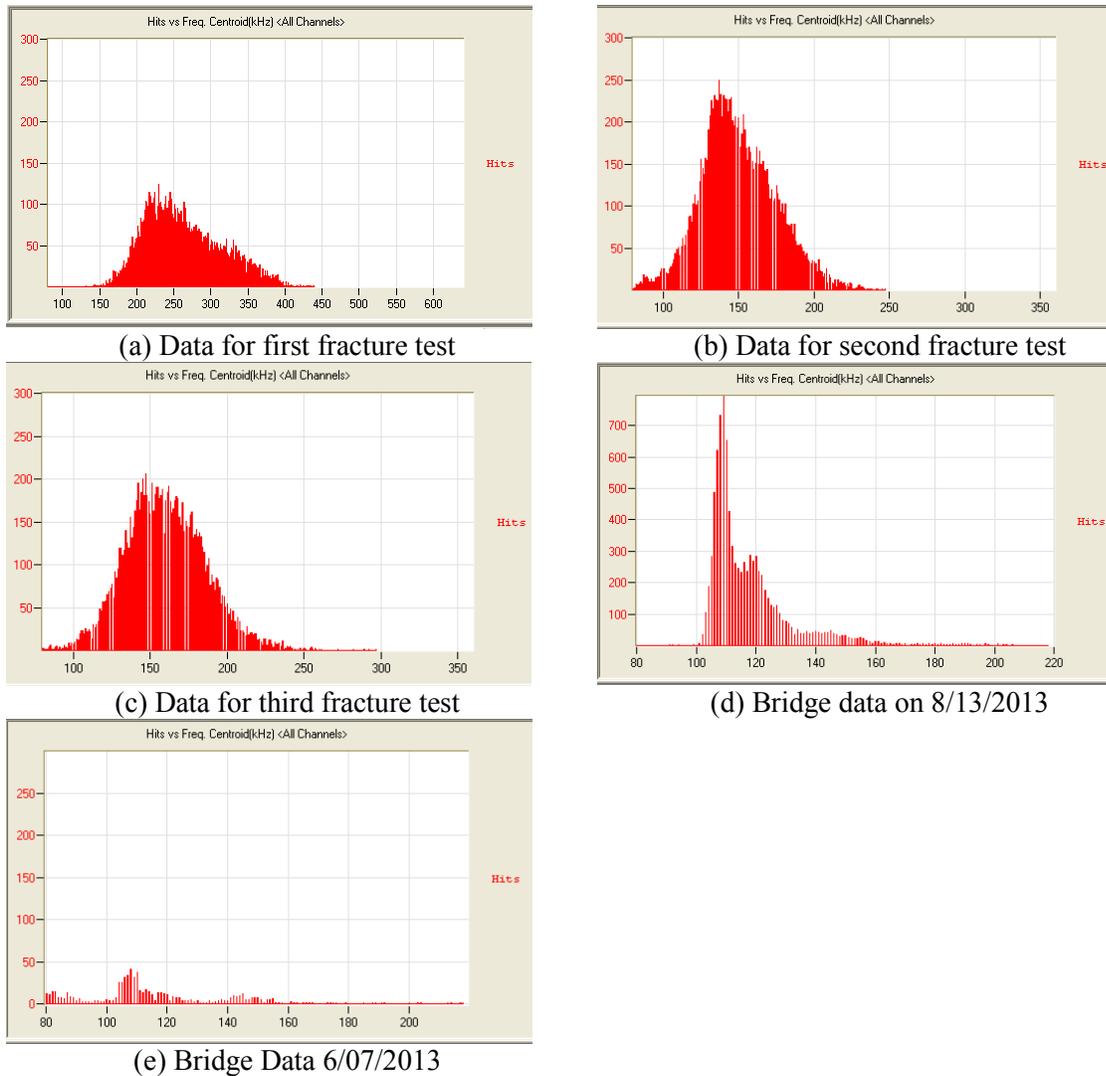
Figure 6.4: Hits vs. frequency centroid (kHz)

The frequency centroid data observed in the “normal” sample of bridge data (Fig. 6.4(d)) is in the range of 100 to 130 kHz, with a peak value of approximately 110 kHz. During the fracture tests, the frequency centroids shifted dramatically to the right, with the majority of hits between in excess of 130 kHz, and the peak values in excess of 140 kHz. These observations suggest that when fracture occurs, the average frequency of the acoustic wave tends to increase in magnitude. The anomalous bridge data recorded on June 7, 2013 does not exhibit the characteristics of either the fracture tests or the “normal” bridge data. In fact, the number of hits is very low since only one sensor is collecting large numbers of hits (Fig. 6.3(e)).

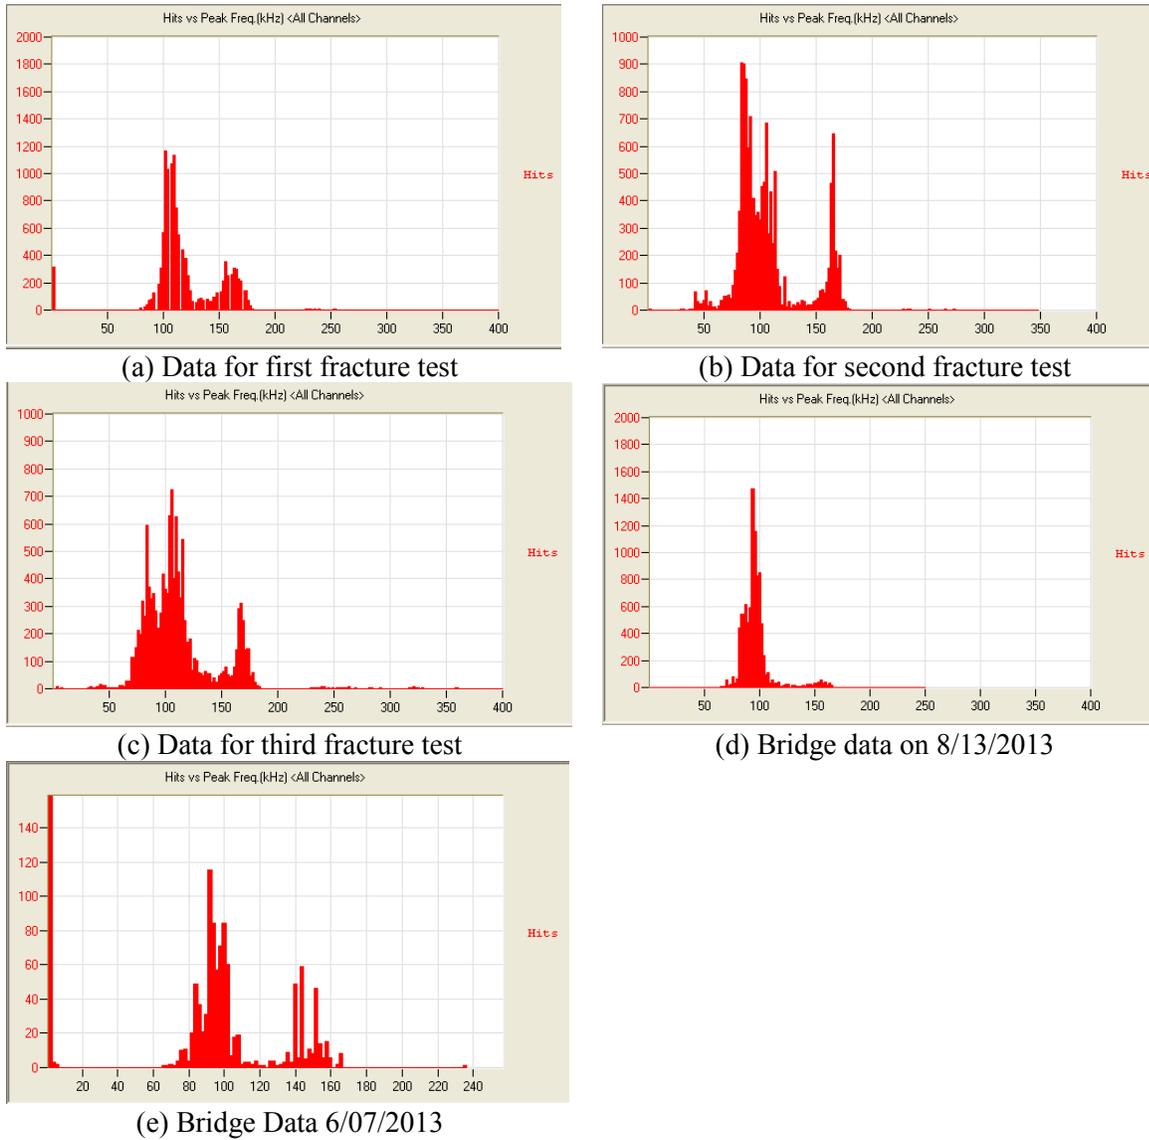
Figure 6.8: Hits vs. peak frequency (kHz)

(i.e., in excess of 150 kHz). Figure 6.8(e) for the anomalous data set shares the same characteristic, with a secondary peak between 140 and 160 kHz.

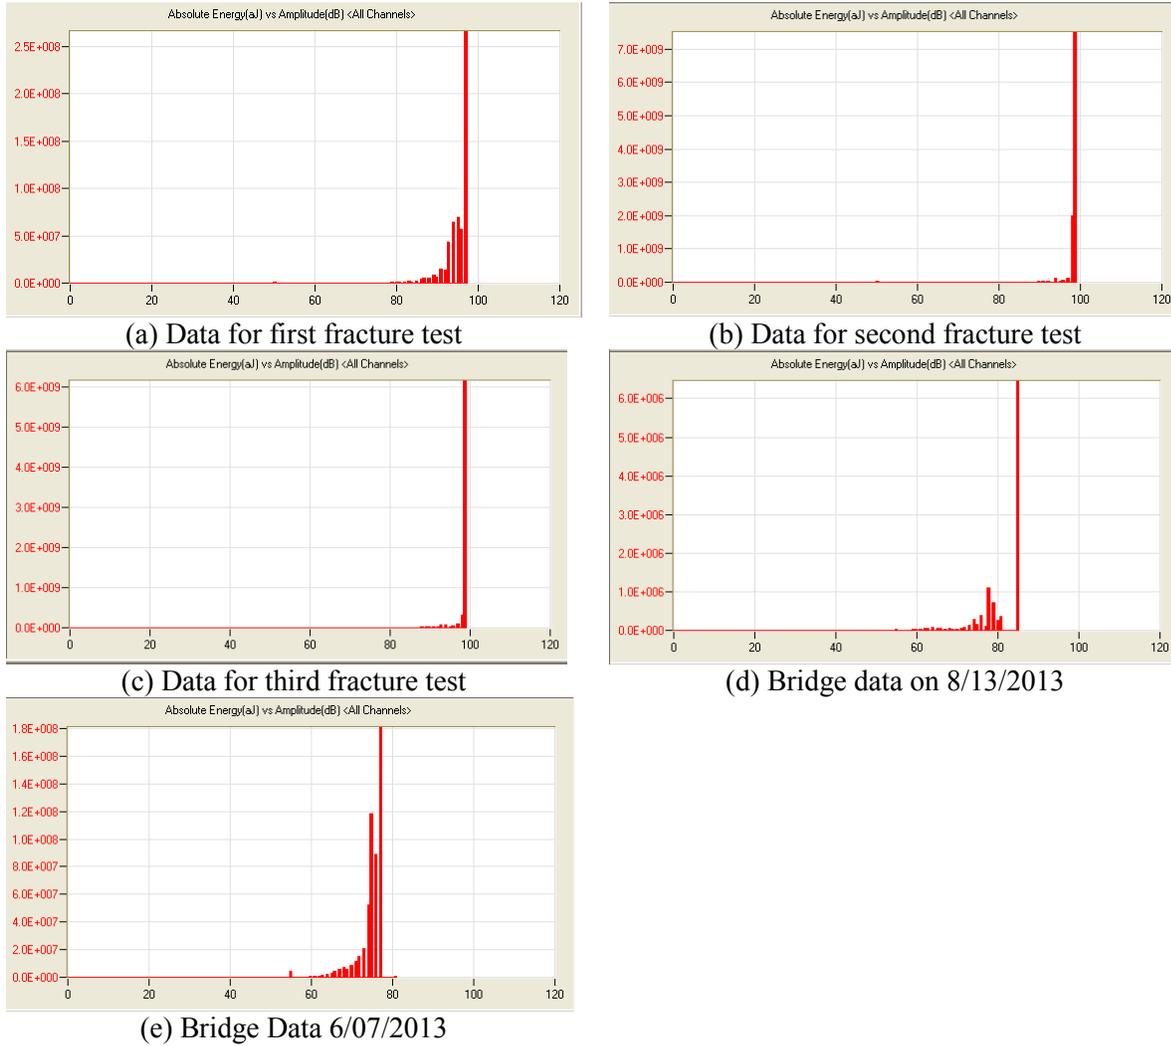
Figure 6.10: Absolute energy (aJ) vs. amplitude (dB)

anomalous data recorded in June 2013 is clearly different from that for fracture. Thus, such anomalous behavior could be separated from fracture events using the plots shown in Fig. 6.10.

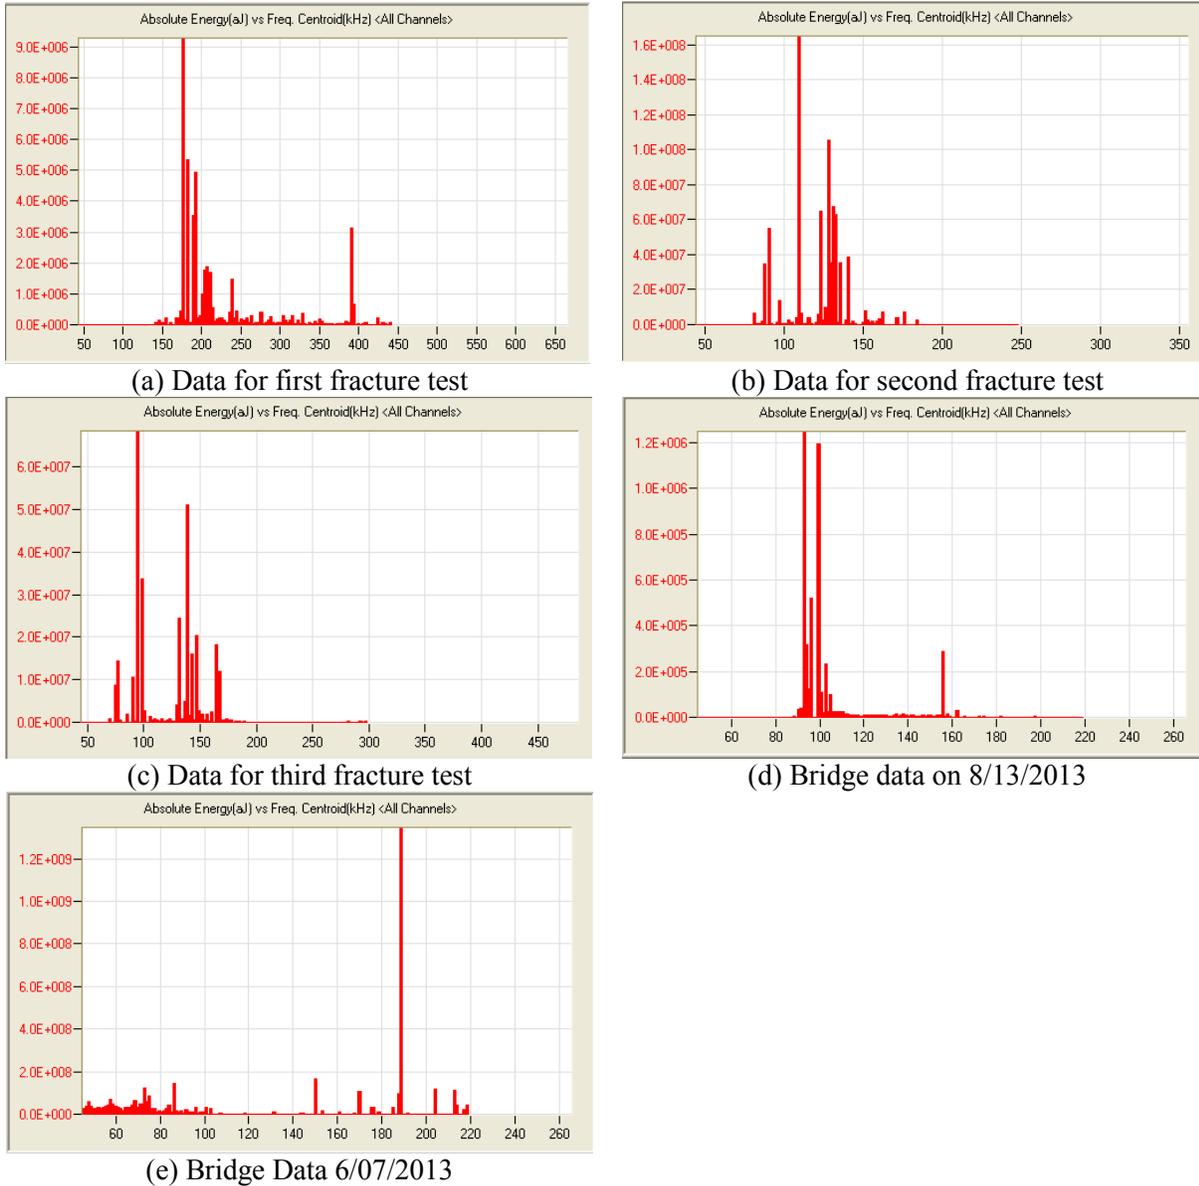
Figure 6.11: Absolute energy (aJ) vs. frequency centroid (kHz)

absolute energy values that range from 10^7 up to 10^9 aJ. The anomalous data also shows frequency centroids that are significantly smaller and larger than 100 kHz, with a large amount of energy.

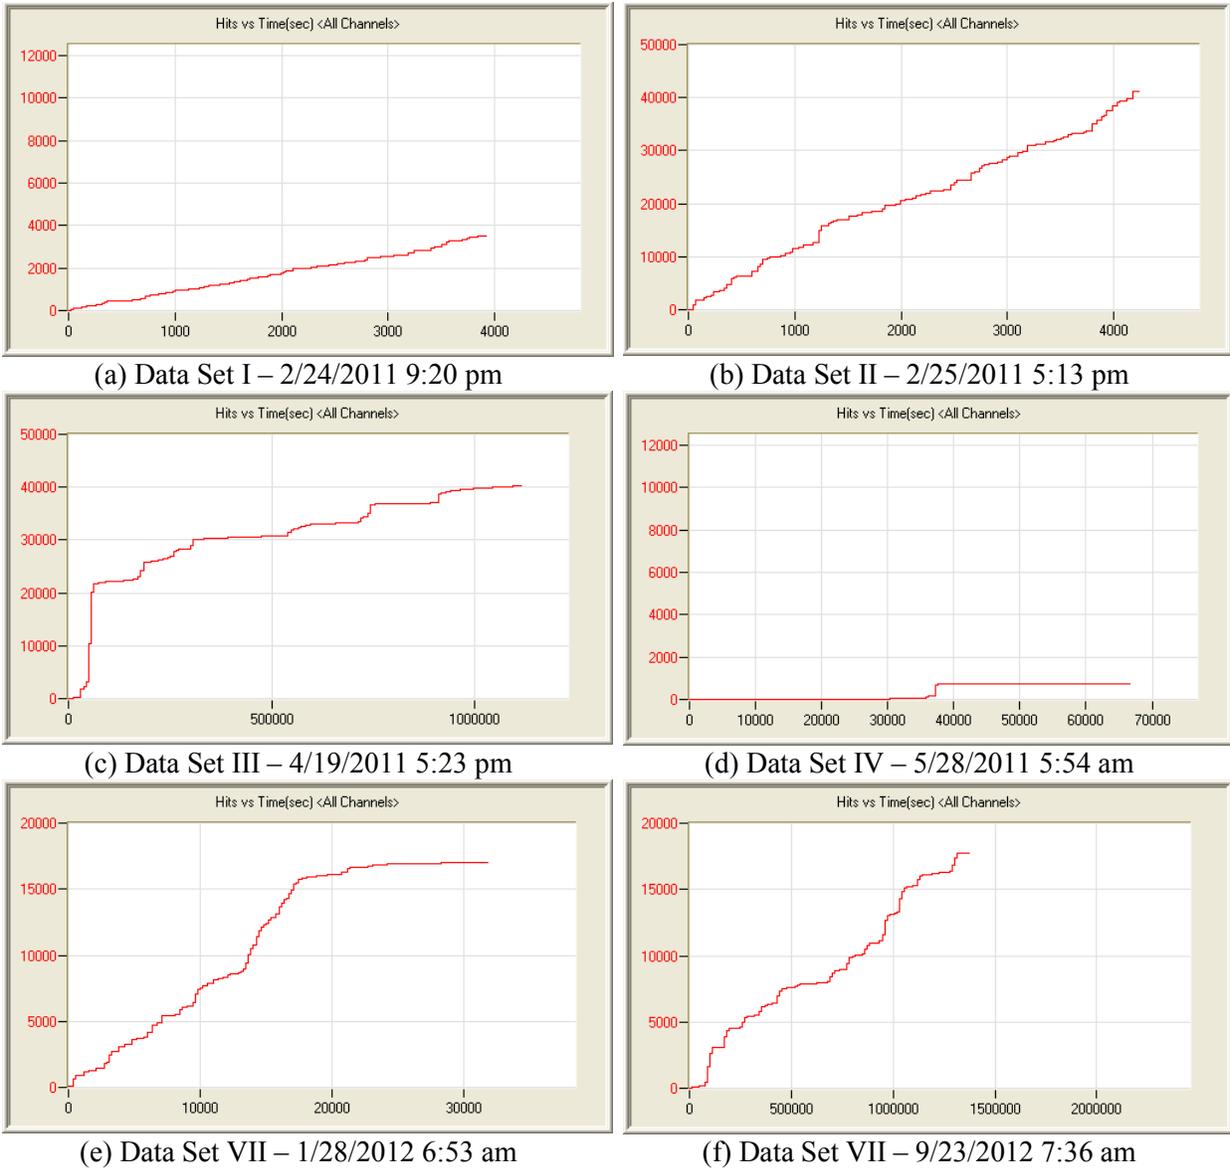
Figure 7.1: Hits vs. time (sec)

The hits vs. time plots in display behavior that is common for the Cedar Avenue Bridge, namely a linearly increasing number of hits with increasing time. Knowing the amplitudes of these hits, the data sets display behavior that can most likely be attributed to traffic loading.

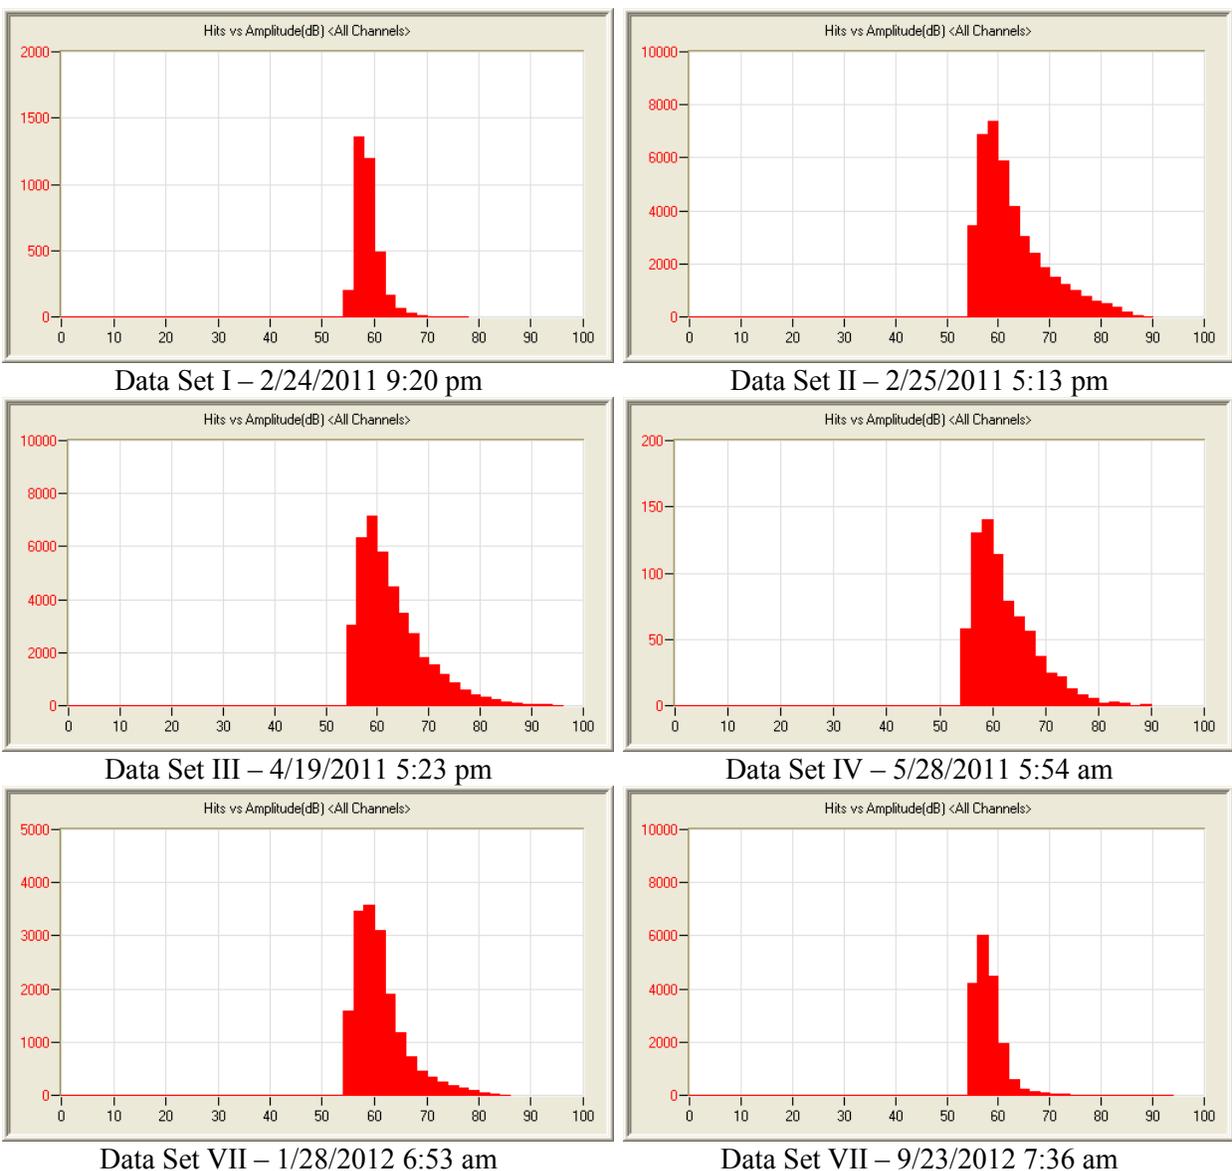
Figure 7.3: Hits vs. amplitude (dB)

Some of the most important information collected and displayed by the software concerns the amplitude in decibels (dB) of the AE signals received by the AE sensors. Based on the information available from Mistras Group, hits with amplitudes below approximately 80 dB are considered nonthreatening to the condition of the Cedar Avenue Bridge. Hits with amplitudes much above 80 dB, say 90 dB or higher, are considered concerning if they occur in large numbers relative to the quantity of other hits. Moreover, in the fracture tests reported in Chapters 5 and 6, fracture events produced a particular distribution of hits vs. amplitude, where the hits did not decay as quickly as is shown in Fig. 7.3. For the fracture events, the decay of hits with amplitude was approximately linear, whereas it is highly nonlinear in Fig 7.3. Moreover, the fracture tests indicated a significant number of hits in excess of 80 dB, and even some non-trivial content in the 90 to 100 dB range.
