Final Report

Saw and Seal Repair Chisholm / Hibbing Airport Taxiway

Construction Report
Leveling Cupped Joints
August 6-8, 2001

Field Review
January 24, 2002

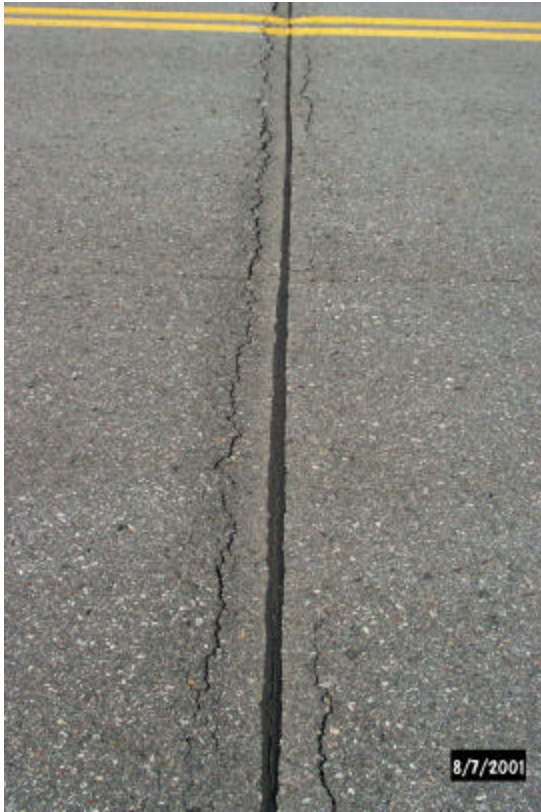
Photo 1. Taxiway section. The centerline of the taxiway is toward the bottom of the photo. The taxiway is 50-ft. wide.

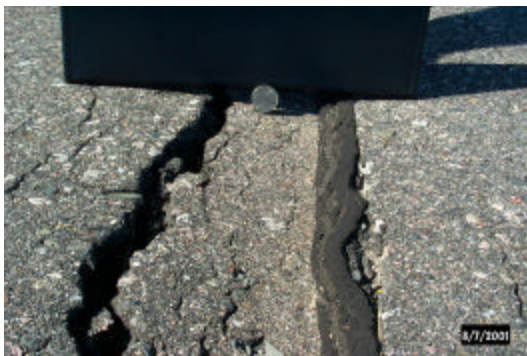
Photo 2. Close up of joint. Severe cupping occurred across the entire joint. The coin is a quarter.

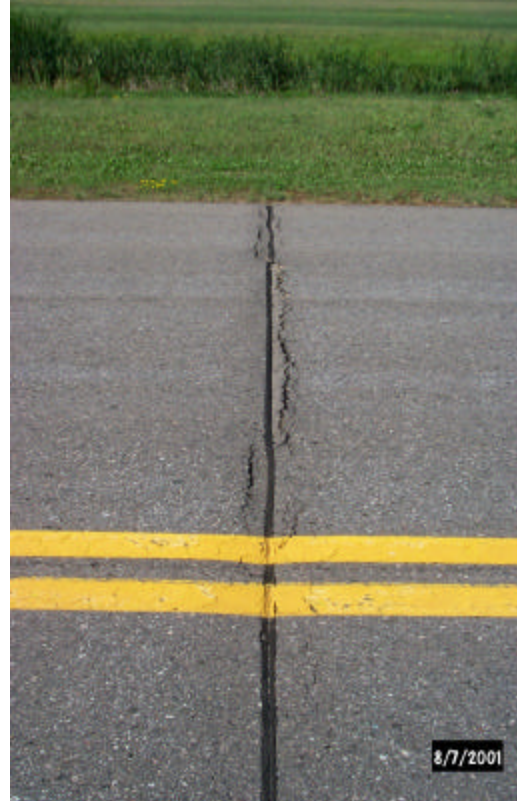
Photo 3. Shoulder section, 20-ft. wide. The shoulder sections were in worse condition than the taxiway.

The sealant often appeared to be performing well, yet deterioration was present. Traffic loading (ESAL's) would be very low for this pavement.

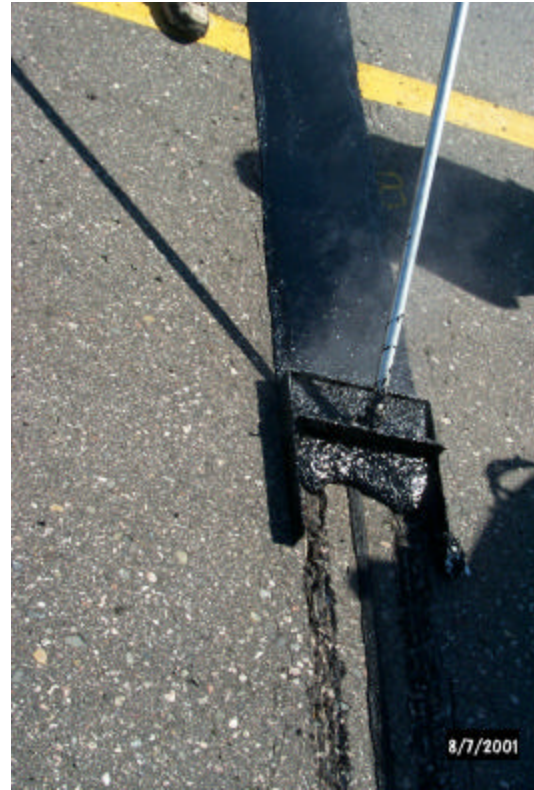
Photo 5. Type 1 material used the larger size aggregate, (vs. the fine mix – type 3). The routed edge provides a better “edge” for the material to bond against.

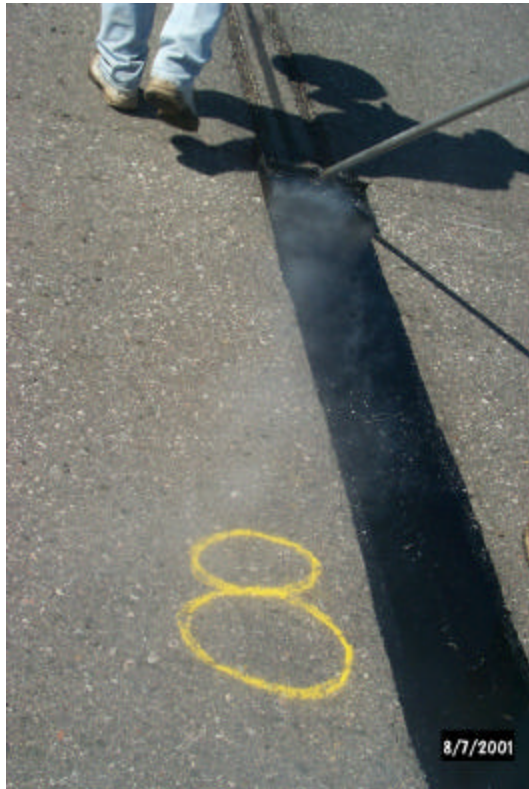
Photo 6. The material easily flowed into cracks and provides a smooth level surface across the joint.

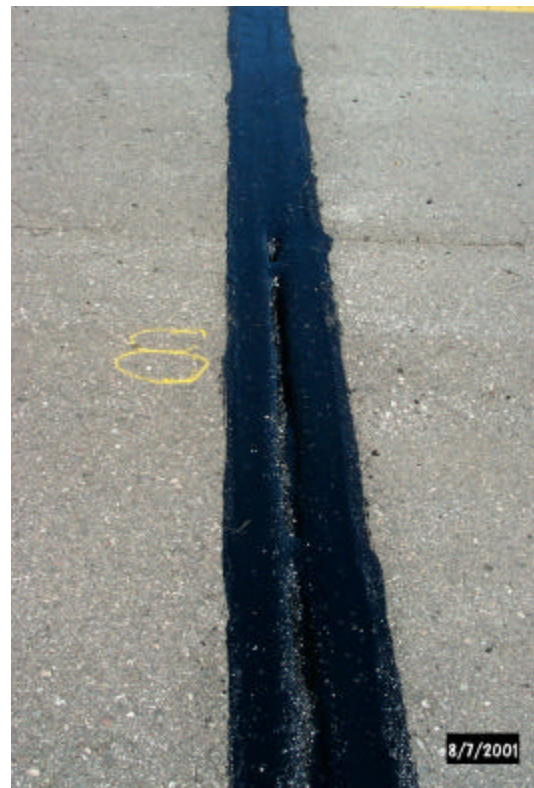
Photo 8. Completed joint 8. A 12-in. wide patch. Due to the settling of material, joints 2-8 were skimmed leveled with the joint sealant.

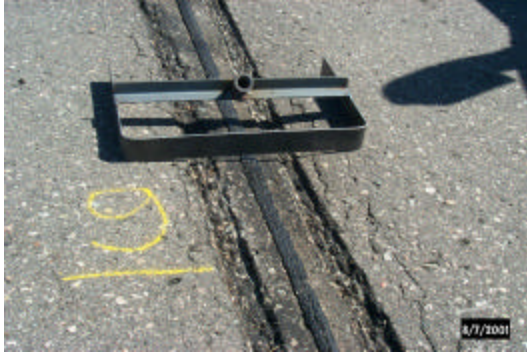
Photo 9. This is joint 9. The 19-in. rake shows that the cupping at the joint was often greater than a foot wide. The router was run across the taxiway on each side of the joint. This provided a better “edge” for the patch material to adhere to.

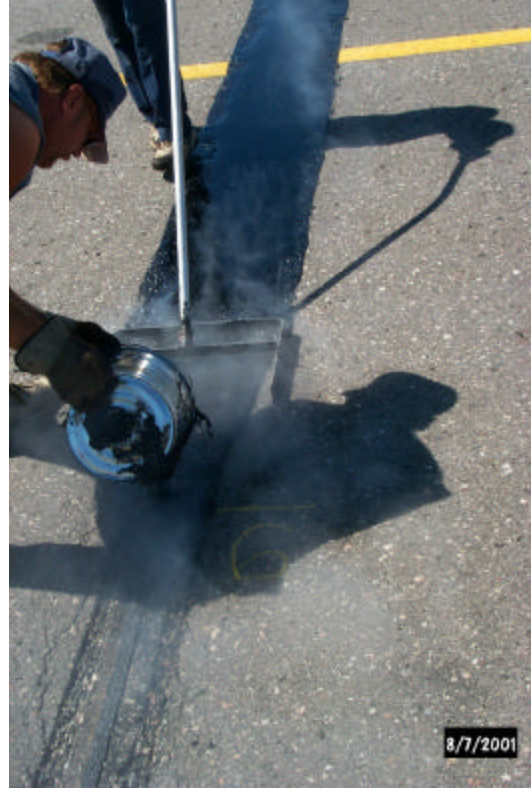
Photo 10. Filling joint 9. This is type 1 material. It will perform better in colder weather than fine mix - type 3. Type 1 has a lower adhesion property than type 3 (15psi vs. 25psi). The routed edge should help the patch material bond to the taxiway. The type 1 also has a larger aggregate size than the fine mix - type 3. Therefore type 1 is better suited for the deeper patches.

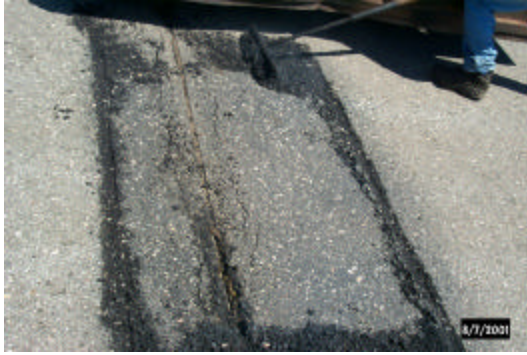
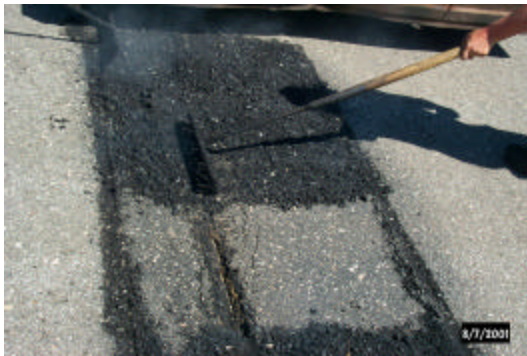
Photos 11 and 12. Raking the heated joint. Additional new fine HMA was added and mixed together with the existing material. The joint will reflect through the patch.

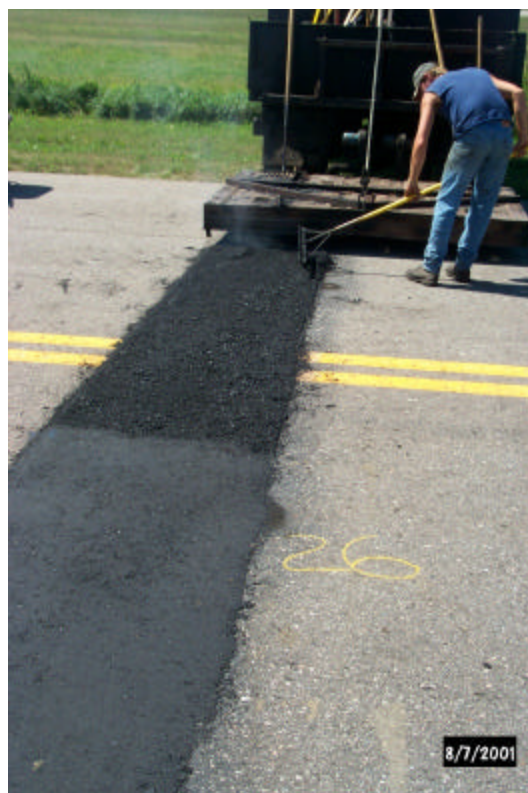
Photo 18. The heating unit progressed across each joint. The sawed and sealed joint will reflect through this repair. The width of this repair is about 41-42 inches.

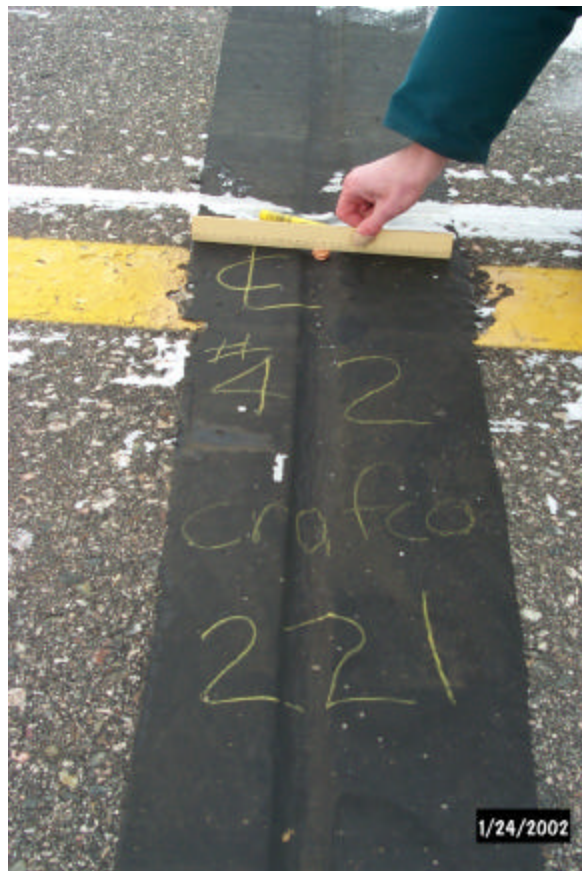
Photo 21. Joint 42. Taken on 1/24/2002 during the field review. Three pennies are stacked under the ruler. The sealant was stretching and sagging, but did not break open.

Joint 42 is shown on page 10. All of the joints with the joint sealant were not cracked.

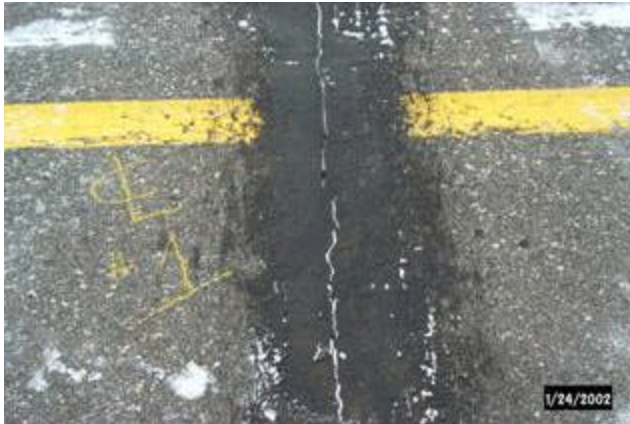
Photo 22.

Joint 1 was cracked. This was the first joint repaired. This was the first time the contractor placed this material. The repair was not as smooth as other repairs. This joint was not covered with the crack sealant material.

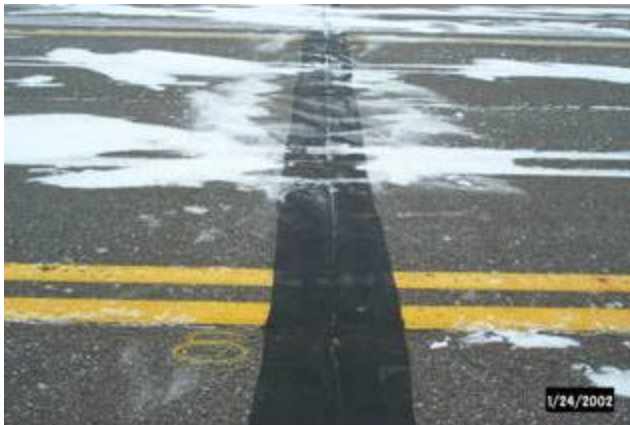
Photo 23. Joint 8 did not appear to be cracked; however joints 2-8 were “skimmed leveled” with joint sealant, approximately two days after placement of the PolyPatch material. The joint sealant may have been masking a small crack in the patching material.

Joint 9 was 50% cracked. Joints 10-23 were 100% cracked. Joints 2-8, with the more flexible material, did not appear to be cracked. However, the joint sealant may have been masking the crack. All joints, at 75-ft. spacing, with the less flexible type 3 material were cracked.

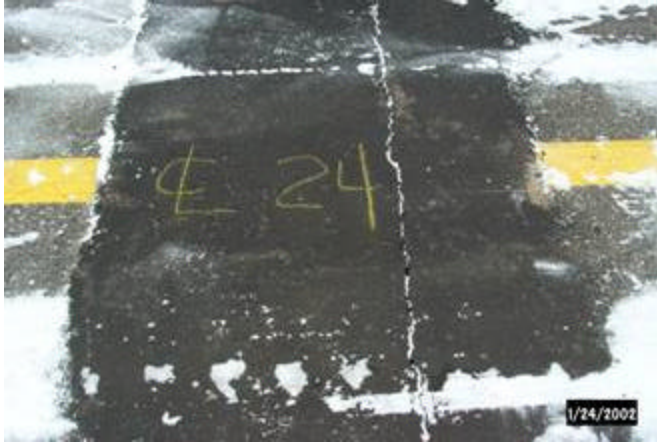
Photo 24. Joint 24. The three joints repaired by the thermo patch method had cracked.

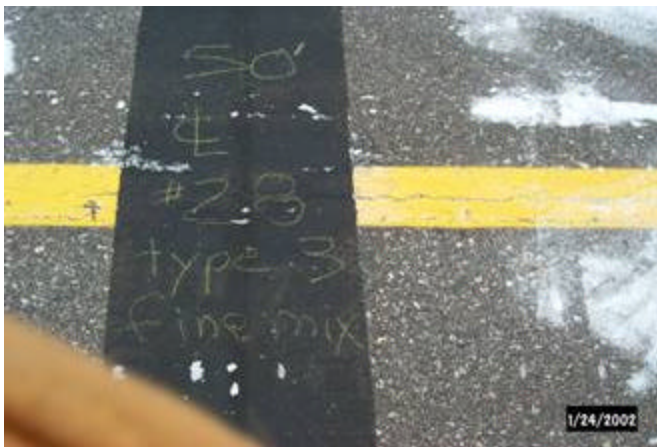
Photo 25. Joint 28.

Joints 28-32 (50-ft. spacing) were not cracked. All joints (10-23) with the same material at 75-ft. spacing were cracked.

Joint 27 was cracked. This joint has a 75-ft. spacing toward joint 26 and a 50-ft. spacing toward joint 28.
