Final Report

Forensic Investigation Report  
For MnROAD Ultrathin Whitetopping  
Test Cells 93, 94 and 95

| 7. Author(s)<br><b>Thomas R. Burnham</b> | | 8. Performing Organization Report No.<br><b>T9PR2004</b> | |

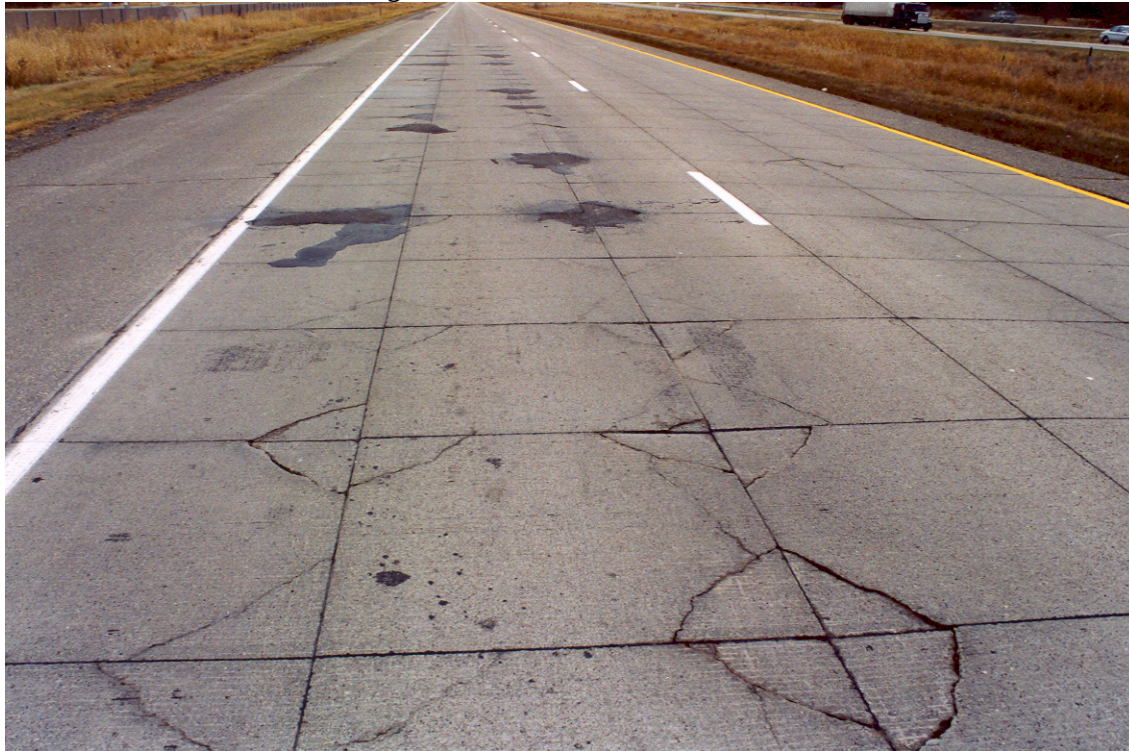
As shown in Figures 2.1-2.3, by the spring of 2004, the driving lane of test cells 93, 94, and 95 had all reached values far below 2.5. The cause of the low PSR numbers was predominantly due to the increasing amount of asphalt patching being placed on the distressed UTW surface. Cell 94 in particular was experiencing punchout type distress in the corners of the interior panels near the wheelpaths. See Photo 2.1 for an example.

*Photo 2.1. Corner cracked areas beginning to punch through the surface in November 2003. MnROAD Test Cell 94, driving lane.*

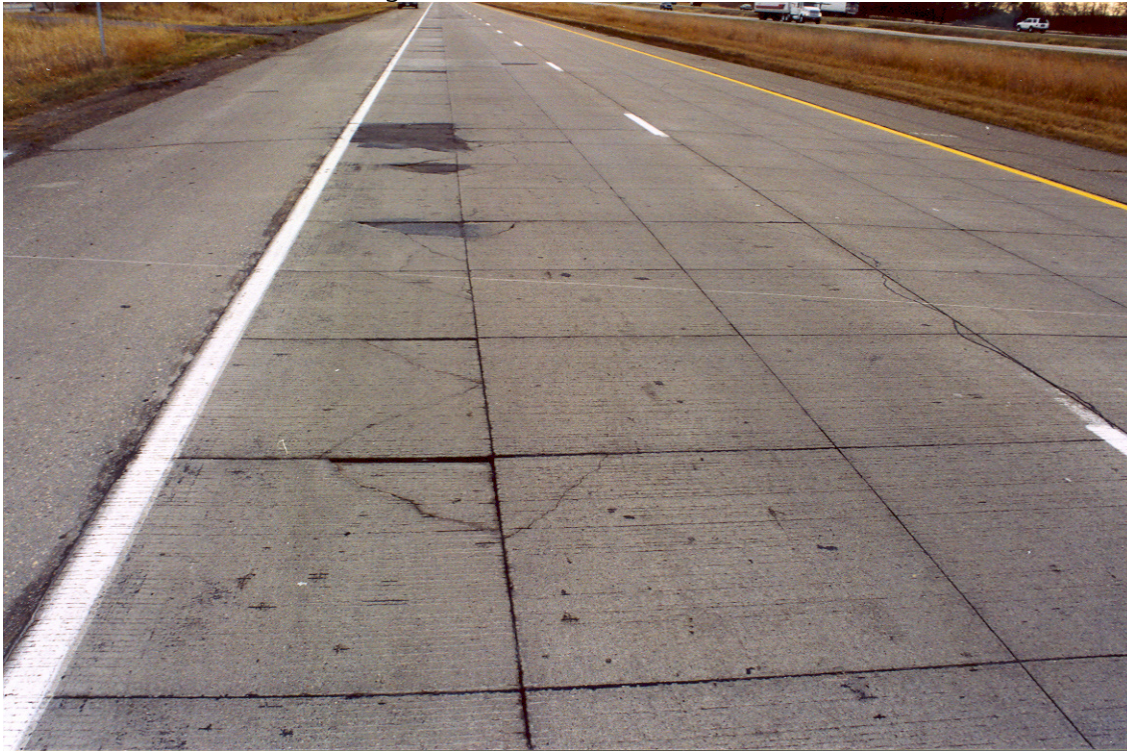
Test cell 93, consisting of a 4 inch (102mm) thick UTW over 9 inches (228 mm) of hot-mix asphalt, experienced most surface distress in the form of corner cracking on the inside edge of the outer panels in the driving lane. Cracking was predominantly located on the approach side of panels, nearest the outside wheelpath of the driving lane. Photos 2.2 and 2.3 (not same location) show examples of the distress before and after patching done by Mn/DOT maintenance crews.

*Photo 2.2. Corner cracks near outside wheelpath, November 2003.  
MnROAD Test Cell 93, driving lane.*

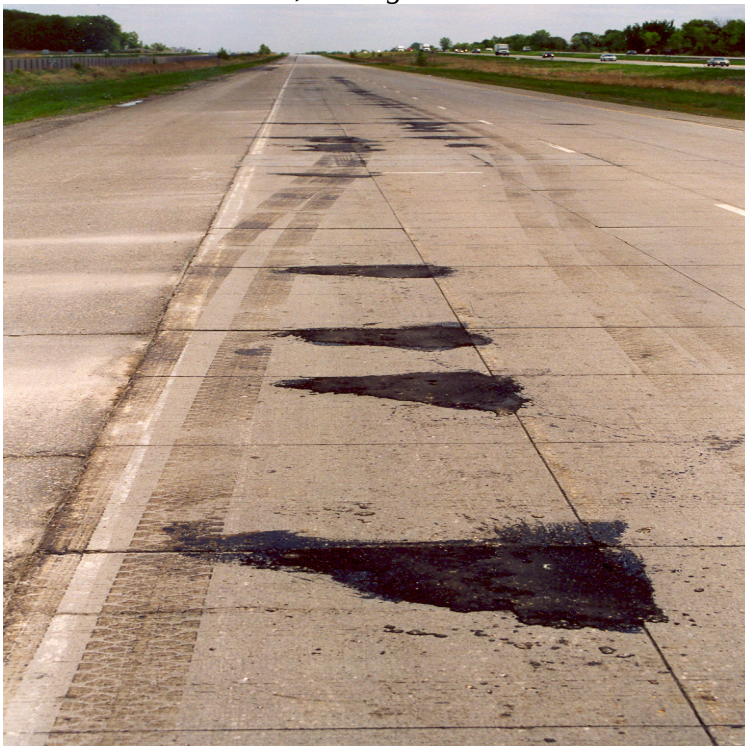
*Photo 2.3. Patched corner crack areas near outside wheelpath, May 2004.  
MnROAD Test Cell 93, driving lane.*

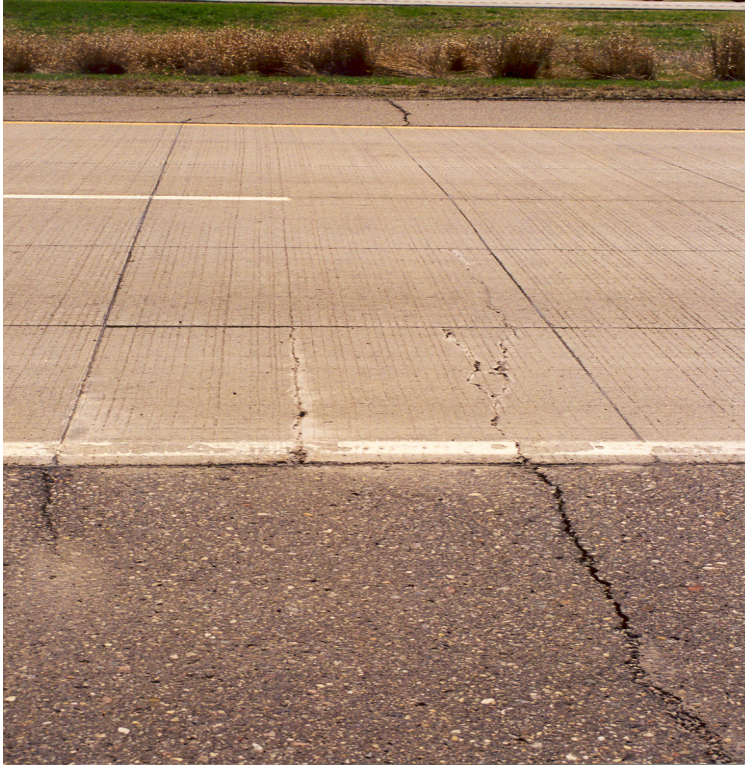
The other predominant distresses in test cell 93 were reflective cracking (from bond with the HMA) and load related cracking. All but a few of these distresses were located in the outer panels of the driving lane, nearest the shoulder. Photos 2.4-2.6 show examples of these types of distress.

*Photo 2.4. Cracks from underlying asphalt layer reflected through UTW overlay, April 2001. MnROAD Test Cell 93, driving lane.*

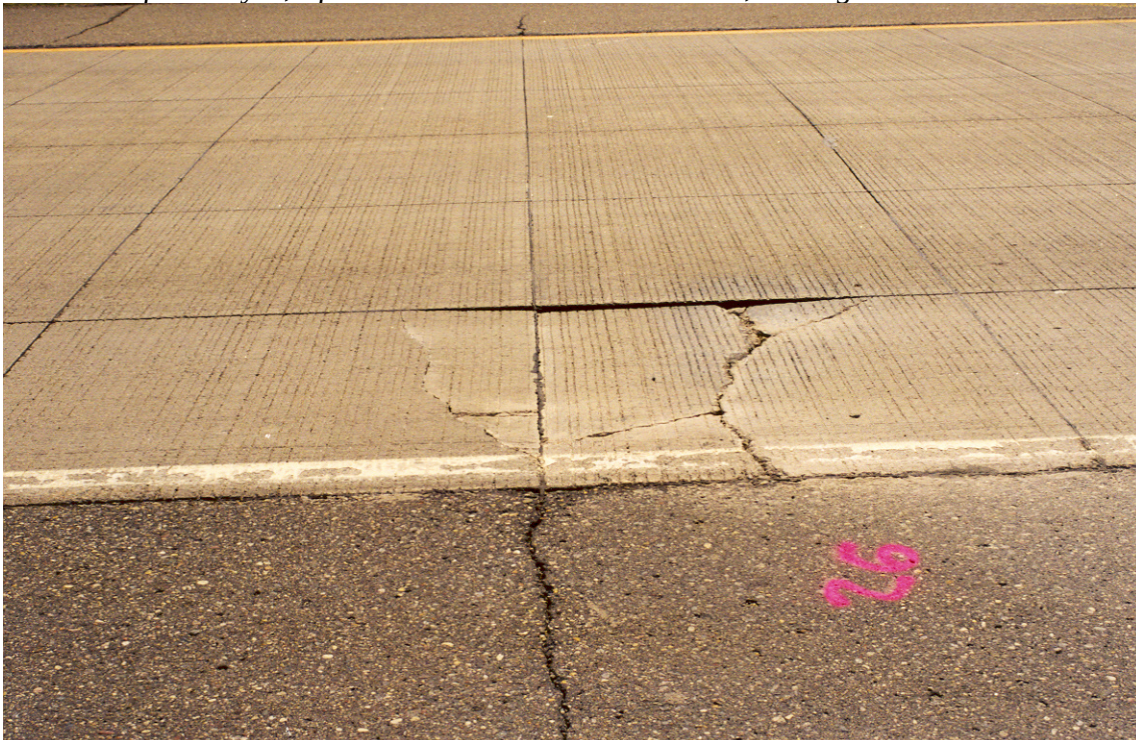
*Photo 2.5. Load related cracking and surface depression (punchout) near existing transverse crack in asphalt layer, April 2001. MnROAD Test Cell 93, driving lane.*

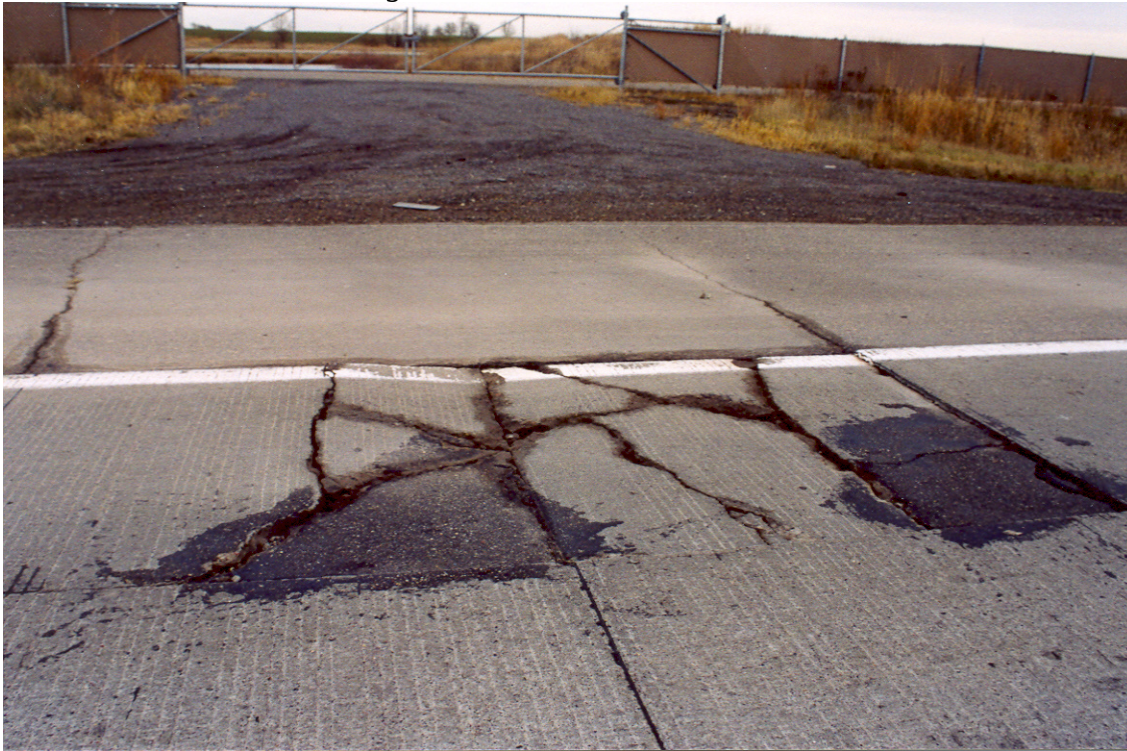
*Photo 2.6. Load related cracking and large surface depression, November 2003.  
MnROAD Test Cell 93, driving lane.*

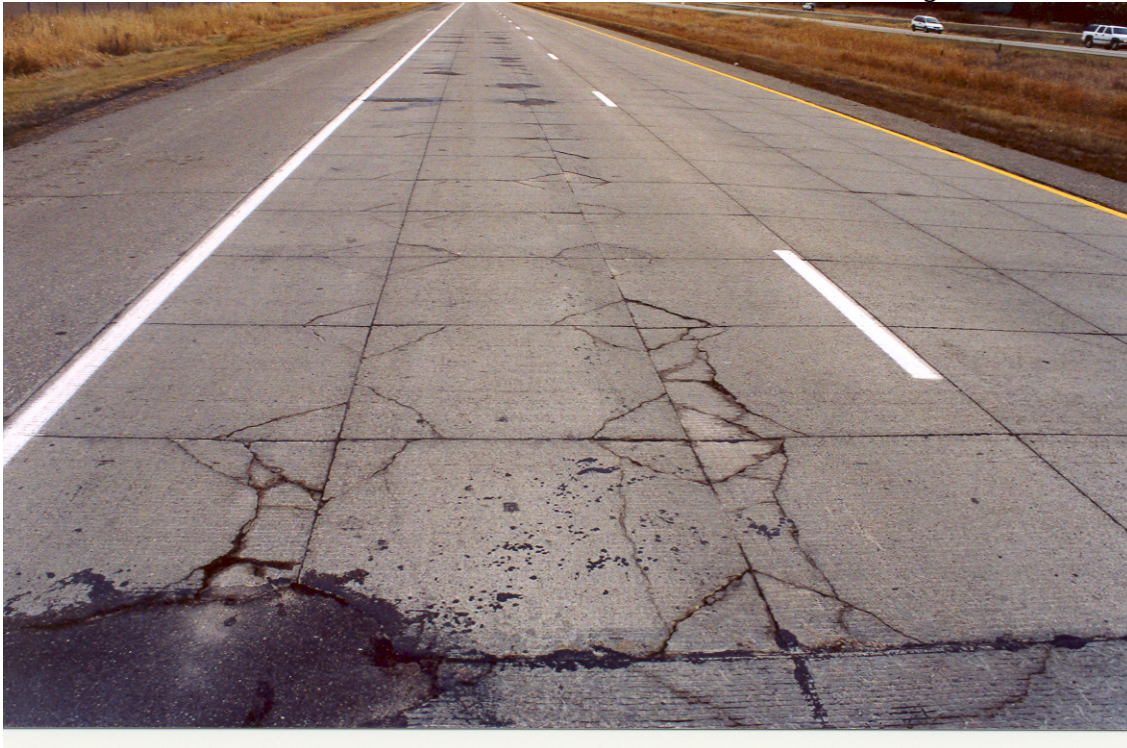
Test cell 94, consisting of a 3 inch (76 mm) thick UTW over 10 inches (254 mm) of hot-mix asphalt, experienced most surface distress in the form of corner cracking near the longitudinal joints of the center panels in the driving lane. Corner cracking was very extensive, resulting in nearly every center panel having diamond shaped punchouts near the corners. In some cases, the corner cracks were connecting to each other, as shown in Photo 2.7. Photo 2.8 shows how extensive the corner crack patching was by the summer of 2004. The thinner panels of test cell 94 also demonstrated more reflective and load related transverse cracking than test cell 93.

*Photo 2.7. Extensive corner cracking on edges of center panels (wheelpaths), beginning to connect to one another, November 2003. MnROAD Test Cell 94, driving lane.*

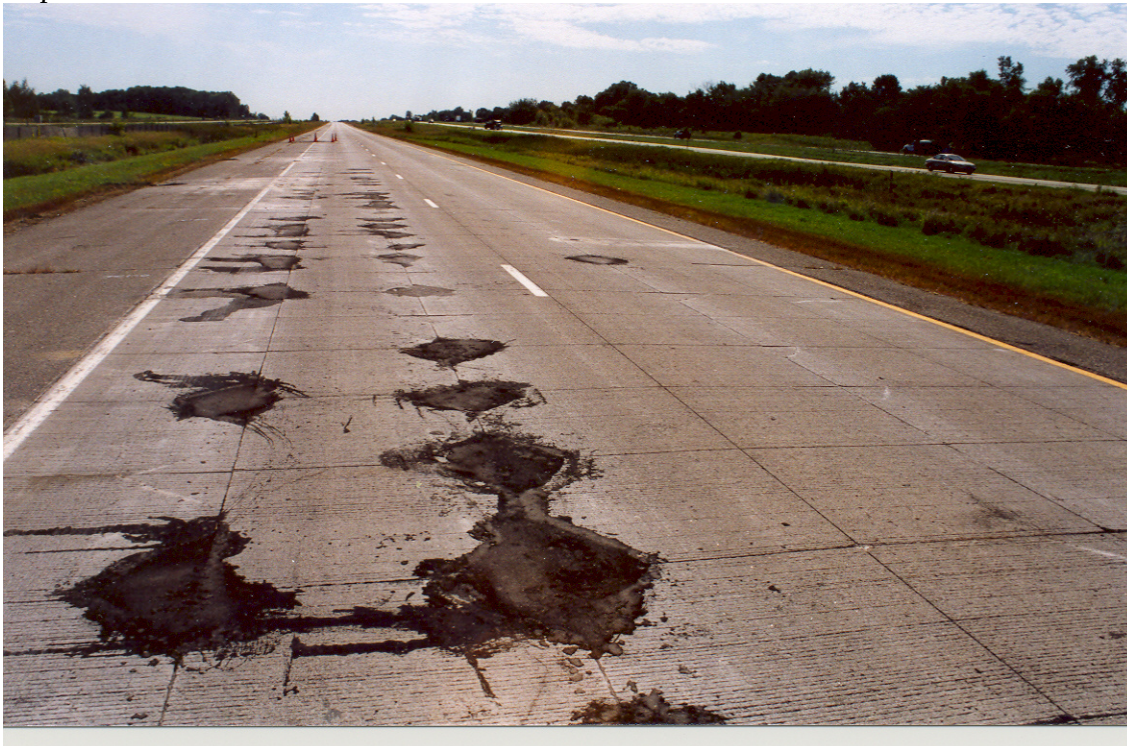
*Photo 2.8. Asphalt patching on nearly every panel in the driving lane of test cell 94, September 2004.*

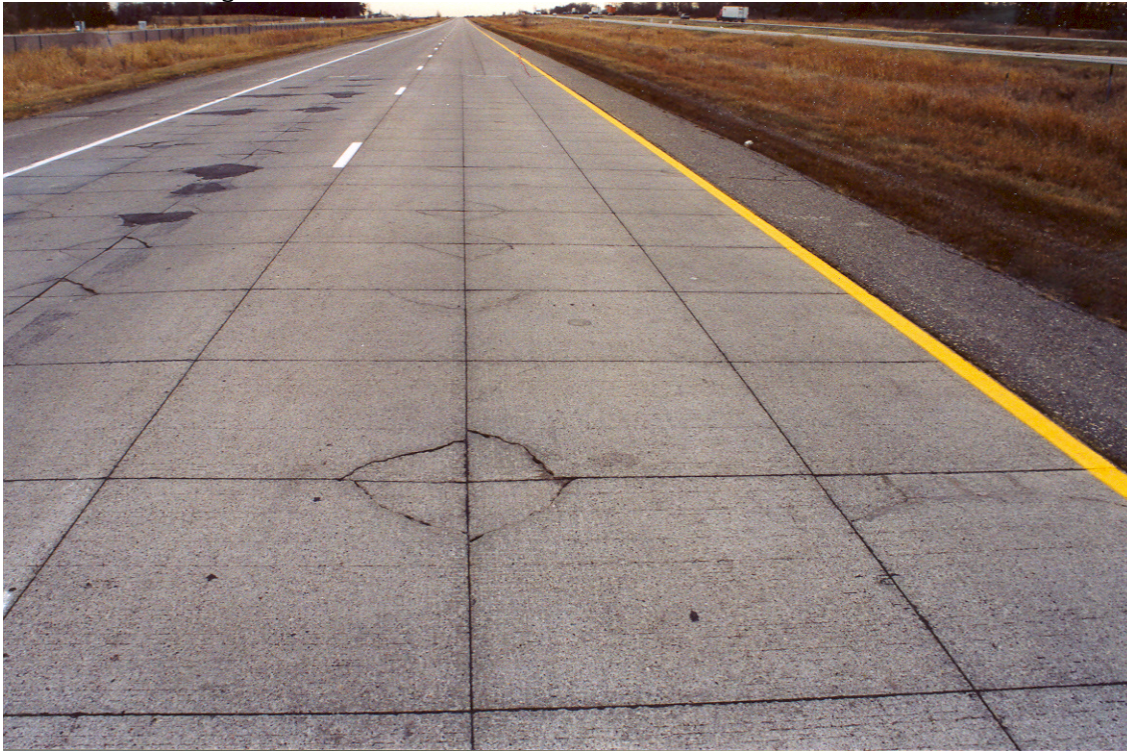
By November of 2003, the inside wheelpath of the passing lane in test cell 94 was starting the exhibit similar distress as the driving lane. See Photo 2.9. The ride quality of the driving lane, however, became so low (PSR=0) that live interstate traffic was removed (for safety reasons) from the MnROAD mainline test sections on June 14, 2004.

*Photo 2.9. Passing lane of test cell 94, beginning to show similar corner cracking distress as driving lane, November 2003.*

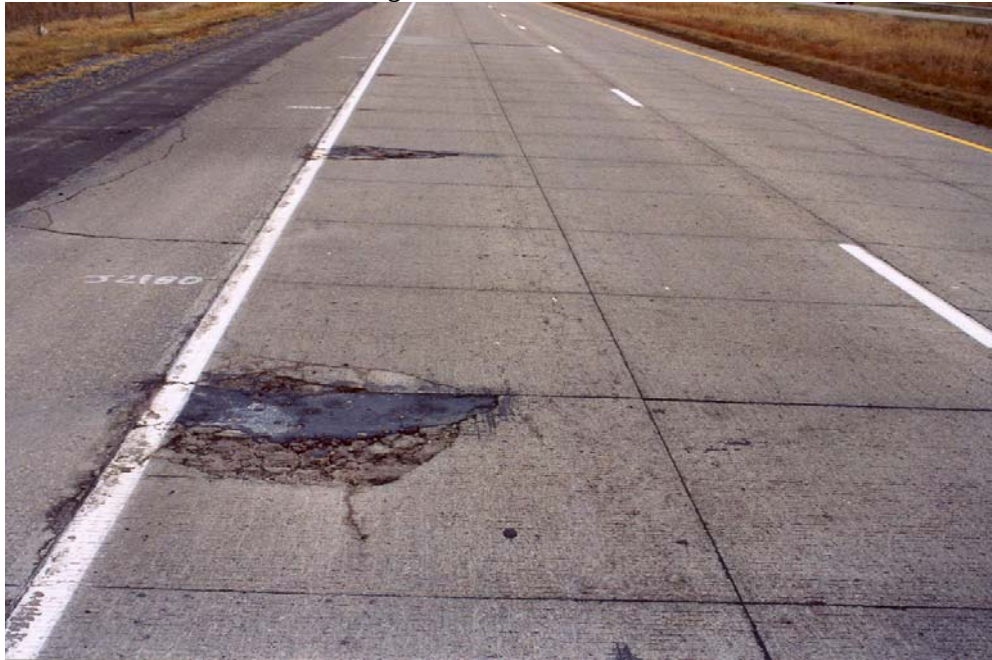
Test cell 95 exhibited a fair amount of corner cracking, mostly on panel corners nearest the shoulder. This was true for both the driving and passing lanes. See photos 2.10 and 2.11. The corner cracking always initiated on the approach side of the panel. Test cell 95 also had a small number of reflective cracks that grew large enough to warrant patching.

*Photo 2.10. Corner cracking on the outside edge of panels near the shoulder, November 2003. MnROAD Test Cell 95, driving lane.*

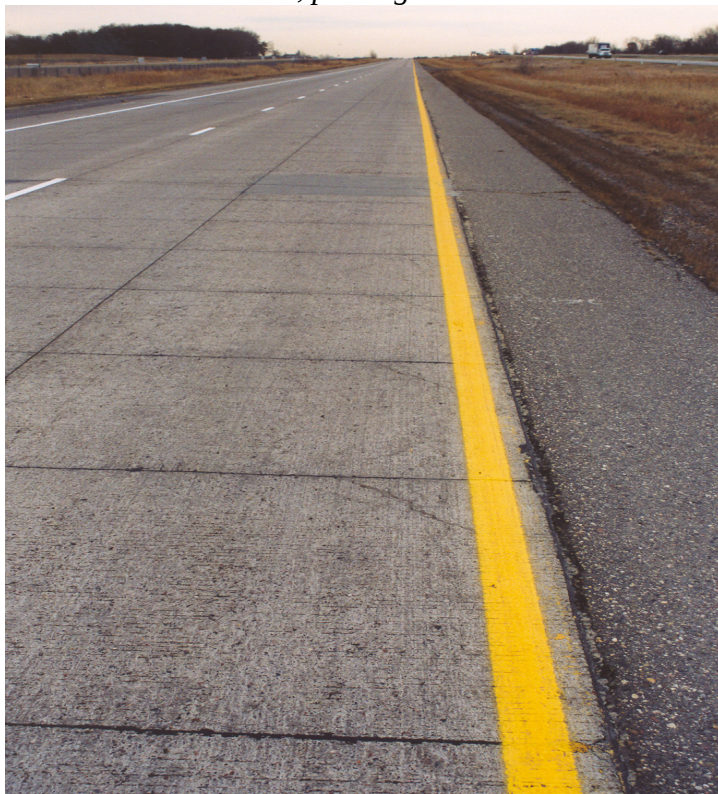
*Photo 2.11. Corner cracking on the outside edge of panels near the shoulder, November 2003. MnROAD Test Cell 95, passing lane.*

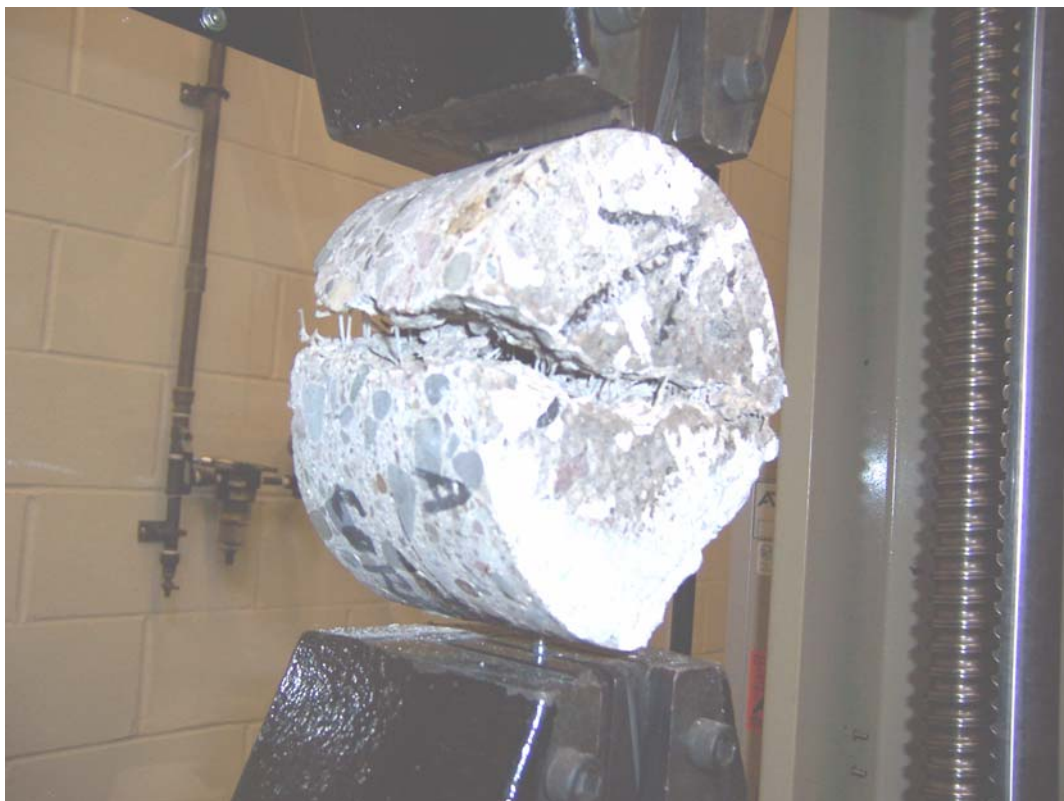
*Photo 3.5. Core sample during testing. Note fibers spanning crack.*

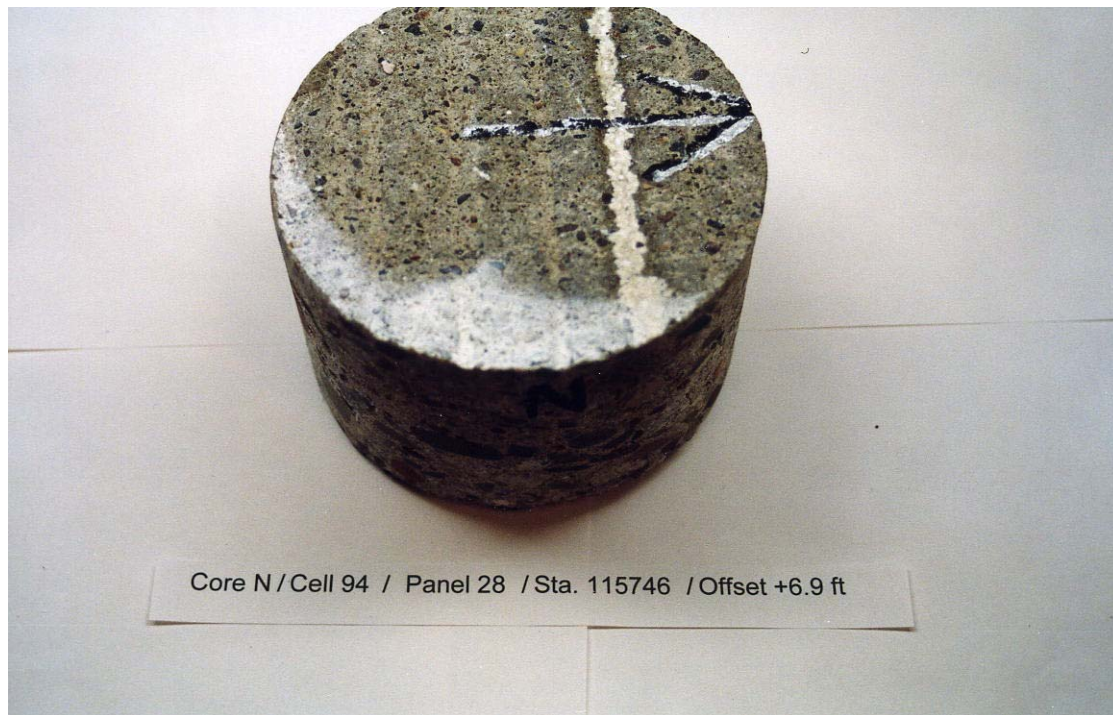
*Photo 3.7 White precipitate over crack in core sample.*

During the field investigation, it was noticed that several of the cracks in the UTW panels had a band of precipitate over the crack. An example is shown in Photo 3.7. Several cores were taken to identify the precipitate.

A spectral analysis was done on the precipitate, which was determined to be calcium carbonate. The presence of calcium carbonate, also known as carbonation, is common and only affects the concrete's ability to protect embedded steel from corrosion (lower alkalinity). Carbonation in UTW is not a concern. More information on carbonation in concrete can be found in reference 4.

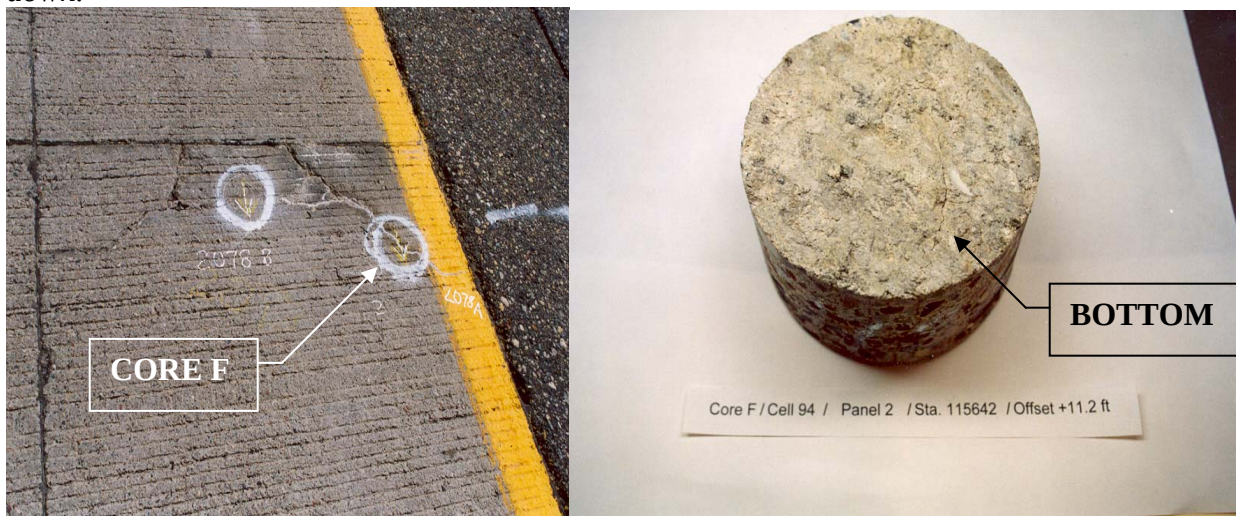
Through examination of the core samples and test pits, there was clear evidence that debonding of the ultra-thin whitetopping from the hot-mix asphalt layer led to cracking, and eventually surface distress. Photos 3.9 through 3.11 show core and test pit samples with significant loss of bond. The location of these cores (Core F, Core N, Forensic Area “A”) can be found on pages A-2 and A-4 of Appendix A. Debonding between the layers always occurred near panel edges or cracks, likely due to asphalt stripping and/or freezing and thawing action from the increased amount of available moisture. Photo 3.12 shows an area of debonding of approximately 6 inches from the edge of the shoulder.

*Photo 3.9 Core sample “F” showing no bond between UTW and HMA. Core shown upside down.*

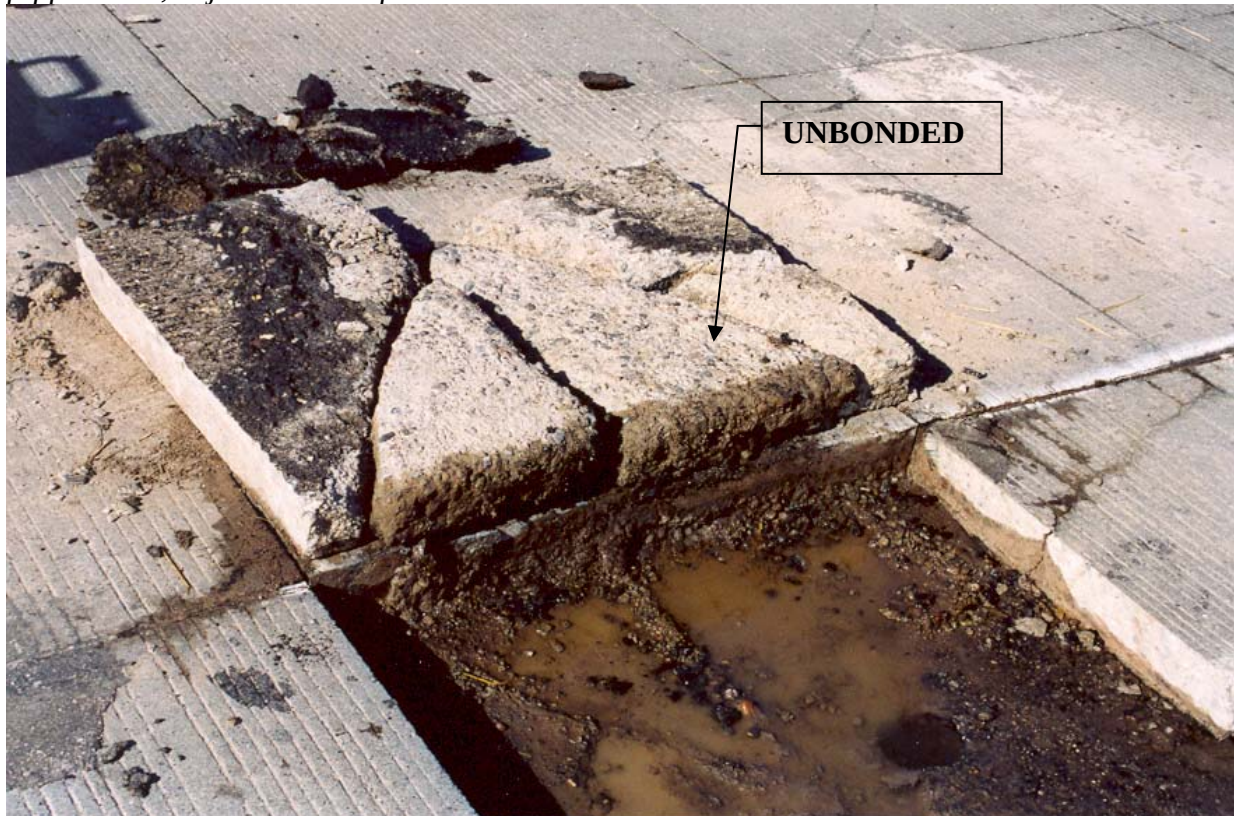
Photo 3.11 Test pit “A” samples showing no bond between UTW and HMA. Pieces shown flipped over, adjacent to test pit.

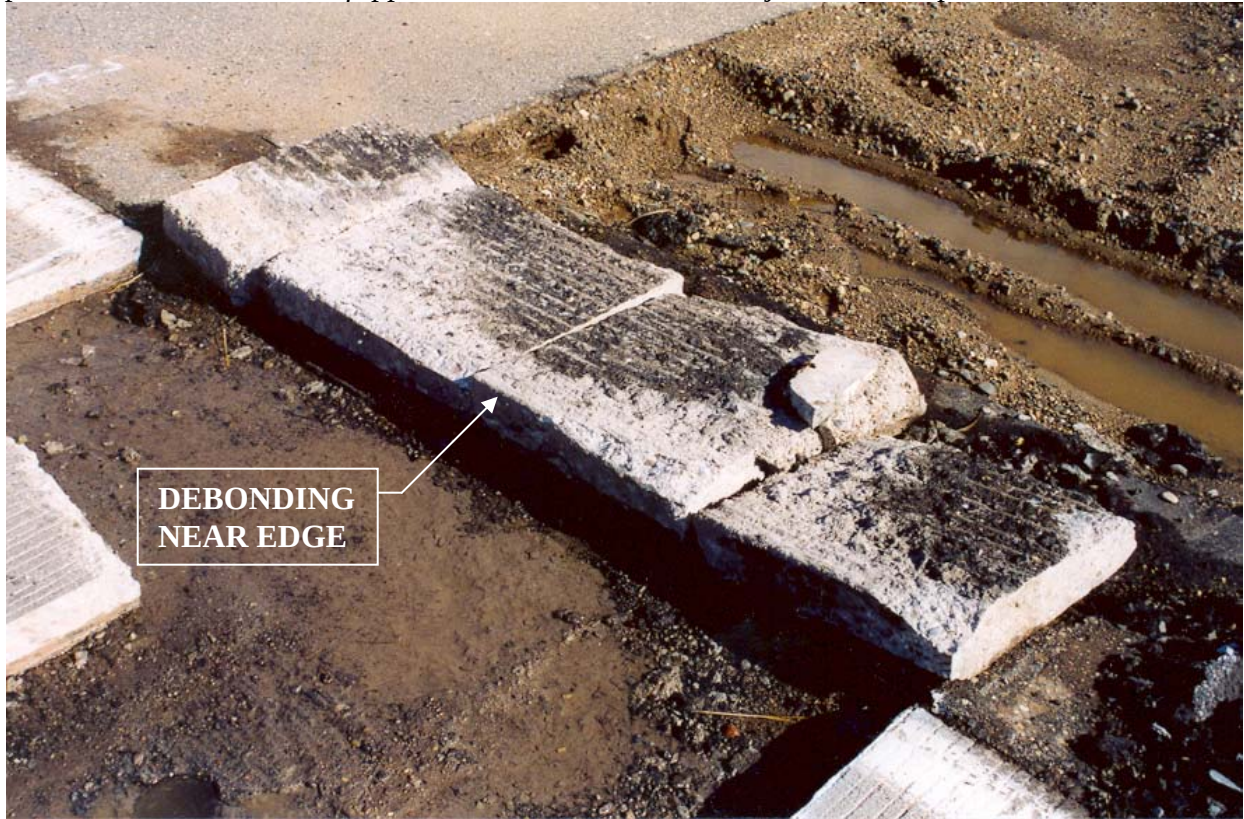
*Photo 3.12 Test pit “A” samples showing an area of debonding near the shoulder edge of the panels. Pieces are shown flipped over in shoulder area, adjacent to test pit.*

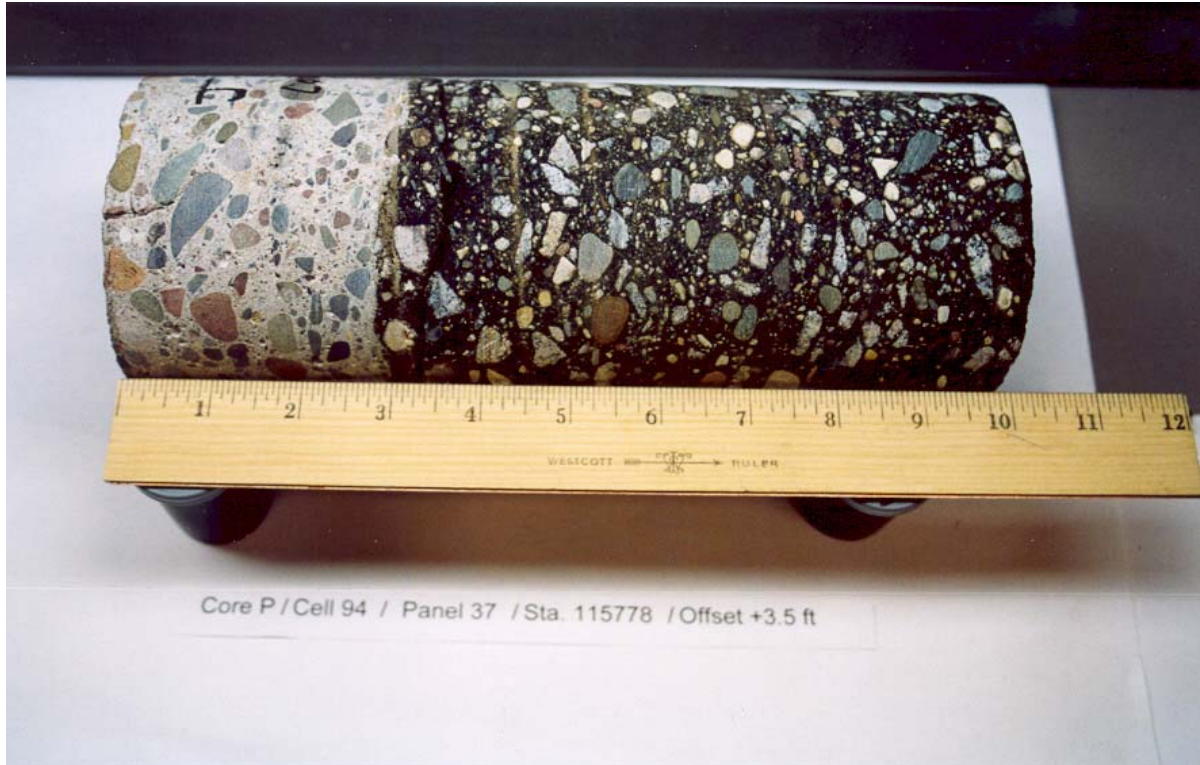
Near the center of panels, bond between the layers was usually found to be intact. Photos 3.1 and 3.13 show core samples with complete bond after 7 years of service.

Photo 3.13 Core sample “P” showing good bond between UTW and HMA. Also note top-down crack in UTW.

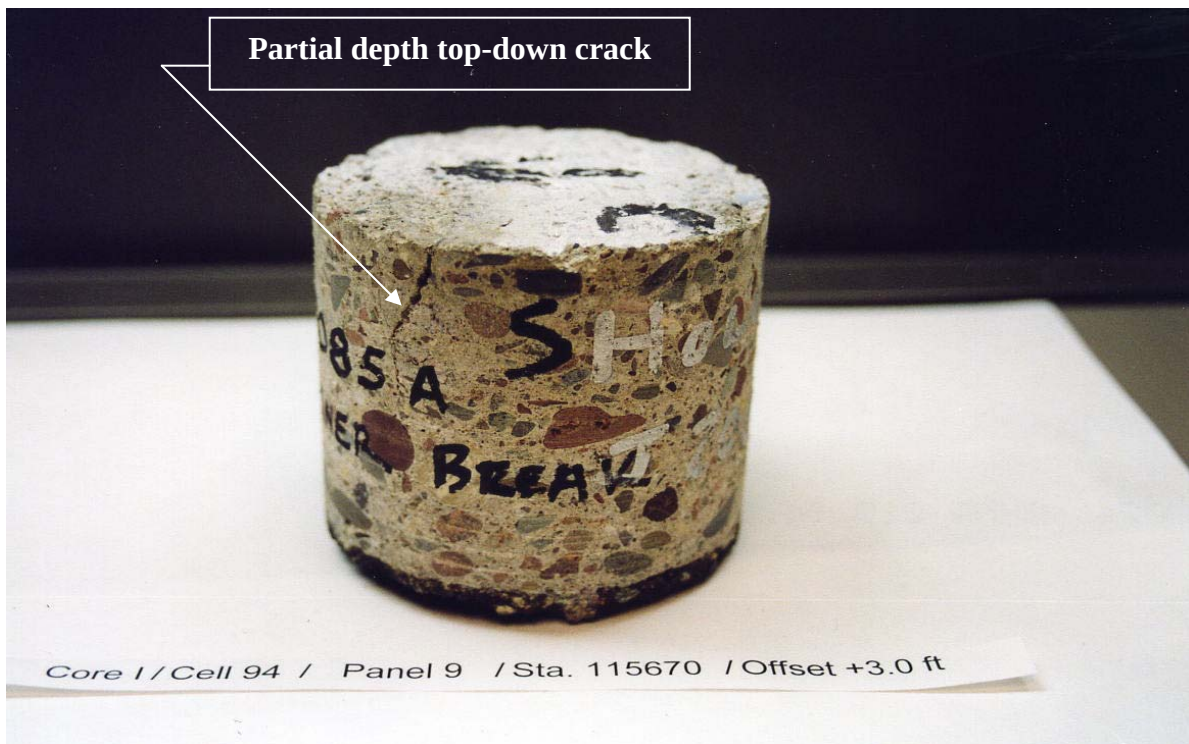
Both full-depth and partial-depth cracking were found in the core samples. Partial depth cracking was found to start from the top of the slab. An example is shown in Photo 3.14. It was also observed that cracking always started on the approach side of a panel. Figure 3.1 shows several examples. It is reasoned that as the UTW debonds from the HMA, the panel warps and curls up, and becomes more exposed to the impact load from tires. With the lack of support on such a thin concrete slab, cracking quickly follows.

Photo 3.14 Core sample “I” showing top-down partial depth cracking.

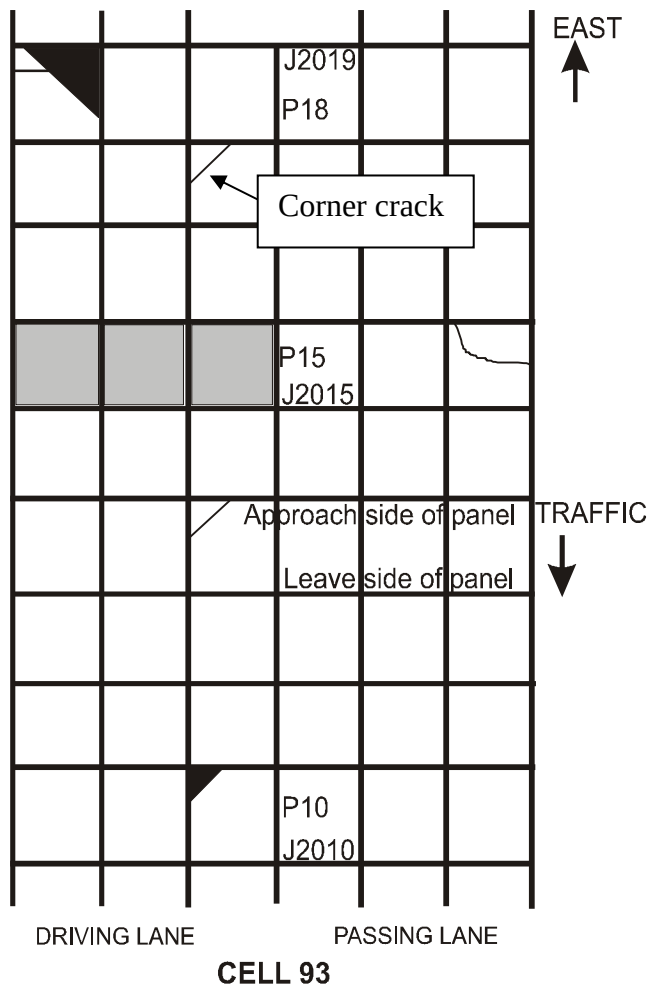
*Figure 3.1. Plan view of Cell 93 showing corner cracks initiating on approach side of panel.*

The close proximity of the tire loads to the panel edges in test cells 93 and 94 resulted in corner cracks on either side of the center panels within a lane. Corner cracks in the driving lane of test cell 94 deteriorated into “punchouts”, which began to connect to one another (Photo 2.7). The distress maps in Appendix A show the extensive corner cracking that occurred in test cell 94.

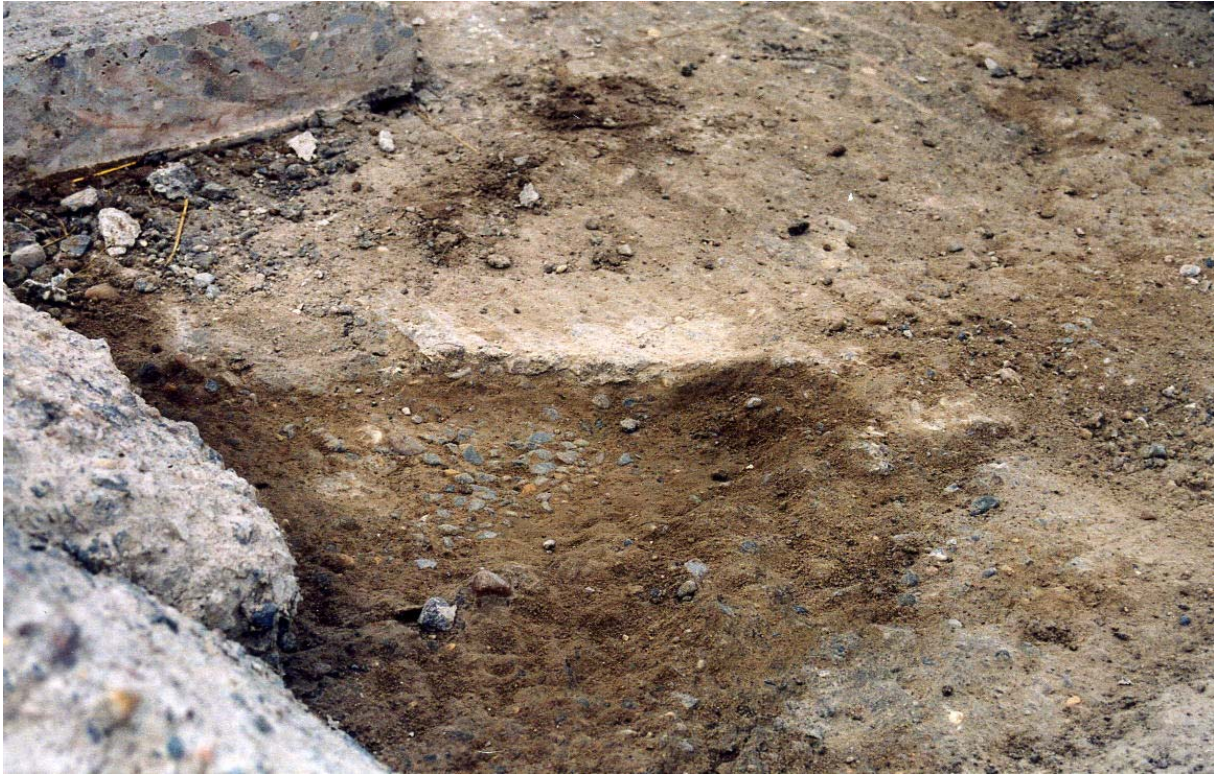
Forensic Area “A” in test cell 93 revealed that the concrete pieces in a punchout are actually driven into the HMA. Photos 3.15 and 3.16 show the depression in the HMA after the UTW was removed (with a skidloader), and the deformation in the top of a core (Core B) pulled from the HMA layer.

*Photo 3.15 Forensic Area “A” showing deformation in HMA from punchout in UTW.*

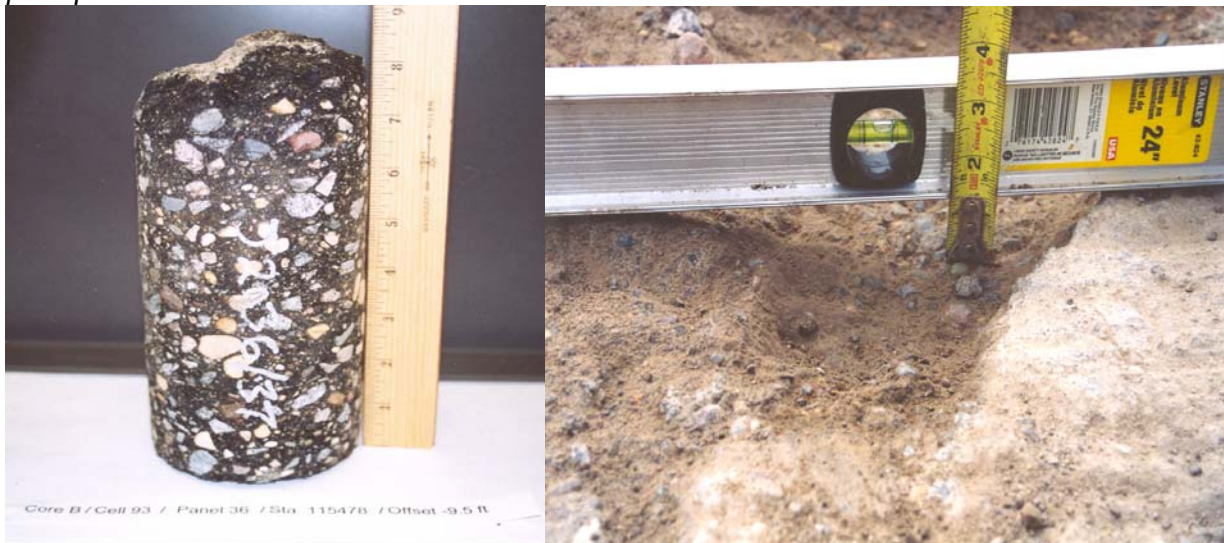
*Photo 3.16 Core sample “B” and close-up of forensic area “A” showing deformation in HMA from punchout in UTW.*

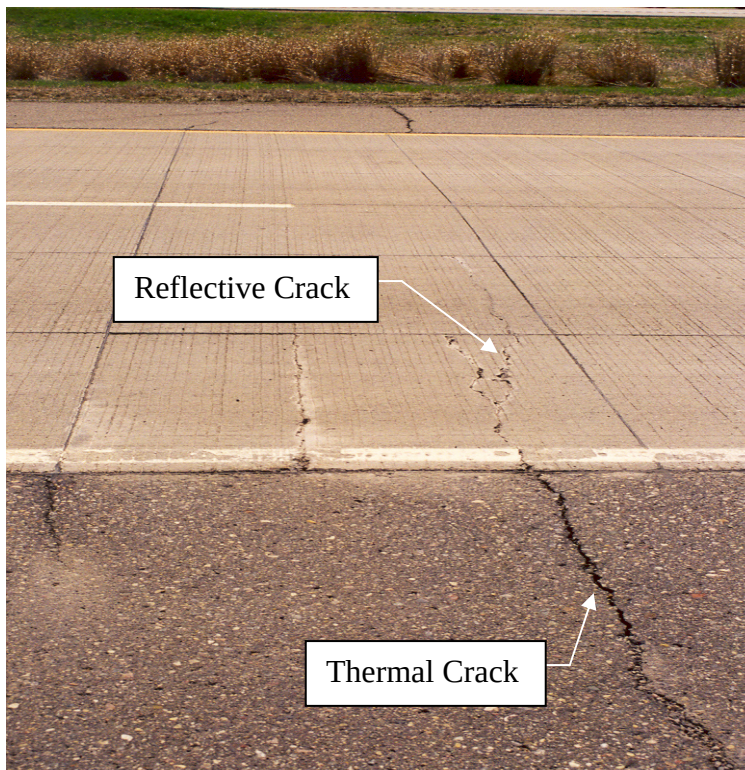
Reflective cracks appeared in all three of the UTW cells, although were more prevalent in the 3 inch (76 mm) thick test cells 94 and 95. The distress maps in Appendix A indicate the locations of the major thermal cracks that were present before the UTW test cells were placed. Photos 3.10 and 3.17 show examples of reflective cracking through the UTW. Not every major thermal crack reflected through the UTW. Photo 3.18 shows an example without reflective cracking in test cell 95.

*Photo 3.17 Major preexisting thermal crack in HMA reflected through UTW in Cell 93.*

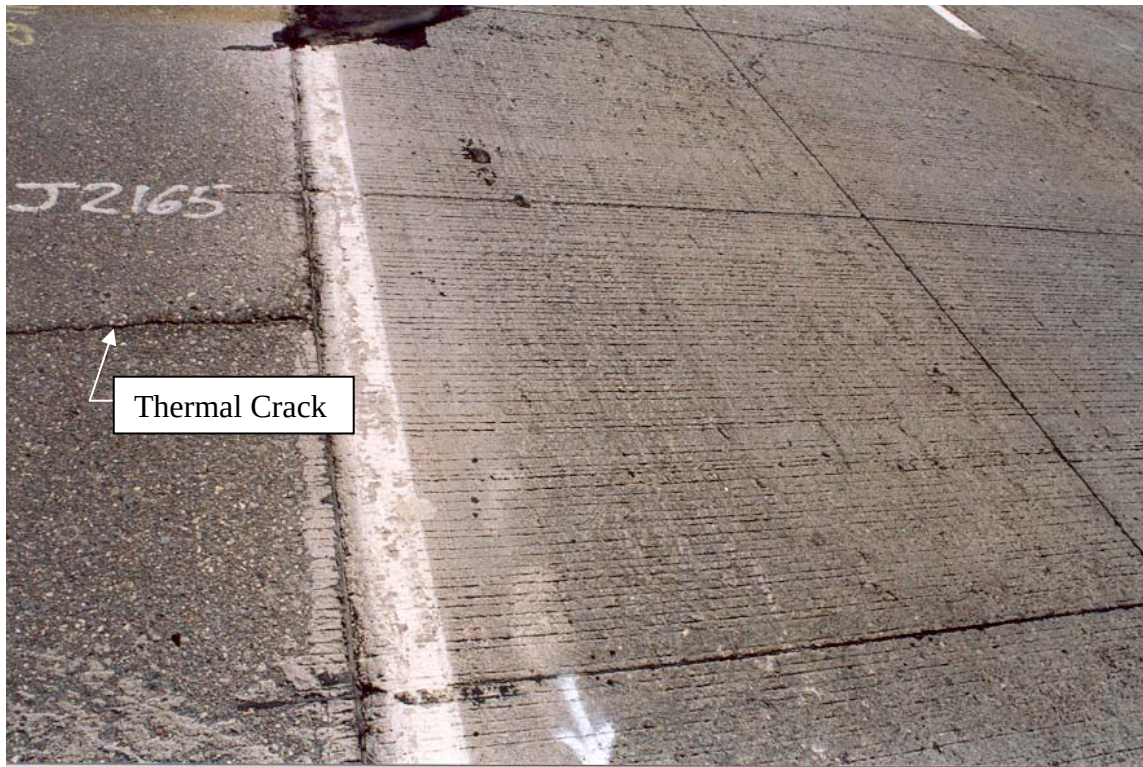
*Photo 3.18 Major preexisting thermal crack in HMA that did not reflect through UTW in Cell 95.*

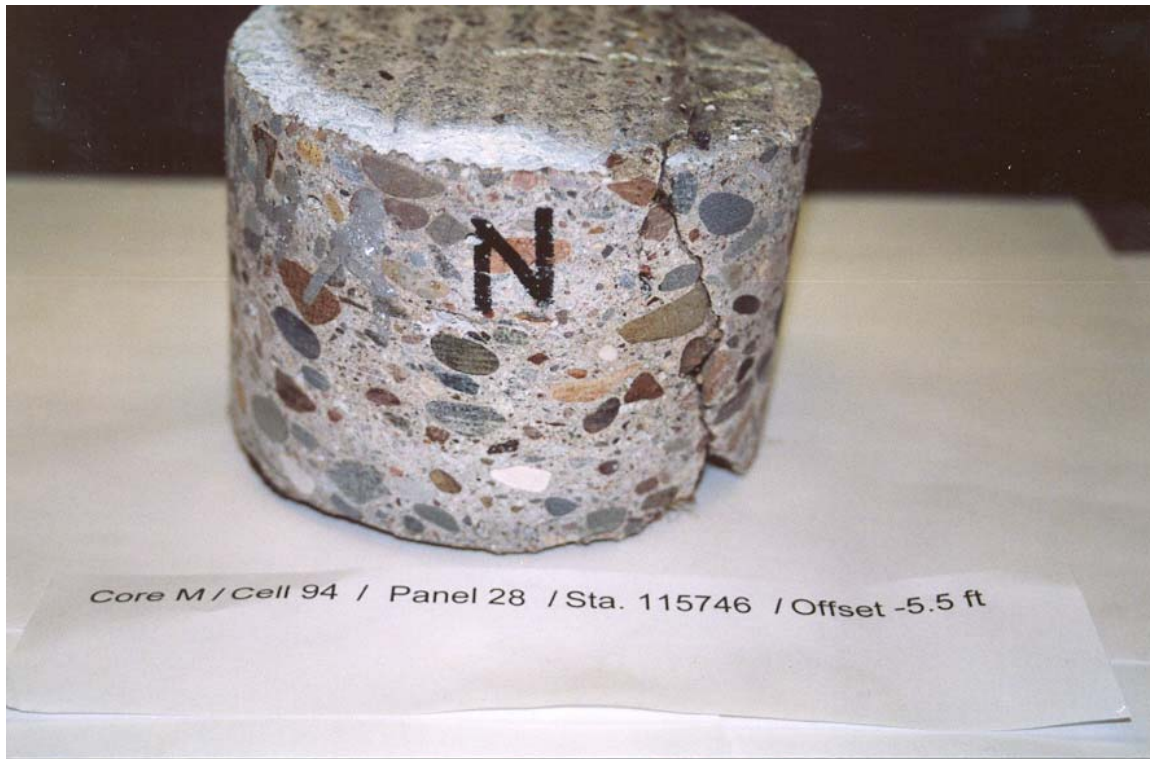
Photo 3.19 shows a side view of a core taken over a reflective crack in test cell 94. Note that the core was substantially debonded from the HMA, most likely due to the increased availability of moisture from the crack.

*Photo 3.19 Core sample “M” showing reflective crack from HMA layer.*

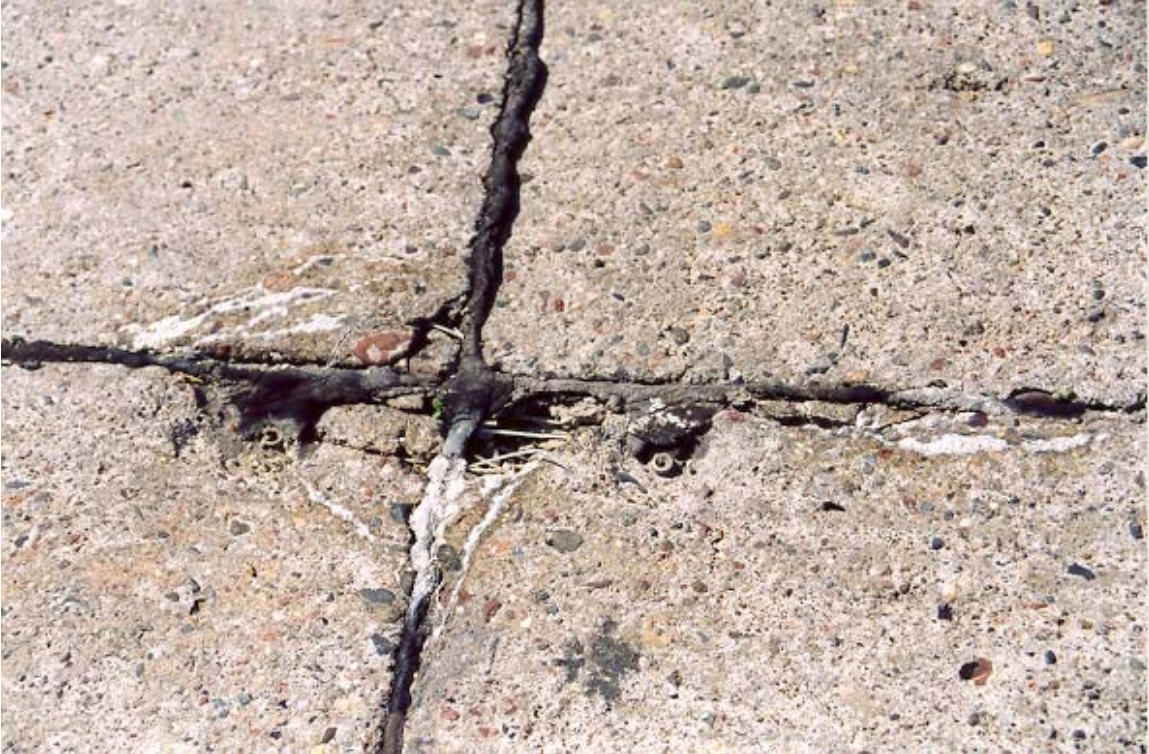
**Cell 95 Joint cracking near joint 2155.**

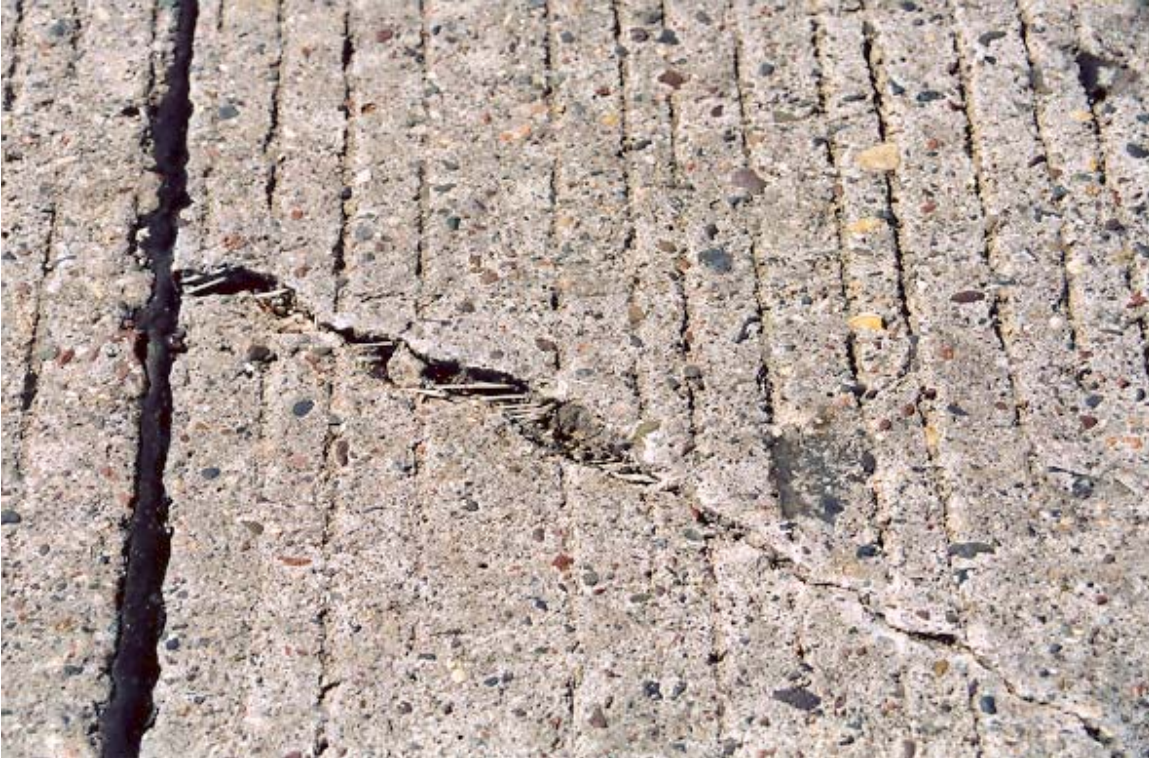
**Cell 95 Corner crack near joint 2155.**
