Final Report

Forensic Investigation Report  
For MnROAD Ultrathin Whitetopping  
Test Cells 93, 94 and 95

| 7. Author(s)<br><b>Thomas R. Burnham</b> | | 8. Performing Organization Report No.<br><b>T9PR2004</b> | |

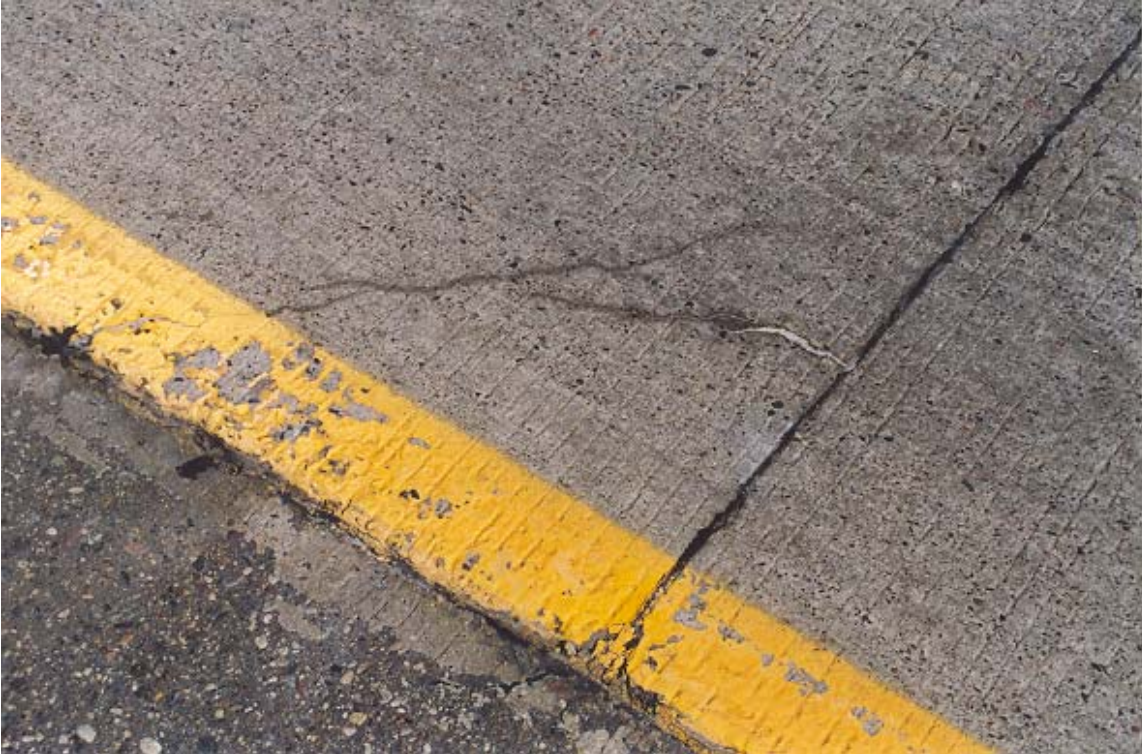
**Cell 95 Initial approach panel cracking in passing lane.**

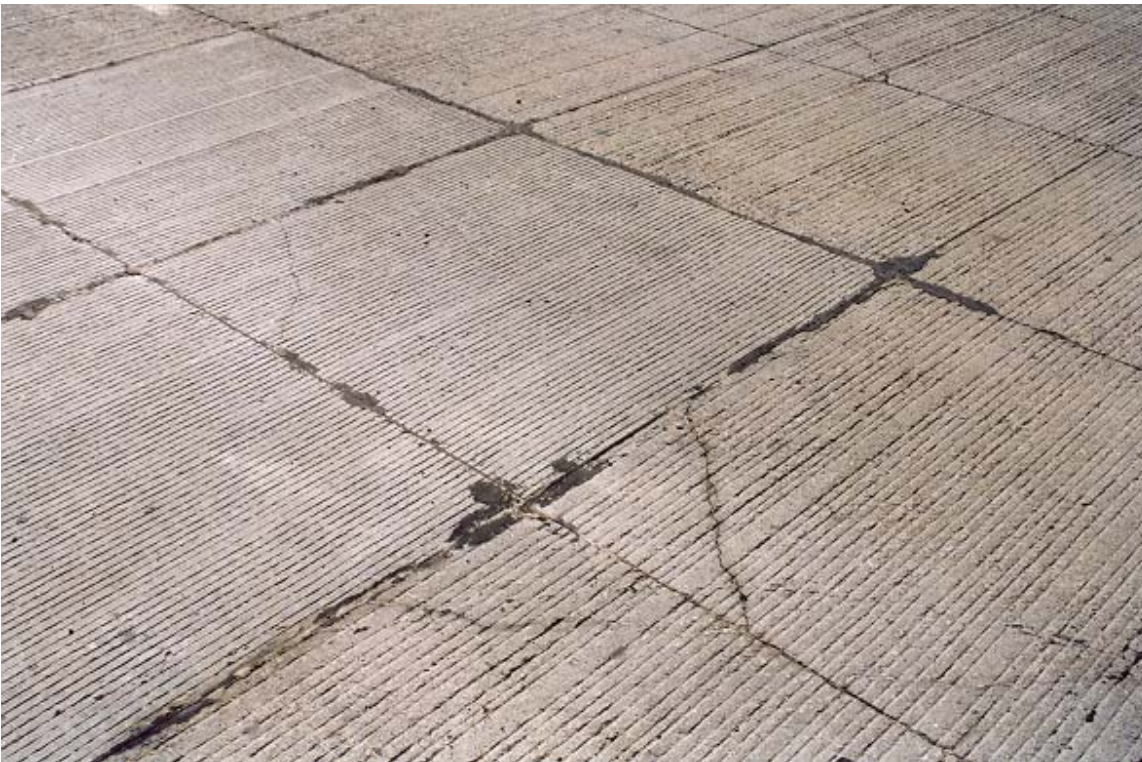
**Cell 94 Early corner cracking on inside wheelpath of driving lane.**

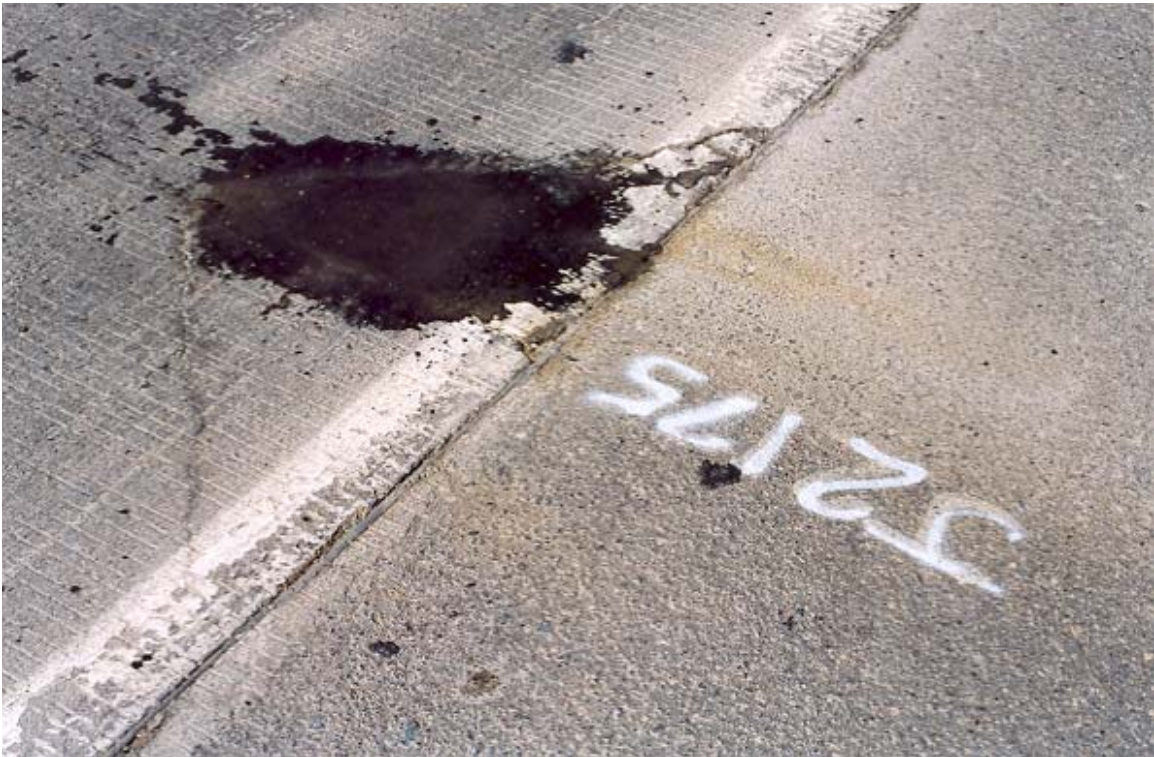
**Cell 95 corner crack forming into “pothole”.**

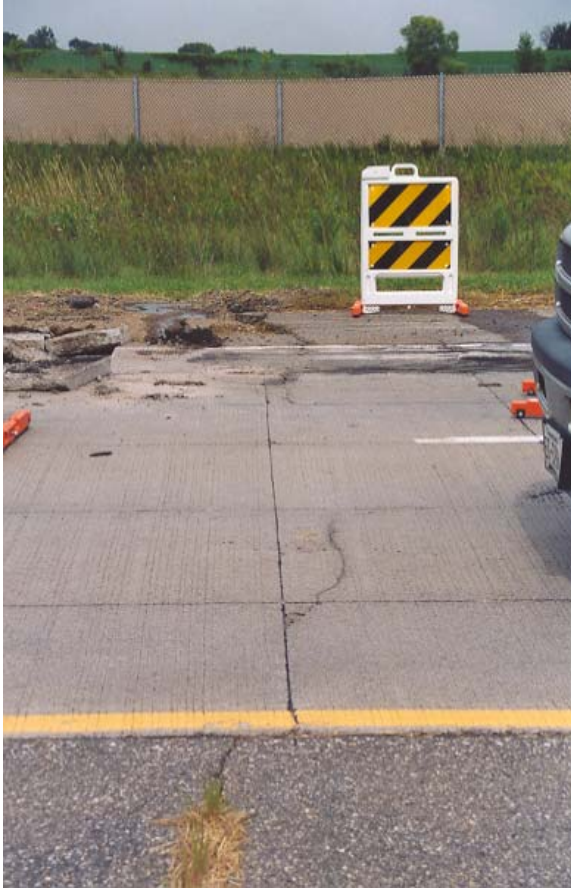
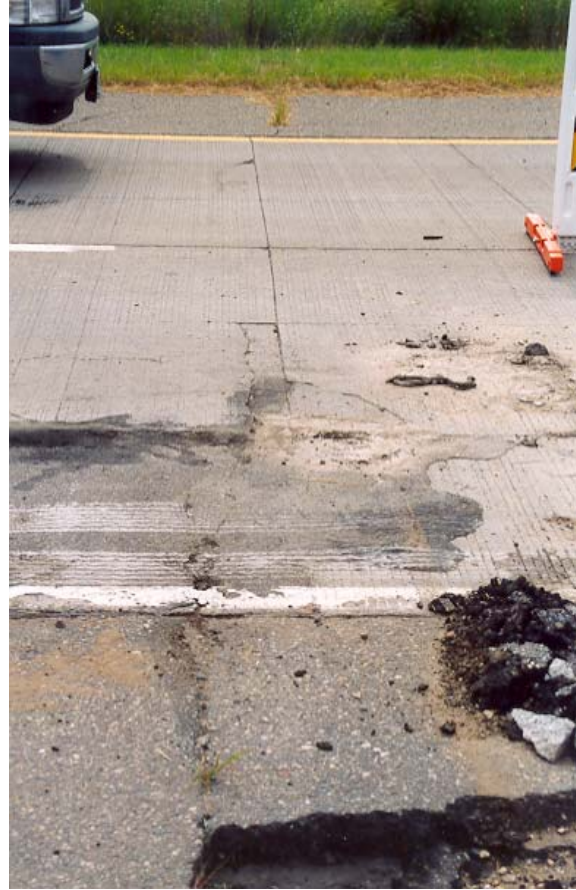
**Cell 93 reflective cracking. Facing north (left photo) and south (right photo).**  
8-25-2004/A-5
