2008-47

## Corrosion Protection Performance of Epoxy-Coated Reinforcing Bars

## **Final Report**

**September 2008**

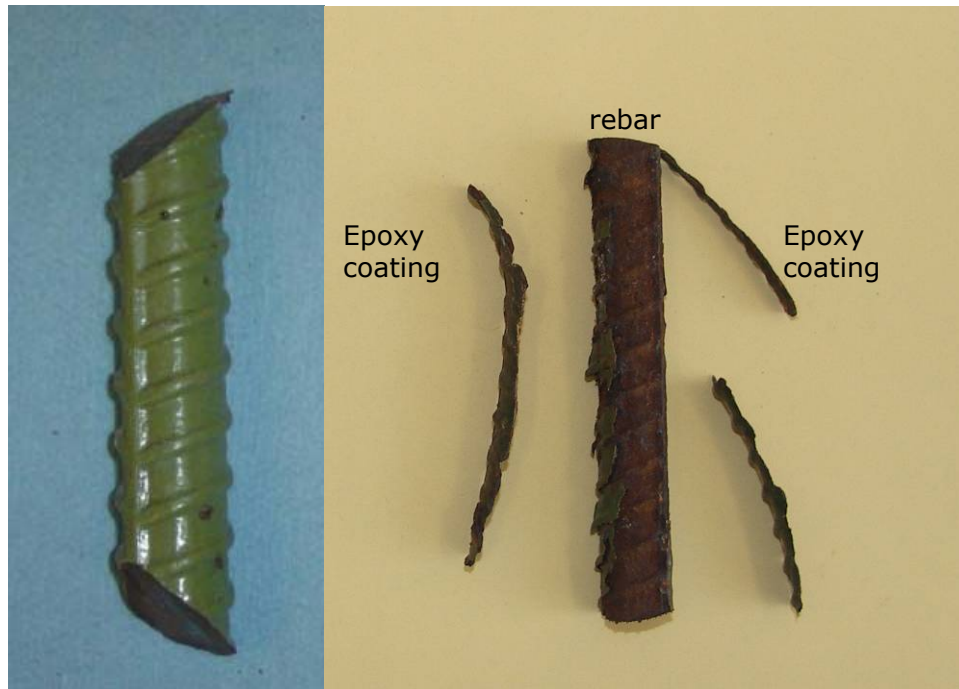
corrosion (right). The bar on the right had severe coating disbondment but it had no section loss. This represents the worst case of all of the bars removed in this study (see Section 8.4.2).

**Figure 2.1** Example of corroded epoxy-coated bars (extracted from bridge 19015 in 2006, core DCS2). The bar on the right has the epoxy coating severely disbonded.

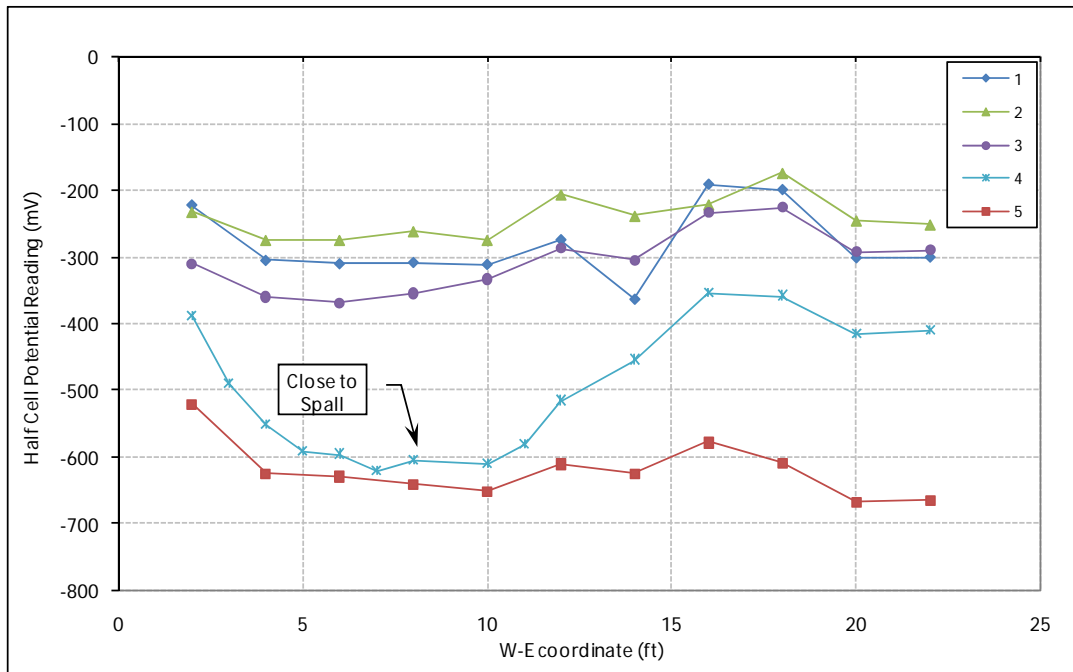
Figure 6.5 shows plots of the voltage readings along transverse grid lines 1, 2, 3, 4 and 5. Lines 1, 2 and 3 showed uniform readings around the -300mV. Lines 4 and 5 show lower half-cell potential readings because of their proximity to the joint over Pier No. 2. In particular, line 4 shows two clear levels among the readings; one around -600mV right on the joint over Pier No. 2 (between 3 and 12 ft in W-E coordinate) and other around -400mV farther that joint (between 12 and 22 ft in W-E coordinate). These measurements confirm the effect of the joint in the half-cell readings.

**Figure 6.5** Half-cell potential readings along grid line 1 to 5 in bridge 19015.

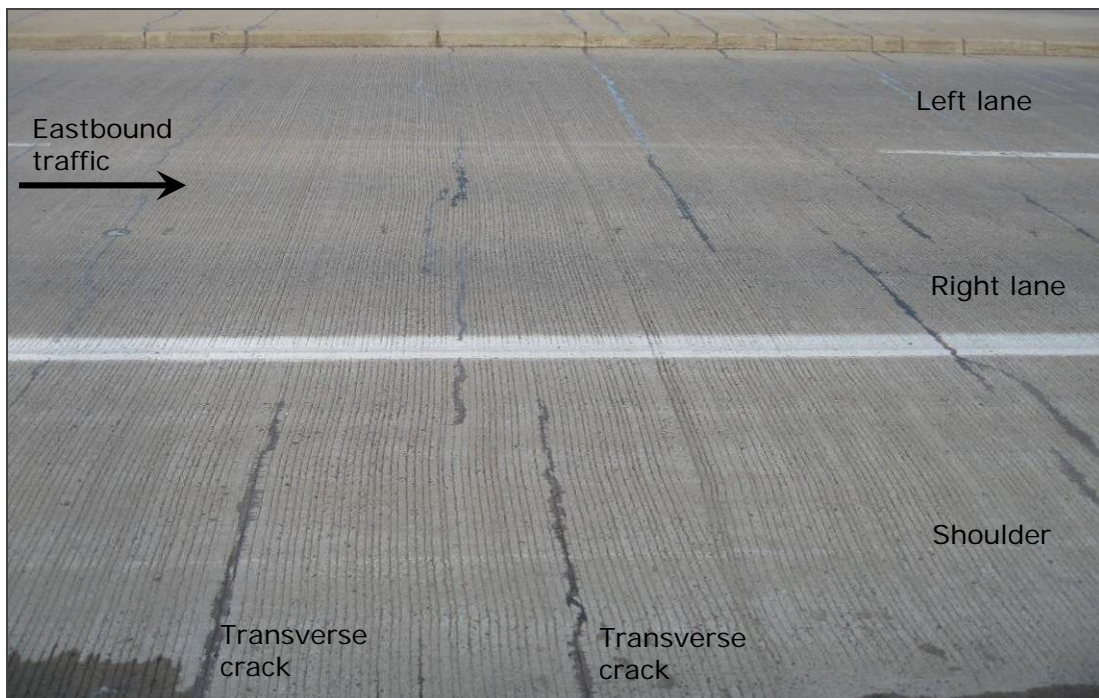
Visual inspection was performed in the shoulder and both eastbound lanes (lane 1 and lane 2). The deck had extensive cracking mainly along the transverse direction as shown in Figure 6.16. These cracks were sealed in the summer 2006, and as a result, it was not possible to measure any of the crack widths. The total crack length in the area inspected was 1134 ft, corresponding to a frequency of 0.129 ft/ft<sup>2</sup>. The deck also had a number of spalled and delaminated regions that had been already patched, mostly in the westbound lanes. There is also evidence of rebar corrosion at the bottom of the deck as shown in Figure 6.17. This corrosion evidence was observed in transverse cracks that coincide with the top of the deck. Figure 6.18 shows the crack layout of the entire bridge 27062 deck.

**Figure 6.16** Detailed view of transverse cracking on the deck of bridge 27062.

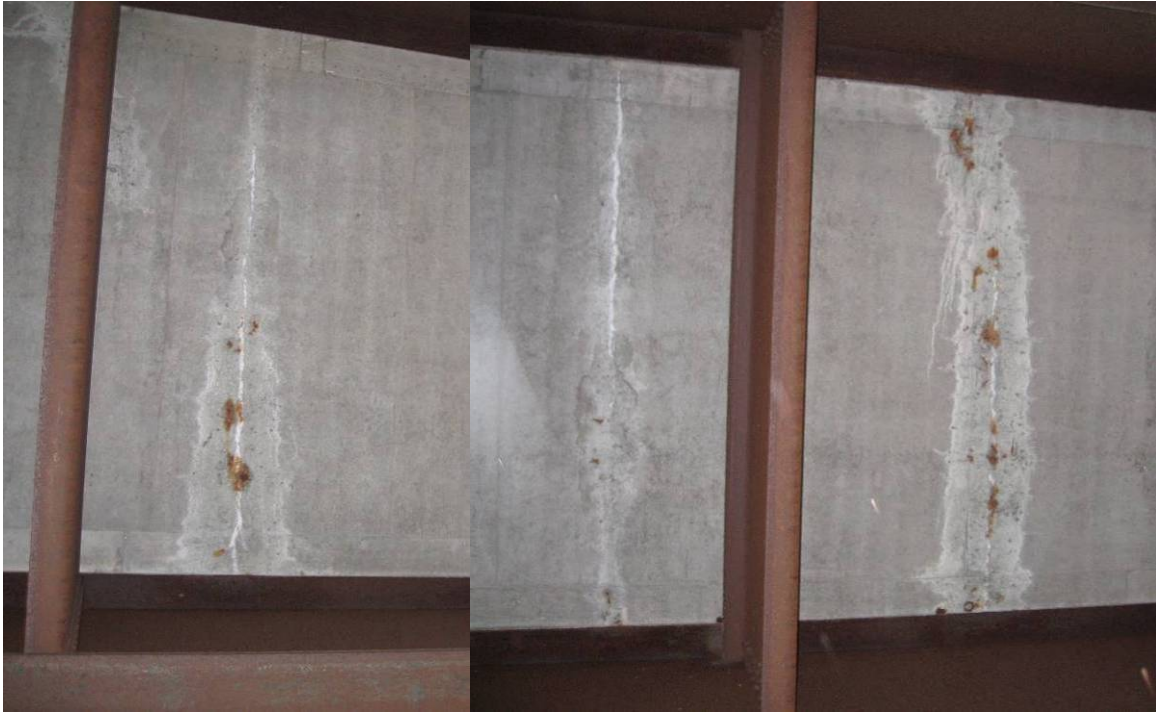
**Figure 6.17** Evidence of efflorescence and rust staining on the underside of the deck of bridge 27062.

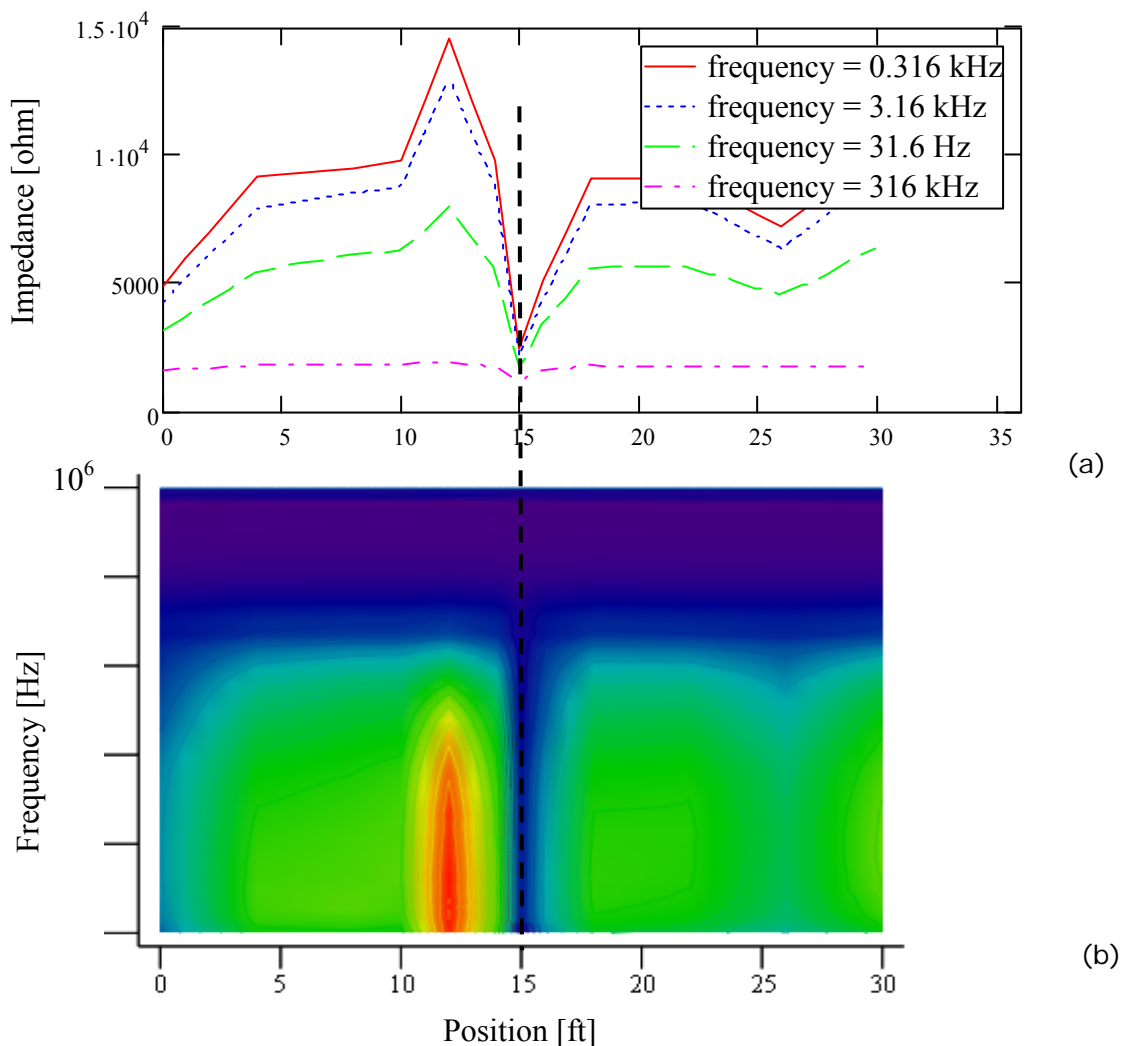
Figure 6.26 summarizes the electrical impedance along survey line C. The dashed line shows a sudden drop in impedance measurement coincides with the presence of a large concrete patch in the bridge deck (coordinate x=137 ft, y=12 ft in Figure 6.19). The response in the half-cell potential readings indicates active corrosion, while the low impedance measurement seems to indicate poor epoxy-coating protection in the reinforcing rebars.

**Figure 6.26** Electrical impedance spectroscopy along longitudinal line C, bridge 27062. (a) Impedance magnitude at four frequencies and (b) Contour plot of impedance amplitude versus frequency and measurement position along the survey line.

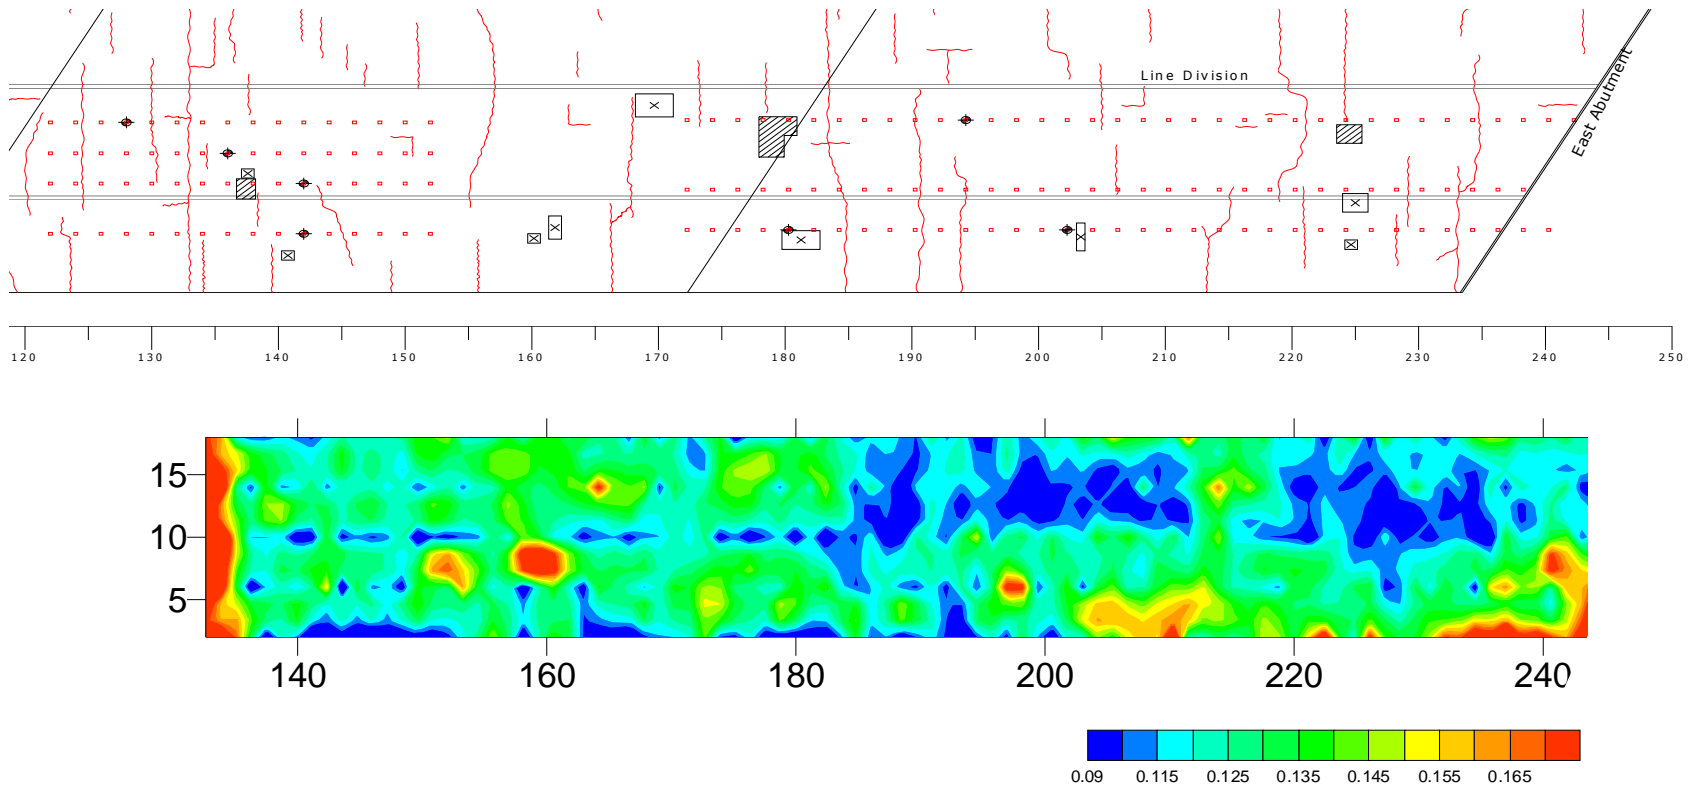
**Figure 6.28** Bridge 27062 (a) Mapping of crack, patches and delamination areas and (b) Calculated velocity contours (m/ns).

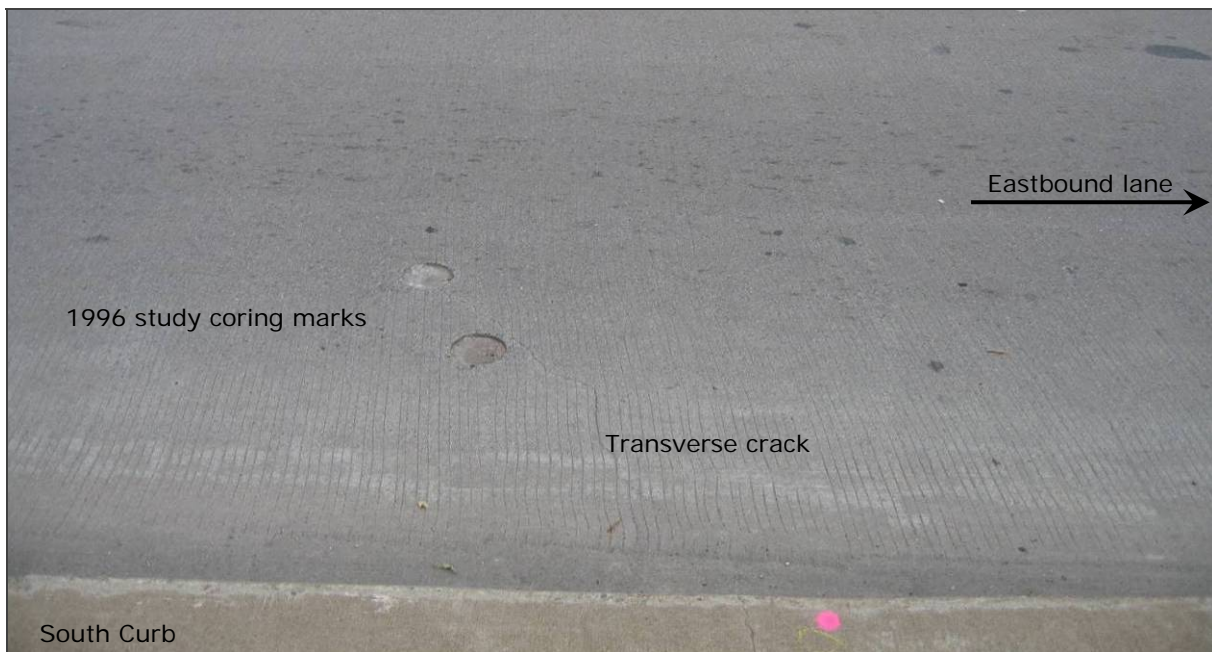
Visual inspection was performed only in the eastbound lane (lane 1). The deck showed minor longitudinal and transverse cracking as shown in Figure 6.31 and Figure 6.33. The total crack length in the area inspected was 263 ft, corresponding to a frequency of 0.038 ft/ft<sup>2</sup>. Crack widths ranged from 0.008 in. (0.2 mm) near the east abutment, to 0.080 in. (2.0 mm) in the longitudinal direction next to the delaminated area in the west abutment. There was also evidence of some efflorescence and light rust staining from the black bars of the bottom reinforcing mat. This efflorescence evidence was observed in a small area on the underside of the deck as shown in Figure 6.32.

*Figure 6.31 Detailed view of transversal cracking on the deck of bridge 27812.*

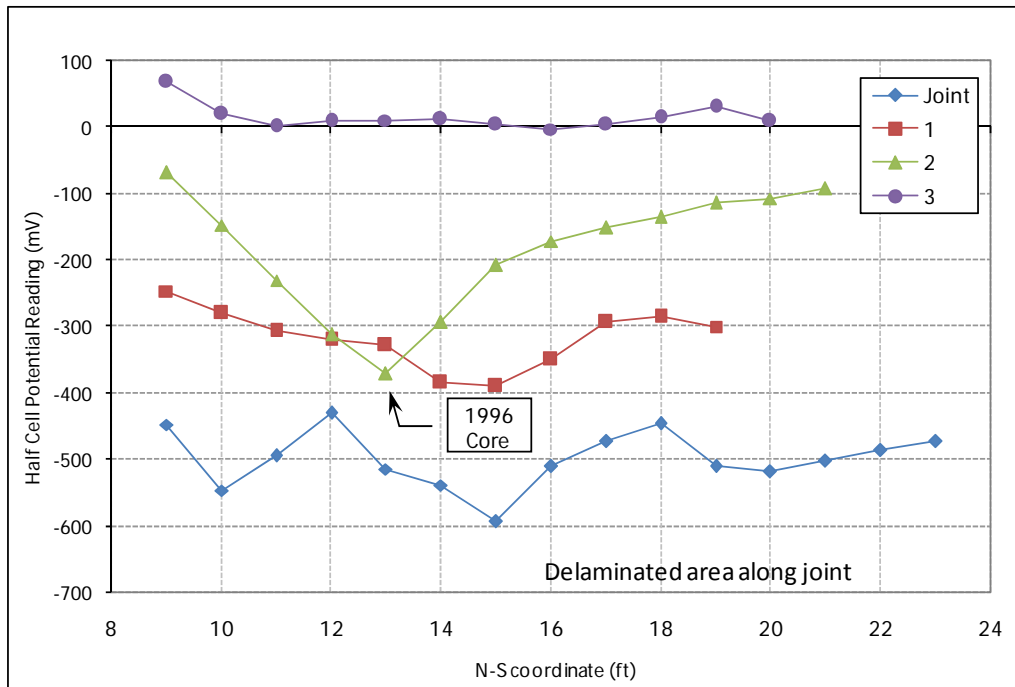
In the transverse direction, the readings along the joint gridline are all below -400mV, which suggest that corrosion activity is concentrated next to the west abutment joint where there is also a delaminated area. Line 3 showed particular higher readings, zero or positive potential, which may indicate a good electrical continuity in that section of the top mat. Survey line 2, which is located following a transverse crack, shows a relative low reading close to an old core sample extracted in 1996 during WJE study.

**Figure 6.37** Half-cell potential readings along grid lines Joint, 1, 2 and 3 in bridge 27812.

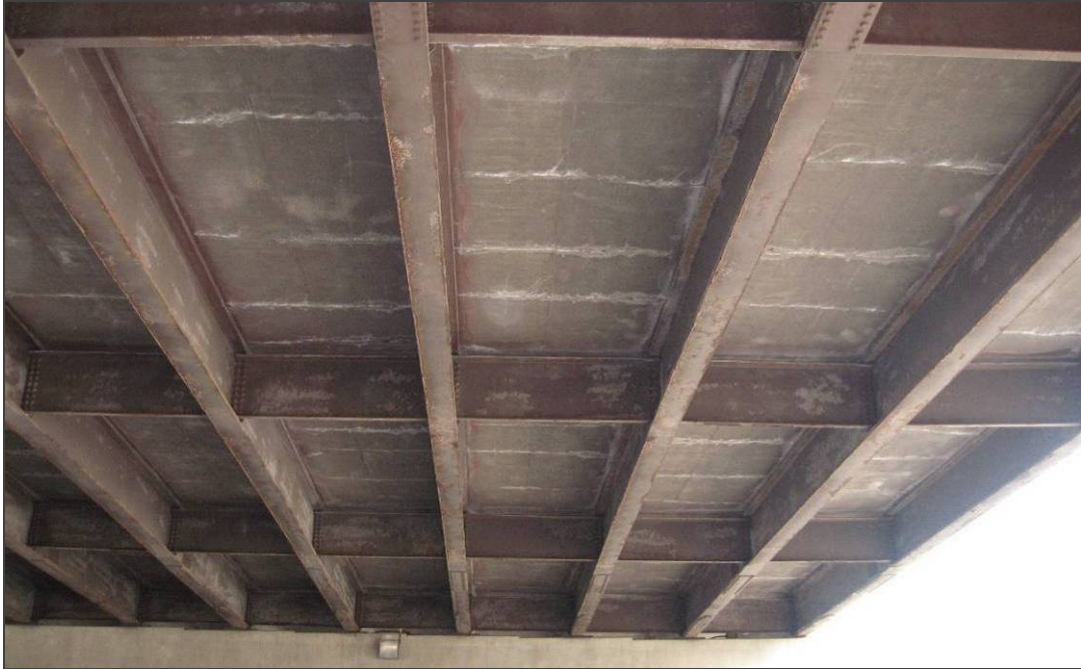
**Figure 6.47** Evidence of efflorescence and rust staining on the underside of the deck of bridge 27815.
