# Predicting the Occurrence of Bumps in Overlays

Minnesota  
Department of  
Transportation

**August 2010**

Research Project  
Final Report 2010-31

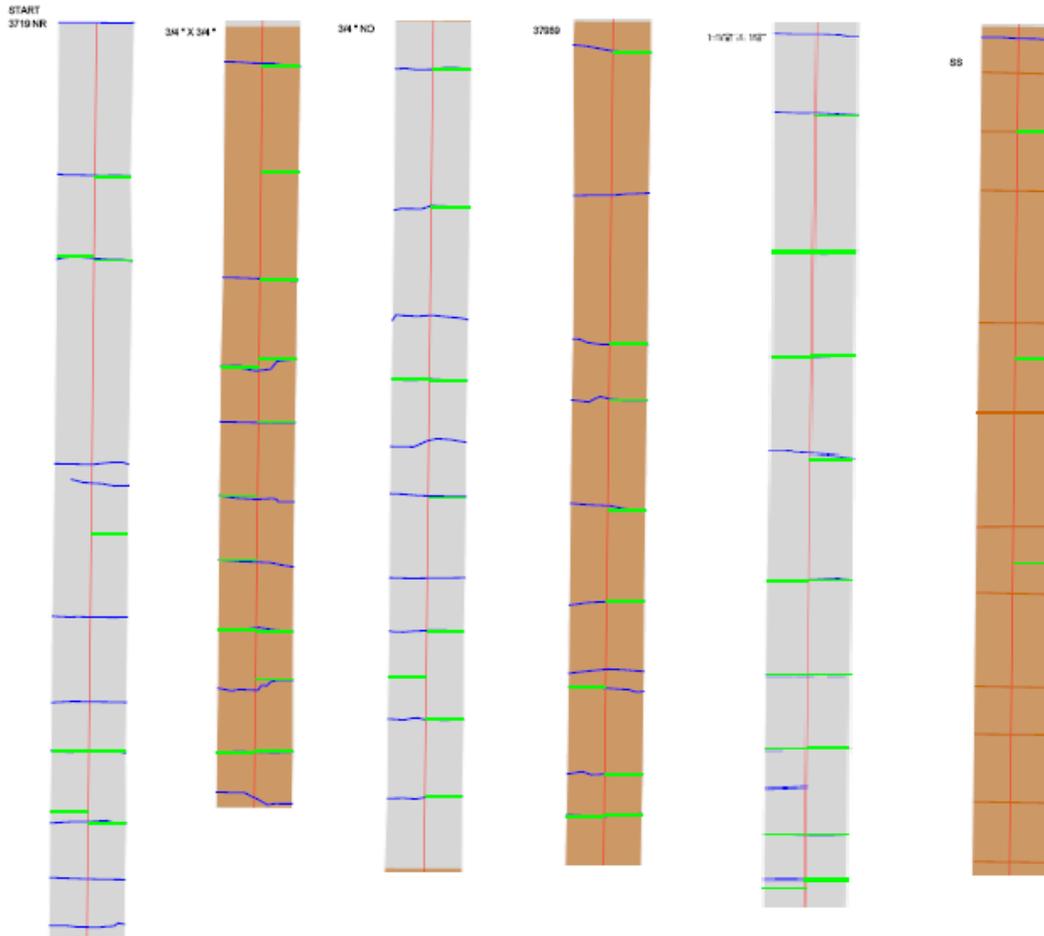
As had been done prior to construction, Jackson County personnel collected GPS data for mapping cracks and bumps on Jackson CSAH 5. Data had been collected before paving to locate each existing crack. After paving, any visible crack location and all bumps were located using the same GPS equipment. Jackson County developed crack maps for the project as shown by the example in Figure 9. The maps show patterns and locations of cracks before the overlay, and locations of cracks after overlay, arranged by sealant and installation types. In the sample below, the meandering lines are the original crack locations, and the straight lines that often only extend from the edge to the center of the roadway indicate the bumps that formed during overlay construction. In order to avoid repeating the intense labor effort donated by Jackson County, GPS location of the bumps was determined by a point at the edge of the pavement and by extending a line to the centerline of the roadway. In this way, each bump can be associated with an original crack, without attempting to locate the meandering characteristics of the original crack. It is sufficient to know that a bump developed at that crack location.

Figure 9. Sample of Crack and Bump Maps at the Sealant Site.

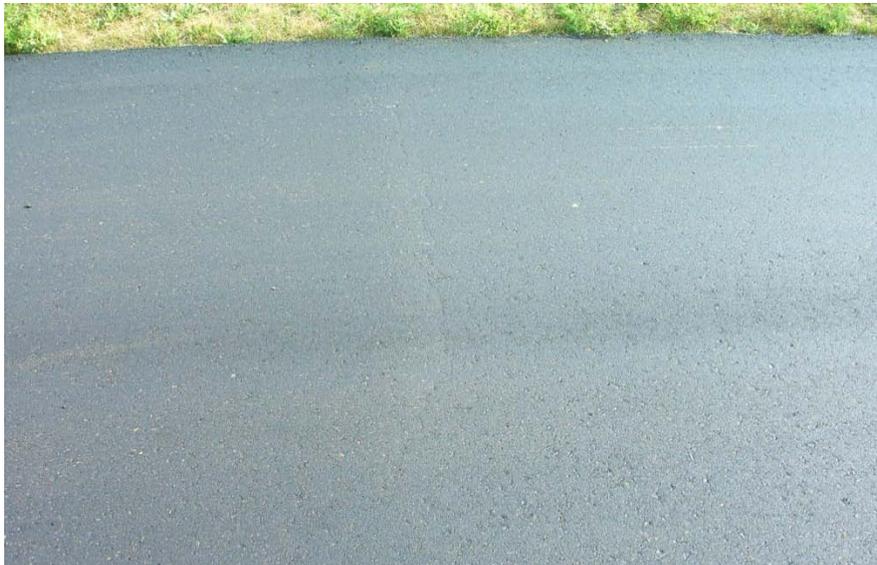
Stakes were set in the south ditch in order to locate the eight cracks observed prior to paving. Figure 11 and Figure 12 are images of bumps in the asphalt mat on the day of construction. The photos were taken after finish rolling was complete. Table 7 lists details of construction observations on CSAH 15 on 2 August 2007.

*Figure 11. Bump Cracked Open over Unleveled Crack, Eastbound CSAH 15.*

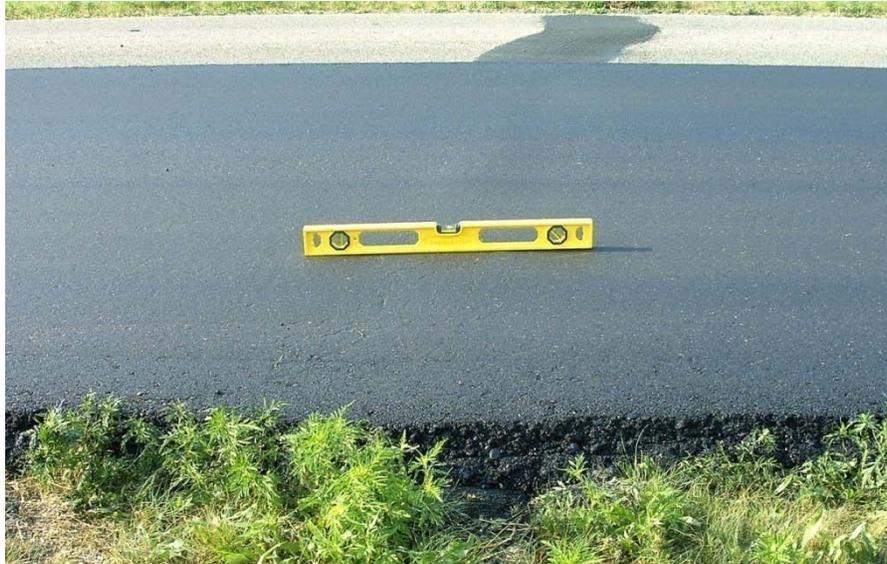
Figure 12. Bump Over Leveled Crack, Eastbound CSAH 15.

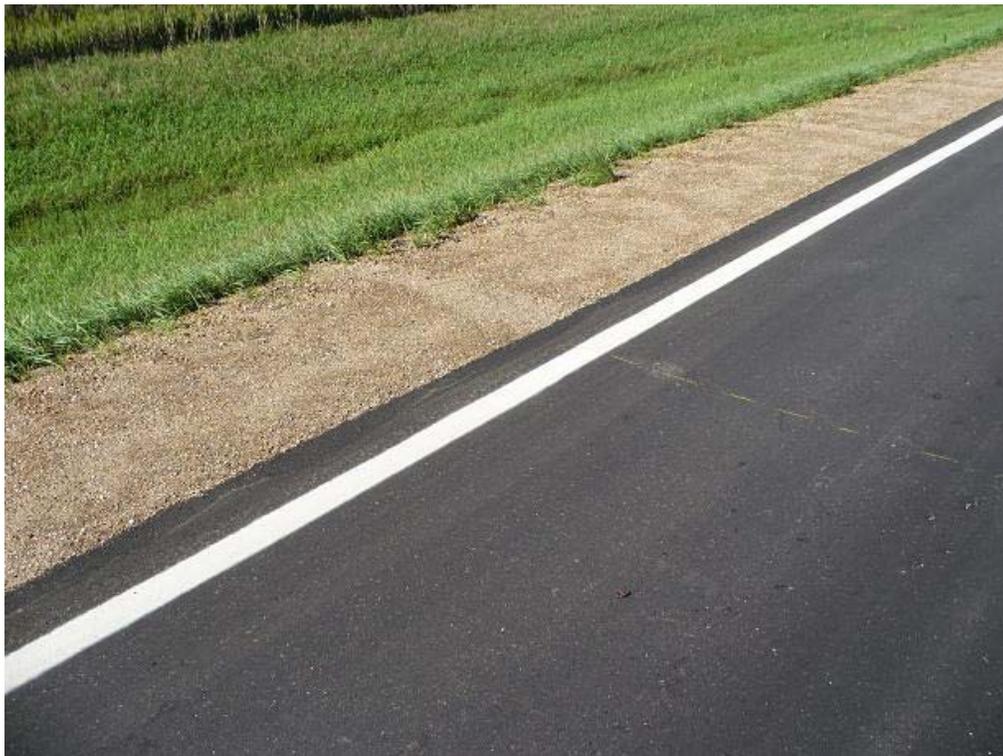
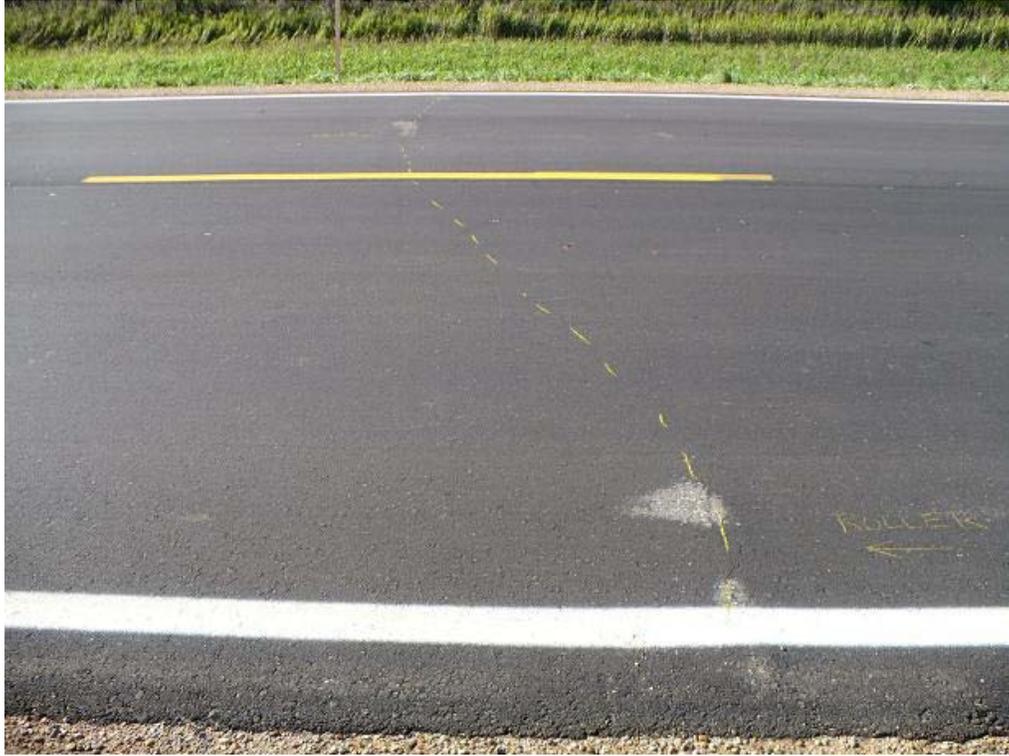
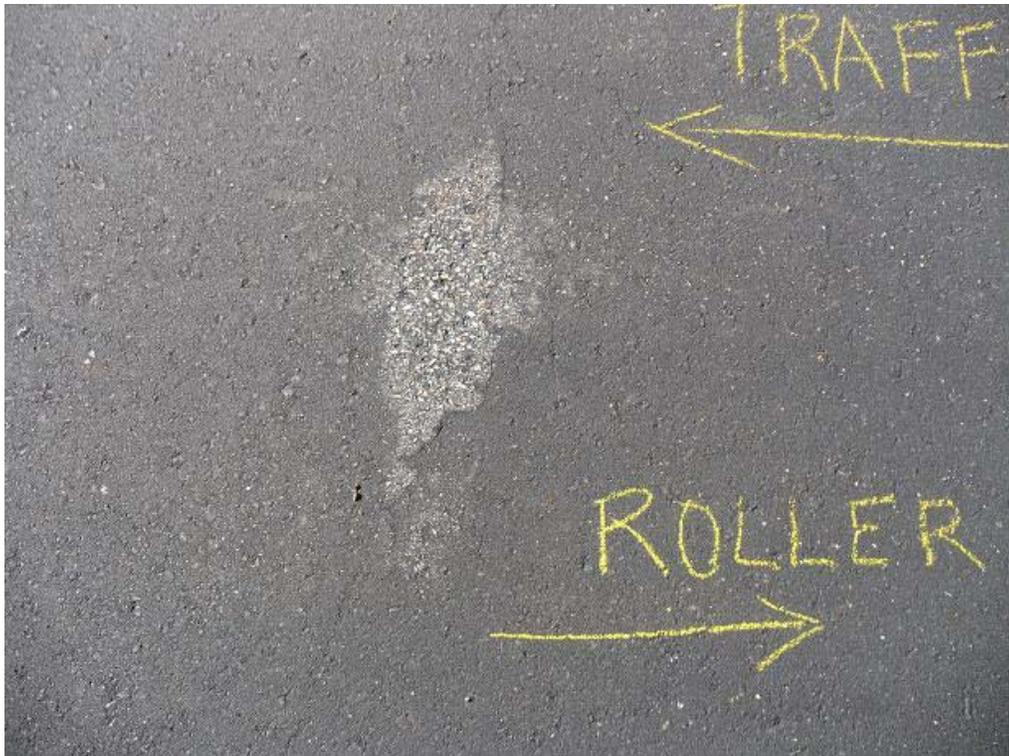
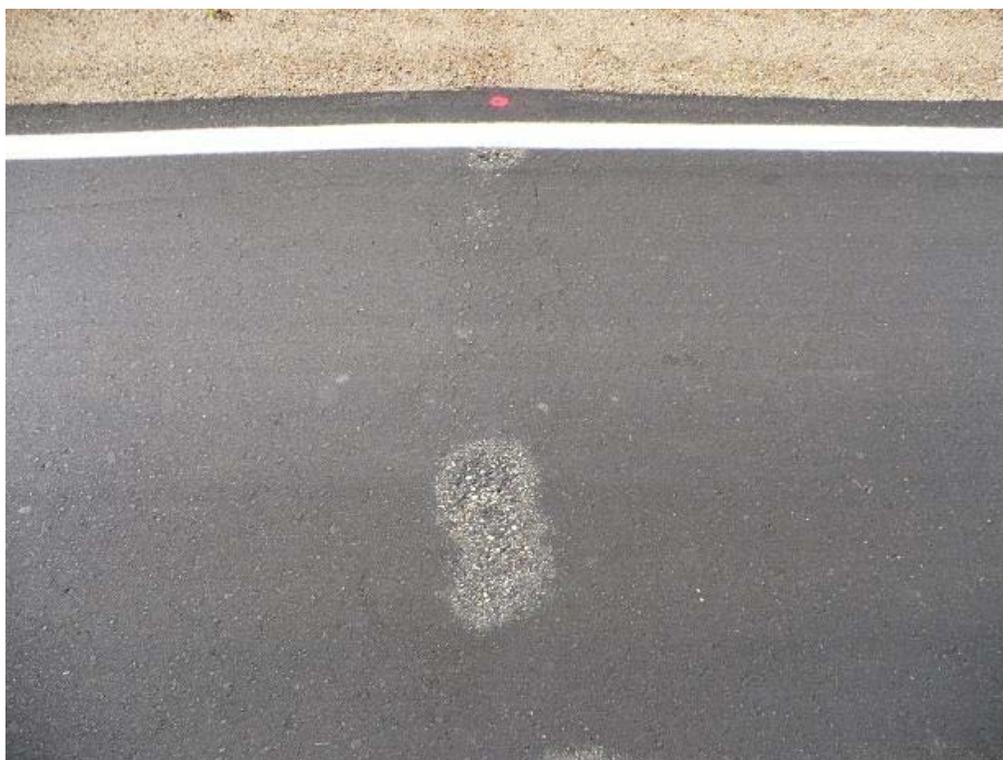
Visual observations of Section 1 showed that segregation of recently placed aggregate shoulder material had routinely occurred near severe bump/dips due to the diversion of rainwater runoff. It was found that scraping of the HMA surface was isolated to bump locations. It is likely that a spreader blade caused the scrapes during placement of aggregate shoulder material. The westbound lane of Section 1 generally had less severe bumps, and the bumps formed in the eastbound lane did not necessarily transfer to the westbound lane. Figure 13 through Figure 16 show the presence of scrape marks and several hairline cracks. Hairline cracks were generally less than 6 feet long. Figure 15 shows how the HMA mixture appears folded over in the direction of rolling at a bump location.

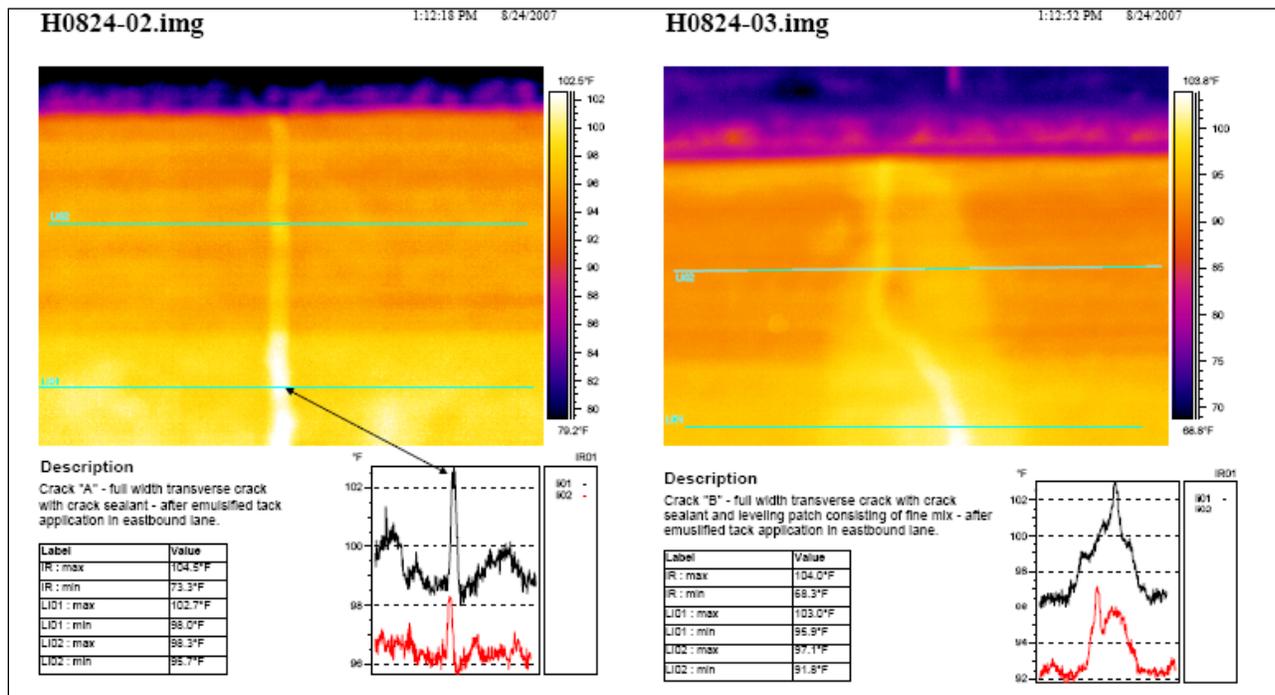
Figure 17 shows the pair of cracks after tack coat application. It was observed that both crack sealant and leveling patch treatments could be detected below the emulsified tack coat, and that the tack coat appeared cooler than the pavement surface. In the thermal signature graphs the presence of sealant material appears as a spike, and the leveling patch is shown by a length of elevated temperatures.

Figure 17. Thermal Signature of Tack-Coated Transverse Cracks on Lincoln CSAH 15.

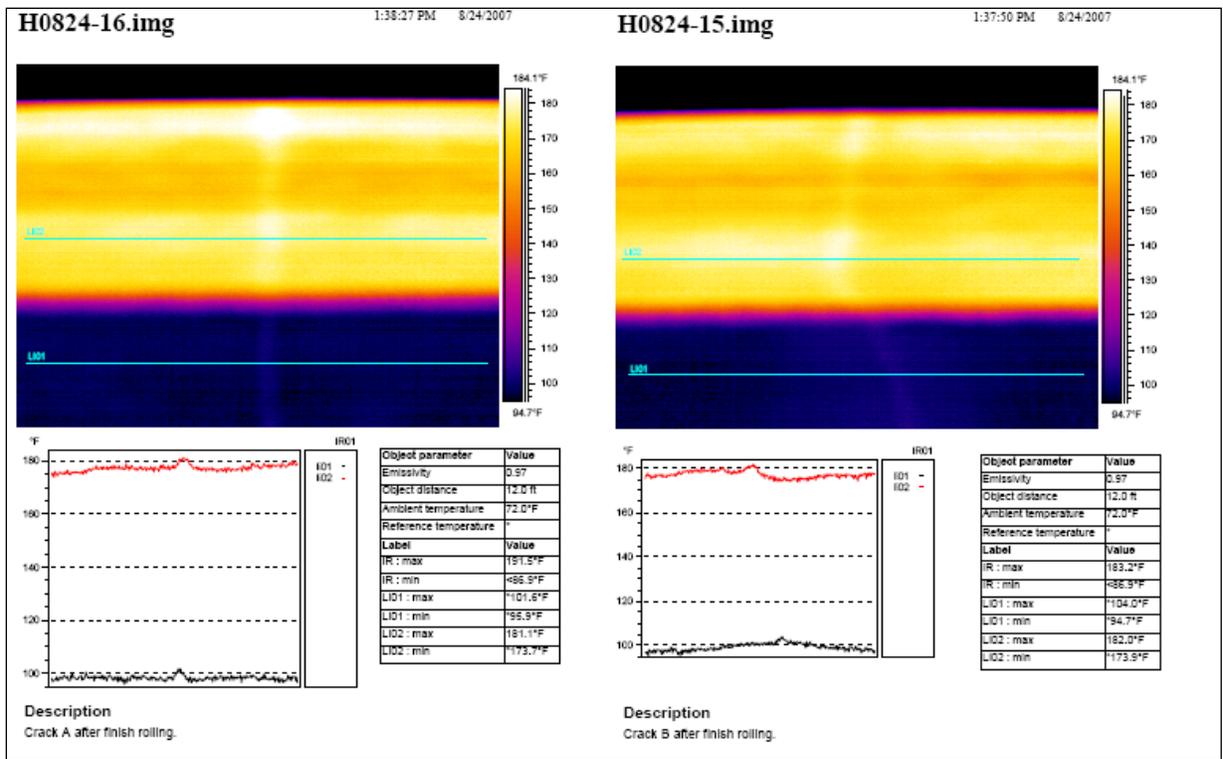
During the time between mat placement and breakdown rolling there was no detectable thermal signature that indicated the presence of a material other than the hot asphalt mat. Conditions were monitored as the mat cooled and rolling continued. At the start of finish rolling (20 minutes after the paver pass) a 2-°F thermal spike was observed in the region of the treated cracks. At this point it was possible to identify the location of the treated crack below the HMA mat. Figure 18 shows the thermal spike increased to 4° F when the final observation was obtained approximately 40 minutes after the paver pass.

Figure 18. Thermal Signature of Transverse Cracks after Finish Roller on Lincoln CSAH 15.

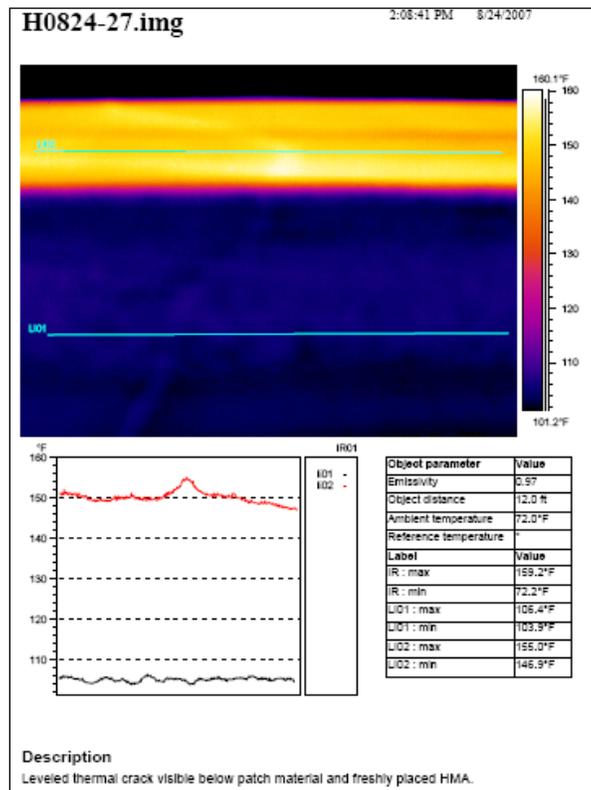
Figure 19. Thermal Signature of Blade-Leveled Treatment and Fresh HMA.

The infrared camera was also used to obtain several images in an area of blade leveling. The leveling work had been performed many days prior to paving, and was generally similar to road temperature. Figure 19 shows that in these areas it is possible to identify the path of transverse cracks below the road-temperature blade-leveled material. Bumps in the overlay did not develop at locations where the thermal camera was used.

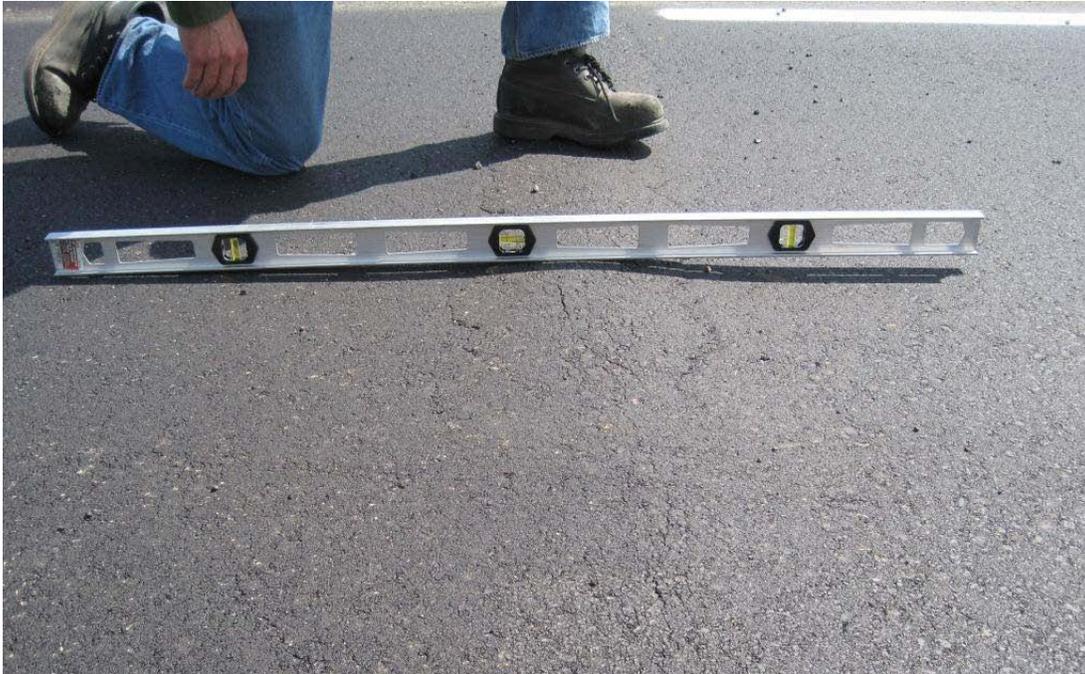
Figure 21 shows the lower lift of HMA and a bump that formed in the lift. The bump was approximately ½-inch tall and contained visible hairline cracking. Such bumps were found often during the initial field visit. Cases of mixture shoving and instability were also located, indicating that compaction equipment had operated while the HMA temperature was in a tender zone.

*Figure 21. Severe Bump in Lower Lift on US 52.*

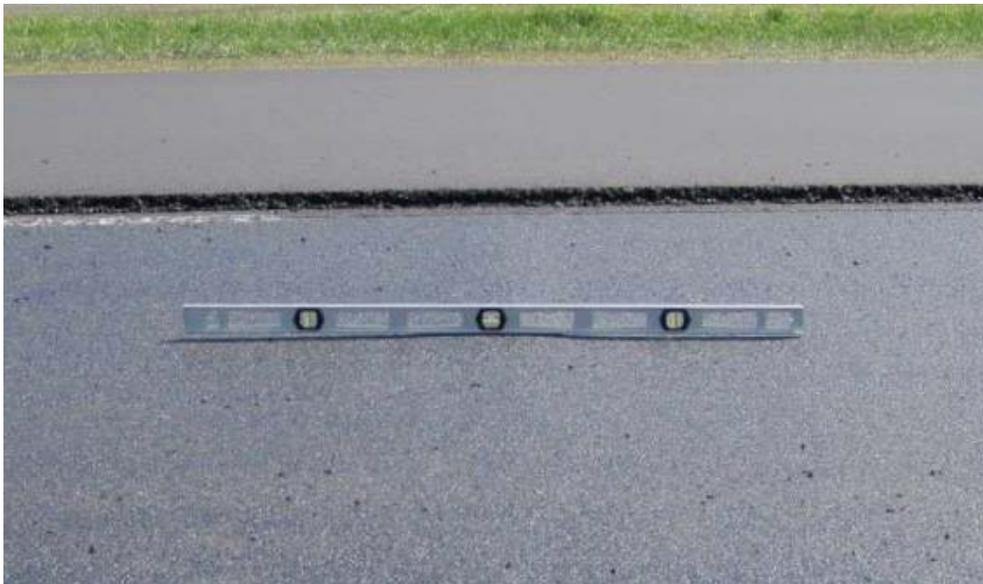
Field evaluations occurred near US 52, mile 119 southbound during paving of the final lift of HMA. Nine locations were selected prior to final lift paving, and were labeled A-I. Six of the locations had bumps in the lower lift that had developed over transverse joints similar to Figure 22.

*Figure 22. Bump Location "A" in Lower Lift of HMA on US 52.*

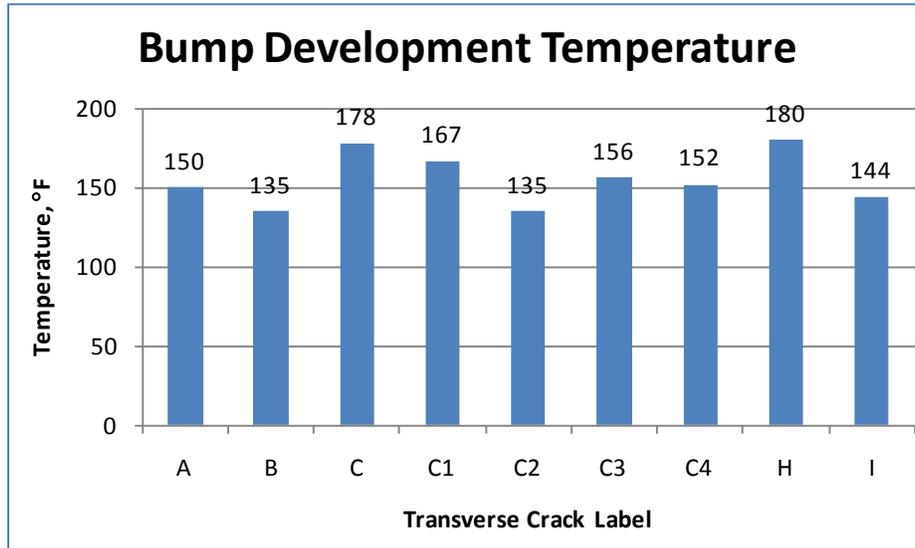
Bumps developed in the final lift in five of six cases. No bumps developed over the shallow dip locations. The bumps labeled C1 through C4 developed after paving over smooth areas in the lower lift. Bumps developed while HMA temperatures were between 180 and 135 °F. Formations generally occurred after vibratory rolling ceased, about 180 °F, and they appeared to increase in size until the temperature was approximately 150 °F. Figure 23 and Table 19 show bump formation temperatures and construction observations.

Figure 23. Bump Formation Temperatures Observed on US 52.

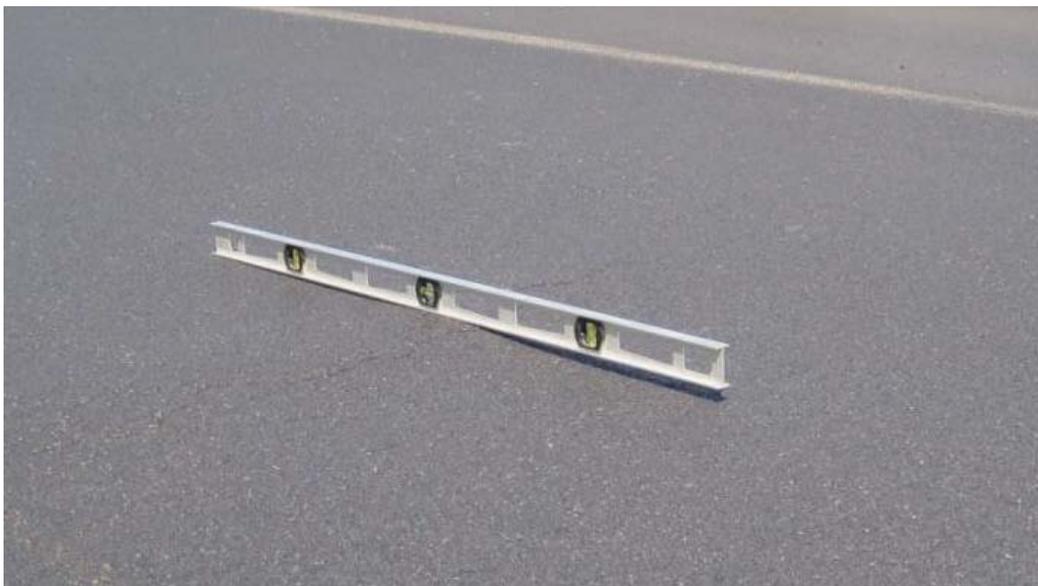
In some cases the bump formations had a folded-over, or shoved appearance that coincided with the motion of the compaction equipment, as seen in Figure 24.

Figure 24. Bump in the Final Lift of HMA on TH 52.

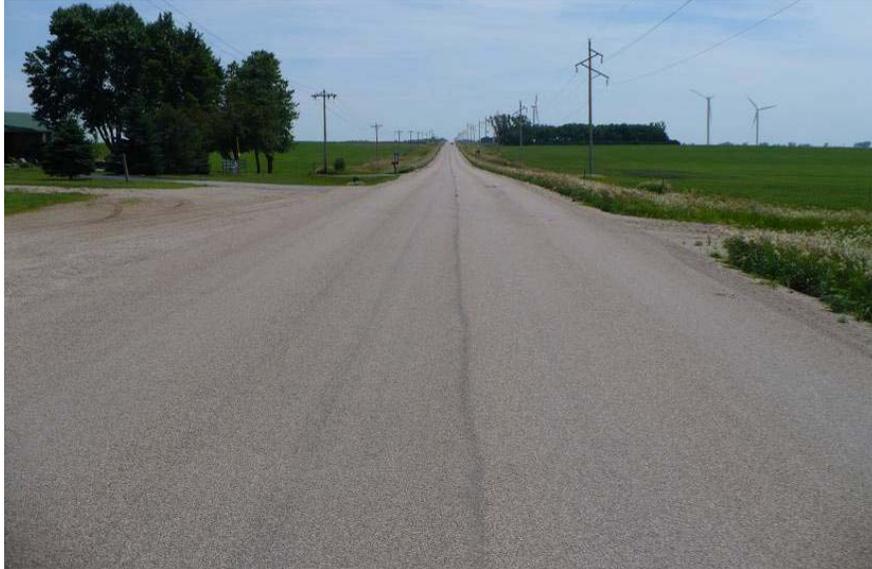
During profile data collection it was also found that a variety of unbound chip thicknesses were encountered throughout the site. When the 2008 profile trace was later evaluated, a number of events were found that were not visible on the 2007 post-overlay trace. These deviations were interpreted as small piles of chip that might occur as a result of transferring aggregate from a dump truck to a chip spreader. This prompted the researchers to perform a follow-up profile evaluation in 2009. Satisfactory conditions were encountered for the 2009 profile collection, and the specific deviations were not observed.

Figure 26. Chip Seal on Sealant Site.
