Unmanned Aerial Vehicle Bridge Inspection Demonstration Project

Minnesota
Department of
Transportation

Barritt Lovelace, Principal Investigator
Collins Engineers, Inc.

Research Project
Final Report 2015-40

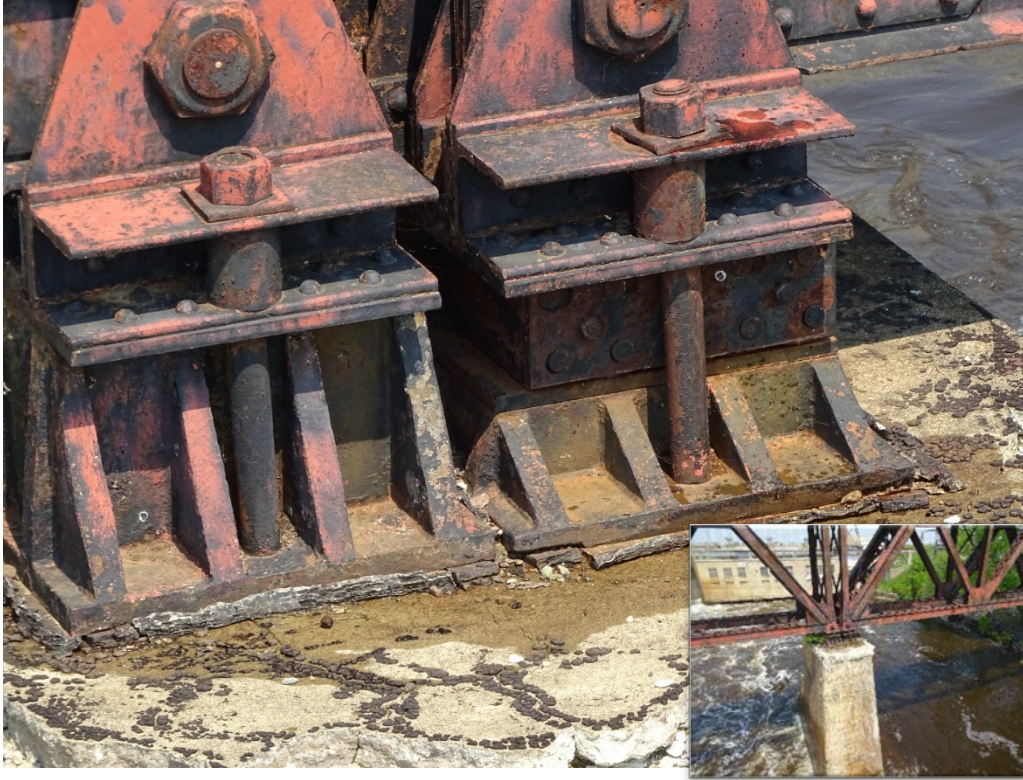
Figure 3-3 Example of the Detail Obtained at a Difficult to Access Bearing Location.

The minimum standards for bridge inspections are defined by the NBIS and are further detailed by the MnDOT Bridge and Structure Inspection Program Manual for bridges in Minnesota. The NBIS defines several different types of inspections including initial, routine, in-depth, fracture critical, damage, special and underwater. The minimum level of detail required varies according to the structure's type, size, design complexity, existing conditions and location. Some bridge elements require a hands-on inspection as specified in the NBIS. A list of these elements is included in the MnDOT Bridge and Structure Inspection Program Manual as part of Section A.5.2 and can be viewed here <http://www.dot.state.mn.us/bridge/inspection.html>. In general, fracture critical members and elements in poor condition require a hands-on inspection which is not possible with the use of a UAV. For members not requiring a hands-on inspection, a UAV can be used as a tool to assist an inspector in gathering better information than would normally be obtained. An example would be the ability to observe the conditions at the bearings or connections that may normally only be observed from some distance much greater than arm's length.

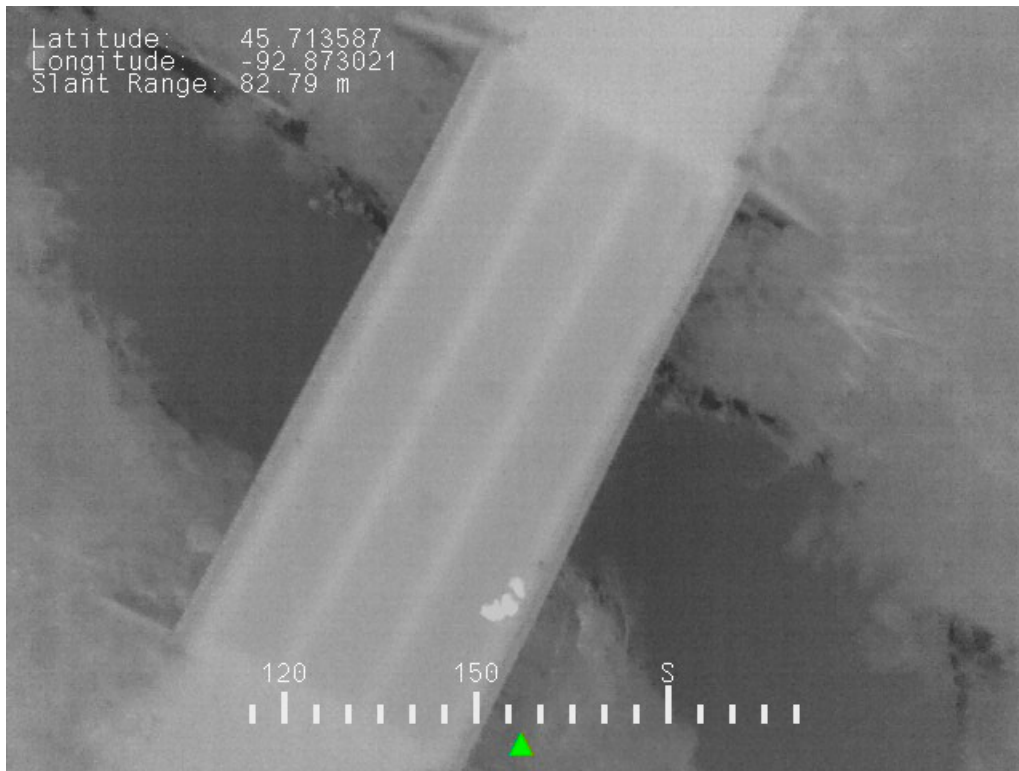
Figure 5-3 Bridge 13509 IR Image of Bridge Deck.

One of the highlights of this investigation was the infrared camera function. The image below shows a still IR image of the deck clearly showing the thermal gradient at the beam locations. While this deck did not have any delamination's that were observed it can be assumed that delamination's could be seen with the IR camera if they were present. The beams are clearly visible in Figure 4.1.3 showing the temperature variations present at the time of inspection. The images could also be dimensionally calibrated to provide repair quantity estimates. Significant research has been performed on the use of IR for evaluating concrete defects, and IR use is an accepted practice in non-destructive evaluation.

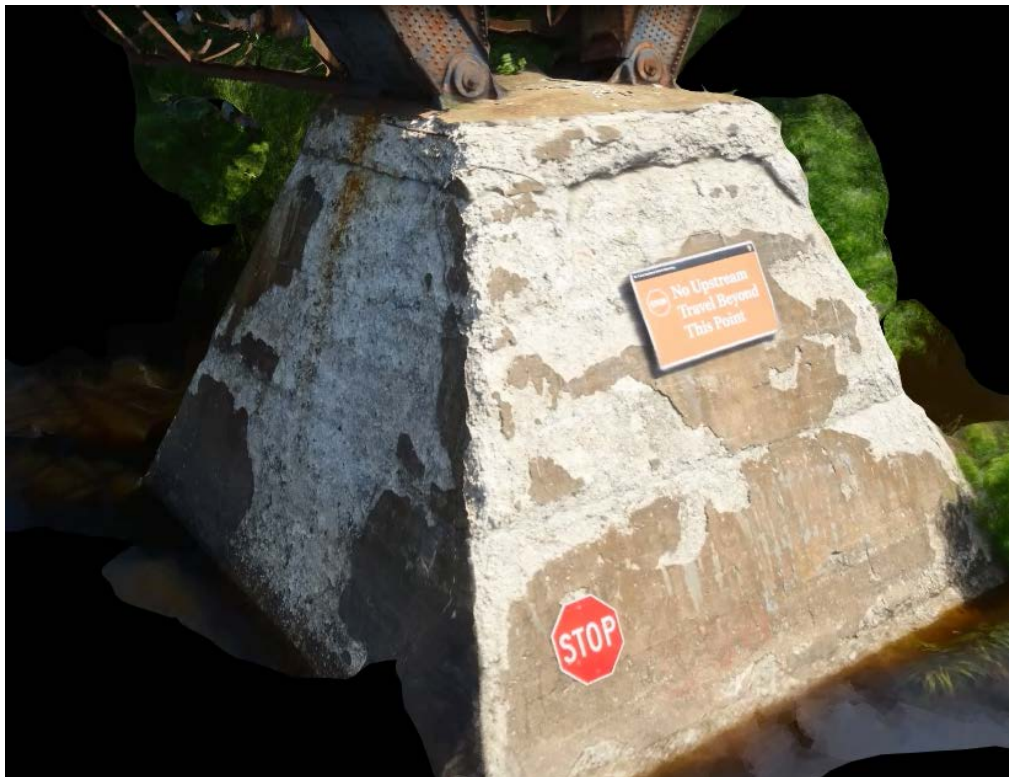
Figure 5-23 3D Orthographic Model of Bridge Foundation.

3D rendering of bridge components was explored using the UAV. Images were taken as the UAV is flown around the bridge foundation. These images are then processed using software to create a 3D model of the foundation. This model is “coordinate correct” and contains a point cloud generated from the photographs and telemetry data. This feature can be enhanced with a variety of additional sensor if deflections or other movement needs to be monitored.

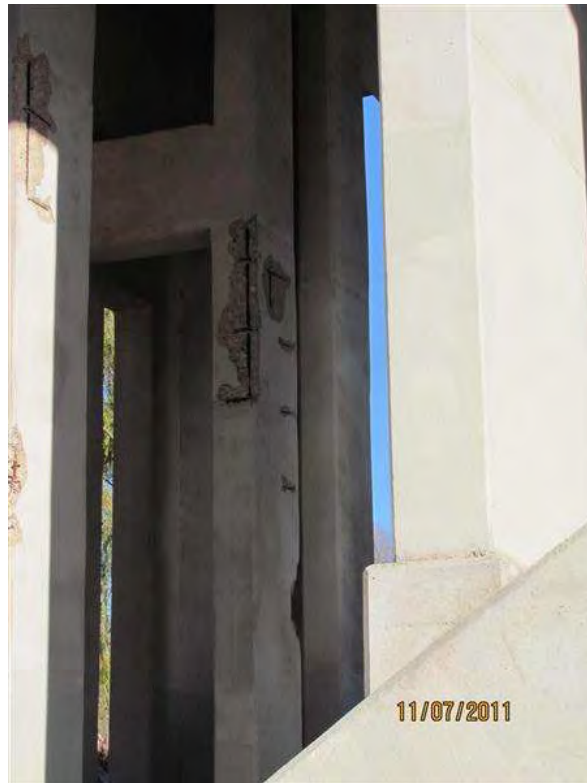
Photo 3 - North Columns spalls

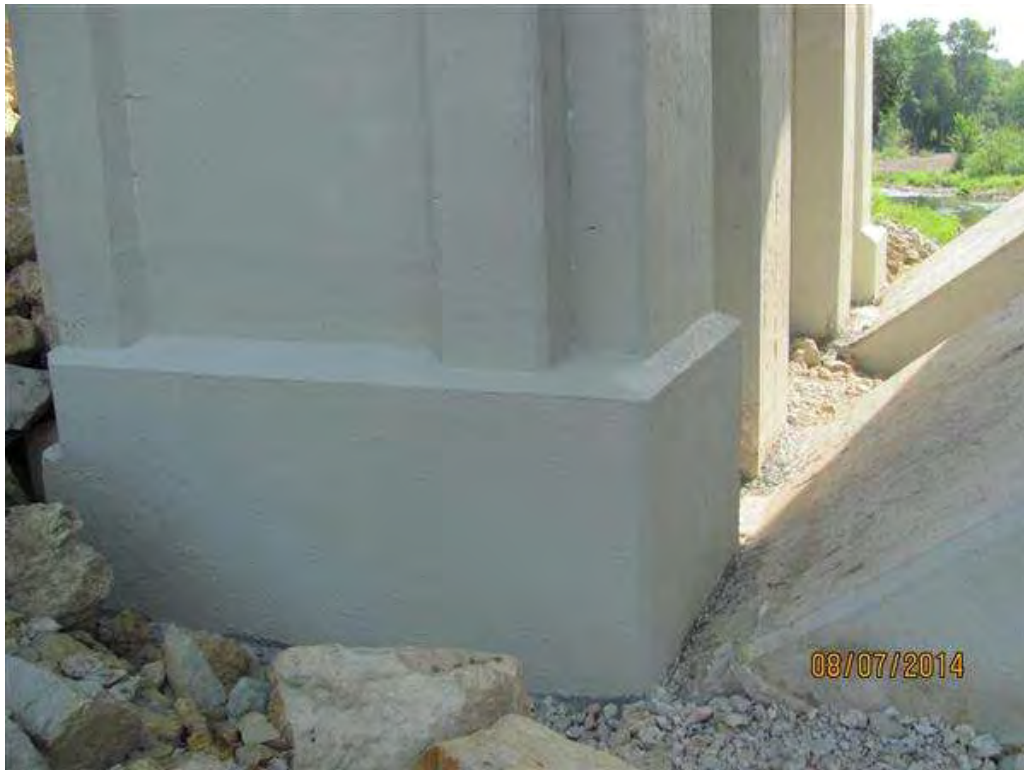
Photo 12 - Repaired Northwest side of Arch ftg.

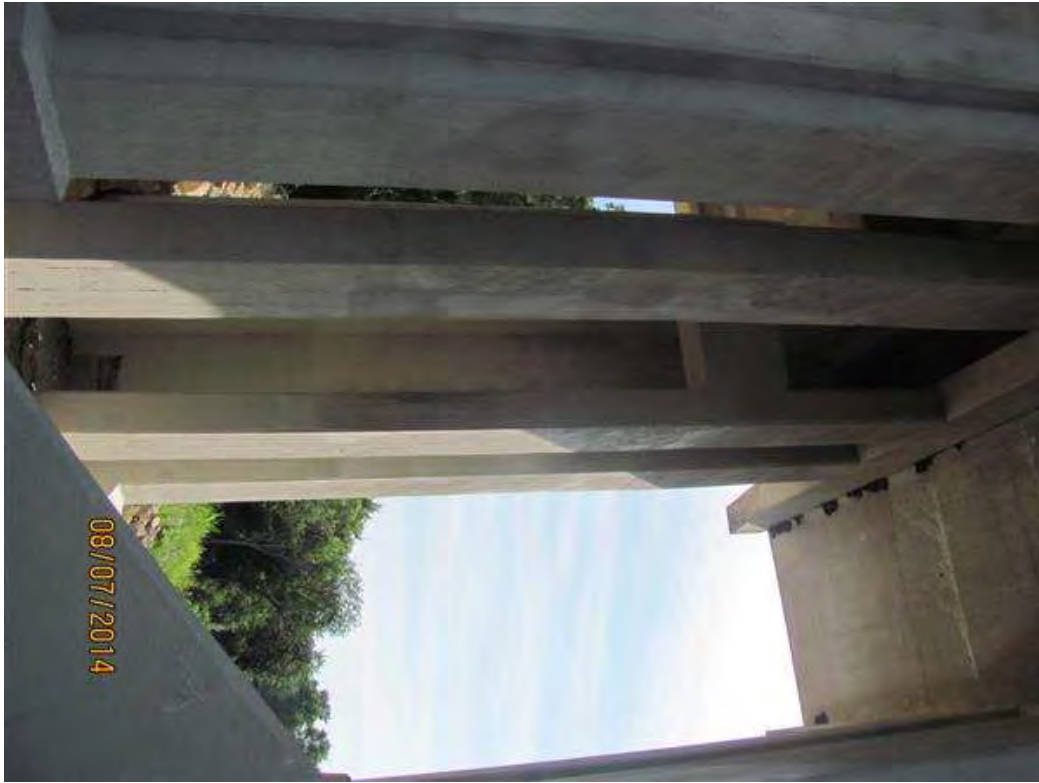
Photo 13 - Repaired columns at NW corner.

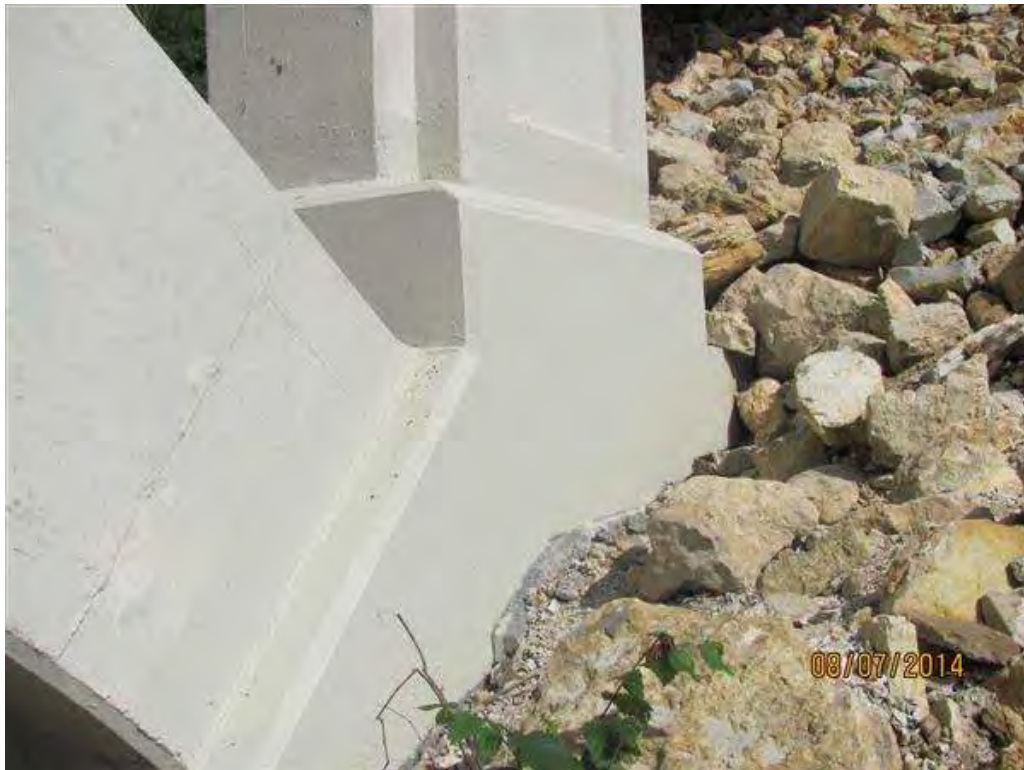
Photo 14 - Repaired Northeast side of the arch.

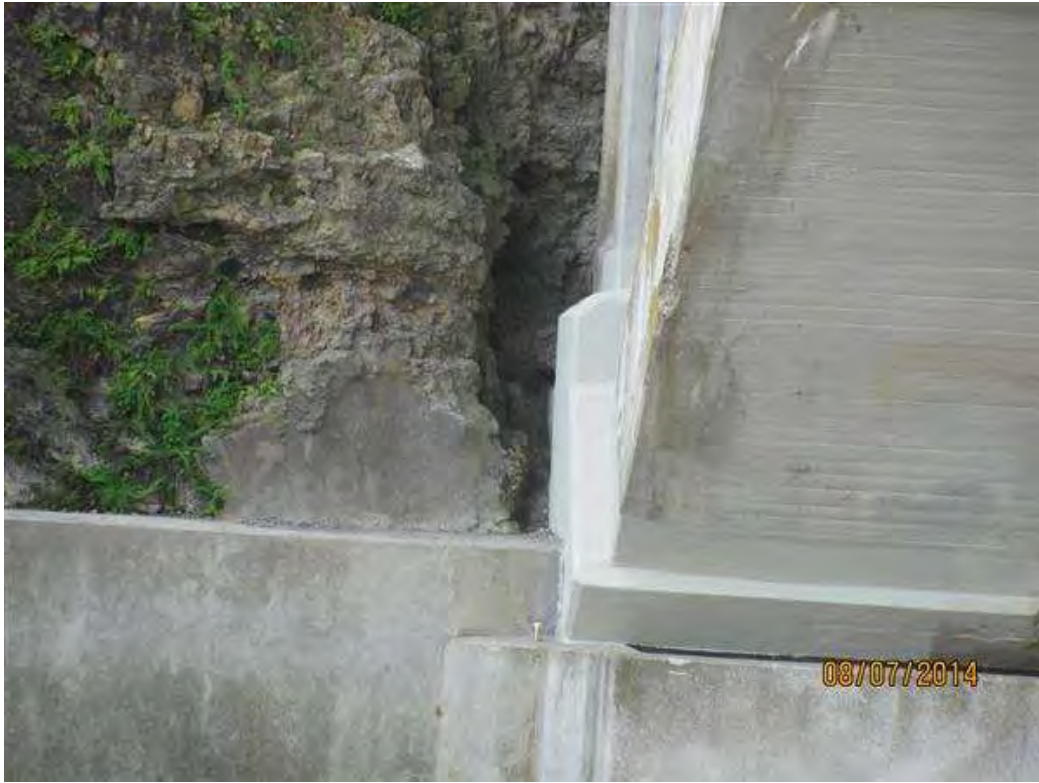
Photo 15 - SE corner of the arch repaired

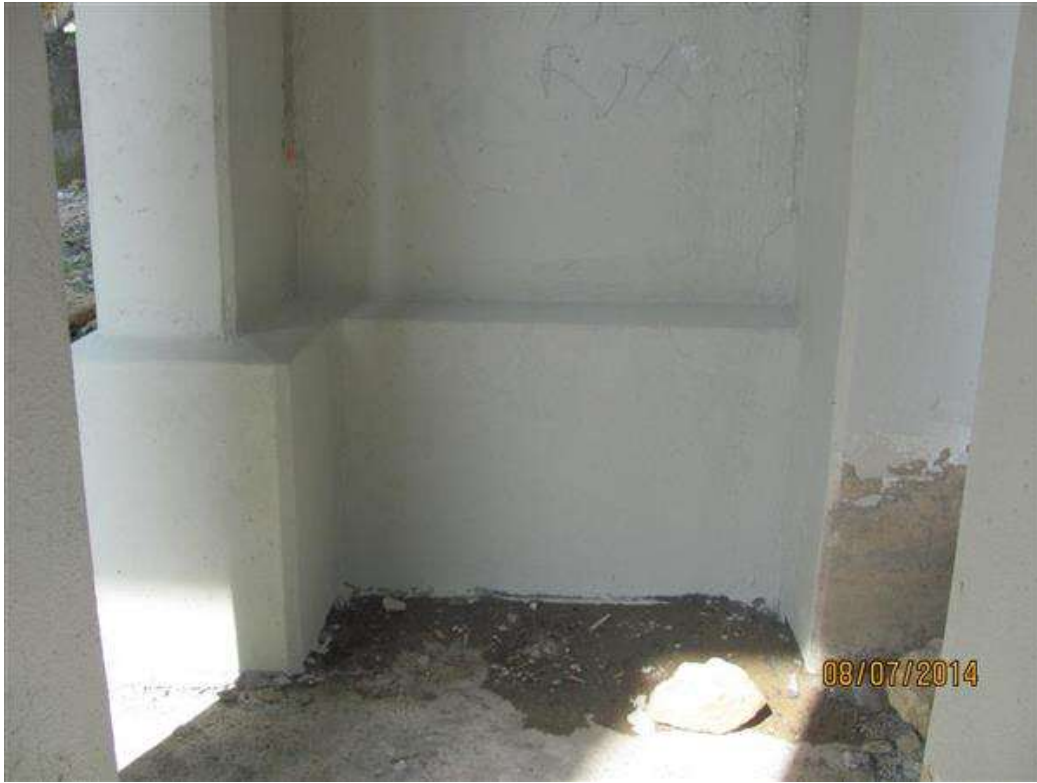
Photo 17 - Column repairs at north base of arch.
