# TECHNICAL SUMMARY

# **Preventing the Occurrence of Bumps in HMA Overlays**

This Technical Summary pertains to the LRRB-produced Report 2010-31, "Predicting the Occurrence of Bumps in Overlays," published August 2010. The full report can be accessed at http://www.lrrb.org/PDF/201031.pdf.

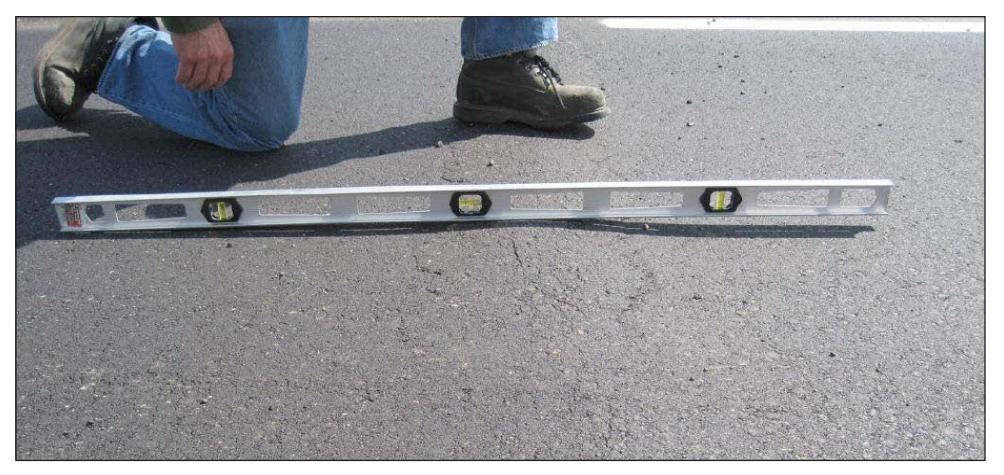
Researchers often found bumps during the first field visit, including this 1/2-inch tall bump with hairline cracking, indicating that compaction equipment had been operated when the HMA temperature was not optimum.

- Rolling when air and pavement temperatures are lower, below 80°F and 125°F, respectively, and possibly slightly delaying rolling operations so that the overlay mat cools while the underlying sealant material heats up.
- Using low-modulus and crumb rubber sealant types, and possibly allowing sealant materials to age at least one year before applying the overlay.
- Routing narrow and shallow crack reservoirs, avoiding sealant overbanding, and possibly leaving sealant material below the pavement surface or removing it before overlay construction.
- The use of pneumatic rollers for breakdown compaction through 200°F followed by a single steel finishing roller.
- The use of nonvibratory breakdown rollers.
