Asphalt Overlay Cost-Effectiveness

Manitoba TGS and Minnesota SPS-5 Projects
10-Year Ranking of Treatments

1. Report No. MN/RC - 2000-31	2.	3. Recipients Accession No.	
4. Title and Subtitle ASPHALT OVERLAY COST-EFFECTIVENESS (Manitoba TGS and Minnesota SPS-5 projects 10-year ranking of treatments)		5. Report Date October 2000

Progress Report

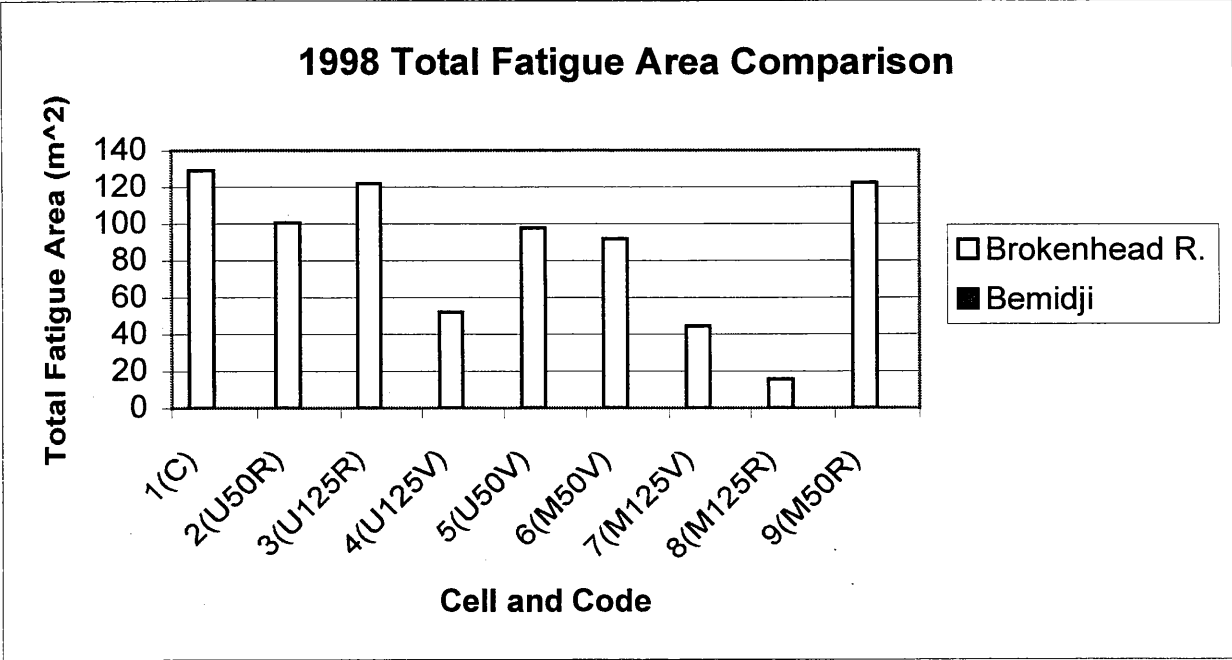
Figure 12 – 1998 Total Fatigue Area Comparison

Surface fatigue area in square metres is plotted as Figure 12. The most noticeable fact is there is no fatigue cracking in evidence on any of the Bemidji cells. The Bemidji site has a much thicker structure and lower traffic that are the probable causes of this difference.

General fatigue cracking trends on the Brokenhead River test site are the 125-mm virgin material overlays with milled surface preparations have less fatigue area than their respective counterparts. The recycled material cells exhibit generally higher fatigue area measurements than the virgin material cells. The additional thickness provided by the 125-mm overlays seems to be limiting fatigue cracking when compared to the 50-mm overlays. The cells with milled surface preparation do not exhibit lower fatigue areas than the unmilled surface cells.

The Brokenhead River test site shows large areas of fatigue cracking while Bemidji shows none. The reason is thought to be caused by the higher traffic (and much higher allowable 62,500 kg GWV of the Canadian B-Trains operating on this site) and the lighter pavement structure. Even with the up to 43-mm more overlay thickness than what was designed for, the Brokenhead River fatigue cracking still is much higher than that at the Bemidji site.

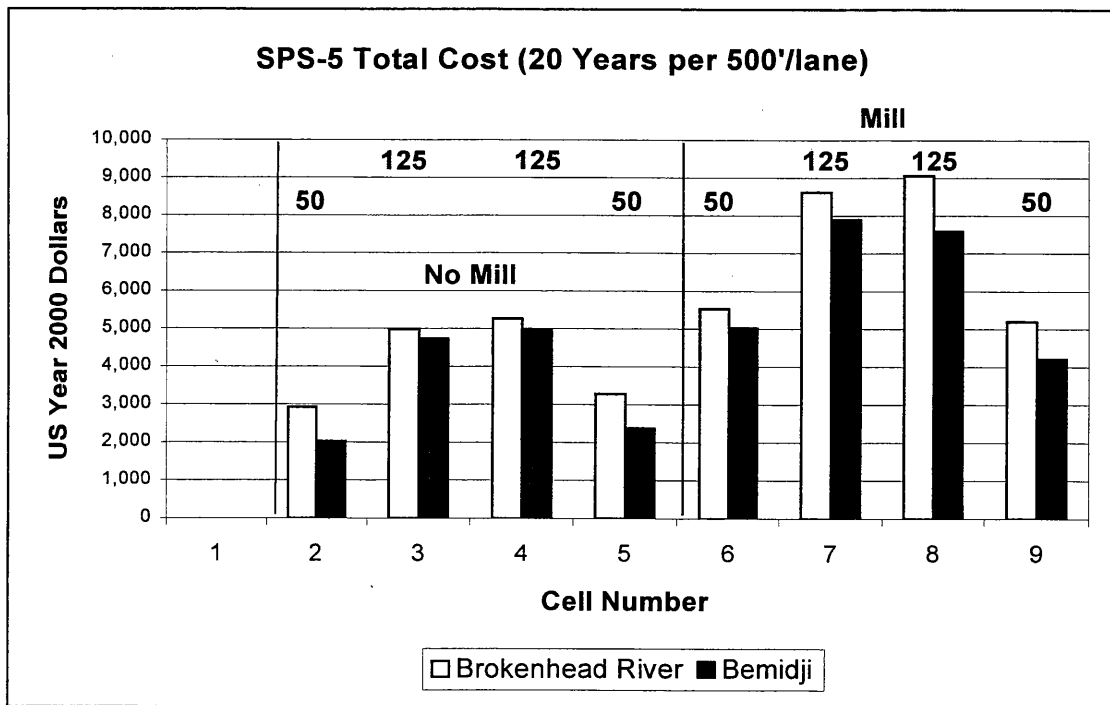
Figure 14 – Total Costs per SPS-5 Treatment

Using the remaining life / distress types along with the estimated maintenance events / costs a total cost for each section is calculated and is summarized in the third part of Tables 15 and 16 as "Cost Summary" for each project. The total 20-year costs are summarized in Figure 14. This shows the most cost-effective SPS-5 treatment consists of a no mill - 50-mm recycled overlay for both Bemidji and Brokenhead River at this time. It also shows that the extra cost to mill a pavement may not be cost-effective for pavements in the poor to fair original condition as these two sites were. The cost comparisons will be confirmed as further reviews are done in the upcoming years.

Based on the pavement section conditions through 1999 all of the rehabilitation procedures are performing well. Therefore, the least cost procedure (50-mm overlay with minimum of surface preparation) would be recommended for a 9 to 10-year service life.
