Safety Effects of Centerline Rumble Strips in Minnesota

SAFETY EFFECTS OF CENTERLINE RUMBLE STRIPS IN MINNESOTA

CAPSTONE PROJECT FOR INFRASTRUCTURE SYSTEMS ENGINEERING PROGRAM

DECEMBER, 2006

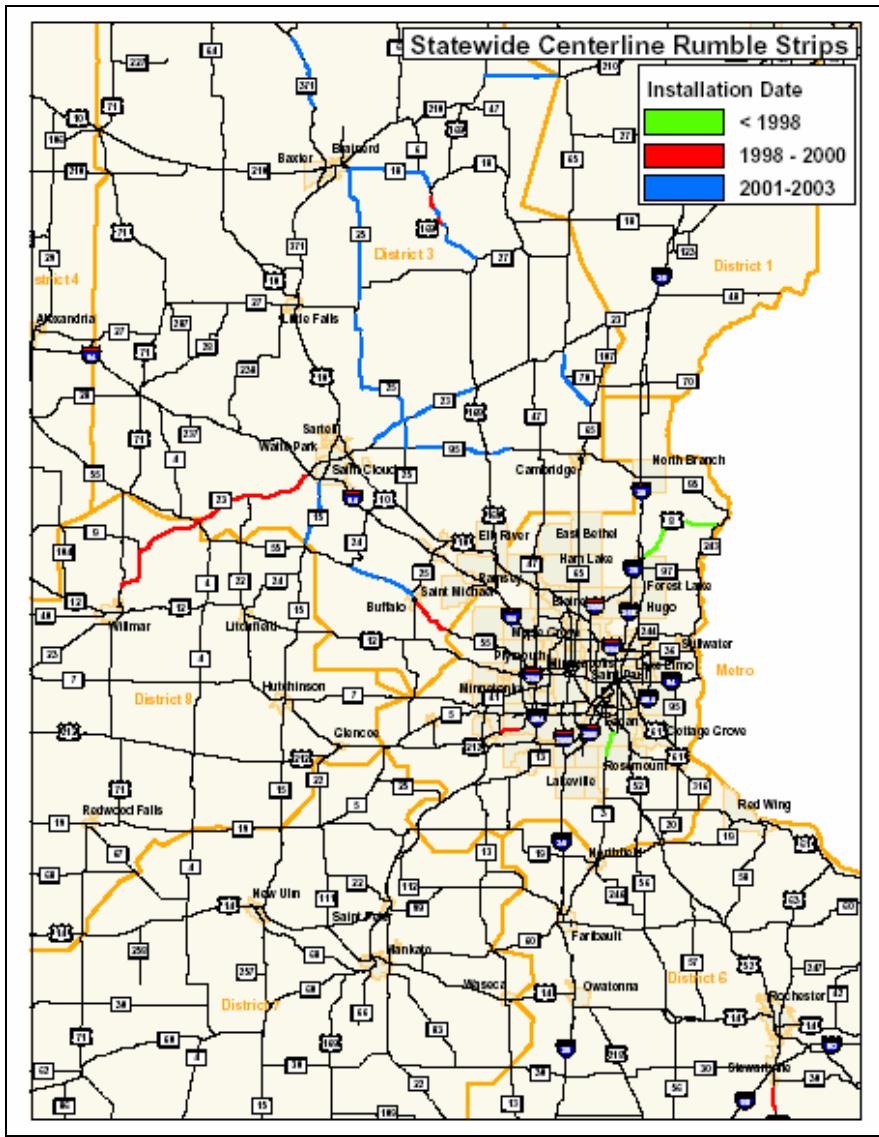
Figure 2-1
Centerline Rumble Strips in Minnesota

As of the fall of 2003, Mn/DOT had installed approximately 270 miles of CLRS in the state, all of which on state trunk highways. There are no CLRS installed on county highways to the knowledge of the author. The majority of these are located in Mn/DOT's District 3, including the St. Cloud and Brainerd areas. District 3 accounts for approximately three quarters of the CLRS in the state. Table 2-1 shows the locations of CLRS in Minnesota and the data installed. Figure 2-1 displays these locations. Note that since fall of 2003, approximately 28 miles of TH 23 (roughly reference points 147 – 163 and 168 – 180) included in the table were reconstructed to a 4-lane divided section with no CLRS. Also, from the table roughly one mile of TH 71 (reference point 129 – 130) had the CLRS removed as part of an overlay project.

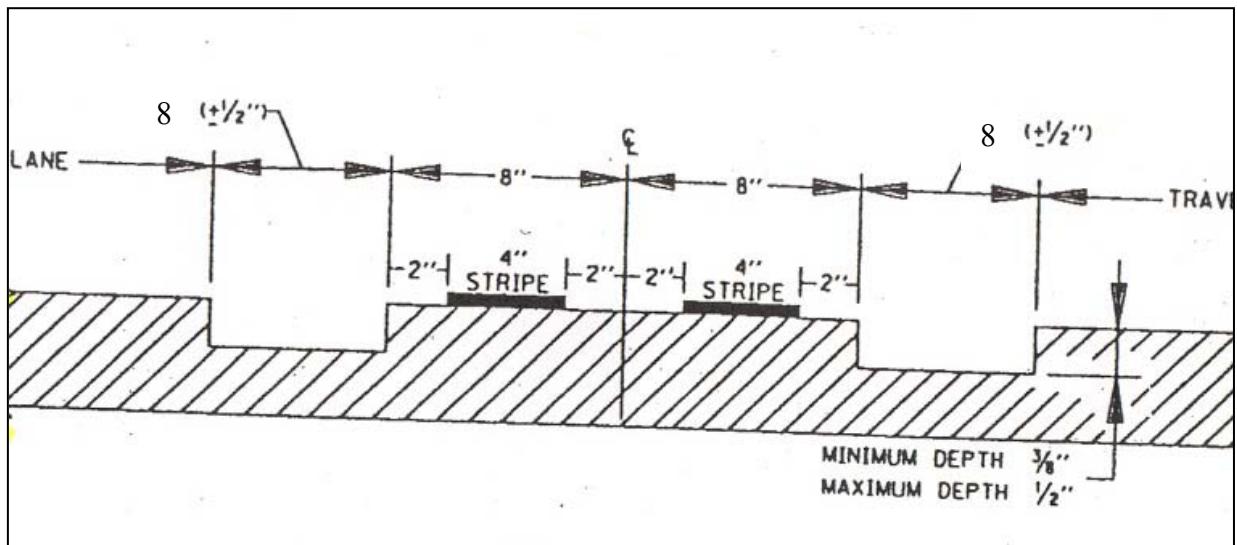
Figure 2-2
Centerline Rumble Stripe Design

Mn/DOT's District 3 (D3) installed approximately 170 miles of centerline rumble strips during the summer and fall of 2003 at a cost of approximately \$1,000 per mile. Figure 2-2 shows the design that was used for the D3 installations. Initially, D3 intended to use six inch grooves on either side of the centerline stripe, rather than the eight inch grooves that eventually were used;

however testing at the St Cloud Safety Center showed that the six inch grooves did not provide adequate noise and vibration for larger vehicles.

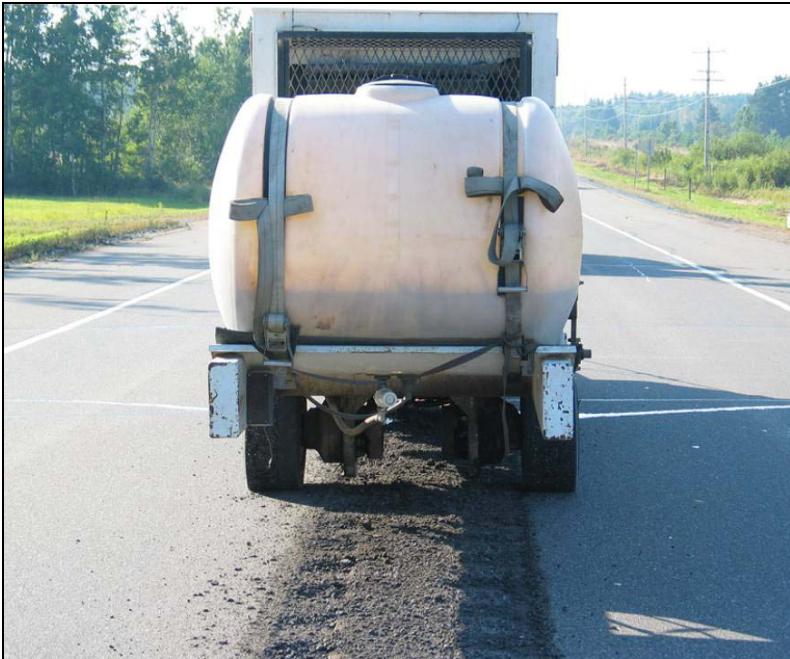
Figure 2-3
Grinding Operation

A grinding machine is used to mill the rumble strips. See Figure 2-3 for a picture of this procedure. The grinder typically should have a water tank mounted to the back in order to minimize the amount of dust that is created as a result of this process. For the design used in D3, a special set of cutting teeth had to be developed and manufactured. They were created so that a single pass of the grinding machine would create both sides of the rumble strips.

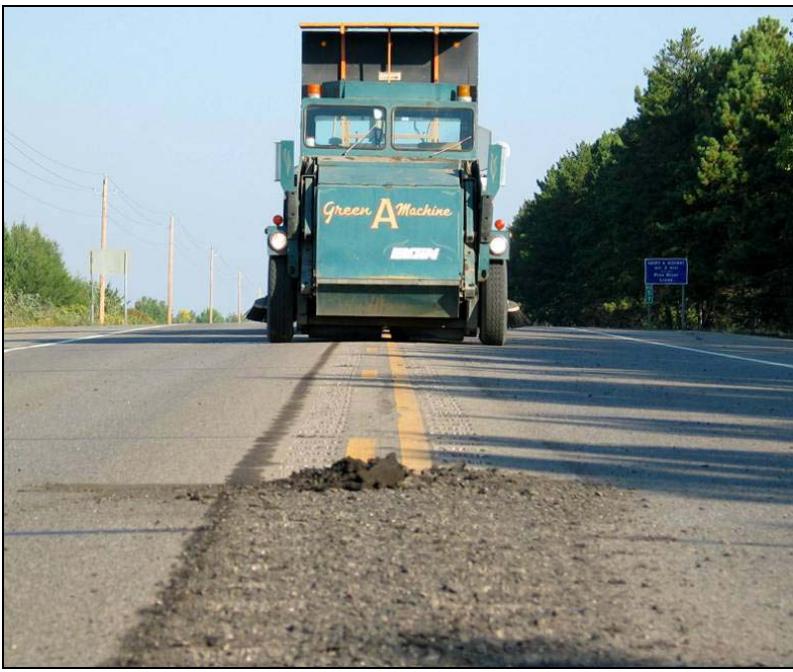
Figure 2-4
Sweeping Operation

After grinding is complete, a street sweeper comes through and sweeps all of the debris off of the road. See Figure 2-4 for a picture. The sweepings can be recycled and used in future mill and overlay jobs. Figure 2-5 shows the completed product. Sometimes rumble strips are fog sealed with an asphalt emulsion or painted with an epoxy stripe. The purpose of fog sealing is keeping moisture out of the pavement to prevent premature pavement deterioration. The purpose of painting an epoxy pavement marking stripe (double yellow, for example) is to get some increased wet reflective properties from the marking. Increased wet reflective performance can be achieved by painting in the rumble strip itself because some of the glass beads that provide retro-reflectivity, become embedded on the nearly vertical face of the rumble strip. Neither of these treatments were done in the D3 installations.

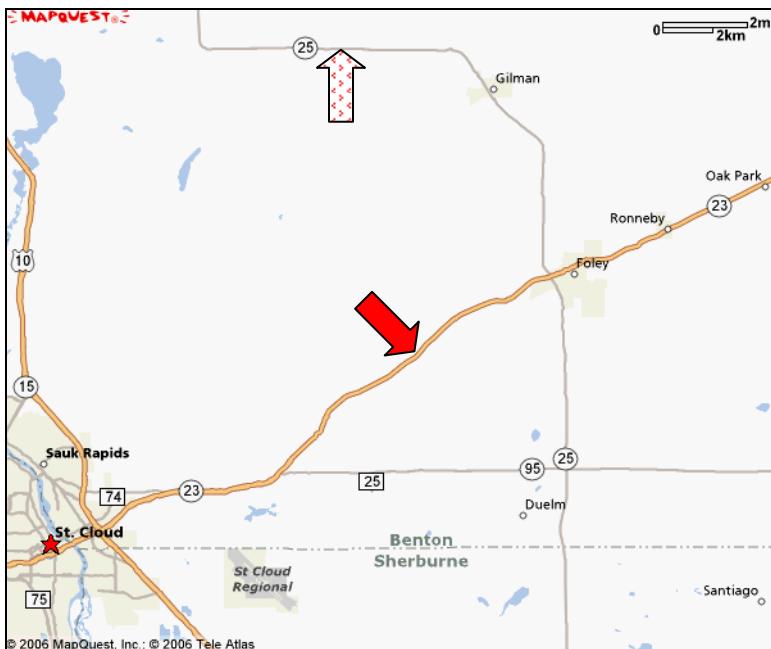
Figure 3-1
Tangent Section Data Collection Sites

Video data was collected by District 3 personnel on Trunk Highway (TH) 23 at reference point 215. Video data was also to be collected at a location on TH 25 at reference point 108, but a problem with the video camera precluded that collection. See Figure 3-1 for the data collection site on TH 23 and the location on TH 25 where data could not be collected. The locations are indicated by a red solid arrow (TH 23) and a dotted red arrow (TH 25). At the TH 23 site, the camera was mounted on the inside post of an “Adopt a Highway” sign directly across the road from an RWIS site. It was installed in sidefire mode, pointing perpendicular to the travel lane,

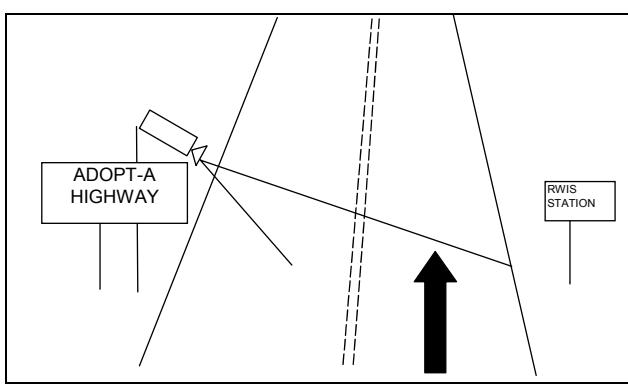
Figure 3-2
TH 23 Camera Setup

looking at traffic traveling northeast. See Figure 3-2. This location was videotaped in the late morning of a sunny, clear day. The reason for this is to have the sun as high in the sky as possible so that the shadows cast by vehicles are as nearly coincident with the vehicles' wheel path as possible. This aided in more accurate data reduction when calculating lateral placement.

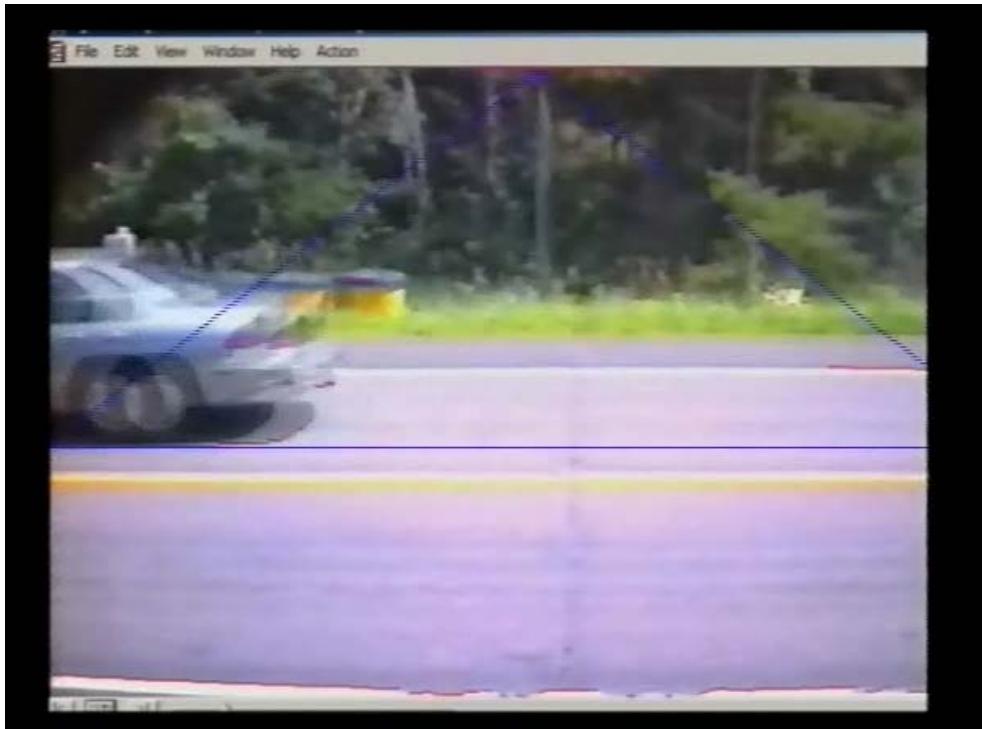
Figure 3-3
Snapshot from Computer Analysis

- A computer program, developed by Dr. Masoud's group, was used to calculate the lateral distance of each vehicle as it passed through the study area. The distance measured was from the centerline stripe to the shadow cast by the vehicle. It was important that data was collected at a time when the sun was located most directly overtop the vehicles, at its highest point in the sky. This was so the shadow cast was as closely coincident with the inside wheels of each vehicle. See Figure 3-3 for a snapshot from the computer analysis. Lateral placement was calculated as the distance from the yellow line to the blue triangle.

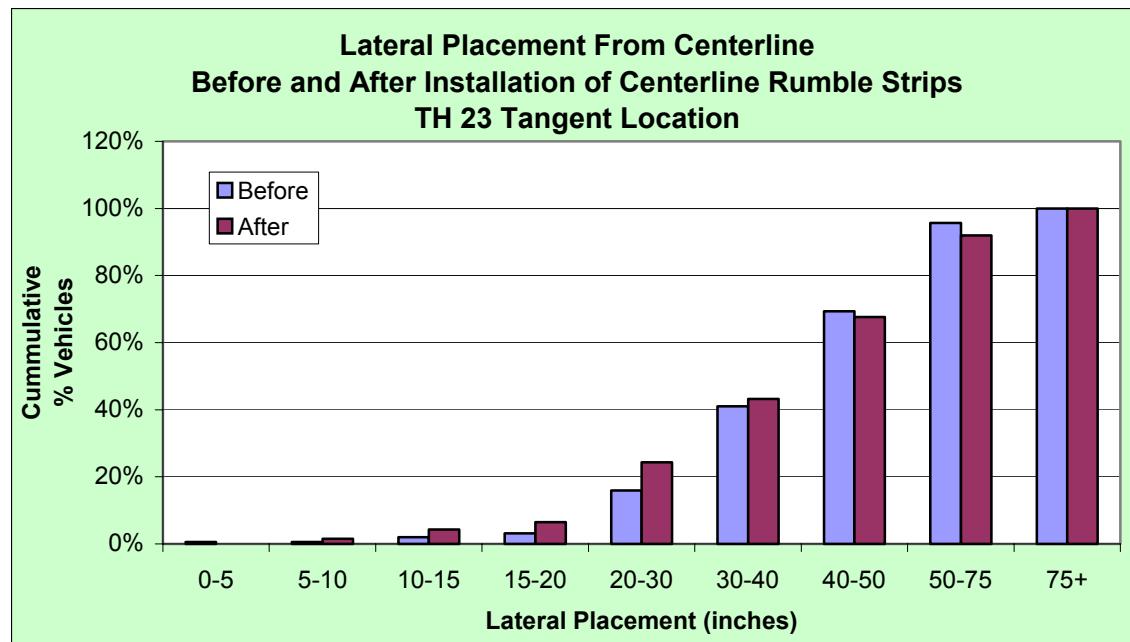
Figure 3-4
Lateral Placement Comparison

Figure 3-4 displays the last set of data from Table 3-1 – cumulative percentage of vehicles that fell into each bin (and the previous bins). This is the most important measure in determining the effect of CLRS on lateral placement of vehicles. The data shows that there was virtually no difference in lateral placement in the ‘before’ and ‘after’ periods. This is interesting because one may expect that CLRS could act as a barrier that may make some motorists uncomfortable, resulting in those motorists driving a little farther away from the centerline. In fact, we saw that vehicles traveled slightly closer to the centerline in the ‘after’ condition. The data suggests that CLRS have minimal impact on lateral placement of vehicles.

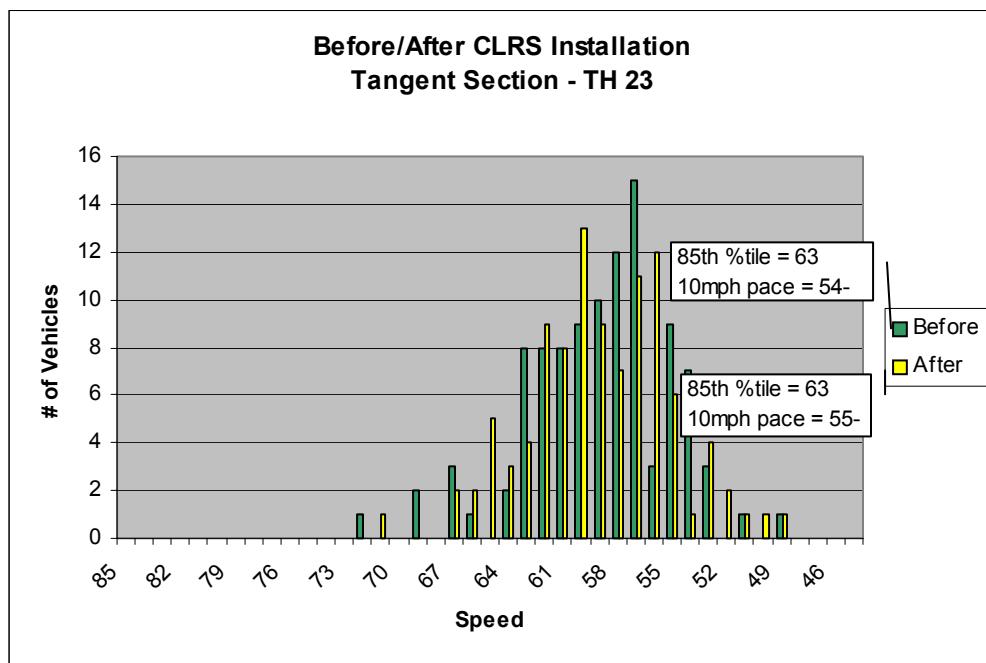
Figure 3-5
Speed Distribution – TH 23 Tangent Section

On TH 23, the ‘before’ and ‘after’ 85th percentile speeds were both 63 mph. The 10 mph pace was 54 – 63 mph in the ‘before’ condition, while the 10 mph pace was 55 – 64 mph in the ‘after’ condition. The data suggests that CLRS had little affect on travel speed at the TH 23 site.

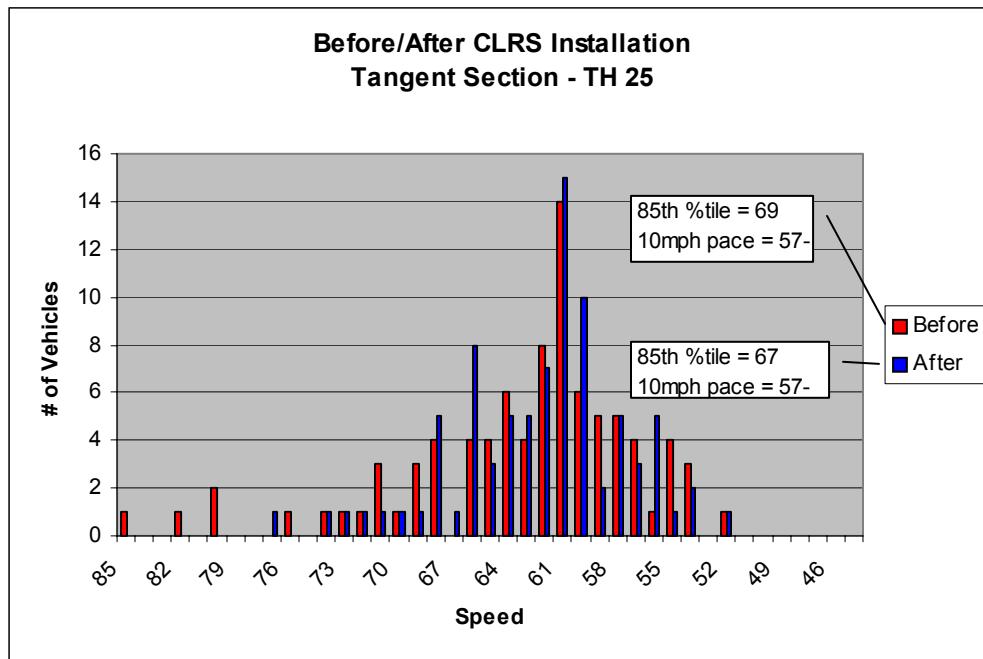
Figure 3-6
Speed Distribution – TH 25 Tangent Section

At the TH 25 site, the ‘before’ and ‘after’ 85th percentile speeds were 69 and 67 mph, respectively. The 10 mph pace in both the ‘before’ and ‘after’ conditions were 57 – 66 mph. The data suggests that CLRS had very little affect on travel speed at the TH 25 site.

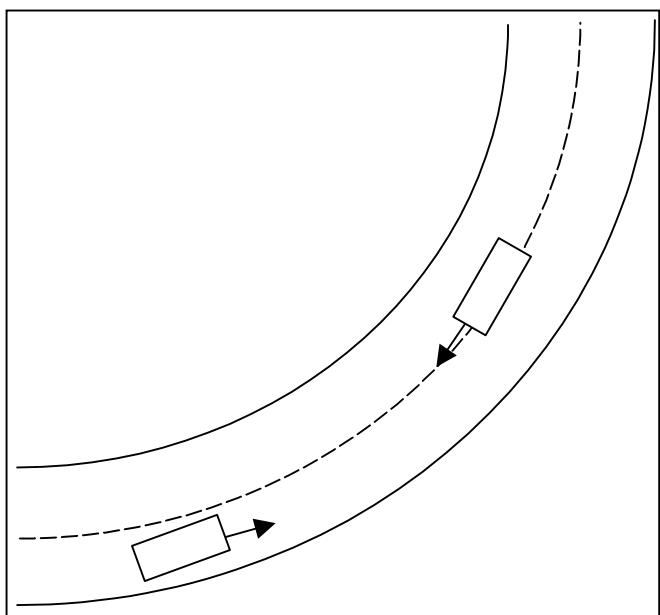
Figure 3-7
Example of Centerline Encroachment

It is obvious that in order for a cross centerline crash to occur, it is first necessary for at least one vehicle to partially or fully cross the centerline. For this reason, an evaluation of centerline encroachments was included in this study. Figure 3-7 is a diagram of an example of a vehicle encroaching on the centerline after it has entered the inside of a curve.

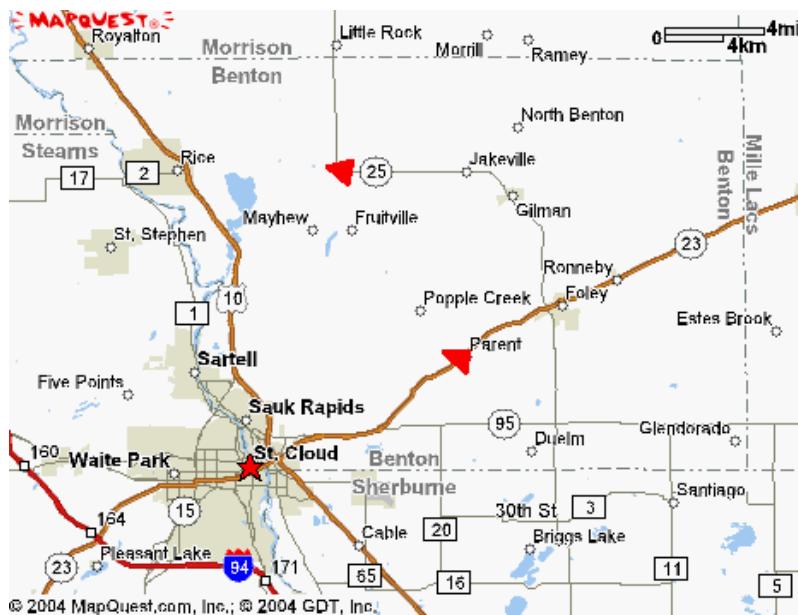
Figure 3-8
Horizontal Curve Data Collection Sites

Video data was studied at two horizontal curve locations on TH 23 and TH 25. These locations are shown in Figure 3-8, and are represented by red solid triangles. TH 23 site was located just

northeast of reference point 217 (near Parent, MN). This horizontal curve has a relatively large radius, resulting in a gradual curve that can be driven at relatively high speeds. The camera was mounted on a tripod and located on the shoulder approximately 50 feet northeast of Benton County Road 83 (85th Ave) pointing in the direction of the horizontal curve to the northeast. The TH 25site was located just west/northwest of reference point 112. This horizontal curve has a relatively small radius of curvature, resulting in a fairly steep curve that cannot be comfortably driven at high speeds. The camera was mounted on a tripod and located on the shoulder just south of Benton County State Aid Highway 2 near the “MNTH 25” sign, pointing in the direction of the horizontal curve to the east.

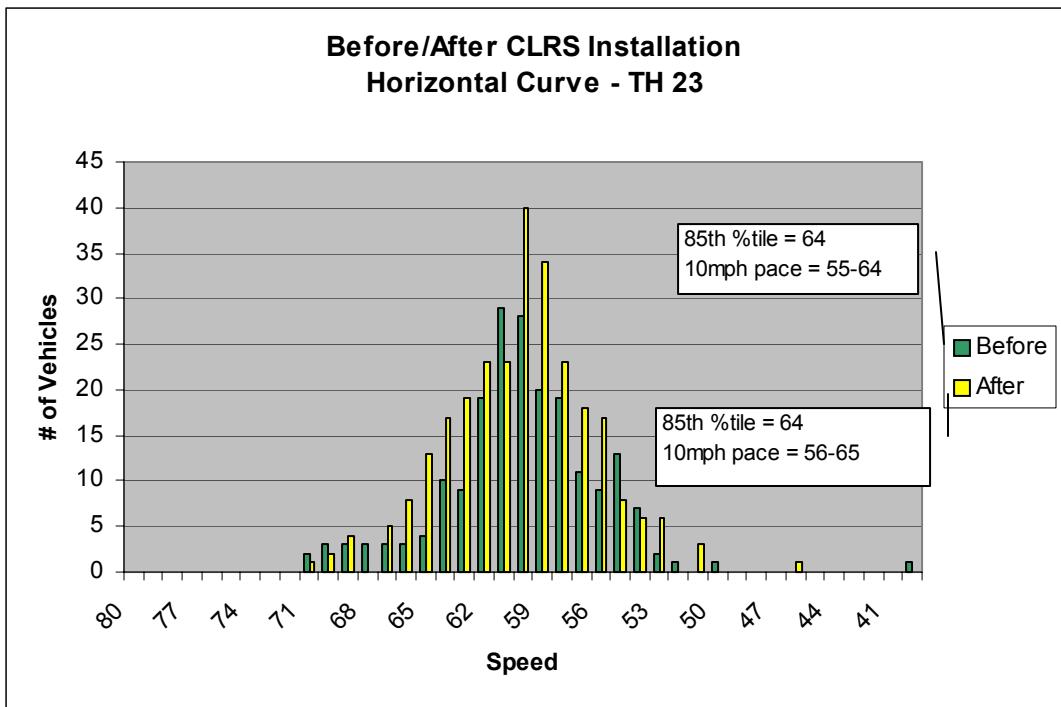
Figure 3-9
Speed Distribution – TH 23 Horizontal Curve

On TH 23, the ‘before’ and ‘after’ 85th percentile speeds were both 64 mph. The 10 mph pace was 55 – 64 mph in the ‘before’ condition, while the 10 mph pace was 56 – 65 mph in the ‘after’ condition. These data elements suggest that CLRS had very little affect on travel speed at the TH 23 site.

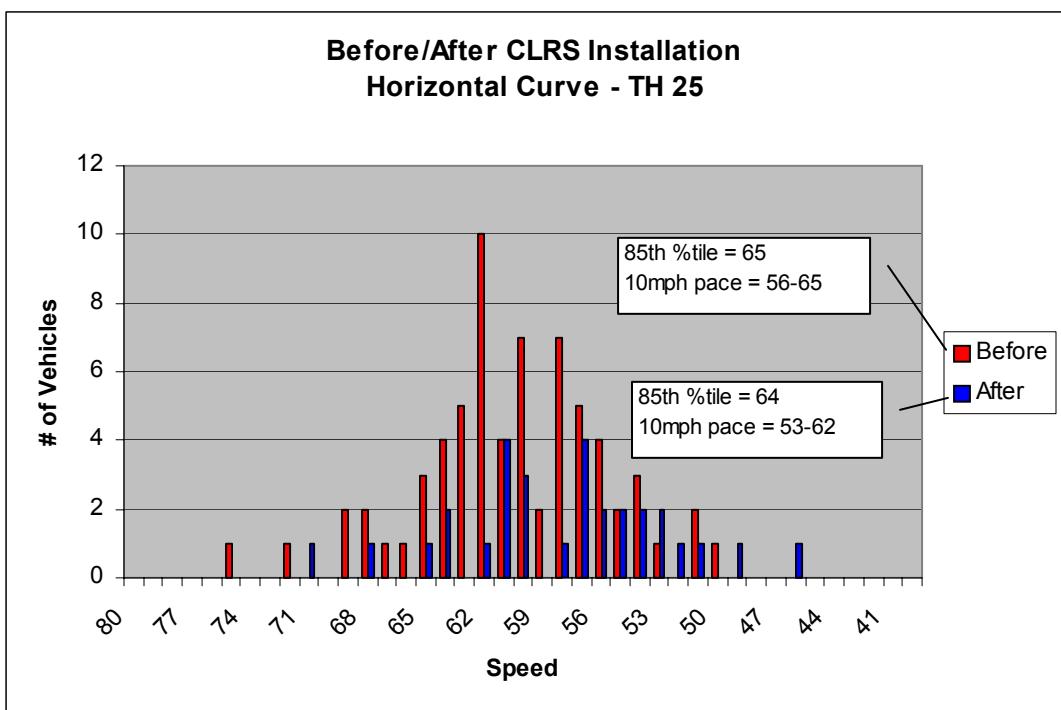
Figure 3-10
Speed Distribution – TH 25 Horizontal Curve

At the TH 25 site, the ‘before’ and ‘after’ 85th percentile speeds were 65 and 64 mph, respectively. The 10 mph pace was 56 – 65 mph in the ‘before’ period and was 53 – 62 mph in the ‘after’ condition. These data elements suggest that CLRS had very little affect on travel speed at the TH 25 site.

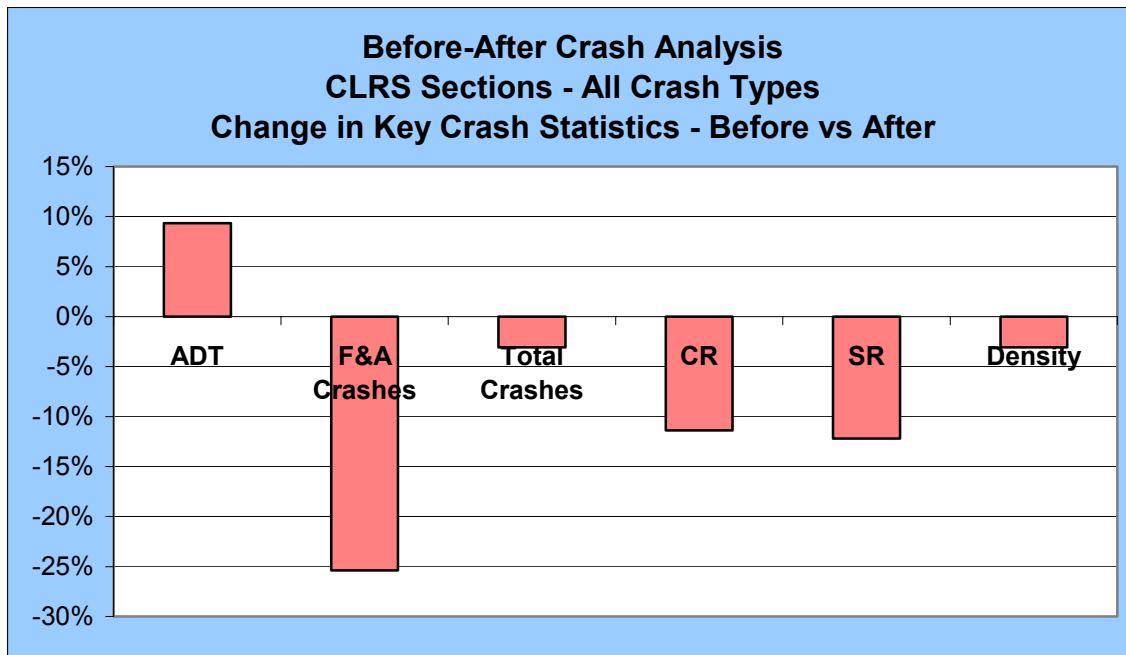
Figure 4-1
Before –After Crash Analysis: All Crashes

For the combined 203 miles of roadway with CLRS that is included in this analysis, the following trends were found, and are displayed in Figure 4-1:

- 25% reduction in fatal and ‘A’ severity crashes per year in the after period (four [4] fewer per year)
- 3% reduction in total crashes per year (10 fewer total crashes per year)
- 11% reduction in crash rate in the after period
- 12% reduction in severity rate in the after period
- 3% reduction in crash density in the after period
- 9% increase in ADT

Assuming the crash data is distributed as Poisson, and that the before and after data sets are independent, all measures of safety identified below are statistically significant.

These results are significant. Every key crash statistic decreased, even those that are positively related to exposure. Total Fatal and ‘A’ Severity crashes decreased by 25%, crash rate and severity rate both decrease by more than 10%, even while ADT increased by nearly 10%. This suggests that CLRS have a positive impact on safety performance of a roadway. In order to make a better determination on the positive effect CLRS have on safety performance, it is necessary to isolate only the target crashes that CLRS are intended to reduce. The next section includes this analysis.

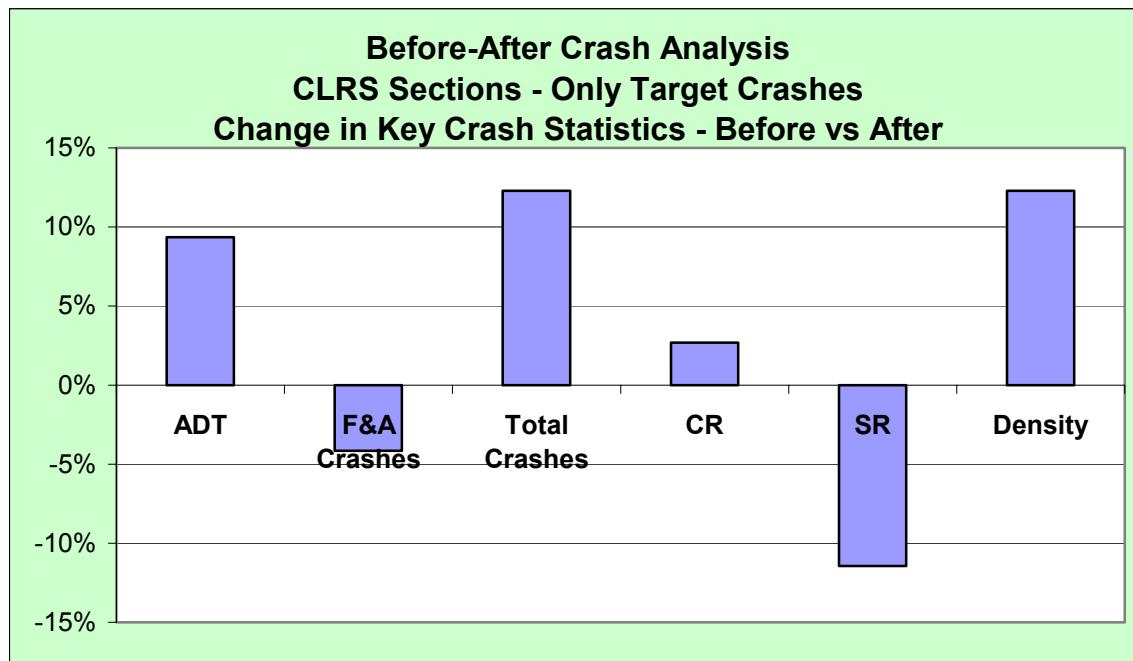
Figure 4-2
Before-After Crash Analysis: Target Crashes Only

For the combined 203 miles of roadway with CLRS that is included in this analysis, the following trends were found, and are displayed in Figure 4-2:

- 4% reduction in fatal and ‘A’ severity crashes per year in the after period (0.3 fewer per year)
- 12% increase in total crashes per year (7 more total crashes per year)
- 3% increase in crash rate in the after period
- 11% reduction in severity rate in the after period
- 12% increase in crash density in the after period
- 9% increase in ADT

Assuming the crash data is distributed as Poisson, and that the before and after data sets are independent, none of the measures of safety identified below are statistically significant.

These results are much less conclusive than are the results for all crashes; however, it is important to remember that by only considering target crashes (which tend to be fairly rare crashes), the pool of crashes is drastically reduced. This is why the results are not statistically significant. The increases in total crashes per year and crash density are consistent with the increase in ADT. This is not unexpected, because total number of crashes and crash density are positively related to the exposure, or number of vehicles that drive past a given point. As ADT increase, total crashes and therefore crash density increase. Crash rate increased slightly, at 3%, while fatal and ‘A’ crashes and severity rate decreased by 4% and 11%, respectively.

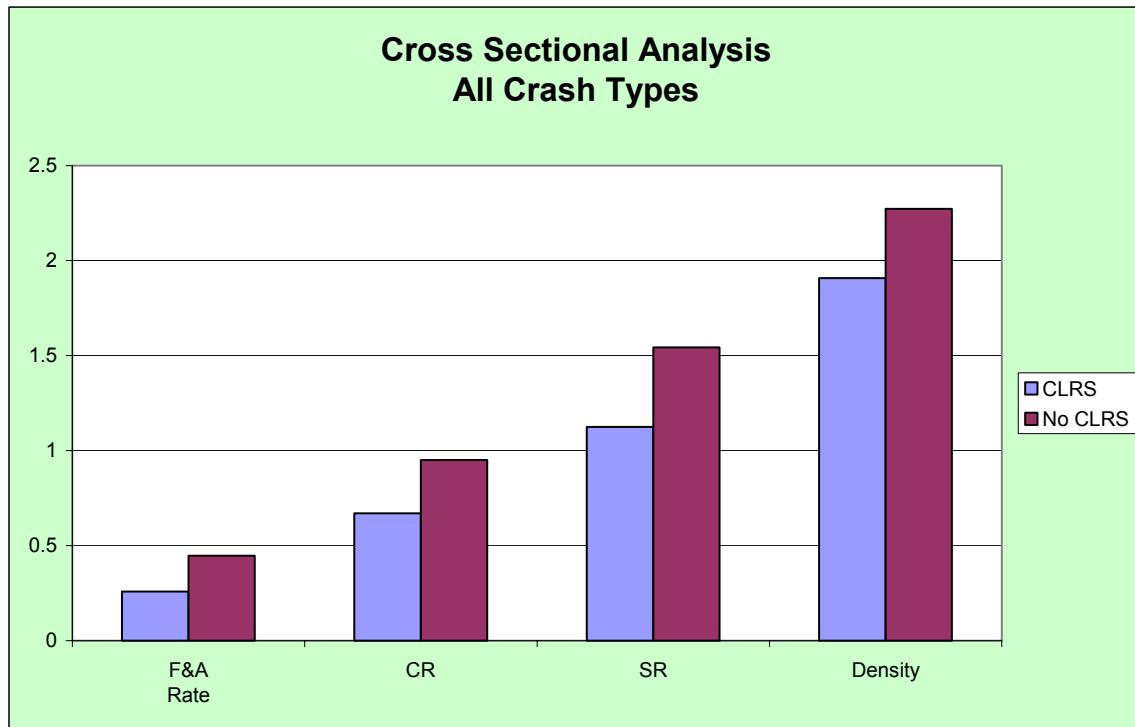
Figure 5-1
Cross Sectional Analysis Summary – All Crashes

The following were found when comparing the treatment group with all crash types to the control group. Figure 5-1 is a graphical representation of these results. Because the number of miles in each group is not the same, it is only appropriate to compare rates or density. Raw numbers cannot be compared.

- 73% lower fatal and ‘A’ severity crash rate on sections with CLRS (0.26 vs. 0.45)
- 42% lower crash rate on sections with CLRS (0.67 vs. 0.95)
- 37% lower severity rate on sections with CLRS (1.13 vs. 1.54)
- 19% lower crash density on sections with CLRS (1.91 vs. 2.27)
- 16% higher ADT on sections with CLRS

These results are significant. Every crash statistic was much lower for the group that had CLRS. Even crash density was lower on roads with CLRS, even though the average ADT on CLRS sections of road is 16% higher than those sections without CLRS. Normally, as ADT goes up, crash density also goes up. This is because crash frequency usually is positively proportional to the amount of traffic on a roadway. The fact that crash density decreased should be considered further evidence that CLRS are an effective safety treatment (no change or even a small increase in crash density would not necessarily be a indication that CLRS are not effective).

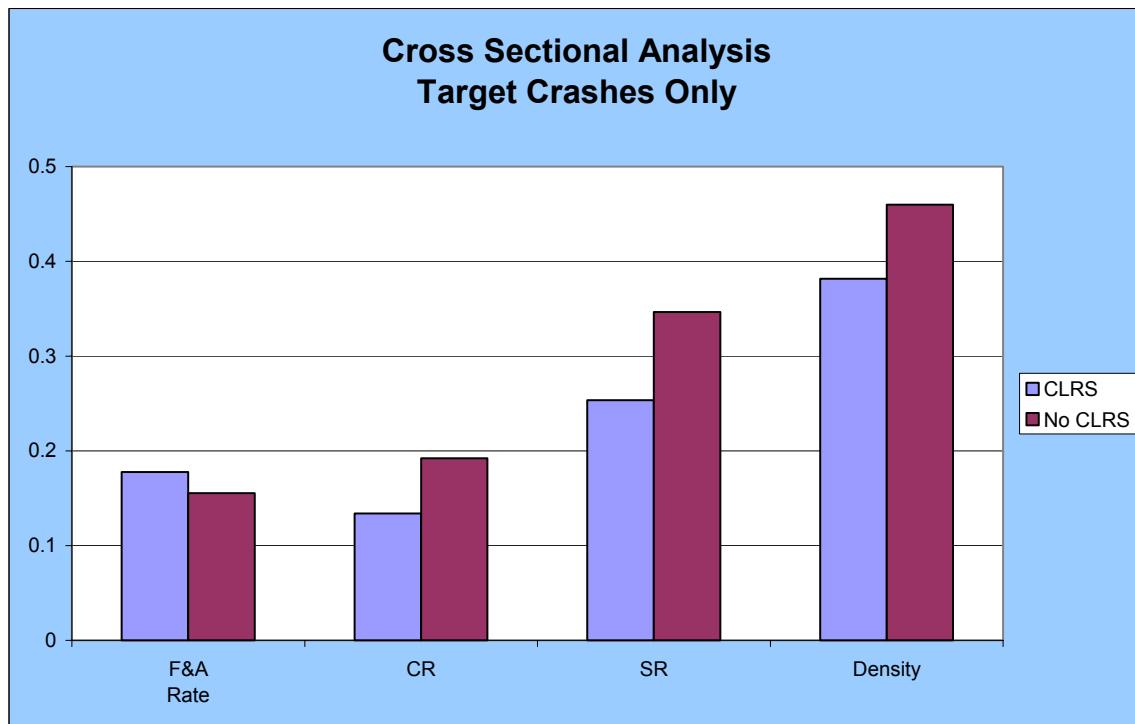
Figure 5-2
Cross Sectional Analysis Summary –Target Crashes Only

The following were found when comparing the treatment group with only target crashes to the control group. Figure 5-2 is a graphical representation of these results. Because the number of miles in each group is not the same, it is only appropriate to compare rates or density. Raw numbers cannot be compared.

- 13% higher fatal and ‘A’ severity crash rate on sections with CLRS (0.18 vs. 0.16)
- 43% lower crash rate on sections with CLRS (0.13 vs. 0.19)
- 37% lower severity rate on sections with CLRS (0.25 vs. 0.35)
- 20% lower crash density on sections with CLRS (0.38 vs. 0.46)
- 16% higher ADT on sections with CLRS

These results are also noteworthy, and are strikingly similar to the analysis for all crash types. The group with CLRS showed lower crash rate, severity rate, and crash density of 43%, 37%, and 20%. These reductions are almost identical to those found for the all crash analysis (42%, 37%, 19%). The only measure that was not consistent with the all crash analysis, and in fact showed an increase, was the F and ‘A’ rate. For the target crash analysis, sections of road with CLRS had a F and ‘A’ rate 13% higher than the control group.
