Portland Cement Concrete Pavement Thickness Variation Versus Observed Pavement Distress

Minnesota
Department of
Transportation

Lev Khazanovich, Principal Investigator
Department of Civil, Environmental, and Geo- Engineering
University of Minnesota

Research Project
Final Report 2016-30

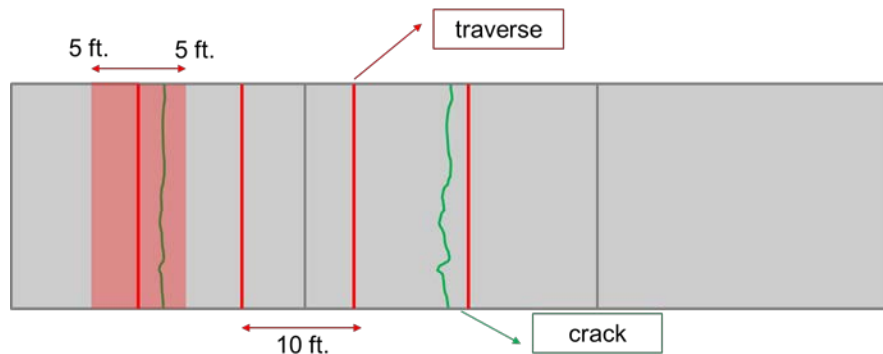
The distress data required much less processing than the thickness data. Distress data regarding distress type, severity, traverse and distance from traverse was entered into a provided field data survey sheet which can be directly processed by MATLAB. During the combination of thickness/shear wave velocity and distress data, if couple thicknesses differ more than 6.35 mm (0.25 in.), this couple was considered as non-conclusive and the data for thickness and shear wave velocity was discarded from further analysis. Satisfactory couples were averaged, resulting in five transverse values to be associated with distress. As the MIRA data was taken at set intervals, and distress data was random, it was determined that MIRA locations would serve as base points and distress would be assigned to MIRA measurements. Specifically, a distress measurement occurring within +/- 5 ft. of a MIRA location was assigned to that MIRA data point (Figure 3). If a distress was recorded at exactly 5ft. from a MIRA location; that is, exactly between two measurements, it was at risk of being assigned to both or neither adjacent traverses. To avoid this, it was determined that a distress would only be associated with a MIRA measurement if the difference in longitude location d was $-5 > d \geq 5$ ft.

Figure 3 - Traverses and distress location

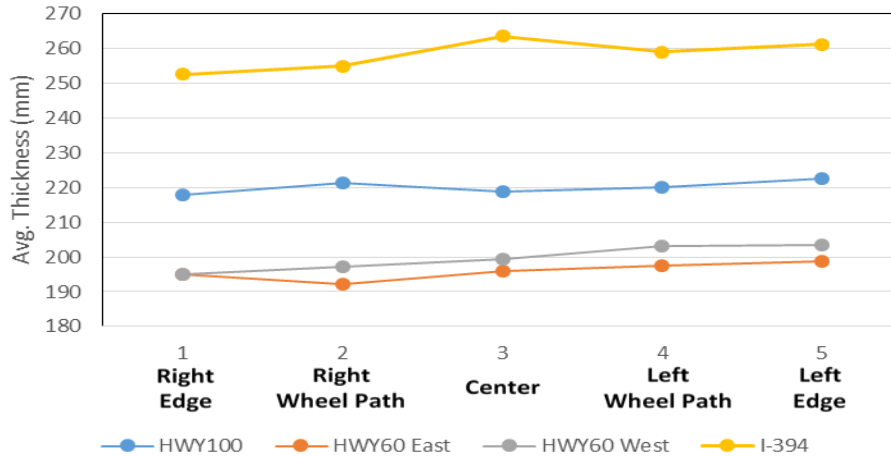
Regarding the thickness transverse variation, all sections, save I-394, present greater thickness in the lane left edge of the slab than the right, as can be seen in Figure 4. Moreover, all sections have thinner slabs closer to the right edge. Locations 1 to 5 are based on the distress locations provided in Table 3.

Figure 4 – Average thickness per location

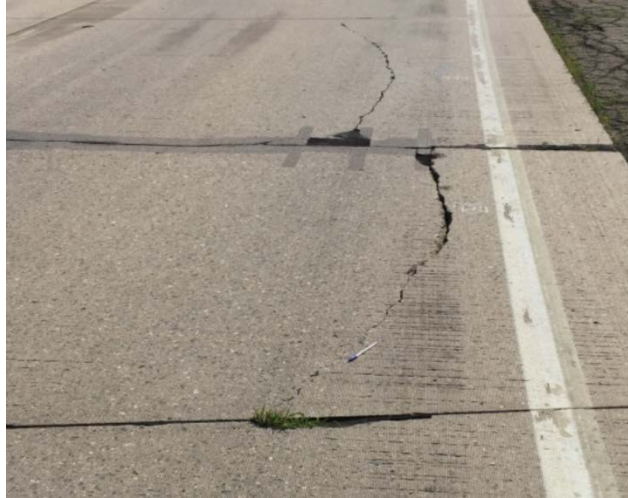
Figure 5 - Broken panels in Highway 60 East

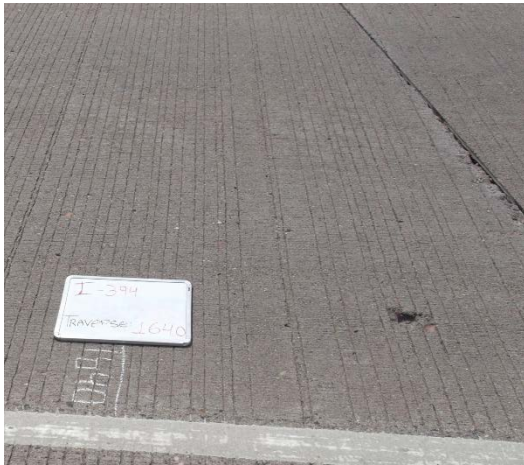
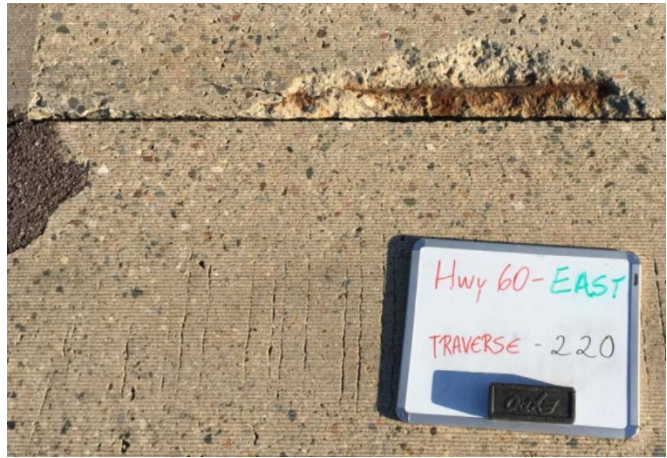
Figure 6 - (a) Transverse joint spalling in I-394 and (b) longitudinal joint spalling in Highway 60 East

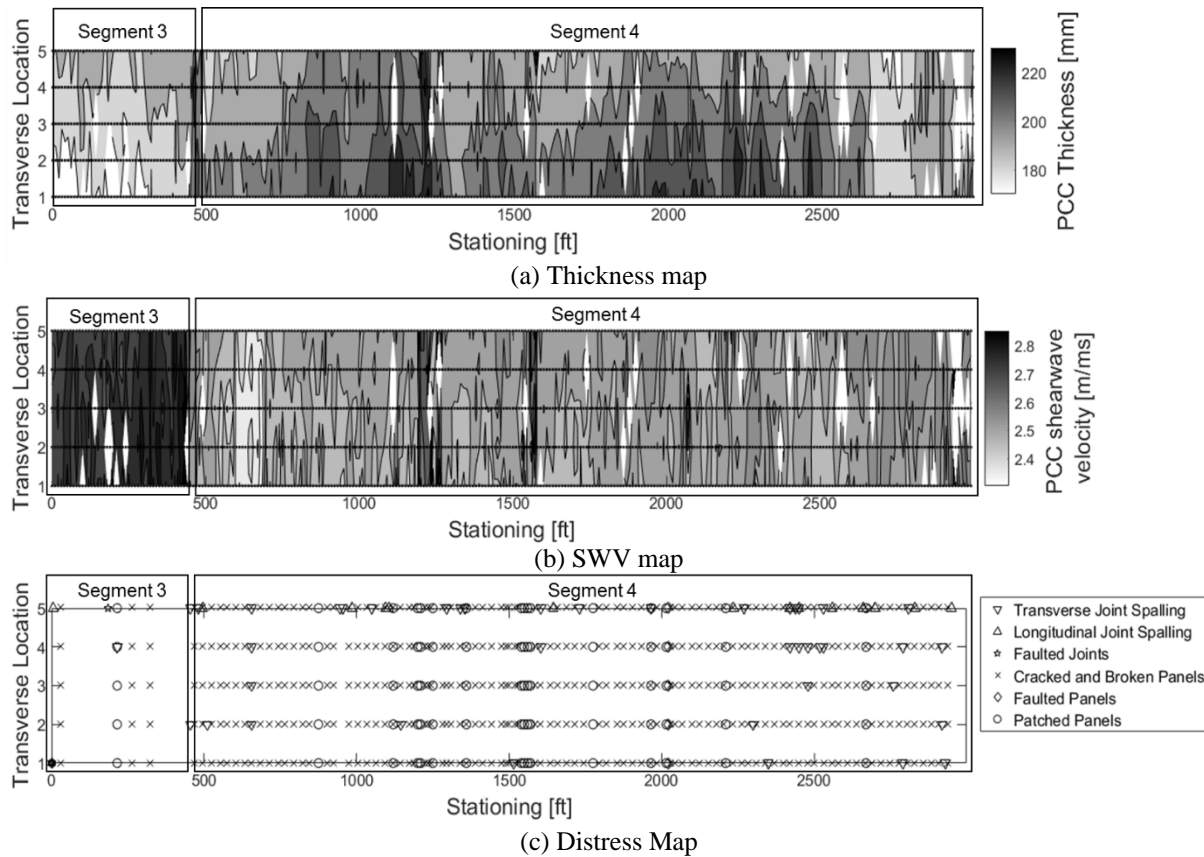
Segment 3 exhibited a higher velocity compared to segment 4, 2.76 vs. 2.52 m/ms, respectively. At the same time, segment 3 exhibited a lower density of distresses compared to segment 4, while the difference in thickness increased from 186 to 202 mm (7.32 to 7.95 in.). Figure 10 further attest this findings.

Figure 9 - Highway 60 West survey of (a) thickness, (b) SWV and (c) distresses.

An analysis of the construction records revealed that this part of Highway 60 was constructed in two stages eight months apart. The first stage covered segments 1 and 4, while the second stage covered segments 2 and 3. Slightly different concrete mixes were used for each stage. Table 7 highlights the differences in concrete mixture design between the two segments.

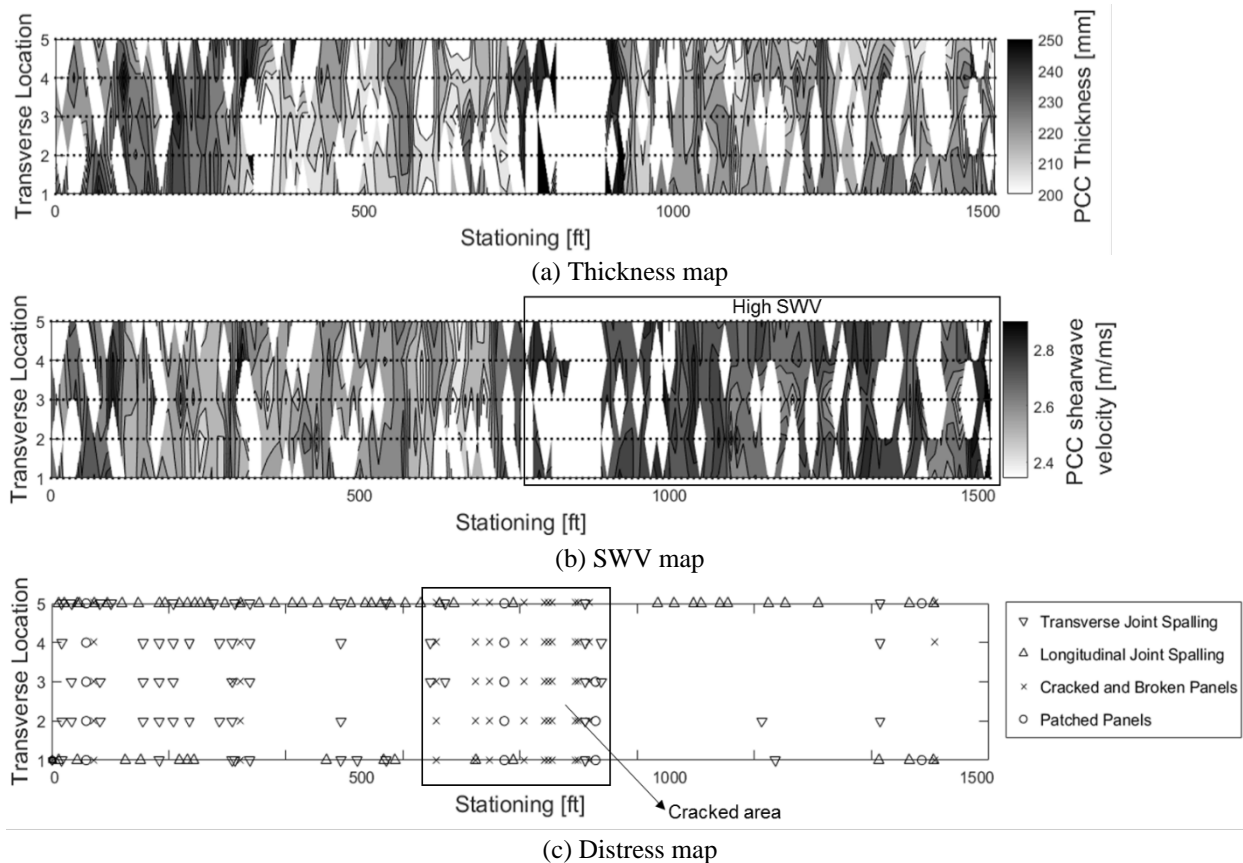
For Highway 100, there is an increase in SWV (around the station 700 ft. in Figure 11b) which corresponds to an area with the presence of cracked panels (Figure 11c) in contrast with the results of Highway 60. Yet, this higher velocity becomes quasi-constant through the survey, including the next area with less distresses. After station 700 ft., the average velocity rises from 2.58 to 2.73 m/ms while the average thickness remains relatively constant around 220 mm. It can be observed that around the cracked area there is also a corresponding great number of thickness couple measurement errors (Figure 11a). As the data procedure eliminates thickness and SWV data whenever a thickness error occurs, the cracked panels presented in this particular area could not be related to the SWV. Additionally, the number of measurement errors in that particular area can be an indicator of distresses within the slab, making it difficult for a consistent thickness determination. The graph on Figure 12 supports this information.

Figure 11 - Highway 100 survey of (a) thickness, (b) SWV and (c) distresses.

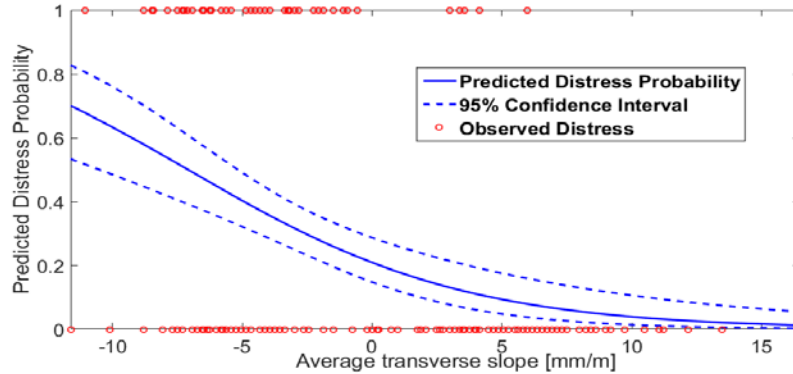
datasets will be compared. Cracked and broken panels were found to significantly relate to several thickness predictors. There was a strong negative correlation ($p < 0.005$) found between cracked and broken panel occurrence and average traverse slope (X_3) (Figure 15) and absolute maximum traverse slope (X_5) (Figure 16) in Highway 60 East. Both of these correlations suggest that pavements with a negative thickness slope (thickness increasing from right edge to left) are more likely to exhibit cracked or broken panels. This relationship can be also verified for Highway 60 West (Figures 17 and 18).

Figure 15 - Highway 60 East (Thickness): Average Traverse Slope *versus* Cracked and Broken Panels.

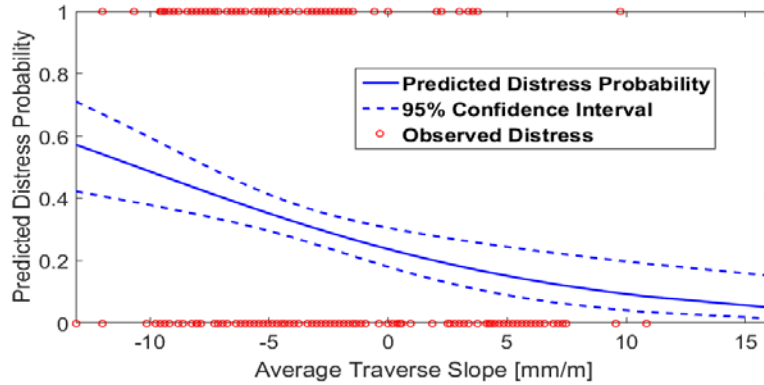
Figure 17 - Highway 60 West (Thickness): Average Traverse Slope *versus* Cracked and Broken Panel.

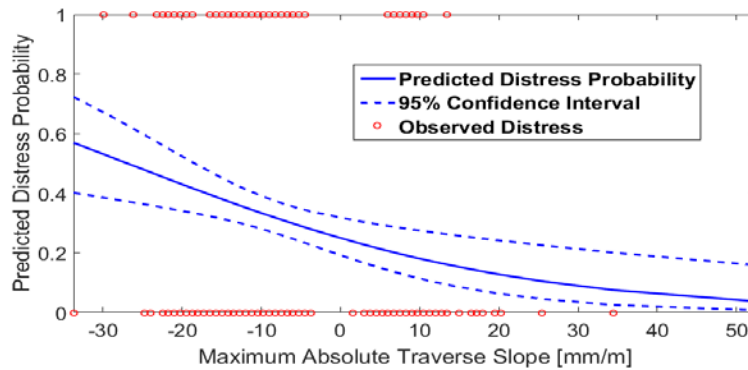
Figure 18 - Highway 60 West (Thickness): Absolute Maximum Traverse Slope *versus* Cracked and Broken panels.

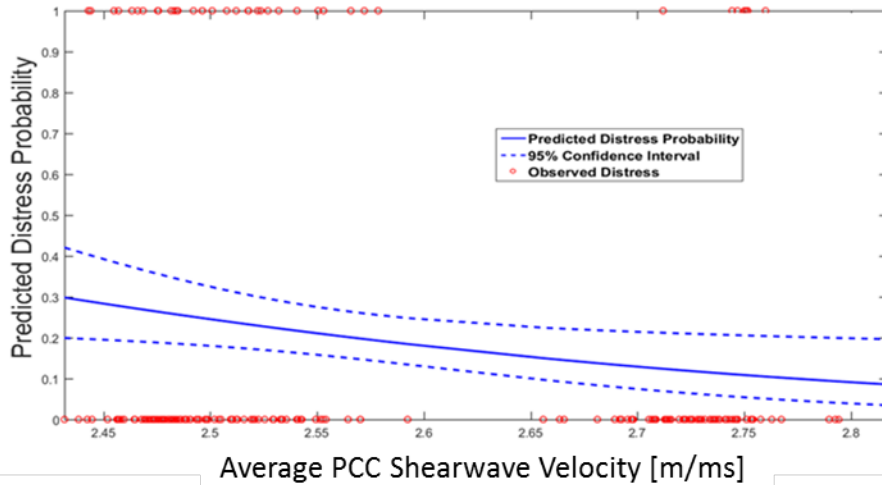
As previously stated, traverse joint spalling is a major distress type in all four surveys. The velocity regression results for traverse joint spalling show a weak ($p < 0.05$), but significant, negative correlation between velocity and traverse joint spalling for Highway 60 East, Highway 60 West, and Highway 100, as shown in Table 9. Only I-394 does not show this correlation. Investigation of the regression shows that fit models (Figures 19 and 20) only span a narrow range of probabilities, suggesting the model lacks the ability to discriminate distress occurrence from non-occurrence. This weakness, combined with weakness of the correlation suggests that models for transverse joint spalling are not useful.

Figure 19 - Highway 60 East (Velocity): Average Traverse Velocity *versus* Transverse Joint Spalling.

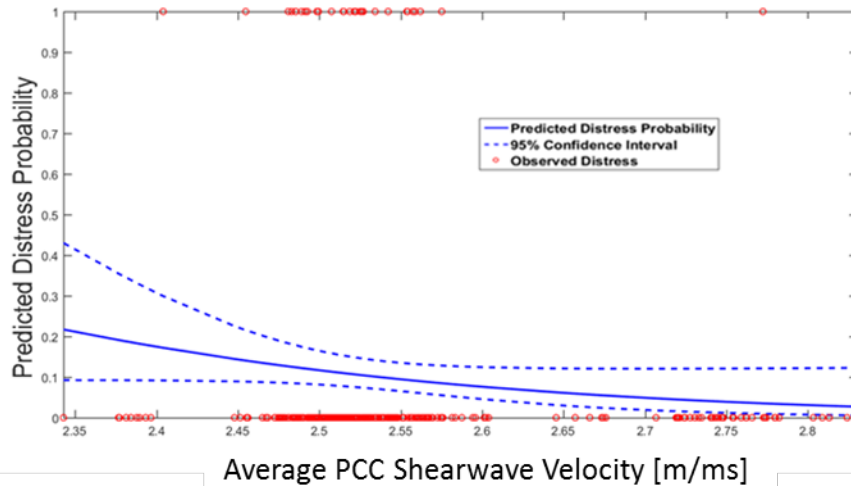
Figure 20 - Highway 60 West (Velocity): Average Traverse Velocity *versus* Transverse Joint Spalling.

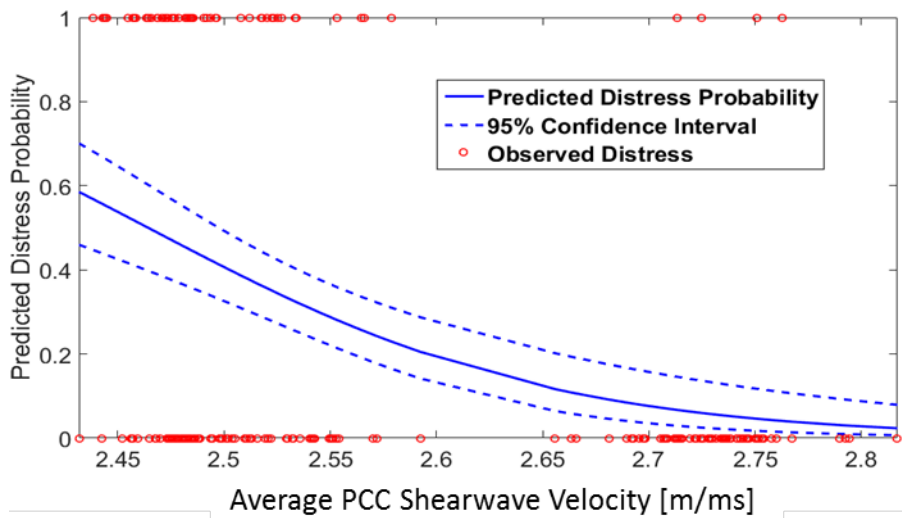
As with the thickness correlations, Highway 60 East and Highway 60 West datasets are of primary interest when investigating cracked and broken panels. There was a very strong negative correlation ($p < 0.0005$) found between average traverse velocity and cracked and broken panels (Figures 21 and 22 and Table 9). Both of these correlations suggest that pavements with a lower velocity are more likely to exhibit cracked or broken panels.

Figure 21 - Highway 60 East (Velocity): Average Traverse Velocity *versus* Cracked and Broken Panel.

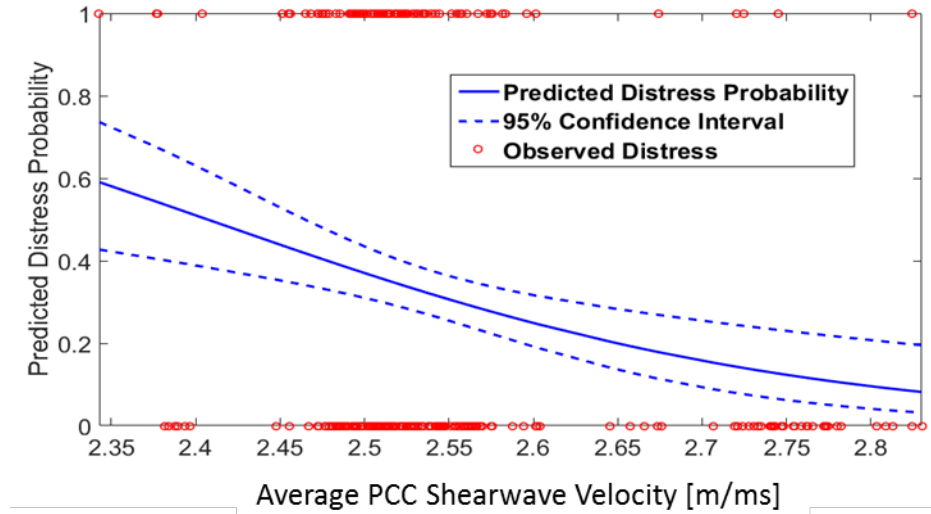
Figure 22 - Highway 60 West (Velocity): Average Traverse Velocity *versus* Cracked and Broken.

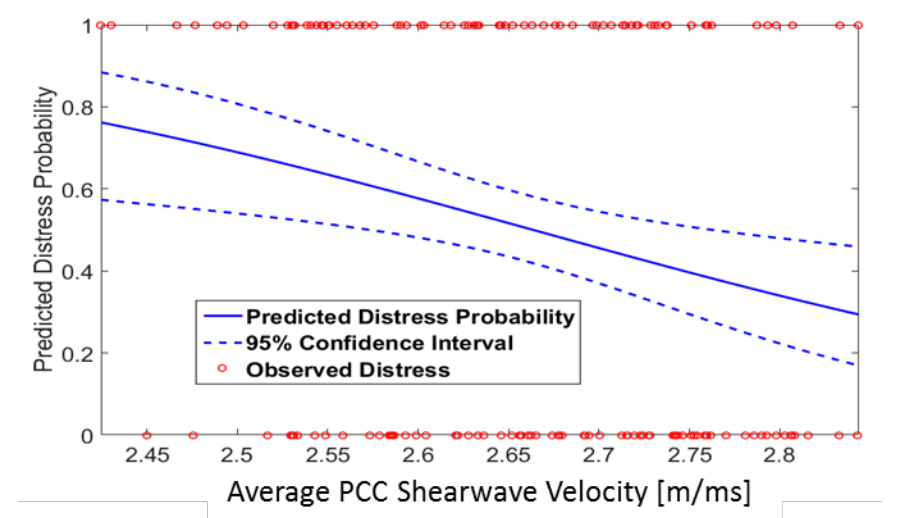
A strong negative correlation ($p < 0.005$) was found between average traverse velocity and all distress in all four surveys (Figures 23 to 26, Table 9). This is not particularly surprising for Highway 60 East, Highway 60 West, or Highway 100, as all three were found to have strong significant negative correlations. However, for I-394, all distress is the only strong significant correlation, suggesting the weaker correlations of other distress are all consistent and add to create a highly significant result. The full regression results support this conclusion. Though the other correlations in I-394 are weak, they overwhelming suggest a negative correlation between velocity and distress.

Figure 25 - Highway 100 (Velocity): Average Traverse Velocity *versus* all Distress.

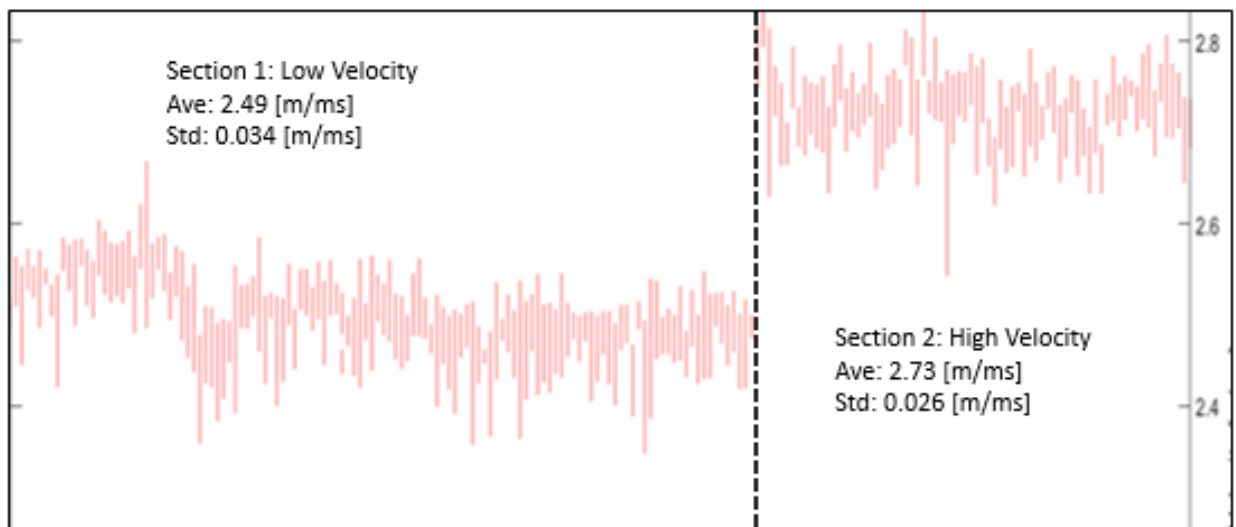
MIRA Ultrasonic tomography was used to conduct surveys of surface shear wave velocity on several pavements. Two of these surveys were performed on Minnesota State Highway 60 (Highway 60). The surface shear wave velocity surveys conducted on Highway 60 resulted in distinct separations within the data sets. Both datasets contained a high velocity (approximately 2.7 m/ms) and a low velocity section (approximately 2.3 m/ms). Within each velocity section, the velocity was found to have a lower standard deviation than the combined section (Table 10). Variogram (var) analysis was performed and determined that there is no significant spatial correlation of velocity within the individual sections. Sections with lower velocity were correlated with a higher probability of distress occurrence, as seen in Section 3. For Highway 60, the discrepancy in velocity between the two sections was investigated and found to coincide with a change in construction date and concrete mix. The velocity profile of Highway 60E is given in Figure 27. Note two distinct sections are observed. Both sections have similar standard deviation, but different means. A similar profile was observed on Highway 60W as it covers the same segment in an opposite direction.

Figure 27 - Surface shear wave velocity profile of Highway 60

The analysis performed above may be applied for the early detections of deficiencies in pavement material properties. As seen in surveys conducted on Highway 60, pavement segments of consistent materials (i.e. when the analysis is performed separately for the segments with high and low velocities) have a standard deviation of shear wave velocity of approximately 0.03 m/ms. If a velocity survey is conducted over a section where material properties change, the standard deviation of the velocity measurements increases dramatically to approximately 0.1 m/ms. Therefore, if a surface shear wave velocity survey is conducted over a section of pavement, a velocity standard deviation greater than a threshold value indicates a potential change in material properties and warrants investigation. Table 10 suggest that 0.1 m/ms can be used as this threshold value until more information is available.
