Minnesota Perpetual Pavement Analysis and Review

Daniel E. Wegman
Mohammadreza Sabouri
Braun Intertec Corporation

July 2016

Research Project
Final Report 2016-33

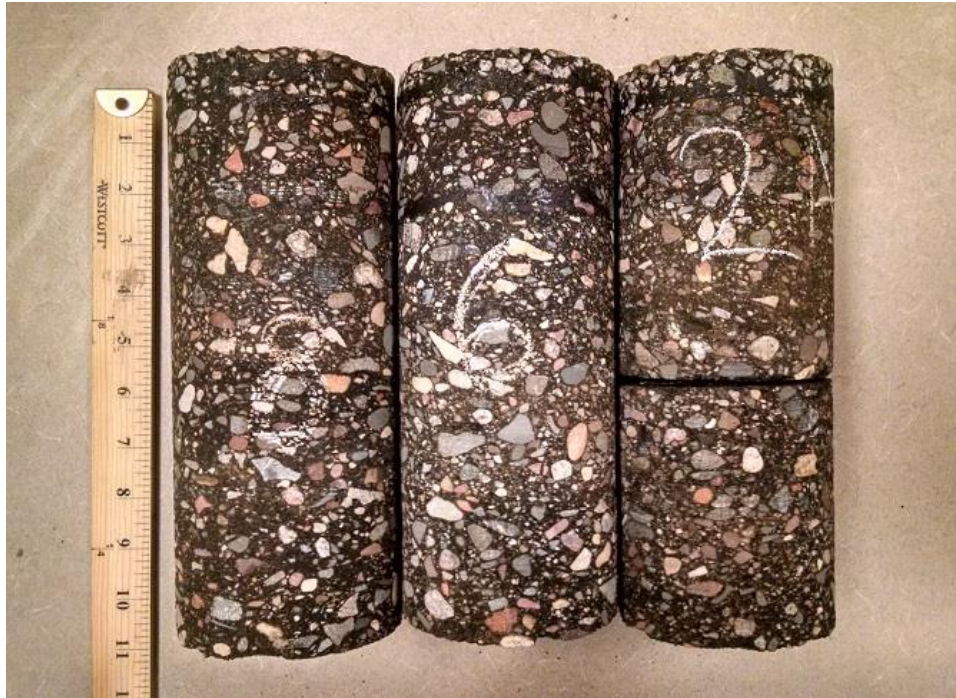
Figure 4-13 TH 10 (2004) cores used for RM (Cores 2, 6, and 8)

Resilient Modulus (RM) tests were performed on the pucks obtained from the bottom of the uncracked non-wheelpath cores (UNWP). These materials were in place for a long time and ideally, have been made from durable, fatigue resistance HMA as they have withstood the maximum tensile strain, which happens at the bottom of the asphalt layer, for an extended period of time. Figure 4-13 through Figure 4-16 show the side view of the UNWP cores after the bottom existing stripping were trimmed off.

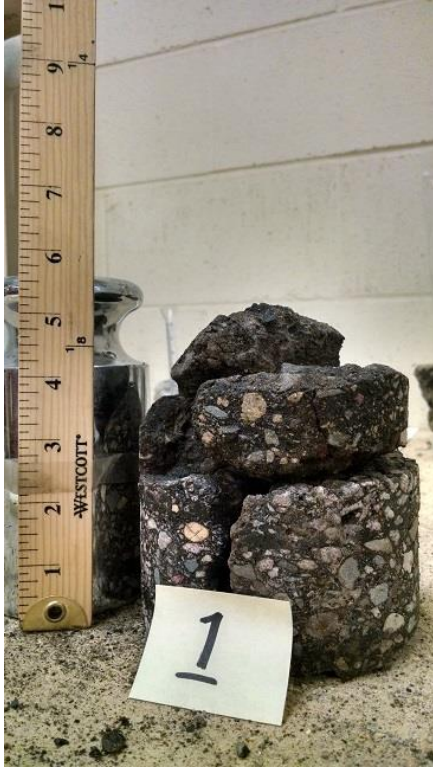
Figure A-1 Core 1; TH 10 (2004), cracked, wheelpath

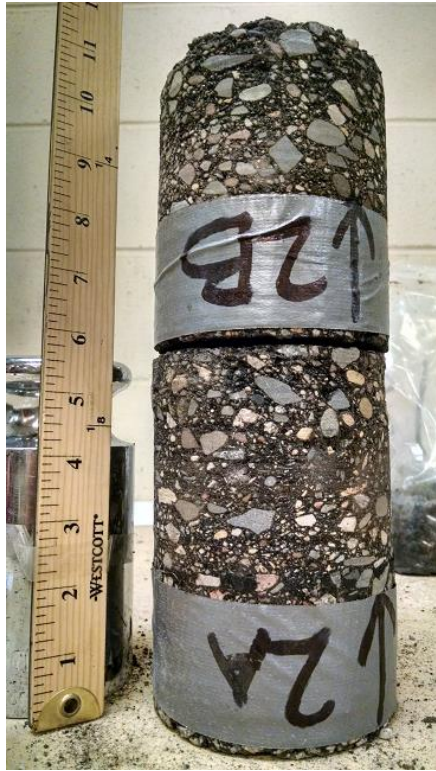
Figure A-2 Core 2, TH 10 (2004), un-cracked, non-wheelpath

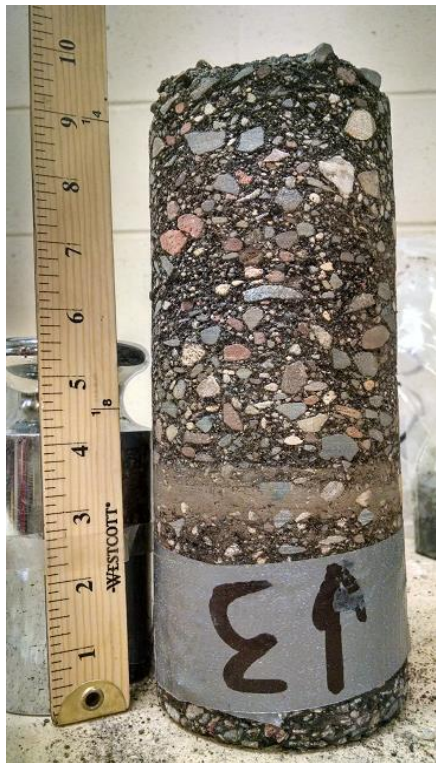
Figure A-3 Core 3, TH 10 (2004), un-cracked, wheelpath

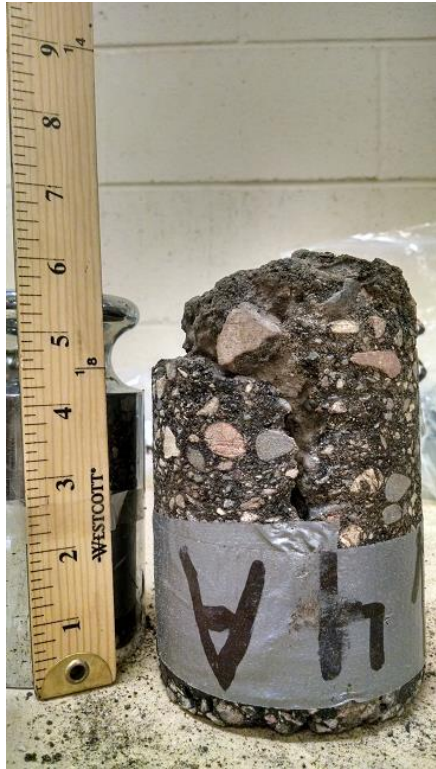
Figure A-4 Core 4, TH 10 (2004), cracked, wheelpath

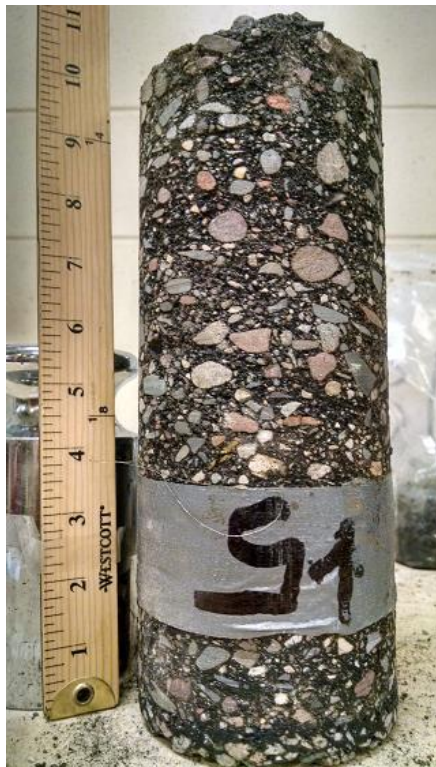
Figure A-5 Core 5, TH 10 (2004), un-cracked, non-wheelpath

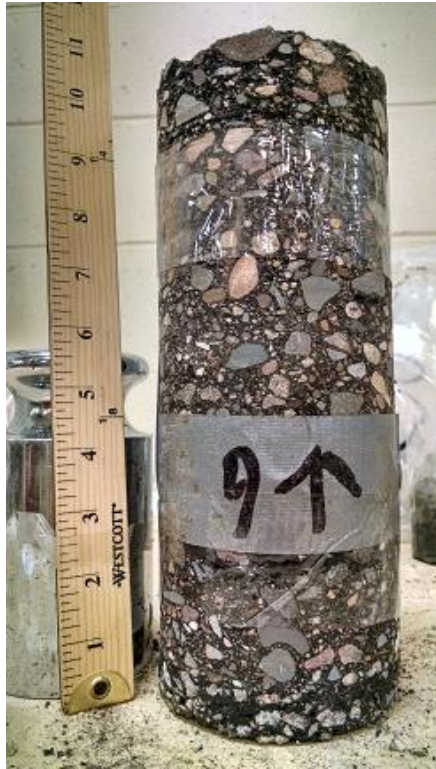
Figure A-6 Core 6, TH 10 (2004), un-cracked, wheelpath

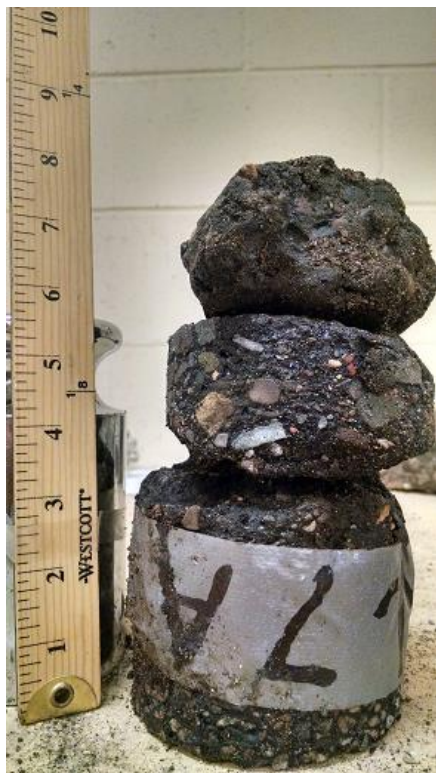
Figure A-7 Core 7, TH 10 (2004), cracked, wheelpath

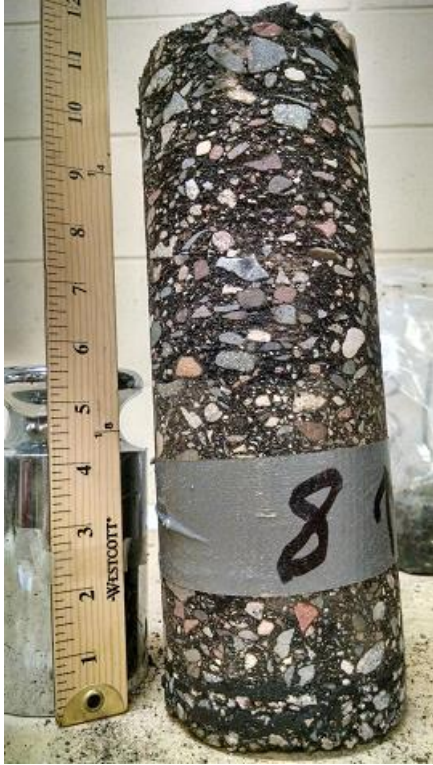
Figure A-8 Core 8, TH 10 (2004), un-cracked, non-wheelpath

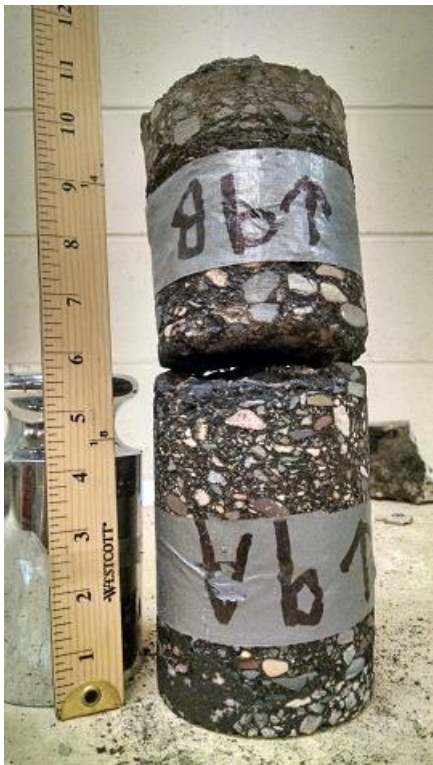
Figure A-9 Core 9, TH 10 (2004), un-cracked, wheelpath

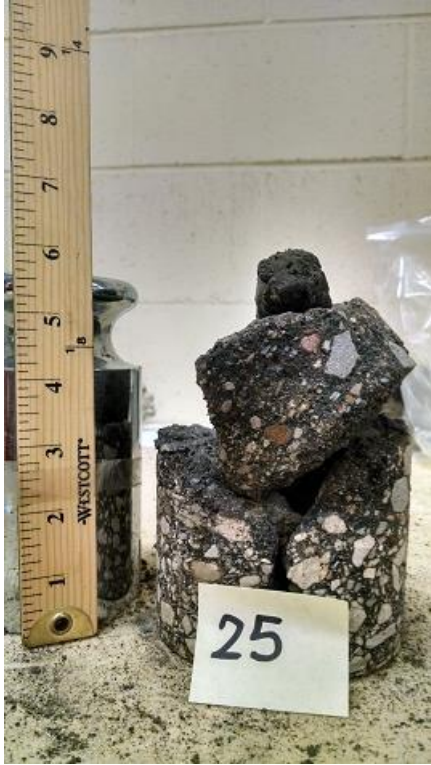
Figure A-16 Core 25; TH 95 (2013), cracked, wheelpath

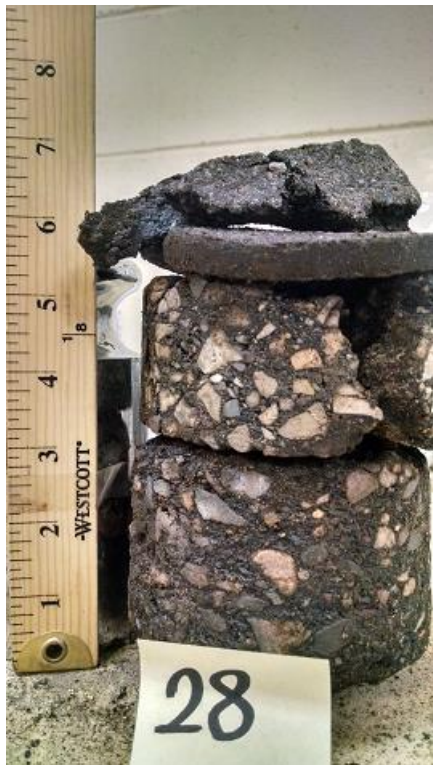
Figure A-19 Core 28, TH 95 (2013), cracked, wheelpath

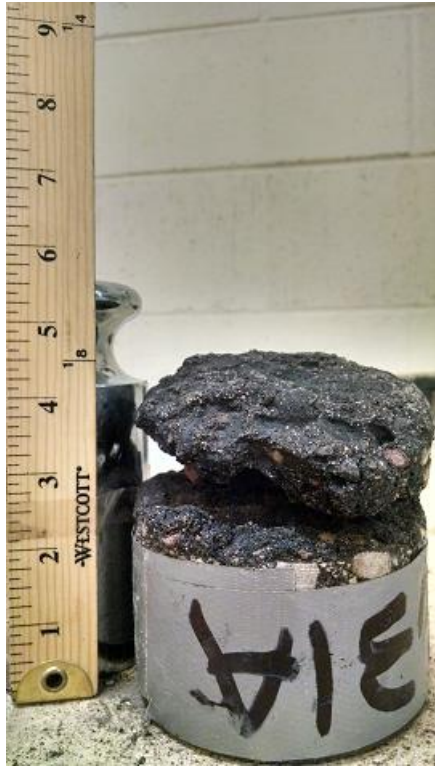
Figure A-22 Core 31, TH 95 (2013), cracked, wheelpath

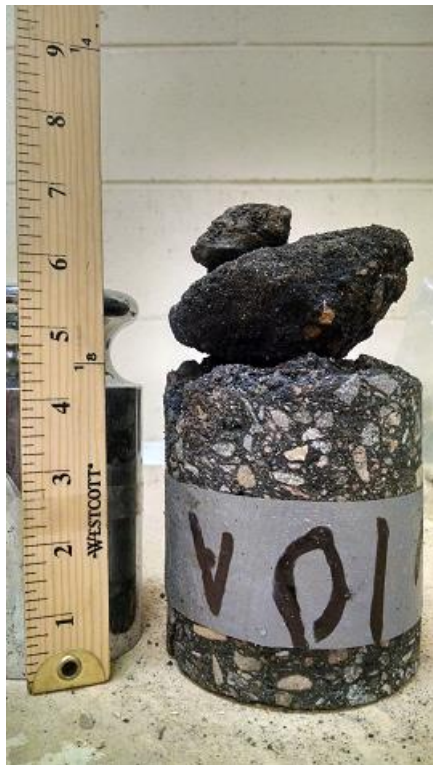
Figure A-25 Core 10; TH 47 (2014), cracked, wheelpath

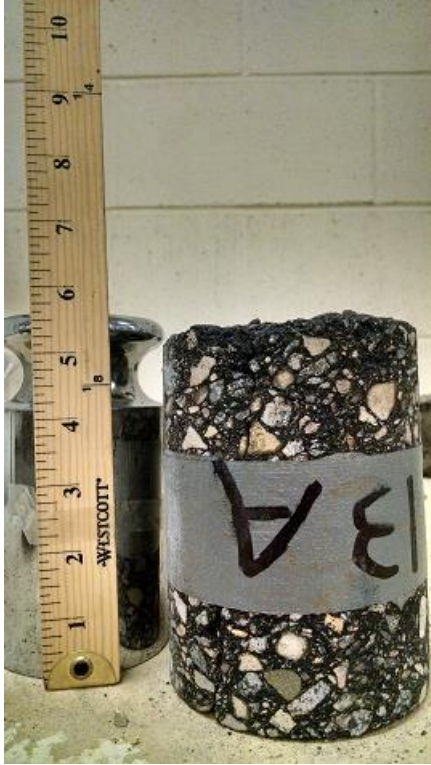
Figure A-28 Core 13, TH 47 (2014), cracked, wheelpath

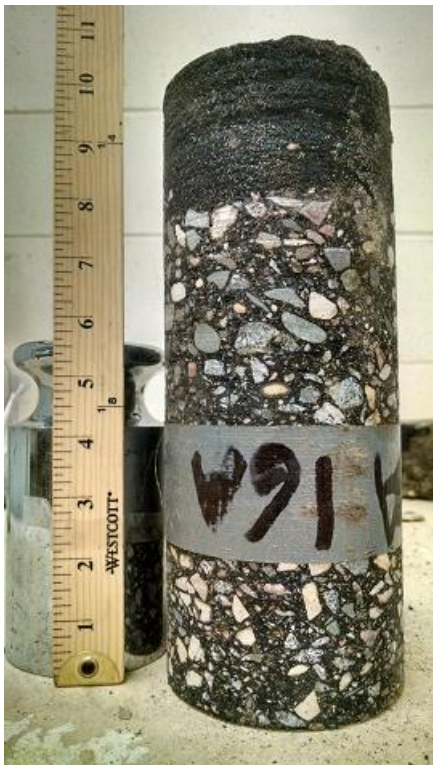
Figure A-31 Core 16, TH 47 (2014), cracked, wheelpath
