MnROAD Cell 64 Pervious Concrete First Year Performance Report

Final Report

February 2007

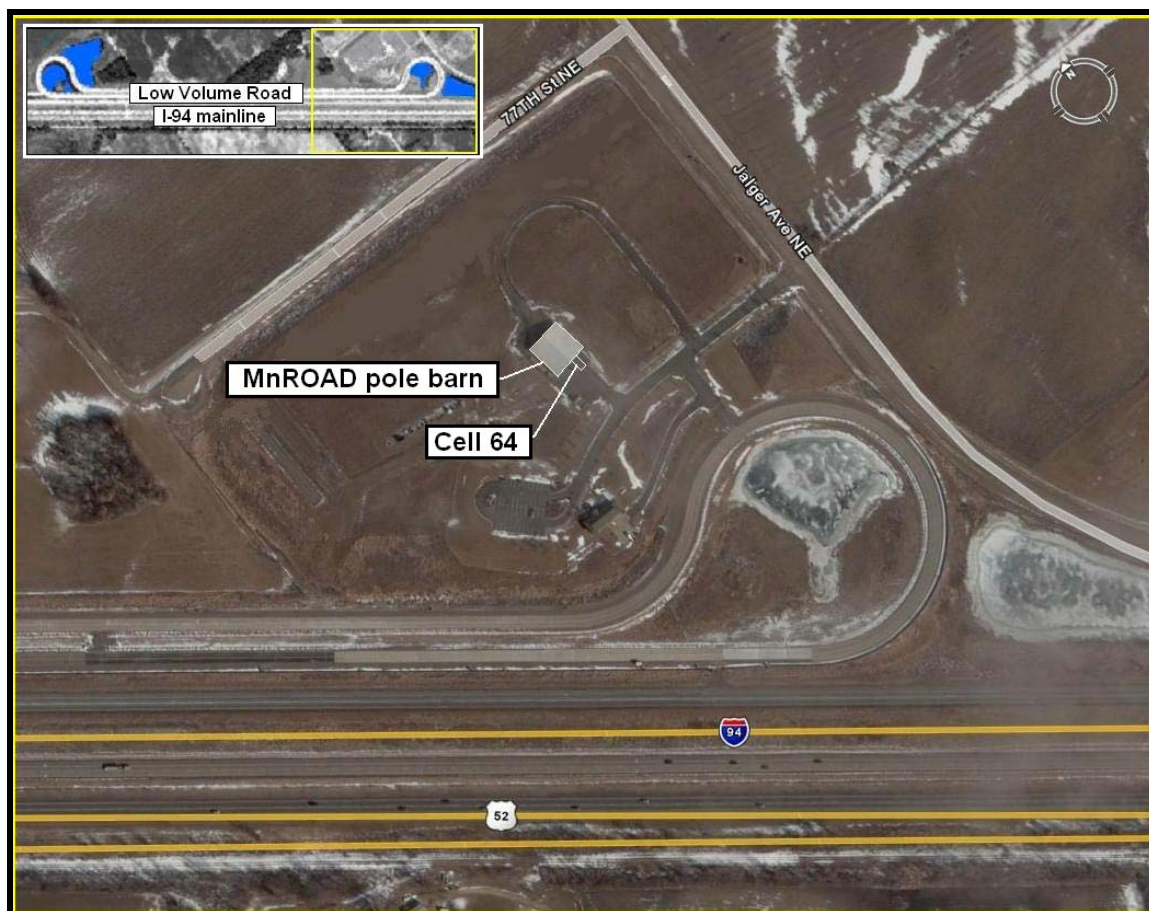
Figure 1. MnROAD Mainline, Low Volume Road, and Cell 64

Although not part of the MnROAD mainline or Low Volume Road (LVR), cell 64 is a part of the overall MnROAD facility. Cell 64 is located on the south side of the MnROAD pole barn as part of a bituminous parking lot (See Figure 2). A 64' by 20' section of the bituminous driveway was removed in order to place the drainage system, base, pervious concrete, and concrete border surrounding the pervious concrete driveway slab. The actual size of the pervious concrete portion of the driveway is 60' by 16', surrounded by a 2' concrete border on all sides.

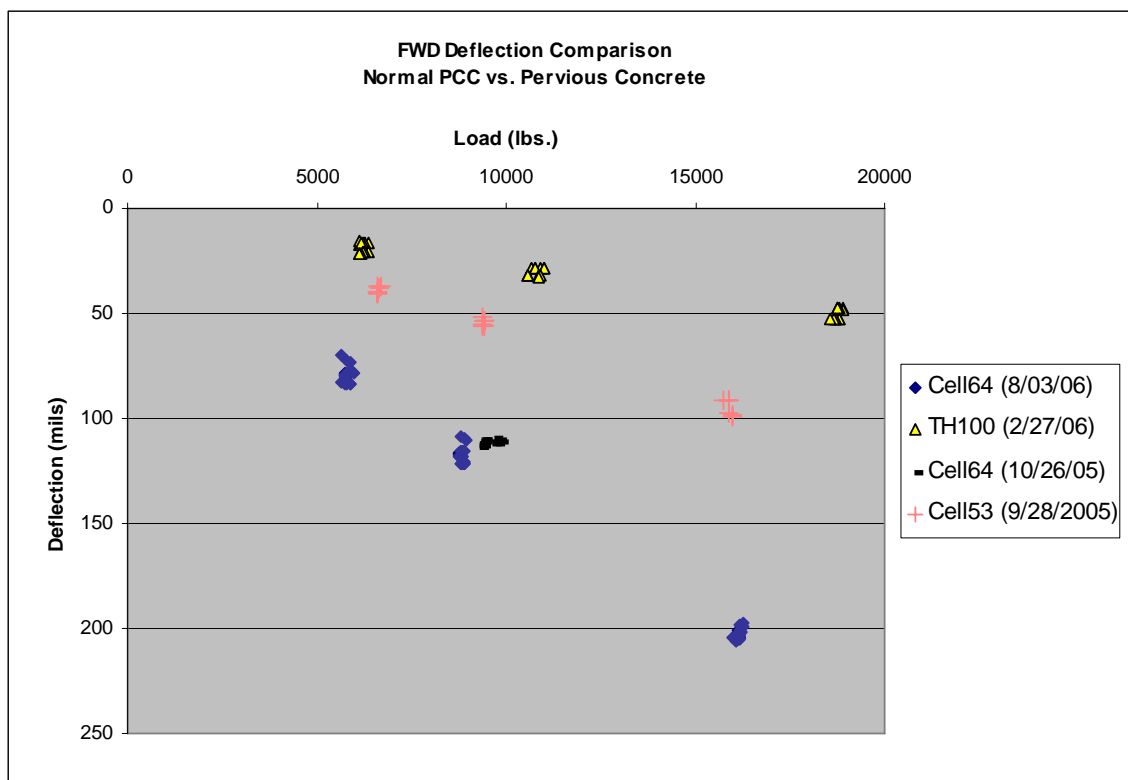
Figure 7. Comparison of Maximum FWD Deflections in Normal PCC versus Pervious PCC

The FWD was used to monitor deflections due to imparted stresses (see Appendix A for deflection basin graphs). Maximum deflection data was compiled from two different sites to compare with the Cell 64 deflection data. The FWD loads imparted greater deflections on the pervious concrete than either the control section of TH100 or the concrete paving of Cell 53. Part of the reason for this may be that the materials and pavement thicknesses differ somewhat between these three pavement sections. The pervious concrete of Cell 64 is 7" thick, while Cell 53 and TH100 pavements are 7.5" and 12" thick, respectively. However, the general pavement and base structure for Cell 64 and Cell 53 are most comparable. Figure 7 shows the maximum deflections of the Cell 64 pervious concrete driveway, the Cell 53 mainline concrete paving, and the TH100 control section.

Stress-strain characteristics of the pavement structure show FWD deflection basins that are larger than those of normal concrete, but within the same order of magnitude. The maximum deflections at drop stresses 6000, 9000 and 15000 lb. loads are 78.8 mils, 118.2 mils, 200 mils, respectively (August 2006). For comparison, the maximum deflection for Cell 53 in the MnROAD Low Volume Road (LVR), similar only in layer thickness but constructed of normal concrete, is 98.9 mils for a 15000 lb. load. The maximum deflection for a 15000 lb. load on TH 100 (Control Section CS2735, 12" pavement) is 39.4 mils. The most important item of note here is that the cell 64 pervious concrete exhibits deflections 2 to 5 times larger than those recorded in non-pervious (normal) concrete pavements (see Figure 7).

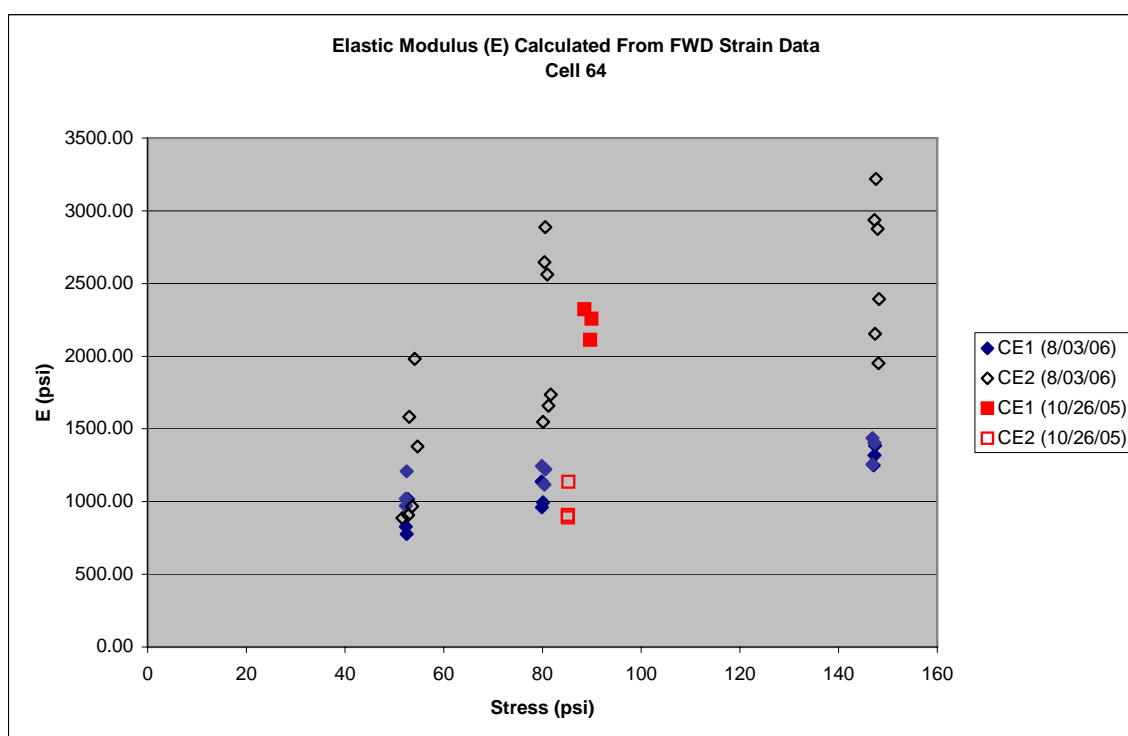
Figure 8. Elastic Moduli Calculated from Cell 64 FWD Strain Data

In addition to the monitored deflections from FWD testing, dynamic strain gauges CE-01 and CE-02 monitored the response to applied loads from the 80 kip Mn/ROAD truck, as well as loads from the FWD. The strain data was extrapolated to the surface of the driveway using plane strain theory, from which a modulus of elasticity (E) could be calculated knowing the stress imparted by the FWD. Figure 8 shows a comparison of the elastic moduli calculated from the Cell 64 FWD stress/strain data.

The strains measured by the concrete embedment sensors CE-01 and CE-02 exhibit time/temperature variability, which may explain a portion of the differences in the calculated moduli shown in Figure 8. The modulus values calculated for CE-02 may be higher, relative to CE-01, because the pervious concrete may have a lower porosity due to reduced air voids from overworking of the concrete during placement as mentioned in the Cell 64 Pervious Concrete Driveway Construction Report (1). The moduli were calculated using a simple $\sigma = E \cdot \epsilon$ strain equation. Where σ , E & ϵ are stress, elastic modulus (E), and strain, respectively. The strain is the value read from the CE strain gauges extrapolated to the surface of the pervious concrete, and the stress is the value calculated from the applied load over the footing area of the load actuator. To use this equation, we assumed that the deformation of the pervious concrete remains in the elastic regime.

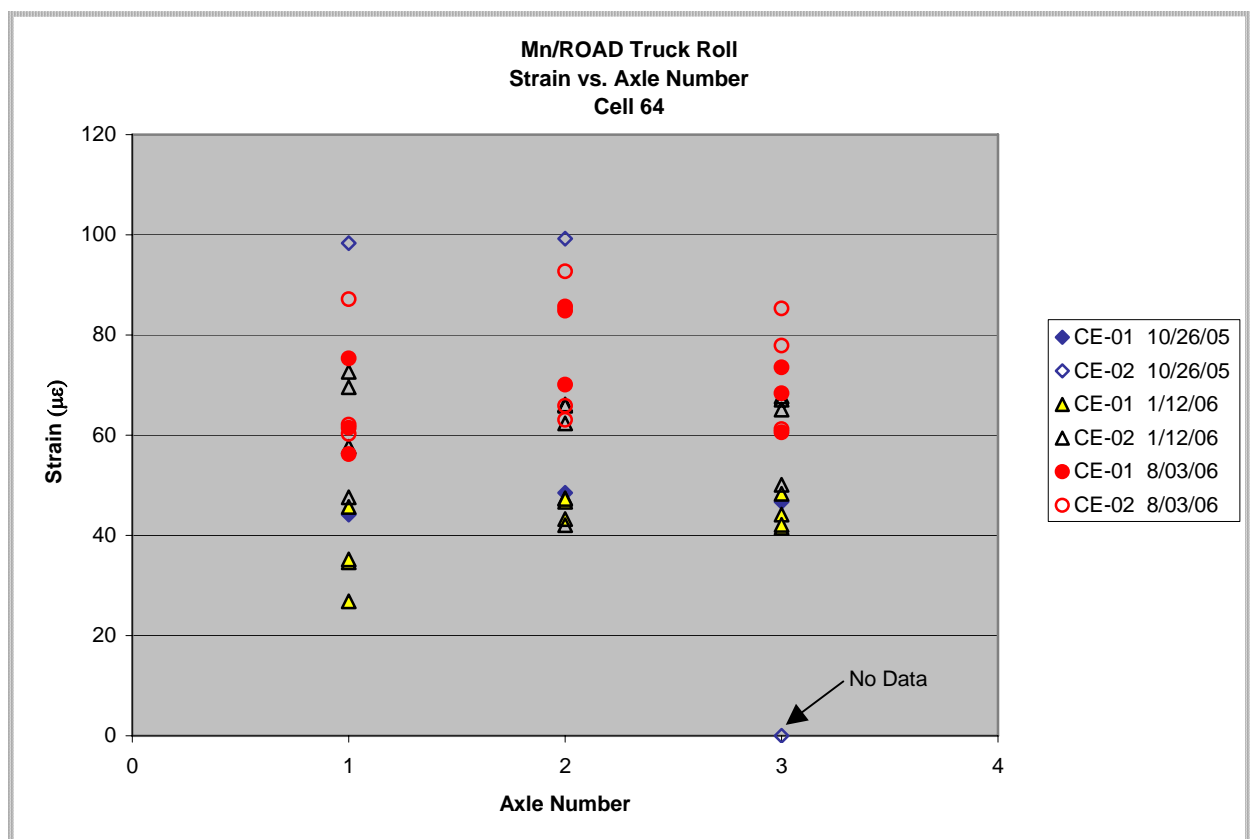
Figure 9. 80 kip MnROAD Truck Passes on Strain Gauges CE-01 and CE-02

Strain data recorded for the 80 kip Mn/ROAD truck passes on gauges CE-01 and CE-02. These strain values have been extrapolated to the surface of the concrete using plane strain theory, as with the FWD strain measurements. The depth of each sensor dictates the multiplier that the data is paired with. For this data CE-01 is multiplied by 1.4, and CE-02 is multiplied by 1.5. This correction factor is based on the thickness of the concrete and the relative depth of the strain gauge in the pavement, which will be confirmed once the gauges are cored out at some time in the future.

Figure 9 shows the corrected strain data for each axle set of the Mn/ROAD truck as it passed over the strain sensor. It is difficult to determine any trends at this point, though the average strains from CE-01 are less than the average strains measured by CE-02 (See the Table B1 in Appendix B). Additionally the measured peak strain is less accurate, relative to the FWD measured peak strains, due to difficulties with aligning the truck tires to the sensor locations.

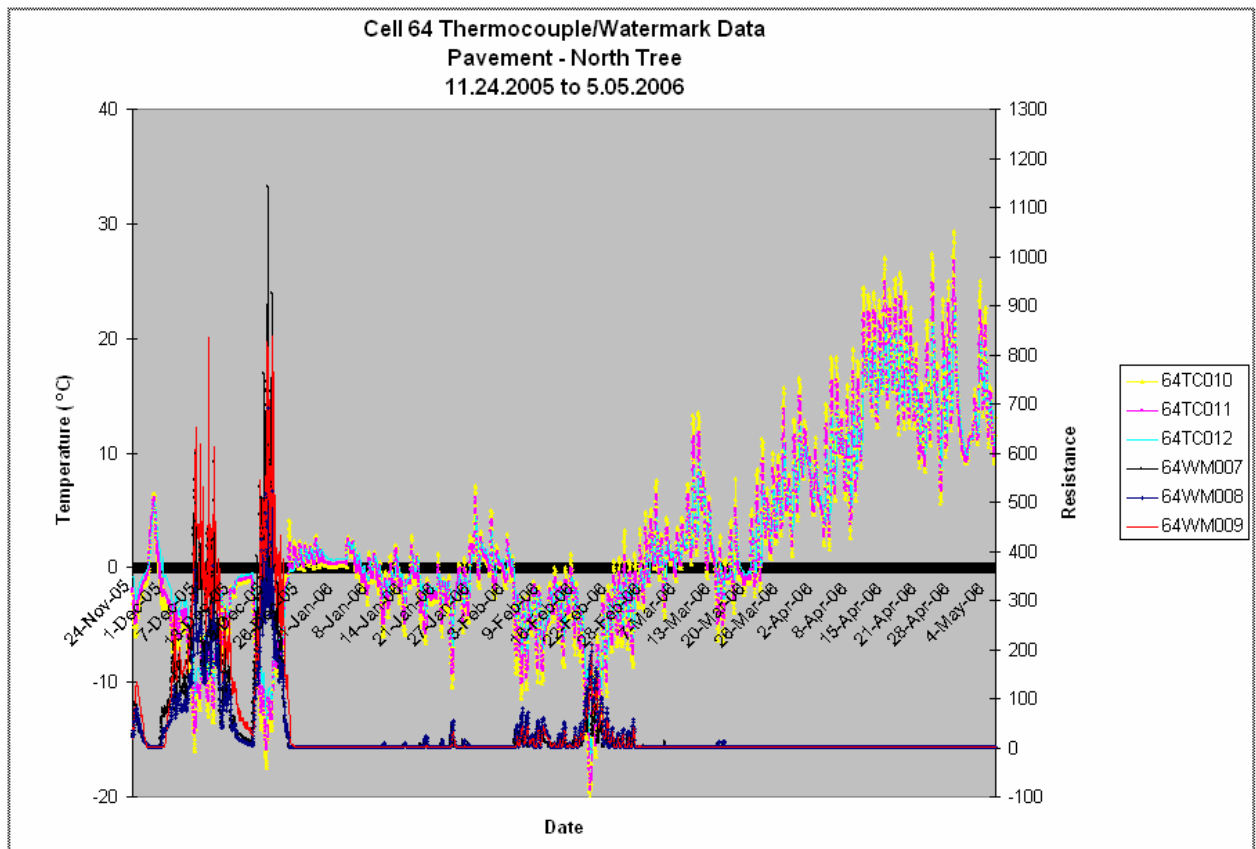
Figures 8 through 11 show the data from the thermocouple and watermark trees. The data has been broken down into graphs that represent the temperature profile and frost events within the pavement, and within the subgrade, respectively. This was done to separate the data curves for the purpose of clarity. Each individual watermark and thermocouple is numbered sequentially increasing downward. See Figure 5 for an illustration of the position of each sensor relative to depth. Limited freeze-thaw events are visible in the watermark data due to a mild winter, however, the temperature and watermark data correlate very well with the few freeze-thaw events that occurred. Mn/DOT will maintain continuous collection of the watermark/thermocouple data for months that have the potential for freezing conditions.

The black, dark-blue, and red lines show the resistance read by the watermark sensor for three discrete depth intervals. The resistance changes markedly when the sensor detects frost, and the graphs show several freeze thaw events that may have even reached to the CA-50 base material. The yellow, pink, and light-blue lines show the temperature at the corresponding thermocouple depth. Overall, the thermocouple temperature data coincide closely with the watermark data for each discrete depth, which helps to properly identify freeze-thaw events. For each graph, the yellow TC line matches the relative sensor depth of the black WM line, the pink TC line matches the relative sensor depth of the dark-blue WM line, and the light-blue TC line matches the relative sensor depth of the red WM line.

Figure 10. South Tree Thermocouple/Watermark Data, Pavement

Figure 11. South Tree Thermocouple/Watermark Data, Subgrade

Figure 12. North Tree Thermocouple/Watermark Data, Pavement

Figure 13. North Tree Thermocouple/Watermark Data, Subgrade

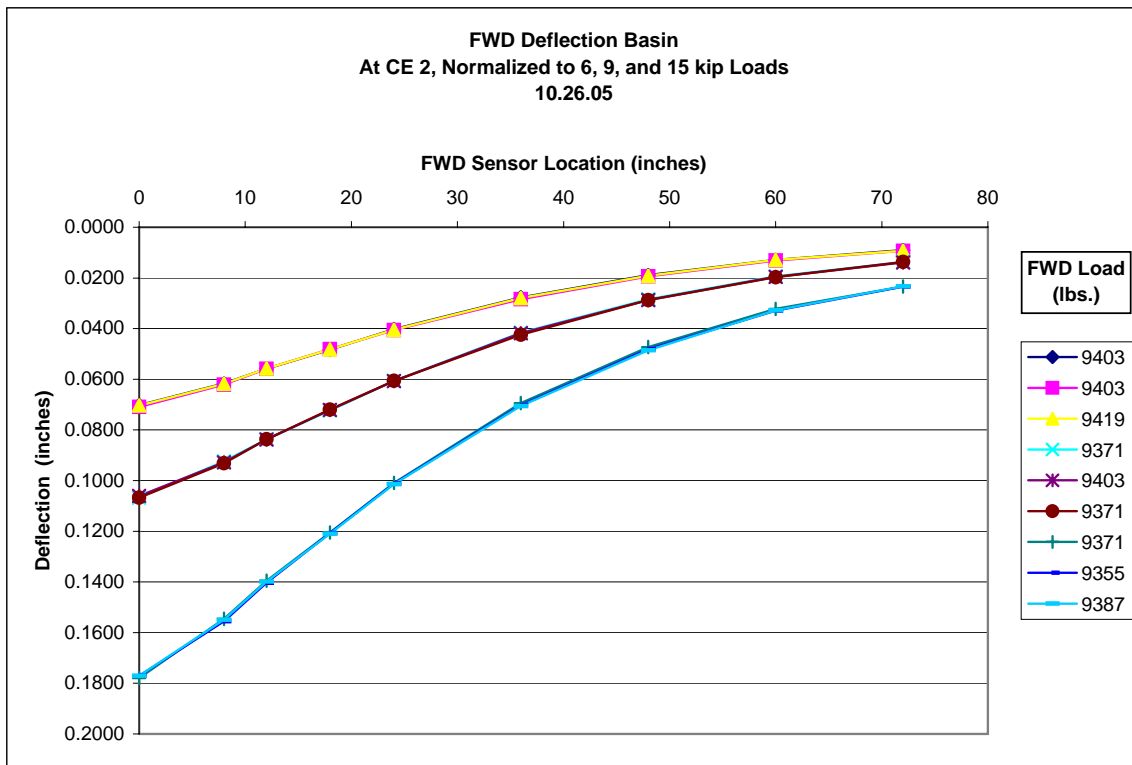
Deflection basins and stress distribution curves were plotted for each load setting (6000 lbs., 9000 lbs., and 15000 lbs.). In addition each of the three FWD loadings, and their corresponding deflections, were normalized to 6000 lbs., 9000 lbs., and 15000 lbs. in order to compare the FWD strain data with the strain measurements obtained by sensors CE-01 and CE-02. The dual tire load on each side of the rear axles on the 80 kip MnROAD truck is approximately 8500 lbs., derived from the 17000 lb. per axle load rating of the truck (12 kips on the front axle, and 17 kips per each of the four rear axles, for a total of 80 kips). Plots of the FWD deflection basins along with the corresponding strain gauge data from FWD and MnROAD truck loading are shown in Appendices A and B, respectively.

Figure A1. FWD Deflection Basin at CE-02, 1st Run, 10.26.05

Figure A2. FWD Deflection Basin at CE-01, 2nd Run 10.26.05

Figure A3. FWD Deflection Basin at CE-02, 3rd Run 10.26.05

Figure A4. FWD Deflection Basin at CE-01, 1st Run 8.03.06

Figure A5. FWD Deflection Basin at CE-01, 2nd Run 8.03.06

Figure A6. FWD Deflection Basin at CE-02, 3rd Run 8.03.06

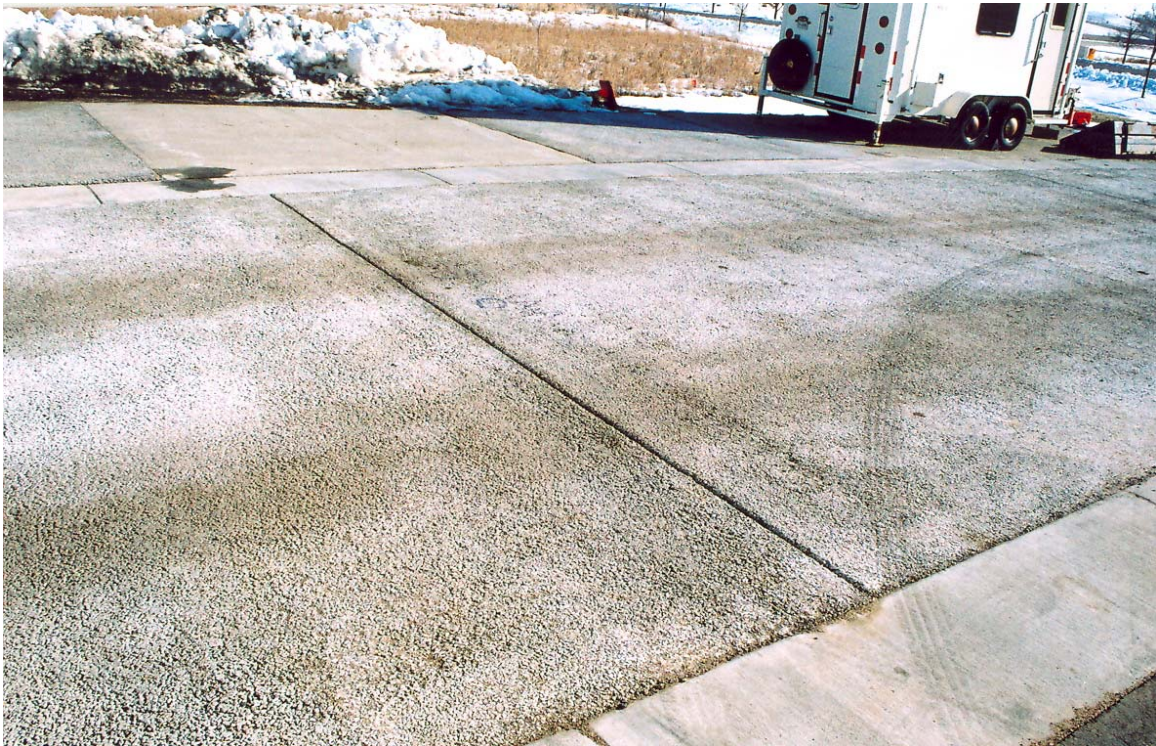
Figure C1. Tooled Joint, Cell 64 Facing Southeast, 9.21.06

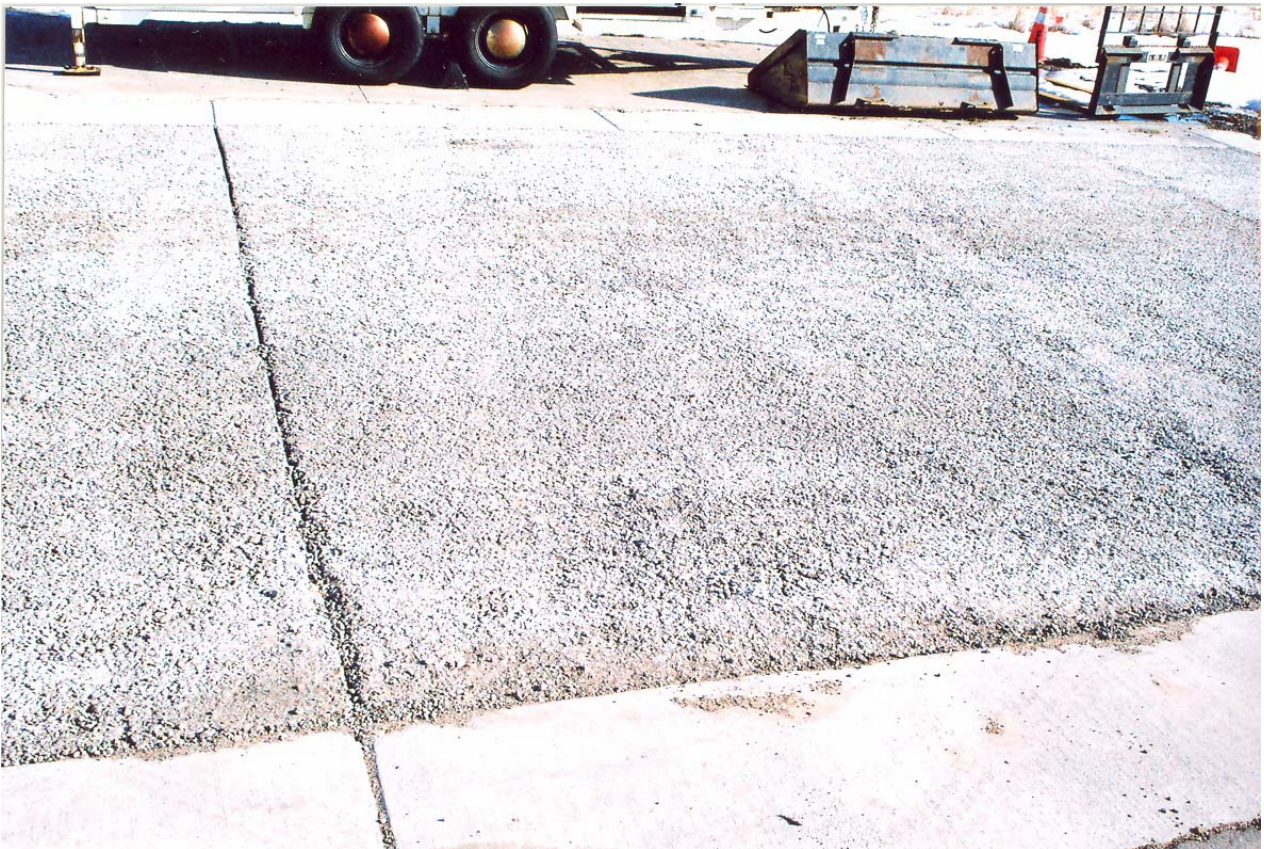
Figure C2. Header/Construction Joint, Cell 64 Facing Southeast, 9.21.06

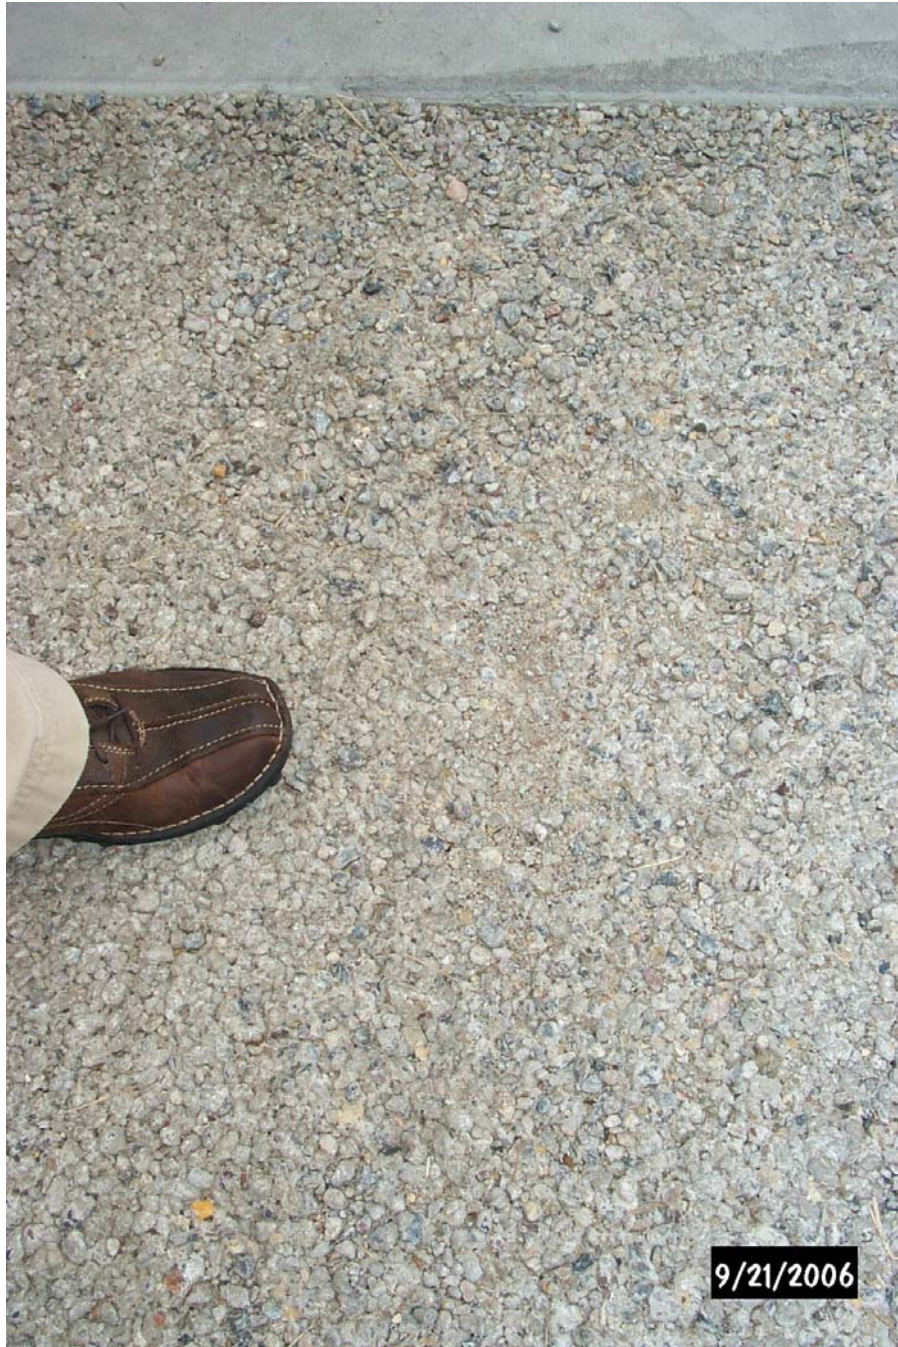
Over the winter of 2005, the top ¼” of the central to southern part of the pervious driveway has raveled somewhat due to freeze thaw action, frequent use by MnROAD equipment, and/or possible overworking of the concrete during placing. Further degradation of the driveway beyond this top quarter inch does not appear to be present, and the cores taken by Mn/DOT on August 14, 2006 exhibit no macro cracking. The northern portion of the driveway exhibits no surficial macro cracking, very little raveling, joint spall, or other abnormal condition, and appears to be in very good condition overall. Furthermore, the Cell64 driveway and Test Pad 4 have not experienced frost heave. Test Pad 3 experienced approximately 1” of frost heave most likely due to the lack of stable base material, and freeze-thaw action.

Figure C3. Mix #2 Surface Raveling, West Edge Cell 64, 9.21.06

Distress observations indicate that poor finishing techniques resulted in raveling and spalling of the pervious driveway surface. The most severe observations of spall/ravel were located in areas that may have been affected by over finishing during placement, the majority of which have occurred in the months after placing the pervious concrete. After further examination, the distress was found to be topical and has not visibly worsened after the first year. In general, the mixture consisting of crushed aggregate performed better than the intermix of crushed and rounded aggregates. This corroborates the findings of the Iowa mix design report for Pervious Concrete by Schaefer et. al. (3).

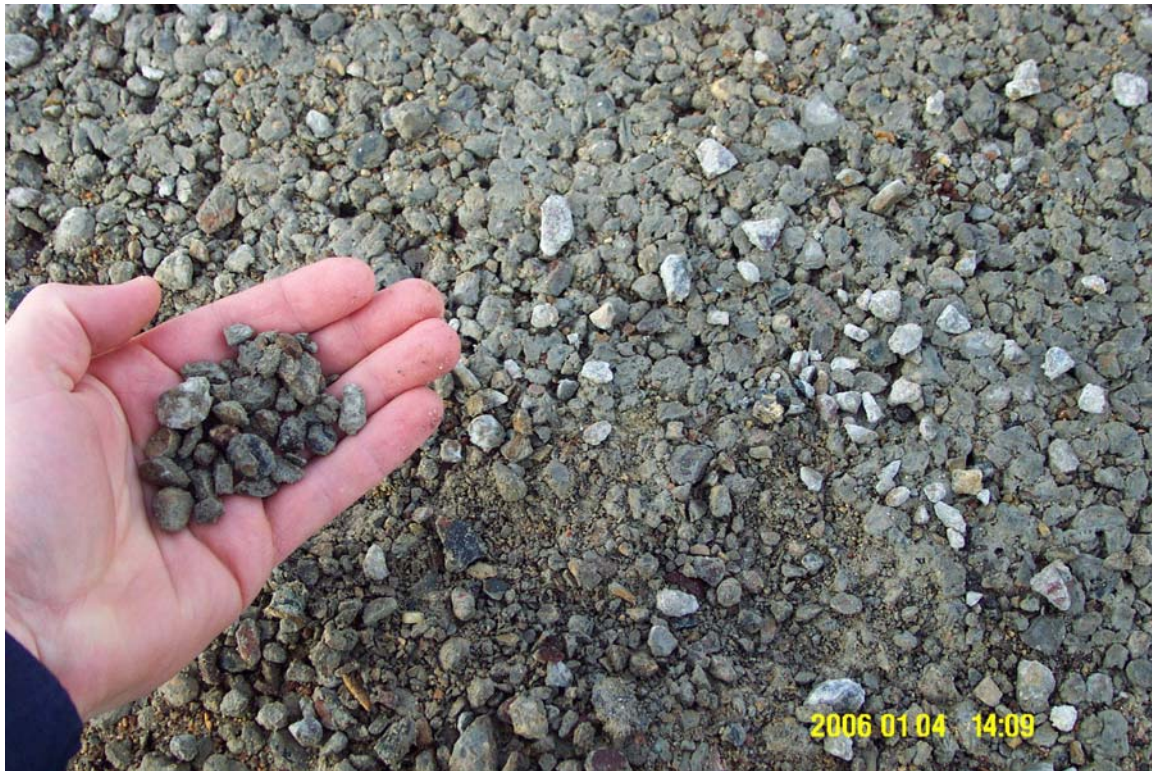
Figure C4. Mix #2, Surface Raveling, 01.04.06

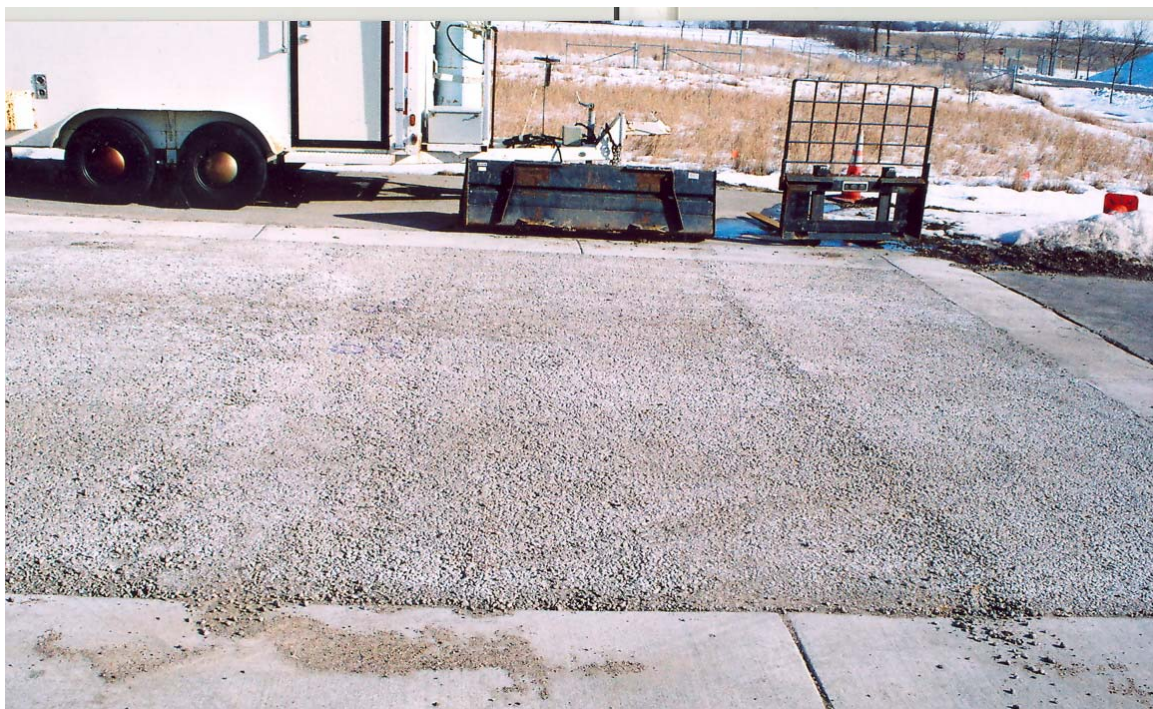
Mix #1 shows low spalling at all joints except the tooled joint and the joint where Mix #1 and Mix #2 are co-terminous. These two joints show moderate spalling and raveling, respectively. The surface of Mix #1 shows low raveling of low severity. Mix #2 shows moderate to severe raveling on the surface of the concrete, with moderate to severe raveling and spall at the joints. Mix #3 shows low raveling on the surface with moderate to severe raveling and spall at the joints. See Figure 6 for a complete diagram of the distress map.

Figure C5. Mix #2 & Mix #3 at South End of Cell 64 at Coterminous Joint, 9.21.06
