# Effects of Implements of Husbandry (Farm Equipment) on Pavement Performance

Minnesota  
Department of  
Transportation

Lev Khazanovich, Principal Investigator  
Department of Civil Engineering  
University of Minnesota

Research Project  
Final Report 2012-08

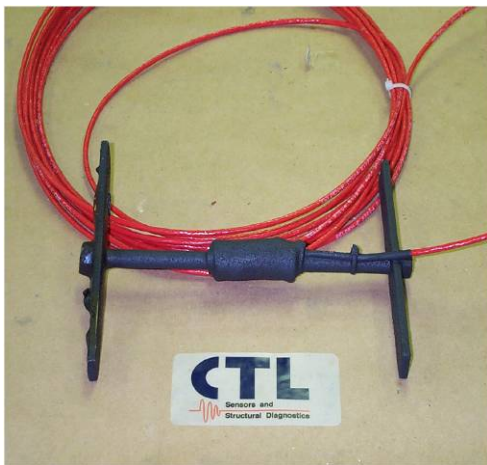
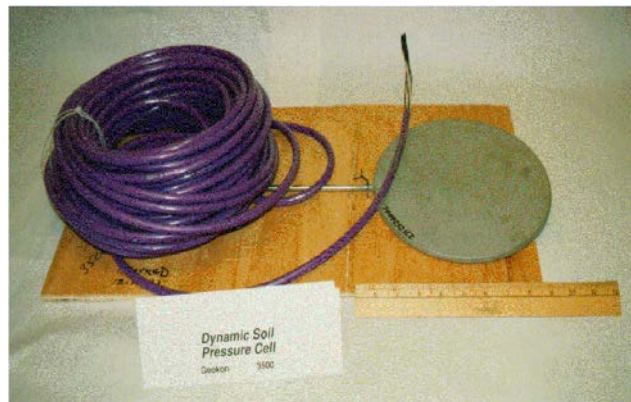
**Figure 3.4. Flexible pavement instrumentation (a) H-shape asphalt strain gauge (b) earth pressure cell**

response under moving traffic loads. The flexible pavement was instrumented with the H-shape asphalt embedment strain gauge ASG-152 by Construction Technologies Laboratories (CTL) shown in Figure 3.4(a). Earth pressure cells were placed on top of the subgrade layer to measure dynamic vertical stress response under moving traffic loads. The earth pressure cells installed at the flexible pavement sections were Geokon 3500 with Ashcroft K1 transducers shown in Figure 3.4(b). Additionally, linear variable differential transducers (LVDT) were installed at mid-depth of the base layer to measure vertical and horizontal displacements in the base layer. It is also important to determine environmental effects within the pavement structure during testing periods. Therefore the flexible pavement sections were equipped with thermocouple trees and time domain reflectometry (TDR) to measure variations in temperature and in situ moisture contents, respectively. All the above sensors were connected to the MnROAD data acquisition systems: the Megadec-TCS for strain gauges and earth pressure cells and the NI system for the LVDTs as shown in Figure 3.5.

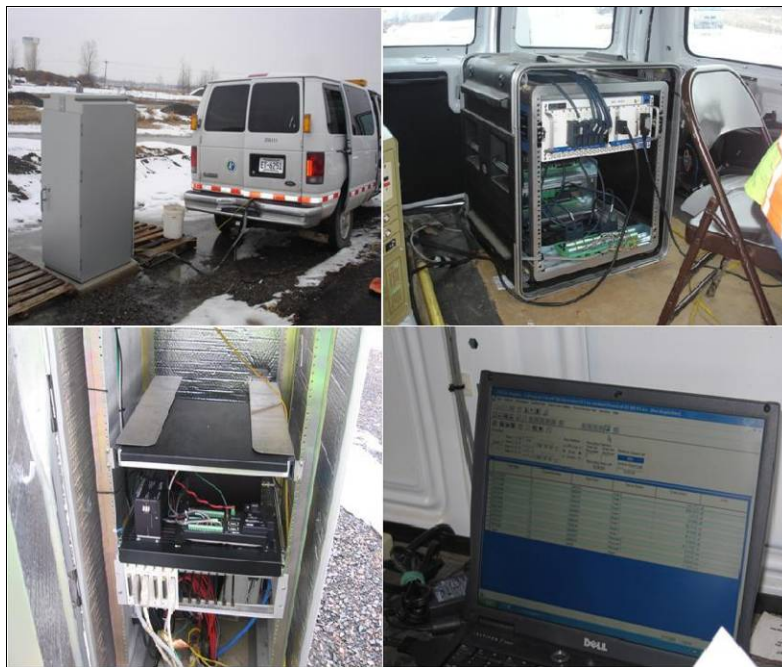
**Figure 3.14. MnROAD pavement response data collection system**

Data acquisition for this research study was accomplished with various types of electronic data collection systems at MnROAD as shown in Figure 3.15. Pavement responses data were collected electronically. All the sensors embedded into each test section were wired into the cabinet as shown in the upper left picture in Figure 3.15.

MnROAD data acquisition system starts to record response measurements when a test vehicle approaches a testing cell and passes a trigger. These systems collected response measurements at a rate of 1,200 data points per second (1,200 Hz) and each vehicle pass typically has a collection time of fifteen to eighteen seconds (Lim, 2011). Approximately 18,000 to 22,000 data points per sensor were recorded under one vehicle run.

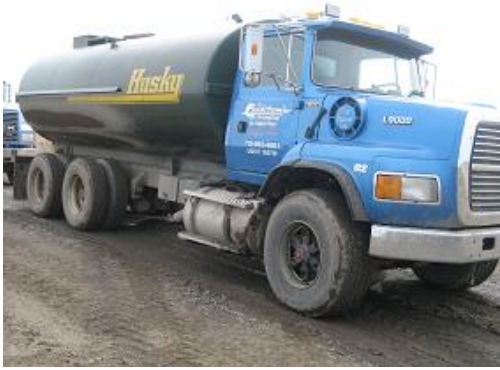
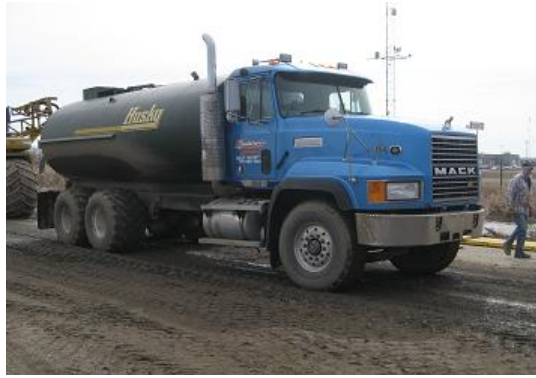
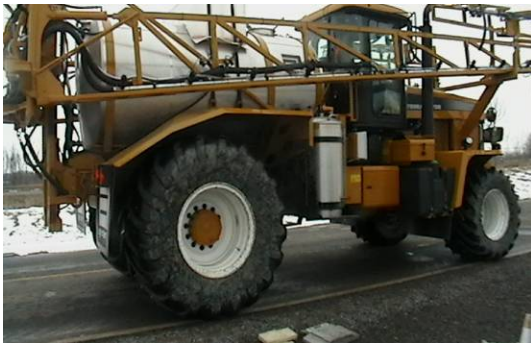
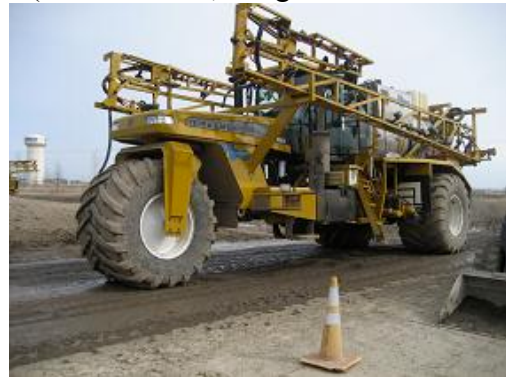
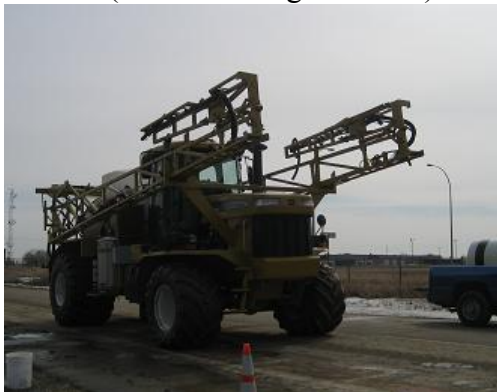
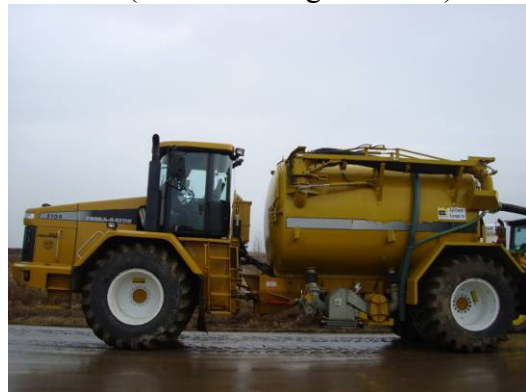
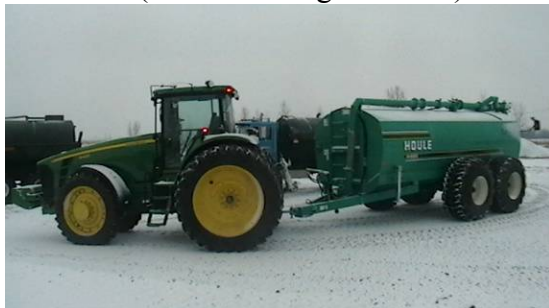
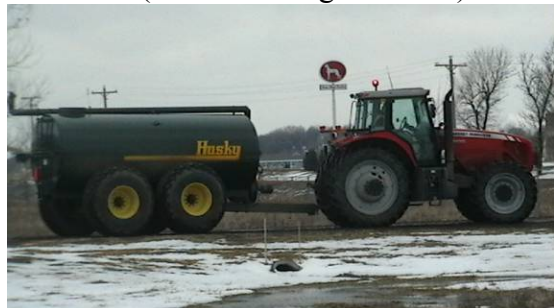
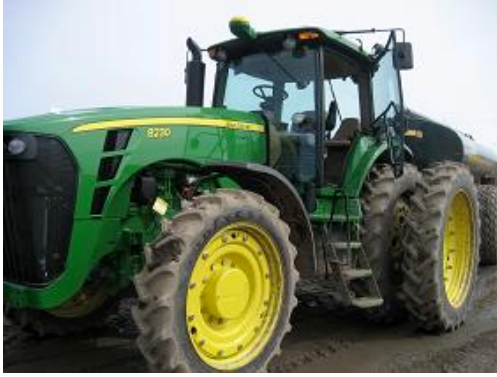
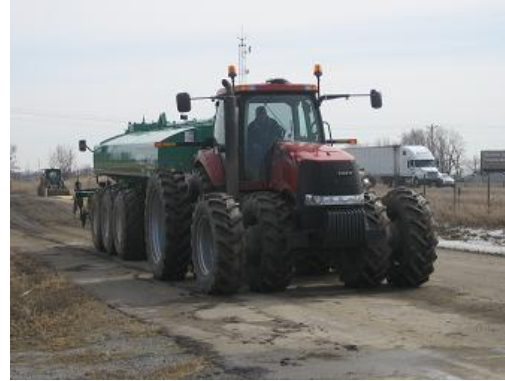
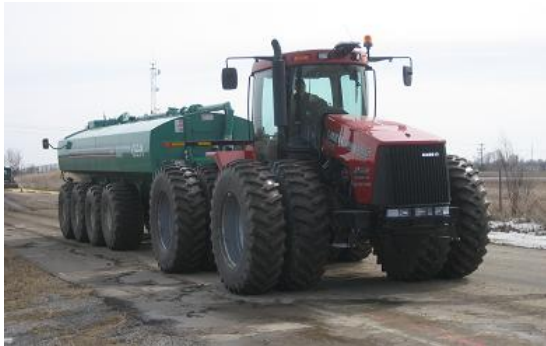
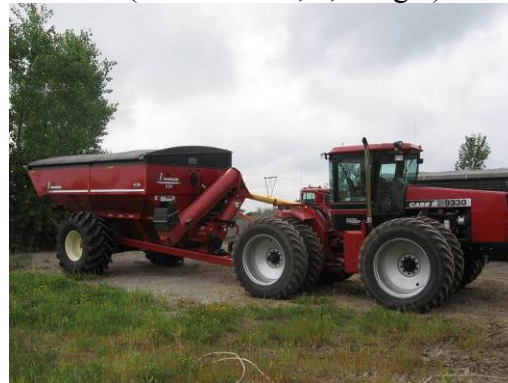
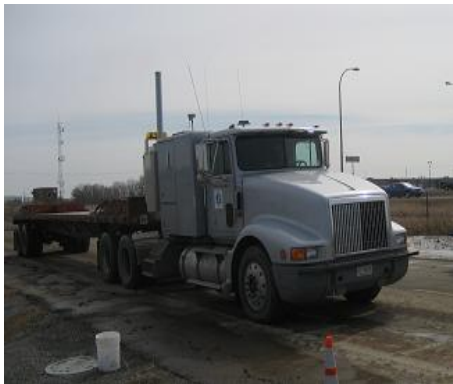
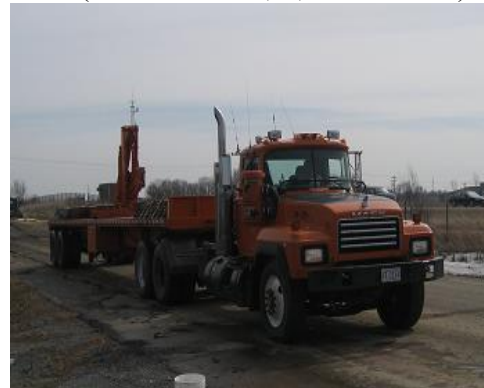
**Figure 3.15. Images of tested vehicles**

Field testing was conducted in 2008, 2009, and 2010. For each round of testing, a test program was developed specifically for the availability of vehicles and manpower. A total of twelve agricultural vehicles were tested throughout the duration of this study. An additional two typical five-axle semi tractor-trailers was included in the test to be used as reference vehicles. These semis have a gross vehicle weight of 80 kips and 102 kips labeled as Mn80 and Mn102, respectively. Due to the large number of vehicles, each vehicle was given a unique vehicle ID to simplify the identification process. A list of vehicles that were tested in this study is included in Table 3.3. Images of all tested vehicles are shown in Figure 3.15.

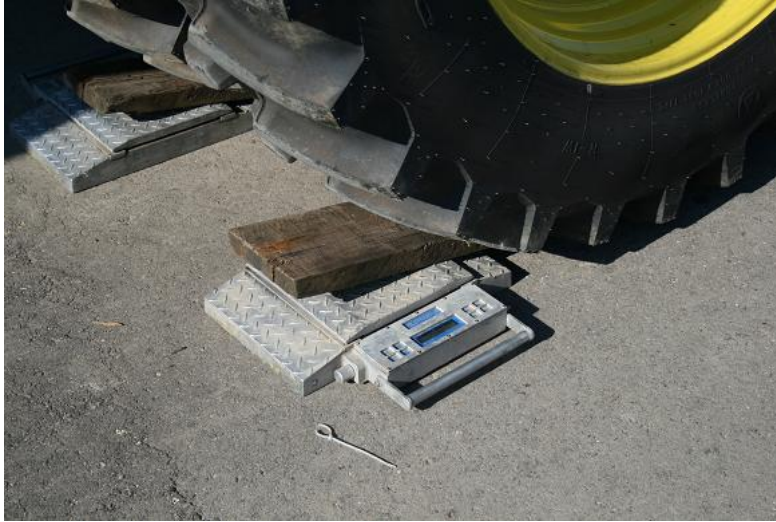
**Figure 3.16. Weighing vehicles using portable scales**

The test program required vehicles to be tested at varying load levels. For each load level, measurements of all vehicle weights were obtained using portable scales. Portable scales were placed in front of each of the vehicles' wheels and the vehicles were carefully driven to place each wheel on top of the scales. It was ensured that the entire vehicle was leveled and no weight bias occurred between axles and between wheels. Figure 3.16 shows an example obtaining weight measurements using the portable scales. Additionally, vehicle axle configurations, wheel spacing, and wheel widths were measured for all tested vehicles. Appendix B contains the vehicle axle weights and dimensions.

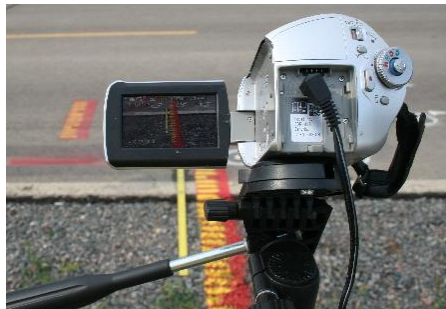
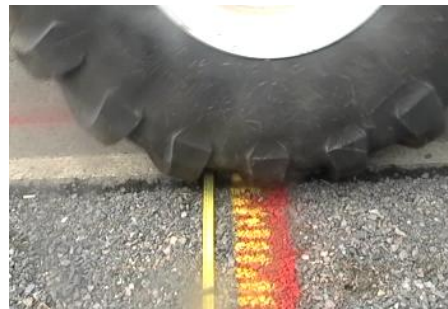
**Figure 3.18. Traffic wander measurements (a) using the Panasonic video camera (b) for a vehicle pass**

Initially, scales were painted onto the pavement surface using scaled pavement stencils but the paint was quickly fading with increasing number of traffic. Therefore, steel scales with 1 in. teeth spaced 1 in. apart were fabricated and installed onto the pavement surface at each of the test sections (i.e. cells 83, 84, 32, and 54) as a more permanent solution. Figure 3.17 shows the initial painted scale and the more permanent steel scale installed at cell 84 of the flexible pavement section. The scales were installed as close as possible to the sensor locations but not too close as it may affect pavement response measurements. Video cameras were placed at each cell of the test sections and configured to produce the optimal view of the scale. A Sony and a Panasonic video camera were used in this measurement. Figure 3.18 shows the video camera used for this measurement and an example of a vehicle pass as it drives over the painted scale.

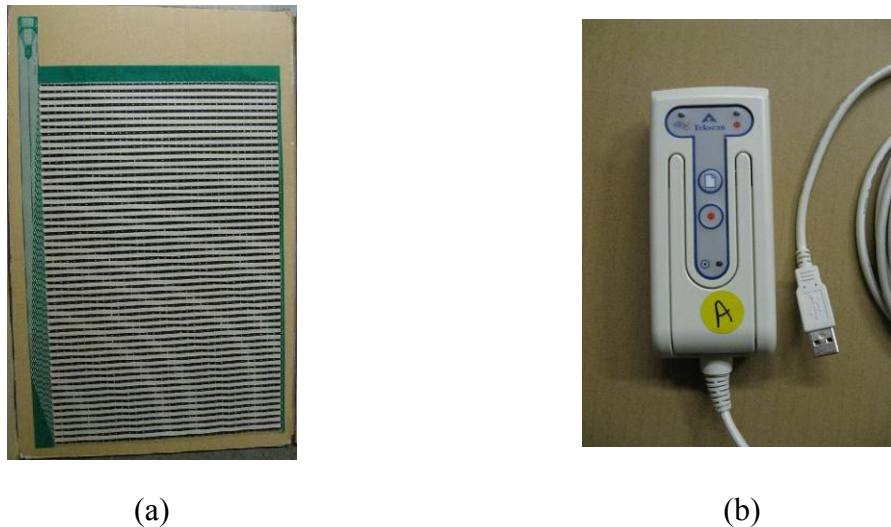
**Figure 3.19. Tekscan hardware components (a) 5400N sensor mats (b) Evolution Handle**

In this study, measurements of tire footprint and vertical contact pressure were obtained using a device called Tekscan. This device consists of four sensorial mats (model 5400N) and four data handles (Evolution Handles) with attached USB cables as shown in Figure 3.19. Each of the sensorial mats is approximately 24 in. by 36 in. with a sensing area of 22.76 in. by 34.80 in. The mats were placed according to the 5400NQ sensor map as per Tekscan Inc. recommendation shown in Figure 3.20. This setup requires four 5400N sensorial mats to be positioned in a two by two arrangement. Using the 5400NQ setup, the sensing area is 45.51 in. by 69.61 in. Each sensorial mat was connected to one Evolution Handle as shown in Figure 3.20 and connected to the USB ports of the computer. Data was collected using the I-Scan version 5.90 software.

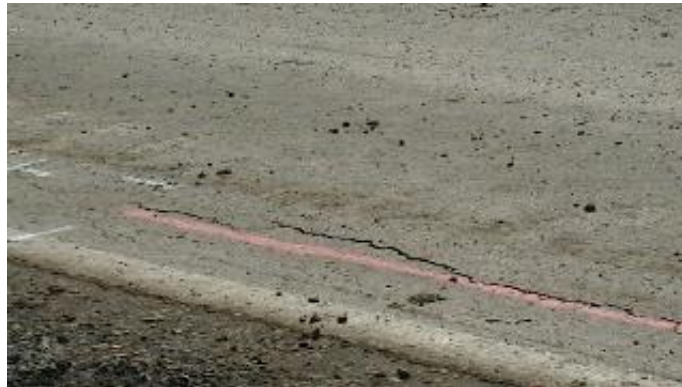
**Figure 3.21. Failure at cell 83 westbound lane on 18<sup>th</sup> March 2009**

After each round of testing, distress surveys were conducted. Initial signs of pavement distress were observed on the third day of testing during spring 2009 (18<sup>th</sup> of March 2009). At cell 83 westbound lane, a longitudinal crack developed approximately 12 in. away from the pavement edge. The condition of the pavement surrounding the longitudinal crack further deteriorated with increasing number of vehicle passes. At the end of the following day of testing (19<sup>th</sup> of March 2009), the pavement section had completely failed in extreme rutting. The total length of the rut was approximately 31.5 ft. at just 14.5 ft. away from the closest sensor location. Figure 3.21 and Figure 3.22 show the initial longitudinal crack and the subsequent rutting failure of cell 83 westbound lane in spring 2009.

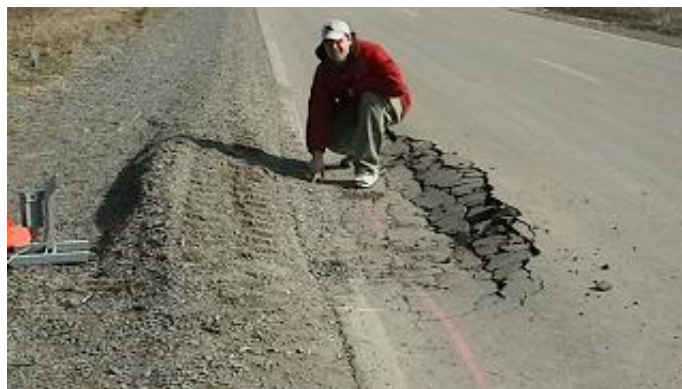
**Figure 3.22. Failure at cell 83 westbound lane on 19<sup>th</sup> March 2009**

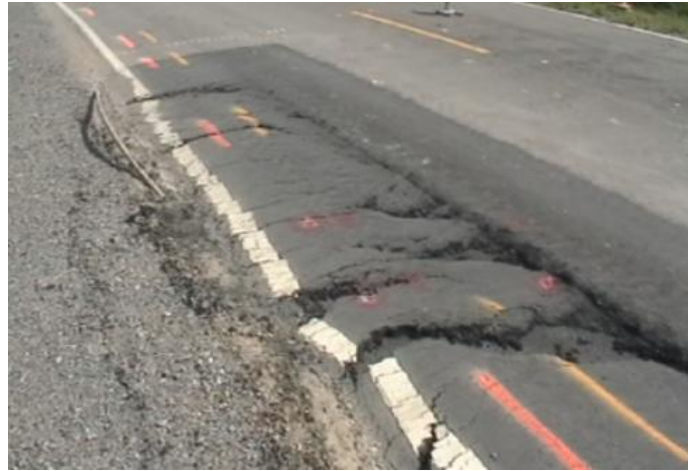
**Figure 3.23. Slippage cracks**

The failed section of cell 83 westbound lane was repaired and patched in preparation for fall 2009 test. On 24<sup>th</sup> August 2009 which was the first day of testing in fall 2009, the patched area experienced slippage cracks shown in Figure 3.23. This failure was due to insufficient bonding between the wearing and binder courses of the asphalt layer. Testing was shifted to cell 83 eastbound lane where it unexpectedly failed on the 25<sup>th</sup> August 2009. Before testing was shifted back to cell 83 westbound lane, the previous slippage cracks were overlaid with  $\frac{3}{4}$  in. steel plates in an attempt to slow down the pavement deterioration as number of vehicle passes and load levels increase. However, deterioration of that section was imminent and rutting at the pavement

edge continued to propagate until the last day of fall 2009 test (27<sup>th</sup> August 2009). A forensic study was conducted on the failure site. A report prepared by the Minnesota Department of Transportation is included in Appendix F [9].

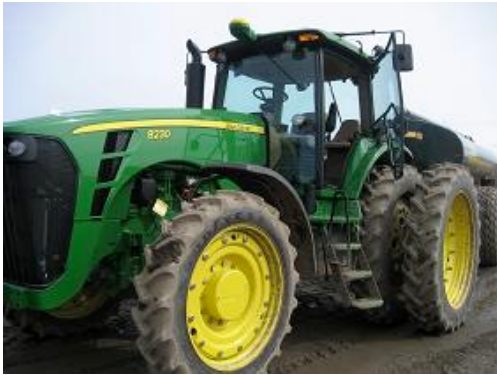
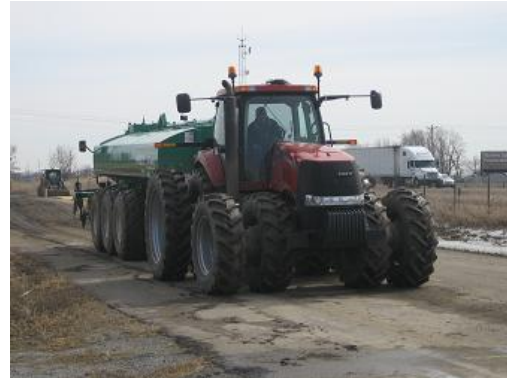
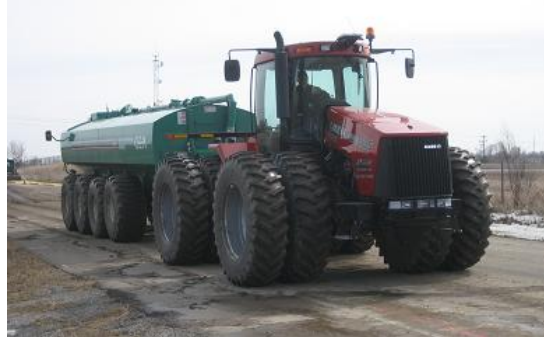
**Figure 5.47. Vehicles with increasing tank capacity and number of axles**

In the past decade, vehicle manufacturers of the agricultural industry began to design and produce larger equipment with larger capacities. However in order to be operating legally on public roads, axle weight restrictions must be met. To help achieve this goal, vehicles are equipped with additional axles. In this study the responses from vehicles T6, T7, and T8 shown in Figure 5.47 were compared. These vehicles are equipped with four, five, and six total axles, respectively, and have tank capacities of 6,000 gallons, 7,300 gallons, and 9,500 gallons, respectively. The following table (Table 5.5

Referring to Table 5.5, note that the first two axles for all three vehicles belong to the tractor. The axle weights of interest here are those belonging to the tankers which are axles three to six. Increasing the tank capacity evidently increases the overall vehicle weight. By adding axles to the tankers the weight per axle was successfully decreased with vehicle T6 having the heaviest tanker axle at 33,500 lb, T7 at 26,300 lb and T8 at 23,700 lb. Figure 5.43 and Figure 5.46 show that vertical subgrade stresses for T6 was largest followed by T7 and finally T8 for both spring 2009 and fall 2009 test. Figure 5.48 above clearly shows that vehicle T6 generates larger

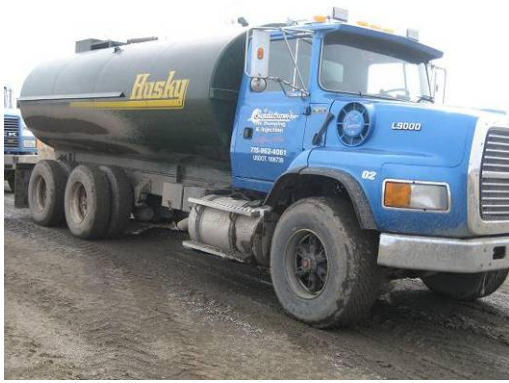
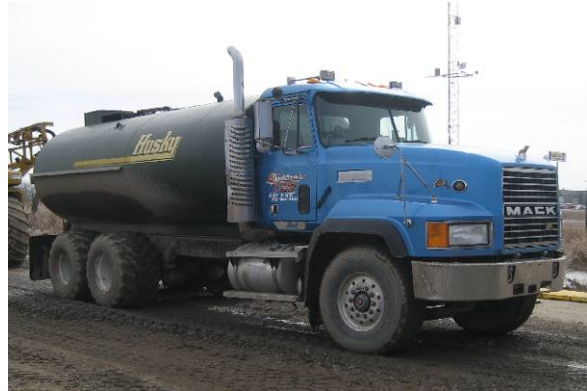
**Figure 5.56. Straight trucks denoted as (a) vehicle S4 fitted with radial tires (b) vehicle S5 fitted with flotation tires**

In this section, two similar straight trucks with the same tank capacity of 4,400 gallons were fitted with two different tire types on the tanks, one with regular radial ply dual tire configuration, and the other with a flotation single tire configuration. Vehicle S4 was fitted with the radials and S5 with flotation tires as shown in Figure 5.56. Comparisons were made using contact area and contact pressure measurements from Tekscan. Additionally, asphalt strains and subgrade stresses produced by these two vehicles were evaluated.

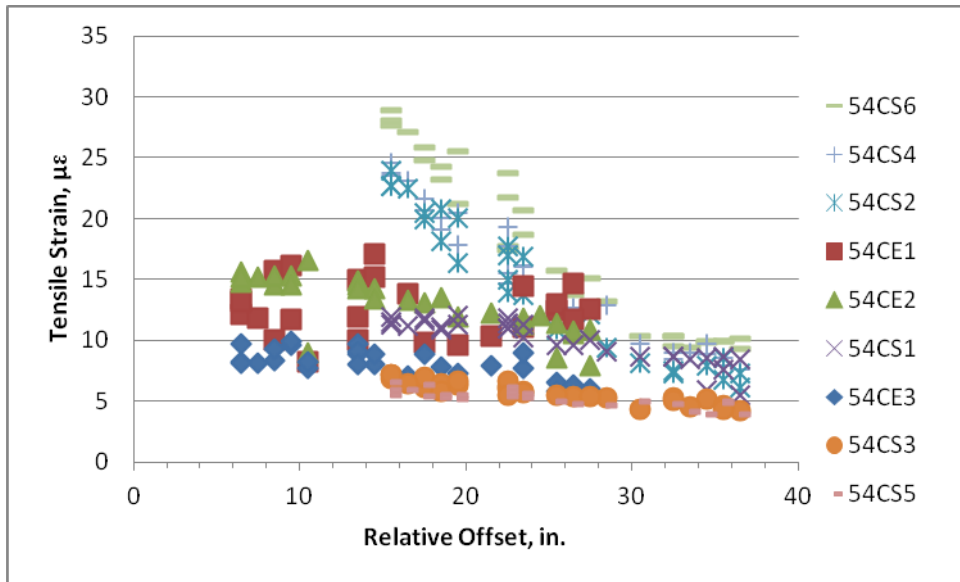
**Figure 6.15. Pavement strains from all 9 sensors produced by Mn80 on cell 54**

As shown in Table 6.5, all 9 strain sensors were functional during fall 2009 field testing. Pavement strains from all these 9 sensors produced by Mn80 are graphically presented in Figure 6.15. As presented in Figure 6.15, pavement strain from sensor “54CS6” exhibited the highest value among all nine strain sensors. This is because sensor “54CS6” is located at middle edge, bottom of the slab where the critical bending stress occurs when pavement experience heavy farm equipment loading. Therefore, strains produced by all farm equipment during fall 2009 test season on cell 54 from this sensor were chosen for future data analysis.

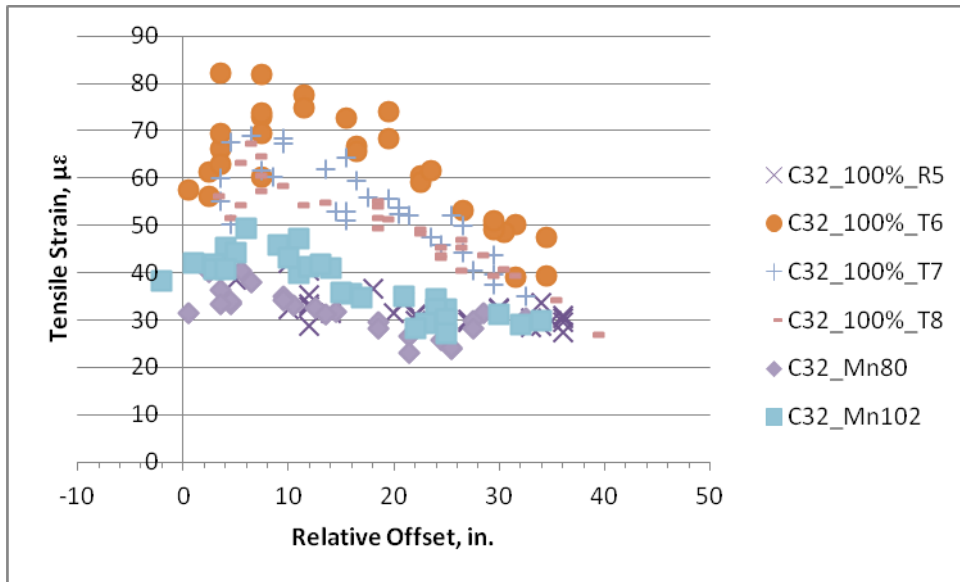
**Figure 6.20. Cell 32 pavement strain responses during fall 2009 field testing at 100% load level**

Figure 6.20 and Figure 6.21 are graphical comparisons of the pavement strain responses generated by various vehicles when they were fully loaded and tested on cell 32 and cell 54, respectively.

As shown in Figure 6.20, the strain responses generated by T6, T7, and T8 at cell 32 were observed higher than those of Mn80 and Mn102. However, the strain responses generated by most farm vehicles tested at cell 54 were same as or less than those of Mn80 and Mn102. Some of strain responses generated by T8 at cell 54 were observed higher than MnROAD vehicles when the relative offset was bigger than 20 inches. Additionally, by comparing the magnitude of the strain response from Figure 6.20 and Figure 6.21, it could be easily found that pavement strain on cell 32 are higher than that produced on cell 54.

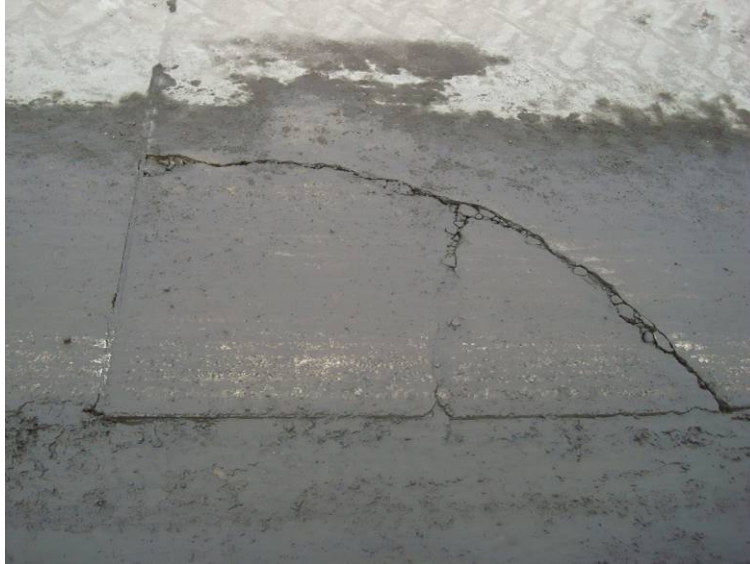
**Figure 6.24. Aggravated corner break from fall 2009 testing cycle**

No visible distress was observed on cell 54. On the cell 32, the corner break observed during the fall 2009 field testing cycle aggravated during the spring 2010 test cycles as seen in Figure 6.24.

The crack width and depth are comparatively smaller compared with the one shown in Figure 6.24. However, this corner break could eventually become the one shown in Figure 6.24 if traffic continues to run.

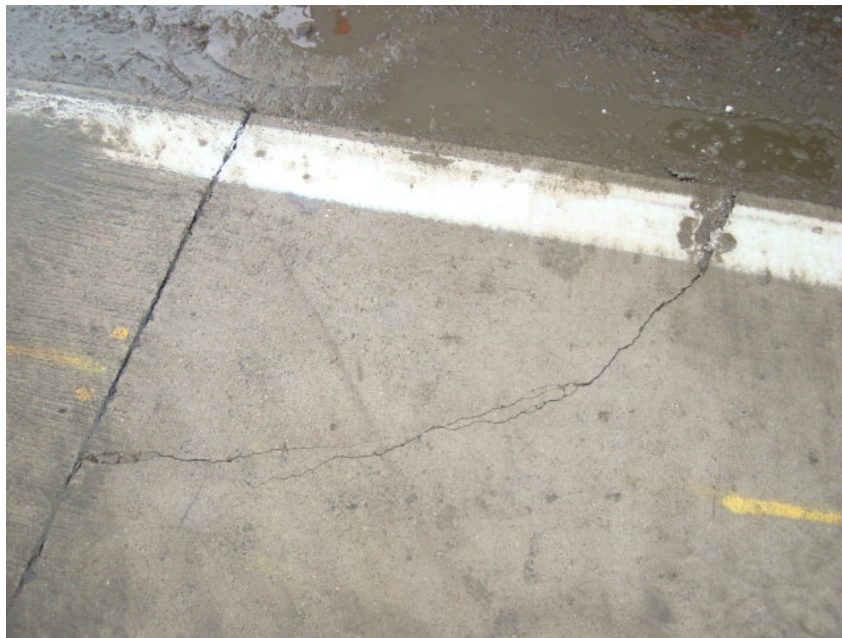
**Figure 6.25. New corner break on cell 32 during spring 2010 testing**

Additional new corner cracks were observed on cell 32 during spring 2010. Figure 6.25 presents one of new corner breaks on cell 32 during spring 2010 field data collecting process.

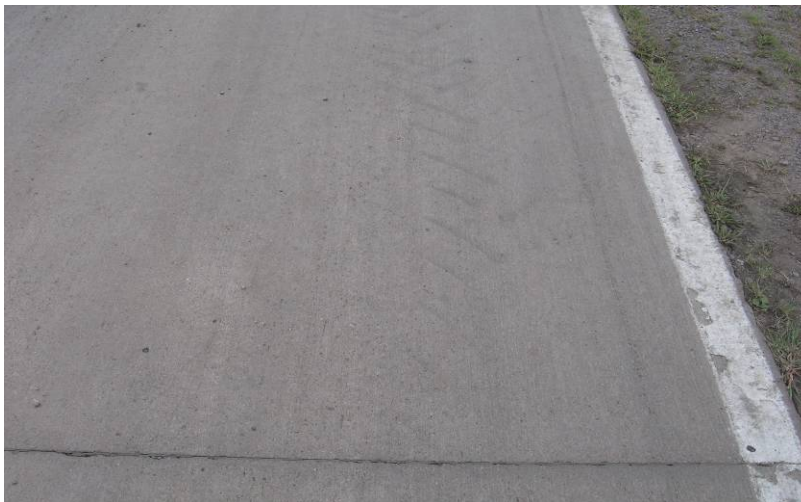
**Figure 6.32. New corner break on cell 32 during fall 2010 testing**

In addition to previously occurred corner cracks, another corner crack as shown in Figure 6.32 occurred seven slabs ahead of the sensed cell 32 slab. The slab is located where testing vehicles speed up to achieve the planned speed requirement. The crack width is so tiny that it is hardly to visualize. However, the crack length covered almost half of the slab width and length, which is far greater than previous corner breaks.

Various factors including heavy loading of grain cart and large amount of load repetition might have contributed to this new corner break. However, it is not clear which vehicle is the dominating one to make this crack.

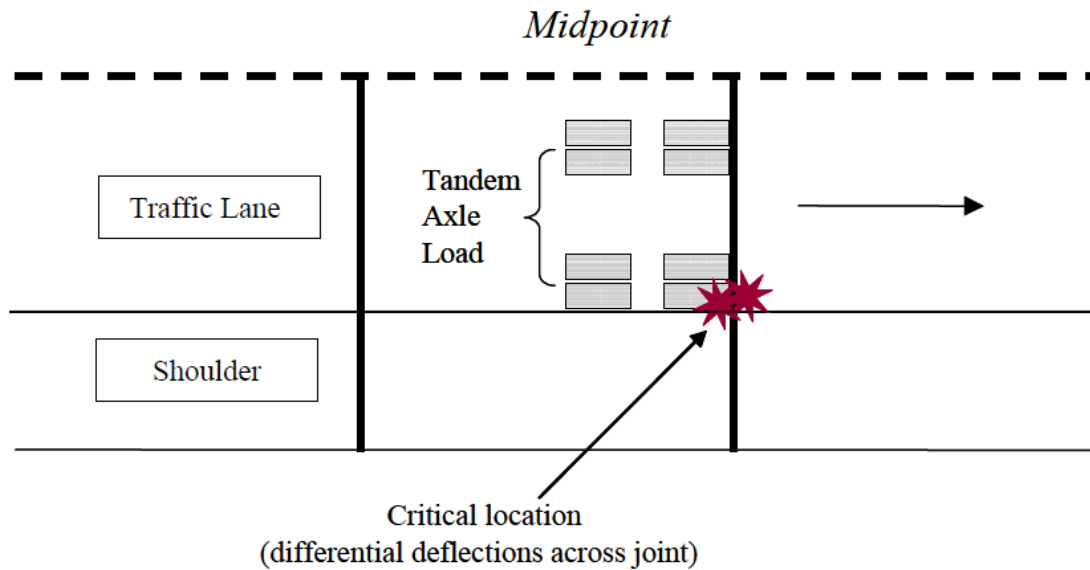
MEPDG use differential deflection across joint as critical response of faulting when repeated heavy axle loads come near transverse joints (critical loading condition of faulting) as shown in Figure 8.14 (NCHRP 1-37A report).

**Figure 8.14. Critical load and structural response location for JPCP joint faulting analysis (NCHRP 2004)**

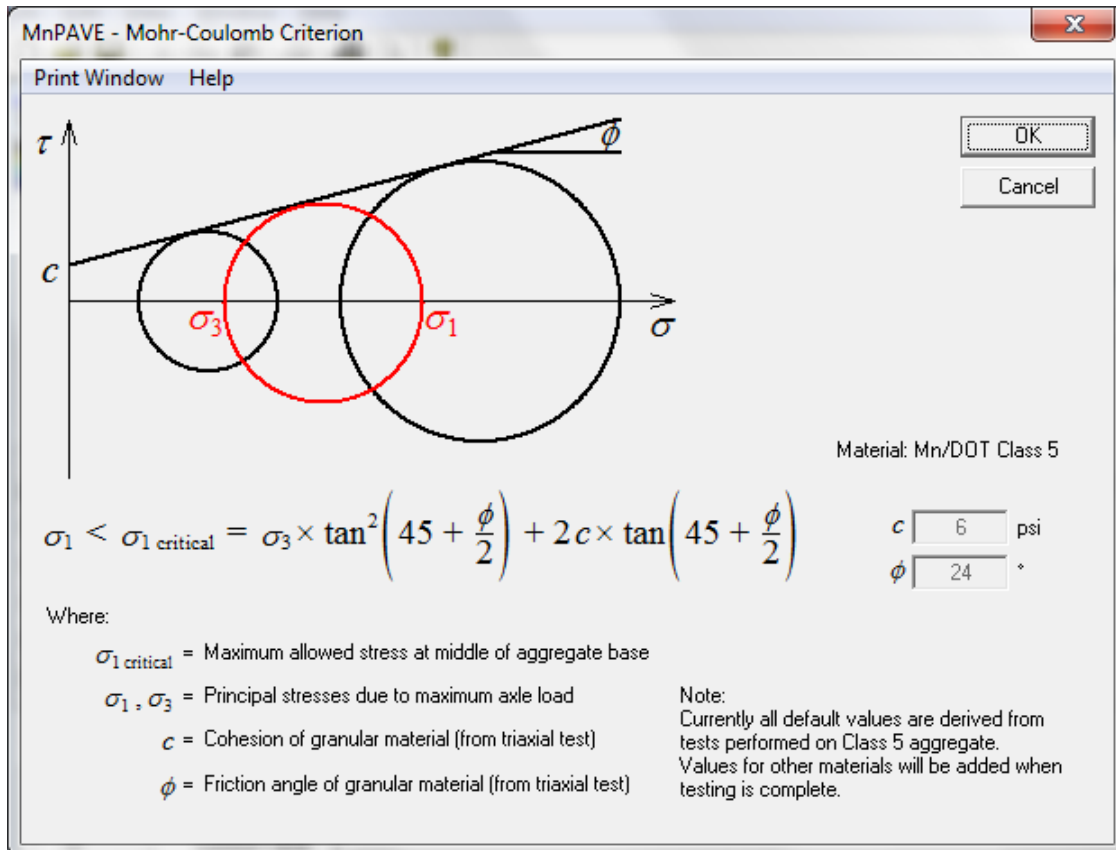
$sc_i$  = seasonal cohesion adjustment factors; by default are equal to 10, 0.2, 1, 1.3, and 1 for the MnPave winter, early spring, late spring, summer, and fall seasons, respectively.

**Figure 8.41. MnPAVE Mohr-Coulomb Criterion input screen**

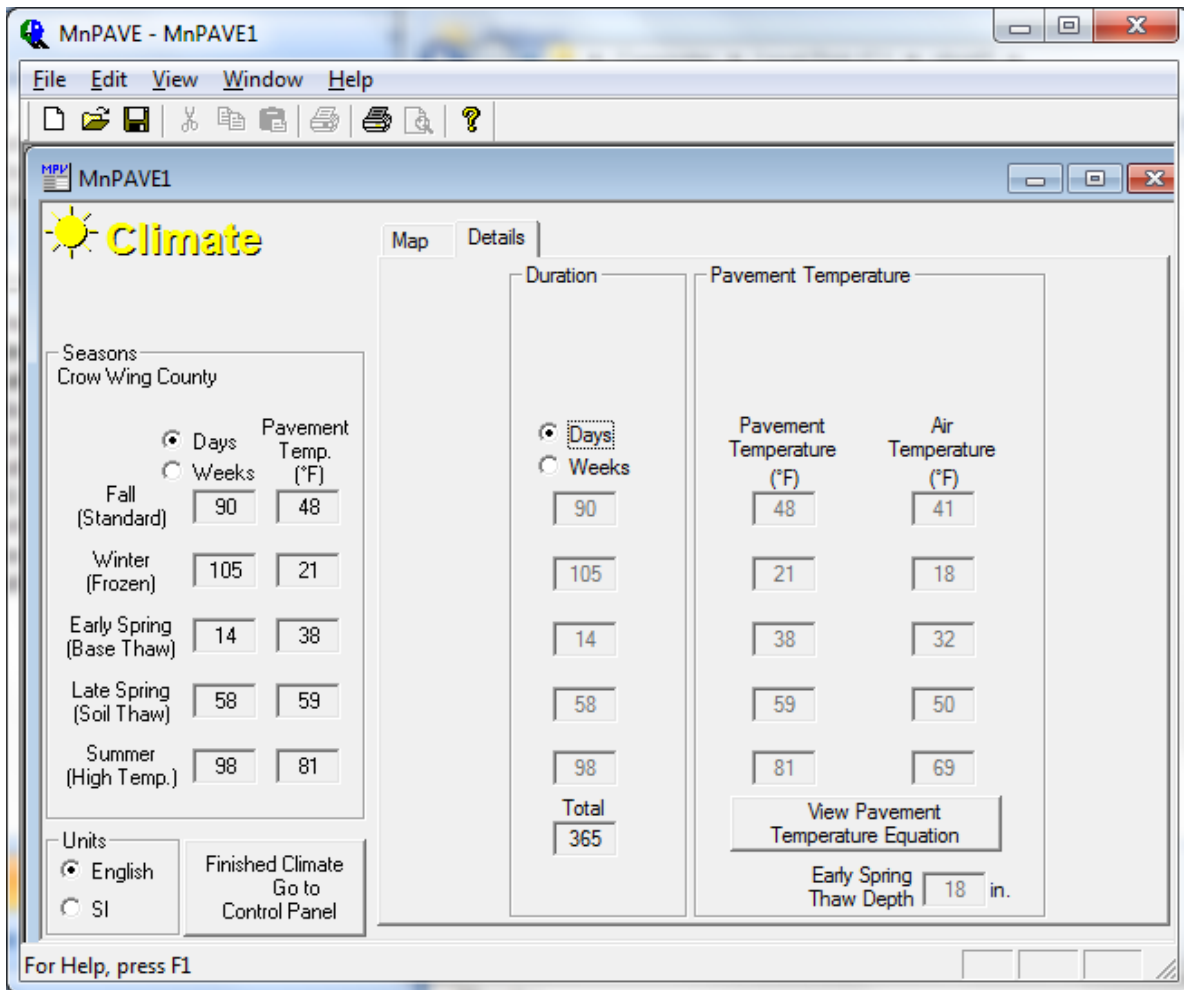
In this study, the MnPAVE seasons were adopted for pavement evaluation process. The seasonal durations were adopted to be equal to the MnPAVE durations. The mean air temperatures for all of the seasons except for early spring were adopted. Field testing at MnROAD indicated that although the mean air temperature may be low due to low nighttime temperatures, the high daytime temperatures induce a relatively high asphalt layer temperature causing a reduction in asphalt stiffness for several hours. Therefore, significant damage can be accumulated in the afternoon during this time. To address this issue, the mean air temperature for early spring was assumed to be equal to the late spring mean air temperature.

**Figure 8.43. MnPAVE climate window**

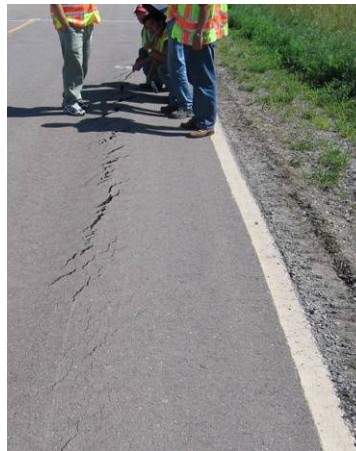
**Figure F.1. Pavement failure in cell 83 eastbound lane**

Soon after load testing began this fall, the patch in the westbound lane began to fail. Therefore, traffic was switched over to the eastbound lane on cell 83 to continue to collect data. Unfortunately the eastbound lane developed a failure after only a few passes of the heavy farm equipment. Traffic was switched back over to the westbound lane in cell 83, with steel plates bridging the failure, to complete the load testing.

As a result, a second forensic investigation was conducted on cell 83 on October 7, 2009. The goal was to determine the cause of pavement failure, focusing on the base and subgrade layers.

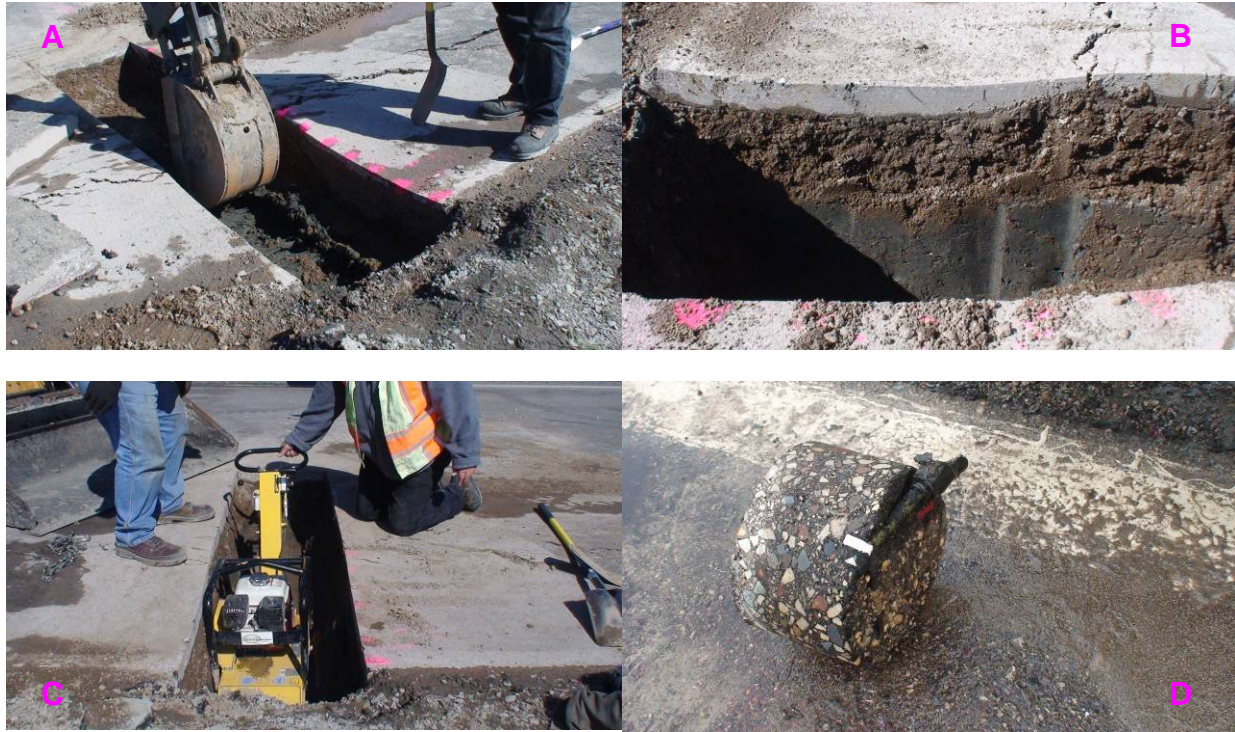
**Figure F.2. Forensic activities: (a) removing material with backhoe, (b) forensic trench, (c) compacting backfill, (d) asphalt core with strain gauge**

The forensic activities were quite simple in this investigation. A transverse trench (2 ft long  $\times$  8 ft wide) was cut across the pavement at station 1002+62. The pavement layers were removed one by one with a small backhoe, while the transverse profile of each layer was surveyed with a rod and level. This would enable the investigators to observe the shape of each layer. Three dynamic cone penetrometer (DCP) tests were performed at the top of the base layer to obtain a measure of the shear strength of the gravel base and clay subgrade layers. A sample of the class 5 aggregate base material was taken to the Maplewood Lab to perform resilient modulus testing at a later date. The moisture contents of base and subgrade samples were measured. Finally, four cores were taken to investigate the position and orientation of asphalt strain gauges.

After the forensic investigation was completed, the trench was filled in with on site gravel materials. The gravel was placed in approximately 6 in. lifts and compacted with a vibratory plate compactor. If necessary the patch will be covered with a steel plate to accommodate load testing in spring 2010.

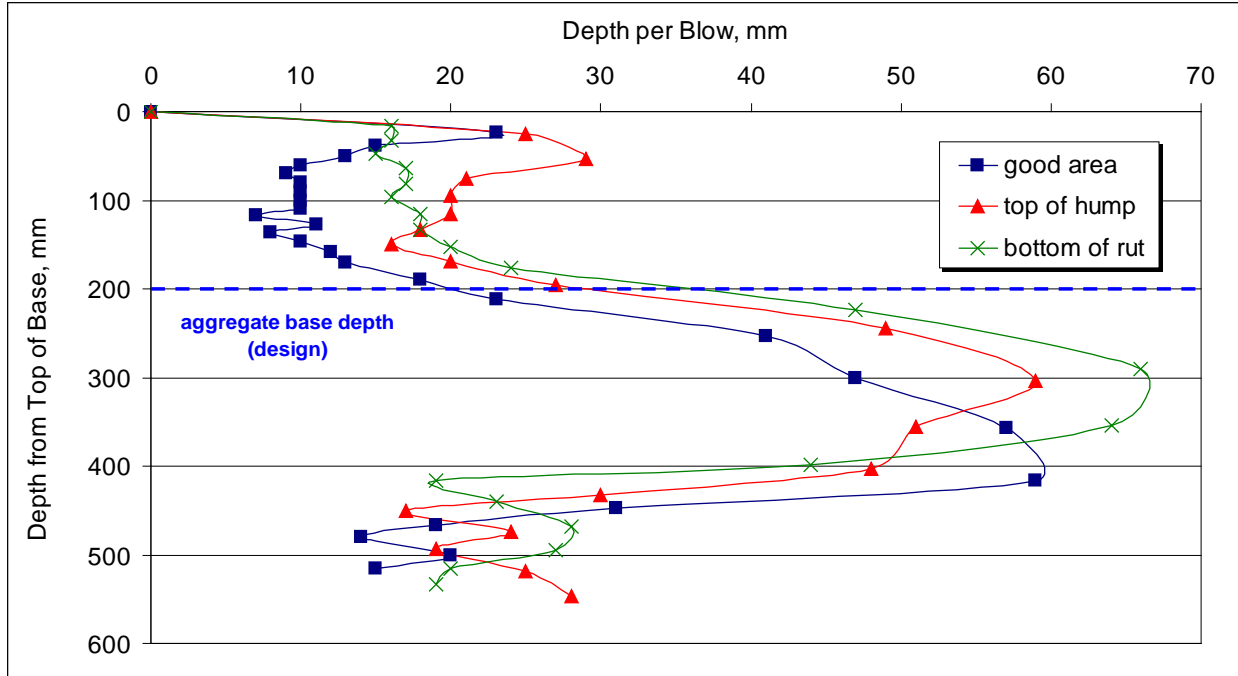
**Figure F.5. Dynamic cone penetrometer results**
