# Investigation of the Impact of the I-94 ATM System on the Safety of the I-94 Commons High Crash Area

Minnesota  
Department of  
Transportation

John Hourdos, Principal Investigator  
Department of Civil Engineering  
University of Minnesota

Research Project  
Final Report 2014-19

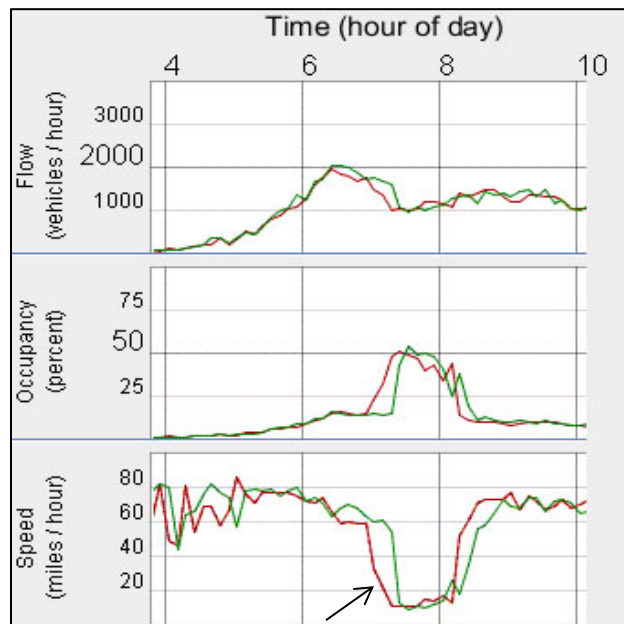
Figure 2. Flow, Occupancy, and Speed for Detector 259 between two of the most highly correlated dates; green is before VSL, red is after VSL.

Regardless, looking at the general congestion patterns, the VSL system did appear to positively impact the most severe congestion (speeds below 10-15 mph). Specifically, the instances and spread of extreme congestion waves (speeds bellow 10 mph) have been reduced after the VSL system activation. Severe shockwaves propagating upstream are a serious danger of rear-end collisions therefore their reduction is a valuable effect of the VSL. Although it is not possible to make definitive observations of this effect through loop detector data, the analysis of the fundamental diagram curves for specific detectors shows that although drivers do not comply with the advisory speed limit, they do take it into consideration. One can hypothesize that the drivers use the advisory speed limit as a gage of downstream congestion and prepare themselves for encountering the upcoming shockwaves. As seen in Figure 2 this behavior may reduce the rate of the speed reduction, i.e. slower moving shockwaves. The effect is observable albeit weak.

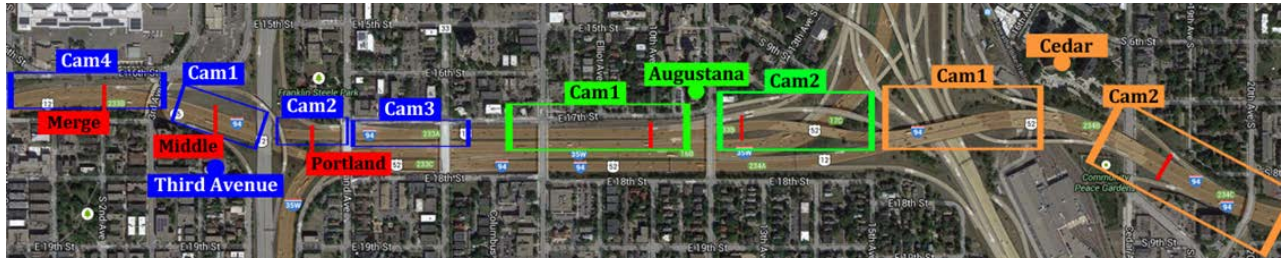
Figure 6. Map of video and machine vision sensors along I-94

Middle, and Portland), Augustana includes two cameras and two MVSs, and Cedar includes two cameras and a single MVS.

To study the shockwaves more directly, the data available from the machine vision detectors was analyzed. In particular, data from the rightmost lane at locations referred to as Middle (Camera 1 in Figure 6) and Portland (Camera 2 in Figure 6) were correlated to visualize the evolution of traffic conditions. The Middle and Portland MVS’s are separated by roughly 450 feet.

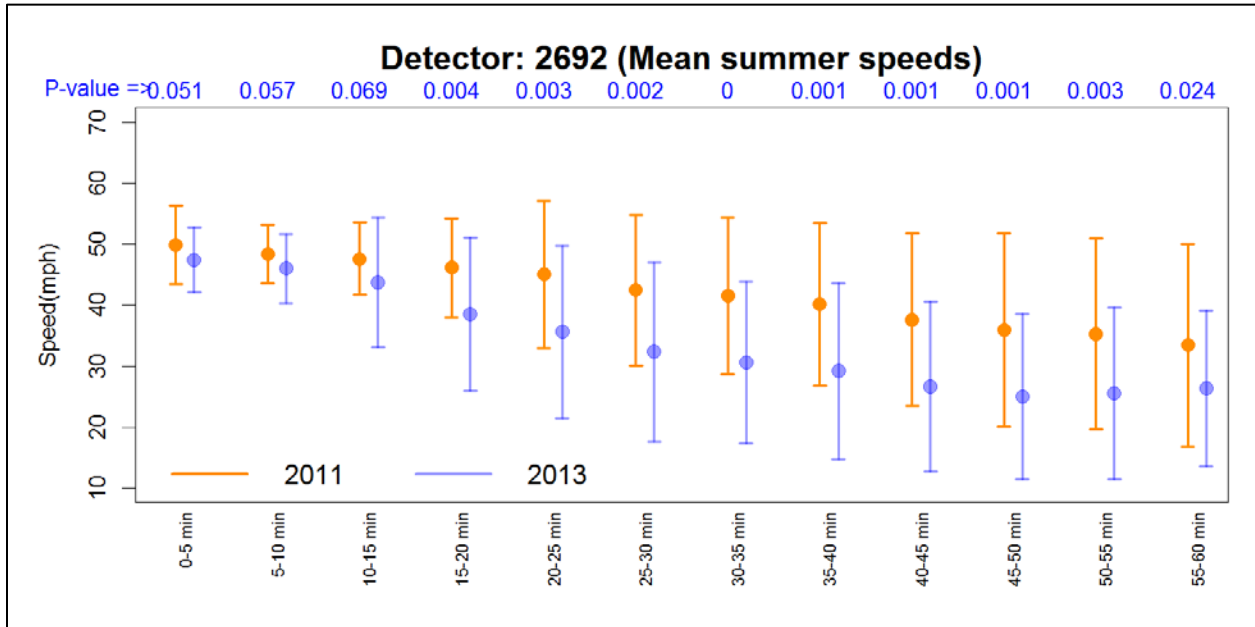
Figure 12. Mean and 1 standard deviation for speeds at detector D2692 for 2011 v. 2013

To extract useful statistical data from these speed measurements, the data from the summer months of 2011, 2012, and 2013 were analyzing using the student t-test. For each 5-minute interval after breakdown, the p-value was determined for 2011 v. 2013 and 2012 v. 2013. The p-value indicates how likely the two data sets are from the same underlying pattern. If the p-value is high, the two samples are likely based in the same distribution, while p-values below 0.05 indicate a strong confidence (95%) that the two data are significantly different. Figure 12 below shows a sample figure showing these results for the first upstream detector in the right lane (D2692) for 2011 v. 2013.

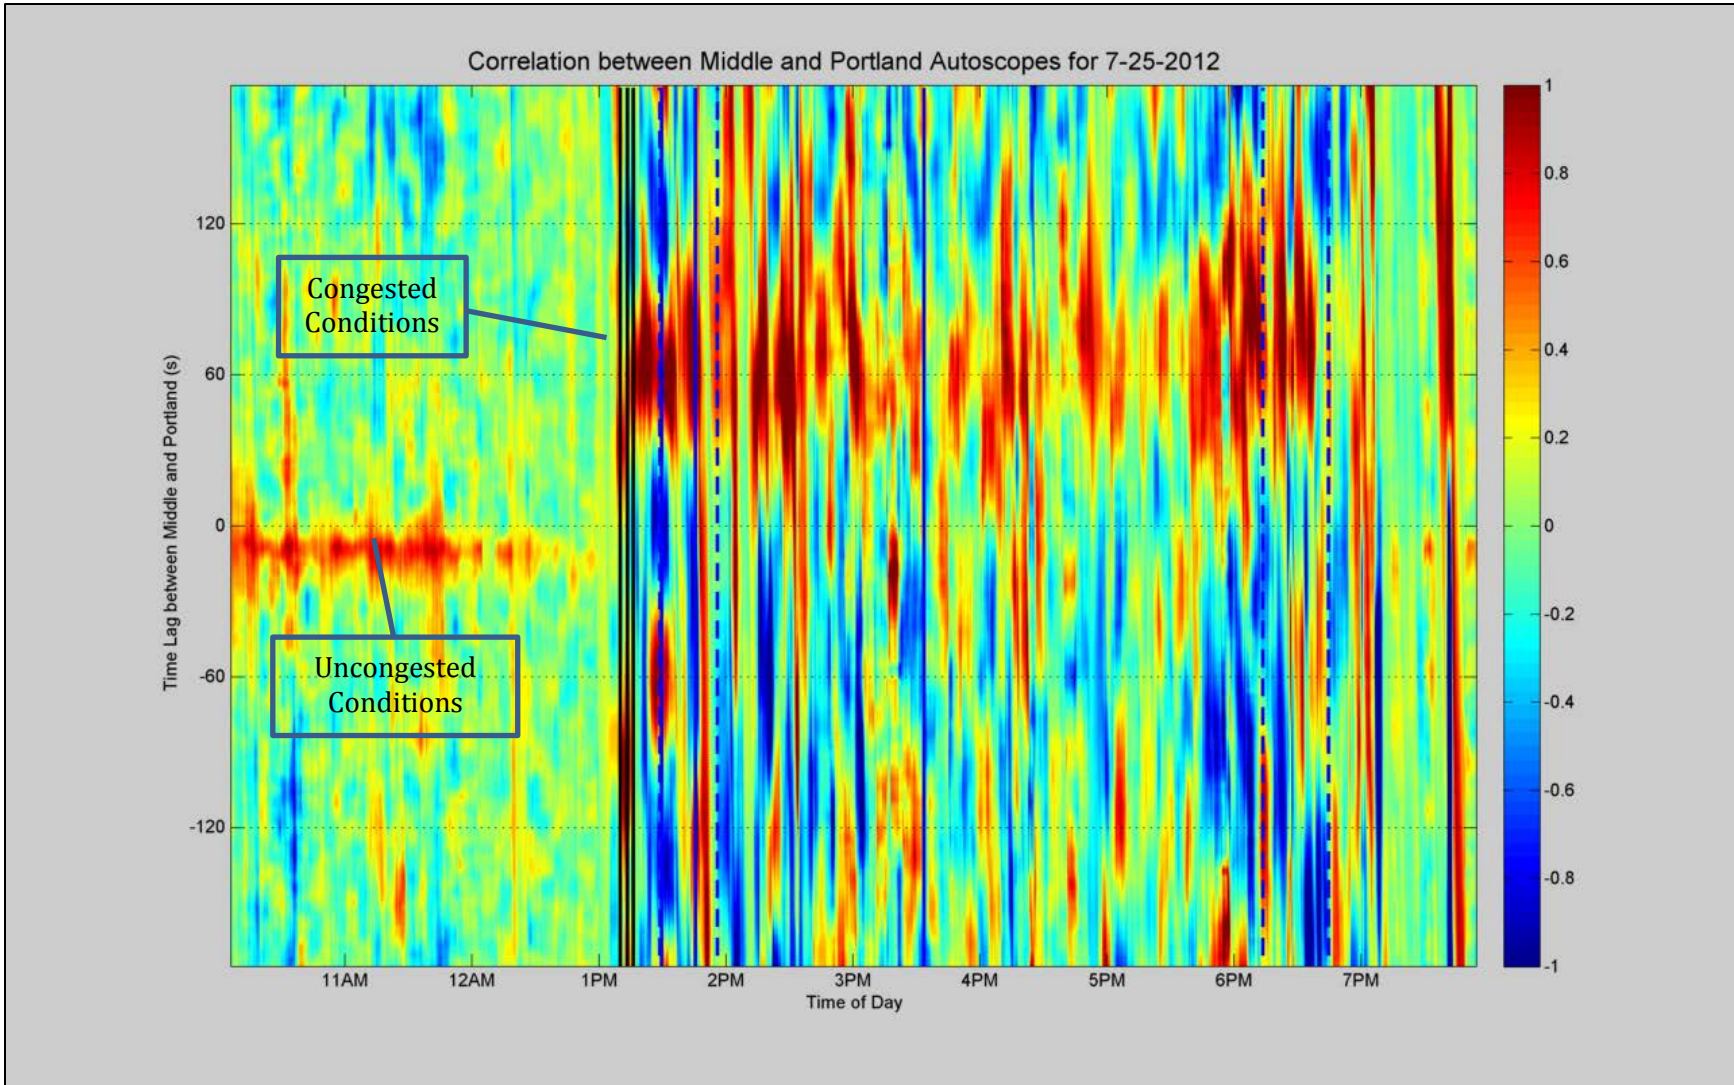
Figure 16. Correlogram for July 25, 2012

Figure 16 shows a sample Correlogram for July 25, 2012 which highlights key features of the Correlogram.

The highly positively-correlated band before noon and just below zero lag represents uncongested conditions. As vehicles pass from the upstream to downstream machine vision sensor at free flow speeds, very little time passes leading to strong correlation at low time differences. At roughly 12:30 PM the correlation drops off, with no significant correlation found at any lag. This represents the time interval when the downstream MVS began experiencing shockwaves that did not propagate sufficiently to reach the upstream MVS. Near 1:15 strong positive correlation regions begin appearing near the 60-second positive lag mark. These indicate shockwaves traveling upstream. This is confirmed by the three vertical black lines marking the first three shockwaves for the day as observed manually.

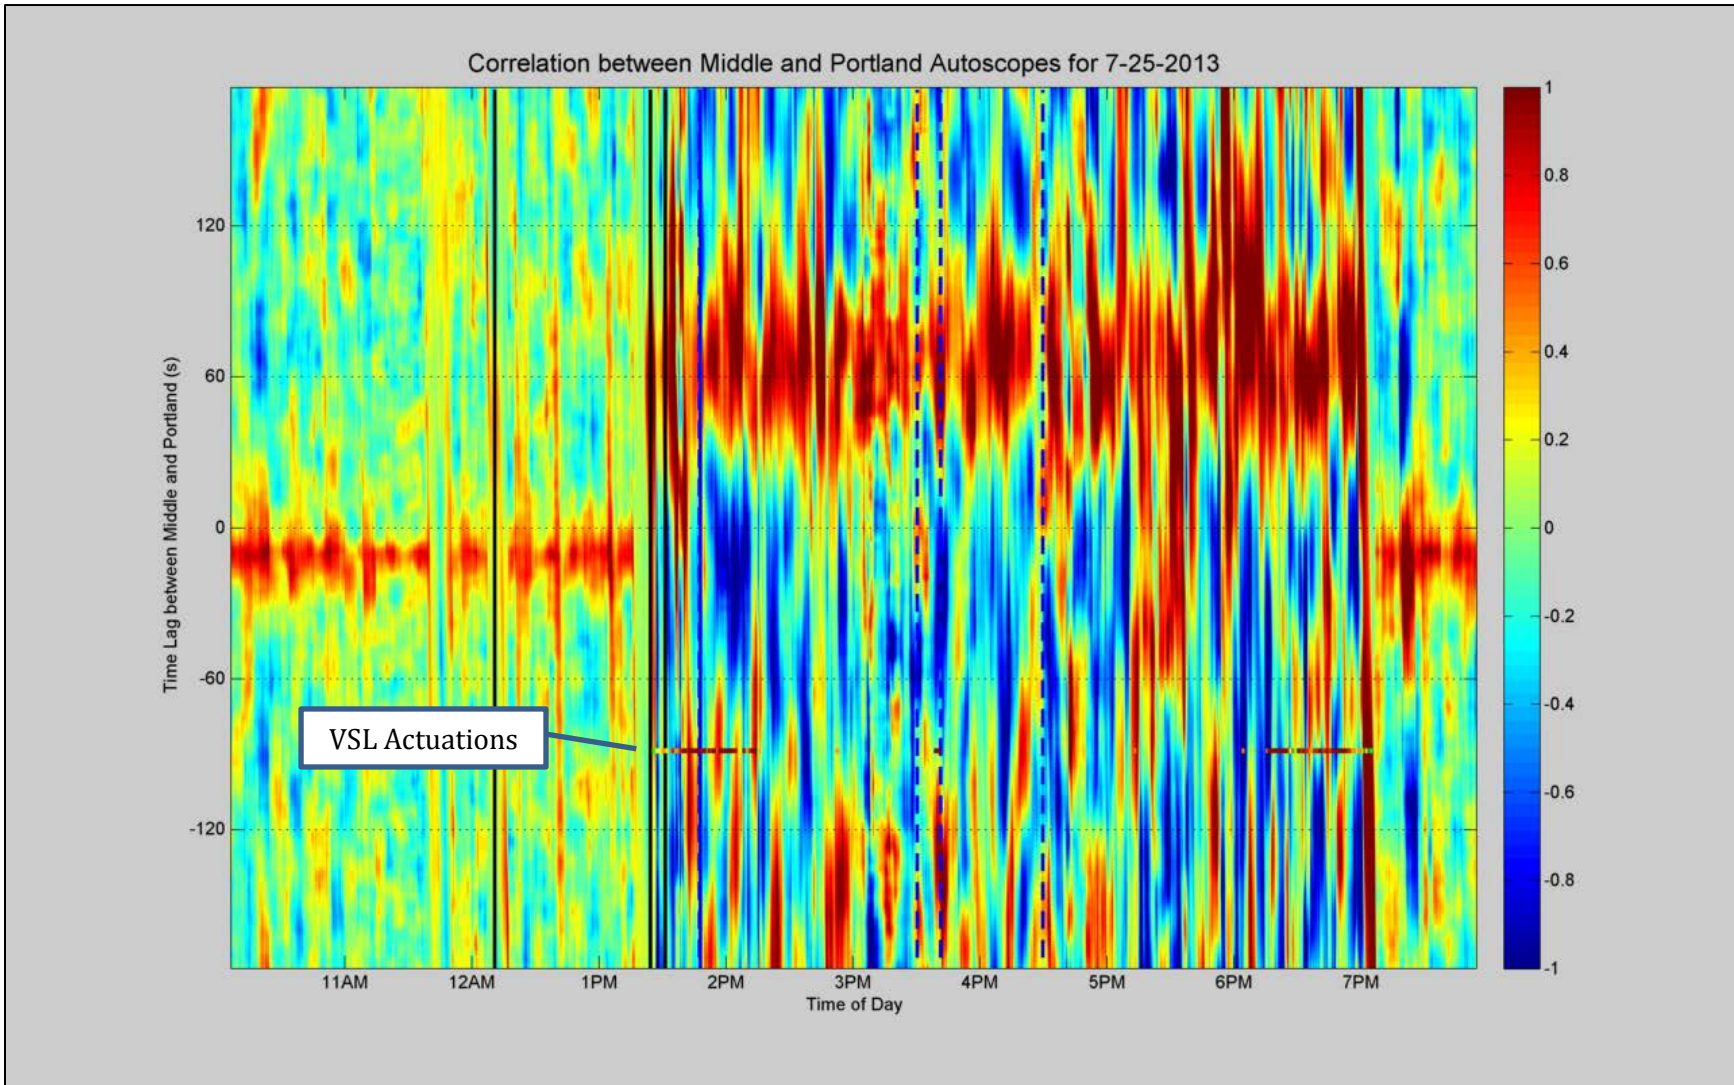
Figure 17. Correlogram for July 25, 2013

Looking at the same day one year later (after VSL implementation), the activations of the VSL can be seen relative to the Correlogram. Figure 49 shows the correlation plot for July 25, 2013. Note the horizontal bands located near -90 seconds lag. These show the speed displayed on the VSL just upstream of the high crash region (with time aligned to the zero-lag line). This sample shows the typical response of the VSL. Activations begin just after the beginning of significant and sustained shockwave activity and continue for a period of 15 to 45 minutes. During the majority of the congested afternoon period, the VSL in this location is deactivated (since complete congestion has set in). Toward the end of congestion, the signs again activate for a period of time and finally remain dark as congestion clears.

The highly correlated patterns in the early and latest portions of the figure representing free flow conditions and should be present at a small negative lag equal to the travel time between upstream and downstream locations. Due to slight desynchronization between sensors, these free flow condition regions were at varying lags. For each day, a synchronization factor was introduced to correct this issue, resulting in each Correlogram displaying free flow correlation patterns in the same region (at small negative lags).

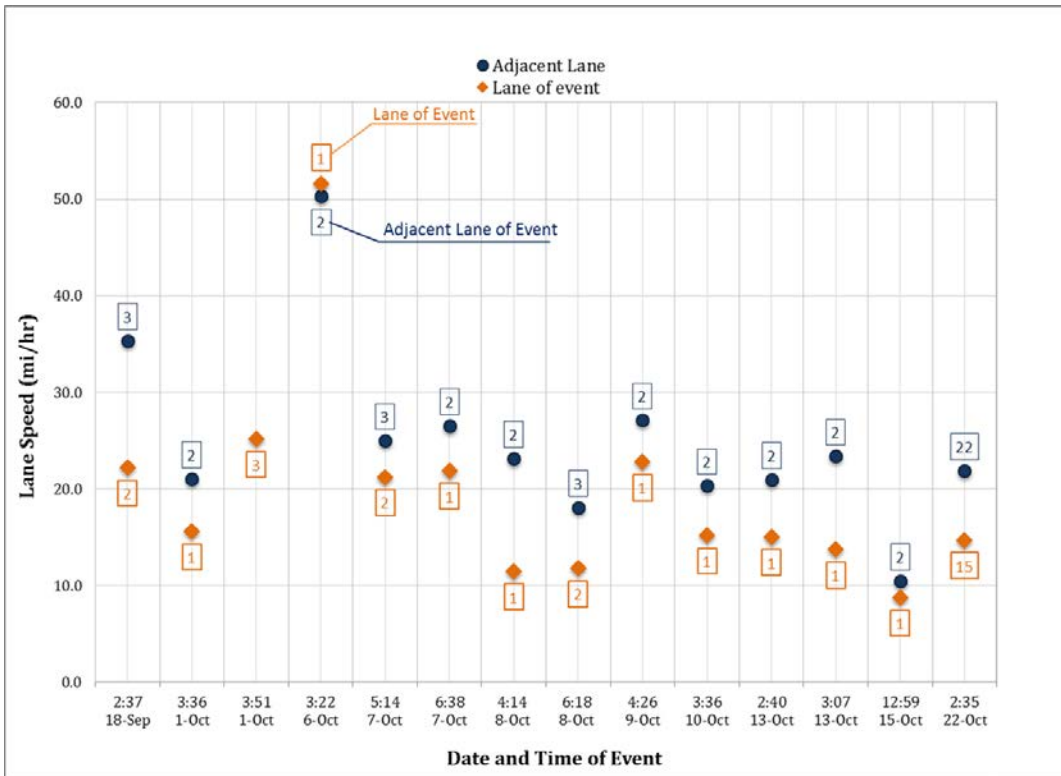
Figure 18. Crash events collected in 2008 - Average speed of event lane and adjacent lane

Figure 18 and Figure 19 present a graphical representation of the near crash and crash incidents from video collection data. These plots are chronologically organized by date and time recorded. Each point in these plots corresponds to the average lane speed of the lane where an incident took place and its adjacent lane. During peak times (3:30PM to 6:30PM), the majority of crashes and near crashes occurred at speeds below 30mph of speed, with an adjacent lane demonstrating a similar speed.

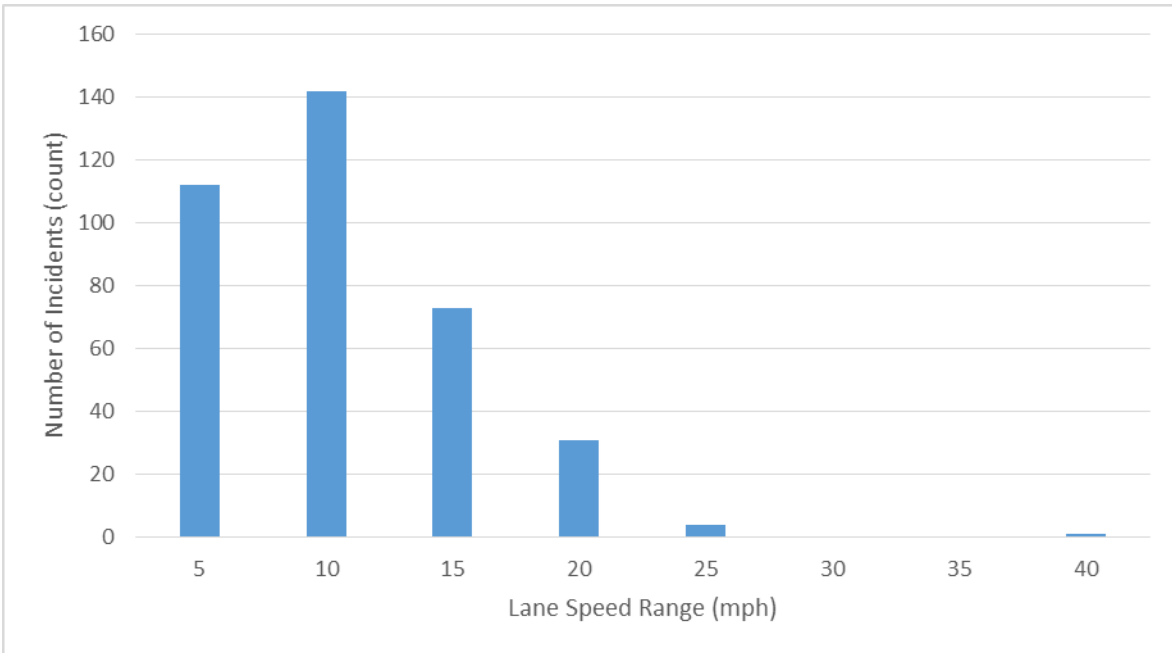
**Figure 26. Histogram of lane speed variance for Before data**

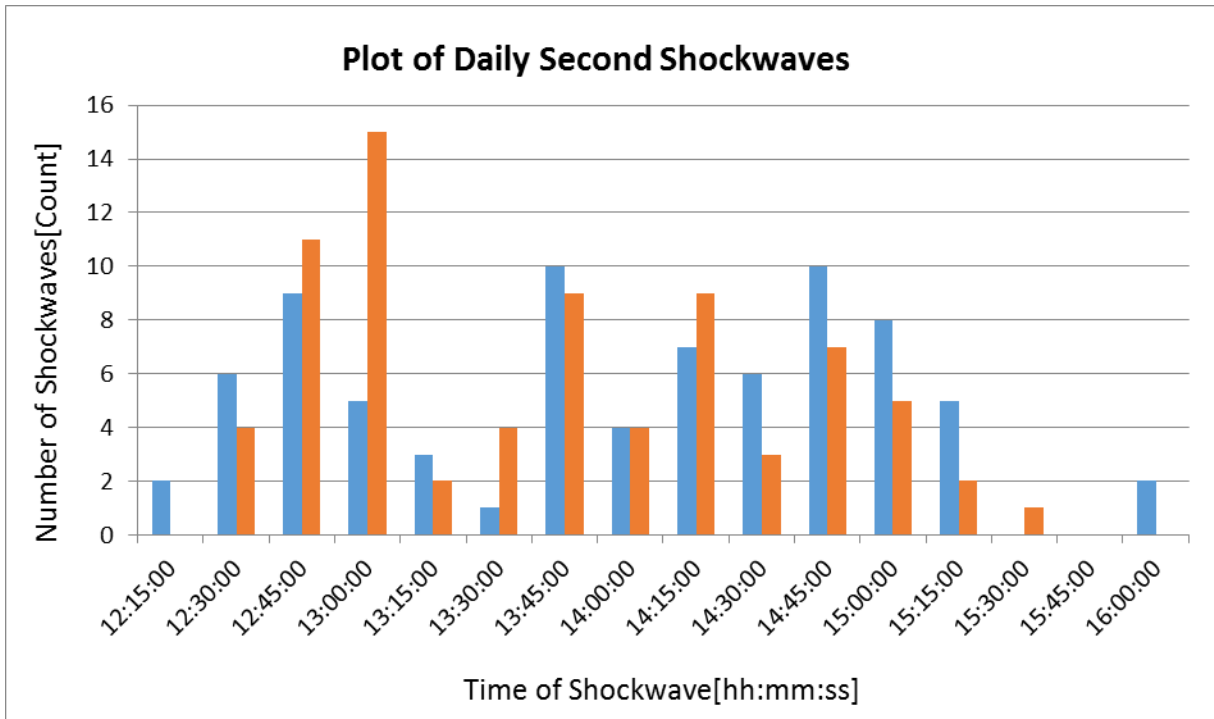
Figure 29. Time of onset of the second shockwave Before and After VSL

The second shockwave for each day follows a similar pattern for both the Before and After data. The Before data shows a local peak at around 12:45, but a more significant peak after 2:30 pm. The After data is, again, more heavily weighted toward the earlier peak at 12:45-1:00 with a more even spread across the rest of the afternoon. The overall trends occur between 15 and 30 minutes later than those of the first shockwave (for both Before and After) and are shown in Figure 29.

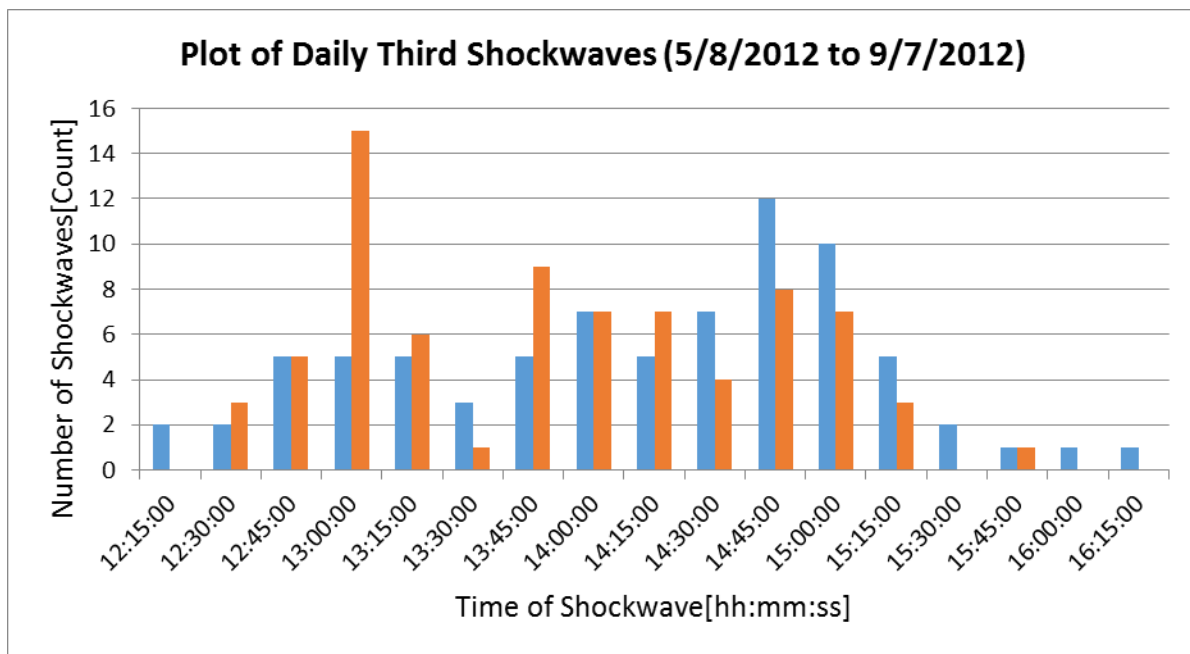
Figure 30. Time of onset of the third shockwave Before and After VSL

The third shockwaves are further delayed in the afternoon and show the same overall trends as suggested by the first and second shockwaves. In the Before data, the early peak has diminished and the later peak (between 2:30 and 3:15 pm) has become dominant. The After data continues to be dominated by the early peak (now at 1:00 pm) with an approximately even distribution later in the afternoon (see Figure 30).
