Minnesota
Department of
Transportation

Evaluation of Concrete and Mortars for Partial Depth Repairs

Eshan V. Dave, Principal Investigator
Department of Civil Engineering
University of Minnesota Duluth

Research Project
Final Report 2014-41

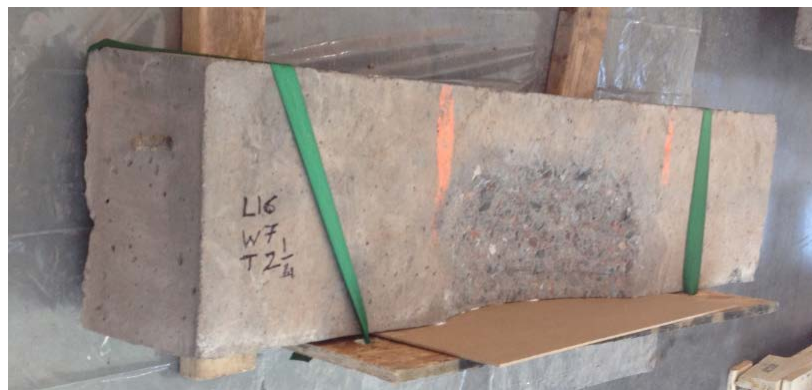
Figure 20: Half slab ready to have patching material added.

Prior to casting the patch material the slabs were set up with a bond breaker similar to what is used in the field (Figure 20). This was done to simulate field conditions as closely as possible.

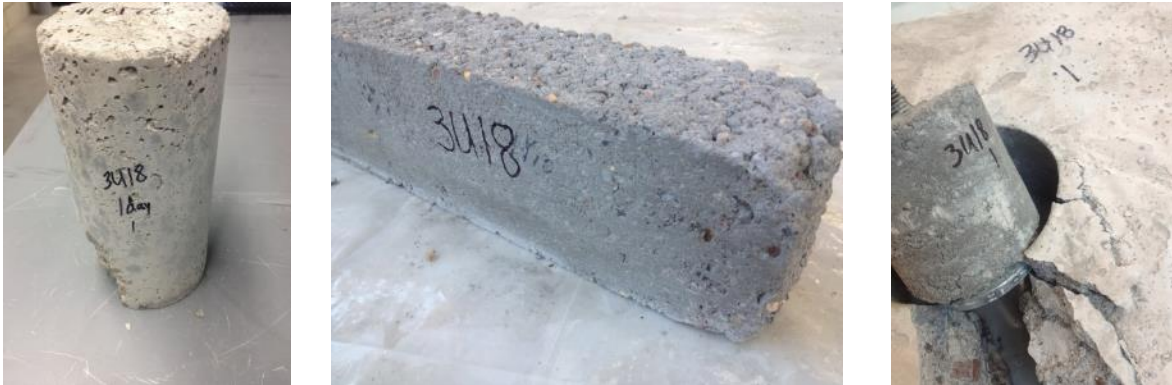
Figure 35: 3U18 compression, freeze thaw and pull out specimens

This mix fails to meet the compressive strength and slump requirement set forth by the ASTM C928. The flexural strength was the lowest of the products that could be measured. Freeze thaw durability ranked the third lowest among all products.

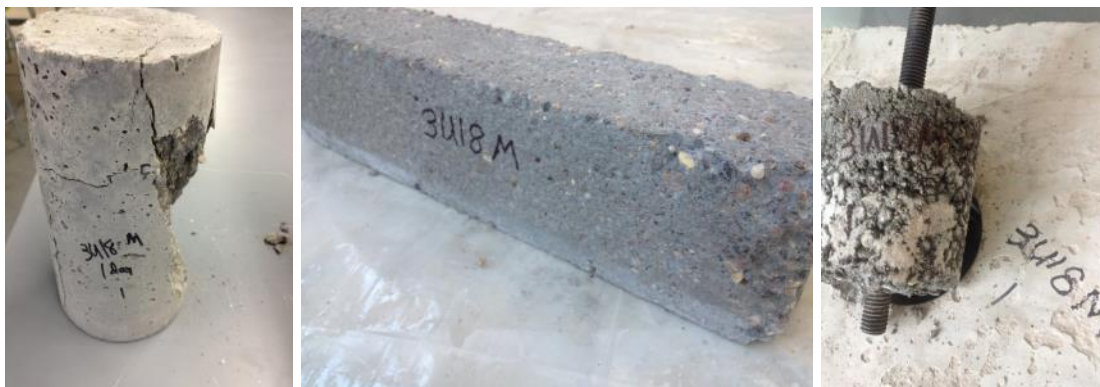
Figure 36: 3U18M compressive, freeze-thaw and pull out specimens

There are similar failures of the ASTM C928 spec, compressive strength and slump. The formed beam specimen for flexural strength was unable to support its own weight at four hours.

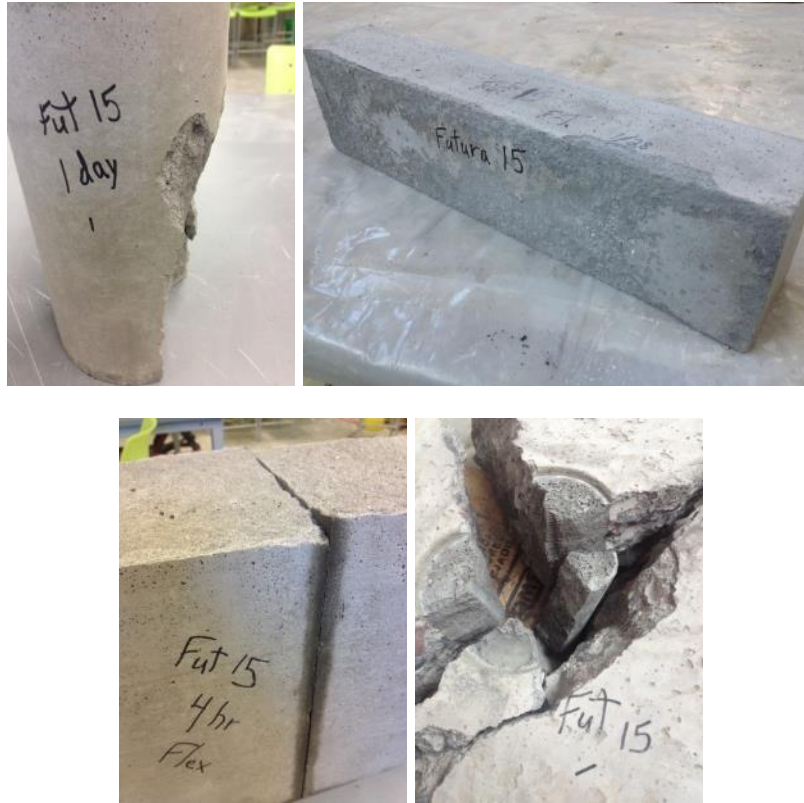
Figure 41: Futura-15 compressive, freeze-thaw, flexural and pull out specimens

Three hour compressive strength was among the top performers of the group. Even though it had achieved over 3,000 psi at three hours the interior of the cylinder molds was moist. It also displayed great compressive gains at 28 days. The modulus of rupture was the highest of the group and contained broken aggregate with a dry interior. Freeze thaw durability factor was below twenty.

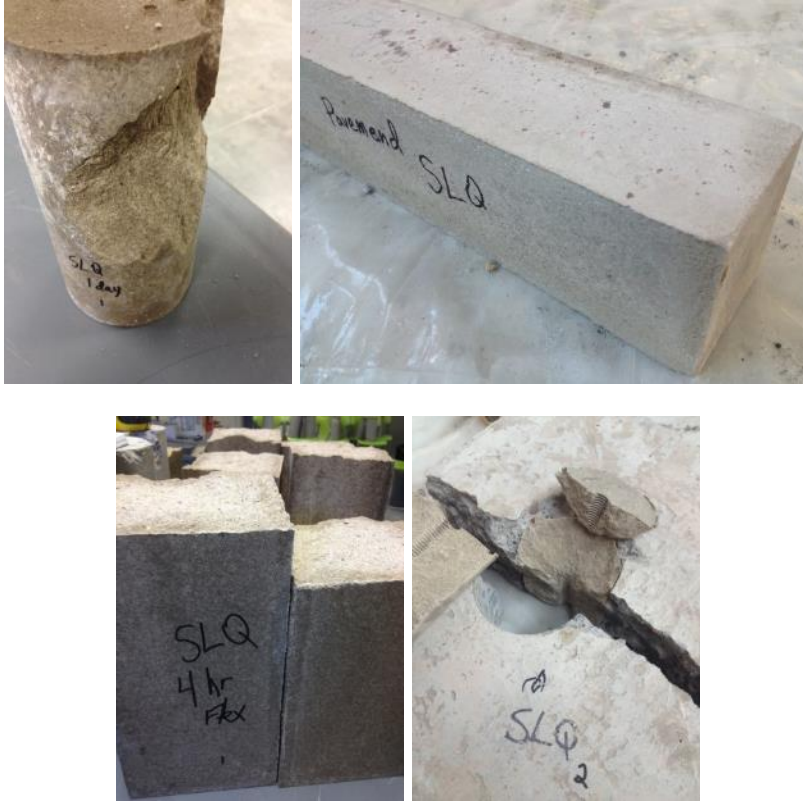
Figure 45: Pavement SLQ compressive, freeze-thaw, flexural and pull out specimens

Three hour compressive strength was below the ASTM C928 specification. It did exceed the 3,000 psi level at one day. This product has high freeze thaw durability with a durability factor above 100. The flexural strength was in the middle of the range for the group, when the beam was broken the interior was found to be dry and set. Like the Mono Patch, which was also magnesium phosphate based, this product expanded while curing in air as well as in water.

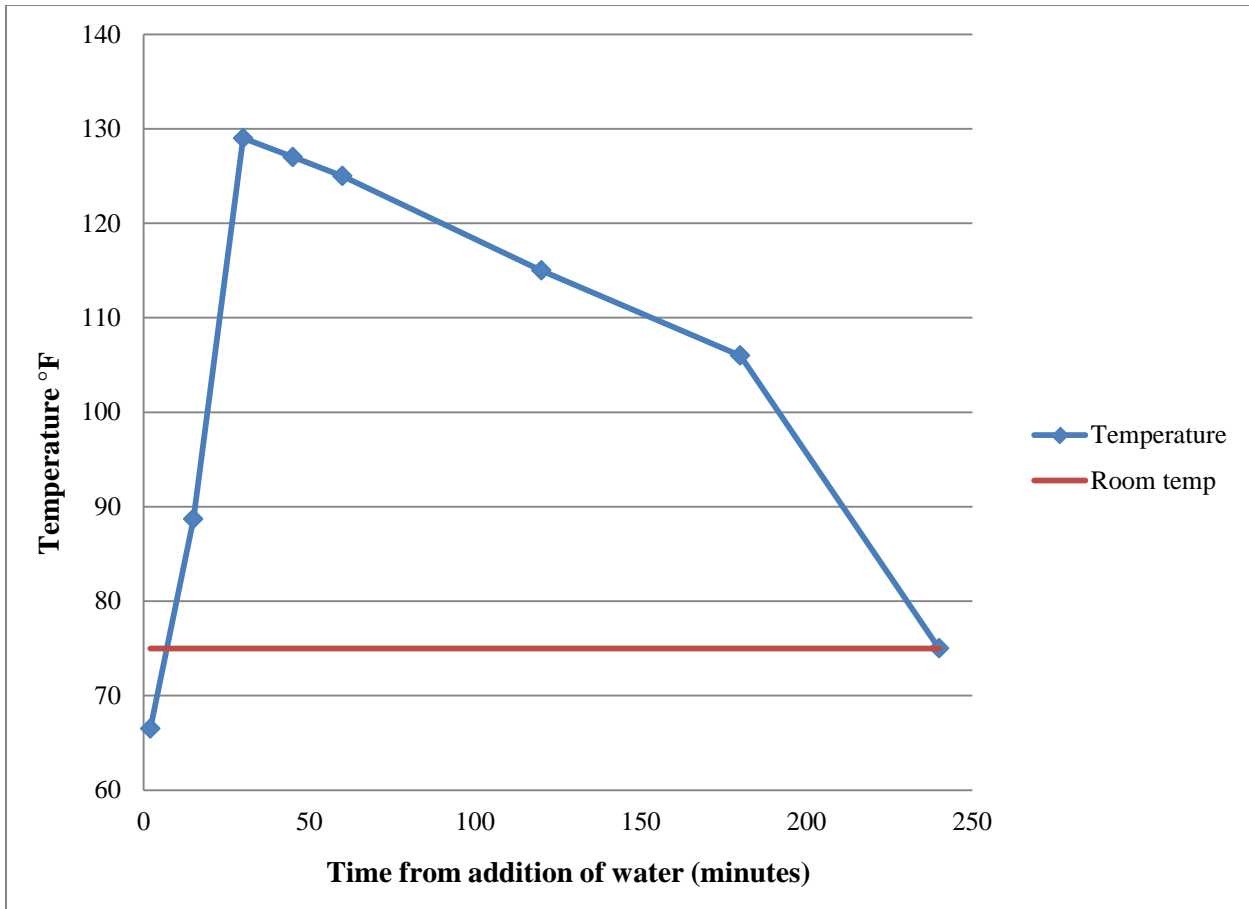
Figure 47: Heat of hydration for TCC taconite mix

The first attempt at mixing these components in the lab was not met with success. The product began to set up in the bucket while the mixing was still taking place. The following attempt was conducted outside on a day when the temperature was 31°F. The three components were placed outside for two hours prior to mixing. The resulting mixture yielded a more reasonable five minute working time. This product generates considerable heat while curing. It reached a temperature of 129°F thirty minutes after the liquid was added (Figure 47).

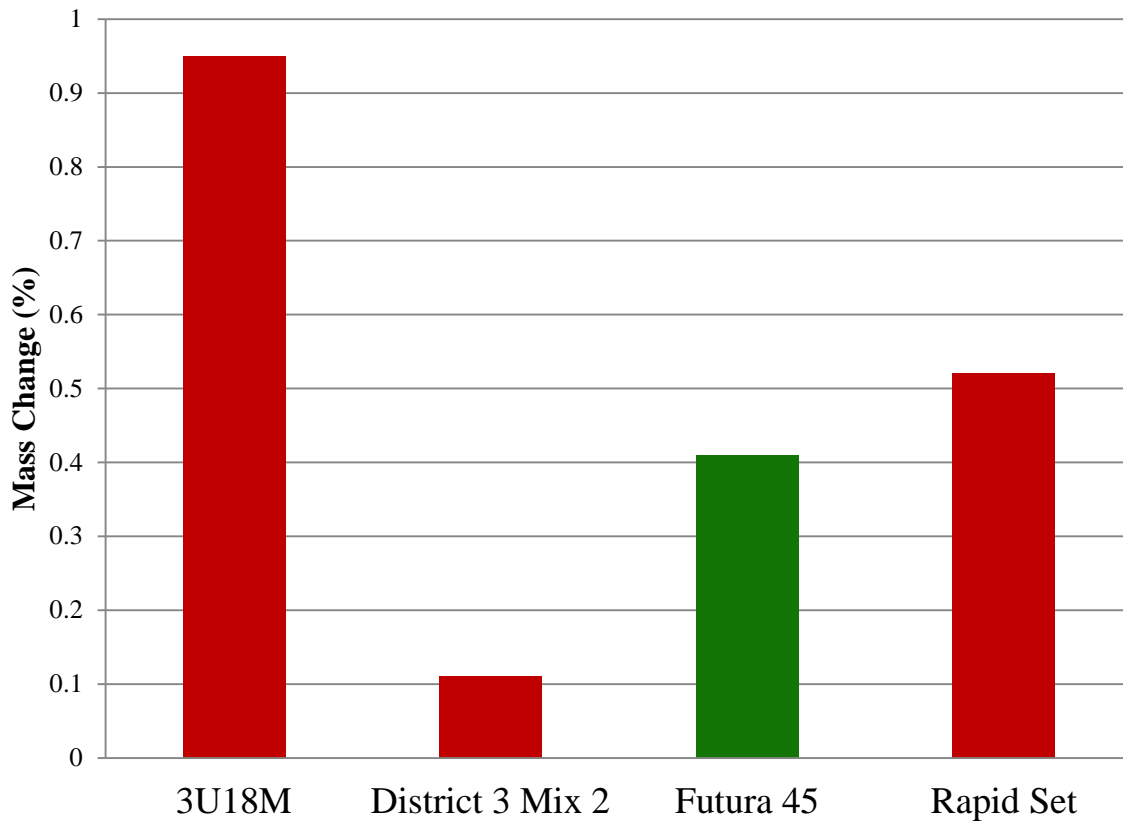
Figure 58: Percent mass change during scaling resistance.

Mass loss was also recorded for all samples included in the scaling resistance testing. The data showed that all of the products except Futura 45 lost mass during the process. The Futura 45 actually gained mass, indicated by the green data bar in Figure 58. This is not surprising as the Futura 45 showed no signs of scaling after fifty cycles. The Rapid Set also had no signs of scaling, however the edges of the sample were quite deteriorated which accounts for the mass loss.

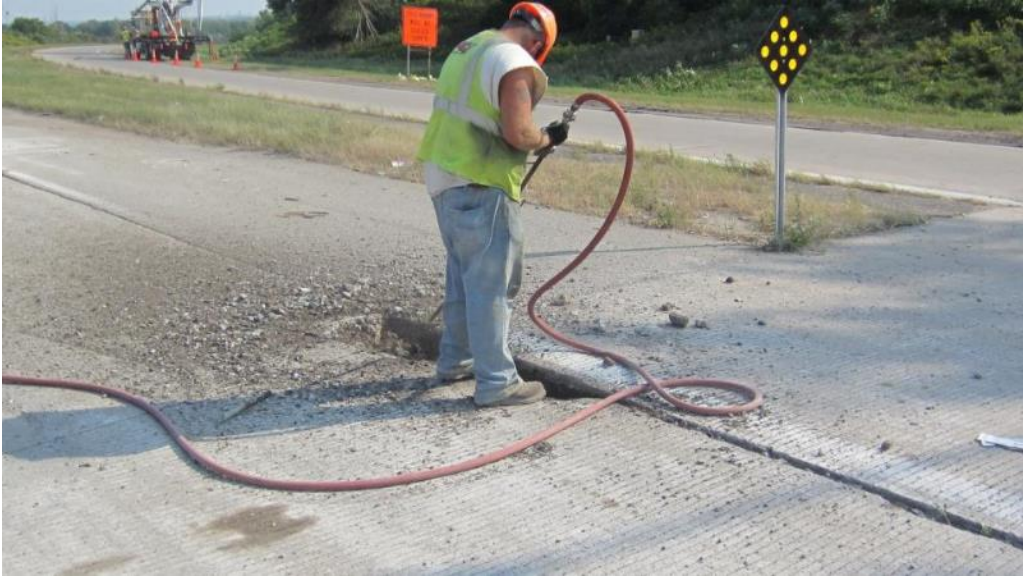
Figure 81: Air blasting the hole to remove excess loose material

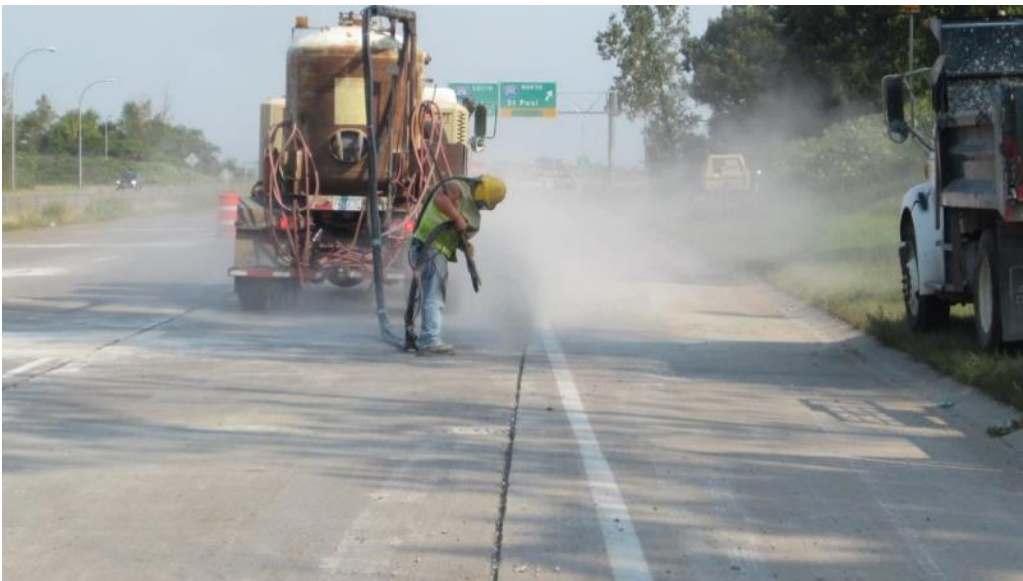
Figure 82: Sandblasting the patch area prior to being filled

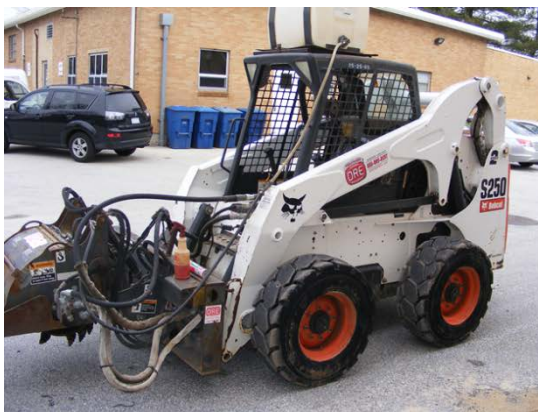
(a) Miller attached to Bobcat loader
