# **Salt Brine Blending to Optimize Deicing and Anti-Icing Performance and Cost Effectiveness, Phase II**

Stephen J. Druschel, Principal Investigator  
Center for Transportation Research and Implementation  
Minnesota State University, Mankato

**December 2014**

Research Project  
Final Report 2014-43

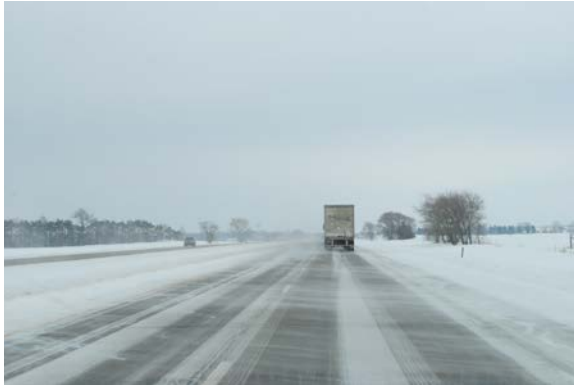
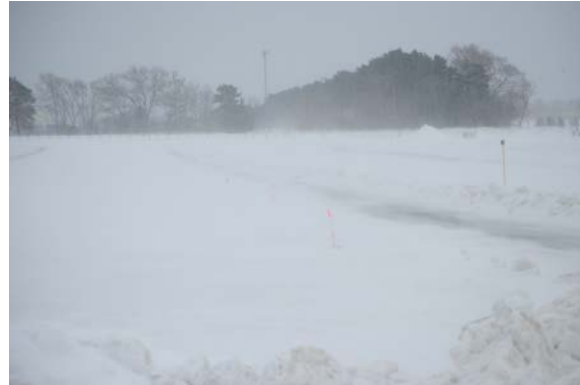
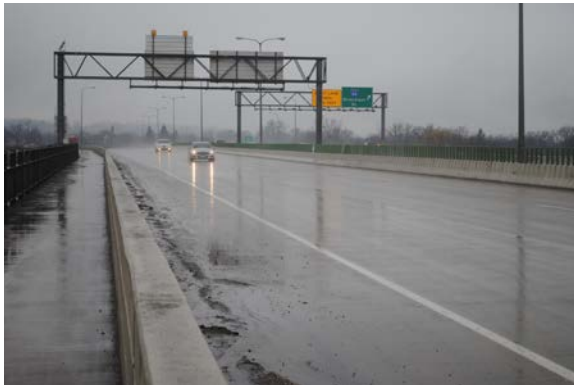
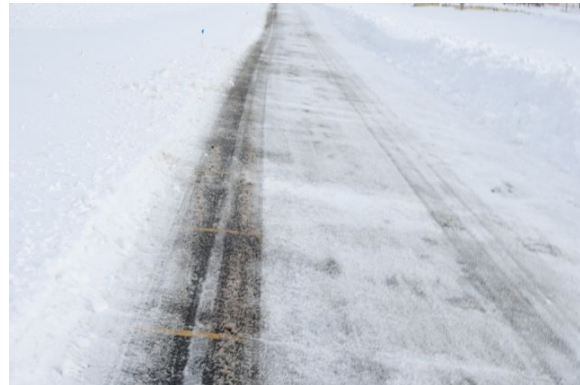
Figure 1. Winter conditions conducive to ice buildup on roadways.

a) Wind blown snow

b) Ice fog

c) Freezing rain

d) Wet snow becoming packed

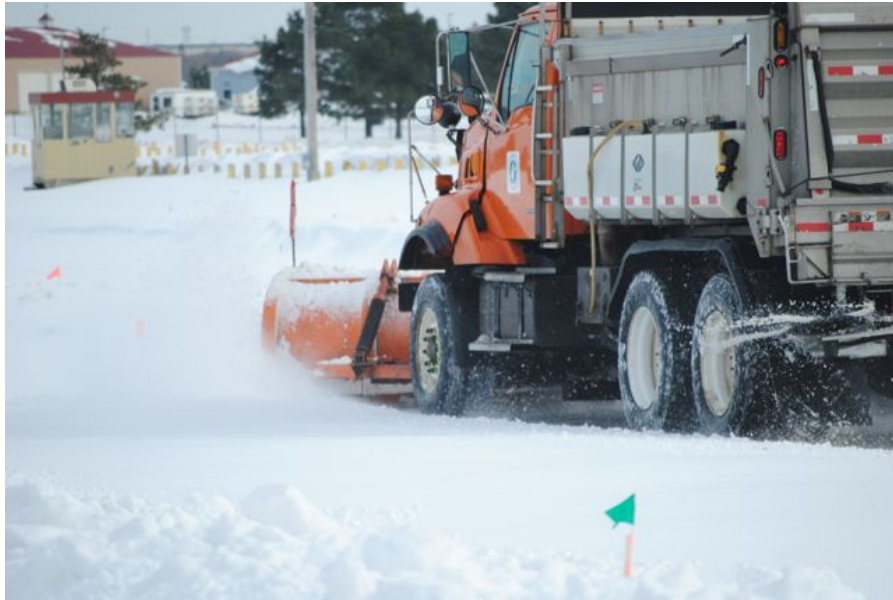
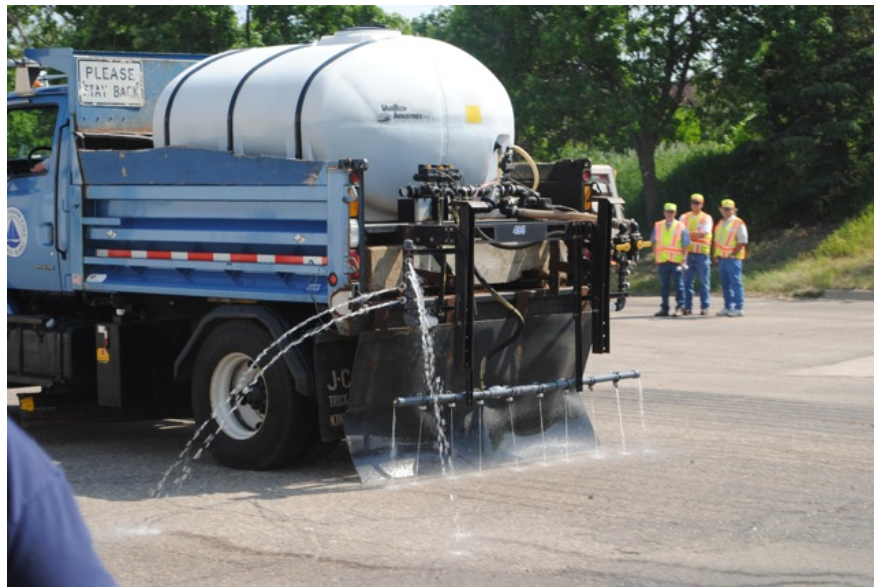
Figure 2. Deicer and anti icer application equipment.

a) MnDOT truck spreading solid deicer with prewet off left rear.

b) Brine application truck during demonstration (non-winter day).

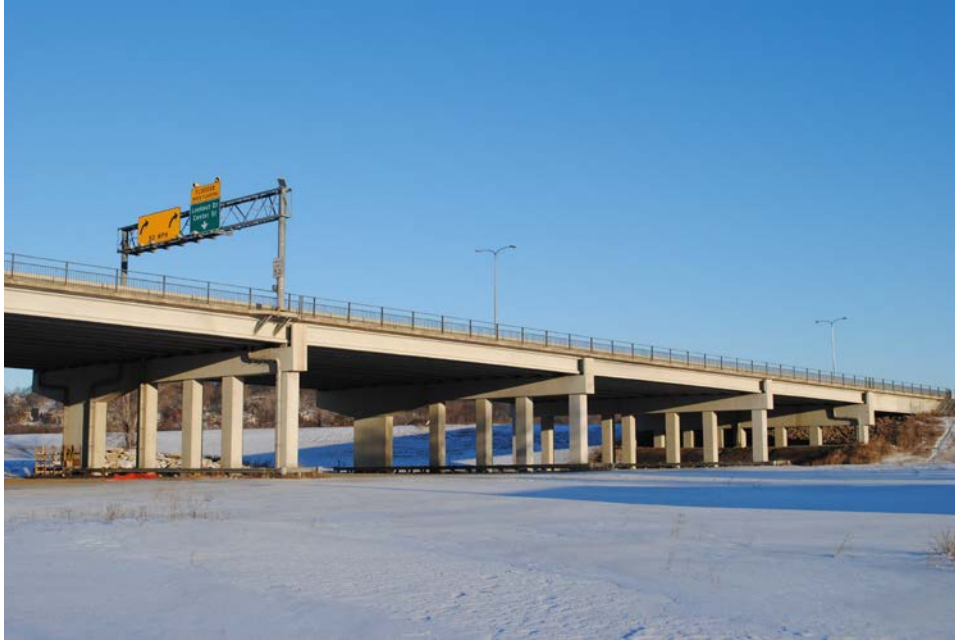
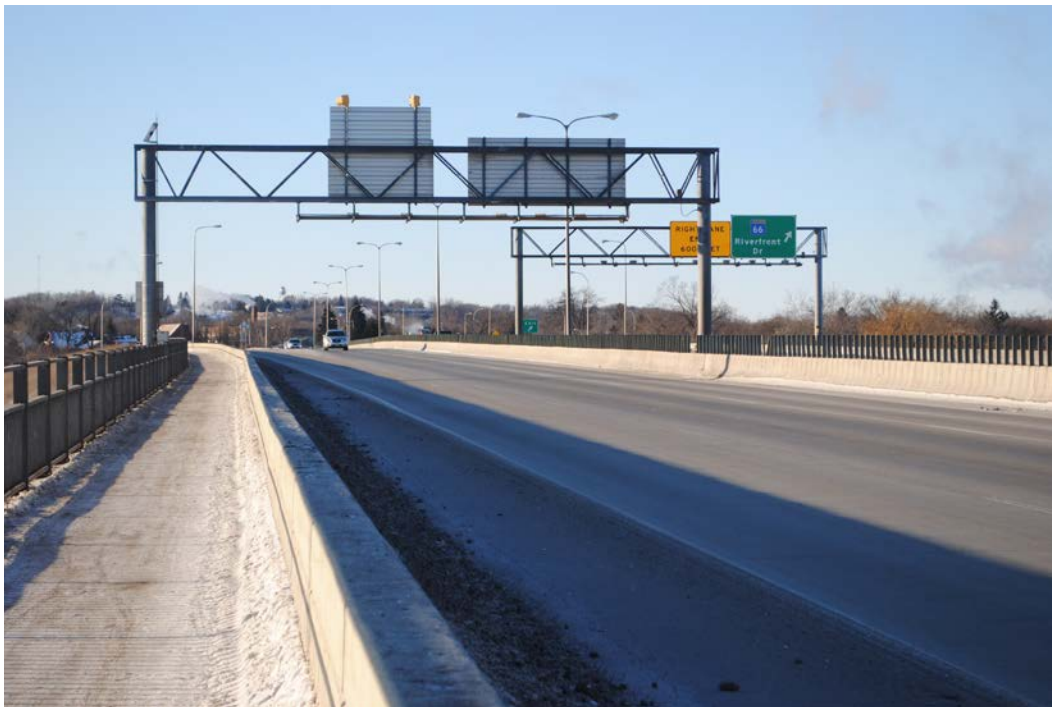
Figure 3. North Star Bridge, US 169 over the Minnesota River at Mankato, Minnesota.

a) Side view, view west.

b) Northbound lanes, view south.

Pavement areas were defined by the contributing drainage area of individual scupper collection points on an elevated section of US 169 in Mankato, Minnesota (Figure 3), part of the Minnesota River crossing. This location was selected because: (1) the elevated highway is an active highway with known anti-icing and deicing procedures; (2) the drainage system is easy to access

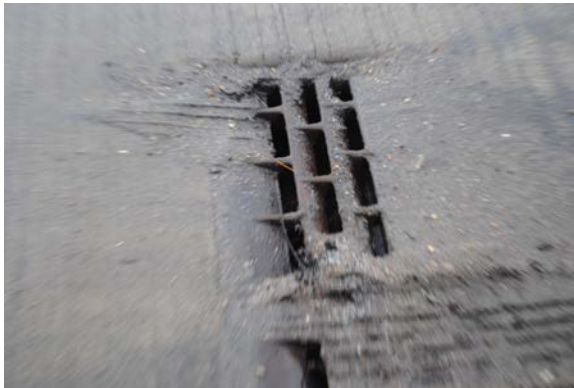
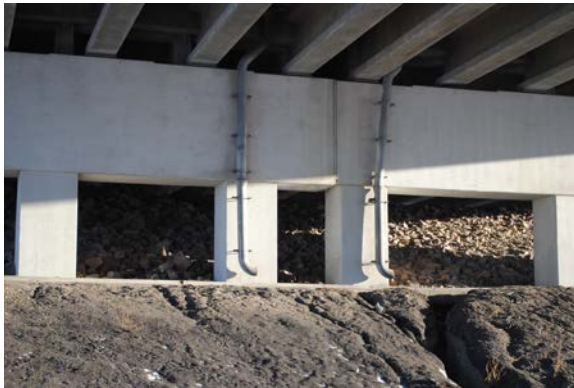
a) Scupper.

c) Down chute piping, inside lanes.

Bridge drainage follows the profile and crown slopes of the bridge deck, draining from south to north and from a crown line between the right and left lanes for both northbound and southbound directions. Drainage is collected from the pavement in scupper inlets, then flows downward through 8-inch ductile iron down chutes to discharge through an open bend to just above a concrete gutter on the ground surface that leads to a catch basin and a subsurface drainage system (Figure 4). Scuppers are located in sets of four located along a single bridge deck joint and coming down a single bridge pier line.

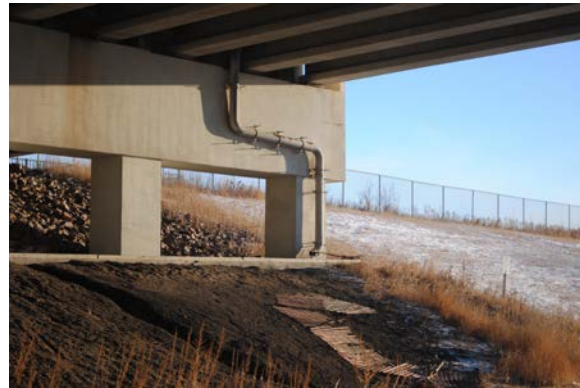
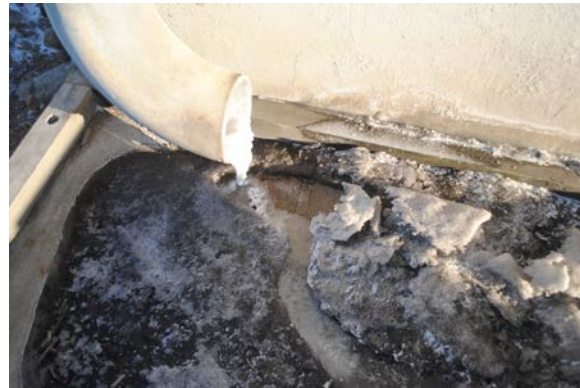
Figure 4. North Star Bridge drainage.

b) Down chute piping, outside lane.

d) Outlet to concrete drainage gutter.

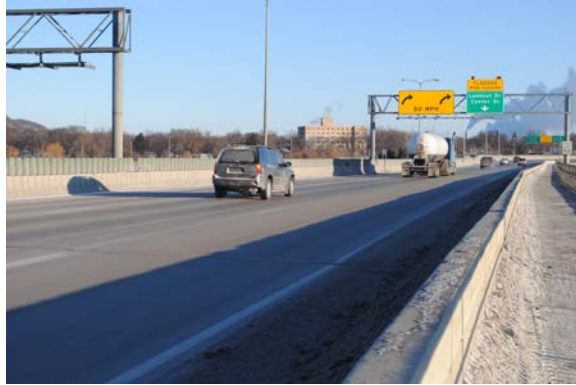
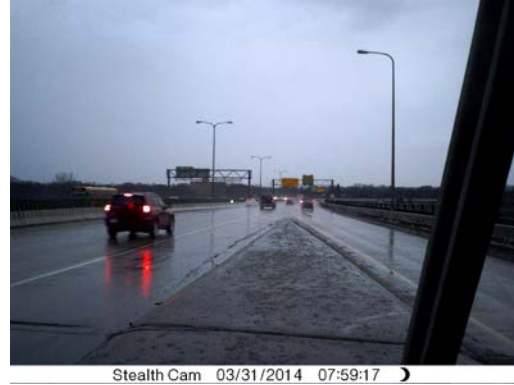
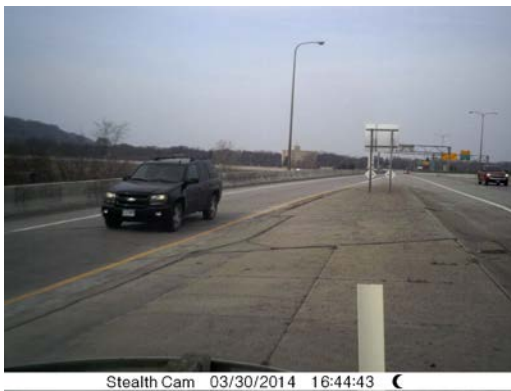
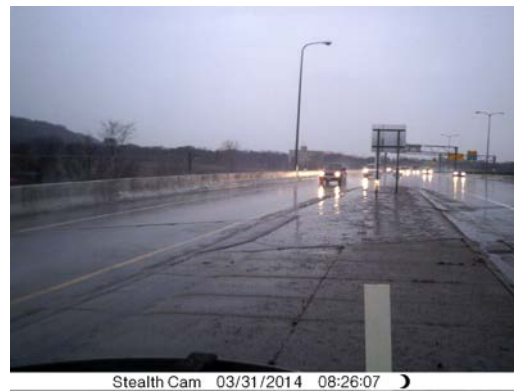
Figure 6. Traffic on the North Star Bridge.

a) Northbound – cold day.

b) Northbound – rain day.

c) Southbound – dry day.

d) Southbound – rain day.

It may be noted that the heavy commercial (truck) proportion is about 7.5% of the total traffic. Figure 6 provides several views of traffic on the bridge.

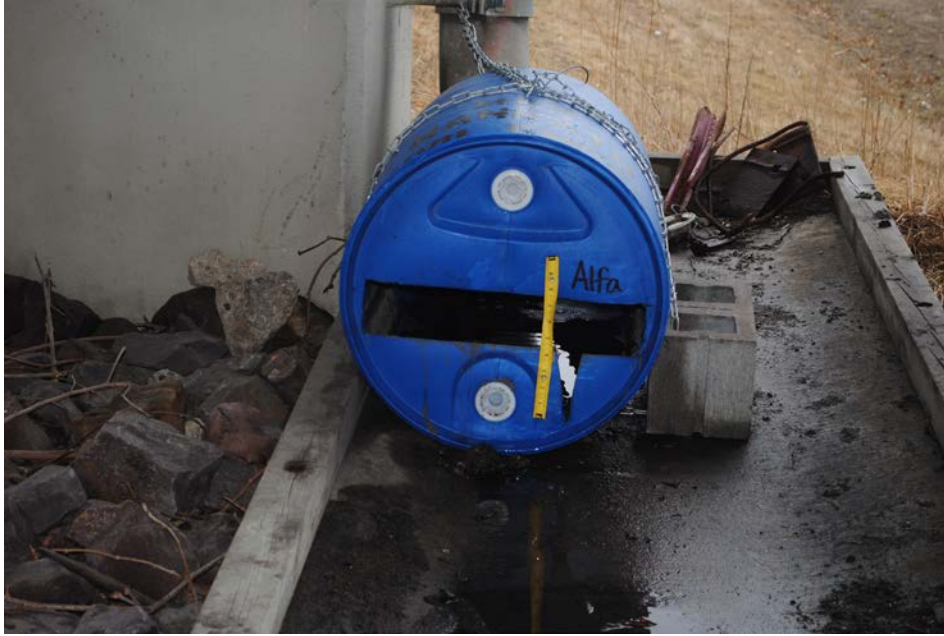
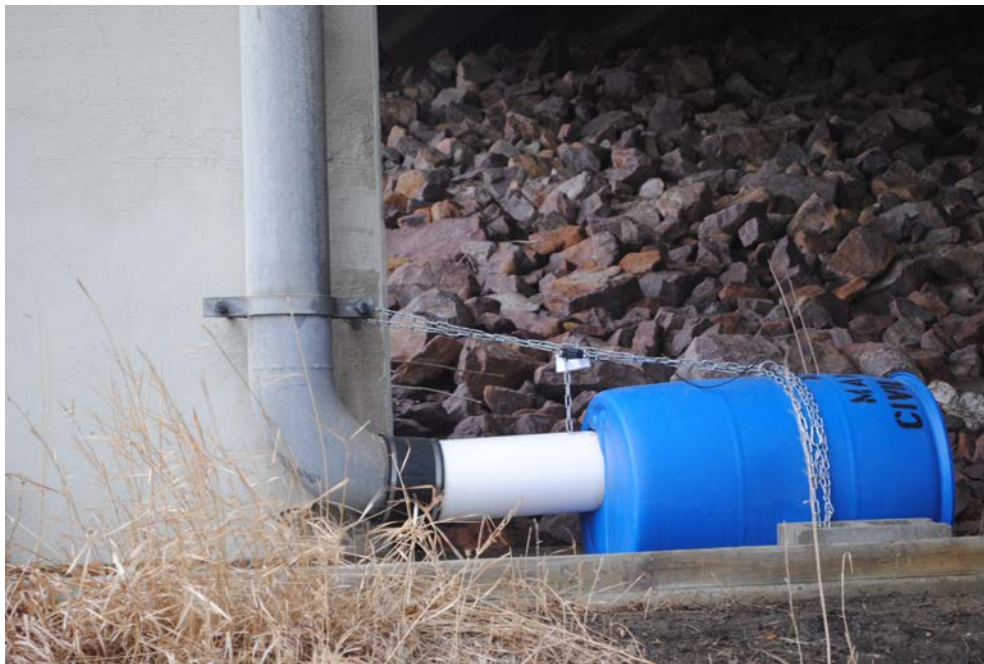
Figure 7. Flow-through cells

a) End view showing plastic drum with V-notch weir, broad weir, manual measurement tape, leveling chain/concrete masonry unit, and security chain.

b) Side view showing down chute piping, boot, PVC stub, plastic drum, leveling chain/concrete masonry unit, and security chain.

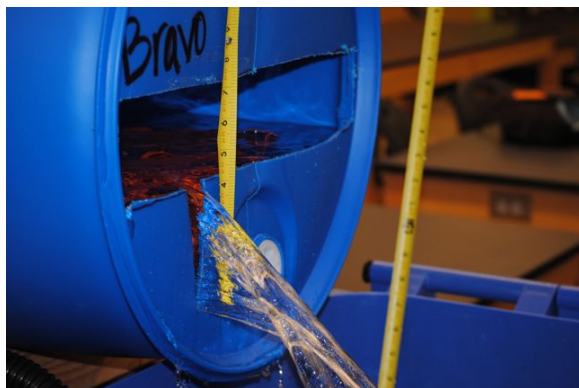
Figure 8. Calibration of flow measurement in weirs of plastic drum.

a) Flow-through V-notch weir into receiving sump.

The weirs of each drum were calibrated for flow by pumping a known flow-through the drum then measuring the depth over the weir (Figure 8). A weir coefficient was obtained particular to each drum using a best fit method (Appendix A). Calibration was done for flows ranging from 0.2 gpm to 4 gpm. Additional evaluation was done for flows up to 50 gpm.

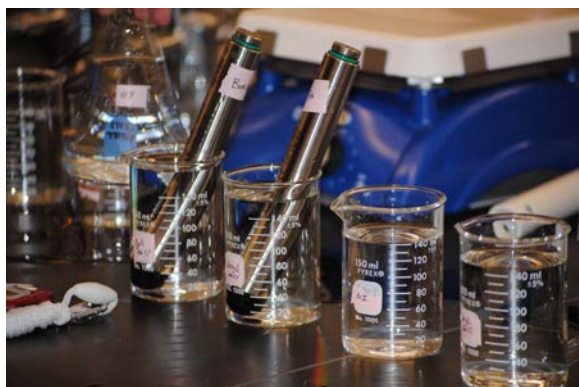
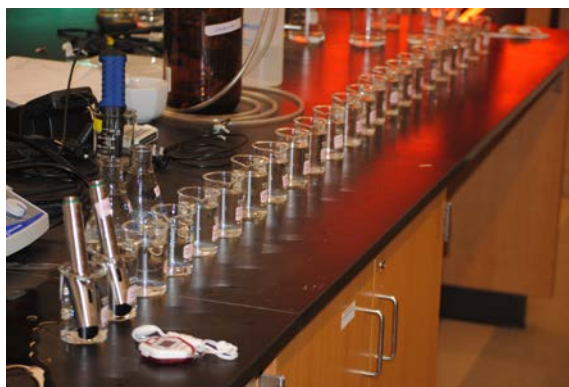
Figure 9. Calibration of conductivity measurement in data loggers.

a) Two data loggers in calibration mixtures.

b) Calibration mixtures lined up for measurement by data loggers.

Conductivity calibration of each Levellogger was done using solutions made with sodium chloride (rock salt) at nine concentrations from 0 to 150 g/L (Figure 9 and Appendix B). Levelloggers were rinsed with deionized (DI) water, placed in the solution and read at four time intervals. The order of the solutions was randomized, and 36 total solution mixtures were evaluated. Results were evaluated and found to bifurcate with a lower range of 0 – 60 g/L and a higher range of 60 – 150 g/L best representing the measured conductivities. However, during the course of the 2013-14 winter season, no field measurements reached to the high range for the conductivity measurement.

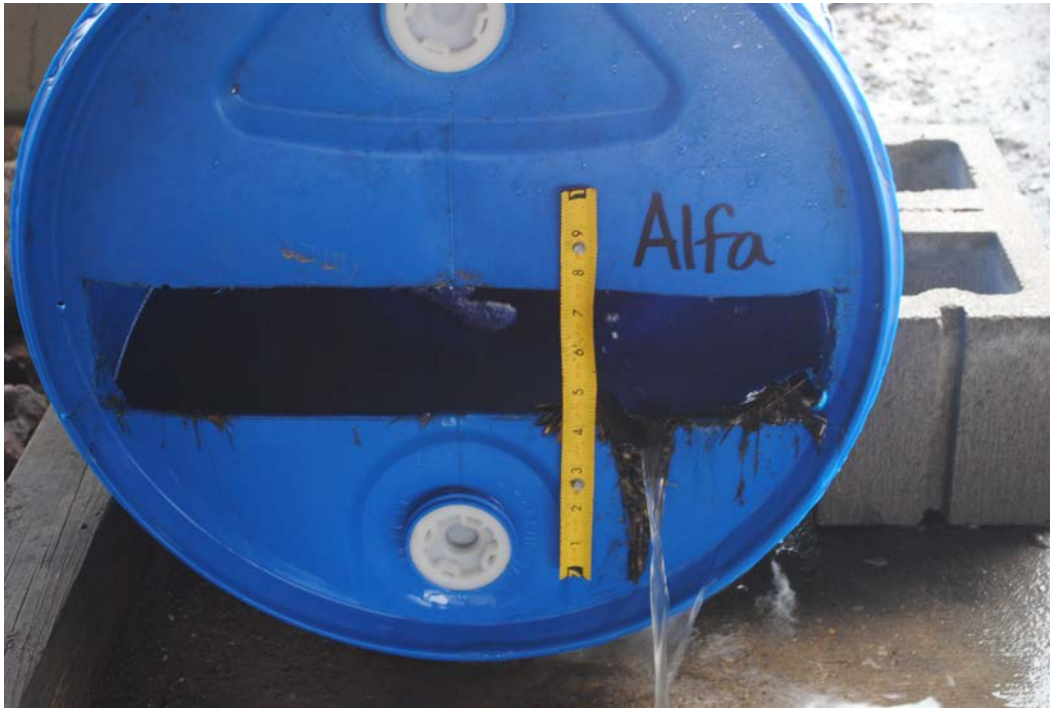
Figure 10. Debris clog at Location A, March 27, 2014.

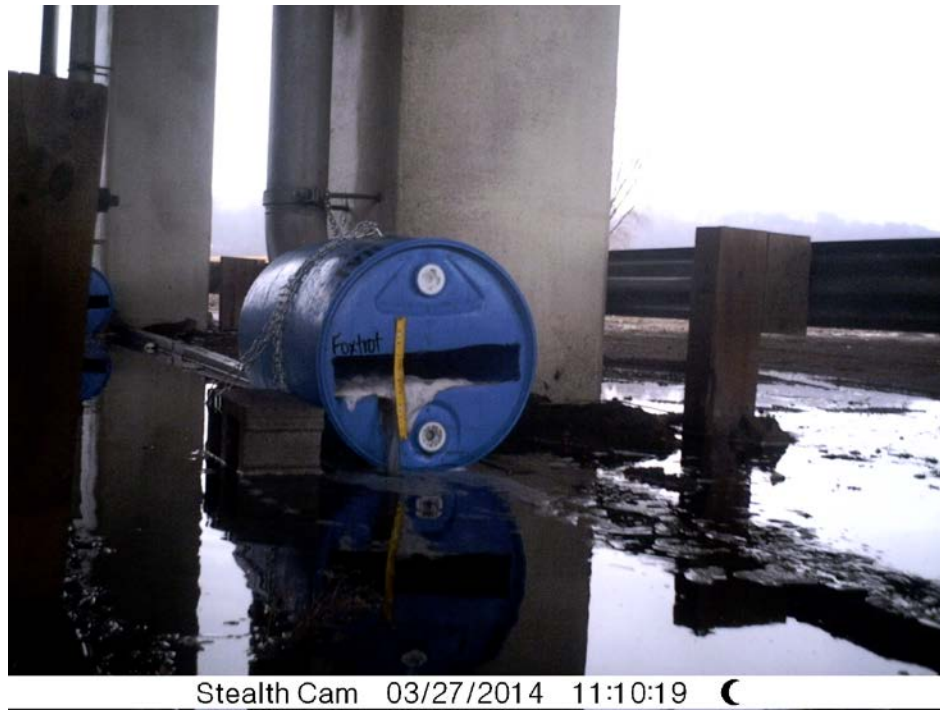
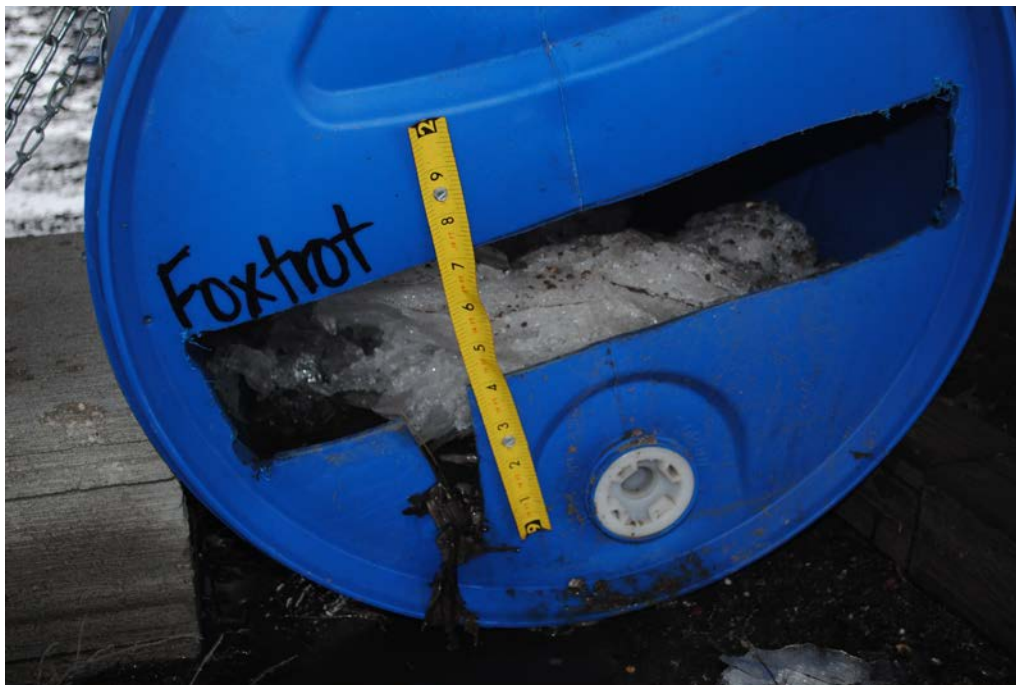
Figure 11. Ice blocking.

a) March 27, 2014, Location F, ice level above broad weir.

b) April 3, 2014, Location F, debris and ice damming flow-through V-notch weir.

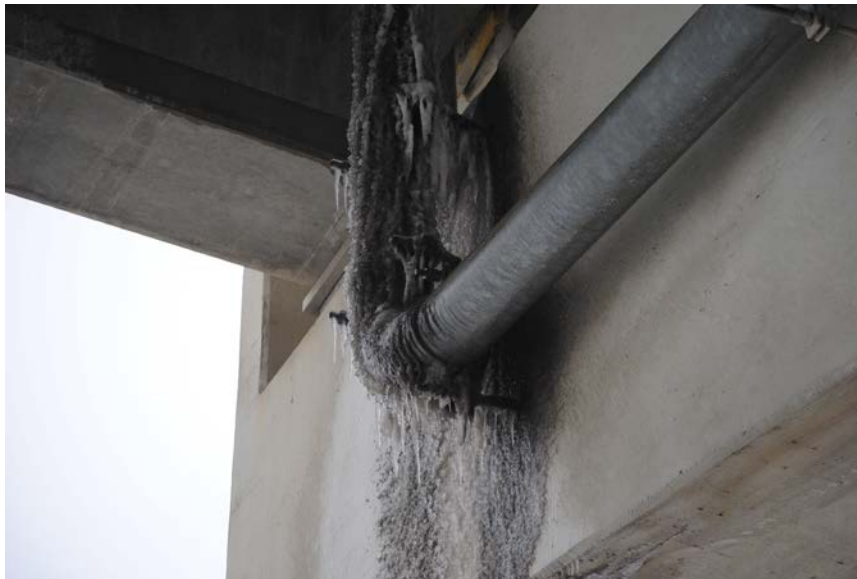
Figure 12. Blocked down chute at Location H.

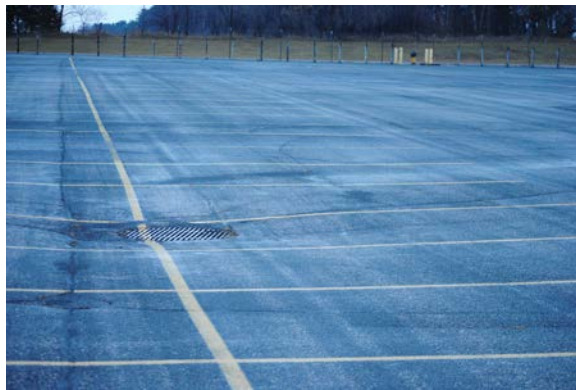
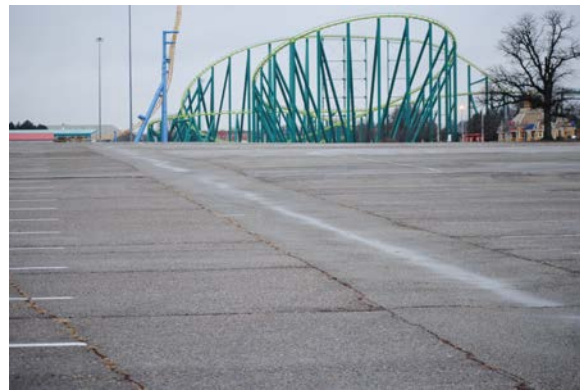
Figure 14. Pavement discontinuities, noted prior to snowfall.

a) Drainage structure at Canterbury Park

b) Transverse drainage gutter at Valleyfair

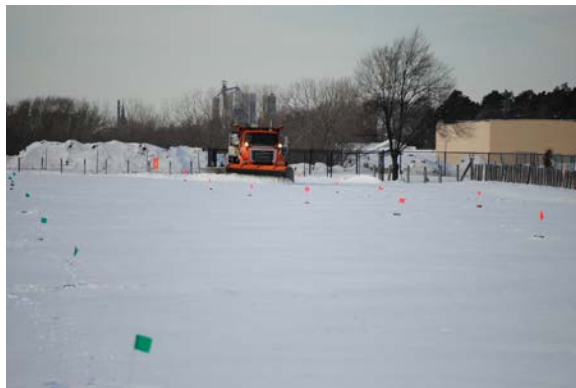
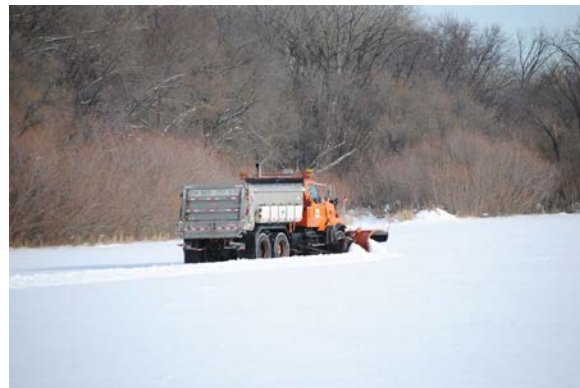
Figure 15. First snowplow cuts.

a) Canterbury Park

b) Valleyfair

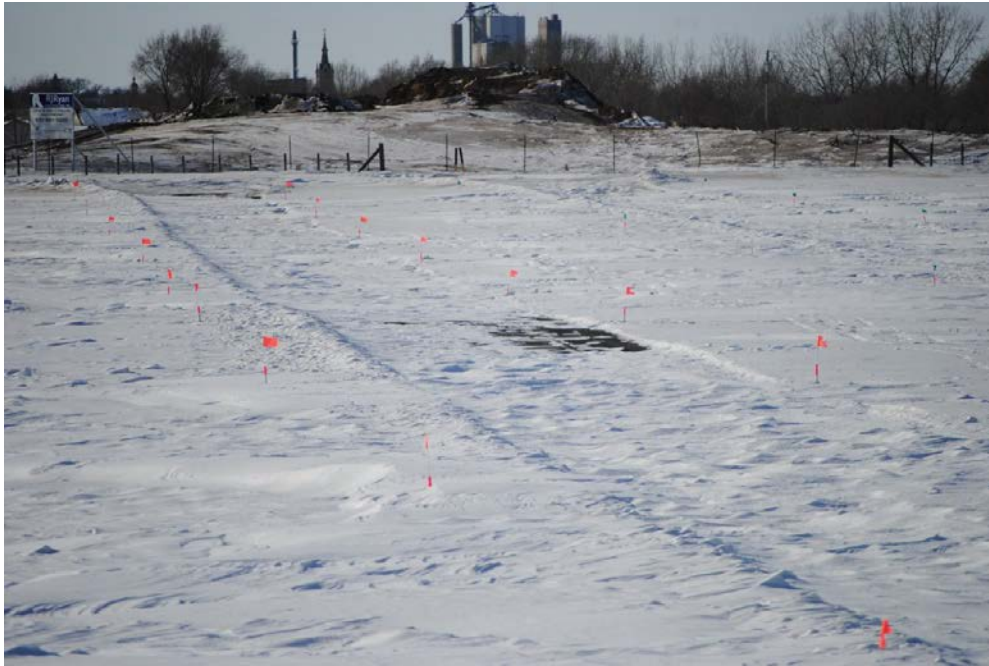
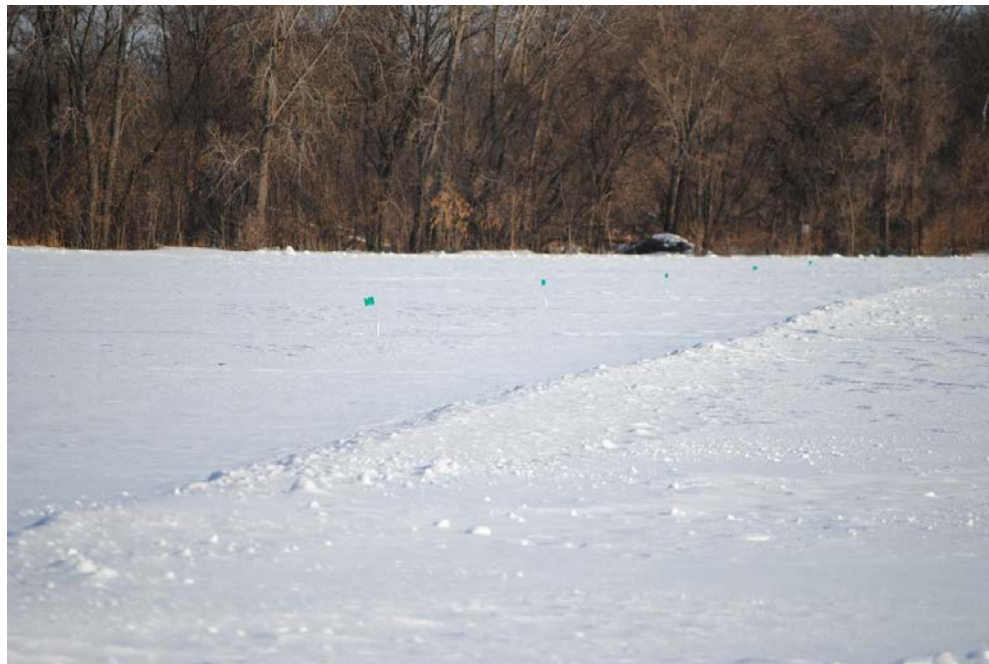
Figure 17. Completed lanes.

a) Canterbury Park

b) Valleyfair

Access agreements were negotiated and agreed upon during early December, 2013. Prior to a lasting snowfall, researchers with support from MnDOT Metro District maintenance staff performed pavement surveys to locate and document surface discontinuities (Figure 14) that could either interfere with or be damaged by plowing. Test lanes were configured to avoid such discontinuities. Lane marking was done with pin flags of various colors; colors were assigned to designate the sides of individual lanes. Pin flags were anchored through 6 in x 3 in x 2 in “sewer” (hollow core) bricks to 8 in x 8 in x ¾ in wooden plates and stabilized by 1 ft lengths of ¾ in diameter Schedule 40 PVC pipe. Anchoring was done to prevent penetration of the pavement by the flags yet maintain the flags in spite of winter winds. Initial lane cuts were made December 18<sup>th</sup> (Figure 15); afterwards flags were reset on measured locations to represent 100-ft stationing along both sides of each lane (Figure 16). Completed lanes are shown in Figure 17, from conditions representative of early January, 2014.

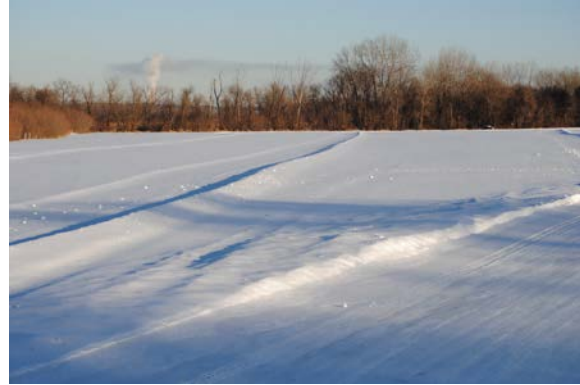
Figure 18. Comparison of conditions possible between field sites.

b) Valleyfair January 8, 2014 showing uniformity of conditions created by river bottomland and tree protection.

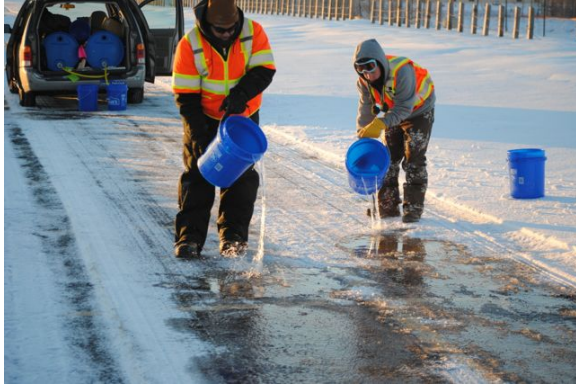
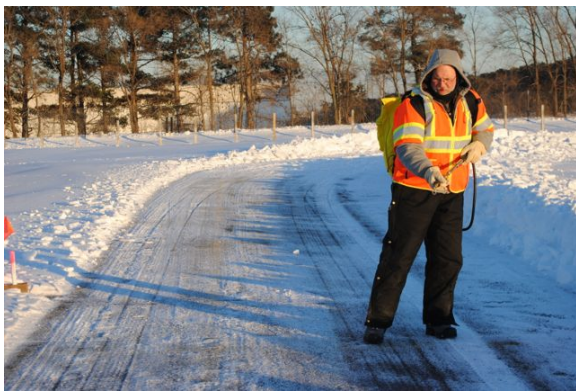
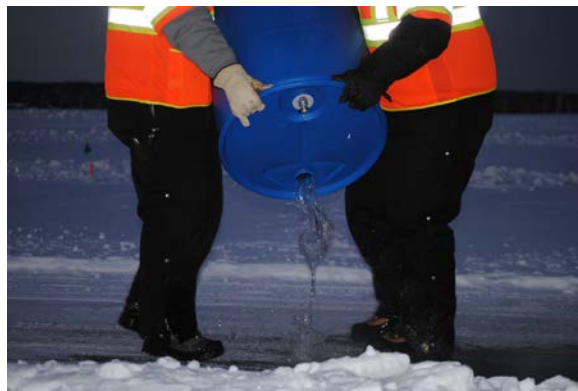
a) Pour from buckets.

c) Woodland fire suppression bladder bag spray.

d) Direct pour from transport drum.

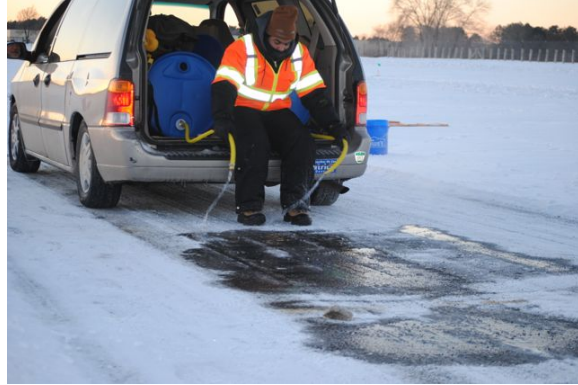
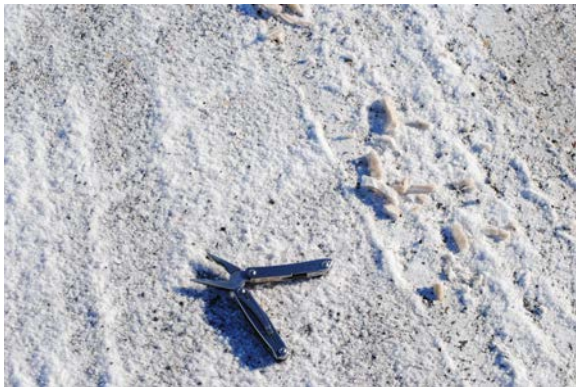
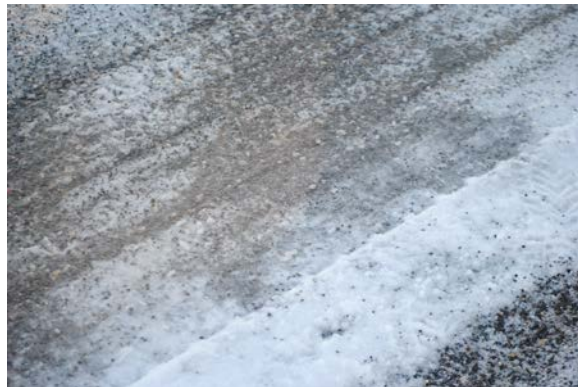
Figure 19. Exploration of techniques to create ice sheet patches on pavement lanes.

b) Hose drizzle.

e) Post plow, pre-icing treatment surface. Note significant amount of unconsolidated snow.

f) Post-icing treatment surface with ice formation.

- Pouring water directly from 5-gal buckets (Figure 19a);
- Drizzling water via hoses from the 55-gal drums (Figure 19b);
- Spraying water from woodland fire suppression bladder bag and hand pump (Figure 19c); and,
- Directly pouring from the 55-gal drums (Figure 19d).

Figures 7e and 7f show the comparison between unconsolidated snow, left after plowing at -5°F, and consolidated snow and ice formed by direct pouring of water from 5-gal buckets.

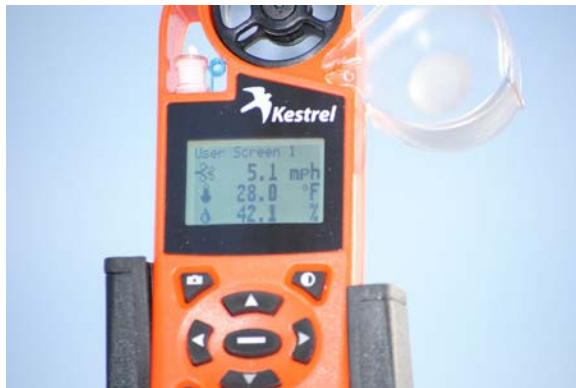
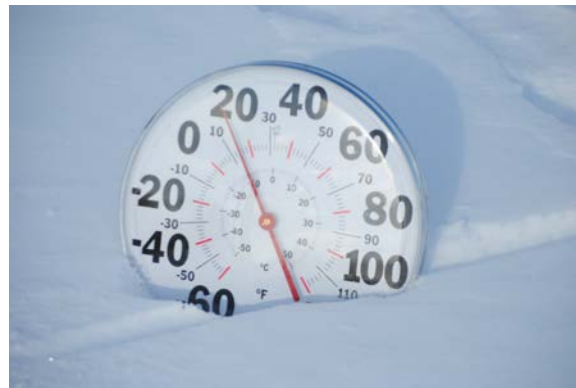
Figure 20. Weather monitoring tools.

a) Handheld weather station.

b) Dial thermometer.

A Kestrel 4000 handheld weather station (Nielsen-Kellerman, Boothwyn, PA), capable of determining temperature, relative humidity, dew point and wind speed, was used to determine conditions during field operations (Figure 20a). A dial thermometer (Figure 20b) was used for illustration and photographic documentation, but was not considered sufficiently accurate to represent field conditions. Weather measurements were augmented with documentation from a paid subscription to WeatherSpark.com, used for interpreting National Weather Service data obtained from Flying Cloud Airport, Eden Prairie, Minnesota, approximately 2 miles north of either field site.

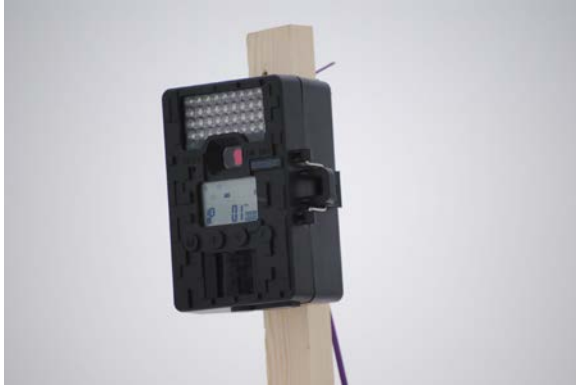
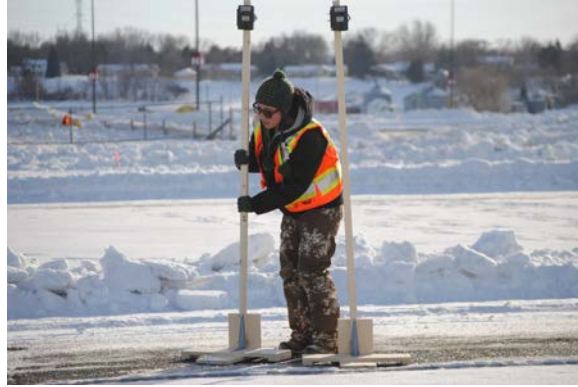
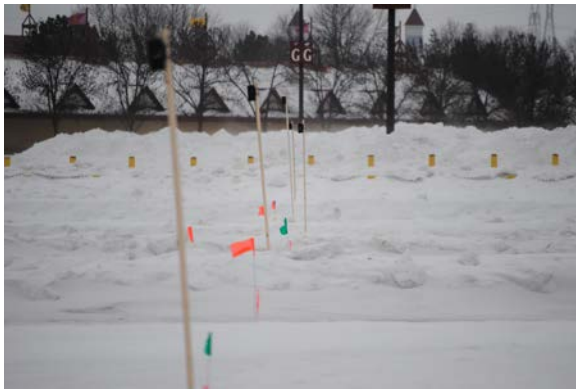
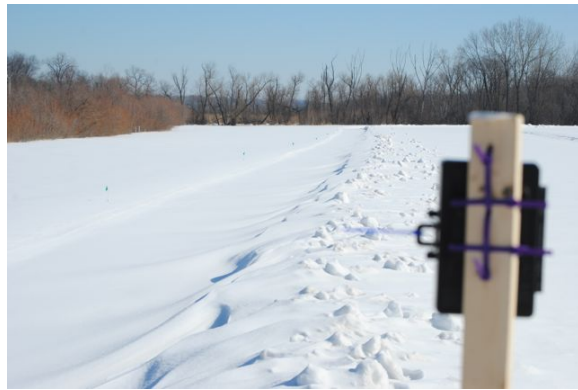
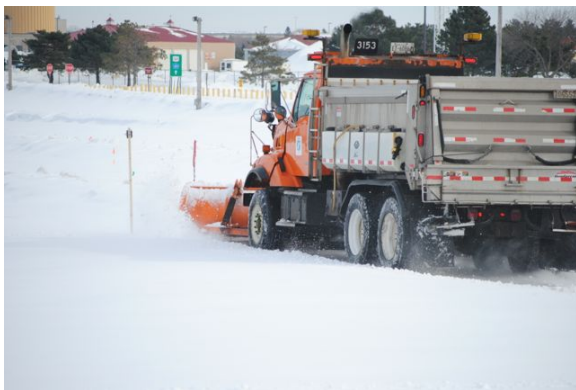
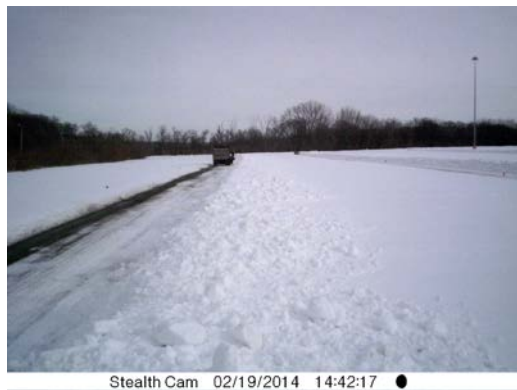
Figure 21. Time-lapse cameras and a resulting photograph.

a) Time-lapse camera, pole mounted.

b) Pole mounted cameras with detachable bases being deployed.

c) Pole mounted cameras directly inserted into plow windrows.

d) Camera in foreground with view of lane prior to plowing.

e) Truck passing pole mounted camera on left.

f) Camera view after truck has just past.

Field conditions were documented through photography using two different camera systems. Handheld, high resolution photographs were taken using a Nikon D3000 camera with a 55-200 mm telephoto lens, occasionally alternating with a 20-55 mm wide angle lens. Time-lapse photographs were taken using Stealth Calm Core 3 time-lapse (game scouting) cameras (Figure 21) (Stealth Cam, LLC, Grand Prairie, TX). Time-lapse cameras were pole mounted at approximately a 6-ft height, with poles attached to wooden bases. Wooden bases were set aside once windrows built up along test lanes, as poles were directly inserted into windrows for support. Typically, time-lapse cameras were installed at lane station 1+00 for each lane, meaning 100 ft from the start of the lane, oriented in the direction of the plow and deicer truck movement. Time increments of 1 minute were typically used. Date and time stamps were made on time-lapse photographs, though all photographs had file origination information that could provide time of capture for verification, if needed.

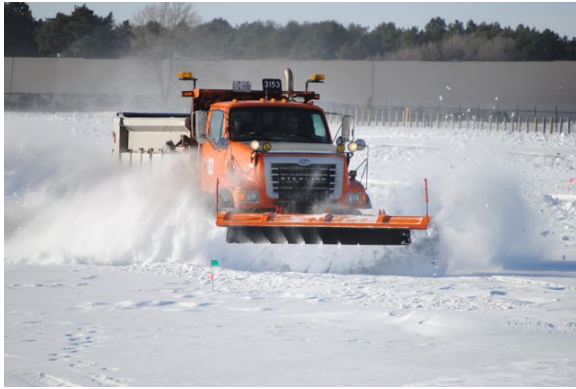
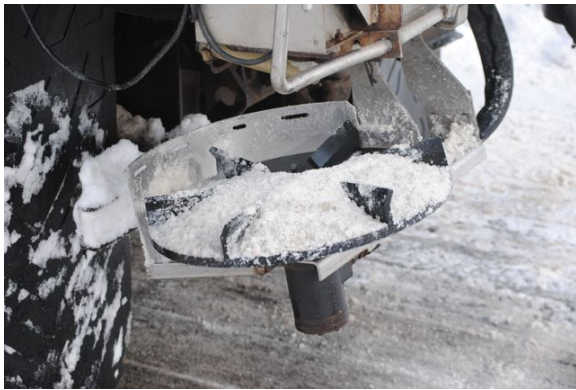
Figure 22. Plow and deicer equipment on a MnDOT truck used for this study.

a) MnDOT tandem axle dump truck with front and right wing plows engaged.

c) Salt distributor behind left rear wheel (not in motion/not being fed deicer at time of photo).

Plowing and deicer spreading (distribution) were done by maintenance personnel from MnDOT Metro District using equipment from the Chaska Truck Station. Typical equipment was a 2006 Sterling tandem axle, automatic transmission dump truck with front, right wing and underbody plows (Figure 22a). Side mounted (saddle) tanks were used to carry brine materials used for prewetting granular deicer (Figure 22b). A transverse auger was mounted in the rear of the dump body to feed deicer either to the left or right chute. Granular deicer was maintained in contact with the auger by frequent plow body raising such that the granular deicer would shift to the back of the plow body where the auger was located. Deicer would fall through the chute to a distributor (spinner) plate (Figure 22c). Prewet was poured via gravity onto the granular deicer when on the distributor plate (Figure 22d). The distributor plate rotated when the truck was in forward motion, spreading deicer rather than having a straight drop (Figure 23).

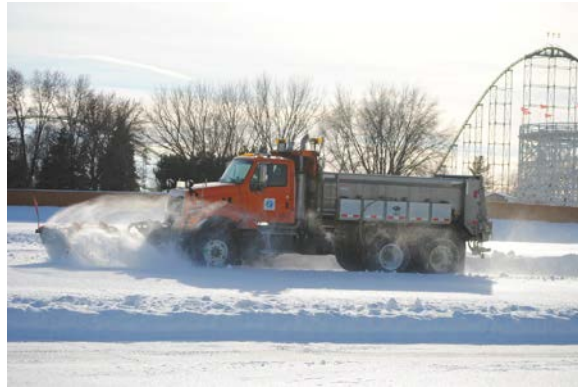
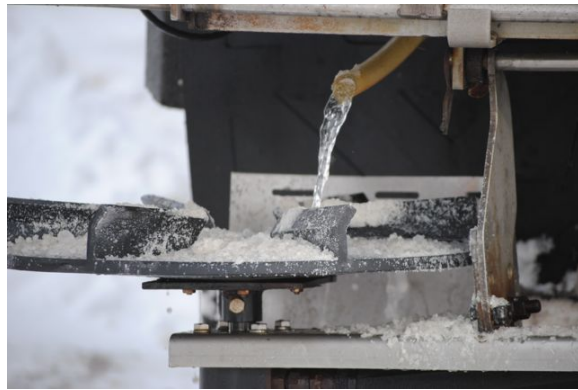
b) MnDOT truck with saddle tanks for prewet fluid.

d) Prewet flow onto salt distributor (not in motion/not being fed deicer at time of photo).

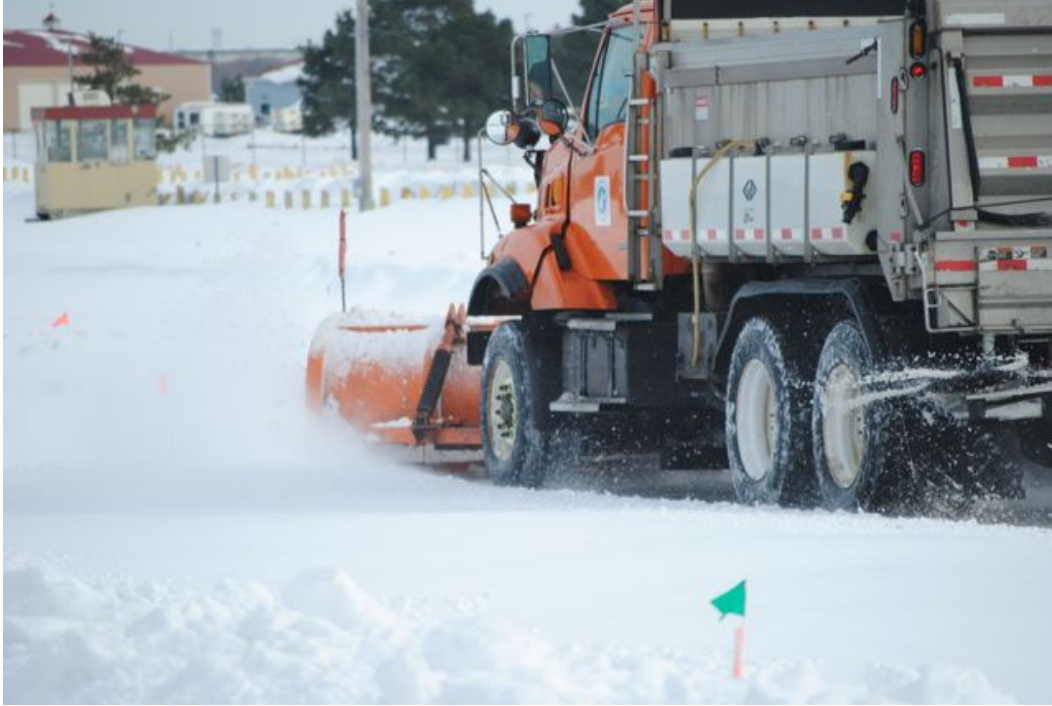
Figure 23. MndOT truck spreading deicer off left rear while moving forward with a right-angled front plow.

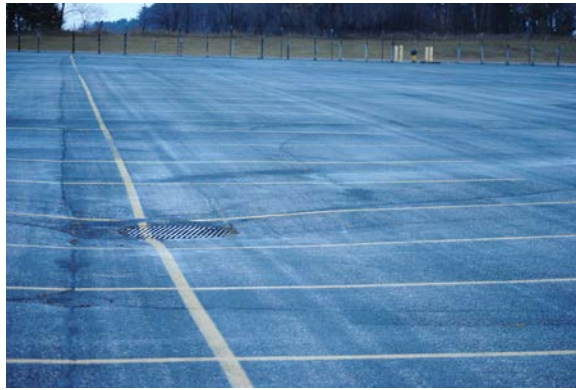
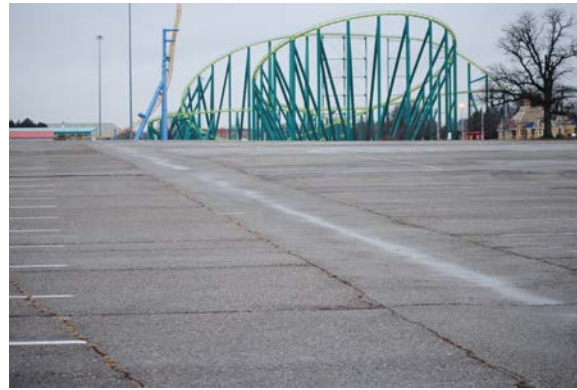
Figure 25. Pavement discontinuities, noted prior to snowfall.

a) Drainage structure at Canterbury Park

b) Transverse drainage gutter at Valleyfair

Access agreements were negotiated and agreed upon during early December, 2013. Prior to a lasting snowfall, researchers with support from MnDOT Metro District maintenance staff performed pavement surveys to locate and document surface discontinuities (Figure 25) that could either interfere with or be damaged by plowing. Test lanes were configured to avoid such discontinuities.

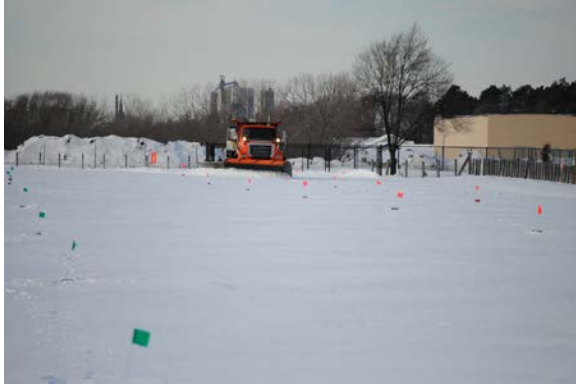
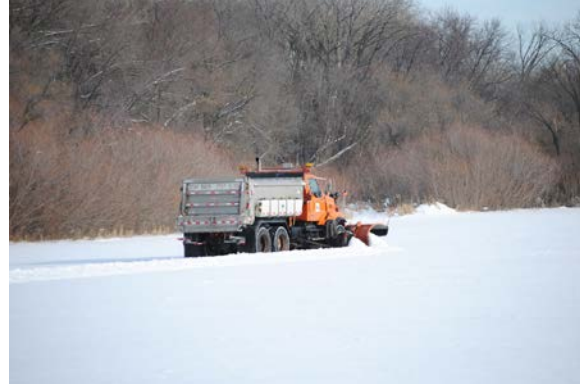
Figure 26. First snowplow cuts.

a) Canterbury Park

b) Valleyfair

Initial lane cuts were made December 18<sup>th</sup> (Figure 26); afterwards flags were reset on measured locations to represent 100-ft stationing along both sides of each lane (Figure 27).

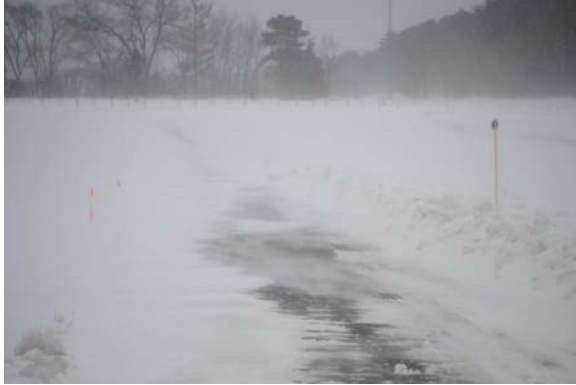
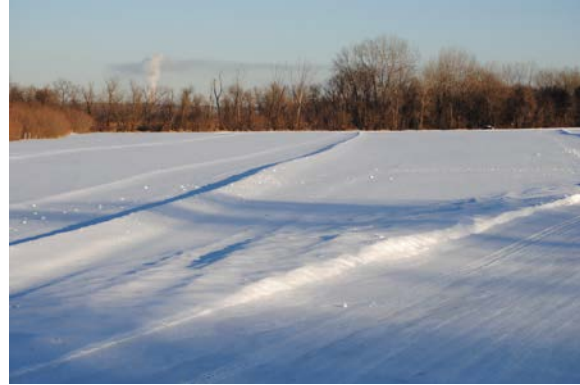
Figure 28. Comparison of conditions possible between field sites.

a) Canterbury Park February 13, 2014 showing wind effects and creation of drift structure.

b) Valleyfair January 8, 2014 showing uniformity of conditions created by river bottomland and tree protection.

Figure 28 shows the benefit of having two separate locations involved in the study. Lanes at Canterbury Park were located on top of a low ridge, and therefore were exposed and often had transverse snow drifts. Conversely, lanes at Valleyfair were located in an area of river bottomland, protected by mature trees on the parking lot perimeter, and therefore were protected and often had uniform snow.

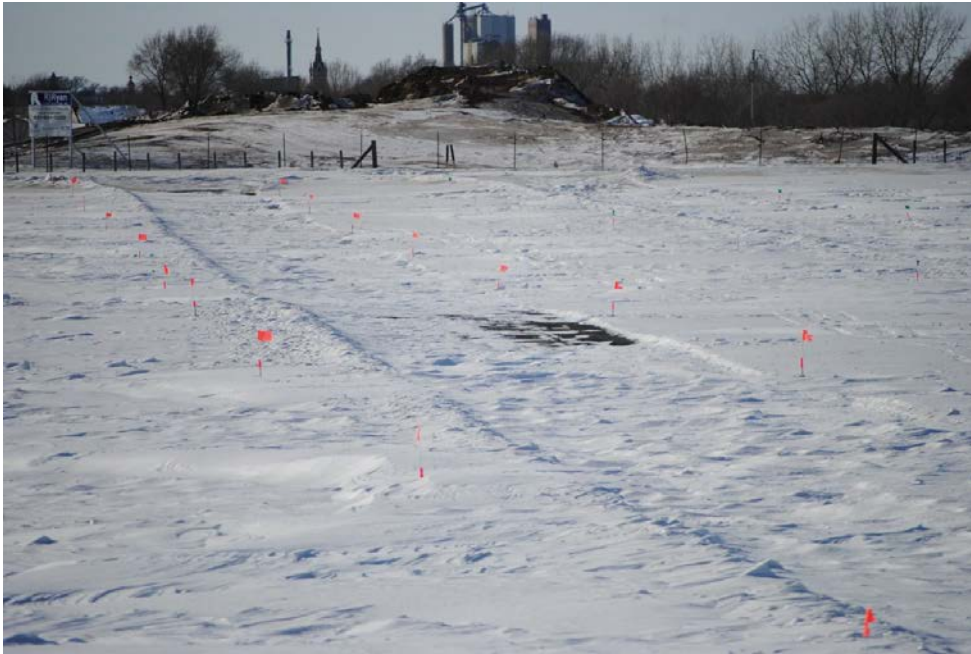
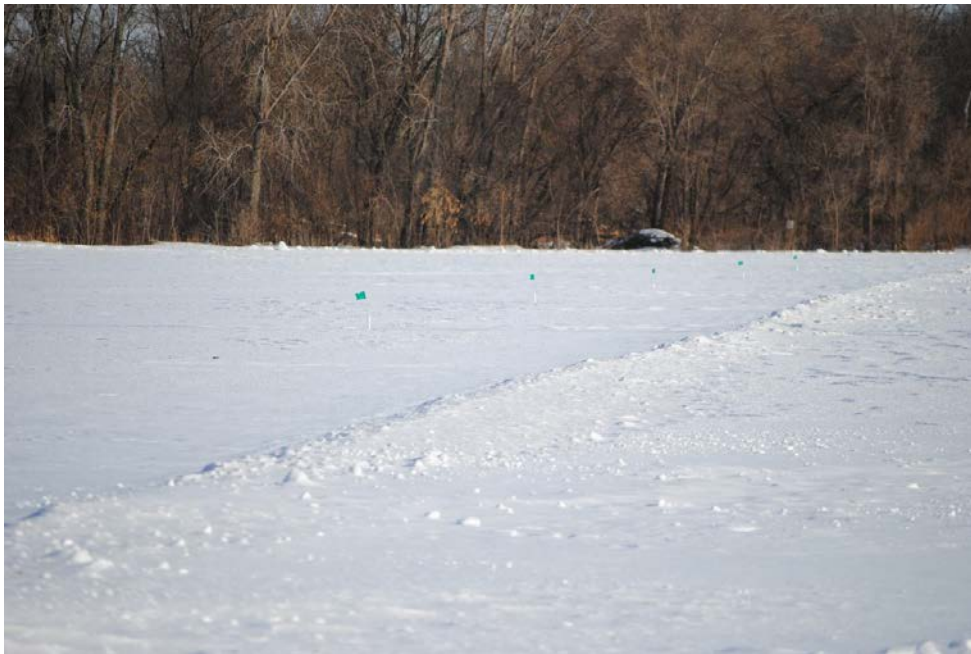
Figure 29. Completed lanes.

a) Canterbury Park

b) Valleyfair

Completed lanes are shown in Figure 29, from conditions representative of early January, 2014.
