# **Salt Brine Blending to Optimize Deicing and Anti-Icing Performance and Cost Effectiveness, Phase II**

Stephen J. Druschel, Principal Investigator  
Center for Transportation Research and Implementation  
Minnesota State University, Mankato

**December 2014**

Research Project  
Final Report 2014-43

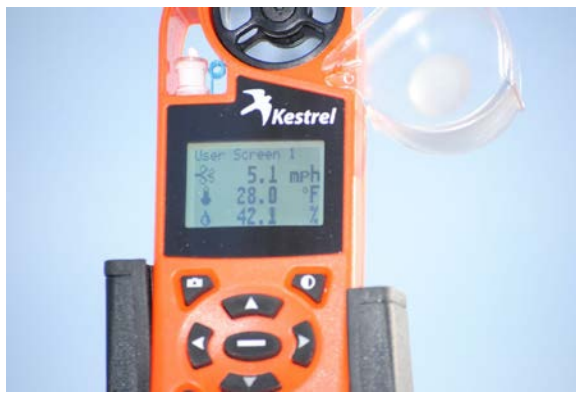
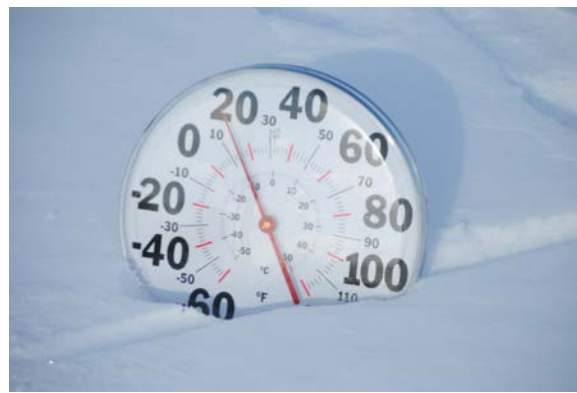
Figure 30. Weather monitoring tools.

A Kestrel 4000 handheld weather station (Nielsen-Kellerman, Boothwyn, PA), capable of determining temperature, relative humidity, dew point and wind speed, was used to determine conditions during field operations (Figure 30a). A dial thermometer (Figure 30b) was used for illustration and photographic documentation, but was not considered sufficiently accurate to represent field conditions. Weather measurements were augmented with documentation from a paid subscription to WeatherSpark.com, used for interpreting National Weather Service data obtained from Flying Cloud Airport, Eden Prairie, Minnesota, approximately 2 miles north of either field site.

a) Handheld weather station.

b) Dial thermometer.

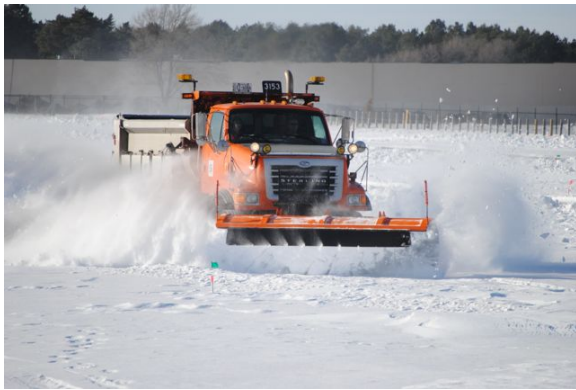
a) MnDOT tandem axle dump truck with front and right wing plows engaged.

Plowing and deicer spreading (distribution) were done by maintenance personnel from MnDOT Metro District using equipment from the Chaska Truck Station. Typical equipment was a 2006 Sterling tandem axle, automatic transmission dump truck with front, right wing and underbody plows (Figure 32a). Side mounted (saddle) tanks were used to carry brine materials used for prewetting granular deicer (Figure 32b). A transverse auger was mounted in the rear of the dump body to feed deicer either to the left or right chute. Granular deicer was maintained in contact with the auger by frequent plow body raising such that the granular deicer would shift to the back of the plow body where the auger was located. Deicer would fall through the chute to a distributor (spinner) plate (Figure 32c). Prewet was poured via gravity onto the granular deicer when on the distributor plate (Figure 32d). The distributor plate rotated when the truck was in forward motion, spreading deicer rather than having a straight drop (Figure 33).

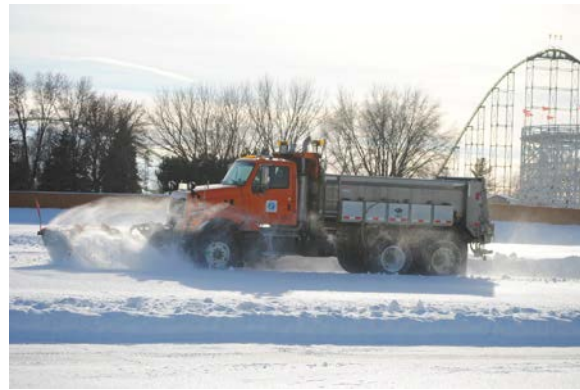
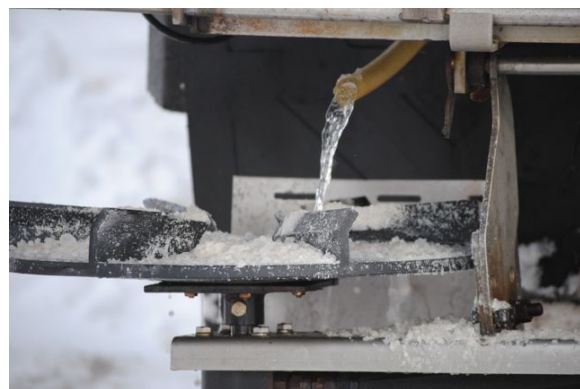
Figure 32. Plow and deicer equipment on a MnDOT truck used for this study.

b) MnDOT truck with saddle tanks for prewet fluid.

c) Salt distributor behind left rear wheel (not in motion/not being fed deicer at time of photo).

d) Prewet flow onto salt distributor (not in motion/not being fed deicer at time of photo).

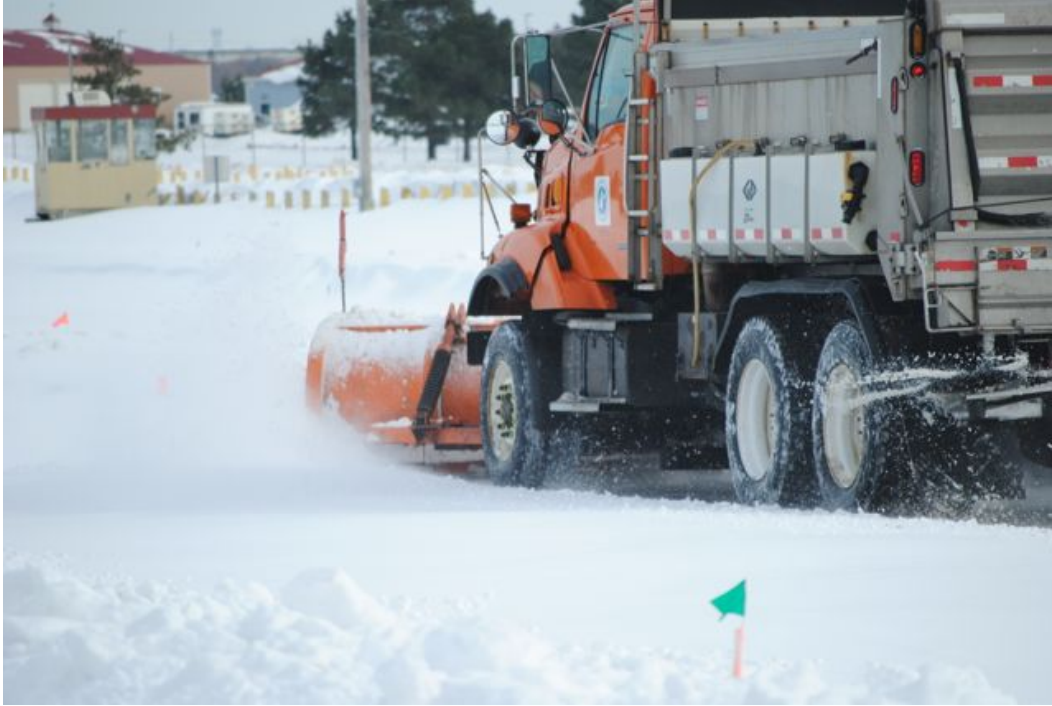
Figure 33. Mndot truck spreading deicer off left rear while moving forward with a right-angled front plow.

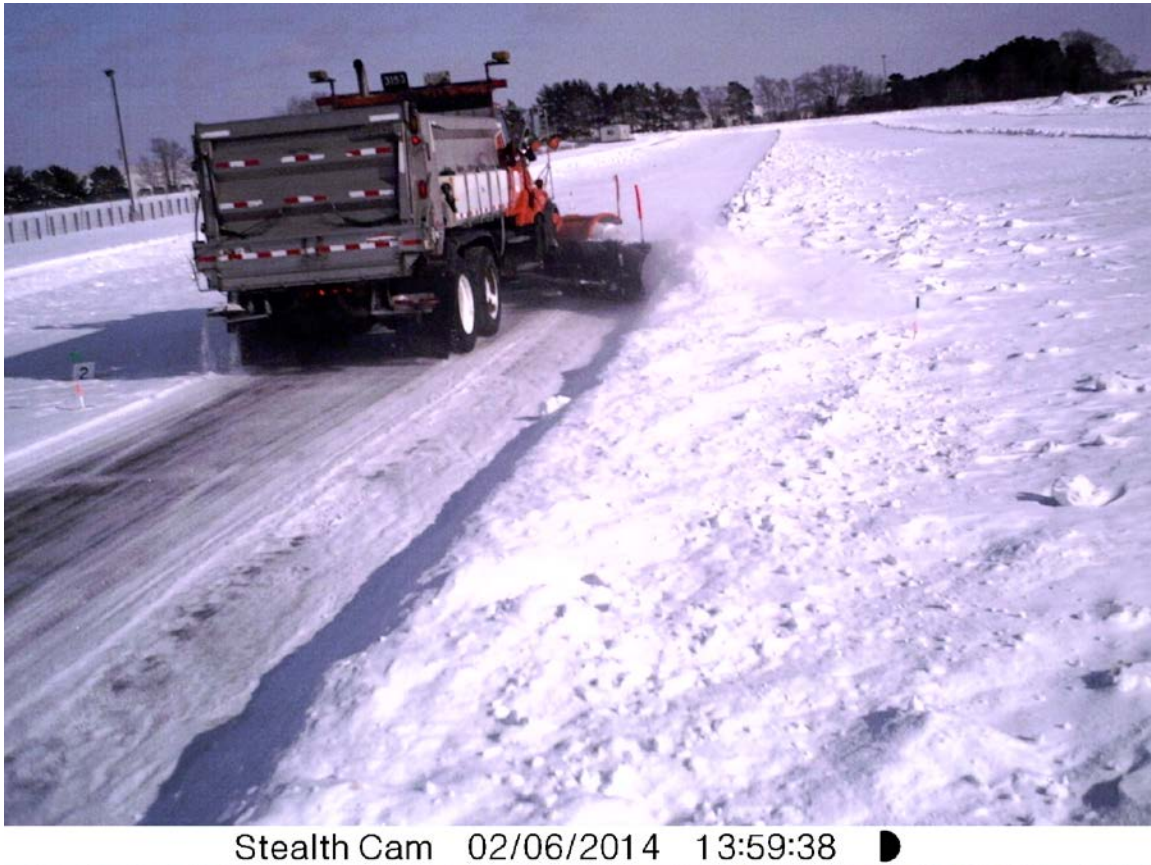
Figure 34. Typical time lapse photograph showing front and wing plowing plus deicer application (left rear distributor). Notice difference of scrape quality between front plow (directly behind truck) and wing plow. Prior to December 18, 2013, snow remaining the day after a storm event was insufficient for testing and evaluation. On March 6, 2014, an additional day of plowing and deicing was planned; however, melting of snow created slick conditions underlying the snow. A MnDOT truck mounted plow was unable to clear access to the pavement lanes at Canterbury Park, resulting in test cancelation. By March 13, 2014, insufficient snow remained on the pavement lanes for additional testing.

Photographs used in the summary forms of Appendix K for the times prior to plowing, immediately after plowing and 10 minutes after plowing were selected to illustrate snow and pavement conditions typical of either before or after plowing. Photographs of the moments during plowing were selected to illustrate dislodgement and casting of snow during the plow action.

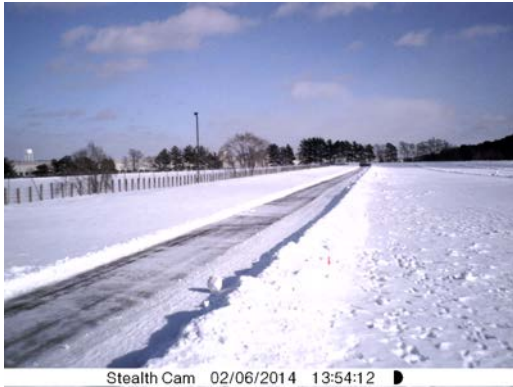
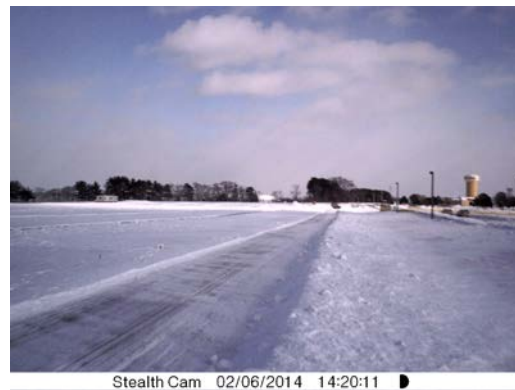
Figure 35. Time-lapse photographs from immediately (~1 minute) after plowing. Photos taken February 6, 2014 with conditions of 4°F, clear and sunny, wind 8-12 mph, 2 – 3 inches slightly moist snow. Front and wing plowing to right at medium speed of about 20 mph.

No significant differences were observed in plowing results across the site from CD1 to CD6 on either day. The front plow scraped to  $\sim \frac{1}{4}$ <sup>th</sup> inch residual snow on average, with a moderate amount of pavement bared. The wing plow scraped to  $\sim \frac{1}{2}$  inch residual snow on average, with no pavement bared. No significant differences were observed between the days, in spite of the temperature difference (air temperatures of 4°F versus 40°F).

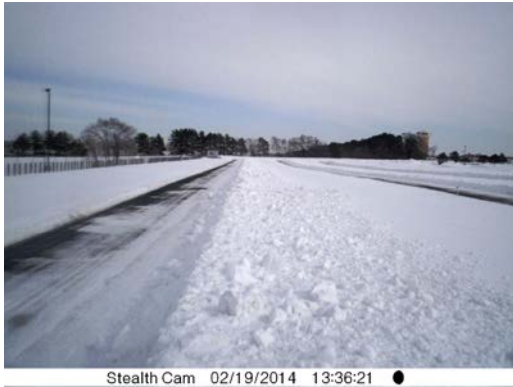
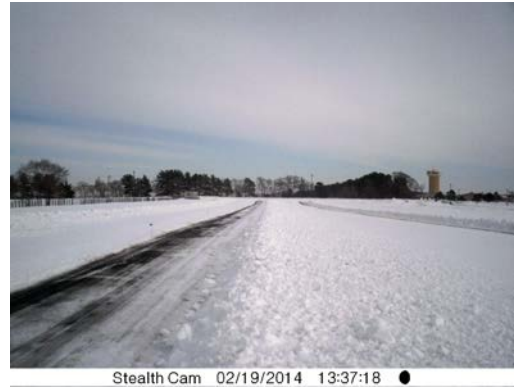
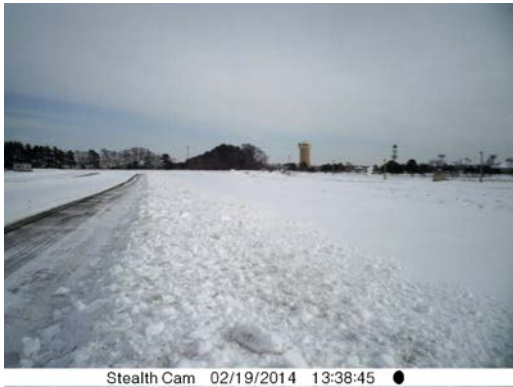
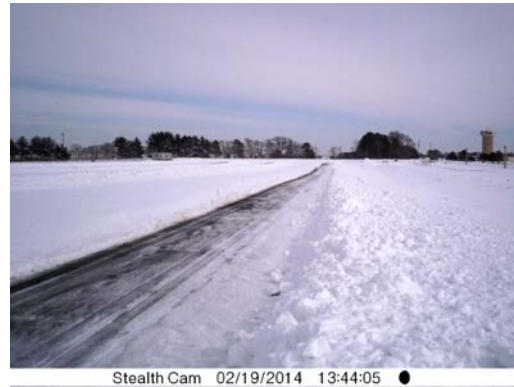
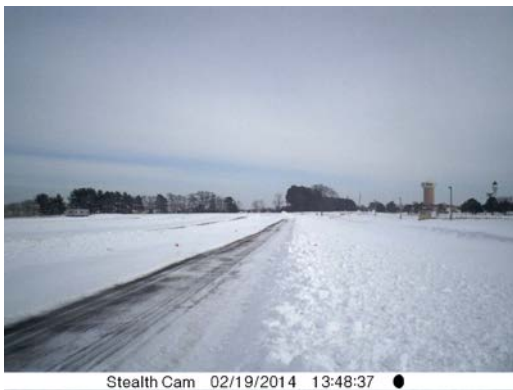
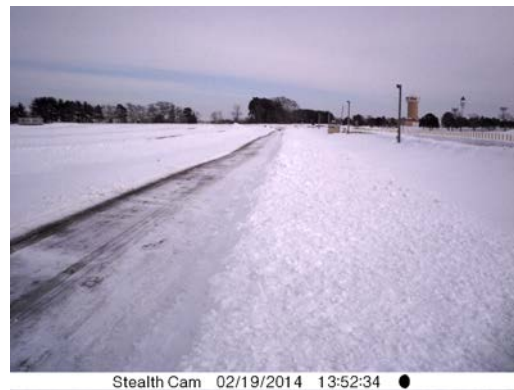
Figure 36. Time-lapse photographs from immediately (~1 minute) after plowing (except CD 1 and CD 2 are from 11 and 6 minutes after plowing, respectively). Photos taken February 19, 2014 with conditions of 40°F, clear and sunny, wind 0 – 3 mph, 2 – 3 inches moist snow. Front and wing plowing to right at medium speed of about 20 mph.

Two different days were evaluated for differences in plow performance across snow and weather conditions at a single site. Results from Canterbury Park lanes CD1 to CD 6 were evaluated for February 6<sup>th</sup>, a colder day with 2 – 3 inches of snow (Figure 35), and for February 19<sup>th</sup>, a warmer day also with 2 – 3 inches of snow (Figure 36). Plow speeds were 20 mph on both days using the same truck.

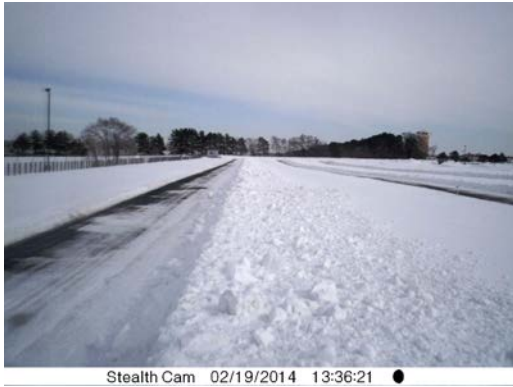
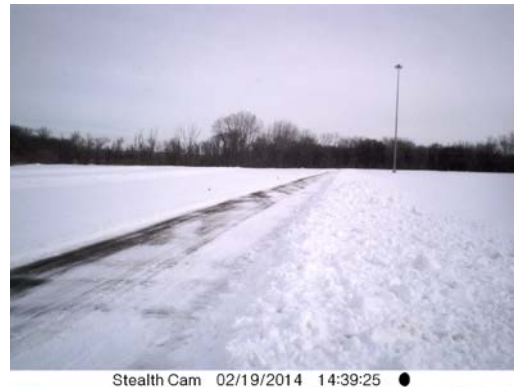
Figure 38. Comparison between Canterbury Park (CD Lanes) and Valleyfair (VF Lanes) sites using time-lapse photographs from immediately (~1 minute) after plowing (except CD 1 and VF3 are from 11 and 6 minutes after plowing, respectively). Photos taken February 19, 2014 with conditions of 40°F, clear and sunny, wind 0 – 3 mph, 2 – 3 inches moist snow. Front and wing plowing to right at medium speed of about 20 mph. Photos a, c, and e repeated from Figure 35.

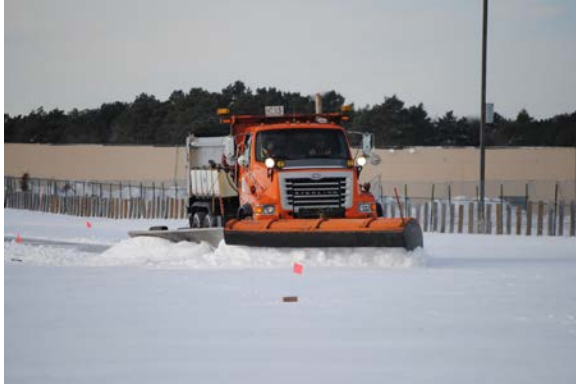
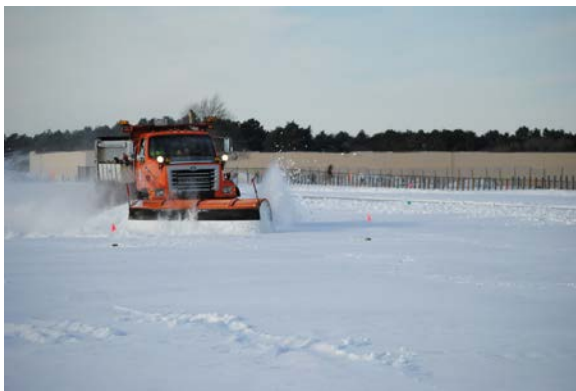
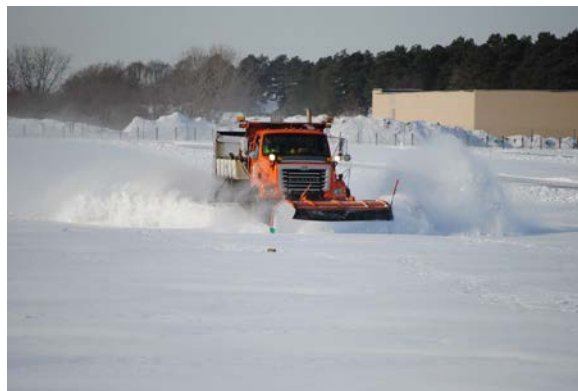
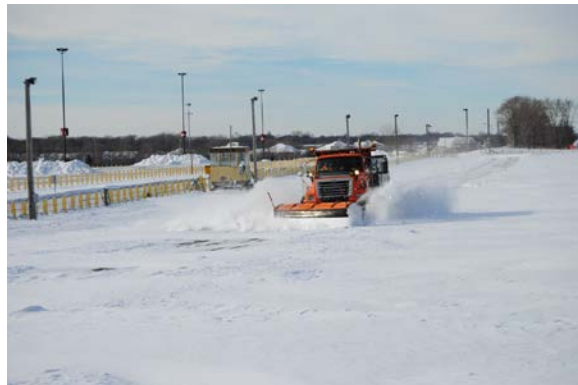
a) CD1 at 5 mph.

c) CD3 at 15 mph.

d) CD4 at 20 mph, front plow angled left.

f) CD6 at 20 mph.

Figure 39. Comparison between different plowing speeds within similar snow and weather conditions of a single site on a single day. Photos taken December 18, 2013 with conditions of 5°F, clear and sunny, wind 0 – 3 mph, 3 – 6 inches crusty, drifted snow. Front and wing plowing to right excepted where noted.

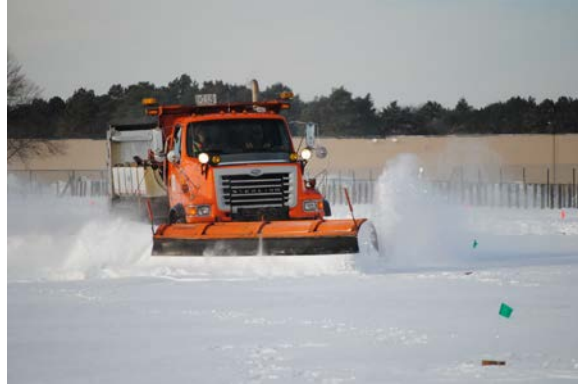
b) CD2 at 10 mph.

Different speeds were also compared across different days and the particular snow conditions (Figure 40), comparing three days with three different speeds:

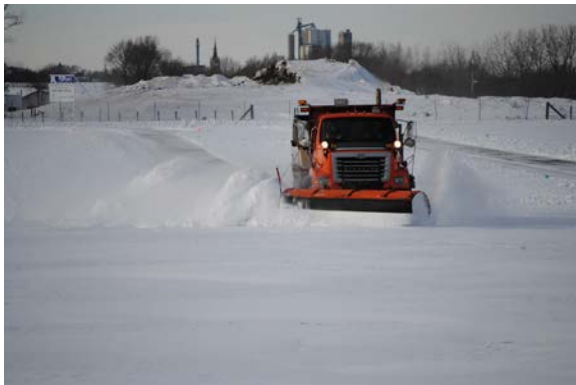
e) CD5 at 20 mph.

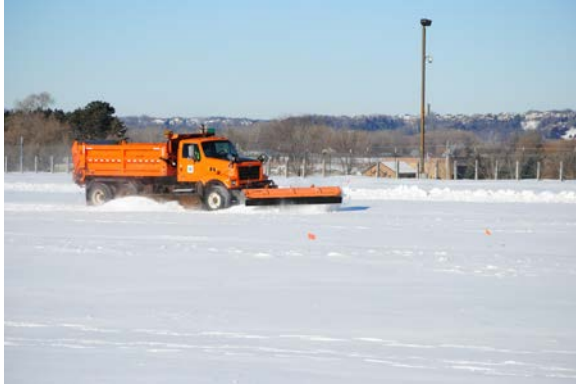
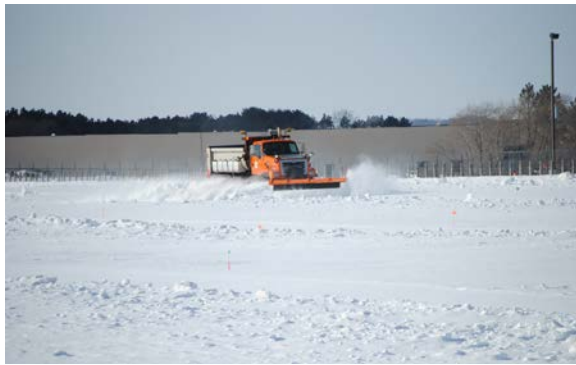
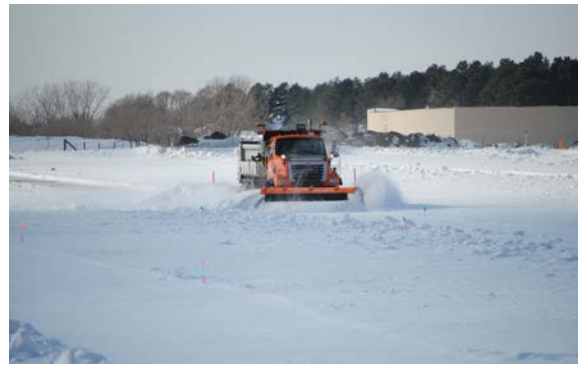
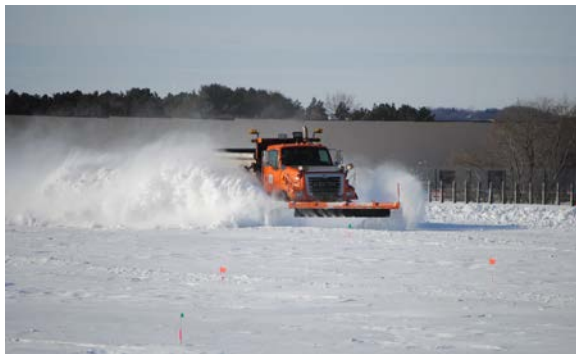
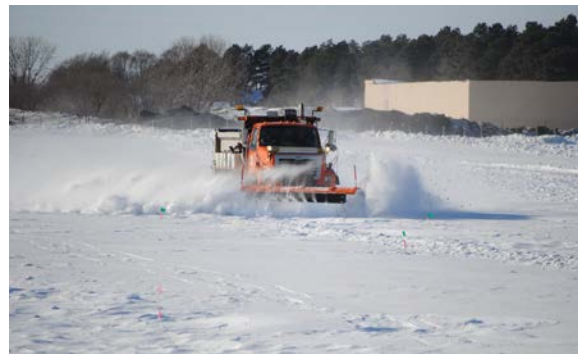
a) CD2, January 8<sup>th</sup>, -5°F, 2 – 3 inches, drifts to 6 inches, dry snow. 10 mph.

b) CD4, January 8<sup>th</sup>, -5°F, 2 – 3 inches, drifts to 6 inches, dry snow. 10 mph.

c) CD2, February 6<sup>th</sup>, 4°F, 2 – 3 inches, slightly moist snow. 20 mph.

d) CD4, February 6<sup>th</sup>, 4°F, 2 – 3 inches, slightly moist snow. 20 mph.

e) CD2, January 29<sup>th</sup>, 25°F, 1 – 2 inches, dry snow with small drifts. 30 mph.

f) CD4, January 29<sup>th</sup>, 25°F, 1 – 2 inches, dry snow with small drifts. 30 mph.

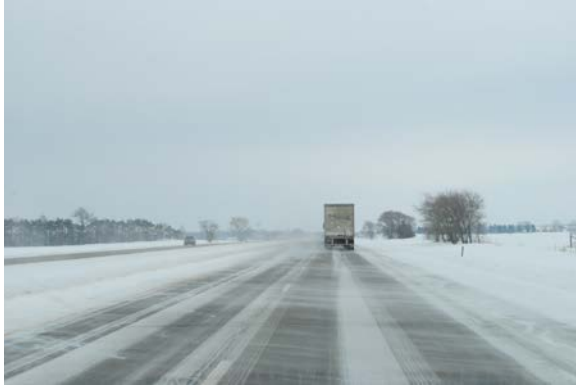
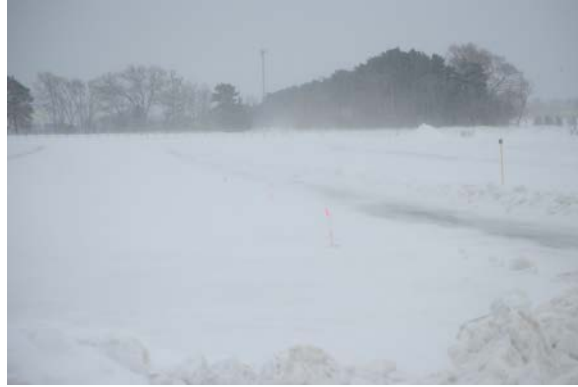
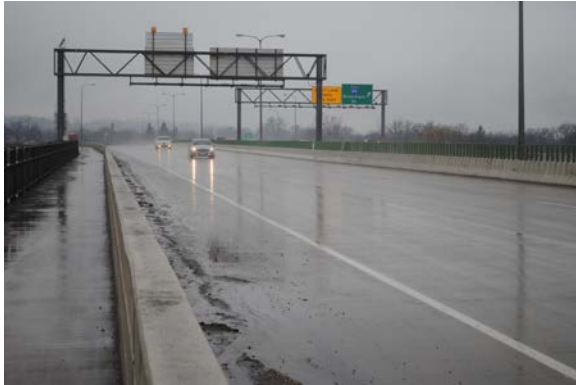
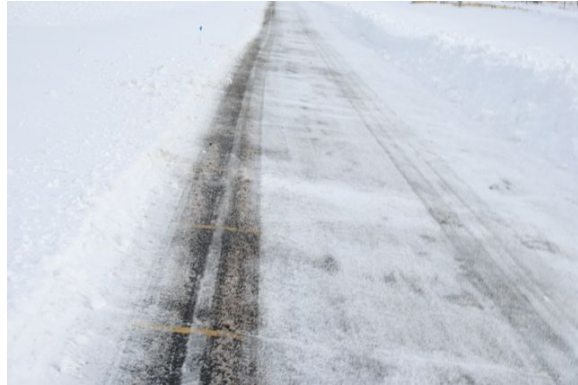
Figure 41. Winter conditions conducive to ice buildup on roadways.

a) Wind blown snow

b) Ice fog

c) Freezing rain

d) Wet snow becoming packed

One technique of winter maintenance operations that has shown great promise is anti-icing, the pre-storm placement of deicer brine to clear pavement done to limit or prevent formation of icing on a roadway. Whether due to wind blown snow, ice fog, freezing rain, or simply wet snow becoming packed (Figure 41), anti-icing has been found to reduce formation and build up. However, winter maintenance operations have often found it difficult to mobilize the anti-icing application trucks, either because of labor shortages prior to a storm (resting crews before potential long shifts) or limited procurement of the anti-icing brine application equipment (Figure 42). Application of sodium chloride (rock salt) brine at typical rates between 10 and 30 gallons per lane mile (gal/LM) also provides a significant deicer material savings, as with a brine saturation of 23% concentration this rate calculates to 20 to 60 lb/LM, about 1/20<sup>th</sup> of the typical deicer application rate during a snow event.

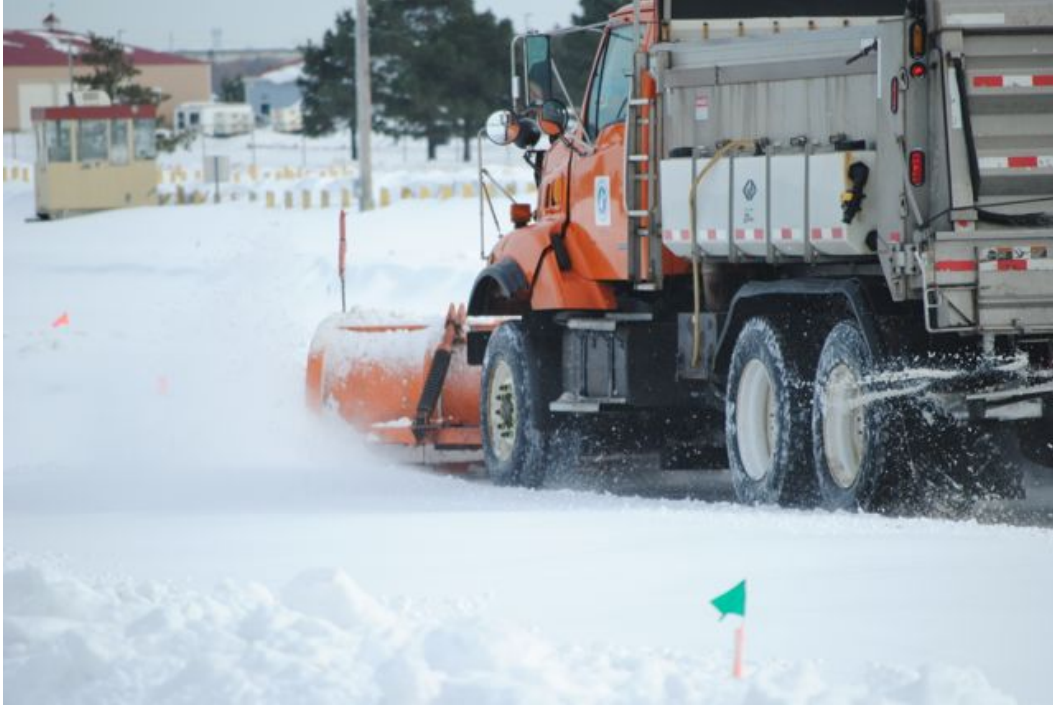
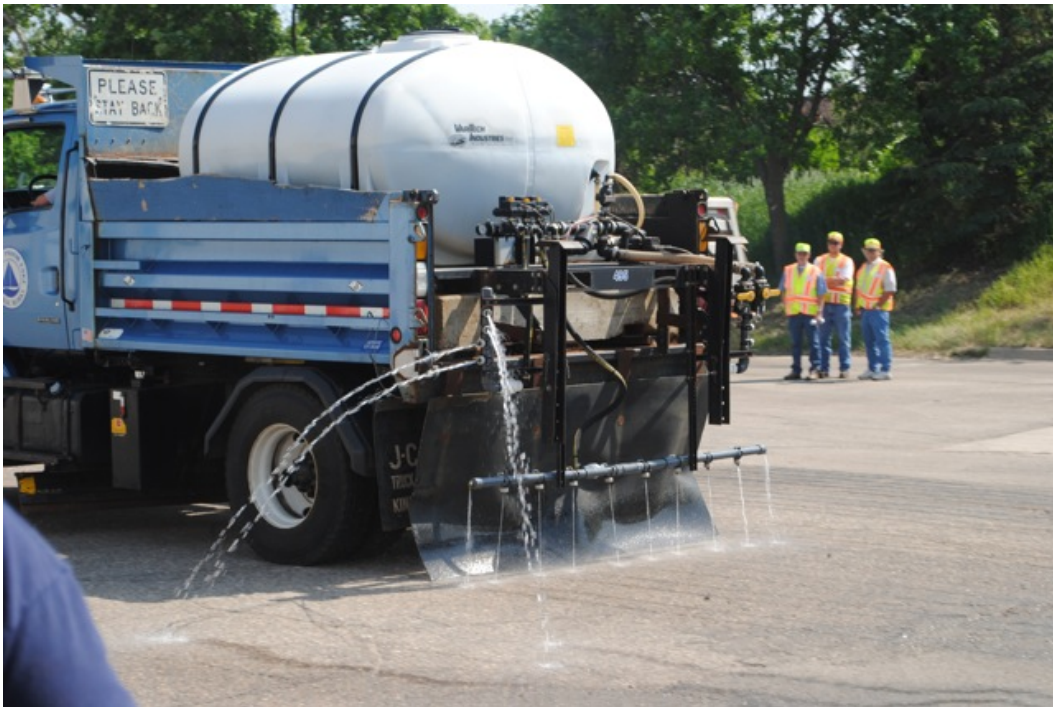
Figure 42. Deicer and anti icer application equipment.

a) MnDOT truck spreading solid deicer with prewet off left rear.

b) Brine application truck during demonstration (non-winter day).

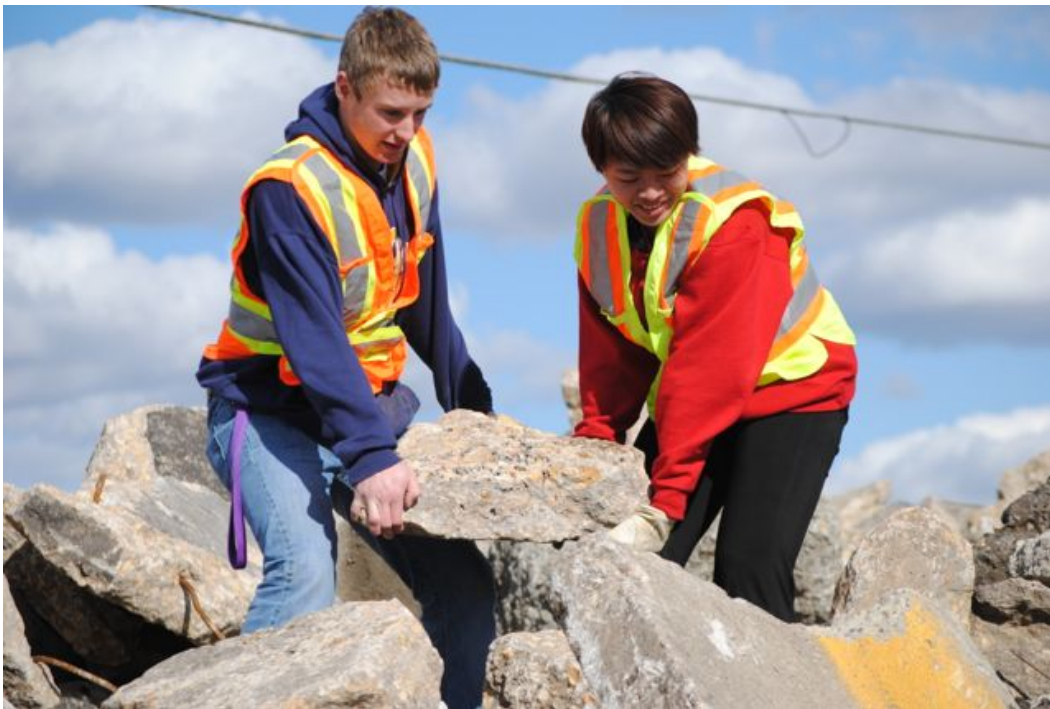
Figure 43. Pavement specimen collection, CSAH 17 project

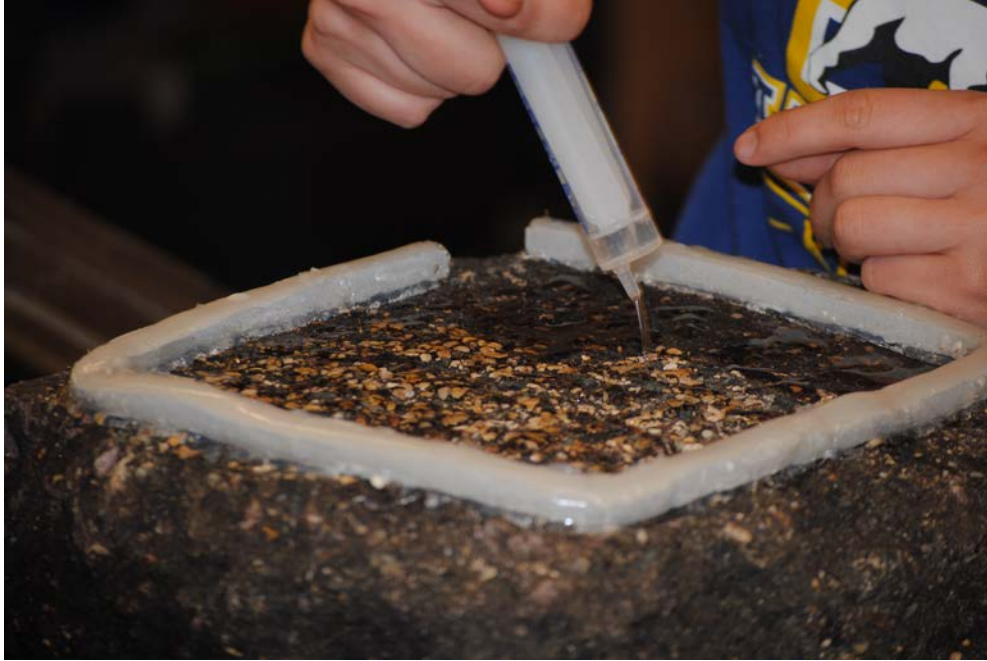
Figure 44. Anti icer application to defined pavement area.

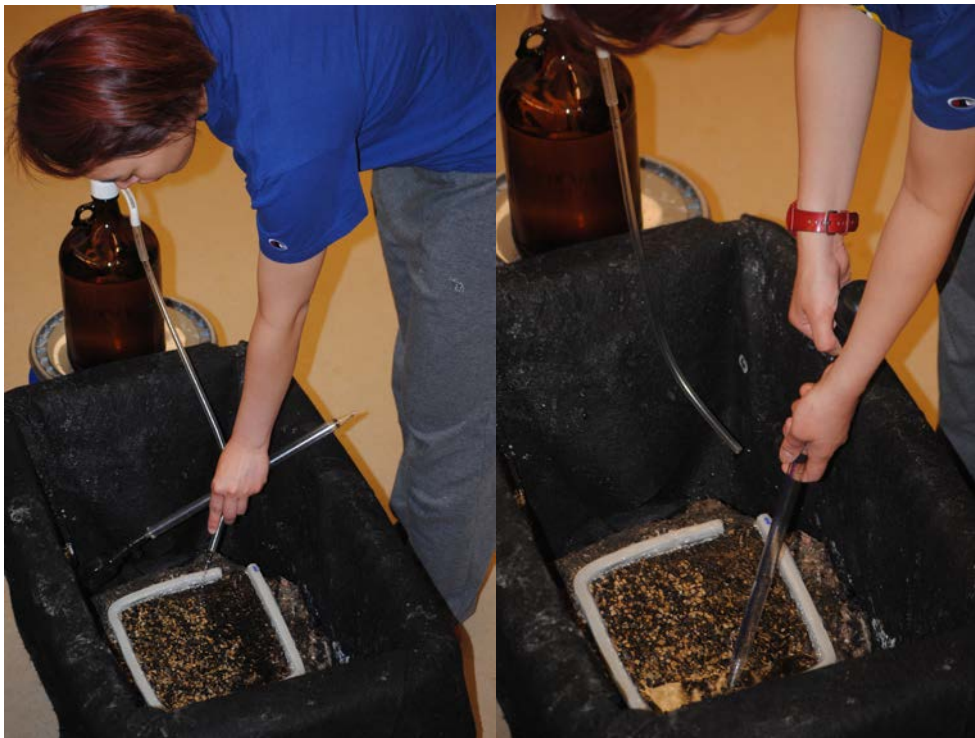
Figure 45. Precipitation water application (left) and drainage collection (right).
