# DCT Low Temperature Fracture Testing Pilot Project

Minnesota  
Department of  
Transportation

**May 2015**

Research Project  
Final Report 2015-20

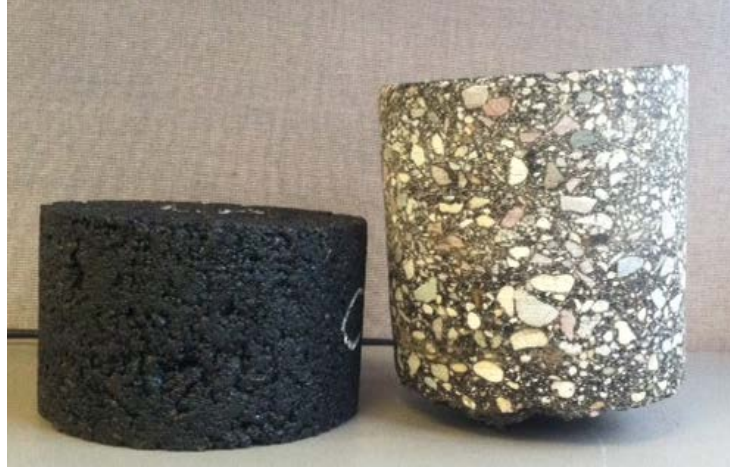
Test specimens for the DCT may come from 150 mm (5.91 inches) gyratory compacted pills or field cores, as seen in Figure 1.1

**Figure 1.1: Gyratory pill (left) and field core (right).**

Sample preparation involves sawing across the diameter of the pill or core to a thickness of 50 mm (1.969 inches) using a water-cooled masonry saw. For gyratory pills, both ends of the specimen should be saw-cut in order to obtain a sample from the middle of the specimen, as there may be gradients in air voids near the ends of the specimen. In the case of field cores cut from brand new pavement, the pavement face may remain uncut. For field cores the objective is to retain as much of the layer thickness as possible, excluding tack coat and underlying pavement, thus thickness may be reduced in the case of lift thicknesses to less than 50 mm. The flat face of the specimen, where the gage points are attached, is then sawn. A marking template is used to indicate the location of the 25 mm diameter loading holes and the notch. A core drill is used to drill the 25 mm (0.984 inches) holes, and a wet band saw is used to cut the notch. A completed DCT specimen is visible in Figure 1.2. The specimens are then allowed to completely dry, either using air or a desiccant, and the gage points are then attached. This specimen geometry was found to be satisfactory for asphalt mixtures with nominal maximum aggregate sizes from 4.75 mm (0.187 inches) to 19 mm (0.748 inches). The specimen geometry can be seen in Figure 1.3 [4] [5].

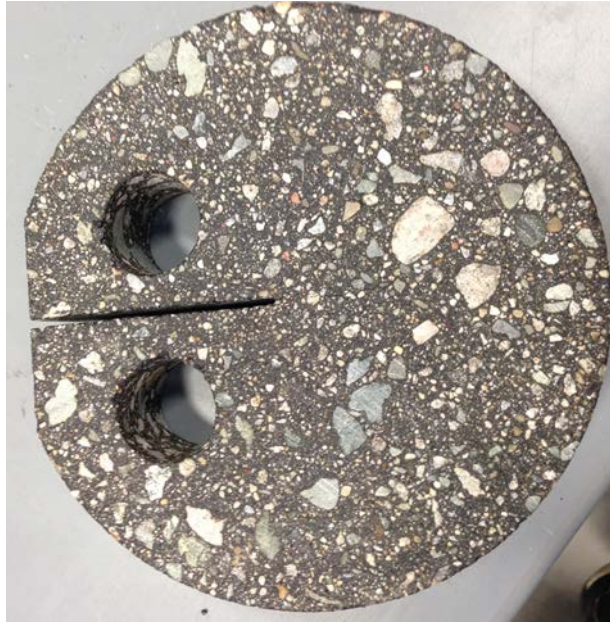
**Figure 1.2: Completed DCT specimen.**

Several templates and jigs were fabricated by MnDOT to increase repeatability and ease of sample preparation. These tools expedite specimen fabrication and also increase confidence samples are being made per correct geometry specifications. A template is used to draw locations on the specimen of the notch cut and two holes. Jigs were made to ensure correct cutting of specimen thickness, flat face, and to eliminate movement of the sample when coring the two holes in the specimen.

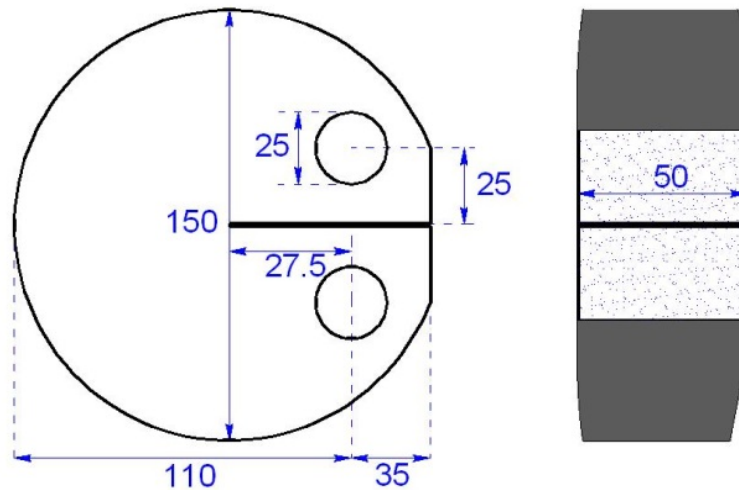
**Figure 1.3: DCT specimen geometry (mm).**

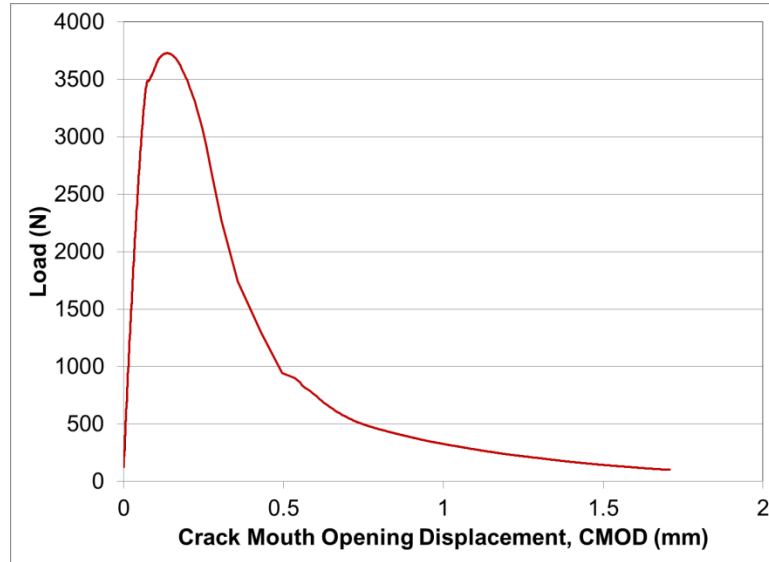
**Figure 1.4: Example of Load vs. CMOD graph.**

The DCT test is controlled by a constant crack mouth opening displacement (CMOD) rate of  $0.017 \text{ mm/s}$  (approximately  $1.0 \text{ mm/min}$ ). This loading rate is fast enough to essentially eliminate the majority of creep behavior of the mixture during testing [4] [6] [7]. Data essential to the calculation of fracture energy are load and CMOD. Load is plotted vs. CMOD, with the area under the curve being fracture work; when normalized for specimen thickness and initial ligament length, area under the load vs. CMOD curve is known as fracture energy. Specimen thickness and initial ligament length are measured prior to DCT testing of the sample. A specimen before and after testing with these measurements illustrated can be seen in Figure 1.5, with L indicating ligament length (straight line measured from end of notch where cracking is initiated to the edge of specimen) and B indicating thickness of specimen. An example of load vs. CMOD plot can be seen in Figure 1.4. Fracture energy is the energy required to create a unit surface fracture of the asphalt mixture. After testing, the specimen is pulled apart to view the path of crack propagation.

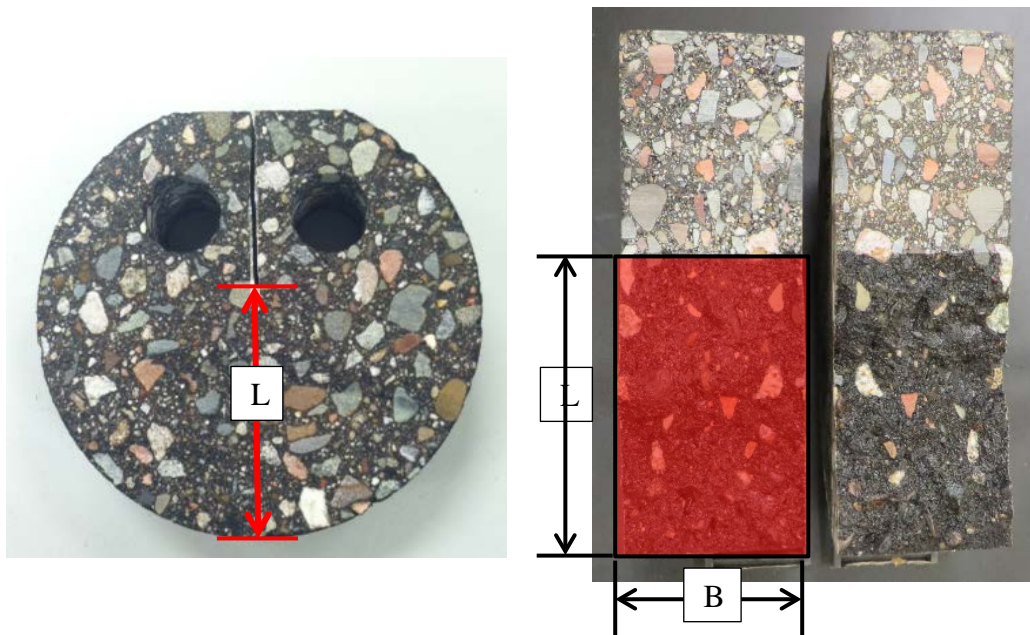
**Figure 1.5: DCT specimen ligament length (L) and width (B)**

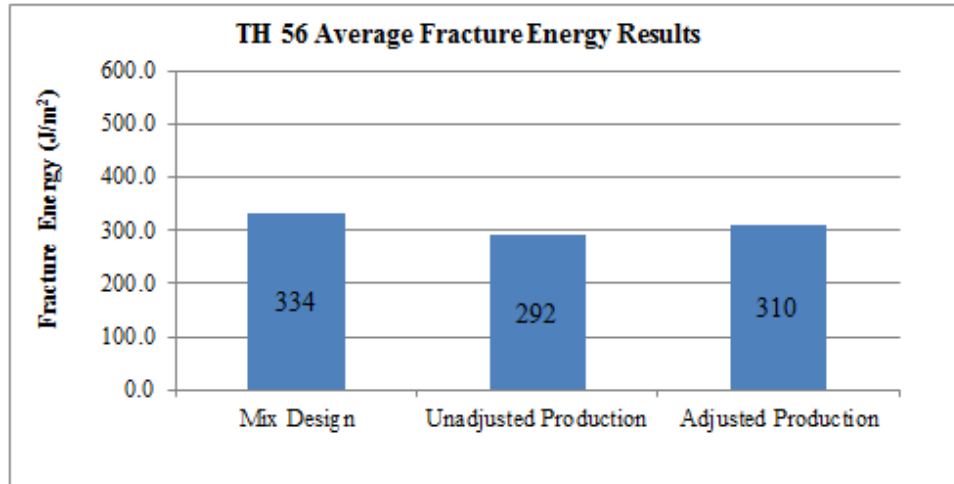
**Figure 3.2: TH 56 fracture energy results.**

Mix design specimens had average fracture energy of 334 J/m<sup>2</sup> and average peak load of 2.78 kN. Because this was below the 400 J/m<sup>2</sup> threshold an adjustment was required. Unadjusted production mix had average fracture energy of 292 J/m<sup>2</sup> and average peak load of 2.92 kN. The difference in fracture energy from mix design to produced mix was substantial, and was also found to be the case in each project.

Test results for the adjusted mix yielded average fracture energy of 310 J/m<sup>2</sup> and average peak load of 2.89 kN, still well below the 400 J/m<sup>2</sup> threshold. The increased virgin binder content of 0.1% resulted in an increase of 18 J/m<sup>2</sup> from the unadjusted production mix. This adjustment was not suitable for this mix, as it did not increase the fracture energy above the required minimum value. However, this difference was not insignificant as it appeared to reliably increase the fracture energy of the mix even though the effect was relatively small. Fracture energy results from mix design and production can be seen in Figure 3.2.

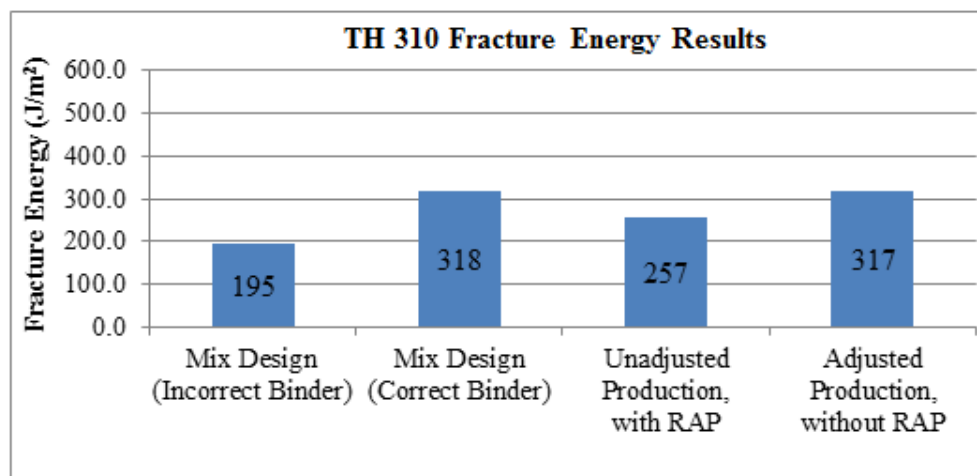
Figure 3.3: TH 310 fracture energy results.

The adjustment from 20% RAP to 0% RAP yielded fracture energy results 60 J/m<sup>2</sup> higher than unadjusted production mix. DCT testing also indicated there was a significant drop in fracture energy from laboratory mix design pills to plant produced mix. The cause of this warrants investigation, but was outside the scope of this project. Mix design and production average fracture energies can be seen in Figure 3.3.

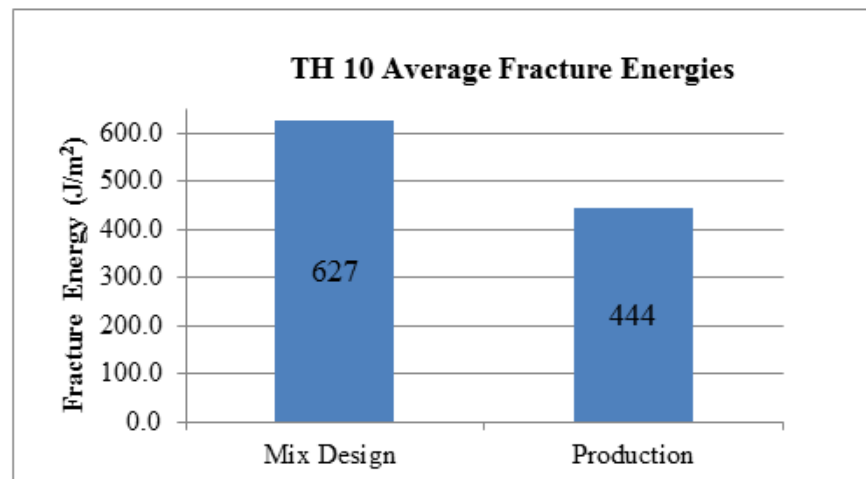
**Figure 3.4: TH 10 fracture energy results.**

The contractor provided raw materials to the MnDOT Trial Mix Laboratory to compact into gyratory pills. The mix design specimens tested for TH 10 had average fracture energy of 627 J/m<sup>2</sup> and average peak load of 3.76 kN. This is well above the required 400 J/m<sup>2</sup> requirement and no mix adjustments were needed. Production mix had average fracture energy of 444 J/m<sup>2</sup> and an average peak load of 3.83 kN, again above the minimum requirement. Although both had average fracture energies above 400 J/m<sup>2</sup>, a significant drop in fracture energy from mix design to production of 183 J/m<sup>2</sup> occurred. These values at mix design and production can be seen in Figure 3.4.

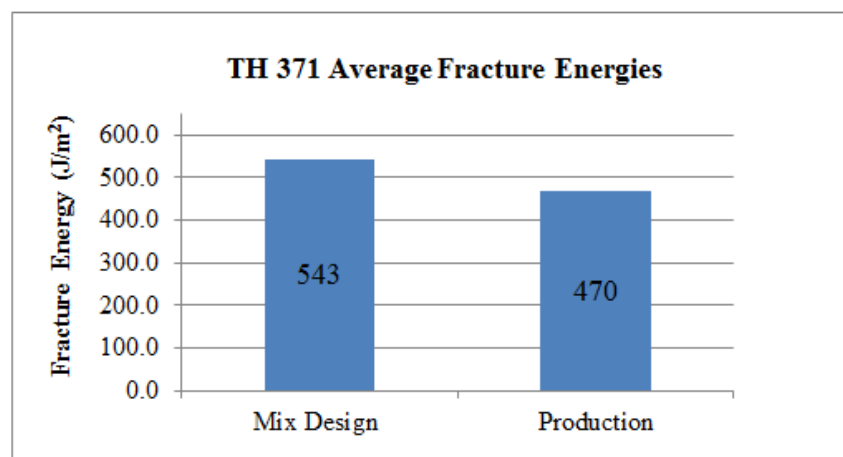
Figure 3.5: TH 371 fracture energy results.

Mix design specimens tested for TH 371 had average fracture energy of 543 J/m<sup>2</sup> and an average peak load of 3.25 kN. As this was well above the minimum of 400 J/m<sup>2</sup>, no adjustments were needed for production mix. Plant production mix yielded average fracture energy of 470 J/m<sup>2</sup> and average peak load of 3.83 kN. This again was above the minimum requirement. Although the 400 J/m<sup>2</sup> base value was met, a drop in fracture energy was seen from mix design to production, resulting in a decrease of 73 J/m<sup>2</sup>. Fracture energy results can be seen in Figure 3.5

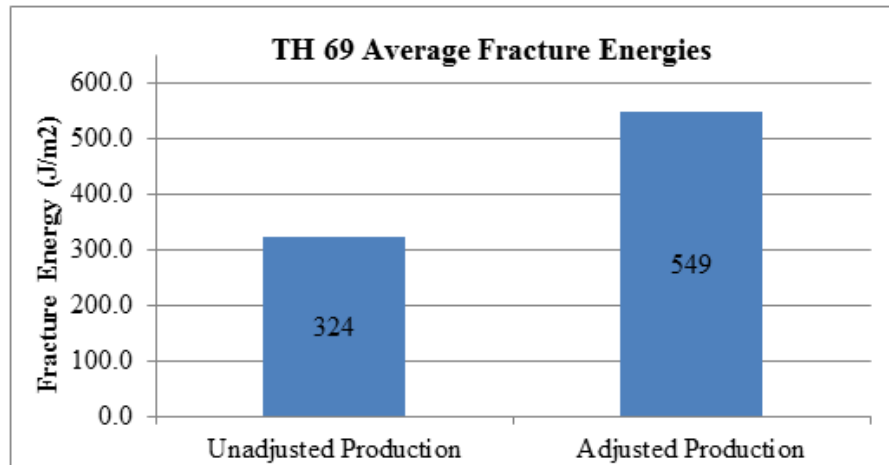
**Figure 3.6: TH 69 fracture energy results.**

The research team suggested a binder change from PG 58-28 to PG58-34. Due to XX-34 binders requiring 80% new asphalt, RAP content was reduced from 30% to 20%. Due to the reduction of recycled material, gradations needed adjustment. In an attempt to match gradation as closely as possible to the original without disturbing volumetrics, virgin material was added to account for the absence of 10% RAP. Average fracture energy from adjusted production mix was 549 J/m<sup>2</sup>, with an average peak load of 3.26 kN. The increase of fracture energy by 225 J/m<sup>2</sup> shows the adjustment had significant effects on the mix. The change in fracture energy from mix design to production can be seen in Figure 3.6.

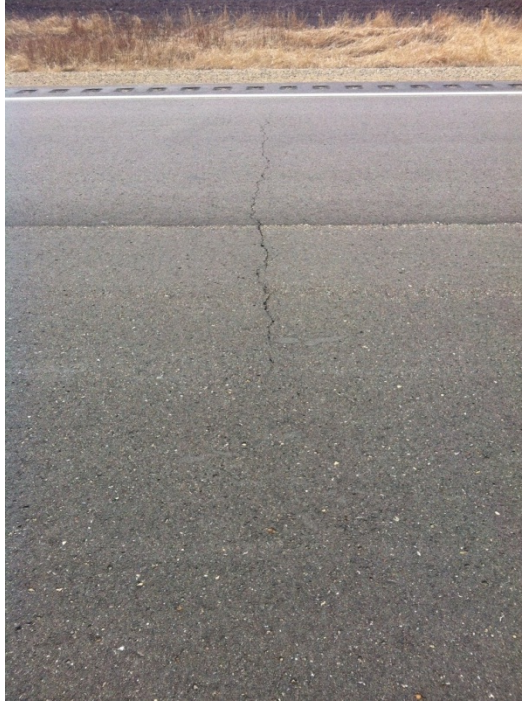
**Figure 4.1: TH 69 Mill and Overlay (represents typical cracking on mill and overlay sections)**

- Projects constructed with mill and overlay exhibited higher amounts of cracking. This could be attributed to reflective cracking from existing underlying pavement, although the condition of underlying pavement was not investigated prior to paving.

- Typical cracking of mill and overlay sections and on reclaims can be seen in Figure 4.1 and Figure 4.2 respectively. Throughout the distress surveys conducted for this project, similar cracking for each construction type was observed. Mill and overlays exhibited cracking in the center through the longitudinal joint in the center of the pavement and reclaimed tended to have cracking begin on the edge of the pavement.

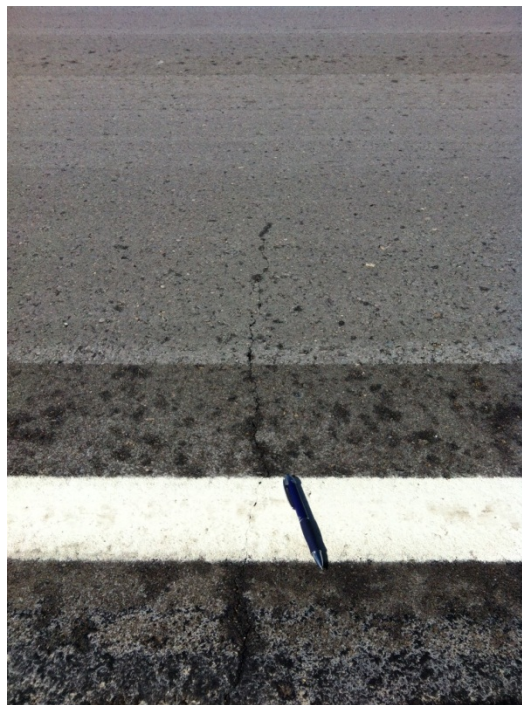
**Figure 4.2: TH 56 SFDR (represents typical cracking on reclaims)**

- The least percentage of cracking occurred with projects constructed with reclaim (SFDR and FDR). TH 56 had less than 1% cracking, as seen in Table 4.1. Although these projects exhibited less cracking, a large portion of cracks recorded were 12 ft. in length. A trend of the majority of cracking being 12 ft. in length was evident in all four projects.

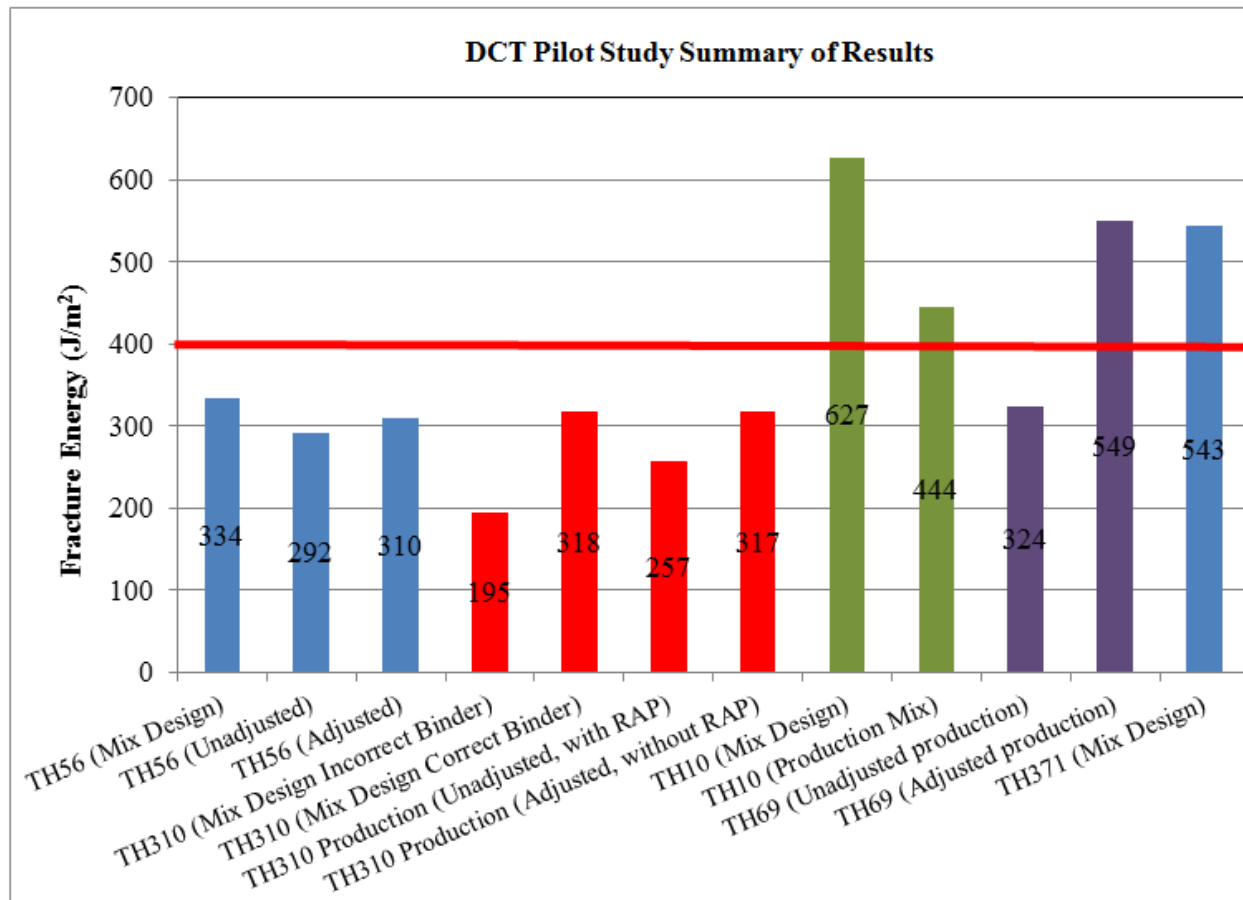
**Figure 5.1: Summary of DCT pilot study testing.**

- During mix design, specimens prepared for DCT testing must match exactly to what will be used during production, specifically binder. Differences in material can greatly affect the fracture energy, as observed with TH 310. If aged binder subjected to multiple re-heating is used in mix design samples, DCT results will not accurately represent production mix. This potentially leads to mixture adjustments recommended based on incorrect data.
- Both projects passing at mix design were level 4 designs, which require a higher percentage of crushed aggregate. The exact cause of higher cracking resistance is unknown but may be due to increased binder adhesion to the aggregate particles.
- Significant drops in fracture energy from mix design to production occurred on multiple projects in this study. The cause of this was outside the scope of this study, but will be further investigated.
