Tack Coat Testing – Measuring Field Bond Strength

Minnesota
Department of
Transportation

May 2015

Research Project
Final Report 2015-25

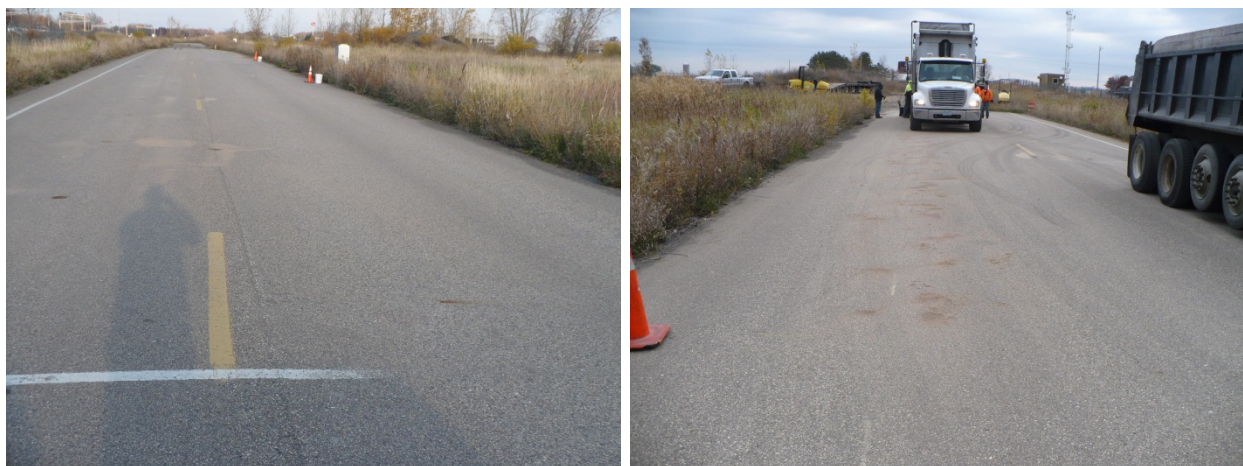
Figure 2 Appearance of the No Tack section before and after contaminant.

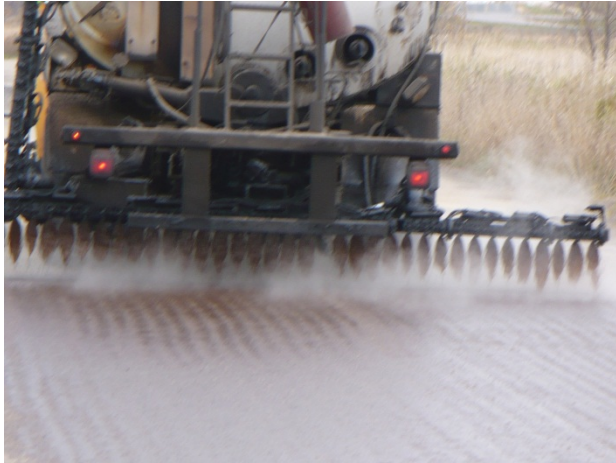
Figure 3 Distributor operations on the Standard Tack section.

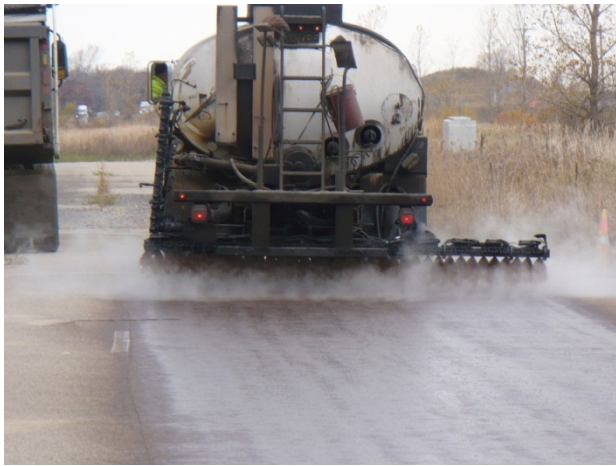
Figure 4 Distributor operations on the High Tack section.

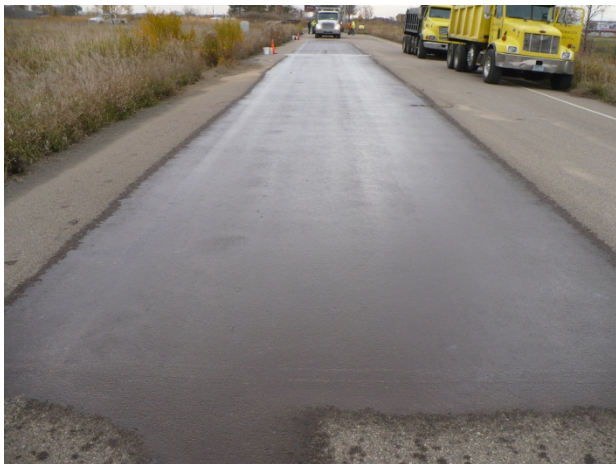
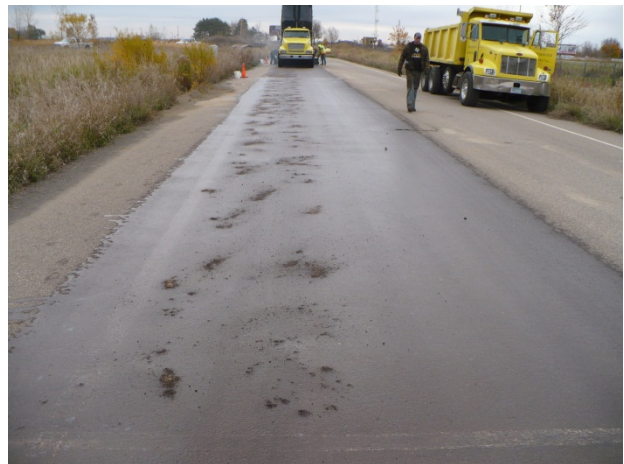
Figure 5 Appearance of tack sections before and after contaminant.

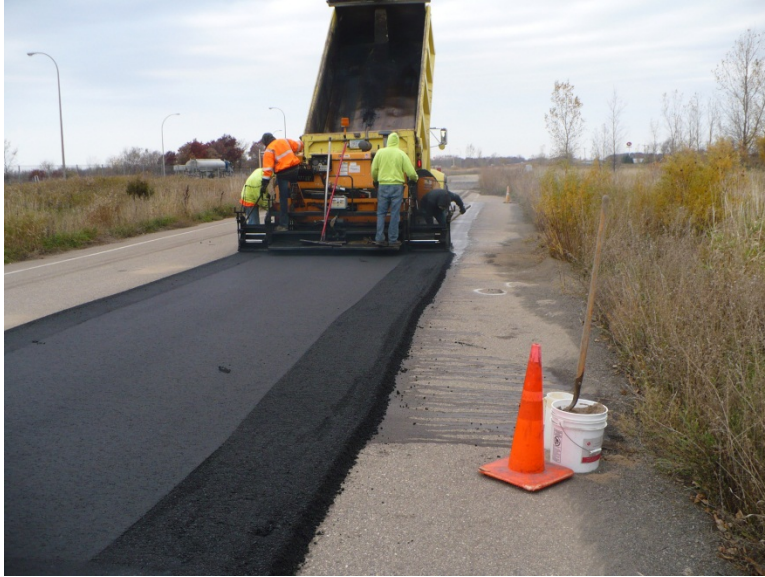
Figure 6 Paving the High Tack section.

- **Contractor paved** 300 feet approximately 2.5 inches thick by 12 feet wide in the north lane of Cell 84 (Figure 6). According to truck tickets, the mixture was a 9.5-mm recycled wear mix containing 6.1 percent total asphalt binder. Performance Grade 58-28 asphalt binder grade was added at 5.1 percent to the mix, making the new/total binder ratio 83.6 percent. The MnDOT mixture designation for this material would be SPWEA230B.
 - During paving, the trucks dumped HMA into the paving machine, and drove along with it until empty. At that point trucks would exit and enter through the tack; these equipment movements are common to paving operations.

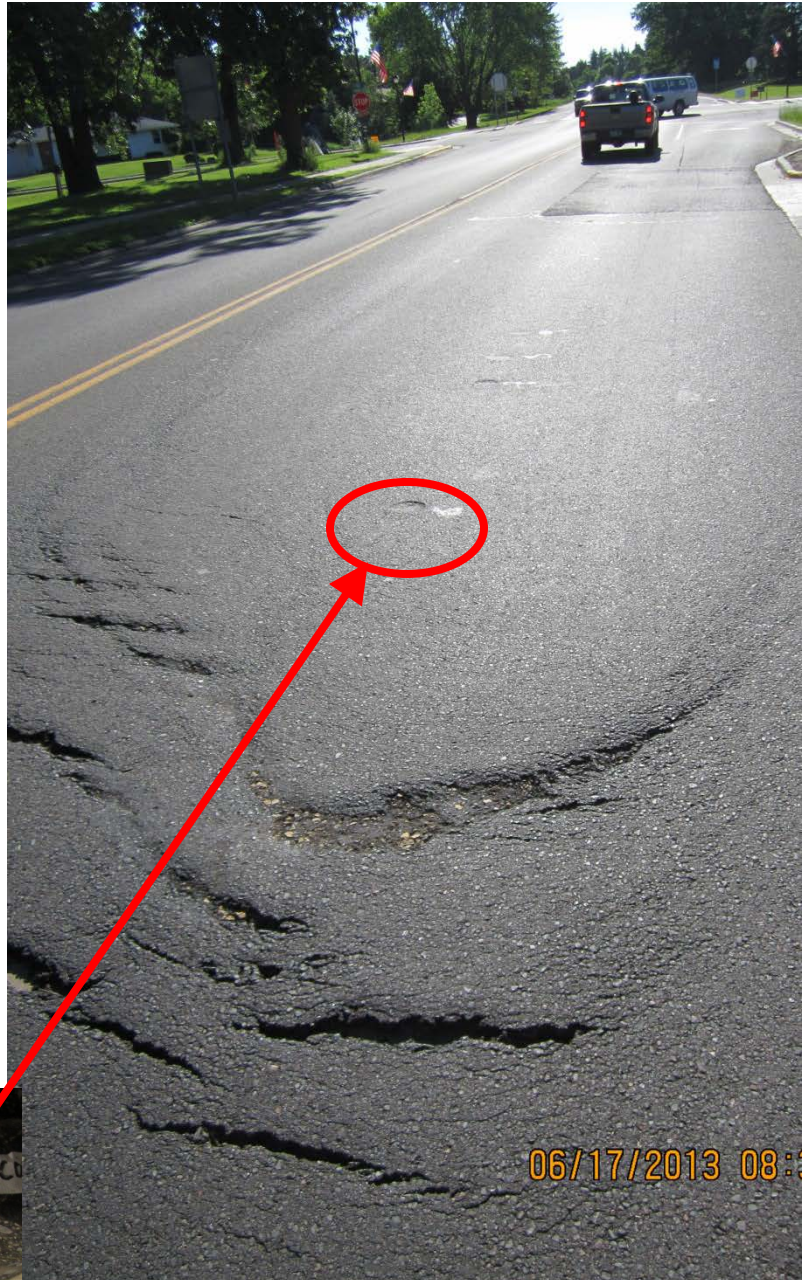
Above: Roadway after coring – Core 6 was the only core in slide area to remain intact for testing (Circled in red).

Conclusions: Distress and no/low bond strength are both present. Presence of fines between paving lifts contributed to low bond strength.

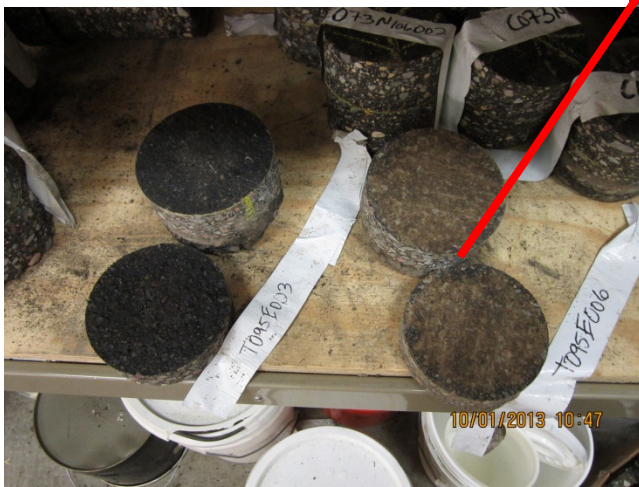
Left: Inside faces After Bond Testing.

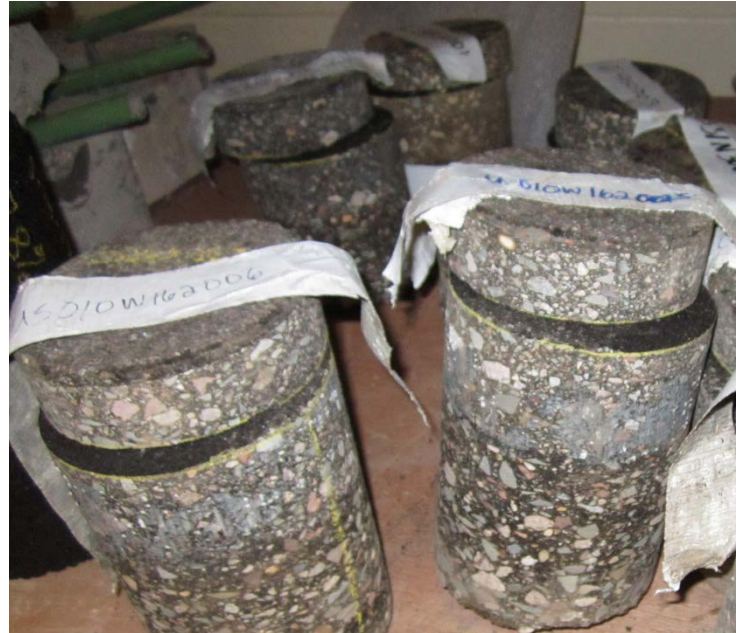
Figure - Cores @ RP162 after testing

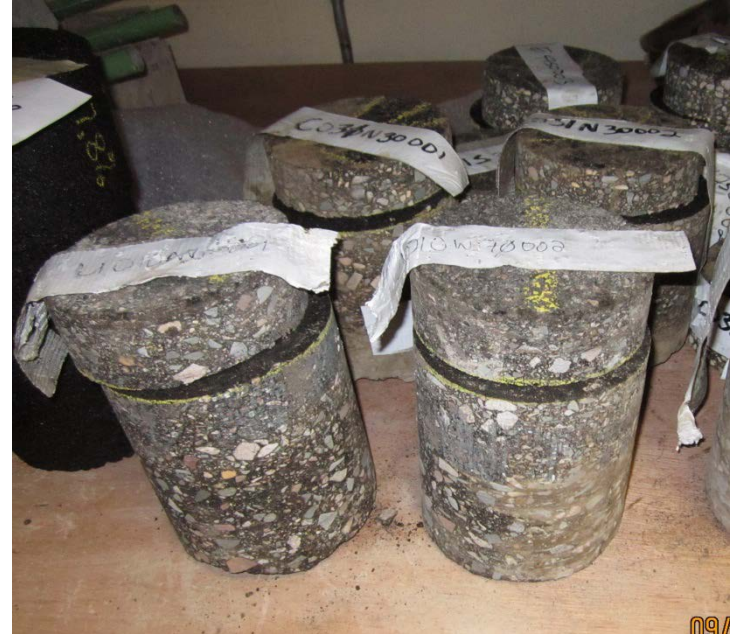
Figure - Cores @ RP170 after testing

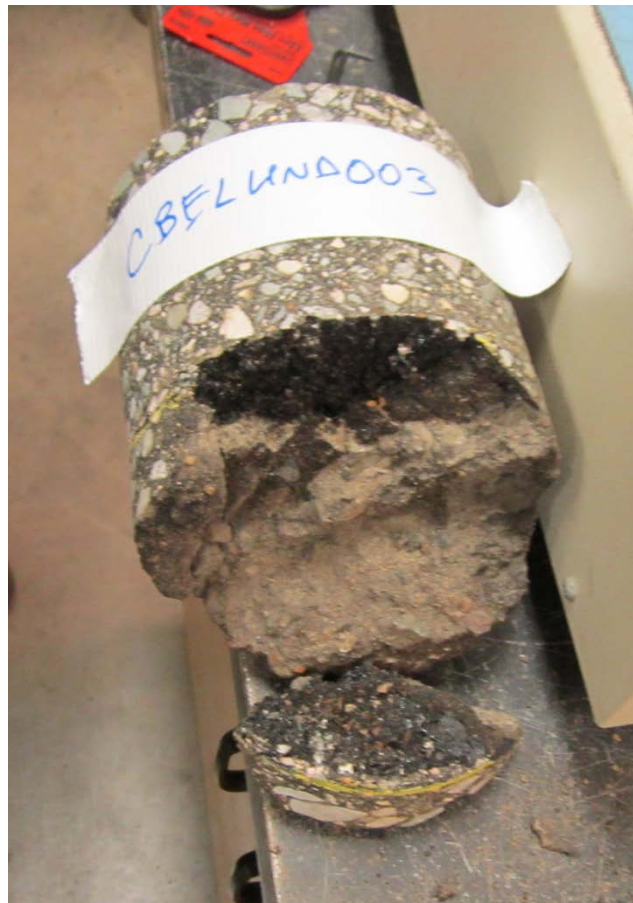
Figure - Underseal sample after testing.

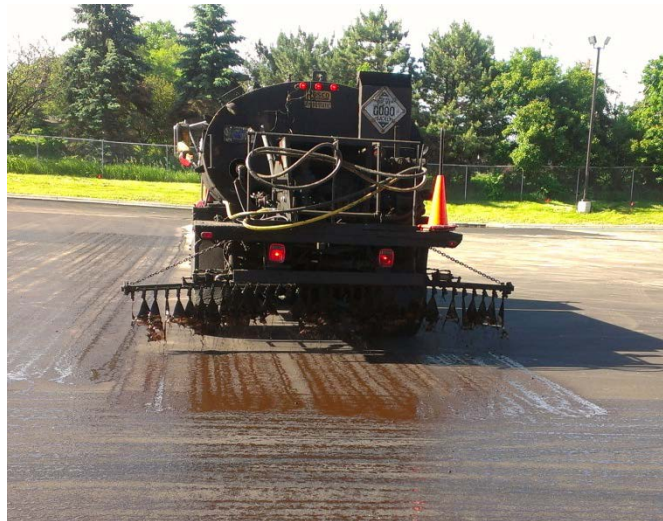
Figure - Distributor applying tack.

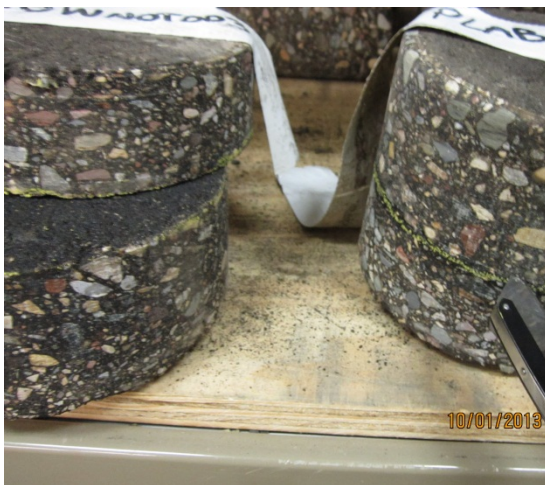
Figure - No-Tack Core (left) with clean layer separation. Tacked Core (right) was semi-bound after shear testing.

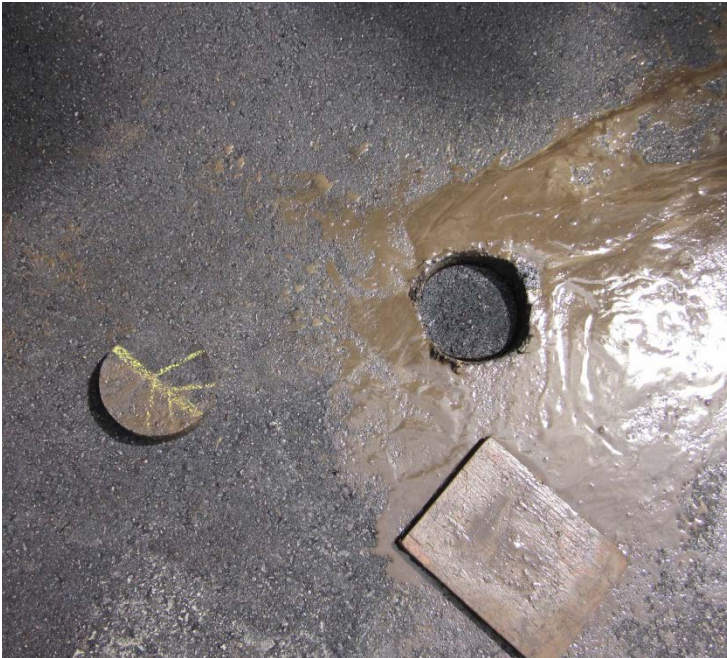
Figure - Core Bond to Base exceeds tight blade layer bond.

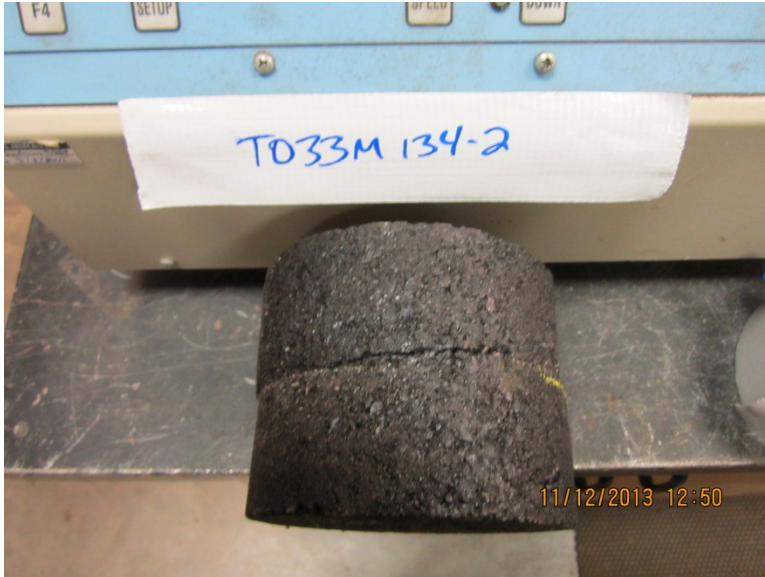
Figure - Gyratory mix specimens broken in shear device - notice apparent layer separation without a layer interface.

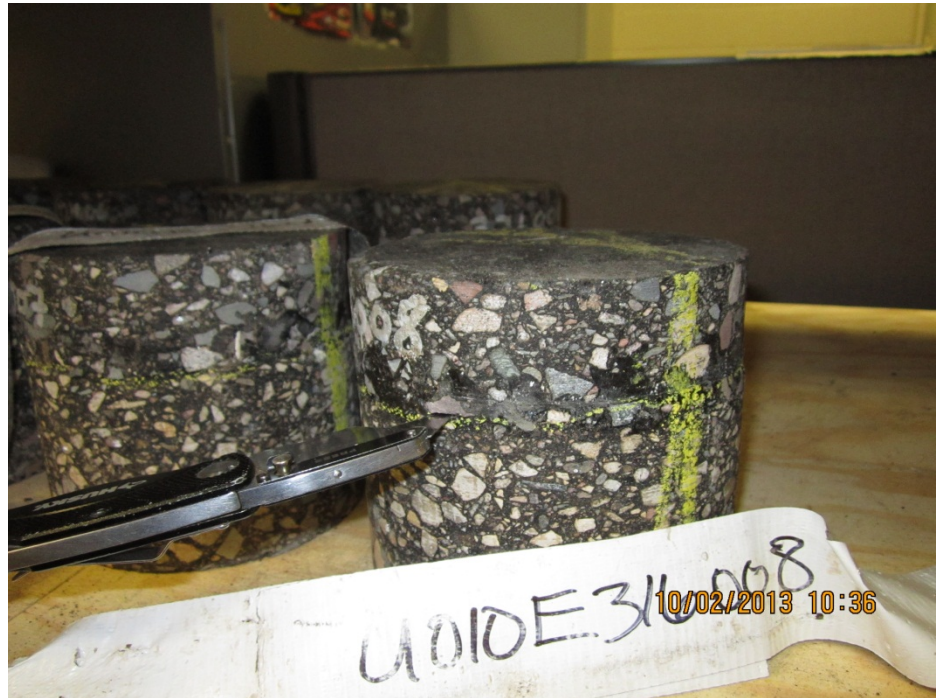
Figure - Typical Core after bond testing - Layers would require tools to separate. 0.24 g/sy PMAE pictured

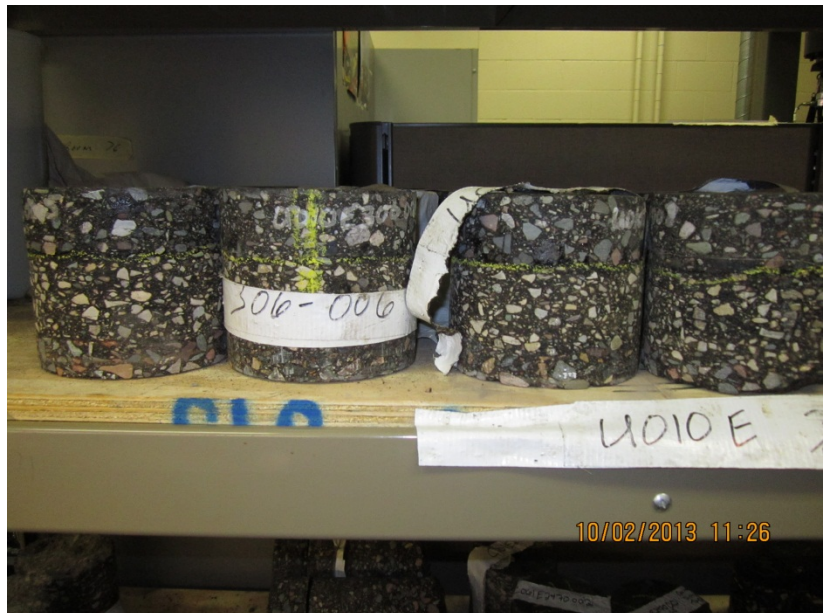
Figure - Samples from 0.144 g/sy PMAE
