Investigation of Winter Pavement Tenting

1. Report No. MN/RC 2008-03	2.	3. Recipients Accession No.	
4. Title and Subtitle Investigation of Winter Pavement Tenting		5. Report Date January 2008

Final Report

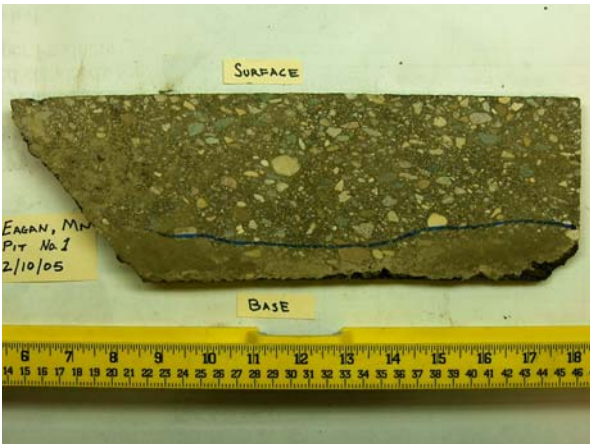
Figure 13 Eagan pit No. 1 with moist regions highlighted.

Inspection of the HMA blocks showed that some moisture was present along the crack edges and the bottom surface. Since the cutting operation used no lubrication, it was apparent that an amount of water had been present in the cracks, between HMA layers, and also in the base material.

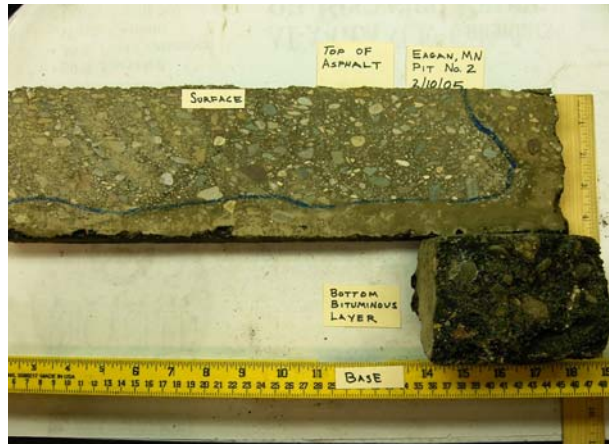
Figure 14 Eagan pit No. 2 with moist regions highlighted.

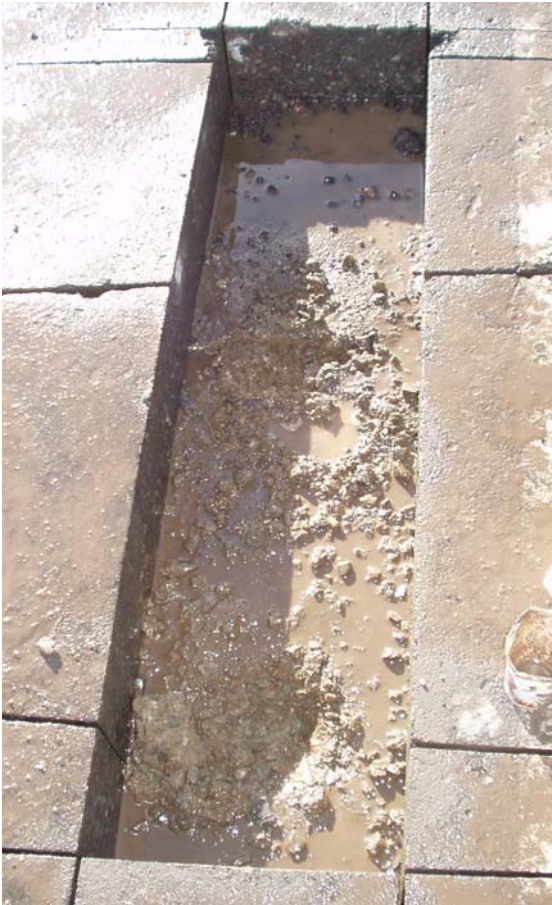
Figure 15 Mn/DOT D1 test pit over saw cut.

The Mn/DOT District 1 Construction Office excavated one test pit on US 169. It will be referred to as the D1 pit. The section had 6.5-in. of sawed and unsealed HMA over a class 6 aggregate base, all above a rubblized concrete pavement. District 1 cut this pit using a pavement saw and water lubrication. Blocks of the HMA sections were removed undamaged using pry bars. Following HMA block removal it was observed that the test pit was 75 percent filled with water. The water was then removed from the pit in order to obtain samples and observations.

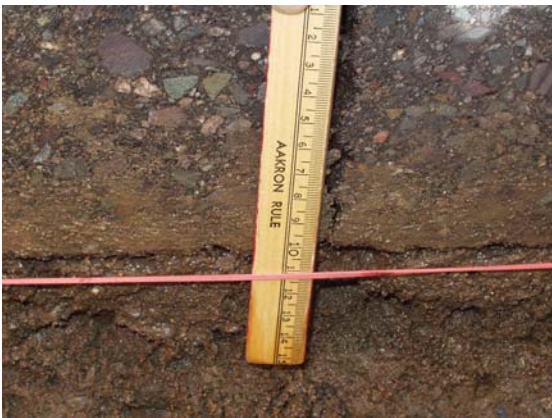
Figure 16 String line shows HMA tenting at bottom of D1 pit.

The HMA layer did not appear to have uneven expansion due to moisture. However, a string line check of the bottom of the HMA layer (Figure 10) showed that the tented saw cut deviated 0.4 in. (10 mm) above the straight line.
