MnROAD Cell 64 Pervious Concrete: Third Year Performance Report

1. Report No. MN/RC 2009-19	2.	3. Recipients Accession No.	
4. Title and Subtitle MnROAD Cell 64 Pervious Concrete: Third Year Performance Report		5. Report Date June 2009	6.

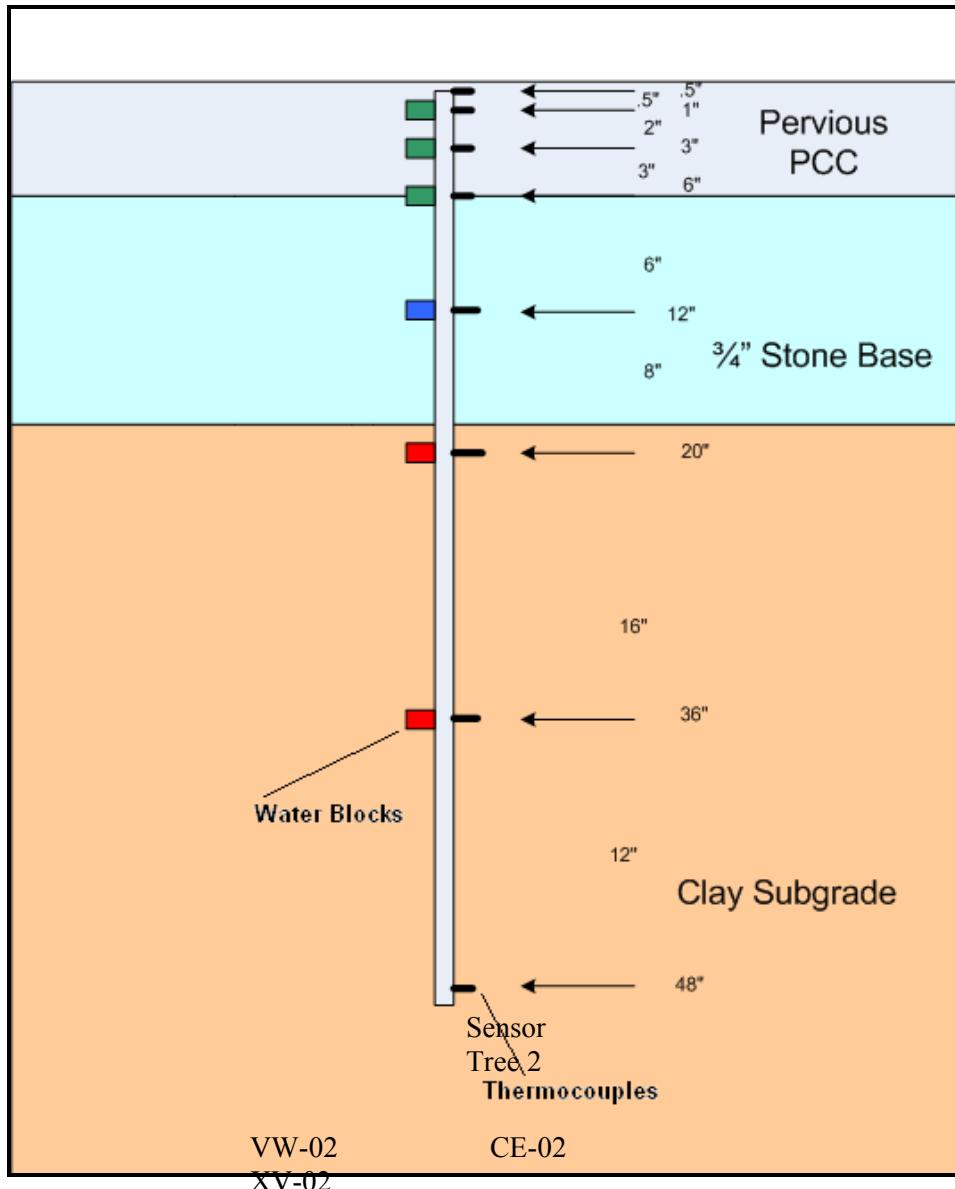
FIGURE 3: Cell 64 sensor tree (profile view, not to scale).

Vibrating wire strain gauges, dynamic strain gauges, thermocouples, and watermarks were embedded in Cell 64 during construction. Two sensor trees of thermocouples and water blocks were installed to an approximate depth of four feet below the surface of the driveway to monitor the temperature profile and frost depth within the pervious concrete, base material, and subgrade. Thermocouples and water blocks were placed at discrete locations on the sensor tree according to Figure 3. The sensor trees were placed two feet east of the driveway centerline, at 15 ft and 45 ft north of the southernmost edge of the pervious concrete driveway in Mixes #3 and #1

respectively. More information on the sensor installation can be found in the first year performance report [2].

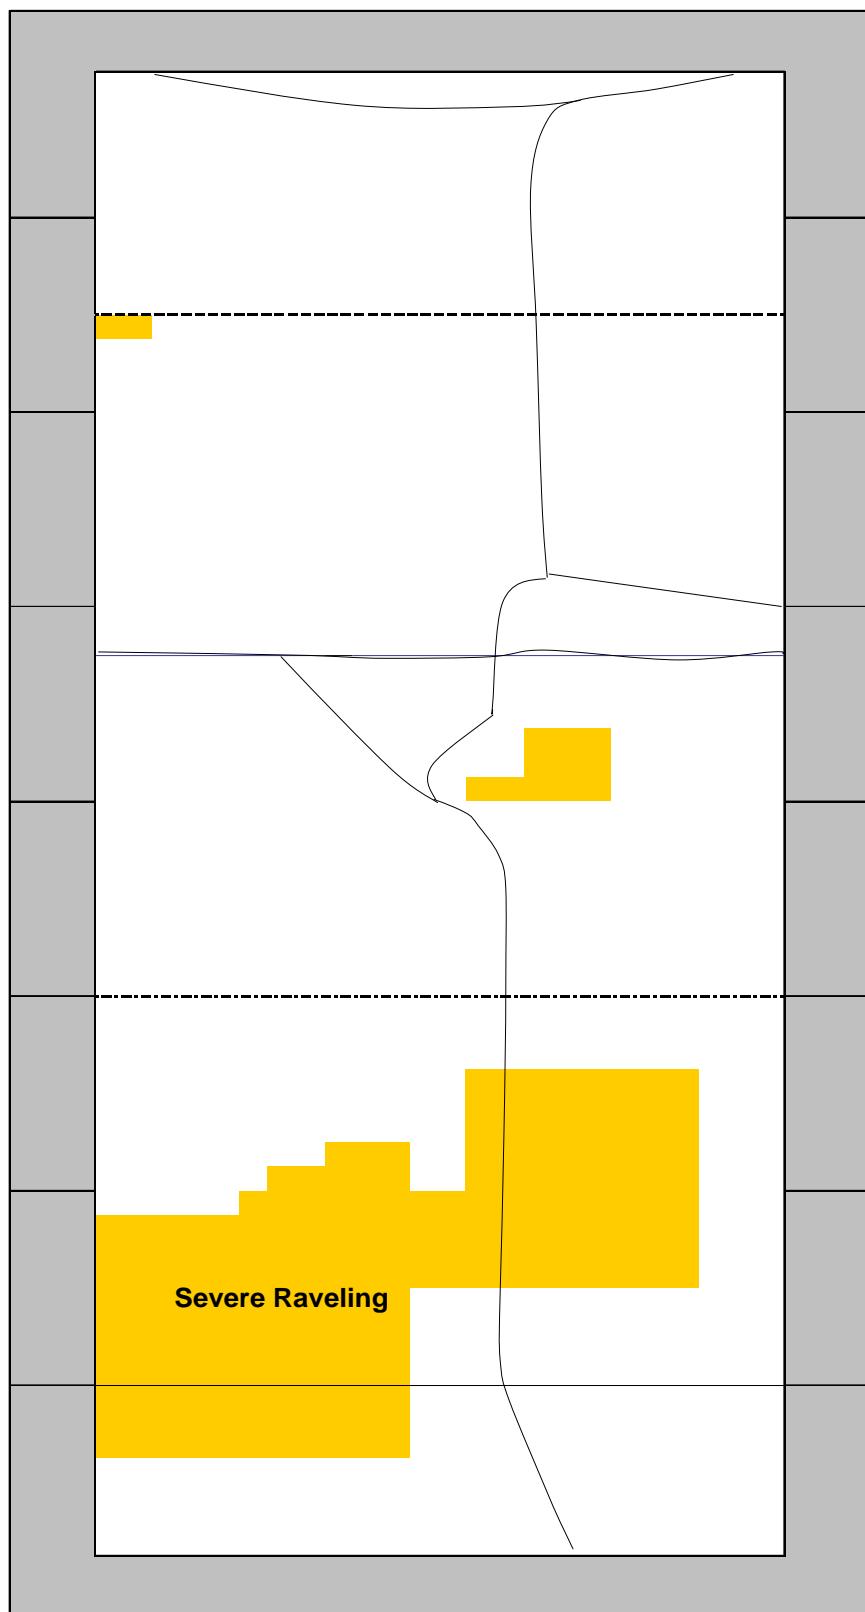
FIGURE 4: Crack mapping and distress survey conducted on April 2, 2009.

The main change in surface condition from the 2006 to the 2008 survey was the presence of a longitudinal crack running the length of the test cell. The crack appeared to have propagated from the joints in the concrete curb that runs between the pole barn and the pervious test cell. This crack could have propagated the length of the slab due to FWD testing, traffic loading, or thermal movement. Also, after the winter of 2008/09, severe surface raveling was observed in portions of Mix #2. This raveling occurred in the same location as the raveling that was observed shortly after construction.

On the August 11, 2008 condition survey, Mix #1 showed moderate spalling at the tooled joint and raveling at the joint where Mixes #1 and Mixes #2 are co-terminus. Mix #2 showed moderate to severe raveling on the surface of the concrete, with moderate to severe raveling and spall at the joints. Mix #3 showed low raveling on the surface with moderate to severe raveling and spall at the joints.

During the winter of 2008/09 significant changes in distress occurred in Cell 64. The top layer of pervious concrete along the tooled joint in Mix #1 as well as significant portions of Mix #2 showed sever raveling. The affected area in Mix #2 is the same area that experienced surface raveling shortly after construction [2]. The locations of cracks in Cell 64 and the areas of raveling are shown in Figure 4.

After three years, Mix #1 shows the least surface raveling/spall with Mix #2 having the most. Most of the raveling/spall in Mix #2 occurred shortly after placement and then again in the spring of 2009. As shown in Appendix D, the top $\frac{1}{4}$ to $\frac{1}{2}$ in. of concrete in some areas of Mix #2 raveled away shortly after placement and again in spring 2009. The original raveling that occurred just after construction likely occurred because the mix became too dry by not being covered with plastic early enough or by over finishing the surface. The raveling that began in spring 2009 likely occurred because the pavement was clogged. Water or snow could have been trapped in the pervious concrete. Then when it froze or was compacted into ice, the expansive pressure could have deteriorated the paste around the top layer of aggregate, resulting in raveling of this layer.

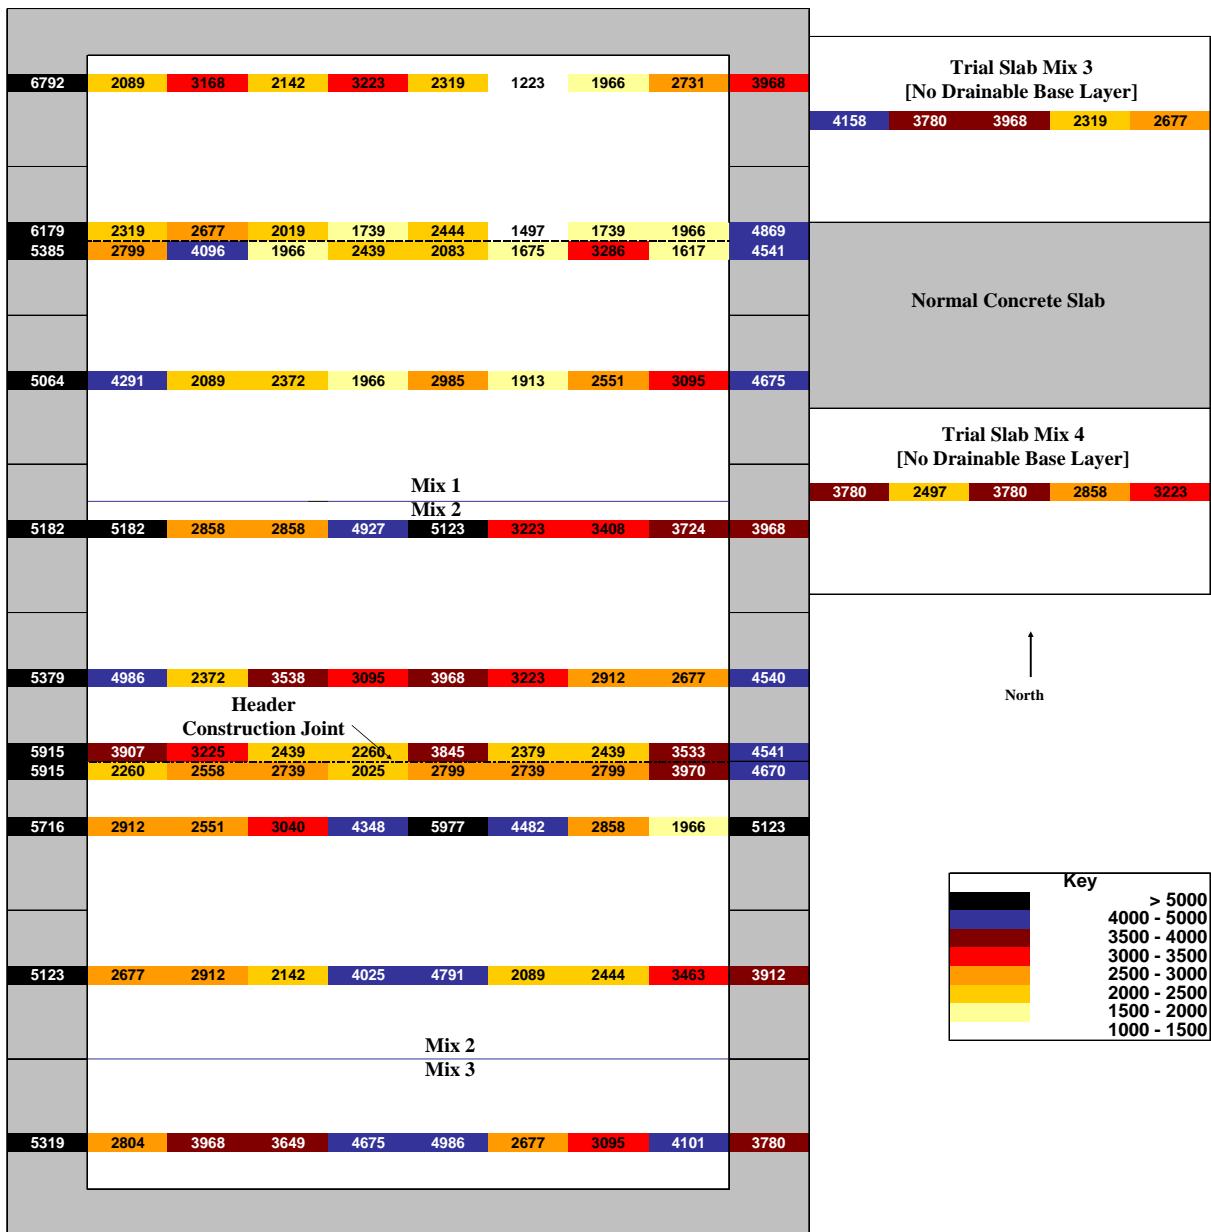
FIGURE 5: Schmidt hammer measurements on July 11, 2008.

The values in Figures 4 and 5 are the average of three measurements at each location. In 2008, the Schmidt hammer results varied from 1223 psi to 5977 psi in the pervious concrete and 3968 psi to 6792 psi in the concrete curb. Mix #1 had the lowest compressive strength values while the raveled portion of Mix #2 had the highest. Because of the high strength of Mix #2, the top layer most likely raveled due to over working or drying. If Mix #2 raveled due to low strength, it would be expected that the Schmidt readings in the raveled areas would indicate low strength, but the opposite is true, the highest strengths were measured in the raveled areas. The lowest Schmidt hammer values measured were for Mix #1, where the surface distress was also the lowest.

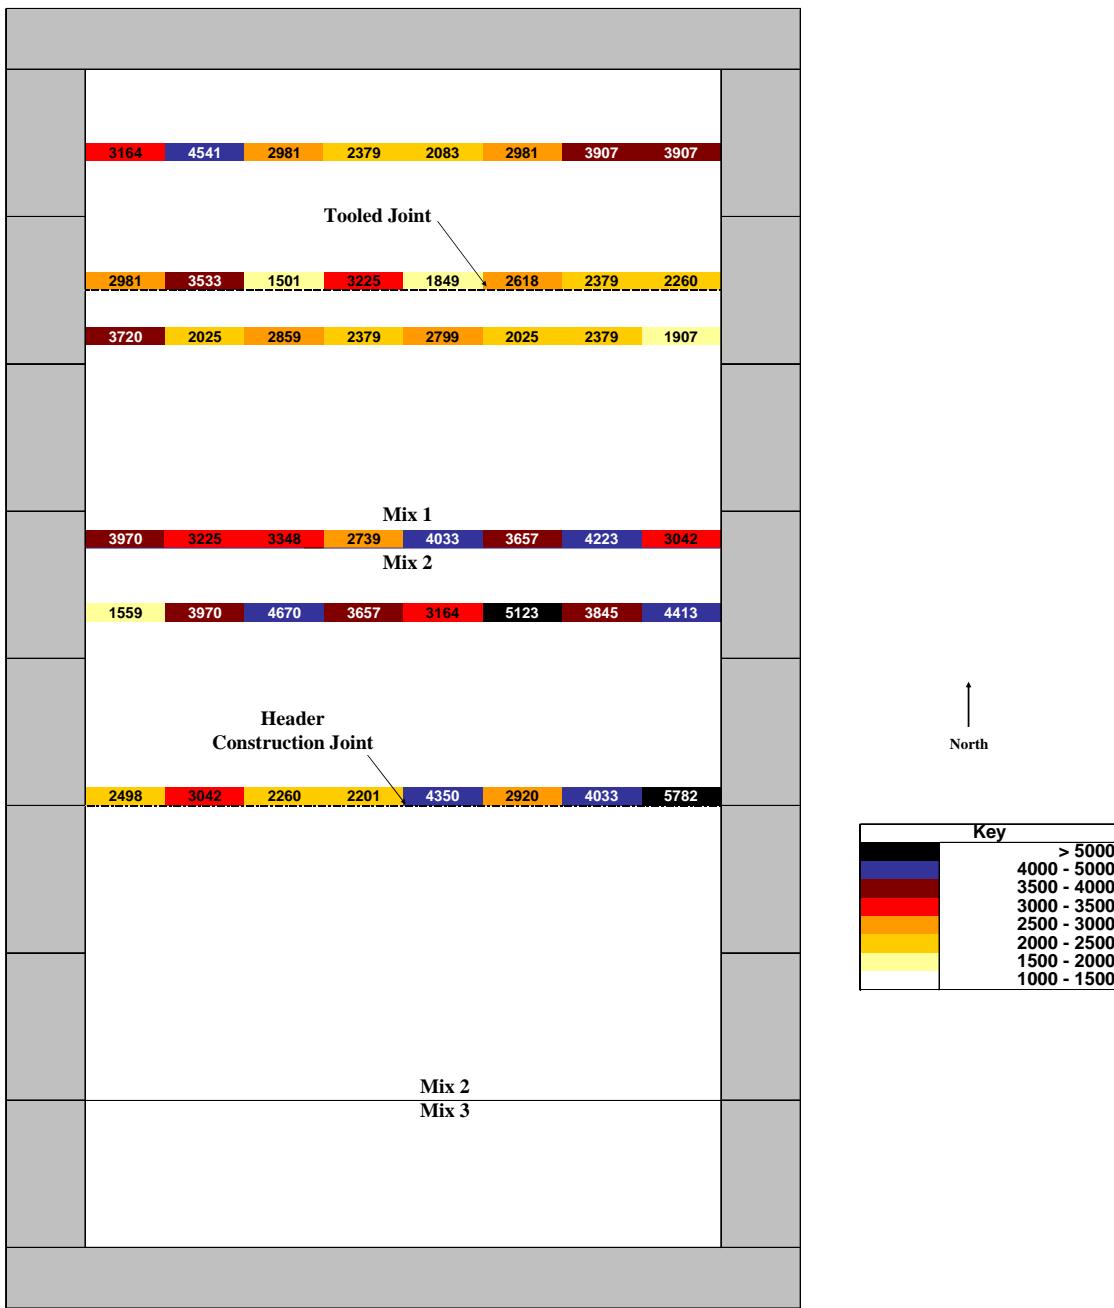
FIGURE 6: Schmidt hammer measurements on April 2, 2009.

The results of the 2009 testing were similar to the 2008 testing. Mix #1 had the lower strength than Mix #2. Measurements were not made on the south end of the test cell because of loose material in that area due to surface raveling. As evident in Figures 4 and 5, there is great variability in the measured Schmidt hammer values. This is likely due to the uneven surface of the pervious concrete.

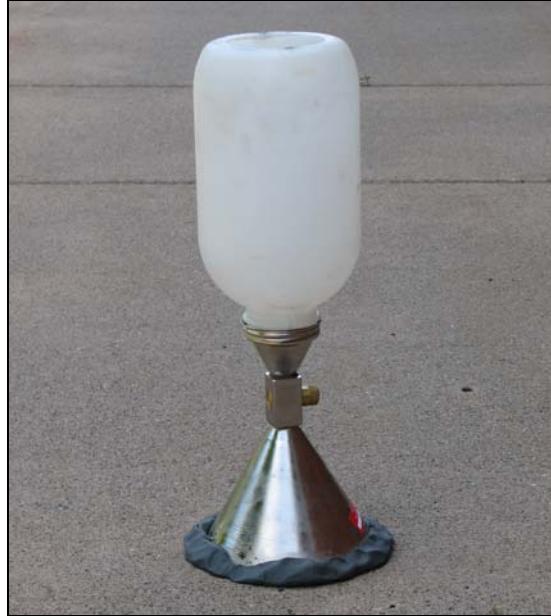
FIGURE 7: In-situ drainability measurement device.

To measure seasonal variations in permeability and also to prevent destroying the test cell by taking concrete cores, an in-field permeability measurement device was developed. This device uses a time function for emptying under a varying head. An inverted Humboldt H-4245 sand cone was modified and used to measure changes in the hydraulic conductivity. A threshold of 5 minutes was used to determine clogging. Measurements made before and after Cell 64 was swept indicate that sweeping decreased hydraulic conductivity and can cause clogging. Further changes in hydraulic conductivity will be monitored seasonally and after significant rainfall or maintenance events.

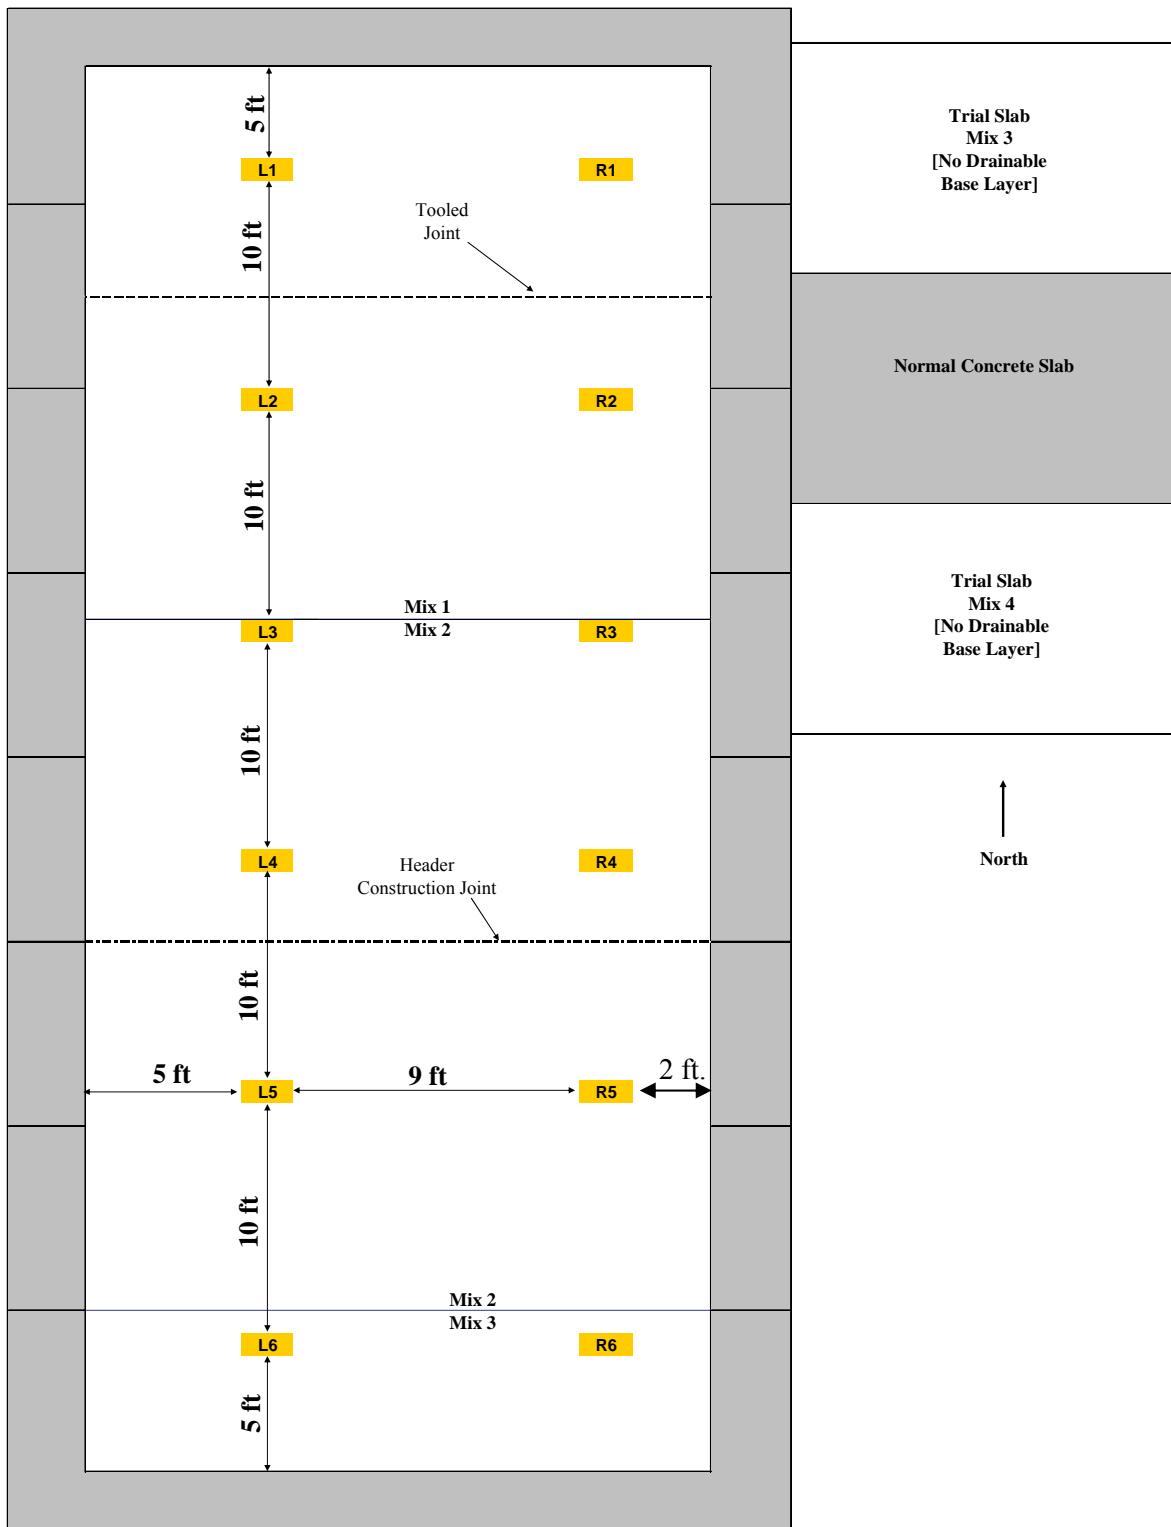
FIGURE 8: Drainability measurement locations.

The measured hydraulic emptying times are shown in Table 1. The threshold for clogging used was 5 min. (300 s). Starting with the 8.04.08 measurement event, if the perveammeter did not empty in 300 s or less, the distance that the water dropped (in inches) from the starting point was measured to determine the severity of clogging.

Between the 7.11.08 and 8.04.08 measurement events, the test cell was swept. As shown in Table 1, measurement locations that were previously clogged remained clogged and locations that were not clogged either became clogged, or the emptying time increased. This shows that sweeping contributes to clogging of the pervious pavement.

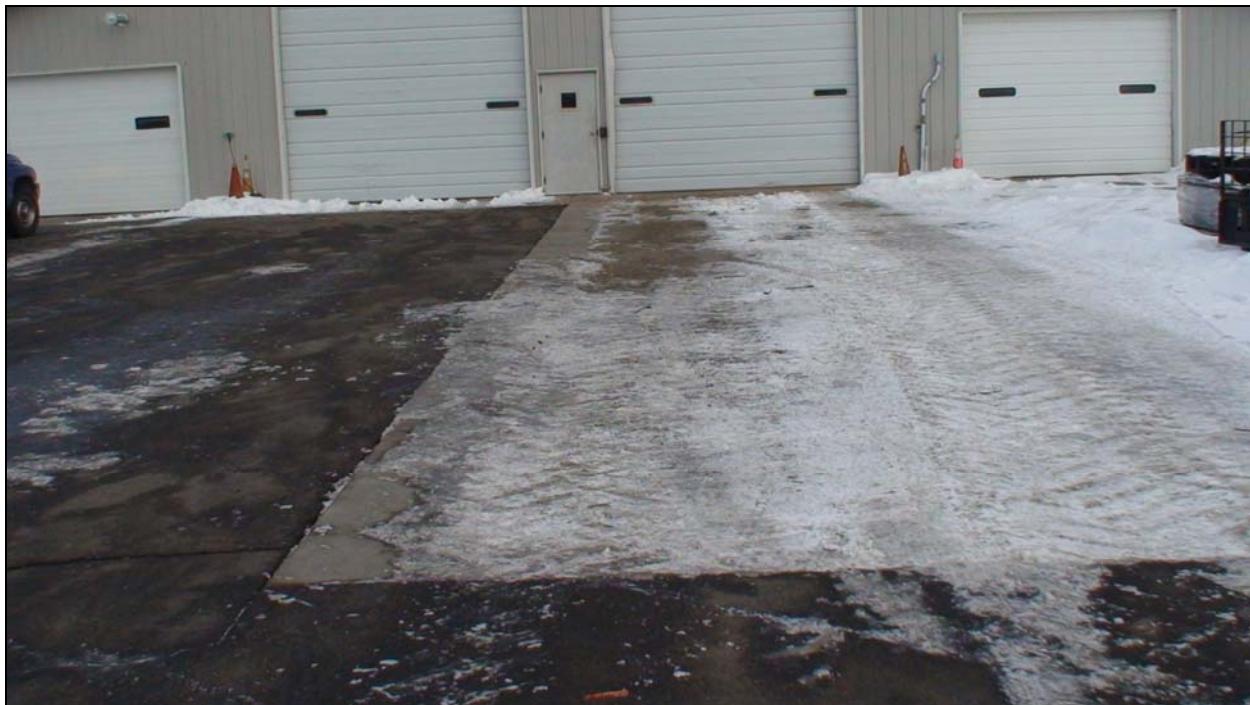
FIGURE 9: Cell 64 on January 23, 2009.

Hydraulic conductivity measurements were attempted on January 26, 2009 to determine if water could still drain through the pavement when frozen. This situation could occur if the surface of the pavement thawed on a warm sunny day while the pavement further from the surface stayed frozen. The measurements were not able to be taken because the surface of the pervious concrete was covered with ice and snow as shown in Figure 9. The MnROAD operations staff noted that salting and plowing was not as effective in keeping the surface free of ice as in impermeable pavements. In the asphalt driveway surrounding Cell 64, the salt would melt the ice and form a salt solution which would then melt the ice in-between the salt grains. In the pervious concrete, this salt solution drained away through the pavement and did not effectively melt the ice at the surface. In the pervious HMA and concrete pavements of test Cell 85, 86, 88, and 89 this phenomena was not observed because salt had not been applied to the LVR. Seasonal measurements will continue to monitor changes in hydraulic conductivity.

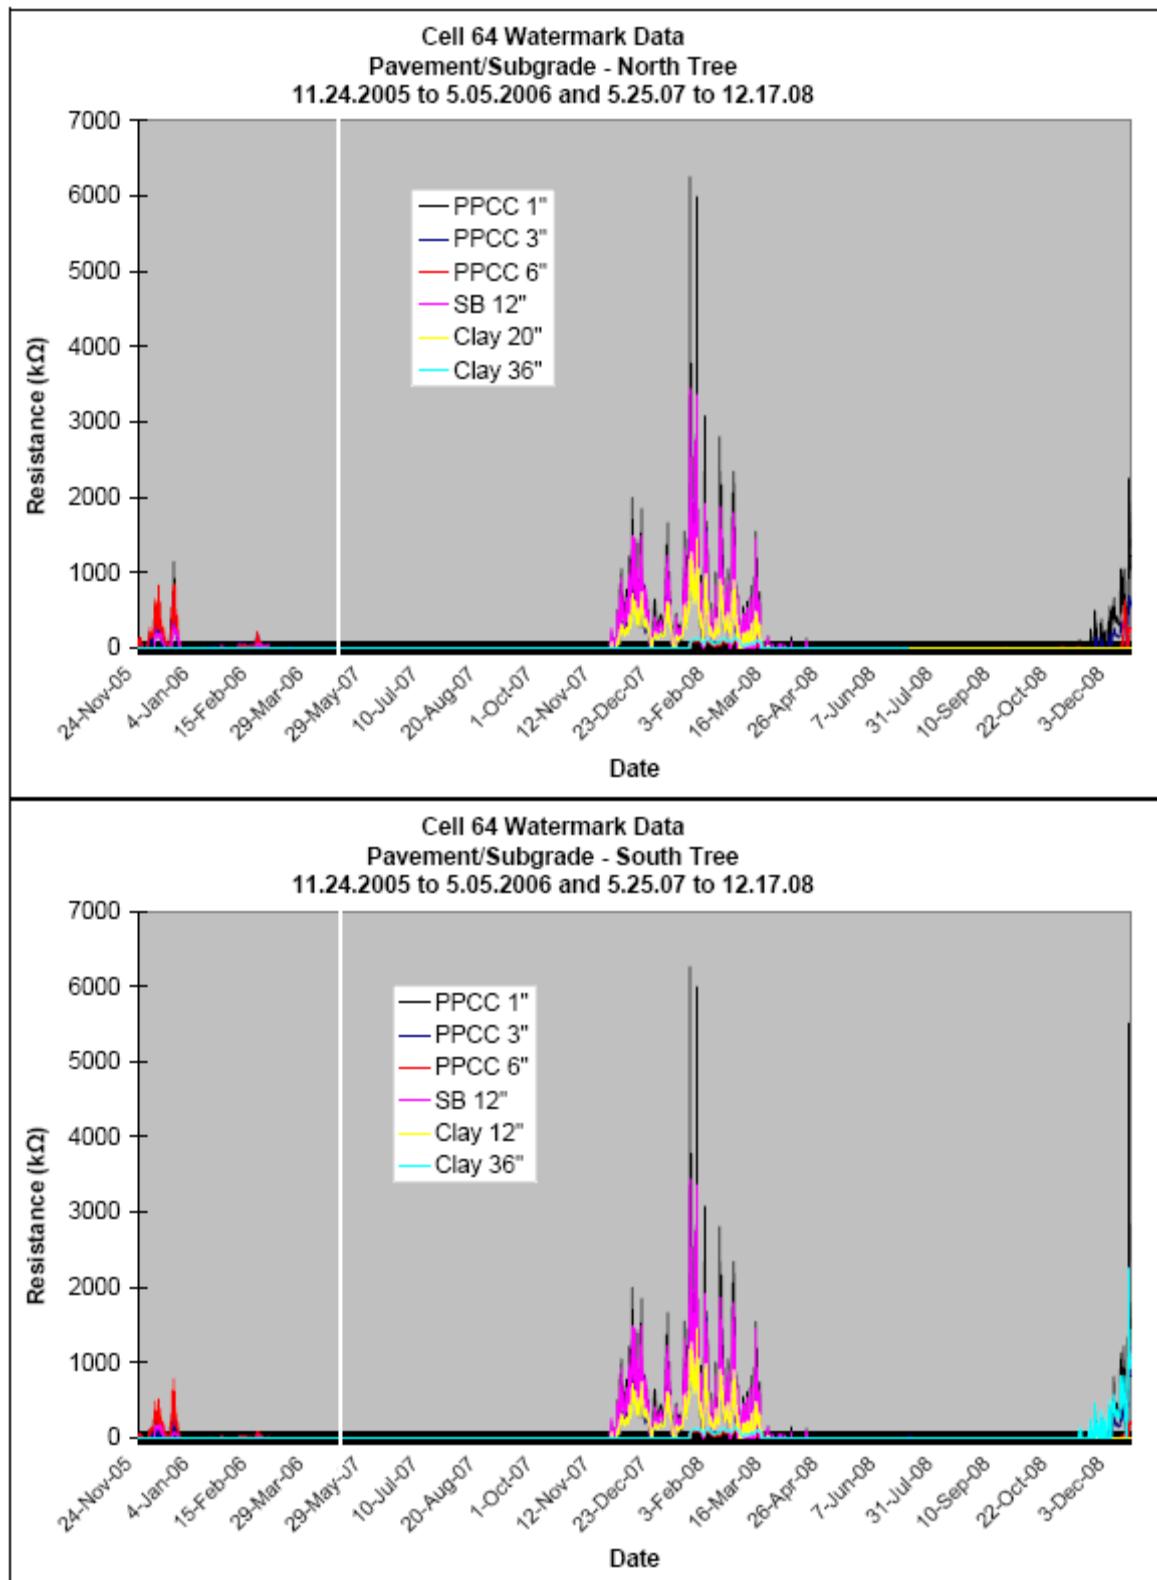
FIGURE 10: Freeze-thaw cycles measured by watermarks in pavement, base, and subgrade.

Figure 10 shows the resistance read by the watermark sensors for six discrete depth intervals taken from November 24, 2005 to December 17, 2008 with the exception that data from May 5, 2006 until April 25, 2007 is missing. The white vertical lines in Figure 10 indicate the location of the discontinuity in the data. The resistance changes markedly when the sensor detects frost, and the graphs show several freeze thaw events that may have even reached to the CA-50 base material. During the winter of 2007/2008, freeze thaw events as deep as 36 in. below the pavement surface are shown.

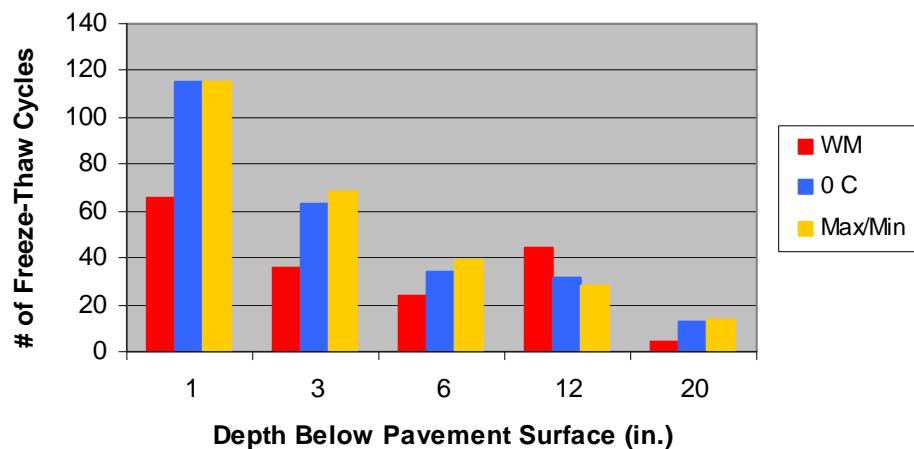
FIGURE 11: Comparison of number of freeze-thaw cycles calculated using different definitions at various depths below Cell 64.

Watermark sensors have been installed at MnROAD to count freeze-thaw cycles for many years. These sensors are typically used in agricultural applications to measure soil water saturation. They are helpful in measuring freezing in pavements because when the moisture in the soil surrounding the sensors changes state from liquid to solid, the sensor measures a spike in resistance as shown in Figure 10. The difficulty is determining how high the resistance spikes when this phase change occurs. For the purpose of counting freeze-thaw cycles in this report, a resistance spike above $1.5\text{ k}\Omega$ was used to indicate freezing. This value was chosen because it was just slightly higher than the maximum measured resistance during the three summers since Cell 64 was constructed. A comparison between different definitions of freeze-thaw cycles was made in Figure 11 at various depths below the pavement surface in Cell 64. The different definitions were:

- WM – watermark, using a spike in resistance above $1.5\text{ k}\Omega$
- 0° C – counting every fluctuation above/below 0° C as one cycle
- Max/Min – counting every time the daily maximum and minimum temperature fluctuates above and below 0° C as one cycle

The time period that the freeze-thaw cycles were counted was the winter of 2005/2006, winter of 2007/2008, and 2008 through December 17. No data was available for the winter of 2006/2007. As shown in Figure 10, the 0° C and Max/Min methods using thermocouple sensors gave a similar number of freeze-thaw cycles and the watermark sensors (WM) typically measured fewer cycles. This could indicate that both procedures using thermocouples measure more cycles than are occurring.

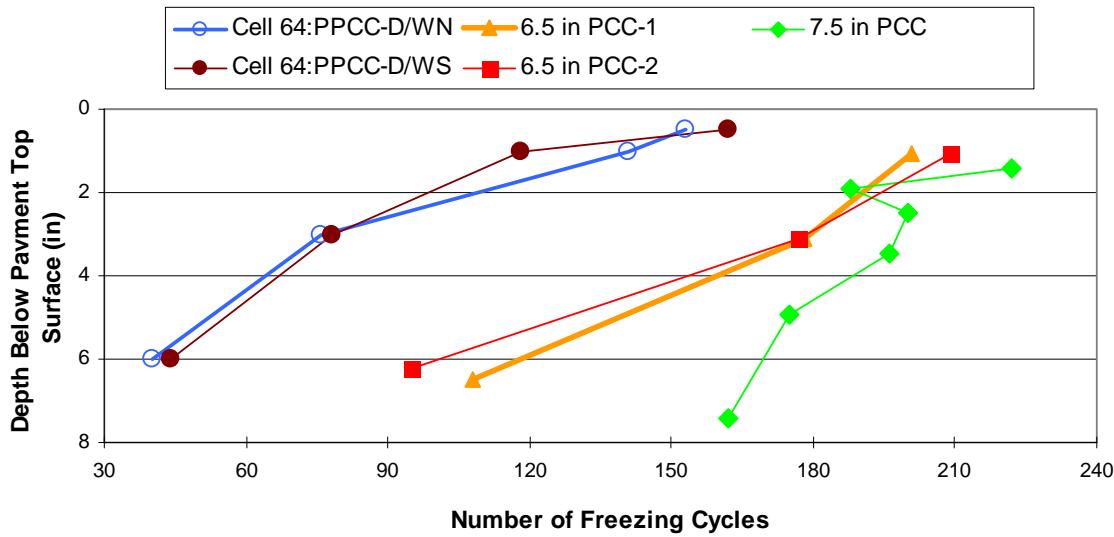
FIGURE 12: Number of freezing cycles at various depths below pervious and impervious PCC pavements of similar thickness.

The number of freezing cycles measured using thermocouple data is shown in Figure 12 at various vertical depths below the pavement surface for the winters of 2005/06, 2007/08, and 2008/09 through March 1. Temperature data was not collected during the winter of 2006/07. One freezing cycle was defined as a fall and rise above 0 °C. While this is a very simple definition, and may not represent the true number of freeze-thaw cycles, this method can be used as an effective comparison between different pavements.

The data from two different thermocouple trees in the 7 in. thick pervious PCC test Cell 64 is shown in the figure; a north (Cell 64:PPCC-D/WN) and south tree (Cell 64:PPCC-D/WS). Three other impervious PCC pavements of similar thickness are also shown, two 6.5 in. thick and one 7.5 in. thick pavement. Pervious Cell 64 experienced 130 freezing cycles at 1 in. below the top pavement surface. The two 6.5 in. thick pavements experienced 205 (58% increase) and the 7.5 in. thick pavement experienced 222 (72% increase) freezing cycles at 1 and 1.5 in., respectively, below the top pavement surface. At pavement mid depth, the pervious pavement experienced 77 freezing cycles compared to 177 (130% more) in the two 6.5 in. thick and 196 (150% more) in the 7.5 in. thick PCC pavements.

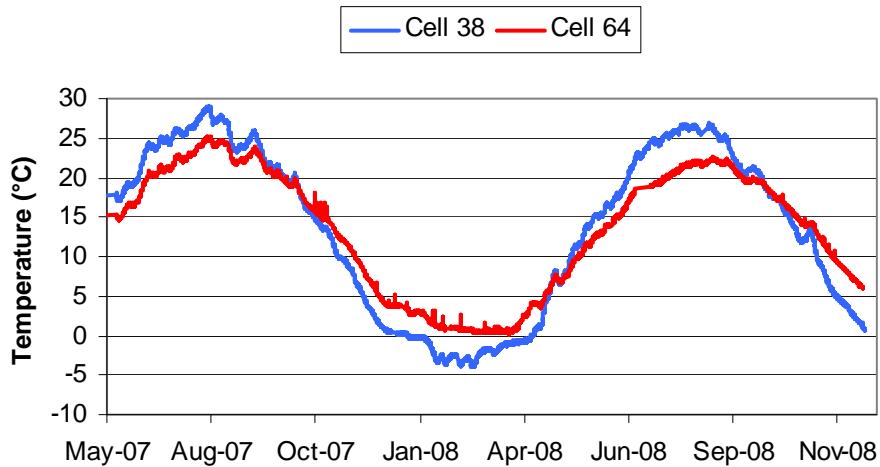
FIGURE 13: Temperature 36 in. below pavement surface.

Backstrom [7] attributed an increased temperature in permeable pavements to two causes; increased subgrade temperature due to elevated moisture content and an insulating effect from the air trapped in the permeable pavement. While Cell 64 did not have the required sensors to

accurately monitor subgrade moisture content, Figure 13 shows that the subgrade was warmer during the winter and cooler in the summer in Cell 64 than in Cell 38, a 6.5 in. thick impermeable concrete pavement. Increased subgrade moisture content could explain this phenomenon.

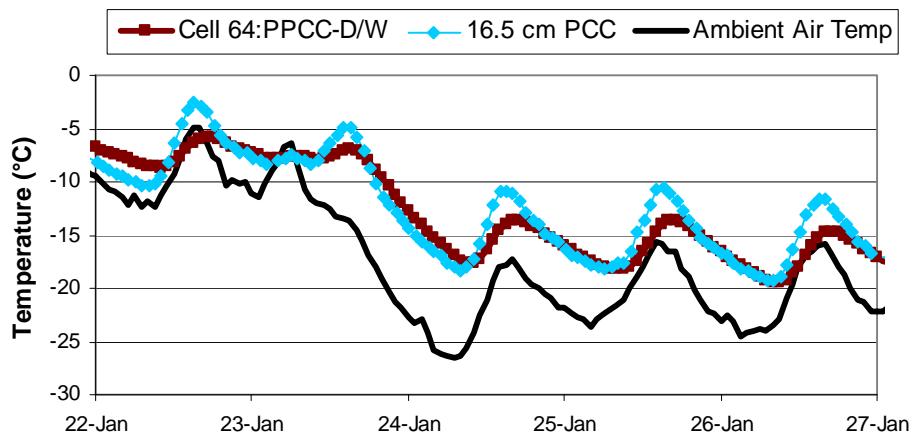
FIGURE 14: Mid-depth temperature in pervious (PPCC) and impervious (PCC) test cells at MnROAD.

Figure 14 shows the temperature at mid depth for Cells 64 and 38. The rate of temperature change was much less in Cell 64 than Cell 38. This could be caused from increased insulation due to the air within the pervious concrete. The trapped air keeps the pervious concrete at a more consistent temperature than the impervious Cell 38. The warmer subgrade, which warms from below, and the insulating effect of the trapped air in the pervious concrete both contribute to fewer freeze-thaw cycles in Cell 64 compared to test cells of similar thickness at MnROAD.

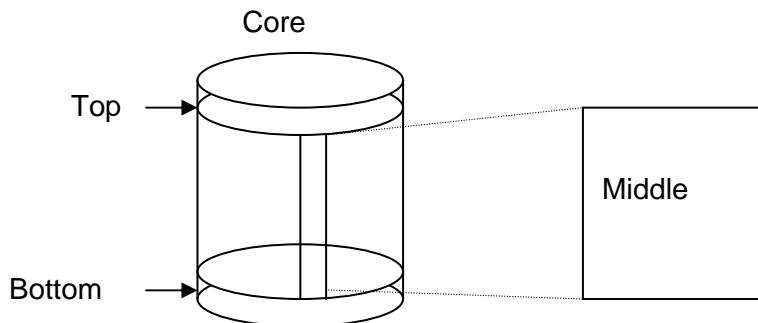
FIGURE B-2: Illustration of how cores are sectioned for microscopic evaluation.

To more precisely quantify the air void system and other mix design parameters, slabs were cut and polished from cores 2 and 3 to represent concrete near the surface, at mid-depth and near the bottom of the test pad (as shown in figure 2). ASTM C457 Linear Traverse was performed on each slab. Table 1 summarizes the results.

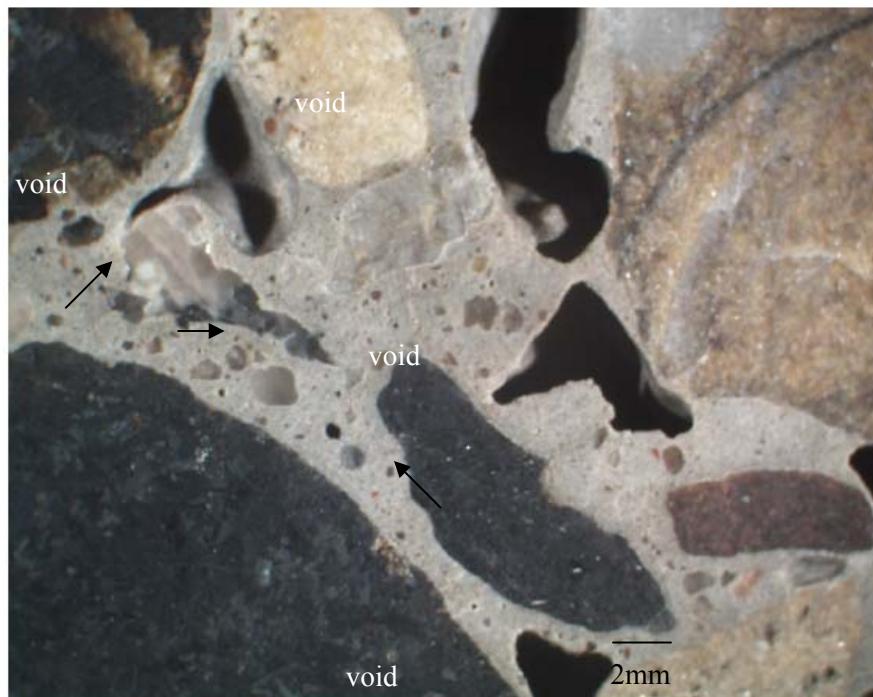
Polished slabs were examined under the stereomicroscope. Fine tight cracks were apparent under low magnification in both cores at all depths. In core 2 the cracks were predominantly through the paste running from air void-to-air void, air void-to-aggregate and/or aggregate-to-aggregate (as shown in figure 3). Occasionally the cracks would follow the aggregate-paste interface. Only rarely were cracks through aggregate particles. There was no visible difference in the abundance of cracks with depth.

FIGURE B-3: Arrows point to fine cracks in paste in core 2.

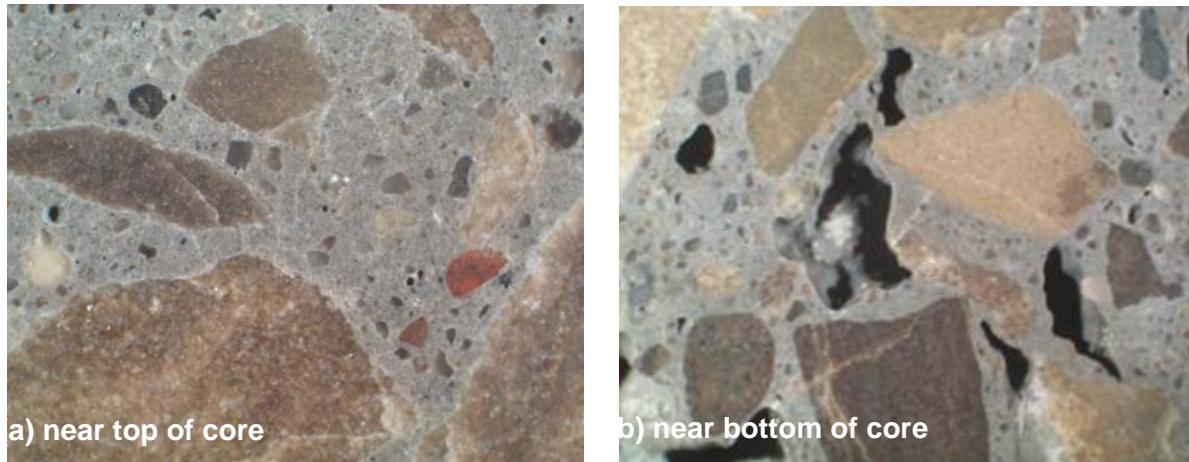
In core 3 the cracks commonly ran through the aggregates as well as through the paste, as seen in Figure E4, more abundant near the top then near the bottom of the core. Cracks were more apparent near the top of core 3 than in core 2.

It is difficult to determine precisely what has caused these cracks, but some possibilities to consider include: 1) environmentally induced from exposure to repeated freeze/thaw cycles, 2) possibly shrinkage from the low w/cm ratio contributed to some cracking, or 3) lower strengths resulted in some mechanical failure from heavy loads.

The fact that there are more cracks in the top portion of core 3 which had a much higher paste:void ratio and much lower air content than any other concrete suggests that freeze/thaw may have contributed. If strength was an issue then the portion of the mix with higher air, such as the bottom of core 3, would have been weaker and shown more distress/cracks. The higher

paste content at the top of core 3 may have led to higher internal stresses caused by drying and shrinkage, but this would not explain cracks that run through the aggregate too.

FIGURE B-4: Microscopic view of polished slabs from core 3 showing several fine tight cracks. Note the lack of air voids and numerous cracks at the top (a) compared to the more abundant air and fewer cracks through paste in the bottom (b) of the slab.

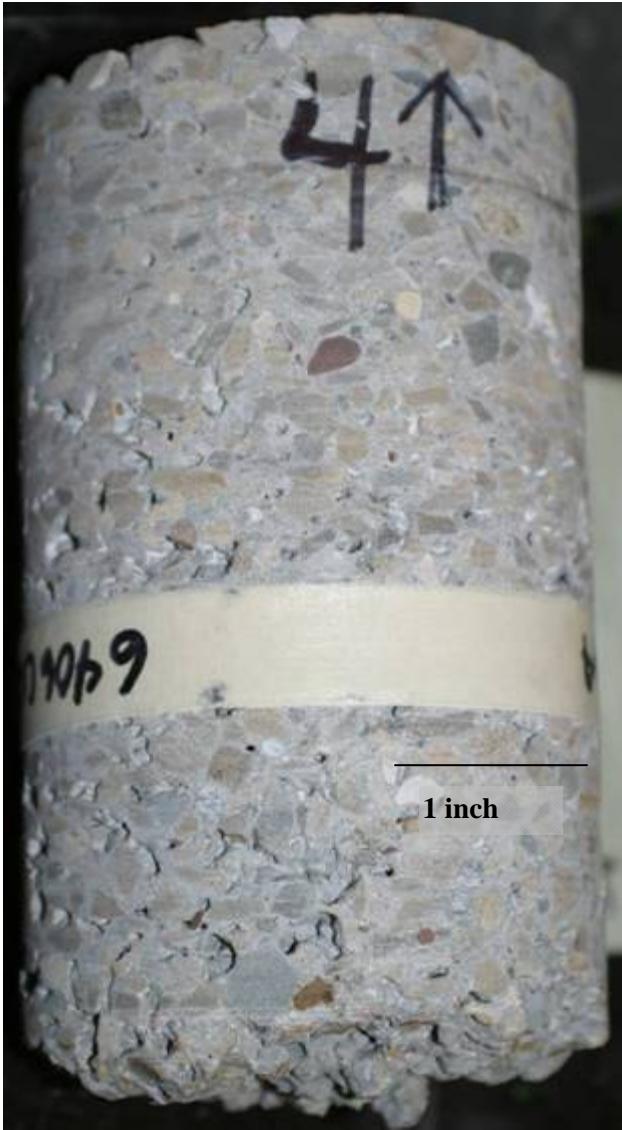
CORES # 3 AND # 4 MEGASCOPIC OBSERVATIONS

3.6" Diameter
6.5" Length

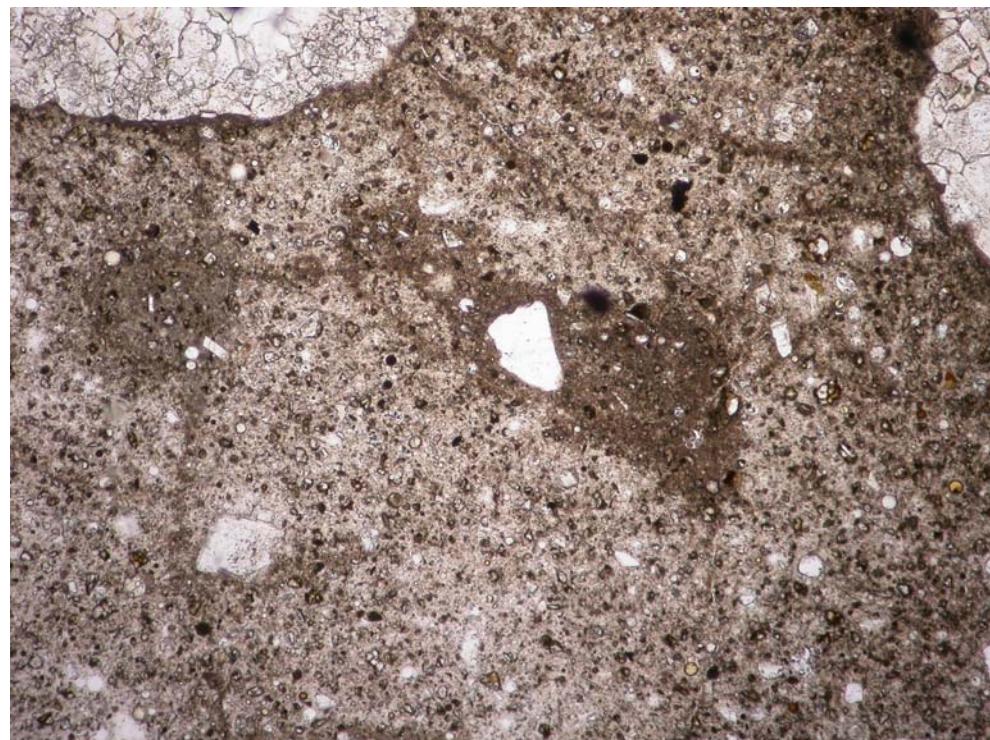
Photo #8: Thin section photomicrograph of paste inhomogeneities in Sample #4.
Planed-polarized light; Field Length = 2.8 mm

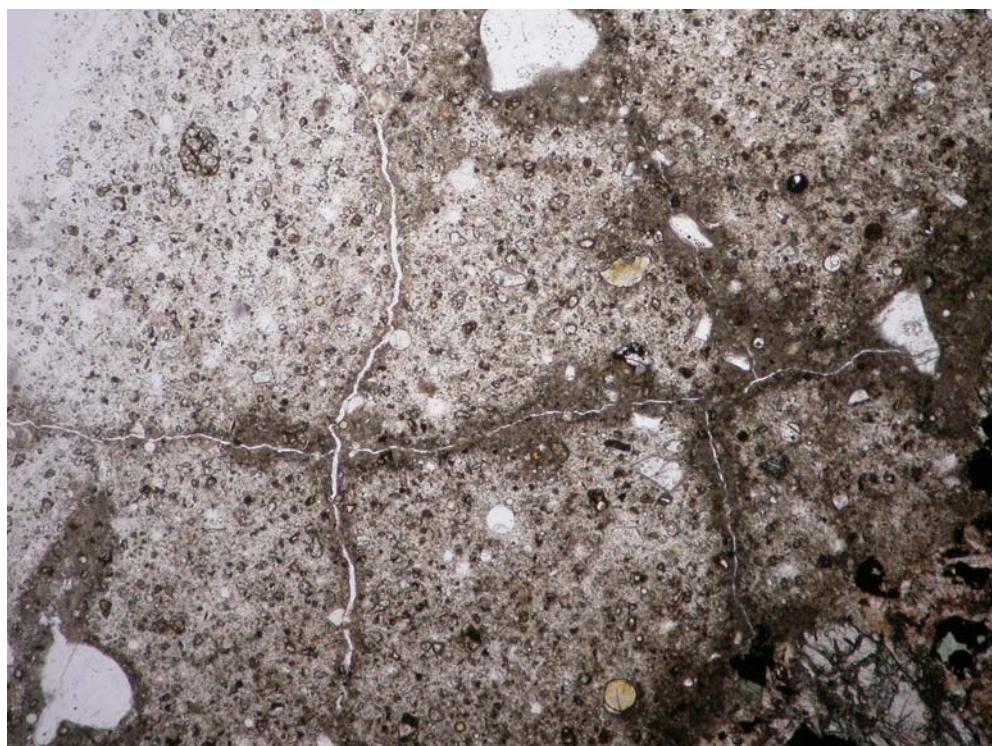
Cracking and microcracking was observed both parallel to, and normal to the top surface. Microcracking oriented parallel to the top surface was observed to depths of approximately 5 cm, 3.5 cm, 7 cm, and 1 cm in Sample #1, #2, #3, and #4, respectively. All samples exhibited extensive microcracking within the top 1 cm, some of which were consistent with severe shrinkage (Photo #9). Carbonation of paste directly adjacent to the microcracks was common. A majority of the microcracks exhibited autogenous healing (Photo #10).

Photo #9: Thin section photomicrograph of the extensive cracking in Sample #1.
Plane-polarized light; Field Length = 2.8 mm

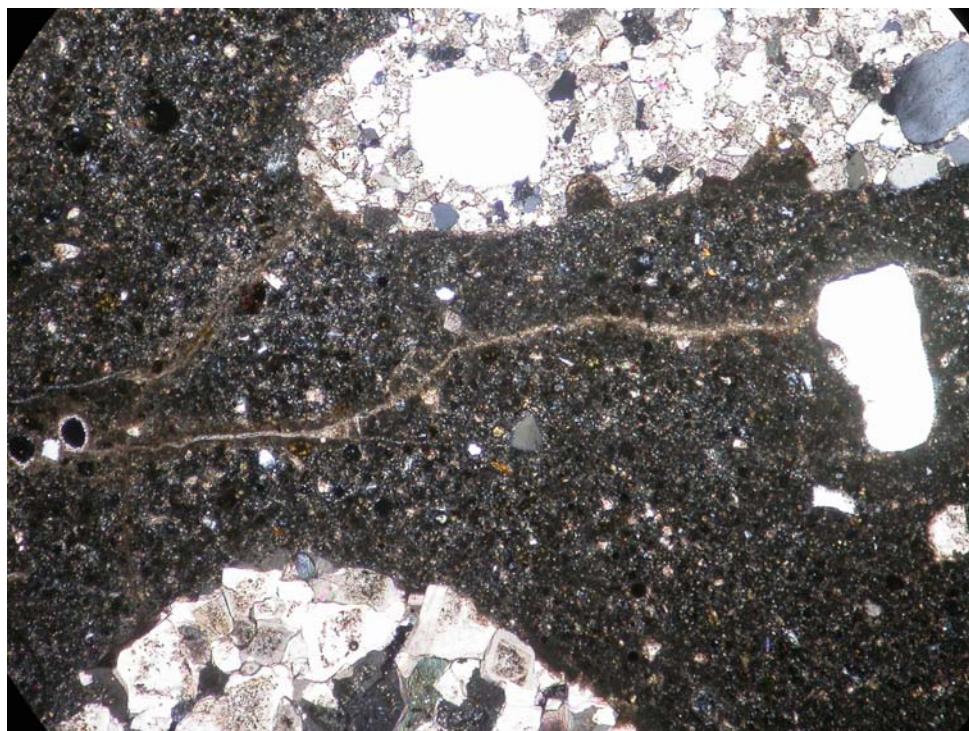
Photo #10: Thin section photomicrograph of a microcrack that has autogenously healed.
Cross-polarized light; Field Length = 2.8 mm

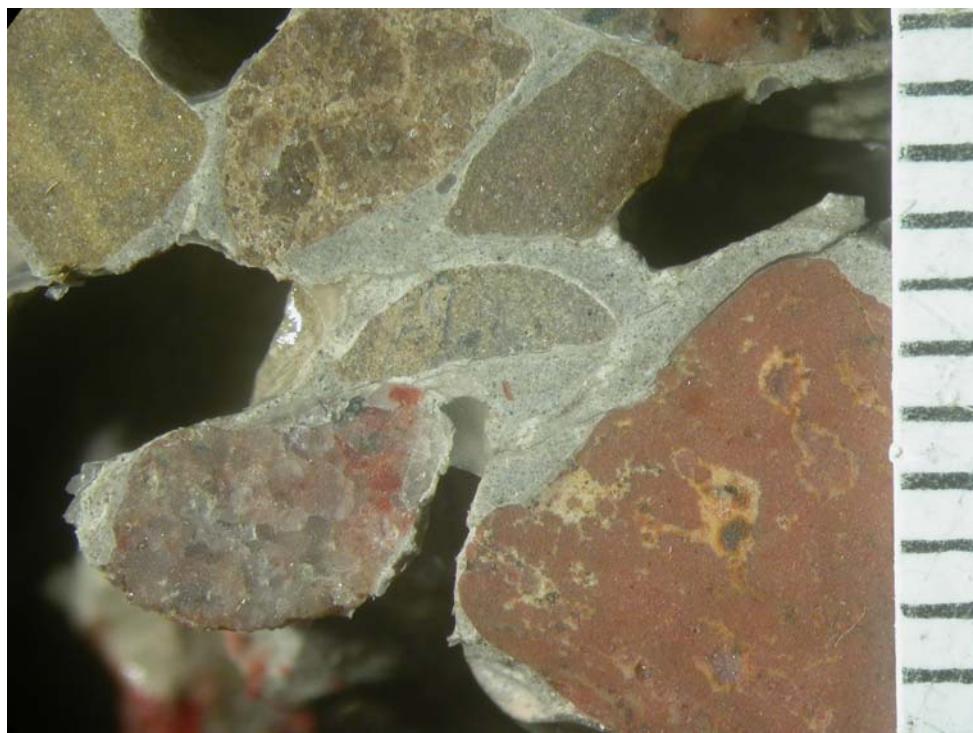
Photo #11: Photomicrograph of the air voids in Sample #1. Note the lack of entrained air in the paste regions. Scale: 1 division = 1 mm

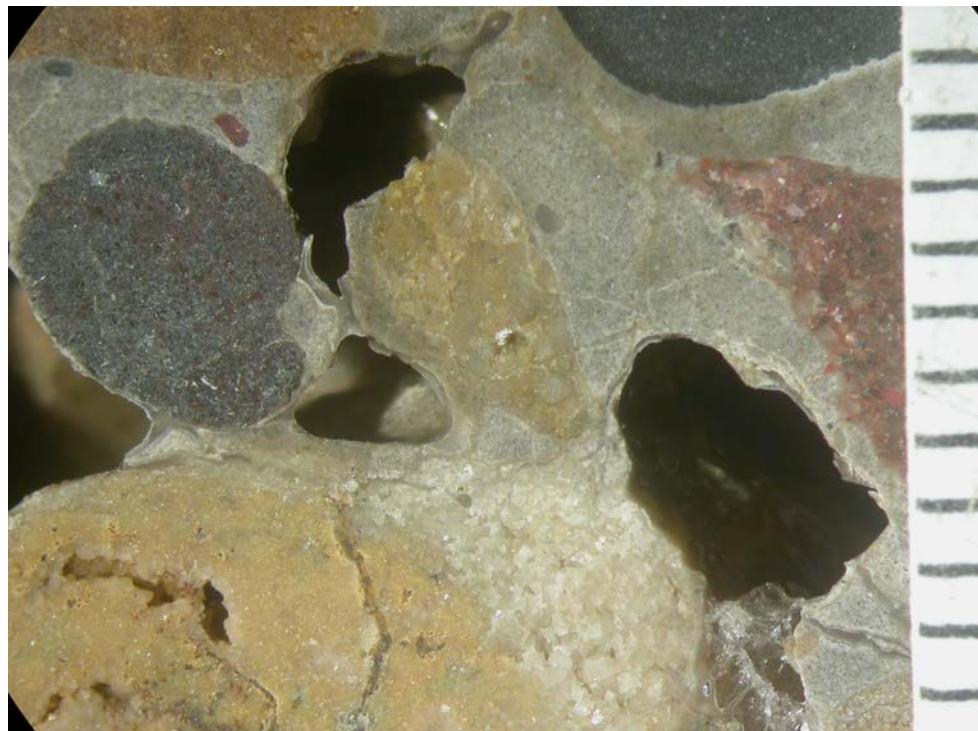
Photo #12: Photomicrograph of the air voids in Sample #2. Note the lack of entrained air in the paste regions. Scale: 1 division = 1 mm
