MnROAD Cell 64 Pervious Concrete: Third Year Performance Report

1. Report No. MN/RC 2009-19	2.	3. Recipients Accession No.	
4. Title and Subtitle MnROAD Cell 64 Pervious Concrete: Third Year Performance Report		5. Report Date June 2009	6.

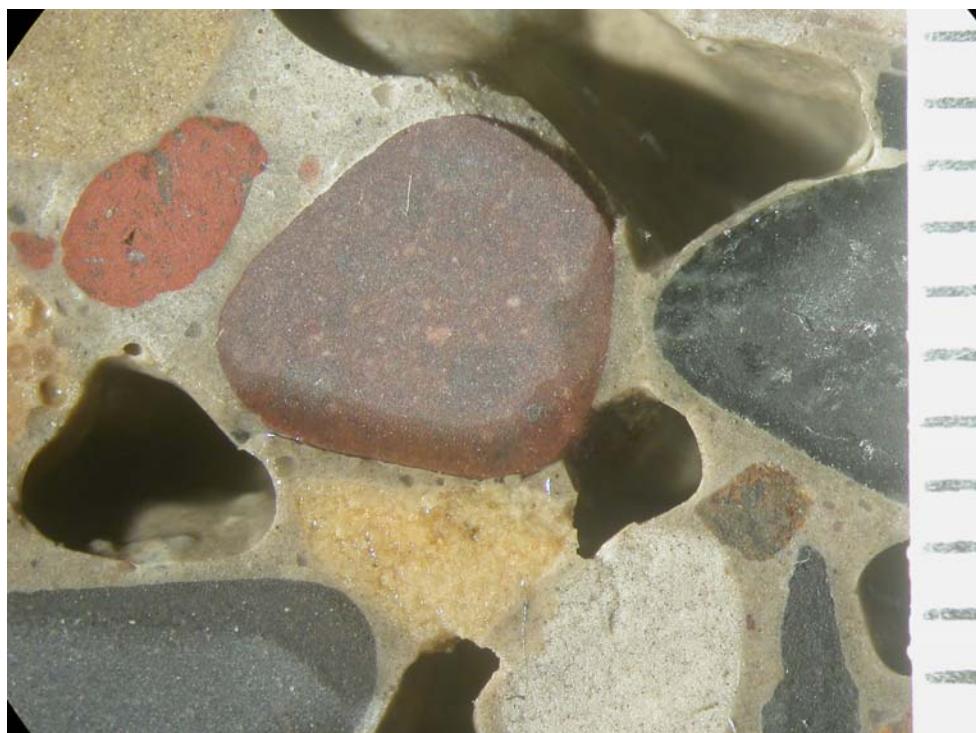
Photo #13: Photomicrograph of the air voids in Sample #3. Note the lack of entrained air in paste regions. Scale: 1 division = 1 mm

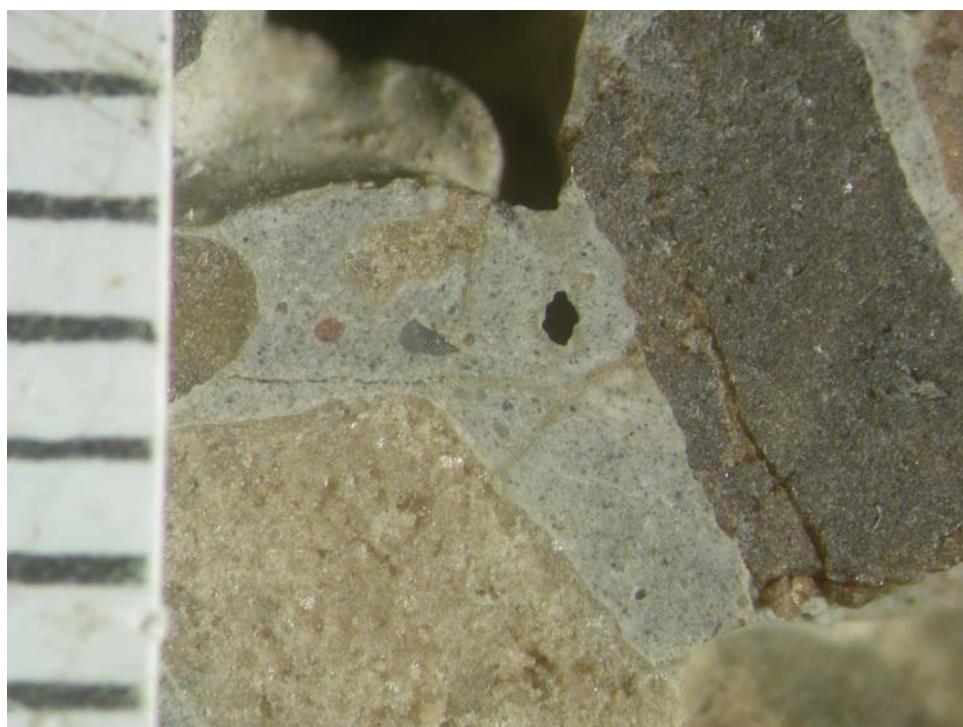
Photo #12: Photomicrograph of the air voids in Sample #4. Note the lack of entrained air in the paste regions. Scale: 1 division = 1 mm

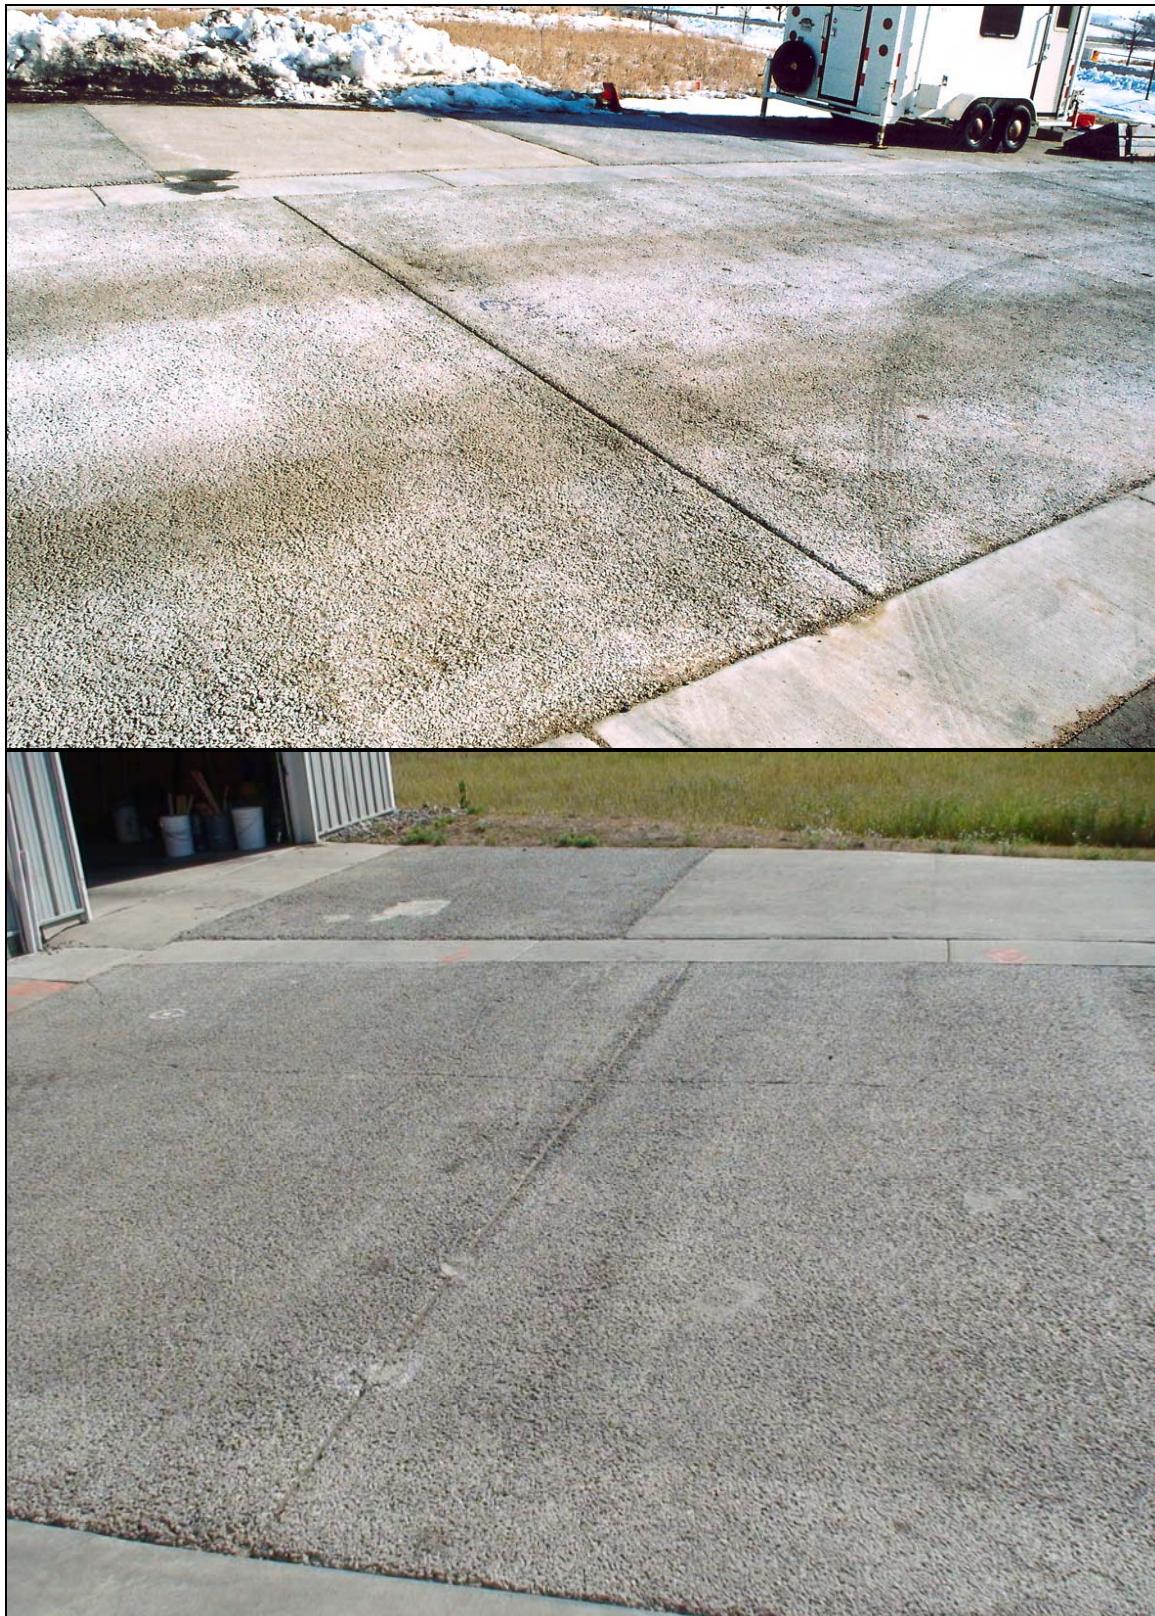
On the August 11, 2008 condition survey, Mix #1 showed moderate spalling at the tooled joint and raveling at the joint where Mixes #1 and Mixes #2 are co-terminus. Mix #2 showed moderate to severe raveling on the surface of the concrete, with moderate to severe raveling and spall at the joints. Mix #3 showed low raveling on the surface with moderate to severe raveling and spall at the joints.

FIGURE D-1: Tooled joint, Top: 9.21.06, Bottom: 8.11.08.

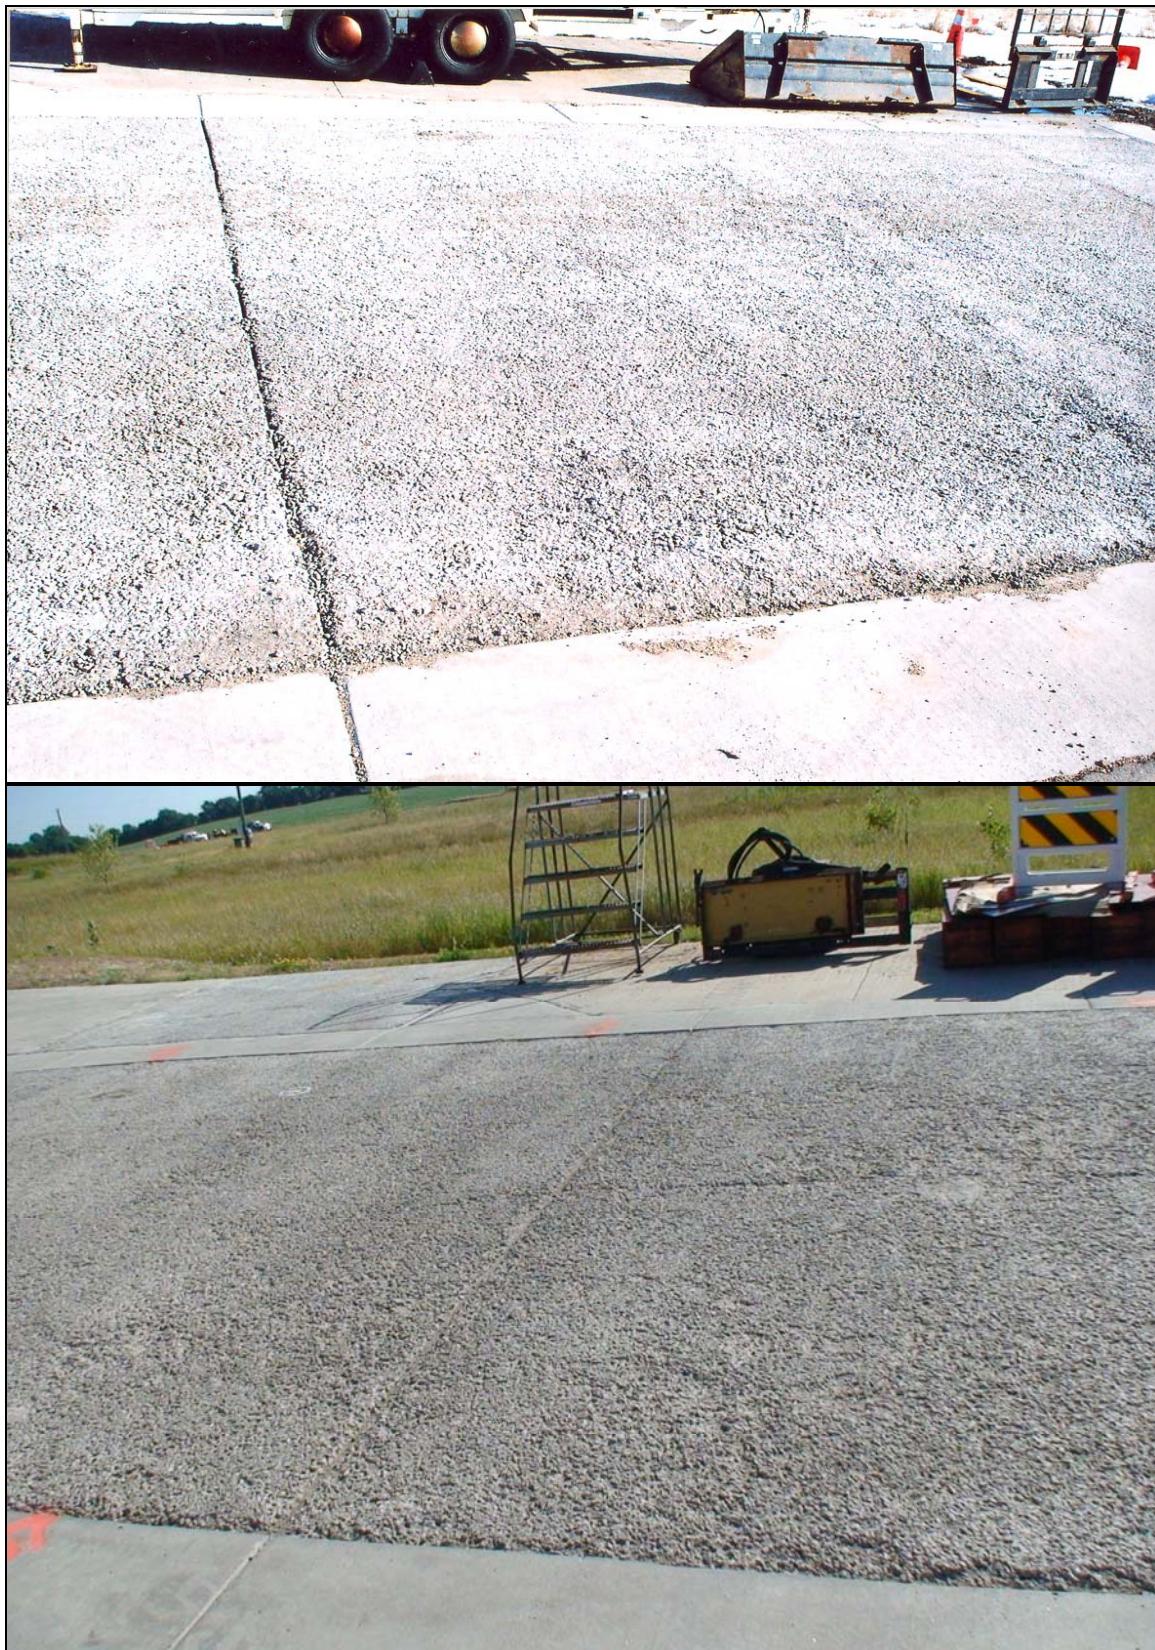
FIGURE D-2: Header/construction joint, Top: 9.21.06, Bottom: 8.11.08.

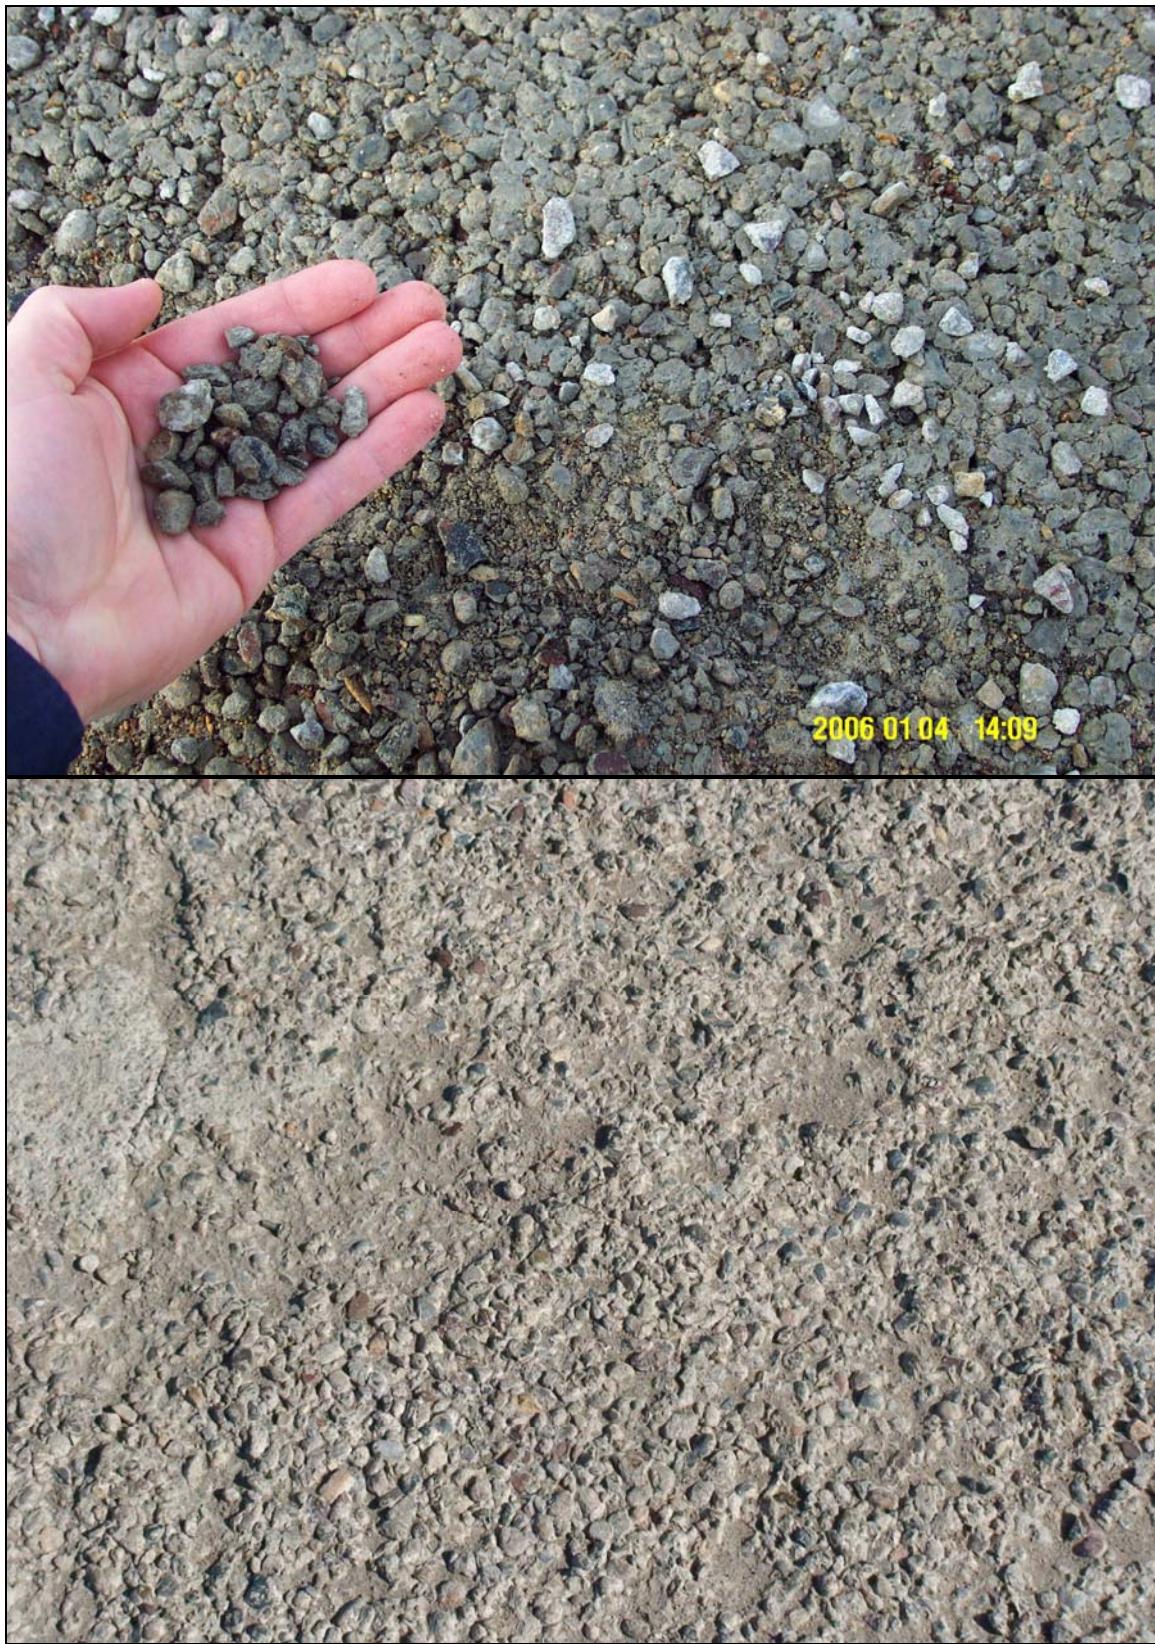
After three years, Mix #1 shows the least surface raveling/spall with Mix #2 having the most. Most of the raveling/spall in Mix #2 occurred shortly after placement and then again in the spring of 2009. As shown in Appendix D, the top $\frac{1}{4}$ to $\frac{1}{2}$ in. of concrete in some areas of Mix #2 raveled away shortly after placement and again in spring 2009. The original raveling that occurred just after construction likely occurred because the mix became too dry by not being covered with plastic early enough or by over finishing the surface. The raveling that began in spring 2009 likely occurred because the pavement was clogged. Water or snow could have been trapped in the pervious concrete. Then when it froze or was compacted into ice, the expansive pressure could have deteriorated the paste around the top layer of aggregate, resulting in raveling of this layer.

FIGURE D-3: Mix #2 surface raveling, Top: 01.04.06, Bottom: 8.11.08.

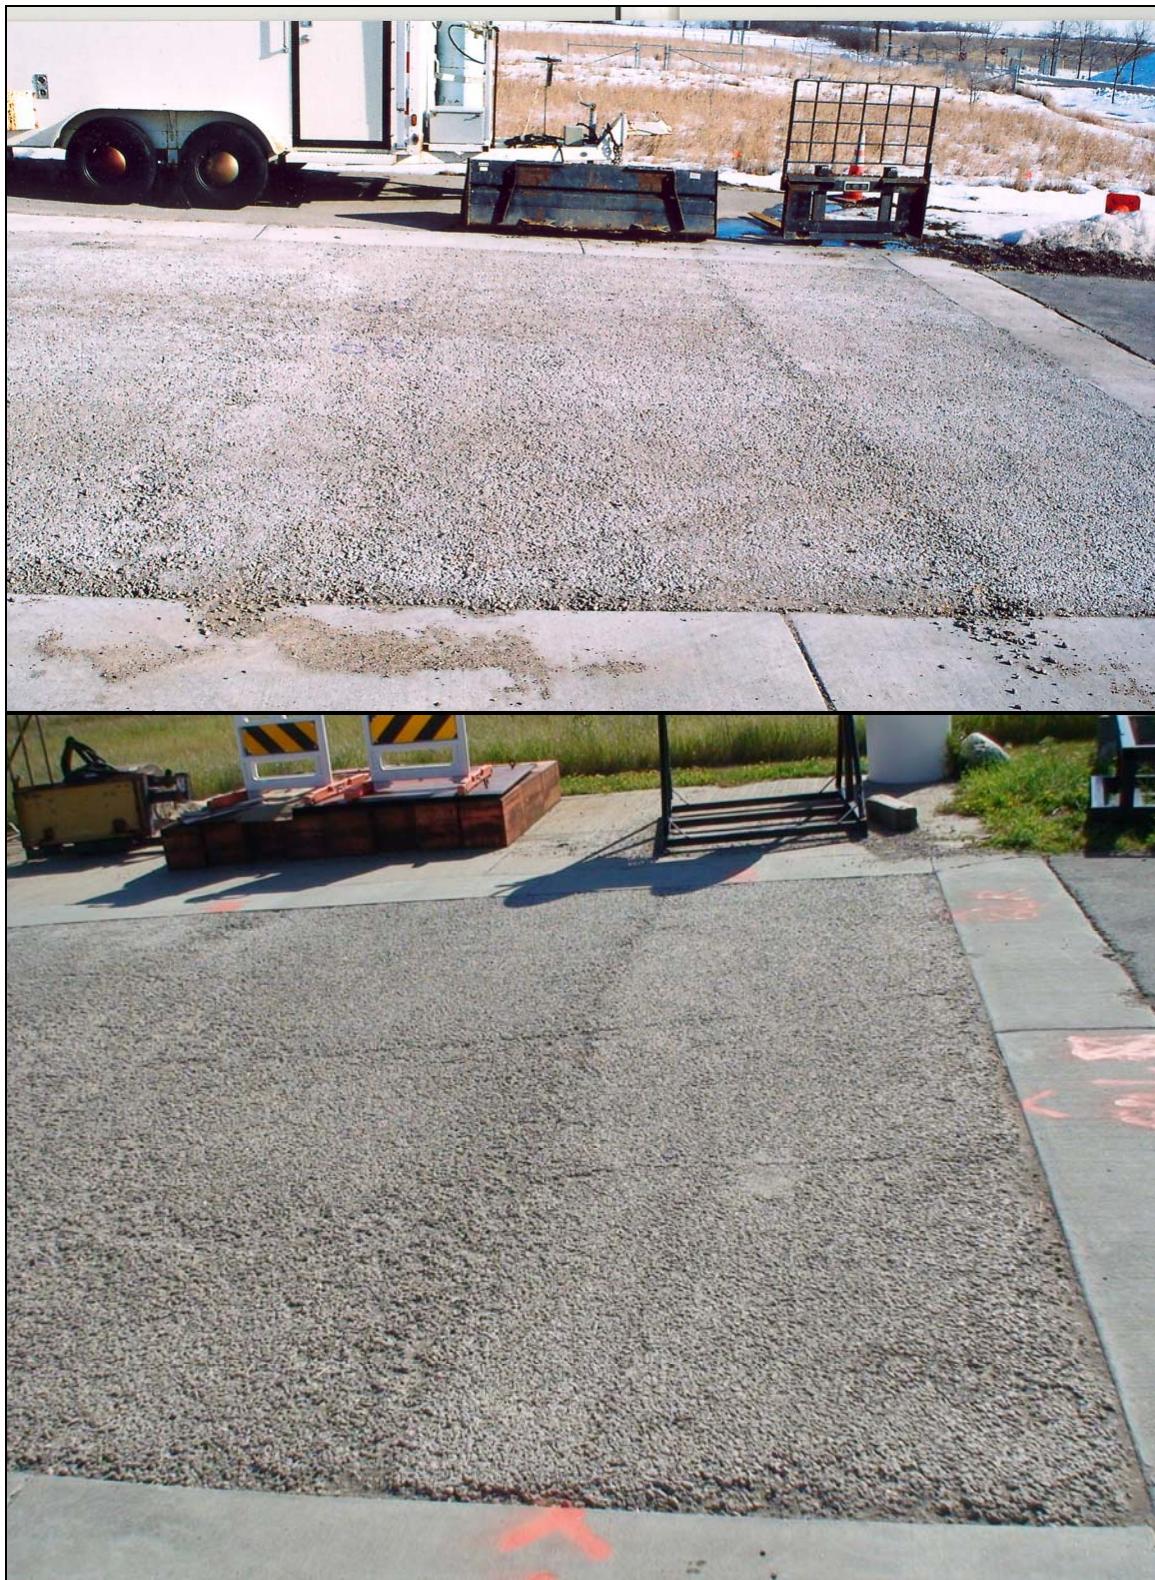
FIGURE D-4: Coterminous joint at Mixes #2 and #3, Top: 9.21.06, Bottom: 8.11.08.

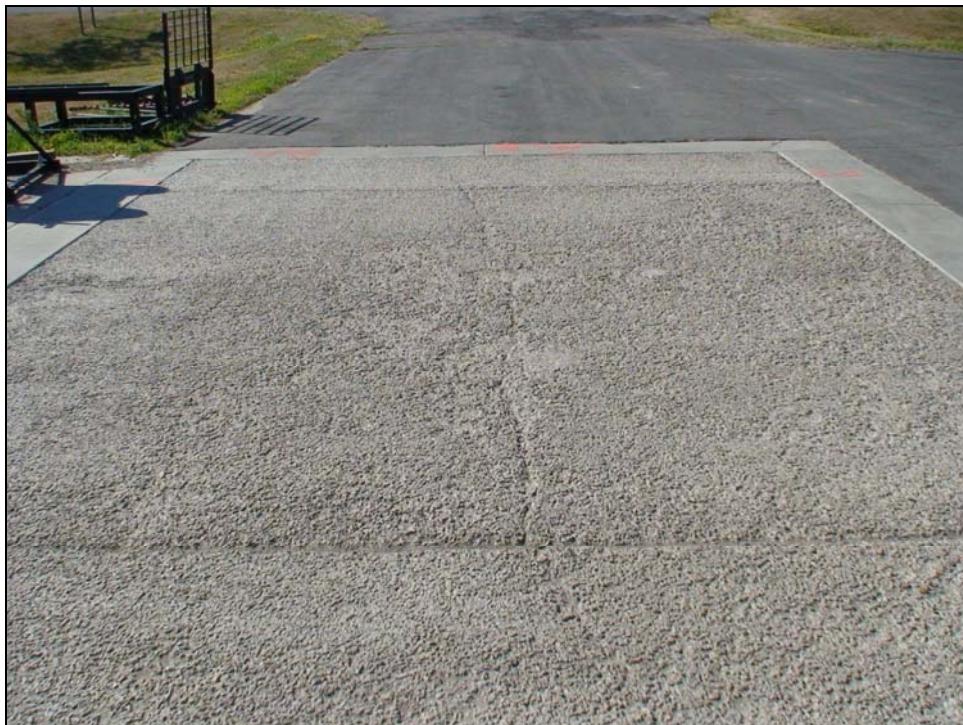
FIGURE D-5: Header/construction joint, facing south, 8.11.08.

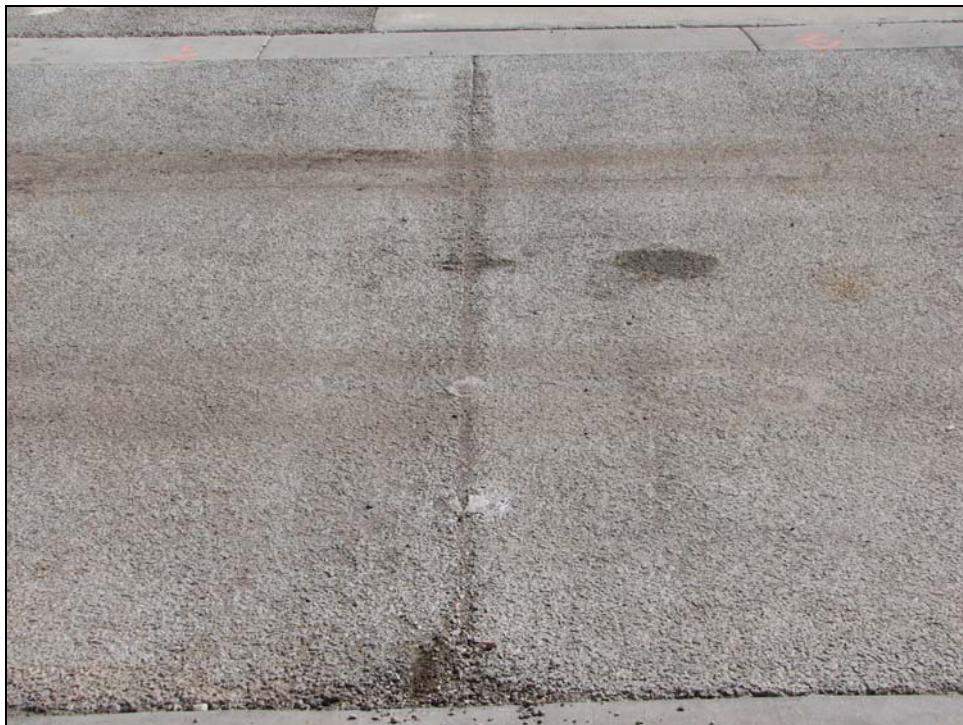
During the winter of 2008/09 significant changes in distress occurred in Cell 64. The top layer of pervious concrete along the tooled joint in Mix #1 as well as significant portions of Mix #2 showed sever raveling. The affected area in Mix #2 is the same area that experienced surface raveling shortly after construction [2]. The locations of cracks in Cell 64 and the areas of raveling are shown in Figure 4.

FIGURE D-6: Tooled joint, 4.02.09.

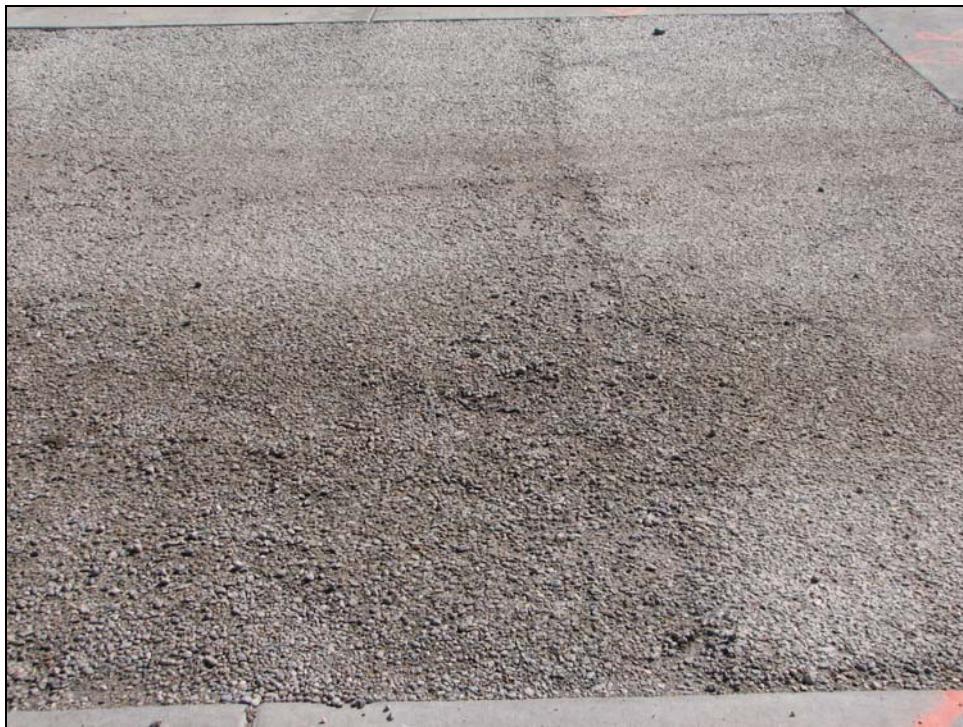
The main change in surface distress from the first year to the third year of service was the presence of a longitudinal crack that extended the length of Cell 64. Initiating at the pole barn at a joint in the concrete curb, it could have propagated the length of Cell 64 due to Falling Weight Deflectometer (FWD), traffic, or thermal loading. After the winter of 2008/09, there was severe raveling of the surface layer in parts of Mix #2.

FIGURE D-7: Area of severe raveling in Mix 2, 4.02.09.

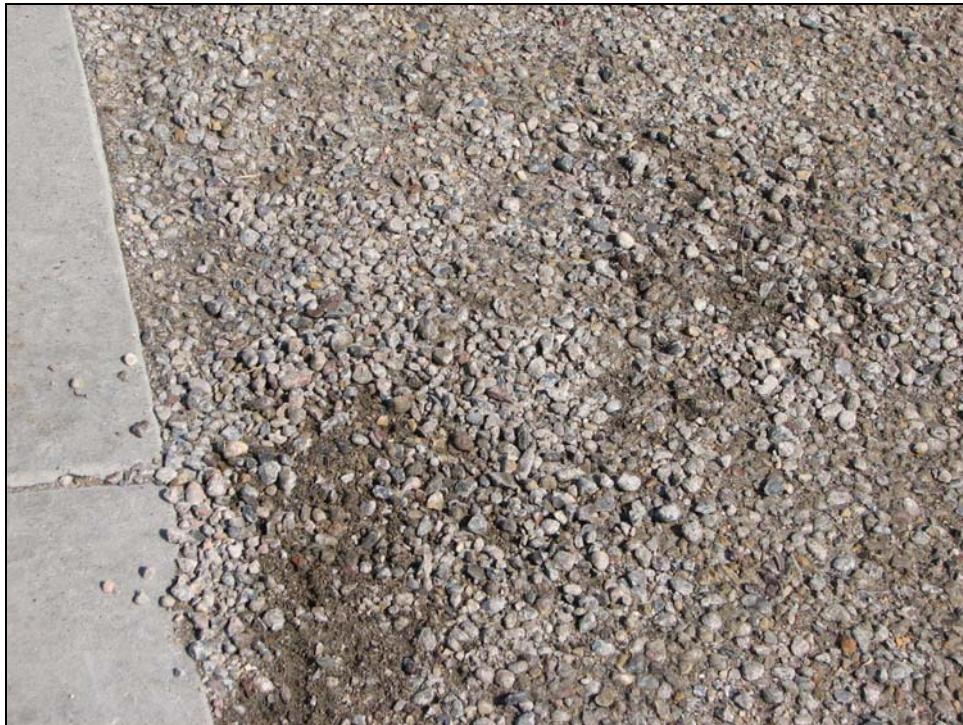
FIGURE D-8: Raveled surface material in Mix 2, 4.02.09.
