## TECHNICAL SUMMARY

# Preventing the Occurrence of Bumps in HMA Overlays

*This Technical Summary pertains to the LRRB-produced Report 2010-31, “Predicting the Occurrence of Bumps in Overlays,” published August 2010. The full report can be accessed at <http://www.lrrb.org/PDF/201031.pdf>.*

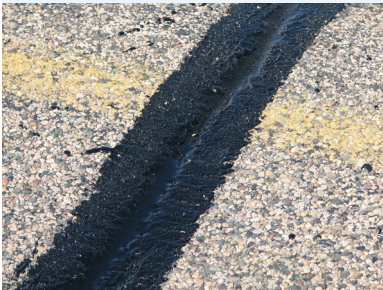
Researchers recommend avoiding sealant overbanding on the sides of cracks.

- The type of sealant used, including its stiffness or elasticity.
- Crack geometry, or reservoir structure, the depth and width to which cracks are routed before they are filled with sealant. Traditionally, enough sealant is applied to overflow the crack and create an overband, or a layer of sealant on each side.
- Construction methods, including the speed, pattern and operation of the rollers used to spread and compact the asphalt layer, and the temperature of this layer during compaction.
