Porous Asphalt Pavement Performance in Cold Regions

Minnesota
Department of
Transportation

April 2012

Research Project
Final Report 2012-12

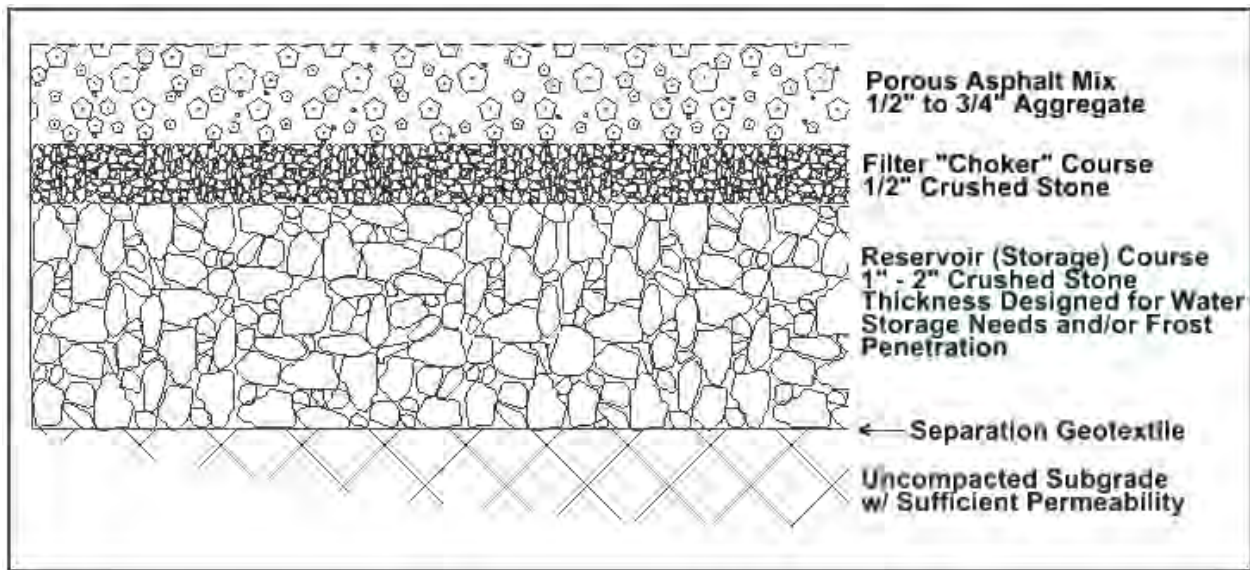
Contemporary full-depth porous asphalt [8] consists of bituminous asphalt pavement with greatly reduced fine aggregate particles (gap graded) and a relatively high (>18%) interconnected air void content. The surface permeability and high porosity allows water to pass vertically through the pavement to the base below. The base material is usually a clean, uniformly graded aggregate storage layer thick enough to allow sufficient water storage during anticipated rain events. A filter or “choker” layer of aggregate is often installed on the top of the base to provide a uniform, stable construction platform. The water in the base is stored temporarily, often allowed to infiltrate into permeable subgrade soils, and can recharge the groundwater directly or have other means of egress. All layers are usually installed without crown or slope to maximize infiltration potential. A typical full depth porous asphalt structure is shown in figure 1.1.

Figure 1.1. Typical full-depth porous asphalt pavement structure

Most PA pavement systems are composed of four layers [9]. At the bottom, a minimally compacted, adequately permeable subgrade is usually needed. Replacement of inadequate subgrade materials is usually not feasible, but disking to loosen soils may be advantageous. The reservoir base usually consists of a 1-2 inch diameter, clean, durable, crushed stone aggregate. A filter or “choker” layer of approximately two inches of ½-inch crushed stone aggregate is commonly applied at the top of the base to provide surface uniformity and stabilization for paving operations. The thickness of the base layer is normally determined based on water storage needs and frost depth considerations. A porous asphalt surface course is installed with thickness determined from bearing strength and pavement design requirements. Most parking lot installations of PA pavement are approximately 3 inches thick.

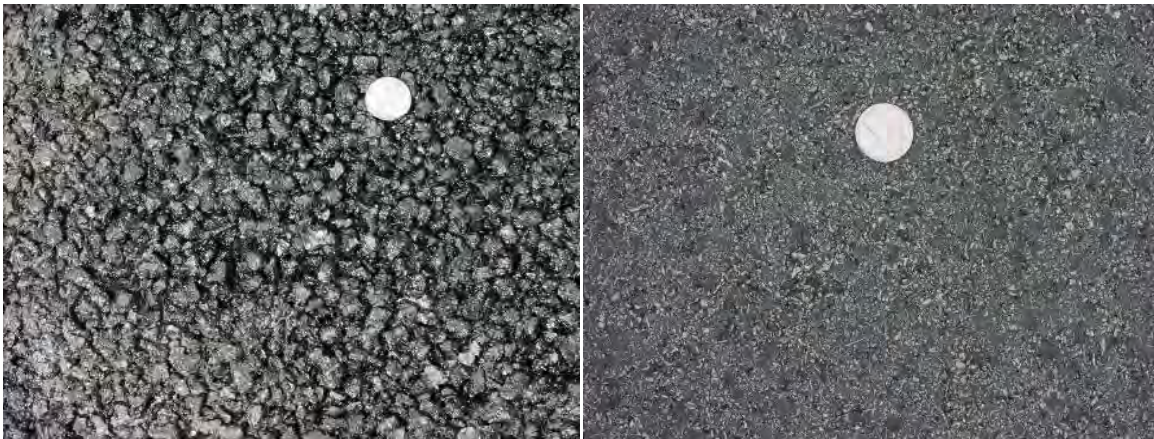
Figure 1.2. Porous asphalt surface texture versus dense graded asphalt surface texture

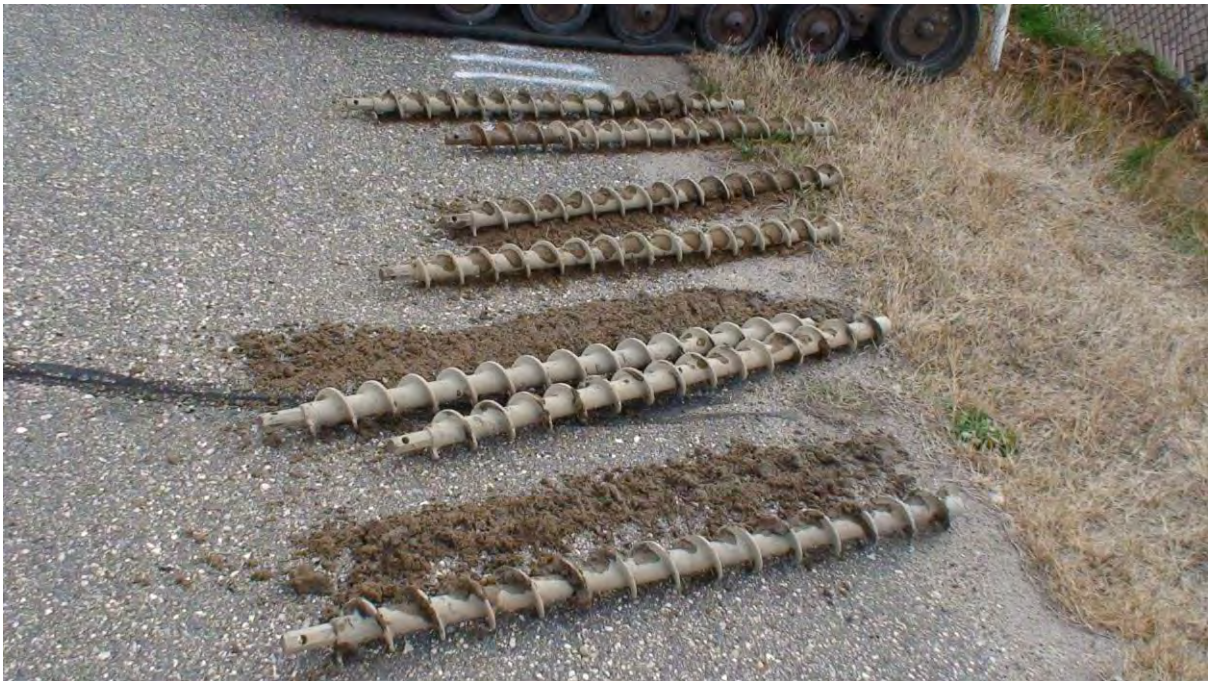
The granular saturated soils were fairly easily retrieved from the auger but the stiff clays tenaciously adhered even after auger sections were dropped on the pavement. The apparently westward sloping aquiclude was supported by the material shown in figure 1.6. It was encountered at 10 ft. in Wells #3 and #4 and at 30ft in Wells #1 and #2.

Figure 1.5. Well #2: Saturated sands at up to 30-foot depths

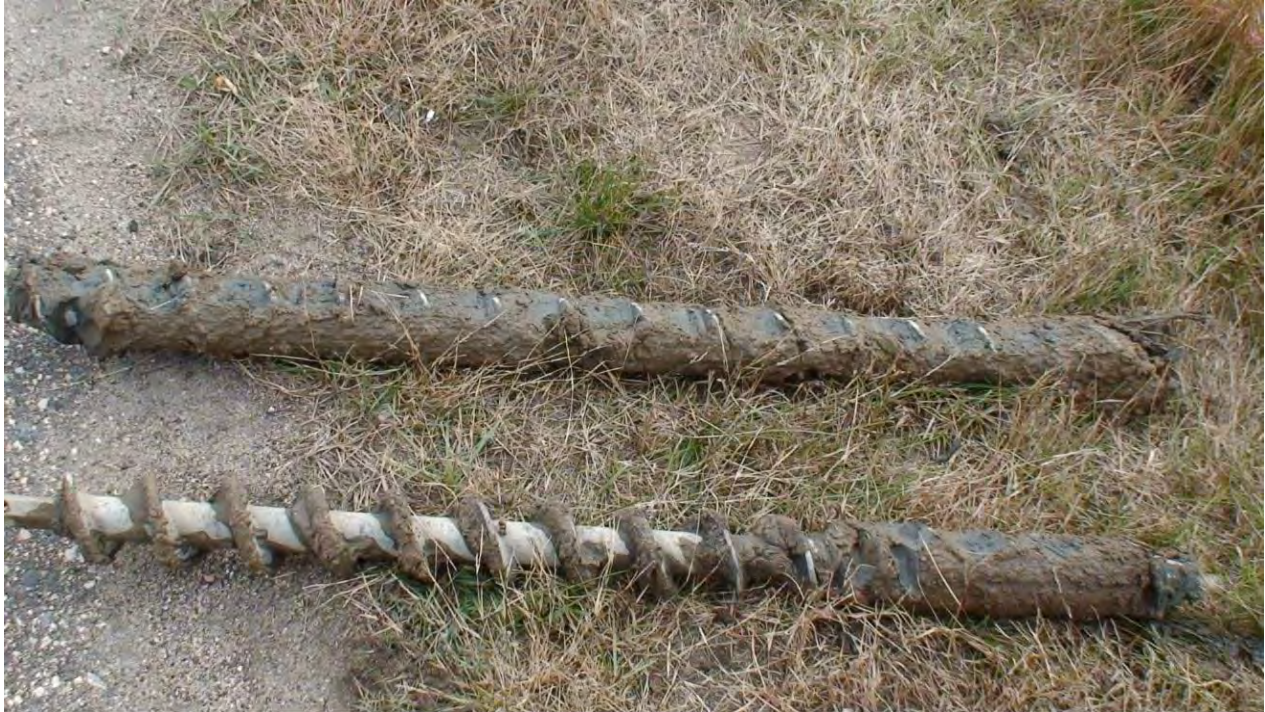
Figure 1.6. Well #2: Stiff gray clays between 32 and 36 feet

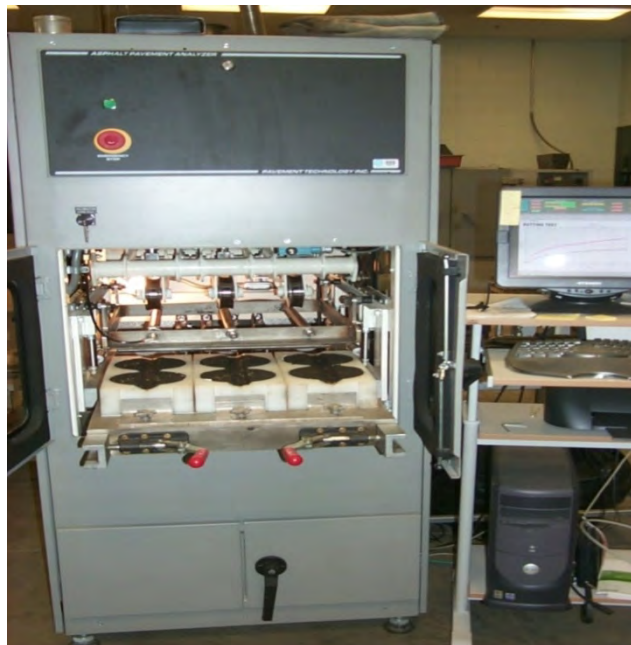
Figure 2.1. Asphalt pavement analyzer (APA) apparatus

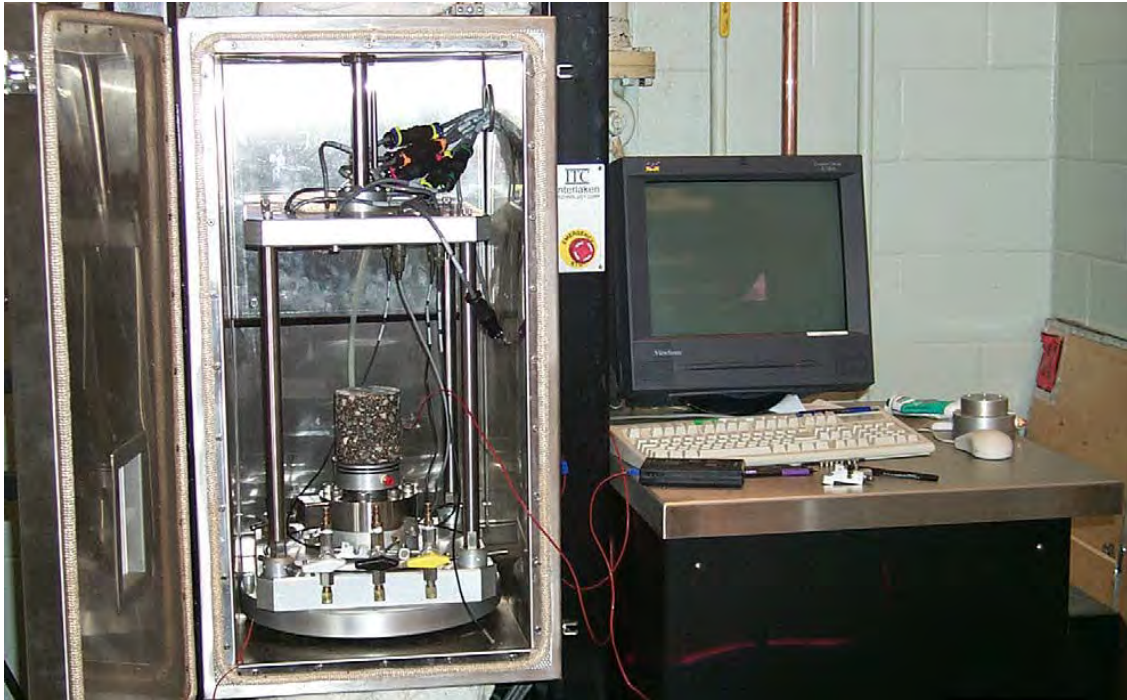
The dynamic modulus testing was performed using an Interlaken Universal Material Testing machine in accordance to the AASHTO TP62 at MnDOT's Maplewood Laboratory. The testing system is a servo-hydraulic, computer-controlled and closed-loop system, which also contains a tri-axial cell and environmental chamber (Figure 2.3).

Figure 2.3. Dynamic modulus E^* testing device

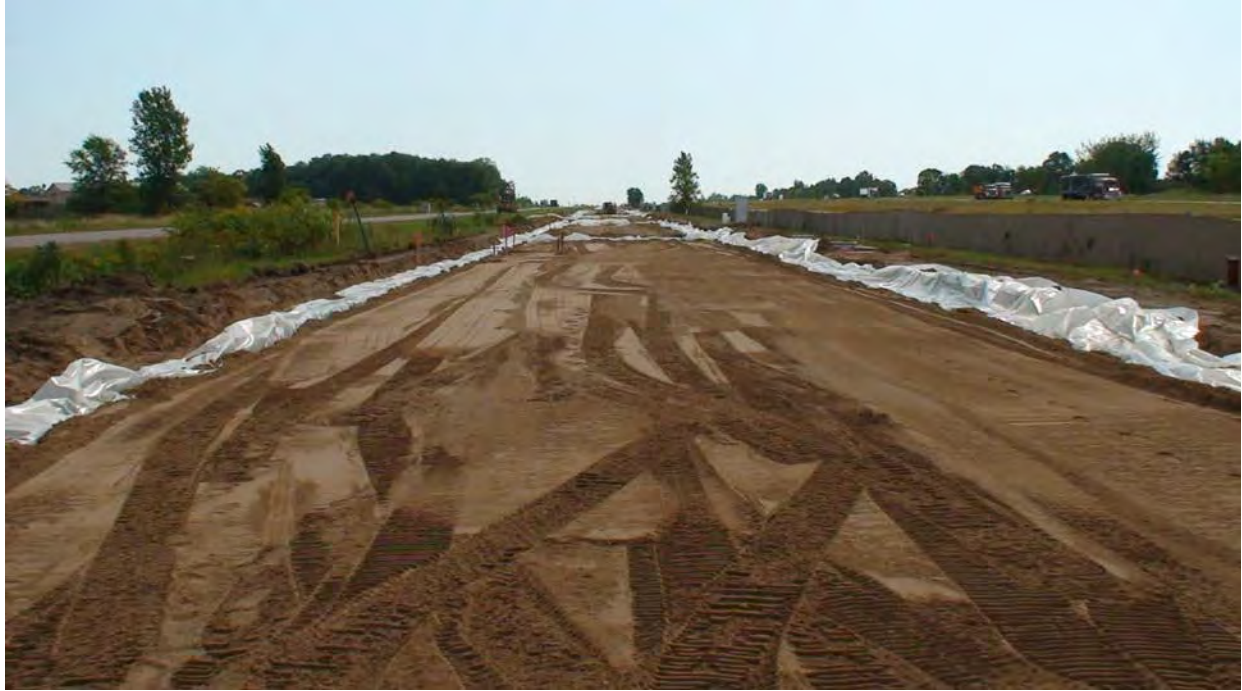
Figure 4.2. Cell 88 (clay subgrade) with plastic edge barriers installed

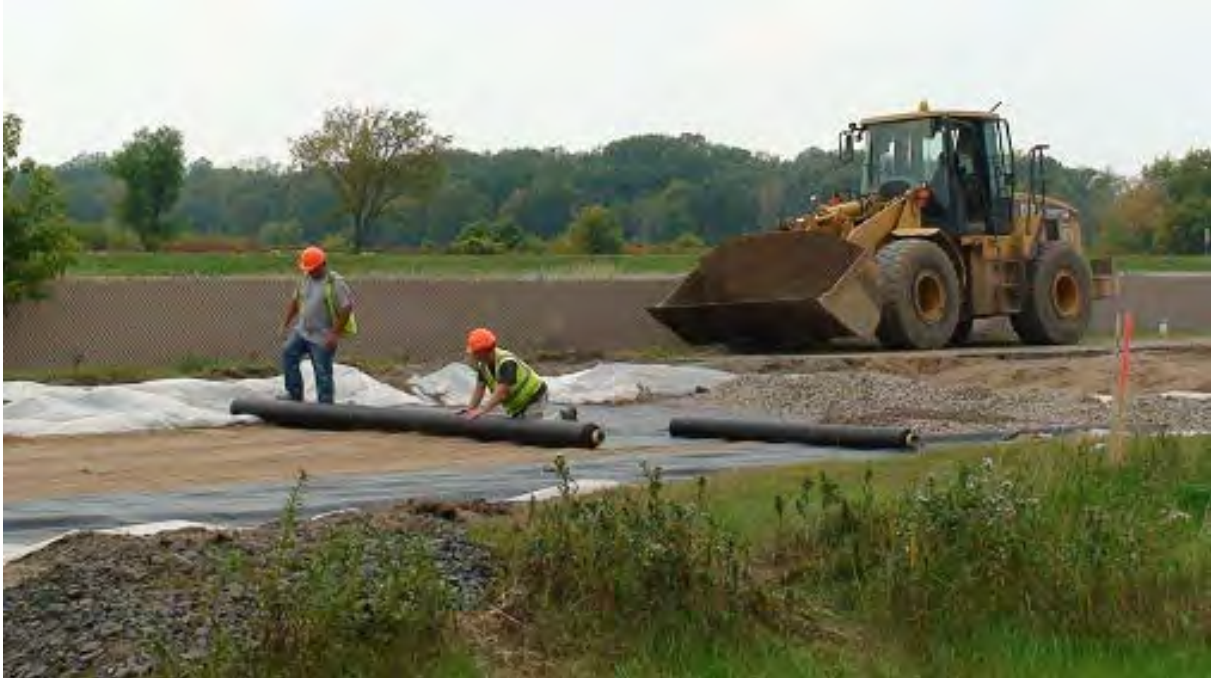
Type V Geotextile fabric was installed (figure 4.3) on top of the prepared subgrade September 15th, 2008 and placement of the planned CA-15 base material was attempted the following week (figure 4.4). The CA-15 obtained by the contractor for cells 85 through 89 demonstrated insufficient stability for supporting construction operations. After on-site attempts at blending and layering other materials, it was decided to replace the top 4 inches of CA-15 base with crushed granite railroad ballast (figure 4.5). On cell 87 the top 4 inches were replaced with crushed iron ore ballast that was leftover from the construction of cell 23. Each lift of base material was lightly rolled to set the material without significant compaction (figure 4.6). The resulting composite base provided an adequate construction platform.

Figure 4.3. Installation of type V geotextile

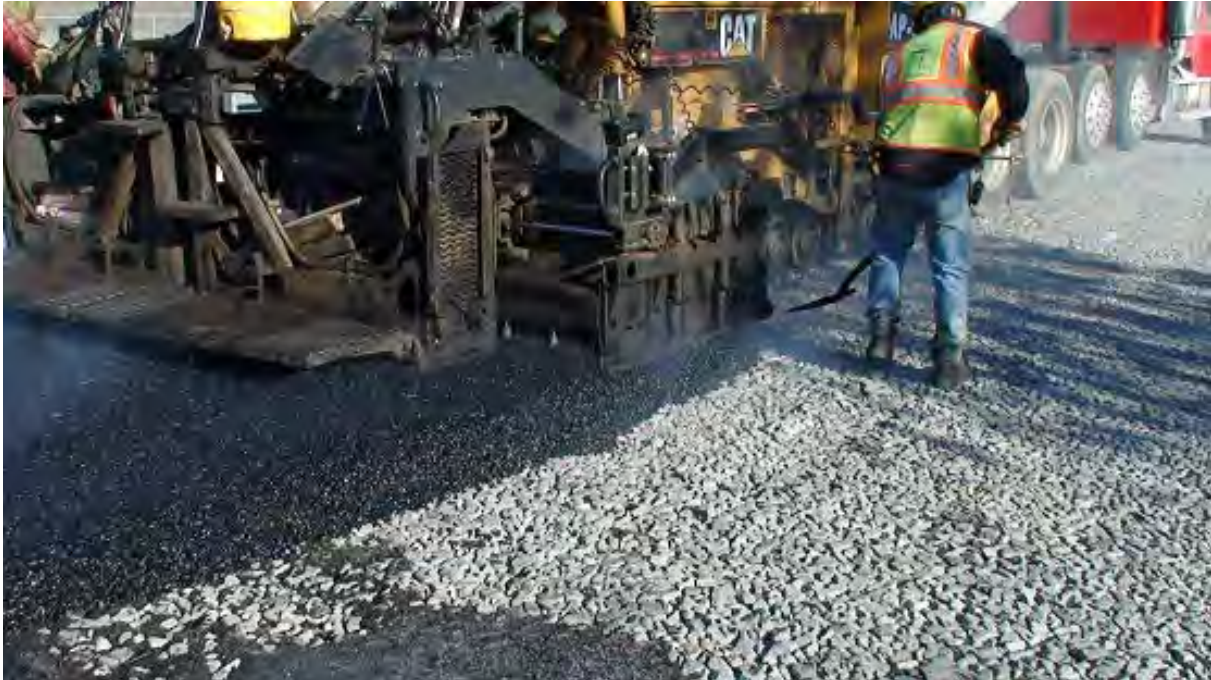
The porous asphalt was initially laid down approximately eight inches thick by the paver in order to obtain the five-inch specified final layer thickness after compaction (the average compacted thickness was later determined by coring to be approximately 6 inches.) The contractor waited about five hours until the surface temperature of the mix was below 100°F before starting the rolling (figure 4.9). Then the pavement mat was rolled once or twice to make it smooth, but no more so as to retain the desired surface porosity. After rolling the pavement appeared to have acceptable smoothness and porosity. This was a learning experience for MnDOT and contractor personnel alike.

Figure 4.8. Porous asphalt paving

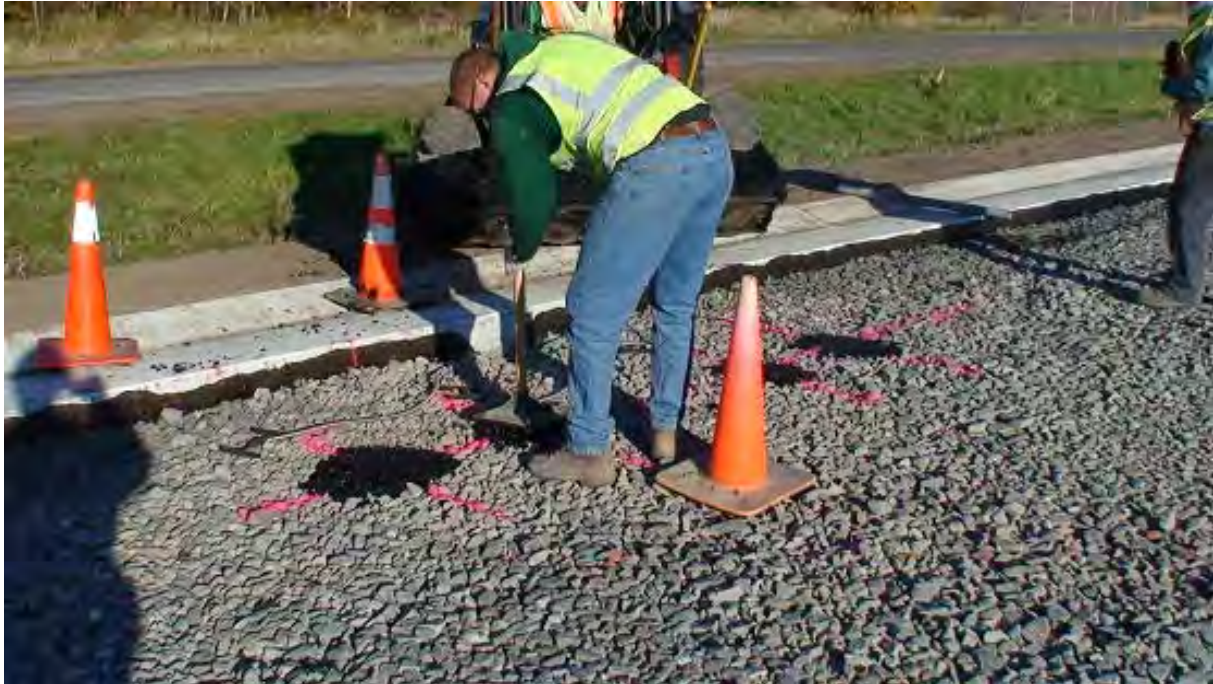
Figure 4.14. Instrumentation installations

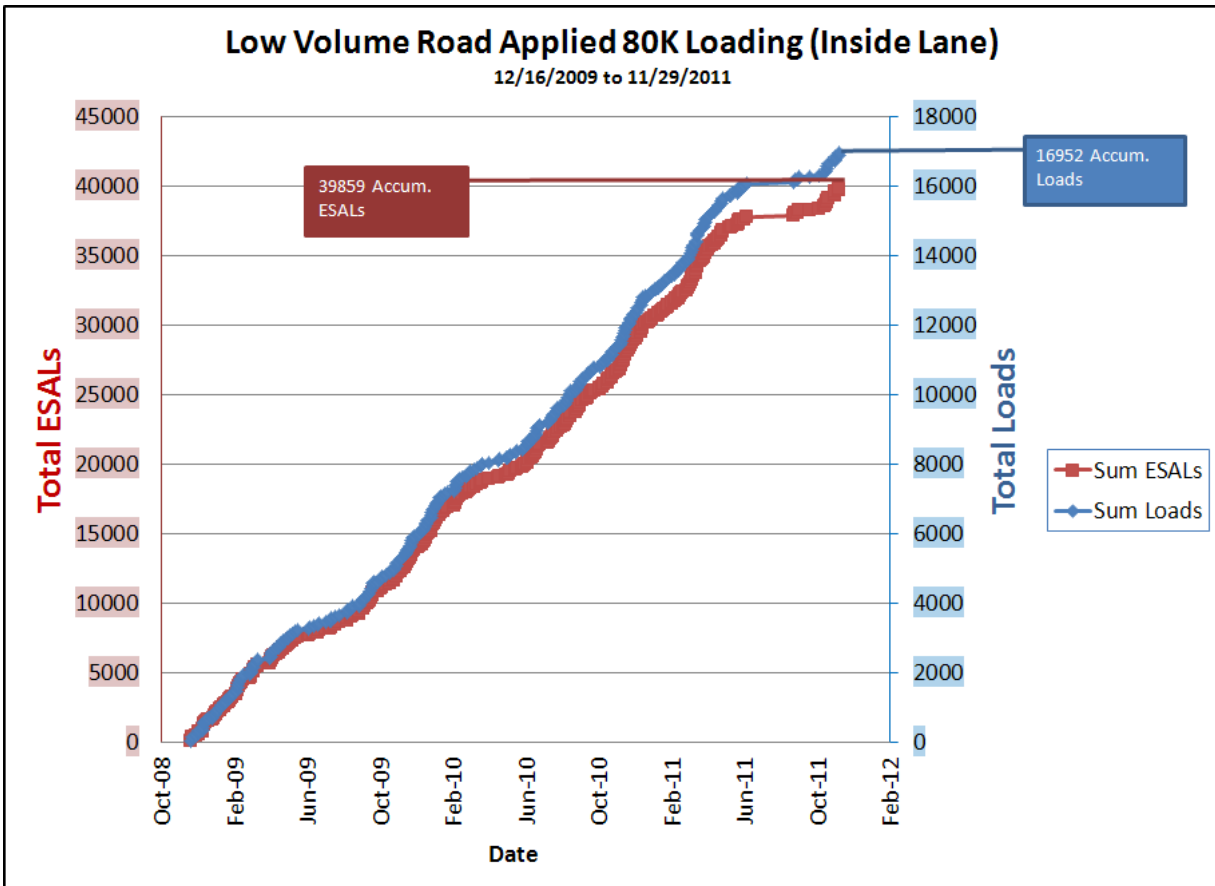
MnROAD vehicle loading of the inside (loaded) lane of the porous asphalt test cells 86/88 and “control” cell 87 began on December 16th, 2008. As of November 29th, 2011, after 3 years of operation, the inside lane of cells 86, 87, and 88 received approximately 17,000 laps of the loading vehicle, resulting in approximately 40,000 applied ESALs. The application of loading occurs fairly consistently throughout the year; however the rate may be reduced during spring and summer, when other testing and data collection is intensified on the LVR or when construction or rehabilitation projects block the inside lane (figure 5.2).

Figure 5.2. LRRB 878 3 years applied loading to LVR

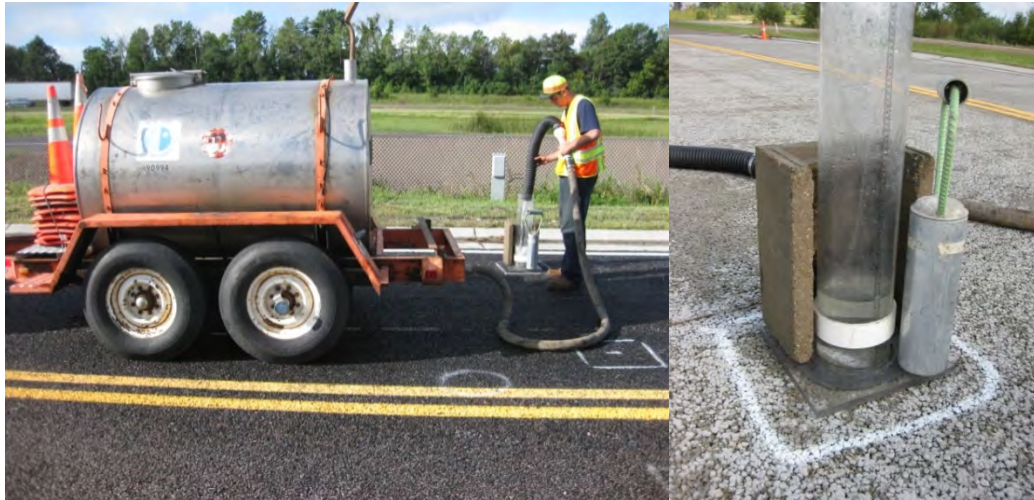
Due to the rapid rate of surface infiltration in these test sections, and the need to regularly evaluate many test points, a simple falling-head apparatus was developed at MnROAD for permeability testing (figure 5.6). The device is a clear, six-inch outside diameter, graduated cylinder. A flexible seal (electrical sealant) is applied to the bottom of the cylinder, the device is weighted to the pavement, and a stream of water is supplied through a 4-inch tube from a water trailer. The cylinder is quickly filled approximately $\frac{3}{4}$ full and the time (t) for the cylinder to empty from an initial to a final level (Δh) is recorded. The rate of flow through the pavement surface is then computed by; $Q = (A \cdot \Delta h) / t$, where the area (A) of the pavement surface tested is 167.53 cm^2 (the inside area of the tube). This test is not used to compute a measure of pavement porosity due to the difficulty of modeling the highly variable water flow through the 3 dimensional pavement pore structure. But it is a convenient and repeatable method of monitoring changes in the volume of water permeating through the surface of the pavement over time.

Figure 5.6. MnROAD permeability testing apparatus

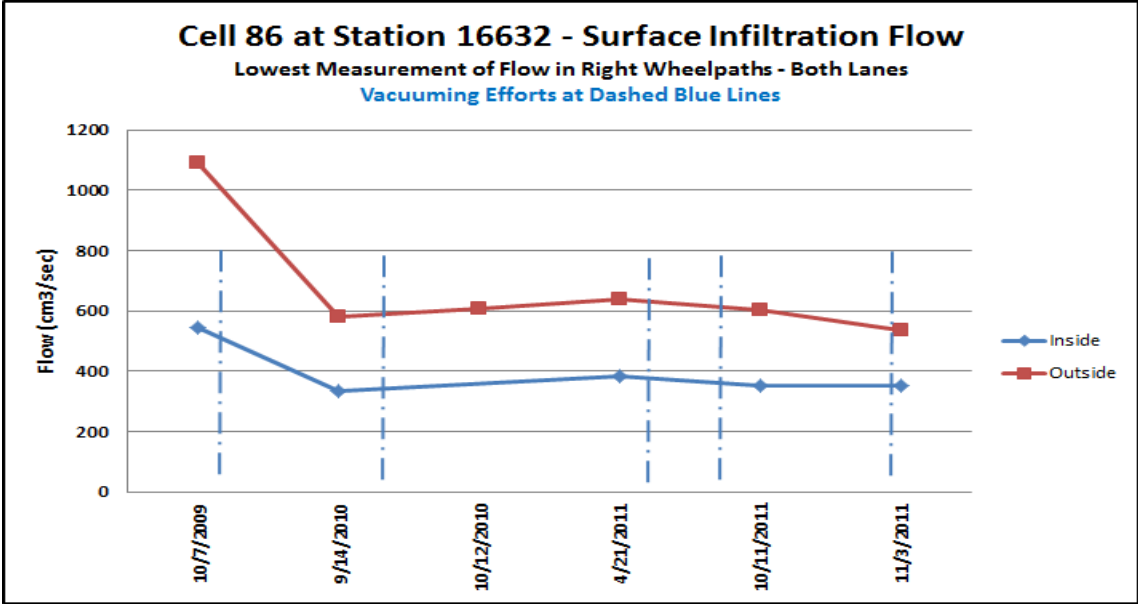
Figure 5.7. Cell 86 surface infiltration flow at station 16632

Rapid clogging on the test sections was not expected due to them having isolation from normal mixed vehicle traffic, no application of deicing sand, and minimal adjacent vegetation or loose soils. However, the most of the sections of the cells have experienced some clogging as of fall 2011, and the clogging seems to be progressing at a fairly constant rate. The cause of the permeability loss is not known at this time. It may be at least partially due to raveled surface particles embedded in the voids. However, the outside lane of cell 86 has also clogged somewhat, indicating that the clogging process is not directly related to the loading process. It should be noted that the current lowest measured flow [1.5cm/sec (0.6 in/sec) in the 6-inch tube] is still much more than adequate to absorb the largest expected rate of any single rain event at MnROAD.

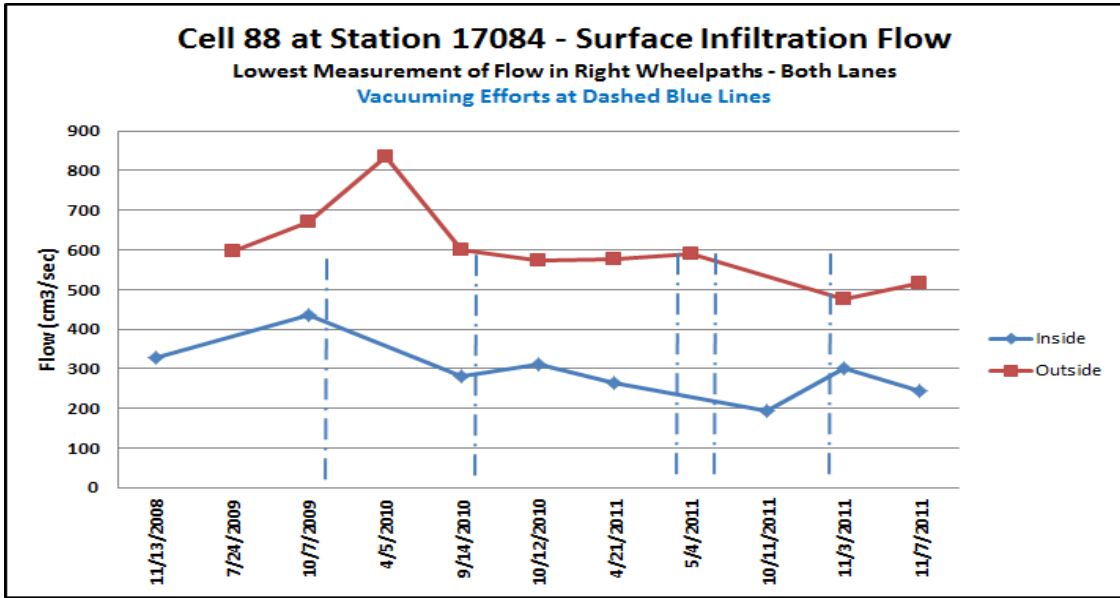
Figure 5.8. Cell 88 surface infiltration flow at station 17084

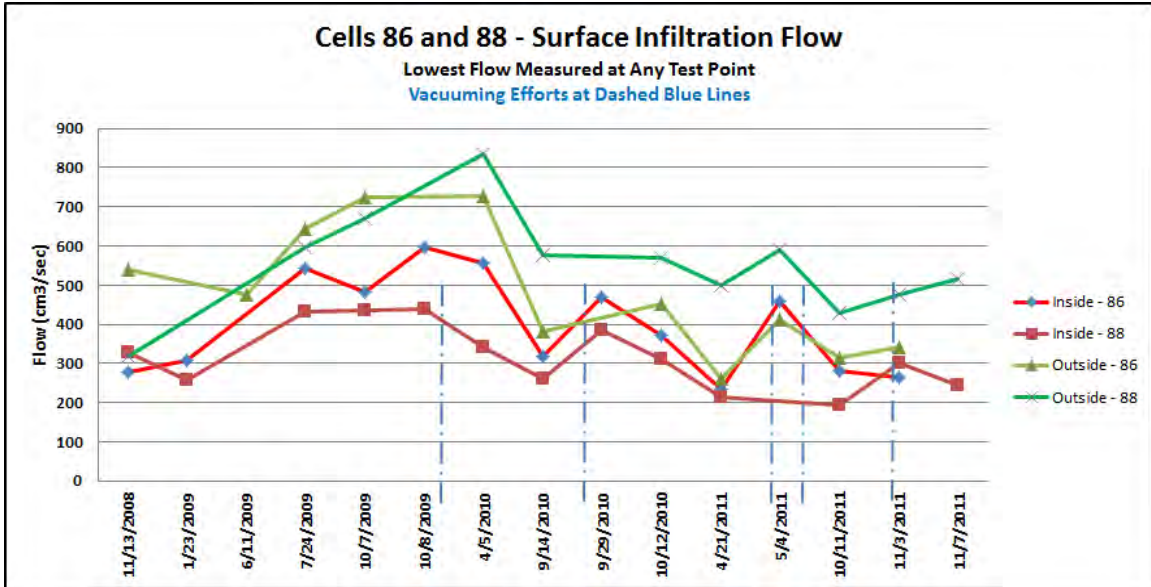
Figure 5.9. Cells 86 and 88 lowest measured flow at any test point

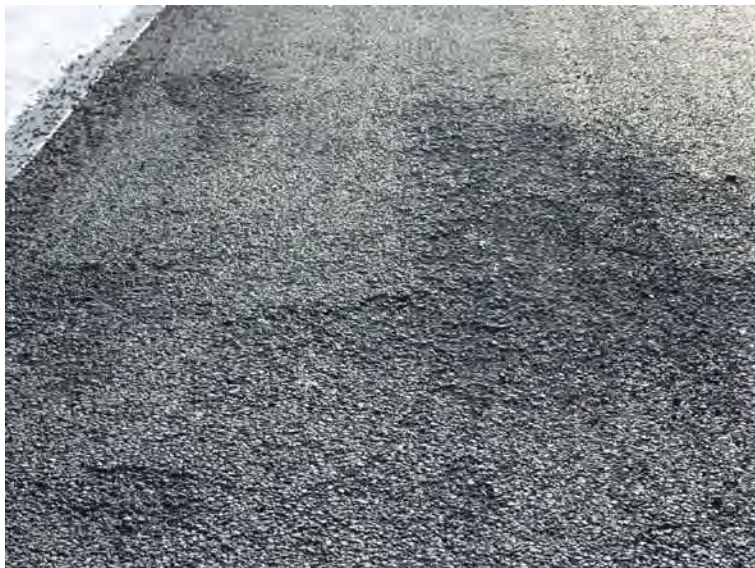
In early 2009, minor surface raveling was observed on the loaded lane of the porous asphalt test sections. The raveling first appeared in “patches” regularly spaced along the loaded lane of the test sections and was recorded within the initial visual distress survey in January 2009. A photo showing the raveled cell 88 porous asphalt surface in 2009 is shown in figure 5.10. The results of the most recent (October 2011) visual distress survey completed on the porous test cells are attached in Appendix N.

Figure 5.10. Surface raveling, cell 88

- Pavement deterioration in the form of raveling (first observed soon after construction) has progressed steadily, but affects only the top 1 inch (or less) of the pavement. Initial raveling appeared to be related to mixture temperature segregation; possibly caused by the long wait time to begin rolling the relatively thick pavement in low ambient temperatures.

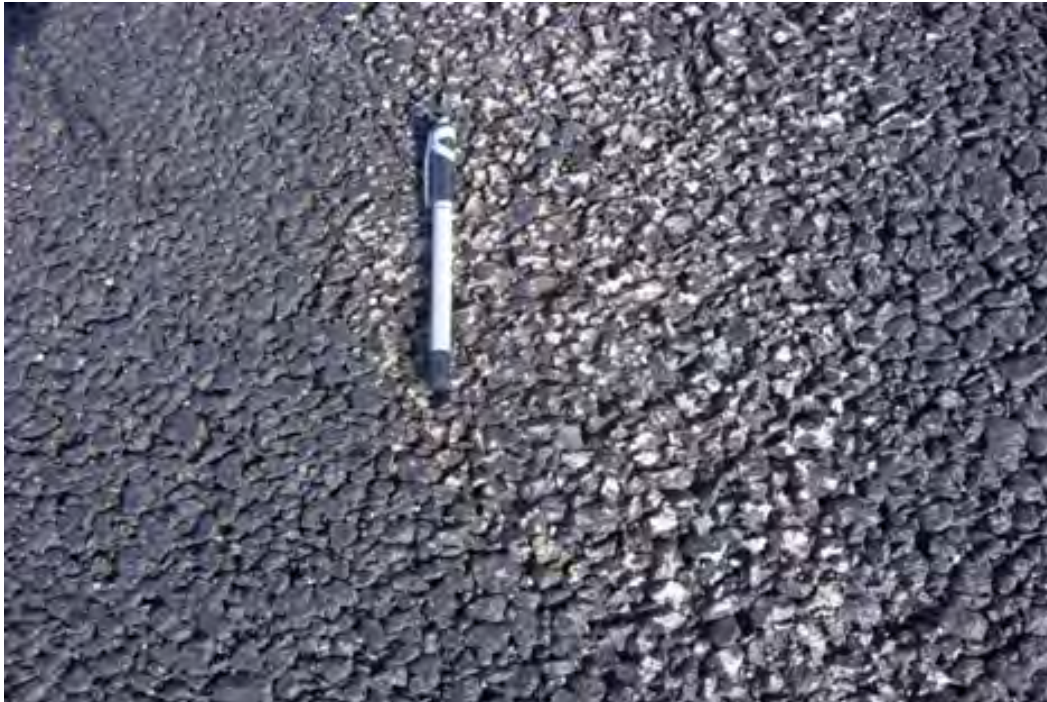
As of fall 2011, no longitudinal or transverse cracking has been observed anywhere on the porous asphalt test cells. Other than minor raveling and very minor snowplow wear (figure 5.11), no distress is visible in the unloaded (environmental) lane of the porous asphalt test cells. Except for minor surface wear in the loaded wheelpaths, the standard HMA asphalt pavement “control” cell 87 has also not developed any visible cracking, raveling or other distresses to date.

Figure 5.11. Minor snowplow scuffing, cell 86

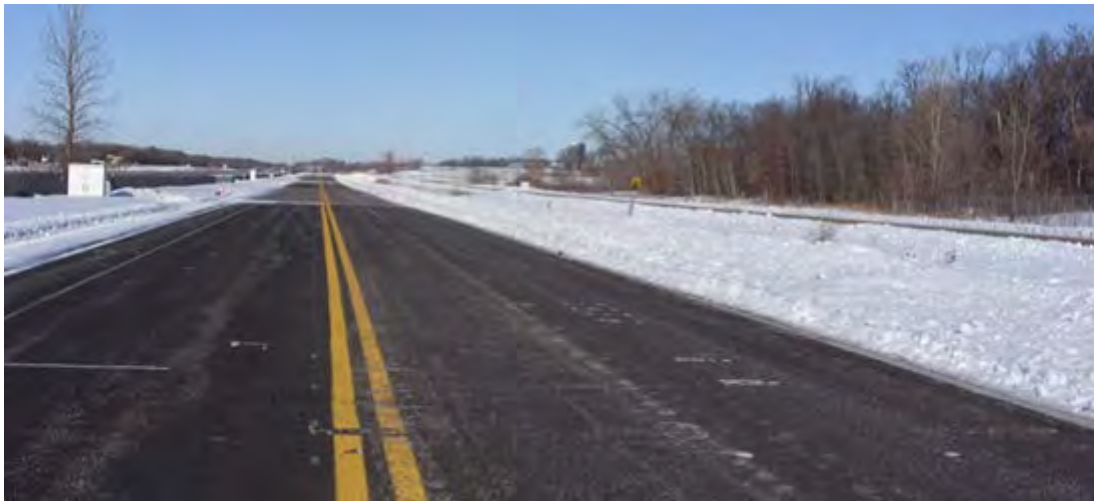
Some rutting is expected given the severity of loading applied to the test sections. Rutting is visible in the wheelpaths of the inside (loaded) lane of each cell, but less so on cell 87. On all cells 86-88, the rutting process appears to be more complicated than what is often observed on a standard dense graded pavement. Figure 5.12 shows the surface of cell 88 (inside lane on the right) in October 2010, with control cell 87 in the background. The porous pavement rutting has been monitored at MnROAD using two different automated methods; “Pathways” Vans and Automated Laser Profiling System (ALPS).

Figure 5.12. Porous cell 88, October 2010

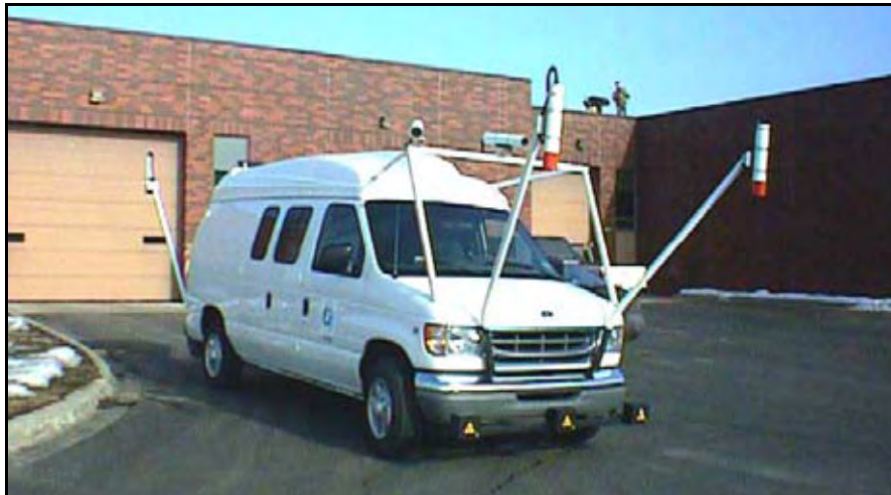
Rutting is measured with the MnDOT Pathways vehicles, by the procedures of ASTM E-950. This vehicle was replaced in 2011 as part of a normal equipment upgrade. The two vans use a similar (but slightly different) laser testing process and the results are usually consistent. [figure 5.13 (old van) and figure 5.14 (new van)]

Figure 5.13. Pathways surface evaluation device, 2009–2010

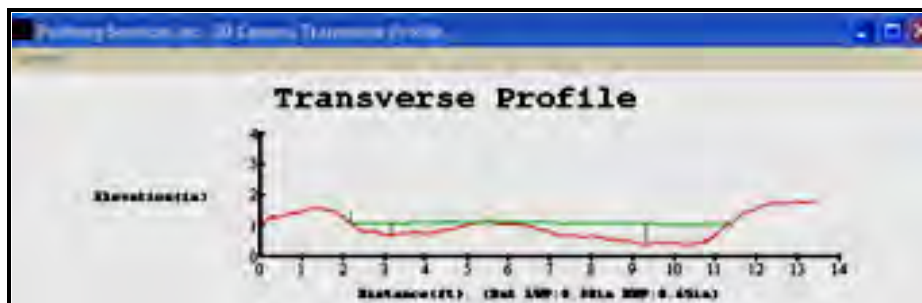
Permanent deformation of bituminous pavements usually increases faster during the warmest periods but usually doesn't decline, so a more thorough analysis of the rutting measurements was indicated. The spring and fall measured cross slopes of the surfaces of cells 86-88 were extracted from the Pathways data for comparison. Figures 5.16 and 5.17 show the transverse profile of the same station on cell 88 in spring and fall 2011. The cross slope data shows that the pavements (of all three cells) are experiencing seasonal vertical distortion. The cause could be a combination of the heavy vehicle loading, movement of the open graded base material, and seasonal (frost/moisture) influences. The measured rutting decreased at this location in the fall and the lane profile also changed noticeably. These images also show how the Pathways measurement is made; rutting is measured in the wheelpaths, from a theoretical horizontal line. A pavement experiencing distortion across the entire lane could fall outside normal testing parameters.

Figure 5.16. Cell 88 spring 2011 transverse surface profile

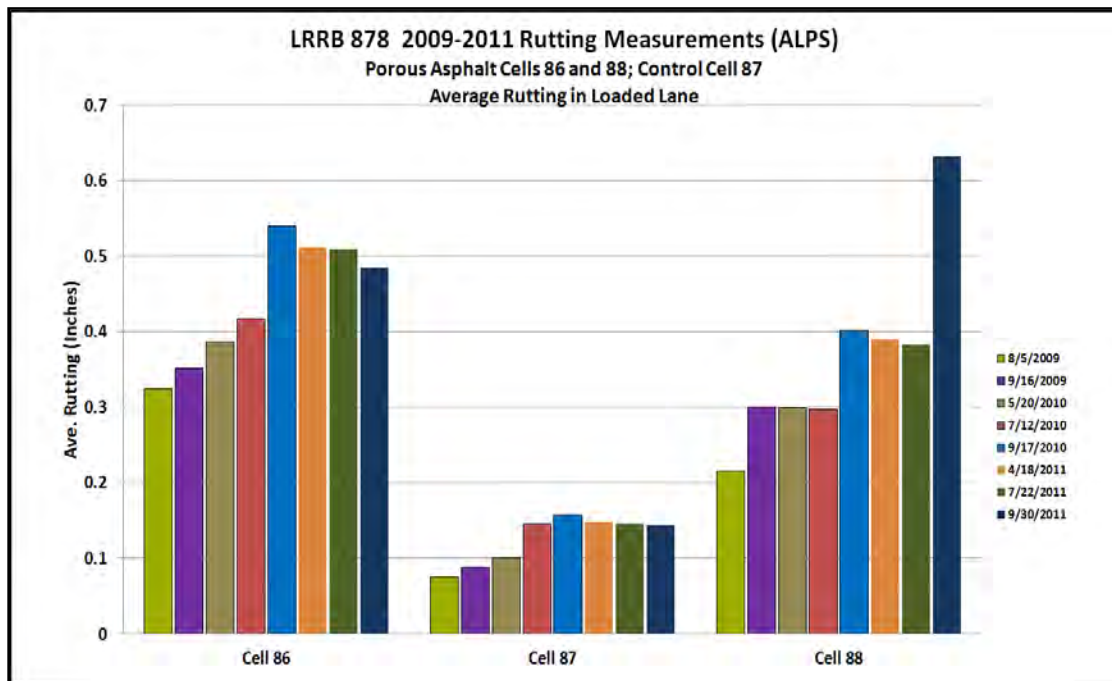
Figure 5.19. Rutting measurements (ALPS)

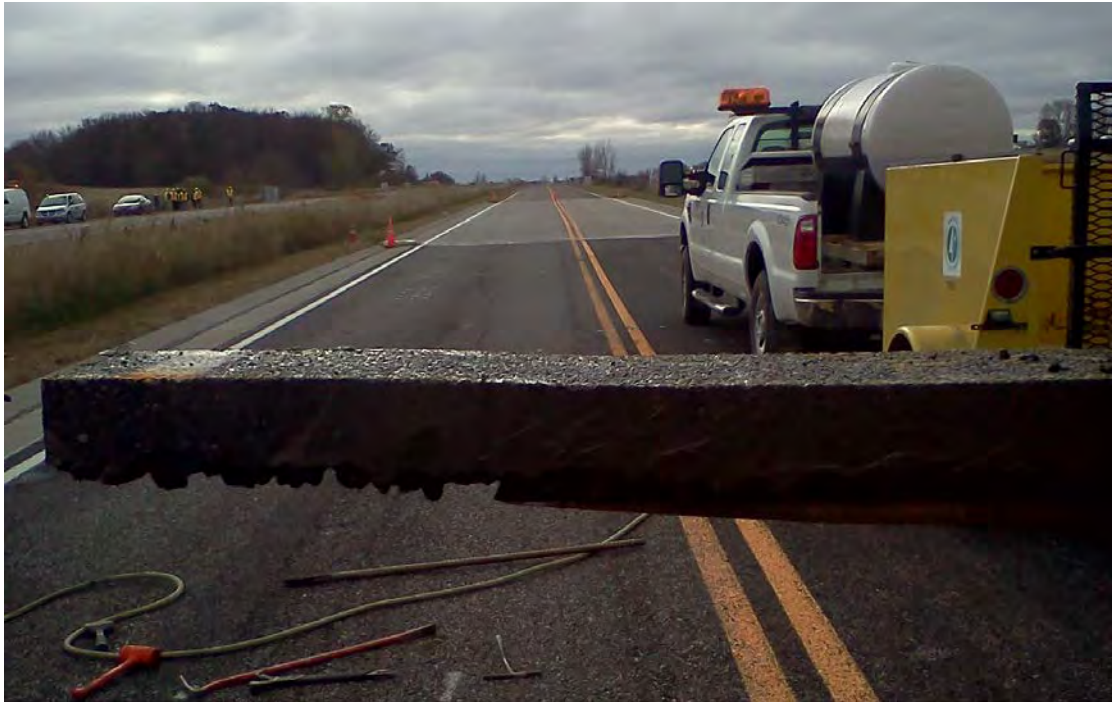
Figure 5.20. Forensic pavement section removed

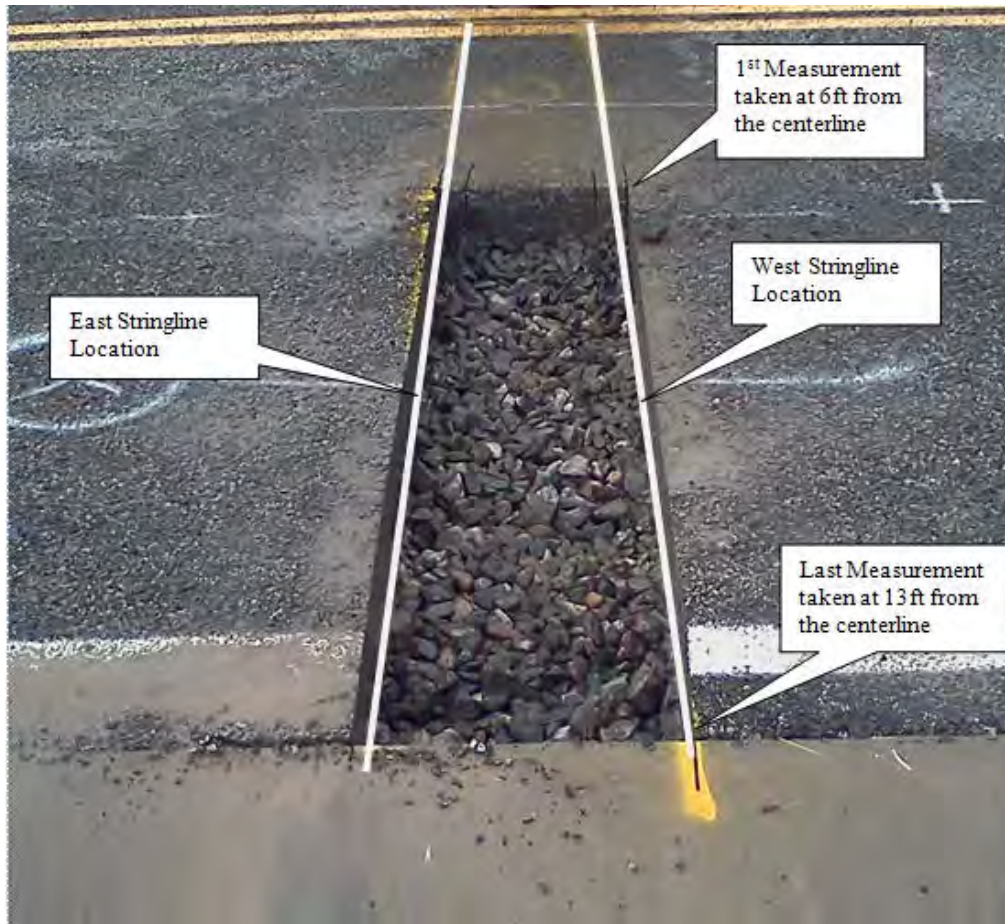
It appears from the data that the entire transverse profile of the lane has settled approximately 1 inch at the center of lane – and is probably negatively influencing the automated rutting measurements. The pavement cross-slope appeared flat after construction; however detailed elevation measurements were not made or tracked on the porous cells. It should be noted that the porous pavement appears to have sufficient flexibility to accommodate the distortion without cracking. The distortion does not appear to be caused primarily by pavement shoving. The cause of the settlement cannot be ascertained without the complete removal of the pavement and base material, which is not immediately planned.

Figure 5.21. Pavement forensic evaluation method

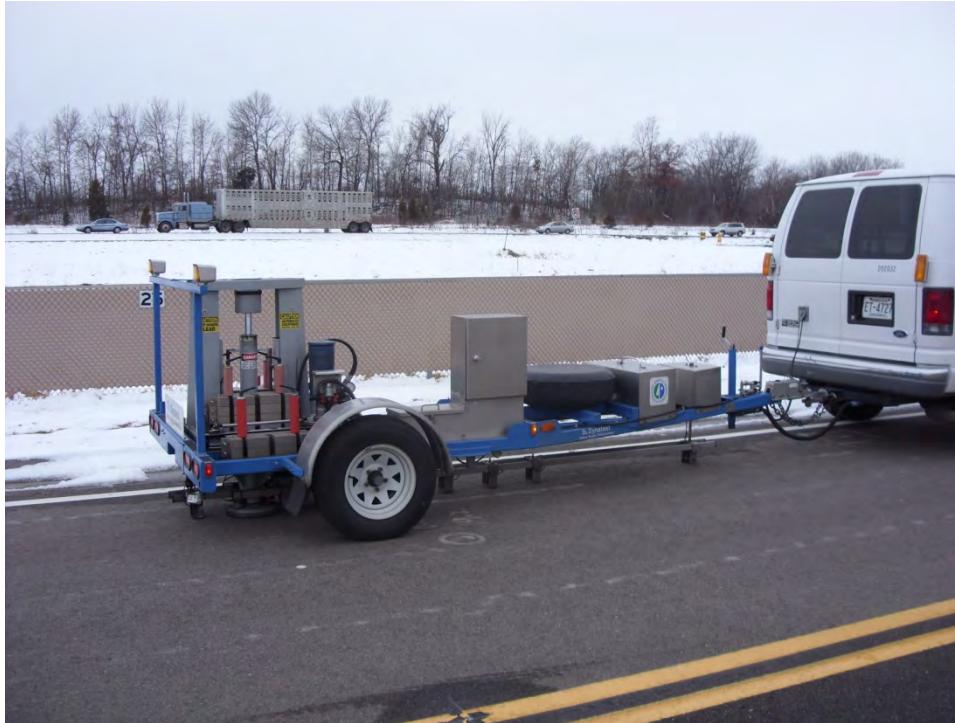
Falling Weight Deflectometer (FWD) data was collected on cells 86 through 88 on multiple dates in 2009 through 2011. Testing is not always performed on the same day for all three cells due to staffing and equipment requirements, but an effort is made to regularly test all cells to monitor seasonal changes in stiffness. The data was collected during the spring, summer, and fall of 2009, 2010, and 2011. This allowed for the calculation of layer moduli values over wide ranges of subsurface moisture and pavement temperature. These two variables have a major influence on the stiffness of the unbound (base & subgrade) and bound (asphalt) materials. A trailer mounted FWD testing vehicle used at MnROAD is shown in figure 5.26.

Figure 5.26. MnDOT FWD testing vehicle

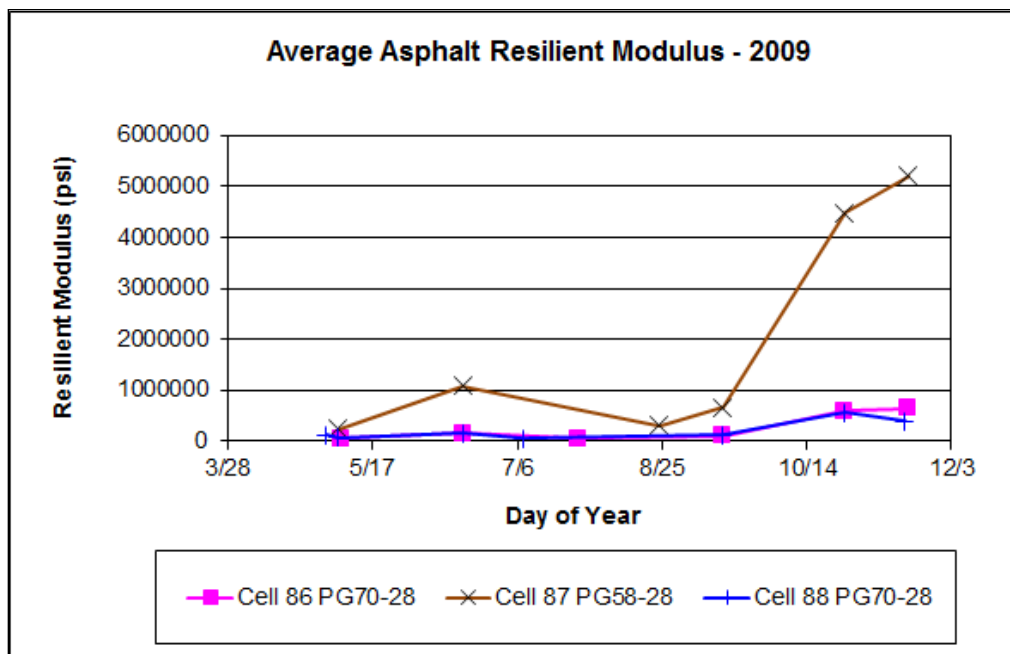
Figure 5.27. Average back-calculated asphalt pavement resilient moduli, 2009

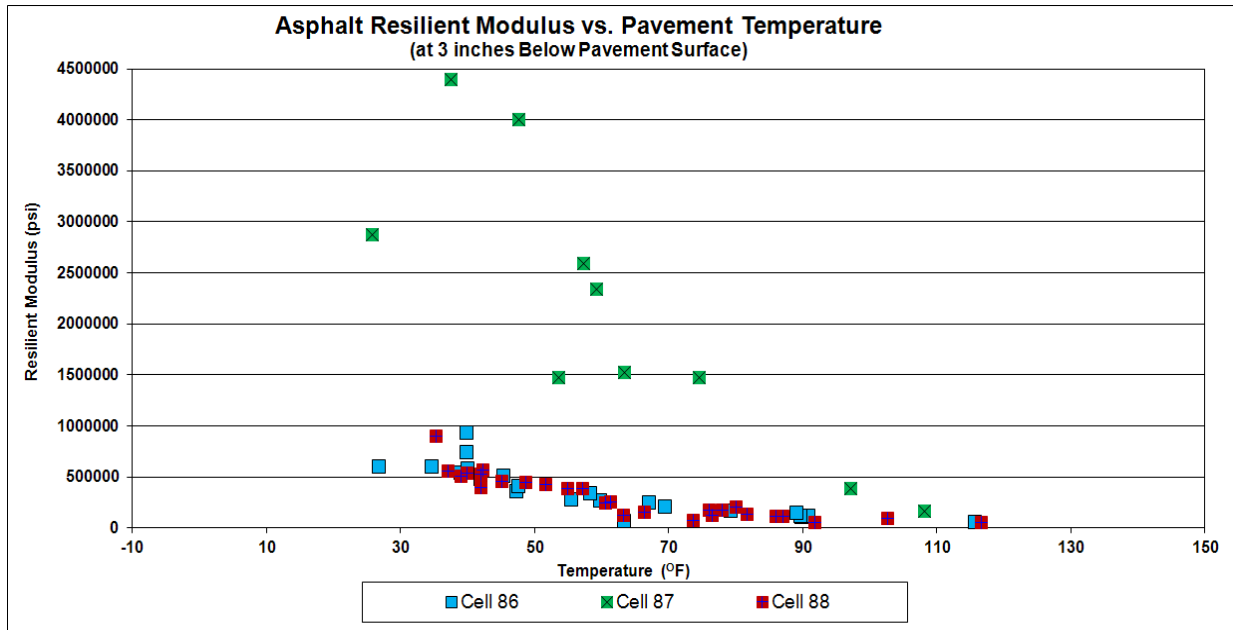
The moduli of both the porous asphalt cells and cell 87 are charted versus temperature at mid-depth in figure 5.30. It can be observed that the porous asphalt moduli seem to have a more direct relationship to internal pavement temperatures than the cell 87 pavement. Although the overall stiffness of the porous asphalt is markedly lower, it apparently has been adequate to support the extensive loading without extreme deformation. Additionally, the reduced stiffness of the porous pavement is probably an important factor in the lack of cracking observed to-date.

Figure 5.30. Porous asphalt resilient moduli versus temperature 2009-2011

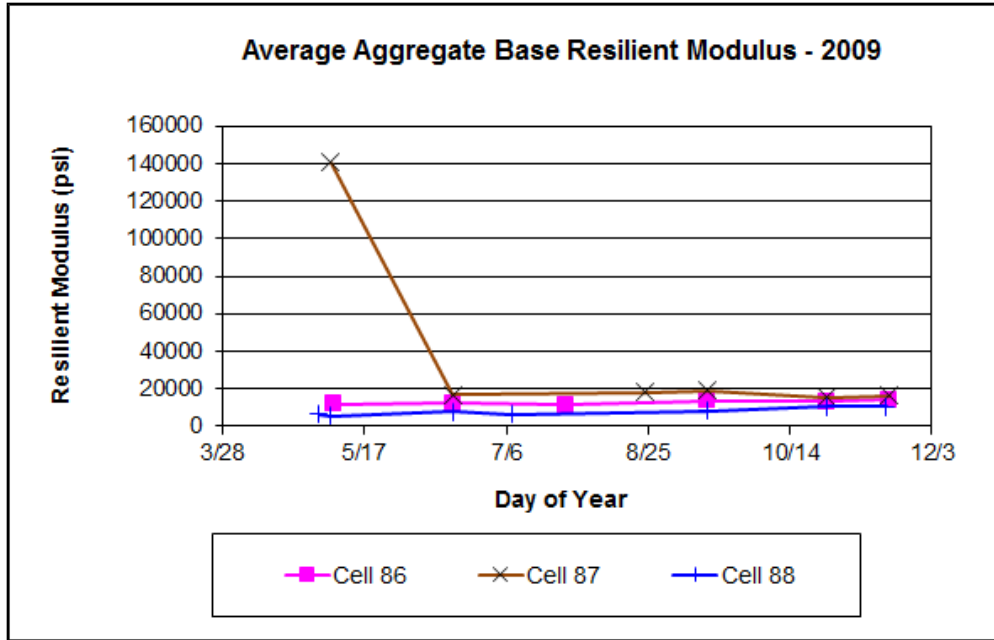
An analysis of the base material moduli (figures 5.31 through 5.33) indicates that the base in cell 88 (above the clay subgrade) has consistently less stiffness than in cell 86 (above the sand subgrade). As the pavement and base materials are identical in cells 86 and 88, the data suggests that the clay subgrade is having a negative effect on the base stiffness. This could be caused by less effective drainage in cell 88; also, the moisture in the base could remain higher, and for longer periods after rain events. It is also possible the clay particles may be clogging the geotextile fabric at the bottom of the base, and the clay could be providing less support to the bottom of the base. The data suggests additional forensic testing may be beneficial after the project is complete.

Figure 5.31. Average back-calculated base resilient moduli, 2009
