Porous Asphalt Pavement Performance in Cold Regions

Minnesota
Department of
Transportation

April 2012

Research Project
Final Report 2012-12

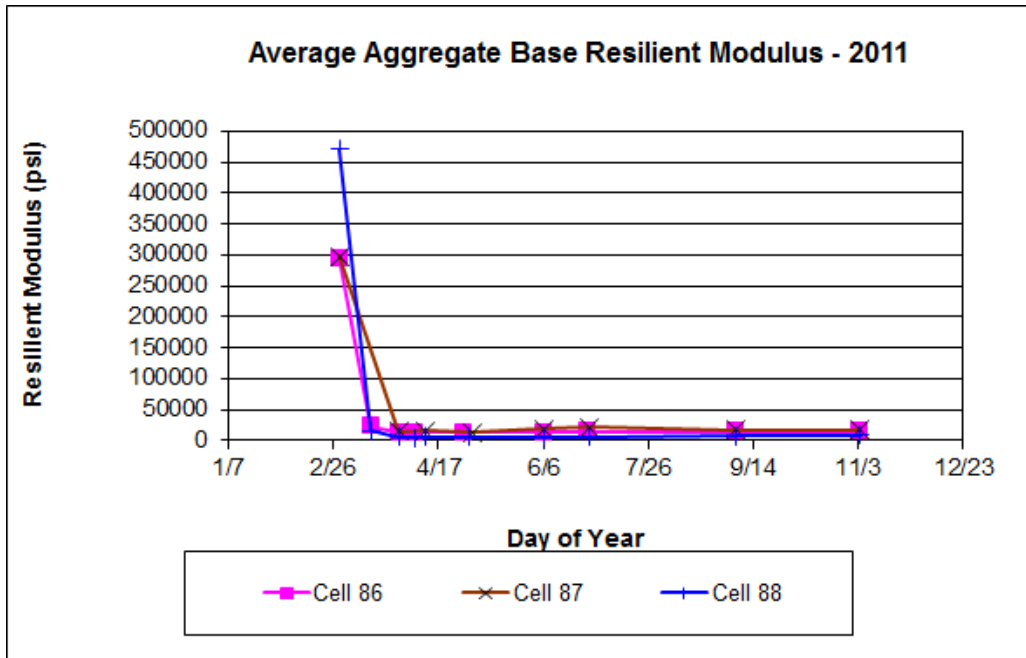
Figure 5.33. Average back-calculated base resilient moduli, 2011

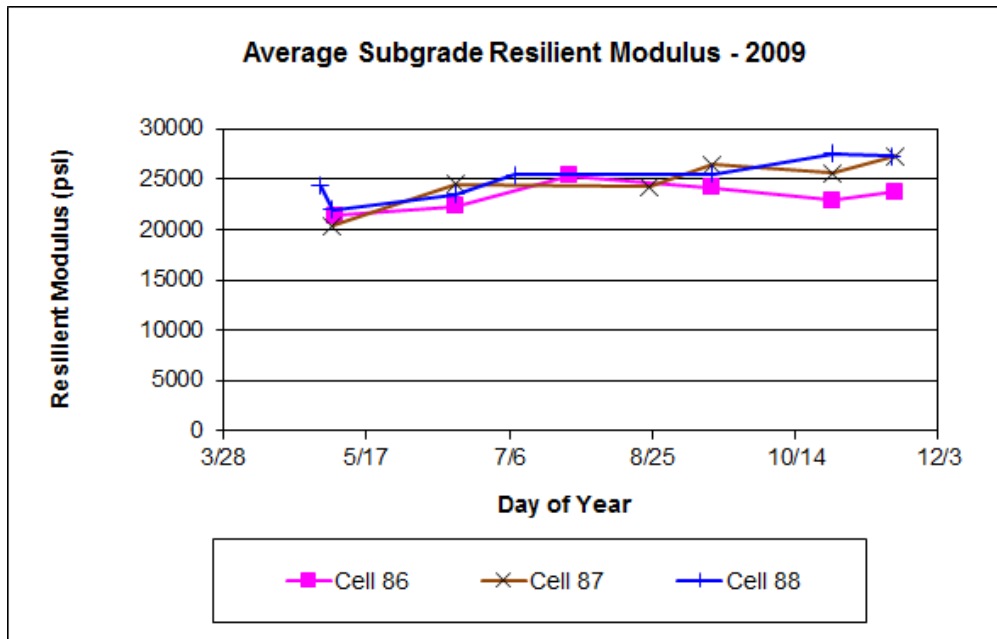
The subgrade modulus data appears generally as expected (figures 5.34 through 5.35). The sand subgrade in cell 86 is similar in stiffness to the clay in spring and summer. The clay subgrade gains higher stiffness in late fall and winter, when the clay would benefit more from the drier conditions, and, if frozen, solidify better than sand. As expected, the subgrade stiffness in cell 87, which is the subgrade transition area from sand to clay, generally falls in a range between cells 86 and 88, but has exceeded them at times – possibly due to being dryer.

Figure 5.34. Average back-calculated subgrade resilient moduli, 2009

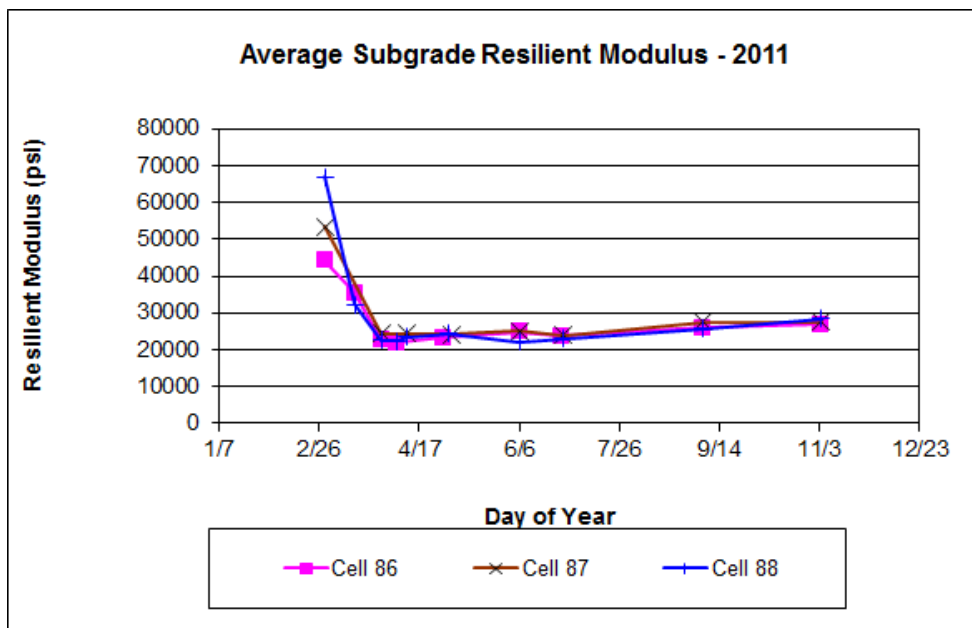
Figure 5.36. Average back-calculated subgrade resilient moduli, 2011

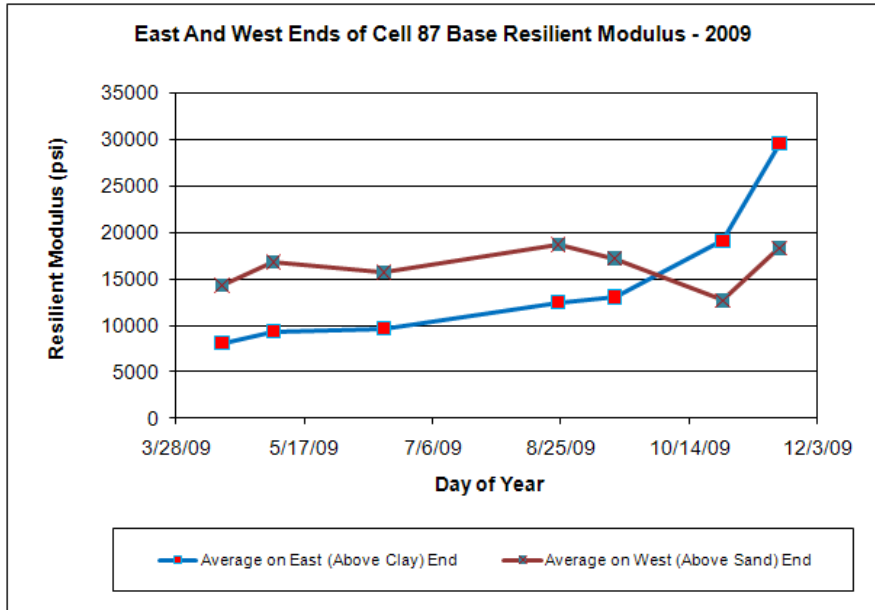
The base and subgrade moduli at both ends of cell 87 were graphed (figures 5.37 and 5.38) in order to corroborate the results. Cell 87 does not experience the effects of water filtering through the porous pavement, and has similar, although slightly higher, base and subgrade stiffness values. The data confirms that the base material above the clay remains considerably less stiff, except in cooler, drier periods. More detailed FWD backcalculation results, for each cell and each lane, are contained in Appendix P.

Figure 5.37. Cell 87 base resilient moduli at cell ends

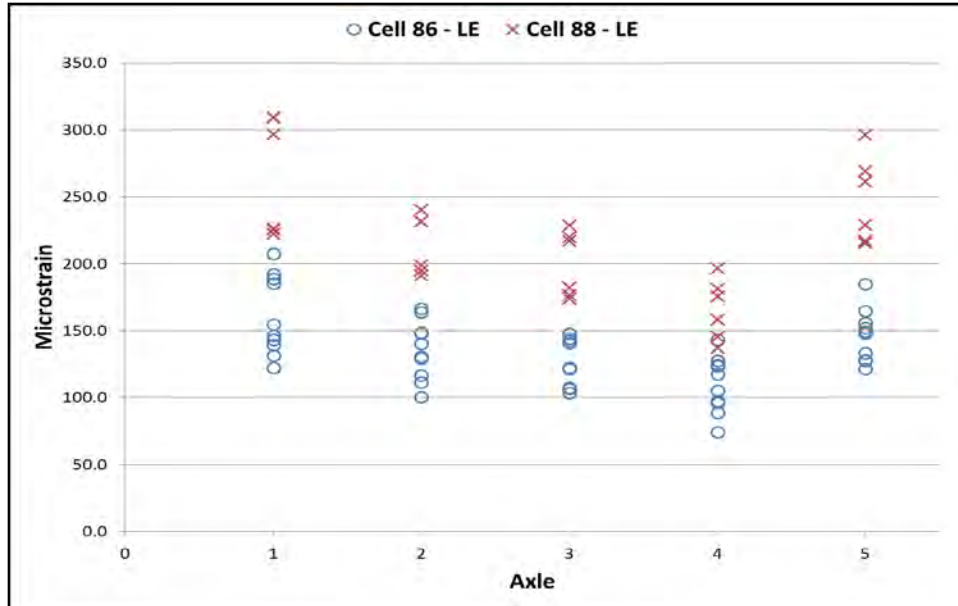
Figure 5.40. Longitudinal strain response in cells 86 and 88, low speed testing

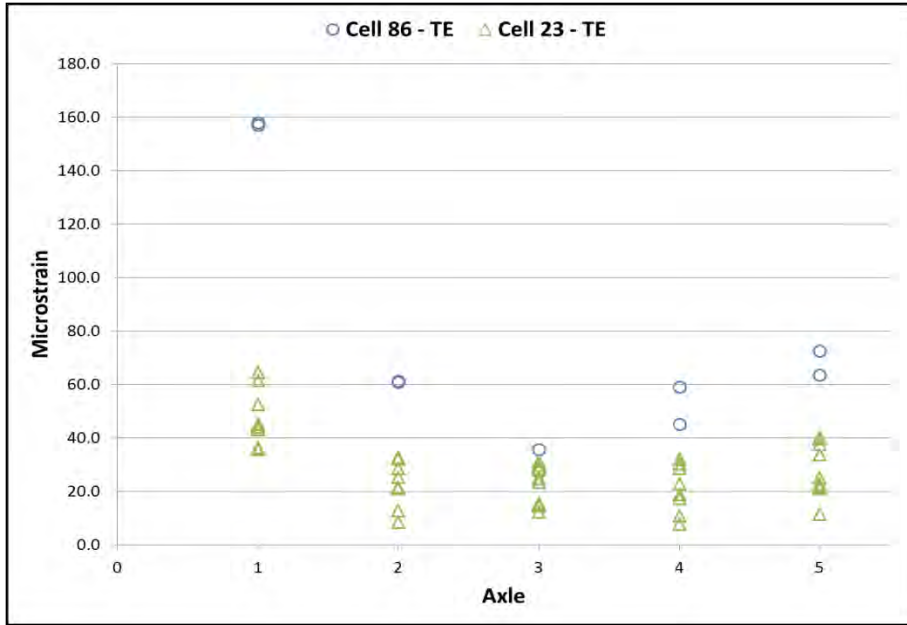
Transverse strain measurements from cell 23 and 86 (cell 88 transverse sensors were not functioning) are presented in figures 5.41 (high speed) and 5.42 (low speed).

Figure 5.41. Transverse strain response in cells 23 and 86, high speed testing

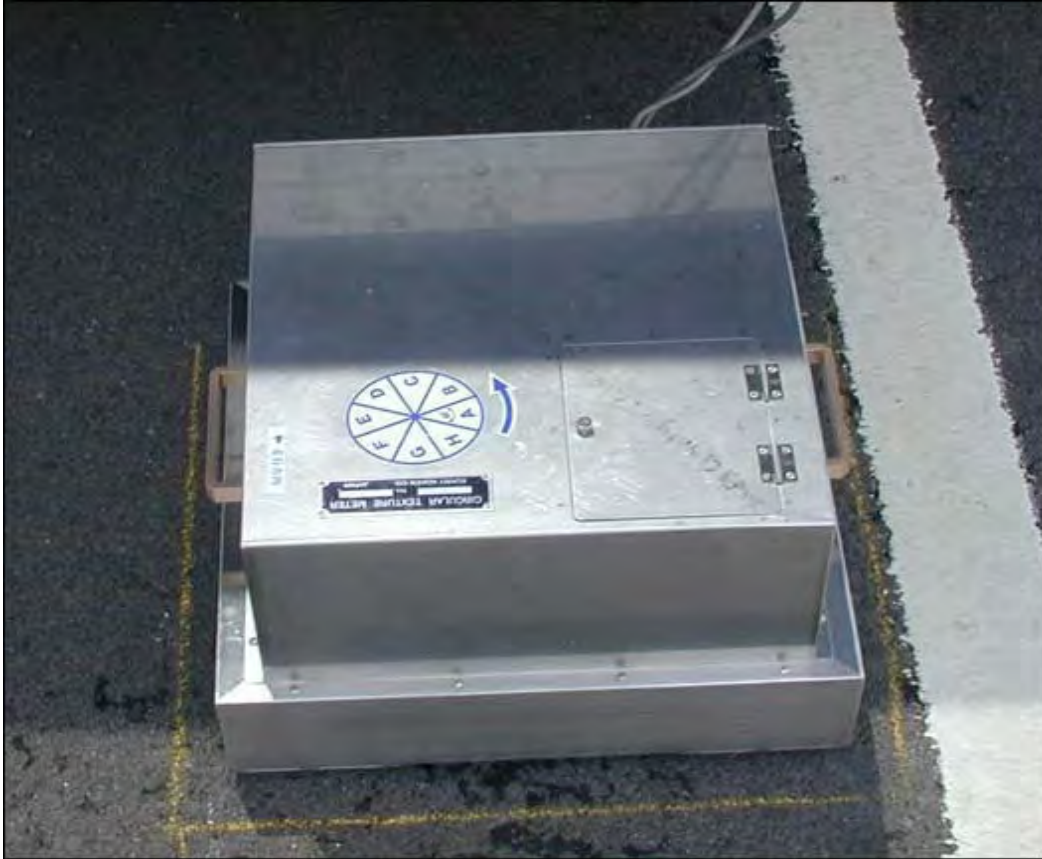
The Circular Track Texture Meter (CT Meter) is being used on the porous pavements at MnROAD to measure clogging of the porous asphalt voids. Measurements are made according to procedures of ASTM E 2157. The CT meter (figure 5.51) uses a laser to measure the profile of a circle 11.2 inches in diameter or 35 inches in circumference. The profile is divided into eight segments of 4.4 inches. The average mean profile depth (MPD) is determined for each of the segments of the circle. The reported MPD (mm) is the average of all eight segment depths for 3 measurements. Temperature, surface moisture, and distress observed at the test locations at the time of measurement are also noted.

Figure 5.51. Circular texture meter

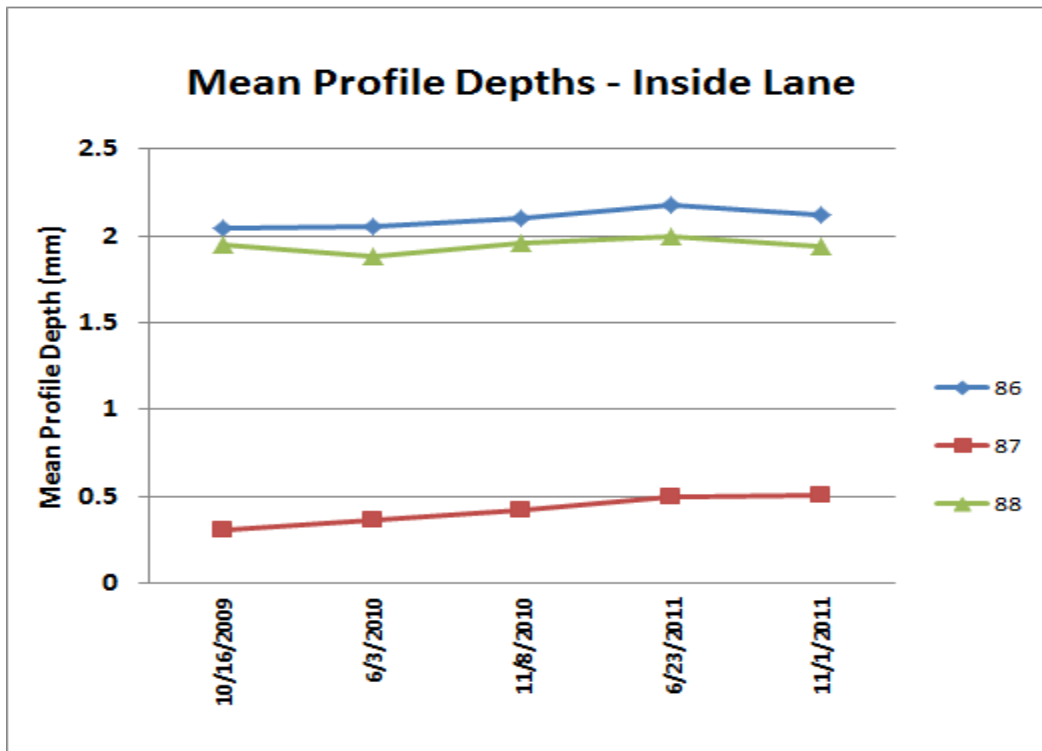
The mean measured profile depth in the outside (unloaded) lane on both cells 86 and 88 has remained essentially the same since 2009, which is expected due to the minimal changes to the surface there. The MPD has increased more rapidly on cell 87 in the outside (unloaded) lane, with no immediately apparent reason. The cell 87 pavement on the inside lane has very little visible wear to date.

Figure 5.52. Mean profile depths (mm) – inside lane

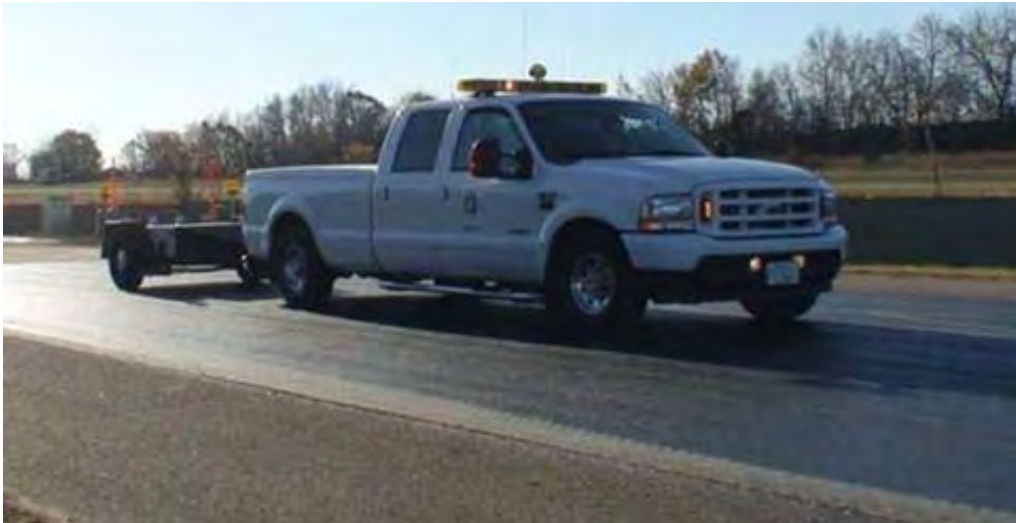
A Friction Number (FN) is calculated as the average coefficient of friction across the lane and can range from 0-100. A FN above 25 on a smooth tire denotes adequate friction, and a FN below 15 indicates that the pavement may need remediation.

Figure 5.54. MnDOT locked wheel skid tester

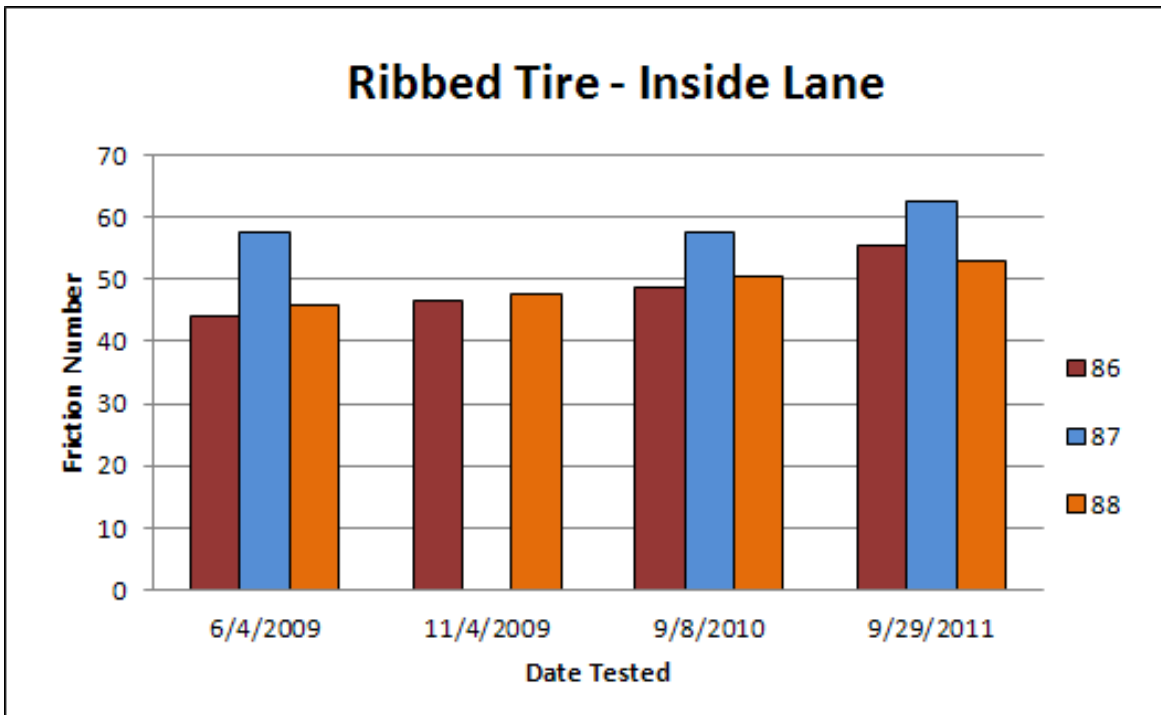
Both the ribbed and smooth “standard” tires were used to take the friction measurements in both wheel paths of the inner and outer lanes of the porous asphalt cells in years 2009-2011. The porous cells 86 and 88 demonstrated very good skid resistance (figures 5.55 - 5.58) with both the smooth and the ribbed tire test, with an overall average FN of approximately 50. The absorption of water in the porous cells contributes to skid resistance, and is highlighted in the smooth tire test results. Although increasing somewhat as the pavement surface has started wearing, the cell 87 smooth tire - loaded lane FN is only 50-60 % that of the smooth tire FN on cells 86 and 88 (figure 5.58).

Figure 5.55. Cells 86-88 friction number (ribbed tire, inside lane)

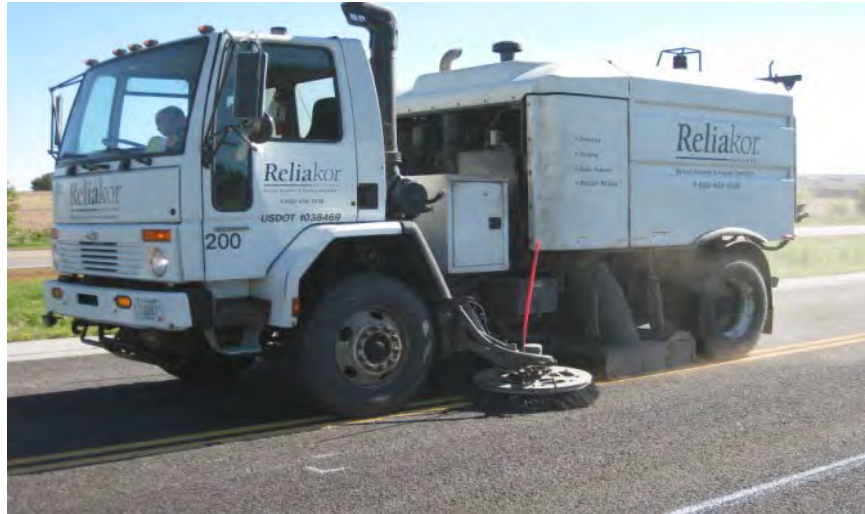
Demonstrations of porous asphalt pavement vacuuming were performed on November 9th, 2009, September 6th, 2010 and May 4th, 2011, June 27th, 2011, and November 2nd, 2011. A Reliakor vacuum truck was employed each time to attempt to clean the porous pavement and determine possible changes in the pavement's hydraulic permeability. The brush on the vacuum truck was not used as to avoid introducing additional material into the pore structure. Figure 5.59 shows the Reliakor Vacuum Truck in operation on cell 88.

Figure 5.59. Reliakor vacuuming

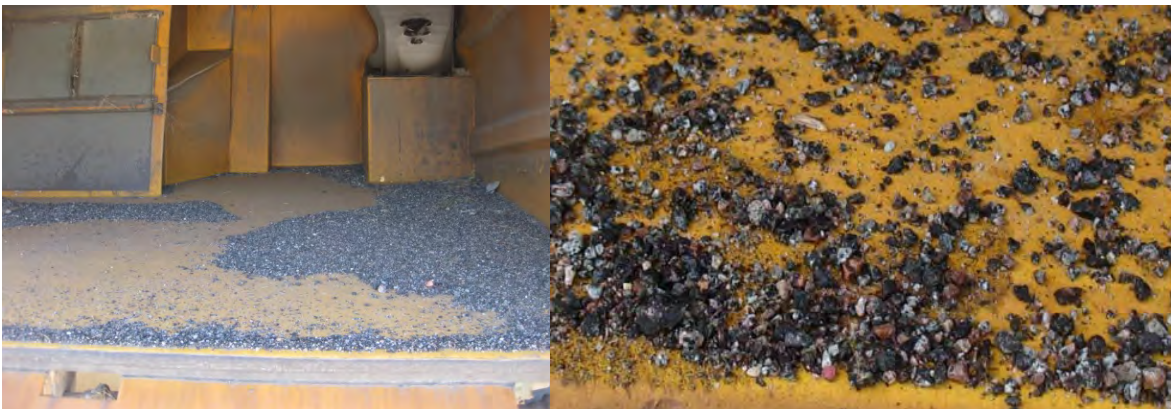
Figure 5.60. Debris removed by vacuuming, 2009

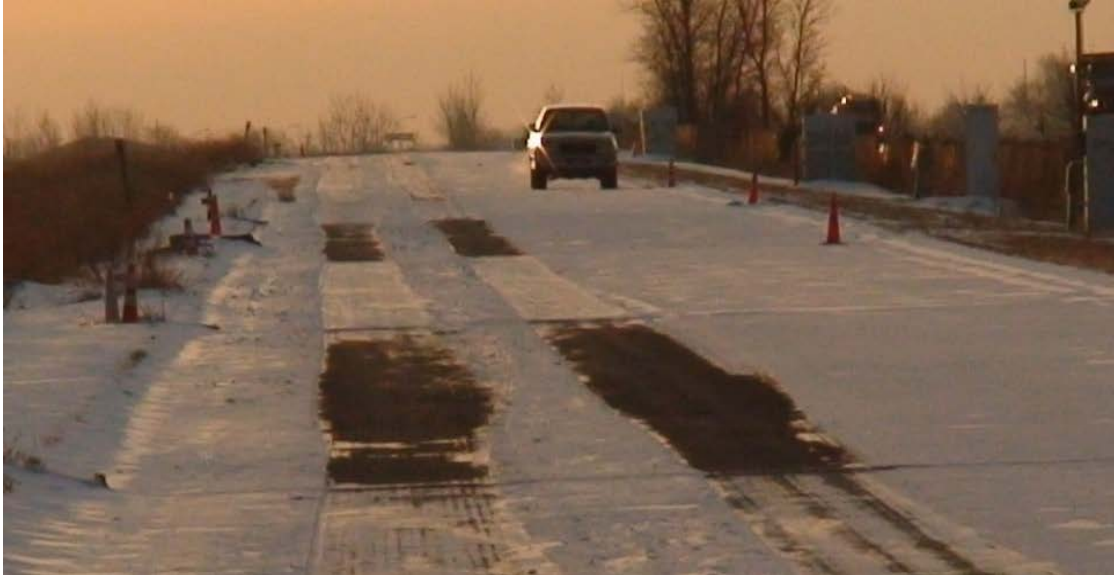
Figure 5.61. Cell 86, 87, and 88 wheelpaths of loaded lane 01/30/2012

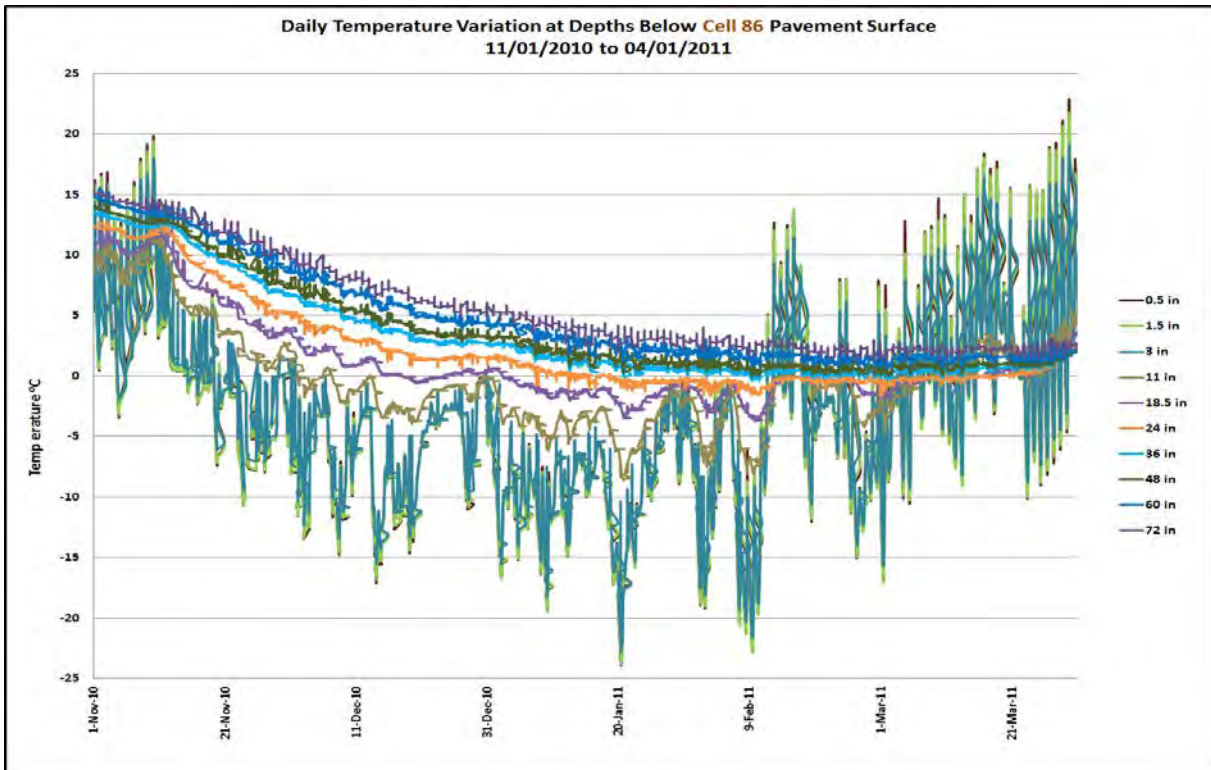
Figure 5.66. Cell 86 subsurface temperatures 11/01/2010 to 04/01/2011

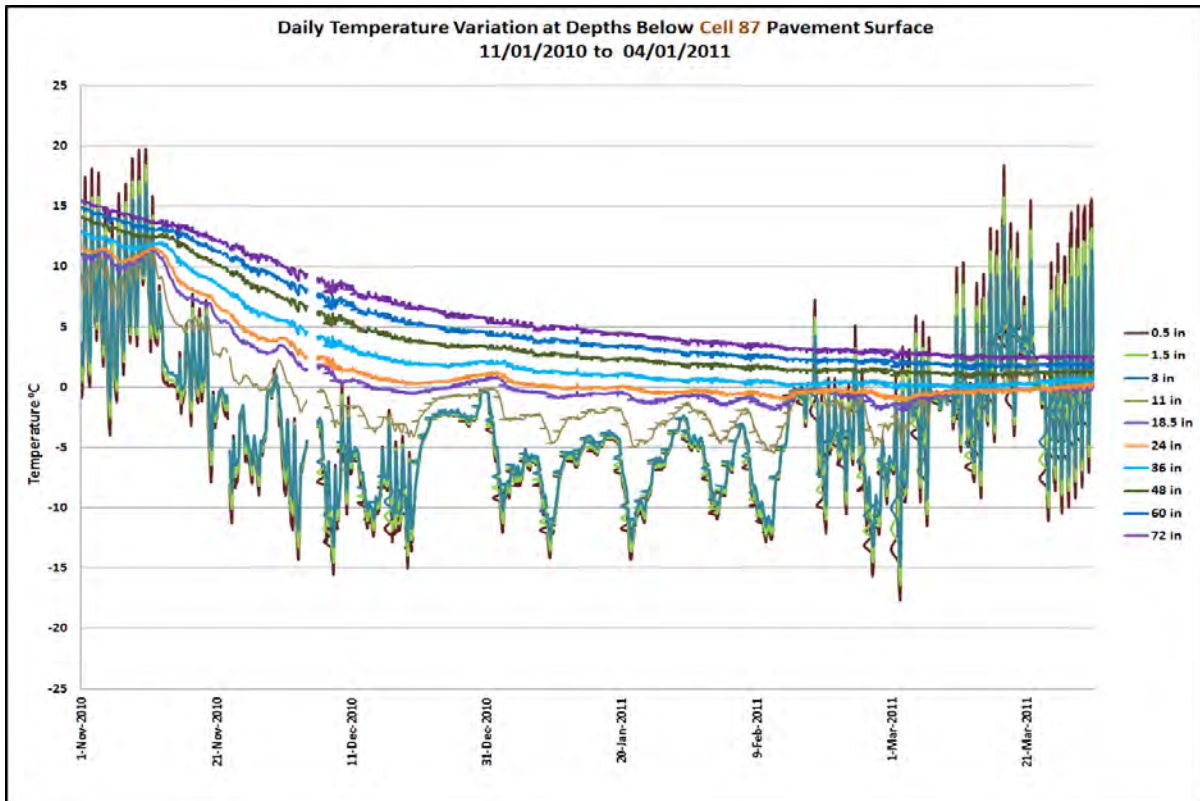
Figure 5.68. Cell 87 subsurface temperatures 11/01/2010 to 04/01/2011

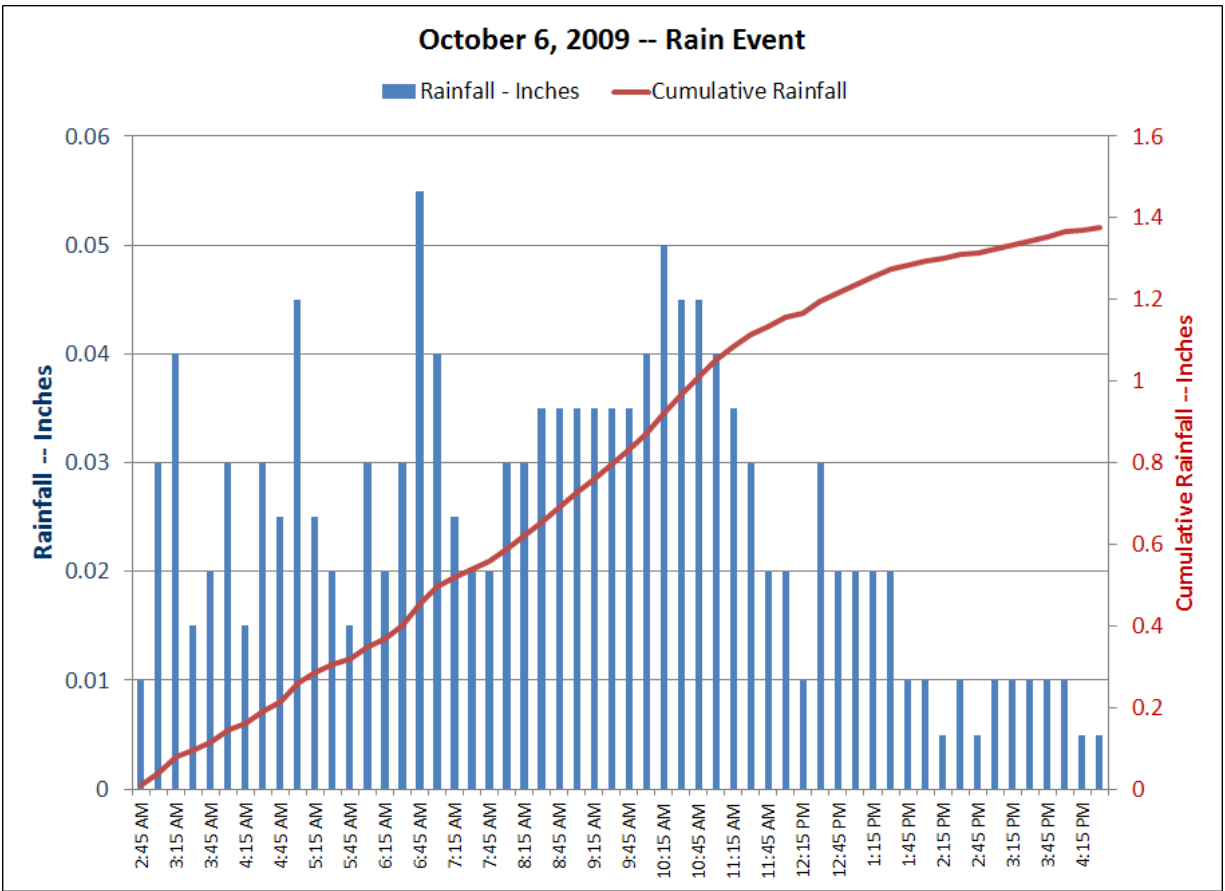
Figure 5.69. Rainfall event 10/06/2009

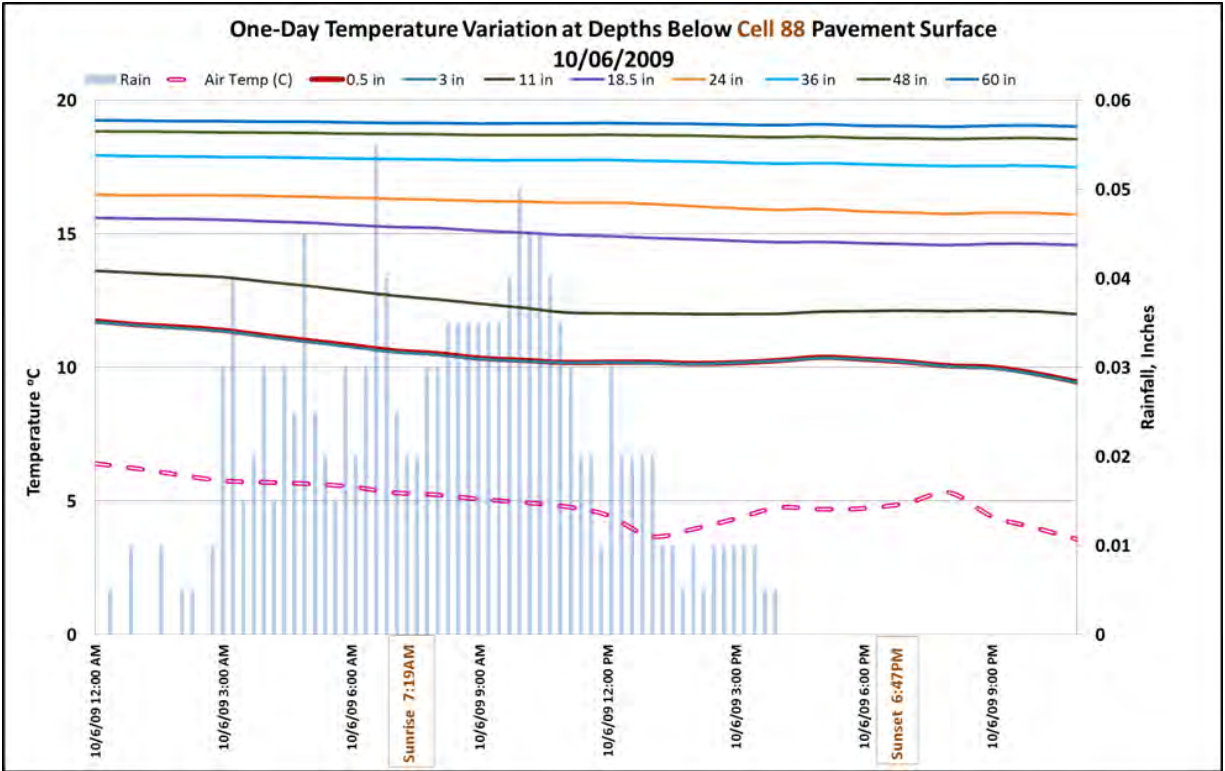
Figure 5.70. Cell 88 subsurface temperatures 10/06/2009

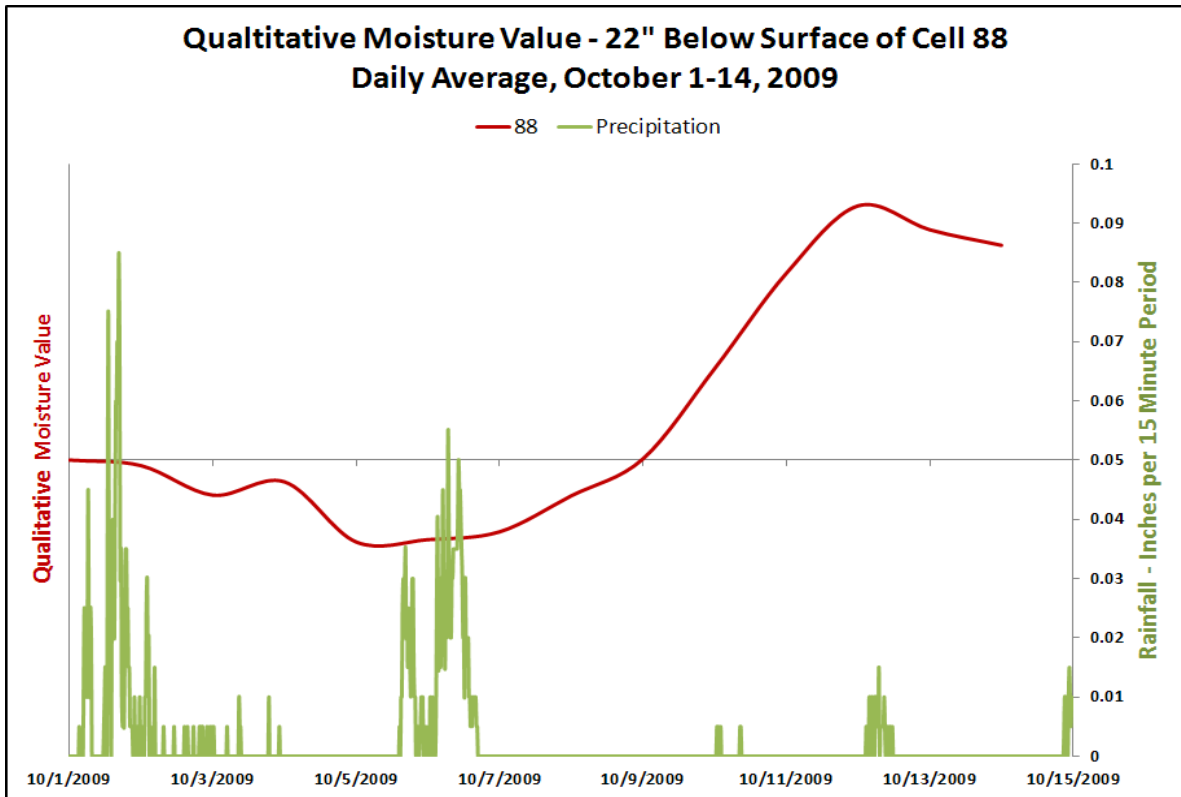
Figure 5.71. Cell 88 subsurface moisture at 22 inches October 1-14, 2009

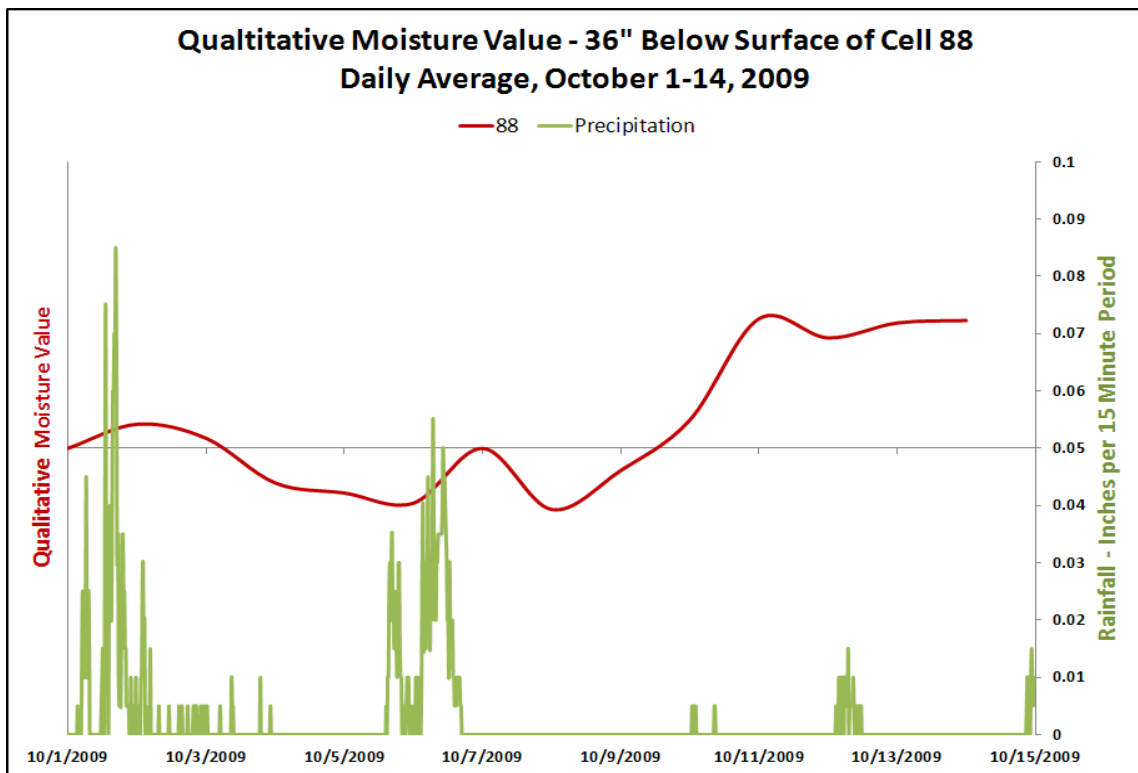
Figure 5.72. Cell 88 subsurface moisture at 36 inches October 1-14, 2009

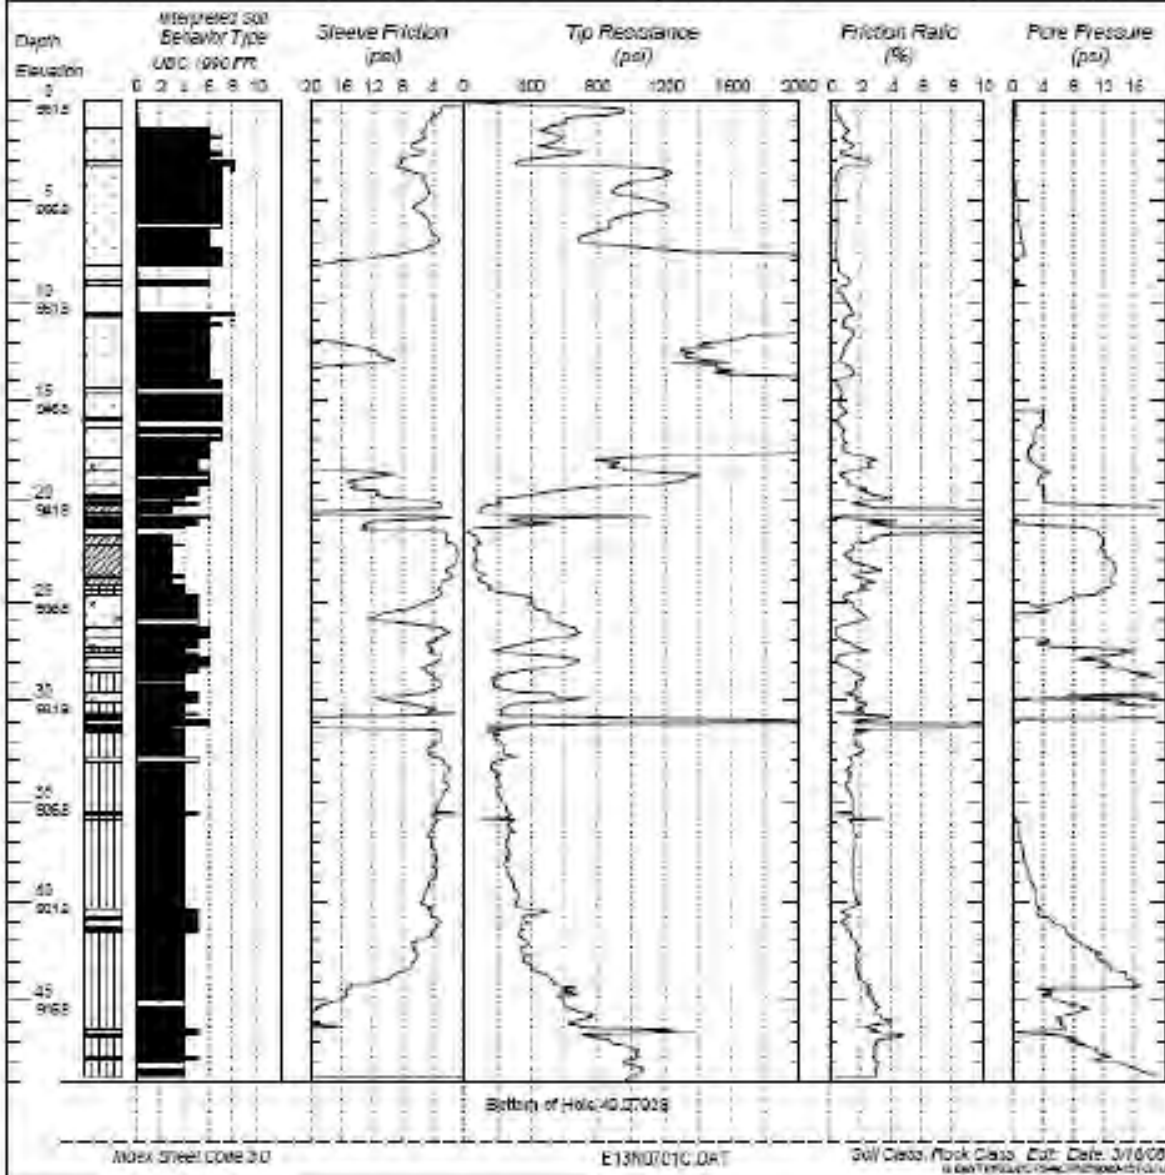
MINNESOTA DEPARTMENT OF TRANSPORTATION - GEOTECHNICAL SECTION
 CONE PENETRATION TEST RESULTS
UNIQUE NUMBER 69250
 U.S. Customary Units
