Evaluate and Develop Innovative Pavement Repair and Patching: Taconite-based Repair Options

Minnesota
Department of
Transportation

January 2016

Research Project
Final Report 2016-03

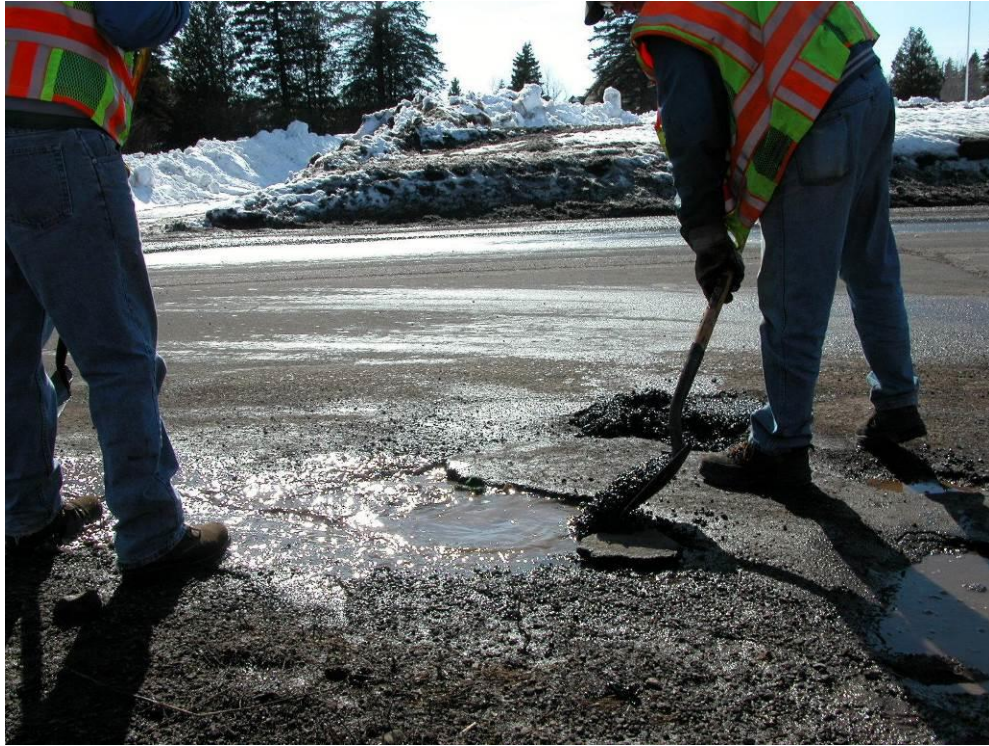
Figure 2.1. “Throw and go” method of pothole repair.

Aside from the obvious challenges posed by attempting repairs under the wet conditions shown in Figure 2.1, throw and go patches do not bond well to the edges of the hole, and when insufficiently compacted they are left vulnerable to freeze/thaw expansion, raveling, and removal by plow trucks or even merely by traffic. Eighty to ninety percent of “throw and go” cold patches deteriorate in just one year (Skorseth, 2000), and a study by Marcus Berlin (Berlin and Hunt, 2007) found instances of “throw and go” patches that had been replaced *15 times* in a single year. The recurring nature of cold patch repair failures was also confirmed to the investigators during discussions with MnDOT District 1 in the fall of 2012 (Steven Baublitz, pers. comm.). Frequent repairs lead to high costs, especially labor. The cold patch also has a finite shelf life. If the stockpile becomes too warm, the binder will lose its elasticity and will more readily deteriorate when it is placed in a pothole (Skorseth, 2000).

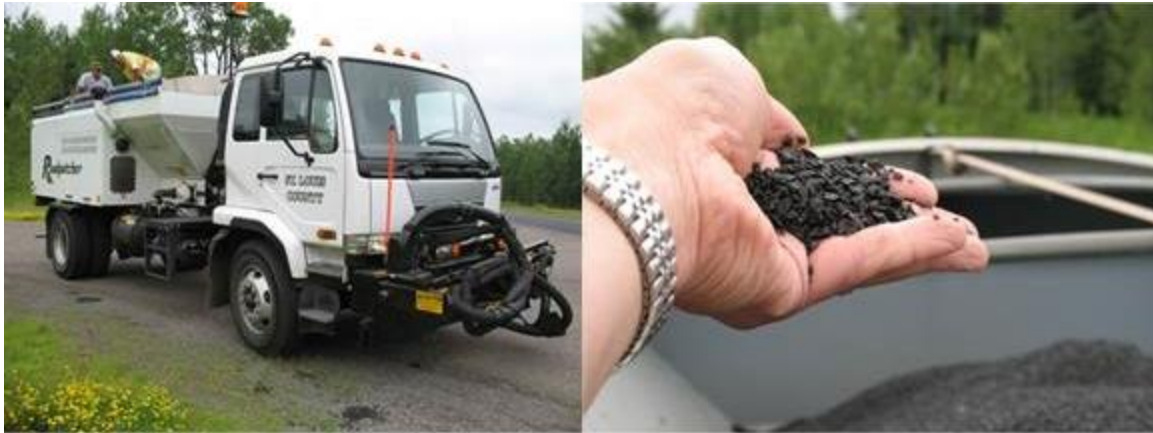
Another method of pothole repair that is gaining popularity across the nation is the use of hot spray injection patching. This method uses specialized equipment to spray a hot RS-2 emulsion into a pothole and a layer of dry aggregate to allow for immediate travel. Figure 2.2 shows a version of a spray patch vehicle ("Roadpatcher") unit owned by St. Louis County, Minnesota. The unit has a hopper that holds coated or uncoated sized aggregate and a tank to hold liquid activator/binder.

Figure 2.2. Spray patch vehicle (left) and coated aggregate used for patching (right).

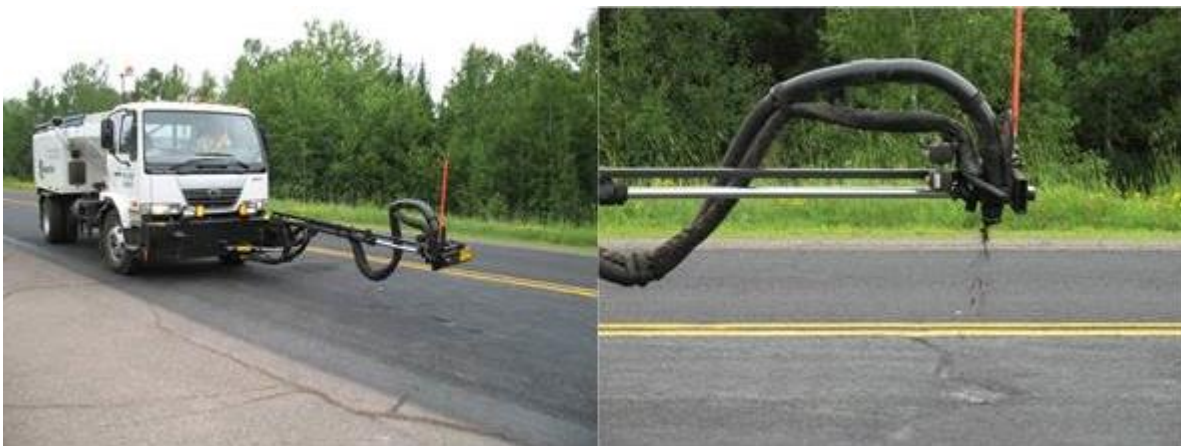
This method has been found to be quite beneficial in terms of the longevity of the patch and in terms of cost (Maupin and Payne, 2003). Automated spray injection allows maintenance workers to remain inside the work truck and move along at a more rapid pace (Fig. 2.3). Barriers and flagging are not necessary for pothole patching, and it can be done under both hot and cold weather conditions. This method has also been found to be more cost effective, as two major costs to road maintenance are labor and traffic control. The automated system can be operated by a single driver and the indicators on the truck eliminate the need for flagging and barriers (Fowler et al., 2008). The patchwork done by the RA-300 Rosco system also lasts just as long as, if not longer than, conventional throw and go patches.

Figure 2.3. Spray patch vehicle deployed (left); close-up of spray nozzle and patching (right).

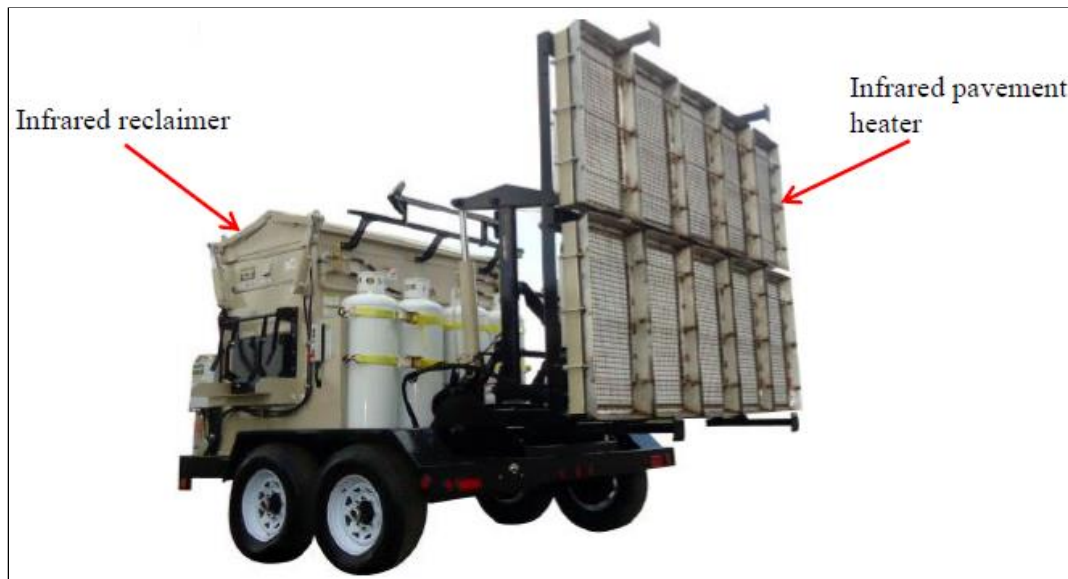
Figure 2.4. Tow-behind combination infrared asphalt heater/reclaimer. (Source: Nazzal et al., 2014)

A recent Ohio University study (Nazzal et al., 2014) evaluated the performance and cost-effectiveness of a tow-behind combination infrared asphalt heater/reclaimer patching method and compared it to throw and roll and spray injection methods. Figure 2.4 (from Nazzal et al., 2014) shows a combination propane-fueled infrared heater and reclaimer, while Figure 2.5 shows another type of infrared heater and its heating.

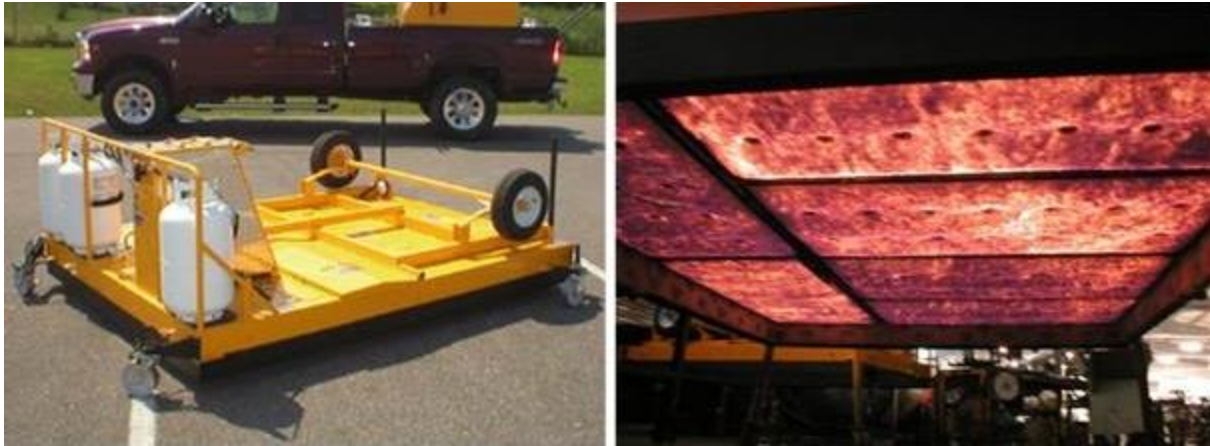
Figure 2.5. Infrared heater (left) and its heating elements (right).
(Source: <http://www.surelineinc.com/asphalt.html>)

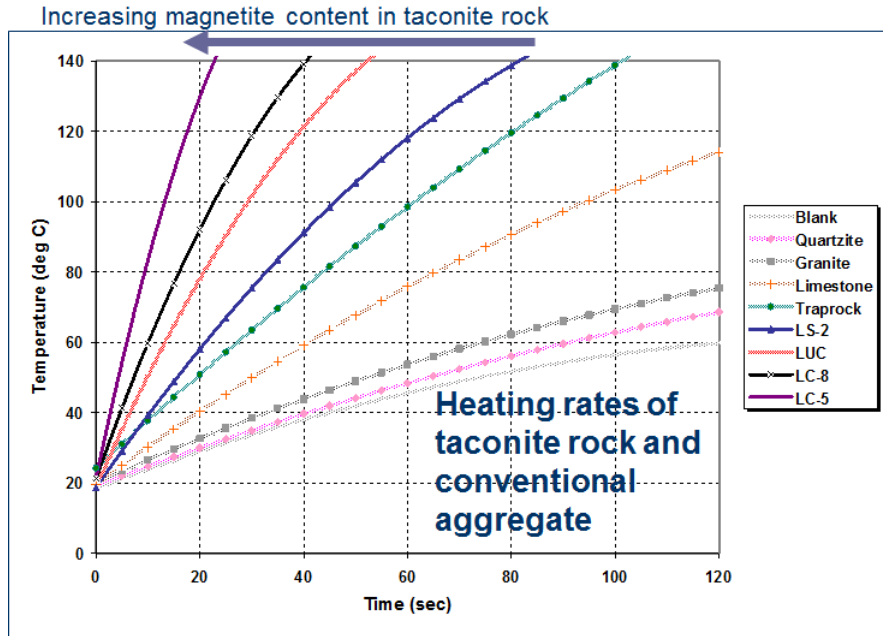
Figure 2.6. Microwave heating rates of taconite rock and conventional aggregate (Zanko and Hopstock, 2004).

Microwave Utilities, Inc. (MUI) is a company that specializes in ground thawing using a patented microwave system capable of thawing frozen ground to a depth of six feet in just 60 minutes (pers. comm., Microwave Utilities, 2012). NRRI and Microwave Utilities have been collaborating to test pothole patching compounds that utilize the microwave-absorbing properties of the iron mineral magnetite. Magnetite is contained in iron ore (aka "taconite" ore) rock mined and processed on Minnesota's Mesabi Iron Range, and has the ability to readily adsorb microwaves and heat very quickly (Fig. 2.6).

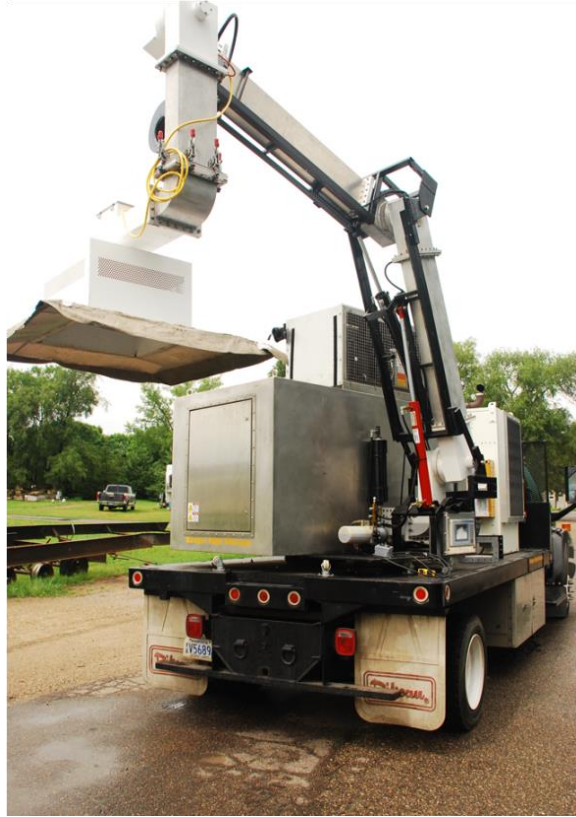
An equipment demonstration was performed on an intact portion of pavement, using MUI's (at the time) latest equipment design (Figs. 2.7 and 2.8). With the microwave set at 50kW, the pavement was heated from 80° F to 200° F in just seven minutes. Two inches below the surface, the pavement reached temperatures over 300° F. The pavement was pliable and easily removed with a shovel (Fig. 2.9).

Figure 2.7. Microwave unit with articulating arm.

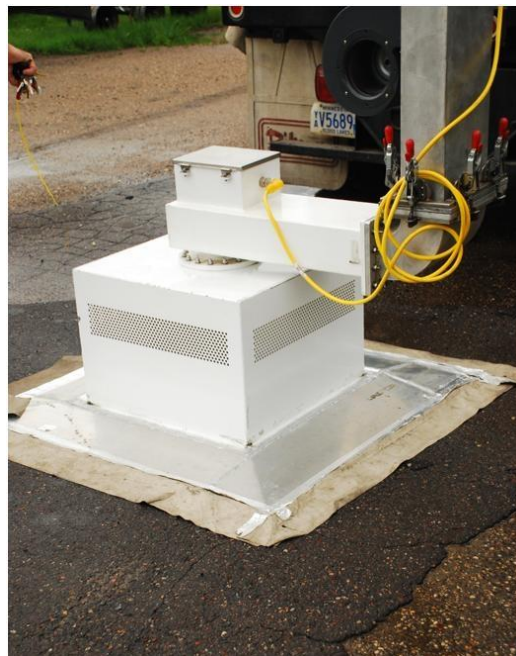
Figure 2.8. Microwave horn and shielding.

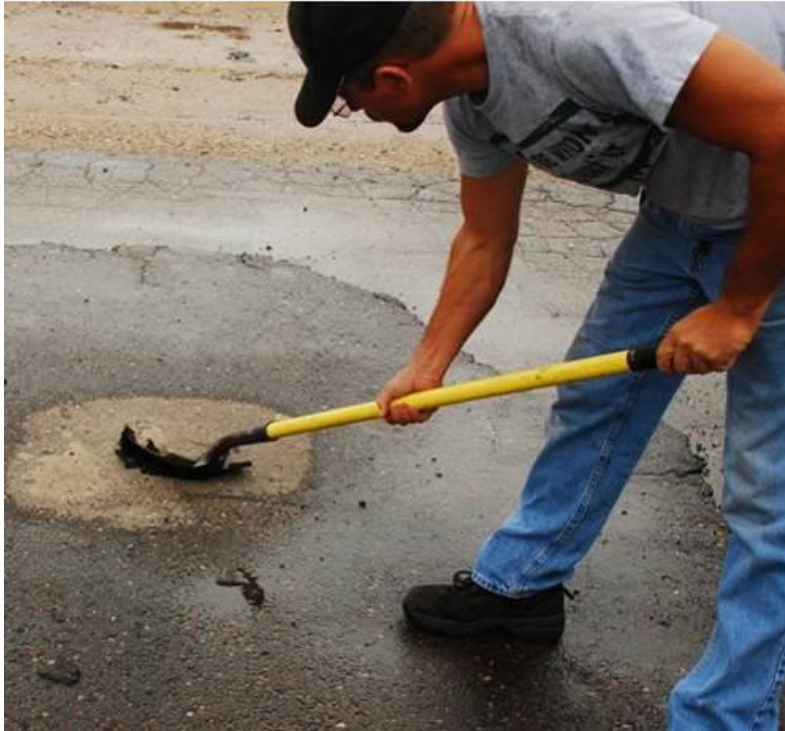
Figure 2.9. Microwave-heated pavement, easily removed with shovel (surface at 200° F).

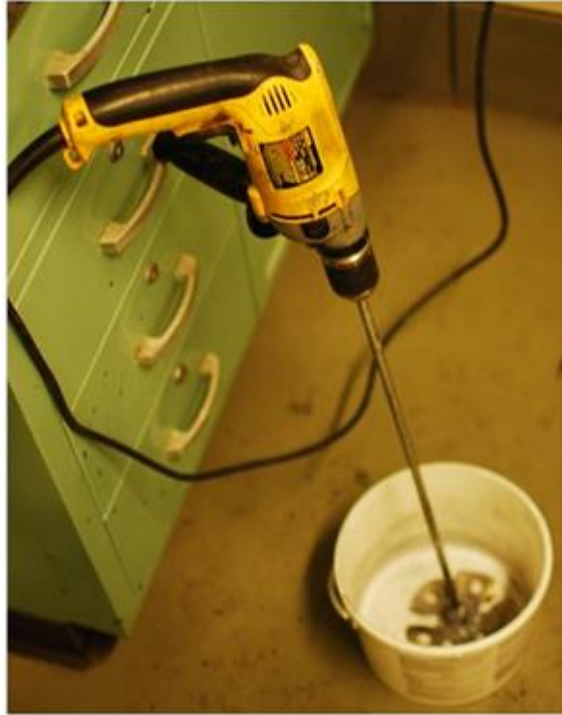
Once ready to begin the mixing, the liquid was added to the white ingredients and the clock was started. The liquid and "white" ingredients were then vigorously stirred using an electric drill and paint paddle (Fig. 2.10) for one minute. The water-add activator had a tendency to bubble upon

Figure 2.10. Drill, paddle, and mixing bucket used for Rapid Patch lab test work.

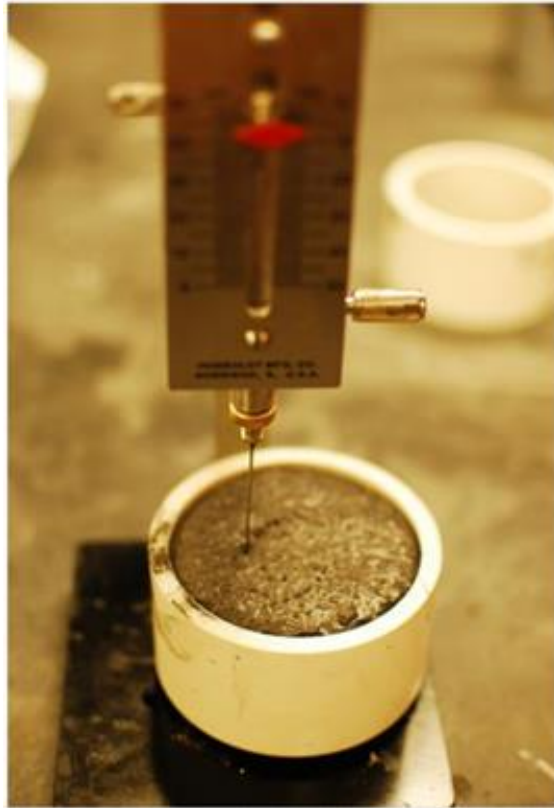
The initial set time test was performed by making a batch of pothole mix, using the standard mixing procedure (described previously). Once the mix was prepared, it was poured into a wide, shallow cylinder made from a 3in. (I.D.) x 50mm section of PVC pipe which had been given a light coat of mineral oil. The mix was leveled off and the needle of the Humboldt Vicat apparatus (Fig. 2.11) was lowered so that the end of the needle met the top surface of the mix. Every sixty seconds, the weighted needle was released and allowed to sink into the mix for ten seconds. When the needle penetration depth became less than 25mm, the initial set had occurred. Following the initial set, this procedure was continued and the needle penetration depth was recorded until it became zero, at which point the final set had occurred. Each Vicat needle drop location was at least ¼” away from other test locations and ½” away from the edge of the cylinder. The initial set was calculated according to ASTM C191-08.

Figure 2.11. Humboldt Vicat needle used for initial Rapid Patch set time tests.

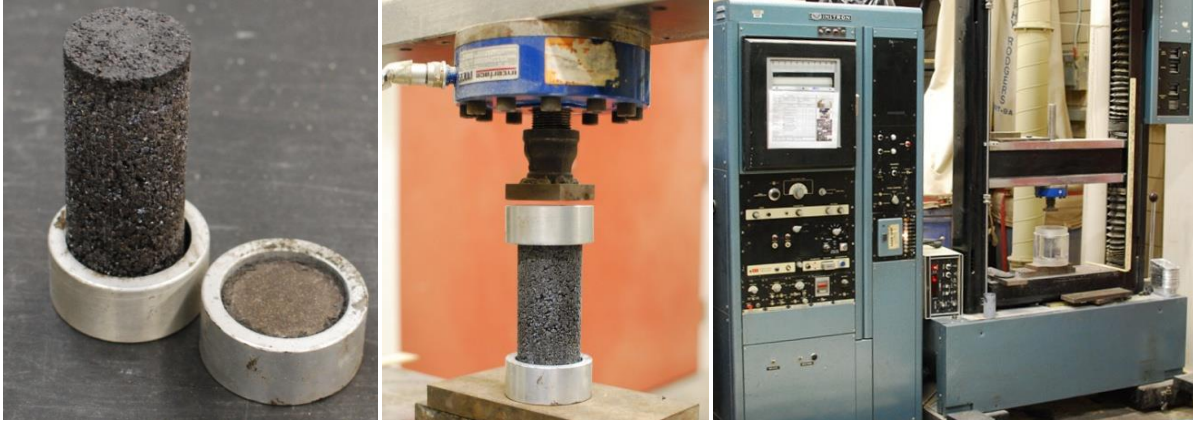
The unconfined compressive strength was tested using a load cell attached to a Universal Testing Instrument from Instron Corp (Fig. 2.12). The load cell had a capacity of 20 kip. Rubber caps were placed on the ends of the cylinders to assure uniform loading.

Figure 2.12. Setup of Universal Testing Instrument for performing unconfined compression test.

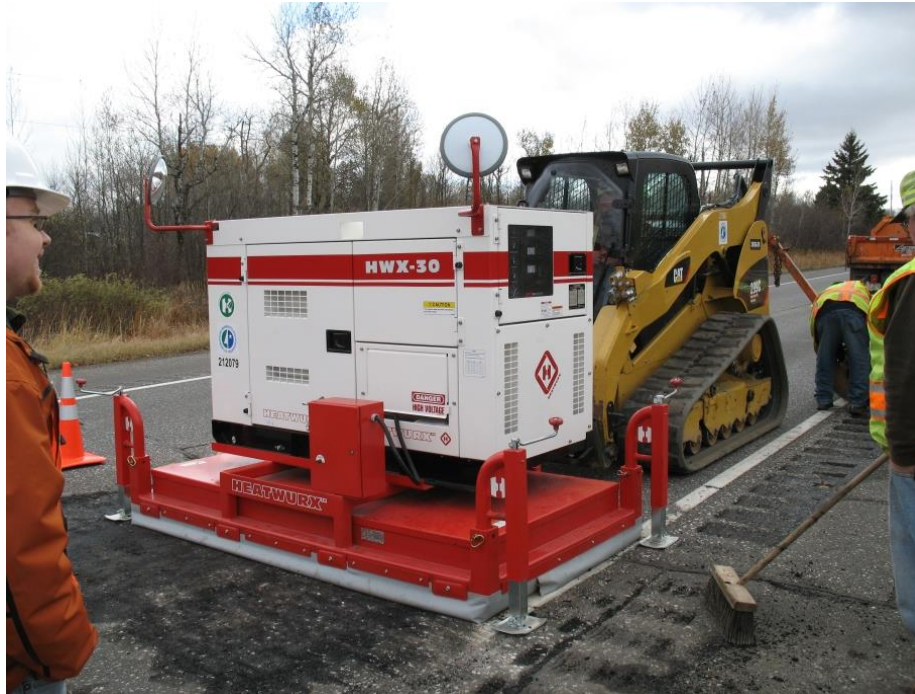
Figure 3.2. HeatWurx unit and skid-steer.

shows, the unit has a broad footprint and is moved/positioned with a skid-steer. After the pavement is heated, crews can use rakes and shovels (Fig. 3.3) or a rototiller type of attachment (Fig. 3.4) to work/disaggregate the softened pavement prior to its re-compaction. The unit essentially acts as a hot in-place recycler.

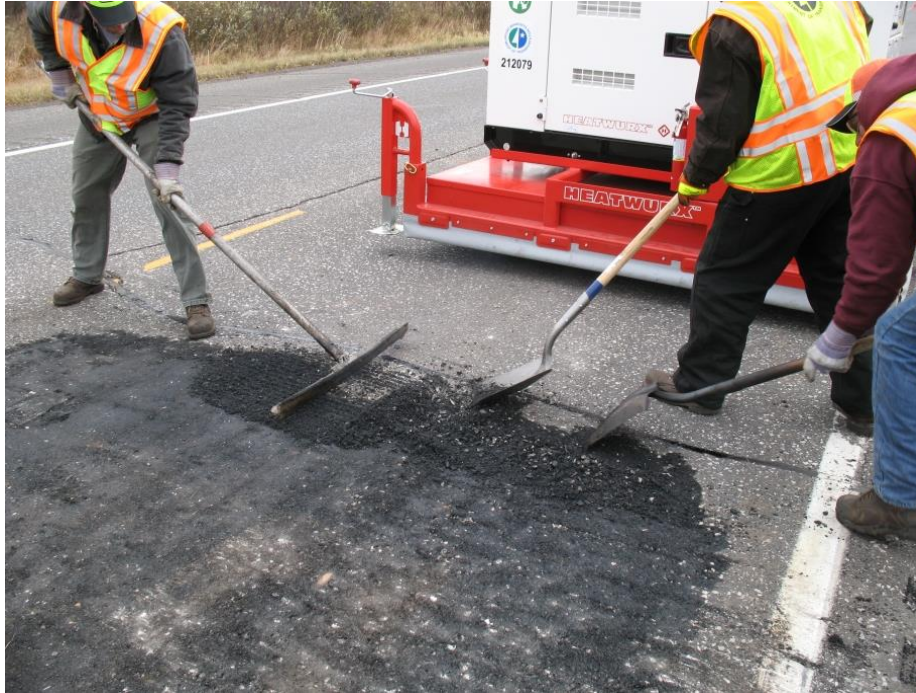
Figure 3.3. Raking heated and softened pavement following use of HeatWurx.

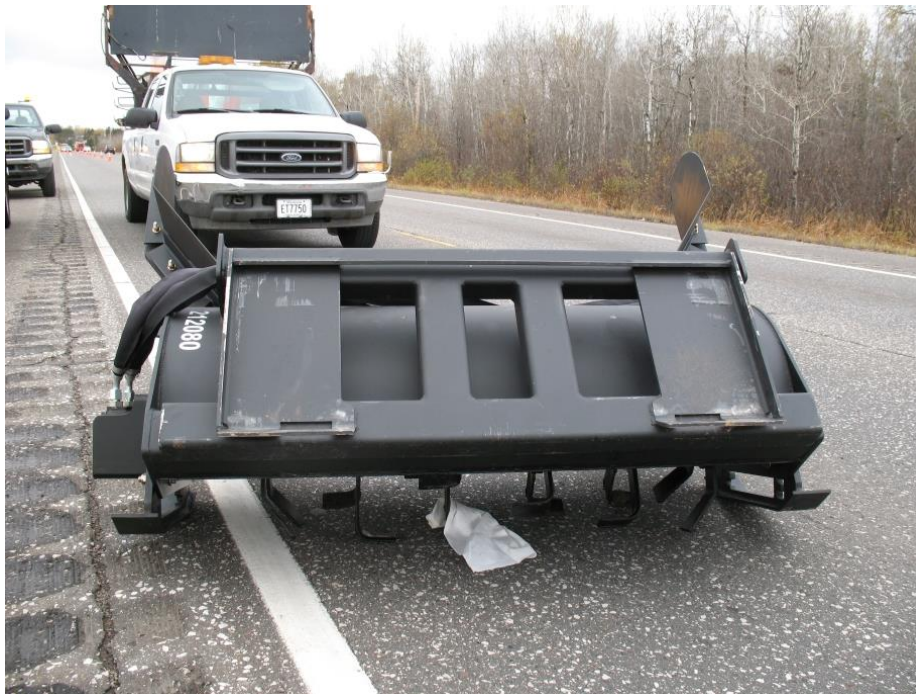
Figure 3.4. "Roto-tiller" attachment for HeatWurx.

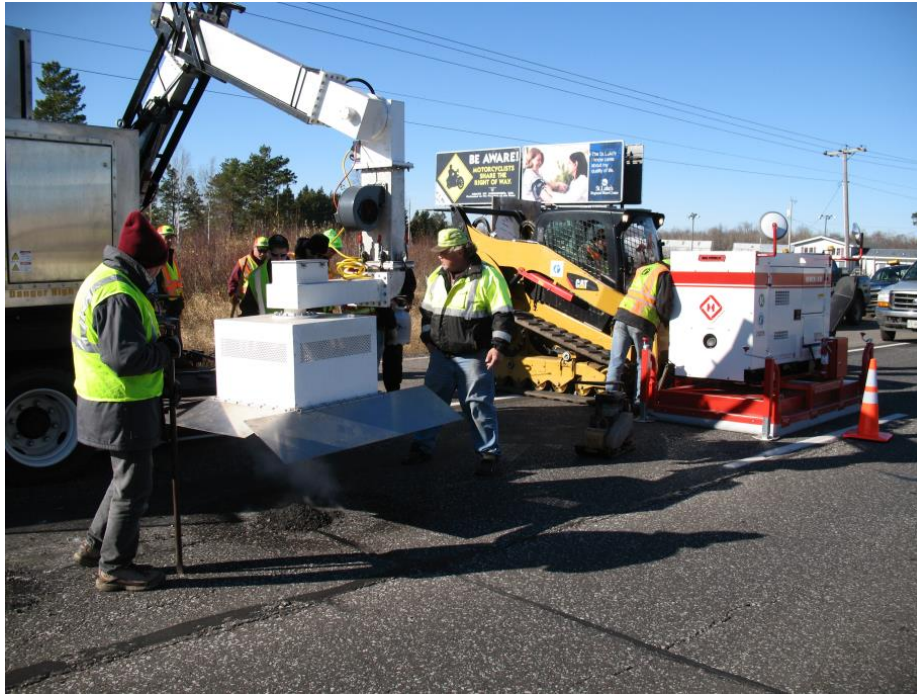
Importantly, the HeatWurx unit was deployed for the October 30 and 31, 2012, field trials, which allowed a direct comparison to be made between its method of heating (radiant/infrared) and microwave heating (Fig. 3.5).

Figure 3.5. Field trial comparison of microwave (left) and HeatWurx (right): October 30, 2012.

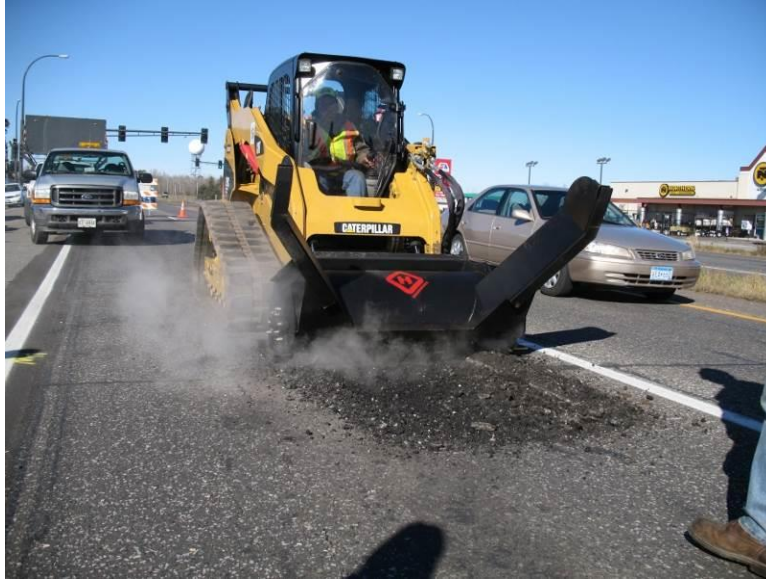
- HeatWurx
 - Test 1: After 30 minutes, ~195° F at depth of 0.5 inches. After 2 hours and 4 minutes, a surface temperature close to 400° F was measured (starting pavement temperature ~35° F). After heating, the pavement was “tilled” (Fig. 3.6) and compacted; and
 - Test 2: After 60 minutes, ~180° F at depth of 2.0 inches. Tilled and compacted.

Figure 3.6. HeatWurx post-heating "tilling" of pavement.

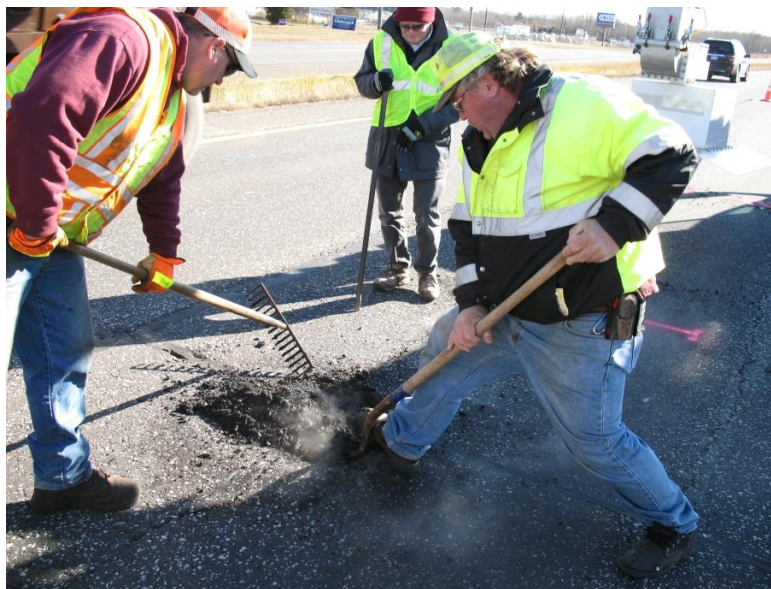
- Microwave: 5-7 minutes to heat pavement and patch material to $>200^{\circ}$ F to a depth of 2 to 3 inches; easy to shovel (Fig. 3.7).

Figure 3.7. Working microwave-heated pavement with shovel.

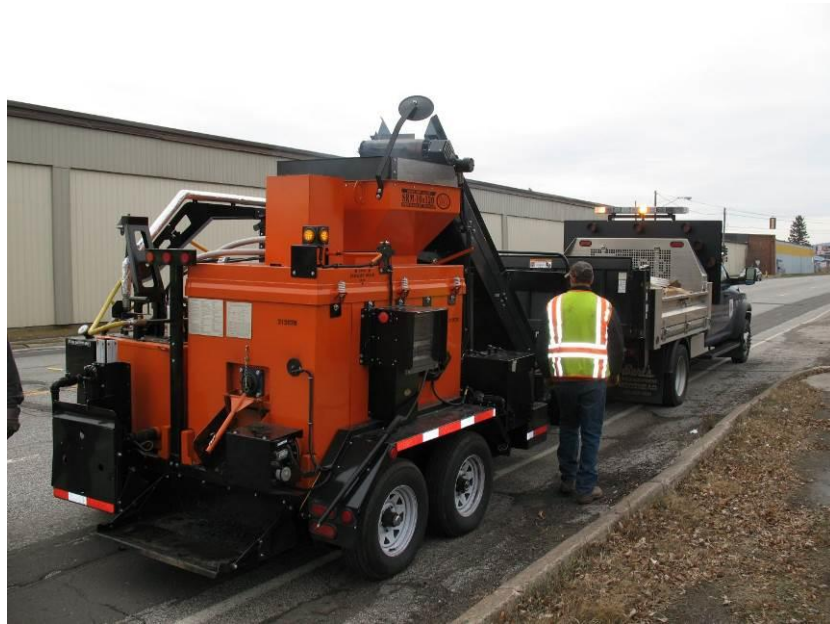
The Stepp asphalt recycler (Fig. 3.8) heats granular RAP/asphalt millings on-board to a temperature approaching 350° F (Fig. 3.9) and dispenses the resulting hot mix as-needed. This mobile (trailer) device makes it possible to prepare hot mix asphalt repair materials year around while making use of readily available RAP. Small quantities of asphaltic additives (Fig. 3.10) can be added to each on-board batch of RAP hot mix to improve its binding characteristics, as was done during a February 26, 2013, repair of potholes near the intersection of Highway 53 and Mall Drive across from Walmart in Duluth (Fig. 3.11).

Figure 3.8. Stepp Asphalt Recycler, Grand Avenue (Hwy. 23), Duluth: November 13, 2012.

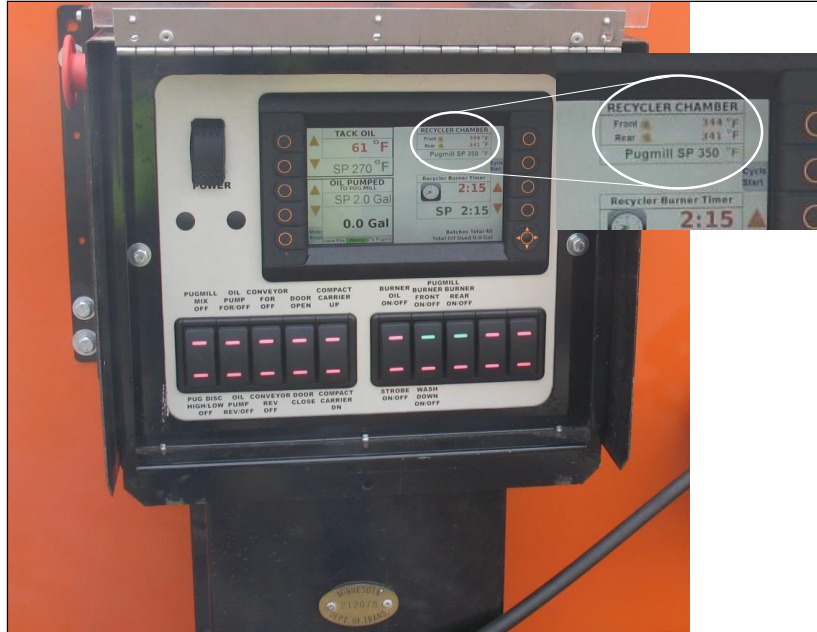
Figure 3.9. Stepp controls, showing recyler chamber temperature (341° F to 344° F).

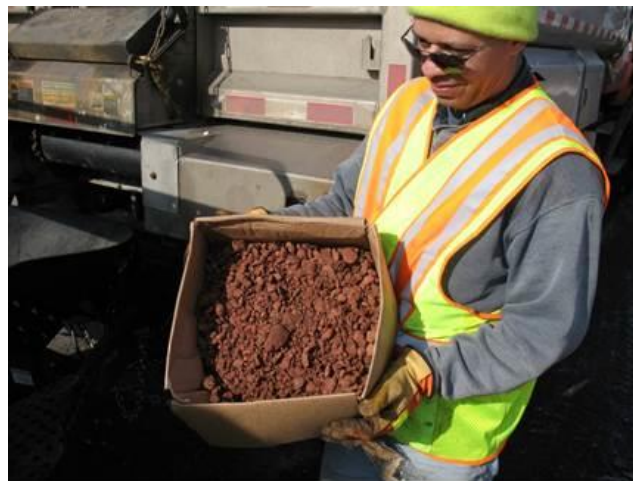
Figure 3.10. Asphaltic additives used with Stepp recycler.

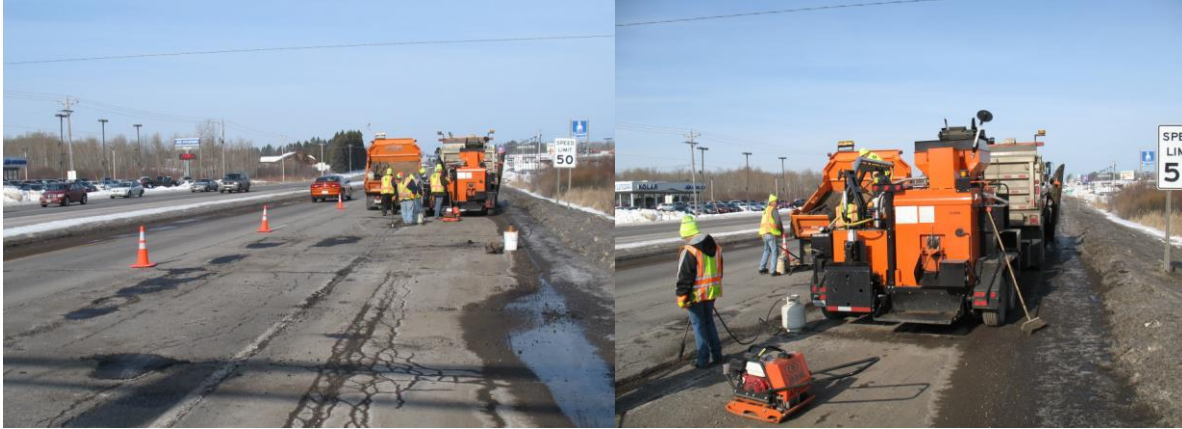
Figure 3.11. Stepp repairs Highway 53, Feb. 26, 2013. Note pre-heating of repair with torch (right photo).

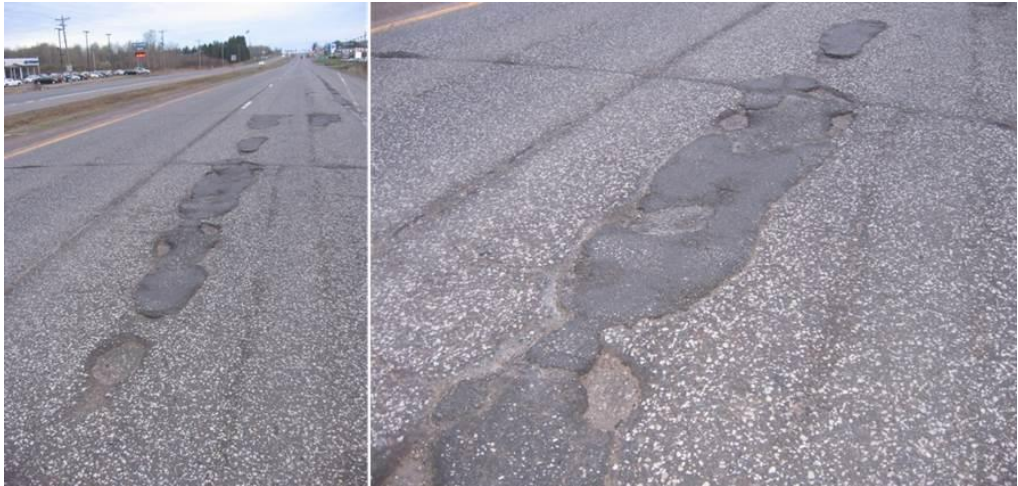
On May 17, 2013, the Highway 53/Mall Drive Stepp repair site was revisited. As Figure 3.12 shows, some of the repair was missing, which suggests inadequate bonding.

Figure 3.12. Stepp hot repair condition on May 17, 2013.

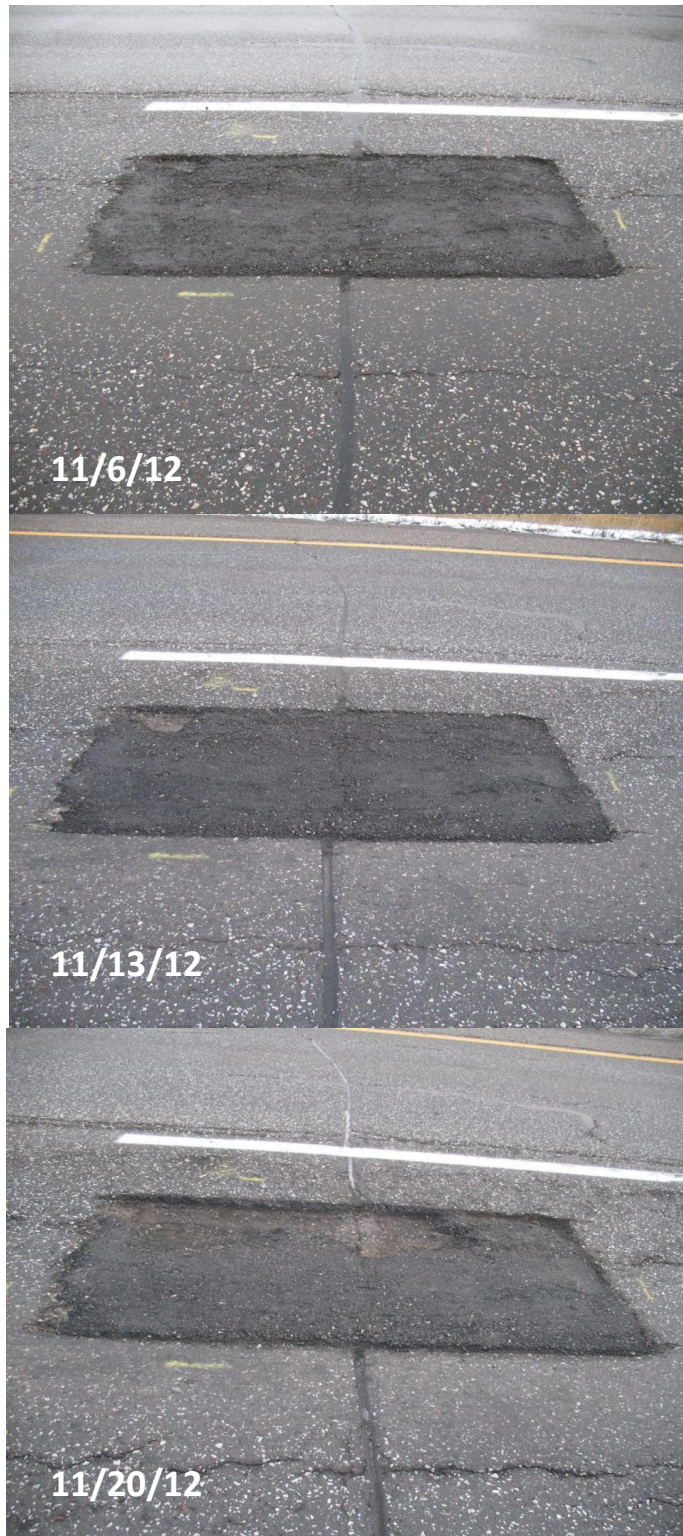
Figure 3.15. HeatWurx repair #1 (Bullyan location), showing progressive loss of material.

To be fair, at this point in time the HeatWurx unit was still in its earliest stages of use. Still, the premature failures could be partially attributed to the nature of IR heating itself. Temperature measurements made with a rigid probe indicated that the HeatWurx's surface-downward heating mechanism resulted in a steep temperature differential between the pavement surface (hot) and the deeper underlying pavement (cooler). If the temperature of the surficial asphalt becomes too hot, the overheated asphalt binder can lose some of its binding properties. That is why a "rejuvenator" is part of the HeatWurx process; it is added to impart additional binding capacity to the recycled pavement. However, it is also likely an insufficient amount of "rejuvenator" was added to the heated and milled asphalt prior to the repair's compaction. Another factor that probably played a role was the mechanical "tilling" of the heated pavement (refer back to Fig. 3.6), which also removed not only what was softened but likely incorporated some deeper asphalt that was merely warm and therefore relatively "dry" (binder not softened). Further, the "tilling" action exposed the disaggregated asphalt to the ambient air, which may have accelerated its cooling. Therefore, when all of these contributing factors are considered and the disaggregated asphalt was recombined and re-compacted, the asphalt probably lacked the cohesive properties it needed for producing a durable and lasting repair.

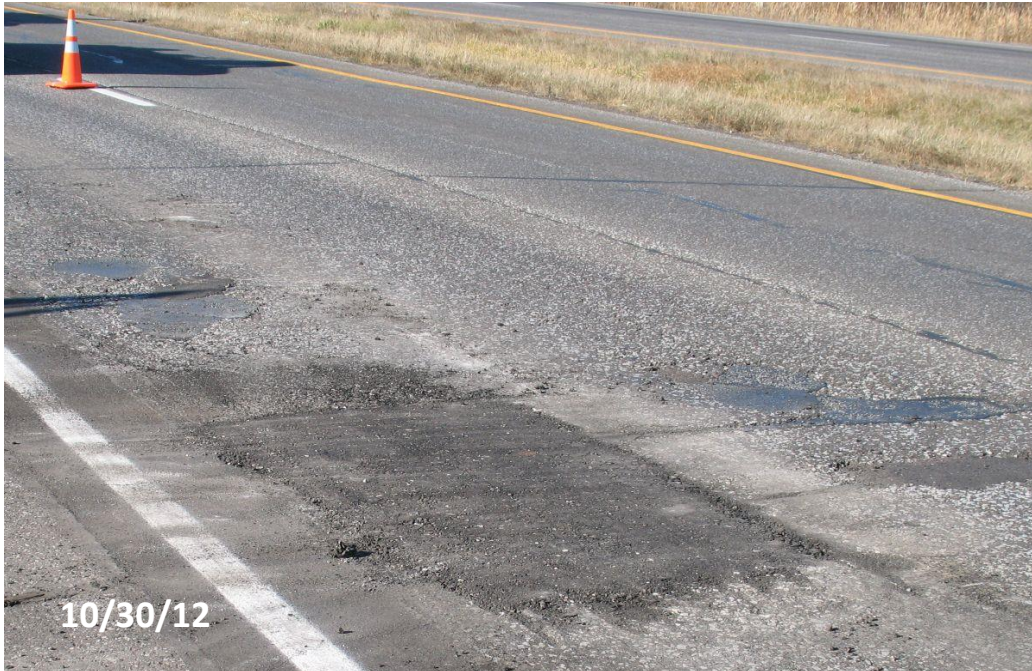
Figure 3.15 documents the week-to-week condition of a repair (Location #1; Bullyan) done with the HeatWurx unit during the October 30, 2012, field trials. The repair deteriorated rapidly and was replaced with hot mix in late November 2012. A second nearby HeatWurx repair (Location #2; Monaco Air sign) failed similarly (Figs. 3.16 and 3.17), with the repair de-bonding from the underlying pavement, and also raveling. It, too, was replaced with hot mix by MnDOT in late November.

Figure 3.16. HeatWurx repair #2, Highway 53 (Monaco Air sign) location, October 30, 2012.

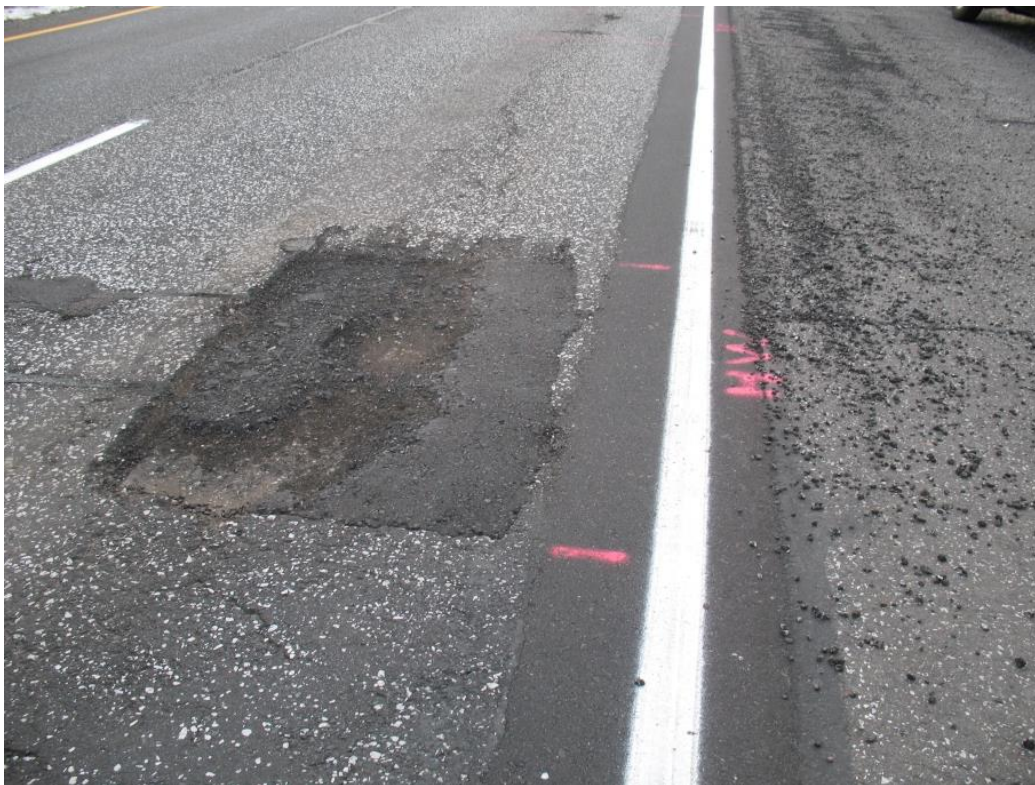
Figure 3.17. HeatWurx repair #2, Highway 53 (Monaco Air sign) location: failing condition on November 13, 2012.

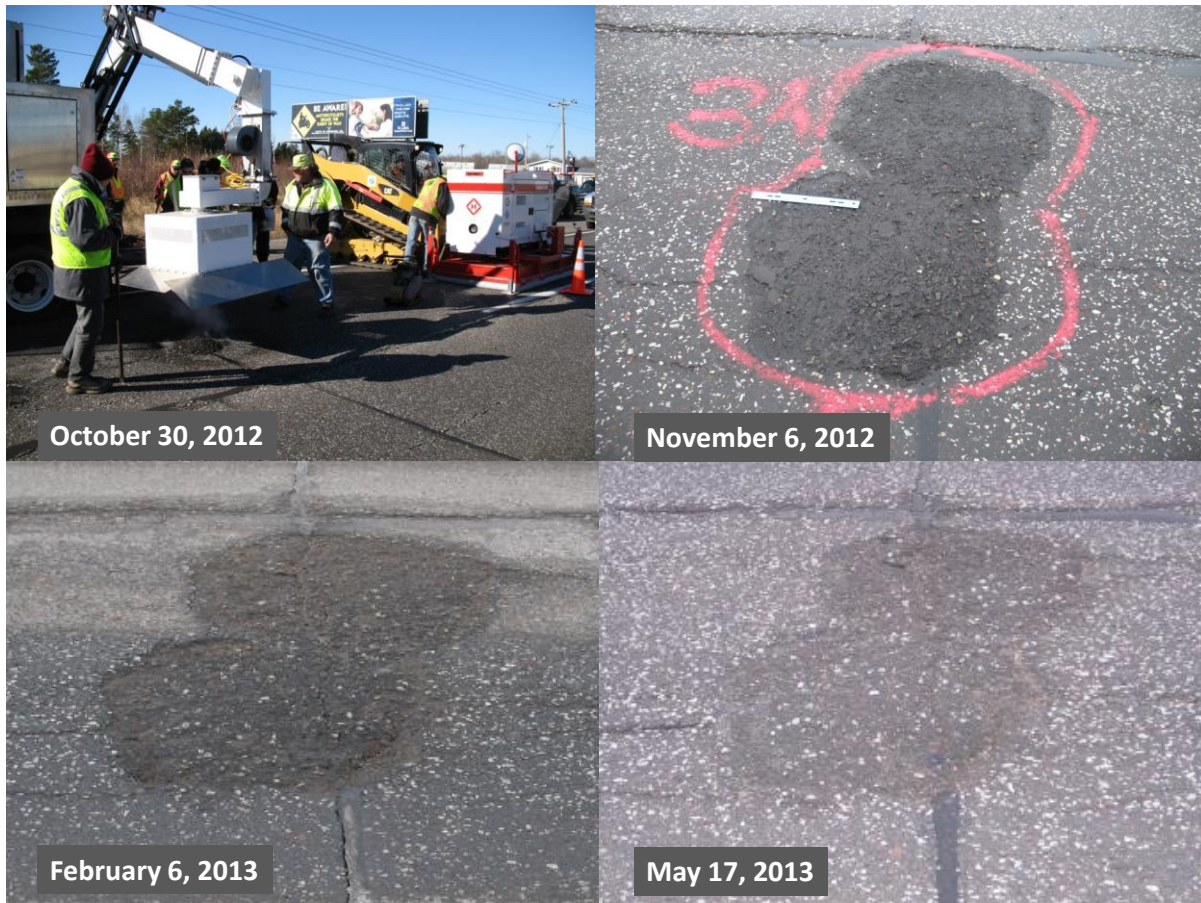
Figure 3.18. Highway 53 microwave pothole (Hole 3) repair; note the 12 inch ruler for scale in the November 6 photo.

The condition of the selected October 30, 2012, microwave repair (noted as Hole 3) is shown in the following sequence of photos, from its installation on October 30, 2012, through May 17, 2013 (Fig. 3.18). The aforementioned repair compound was placed in the hole (slightly overfilled to accommodate compaction); heated with MUI's microwave for 6 minutes at 50kW; shoveled, raked, and combined with the softened adjacent pavement; and compacted. The temperature of the pre-compacted mixture was noted to average 105° C (220° F). As Figure 3.18 shows, the repair held up well following installation, exhibiting a minor amount of surface loss (raveling).

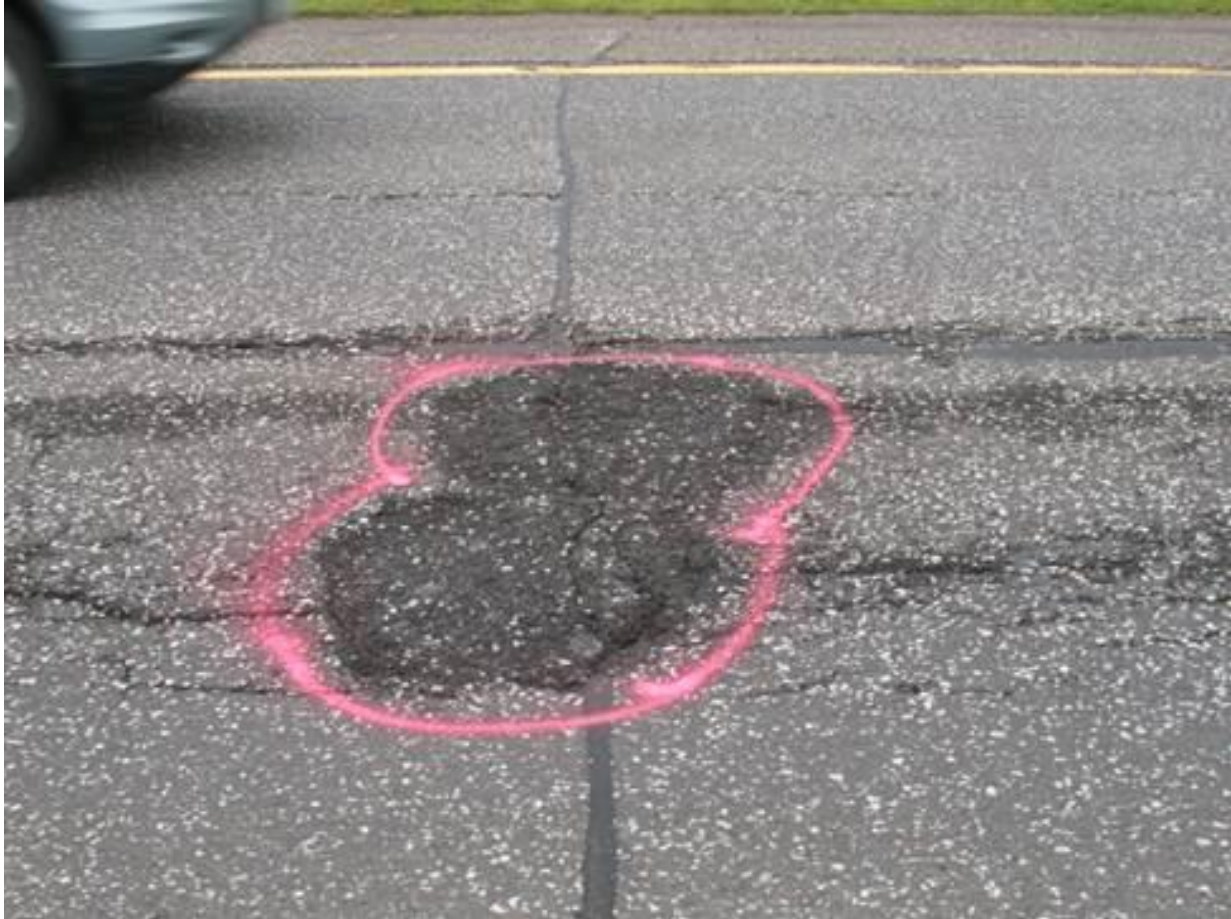
Figure 3.19. Highway 53 microwave pothole (Hole 3) repair condition on July 30, 2013.

Figure 3.19 shows the repair's condition on July 30, 2013. While continuing to exhibit minor raveling, it generally remained a sound repair. The surrounding pavement, however, continued to deteriorate, which led MnDOT to mill-and-fill this section of Highway 53—including this repair.

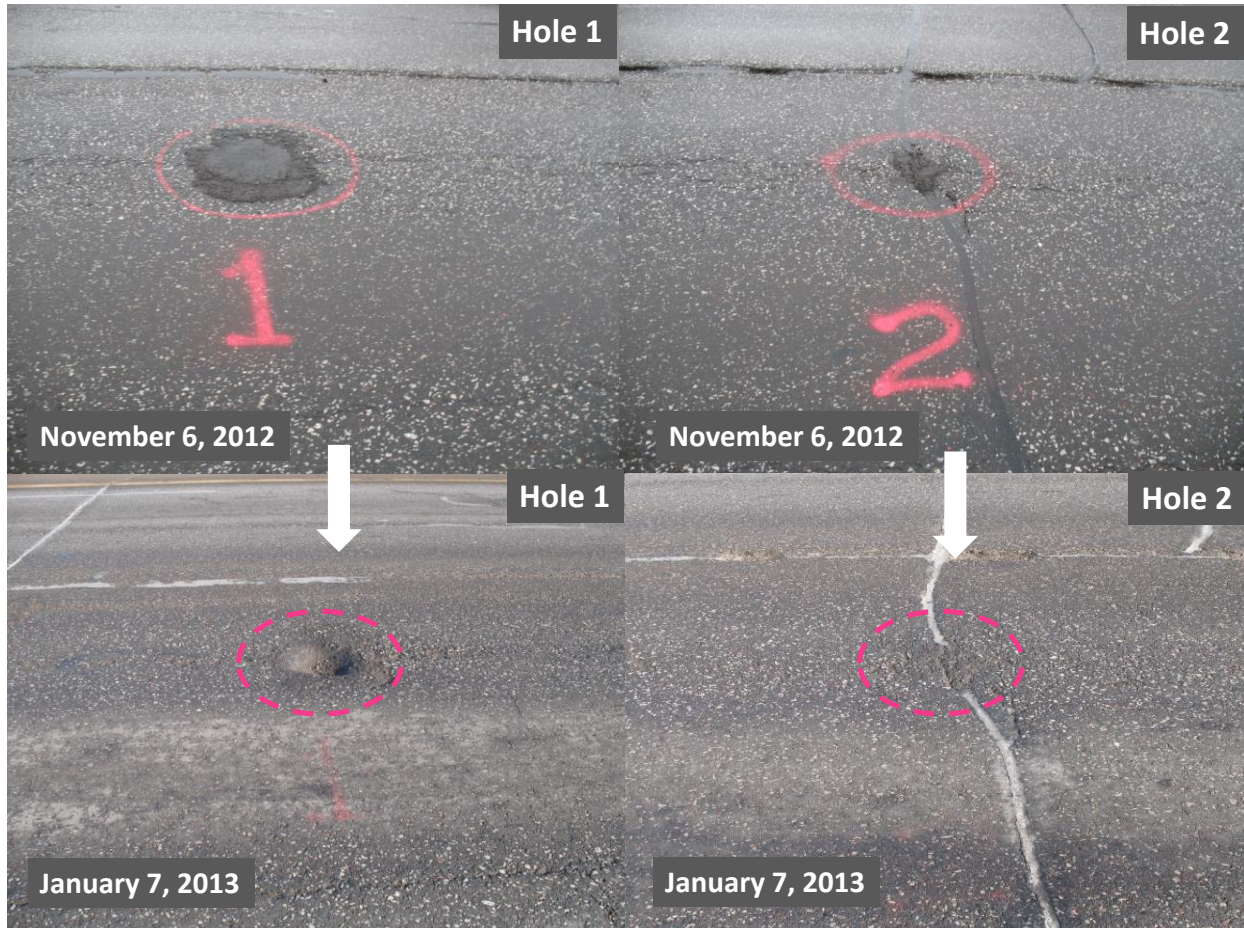
Figure 3.20. Highway 53 microwave pothole repairs (Holes 1 and 2): November 6, 2012 condition (top); and January 7, 2013 condition (bottom).

Two other microwave repairs were performed on October 30, 2013 (Holes 1 and 2). Hole 1 used as-is RAP (no magnetite nor RAS). Later that day, the center of the repair was replaced with a patching material that MUI had brought to Duluth and was interested in testing. Hole 2 was a small pothole repair along a transverse crack; RAP + magnetite only (no RAS) was used. It was heated for four minutes at 50kW power and compacted. This repair attained a temperature of about 80° C to 105° C (180° F to 220° F). Figure 3.20 compares the condition of both repairs, within one week of installation (November 6, 2012) and two months later (January 7, 2013). As Figure 3.20 shows, the center of the Hole 1 repair (the MUI test patch portion) lost material with time, while the as-is RAP remained relatively intact. The Hole 2 repair remained intact until it was also removed by the fall 2013 mill-and-fill repairs described previously.

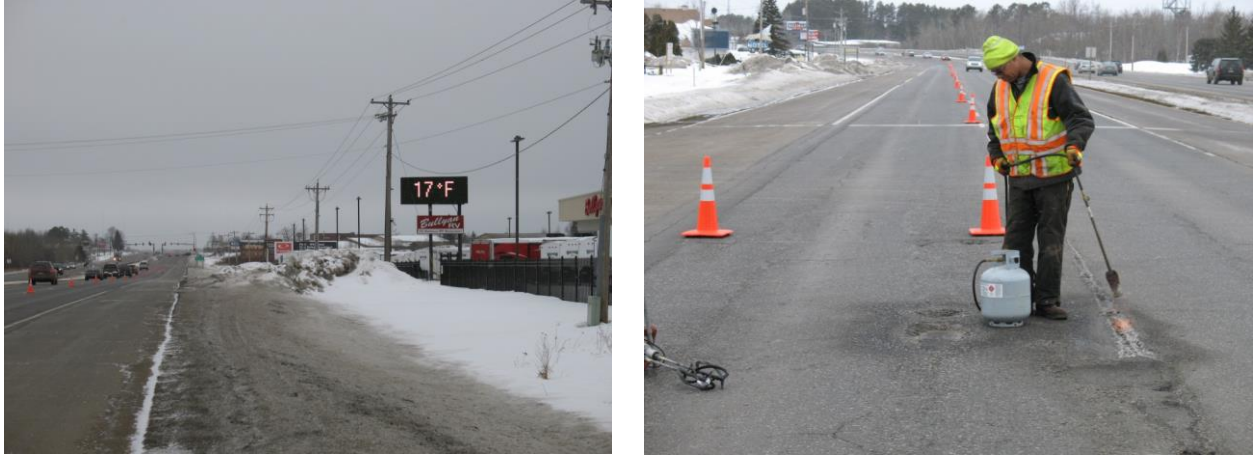
Figure 3.21. Temperature conditions (17° F; -8° C) and pavement preparation for March 1, 2013, field trial/demonstration.

This second project field trial/demonstration in Duluth was truly an opportunity to conduct cold-temperature repair tests (Fig. 3.21). Again, MnDOT District 1 personnel provided traffic control and prepared the pavement and potholes for repair. A representative from TCC Materials (Rapid Patch) was present, and Microwave Utilities, Inc. (MUI) provided the microwave equipment and operators.
