Evaluate and Develop Innovative Pavement Repair and Patching: Taconite-based Repair Options

Minnesota
Department of
Transportation

January 2016

Research Project
Final Report 2016-03

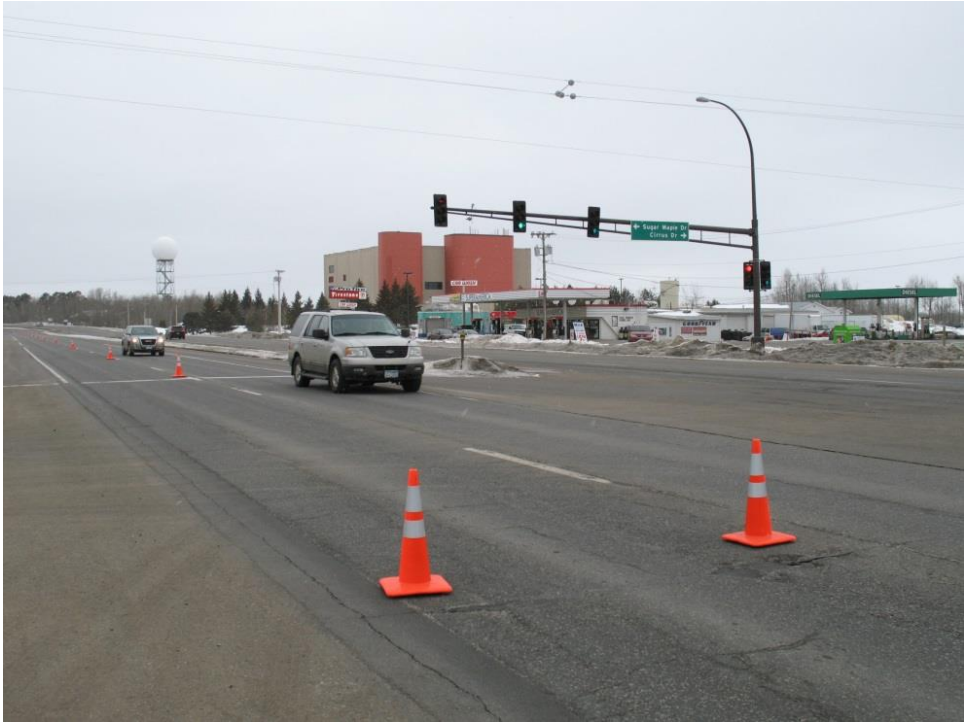
The Rapid Patch repairs were installed at two locations along Highway 53 in Duluth: 1) near the traffic lights at the intersection of Cirrus Drive and Highway 53 (Fig. 3.22); and 2) about a quarter mile to the southeast, at the same location of the October 30, 2012, HeatWurx #2 repair (next to the Monaco Air sign). Microwave repairs were also made at the Monaco Air sign location.

Figure 3.22. Location of first March 1, 2013, Rapid Patch repair; Highway 53, Duluth (NRRI building in background).

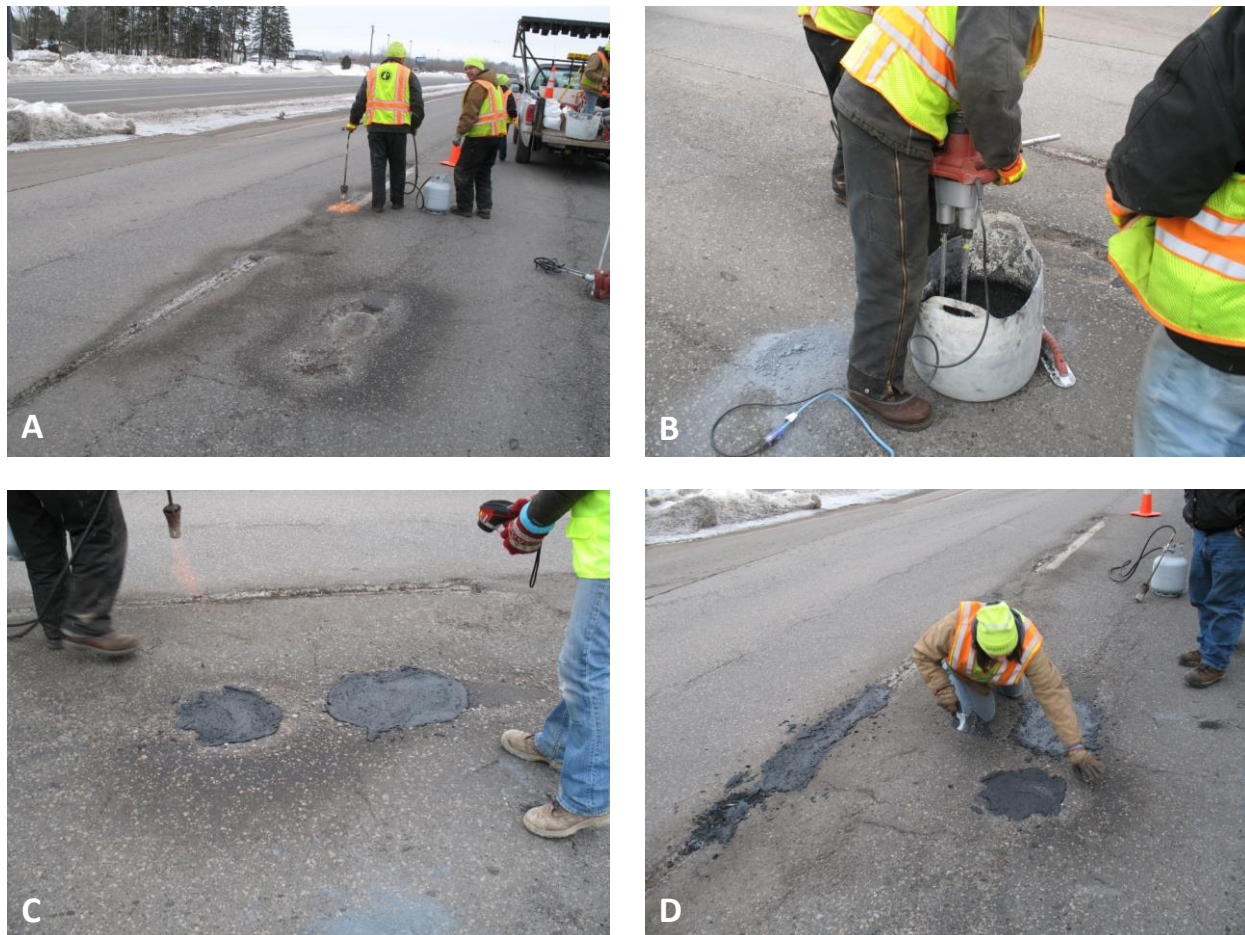
Figure 3.23. Rapid Patch preparation and repairs at Cirrus Drive/Highway 53 intersection location, March 1, 2013.

Figure 3.23 summarizes the Rapid Patch repair preparation and installation performed at the Cirrus Drive/Highway 53 intersection location on March 1, 2013.

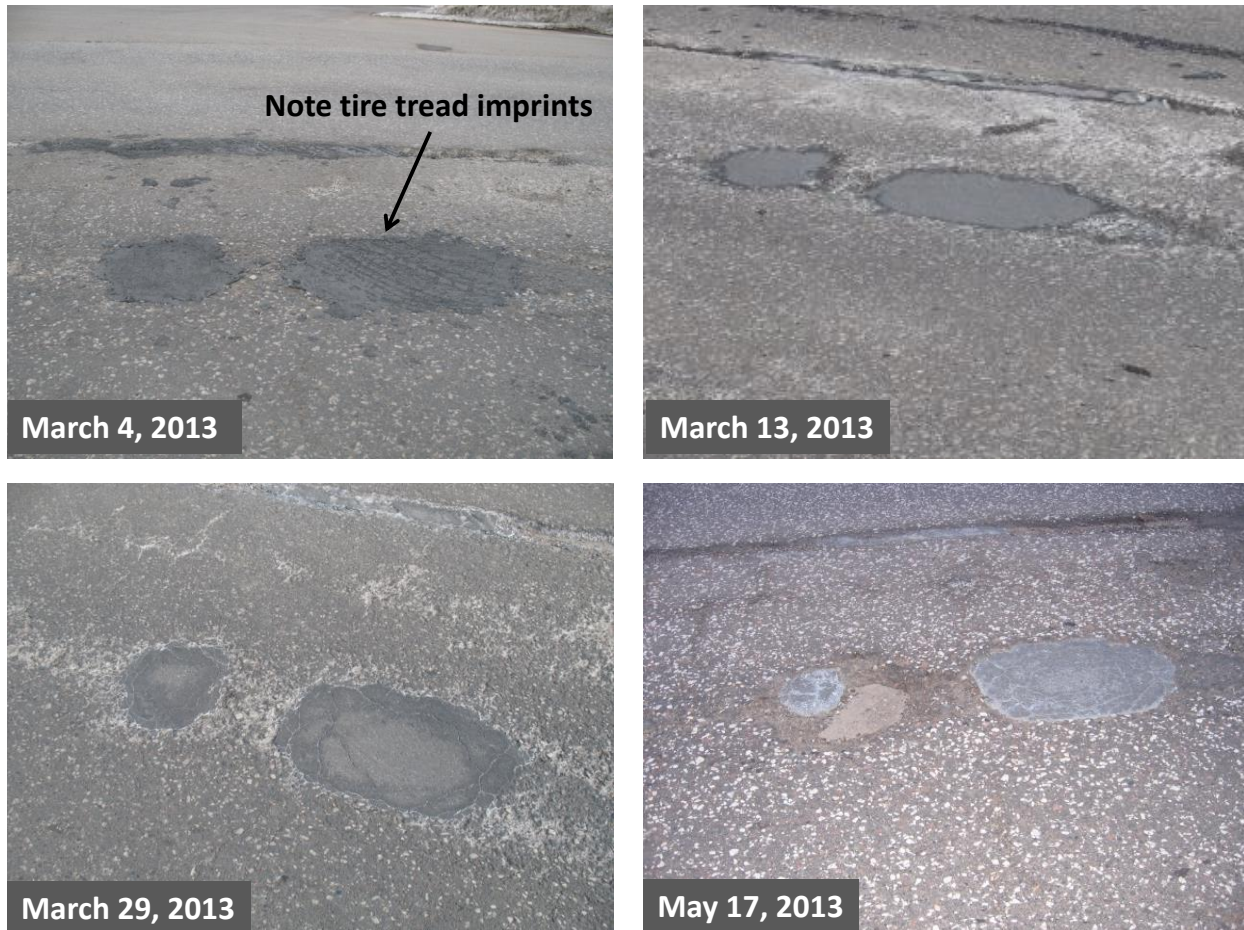
Figure 3.24. Documentation of condition of the Rapid Patch Cirrus Drive/Highway 53 repair over time (March 4 through May 17, 2013).

As described previously, the Rapid Patch compound can be provided in either a summer or winter formulation (i.e., longer workability and slower set time in the summer, or quicker workability and faster set times in the winter). Unfortunately, the summer formulation was used during the March 1, 2013 installation and took much longer to set up than it did in the fall, despite the exothermic reaction that occurs when the compound is mixed. As the tire tread imprints in the March 4 photo of Figure 3.24 indicate, the compound remained soft at its surface more than an hour after installation. Still, it had firmed sufficiently to resist serious deformation. Given that the ambient temperature was -8 C° (17° F), this outcome showed that a winter formulation would have been the better choice for the cold conditions. Figure 3.24 also documents the condition of the Rapid Patch Cirrus Drive/Highway 53 repair over time. Note that most of the repair was missing from the smaller of the pothole repairs by May 17, 2013, while the other larger repair remained intact.

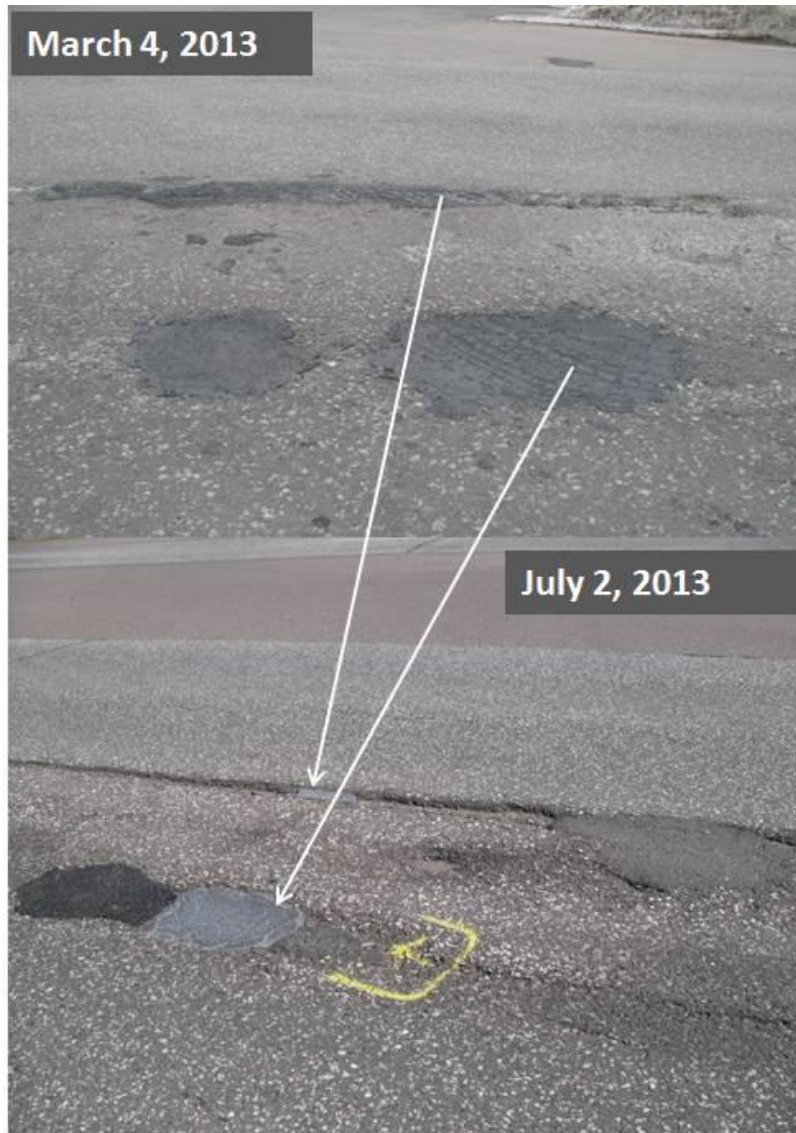
Figure 3.25. Condition of Hwy 53/Cirrus Drive Rapid Patch repair on March 4 and July 2, 2013.

Figure 3.25 shows the repair's condition on July 2, 2013, compared to its condition shortly after installation (March 4). By July 2, most of the material placed in the longitudinal crack was missing, while most of the larger "tread-imprinted" repair remained intact. Figure 3.26 shows the repair as of July 30, 2013. Despite its cracked appearance, the repair stayed in place. Later in 2013 a mill-and-fill was performed to repair the longitudinal and wheel-path cracking prevalent along this stretch of Highway 53, and the repairs at this location—as they were at the Bullyan HeatWurx and microwave repair location—were paved over (Fig. 3.27).

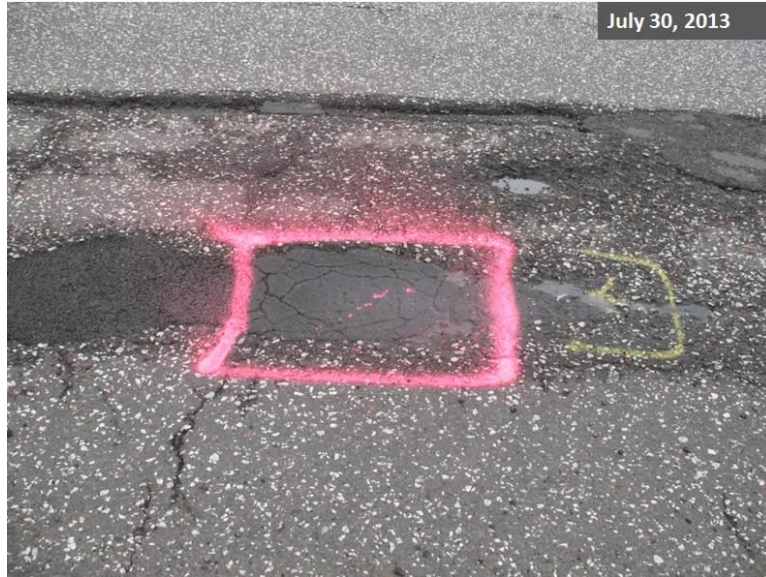
Figure 3.26. Condition of Hwy 53/Cirrus Drive Rapid Patch repair on July 30, 2013.

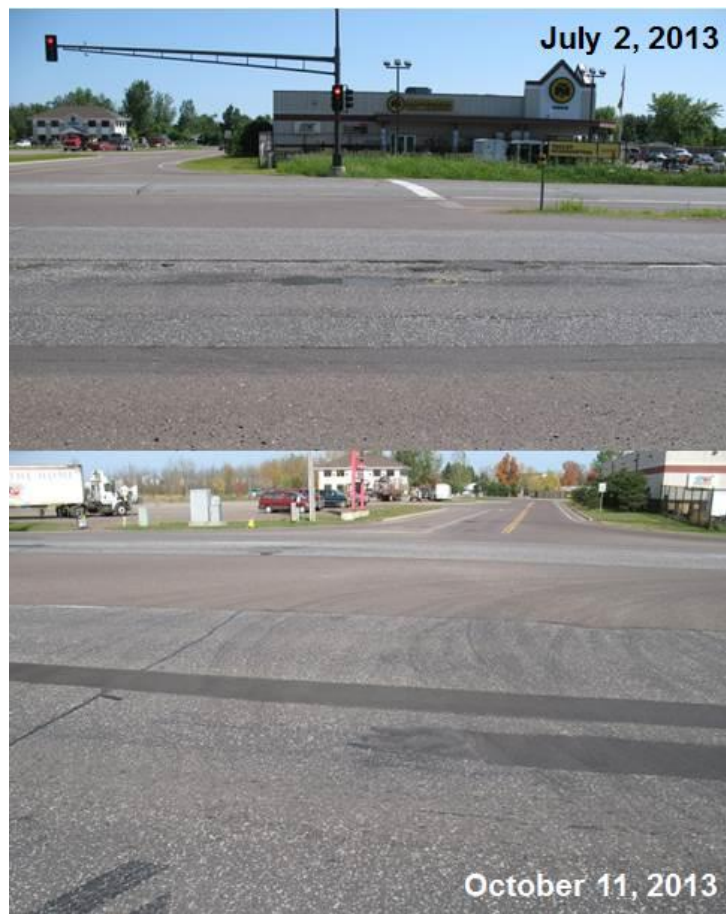
Figure 3.27. Mill-and-fill of Hwy 53/Cirrus Drive repair location.

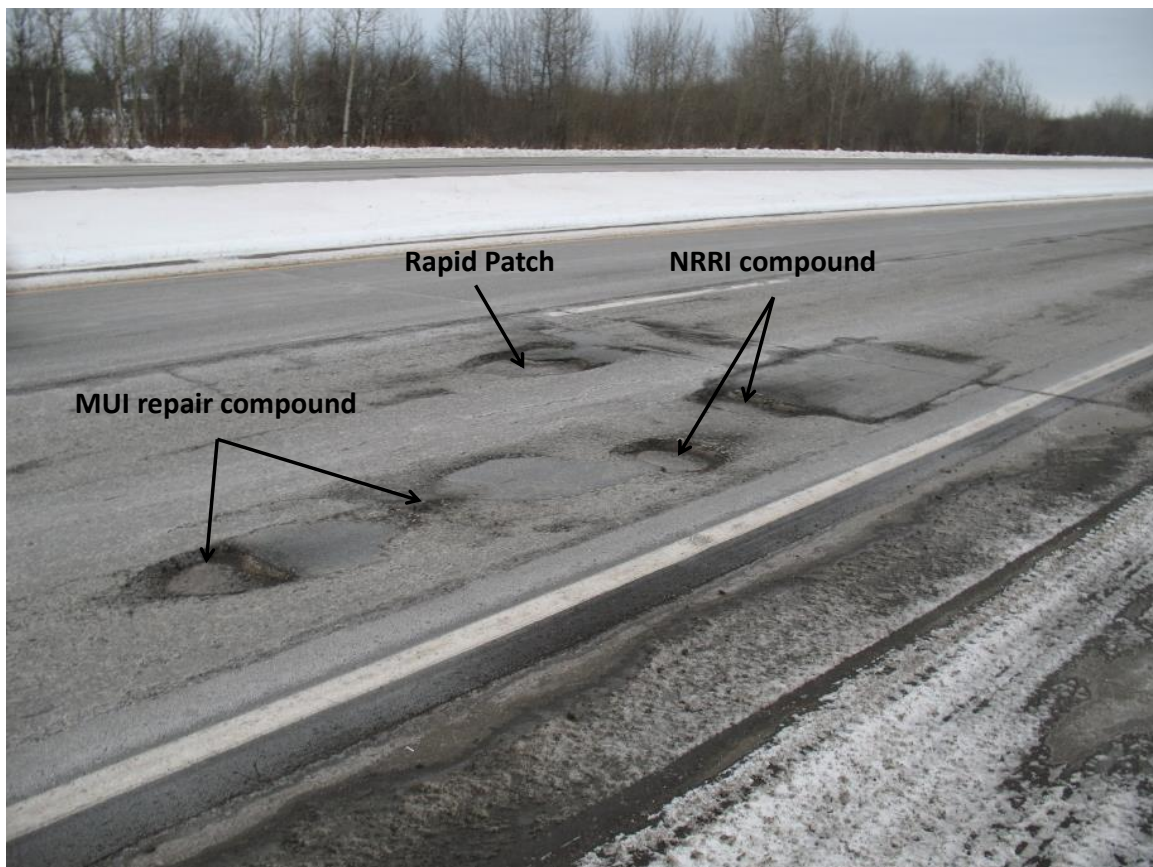
Figure 3.28. Highway 53 Monaco Air sign location for March 1, 2013 field trial; target holes prior to patching.

Figure 3.28 shows the pre-repair condition of target potholes, and notes where each repair was to be placed. Note also: 1) the large rectangular patch to the right of the notation, "NRRI compound" in Figure 3.28; it was a hot-mix repair installed in late November 2012 that replaced the original October 30, 2012, HeatWurx repair; and 2) the two patches to the immediate right of both MUI arrows; they are an epoxy product previously placed by MnDOT at this location.

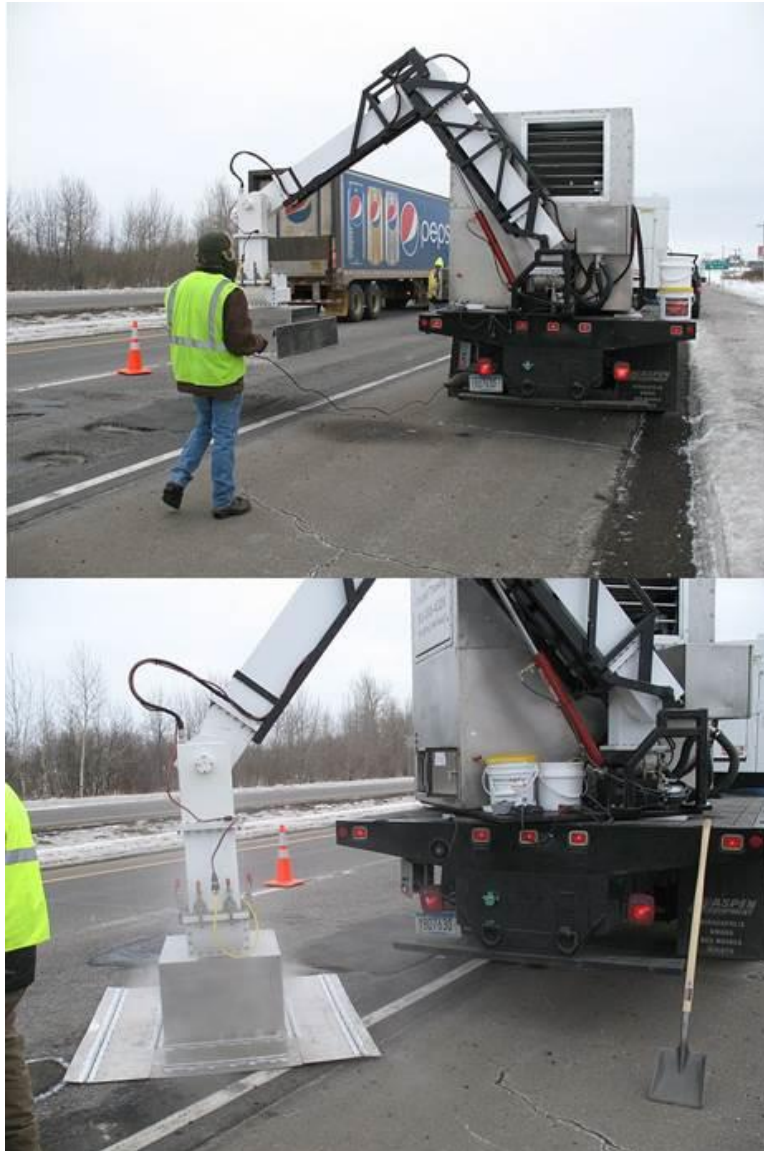
Figure 3.29. Positioning microwave unit (upper photo) and microwave heating (lower photo), Highway 53 Monaco Air sign location: March 1, 2013.

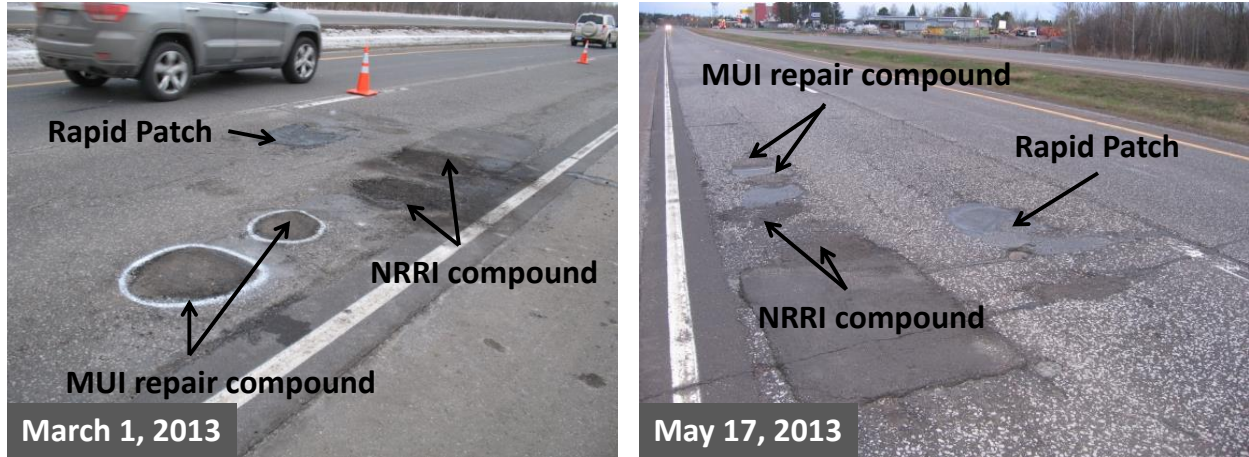
Figure 3.30. Condition of Highway 53 (Monaco Air sign) repairs: March 1 and May 17, 2013.

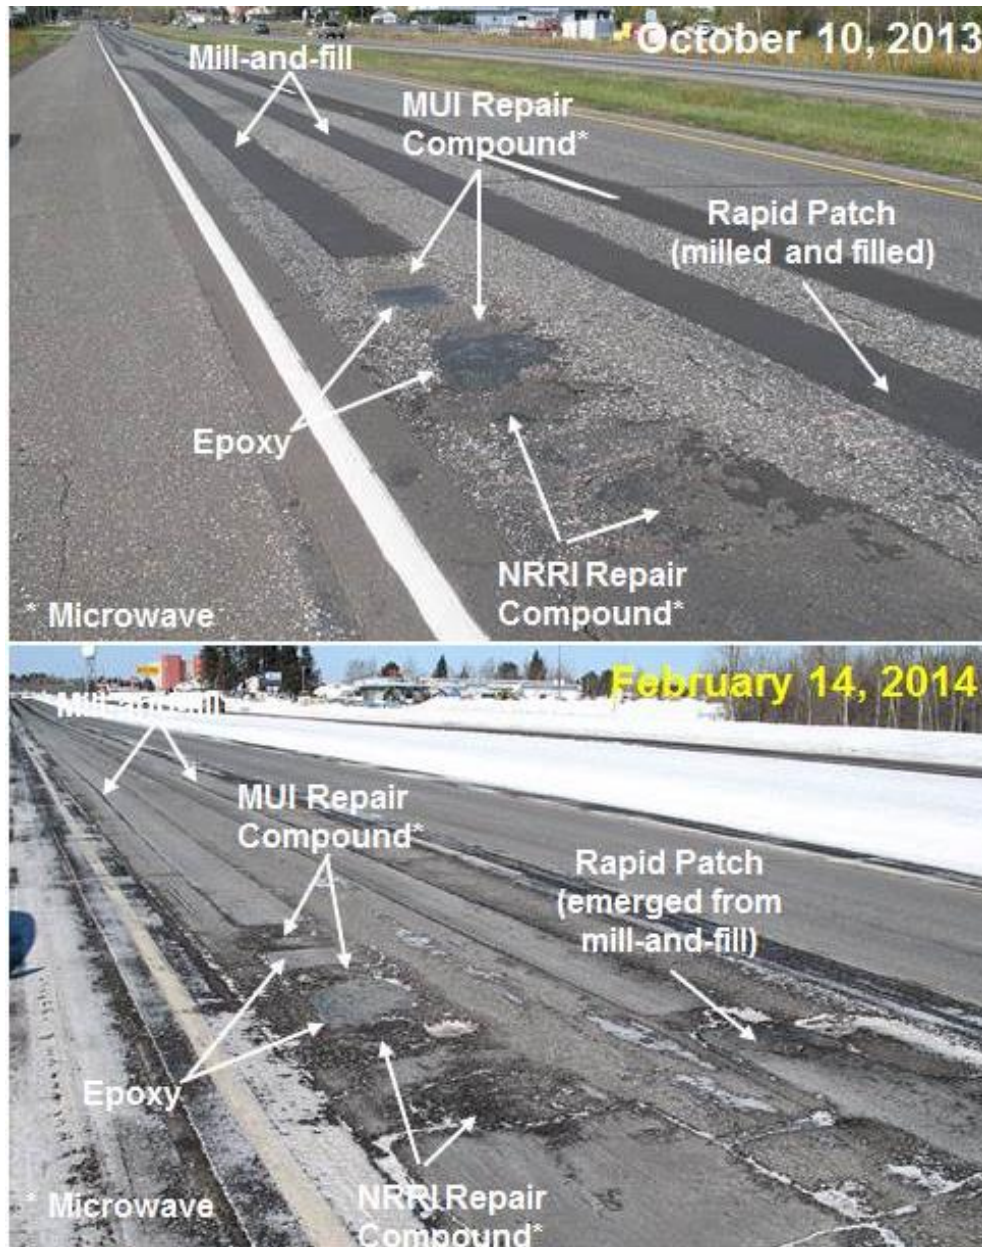
However, Figure 3.33 (February 14, 2014) shows the Rapid Patch repair had only been partially milled out and filled; its hard cementitious properties evidently prevented a full-depth milling and filling to be achieved, with the thin veneer of fill wearing away and exposing the Rapid Patch. Importantly, Figure 3.33 shows that each repair was largely intact nearly one full year after installation.

Figure 3.33. Condition of Highway 53 (Monaco Air sign) location repairs: October 10, 2013 and February 14, 2014.

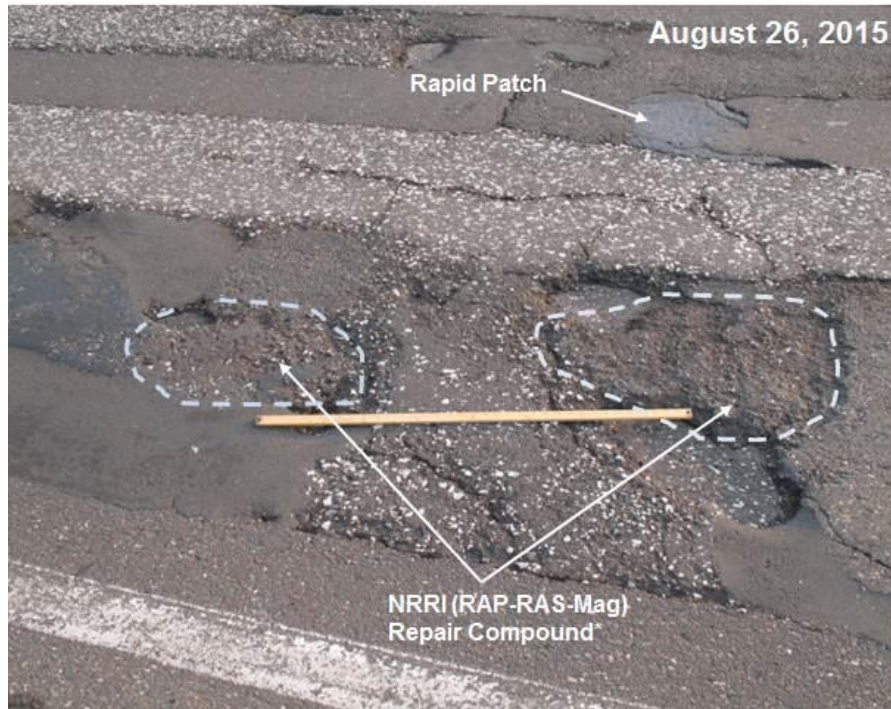
Figure 3.36. Highway 53 (Monaco Air sign) location, NRRI RAP-RAS-Mag microwave repairs (dashed outlines) and the Rapid Patch repair: August 26, 2015.

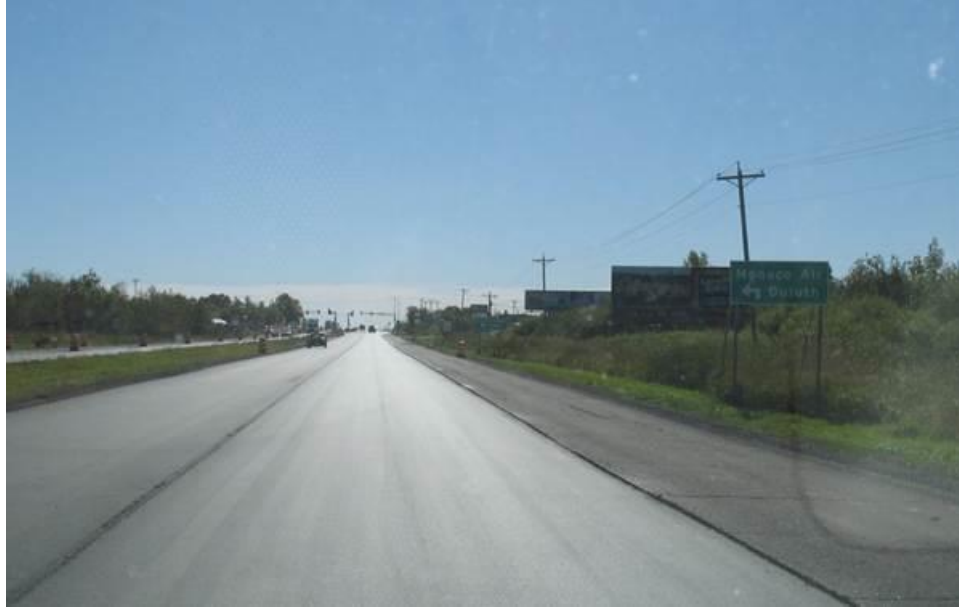
As of September 29, 2015, this section of Highway 53 had undergone a complete mill-and-overlay rehabilitation (Fig. 3.37). No pothole repairs should be necessary for quite some time.

**Figure 3.37. New mill-and-overlay of Highway 53 at Monaco Air sign field trial location:
September 29, 2015.**

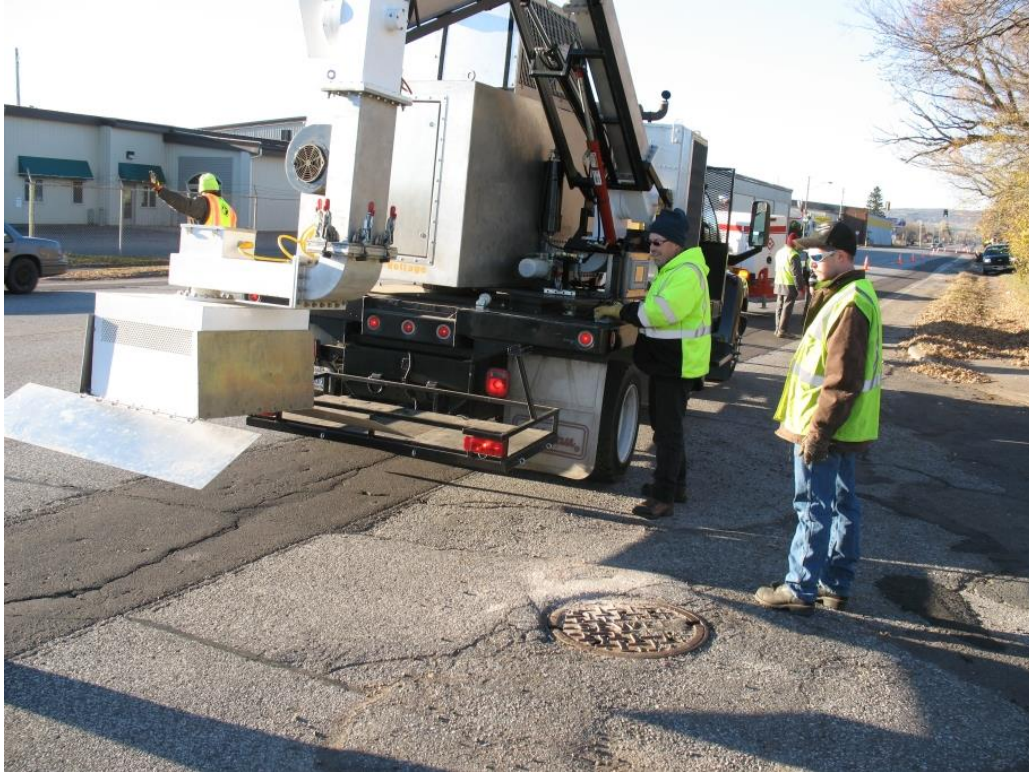
Prior to the repair, MUI’s microwave unit was also tested on top of the manhole cover to evaluate how the microwaves interacted with the steel (Fig. 3.39). The unit straddled the cover and pavement, and was operated at 50kW. After a few minutes of microwave treatment, the manhole cover remained much cooler (100° F to 110° F) than the adjacent asphalt pavement (200° F), showing that the microwave energy was being reflected by the steel. However, the reflected microwaves also caused interference with the incoming microwaves, tripping the unit’s safety mechanism; this required the equipment be shut down and reset.

Figure 3.39. Preparing microwave for manhole repair test: 64th Avenue West and Grand Avenue.

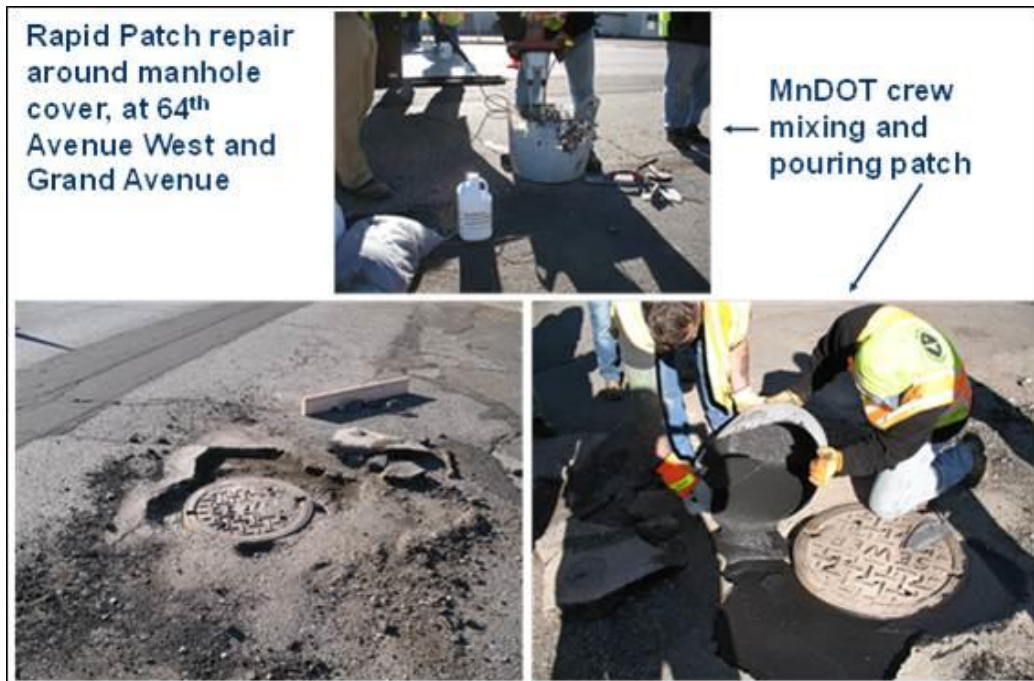
Following microwave treatment, loosened pavement and debris surrounding the manhole was removed, and the Rapid Patch repair was performed (Fig. 3.40).

Figure 3.40. Rapid Patch manhole repair: 64th Avenue West and Grand Avenue.

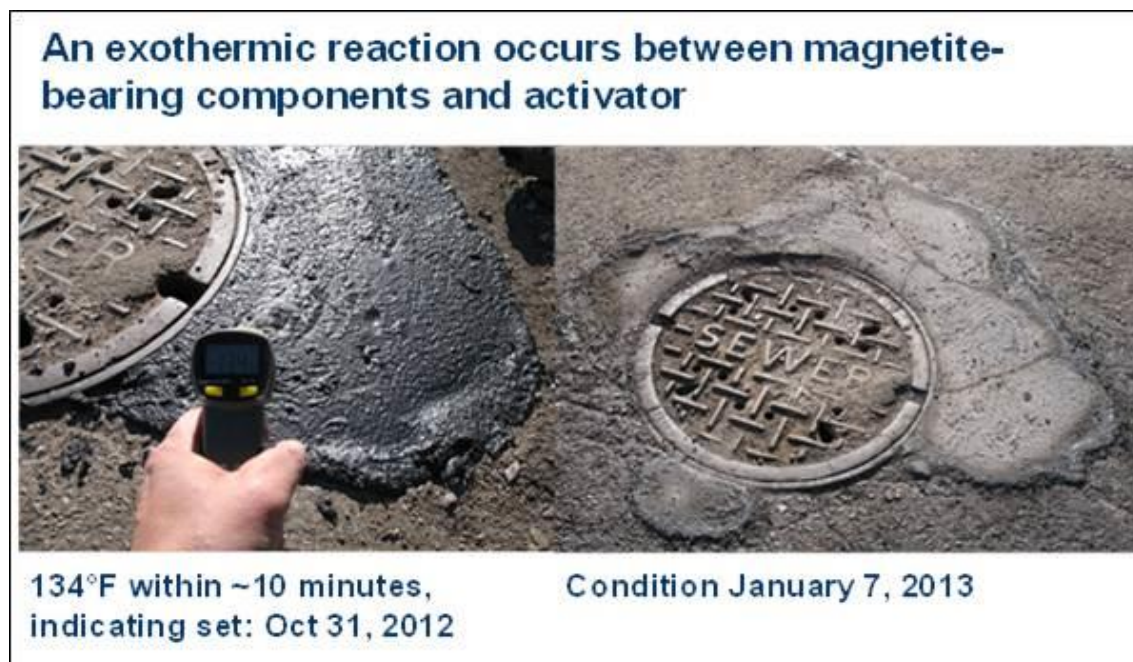
Figure 3.41. Rapid Patch manhole repair: initial set, and condition on January 7, 2013.

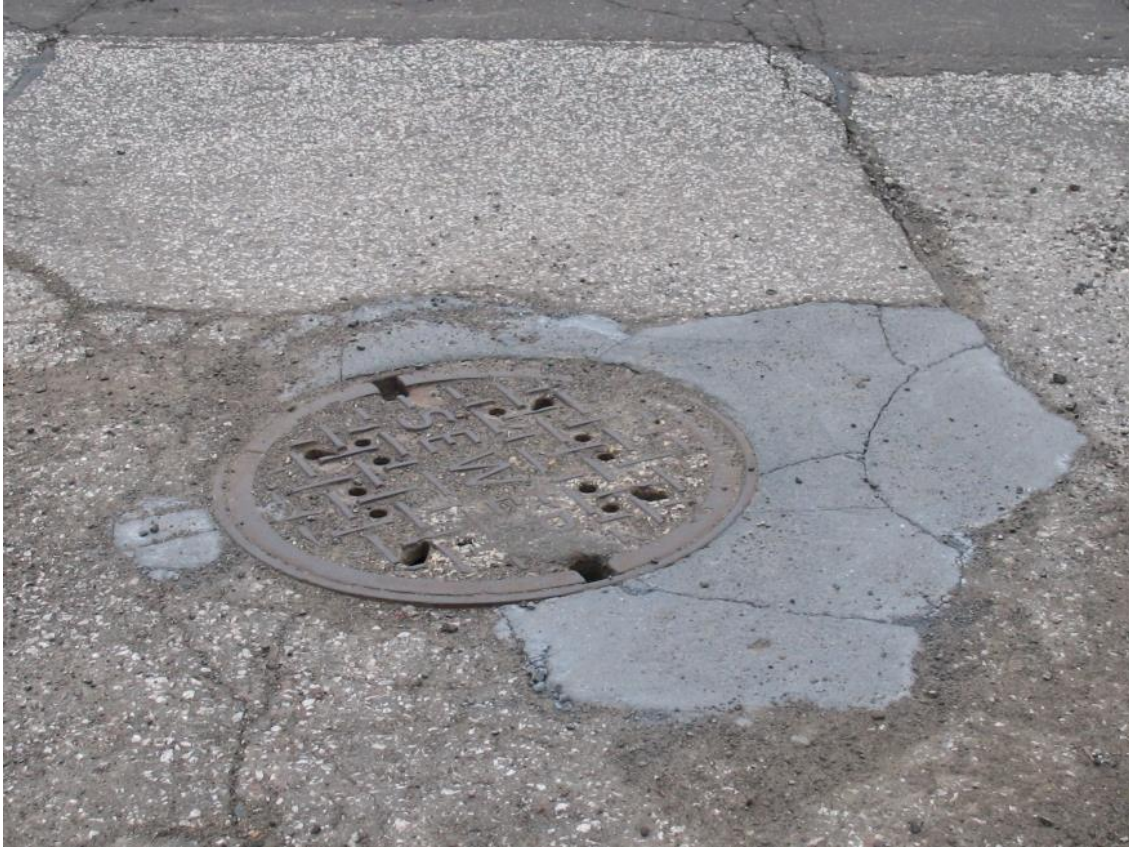
Figures 3.41 and 3.42 show that aside from some cracking, the repair remained well bonded to the manhole rim and pavement, well into the spring of 2013.

Figure 3.42. Rapid Patch manhole repair: Condition on May 5, 2013.

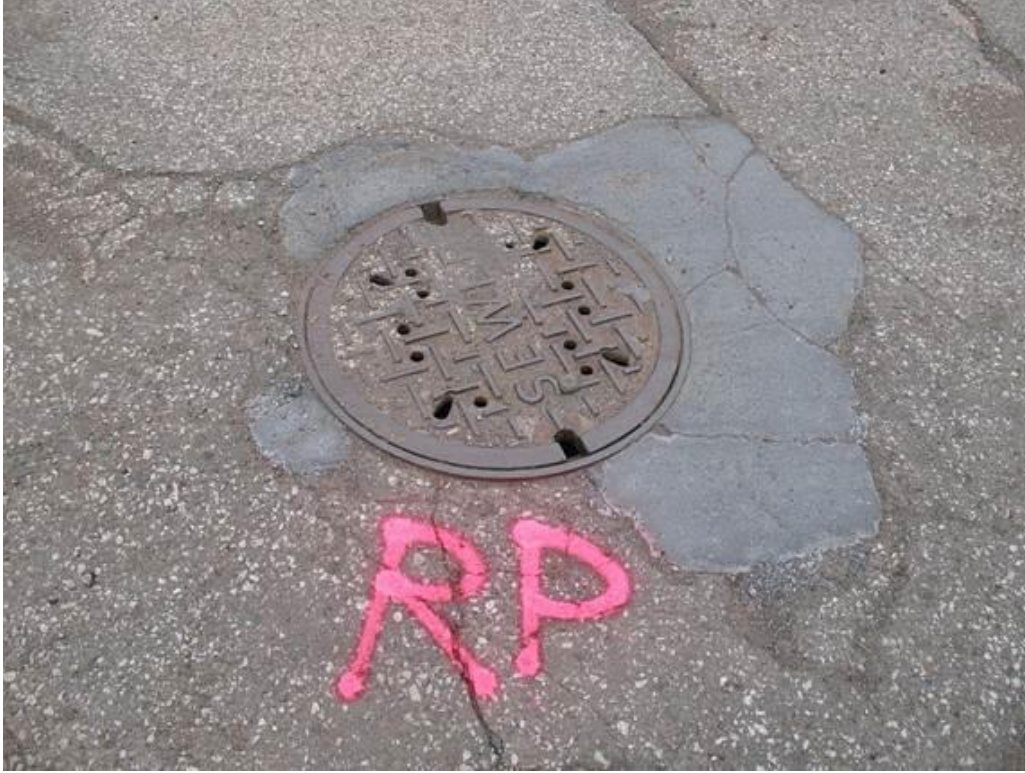
The extended project time allowed for longer-term monitoring and photo-documentation of this repair. Figures 3.43, 3.44, and 3.45 show the condition of the repair on July 30, 2013, December 26, 2014, and August 26, 2015, respectively—a span of over two years.

Figure 3.43. Rapid Patch manhole repair: Condition on July 30, 2013.

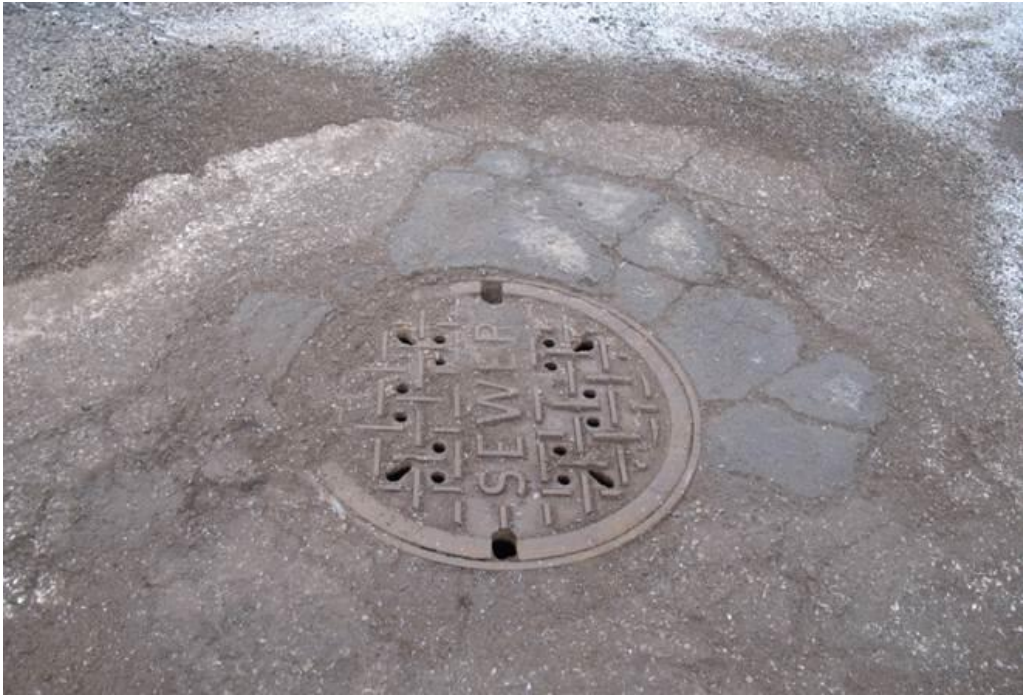
Figure 3.44. Rapid Patch manhole repair: Condition on December 26, 2014.

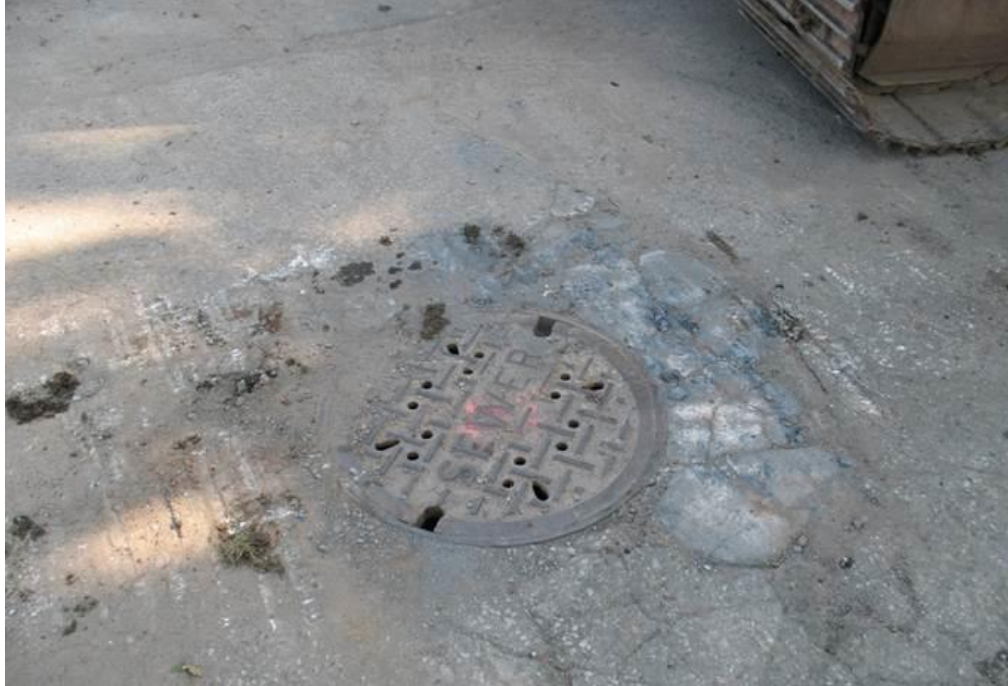
Figure 3.45. Rapid Patch manhole repair: Condition on August 26, 2015.

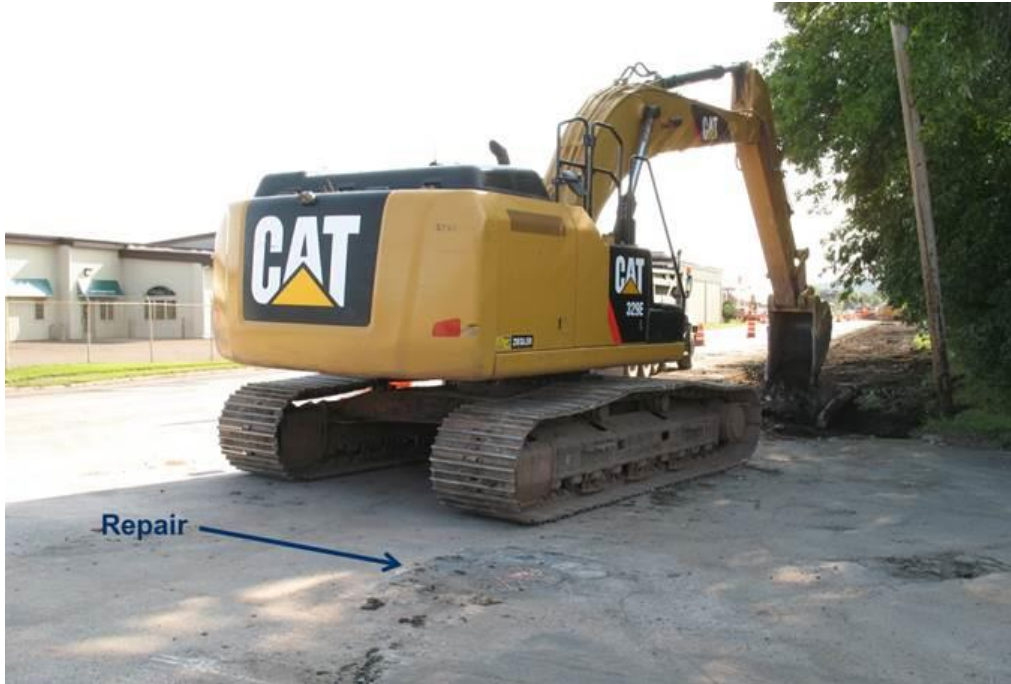
Note the excavator track in the upper right-hand corner of Figure 3.46. The photo was taken literally minutes before the segment of pavement at the repair location was to be removed, as part of a major rehabilitation of Grand Avenue (Fig. 3.46).

Figure 3.46. Rapid Patch manhole repair prior to removal: August 26, 2015.

While the repair exhibited cracking and some material loss, most of the repair remained in place after nearly 34 months of service.

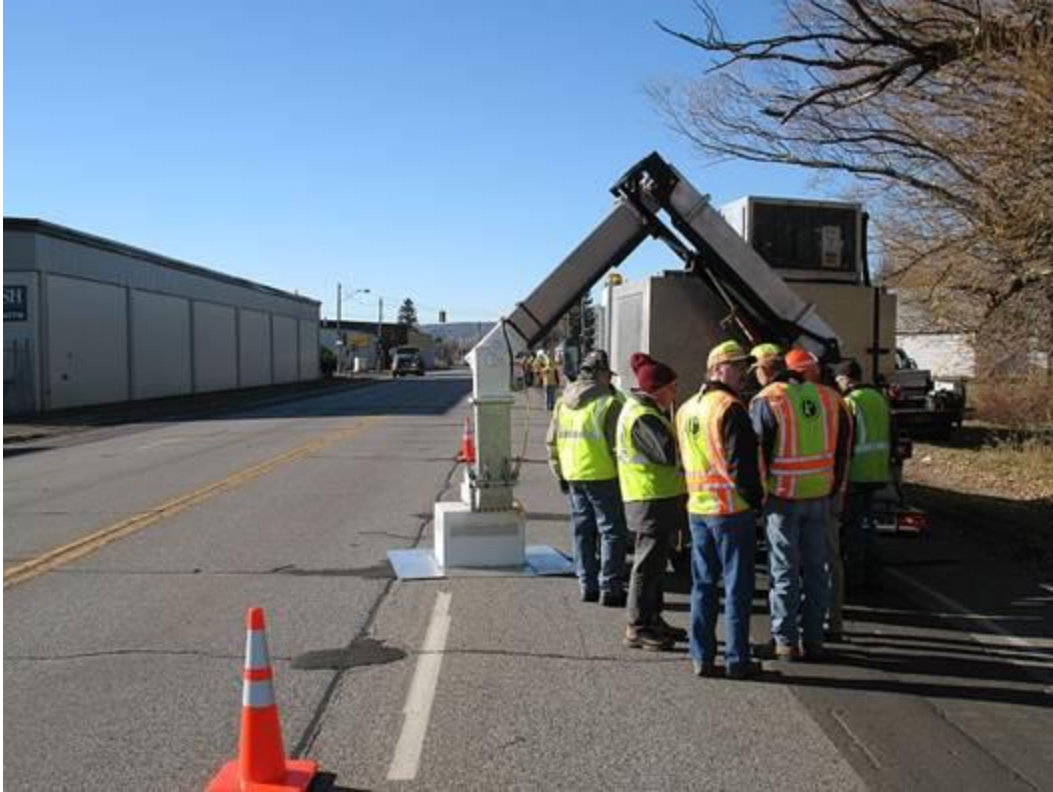
About 200 feet west of the manhole repair, a Rapid Patch repair was placed in the right hand westbound driving lane. A hole was prepared (created) by heating a cold-patch repair and pavement with MUI’s microwave equipment (Fig. 3.47) and removing the asphalt, exposing the rigid concrete pavement below. The surface temperature of the underlying concrete pavement, as measured with an IR thermometer, was about 110° C (230° F); the edge of the surrounding asphalt pavement ranged from about 80° C to 90° C (~180° F to 200° F). This “hot hole” was filled with the Rapid Patch. The heat accelerated the patch’s set time.

**Figure 3.47. Preparing Grand Avenue Rapid Patch repair with microwave unit:
October 31, 2012.**

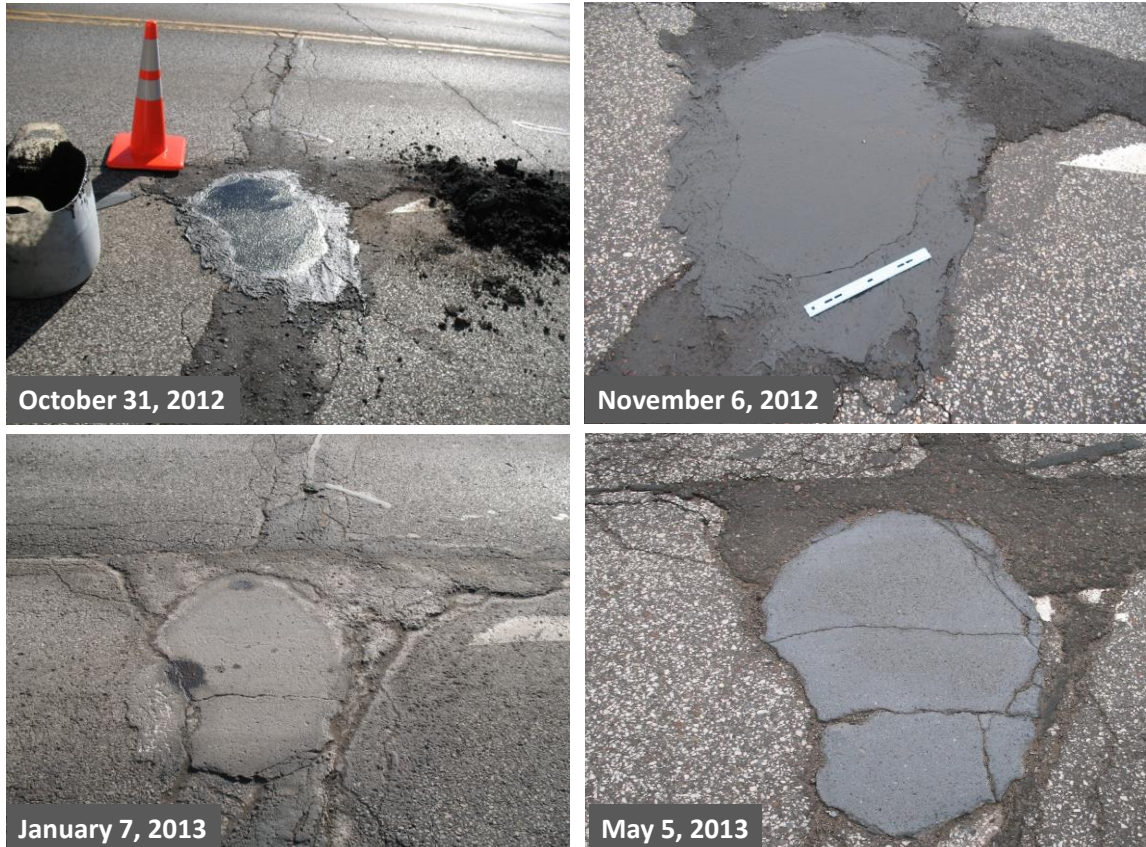
Figure 3.48. Rapid Patch repair condition over time: Grand Avenue driving lane.

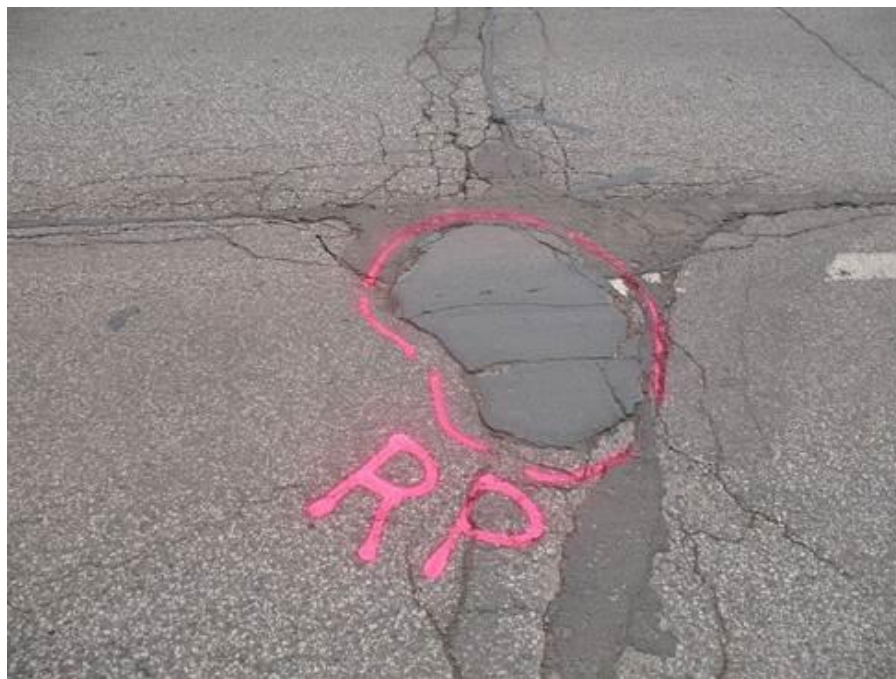
The repair was monitored and photo-documented; its condition over time is shown in Figure 3.48. Considering its location (straddling a large transverse crack in pavement in relatively poor condition) and its rigid nature, the Rapid Patch repair remained resilient through the winter of 2012-2013. Figure 3.49 shows the repair to be in good condition on July 30, 2013. By February 14, 2014 (Fig. 3.50), the repair was showing some degradation and material loss, but most of its volume was still in place 16 months after installation. Later in 2014 it was covered by an asphaltic patch.

Figure 3.49. Rapid Patch repair condition, Grand Avenue driving lane: July 30, 2013.

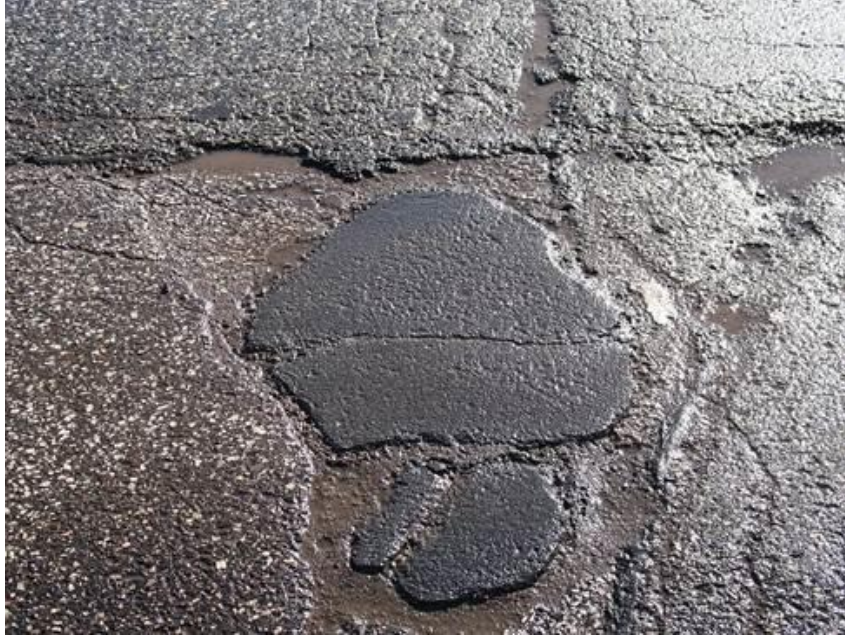
Figure 3.50. Rapid Patch repair condition, Grand Avenue driving lane: February 14, 2014.

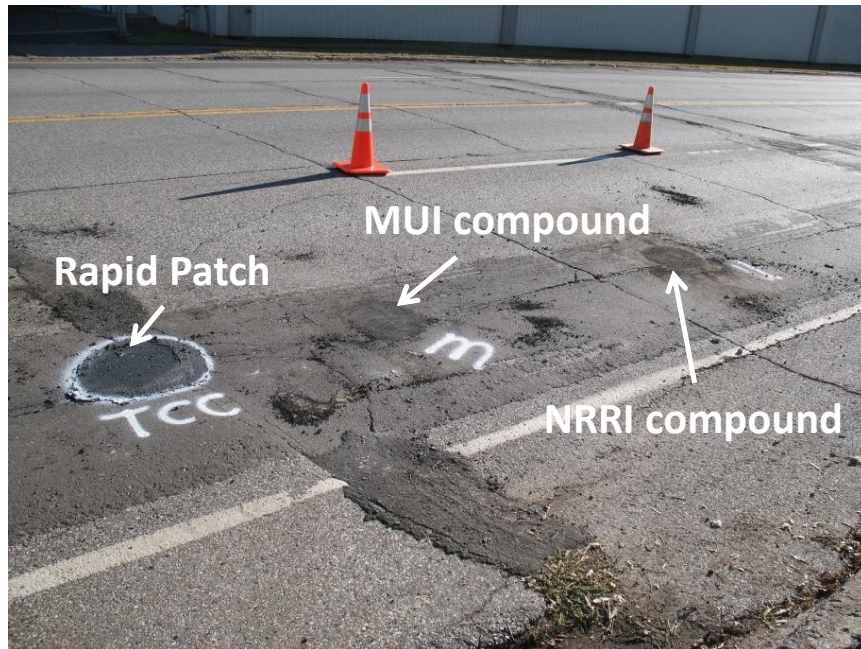
Figure 3.51. Three-hole repair, October 31, 2012, Grand Avenue: TCC Rapid Patch (left); MUI microwave (center); NRRI microwave (right).

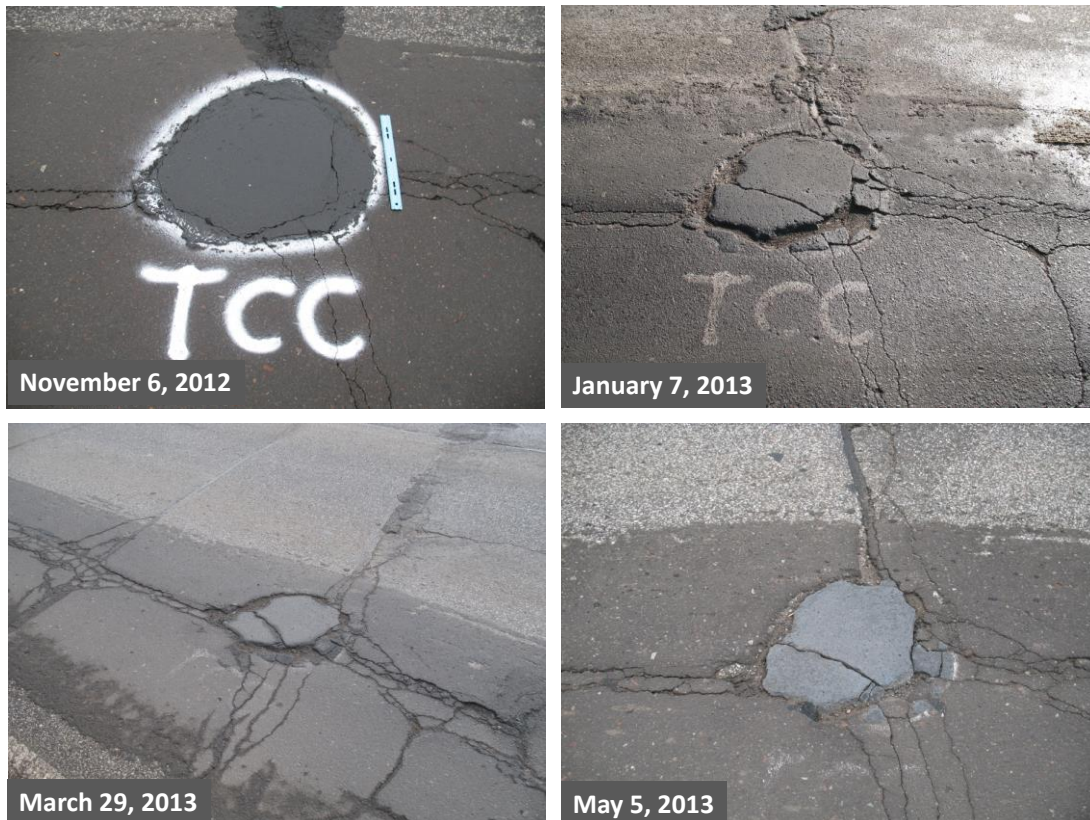
Of the three repairs, only the Rapid Patch repair survived past March of 2013. Figure 3.52 shows the condition of the Rapid Patch repair over time (through May 5, 2013), and Figure 3.53 shows its July 30, 2013 condition and position, next to the patches which replaced the two prior microwave repairs. While cracked, the Rapid Patch repair remained largely intact.

Figure 3.52. Rapid Patch repair condition through May 5, 2013; Grand Avenue wheel path.
