Evaluate and Develop Innovative Pavement Repair and Patching: Taconite-based Repair Options

Minnesota
Department of
Transportation

January 2016

Research Project
Final Report 2016-03

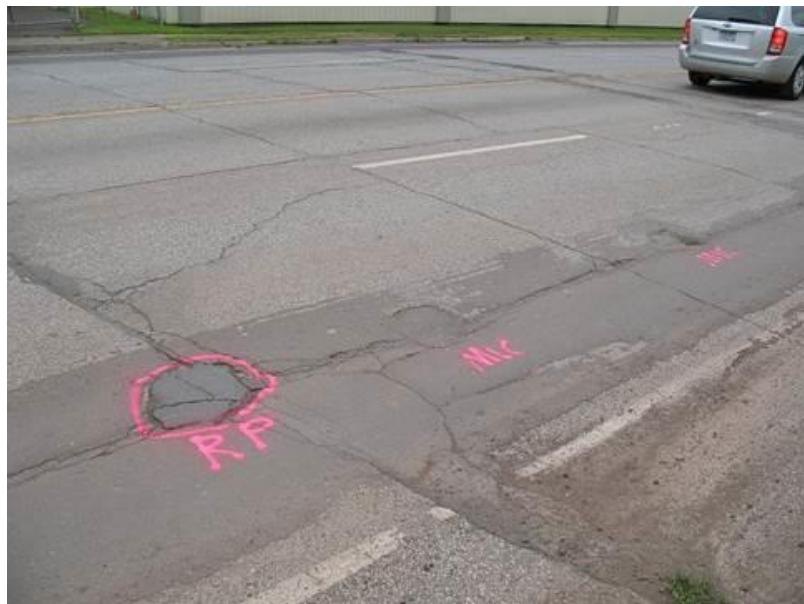
Of the three repairs, only the Rapid Patch repair survived past March of 2013. Figure 3.52 shows the condition of the Rapid Patch repair over time (through May 5, 2013), and Figure 3.53 shows its July 30, 2013 condition and position, next to the patches which replaced the two prior microwave repairs. While cracked, the Rapid Patch repair remained largely intact.

Figure 3.53. Rapid Patch repair condition on July 30, 2013. Replaced microwave repairs to the right.

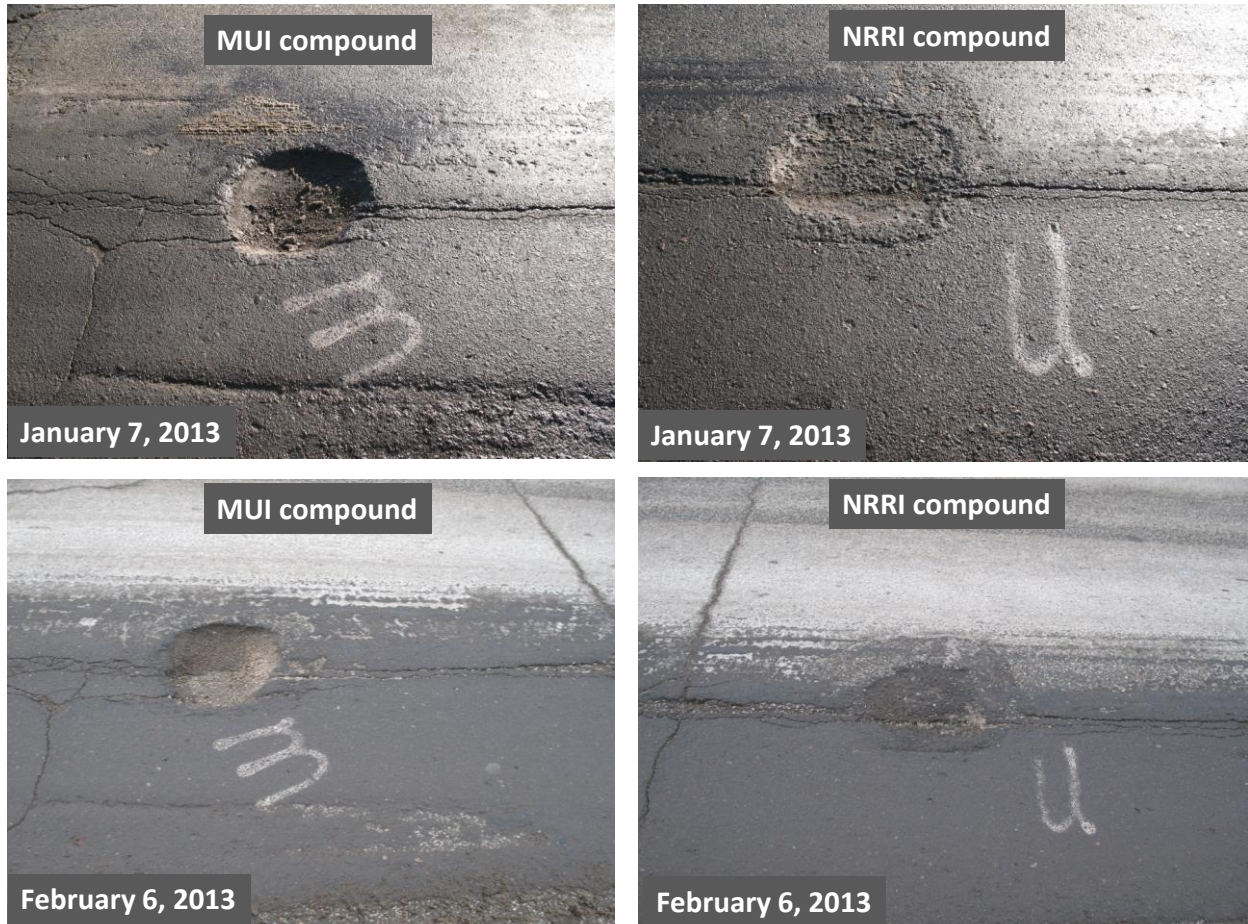
Figure 3.54. MUI and NRRI microwave compounds, Grand Avenue repair comparison.

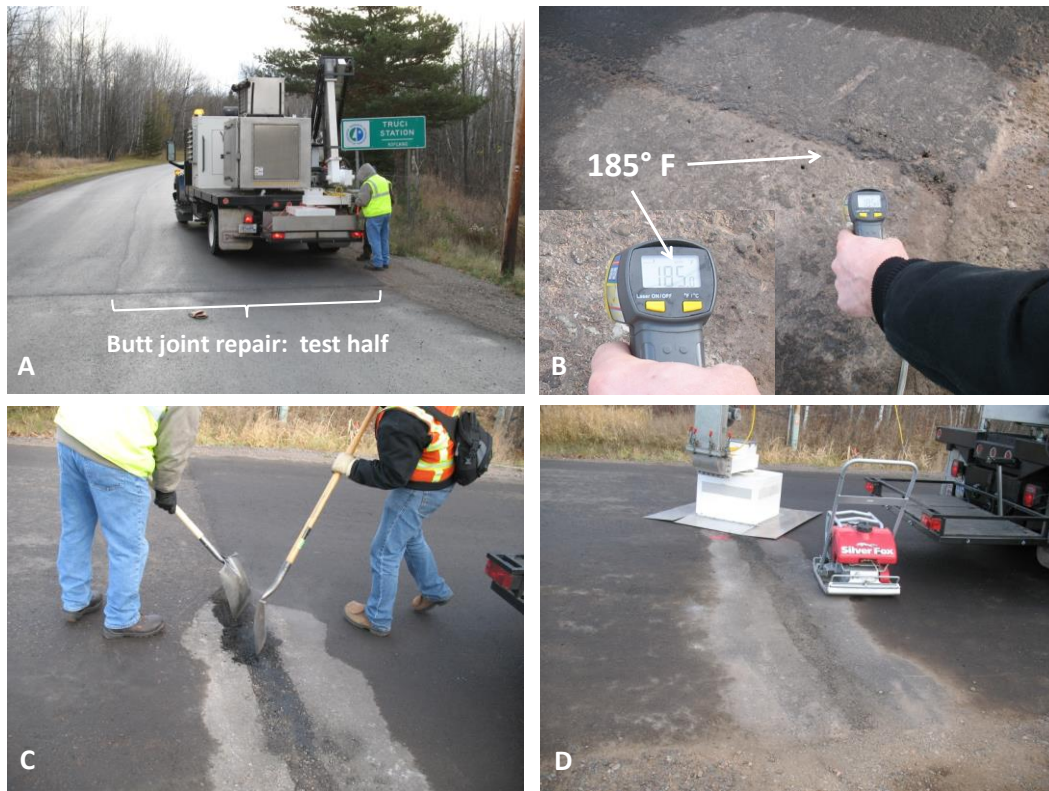
Figure 3.56. Microwave butt joint repair test, Nopeming Truck Station entrance, November 1, 2012.

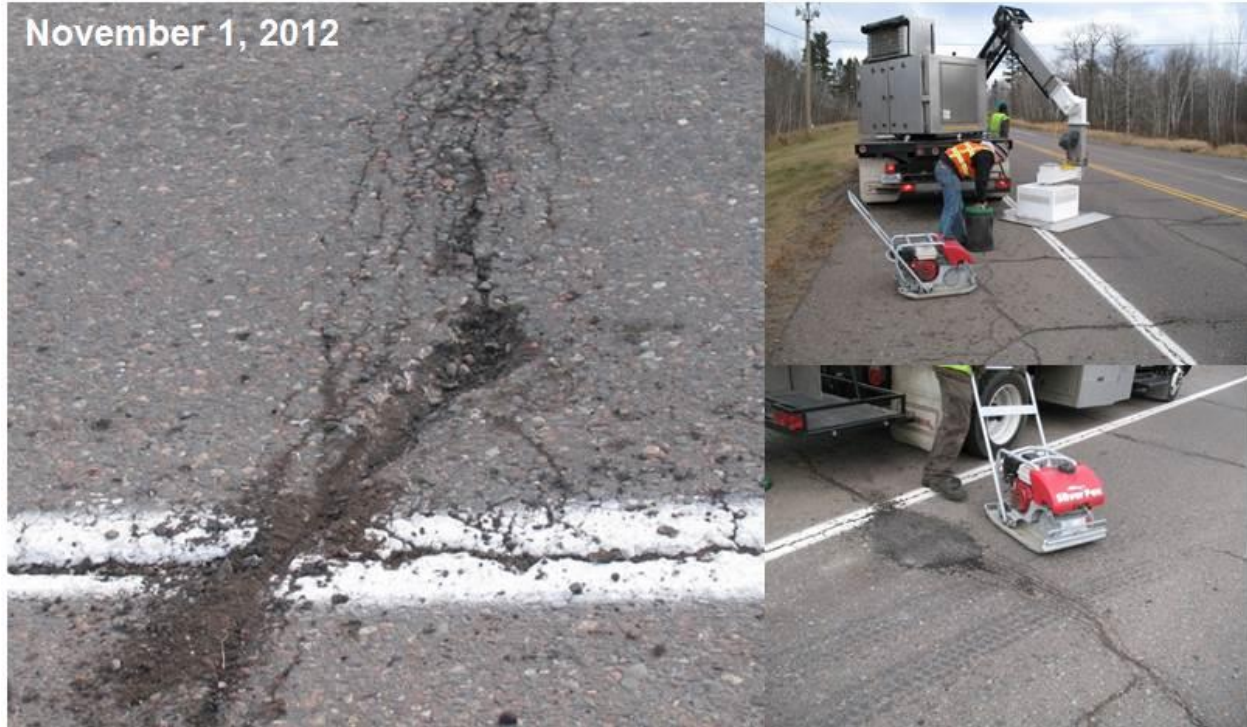
A microwave repair was also performed at the Becks Road/Midway Road location (refer to Figure 3.55) on November 1, 2012. Figure 3.62 (left photo) shows the transverse crack pothole near the fog line of the southbound lane; the smaller two photos show the equipment deployed and the compacted repair.

Figure 3.62. Becks Road/Midway Road pothole (left) and microwave repair (right): November 1, 2012.

The repair was performed as follows: The hole was first pre-heated for six minutes at 50kW. The softened asphalt was then shoveled and stirred, and NRRI's RAP-RAS-Mag mix was added and mixed to provide sufficient volume to fill the hole when compacted. The mixture was tamped slightly with a shovel, and microwave energy was applied for two more minutes at 50kW. A portable compactor was used to complete the repair. The temperature of the repair was measured at about 210° F (100° C). The entire repair took about ten minutes to perform.

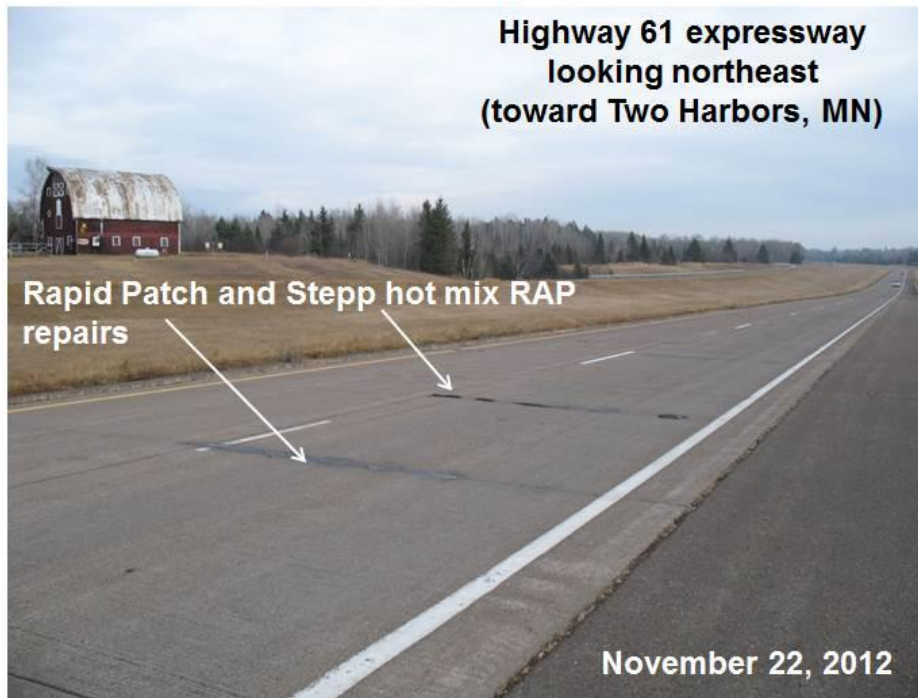
As described earlier, in November 2012, MnDOT used Rapid Patch and the Stepp equipment to repair potholes that formed between deteriorating panel joints and transverse cracks along a section of concrete pavement on the Highway 61 expressway between Duluth and Two Harbors (Figs. 3.64 and 3.65).

Figure 3.65. View of Highway 61 expressway Rapid Patch and Stepp hot mix RAP repairs: November 22, 2012.

The Highway 61 expressway repairs were conducted to allow for a side-by-side comparison of two repair techniques: 1) the Stepp asphalt (RAP) recycler; and 2) the Rapid Patch product. NRRI performed inspection and documentation of the Highway 61 repairs in November and December 2012. An illustrative/photographic summary of the Hwy 61 repair documentation was assembled and provided to members of the project's technical advisory panel (TAP) in late December 2012. Intermittent follow-up inspection and photo-documentation of the Highway 61 expressway occurred through 2014. Figures 3.66-3.68 show how the Rapid Patch repairs performed relative to the Stepp asphalt repairs. The cementitious nature of Rapid Patch makes it well-matched for rigid concrete pavement repairs and maintenance.

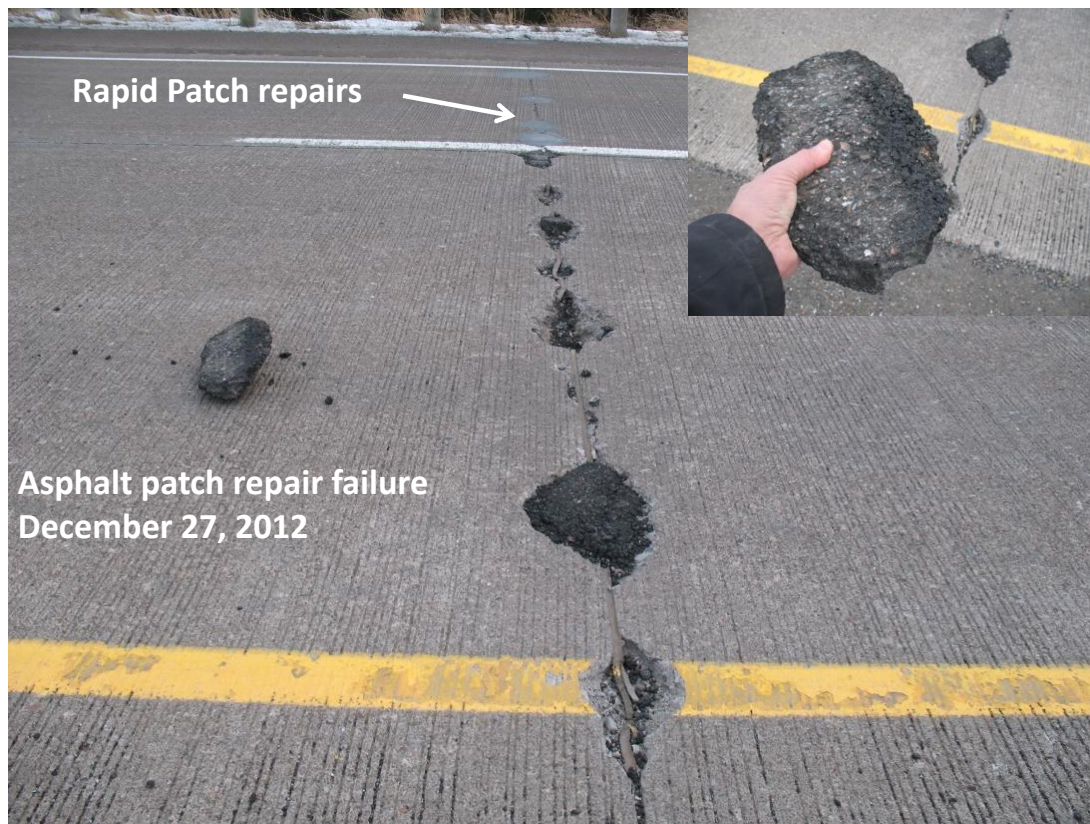
Figure 3.66. Highway 61 expressway asphalt patch repair failure: December 27, 2012.

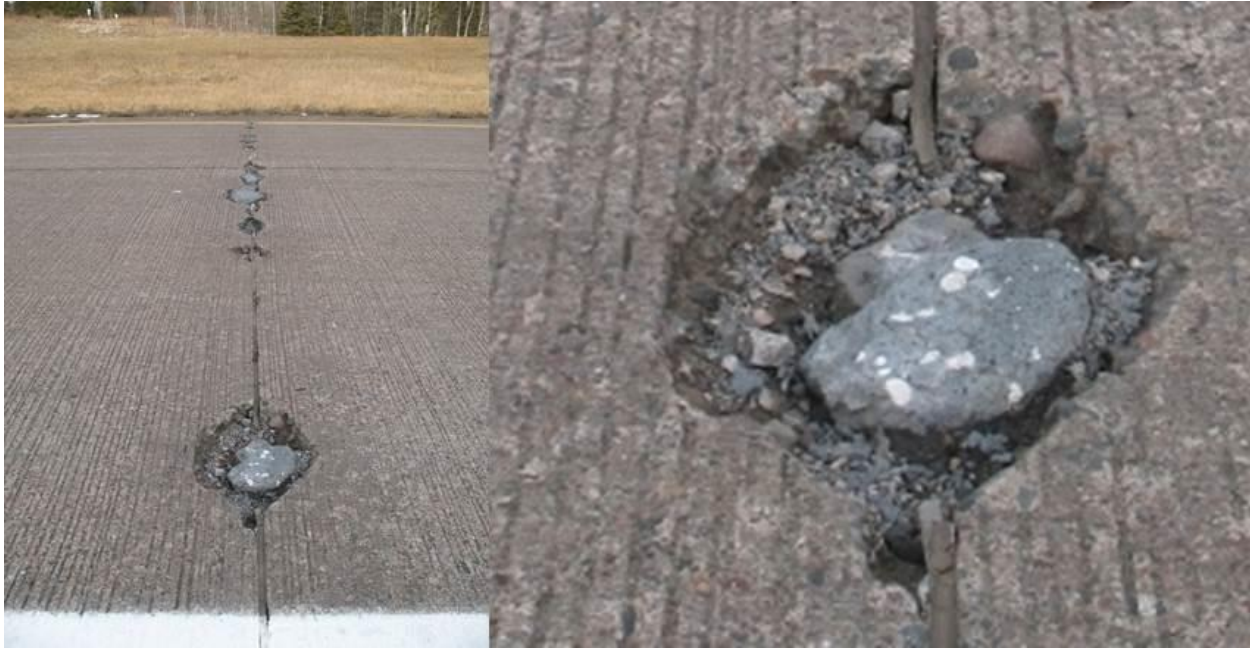
Figure 3.69. Failing condition of a Highway 61 Rapid Patch repair 2 years after installation: December 26, 2014.

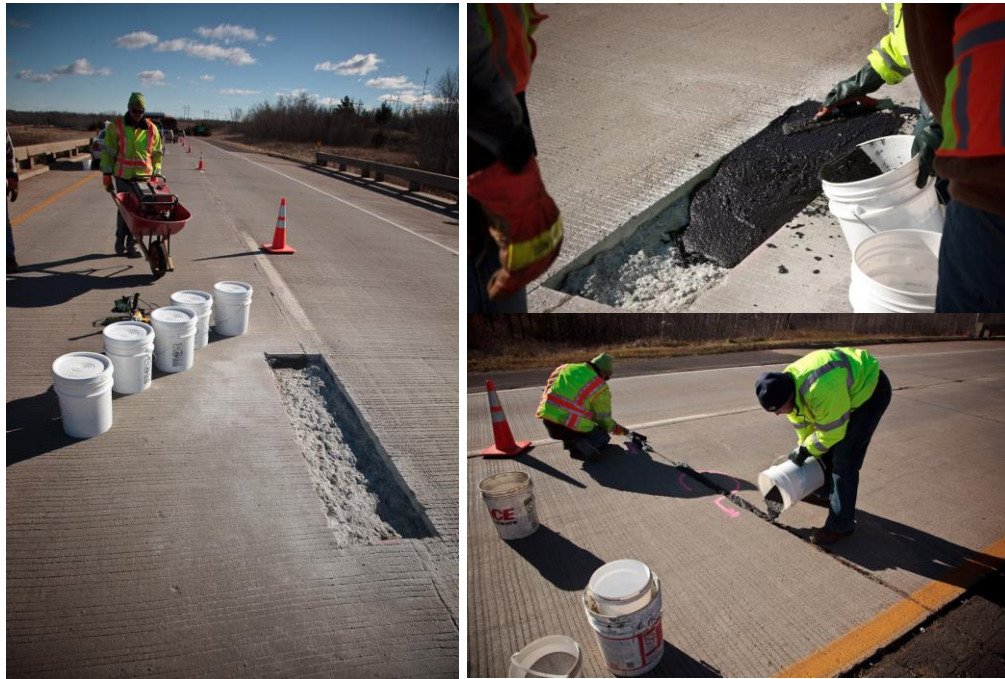
Well before the start of this project, NRRI developed the prototype formulation for the Rapid Patch repair compound. An early field test was conducted with MnDOT District 1 to fill a saw-cut on a concrete bridge deck near Keewatin, MN. The installation (Fig. 3.70) was made on November 4, 2010, on the northbound lane of Highway 169. The sequence of photos in Figure

Figure 3.70. Installation of Highway 169 Keewatin bridge deck Rapid Patch repair: November 4, 2010.

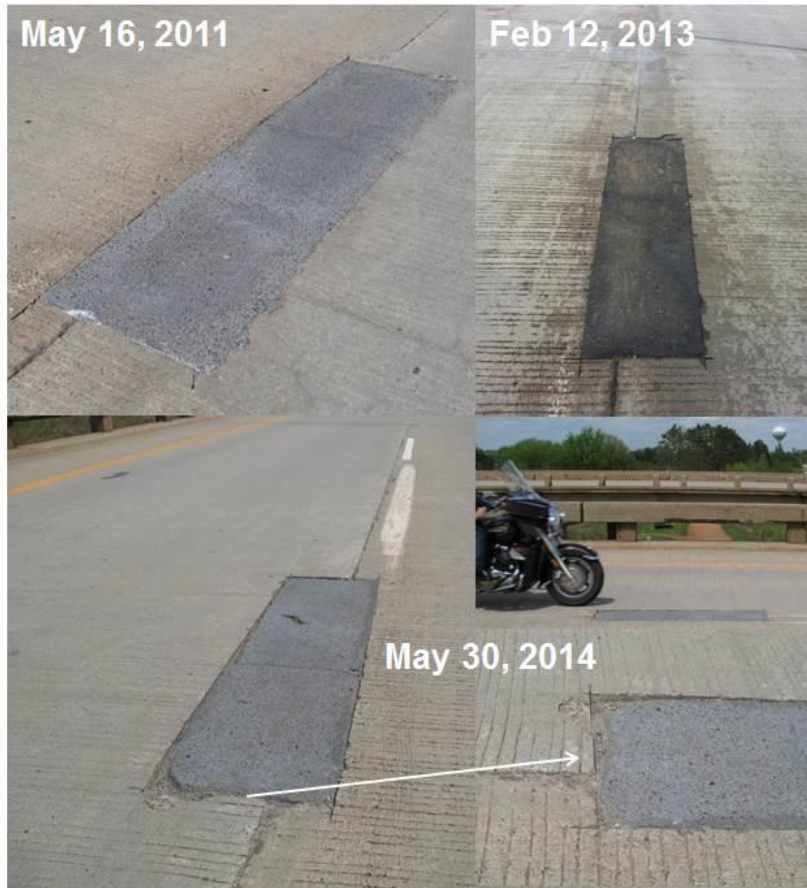
Figure 3.71. Photos showing condition of Highway 169 Keewatin bridge deck repair from May 16, 2011 through May 30, 2014.

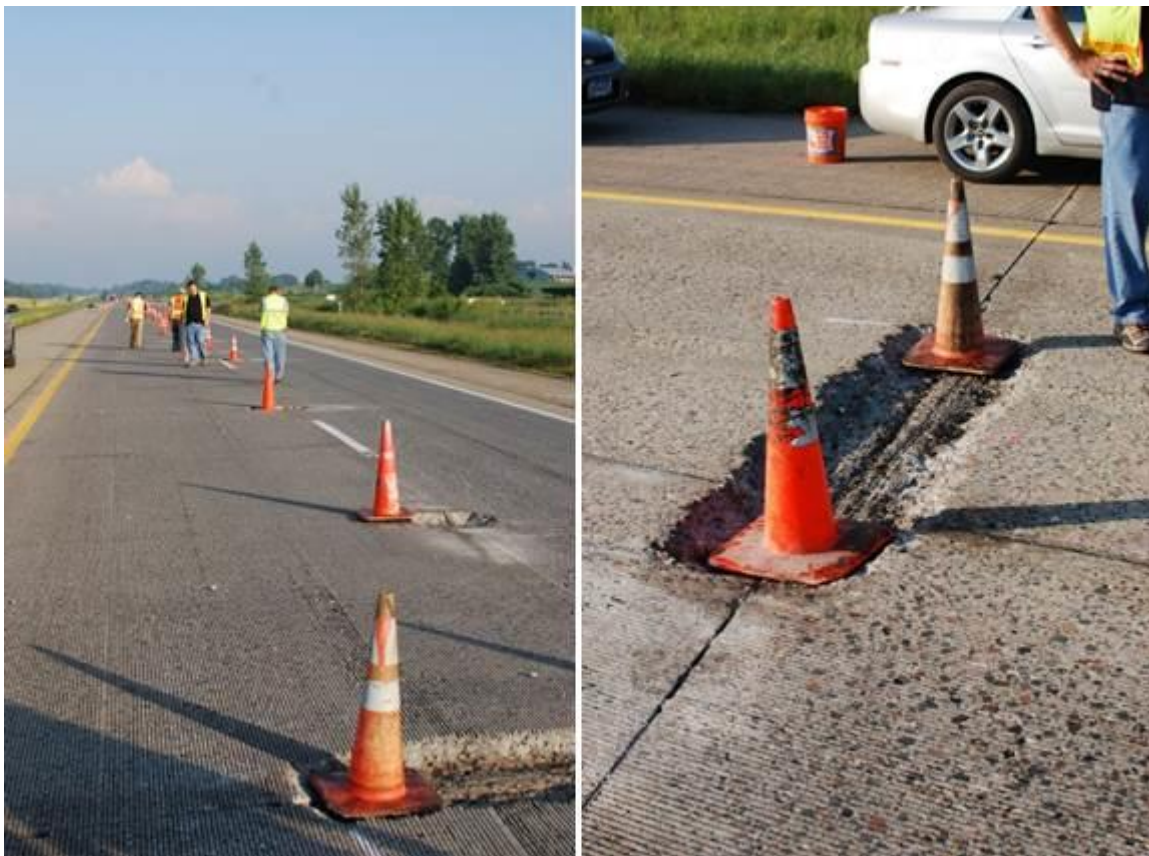
Figures 3.73 and 3.74 show the Rapid Patch installation at joint location 162. Photographs taken with a thermal imaging camera by NRRI reveal the development of the exothermic reaction that occurs as the Rapid Patch compound sets (Fig. 3.75).

Figure 3.73. Rapid Patch repair location on MnROAD I-94 mainline: Joint location 162, September 1, 2010.

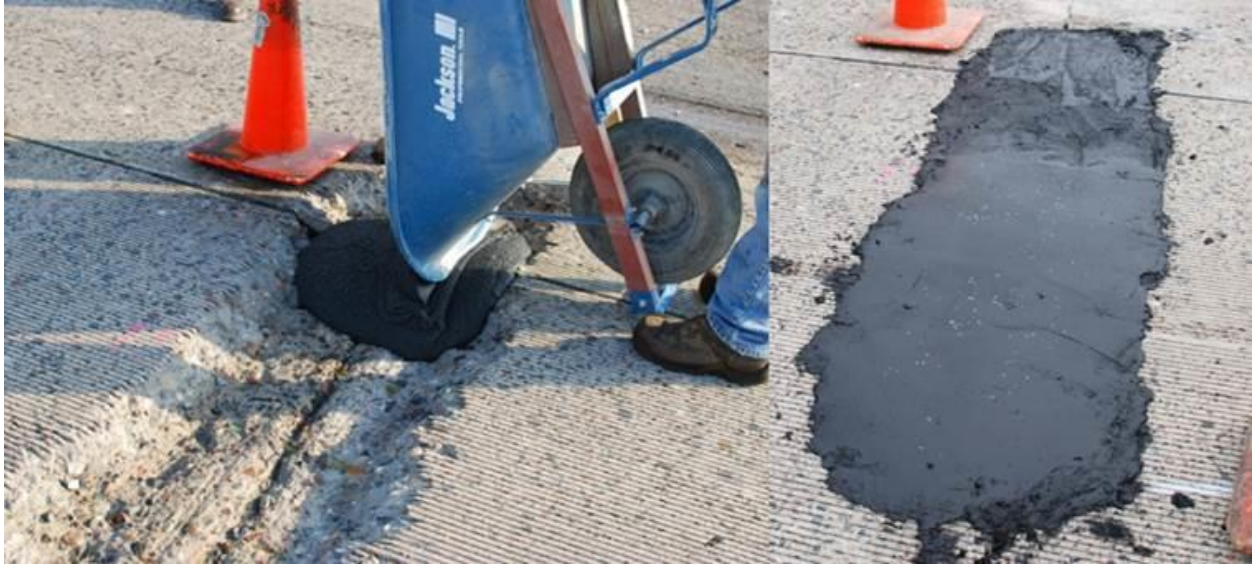
Figure 3.74. Rapid Patch installation on MnROAD I-94 mainline: Joint location 162, September 1, 2011.

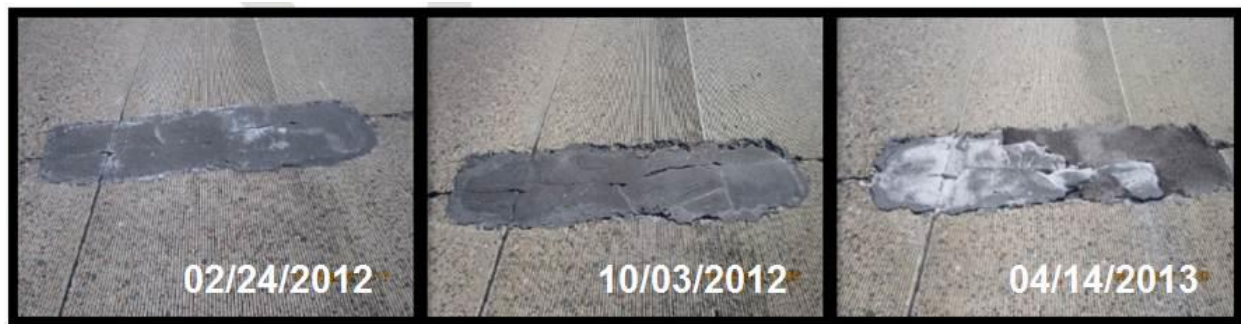
MnDOT evaluated and documented the condition of each repair over time. Johnson's (2013; revised February 19, 2014) draft summary document indicates that overall, the repairs had a mixed performance, showing about 90% survival rate after one year and declining to about 65% after two years. In all instances the repairs developed cracks, which is not unusual for this compound. However, as the photos of Figure 3.76 show (also extracted from the Johnson summary), the repair at Joint 162 was exhibiting perimeter edge loss, cracking, and deteriorating cracked blocks by the fall of 2012, and required a maintenance asphalt patch. By April 2013, the repair had degraded significantly, with more than half replaced by a secondary patch. Interestingly, this repair and the repair made at Joint 156 exhibited similar degradation characteristics. Because of the large size and volume of these two repairs, the Rapid Patch compound had to be placed in separate pours (see Figure 3.75). So rather than being a single monolithic repair, the separate pours may have formed a repair with internal boundaries of differential bonding and strength. The ambient pavement temperature was also 73° F (23° C) on the day of the installations, and the NRRI representative on site later reported that the compound had set up very quickly, perhaps exacerbating the effect of the separate pours.

Figure 3.76. Photo sequence of Rapid Patch repairs, MnROAD I-94 mainline Cell 9, Joint 162 location: 2/24/2012 to 4/14/2013 (Johnson, 2014).

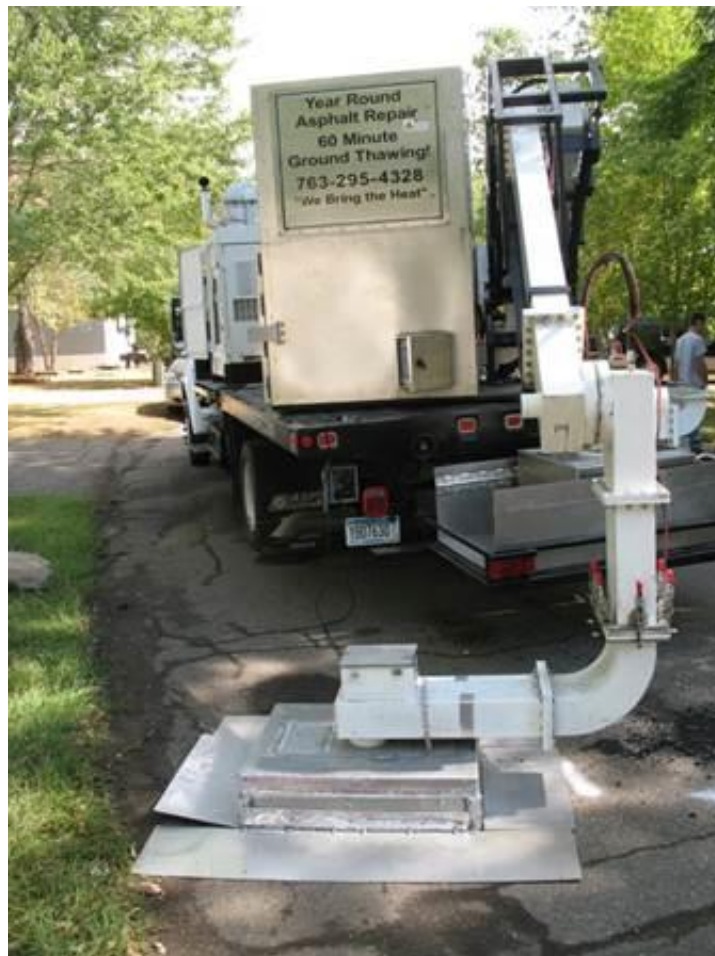
Figure 3.77. Modified microwave equipment: September 10, 2013 field test, Monticello, MN.

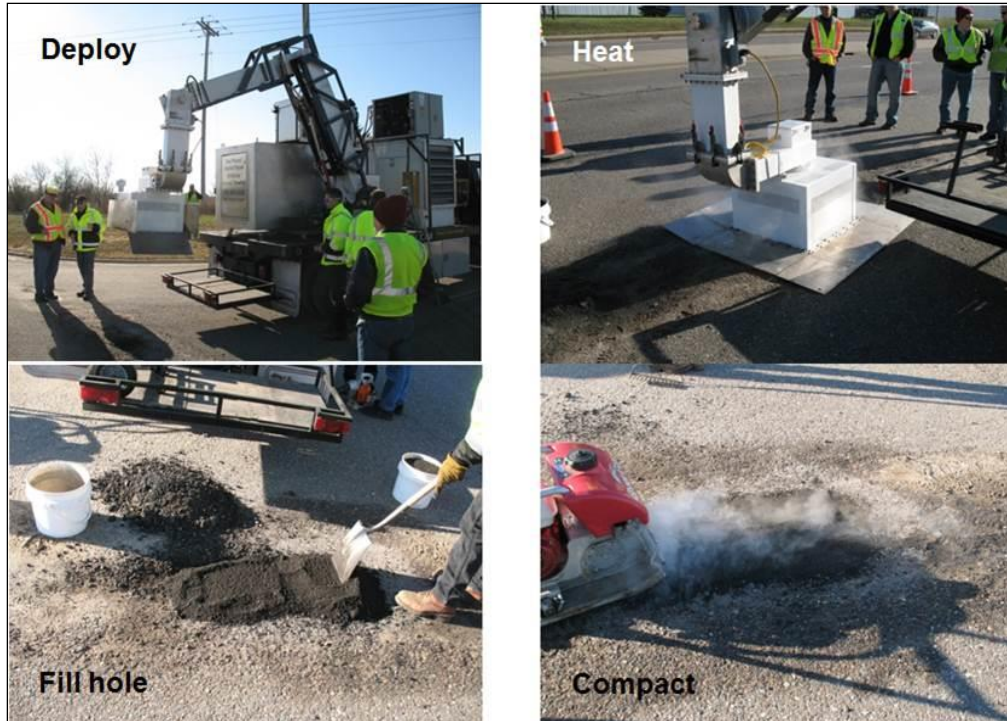
MUI was asked to conduct an additional field demonstration of its technology and equipment in Monticello on November 14, 2013. Prior to this demonstration, MUI performed another for MnDOT on October 30 in St. Cloud, Minnesota. The Monticello demonstration highlighted all aspects of how the microwave repair technology and methodology works (Fig. 3.80), and the type of heating it achieves (Fig. 3.81).

Figure 3.80. Microwave equipment and repair demonstration: November 14, 2013, Monticello, MN.

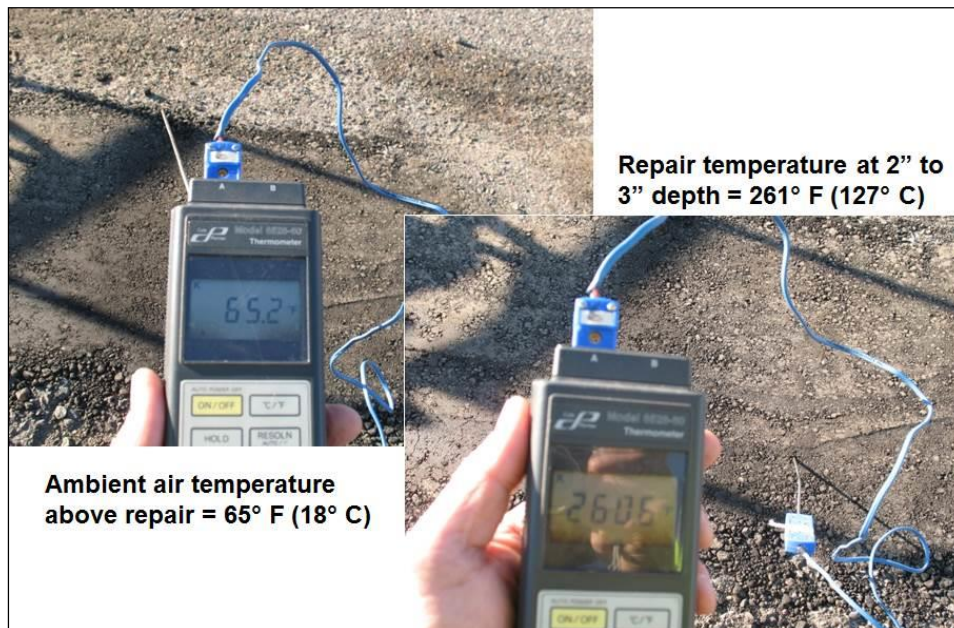
Figure 3.81. Photographs showing air temperature and internal temperature of microwave repair: November 14, 2013, Monticello, MN.

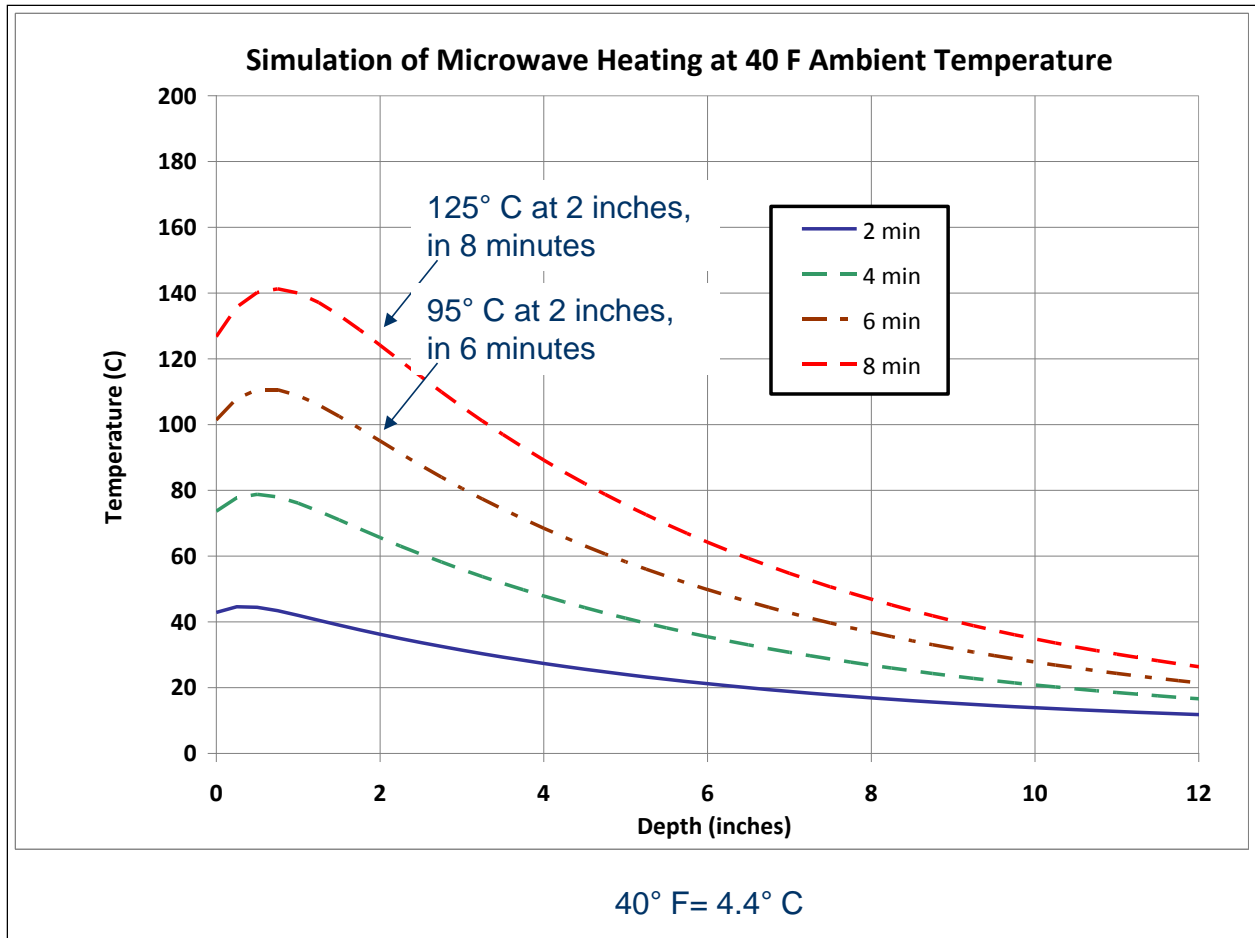
Figure 3.82. Simulation of microwave heating of asphalt pavement at 40° F ambient temperature.

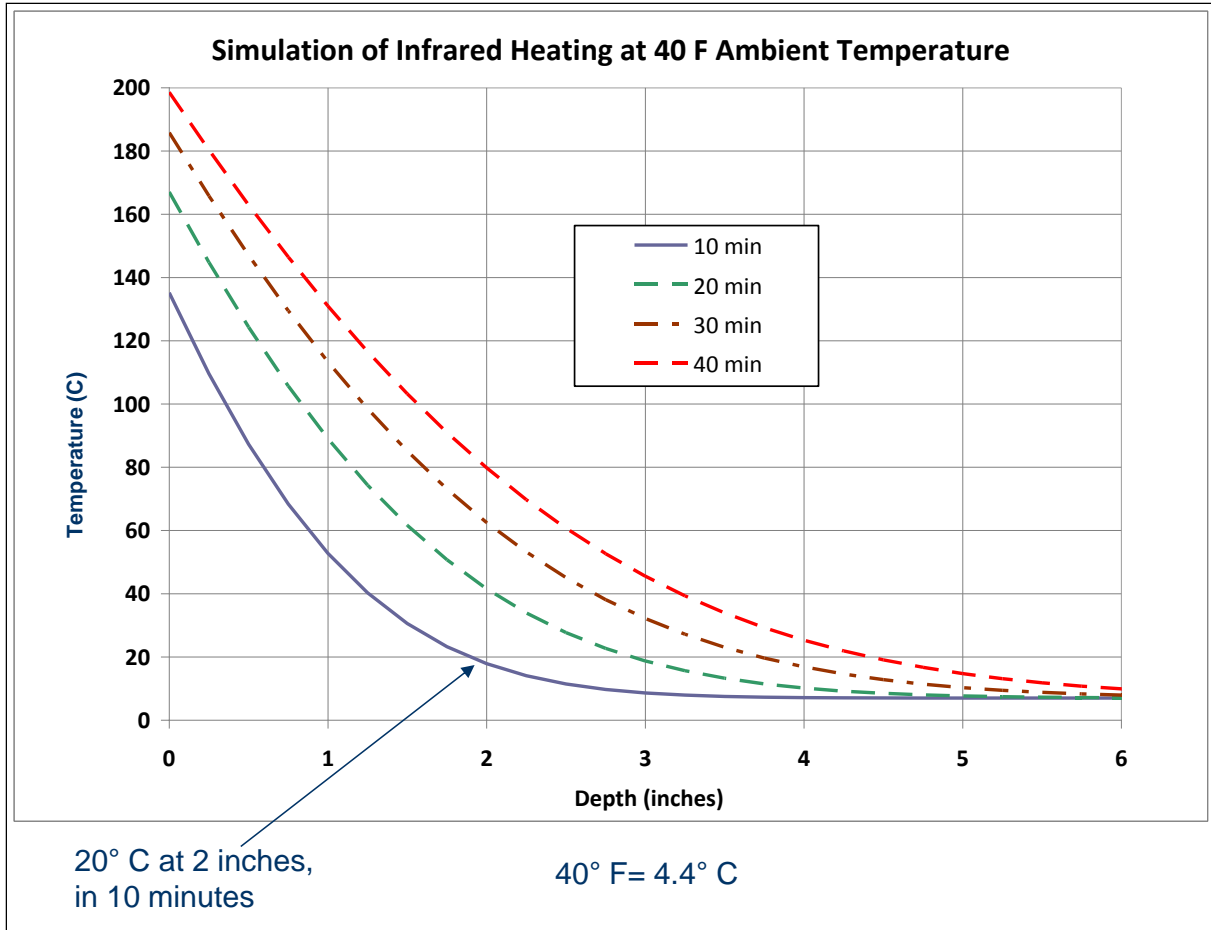
Figure 3.83. Simulation of infrared heating of asphalt pavement at 40° F ambient temperature.

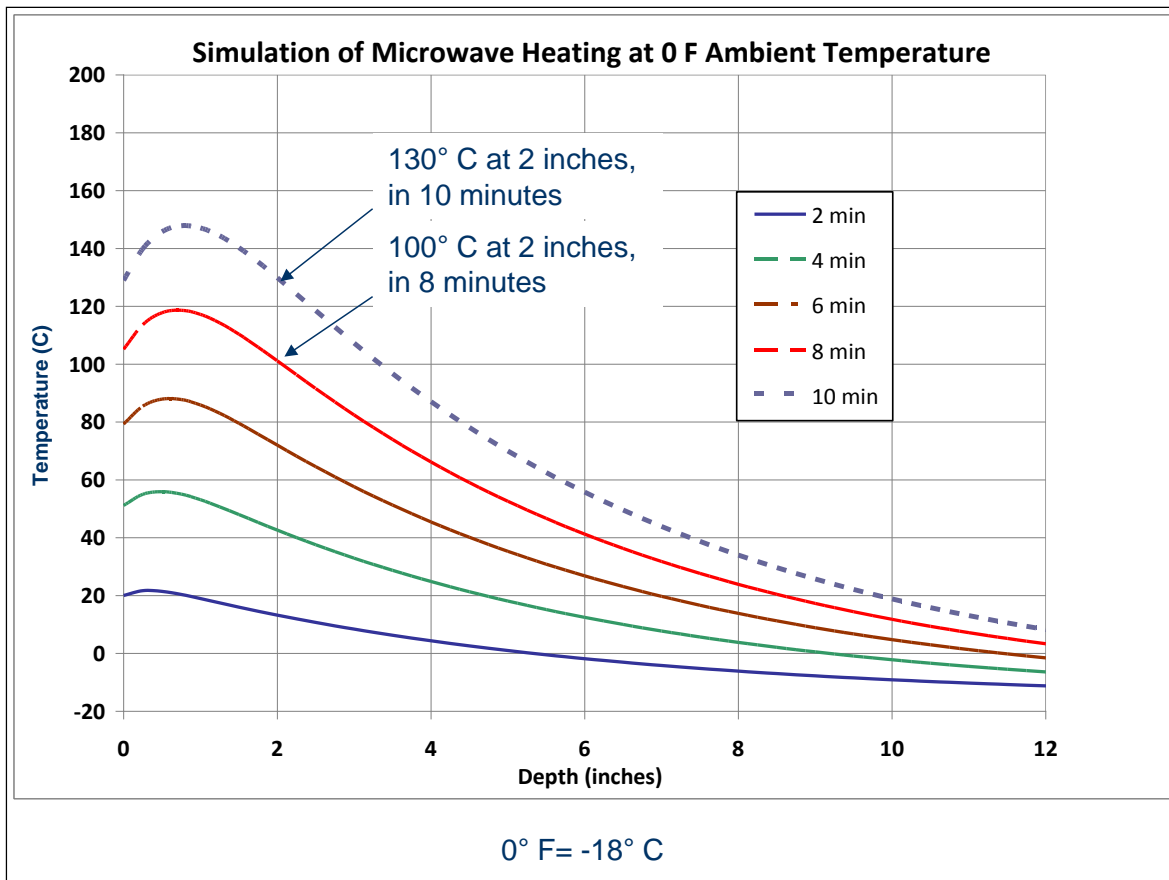
Figure 3.84. Simulation of microwave heating of asphalt pavement at 0° F ambient temperature.
