The Construction and Performance  
of Ultra-thin Whitetopping  
Intersections on US-169

**State Project No. 7106-60**

## **Final Report**

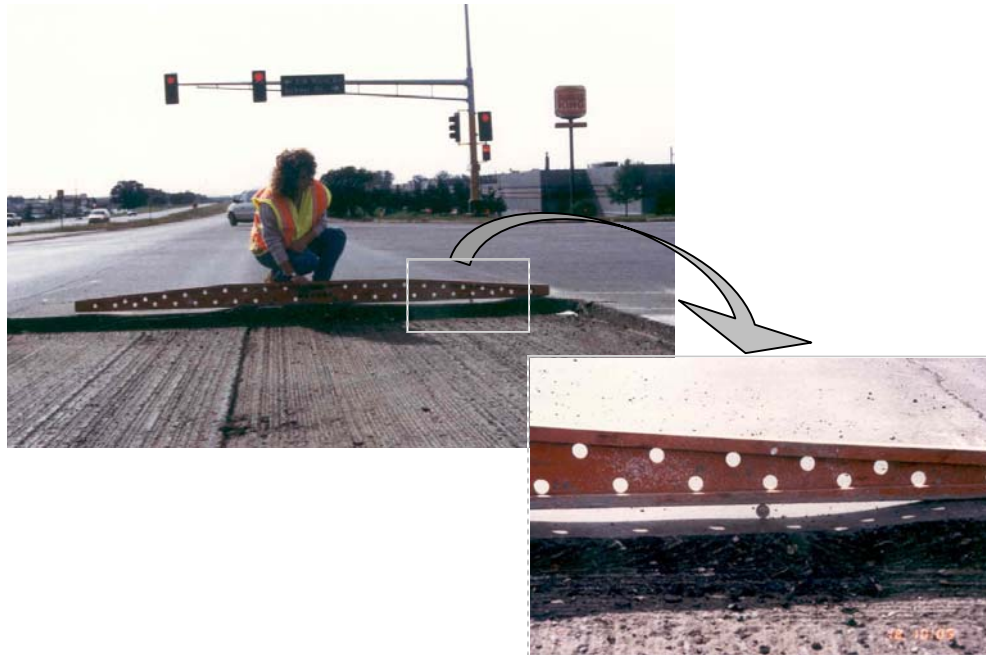
**Figure 2.1. Ruts at the Jackson Street intersection prior to the UTW overlay.**

A distress survey was performed on each 244-m (800-ft) section prior to the construction of the overlay. Transverse joints were sawed into the HMA pavement approximately every 9 m (30 ft). The average transverse crack/joint spacing at the Jackson Street, School Street and Main Street test sections was 5-m (17 ft), 6-m (20-ft) and 7-m (22-ft), respectively. The driving lane of the Jackson Street test section contained 180 m (590 ft) of transverse cracks/joints and the School and Main Street test sections contained 150 m (490 ft) and 160 m (530 ft), respectively. The cracks were all low to medium severity. The HMA was raveled in areas, especially along the outer edge. Severe rutting (greater than 32 mm (1.25 in)) and shoving was also present prior to milling as a result of heavy trucks stopping and starting at each intersection. See figure 3. A copy of the distress survey has been included in appendix A.

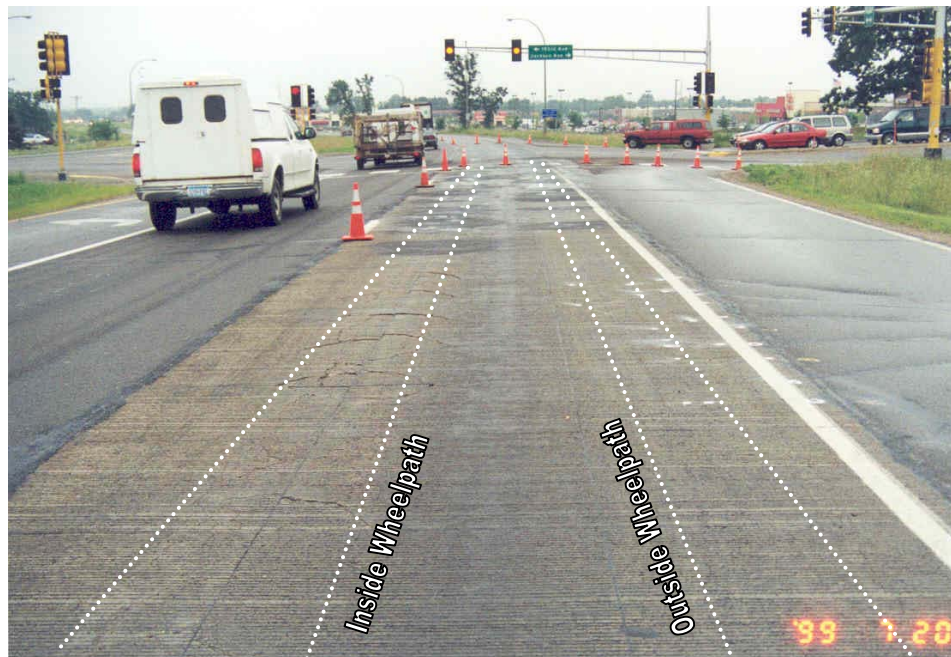
Cracks observed in the ultra-thin whitetopping test sections with 1.2-m x 1.2-m (4-ft x 4-ft) joint pattern include corner breaks and transverse cracks. The corner breaks occurred primarily along the inside longitudinal joint and the lane/shoulder (L/S) longitudinal joint. Many of the corner breaks that developed along the inside longitudinal joint did not appear until 1999. The inside longitudinal joint lies directly in the inside wheelpath resulting in high edge and corner stresses. Transverse cracks developed in the panels adjacent to the shoulder. The transverse cracks typically develop 0.4 m (1.3 ft) away from the transverse joint, which is approximately 1/3 of the length of the panel. This crack pattern is shown in figure 10 and 11. The photo in figure 7 was taken of the Jackson Street test section on March 30, 1998 and the photo in figure 8 was taken July 20, 1999. A copy of the distress survey performed on March 30, 1998 for the Jackson Street test section is provided in appendix D.

**Figure 4.2. Corner breaks in the inside wheelpath at the Jackson Street test section (photo was taken on 07.20.99).**
