2004-47

Final Report

**Scoping Study for the
Development of Design
Guidelines for Bioengineering
in the Upper Midwest**

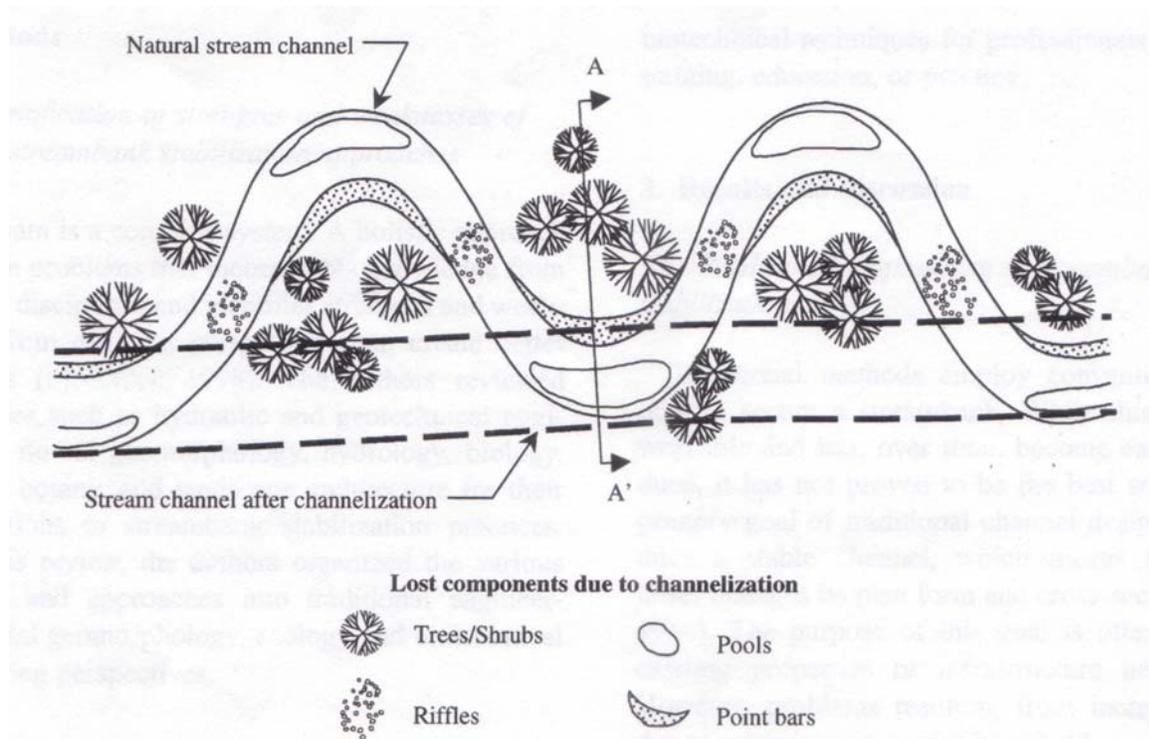
Figure 1.1 Comparison of a channelized stream and a natural stream channel (from Li and Eddleman, 2002).

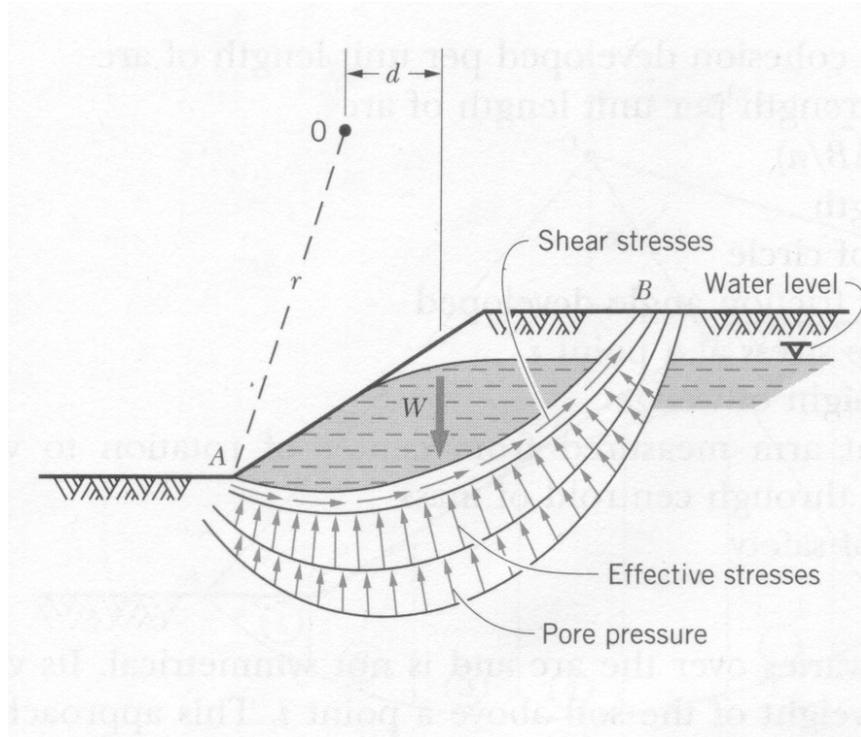
Rotational or circular failures are generally the more common form of failure on finite slopes. The failure surface is usually somewhat curved, similar to a circular arc, with ends which are more or less flat and a center which has a sharper arc (Figure 2.3). However, with the large variation in soil types and properties, each failure surface is unique. A failure in a homogeneous, isotropic soil will often be fairly circular in shape, but inhomogeneities in the soil profile make the failure surface different from a circular shape. In general, failure surfaces are deep in the slope where shear resistance is low and shear stress is high. Rotational failures are governed by the following forces (35):

Figure 2.3 Rotational failure (from Das, 2002).

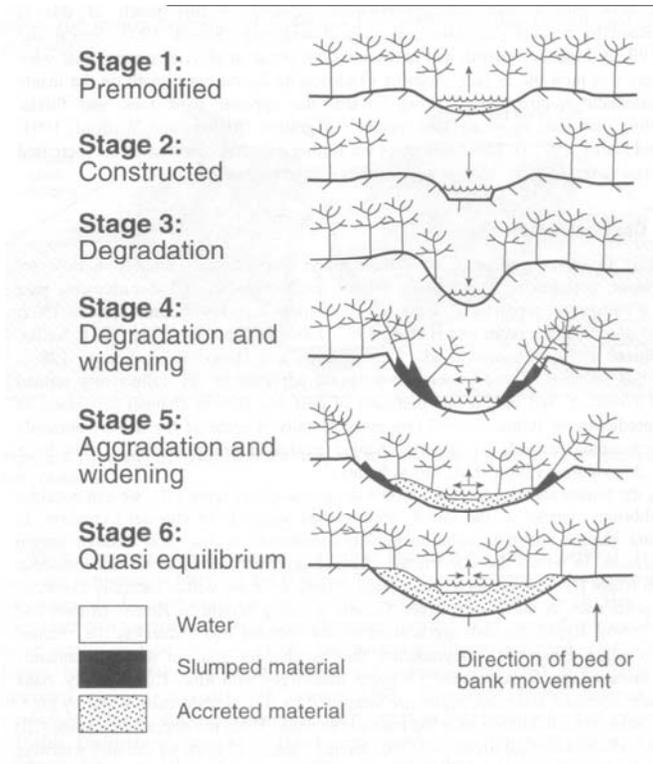
- 1) Initial stage – stable, low gradients, well-vegetated banks,
- 2) Channel straightening,
- 3) Channels incision by deepening at knick points,
- 4) Rapid channel widening as banks attain a critical height and fail,
- 5) Aggregation in downstream reaches,
- 6) Slow return to equilibrium.

Figure 2.4 Stages of channel response to modifications (from Darby and Simon, 1999).

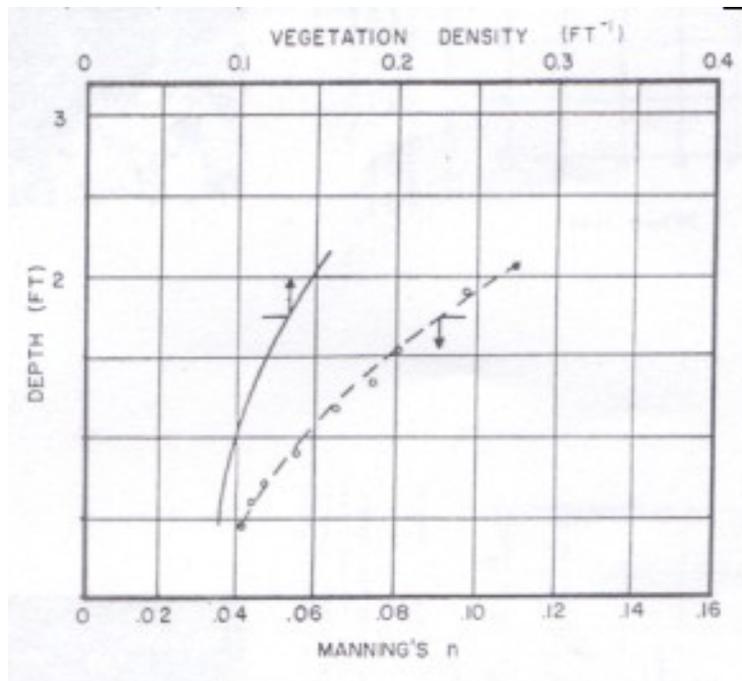
Some open-channel flow publications provide general estimates for Manning's n roughness coefficient (19), but they tend to use subjective categories, such as "scattered brush, heavy weeds" or "dense willows." Several researchers have attempted to use more thorough approaches to adjust Manning's n to account for drag. Dudley et al. (1998) compared methods for measuring vegetation density and Fischenich and Dudley (2000) used that information to develop methods to determine drag coefficients that uses the frontal area of the plants (projection of the plant over a plane perpendicular to the flow direction) and the Reynolds number (44, 48). They also acknowledged that the practice of estimating vegetation area, density and their effects on flow is generally new and still being developed, and as more researchers use different methods, the estimates of vegetation density and drag coefficients will become more accurate. Nonetheless, Fischenich (2000) followed this study by providing methods and equations to estimate the Manning's n roughness coefficient based on the drag coefficient and vegetation density, assuming that they are measured accurately (42). These efforts built on the work done by Petryk and Bosmajian (1975), who were able to determine relationships between unit vegetation density (ft^{-1}), flow depth (ft) and Manning's n (49). Typical results (Figure 3.1) show that as vegetation density increases (solid line), Manning's n increases (dotted line).

Figure 3.1 The relationships between flow depth, vegetation density (solid line), and Manning's n (dotted line) (from Petryk and Bosmajian, 1975).

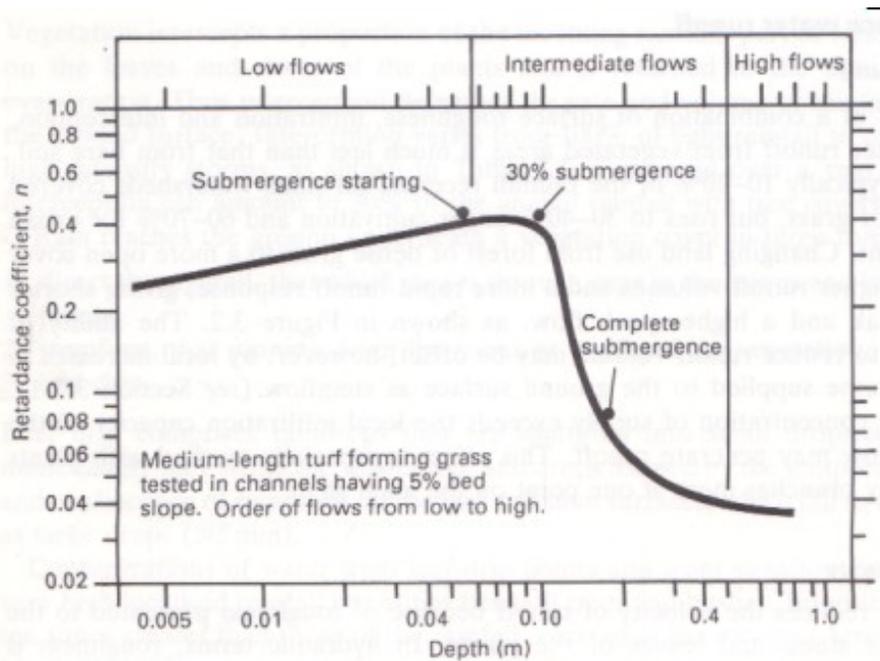
Riparian vegetation will bend as flow increases, and as it bends, total roughness decreases (43). The amount it bends depends upon the type and age of the vegetation and the flow velocity. It is a difficult task to accurately estimate the channel roughness when vegetation starts bending as flow increases (50). Figure 3.2 shows the relationship between flow depth and Manning's n for flexible vegetation. As the plants become completely submerged, they bend and the effective roughness coefficient decreases.

Figure 3.2 Relationships between flow depth and the retardance coefficient (Manning's n) as vegetation is submerged (from Coppin and Richards, 1990).

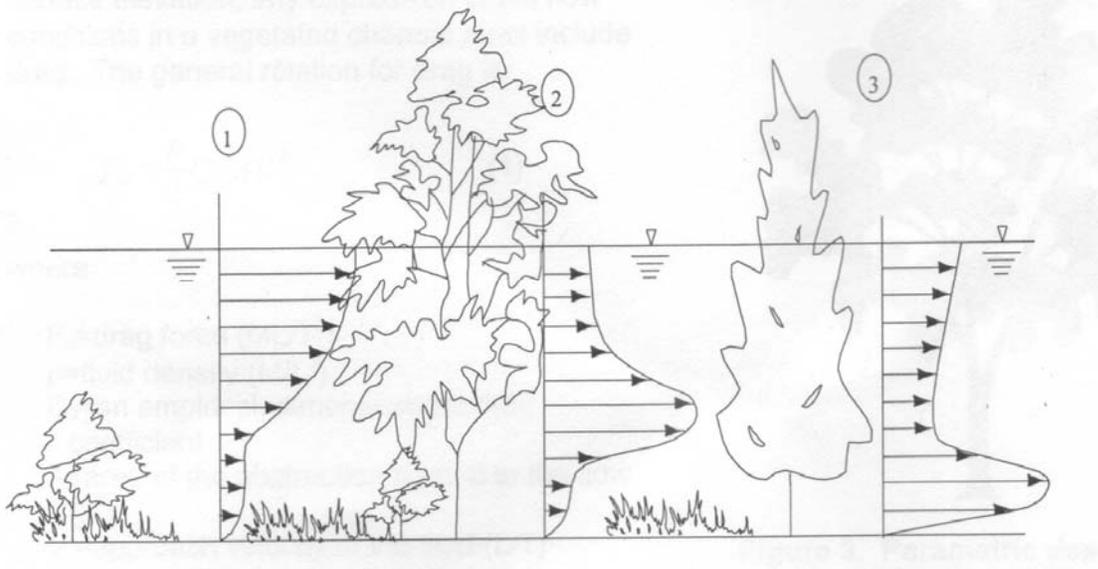
The net effect of an increase in vegetal presence on a streambank is that near-bank velocities and shear stresses on the bank will decrease. The decrease in shear stresses, in turn, reduces the amount of channel erosion on the toe and bank (54). Thornton et al. (2000) found that by doubling the unit vegetation density from 0.082 ft^{-1} to 0.160 ft^{-1} , the shear stress on the bed was reduced from $2.17 \times 10^{-2} \text{ lbs ft}^{-2}$ to $0.948 \times 10^{-2} \text{ lbs ft}^{-2}$. Figure 3.3 shows the effects of vegetation on velocity distribution in channels. Each velocity profile goes with the vegetation to its left.

Figure 3.3 Effect of vegetation on velocity profiles (from Fischenich, 2000).

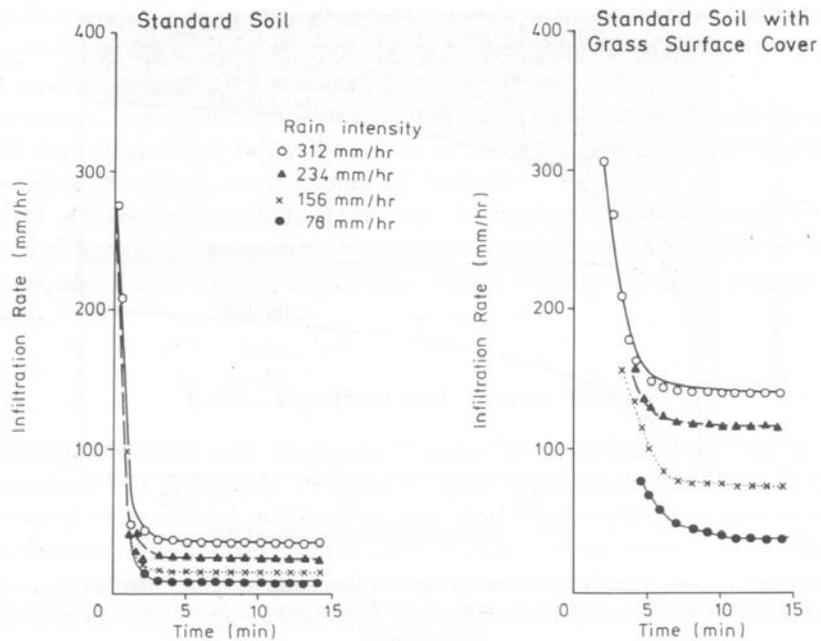
Sheet, rill or gully erosion occur when there is excess rainfall, which is a function of the infiltration capacity and moisture content of the soil. During a storm event, the vegetation cover not only postpones the onset of runoff due to interception and canopy storage, but it also increases the infiltration rate due to the presence of organic matter, root growth, decaying roots, and earthworms. Vegetation litter may decrease the infiltration rate, but the net effect often results in a greater infiltration rate and reduced runoff (3, 18). Figure 3.4 shows a comparison between infiltration rates of soil with and without vegetation.

Figure 3.4 Comparison of infiltration rates in vegetated and non-vegetated slopes (from Greenway, 1987).

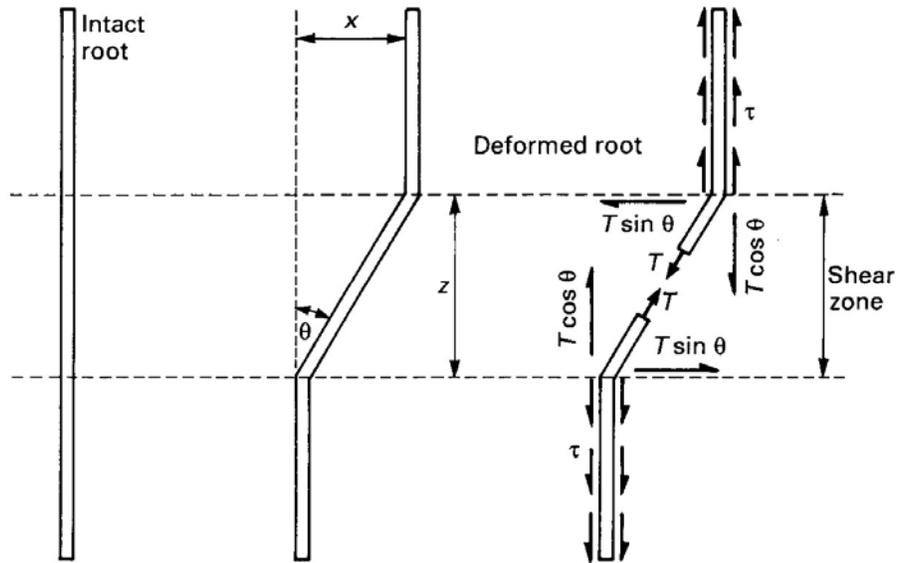
Numerous researchers acknowledge that soil-root interactions work to strengthen and reinforce an embankment (1, 3, 9, 18, 19, 23, 41, 63, 64, 65, 66). Wu et al. (1979) laid the foundation for the current understanding of soil-root reinforcement when they measured the effect of tree roots on slope stability in Alaska. They determined that soil is reinforced by roots as the shear stress in the soil is transferred to the tensile resistance in the roots. When shear stress is exerted upon the root, the root fiber is deformed and elongated as illustrated in Figure 3.5 (63). In order to come to these conclusions, Wu et al. (1979) measured *in situ* tensile strengths of Sitka spruce trees. They were able to develop a relationship between the tensile strength of the roots, the root-area ratio (the area of the roots per area of soil), and the increase in shear strength of the soil. This relationship was added to the Mohr-Coulomb equation for soil shear strength to provide a means to estimate the total shear strength of a slope. They also compared results from a slope with live trees to a slope that had been recently clear-cut and found a marked decrease in shear strength of the roots. This can be seen in Figure 3.6 where the tensile strength within the dotted line labeled B are from the clear-cut slope and the line marked A is from the uncut slope with live root systems. Figure 3.6 also shows that an increase in root diameter contributes to a greater tensile strength.

Figure 3.5 Perpendicular root fiber reinforcement model (from Wu et al., 1979).

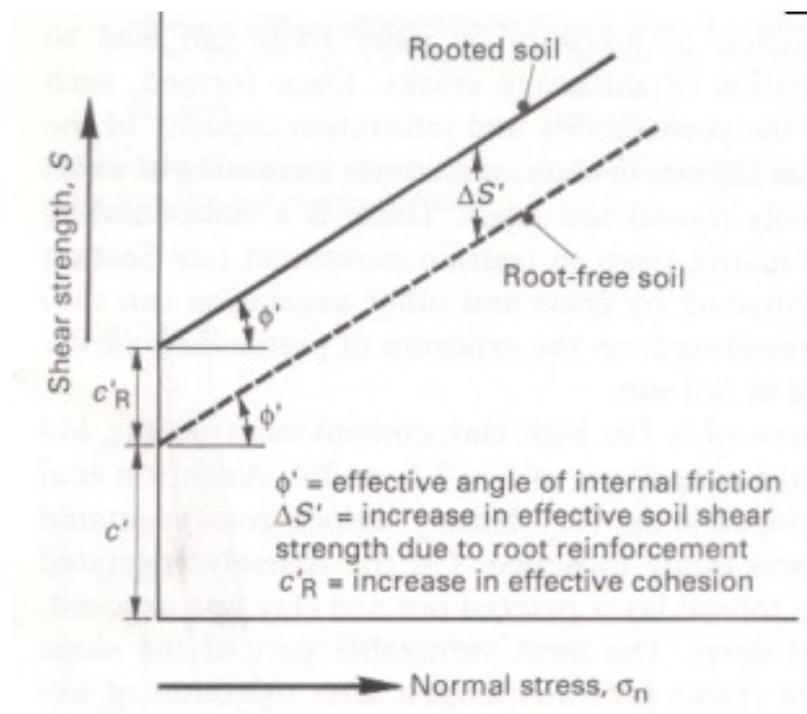
Following work by Wu et al. (1979), there have been many attempts to quantify the effect of roots on the shear strength increase in soil (64, 65, 66, 67, 68, 69). Most of them have also used the Mohr-Coulomb equation for soil shear strength and have attempted to add a factor to account for the reinforcement performed by the roots (Figure 3.7), similar to Wu et al (1979). Simon and Collison (2002) found that different species and types of vegetation had different influences on the added shear strength of the soil (59). Depending on the species, trees can increase soil strength by 21-366 lbs ft⁻² and grass roots can add 125-377 lbs ft⁻² (9, 59, 63) while Tengbeh (1993) found that roots increase soil strength by more than 50% (69). Other results have shown that the overall reinforcement is a function of root strength, friction between the root and the soil, root distribution in the soil, root density, tensile strength, tensile modulus of elasticity, length/diameter ratio, surface roughness, alignment with respect to the failure surface and orientation to the direction of the stresses (9, 18, 66). Some publications, such as Scheichtl (1980) provide information about the root tensile strengths of many species, but information about the root density, or root unit area (the area of roots per area of soil for a given profile), for those species is not necessarily available (5). Figure 3.8 shows that it is possible for a stand of vegetation to penetrate failure planes for either translational or rotational failures, however it is much more common for vegetation to protect against translational failures because the failure planes are usually much more shallow in the soil profile.

Figure 3.7 Increase in shear strength due to the presence of roots (from Coppin and Richards, 1990).

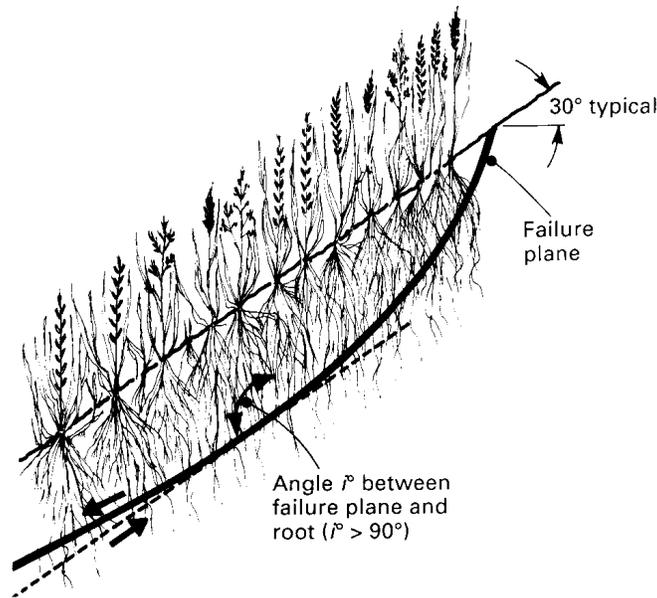
Figure 3.8 Root penetrating a failure plane (from Coppin and Richards, 1990).

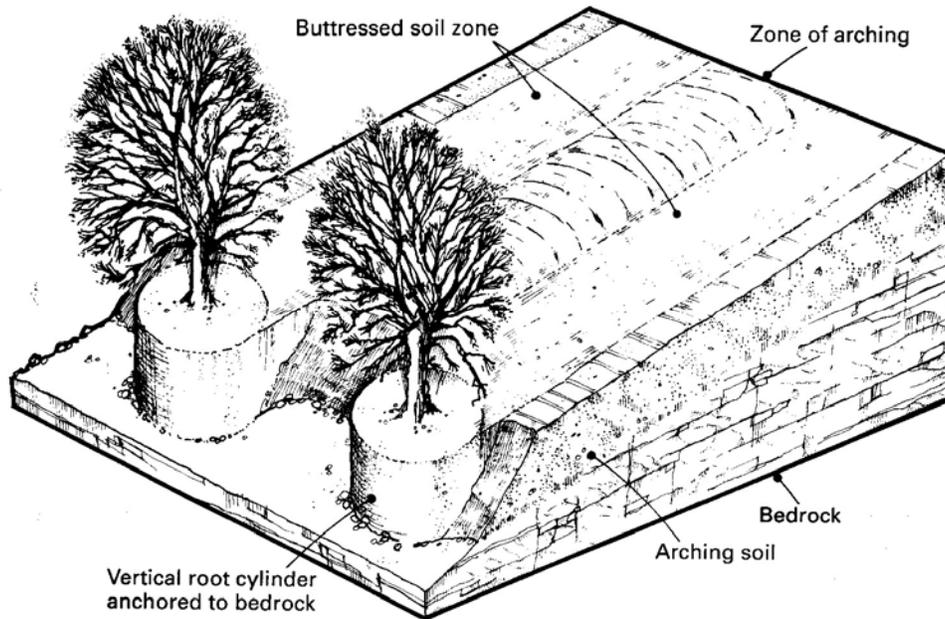
large root mass, usually associated with trees. It occurs when tap and sinker roots of many tree species extend into the underlying bedrock, thereby anchoring them to the slope and also preventing the slope from moving downward. When two trees are close enough and both are anchored into the slope, arching between the buttressed zones can occur. (Figure 3.9)

Figure 3.9 Anchoring, arching and buttressing on a slope (from Coppin and Richards, 1990).

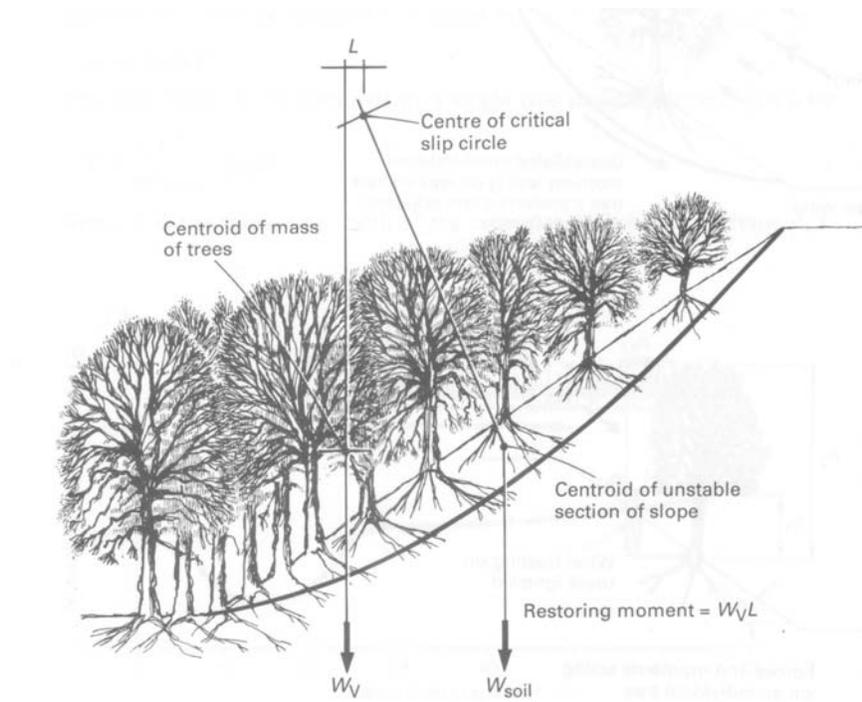
The added weight of vegetation can potentially be a stabilizing force on an embankment as it increases the normal stress on the bank (72). Usually, the effect of surcharge on the stability of a slope, either beneficial or adverse, is only felt for large vegetation, such as trees, and is not generally felt with the presence of grasses or shrubs (1). When weighty vegetation is present, however, the size and location is the primary factor, as can be seen in Figure 3.10.

Figure 3.10 Effect of surcharge on the center of gravity on a slope (from Coppin and Richards, 1990).

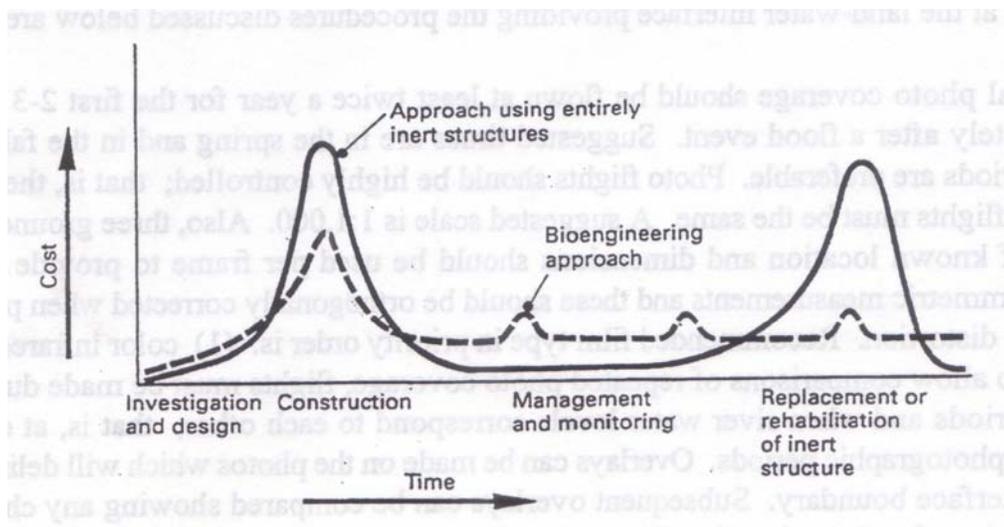
Figure 3.11 Comparison of cost profiles and maintenance of hard armoring and soft armoring techniques (from Coppin and Richards, 1990).

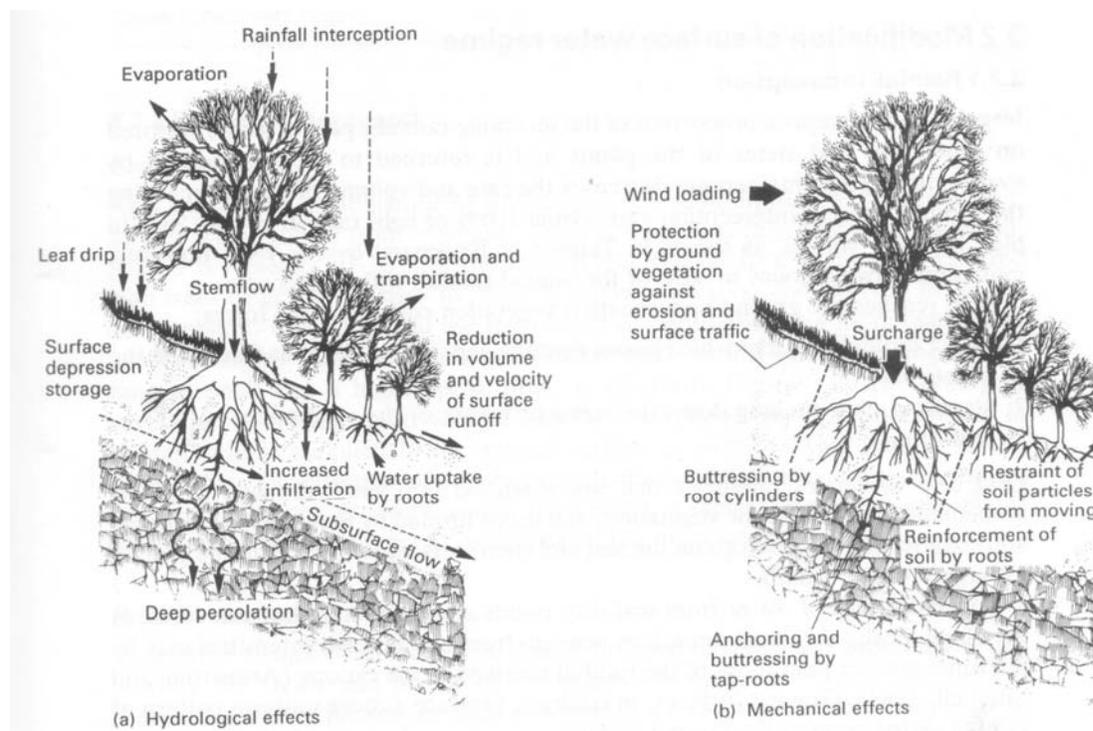
Figure 3.12 Hydrological and mechanical effects of vegetation on slopes (from Coppin and Richards, 1990).

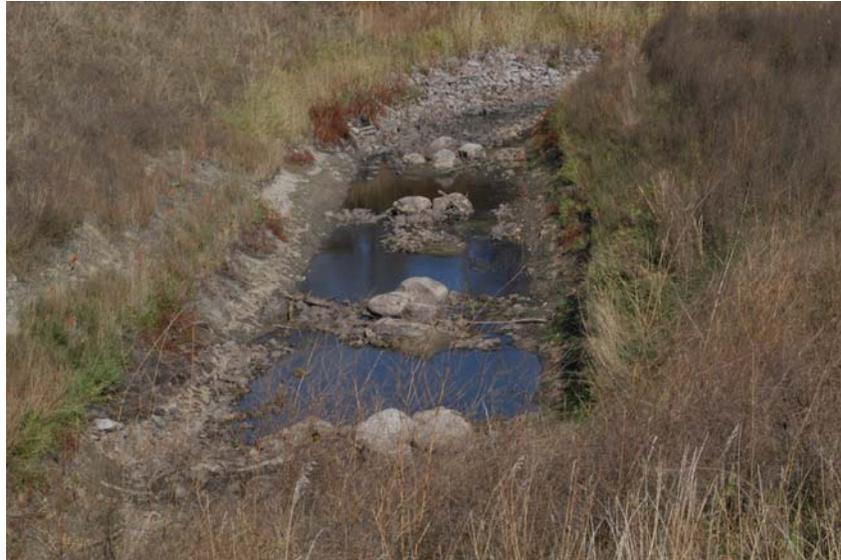
Figure 6.1 The reach initially downstream of the culvert under TH-12. Erosion on the banks can be noted, along in-stream structures that were placed in the stream.

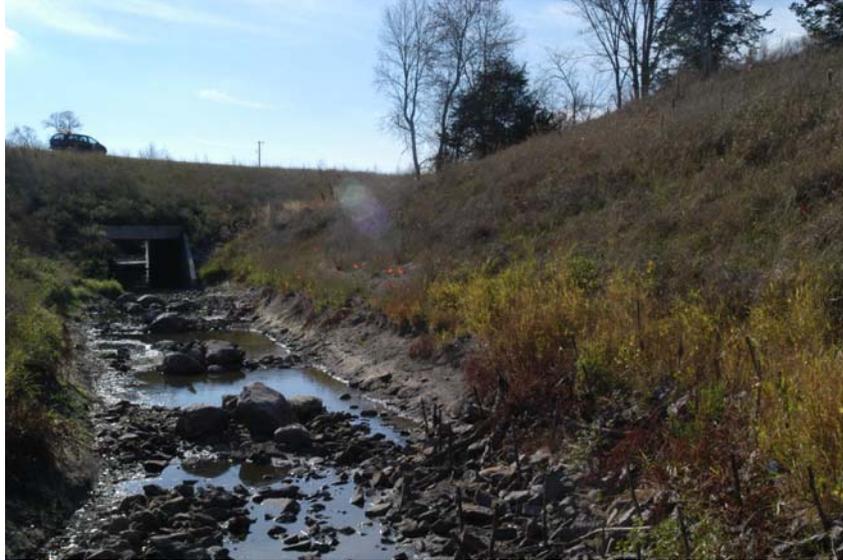
Figure 6.2 Same reach of the stream, but looking back at the culvert. The bank on the right side is showing signs of instability.

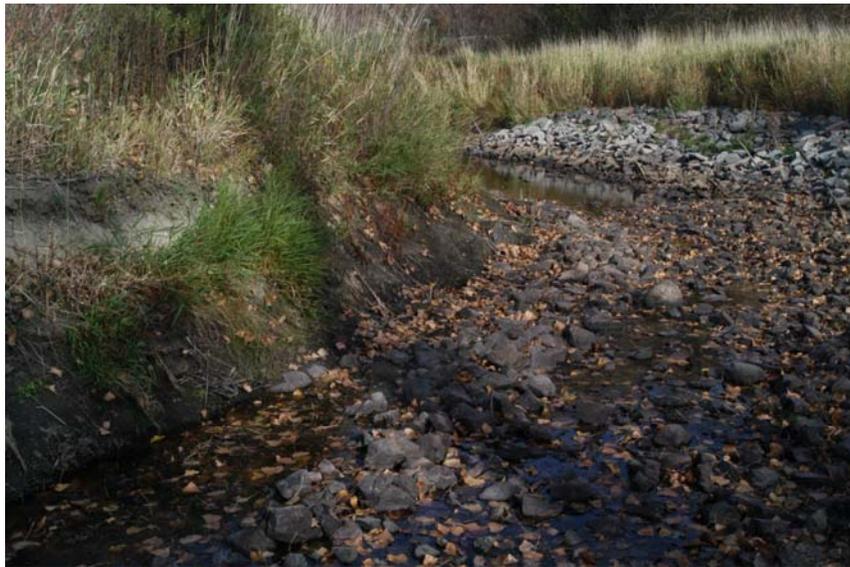
Figure 6.3 A bank where it can be seen that the riprap is no longer on the bank. Either the bank has eroded from behind the riprap or the rocks were carried downstream from the upstream bend where riprap was placed.

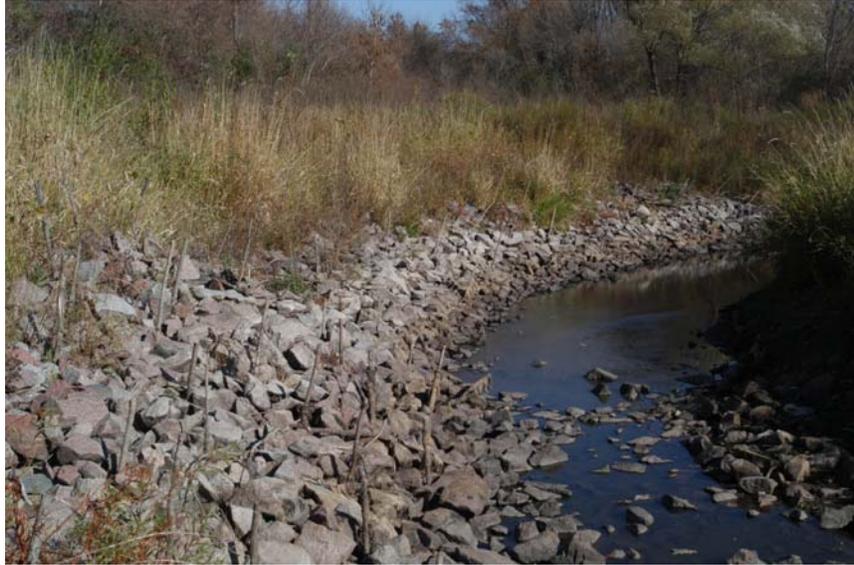
Figure 6.4 Dead willow posts in the riprap.

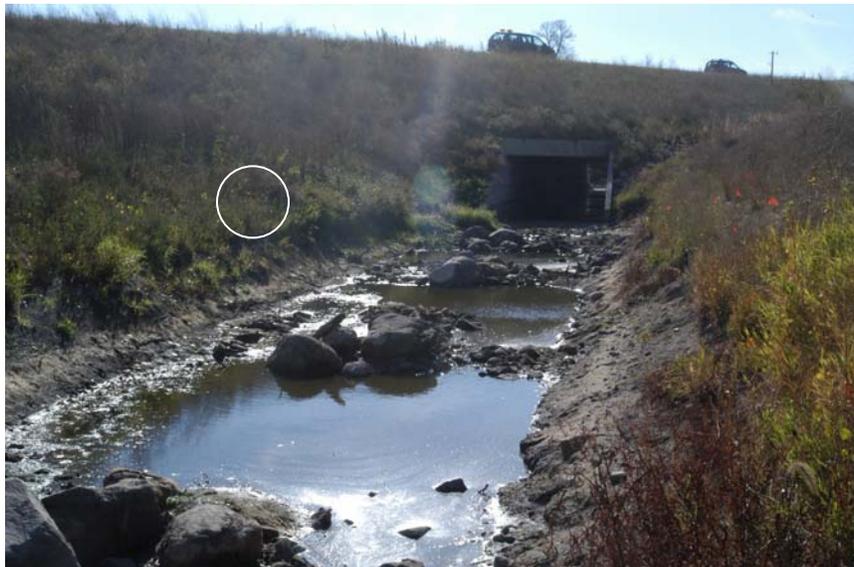
Figure 6.5 Another photo looking upstream. The white circle points out the area where there is a localized slumping of the bank. Runoff from the highway surface is directed into that area.

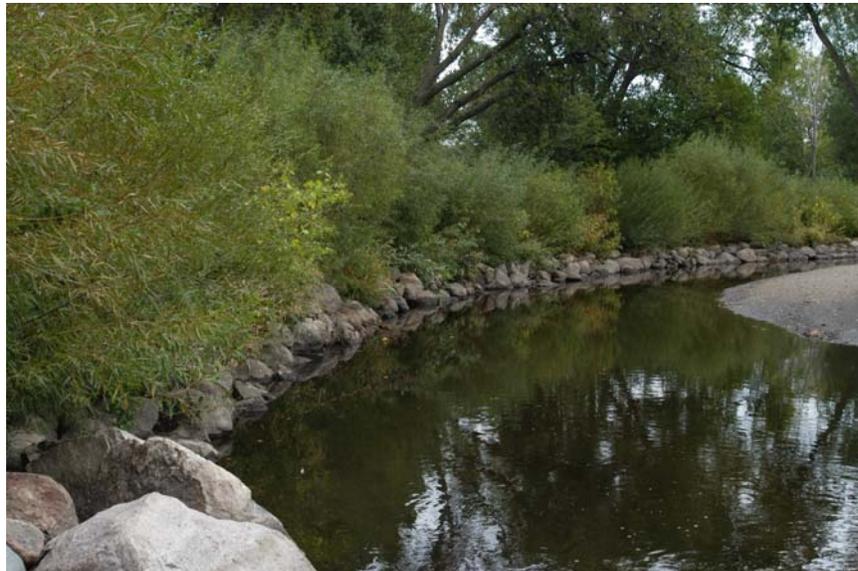
Figure 6.6 MHC site at 18th Ave. S. Boulder cover below, willows on top of bank.

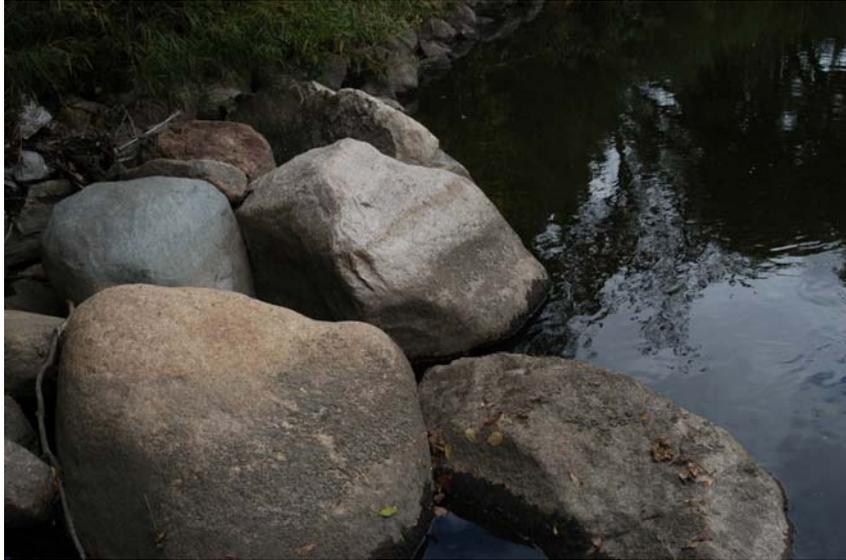
Figure 6.7 Rock vane and eddies in the water.

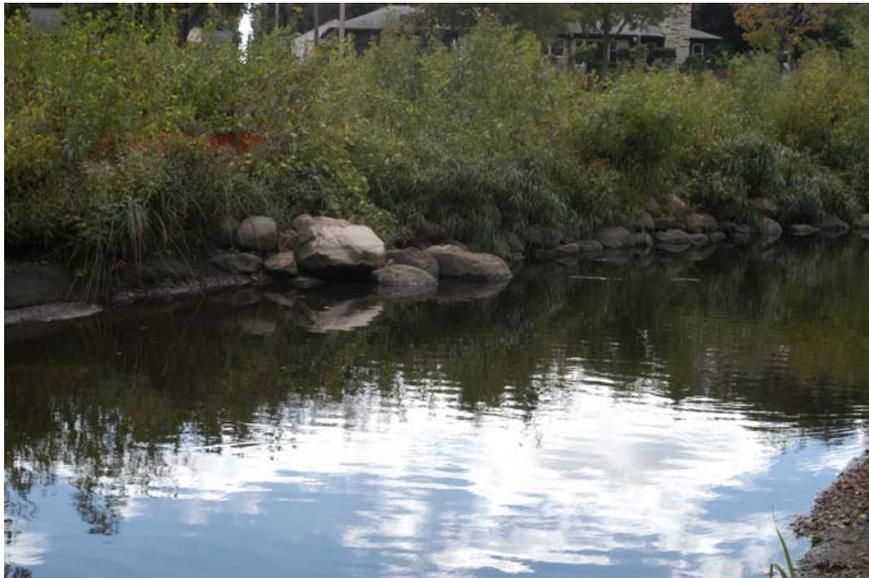
Figure 6.8 Rock vane, boulder toe, and willows.

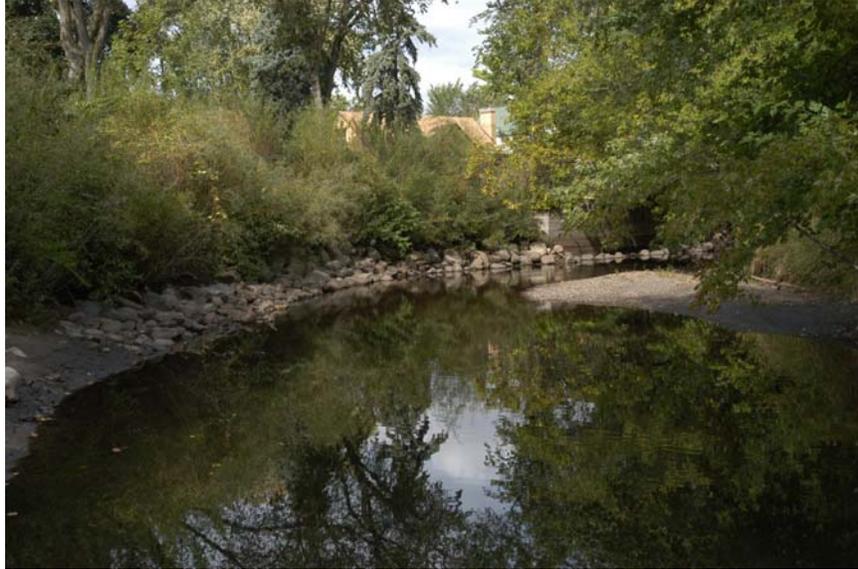
Figure 6.9 Boulder toe and vegetated geogrids at a site slightly upstream of the 18th Ave. S. site.

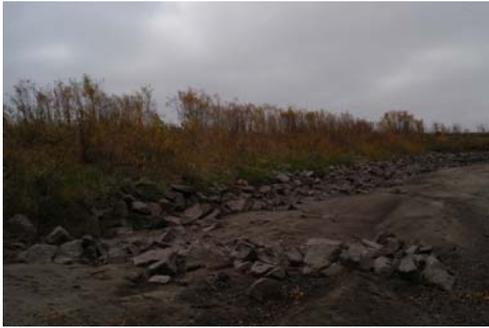
Figure 6.30 Looking upstream. Fascines are in the foreground and brush mattresses are in the background.

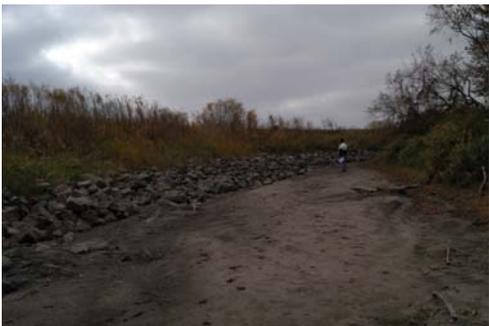
Figure 6.34 Entire channel. Note rocks from riprap in center of channel.

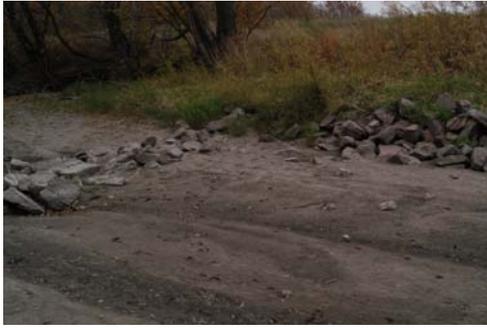
Figure 6.36 Sedimentation behind stream barb.

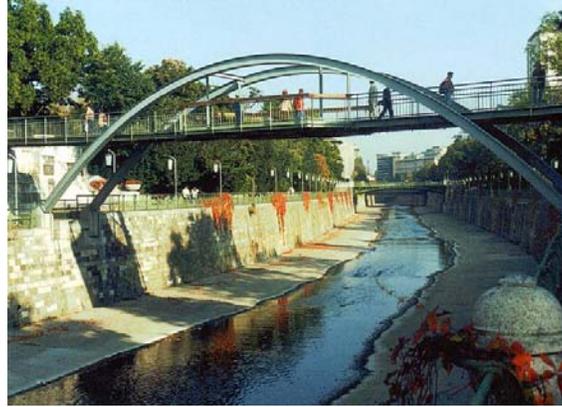
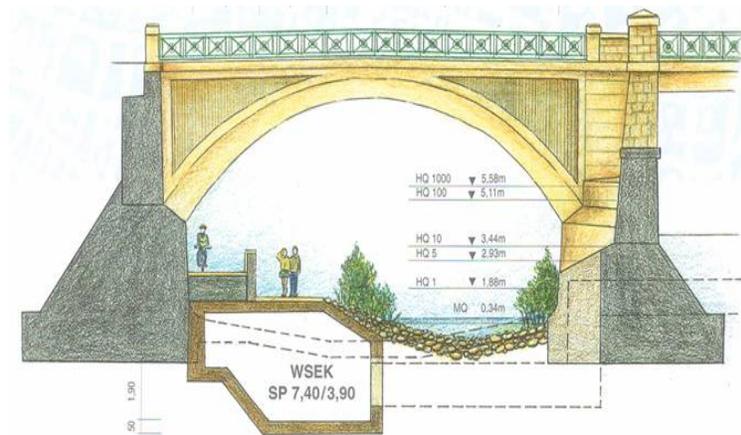
Figure 8.1 Existing and the future design of the Wien River cross section.

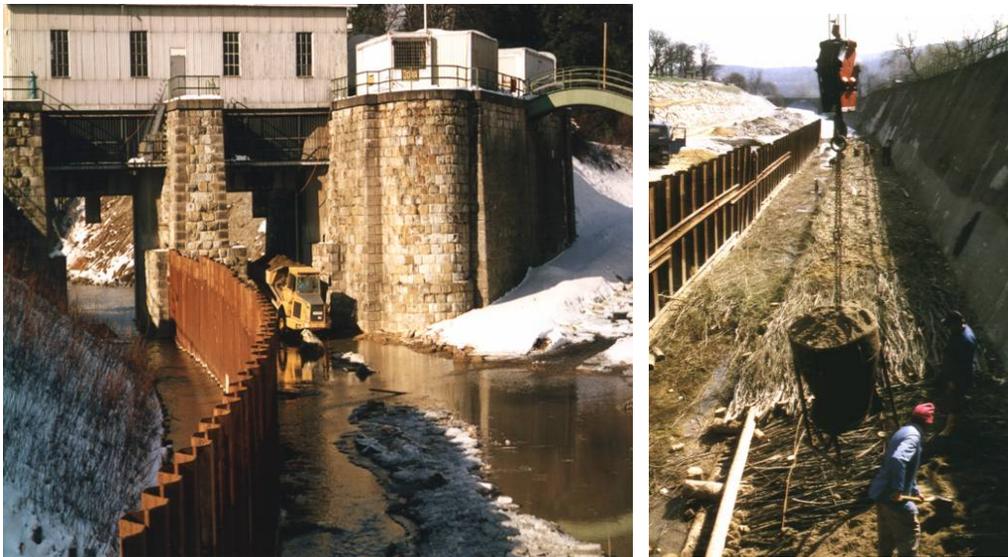
The construction of the test flume began in 1996 with a run of sheet piling that divides the test channel into two parts which can be flooded separately. The flume was completed in 1998, and was tested for three soil bioengineering techniques.

Figure 8.2 Construction of the test flume

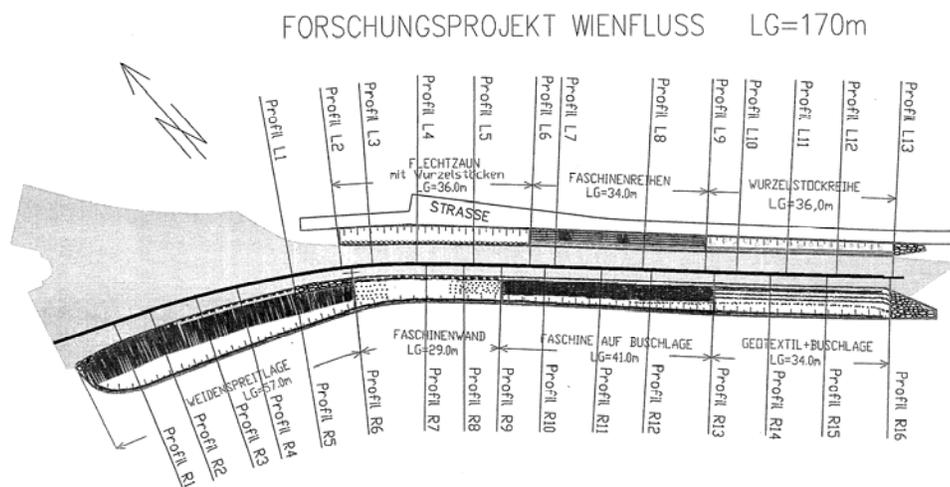
The flume is 560 ft (170 m) long (Figure 8.3), with a width varying from 20 to 26 ft (6 to 8 m), and a maximum height of 10 ft (3 m). Artificial floods are simulated by opening a sluice gate which is located just upstream of the test flume. The sluice gate serves as a wicket dam with a 458,000 yd³ (350,000 m³) retention reservoir. During artificial flooding, a discharge from 700 to 1,300 cfs can be achieved for 40 to 60 minutes.

Figure 8.3 Plan view of the flume.

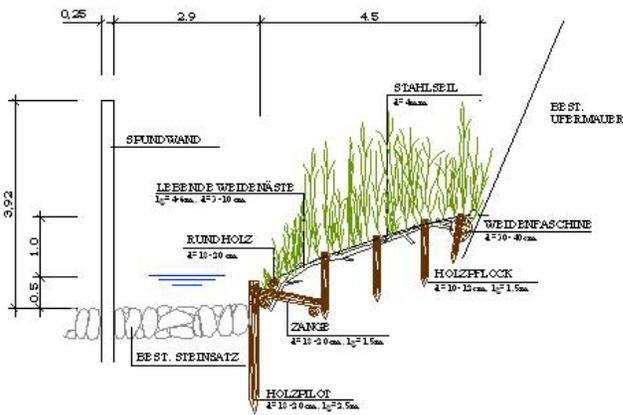
Figure 8.4 Brush mattress with willows. All dimensions are in meters (1 m = 3.3 ft).

Three soil bioengineering structures were constructed in 1998 from woody plants as shown in Figures 8.4 to 8.6 (Gerstgraser, 2000).

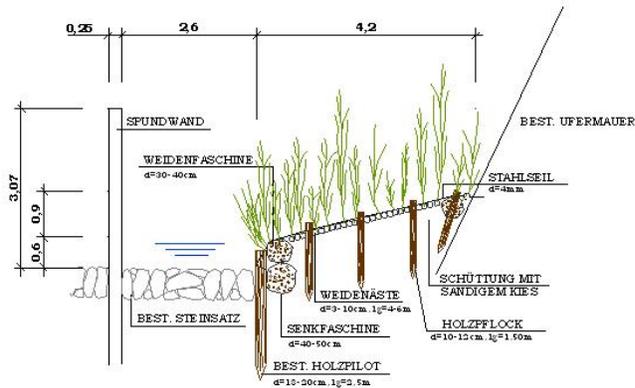
Figure 8.5 Branch layer. All dimensions are in meters (1 m = 3.3 ft).

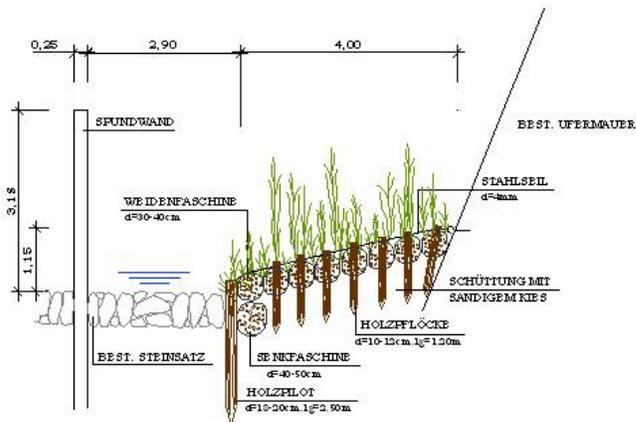
Figure 8.6 Fascine layer. All dimensions are in meters (1 m = 3.3 ft).

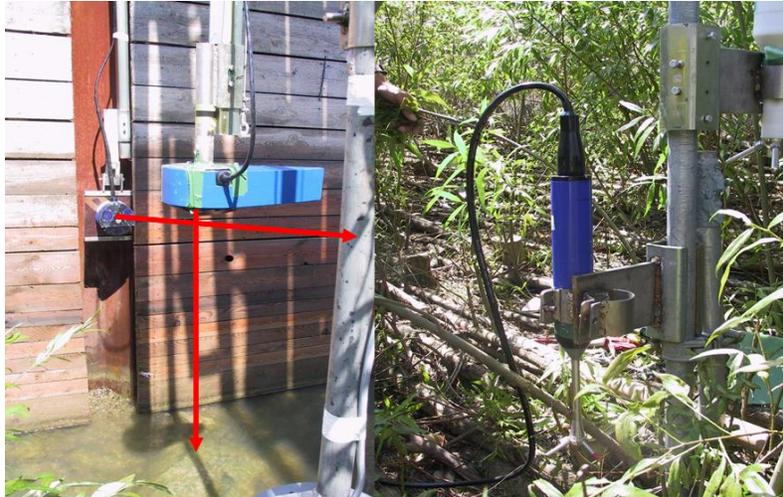
The research focused on the hydraulic impact of vegetation in successive growth stages. An ADV (Acoustic Doppler Velocimeter) and an ADP (Acoustic Doppler Profilers) were used to acquire local and cross-sectional velocity data (Figure 8.8). Velocity distributions were acquired at a fixed cross-section. Discharge was only measured using the water level in the retention reservoir and the opening of the gate. In addition, water level was measured at five other cross-sections. Figure 8.9 shows the velocity distribution at the fixed cross-section and the influence of the vegetation on the flow conductance.

Figure 8.8 Measuring devices: acoustic Doppler profiler (left), acoustic Doppler velocimeter (right).

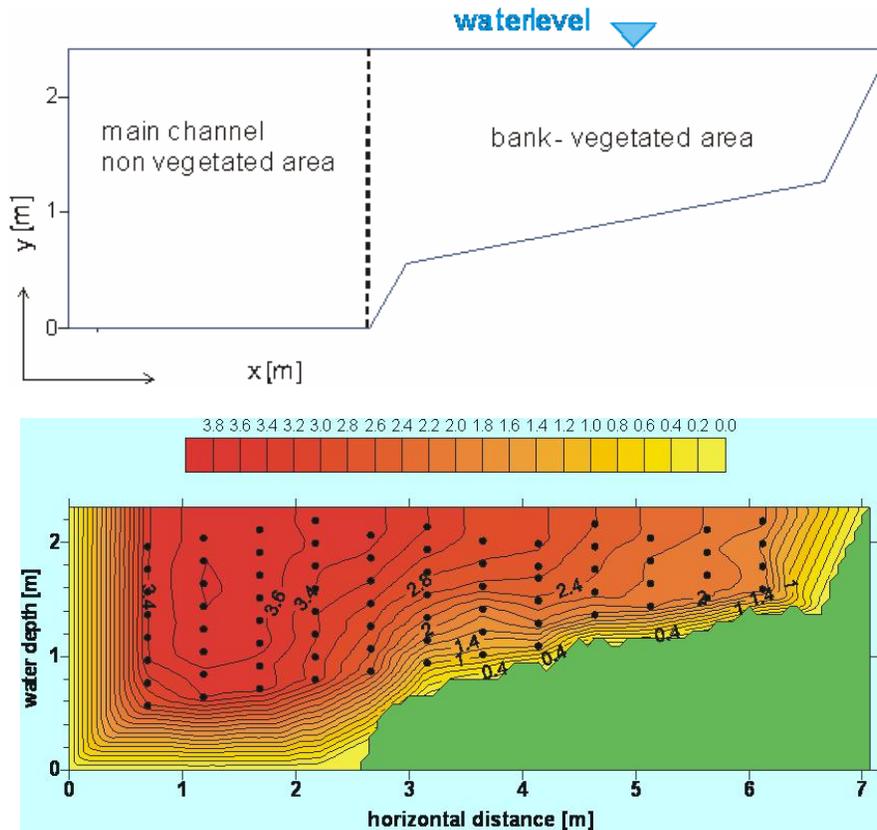
Figure 8.9 Velocity profile along the vegetated and non-vegetated area. Velocities are in m/s (1 m/s = 3.3 fps).

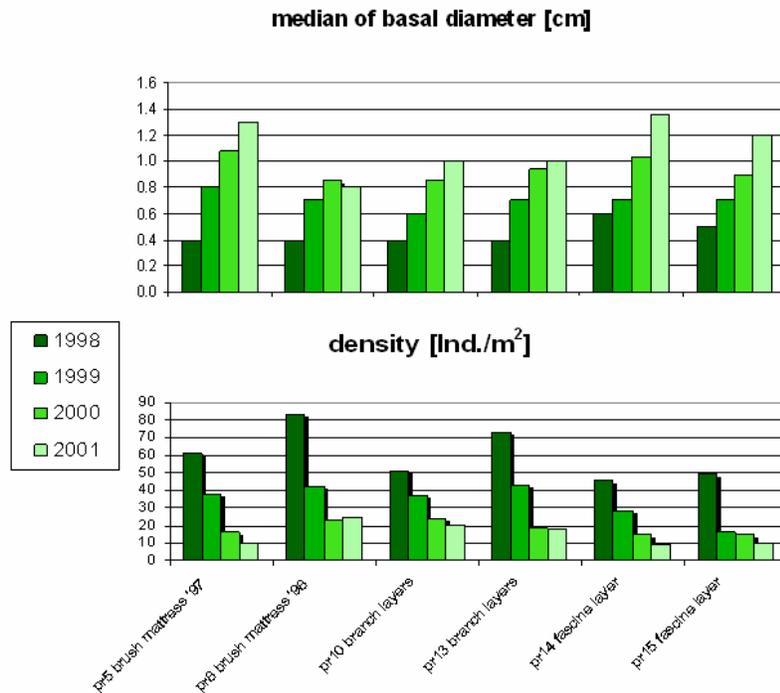
their diameters at a height of 3.3 ft (1 meter), the shoot length, and the shape of the crowns were collected once a year. Analysis of these data on an annual basis provided an overview of vegetation development (Figure 8.10). Typical growth patterns indicated how plants coped with the applied loads. The data in Figure 8.11 show how at a fixed discharge, mature plants increase the water level and decrease the velocity and subsequently the shear stress on the banks.

Figure 8.10 Variation in time of median basal diameter and vegetation density in different sections of the flume.

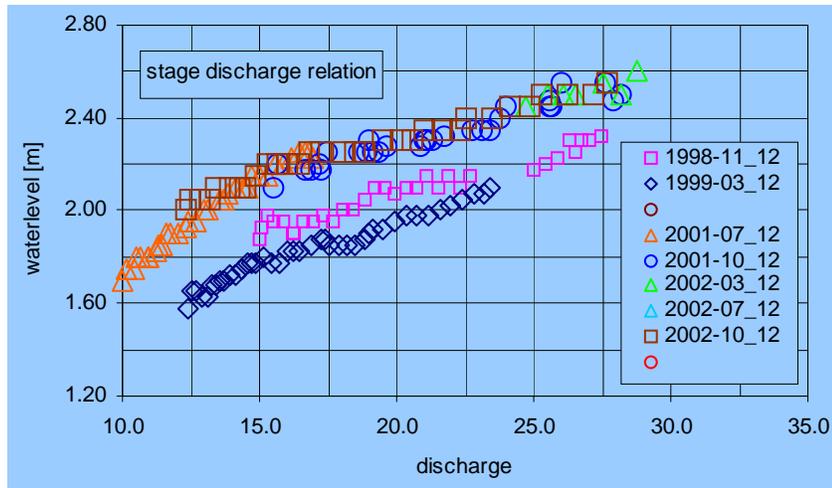
Figure 8.11 Relationship between water level and discharge observed during floods in 1999 and 2001. Velocities are in m/s (1 m/s = 3.3 fps).

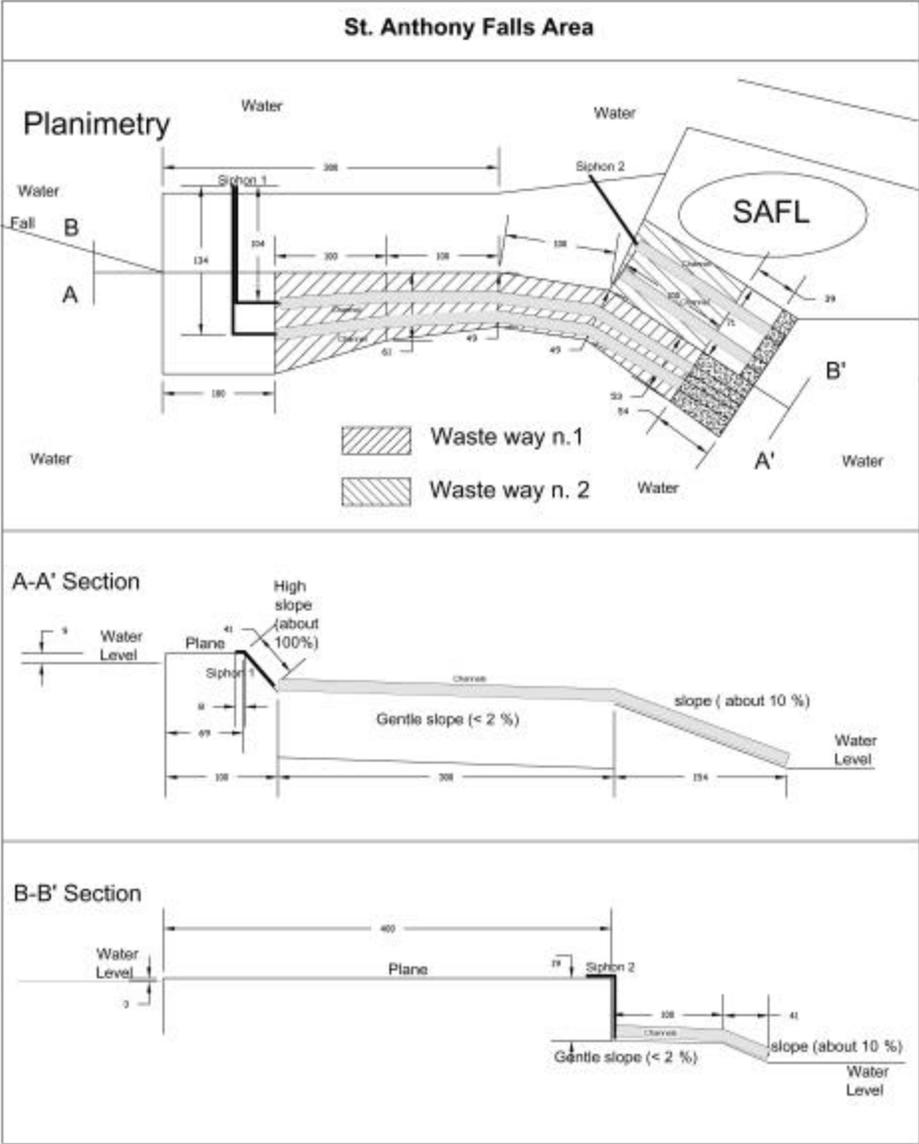
The St. Anthony Falls site is located on Hennepin Island in the heart of Minneapolis. Currently, there are two abandoned wasteways on the islands which used to convey part of the Mississippi River water to the bwer St. Anthony Falls impoundment. The wasteways which are located on the left bank of the Mississippi River are ideal sites regarding space, access, water requirement, and security. The dimensions of the sites are illustrated in Figure 8.12 and the wasteway are designated as zone 1 and zone 2.

Figure 8.12 Plan view and profiles of the St. Anthony Falls wasteways.

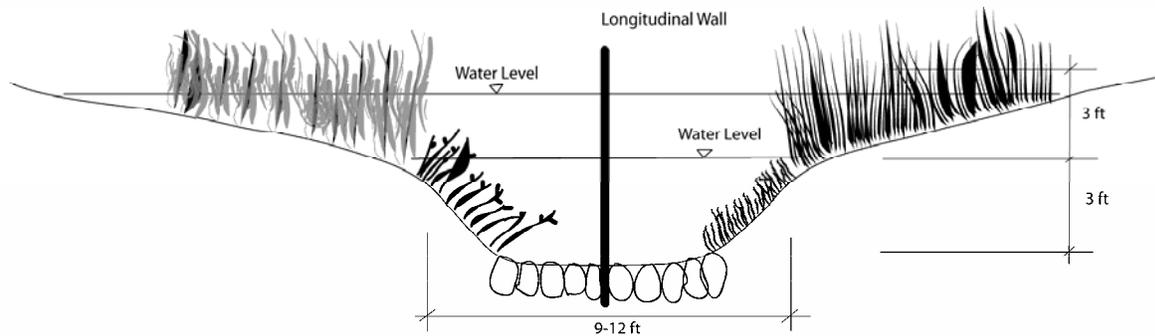
Figure 8.17 Schematic of a test flume cross section with a dividing wall.
