2004-47

Final Report

**Scoping Study for the
Development of Design
Guidelines for Bioengineering
in the Upper Midwest**

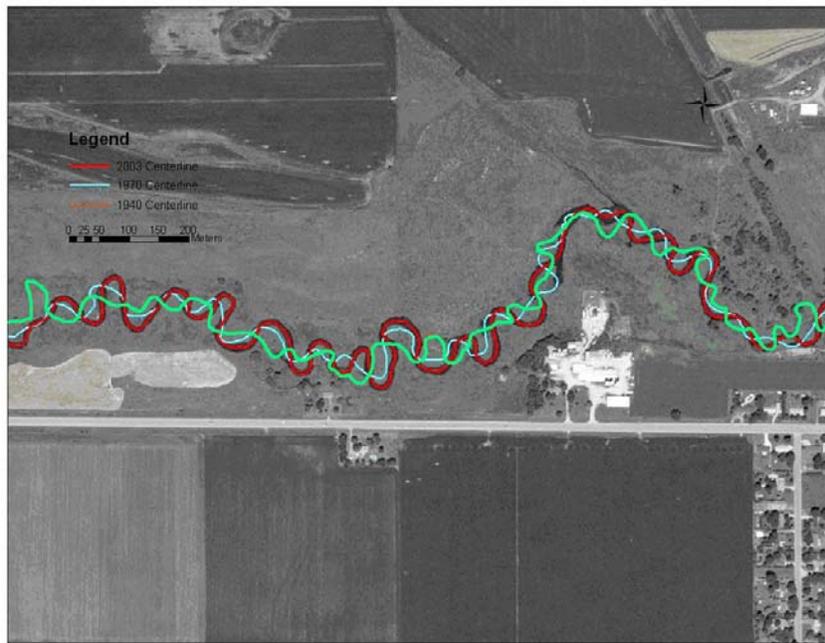
Figure 8.22 Vermillion River: Evolution of the center line.

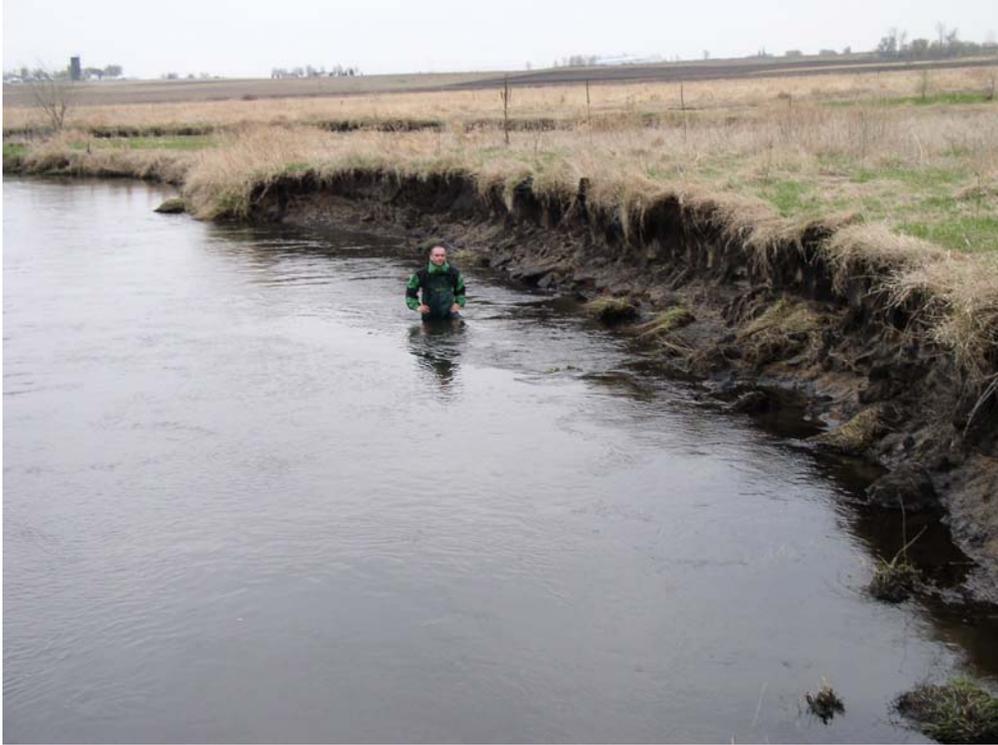
Figure 8.23 Bank erosion along a bend

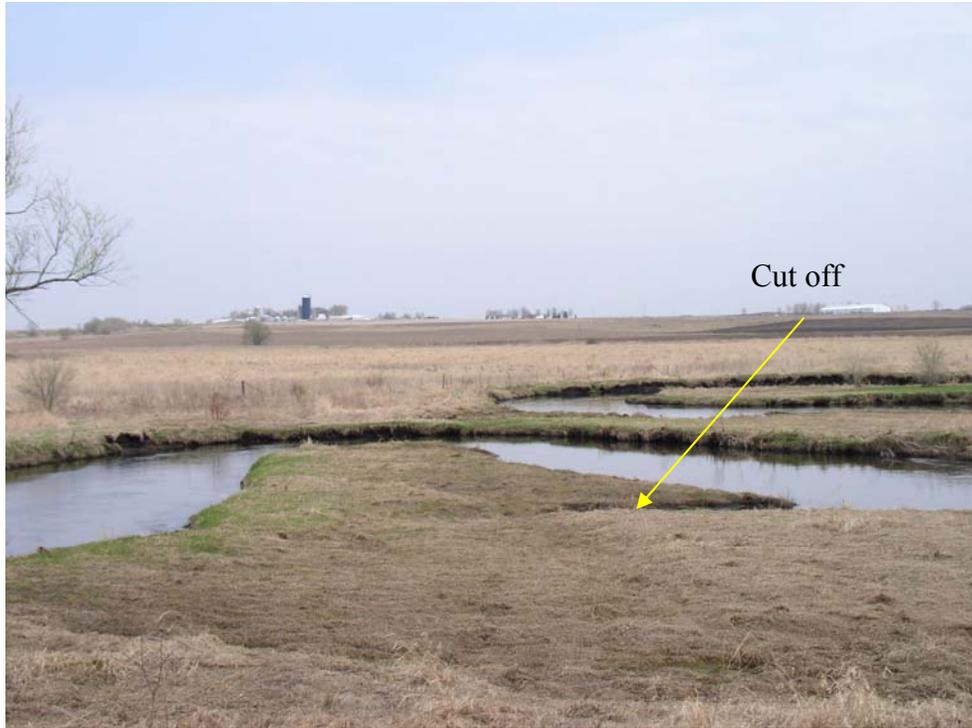
Figure 8.25 Erosion on the flood plane shows a cutoff.

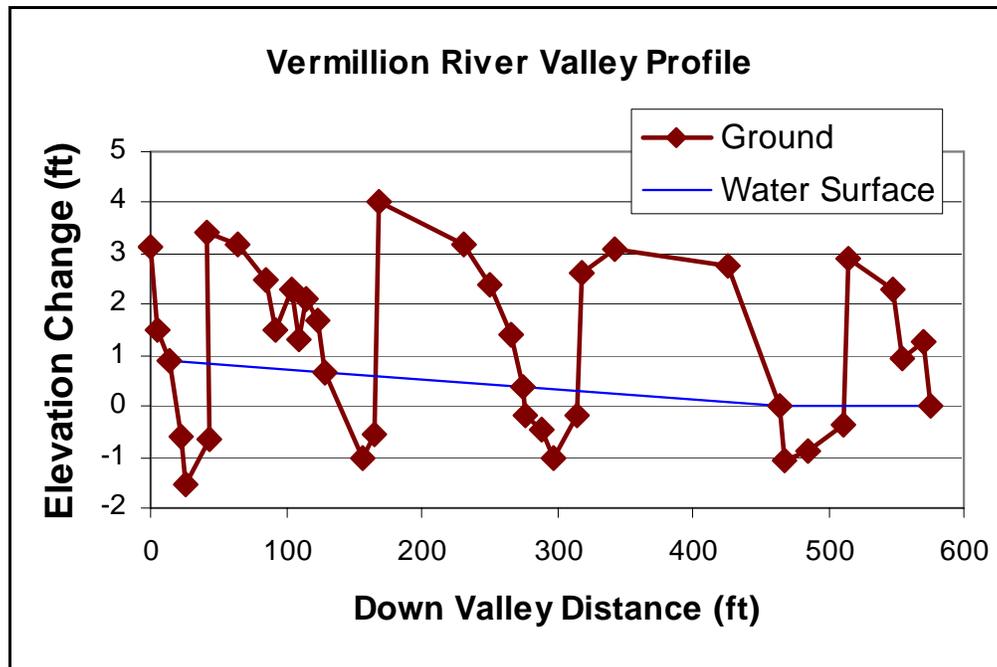
Figure 8.27 Ground and water level profiles along the surveyed section.

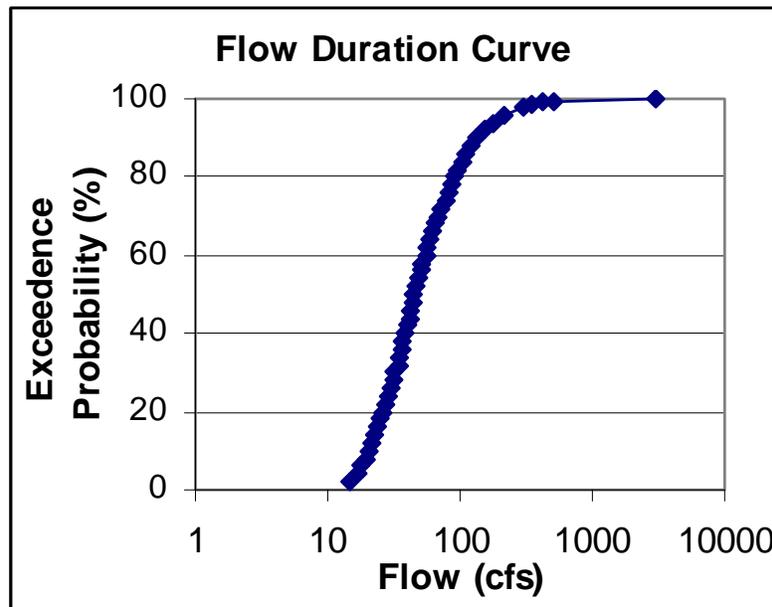
Figure 8.28 Probability of flow exceedance at gaging station no. 05345000.

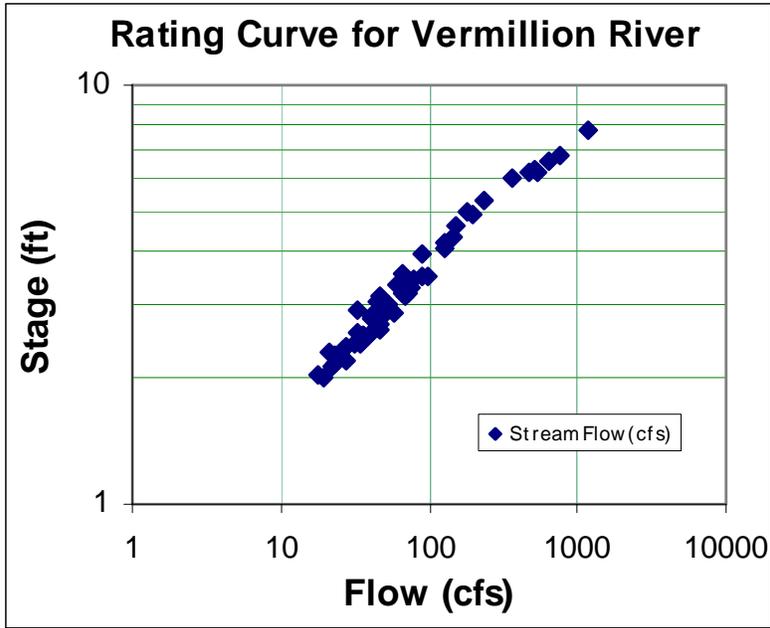
Figure 8.29 Rating Curve of the Vermillion River at the USGS gaging station no. 05345000 near Empire, about one mile upstream of the site.

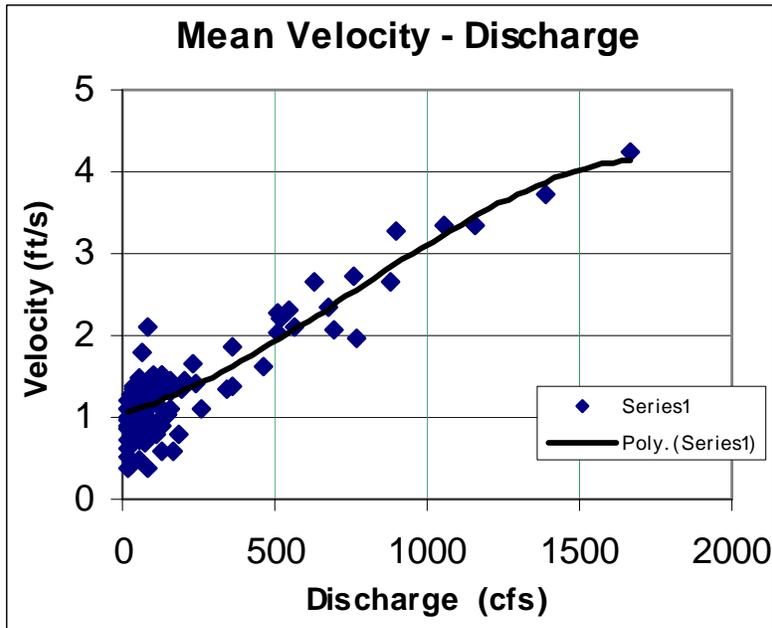
Figure 8.30 Flow and mean velocity relationship of the Vermillion River at the USGS gaging station no. 05345000 near Empire, about one mile upstream of the site.

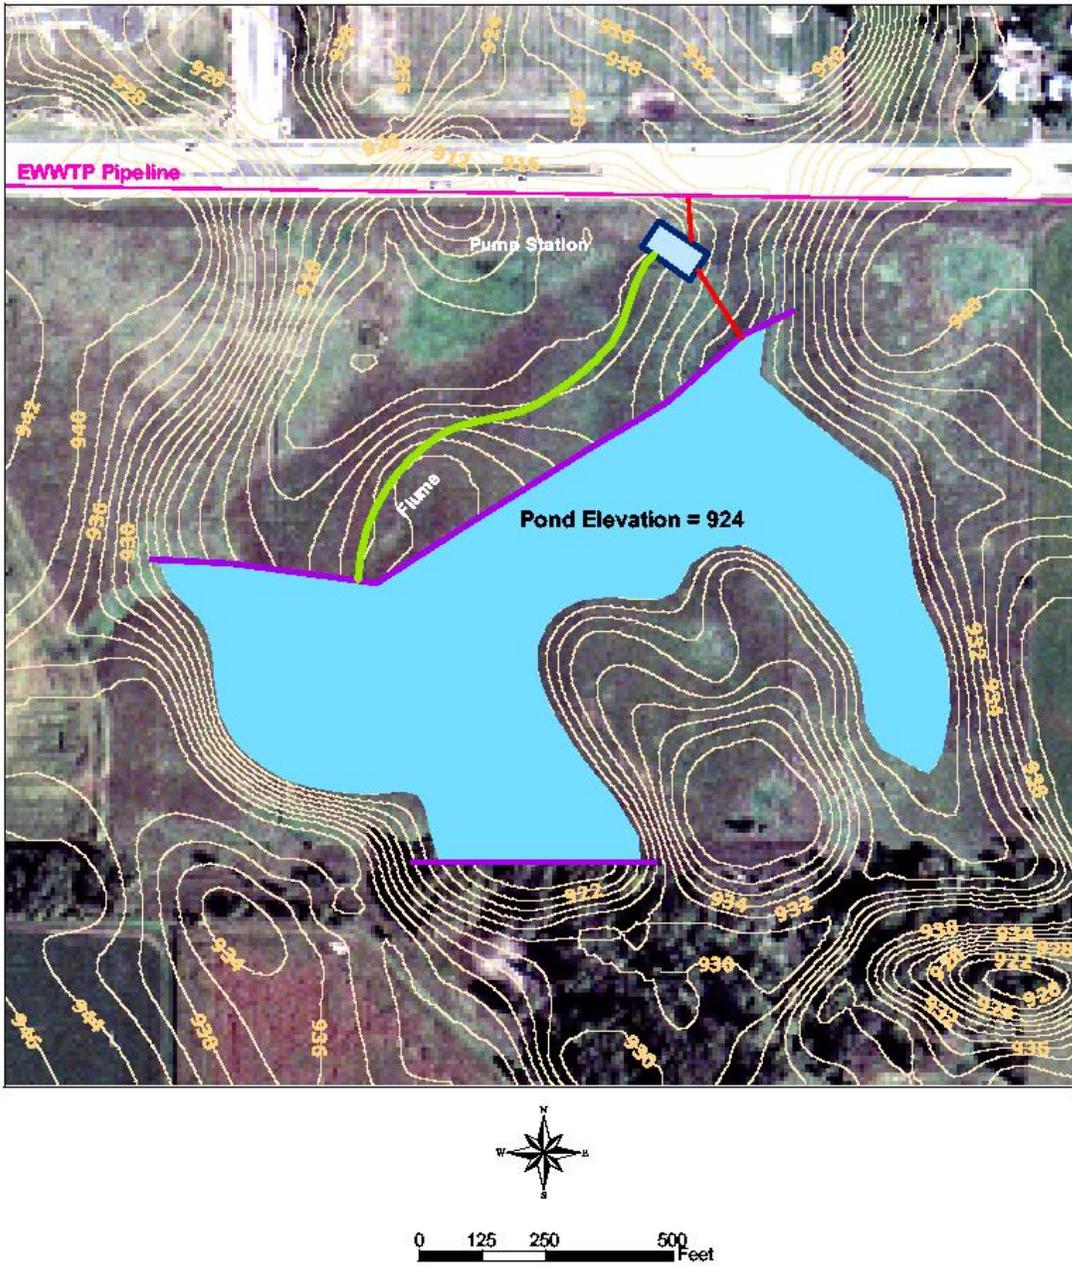
Figure 8.34 The layout of the pond, pipeline, pump house and the flume in UMore Park.

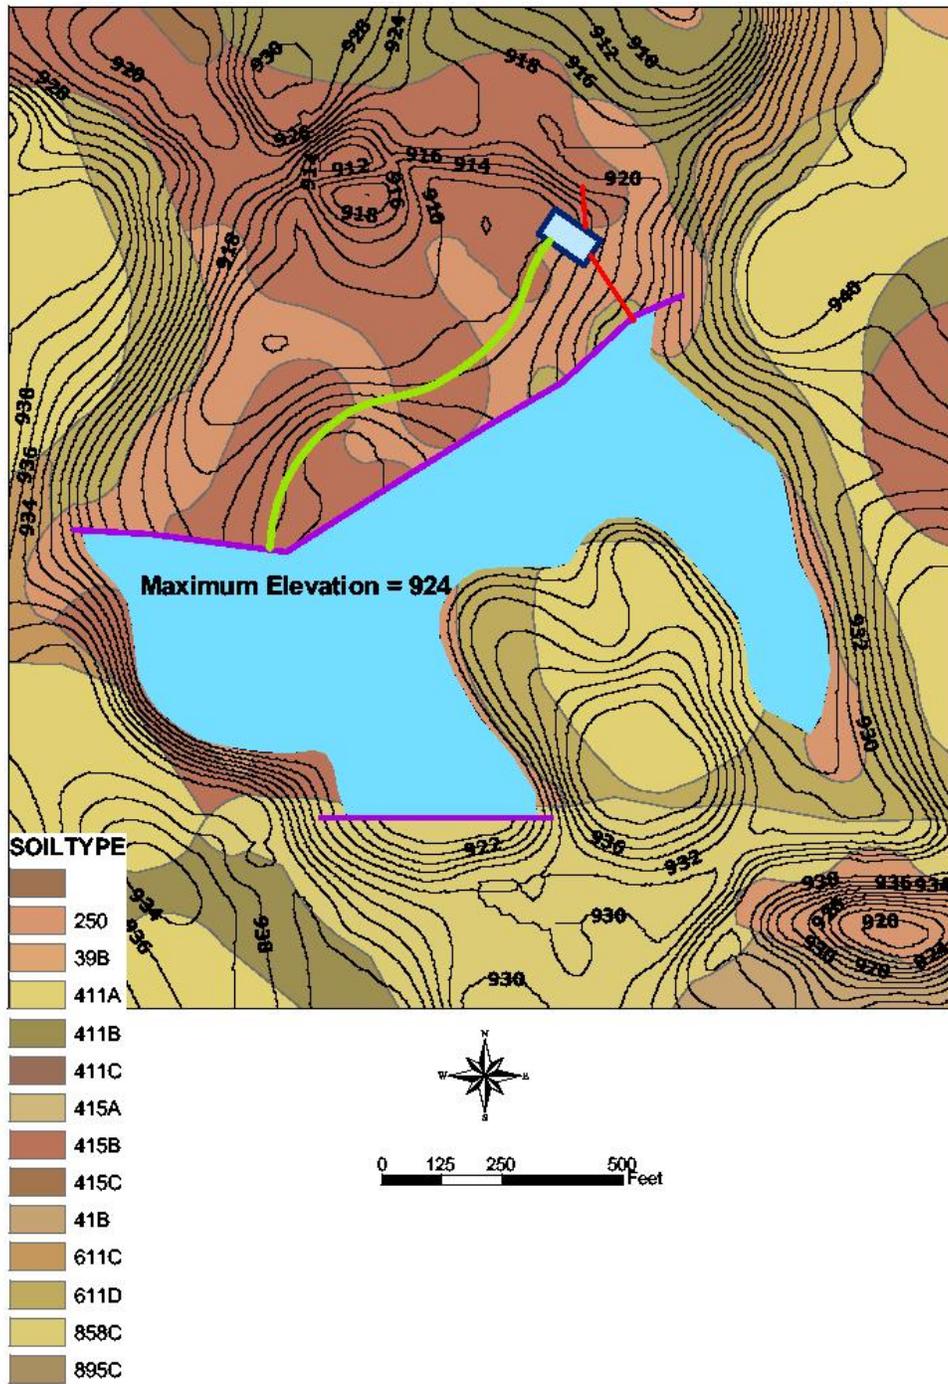
Figure 8.35 Soil types in the vicinity of the potential outdoor facility. The soils shown in the figure drain moderately well to well, i.e. according to NRCS hydrologic groups A and B. Therefore, there will be a significant water loss from the pond.
