2005-49B

Final Report

**Impact of Alternative Storm Water
Management Approaches on
Highway Infrastructure:
Project Task Reports—Volume 2**

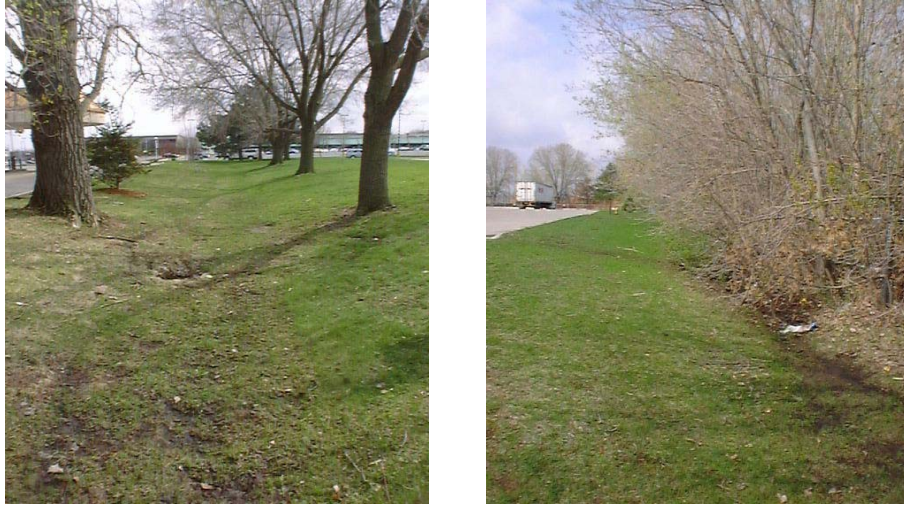
This practice measures approximately 80 meters long by 10 m top width. It is located approximately 20 feet east of the Caterpillar parking lot in Roseville (1901 County Rd B2 Roseville) – see map, figure 1. Elevation difference between its outlet and the parking lot pavement was estimated at 0.5 m. Inspection of the site was conducted on April 21, 2004. The swale runs north-south along the east side of the Caterpillar's east parking lot, receiving runoff from both the parking lot and the extensive 'go-down' roofs. A grated outlet is located near the midway point along its length. No standing water was observed at the time of the inspection, though there was modest rainfall event less than a week previously. Runoff is conveyed into the swale from the parking lot area via curbless sections of the parking lot. The grass sides and bottom of the swale appears stabilized with little signs of erosion, except in areas with less than 100% grass cover as well as relatively steep slopes next to the outlet. Well established grass cover was observed along most of the swale. There was significant erosion or sedimentation observed in the swale.

Figure 1. Photograph of the Dry Swale at the Caterpillar facility, Roseville

The practice appears to be functioning according to design and purpose of installation.

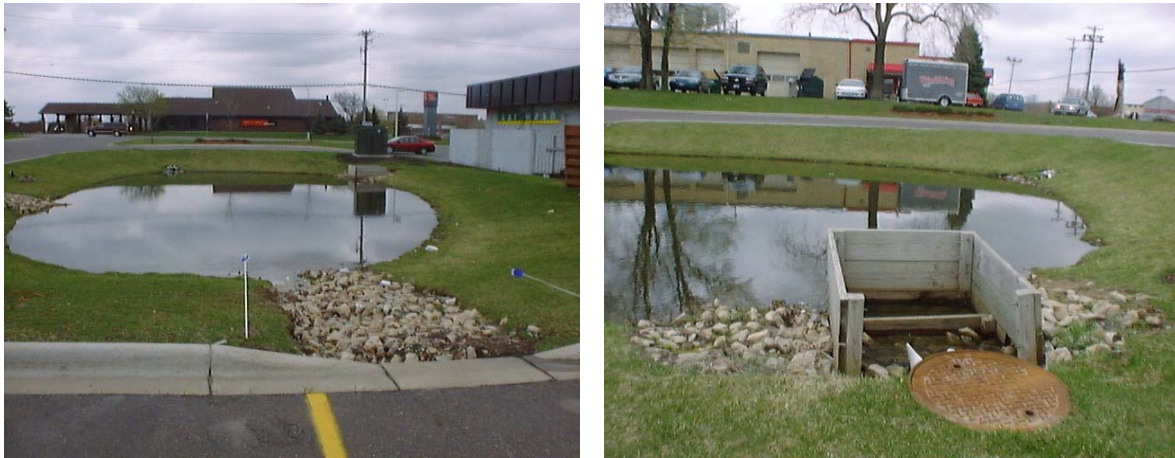
Further investigations were recommended for the following: elevation difference between pavement and basin floor, infiltration rate at basin floor, water table elevation (through coring), and area of watershed served by the practices. Further, need for periodic monitoring of water level in basin was felt justifiable, because the practice is serving apparently large 'watershed' area. A map (or GIS database if available) of the stormwater drain system would also be useful.

Figure 2. Photograph of Constructed infiltration Basins at the Inter-bank, Roseville

The practice was mapped by tracing its perimeter using GPS unit on December 5, 2004. Coordinates and elevation data for the inlet and outflow points were recorded. A GIS database has been created using this data, together with other attribute information collected with the GPS unit. Soil samples were collected for profile descriptions. Details on data collected using GPS for the site are presented in table 1a. Further measurements and tests for the site will be completed at a later date.

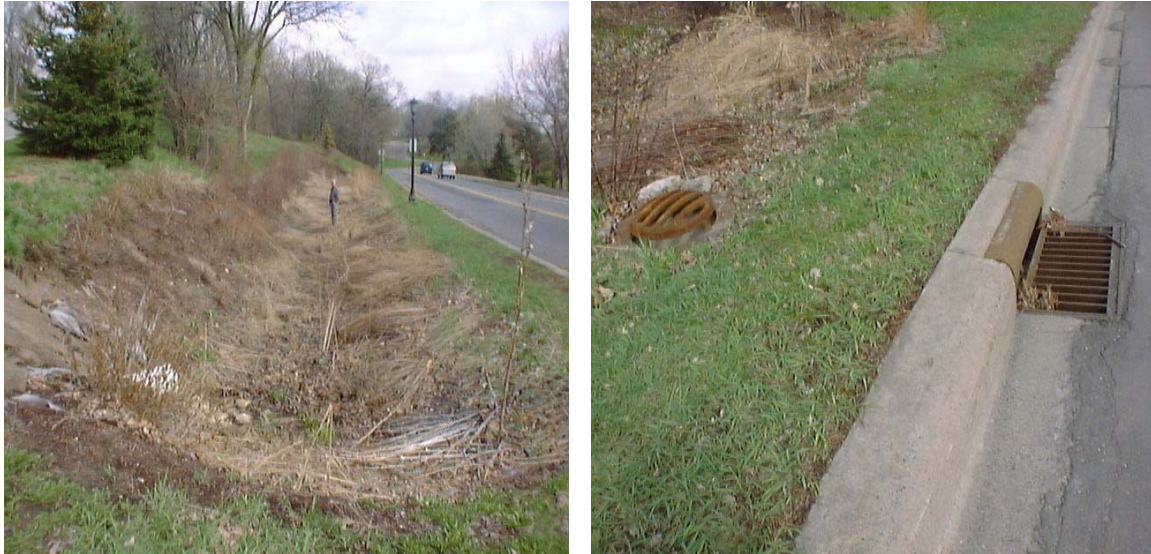
Further investigations into infiltration capacity of garden were considered important. This is because the structure is placed very close to the road, hence is likely to impact the infrastructure.

Figure 3. Photograph Rain Garden, Como Park, Roseville

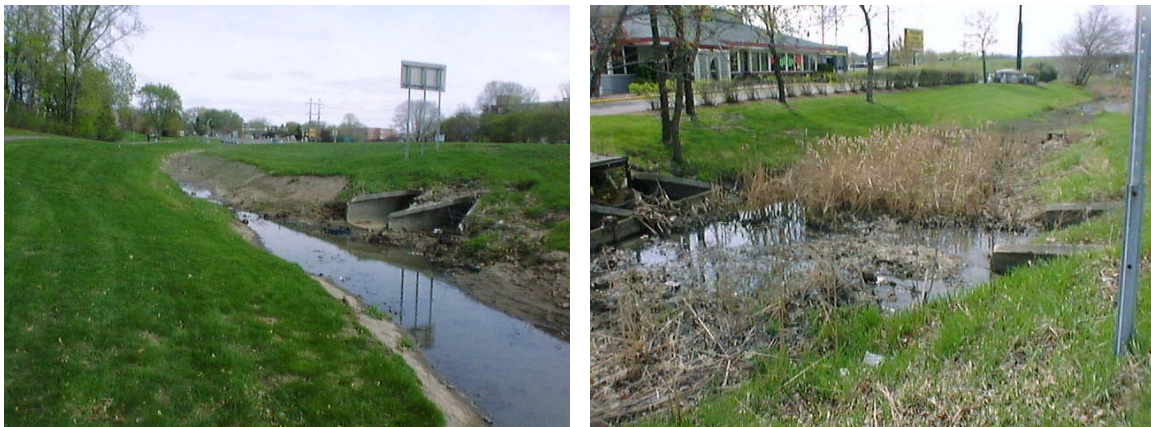
The distance between swales floor and edge of infrastructure is approximately 30 feet. The elevation difference between road pavement and swale floor was approximately 10 feet. The west side swale had water flowing north to south, with a fairly large gradient, while that one in the east side flowed south to north with a more gradual gradient. There was standing water in both swales.

Figure 5. Photograph of Wet Swales on the west and east sides, respectively, of Century Avenue, Maplewood

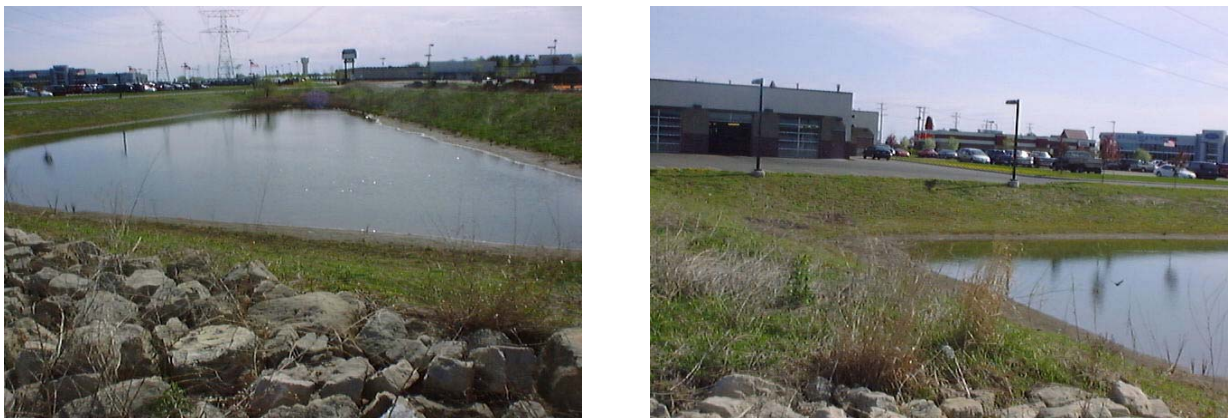
Further investigations to determine size of actual contributing area served by the practice, infiltration measurements at floor of basin, map flow into and out of the basin as well as to establish if the adjacent swales served as extra storm treatment area.

Figure 6. Photograph of Constructed Infiltration Basin at the Pony Express Car Wash in Oak Park Heights

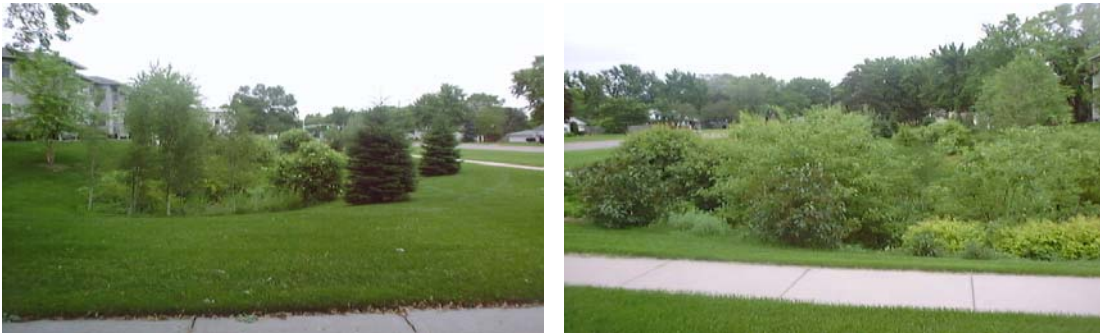
Further study of BMP may not be useful to this project. Further study to establish actual infiltration compared to design values recommended.

Figure 7. Photograph of Constructed Infiltration Basin at Realife Coop apartment complex in Bloomington

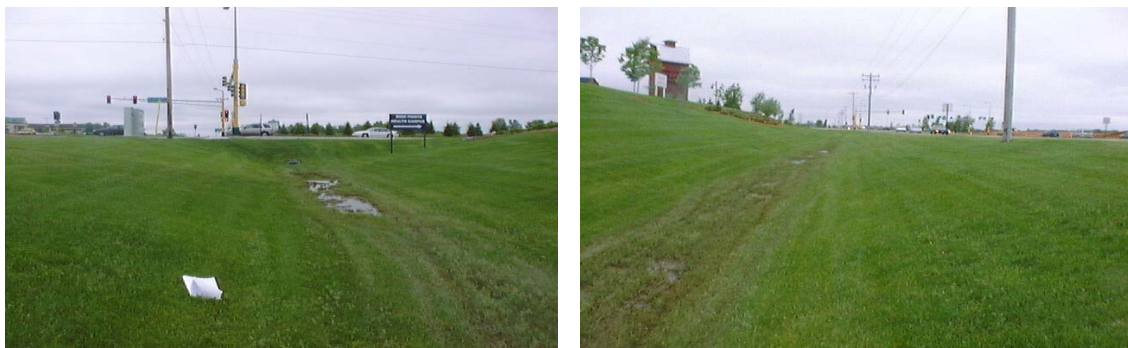
There was some standing water (less than 1 inch) at few spots along floor of the swale. Daily rainfall data showed a 0.4 inch cumulative for previous 5 days. The road is smooth and well maintained with no stress signs.

Figure 8. Photograph of Grassed Swale east of CR 13, Lake Elmo Dental Clinic

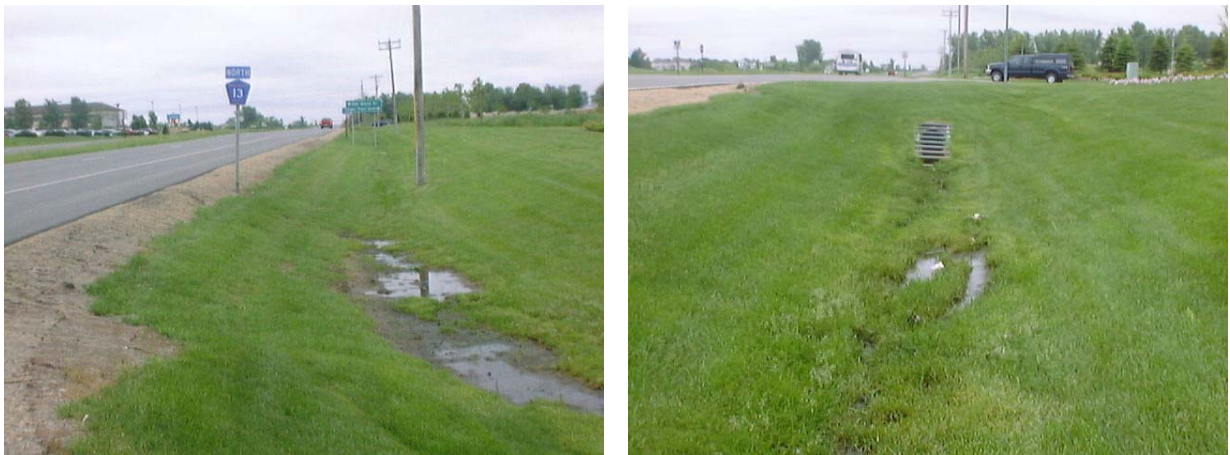
Some standing water (less than 1 inch) observed at few spots along bottom of swale.

Figure 9. Photograph of Grassed Swale with check dams at Bremer Bank, CR 13

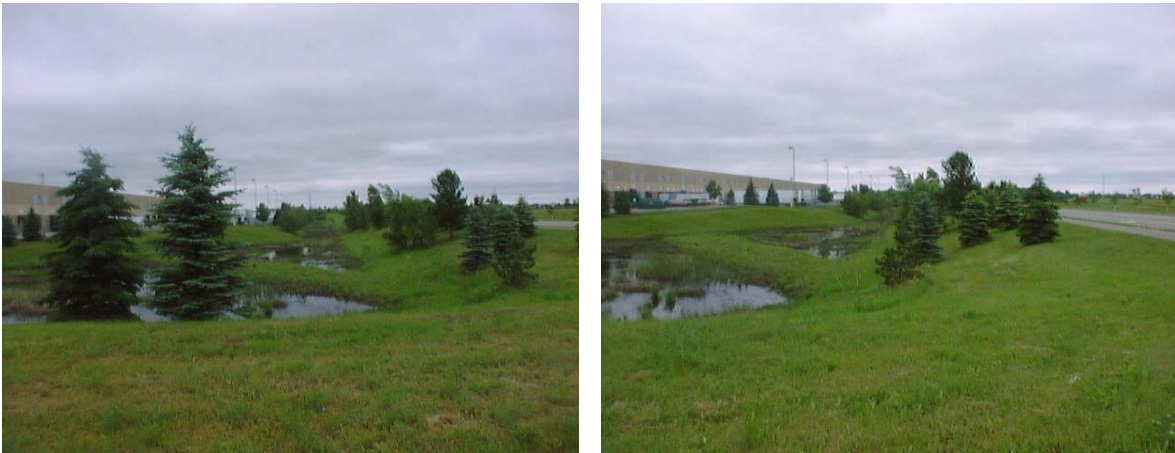
There is a large elevation difference between this BMP's outlet and the infrastructure pavements. No visible stress was observed on the relatively new road pavements. Further study of this site may not yield useful data for this project.

Figure10. Photograph of Infiltration Basin NW quadrant of 93rd and Hampshire Ave. N, Brooklyn Park

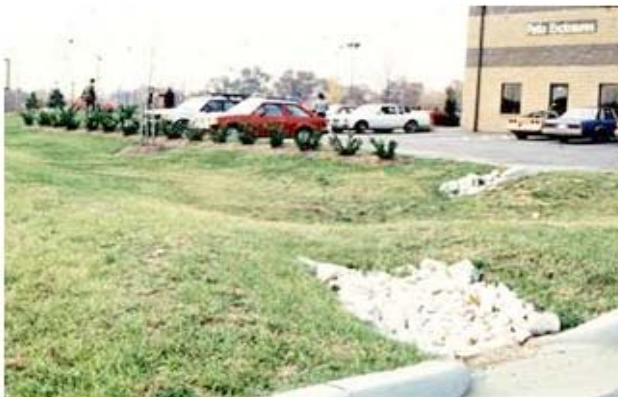
Infiltration Basin.

A normally dry depression or basin constructed in undisturbed soil to capture and infiltrate the first flush of storm water runoff into the ground. The floor of the basin is typically flat and vegetated with grasses. Flows in excess of the first flush are directed to overflow or otherwise bypass the infiltration basin.

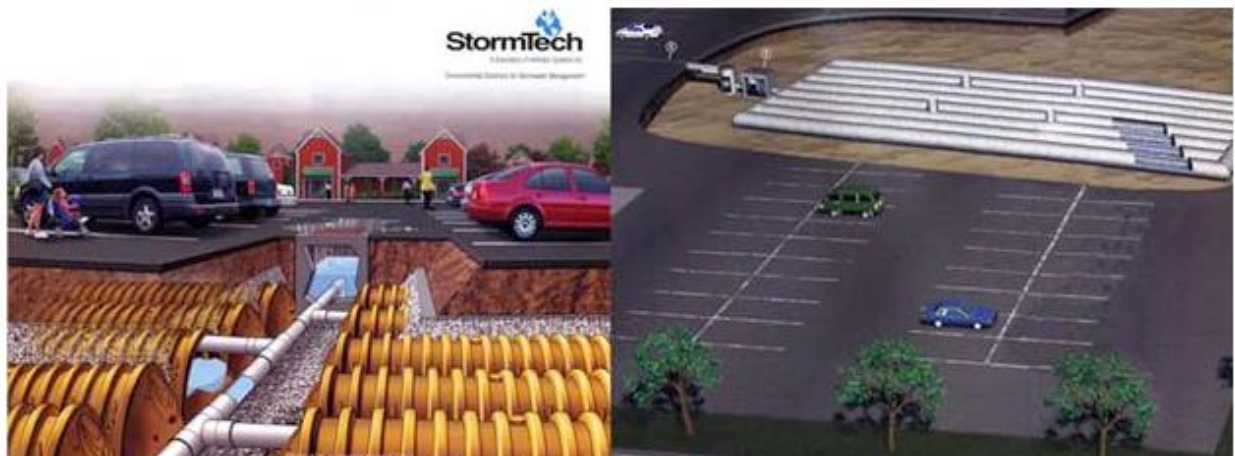
Infiltration Bed.

A constructed bed (or layer) of drainage rock or stone used either alone, or in combination with large diameter perforated pipes or a system of proprietary modules, to create a large underground reservoir from which storm water may infiltrate into the ground. Infiltration beds are typically set below lawns or parking areas and used in lieu of, or to reduce, the land area that would otherwise be committed to surface pond storage. Storm water runoff is typically admitted to the bed through a pre-treatment device such as an oil/grit separator or water quality inlet.

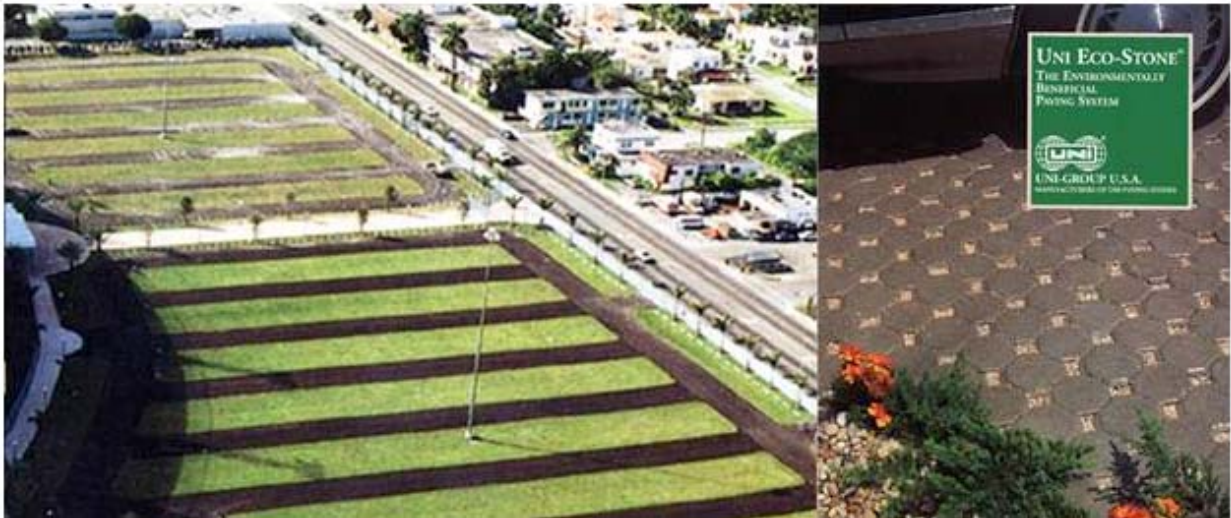
Porous Pavement.

Porous pavement may be open-graded asphaltic aggregate pavement, pervious concrete pavement, pre-cast concrete unit pavers, or plastic grid paving (typically filled with soil and vegetated) systems. Storm water infiltrates through the porous upper pavement layer and then into a storage reservoir of stone or rock below. Water from the reservoir either percolates into the soil beneath or is collected by a perforated pipe underdrain system and carried to a surface discharge location.

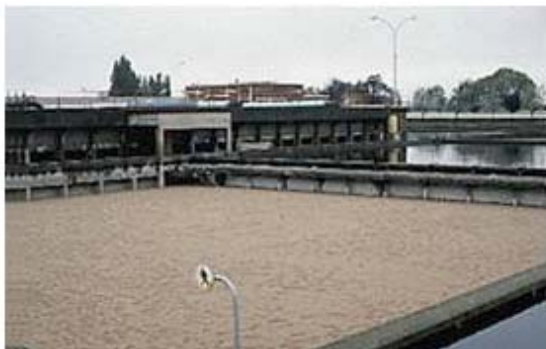
Sand Filter.

A device, usually a chamber, that cleans runoff water by passing a specified design flow through a bed of sand to reduce the concentration of pollutants to an acceptable level and then discharging it into the surface environment. May be above ground or below ground and is typically designed to treat the first flush of runoff, bypassing larger flows.

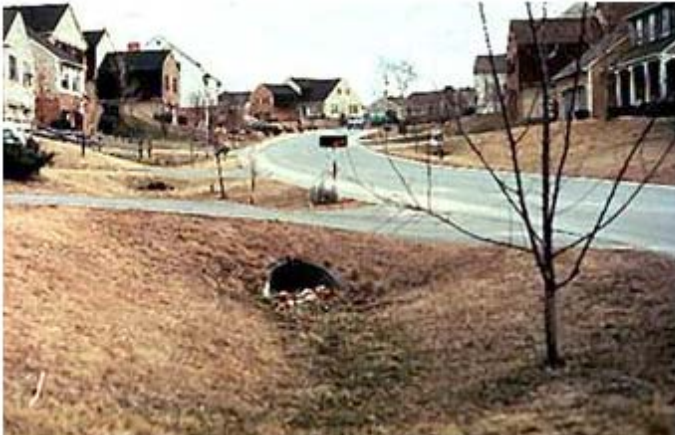
Dry Swale.

A normally dry, vegetated, earth-lined channel constructed to convey runoff flow from specific design storms from one place to another. A dry swale reduces pollution in runoff by passing flows from first flush runoff in close contact with vegetation leaf and root structures, and by allowing water to exfiltrate from the swale into the ground as it flows downstream.

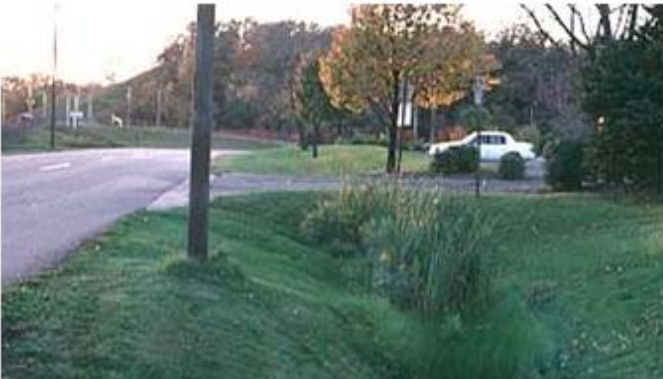
Wet Swale.

A vegetated, earth-lined channel that normally has standing water in its bottom. It is constructed to convey runoff flow from specific design storms from one place to another. A wet swale reduces pollution in runoff by passing flows from first flush runoff in close contact with vegetation leaf and root structures, by allowing water to exfiltrate from the swale into the ground as it flows downstream, and by settling action.

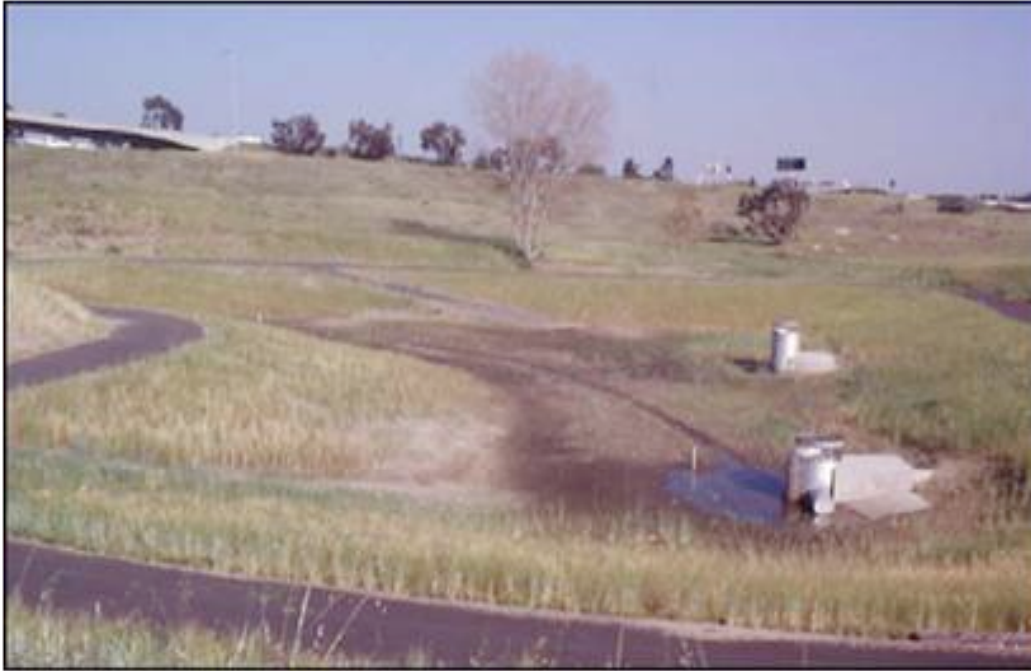
Extended Dry Detention Basin.

A normally dry detention pond that drains completely over a specified extended period of time sufficient to remove settleable pollutants to acceptable levels of concentration. An extended dry detention basin may or may not include features to provide flood control functions.

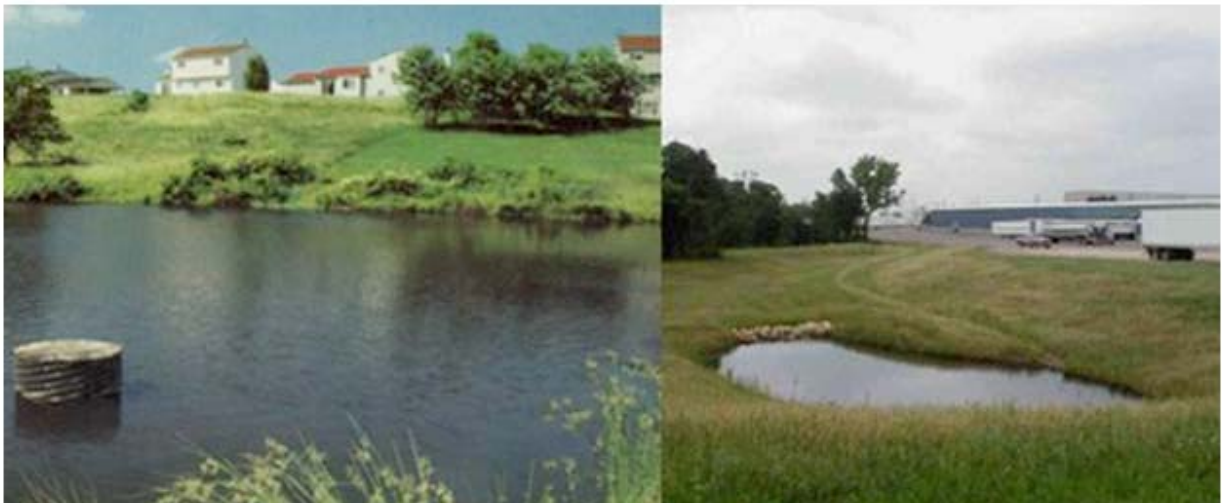
Wet Pond.

A pond that normally has water in it and is designed to slowly release water over a specified period of time sufficient to remove settleable pollutants to acceptable levels of concentration. Requires an outlet structure that controls the release velocity of water from the target storm and enables larger storms to be released at higher rates. A wet pond may or may not include features to provide flood control functions.

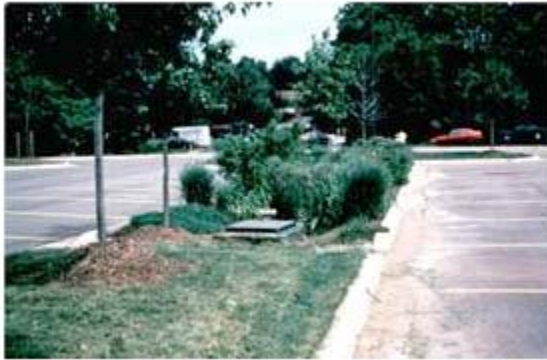
Bio-Retention Pond.

A shallow, normally dry basin that is designed to capture the first flush of runoff and pass it through a constructed artificial soil profile two to five feet deep put in place beneath the floor of the basin to filter and clean it. The floor of the basin is usually planted with a community of plants selected to provide a high degree of plant uptake of water and nutrients in addition to the filtering effect the soil profile. It is hydraulically designed to bypass flows in excess of its treatment capacity. Water leaving the bottom of the soil profile is typically picked up by an under-drain system of perforated pipe and directed to a surface water body. Alternatively, cleaned runoff may be allowed to infiltrate into undisturbed soil beneath the artificial soil profile without the presence of an under-drain system.

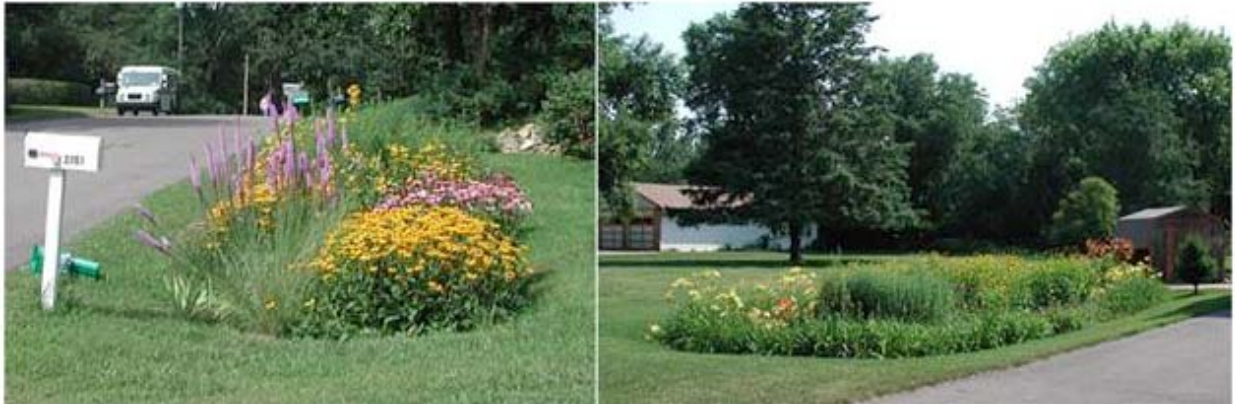
Rain Garden.

A small, shallow, normally dry basin, constructed to capture runoff and treat it by exposing it to plant use and infiltration. The floor of the basin is usually planted with a community of plants selected to provide a high degree of plant uptake of water and nutrients, and to promote infiltration. Rain gardens are typically not hydraulically designed, and do not have the constructed artificial soil profile associated with bio-retention. Water outflow is by infiltration only.

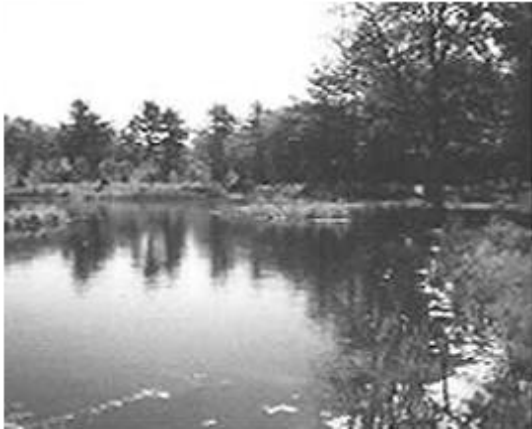
Storm Water Wetland.

An artificial wetland specifically constructed to treat runoff water by removing pollutants by sedimentation, plant filtration and plant uptake. May or may not be a open water wetland

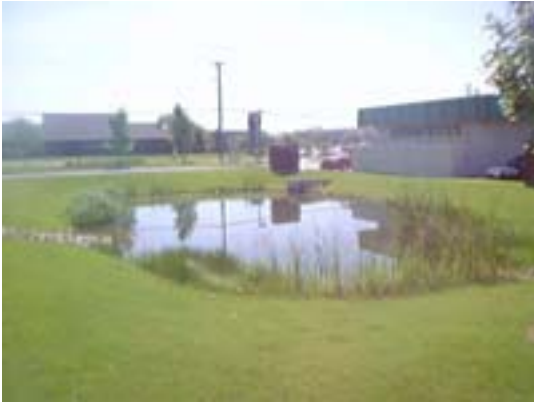
Figure 1: USBank infiltration basin.
Photo taken 6/22/05 (Pre-10-day precip. >2")

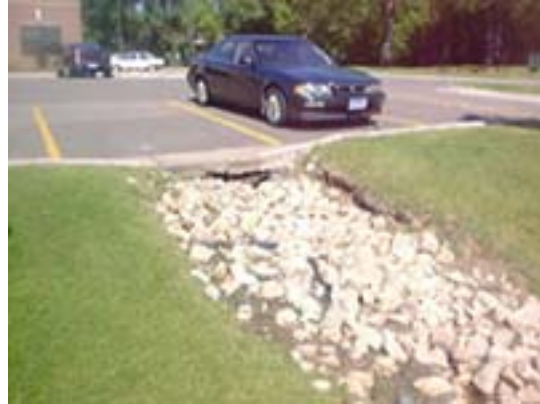
Figure 2: Erosion at USBank.
Taken 6/22/05 (Pre-10-day precip. >2")

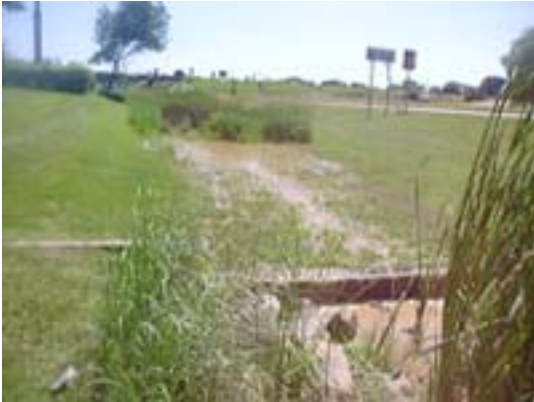
Figure 3: Denny's swale.
Photo taken 6/15/05 (Pre-10-day precip. >4")

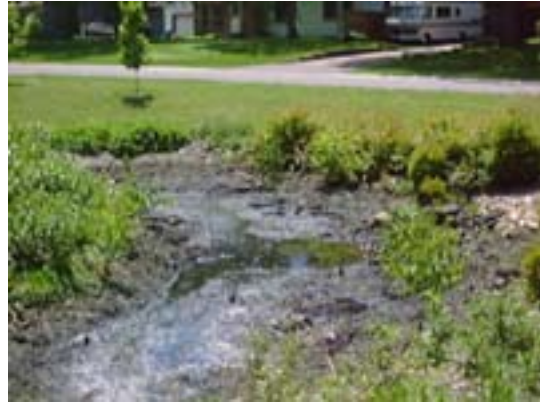
Figure 4: Rain garden at Barclay and Gulden
Taken 6/15/05 (Pre-10-day precip. >4")

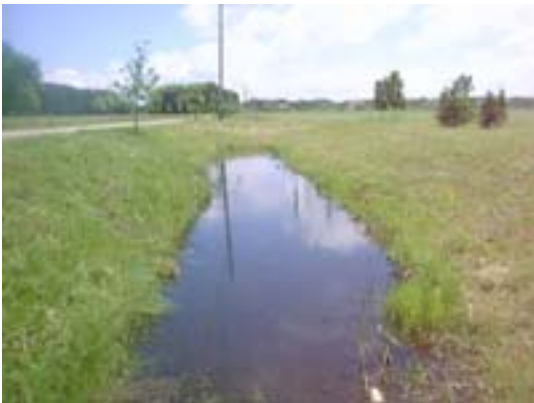
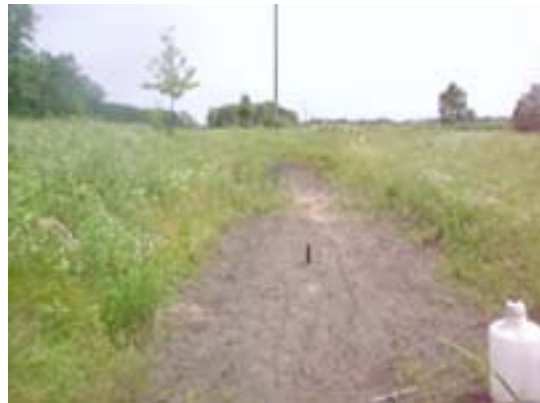
Figure 5: 50th Street (1). Rain garden.
Photo taken 6/15/05 (Pre-10-day precip. >4")

Figure 6: 50th Street (1). Rain garden.
Taken 7/12/05 (Pre-10-day precip. < 1/2")

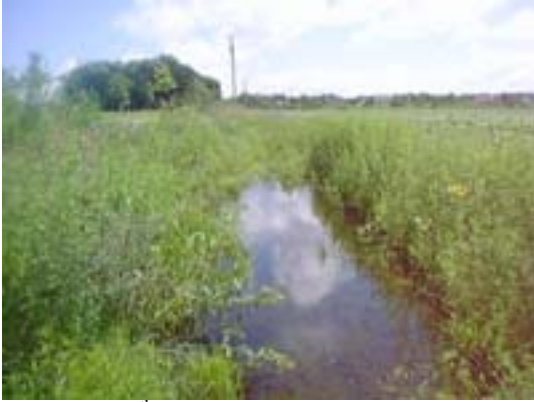
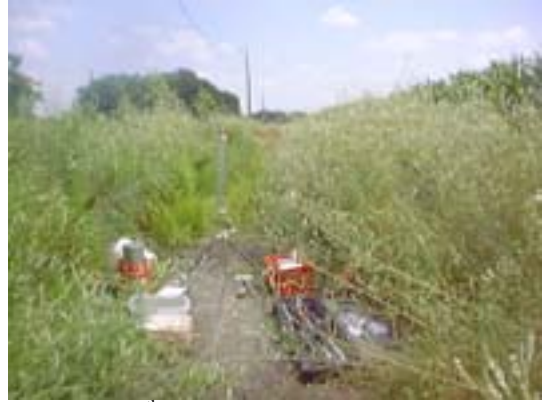
Figure 7: 50th Street (2). Rain garden
Photo taken 6/15/05 (Pre-10-day precip. >4")

Figure 8: 50th Street (2). Rain garden
Taken 7/12/05 (Pre-10-day precip. < 1/2")

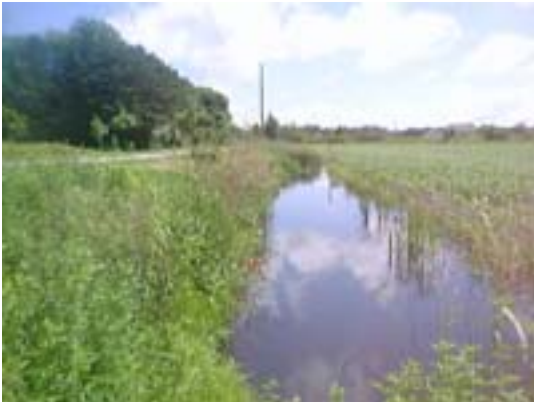
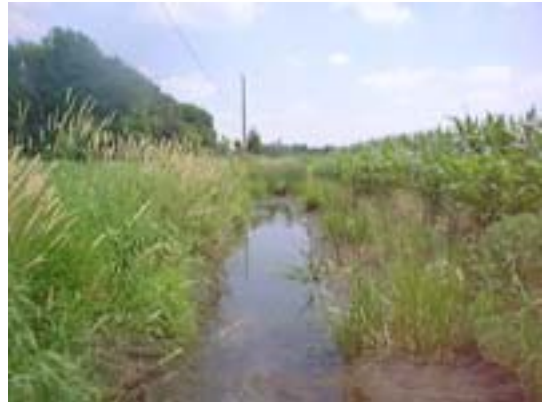
Figure 9: 50th Street (3). Rain garden
Photo taken 6/15/05 (Pre-10-day precip. >4")

Figure 10: 50th Street (3). Rain garden
Taken 7/12/05 (Pre-10-day precip. < 1/2")

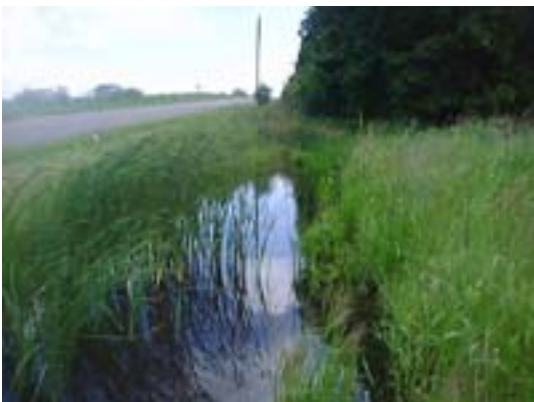
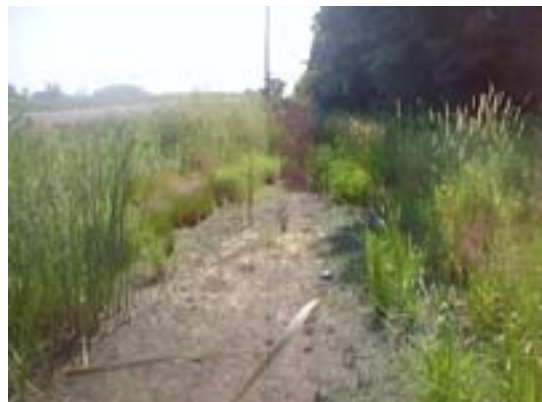
Figure 11: 50th Street (5). Rain garden
Photo taken 6/15/05 (Pre-10-day precip. >4")

Figure 12: 50th Street (5). Rain garden
Taken 7/12/05 (Pre-10-day precip. < 1/2")

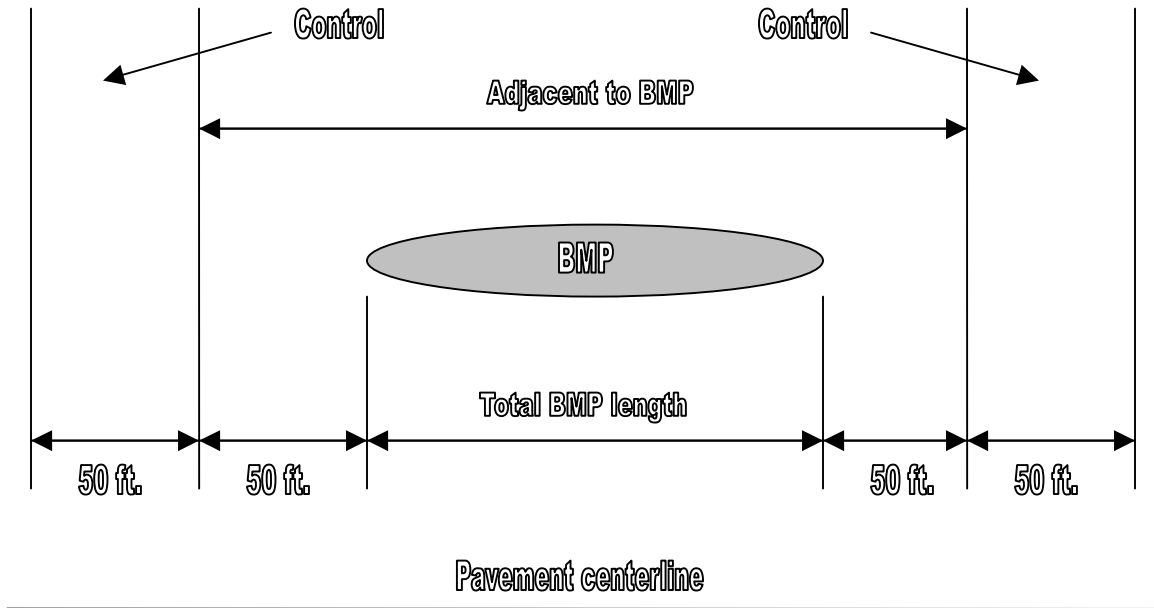
Appendix A: Pavement Evaluation Schematic (not to scale)

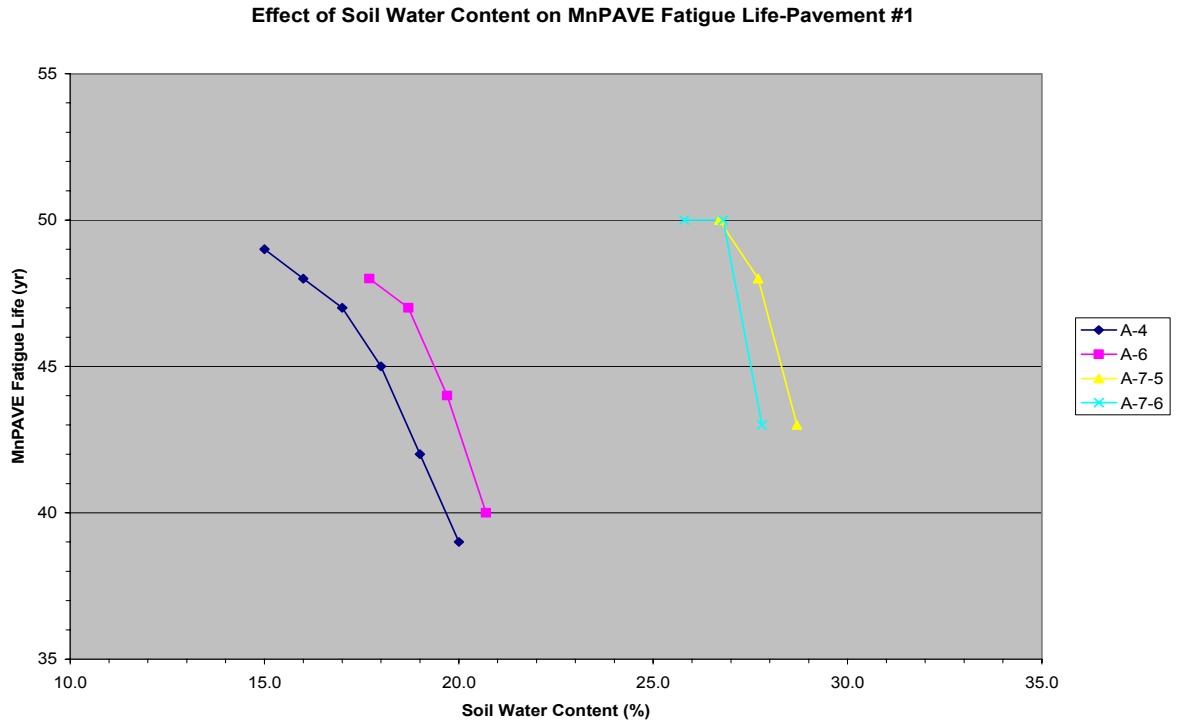
Figure 1: Effect of Soil Water Content on MnPAVE Fatigue Life-Pavement #1

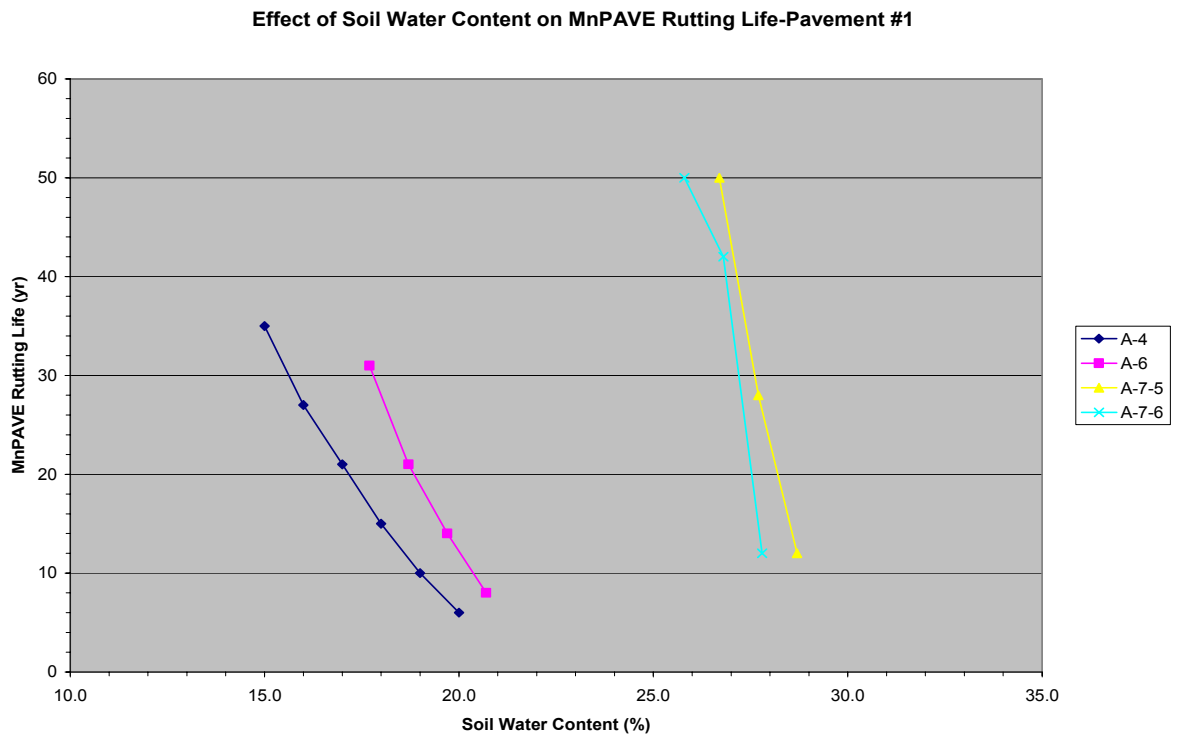
Figure 2: Effect of Soil Water Content on MnPAVE Rutting Life-Pavement #1

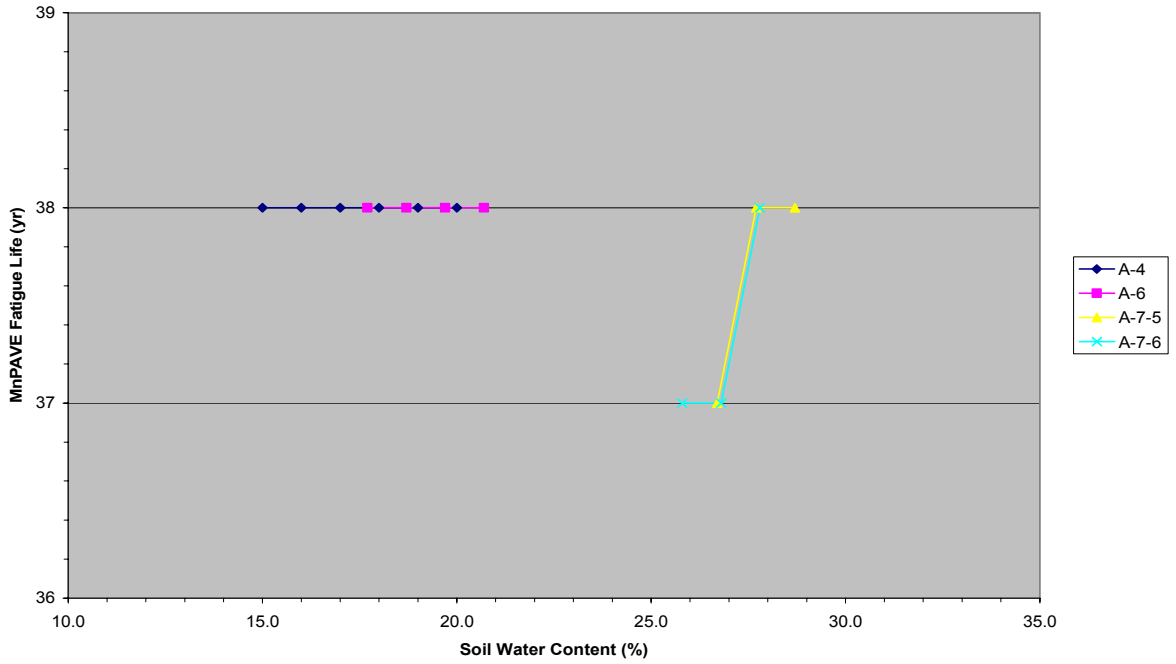
Figure 3: Effect of Soil Water Content on MnPAVE Fatigue Life-Pavement #2

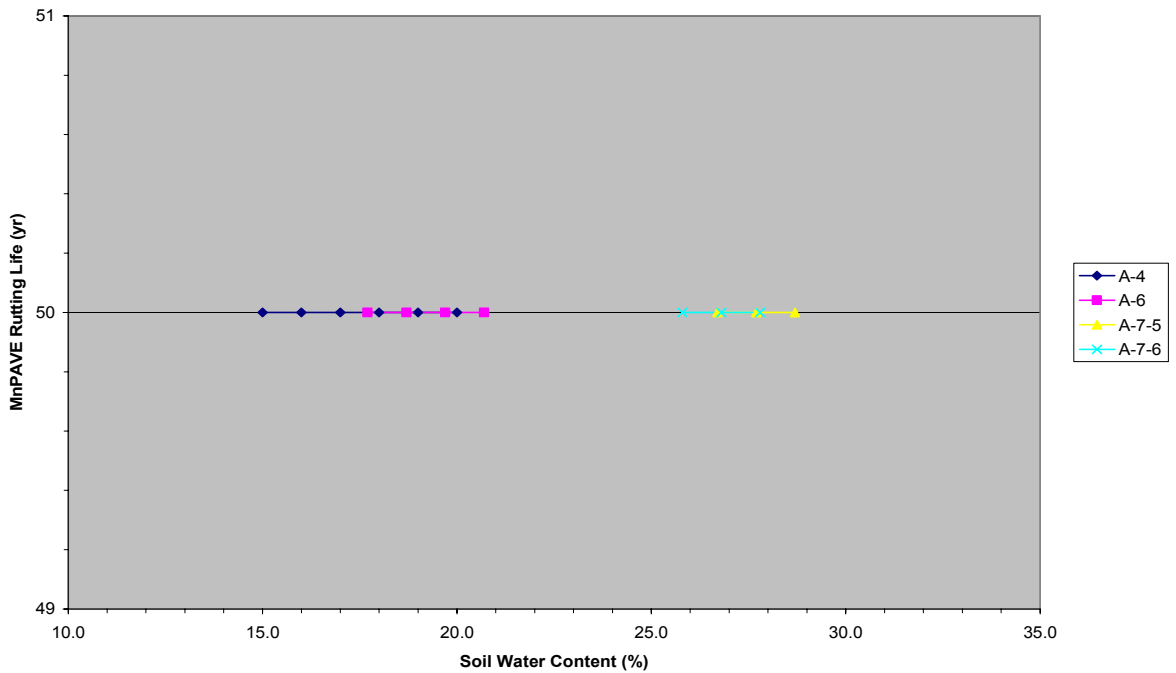
Figure 4: Effect of Soil Water Content on MnPAVE Rutting Life-Pavement #2

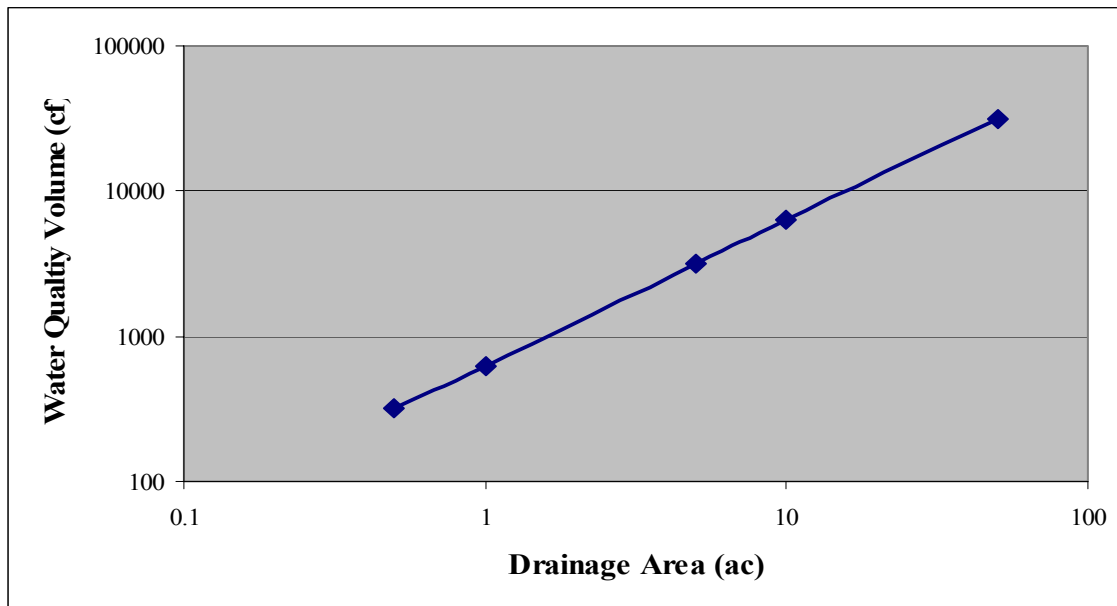
$Q = \frac{(P-0.2 S)^2}{(P+0.8 S)}$		where	Q is the runoff depth (in)		
			P is the rainfall depth (in)		
			S is the potential runoff (in)		
$S = \frac{1000 - 10}{CN}$		where	CN is the Curve Number		
$S = 1.7647$		(for a CN ≈ 85)			
VARIABLES	DRAINAGE AREA				
	0.5 ac	1 ac	5 ac	10 ac	50 ac
P (in)	1	1	1	1	1
Q (in)	0.1736	0.1736	0.1736	0.1736	0.1736
Qv (in-sm)	0.0001	0.0003	0.0014	0.0027	0.0136
Qv (cf)	315	630	3151	6302	31511
Qv (ac-ft)	0.0072	0.0145	0.0723	0.1447	0.7235

Figure 1. Water Quality Volume computed for the Twin Cities Area

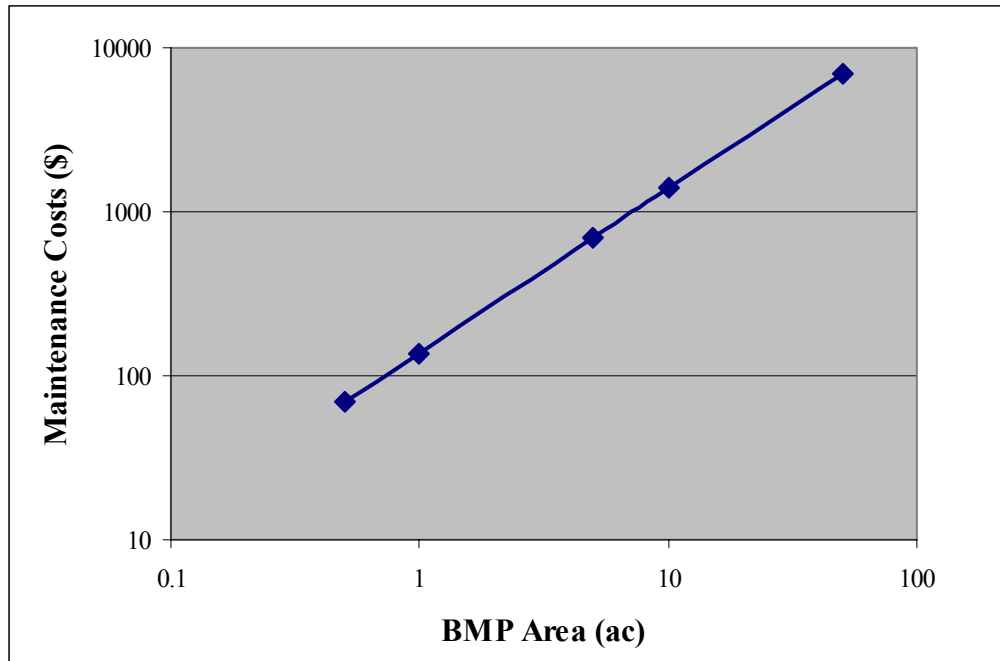
Figure 3. Present Worth Maintenance Costs for Grassed Swales, for a period of analysis (n) of 20 years and a discount rate (i) of 7%
