2006-42

Final Report

Stopping Behavior at Real-World
Stop-Controlled Intersections
with and without In-Lane Rumble Strips

**Center for Human Factors Systems Research and Design
University of Minnesota**

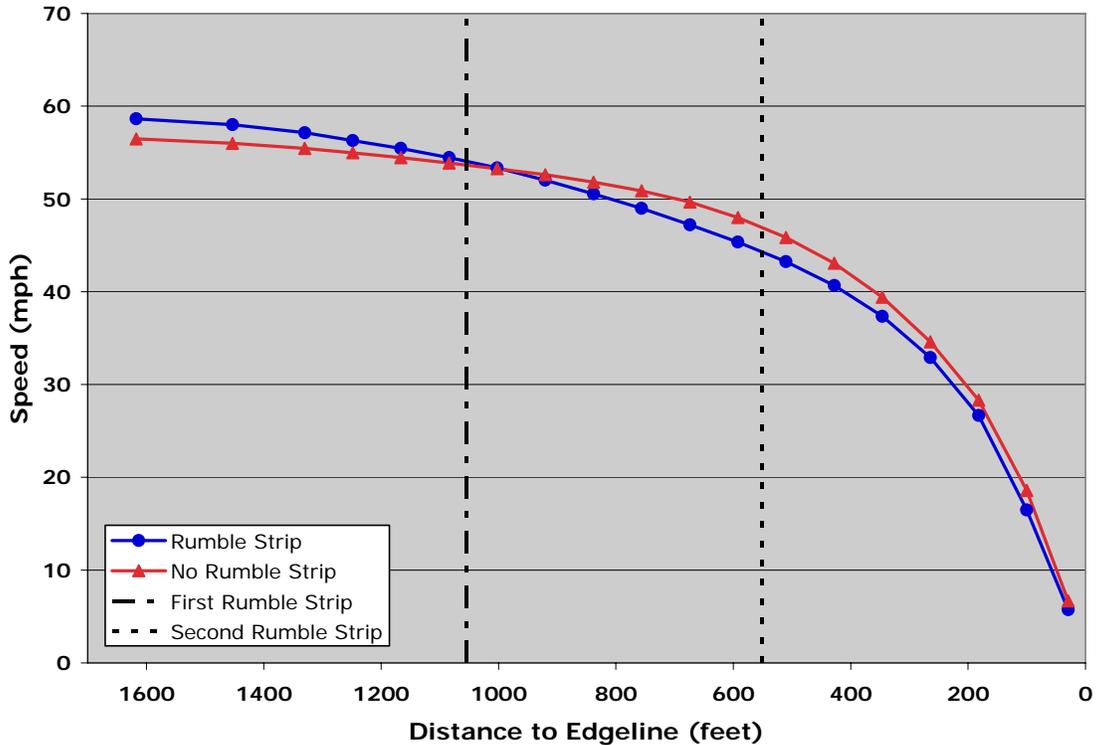
Figure 3.1: SUV/Pick-Up Truck/Van Category—Mean Speeds on the Approach to *Obscure Both* Intersections With Rumble Strips and Without Rumble Strips.

The significant interaction between Rumble Strip Conditions and Segments, for the SUV/Pick-Up Truck/Vans category, is illustrated in Figure 3.1.

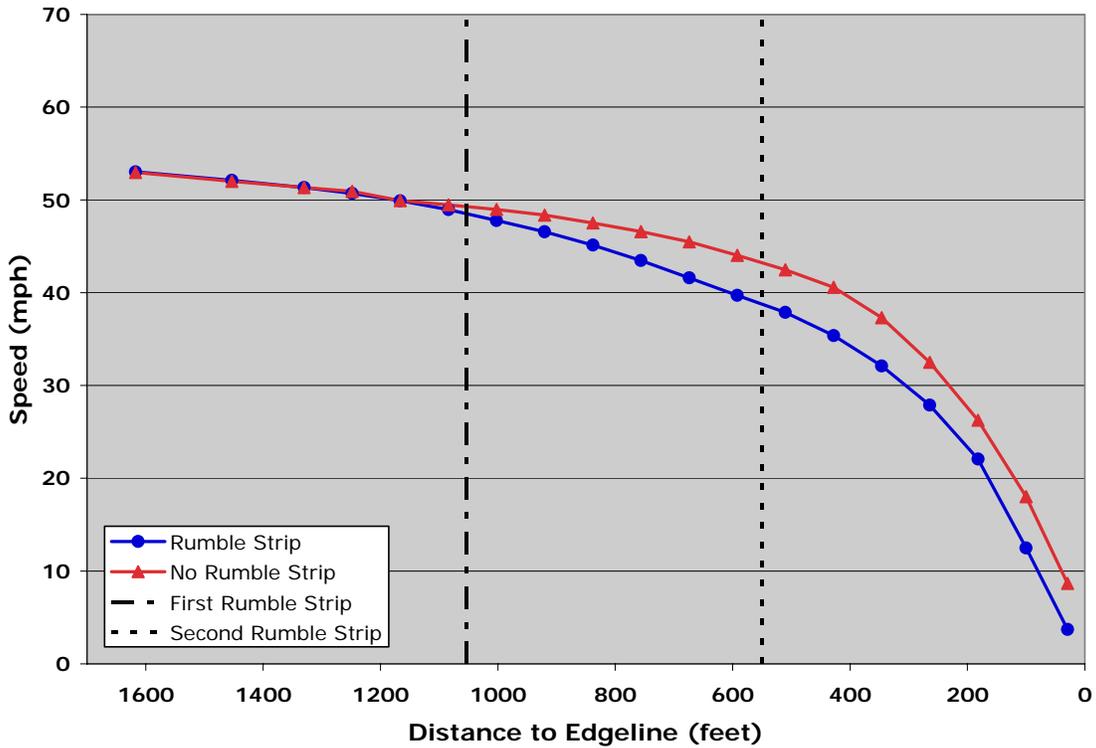
Figure 3.3: Commercial Vehicle/Heavy Truck Category—Mean Speeds on the Approach to *Obscure Both* Intersections With Rumble Strips and Without Rumble Strips.

The significant interaction between Rumble Strip Conditions and Segments, for the Commercial Vehicle/Heavy Truck Category—indicated in Table 3.6—is illustrated in Figure 3.3.

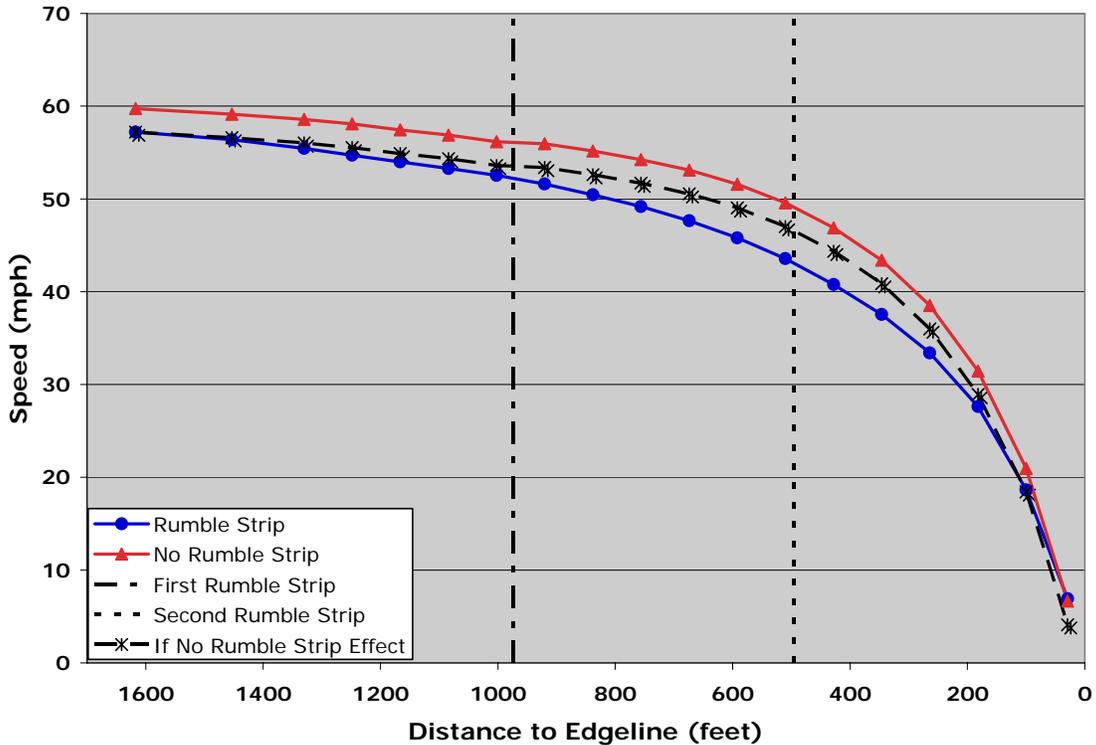
Figure 3.5: SUV/Pick-Up Truck/Van Category—Mean Speeds on the Approach to *Obscure/Visible* Intersections *With Rumble Strips* and *Without Rumble Strips*.

The significant Rumble Strips effect and the significant interaction between Rumble Strip Conditions and Segments, for the SUV/Pick-Up Truck/Vans category, are illustrated in Figure 3.5.

Figure 3.5 shows that the drivers who approached the intersection *Without Rumble Strips* drove faster throughout the approach than the drivers who approached the intersection *With Rumble Strips*. Figure 3.5 also includes an *adjusted* curve (labeled “If No Rumble Strip Effect” in the figure). This *adjusted* curve shows the speed at which drivers in the *With Rumble Strips* Condition would have driven *if* there had been no effect of encountering the rumble strips—i.e., *if* the average speed differential between them and the drivers in the *Without Rumble Strips* Condition had been maintained at the level it was early in the approach, 1,700 feet (468 meters), from the intersection and well before the first set of rumble strips were encountered. The difference between the adjusted curve and the curve for the drivers in the *With Rumble Strips* Condition accounts for the statistically significant interaction between Rumble Strip Conditions and Segments. The adjusted difference, which is as much as 3.3 mph, can be attributed to the effect that encountering the rumble strips had on the drivers in the *With Rumble Strips* Condition.

Figure 3.5 shows the effect of rumble strips on the *average* speed of drivers of vehicles in the SUV/Pick-Up Truck/Van category as they approached an intersection with traffic obscured on one side of the crossing road but visible on the other. It does not show the effect of rumble strips on *outliers*. To further explore the speed data, we examined the boxplots associated with the mean speeds shown in Figure 3.5. The resultant boxplots are presented in Figure 3.6.

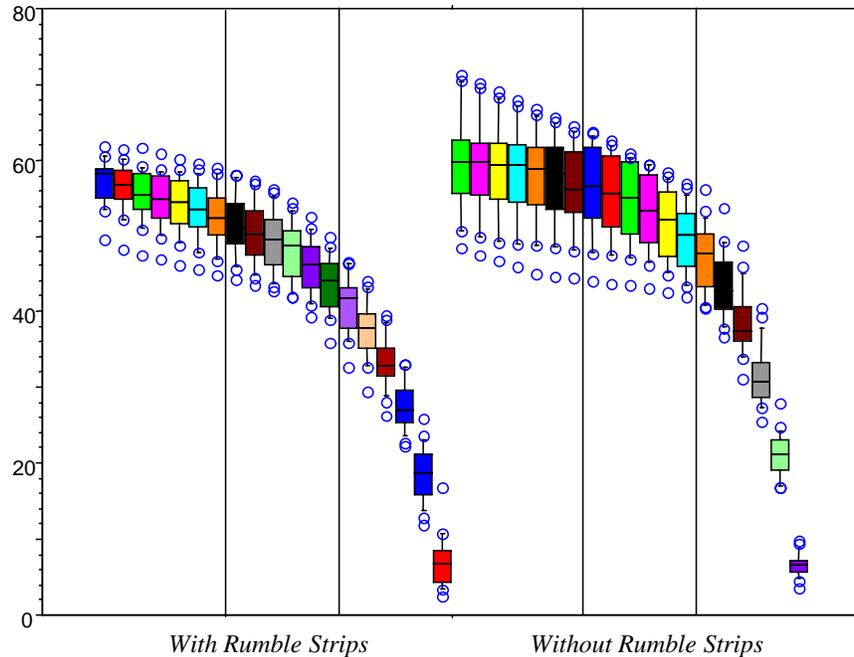
Figure 3.6: SUV/Pick-Up Truck/Van Category—Boxplots of Individual Mean Speeds in the Segments on the Approach to *Obscure/Visible* Intersections *With Rumble Strips* and *Without Rumble Strips*.

When the two sets of boxplots presented in Figure 3.6 are compared, the effect of rumble strips becomes more apparent. The drivers in the *With Rumble Strips* Condition show a gradual reduction in speed after encountering the first set of rumble strips. In contrast, Figure 3.6 reveals that most drivers in the *Without Rumble Strips* Condition—including the outliers who were driving fastest—have much smaller early reductions in speed, so that when they are relatively close to the intersection, have to slow down much more abruptly than the drivers in the *With Rumble Strips* Condition.

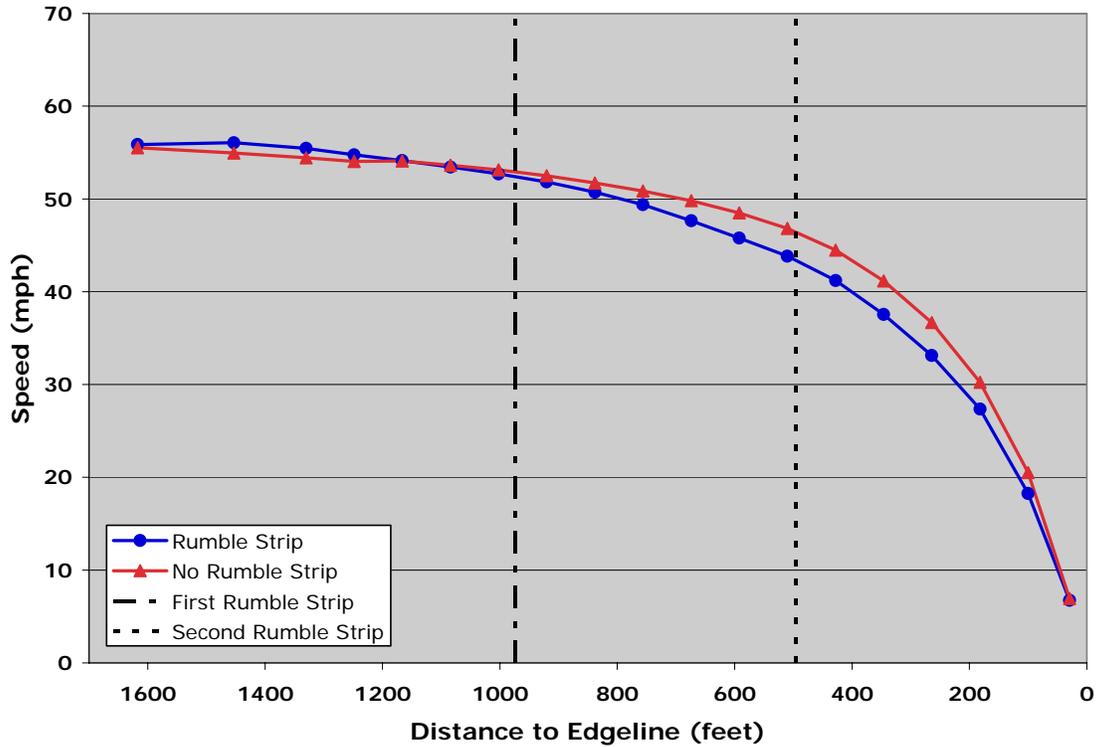
Figure 3.7: Passenger Car Category—Mean Speeds on the Approach to Obscure/Visible Intersections With Rumble Strips and Without Rumble Strips.

The significant interaction between Rumble Strip Conditions and Segments, for the Passenger Cars category that was indicated in Table 3.9 is illustrated in Figure 3.7.

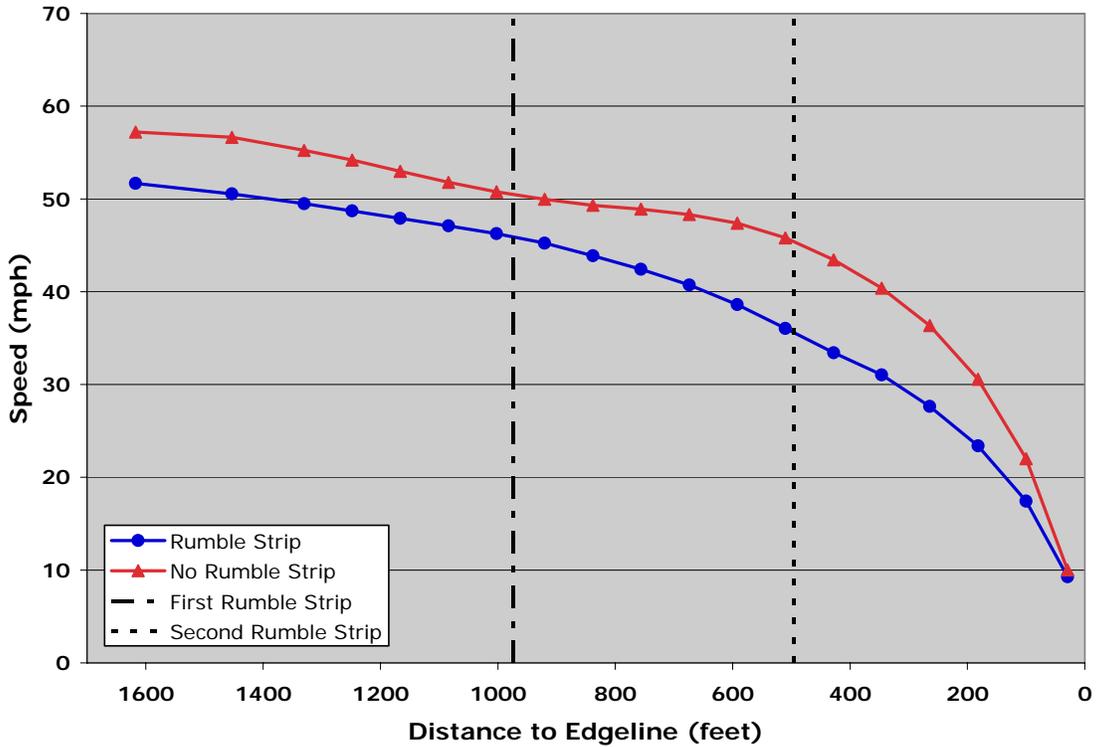
Figure 3.9: Commercial Vehicle/Heavy Truck Category—Mean Speeds on the Approach to *Obscure/Visible* Intersections *With Rumble Strips* and *Without Rumble Strips*.

The significant interaction between Rumble Strip Conditions and Segments, for the Commercial Vehicle/Heavy Truck Category—indicated in Table 3.10—is illustrated in Figure 3.9.

Figure 3.9 shows that for the Commercial Vehicle/Heavy Truck Vehicle Category on the initial part of the approach to the intersection—i.e., before the first set of rumble strips were encountered by the drivers in the *With Rumble Strips* Condition—there was already a difference in speed, with the drivers in the *Without Rumble Strips* Condition driving approximately 4.0 mph faster than the drivers in the *With Rumble Strips* Condition. Then, later in the approach—i.e., after the drivers in the *With Rumble Strips* Condition encountered the first set of rumble strips—the speed differential between the drivers in the two conditions increased. The greatest difference in speed occurs when the drivers are between 592 feet (180.5 meters) and 264 feet (80.5 meters) from the intersection. Then the drivers in the *With Rumble Strips* Condition are traveling 8 mph to 9 mph slower than the drivers in the *Without Rumble Strips* Condition. Therefore, when we consider that the drivers in the *With Rumble Strips* Condition were already driving approximately 4.0 mph slower, it appears that the effect of encountering the first set of rumble strips accounts for an additional reduction in speed of 4.0 mph to 5.0 mph, when these drivers are compared with the drivers in the *Without Rumble Strips* Condition.

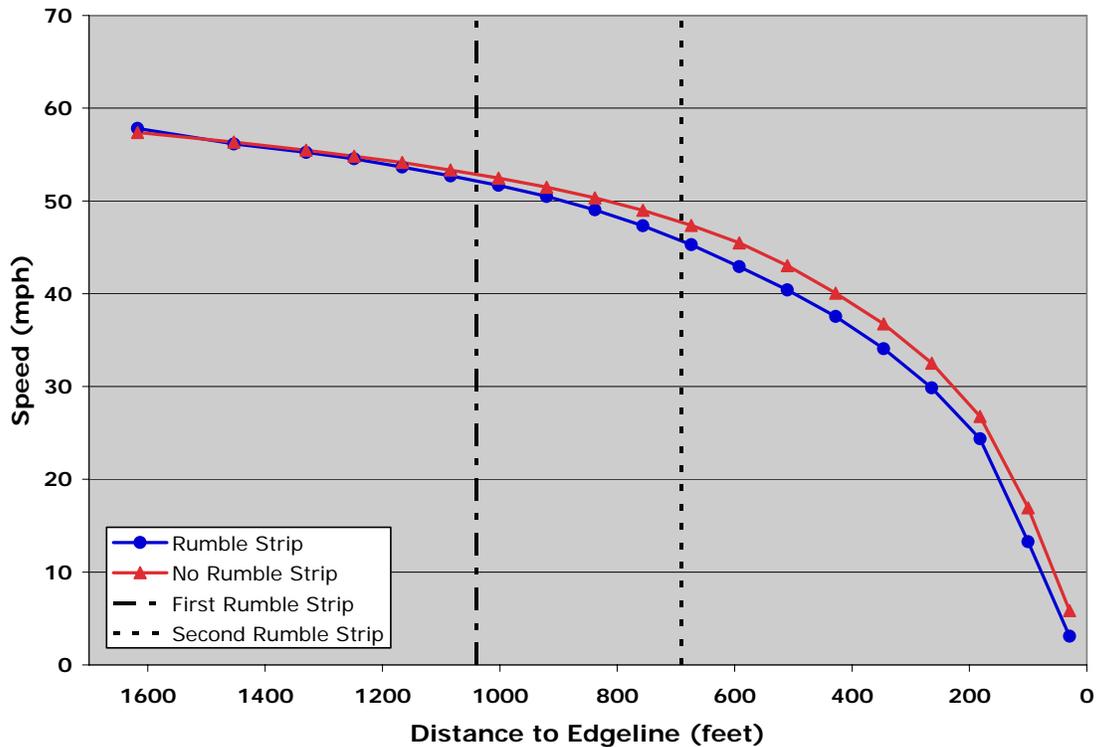
Figure 3.11: SUV/Pick-Up Truck/Van Category—Mean Speeds on the Approach to Visible/Both Intersections With Rumble Strips and Without Rumble Strips.

The significant interaction between Rumble Strip Conditions and Segments, for the SUV/Pick-Up Truck/Vans category, is illustrated in Figure 3.11.

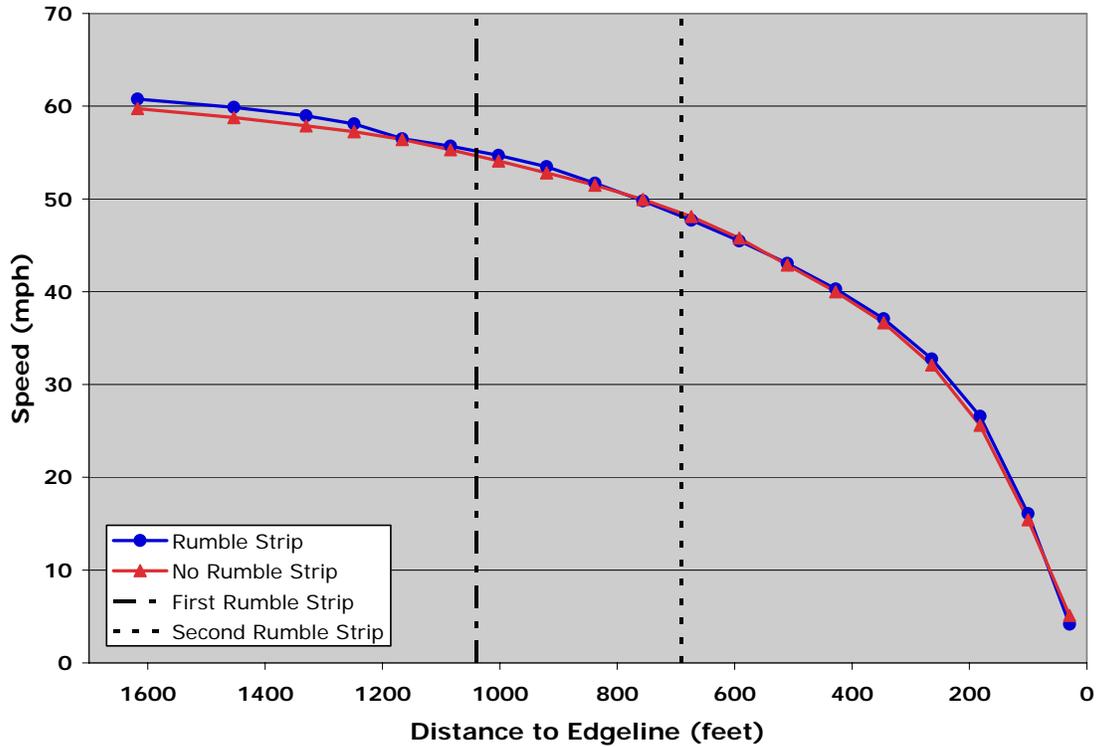
Figure 3.13: Passenger Car Category—Mean Speeds on the Approach to *Visible Both Intersections With Rumble Strips and Without Rumble Strips.*

For the Passenger Cars Category, the interaction between Rumble Strip Conditions and Segments was *not* statistically significant—as Figure 3.13 shows.

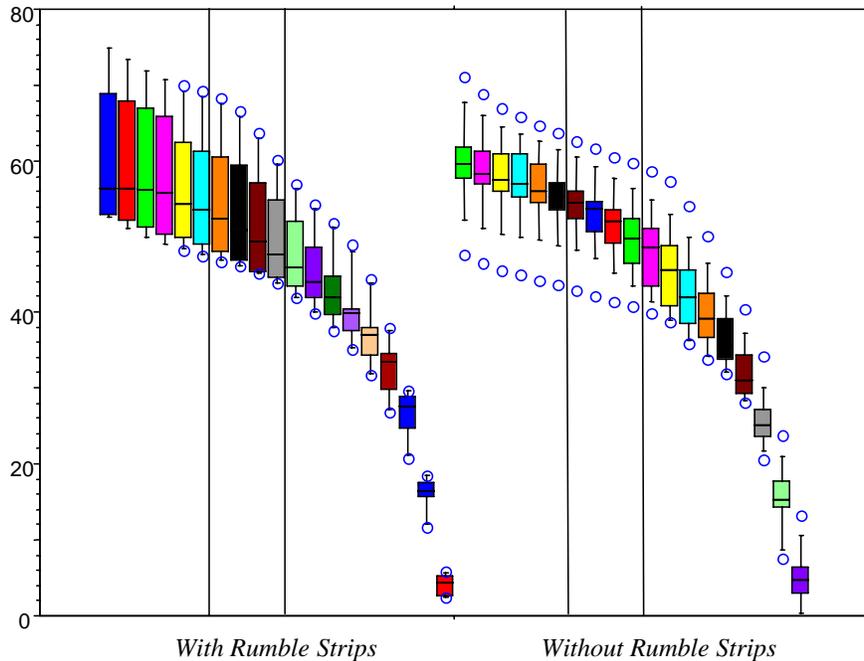
Figure 3.14: Passenger Car Category—Boxplots of Individual Mean Speeds in the Segments on the Approach to *Visible Both* Intersections *With Rumble Strips* and *Without Rumble Strips*.

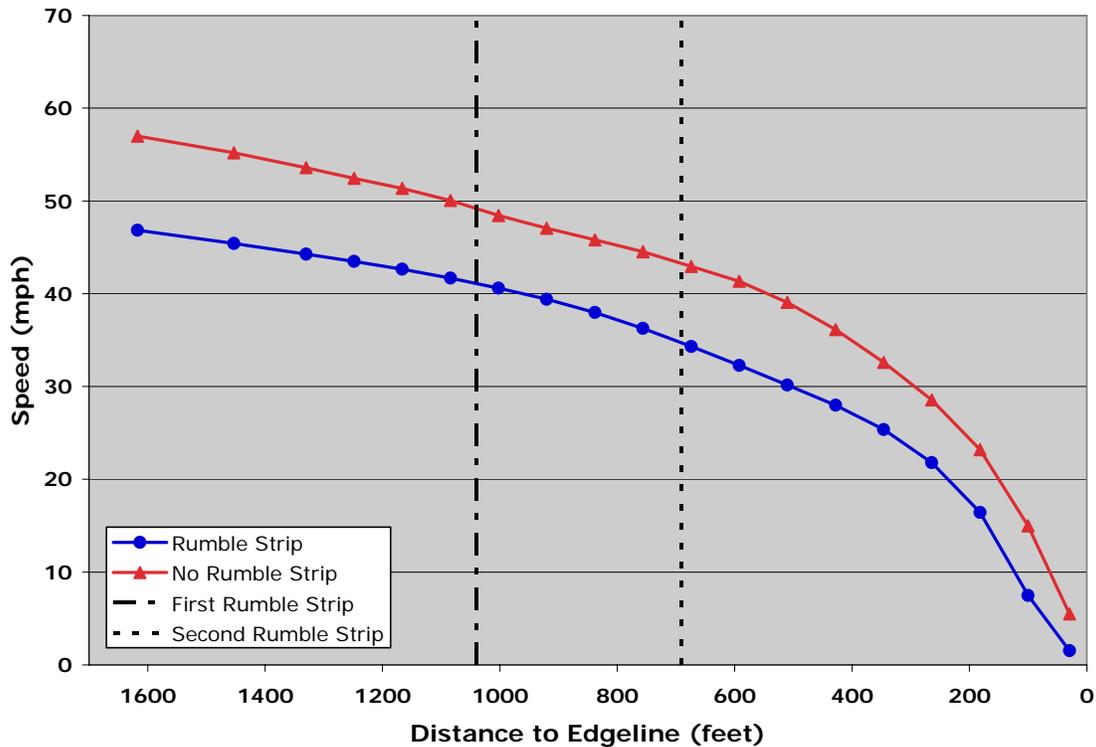
Figure 3.15: Commercial Vehicle/Heavy Truck Category—Mean Speeds on the Approach to *Visible Both* Intersections With Rumble Strips and Without Rumble Strips.

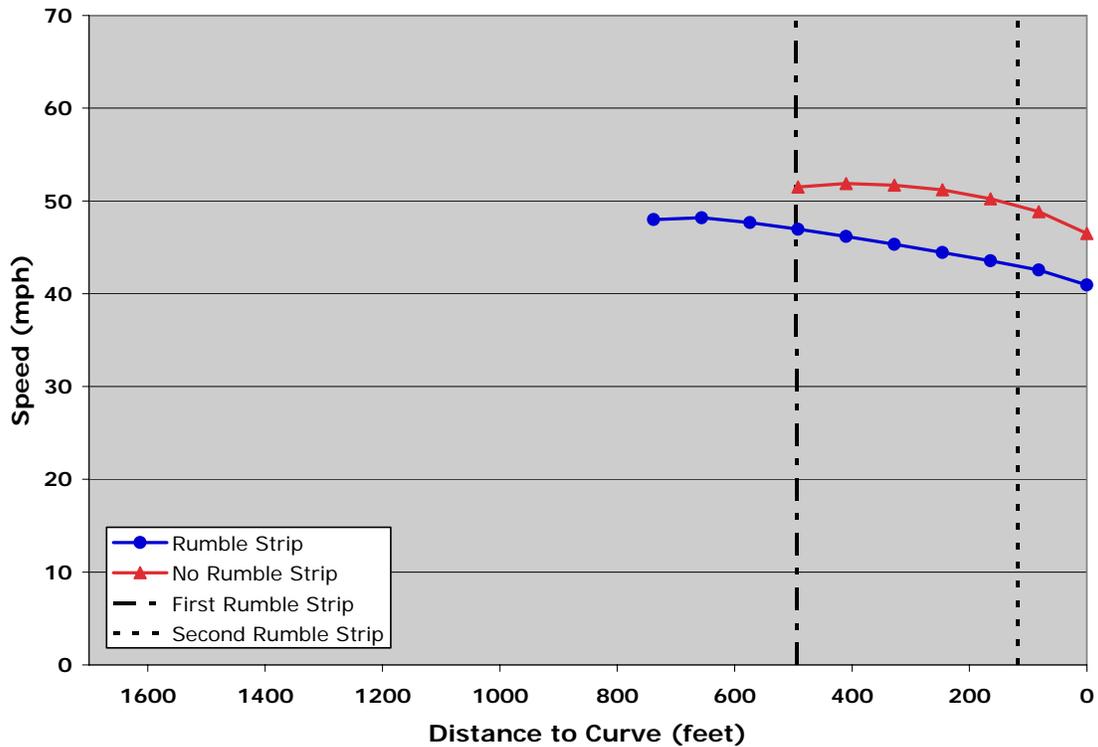
Figure 3.17: SUV/Pick-Up Truck/ Van Category—Mean Speeds on the Approach to Horizontal Curve Intersections With Rumble Strips and Without Rumble Strips.

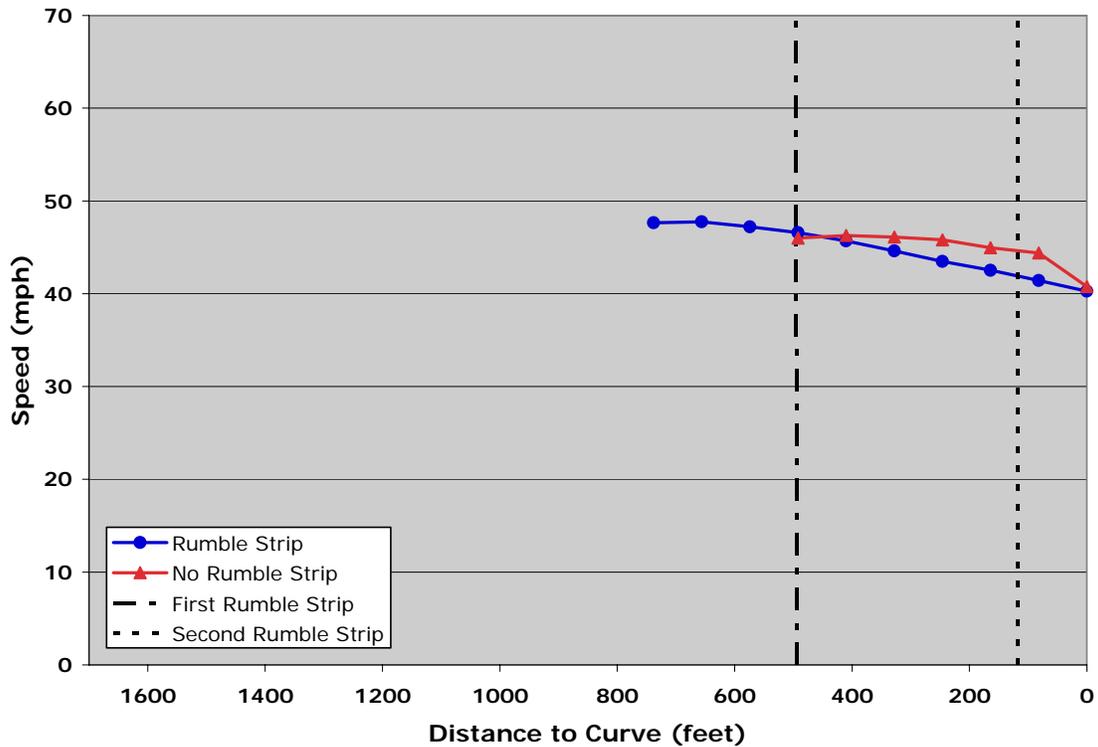
Figure 3.19: Commercial Vehicle/Heavy Truck Category—Mean Speeds on the Approach to *Horizontal Curve* Intersections *With Rumble Strips* and *Without Rumble Strips*.

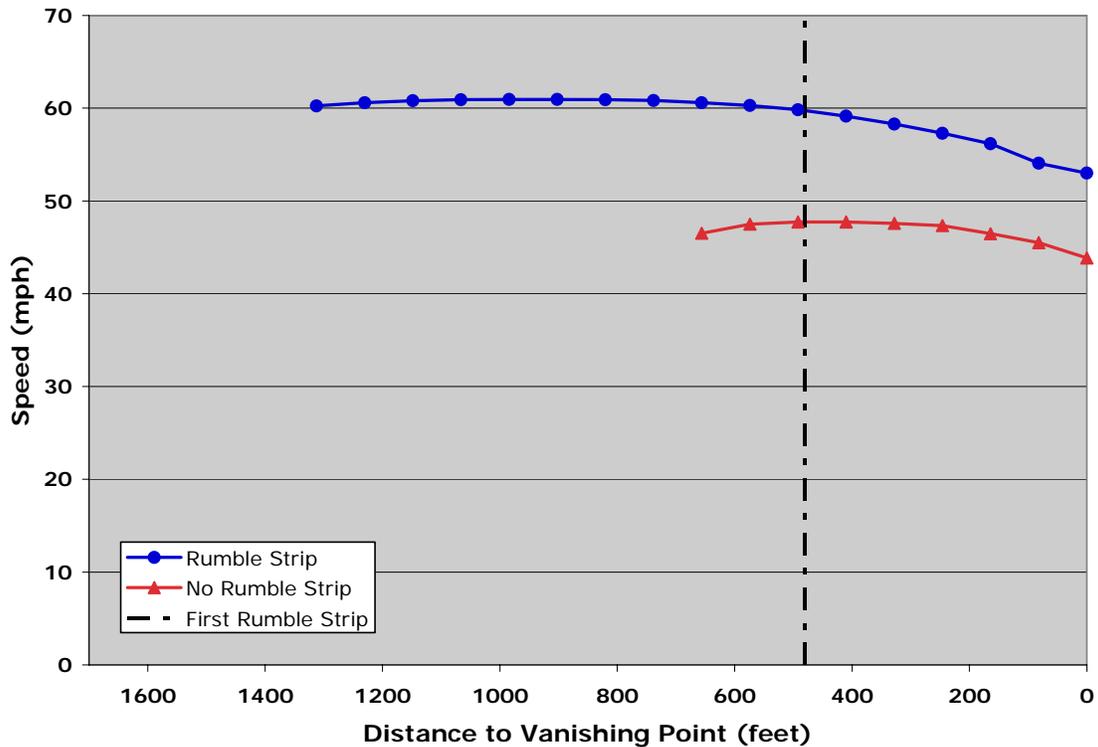
Figure 3.21: Passenger Car Category—Mean Speeds on the Approach to *Vertical Curve* Intersections *With Rumble Strips* and *Without Rumble Strips*.

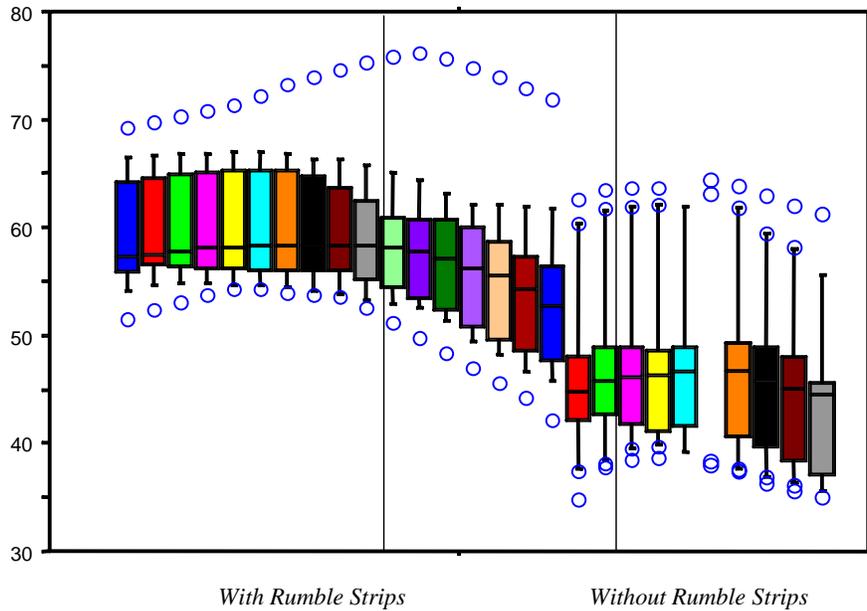
Figure 3.22: Passenger Car Category—Boxplots of Individual Mean Speeds in the Segments on the Approach to Vertical Curve Intersections *With Rumble Strips* and *Without Rumble Strips*.

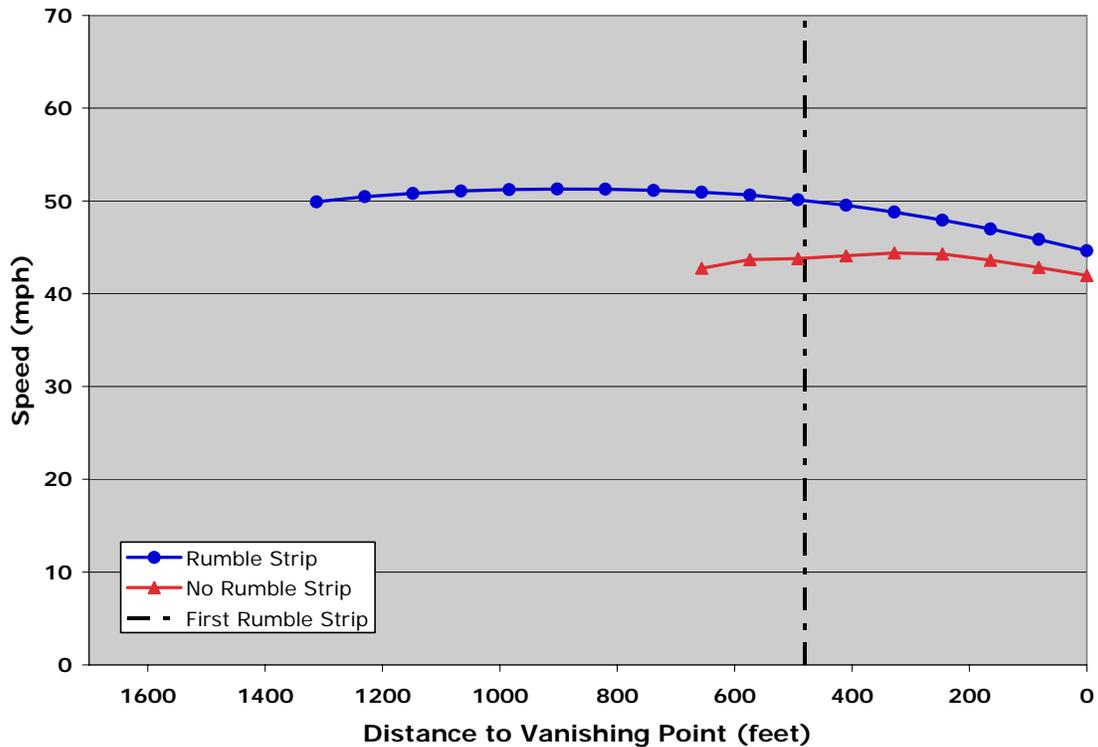
Figure 3.23: Commercial Vehicle/Heavy Truck Category—Mean Speeds on the Approach to Vertical Curve Intersections With Rumble Strips and Without Rumble Strips.

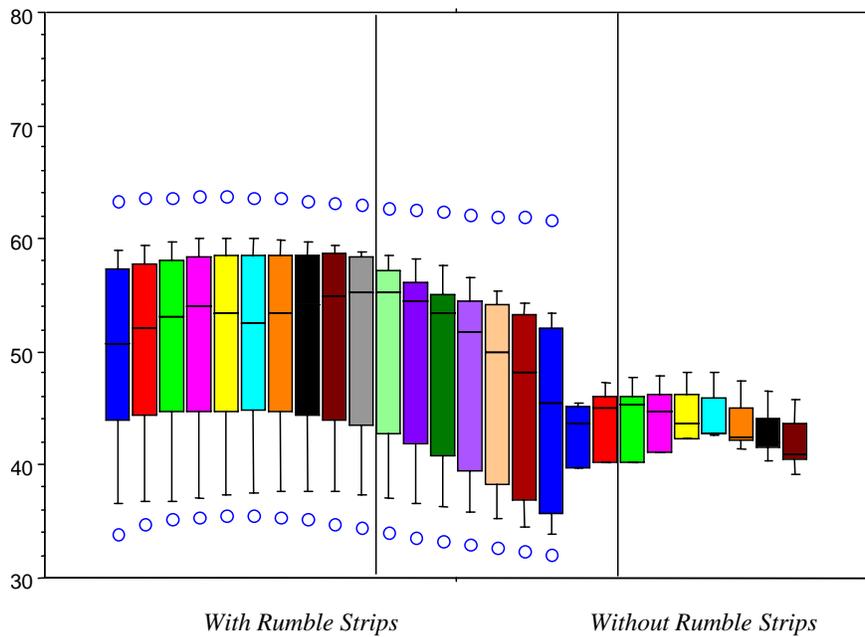
Figure 3.24: Commercial Vehicle/Heavy Truck Category —Boxplots of Individual Mean Speeds in the Segments on the Approach to Vertical Curve Intersections With Rumble Strips and Without Rumble Strips.

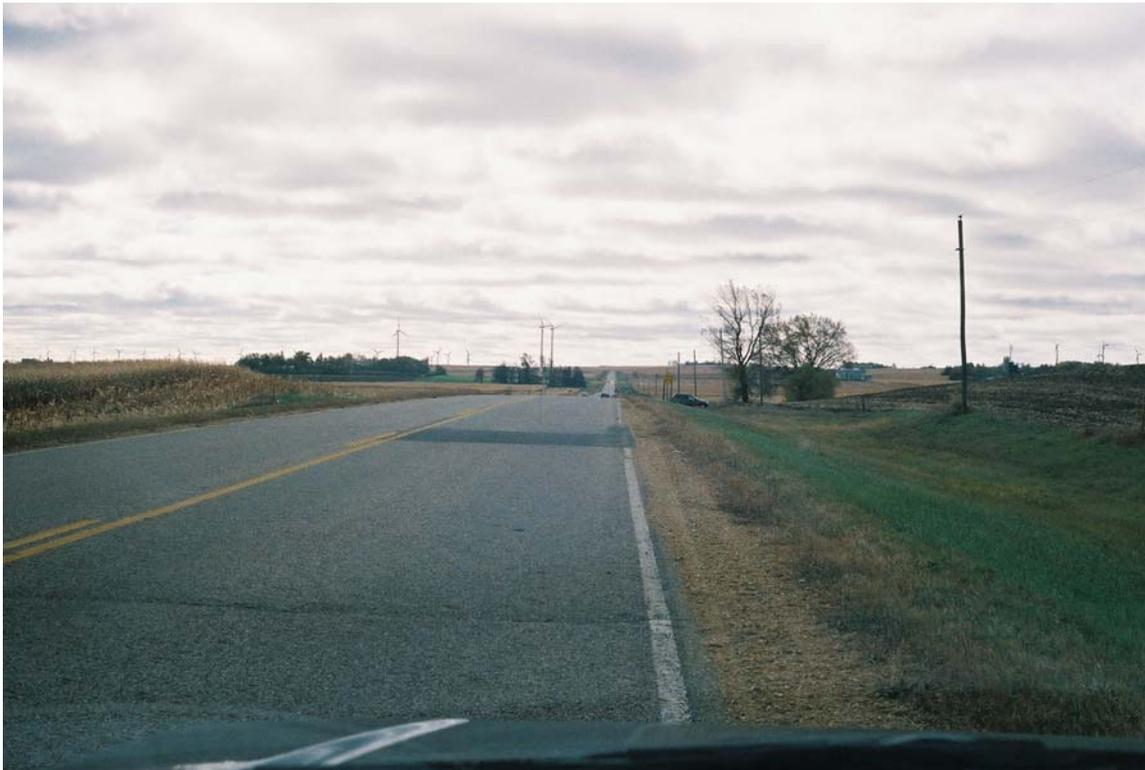
On North Side (looking South): traffic on both sides of major road obscured—to West by slight vertical curve and trees; to East by corn and slight vertical curve.

Photograph #1 (Reel #1, 15A) (from North, looking South): first rumble strip and warning sign in view (just *before* crest of vertical curve).

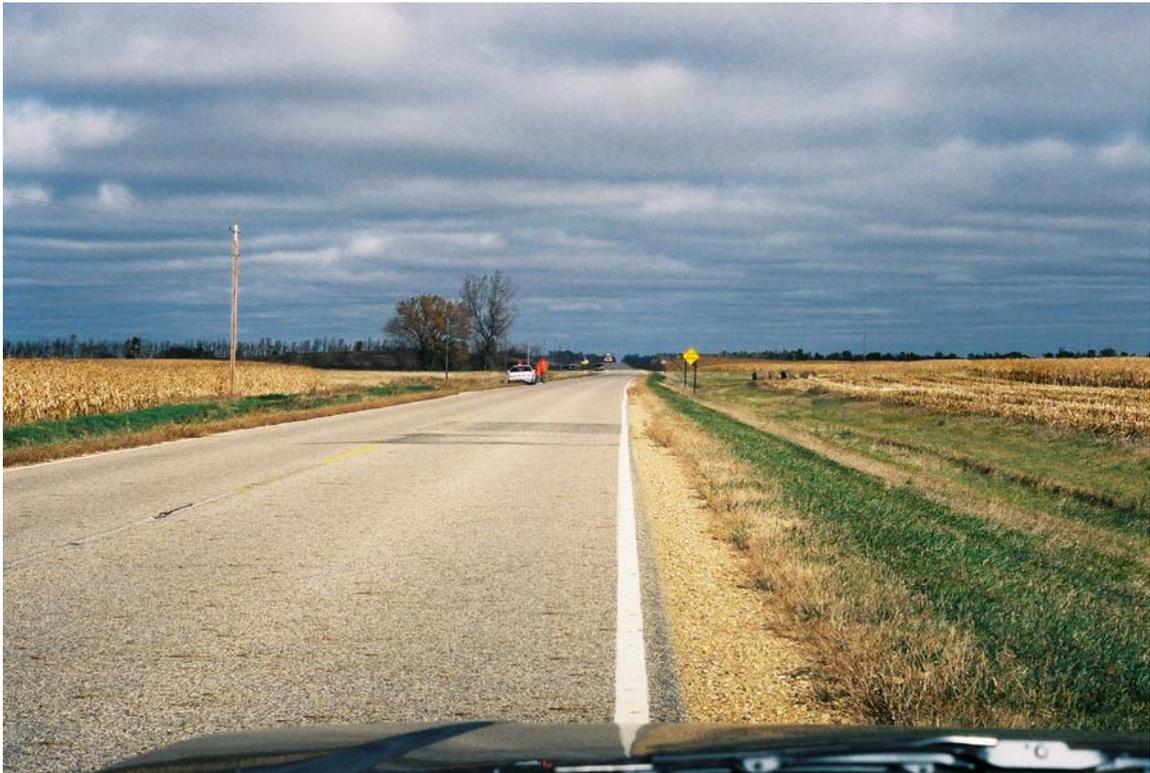
On South Side (looking North): traffic on both sides of major road obscured by slight depression and uncut corn.

Photograph #3 (Reel #1, 17A) (from North, looking South): first rumble strip and warning sign in view—and hunters with car.

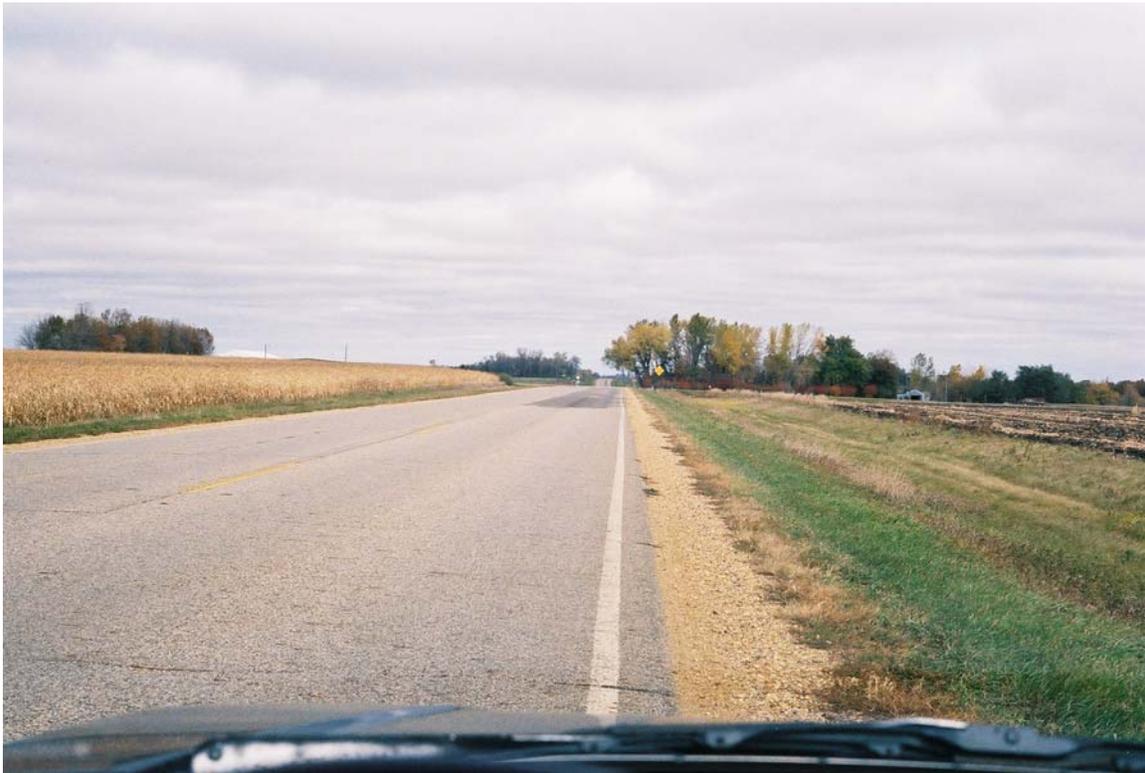
On South Side (looking North): to West—corn obscures traffic on major road (and building before road); to East—traffic on major road clear (traffic passes in front of line of trees).

Photograph #5 (Reel #1, 19A) (from South, looking North): taken at approximate distance that rumble strip *would* be installed—warning sign in view.

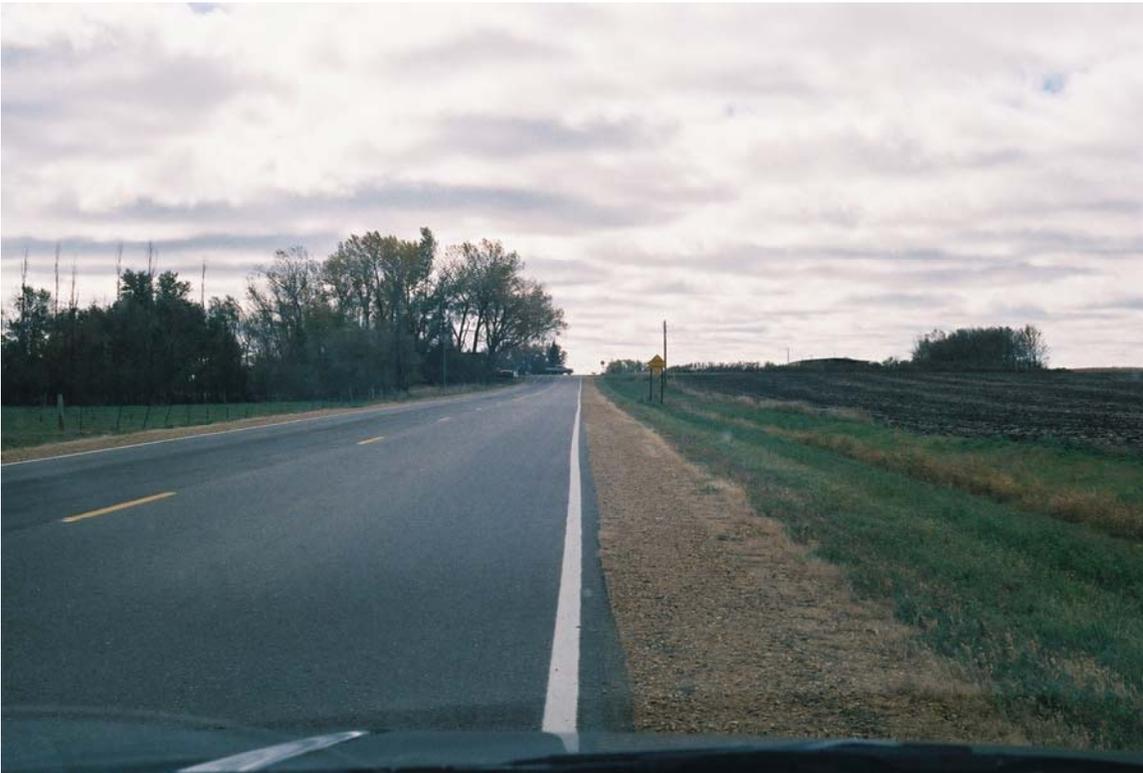
On North Side (looking South): to West—traffic on major road partially obscured by trees (traffic passes in front of building); to East—trees obscure traffic on major road.

Photograph #7 (Reel #1, 21 A) (from North, looking South): taken at approximate distance that rumble strip *would* be installed—warning sign in view; also, vehicle in the intersection.

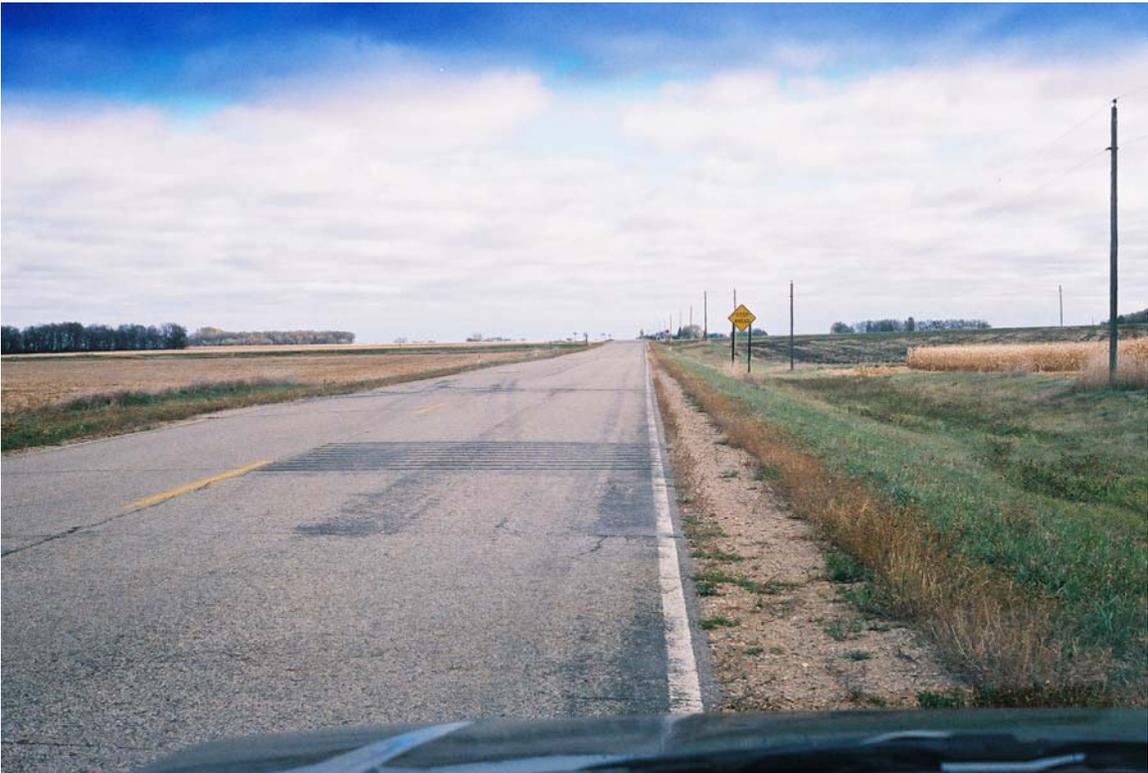
On West Side (looking East): to North—traffic on major road visible; to South—traffic on major road immediately adjacent to intersection visible, but further out view of traffic on major road obscured.

Photograph #8 (Reel #1, 22A) (from West, looking East): first rumble strip and warning sign in view.

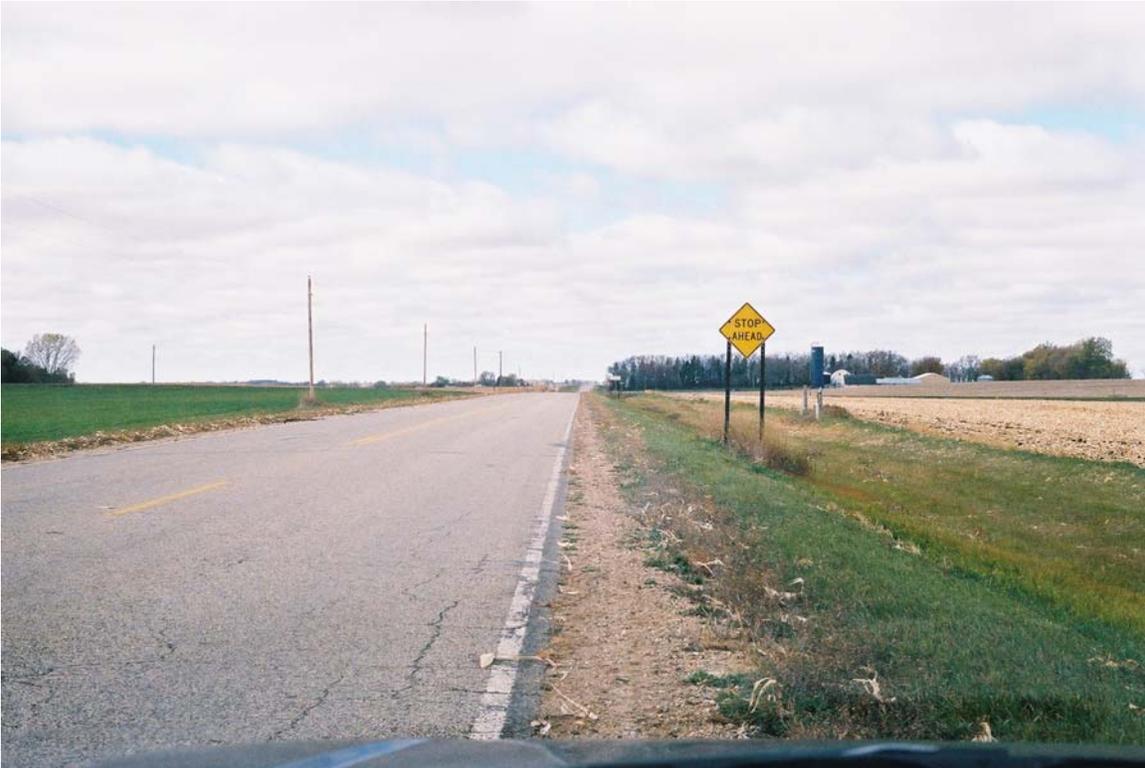
On East Side (looking West): both sides of major road—traffic on major road relatively unobstructed.

Photograph #10 (Reel #1, 24A) (from East, looking West): at approximate distance that rumble strip *would* be installed—warning sign in view.

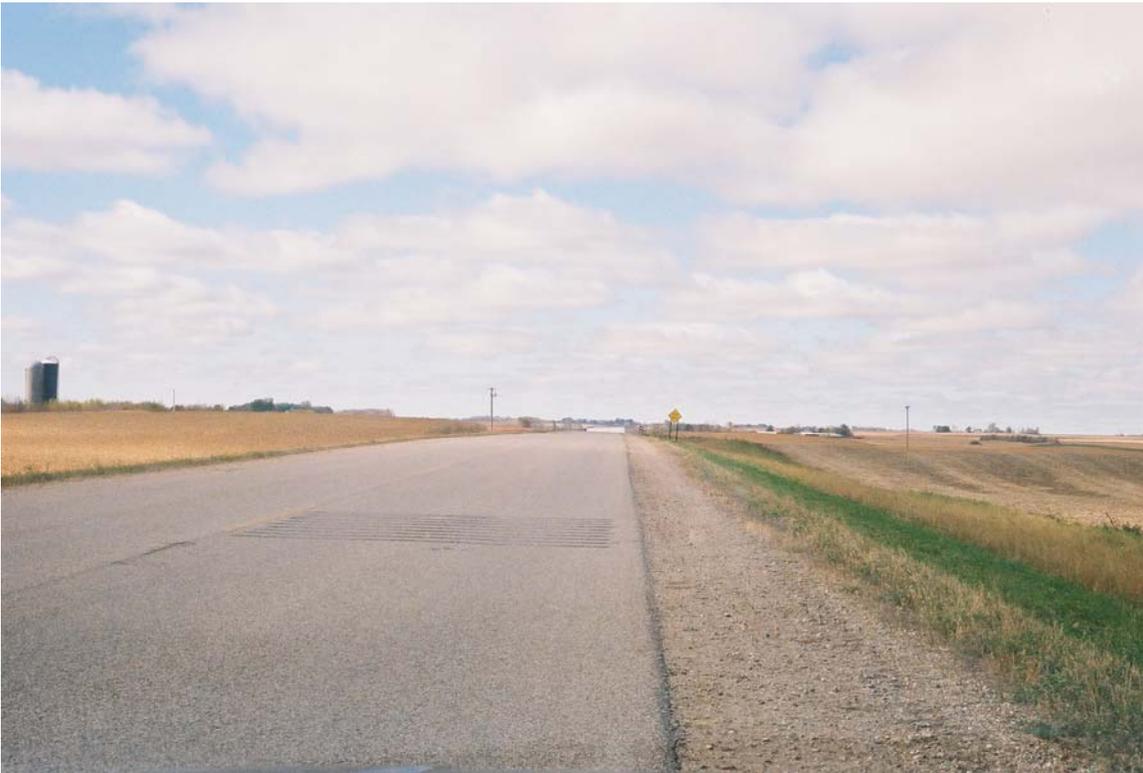
On East Side (looking West): intersection itself is partially obscured; to South—traffic on major road obscured by vertical curve and corn; to North—traffic on major road visible.

Photograph #11 (Reel #2, 1A) (from East, looking West): first rumble strip and warning sign in view—truck turning at intersection.

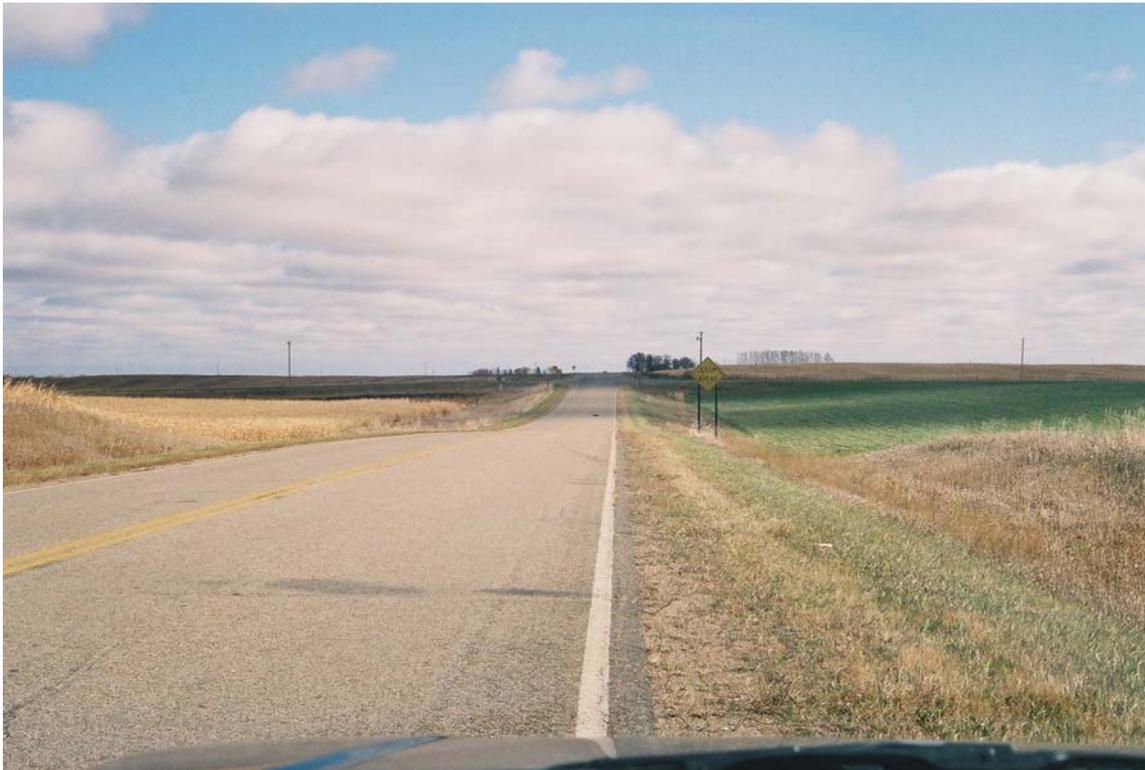
On West Side (looking East): both sides—view of traffic on major road relatively unobstructed (because of slightly elevated position).

Photograph #15 (Reel #2, 5A) (from West, looking East): at approximate distance that rumble strip *would* be installed—warning sign in view.

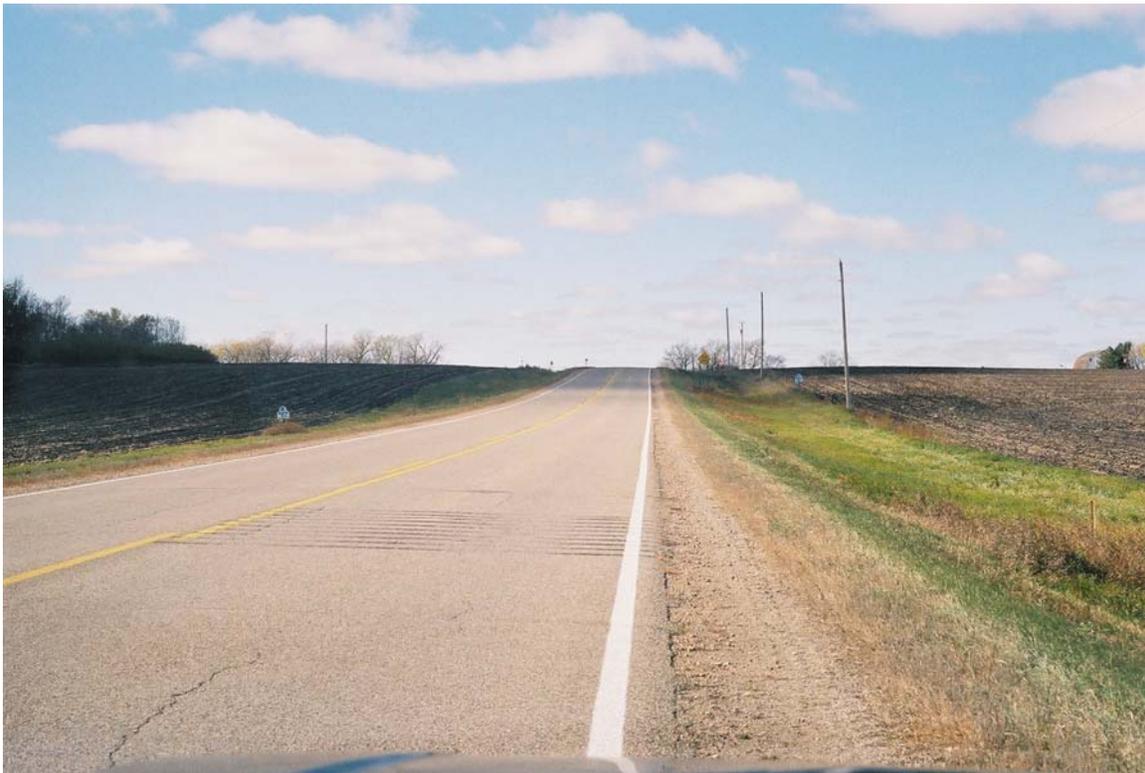
On East Side (looking West): Note: vertical curve on the approach to the intersection obscures the fact that the minor road curves to North before reaching the intersection. The vertical curve also obscures the intersection, itself, and the traffic on both sides of the major road.

Photograph #16 (Reel #2, 6A) (from North, looking South): first rumble strip and warning sign in view.
