2006-42

Final Report

Stopping Behavior at Real-World
Stop-Controlled Intersections
with and without In-Lane Rumble Strips

**Center for Human Factors Systems Research and Design
University of Minnesota**

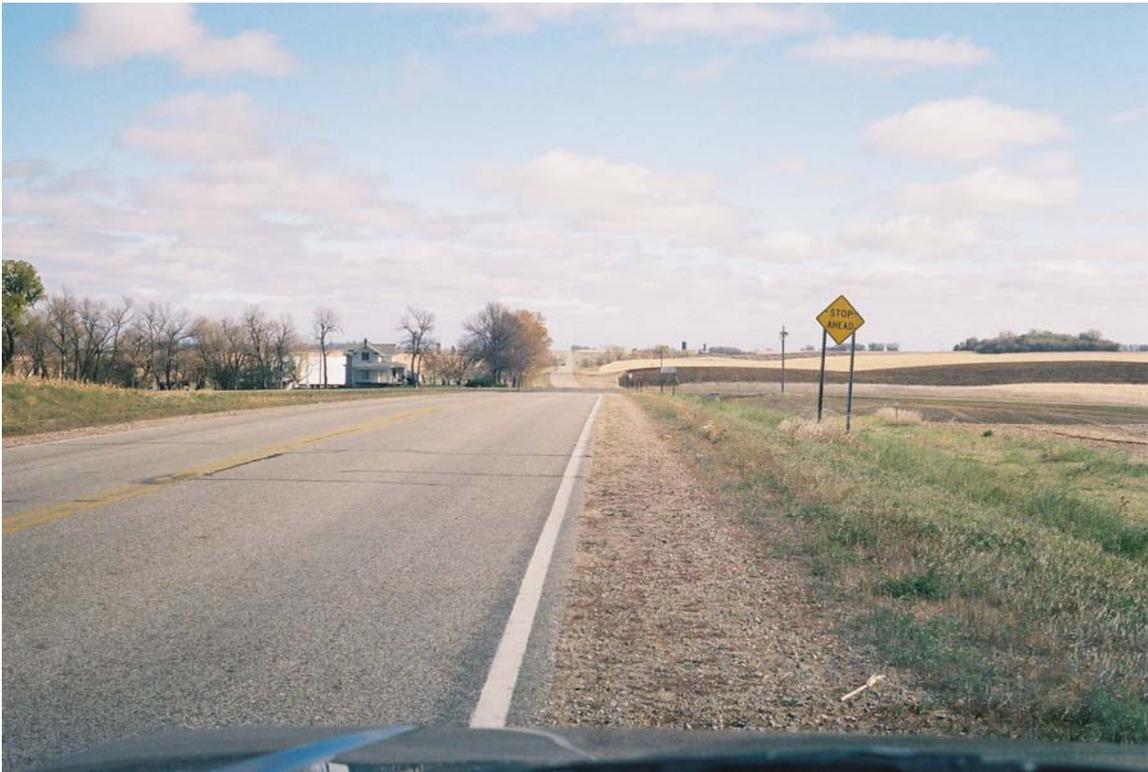
On West Side (looking East): both to North and South—traffic on major road relatively unobstructed.

Photograph #19 (Reel #2, 9A) (from West, looking East): at approximate distance that rumble strip *would* be installed—warning sign in view.

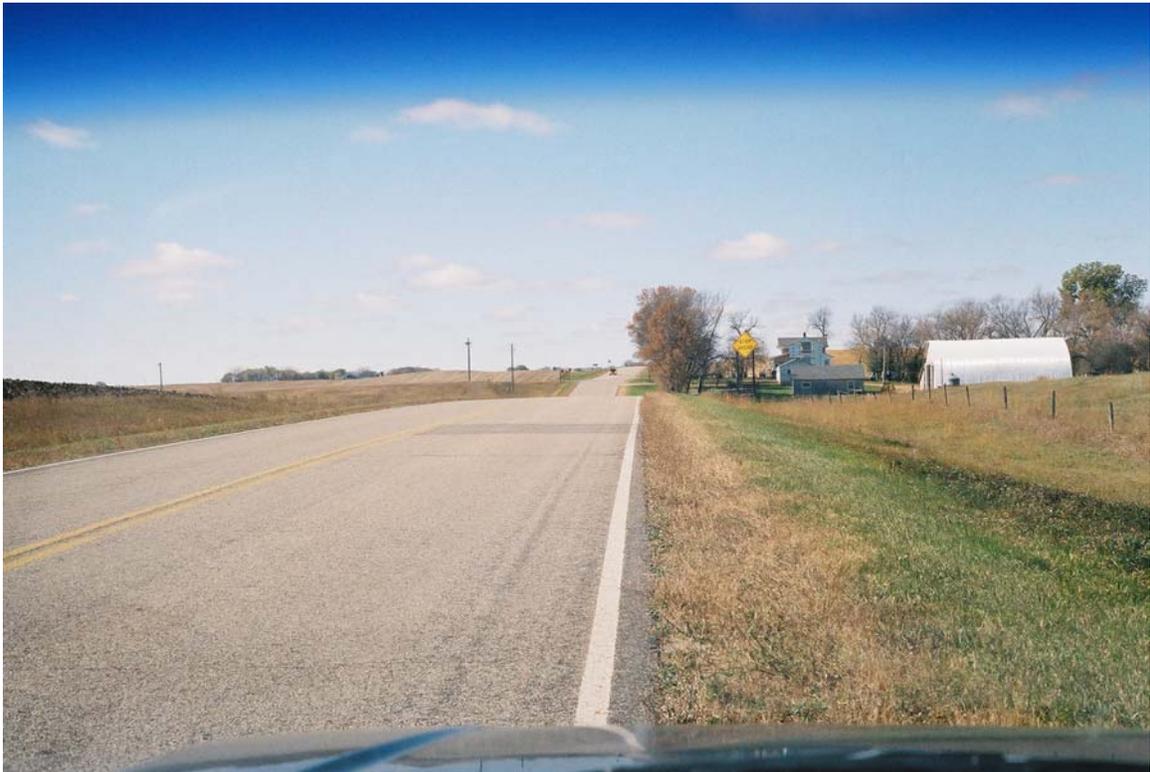
On East Side (looking West): to South—vertical curve obscures traffic on major road; to North—buildings obscure traffic on major road.

Photograph #20 (Reel #2, 10A) (from East, looking West): first rumble strip and warning sign in view.

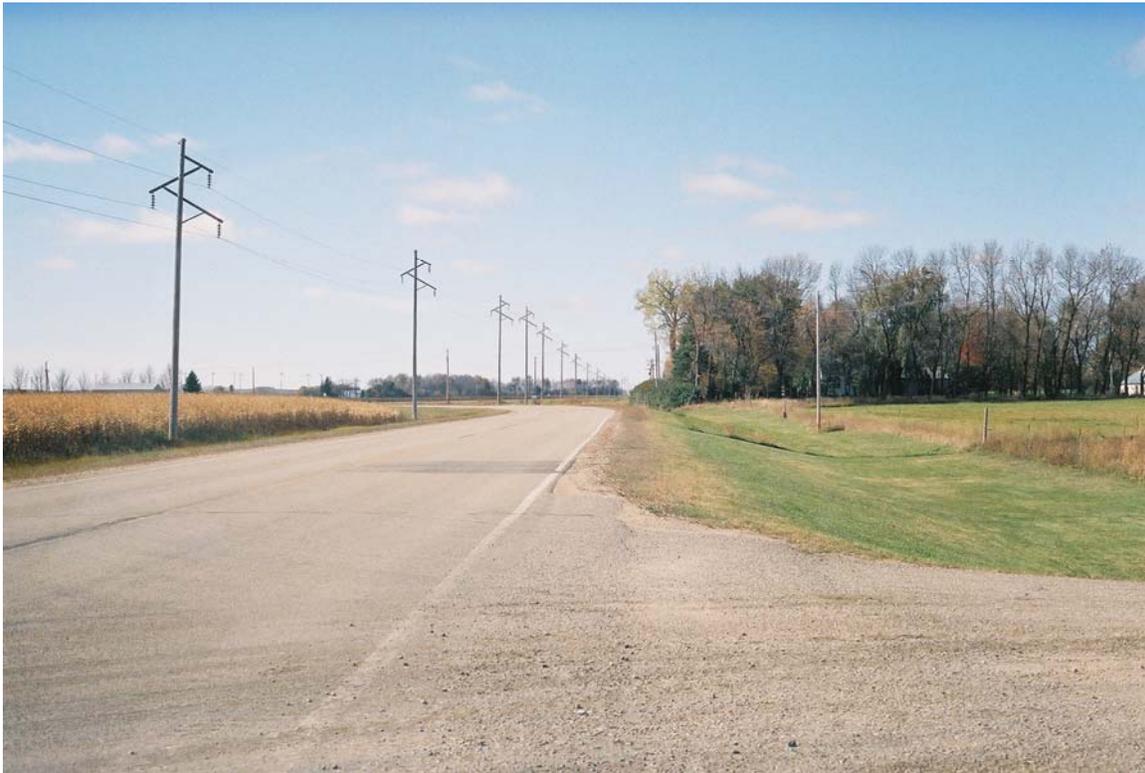
On East Side (looking West): to South—corn currently largely obscures traffic on major road; to North—trees obscure traffic on major road.

Photograph #23 (Reel #2, 13A) (from East, looking West): first rumble strip in view. [Note, at this intersection, the warning sign, which is barely visible against the bushes, is positioned *after* the second rumble strip (which is cannot be seen in this photograph).]

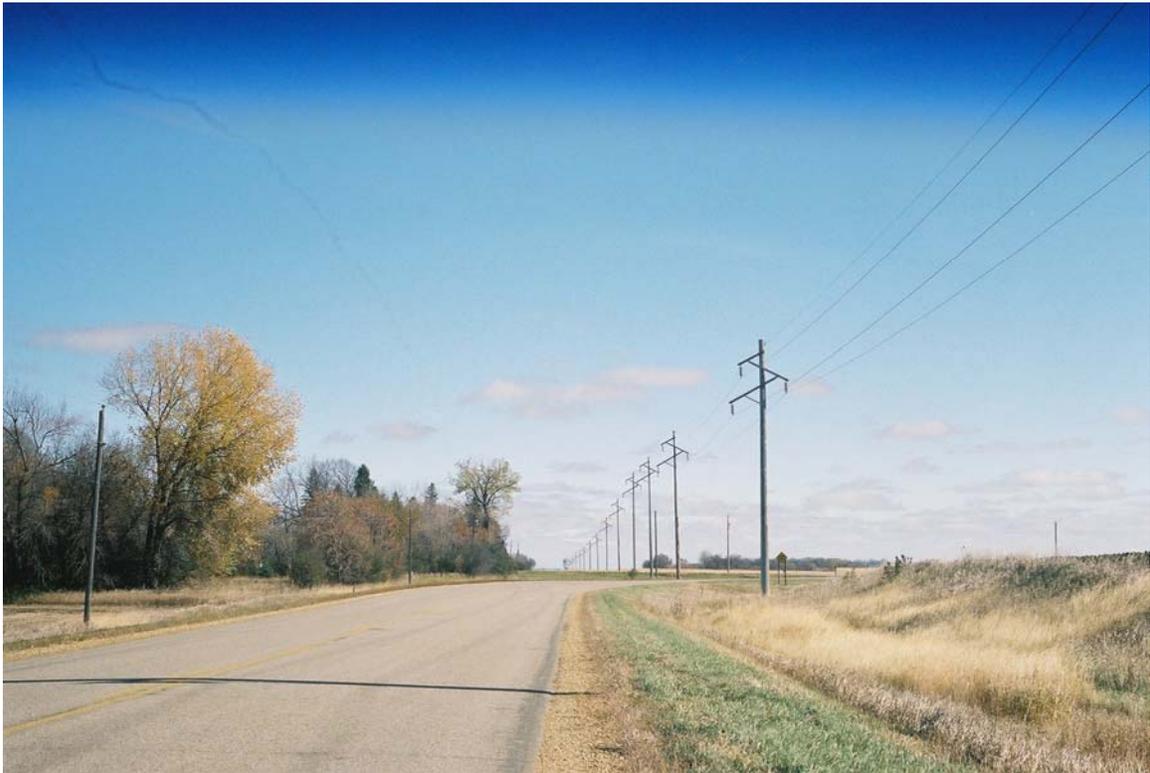
On West Side (looking East): to North—trees obscure traffic on major road; to South—rise and corn largely obscures traffic on major road.

Photograph #25 (Reel #2, 15A) (from West, looking East): at approximate distance that rumble strip *would* be installed—warning sign visible (although it is nearer to intersection than usual for Lincoln County).

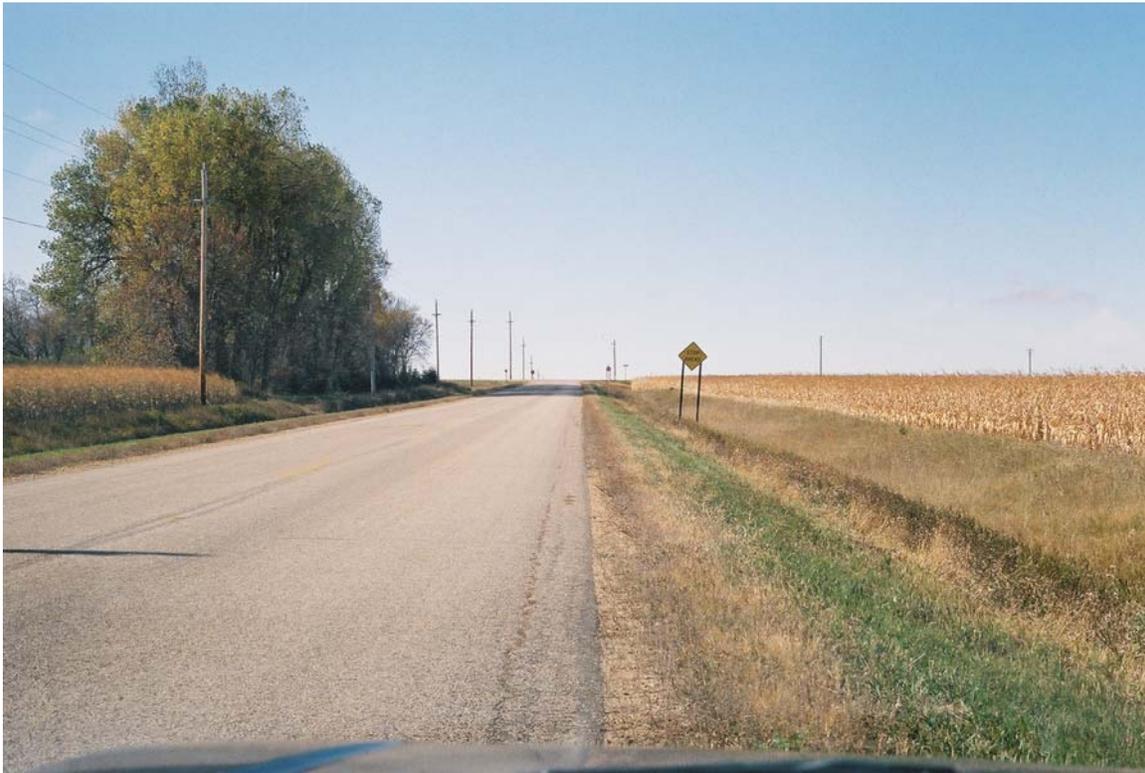
On East Side (looking West): to South—tree obscures traffic on major road; to North—
corn obscures traffic on major road.

Photograph #27 (Reel #2, 19A) (from East, looking West): at approximate distance that
rumble strip *would* be installed—warning sign in view.

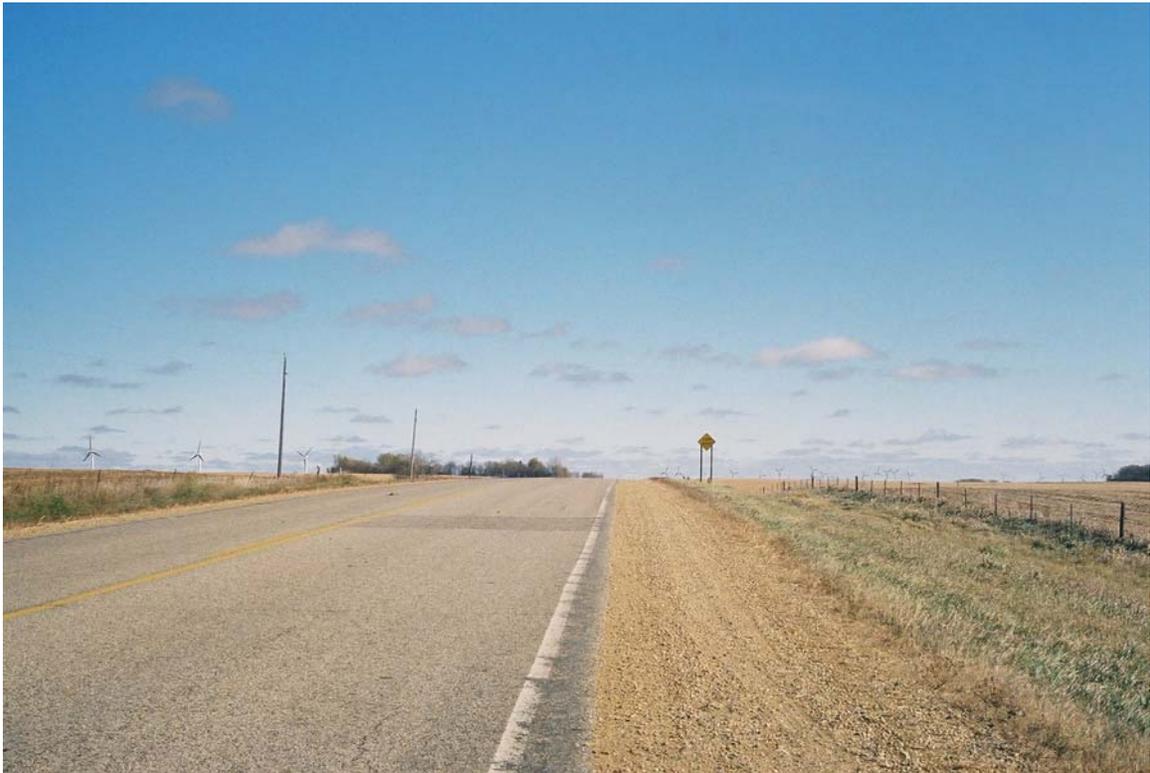
On West Side (looking East): on both sides—vertical curve obscures intersection and traffic on major road.

Photograph #28 (Reel #2, 20A) (from West, looking East): first rumble strip in view and warning sign in view.

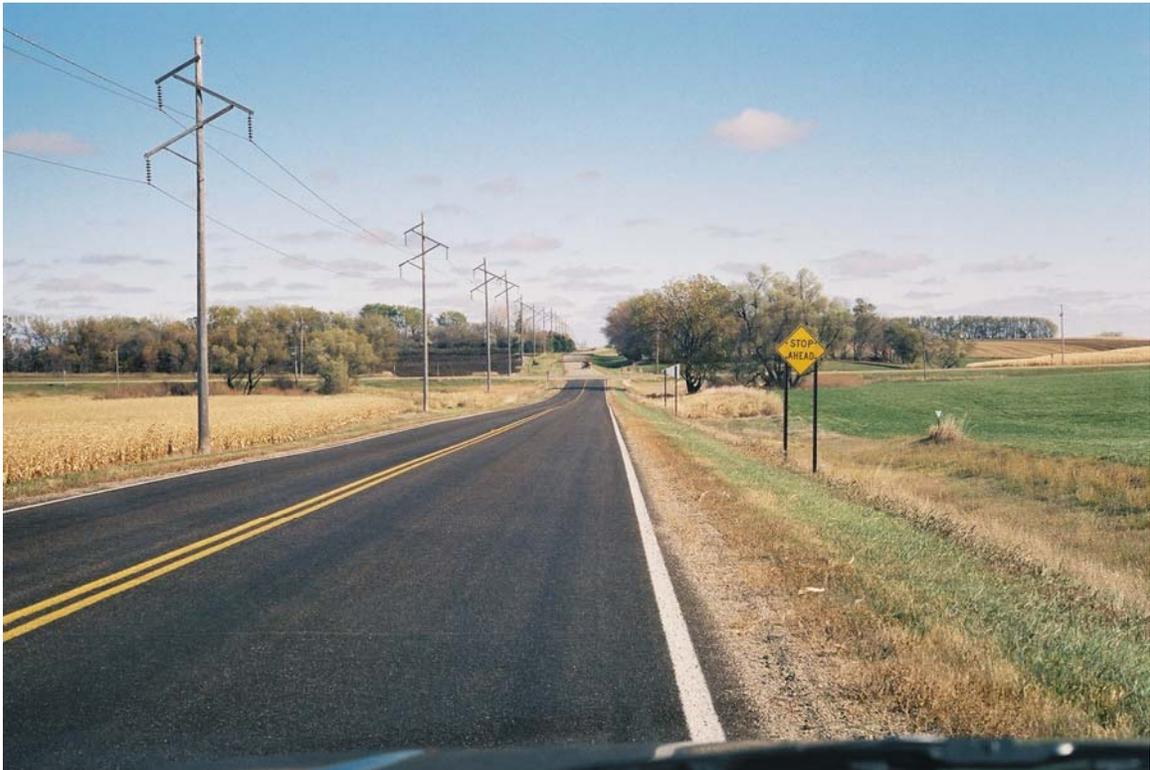
On West Side (looking East): on both sides—view of traffic on major road is slightly obscured.

Photograph #30 (Reel #2, 22A) (from West, looking East): at approximate distance that rumble strip *would* be installed—warning sign in view.

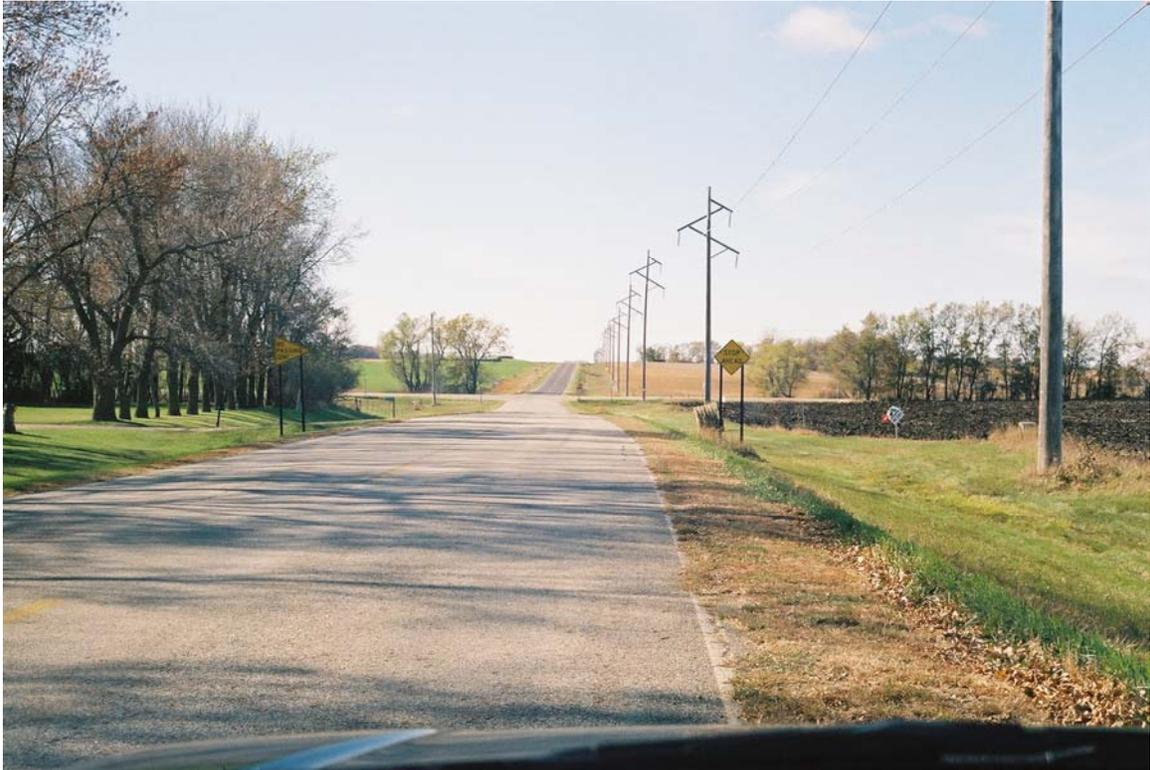
On East Side (looking West): on both sides—trees and bushes obscure traffic on major road.

Photograph #31 (Reel #2, 23A) (from East, looking West): at approximate distance that rumble strip *would* be installed—warning sign in view.

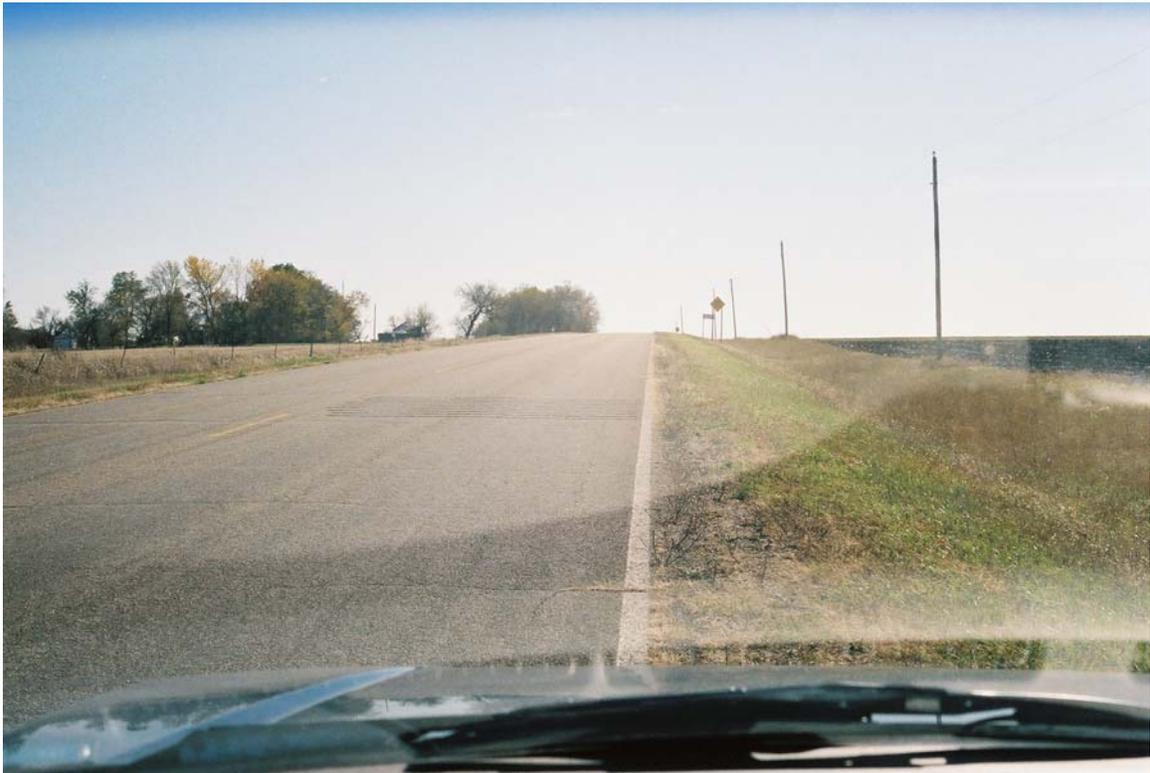
On North Side (looking South): vertical curve obscures intersection; to North—vertical curve obscures traffic on major road; to South—traffic on major road visible.

Photograph #32 (Reel #2, 24A) (from West, looking East): first rumble strip and warning sign in view.

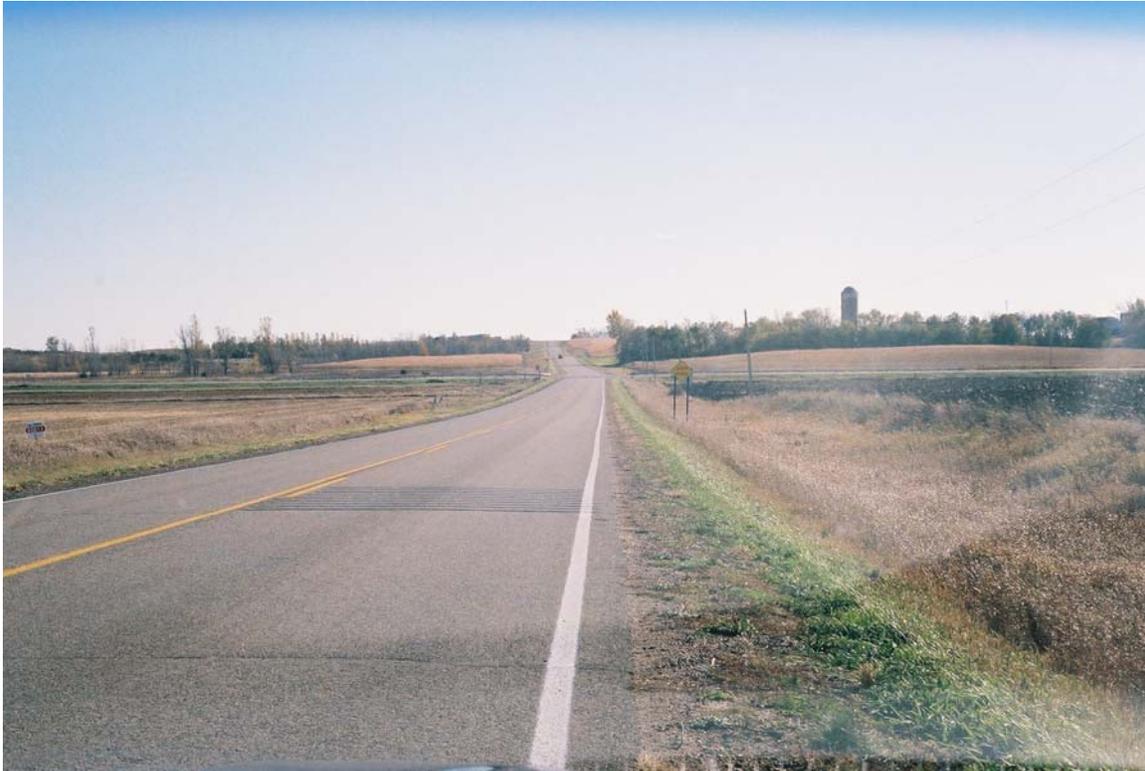
On North Side (looking South): on both sides—clear view of traffic on major road.

Photograph #35 (Reel #3, 3A) (from North, looking South): first rumble strip and warning sign in view.

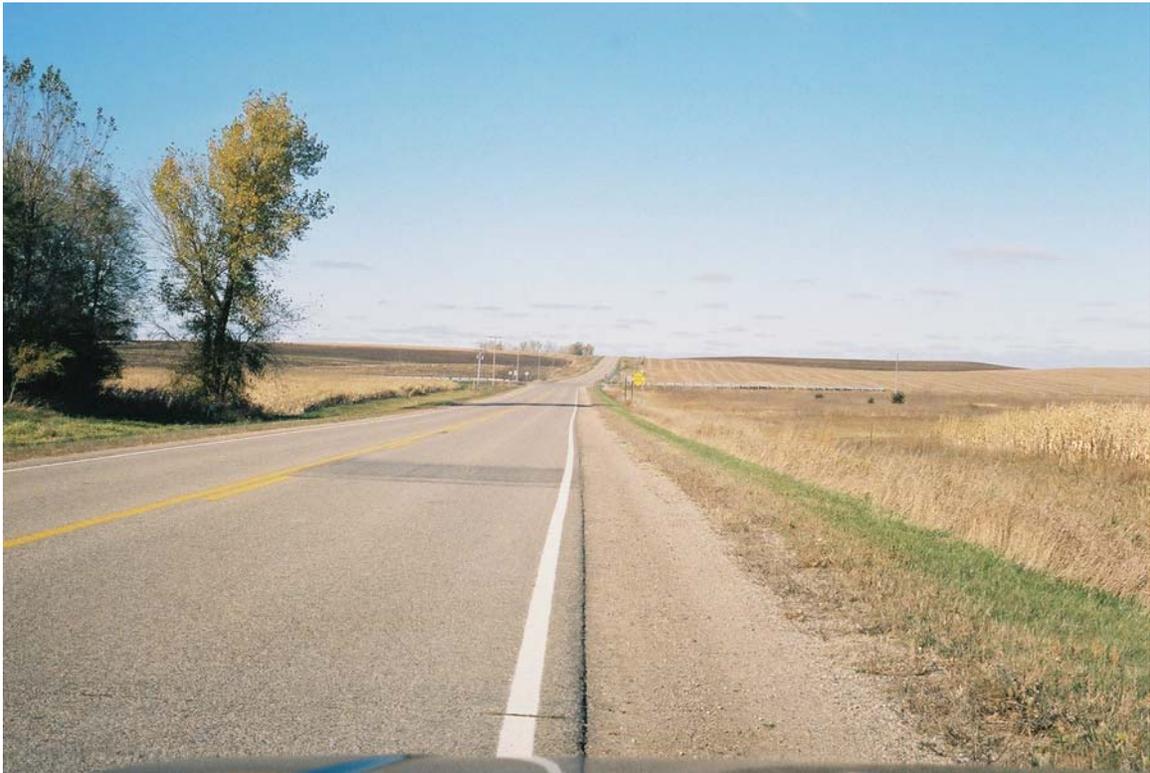
On South Side (looking North): to East—clear view of traffic on major road; to West—trees partially obscure view of traffic on major road.

Photograph #37 (Reel #3, 5A) (from South, looking North): first rumble strip and warning sign in view.

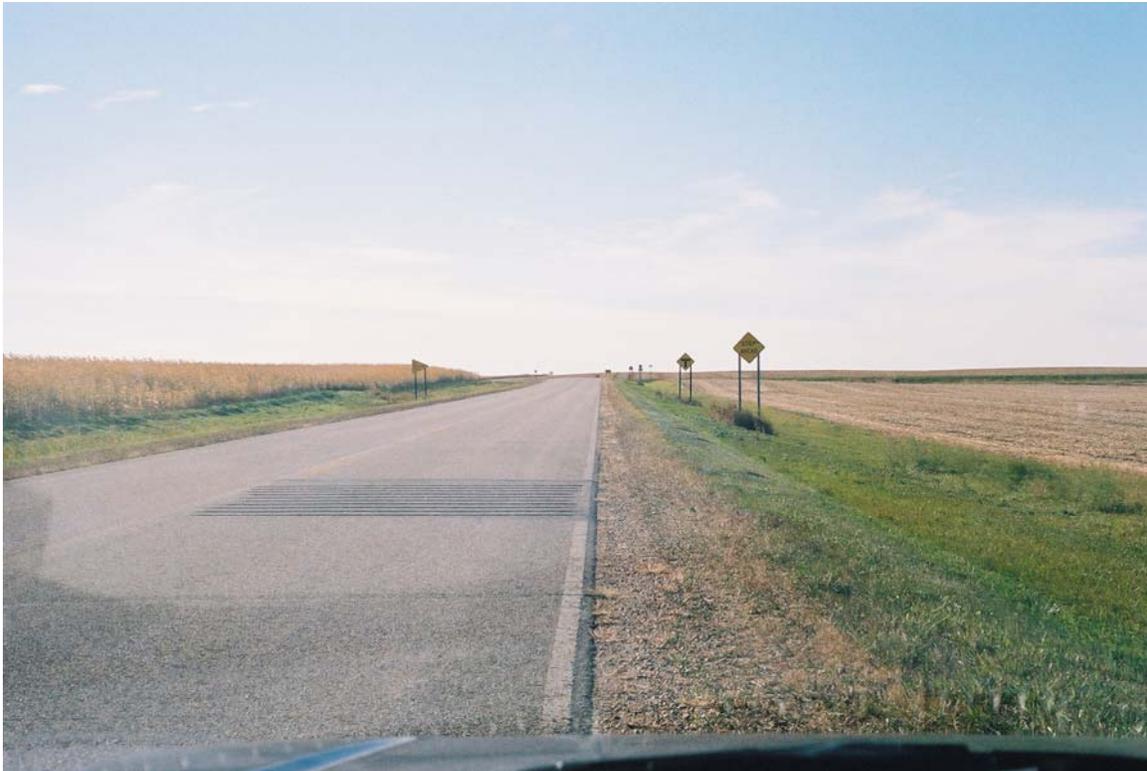
On East Side (looking West): intersection obscured by rise; to South—rise and corn obscure traffic on major road; to North—clear view of traffic on major road.

Photograph #39 (Reel #3, 7A) (from East, looking West): first rumble strip and warning sign in view.

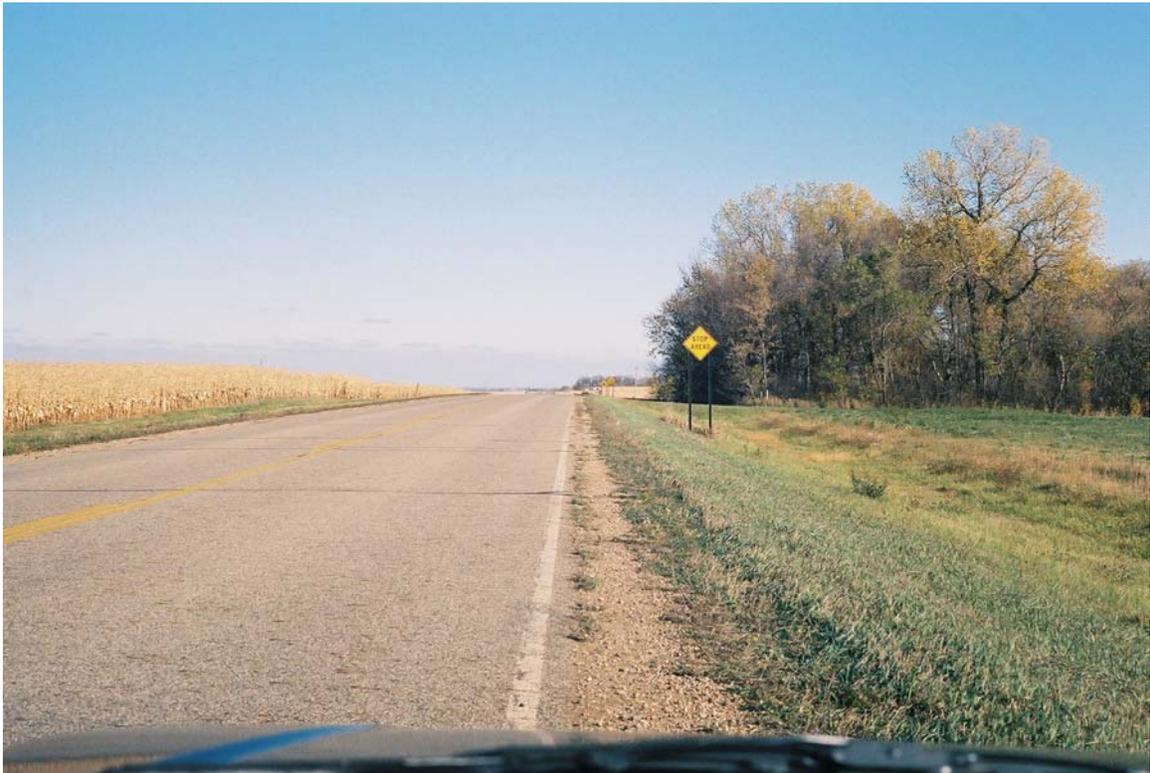
On West Side (looking East): to South—trees obscure traffic on major road; to North—
rise and corn obscure traffic on major road.

Photograph #41 (Reel #3, 9A) (from West, looking East): at approximate distance that
rumble strip *would* be installed—warning sign in view.

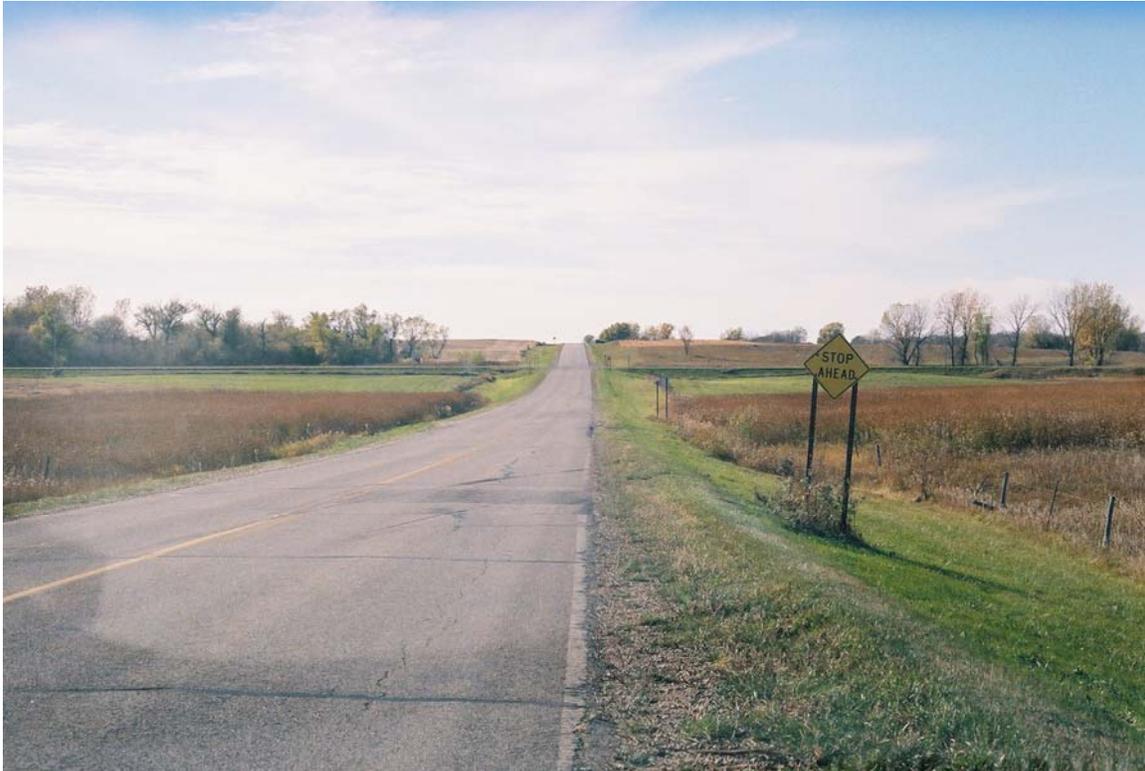
On East Side (looking West): on both sides—clear view of traffic on major road.

Photograph #43 (Reel #3, 11A) (from East, looking West): first rumble strip and warning sign in view. [Note: rumble strip and warning sign at about same distance from intersection.]

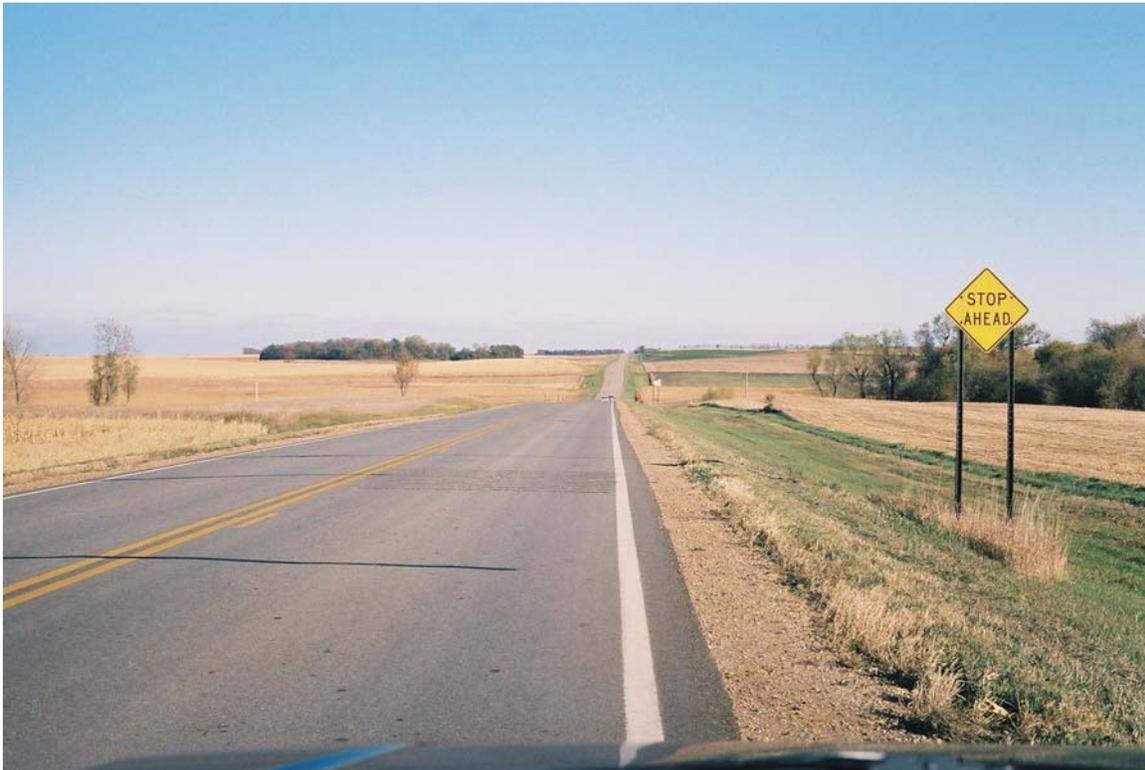
On West Side (looking East): to South—rise and trees obscure traffic on major road; to North—rise and trees obscure traffic on major road.

Photograph #45 (Reel #3, 13A) (from West, looking East): first rumble strip and warning sign in view. [Note: rumble strip and warning sign at about same distance from intersection.]

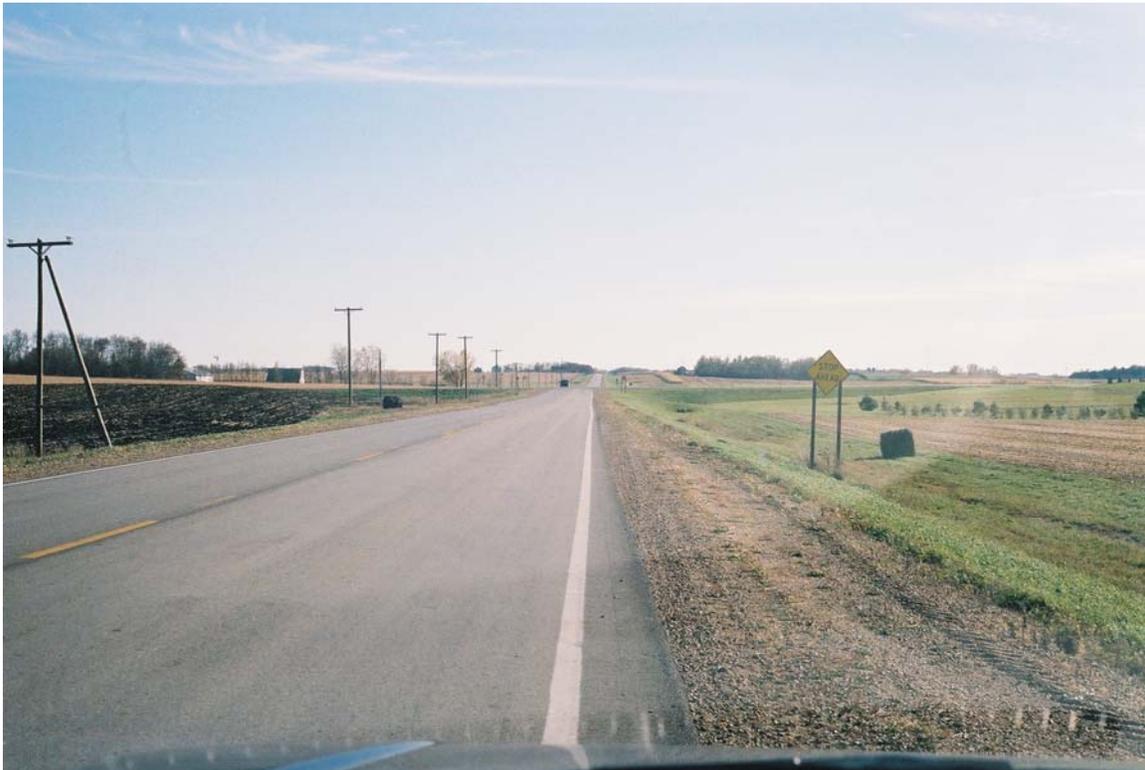
On North Side (looking South): to West—clear view of traffic on major road; to East—
view of traffic on major road slightly obscured.

Photograph #47 (Reel #3, 15A) (from North, looking South): at approximate distance that first rumble strip *would* be installed—warning sign in view.

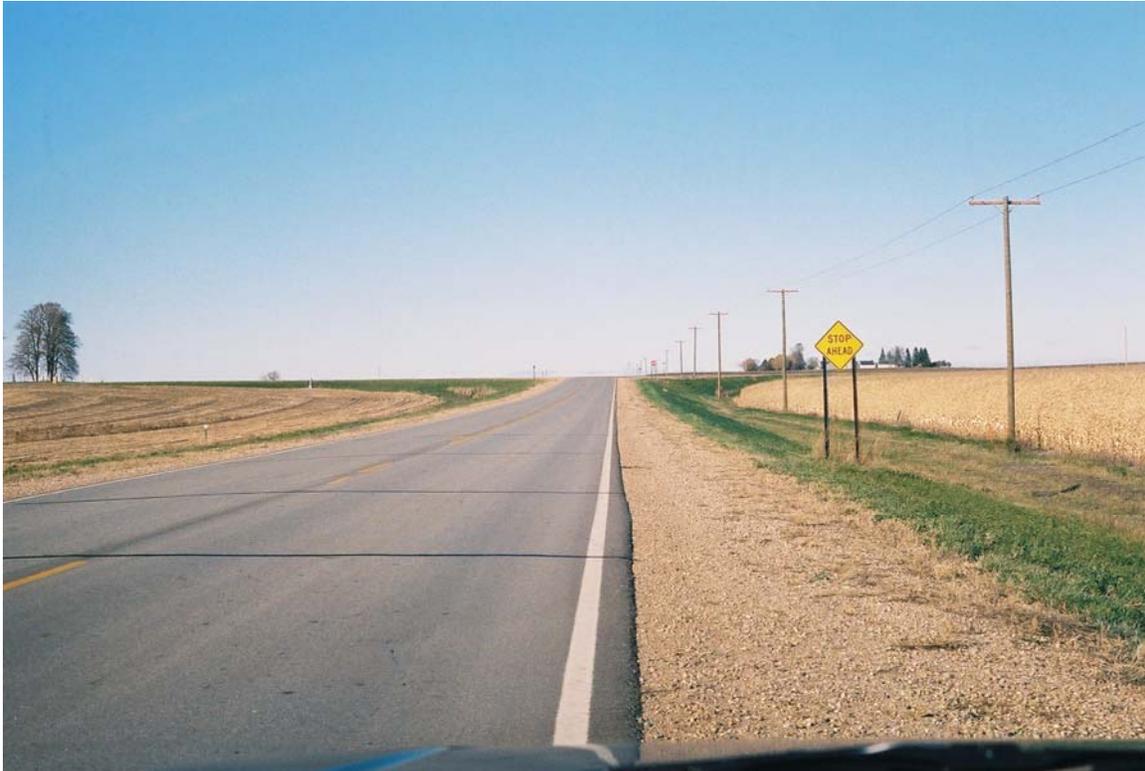
On South Side (looking North): on both sides—clear view of traffic on major road.

Photograph #48 (Reel #3, 16A) (from South, looking North): at approximate distance that first rumble strip *would* be installed—warning sign in view.

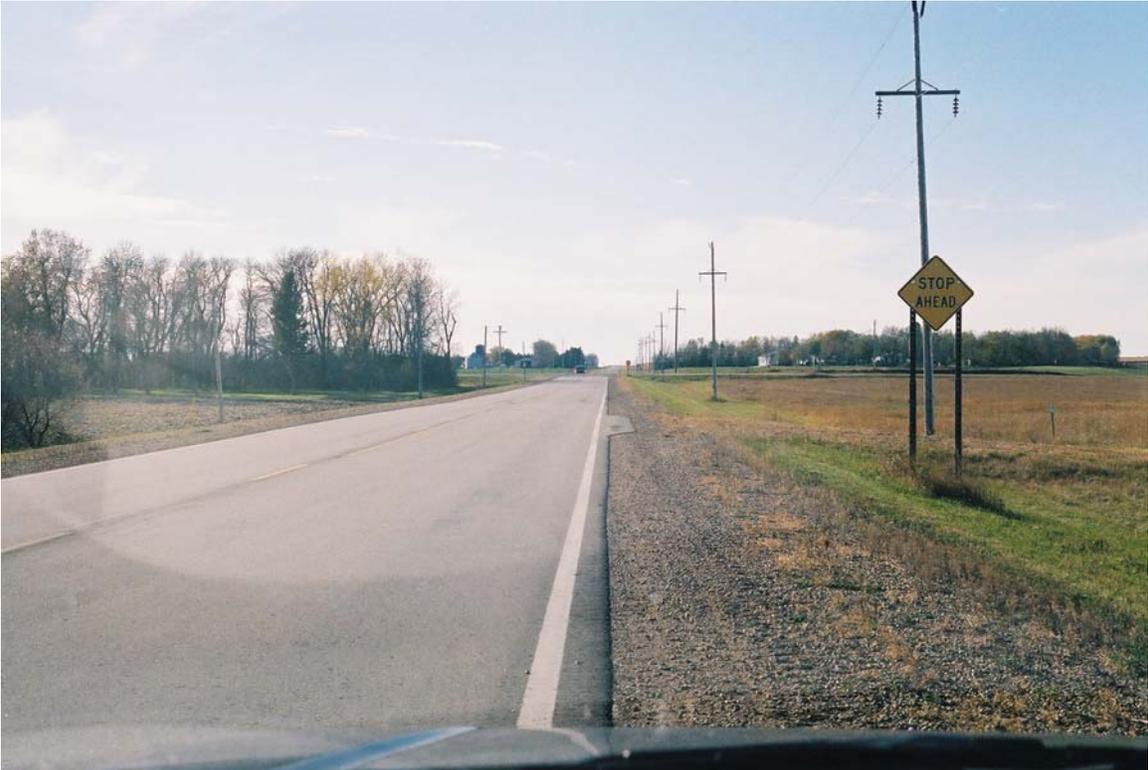
On East Side (looking West): to North—clear view of traffic on major road; to South—
trees obscure traffic on major road.

Photograph #49 (Reel #3, 17A) (from East, looking West): at approximate distance that first rumble strip *would* be installed—warning sign in view.

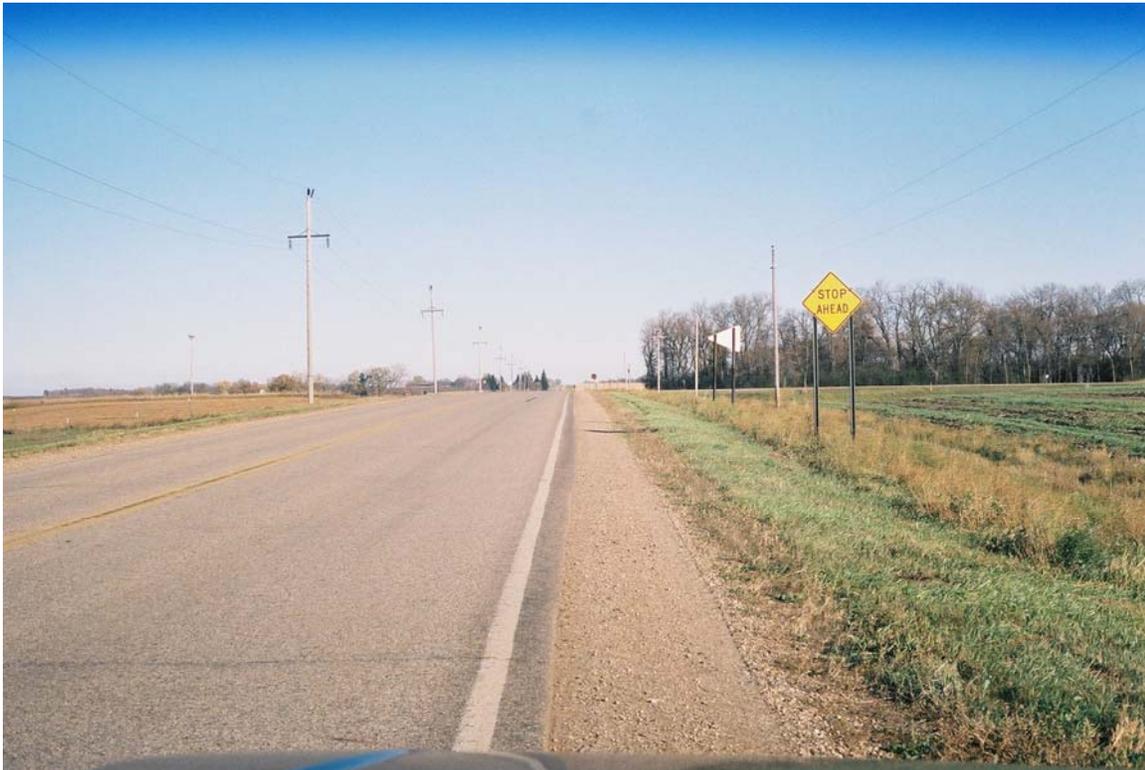
On West Side (looking East): on both sides—clear view of traffic on major road (road runs in front of trees to South).

Photograph #50 (Reel #3, 18A) (from East, looking West): at approximate distance that first rumble strip *would* be installed—warning sign in view.

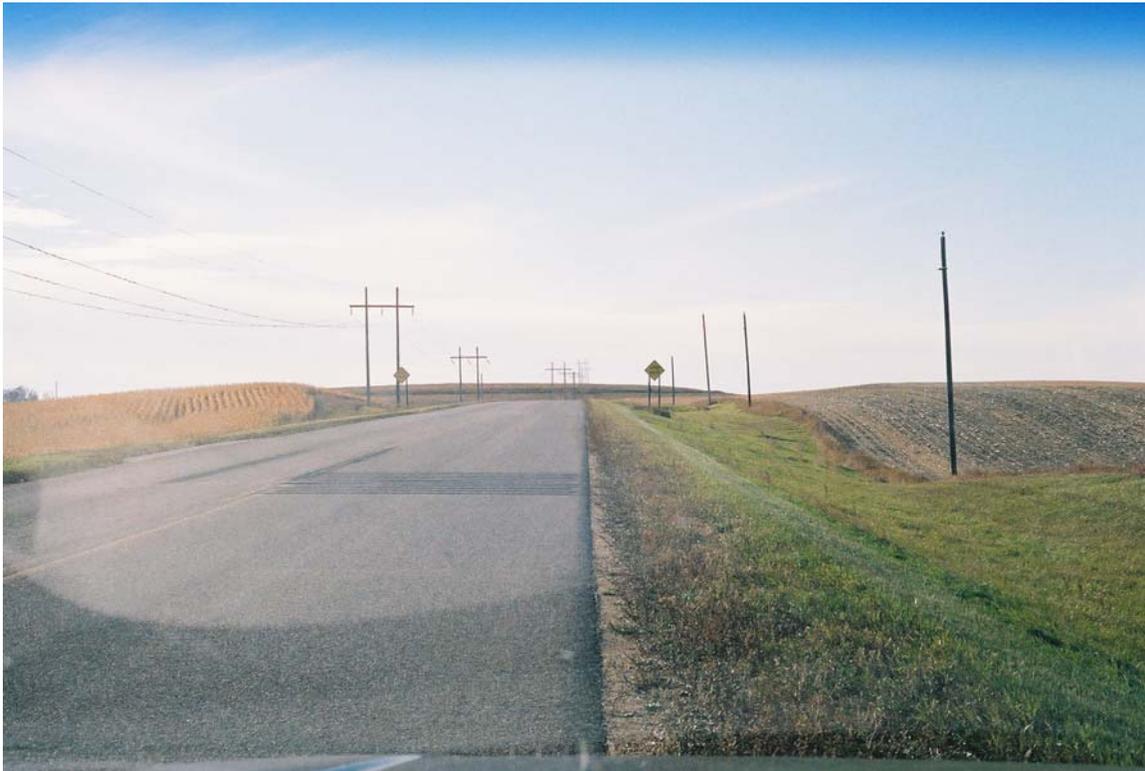
On East Side (looking West): intersection and view of traffic on major road on both sides obscured by vertical curve.

Photograph #51 (Reel #3, 19A) (from East, looking West): first rumble strip and warning sign in view.

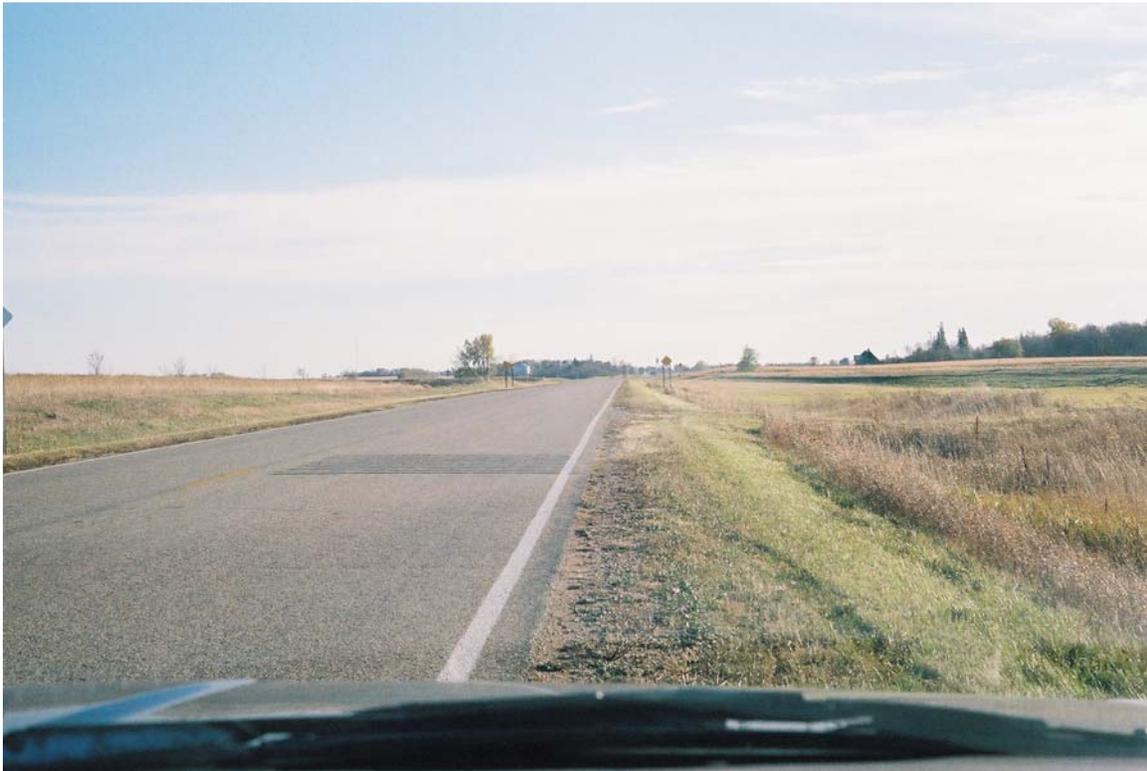
On North Side (looking South): minor road curves to West at intersection; the curve and the intersection are obscured; on both sides—traffic on the major road is obscured.

Photograph #53 (Reel #3, 21A) (from North, looking South): first rumble strip and warning sign in view.

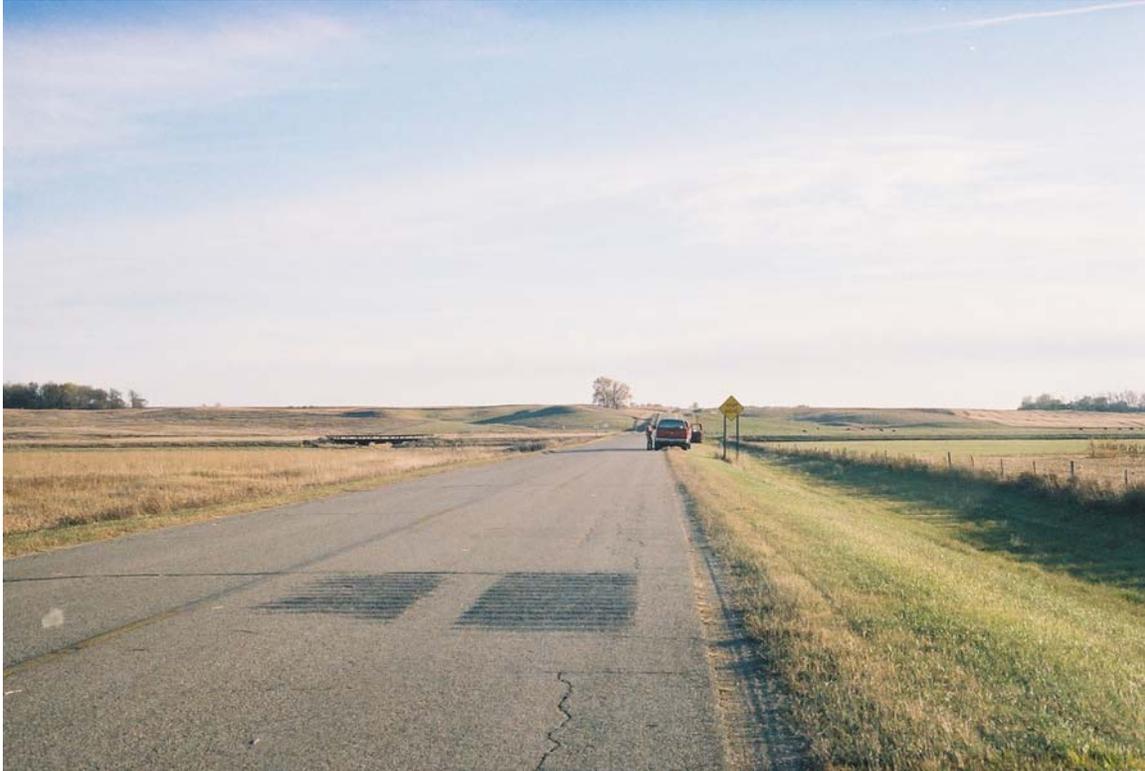
On North Side (looking South): on both sides—clear view of traffic on major road.

Photograph #56 (Reel #3, 24A) (from North, looking South): first rumble strip and warning sign in view.

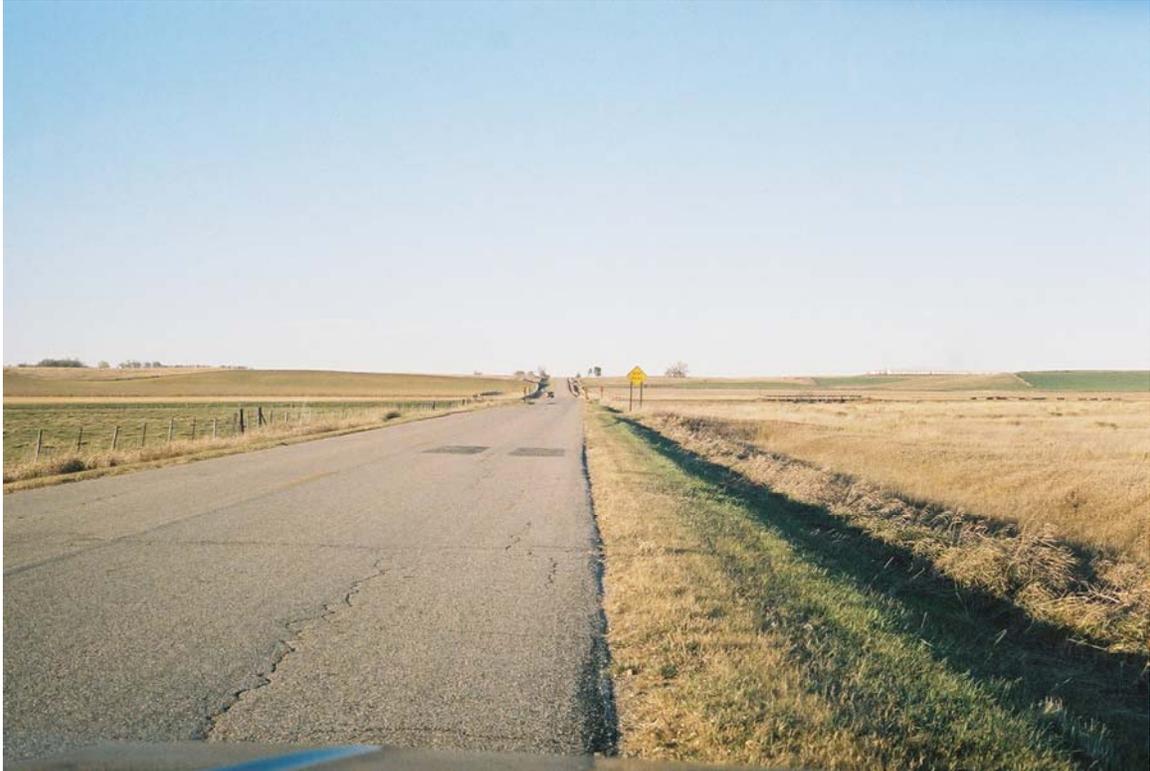
On South Side (looking North): on both sides—clear view of traffic on major road.

Photograph #57 (Reel #4, 1A) (from South, looking North): first rumble strip and warning sign in view.

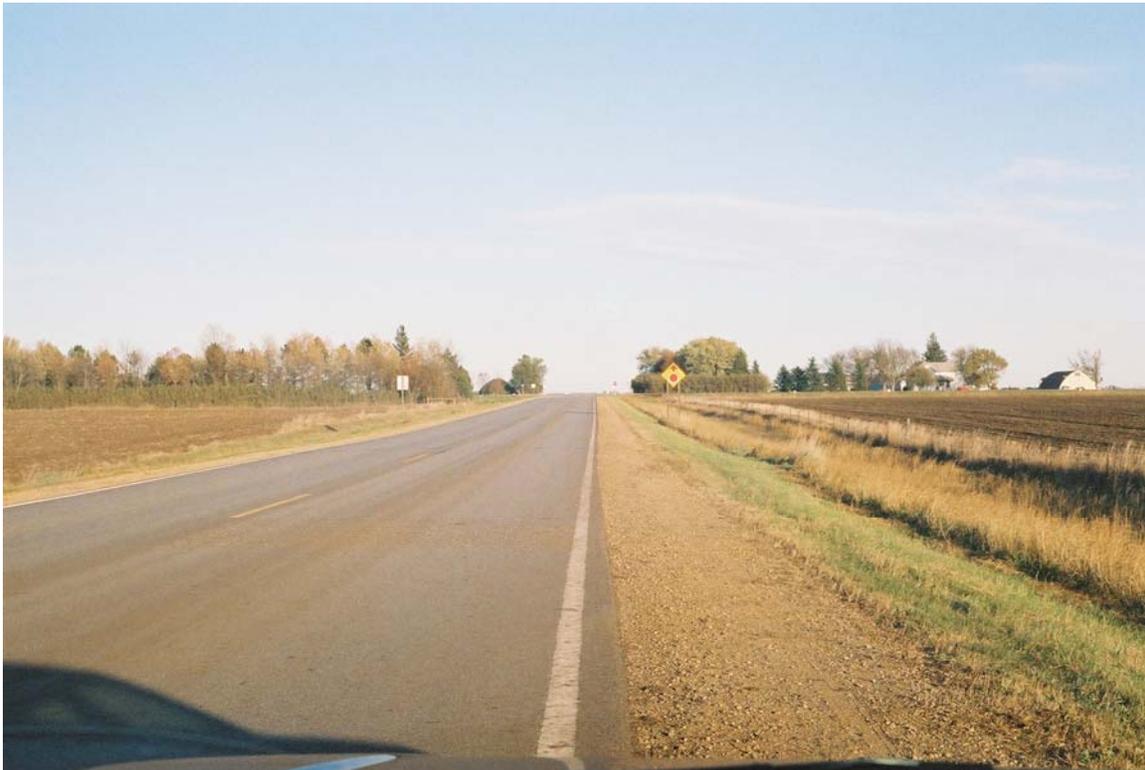
On West Side (looking East): to North—trees obscure view of traffic on major road; to South—clear view of traffic (it travels in front of trees and buildings).

Photograph #59 (Reel #4, 3A) (from West, looking East): first rumble strip in view (in near foreground, but difficult to see because of low angle of the sun)—warning sign also in view.
